**Report No. UT-25.16**

# **IDENTIFYING SAFETY HOT SPOTS IN CLOSE PROXIMITY TO K-12 SCHOOLS**

Utah Department of Transportation  
Research & Innovation Division

**Final Report  
November 2025**

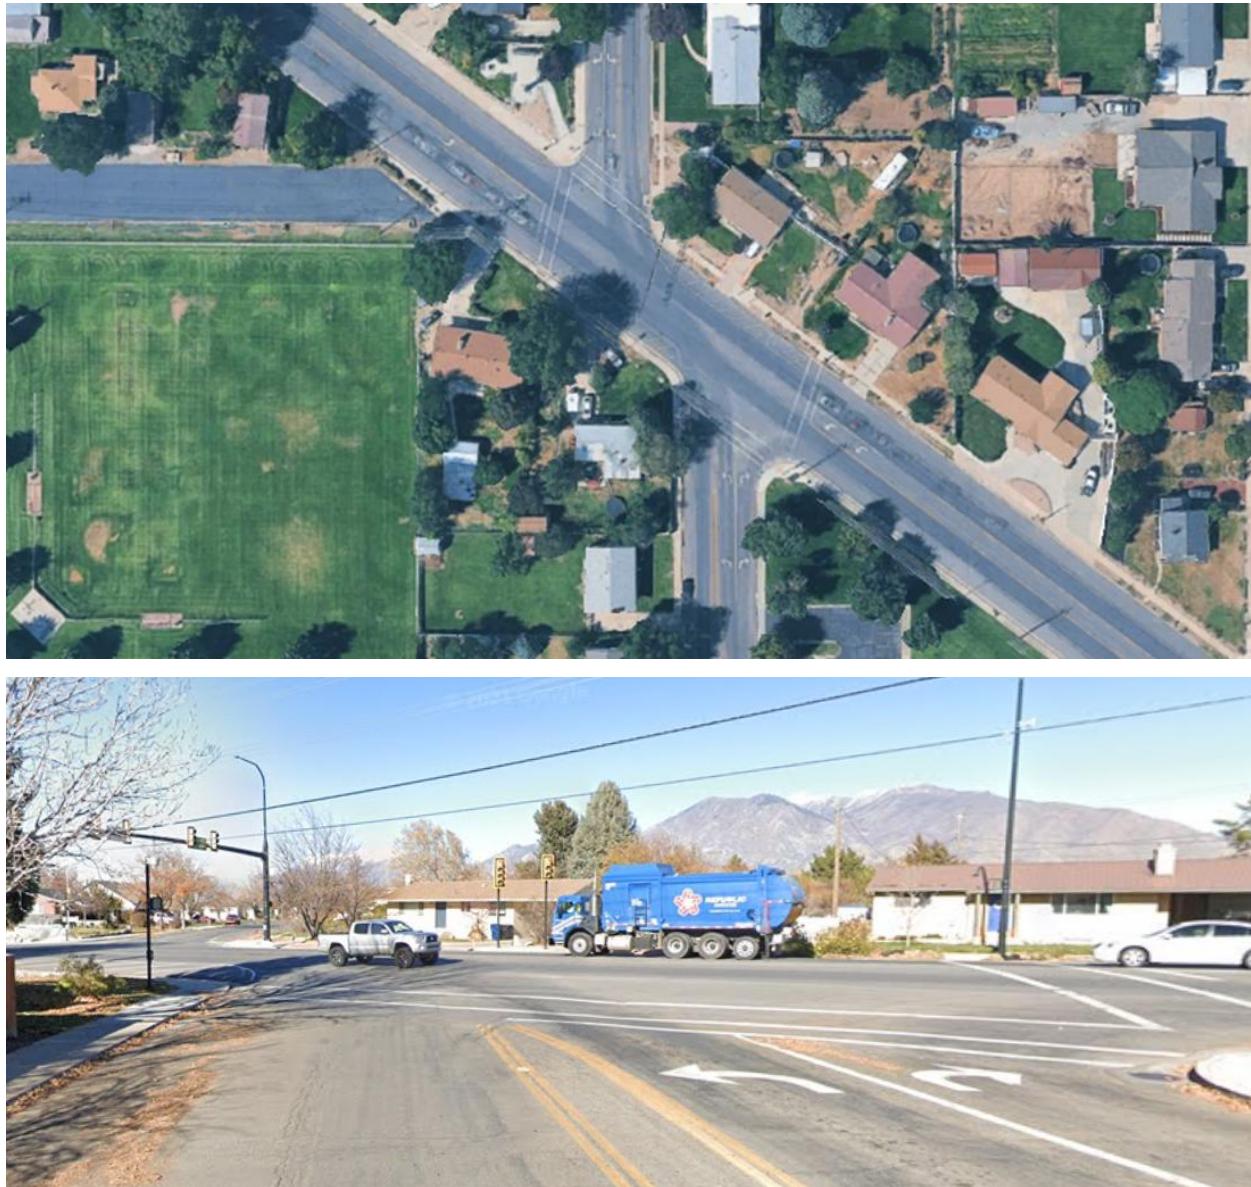
**Figure 5.18 Canyon Road and 800 East**

As shown in Figure 5.18, the intersection of Canyon Road and 800 East (to the north) / 820 East (to the south) is a skewed intersection which leads to visibility issues for turning vehicles. It also includes an offset for the northbound and southbound approaches, which can be hazardous. This intersection could be realigned and have vehicle movements restricted to help improve safety. If movements are restricted, alternative routes may need to be identified. However, 800 East has a very low traffic volume and could be restricted, turning the current

layout into a three-leg intersection with Canyon Road and 820 East. Issues and recommended countermeasures for this site are listed in Table 5.18.

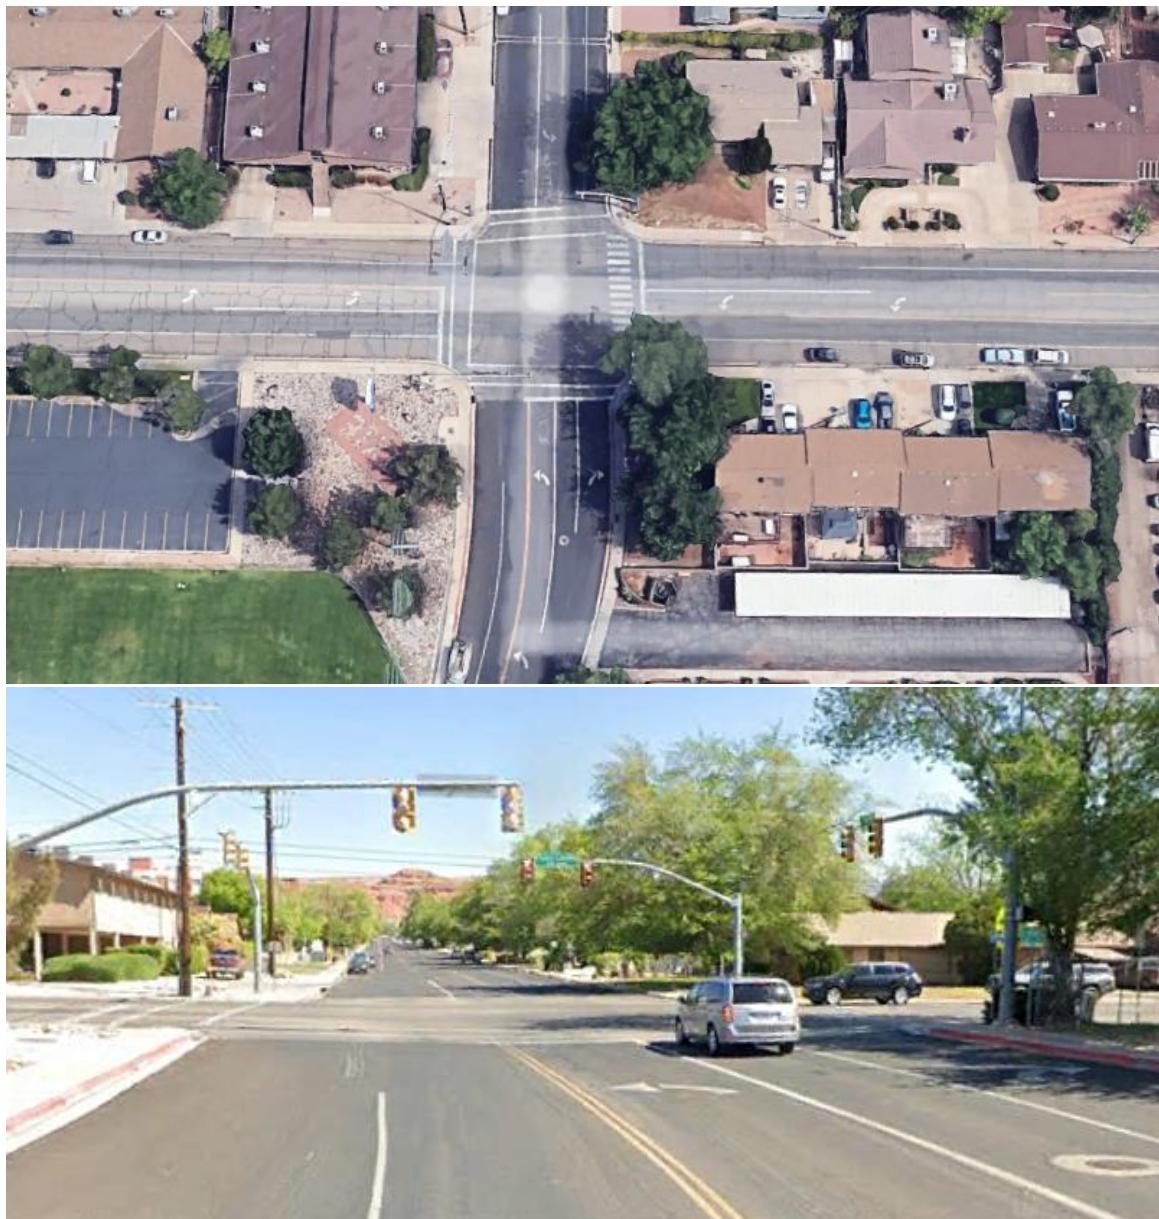
**Figure 5.19 700 South and 400 East**

As seen in Figure 5.20, north and southbound 400 East both feature one through lane in each direction, and a dedicated permissive left-turn lane. Northbound 400 East also features a right-turn lane. The east and westbound directions feature one through lane and one permissive dedicated left-turn lane. The roadway has a wide shoulder. Signage identifies “no on-street parking” along 700 South, however, many of the signs are obscured by the park strip trees. There is a school crosswalk on the east intersection approach, which may not be an appropriate location, given that there is not a connecting crosswalk on the south approach to access the school. Overall, the roadway environment does not provide an indication that drivers should be aware of the presence of a school or the potential for a large number of pedestrians. Issues and recommended countermeasures for this site are listed in Table 5.19.

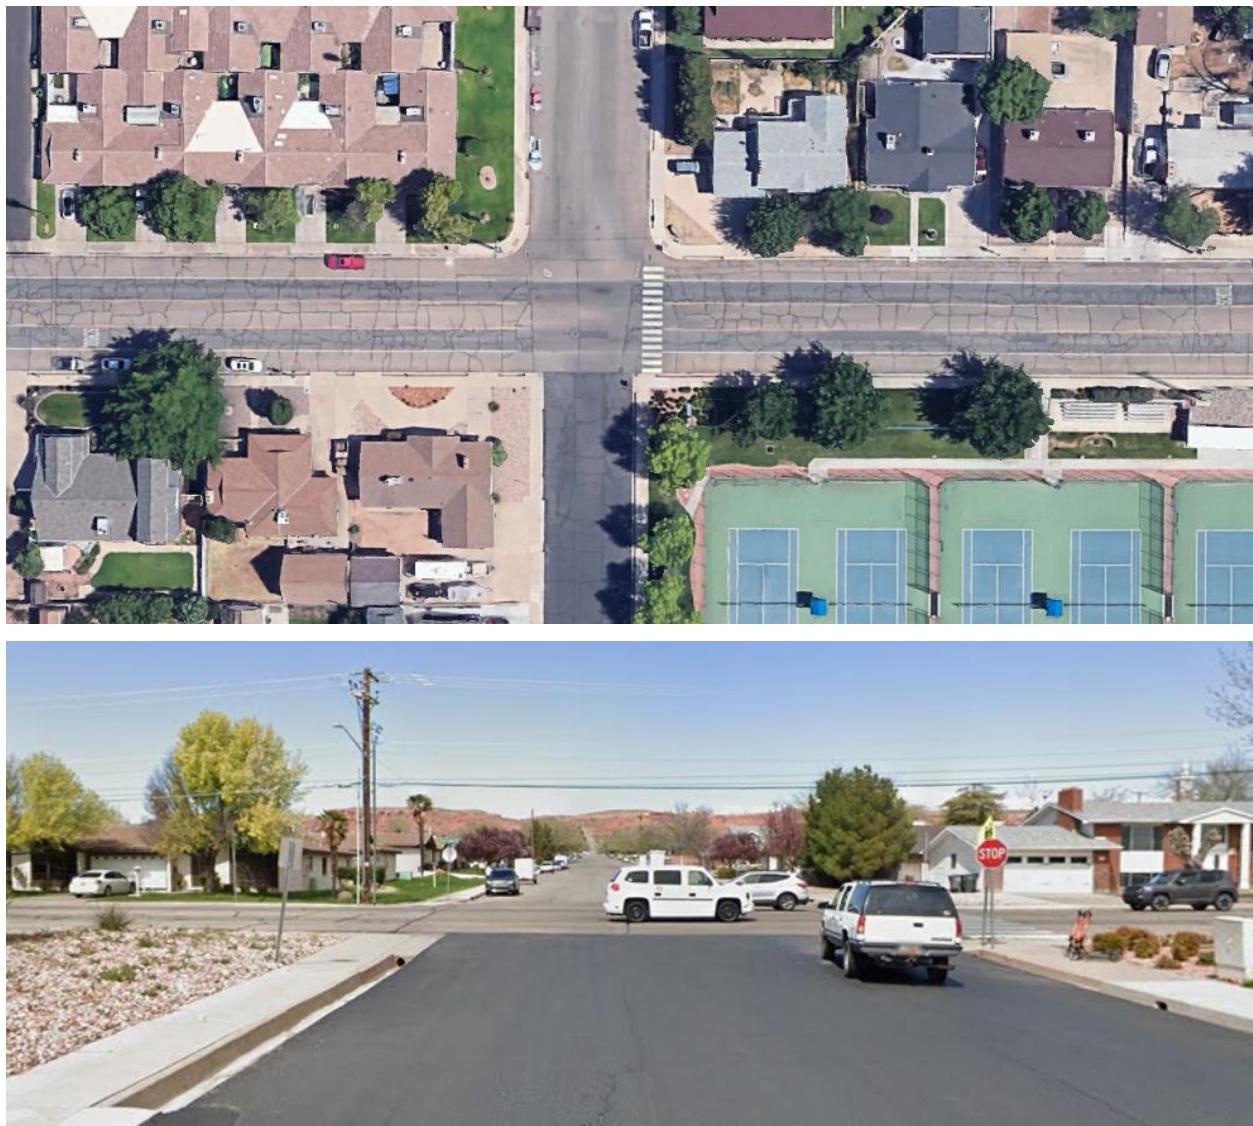
**Figure 5.20 700 South and 100 East**

At 700 South and 100 East, as seen in Figure 5.21, north and southbound travel is controlled with stop signs, while east/west traffic is free flow. There is a school crosswalk on the east approach. However, there is no signage or signalization to stop traffic, just a school crossing sign with an arrow to the crosswalk. The roadway on the northbound approach is about 45 feet wide, while the southbound approach is 60 feet wide. There are no environmental indicators to indicate that this is a school zone, and 700 South has a moderate AADT of 18 – 21,000 which can make crossing for students very difficult. Some form of traffic control, such as a rectangular rapid flashing beacon (RRFB) may be necessary on 700 South to improve the pedestrian experience. Issues and recommended countermeasures for this site are listed in Table 5.20.

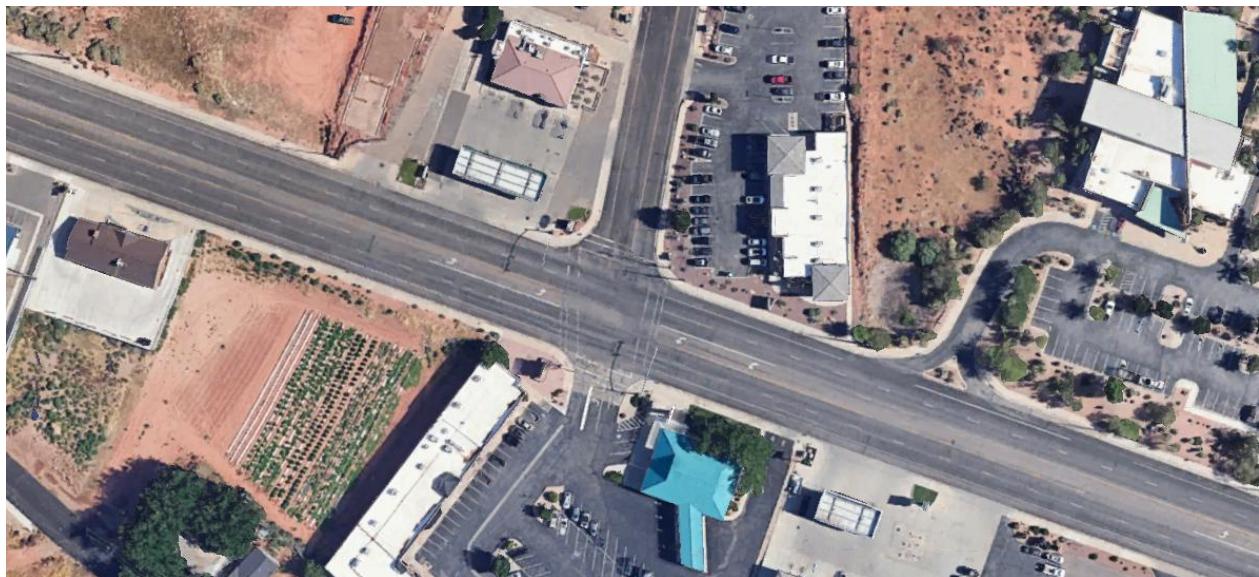
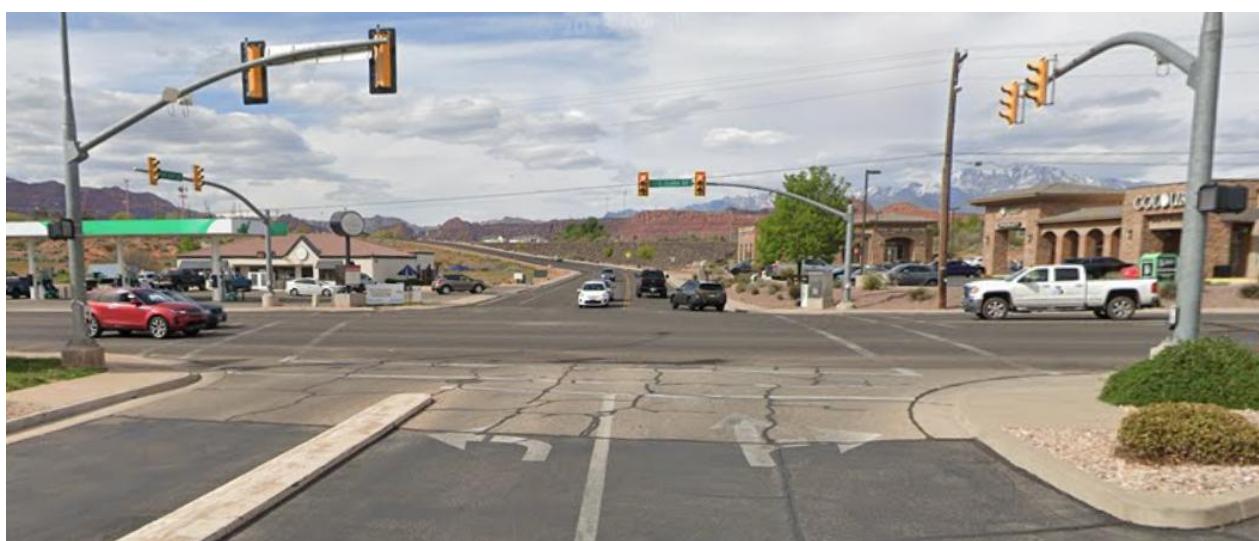
**Figure 5.21 Santa Clara Drive and Canyon View Drive**

As seen in Figure 5.22, Canyon View Drive provides secondary access to Snow Canyon Middle School by way of a pedestrian/bicycle access path about 900 feet north of this intersection. This access encourages the broader use of this route for pedestrian and bicycle travel. Also, Canyon View Park is on the east side of Canyon View Drive about 1/3 mile north of the intersection and 900 feet from the access path. The park has baseball and softball fields, pickleball and tennis courts, sand volleyball, and a BMX track, which serve as community amenities and destinations for non-motorized travel. The intersection is unique, as the southbound approach enters from the parking lot of a strip mall. Land use for all four corners is commercial, including a bank, gas station, and other general commercial properties. The student crash at this intersection involved a cyclist crossing the east leg in a marked crosswalk (northbound) being hit by a permissive left-turning vehicle. The ramp-to-ramp crossing distance for this leg is 100 feet, compared to the roadway width of 80 feet (curb-to-curb). Issues and recommended countermeasures for this site are listed in Table 5.21.

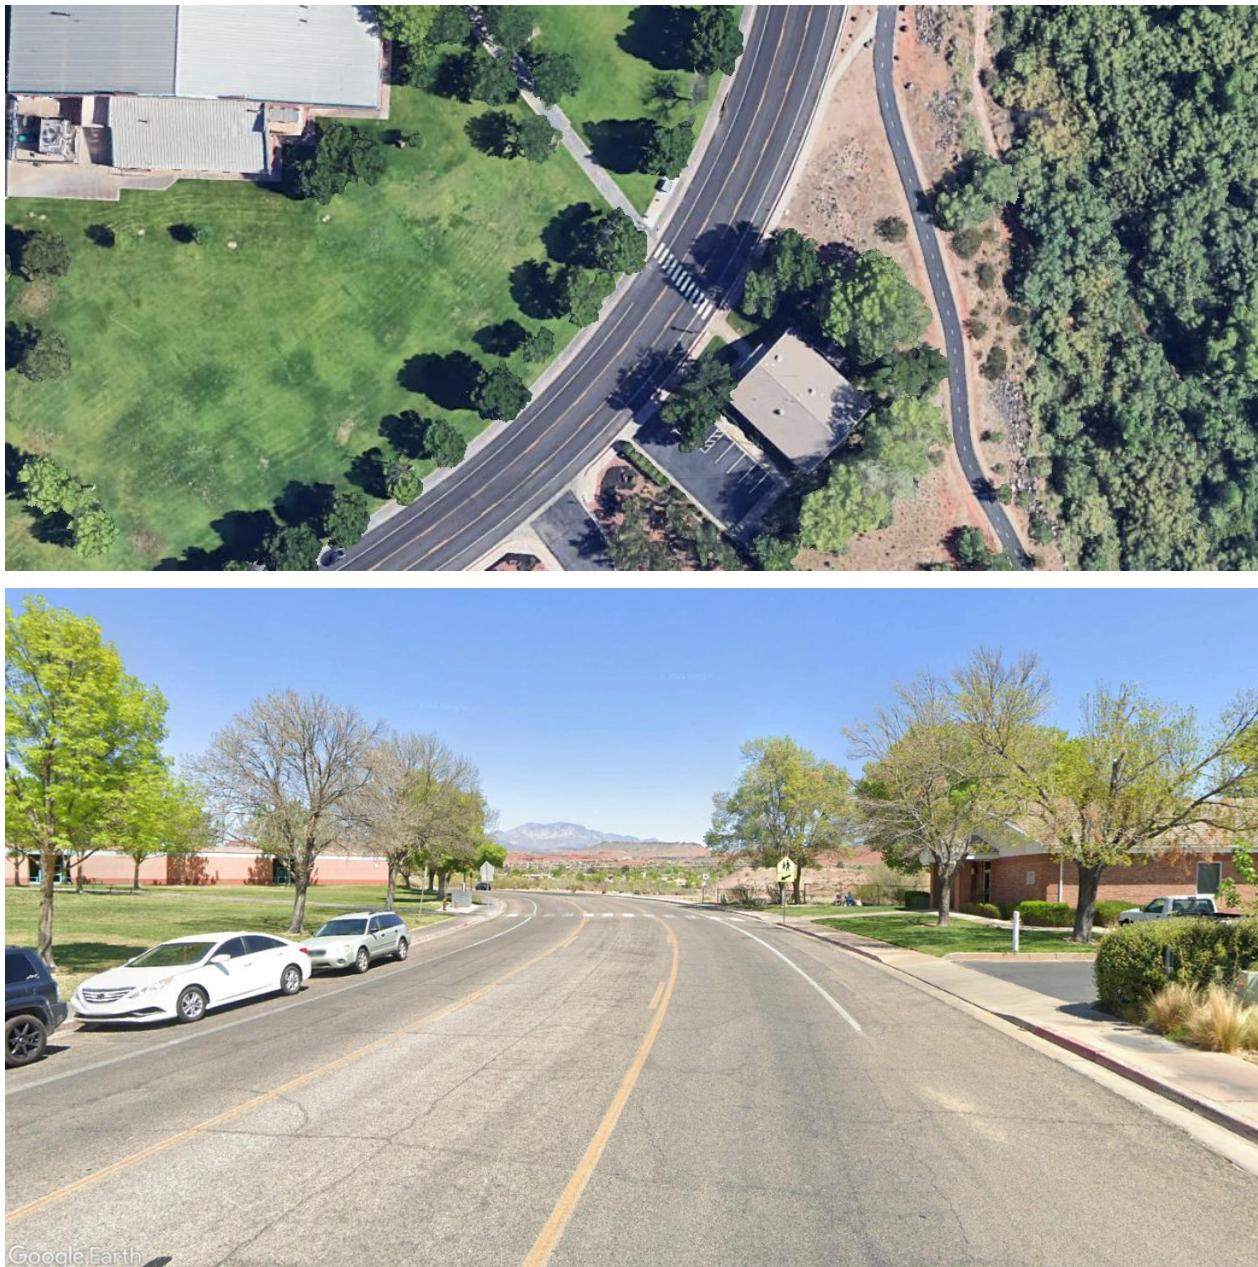
**Figure 5.22 Lava Flow Drive North of Sunset Boulevard**

being hit by a vehicle traveling northbound. The ramp-to-ramp crossing distance for this leg is 70 feet, compared to the roadway width of 50 feet (curb-to-curb). Issues and recommended countermeasures for this site are listed in Table 5.22.

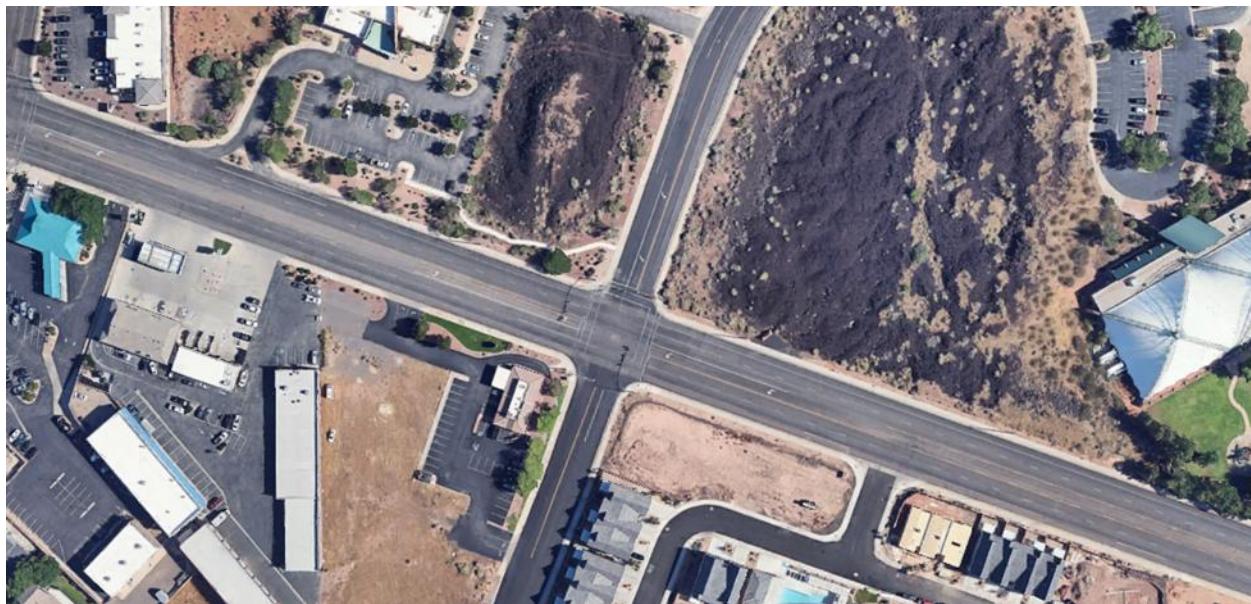
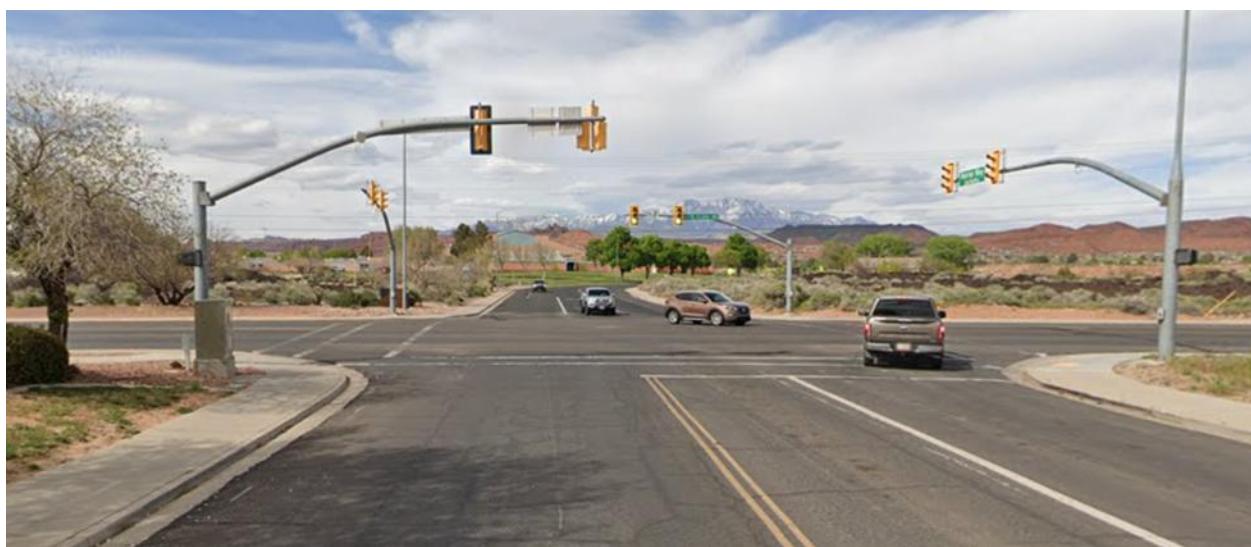
**Figure 5.23 Sunset Boulevard/Santa Clara Drive and Lava Flow Drive**

Lava Flow Drive (2400 West) provides vehicle and non-motorist access to both Snow Canyon High School and Snow Canyon Middle School. As seen in Figure 5.24, the north corners are both vacant parcels, while the southwest parcel features a restaurant and the southeast parcel consists of residential townhomes. The student crash at this intersection involved a cyclist crossing in a marked crosswalk being hit by a permissive left-turning vehicle. The ramp-to-ramp crossing distance for this leg is 95 feet, compared to the roadway width of 75 feet (curb-to-curb). Issues and recommended countermeasures for this site are listed in Table 5.23.

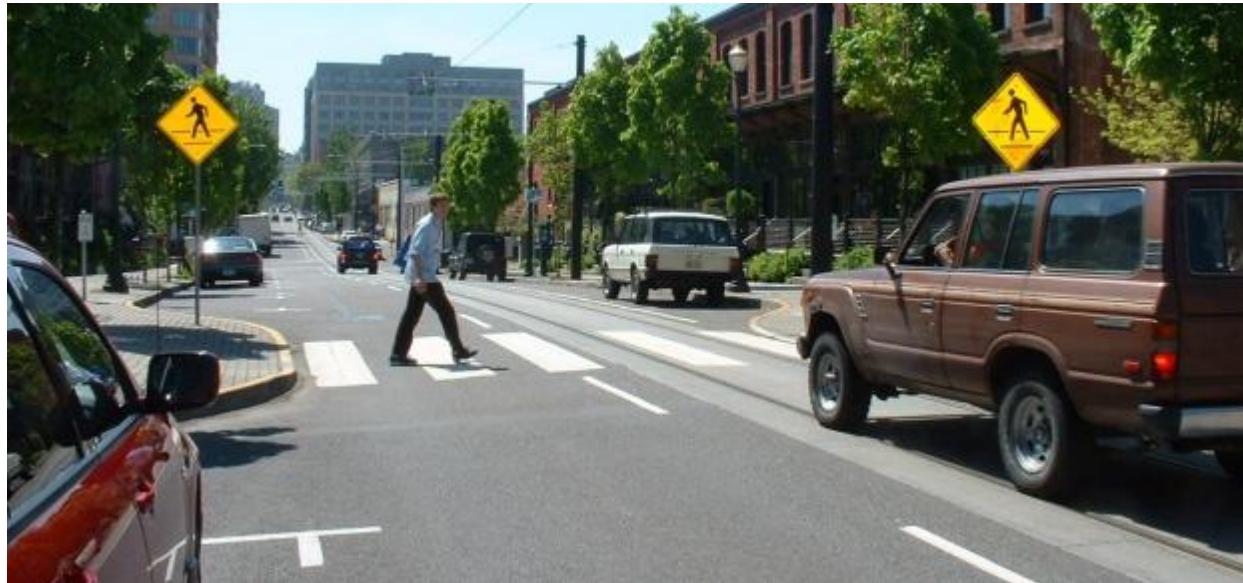
**Figure 6.1 Midblock Curb Extension (also known as pinch point or choker)**

Curb extensions, also called bulb-outs, extend the sidewalk and reduce the width of the roadway. They include midblock curb extensions, known as pinch points or chokers (Figure 6.1); intersection curb extensions (Figure 6.2); and bus stop curb extensions, known as bus bulbs (Figure 6.3). Some curb extensions may include cut-throughs for bicyclists (Figure 6.4), and others may include truck aprons to allow heavy trucks to make wider turns (Figure 6.5).

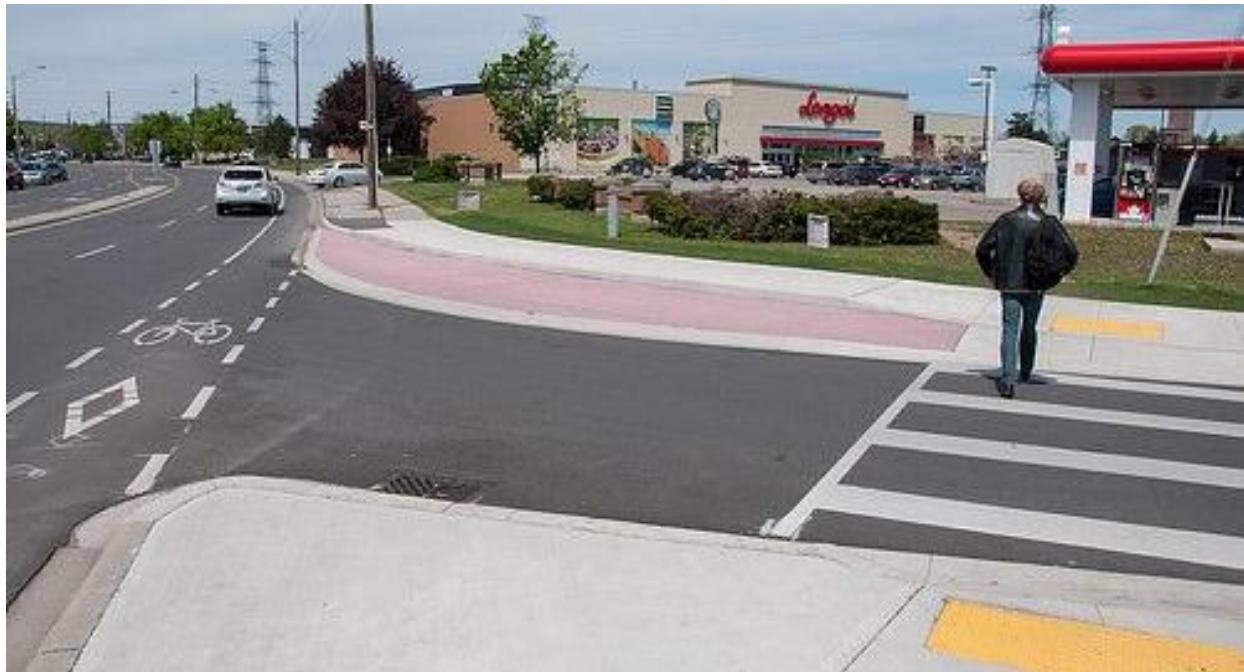
**Figure 6.7 Curb Extension with Truck Apron – Right-Turn Curve**

Due to frequent heavy vehicle use, it may not always be possible to install a traditional curb extension. In these cases, truck aprons combined with curb extensions allow trucks to mount the curb for wider turns if needed. These should be designed in a way that vehicles cannot comfortably mount the curb at high speeds to discourage most drivers from using the truck apron and to prevent dangerous turns at high speeds. Figure 6.7 shows an example of a truck apron for a right-turn curve.

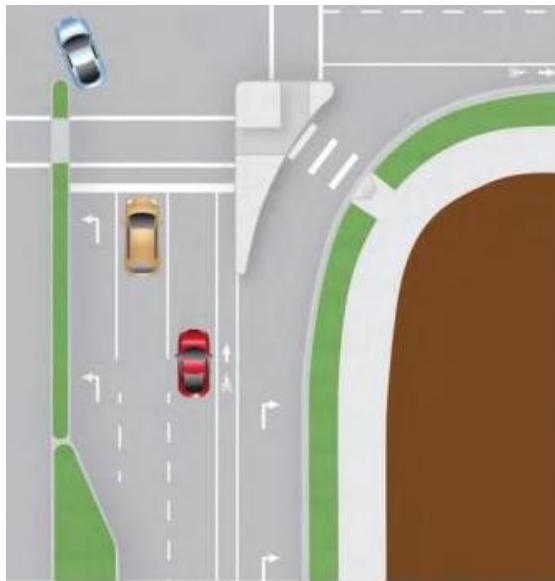
## Right-Turn Slip Lane - Details

Right-turn slip lanes may be implemented at intersections with a designated right-turn lane. They are often used to improve the turning radius for right-turning vehicles, but the inclusion of a pedestrian island makes them advantageous for pedestrians as well. As shown in Figure 6.9, this design allows right-turning vehicles to traverse the crosswalk before entering traffic, which simplifies driver workload and allows them to yield to pedestrians more effectively. The pedestrian island also shortens the crosswalk distance for pedestrians into two smaller crosswalks instead of one long crosswalk. Figure 6.10 and Figure 6.11 show examples of some right-turn slip lanes with various designs highlighting their flexibility and utility.

A good slip lane design for pedestrian safety should include a short radius which forces turning vehicles to slow down and pay attention to pedestrians. It should also include an amply-sized pedestrian island to make pedestrians feel comfortable, and a well-placed crosswalk to make sure turning drivers are focused on pedestrians and not merging with traffic. In Utah, the estimated cost to install a right-turn slip lane is \$100,000 to \$250,000.

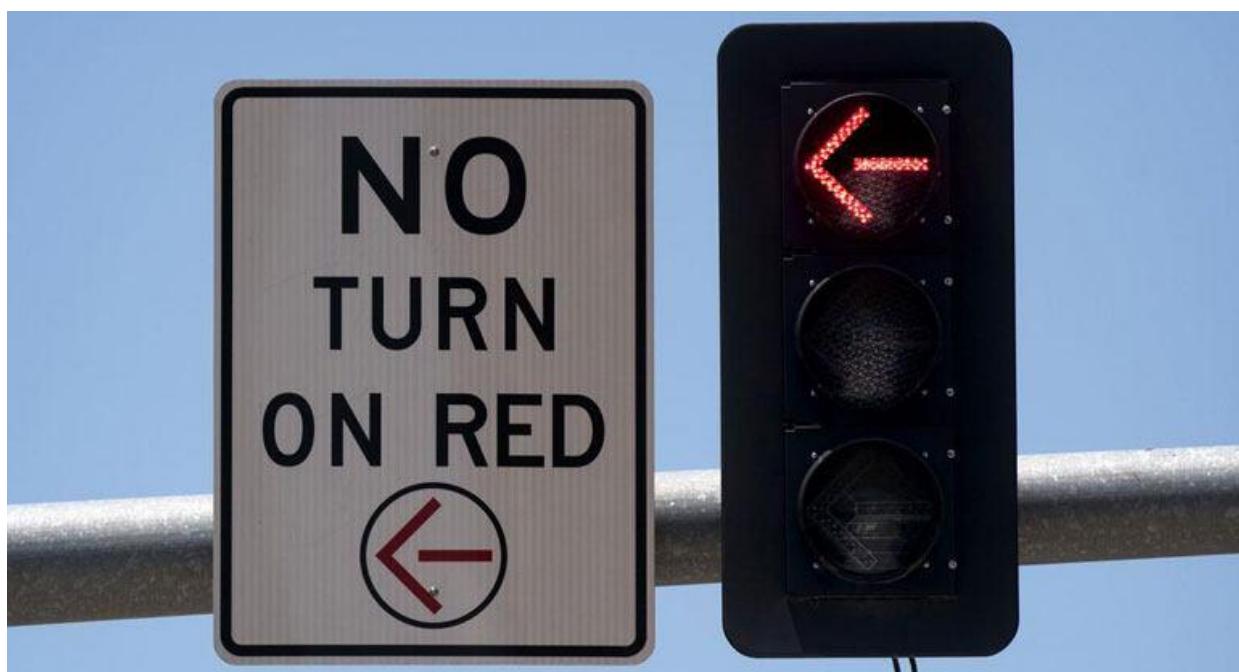
**Figure 6.12 Left-Turn Signal Head and Sign for Control Over Left-Turn Phasing**

Left turns at signalized intersections are often a source of conflicts, especially for unprotected or protected-permissive left-turn phasing. During an unprotected left turn, the turning vehicle must watch opposing traffic to find an acceptable gap in traffic. During this time, pedestrians in the crosswalk often go unnoticed, creating an opportunity for dangerous conflicts. Protected phasing ensures there will be no conflicting through traffic while the left-turning vehicle moves through the intersection, thereby allowing them to watch for pedestrians. It should also ensure that pedestrians will not be in the crosswalk (unless they are jaywalking) when vehicles are turning left. While protected left-turn phasing is often implemented to improve the operation at a signalized intersection with high left-turning volume, it can be worthwhile to implement for safety reasons even if there are few operational benefits or it degrades traffic operations. The cost to change left-turn phasing to protected phasing is negligible if the hardware already exists but may cost between \$12,000 to \$25,000 to install in Utah otherwise. Figure 6.12 shows an example of a left-turn signal head used for protected left-turn phasing.

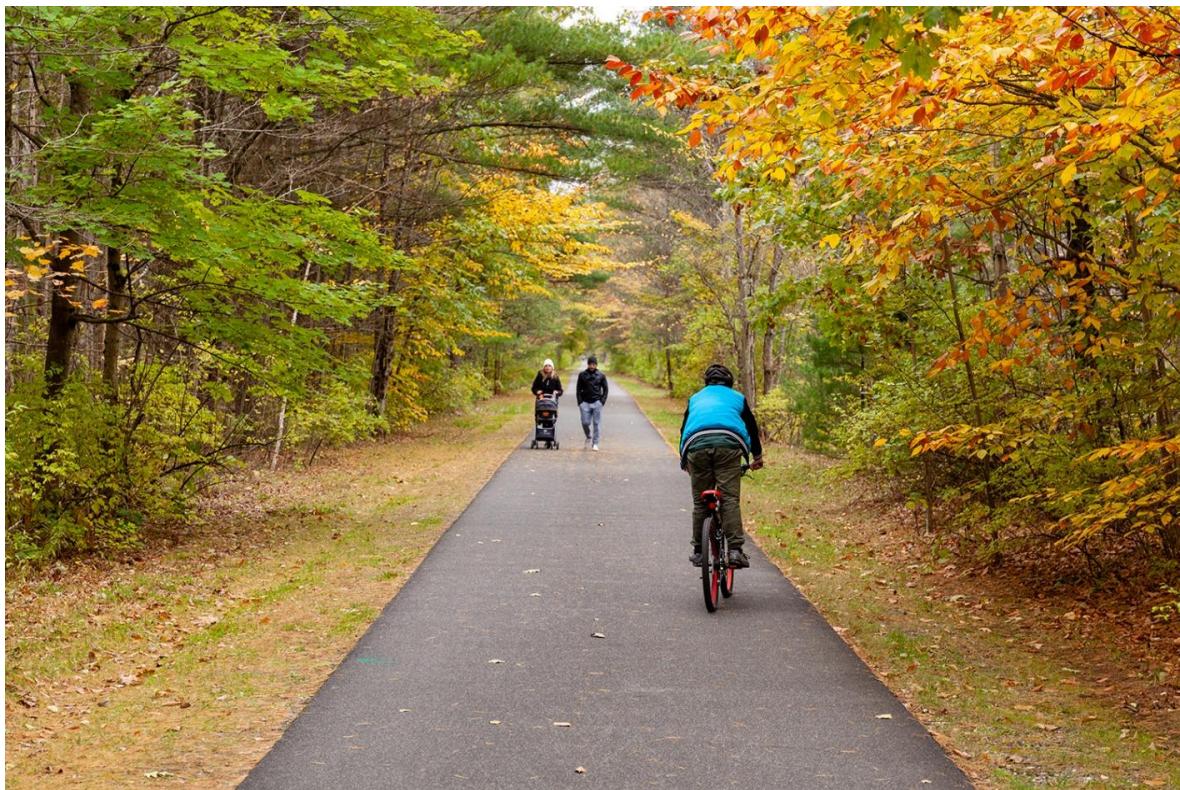
**Figure 6.13 Shared-Use Path Separated from Roadway**

Shared-use paths are beneficial to pedestrian safety since they separate pedestrians and cyclists from the roadway area and create a more comfortable walking environment. Some cities may regulate design standards for shared-use paths, but they are very flexible and simple to install otherwise. In Utah, their cost ranges from \$13 to \$28 per square foot. This cost does not include the cost of right-of-way acquisition, which will increase the total cost of the pathway.

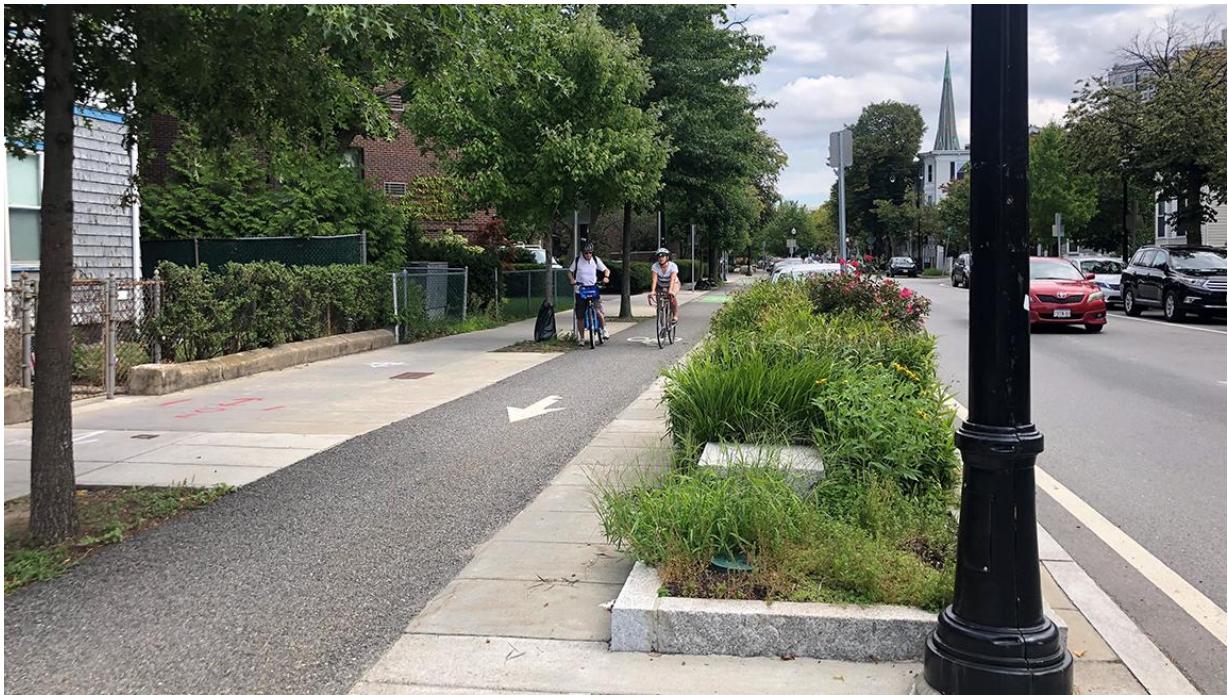
**Figure 6.14 Shared-Use Path Adjacent to Roadway**

A shared-use path is a trail or sidewalk used by pedestrians, cyclists, and other forms of active transportation which separates these vulnerable road users from vehicle traffic. Shared-use paths come in a wide variety of forms and may be completely separated from the roadway such as in Figure 6.13 or directly adjacent to the roadway such as in Figure 6.14. Figure 6.15 shows an example of a shared-use path along the Provo River Trail in Utah.

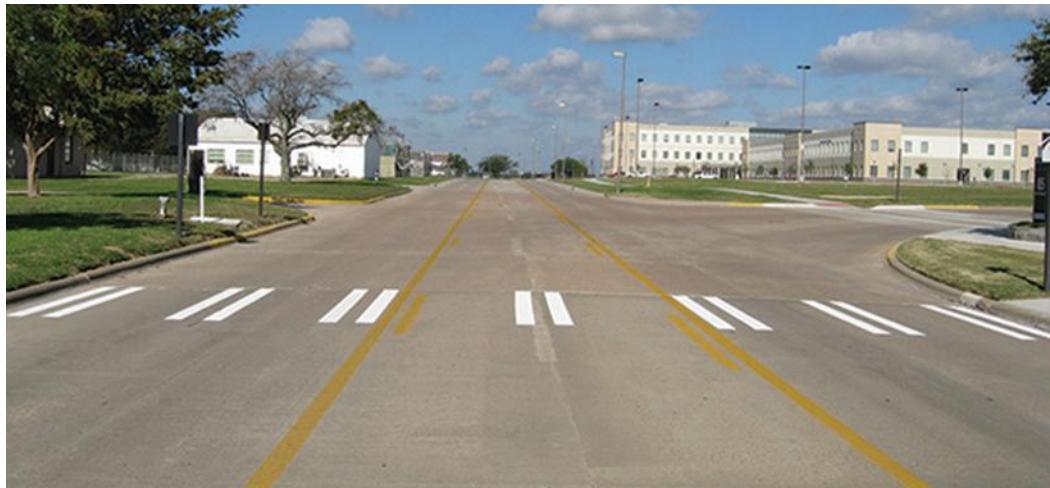
**Figure 6.16 High-Visibility Crosswalk (Bar Pair/Piano Key Design)**

High-visibility crosswalks (HVCs) use patterns which are more recognizable to drivers and pedestrians (i.e., bar pairs, continental, and ladder). See Figure 6.16 through Figure 6.18 for

examples of these crosswalk patterns and potential designs. HVCs should use inlays or thermoplastic tape instead of paint or brick to make them highly reflective. Lighting at HVCs is also vital and should illuminate pedestrians in a way that provides positive contrast, meaning light falls on pedestrians but not behind them allowing them to stand out to drivers. Signage and pavement markings telling drivers to “STOP” or “YIELD” to pedestrians along with a STOP or YIELD bar, also help improve the visibility of HVCs.

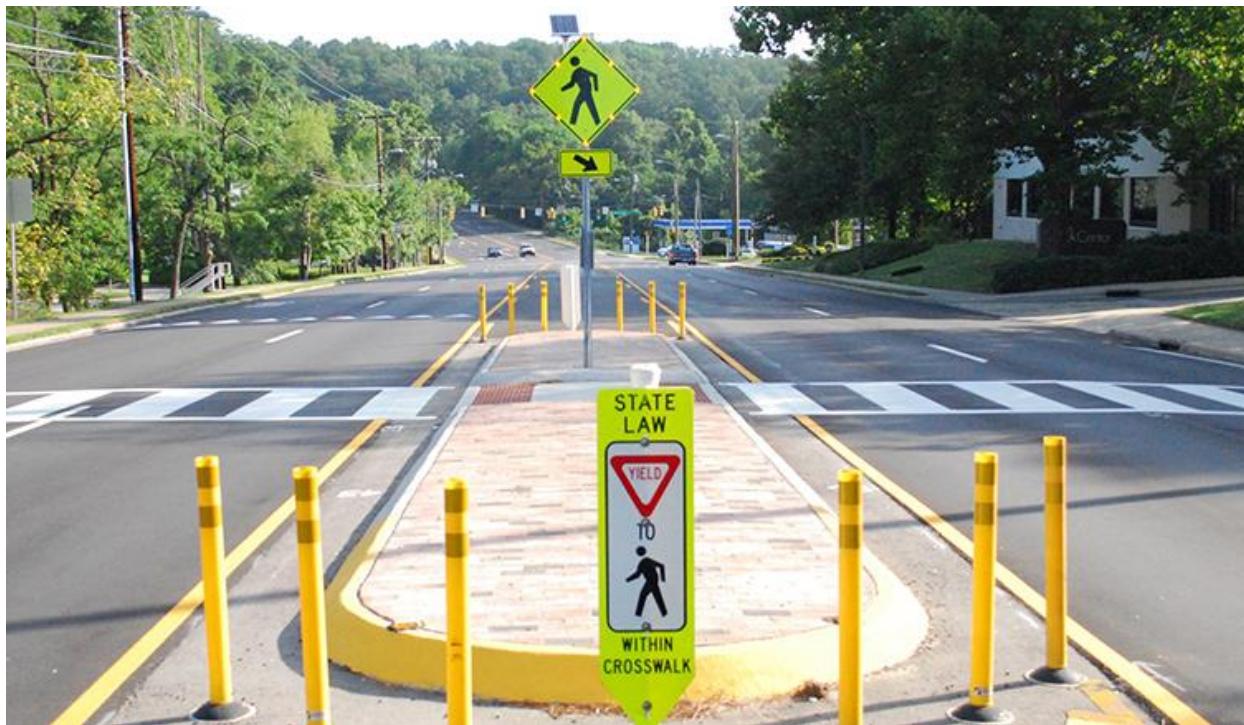
**Figure 6.19 HVC and Center Median Island Example 1**

In addition to HVCs, center pedestrian islands (also known as pedestrian refuge islands) enhance pedestrian experience and safety at crosswalks. Pedestrian islands are built in the middle of the roadway, giving pedestrians a place to wait if there is oncoming traffic and narrowing the roadway to encourage drivers to slow down at crosswalks. Examples of crosswalks with center pedestrian islands are shown in Figure 6.19 through Figure 6.21. An HVC with a center pedestrian island is estimated to cost \$13,000 to \$20,000 to install in Utah.

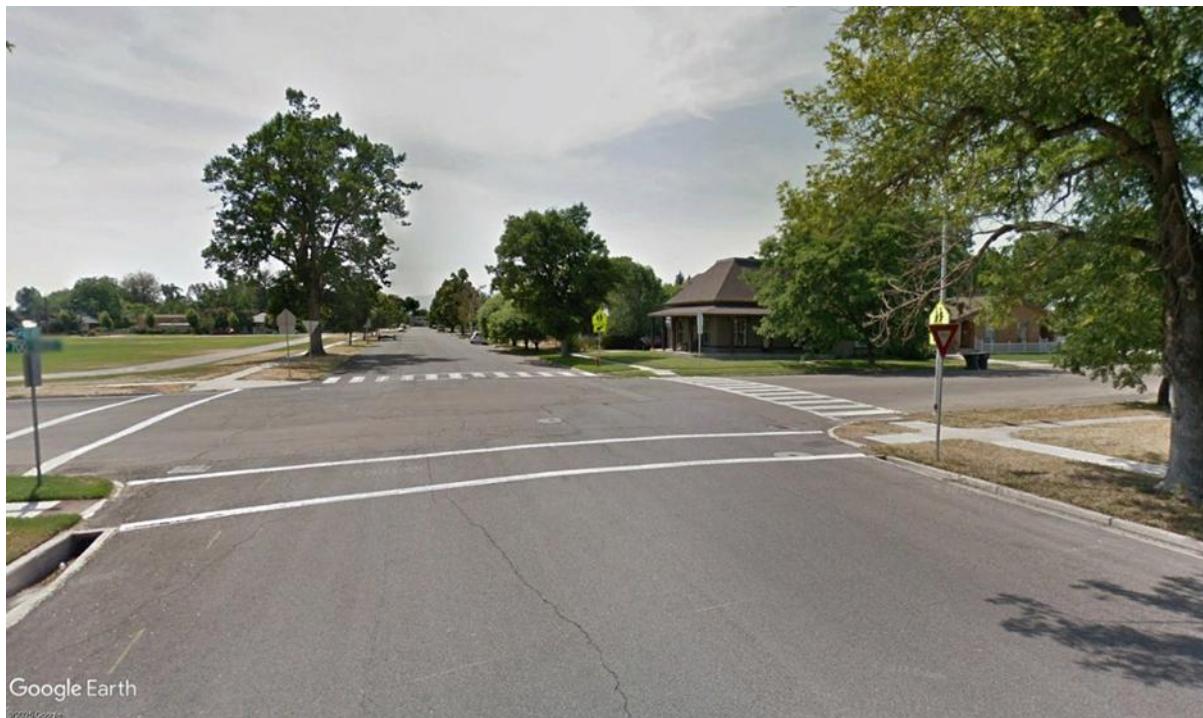
**Figure 6.22 School Crosswalks at Yield-Controlled 4-Way Intersection**

Some crosswalks are specifically designed for paths to school as part of UDOT's SRTS program. Under this program, schools outline safe paths for students to take on the way to school. If these paths include a crosswalk, that crosswalk should be designed as a school crossing according to MUTCD Chapter 7. School crosswalks should be designed as HVCs and should include specific signage and pavement markings. Figure 6.22 through Figure 6.24 show examples of school crosswalks. The cost to upgrade an existing crosswalk to a school crosswalk in Utah, excluding a center pedestrian island, is estimated as \$750 to \$2,000.

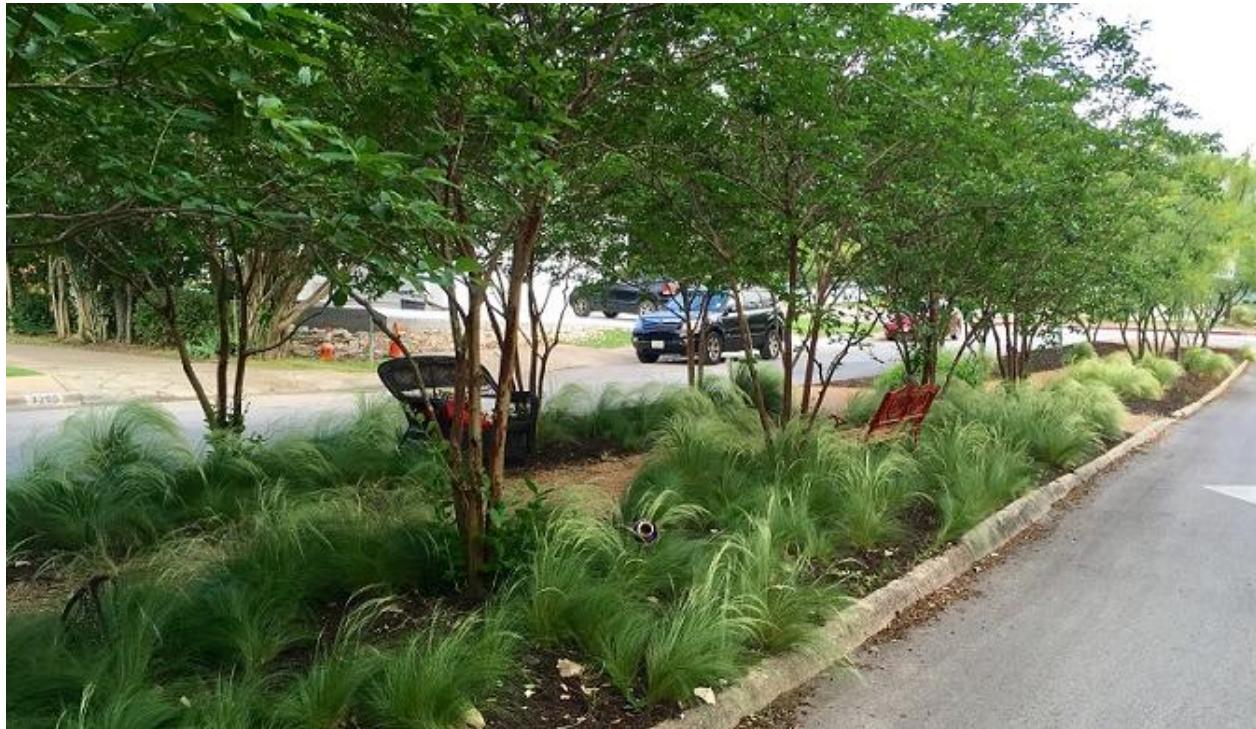
**Figure 6.25 Landscaped Median Barrier with Pedestrian Walkway and Benches**

A large portion of vehicle-to-pedestrian crashes near schools observed in this study involved a vehicle turning from a driveway onto a busier road which distracted them from an approaching pedestrian. Thus, median barriers may be an effective way to improve pedestrian safety near schools in Utah. Figure 6.25 through Figure 6.27 show examples of landscaped median barriers. While landscaping costs can vary significantly, the cost to install a landscaped

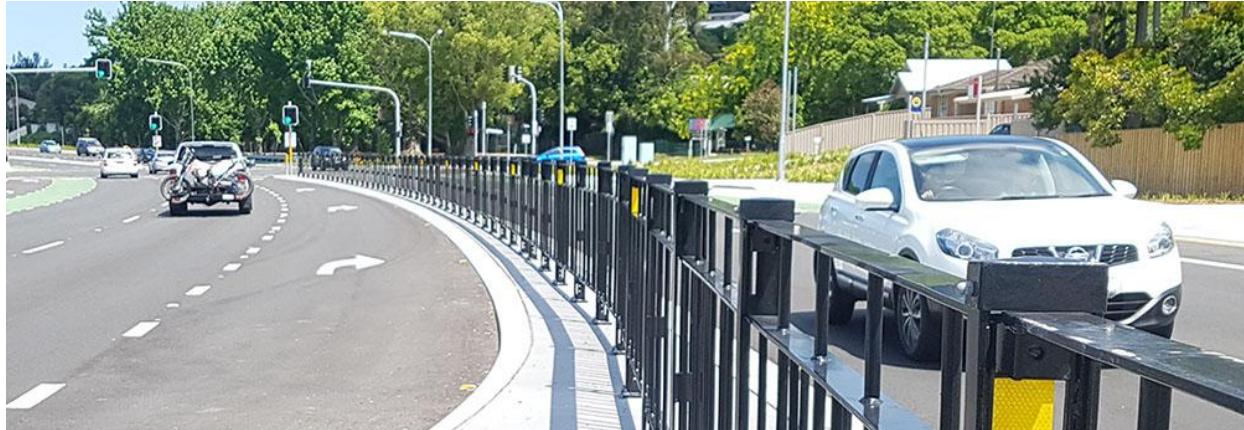
**Figure 6.28 Fenced Median Barrier Example**

median barrier in Utah is between \$95 to \$190 per foot. Figure 6.28 shows an example of a fenced median barrier. Fenced median barriers have a similar cost for installation (typically ranging from \$90 to \$180 per square foot) but would have fewer maintenance requirements than landscaped medians.

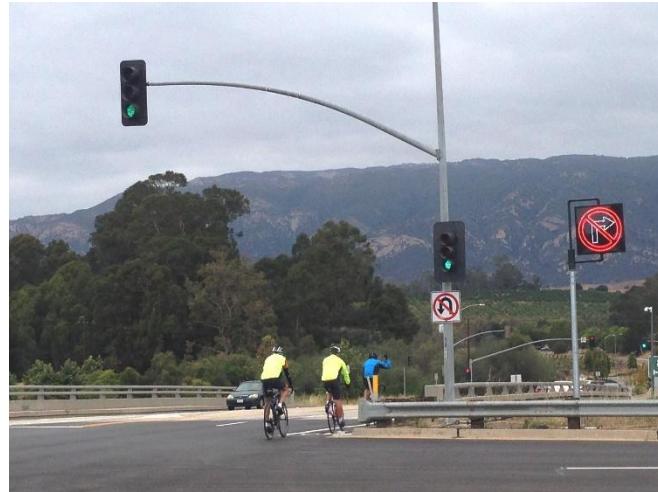
**Figure 6.30 No Right-Turn LED Blank-Out Lane Control Sign at Intersection**

LED blank-out road signs are designed to alert motorists to changing traffic patterns. Signs are designed with narrow-angle, high performance LEDs for superior readability. Automatic photo-dimming adjusts LED brightness to ambient lighting conditions, and the message disappears when turned off. Figure 6.29 and Figure 6.30 show examples of LED blank-out road signs. In Utah, installation costs are approximately \$5,500 to \$12,000 per sign.

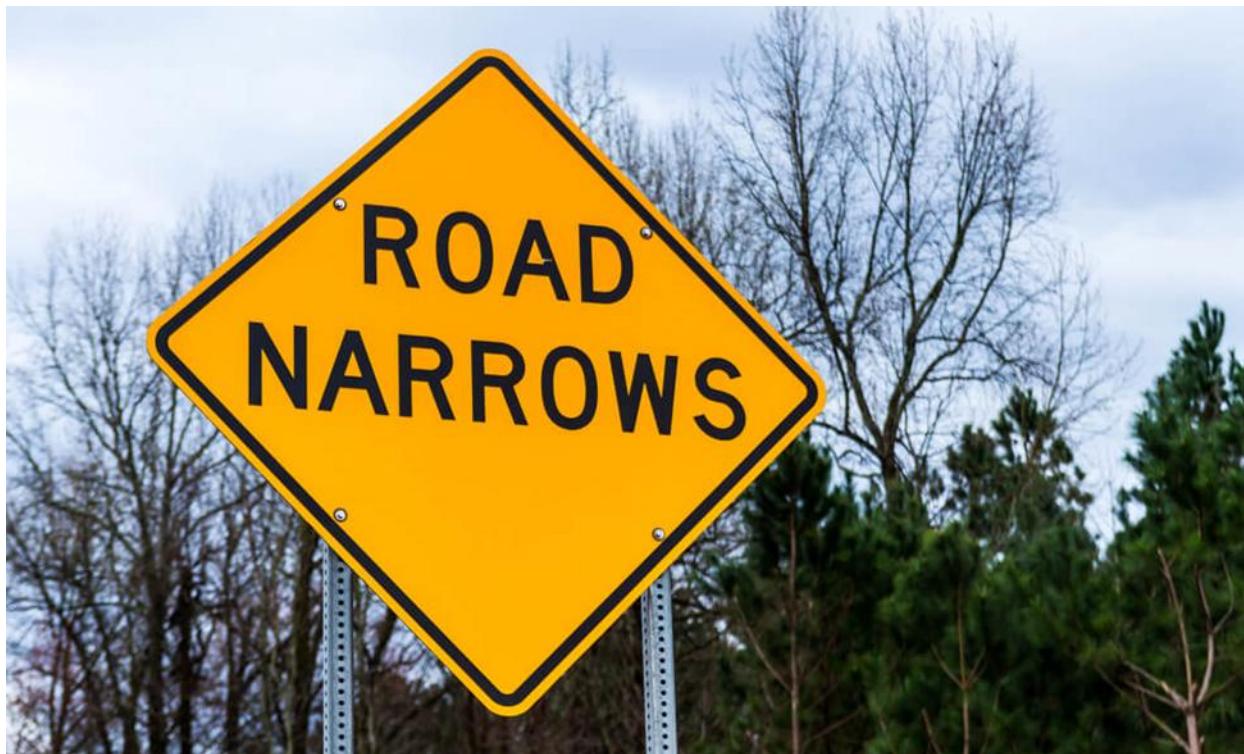
**Figure 6.31 “Road Narrows” Sign Example**

**Whereas curb extensions narrow the roadway at intersections and midblock crossings, roadway narrowing extends along an entire corridor. Reducing the width of the roadway influences drivers to lower vehicle speeds and increases driver awareness. This allows drivers to pay more attention to pedestrians and reduces the risk of high-speed collisions with pedestrians. Figure 6.31 “Road Narrows” Sign Example**

through Figure 6.34 show a “Road Narrows” sign and examples of narrow roads. It is estimated to cost \$250k to \$500k per mile to narrow an existing roadway in Utah. It should be noted that striping can be used to create a perceived narrowing of the road, but this is not the same as narrowing the road and is not what roadway narrowing means in this case.
