**Report No. UT-25.16**

# **IDENTIFYING SAFETY HOT SPOTS IN CLOSE PROXIMITY TO K-12 SCHOOLS**

Utah Department of Transportation  
Research & Innovation Division

**Final Report  
November 2025**

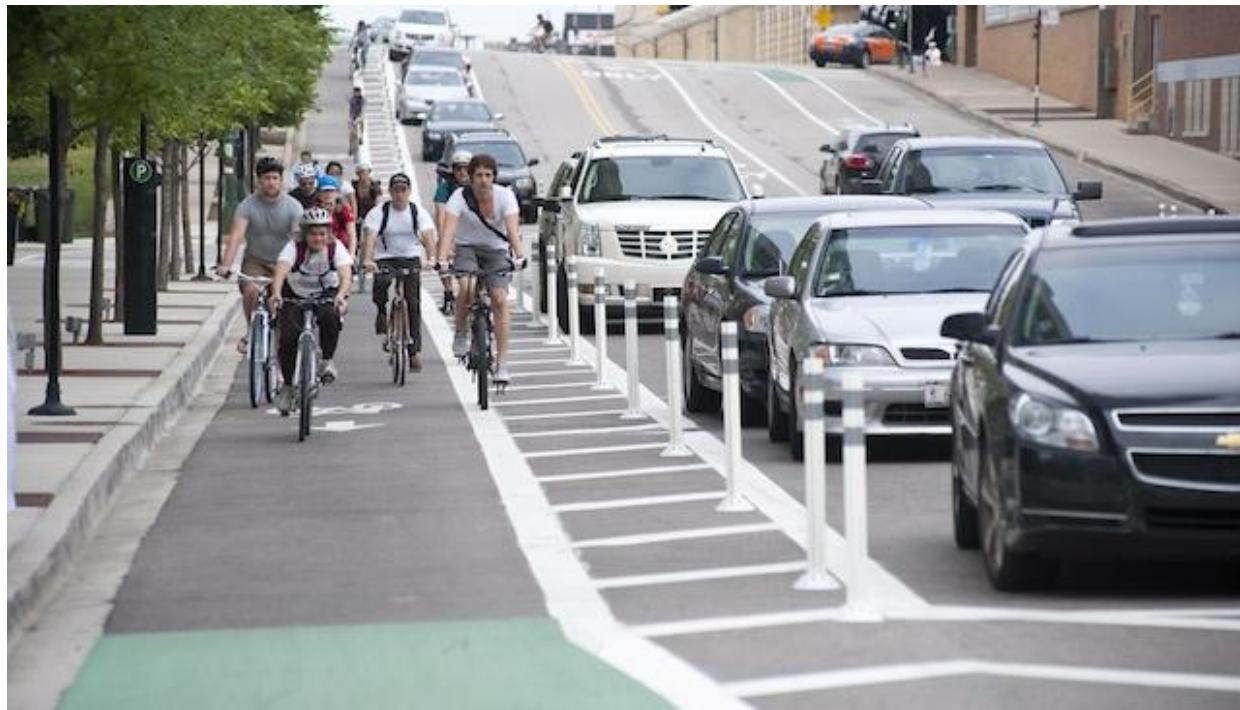
**Figure 6.35 Roadway with Shoulder Bike Lane**

There are several kinds of bike lanes including shoulder bike lanes (Figure 6.35), median bike lanes (Figure 6.36), and separated bike lanes (Figure 6.37). Median and separated bike lanes should include a barrier separating them from vehicle traffic but can also be created by striping alone. For bike lanes without barriers using striping and signage alone, it is estimated to cost \$20k to \$100k per mile to install bike lanes in Utah.

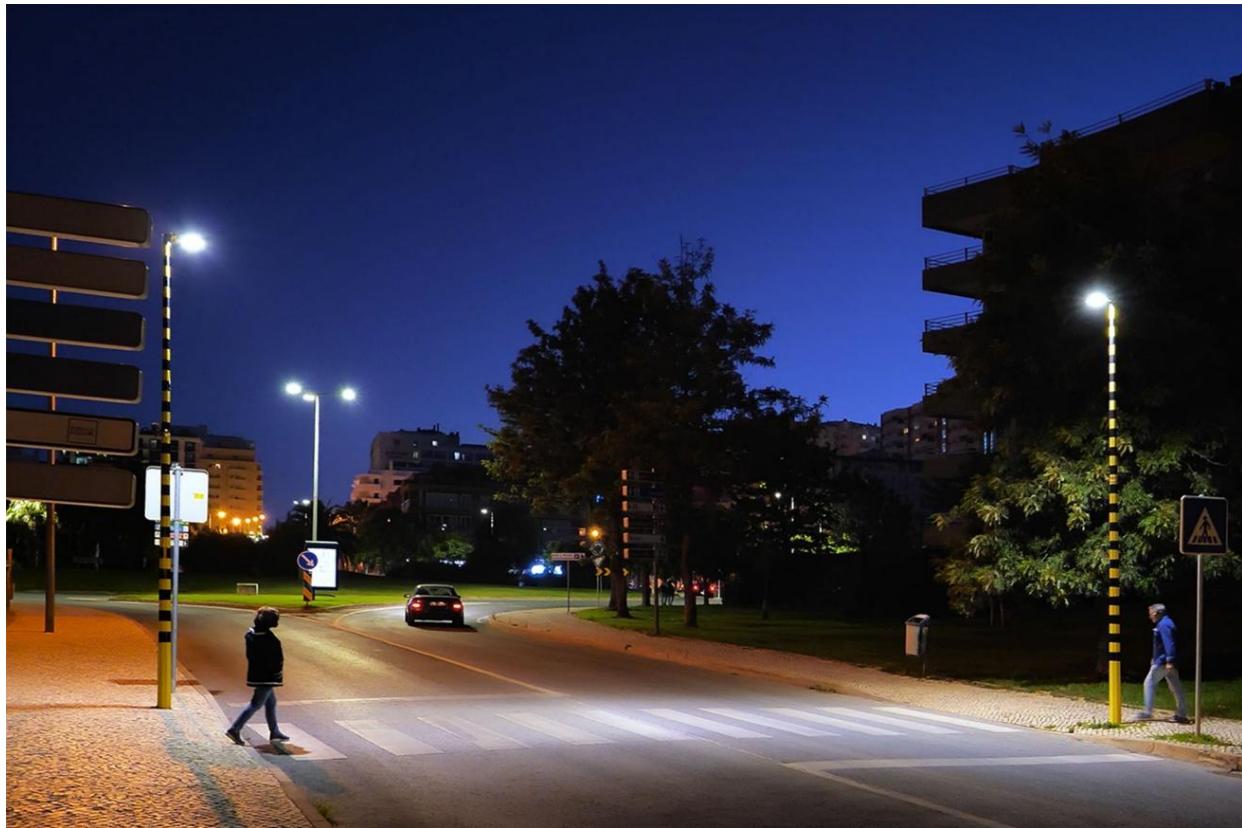
**Figure 6.38 Pedestrian Street Lighting with Crosswalk (Example 1)**

Figure 6.38 and Figure 6.39 show examples of street lighting for pedestrians. It is estimated to cost \$25,000 to \$50,000+ to install street lighting at a crosswalk in Utah.

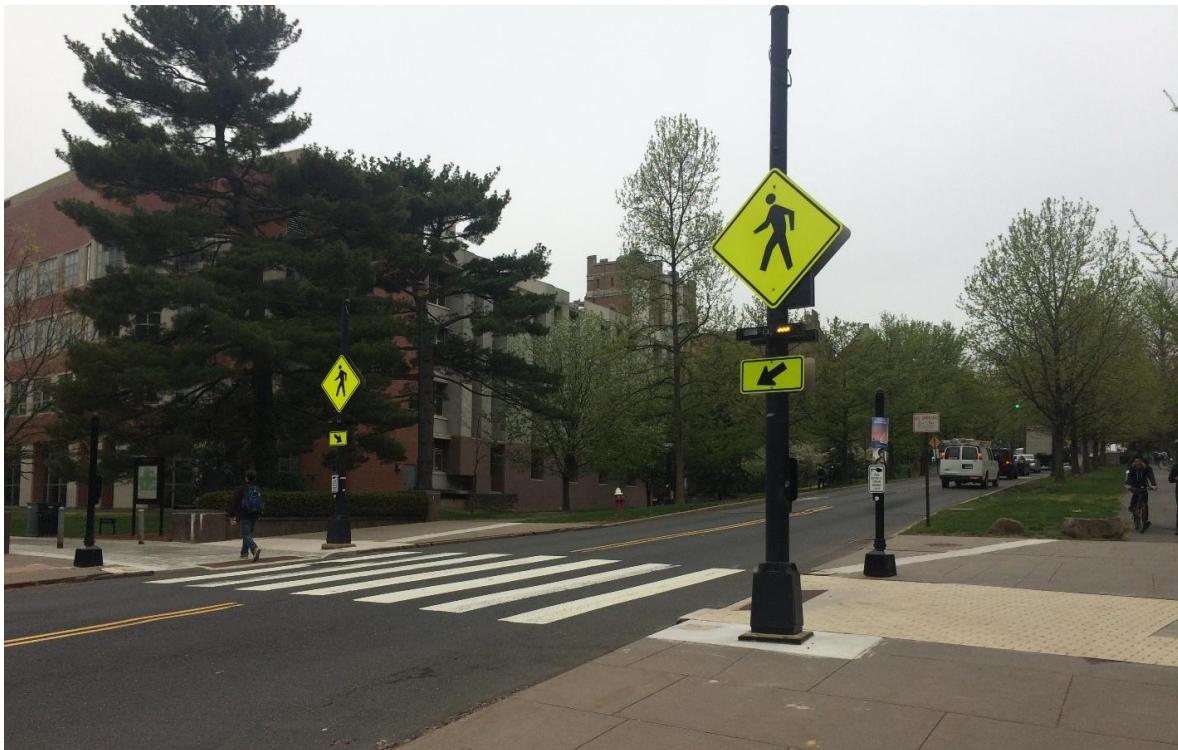
**Figure 6.43. RRFB Installed at a Short Crosswalk**

RRFBs include pedestrian warning signs with rectangular flashing LED beacons on each side of the road next to a crosswalk. They may be used at midblock crosswalks or uncontrolled intersection crosswalks to require vehicles to stop or yield when a pedestrian activates a push button. This can be useful for crossings with periodic, high pedestrian volumes, such as school crossings during school peak hours. According to the FHWA, RRFBs are particularly effective at multilane crossings with speed limits less than 40 MPH. When possible, they should be installed in the median of a roadway if there is a pedestrian refuge island, rather than the far side of the roadway. They may also be installed with an overhead mast for longer crossings.

Figure 6.43 to Figure 6.45 show examples of RRFBs installed at different crosswalks, including crosswalks with a median pedestrian refuge island and an overhead mast. It is estimated to cost \$10,000 to \$20,000 to install an RRFB in Utah, although costs may be higher for installing an overhead mast or a median refuge island.
