1994 Ford Explorer XLT Broadside

Collision with a Narrow Fixed Object:

FOIL Test Number 98S005

PUBLICATION NO. FHWA-RD-98-150

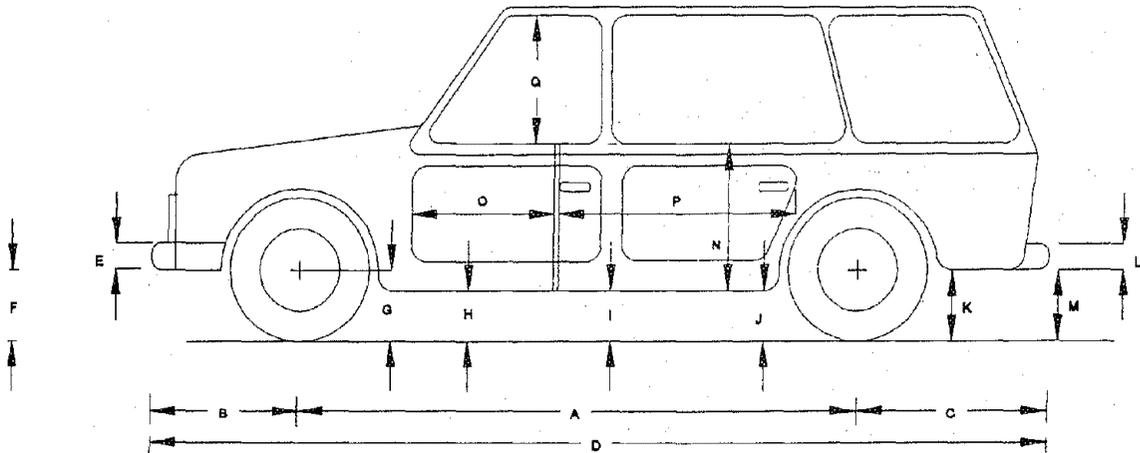
Figure 1. Vehicle physical parameters in millimeters.

PRE-TEST	POST-TEST	ΔCHANGE
A	2850	2770	-80
B	752	750	-2
C	1042	1012	-30
D	4644	4482	-162
E	195	195	0
F*	480 / 480	495	15
G*	328 / 328	334	6
H*	328 / 328	340	12
I*	329 / 329	335	6
J*	325 / 325	371	46
K*	430 / 430	472	42
L	198	198	0
M*	440 / 440	484	44
N	670	682	12
O	1050	923	-127
P	940	838	-102
Q	485	454	-31

* These measurements were taken in the "as delivered" and in the "as tested" configuration, respectively.

A list and sketches of the vehicle's physical parameters are shown in table 2 and figure 1, respectively. Figure 1 includes post-test damage measurements.

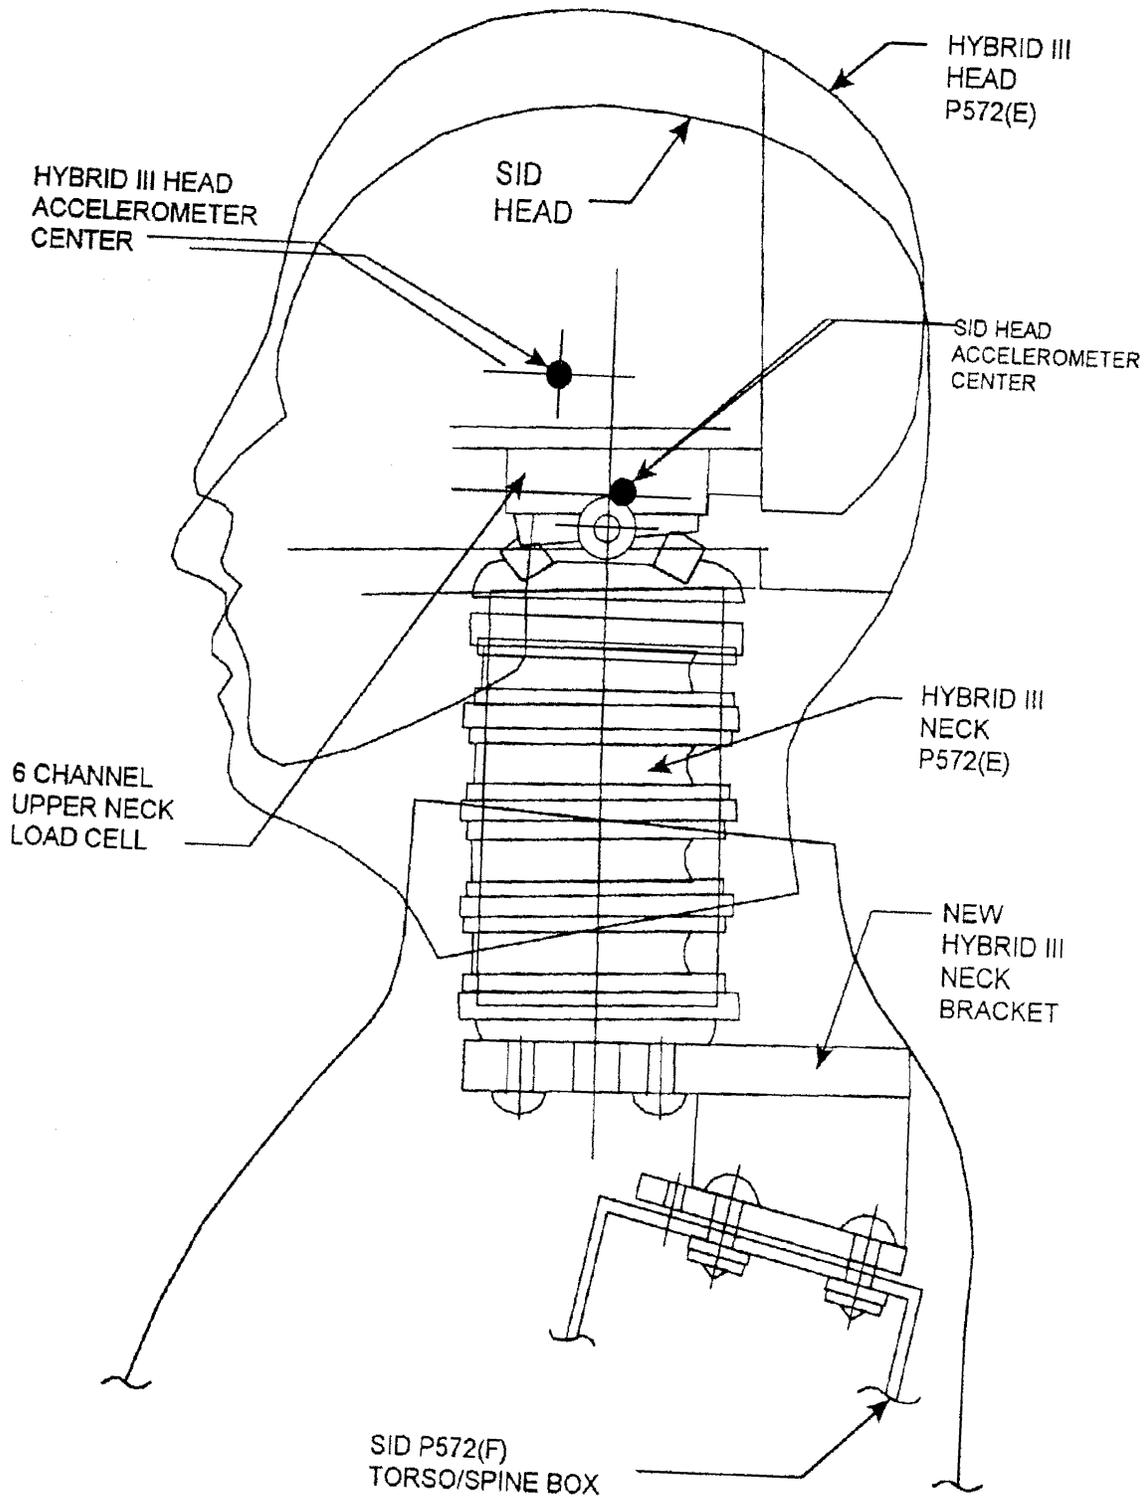
Figure 2. HYBRID III neck and head assembly on SID/HIII #26.

P572M HEAD/NECK/TORSO ASSEMBLY

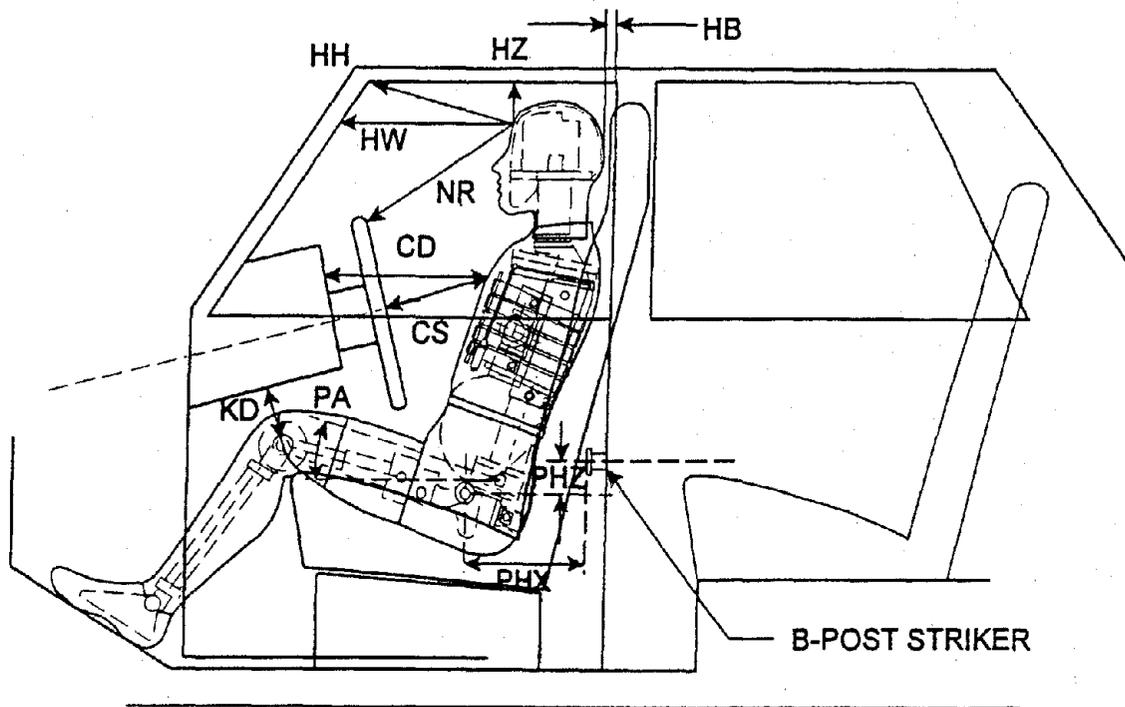
Figure 3. SID/HIII longitudinal clearance and position measurements.

LEFT SIDE VIEW

MEASUREMENT (mm)	DRIVER SID/HIII ID# 26
HB	83
HH	331
HW	508
HZ	211
NR	400
CD	537
CS	235
KDL(KDA°)	1601(45°)
KDR(KDA°)	1531(46°)
PA°	22.1°
PHX	165
PHY	257
PHZ	-95

The minimum clearance was achieved after step 3. The seat back angle was adjusted approximately 5 degrees and the seat track was adjusted to the most forward position. No interference between the SID/HIII's knees and the dash was observed, however, the knees made slight contact with the steering column. The knees were spread enough to eliminate knee-steering column contact. The final seat back angle was 5 degrees (measured on the back of the seat) from vertical, a 5.3 degree difference from the original FMVSS 214 angle of 10.3 degrees. Using FMVSS 214 as a guide and alignment tools supplied by the NHTSA, the SID/HIII's feet, legs, thighs, pelvis, torso, and head were positioned just before the test. Pertinent SID/HIII-to-interior longitudinal and lateral clearance measurements are shown in figure 3 and figure 4. Several different color chinks were put on the side surfaces of the dummy to determine the contact points between the dummy and the vehicle's interior, as shown in table 3 below.

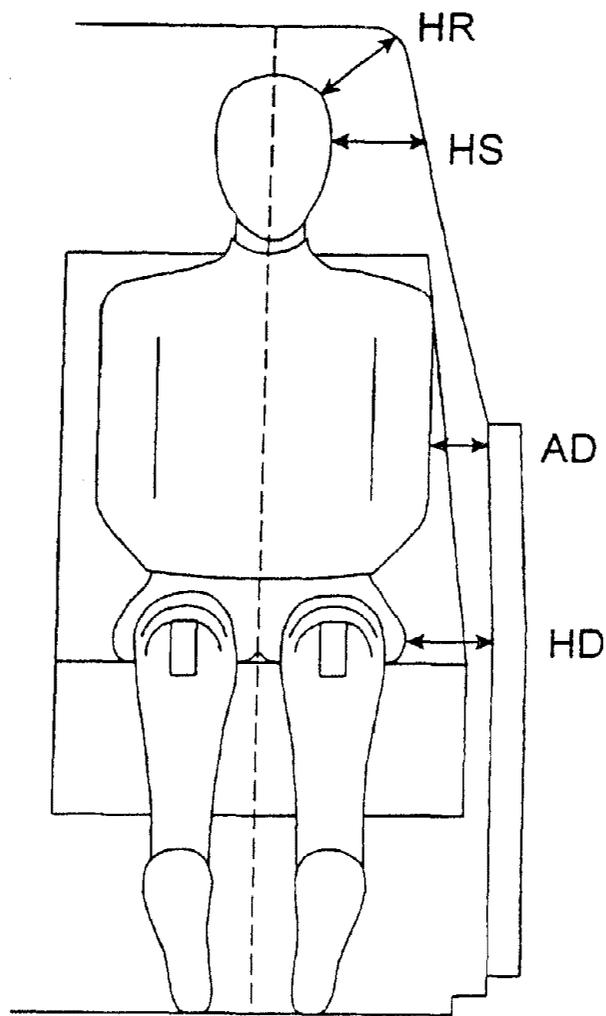
Figure 4. SID/HIII lateral clearance and position measurements.

MEASUREMENT (mm)	DRIVER SID/HIII ID# 26
HR	275
HS	360
AD	122
HD	160

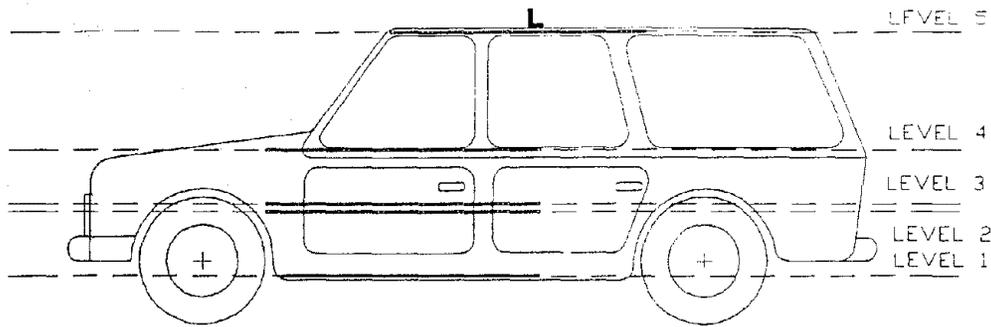
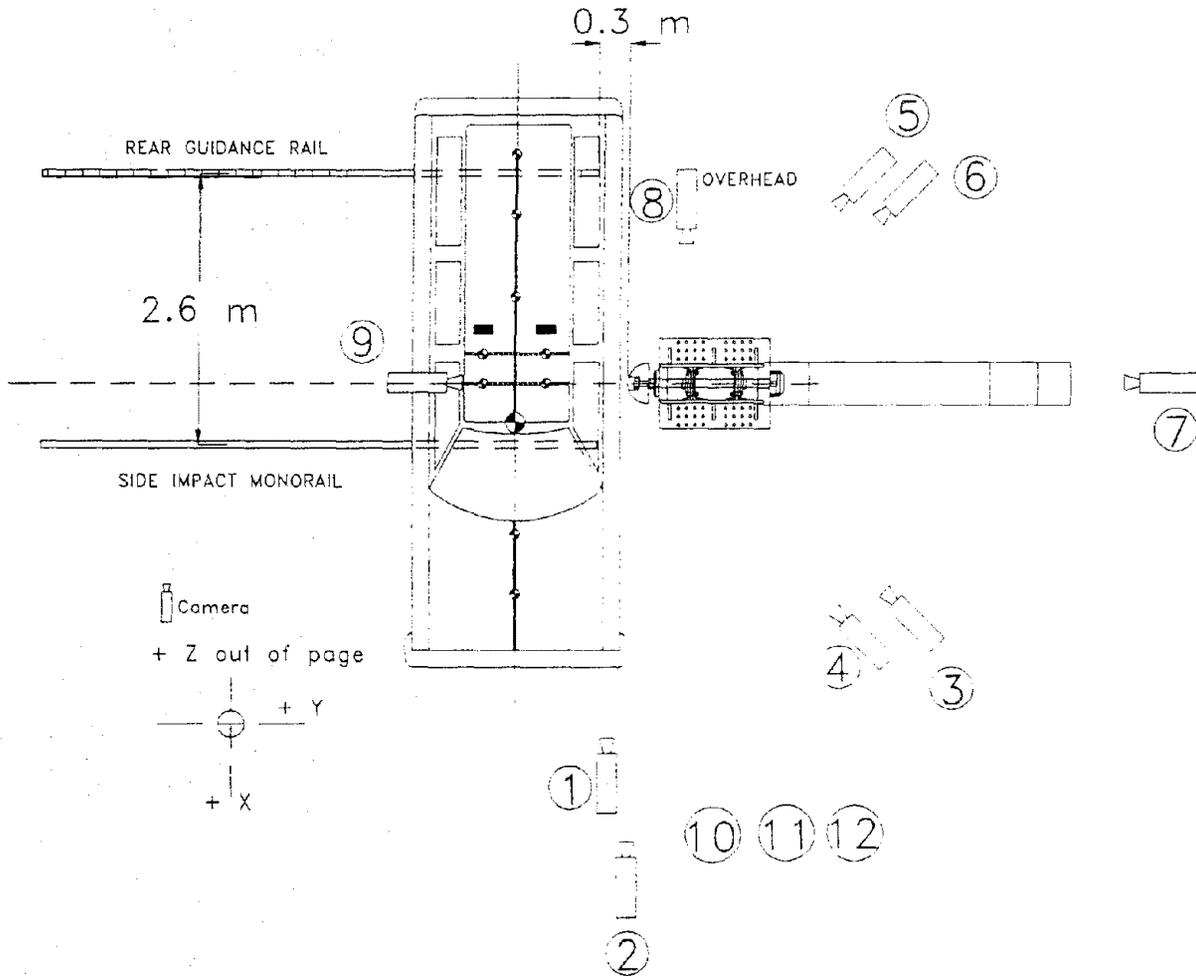
Figure 6. Camera locations and test setup.

Figure 6 presents a side view of the test vehicle, showing the target tape locations. Figure 6 also contains an overhead sketch of the facility depicting the setup of the vehicle, rigid pole, test track, and the location of each high-speed camera. Positioned in each camera's view was at least one strobe light. The lights flashed when the vehicle struck the pole. This synchronized the film with the electronic data.

- One target on top of the rigid pole's top semicircular impact face.
- Two targets on the front and rear bumper (YZ plane) 610 mm apart centered on the longitudinal centerline.

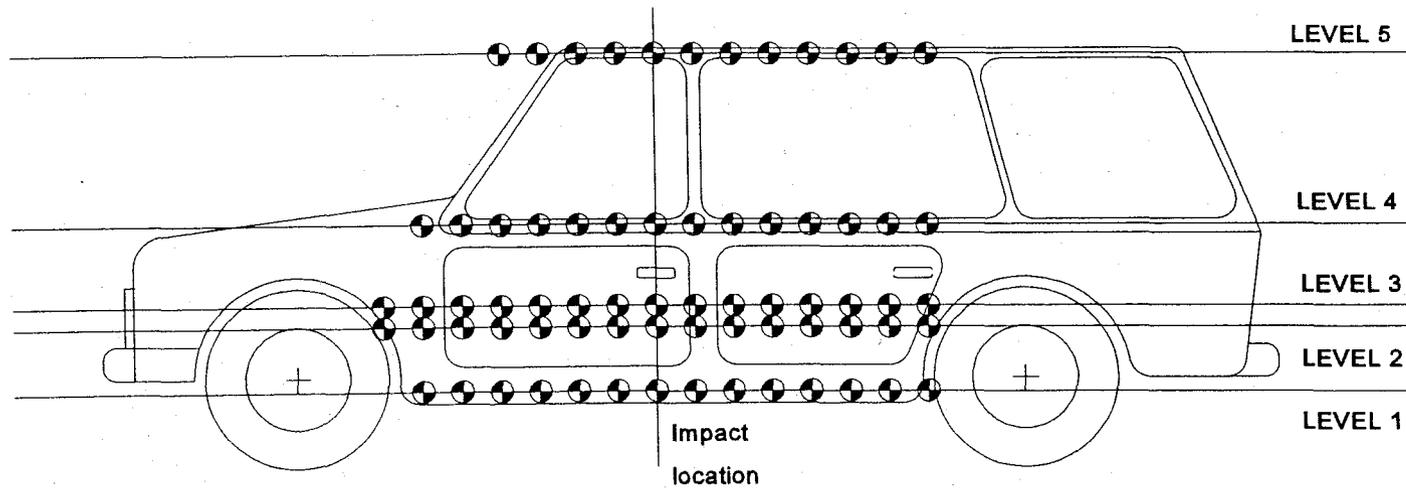
Level 1 - Sill height Level 2 - Occupant H-point Level 3 - Mid-door Level 4 - Window sill Level 5 - Window top

LEVEL	HEIGHT		Distance from impact point (mm).												
			-1219	-1067	-914	-762	-610	-533	-457	-381	-305	-229	-152	-76	0
1	435	PRE				658	660	660	660	660	665	665	665	665	665
	433	POST				718	775	809	842	873	912	948	1011	1065	1094
		CRUSH	0	0	0	60	115	149	182	213	247	283	346	400	429
2	800	PRE		570	580	575	576	576	577	578	579	579	579	579	579
	814	POST		595	617	655	727	769	814	862	908	957	1012	1068	1098
		CRUSH	0	25	37	80	151	193	237	284	329	378	433	489	519
3	729	PRE		570	580	575	576	576	577	578	579	579	579	579	579
	741	POST		603	622	651	728	779	828	881	928	975	1017	1072	1092
		CRUSH	0	33	42	76	152	203	251	303	349	396	438	493	513
4	1066	PRE	618	611	608	605	608	607	608	608	608	608	608	607	607
	1078	POST	630	630	630	650	720	760	810	850	900	950	1004	1057	1093
		CRUSH	12	19	22	45	112	153	202	242	292	342	396	450	486
5	1628	PRE									810	810	800	797	797
	1164	POST									920	980	1020	1080	1130
		CRUSH	0	0	0	0	0	0	0	0	110	170	220	283	333

After the test, damage profile measurements were taken using two techniques. Table 8 summarizes the damage profile distance (DPD) technique. Figure 7 depicts the driver-side profile measurements before and after the test. The measurements were made using a reference line parallel to the driver side of the vehicle. The parallel line was drawn a certain distance from and perpendicular to a line formed by the passenger side sill across from the impact location. This allowed the same reference line to be drawn after the test to measure the post-test measurements. The measurements were made in 75-mm and 150-mm increments forward and aft of the impact point. After the test, measurements were taken at the same points forward and aft, rather than measuring at the same increments. From the figure, the maximum static deflection recorded was 530 mm at the mid-door height 76 mm rearward of the vertical impact target tape.

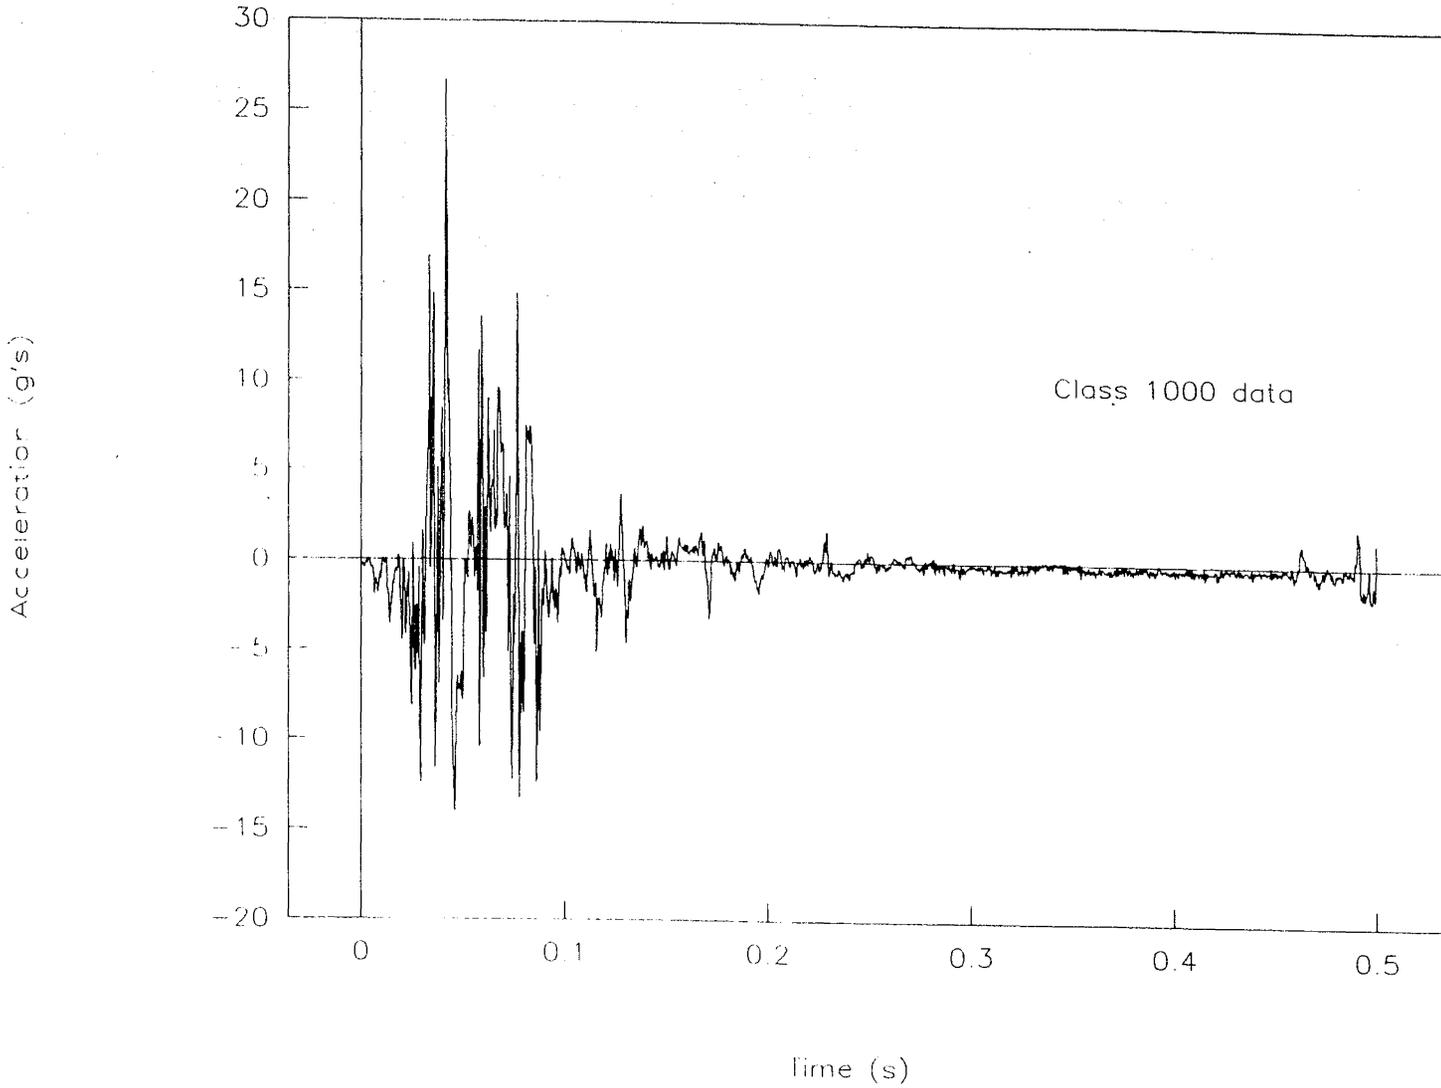
Figure 8. Acceleration vs. time, X-axis cg, test 98S005.

Test No. 98S005
X-axis, acceleration vs. time cg data

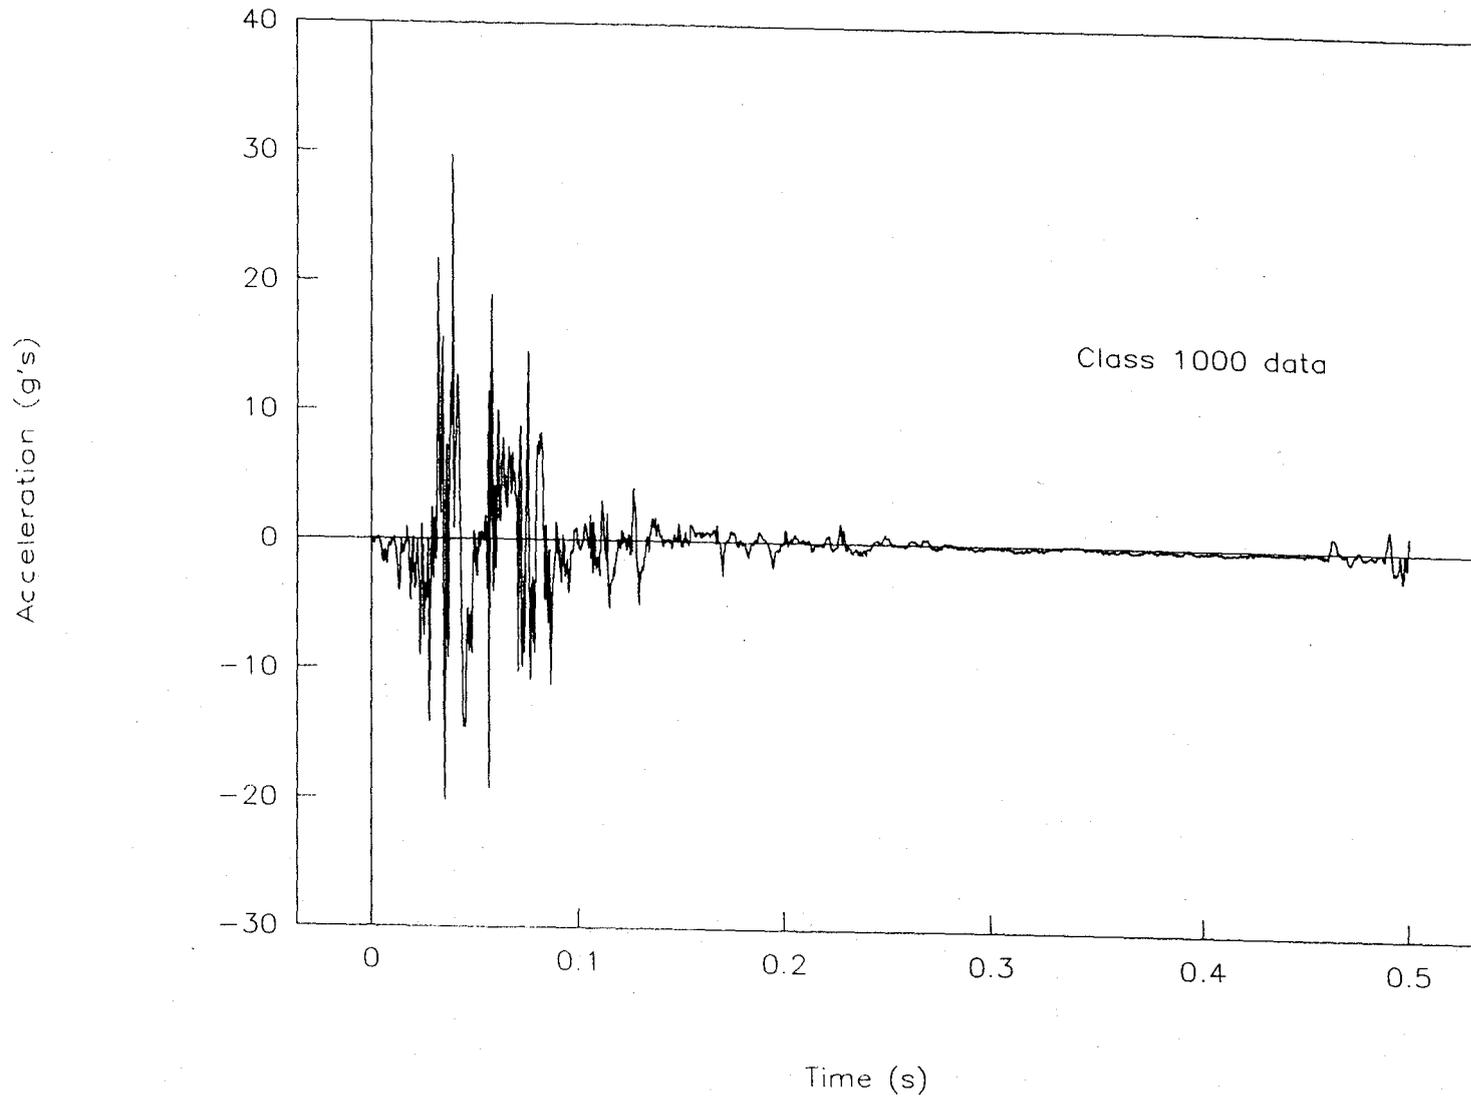
Figure 9. Acceleration vs. time, redundant X-axis cg, test 98S005.

Redundant X-axis cg data

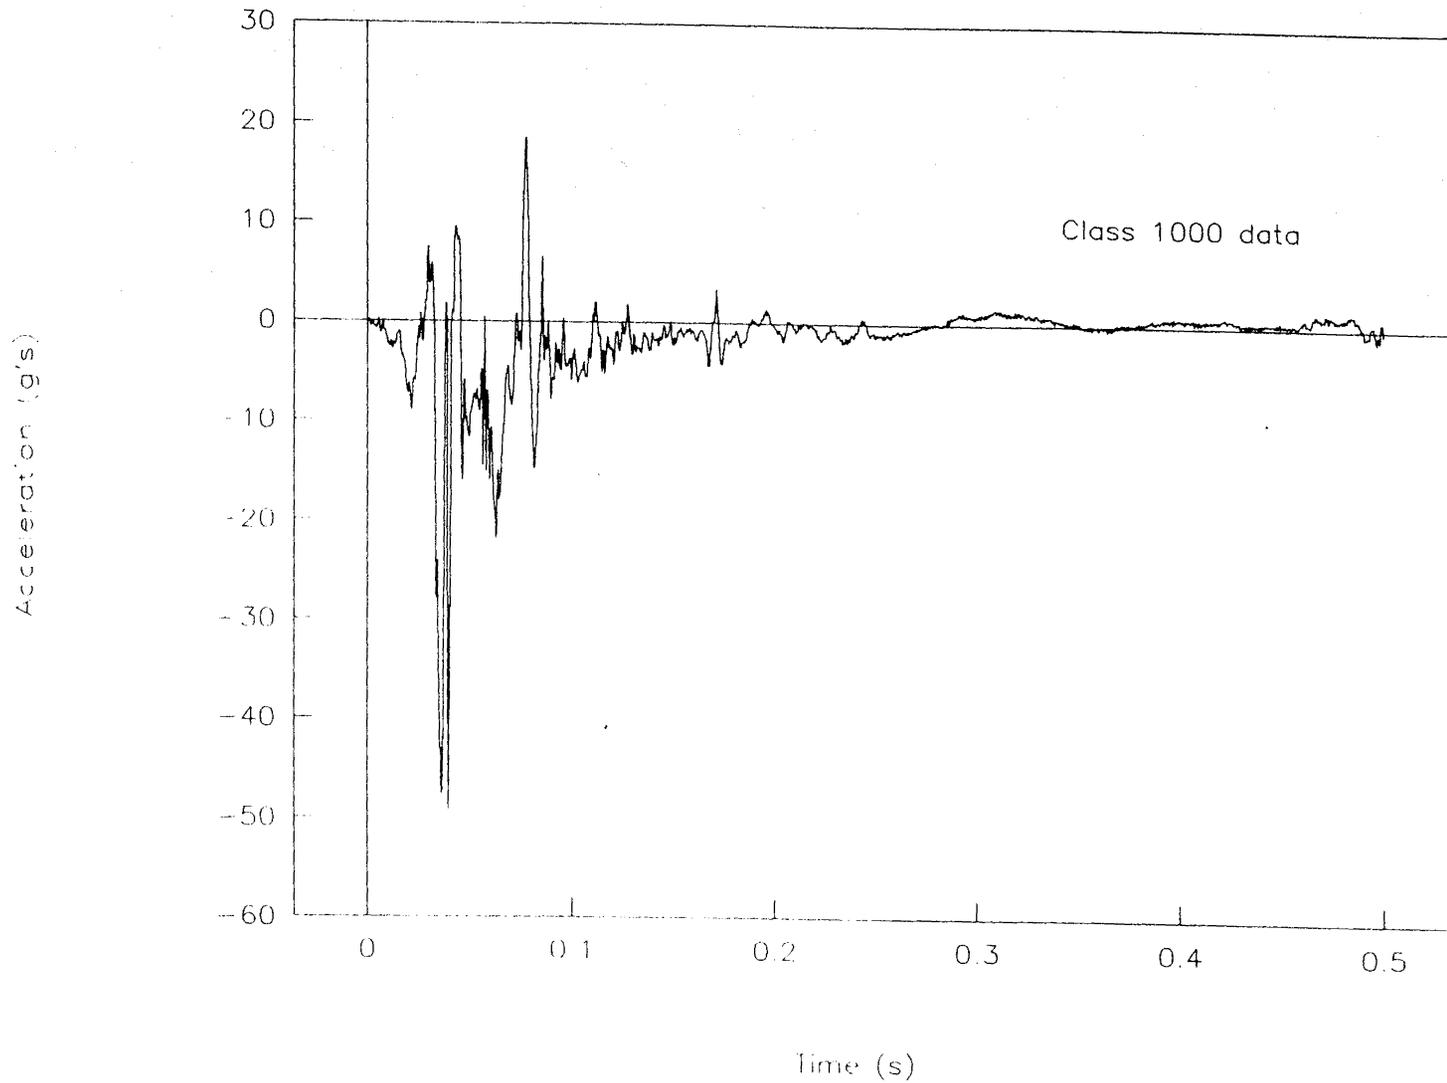
Figure 10. Acceleration vs. time, Y-axis cg, test 98S005.

Y-axis, acceleration vs. time cg data

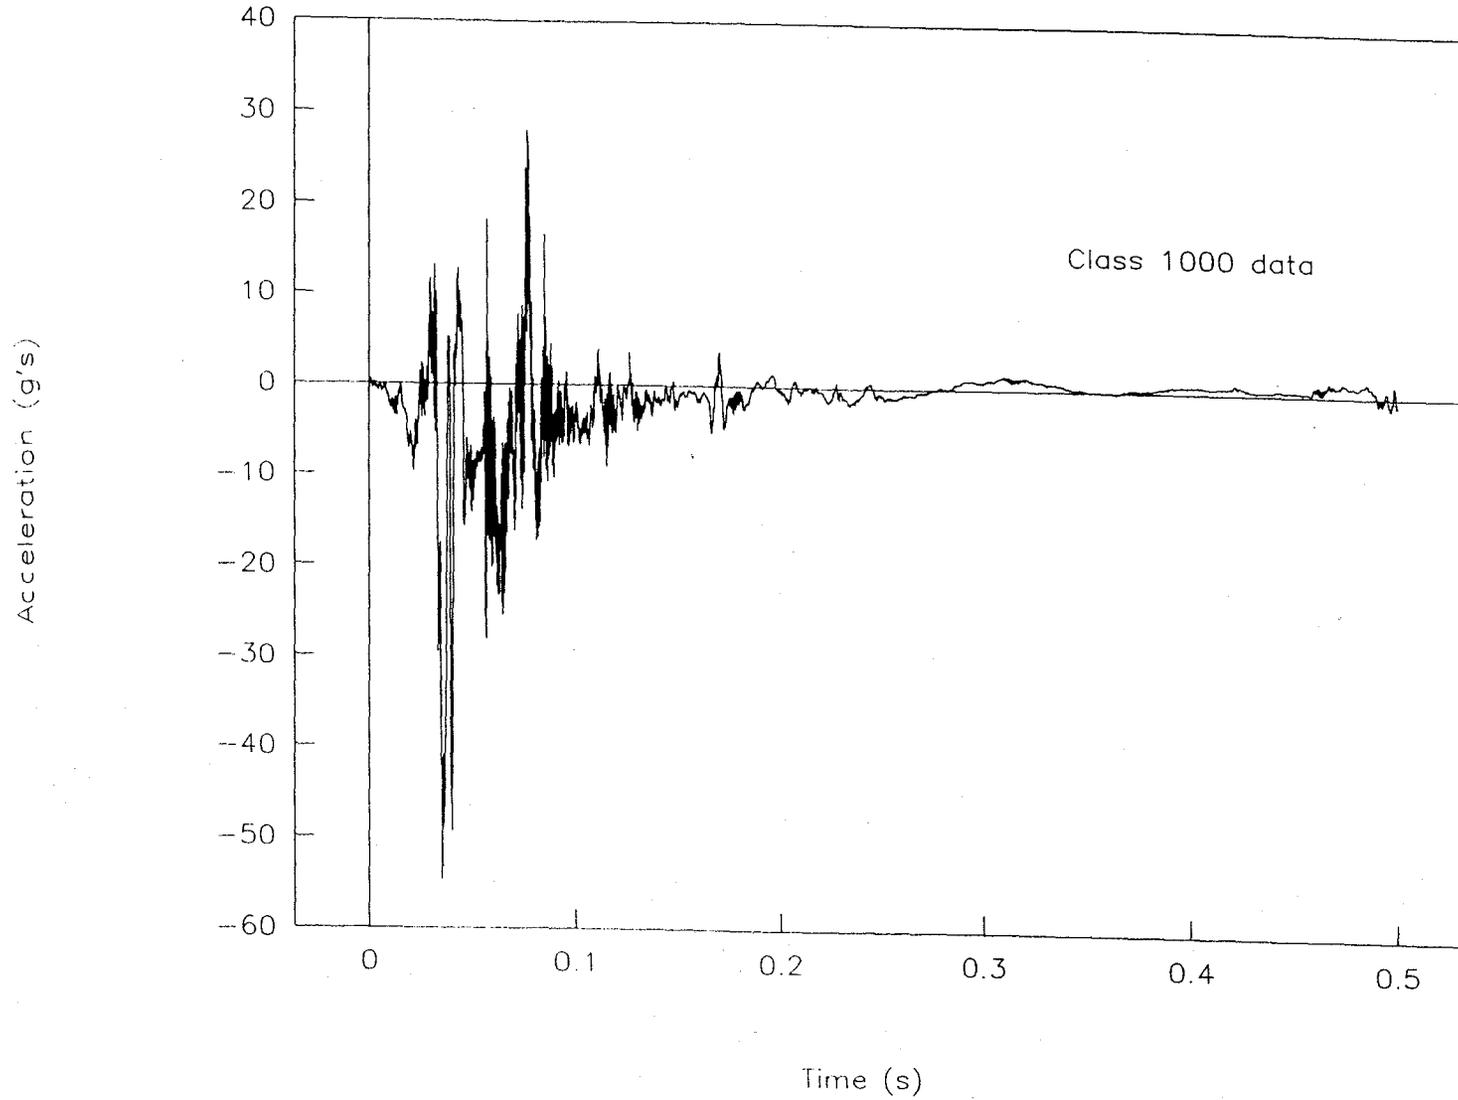
Figure 11. Acceleration vs. time, redundant Y-axis cg, test 98S005.

Redundant Y-axis cg data

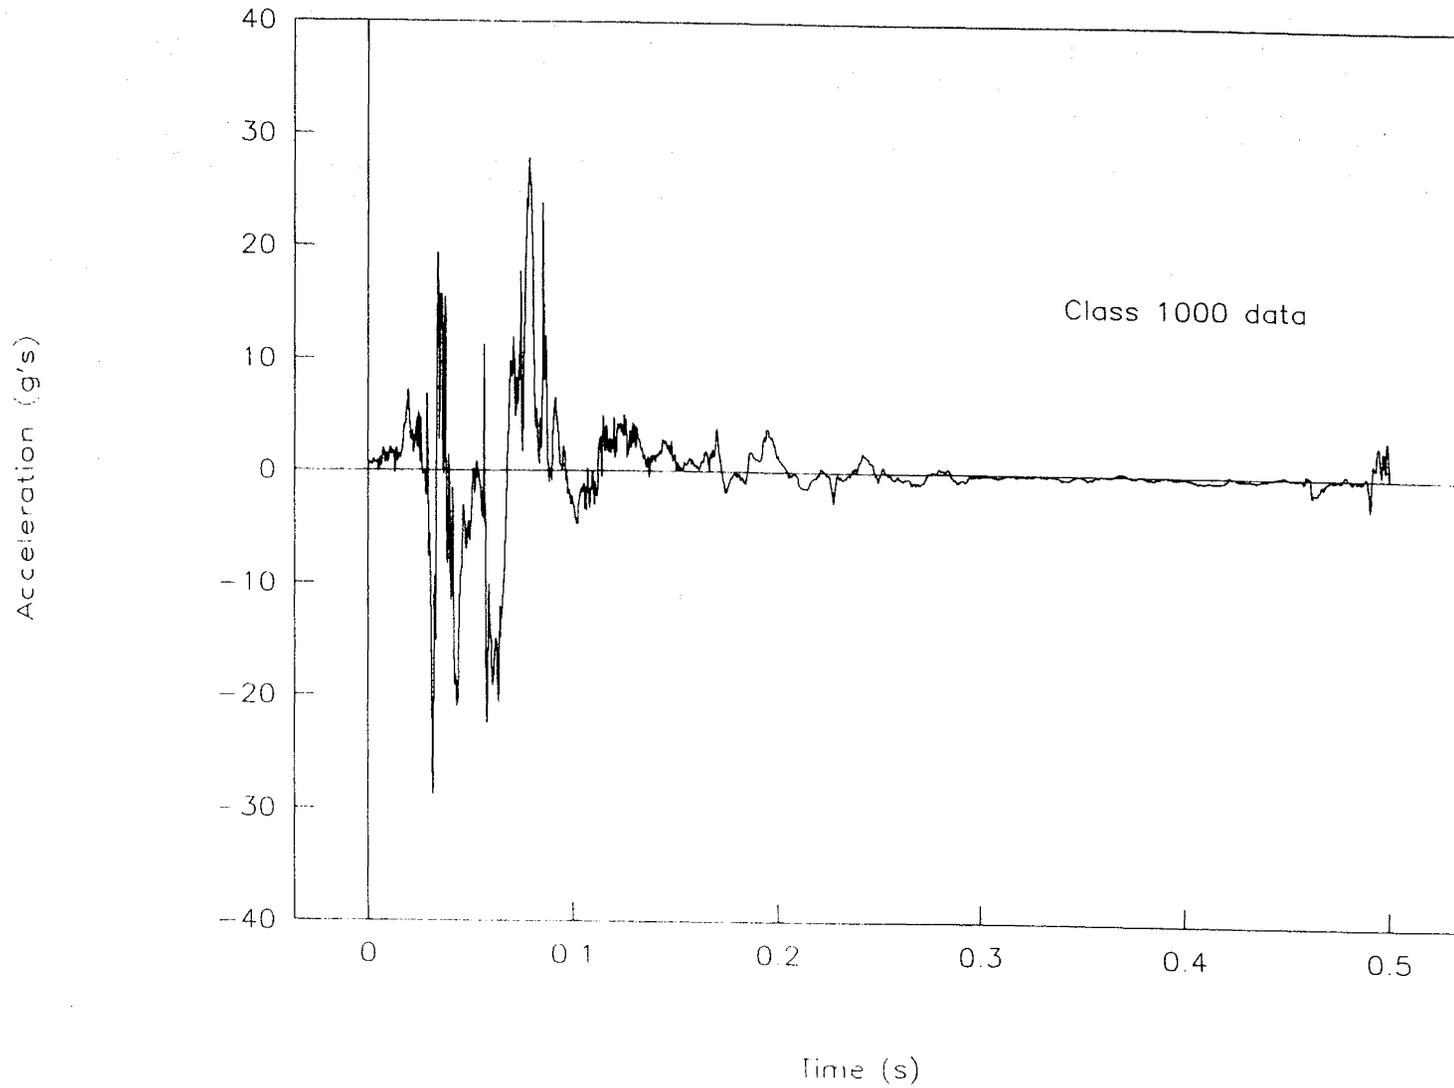
Figure 12. Acceleration vs. time, Z-axis cg, test 98S005.

Z-axis, acceleration vs. time cg data

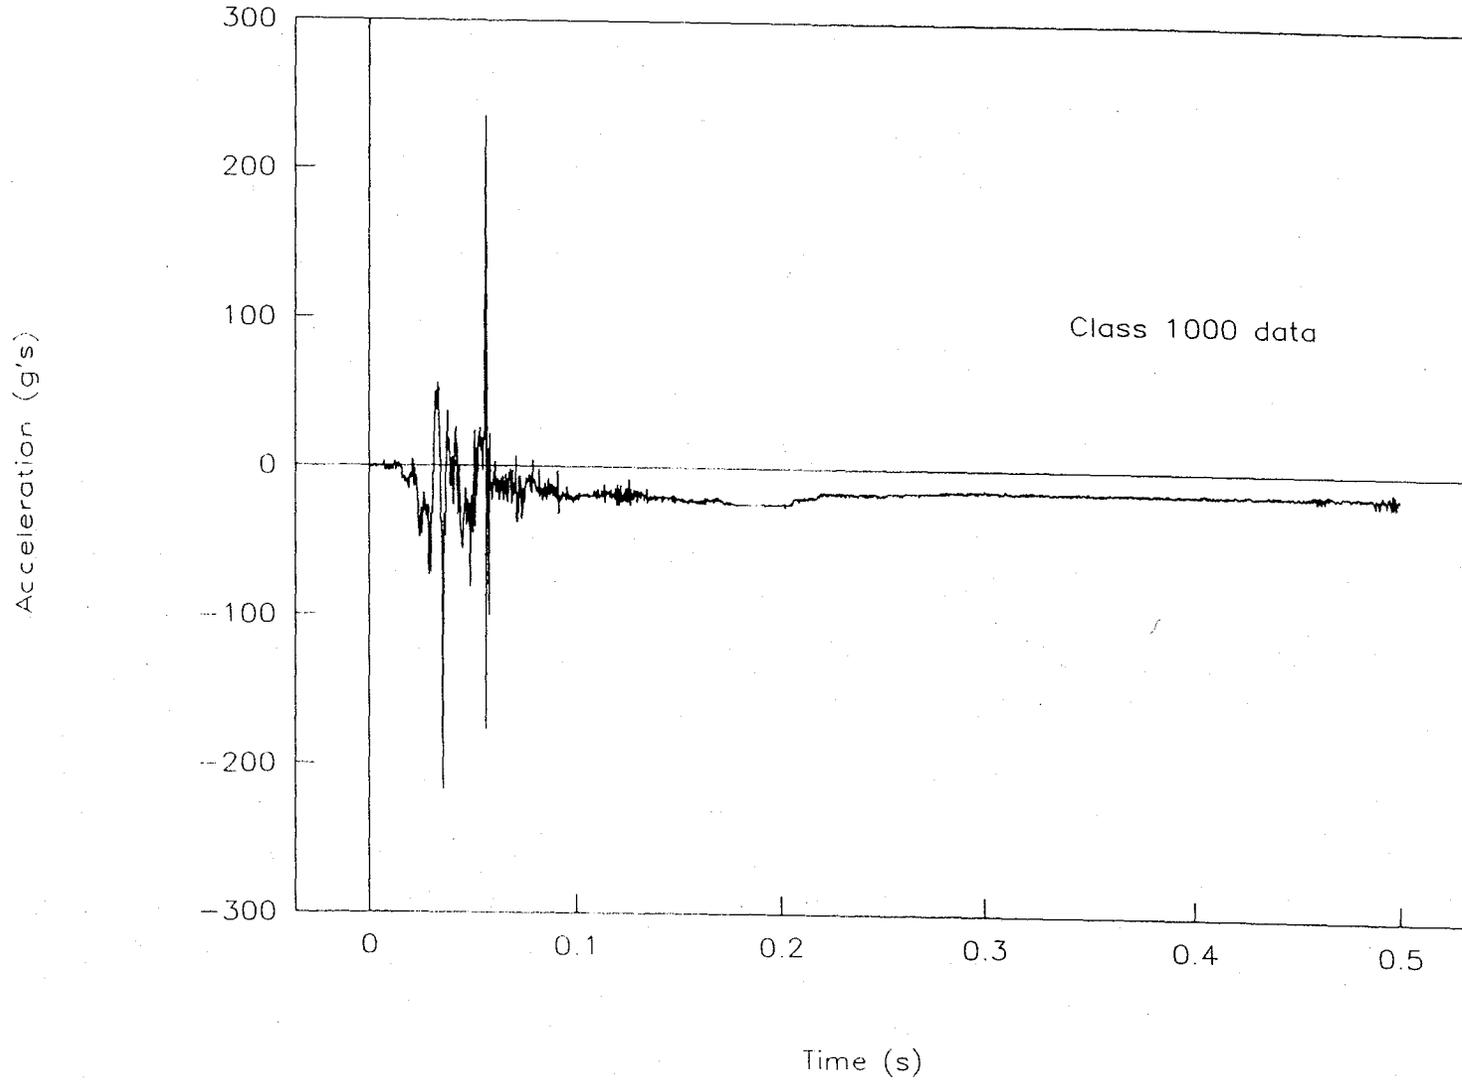
Figure 13. Acceleration vs. time, Y-axis driver seat track, test 98S005.

Y-axis driver seat track

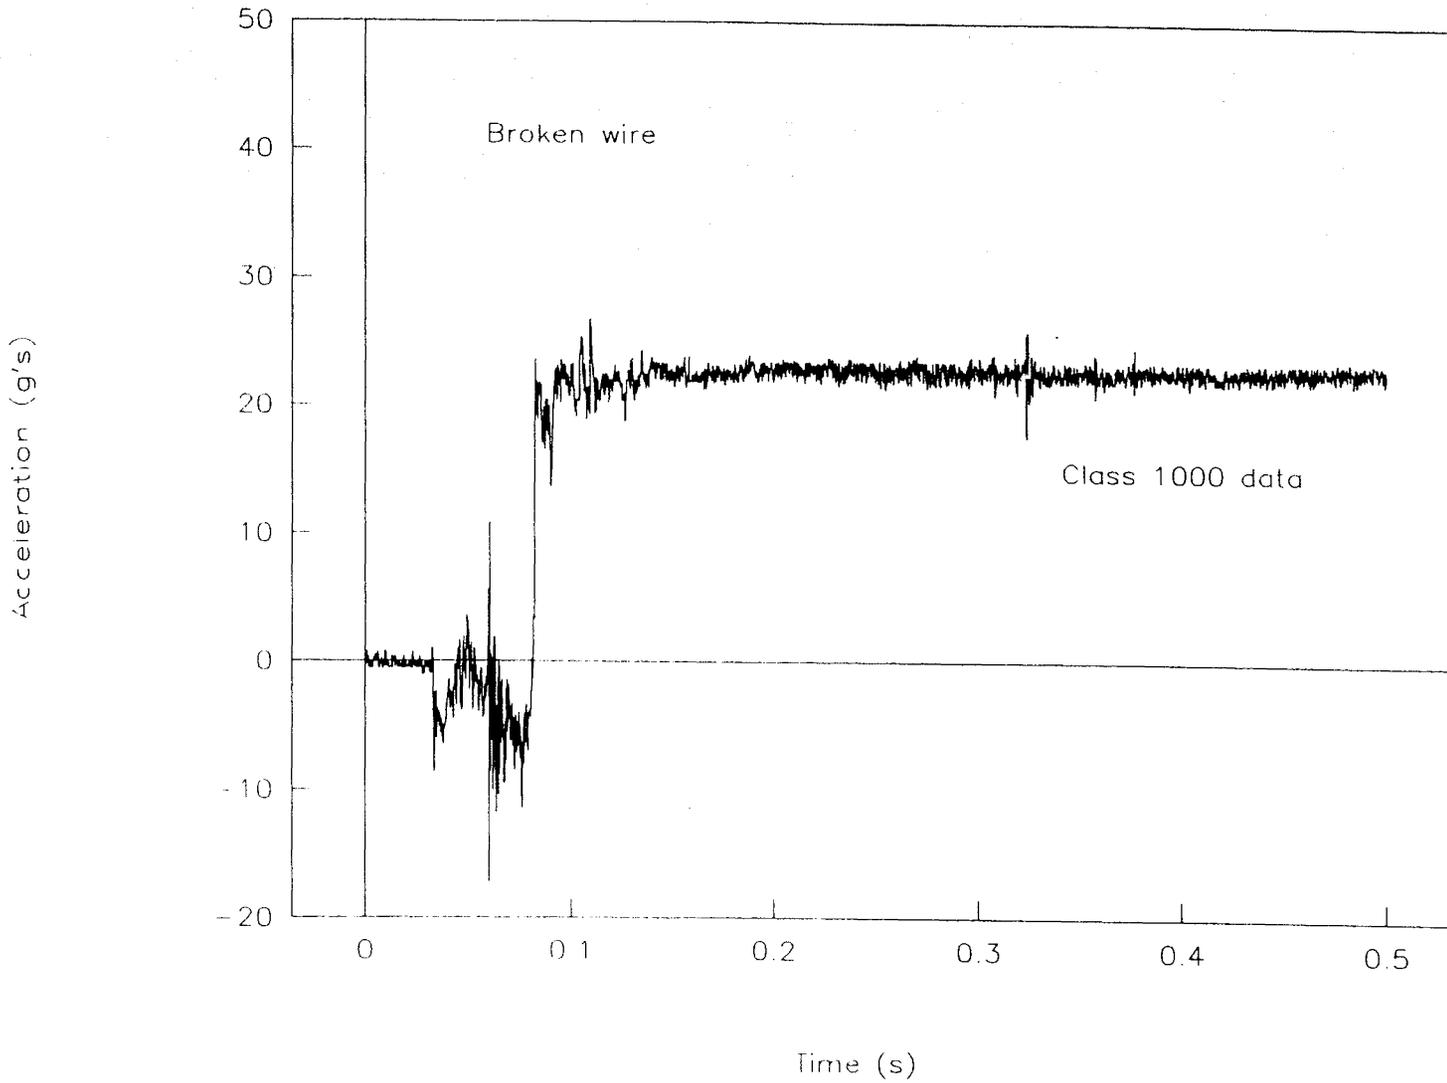
Figure 14. Acceleration vs. time, X-axis engine block, test 98S005.

X-axis, engine block

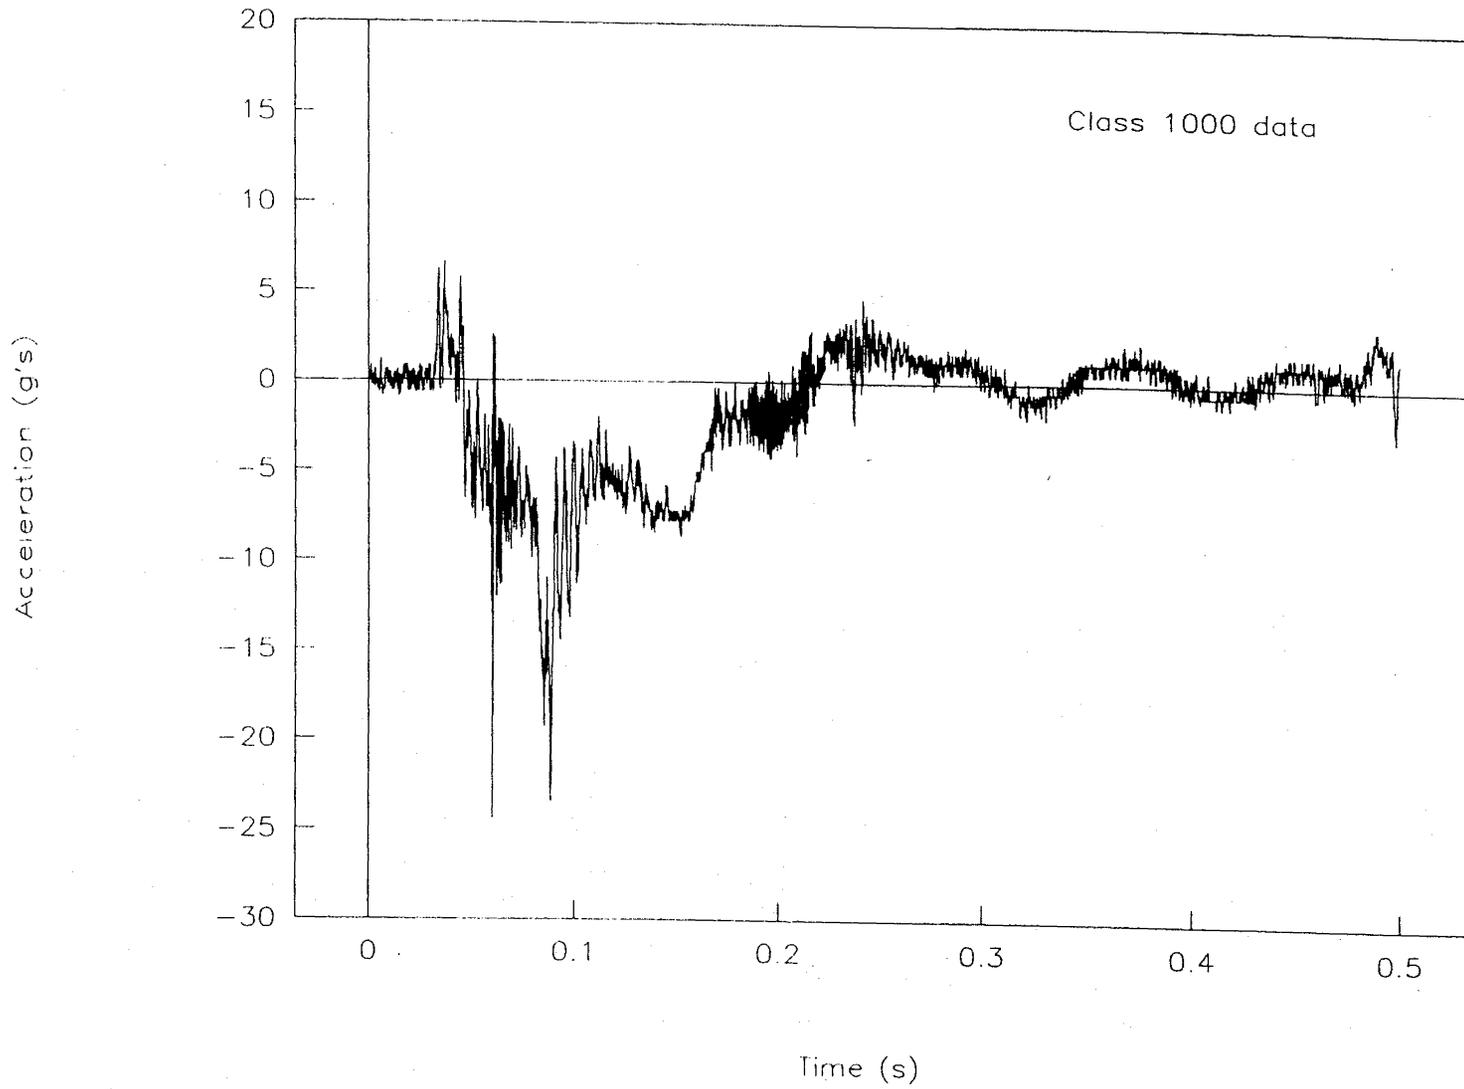
Figure 15. Acceleration vs. time, Y-axis engine block, test 98S005.

Y-axis, engine block

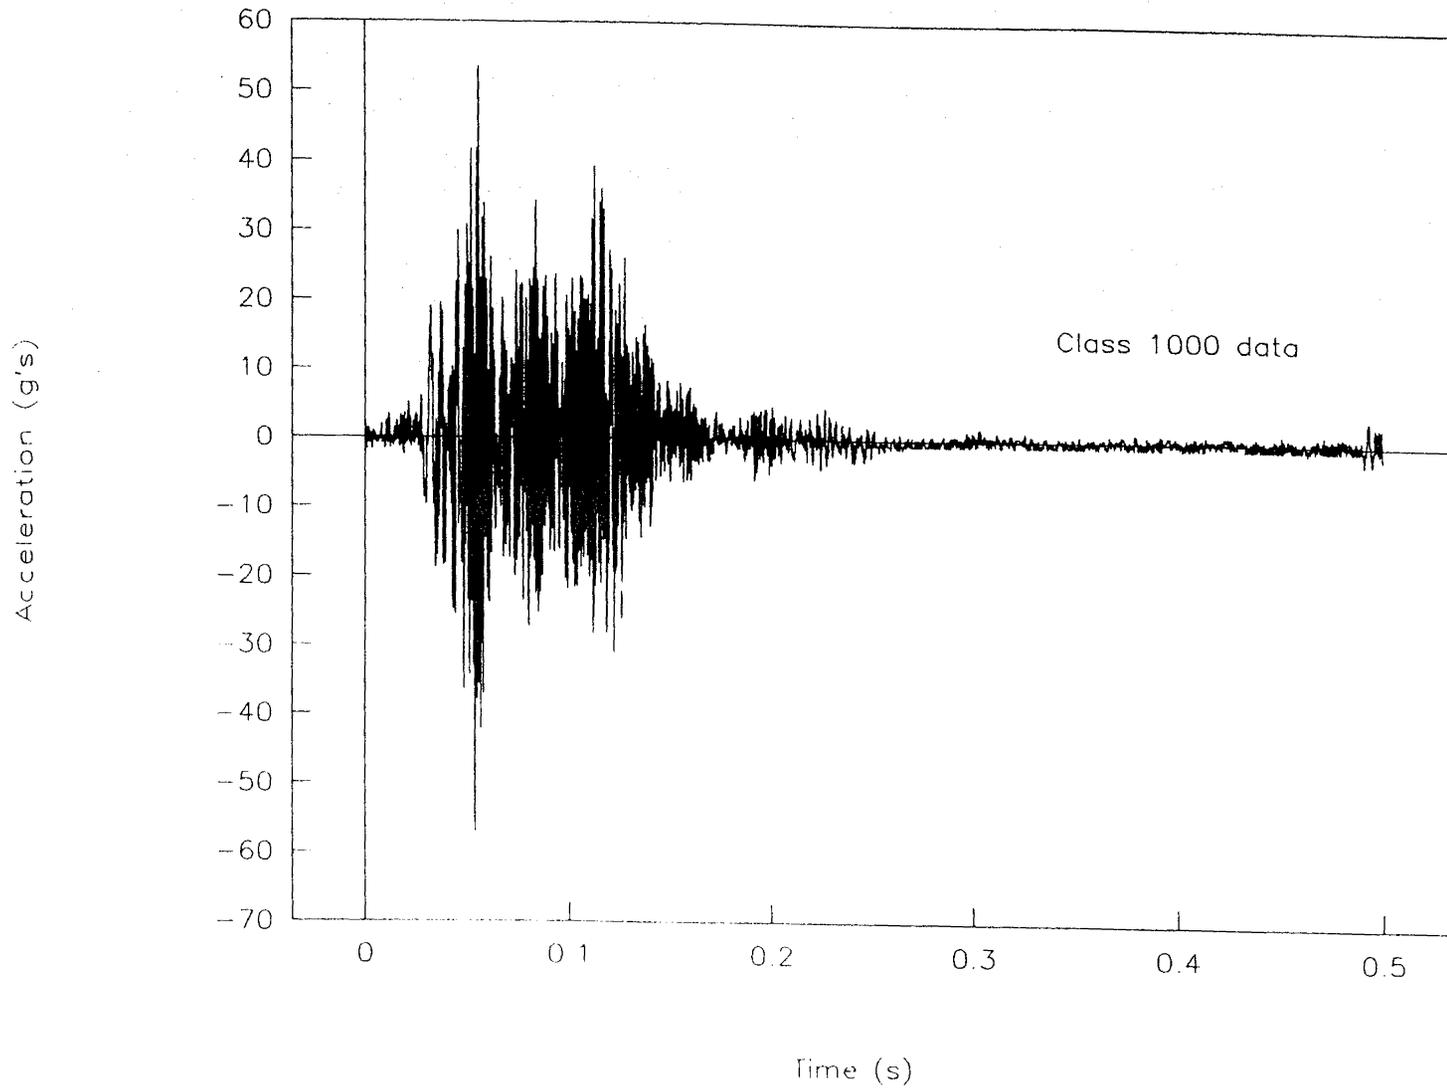
Figure 16. Acceleration vs. time, X-axis rear axle, test 98S005.

X-axis rear axle

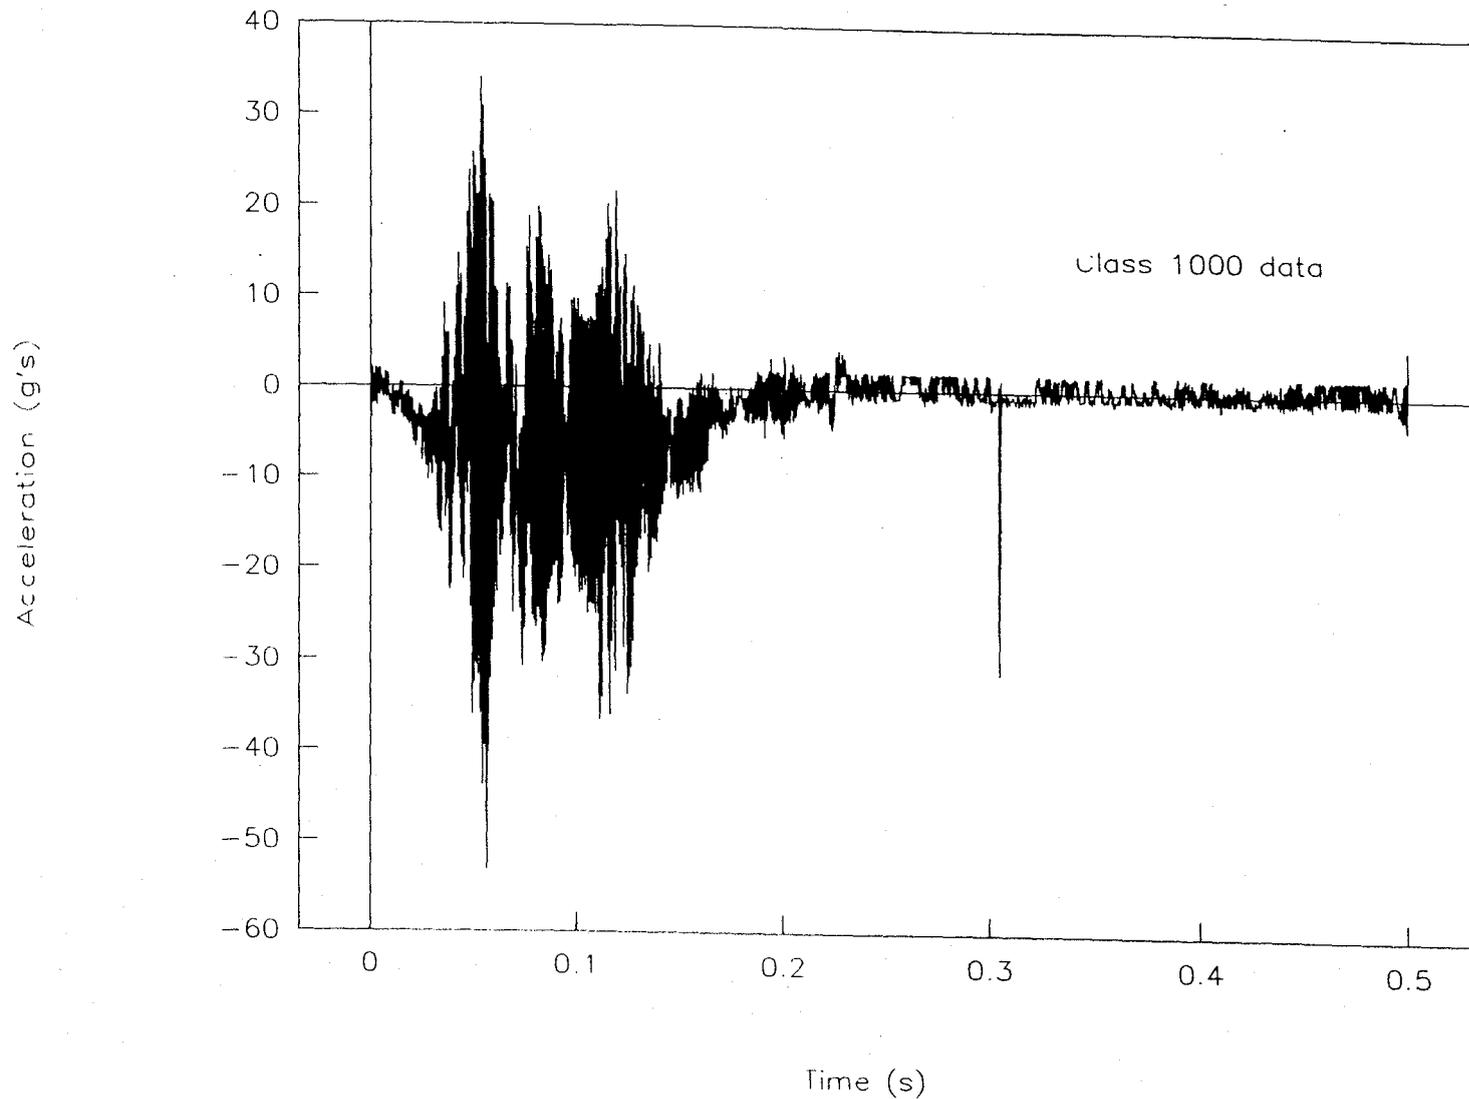
Figure 17. Acceleration vs. time, Y-axis rear axle, test 98S005.

Y-axis rear axle
