1994 Ford Explorer XLT Broadside

Collision with a Narrow Fixed Object:

FOIL Test Number 98S005

PUBLICATION NO. FHWA-RD-98-150

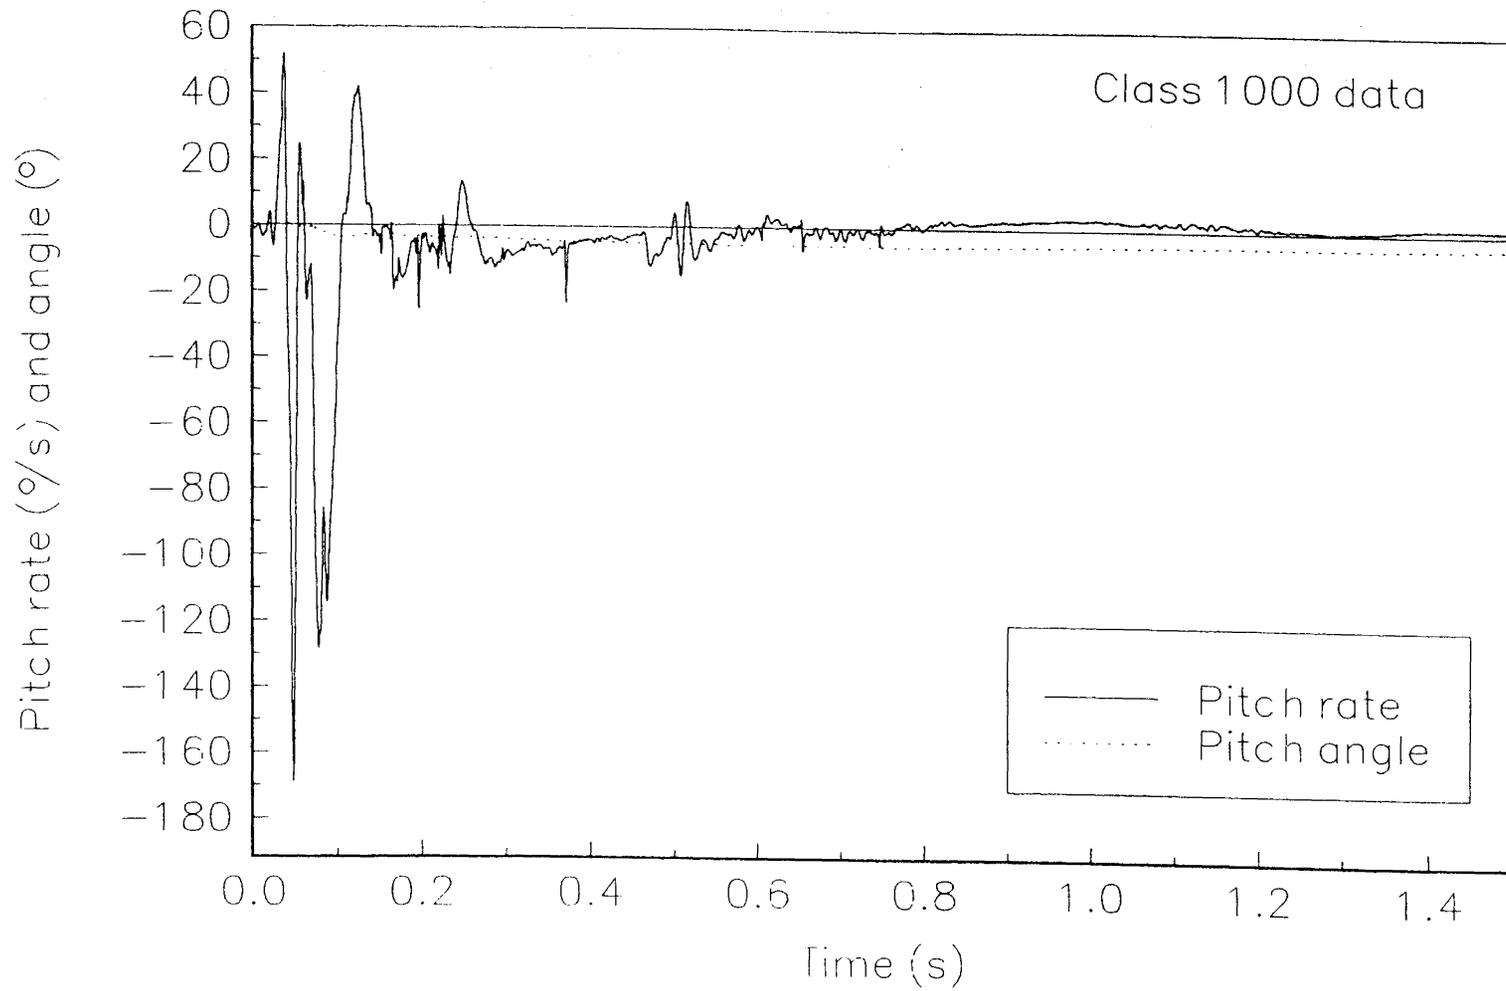
Figure 18. Pitch rate and angle vs. time, test 98S005.

Test No. 98S005
Pitch rate and angle vs. time

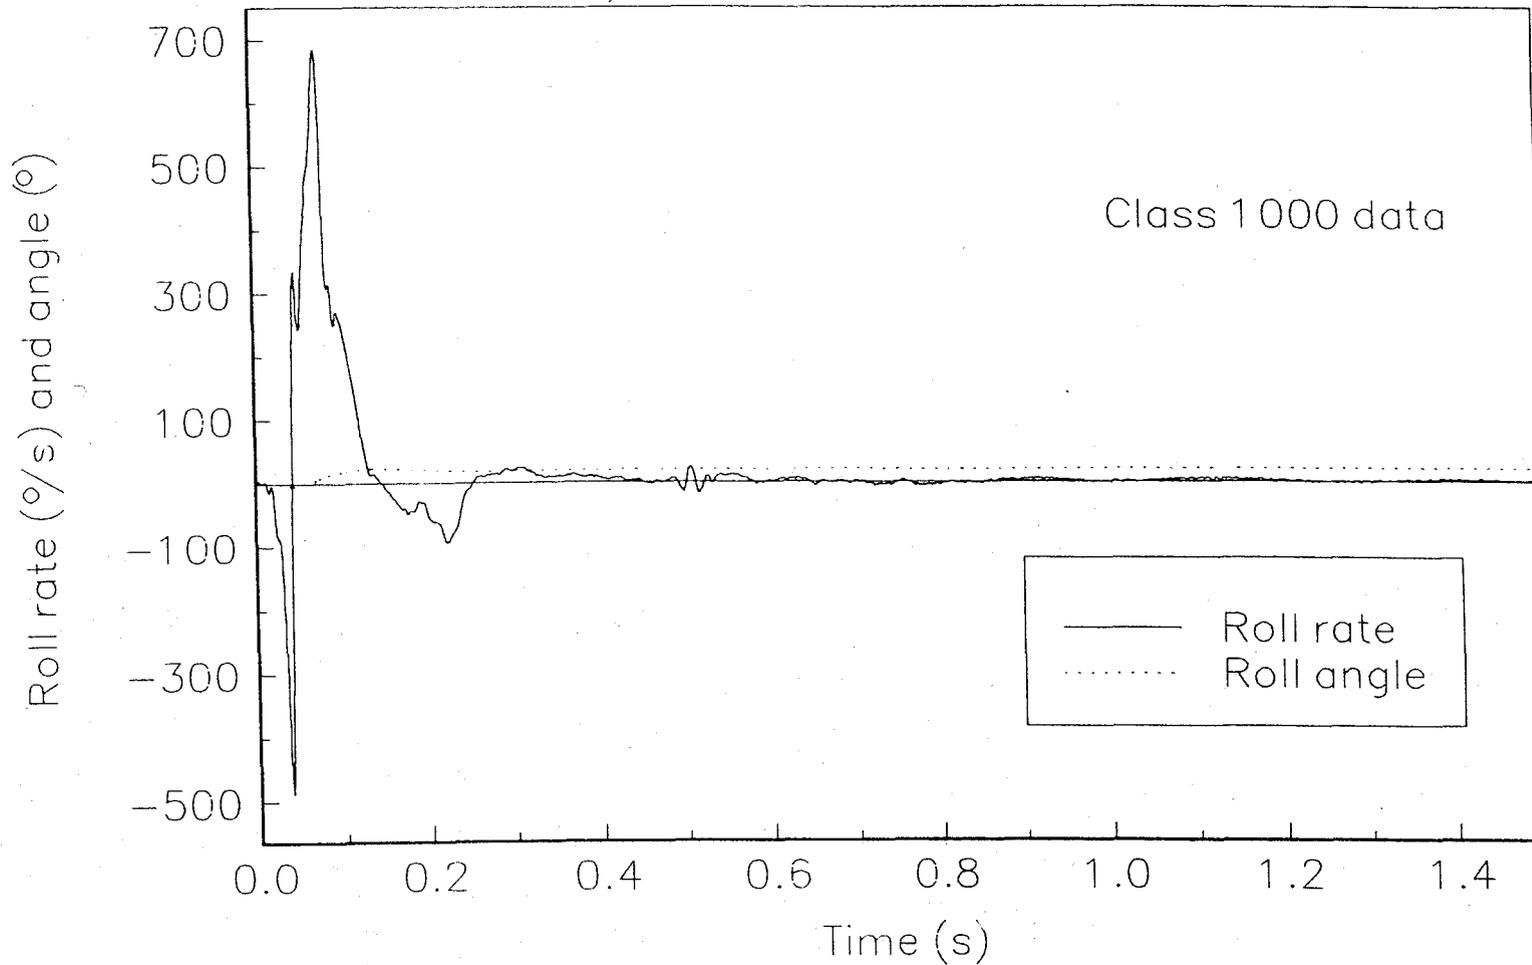
Figure 19. Roll rate and angle vs. time, test 98S005.

Test No. 98S005
Roll rate and angle vs. time

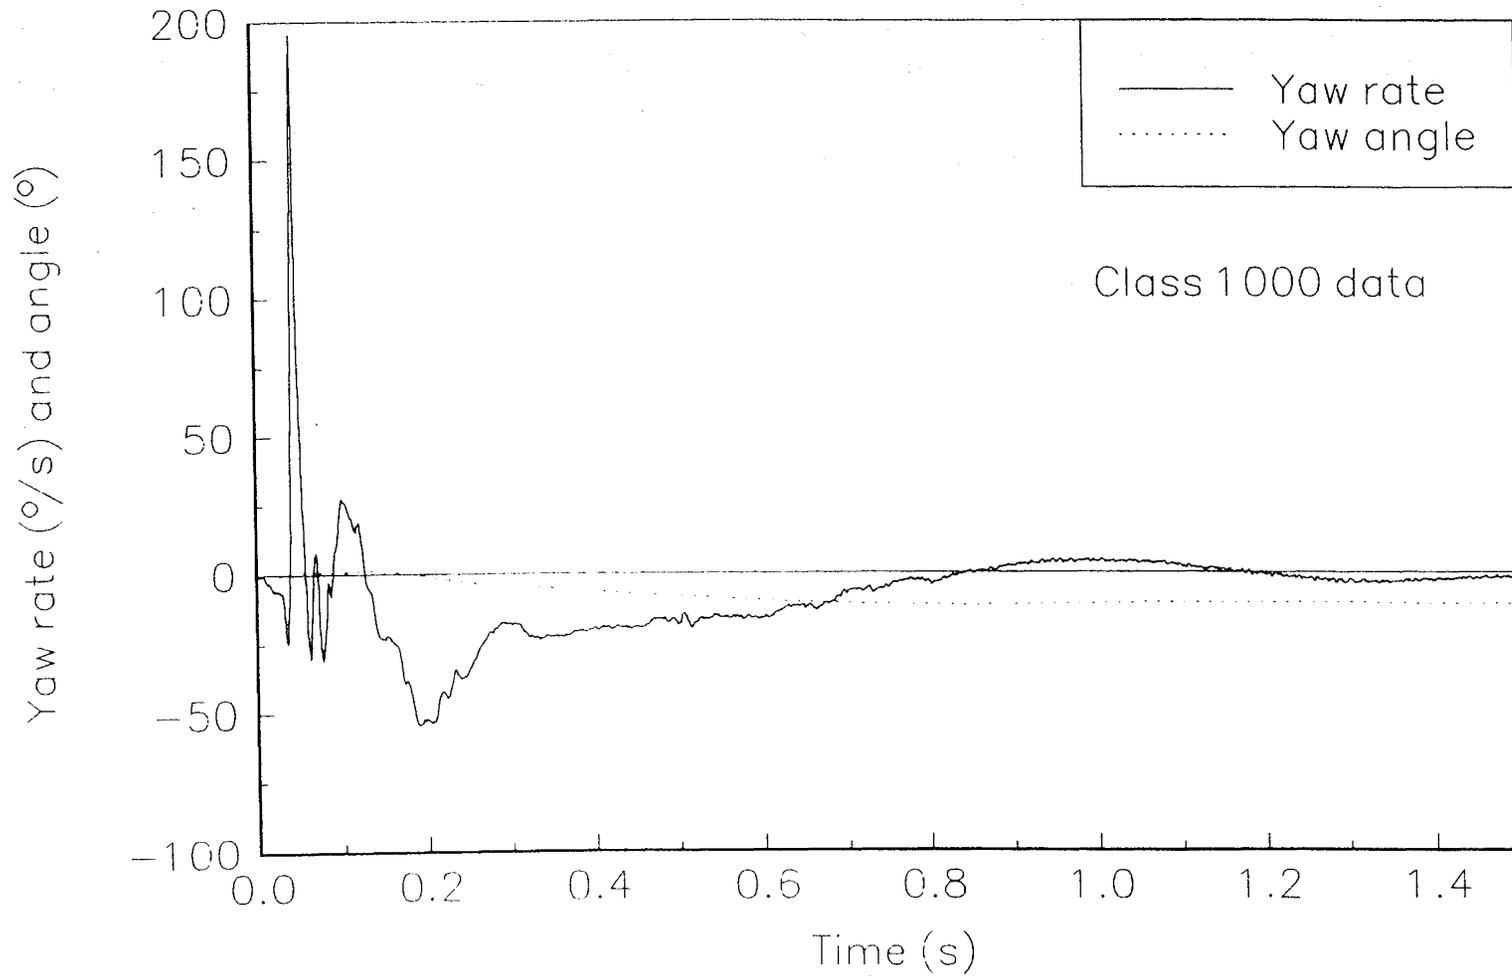
Figure 20. Yaw rate and angle vs. time, test 98S005.

Test No. 98S005
Yaw rate and angle vs. time

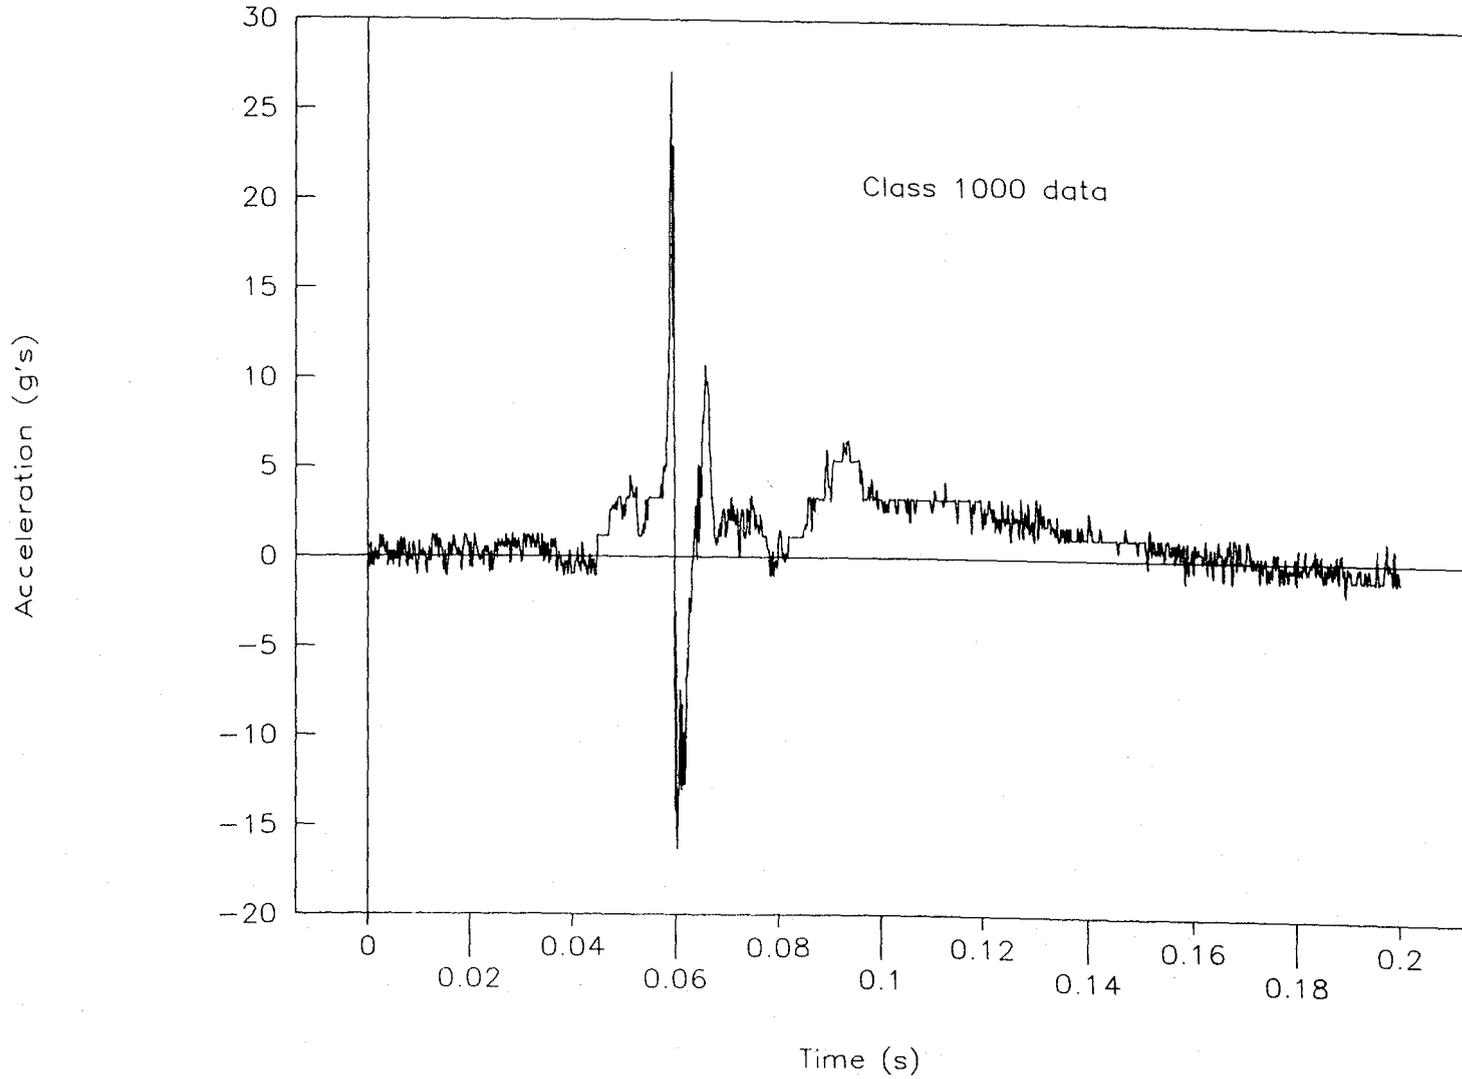
Figure 21. Acceleration vs. time, X-axis head, test 98S005.

X-axis, head acceleration vs. time

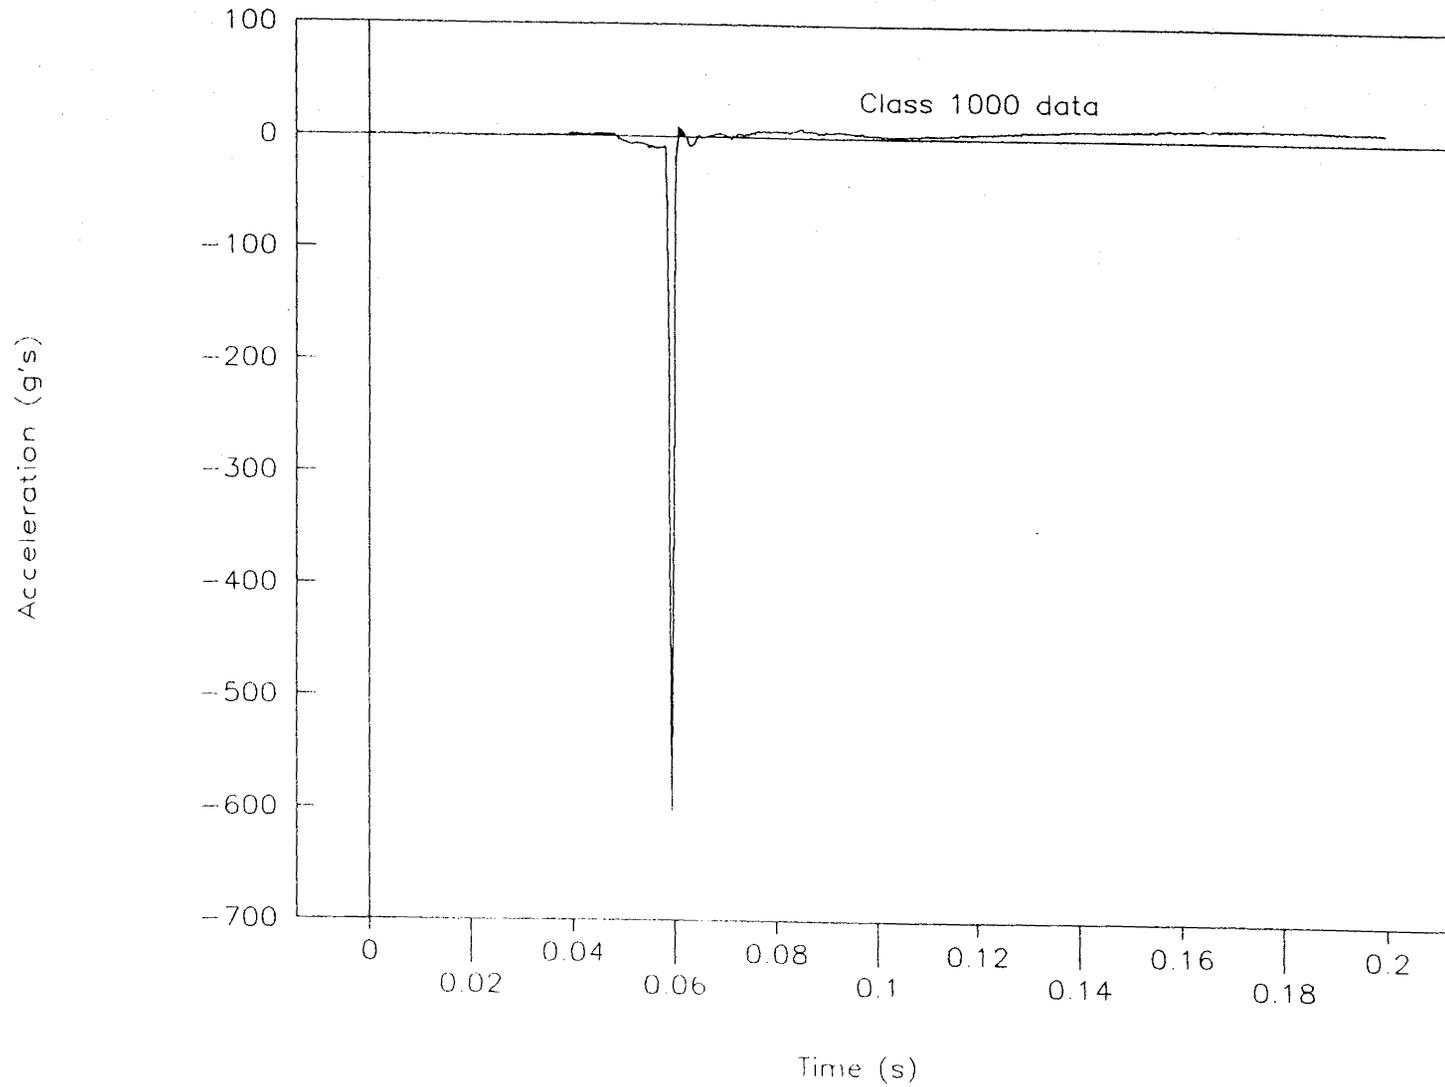
Figure 22. Acceleration vs. time, Y-axis head, test 98S005.

Y-axis, head acceleration vs. time

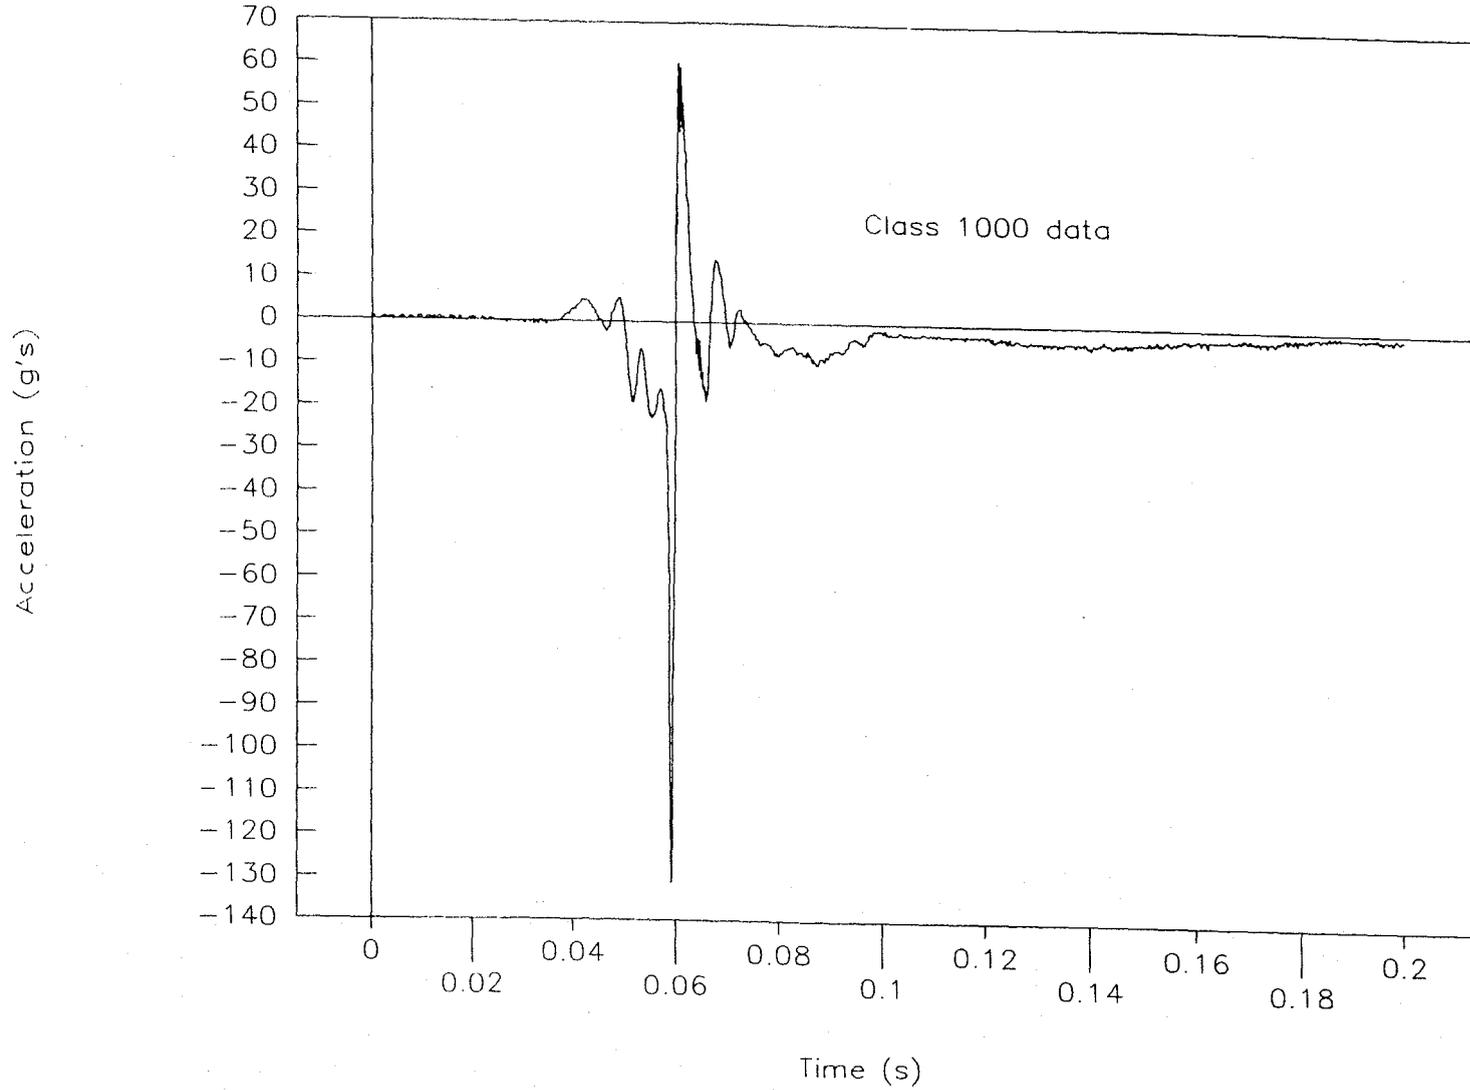
Figure 23. Acceleration vs. time, Z-axis head, test 98S005.

Test No. 98S005
Z-axis, head acceleration vs. time

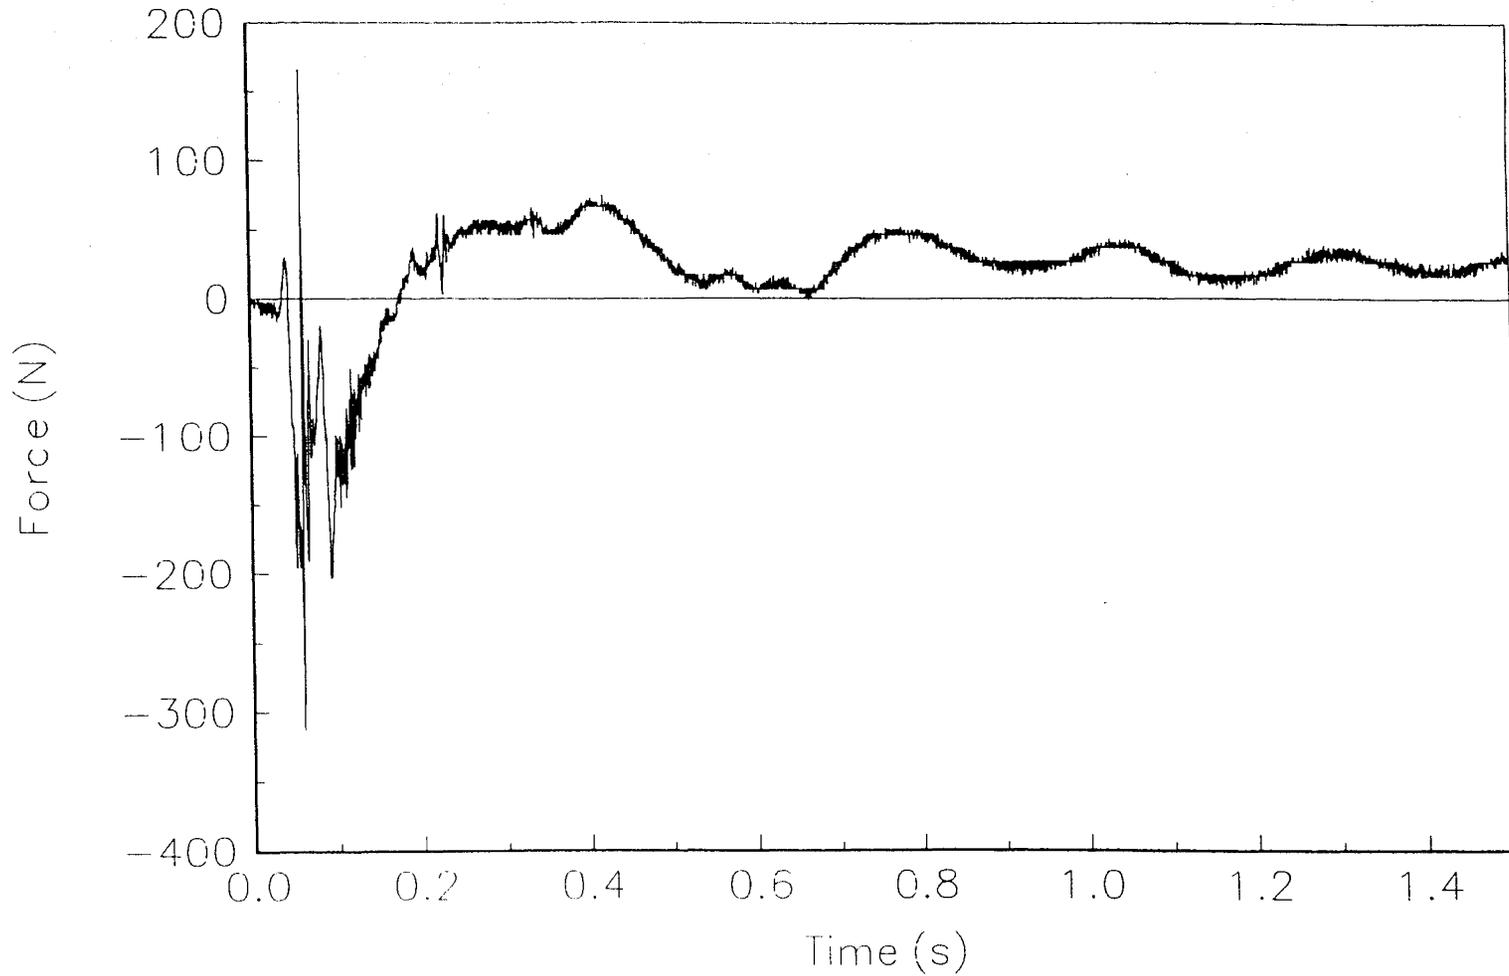
Figure 24. Force vs. time, X-axis neck, test 98S005.

Test No. 98S005
X-axis, neck force vs. time

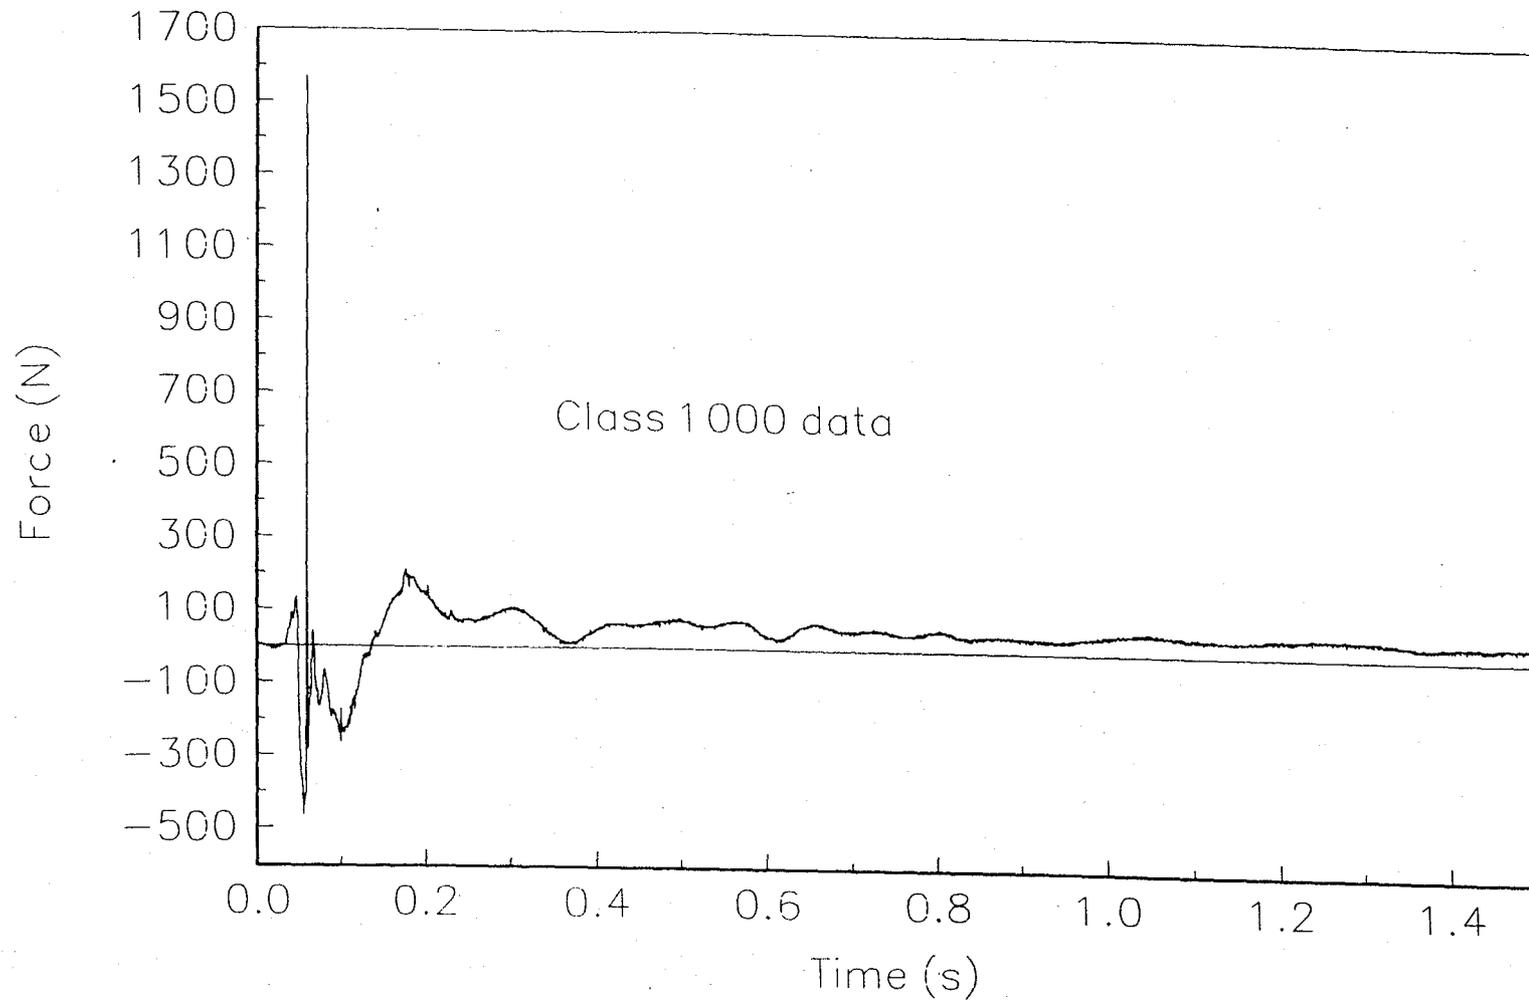
Figure 25. Force vs. time, Y-axis neck, test 98S005.

Test No. 98S005
Y-axis, neck force vs. time

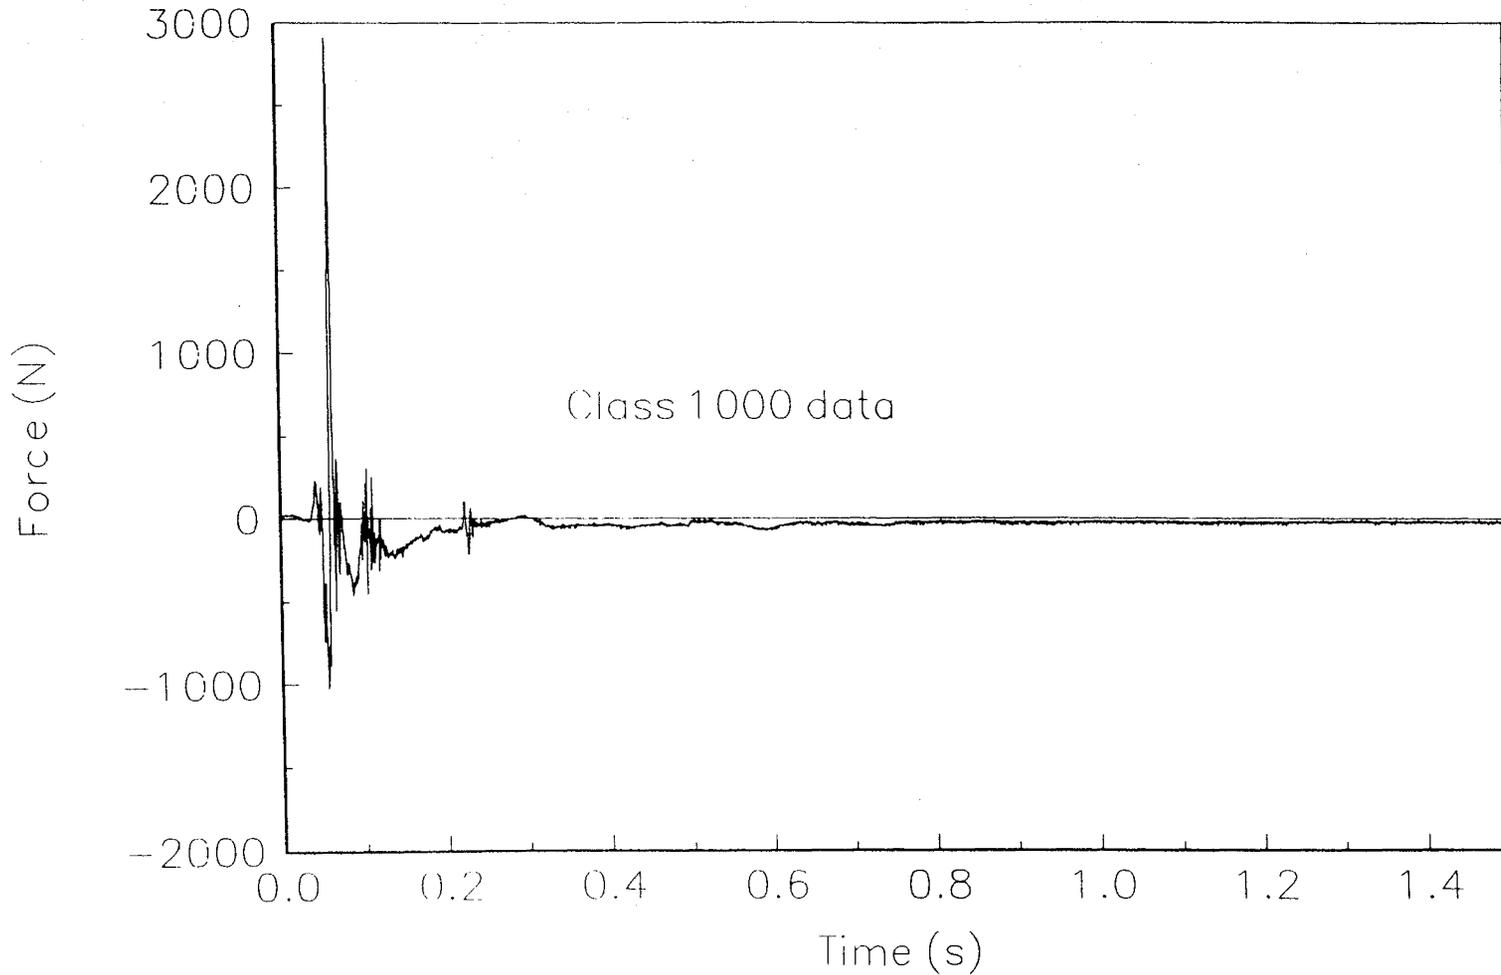
Figure 26. Force vs. time, Z-axis neck, test 98S005.

Test No. 98S005
Z-axis, neck force vs. time

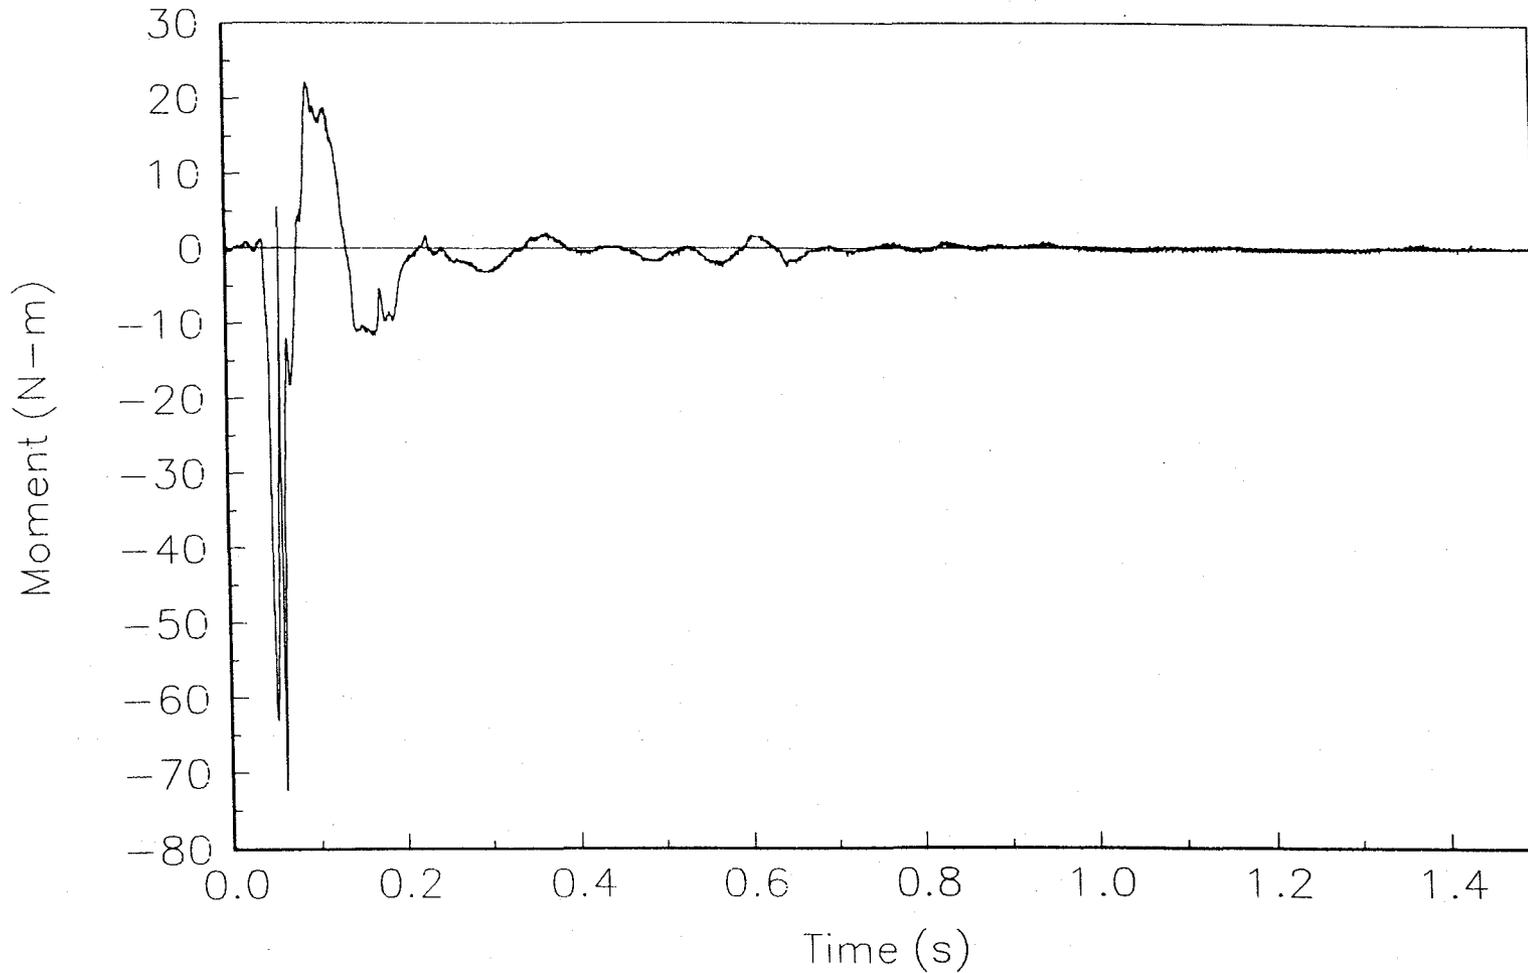
Figure 27. Moment vs. time, X-axis neck, test 98S005.

Test No. 98S005
X-axis, neck moment vs. time

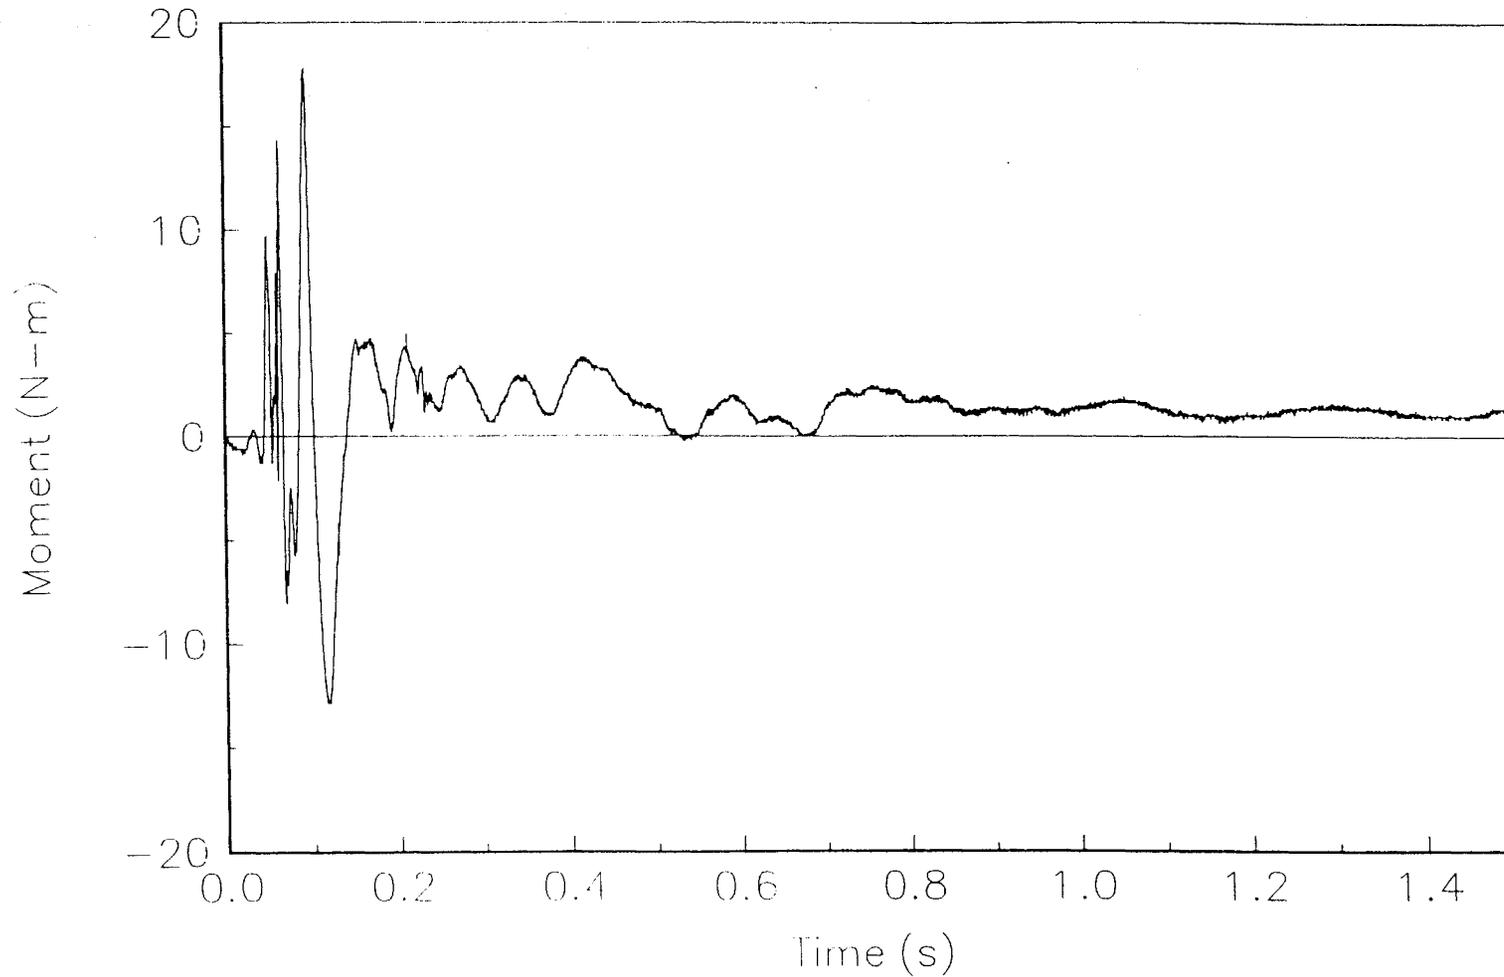
Figure 28. Moment vs. time, Y-axis neck, test 98S005.

Test No. 98S005
Y-axis, neck moment vs. time

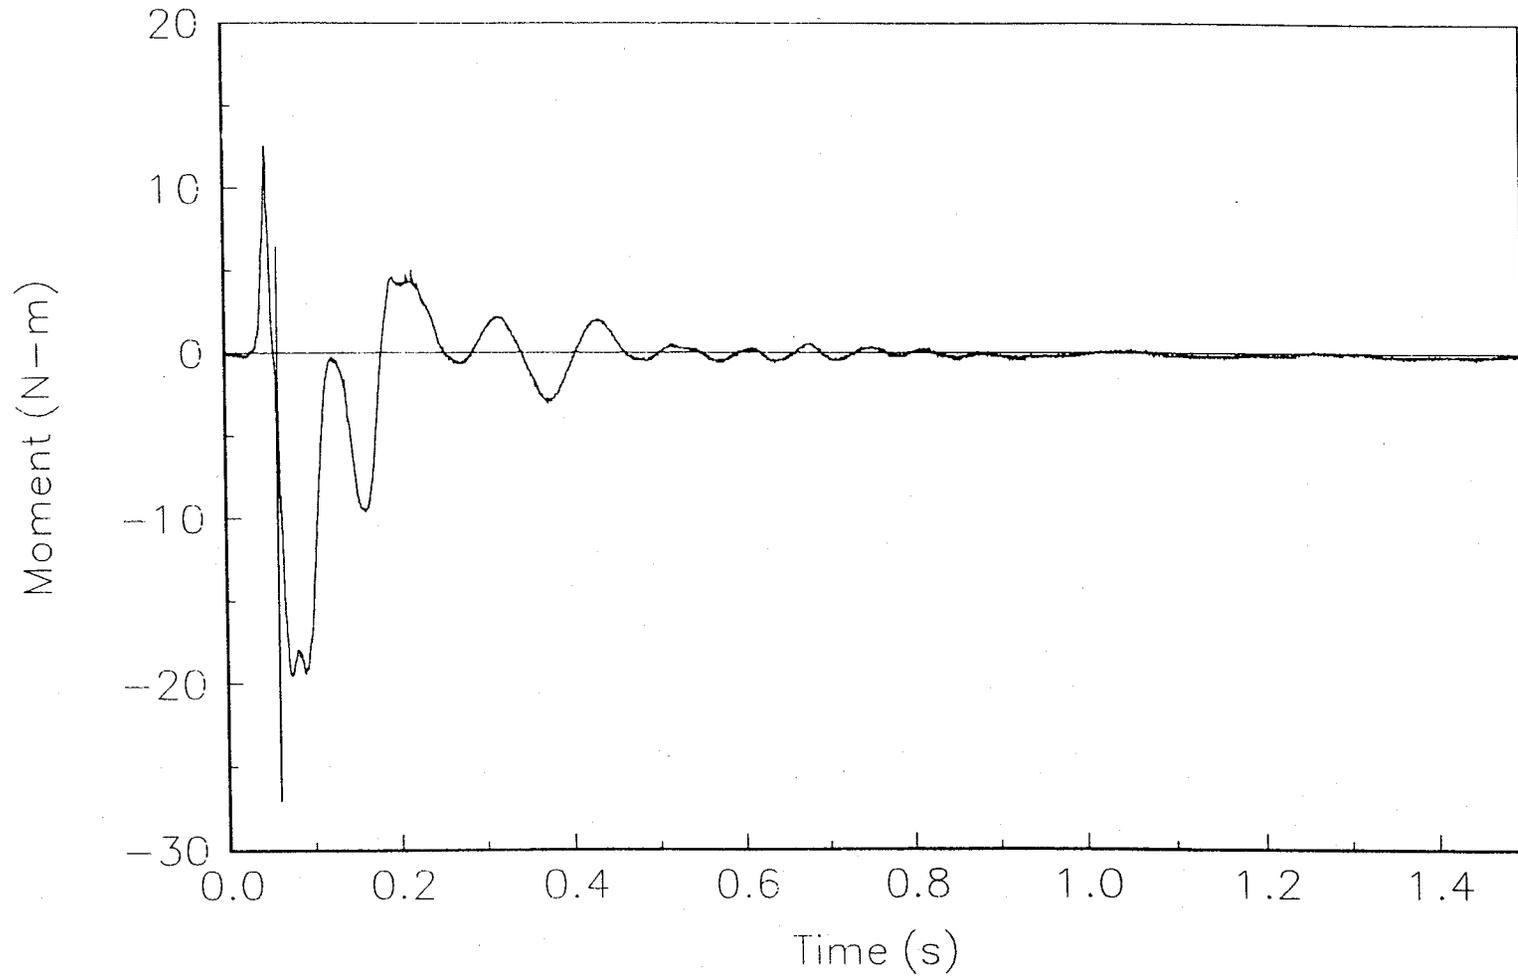
Figure 29. Moment vs. time, Z-axis neck, test 98S005.

Test No. 98S005
Z-axis, neck moment vs. time

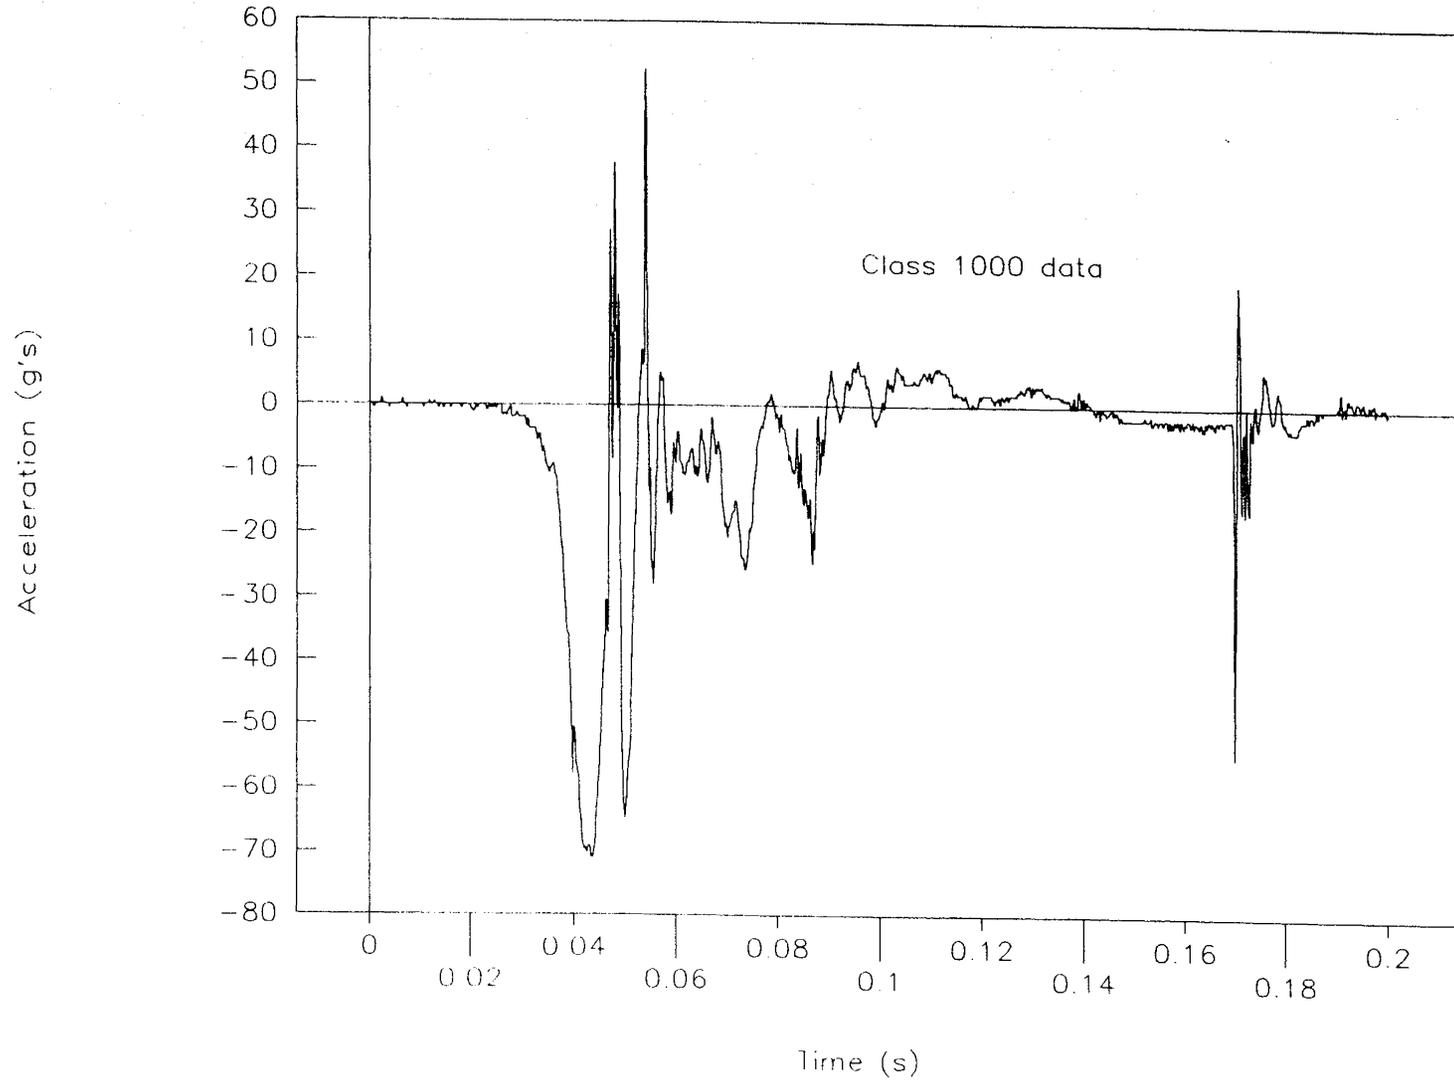
Figure 30. Acceleration vs. time, primary upper rib, test 98S005.

Primary upper rib

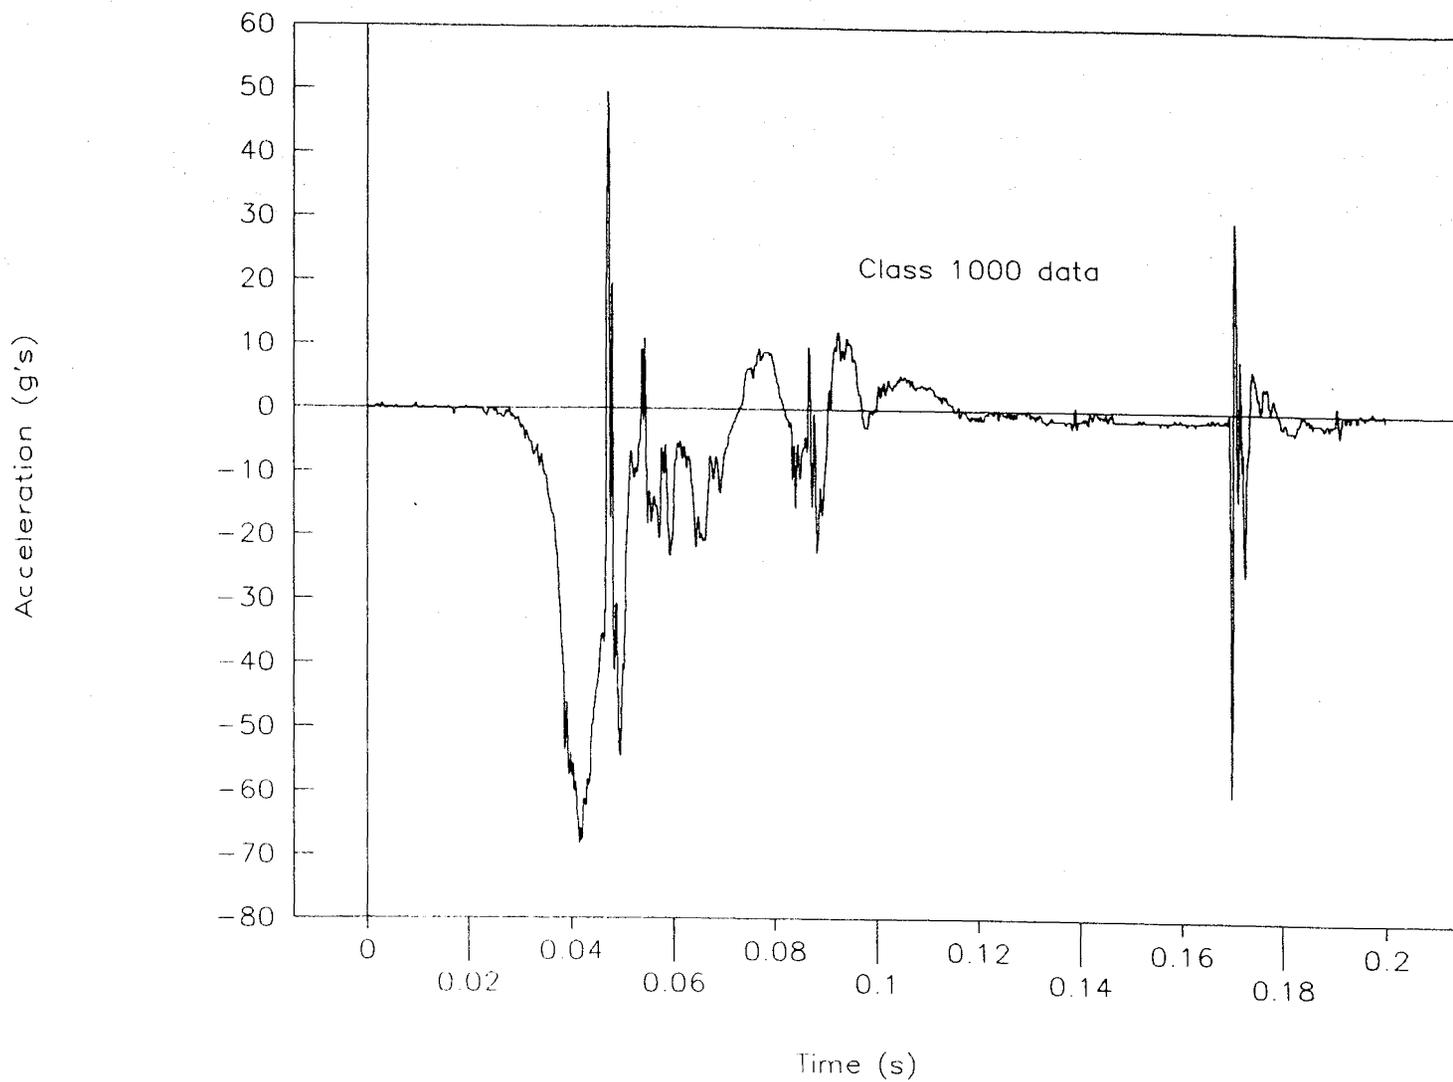
Figure 32. Acceleration vs. time, primary lower rib, test 98S005.

Primary lower rib

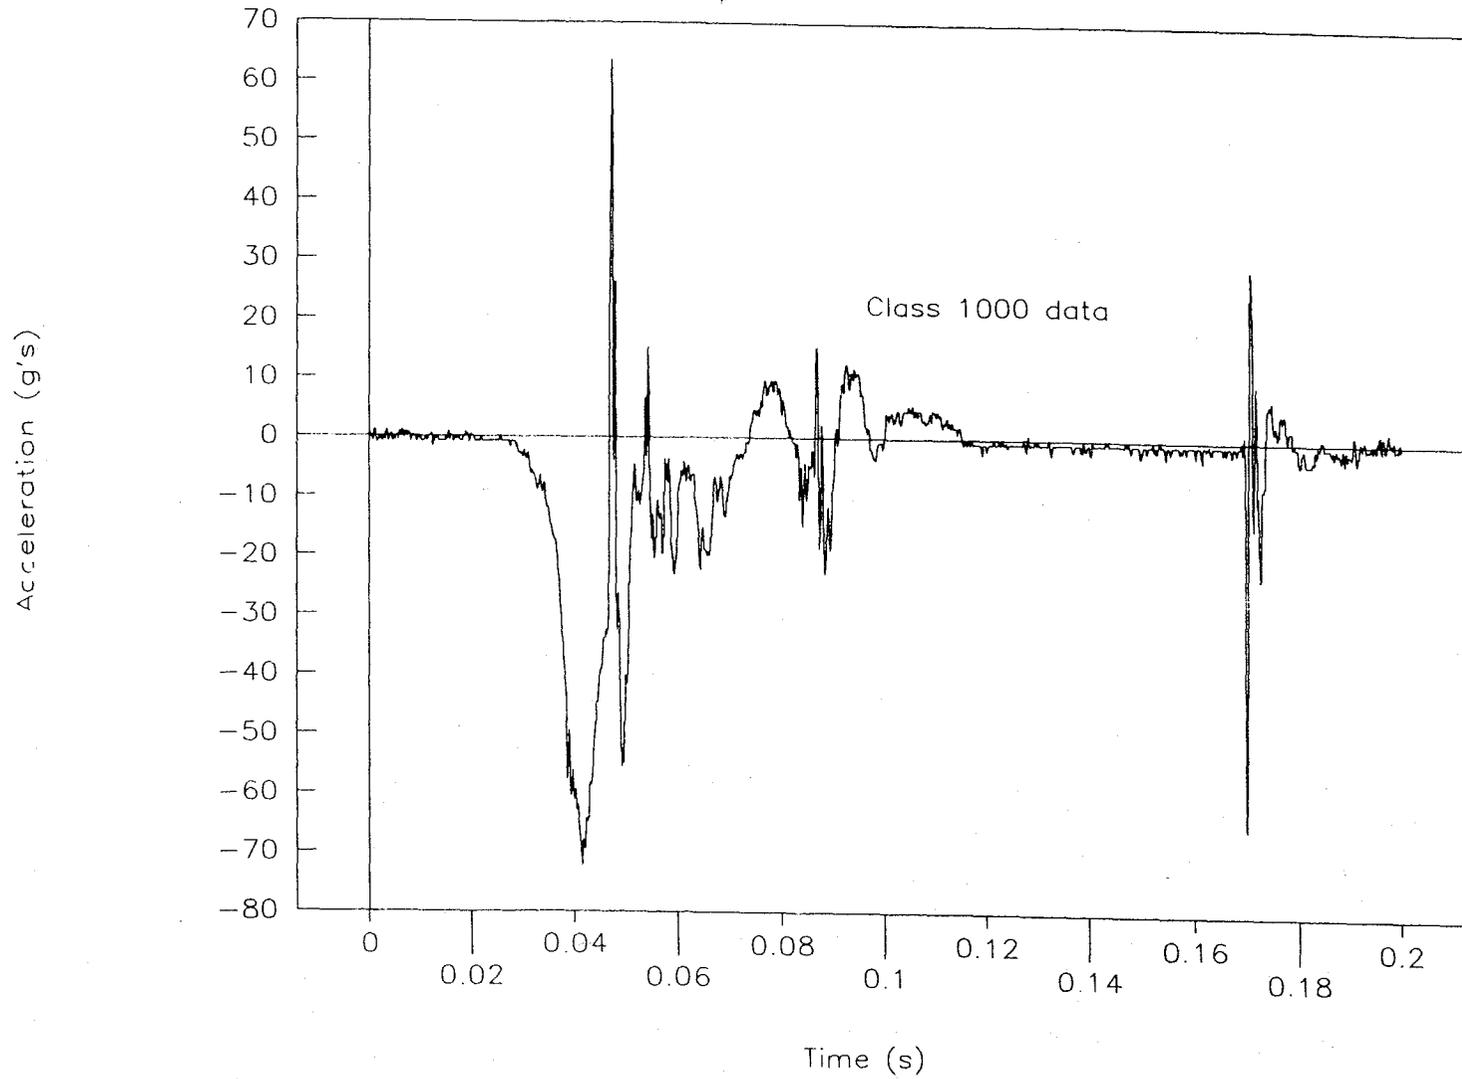
Figure 33. Acceleration vs. time, redundant lower rib, test 98S005.

Redundant lower rib
