1994 Ford Explorer XLT Broadside

Collision with a Narrow Fixed Object:

FOIL Test Number 98S005

PUBLICATION NO. FHWA-RD-98-150

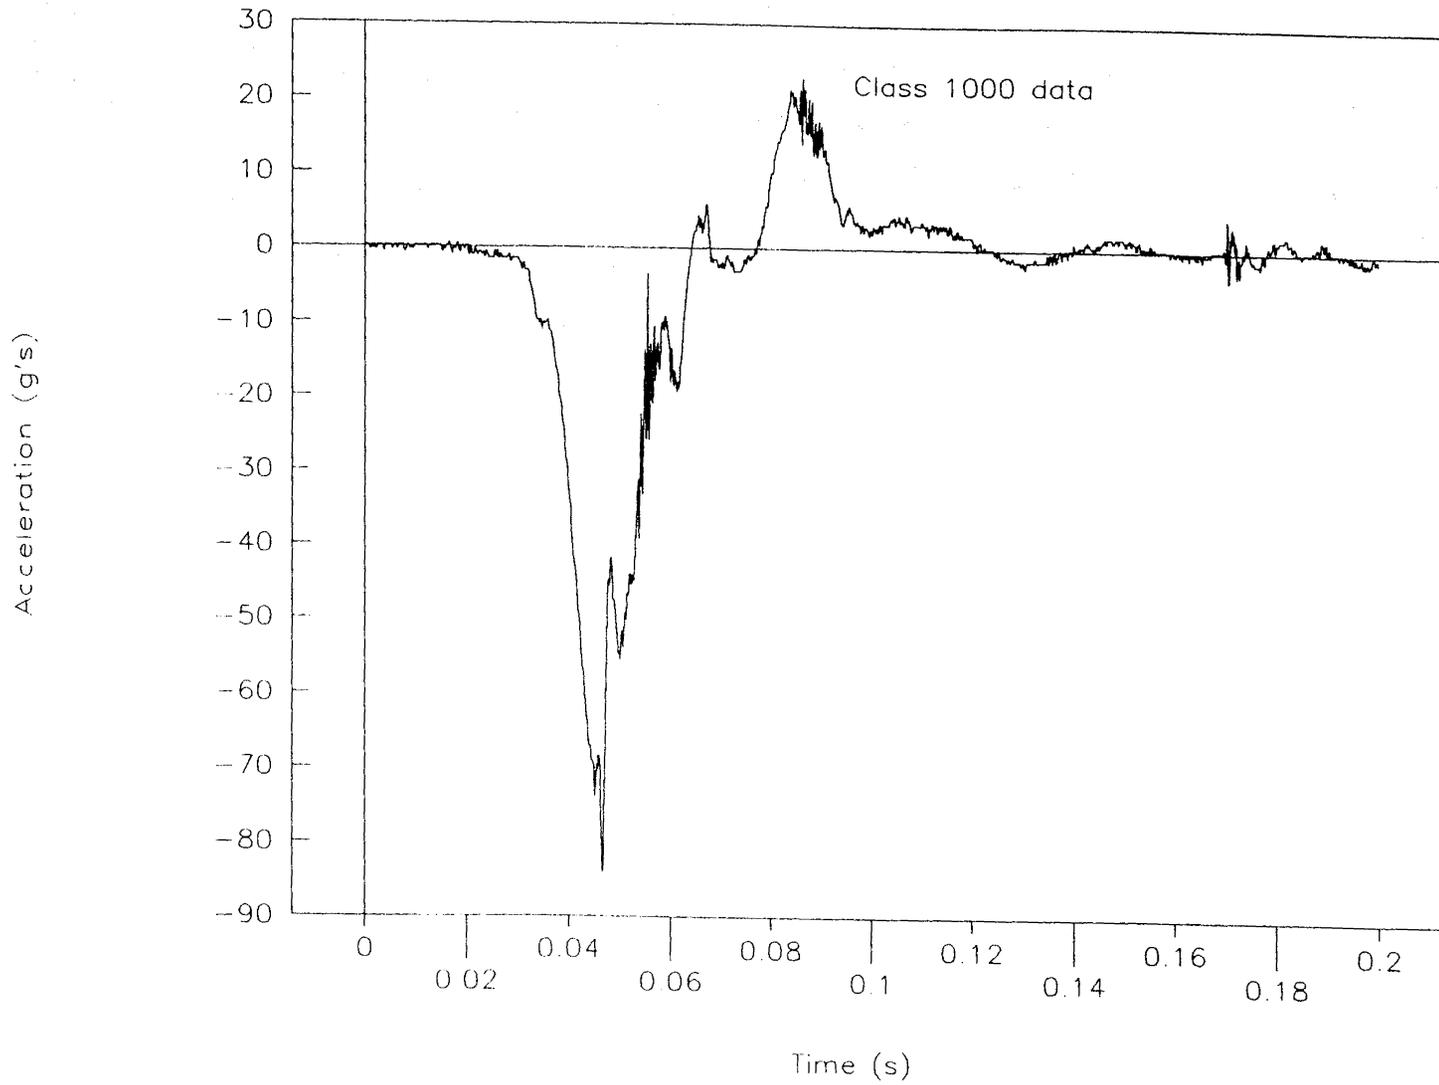
Figure 34. Acceleration vs. time, primary T12 spine, test 98S005.

Primary T12 spine

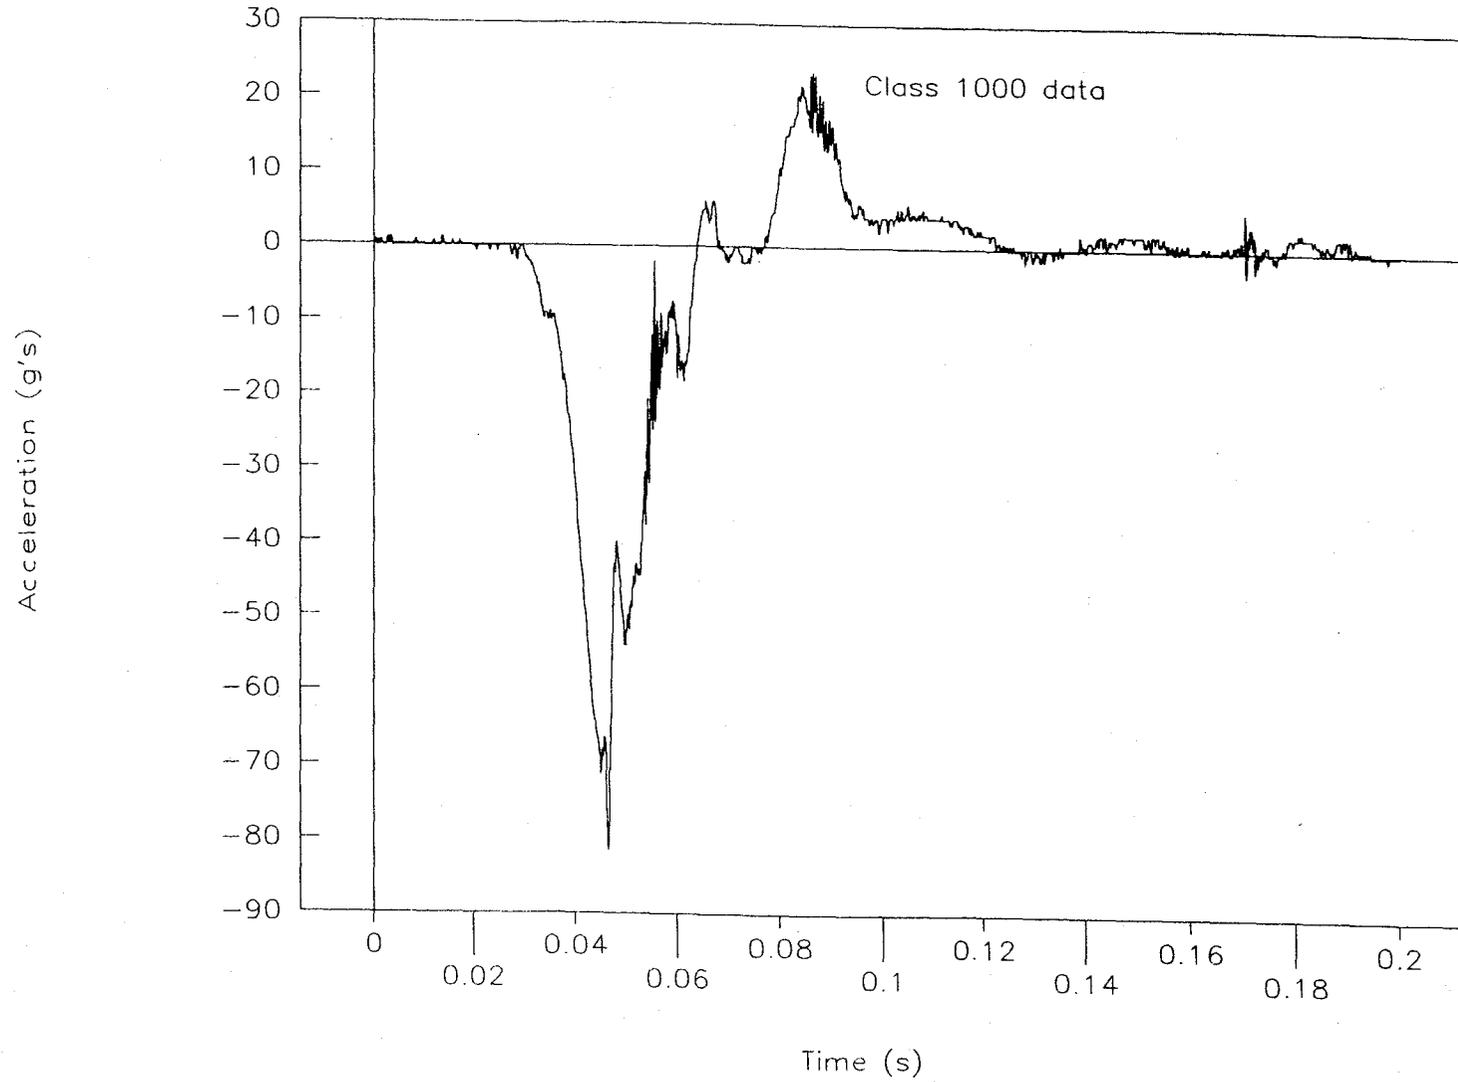
Figure 35. Acceleration vs. time, redundant T12 spine, test 98S005.

Redundant T12 spine

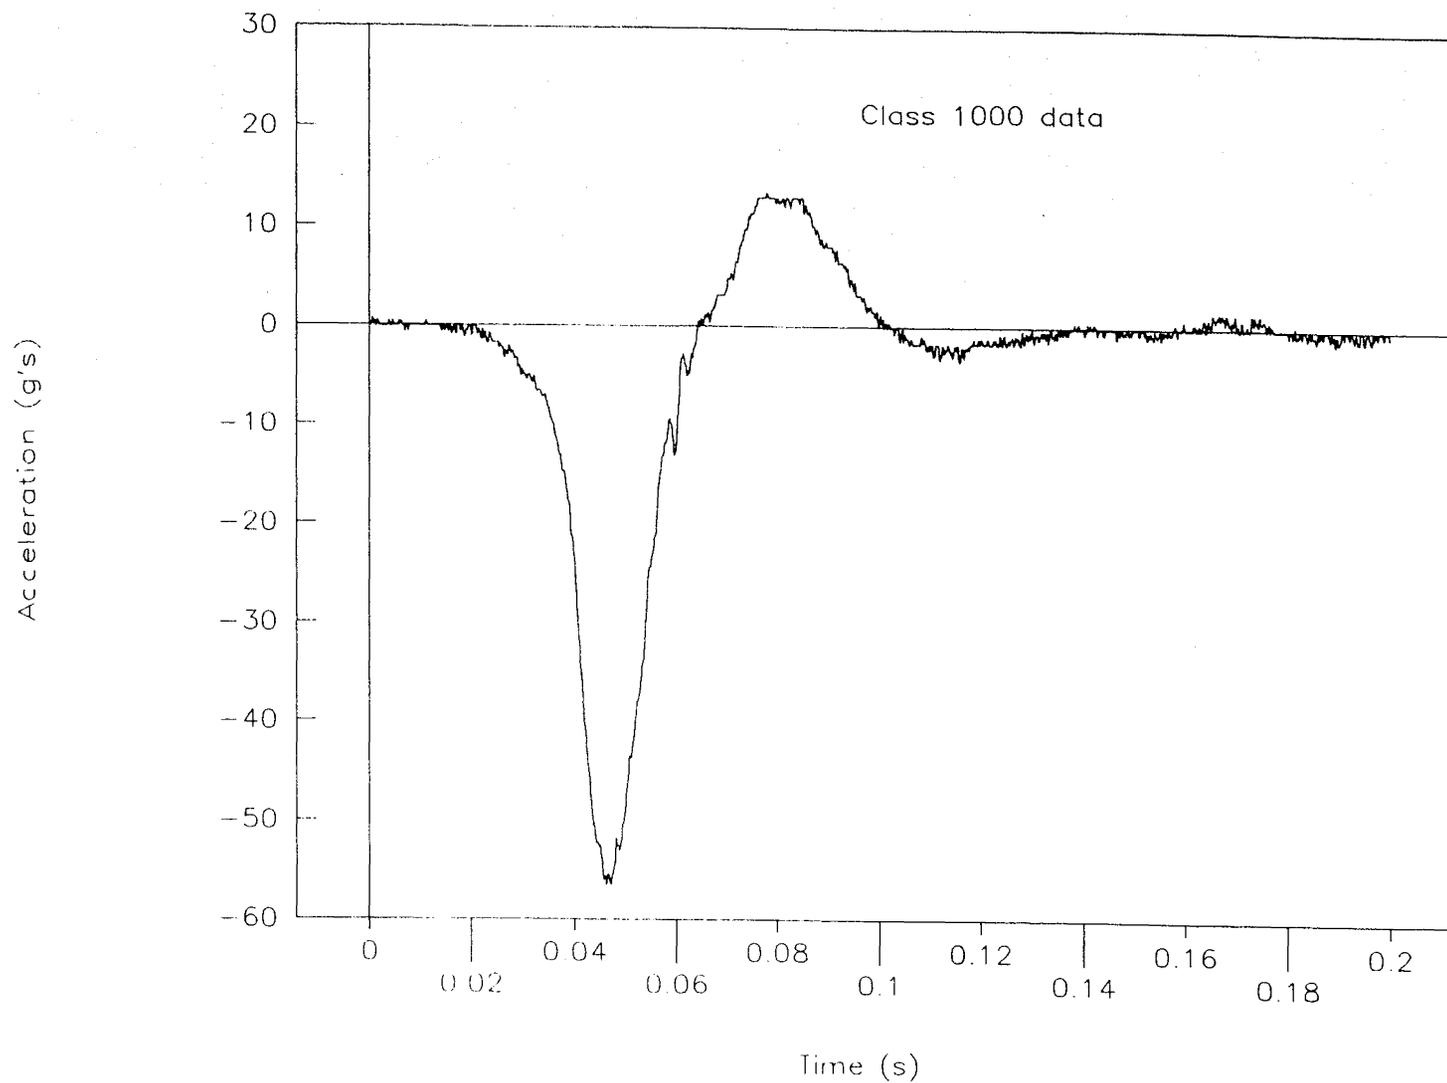
Figure 36. Acceleration vs. time, Y-axis pelvis, test 98S005.

Y-axis pelvis

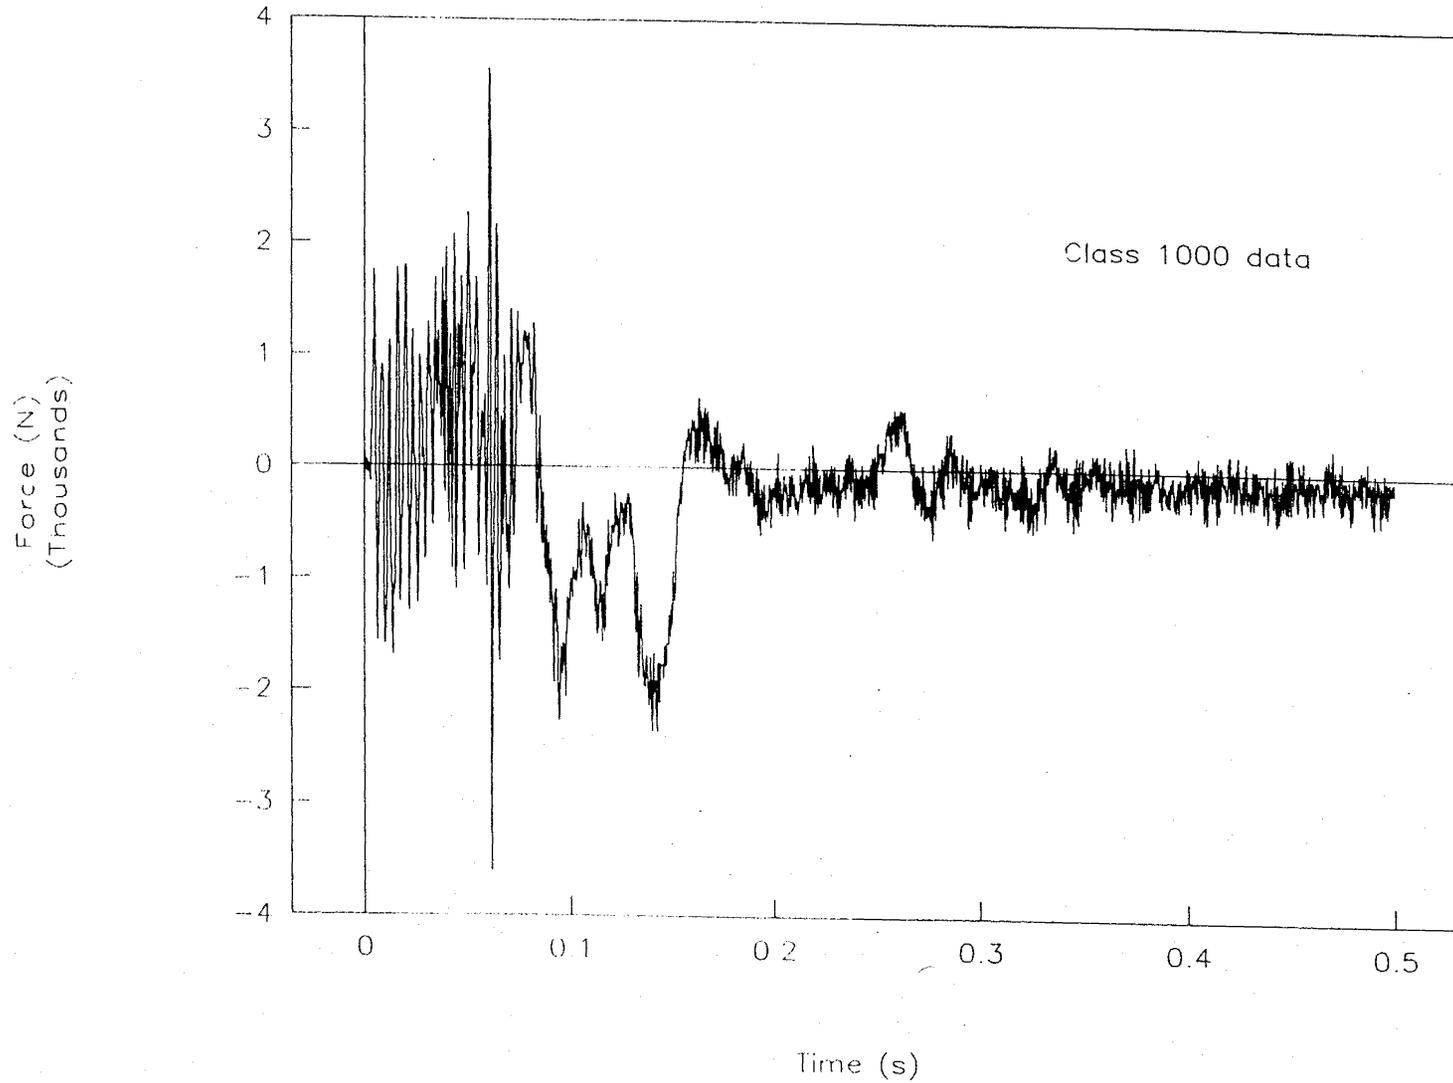
Figure 40. Rigid pole, force vs. time, upper face upper load cell, test 98S005.

Upper face upper load cell

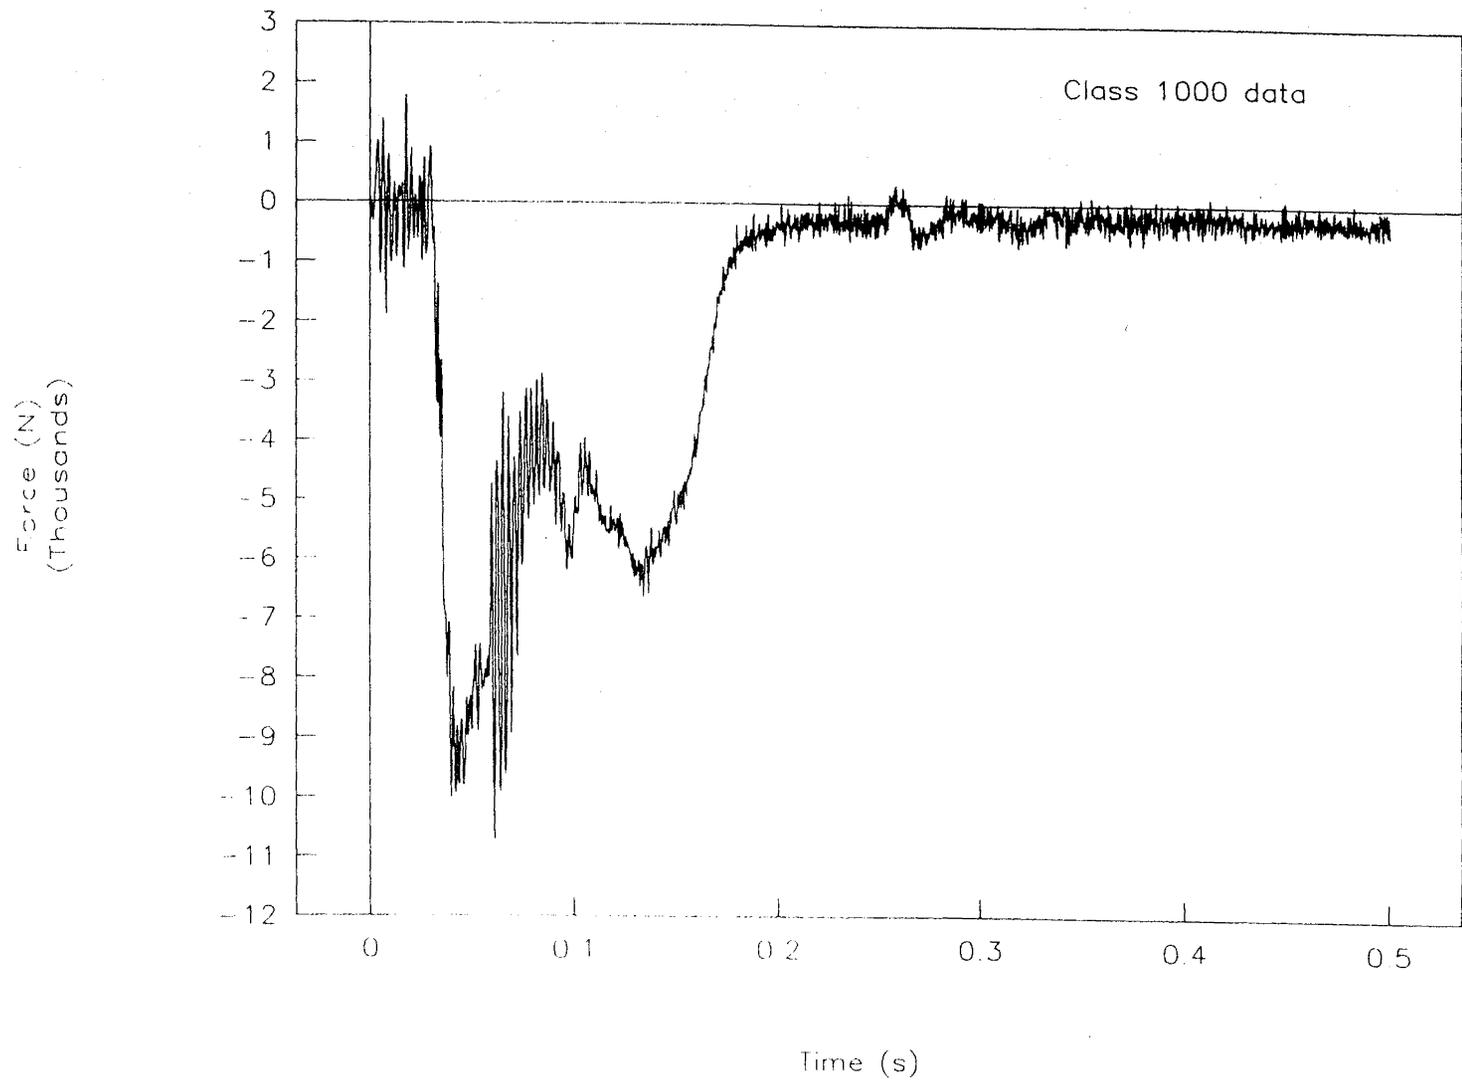
Figure 41. Rigid pole, force vs. time, upper face lower load cell, test 98S005.

Upper face lower load cell

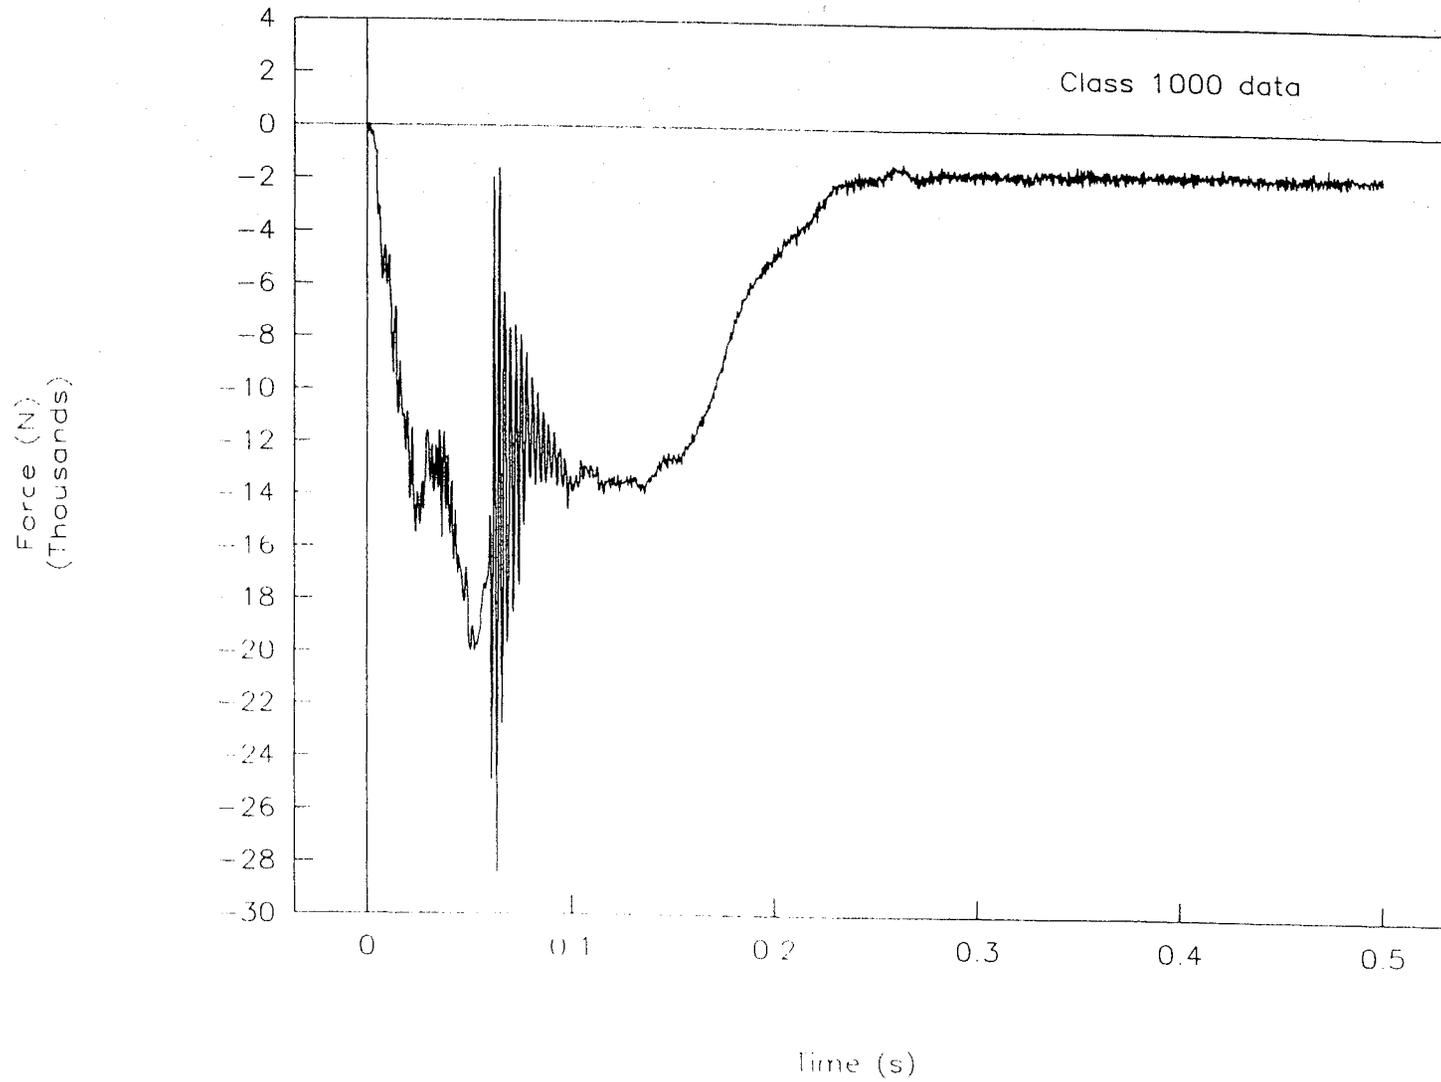
Figure 43. Rigid pole, force vs. time, upper-middle face lower load cell, test 98S005.

Upper-middle face lower load cell

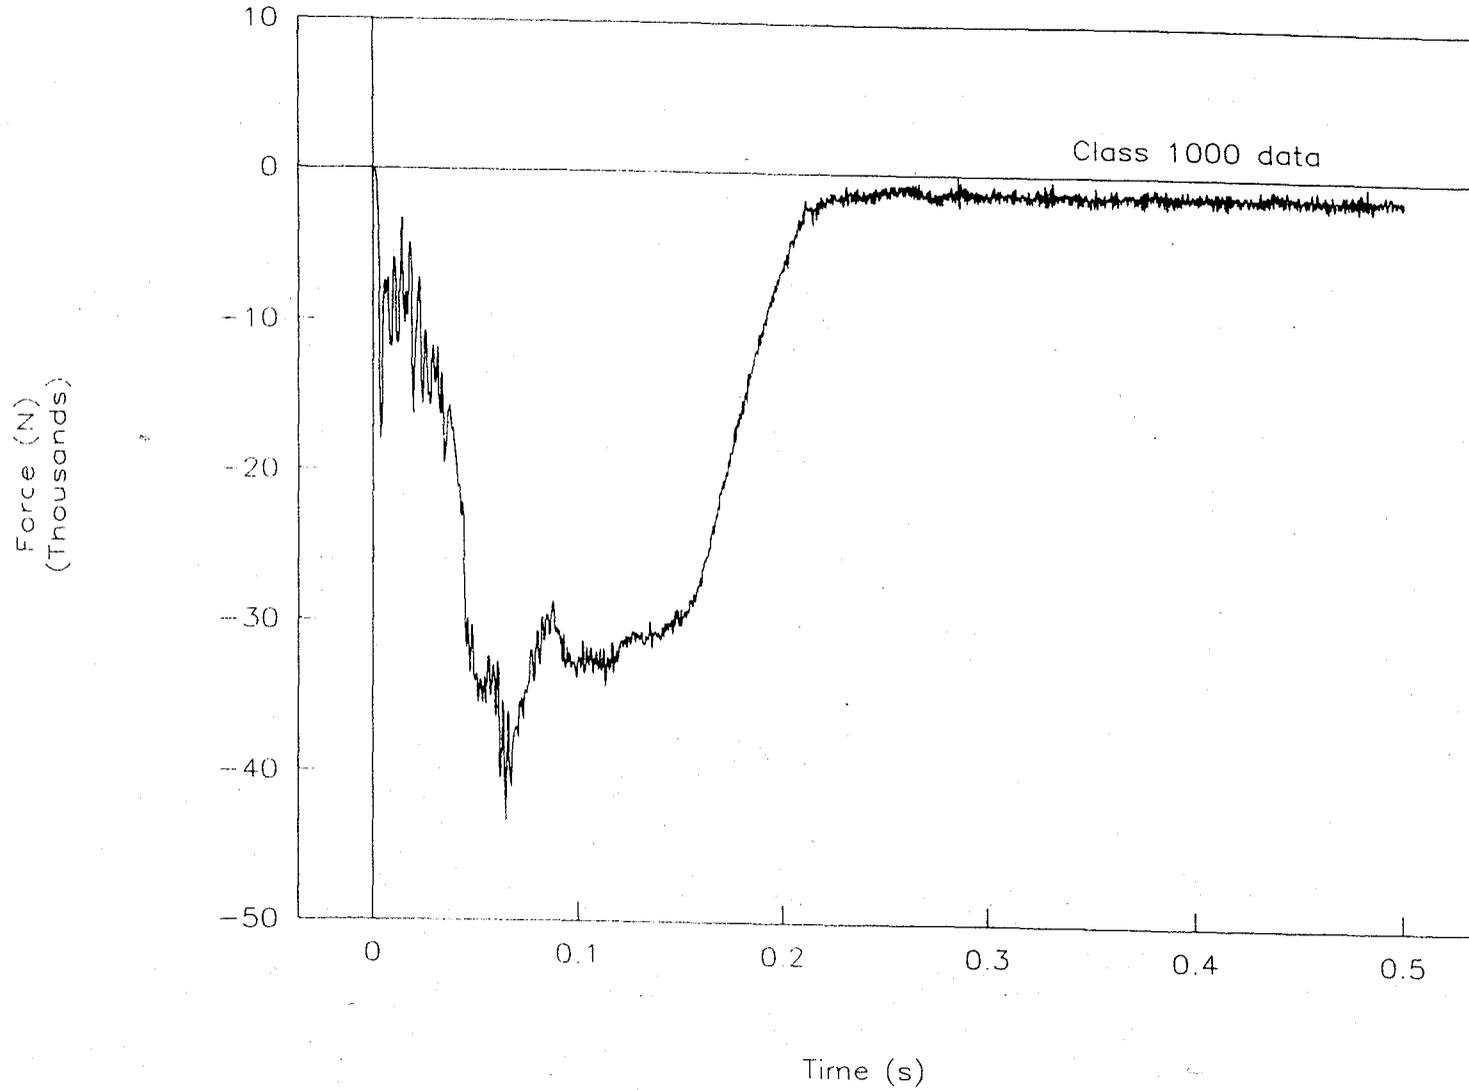
Figure 44. Rigid pole, force vs. time, lower-middle face upper load cell, test 98S005.

Lower-middle face upper load cell

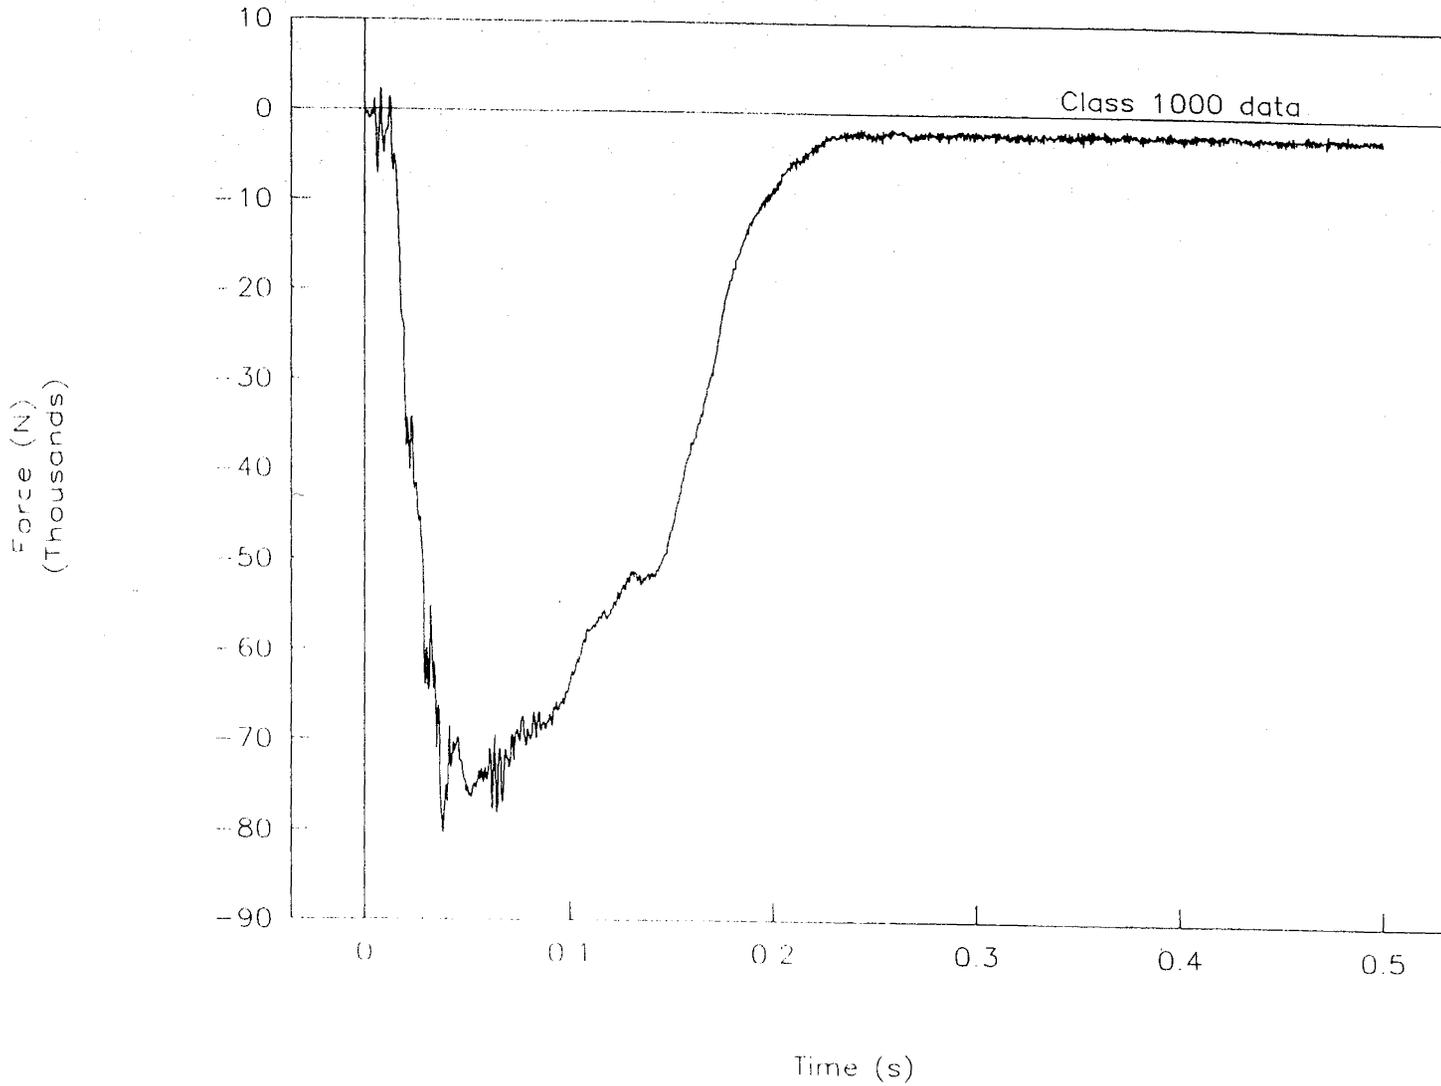
Figure 45. Rigid pole, force vs. time, lower-middle face lower load cell, test 98S005.

Lower-middle face lower load cell

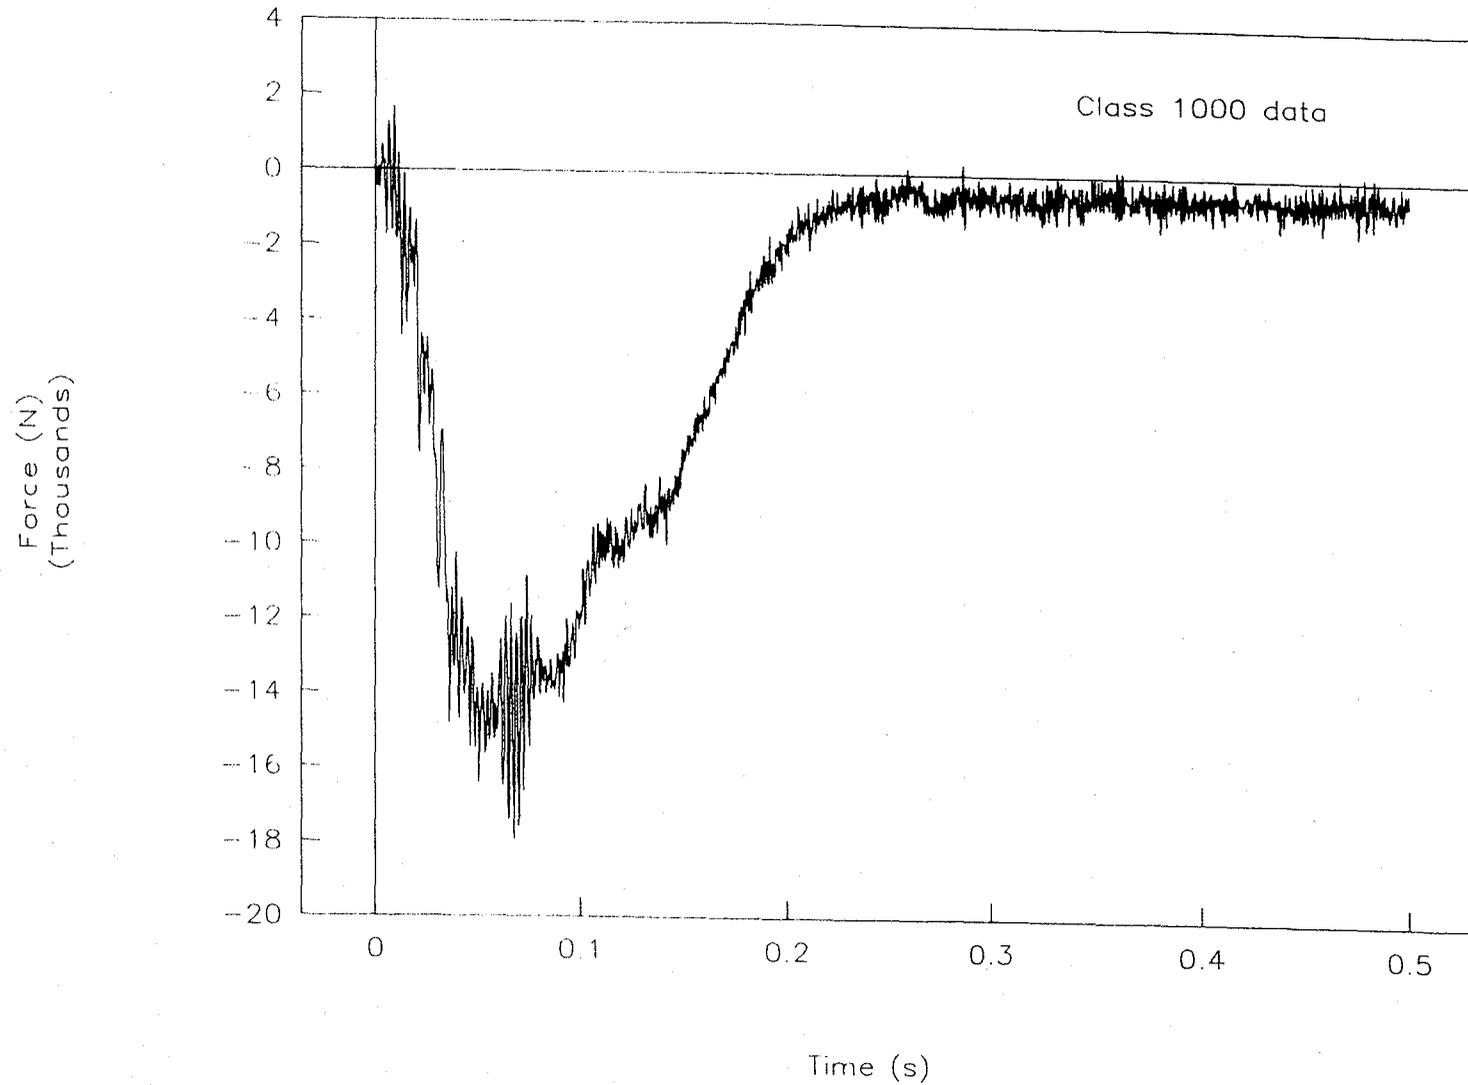
Figure 46. Rigid pole, force vs. time, bottom face upper load cell, test 98S005.

Bottom face upper load cell

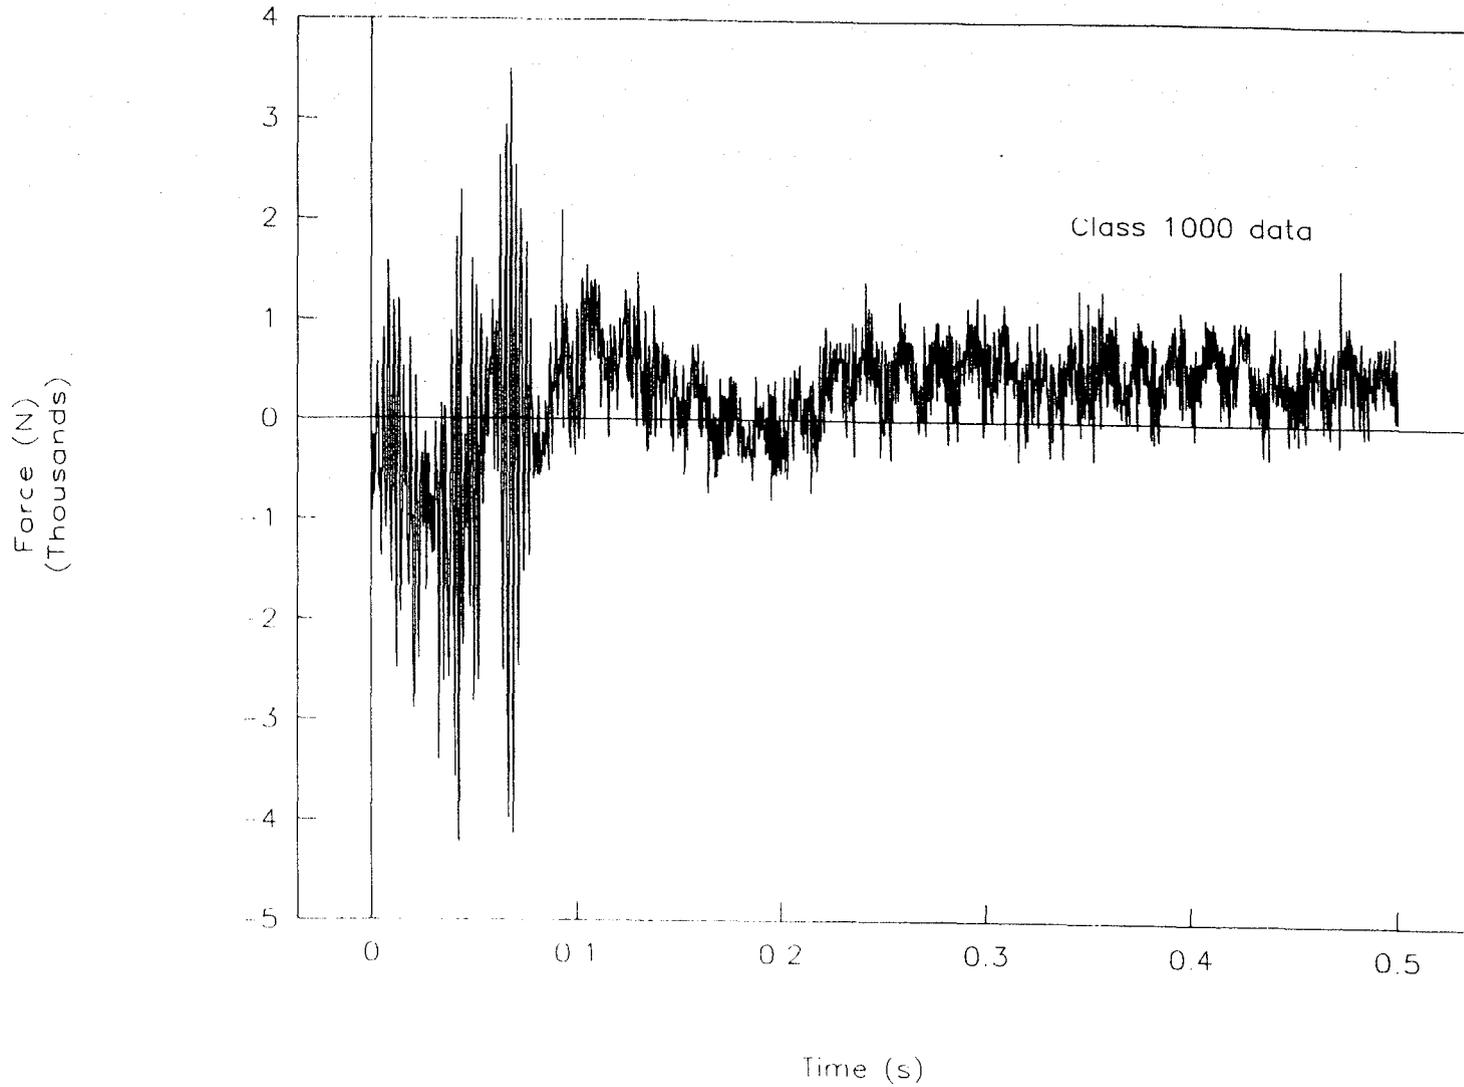
Figure 47. Rigid pole, force vs. time, bottom face lower load cell, test 98S005.

Bottom face lower load cell
