Taconite As a Lower-Cost, Alternative High-Friction Surface Treatment to Calcined Bauxite for Low Volume Roads in Minnesota

June 2025

Research Project
Final Report 2025-41

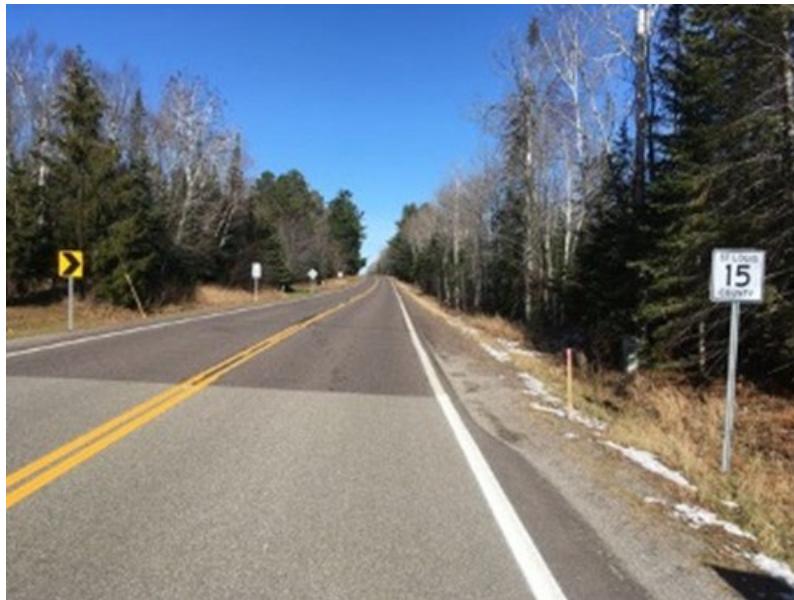
Figure 3.2. Calcined bauxite surface treatment (foreground) and existing pavement at CSAH-15 location (looking north): November 2, 2020

The calcined bauxite treatment is the lighter-colored pavement (relative to the existing darker-colored pavement) in the foreground of the photograph (Figure 3.2). The view is looking north. The effect that aggregates and pavement surface treatment color has on pavement temperature were to be measured and documented using thermal imaging. Figure 3.3 is a close-up view of the existing pavement (left) and the calcined bauxite treatment (right). Note the finer size of the calcined bauxite aggregate, which reflects the specified HFST gradation.

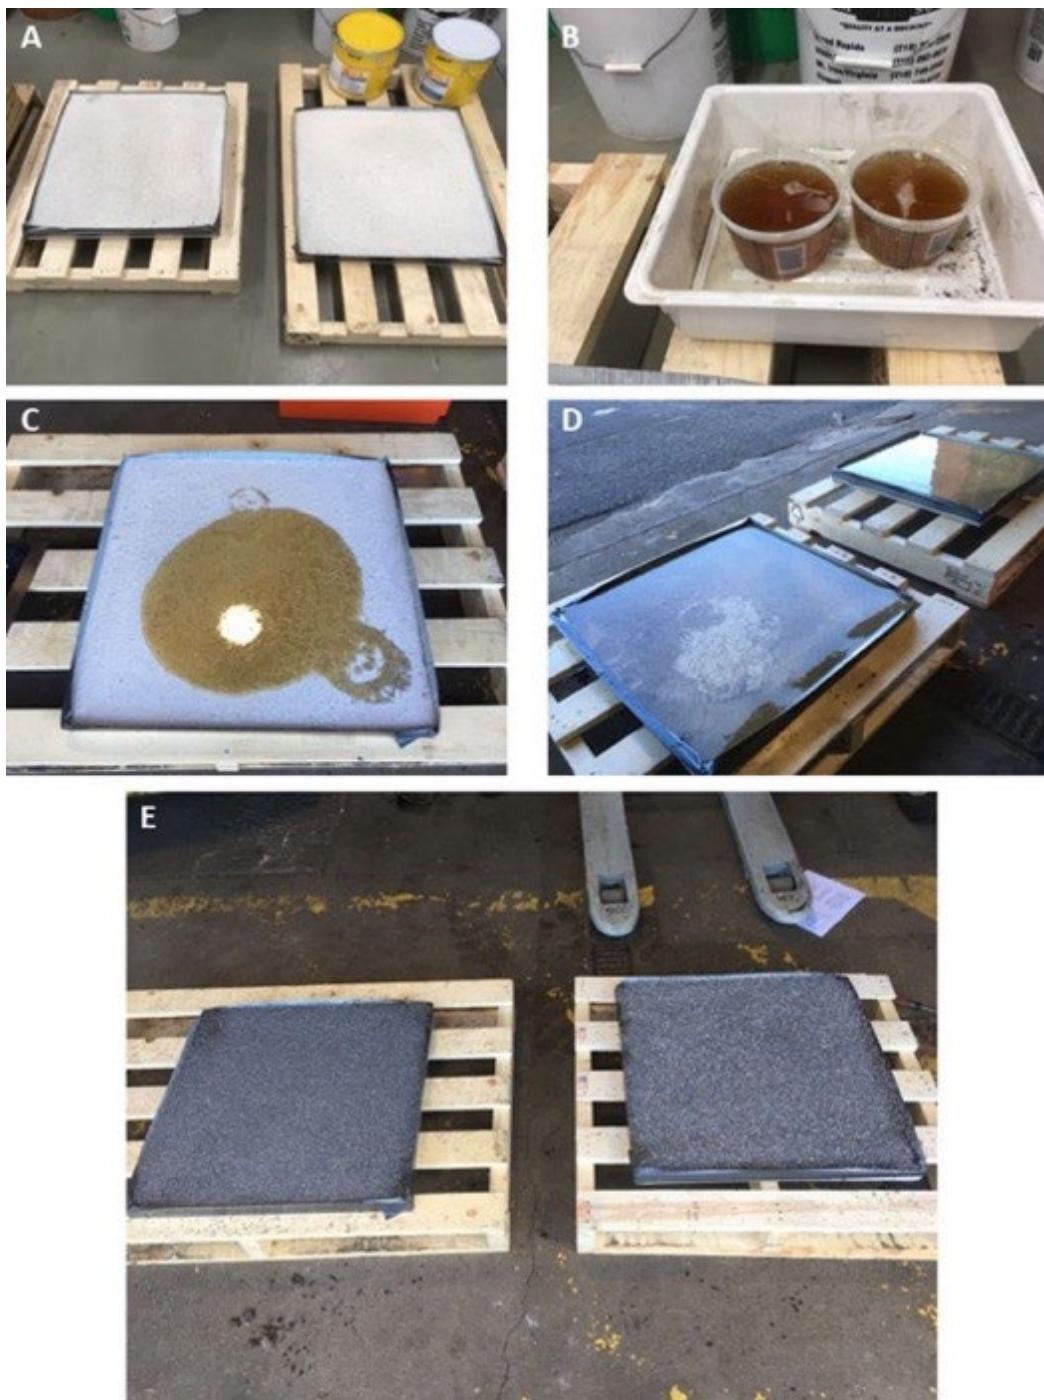
Figure 4.1. Laboratory-scale specimens to simulate the epoxy/resin-based surface treatments: A) 23.5" x 23.5" (60cm x 60cm) concrete pavers/slabs used to simulate pavement; B) resins mixed at appropriate volume to match specification requirement for treated pavement (and specimen) surface area; C) resin applied to specimen; D) specimens completely covered with resin and ready to receive aggregate; E) HFST aggregates applied to both specimens (taconite left; calcined bauxite right)

Laboratory-scale specimens were prepared at the NRRI to simulate the epoxy/resin-based surface treatments to be installed at the project's field test site. Two 23.5" x 23.5" (60cm x 60cm) concrete pavers/slabs were used as a simulated pavement surface to which quantities of epoxy/resin and HFST aggregates were applied, per the application rate specifications established for HFST applications. According to the HFST contractor, the recommended resin application rate achieves coverage of 25 to 32 ft² per gallon and a thickness of 60 mils, and aggregate is applied at 12-15 lb/yd². A 1:1 two-part resin product (Sikadur®-22 Lo-Mod) provided by Sika Corporation to the NRRI in January 2021 was used (see HFST product information sheets in Appendix C, topped with the project's taconite and calcined bauxite HFST aggregates (Figure 4.1).

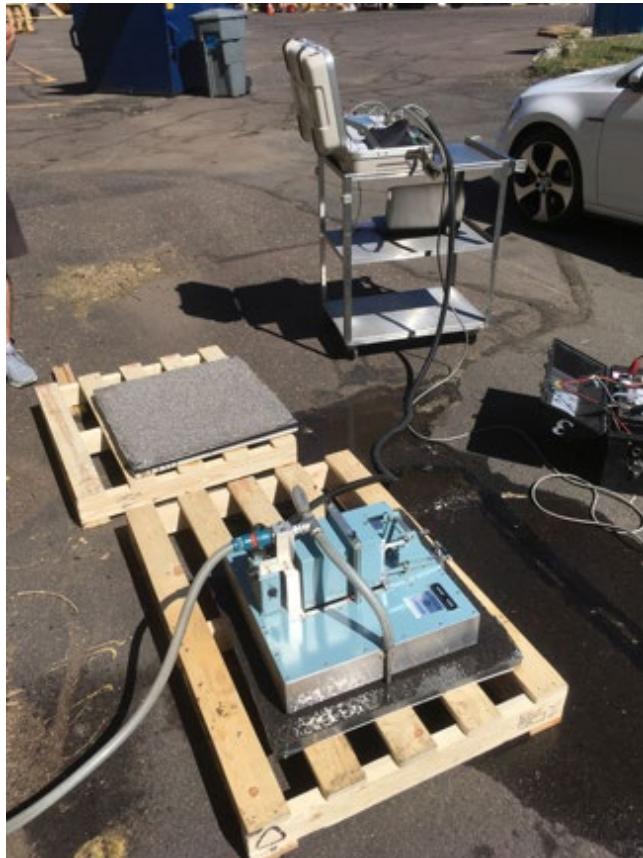
Figure 4.2. Dynamic friction tester (DFT) evaluation of simulated pavement specimens at the NRRI on June 16, 2021. Setup shows DFT, water supply hose, data interface and acquisition laptop on cart, and 12V battery for power

The DFT – on loan from MnDOT to the University of Minnesota’s Department of Civil, Environmental, and Geo-Engineering (CEGE) – was brought to the NRRI by Mugurel Turos on the morning of June 16, 2021. The testing was conducted to confirm the DFT’s operating parameters, data acquisition, and data transfer prior to its use at the project test site later that afternoon and for subsequent project testing. Figure 4.2 shows the setup in the NRRI’s rear parking lot.

When the DFT reaches the target speed (velocity), its rotating disk/platen drops, and the affixed rubber pads engage with the pavement surface to simulate braking/skidding. An example of how velocity and the friction value (μ) are plotted and recorded is shown in Figure 4.3.

The DFT is operated under simulated wet pavement conditions, with water supplied to the DFT and pavement from an elevated stainless-steel tank. Initial testing at the NRRI began with the DFT's speed set at 80 kilometers per hour (50 mph), using the taconite HFST specimen slab. After four runs, it became apparent that the 80 km/h setting drew too much power from the stand-alone 12V battery powering the DFT to reach the targeted speed in a timely manner. Therefore, the remaining DFT testing was conducted at a 70 km/h (43.5 mph) setting.

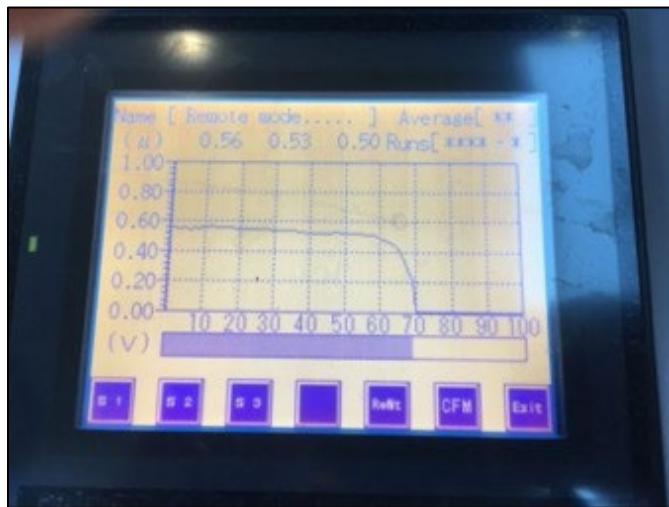
Figure 4.3. DFT data as displayed on the laptop screen. Velocity (in km/h) is shown on the x-axis, and friction (μ) is shown on the y-axis

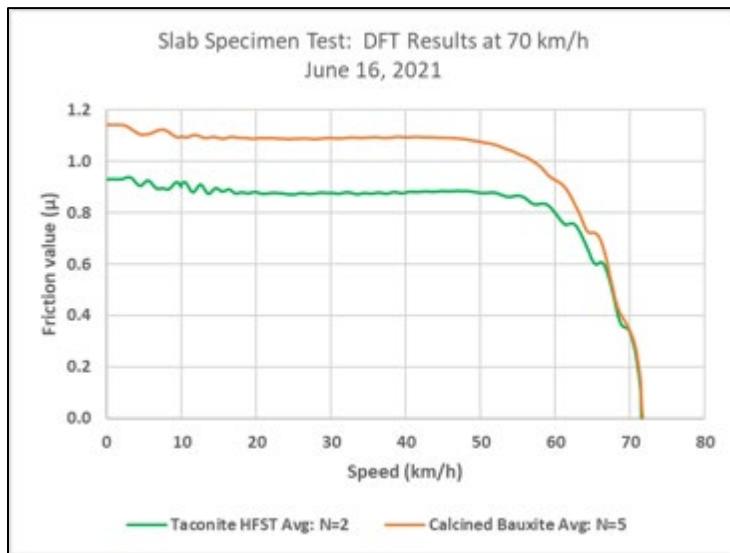
Figure 4.4. DFT test results for HFST specimen slabs: taconite and calcined bauxite treatments

DFT tests were run on the two pavement specimens to establish baseline laboratory friction values for both aggregate types: two for the taconite slab and five for the calcined bauxite slab. These baseline values will be available for comparison to additional lab specimens and the installed pavement sections that have been subjected to wear. The rubber pads were replaced with the taconite and calcined bauxite tests. The results are presented in Figure 4.4.

The 80 km/h tests run on the taconite HFST specimen slab showed a trend of decreasing friction values with each successive test. A similar trend occurred with the tests run on the calcined bauxite HFST specimen slab at 70 km/h, as Figure 4.5 and the inset illustrate. The trend could be due to increasing abrasion (wear) of the DFT's rubber pads and/or a buildup of abraded pad rubber on the specimen.

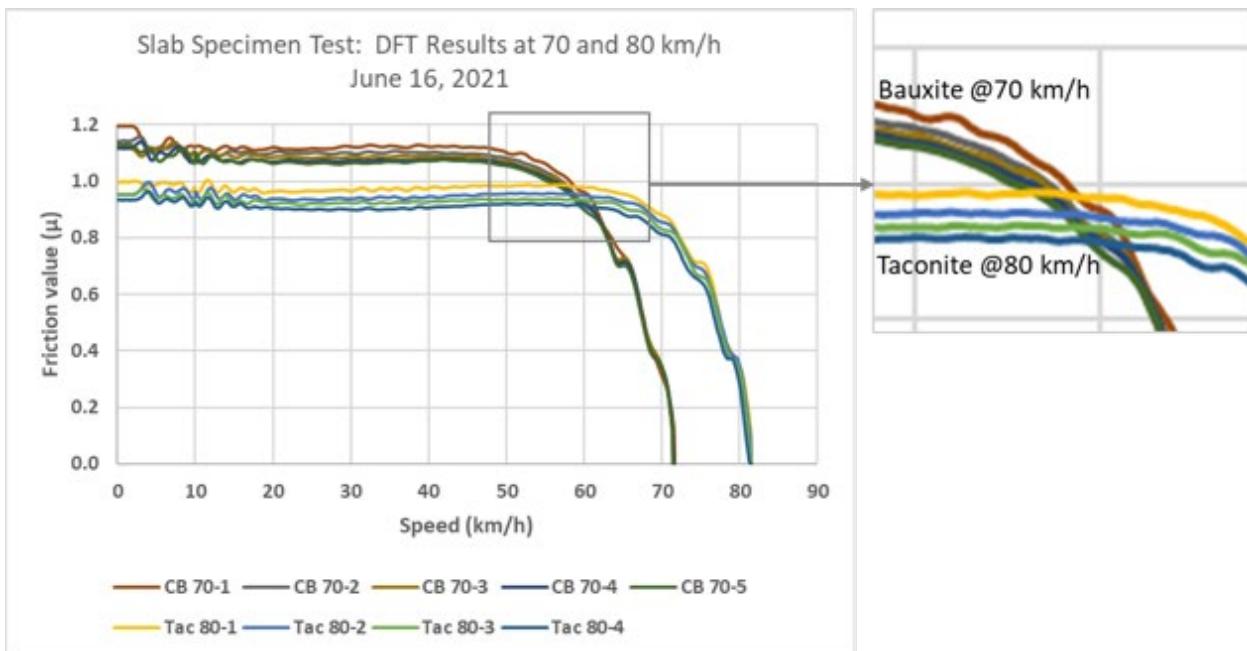
Figure 4.5. Individual DFT slab specimen results for calcined bauxite at 70 km/h and taconite at 80 km/h (inset shows trends)

Considering this trend and the potential reasons for it, the investigators agreed that for all future tests the DFT should be moved between runs to avoid repeated operation over the same circular path.

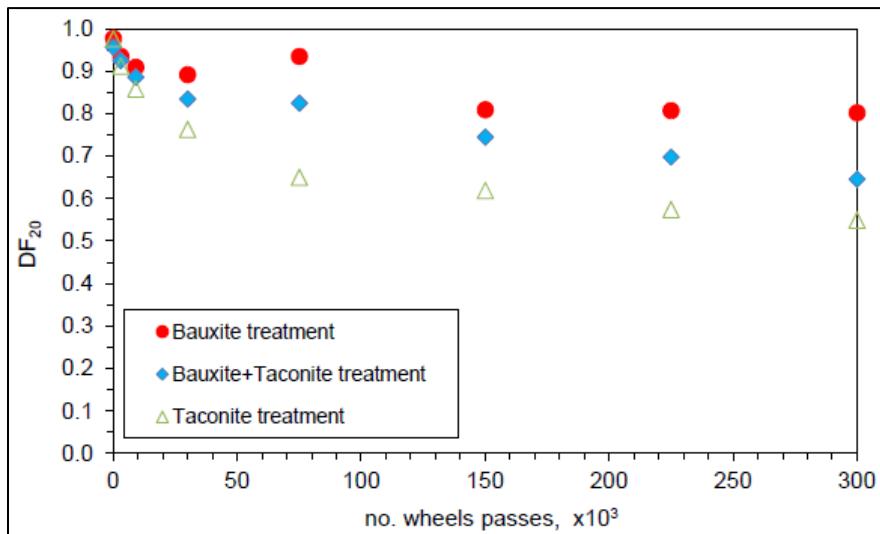
Figure 4.7. DFT20 vs. wheel passes (Source: Shah, 2021)

Figure 4.7 shows the difference in friction between the 100% bauxite, 50:50 bauxite/taconite, and 100% taconite treated specimens, as determined by NCSC's testing after 300K wheel passes. The 100% bauxite and 100% taconite friction differential are significantly greater than what the project's field testing has shown through May of 2025 after an estimated 2 million wheel-passes by actual vehicle traffic and four seasons of snow plowing. These finding differences are discussed in greater detail in Chapter 7.

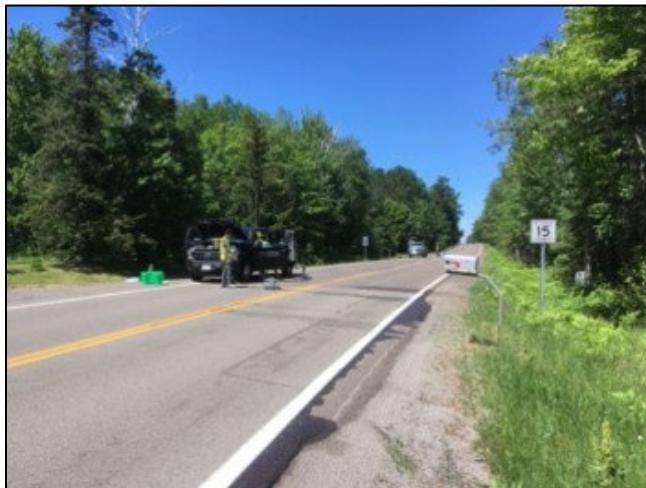
Figure 4.9. DFT and British Pendulum setup at calcined bauxite surface treatment (foreground) and existing pavement at CSAH-15 location (looking north): June 16, 2021

Initial friction testing using the DFT and a British Pendulum took place at the project's field test location the afternoon of June 16, 2021 (Figure 4.9). Baseline friction measurements were made of the existing pavement and the recent (2020) calcined bauxite HFST installation, within and between the wheel paths of both pavement surfaces. The June 16 field testing was coordinated with St. Louis County, which provided traffic control support.

DFT and BP testing took place where the existing pavement and the previously installed (2020) calcined bauxite HFST meet. The southbound lane of CSAH 15 was chosen for running the friction tests because it provided the longest sightline for traffic approaching from the north, which made traffic control safer and more effective.

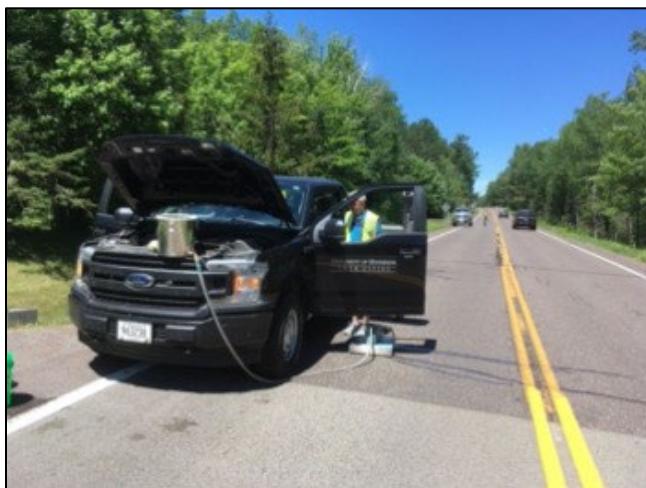
Figure 4.10. DFT setup at the project test location on June 16, 2021, where the light-colored calcined bauxite treatment from 2020 and the darker existing (control) pavement abut. Note St. Louis County traffic control personnel in the background

DFT power was supplied by connecting cables to the battery terminals of the University vehicle. The vehicle was kept running to maintain steady power. The DFT's water supply tank was placed under the open hood of the vehicle (Figure 4.10), to which water was periodically added. Supply water was brought to the project location in a 75-gallon tank filled at the NRRI.

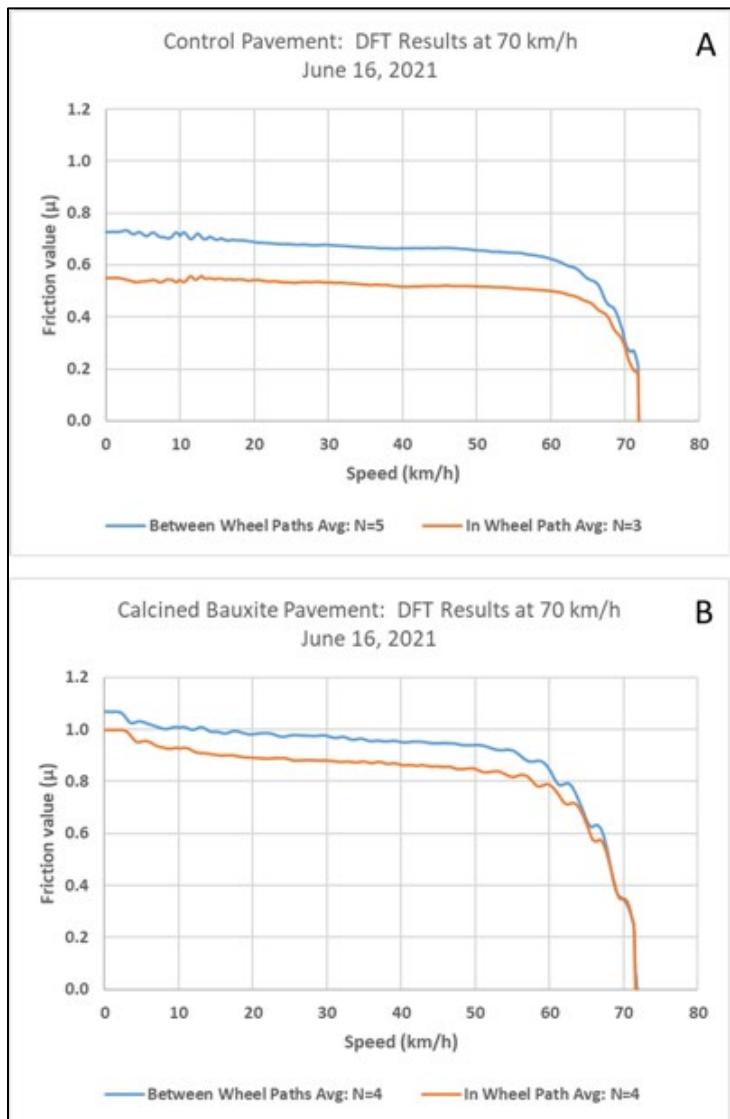
Figure 4.11. DFT field test results at 70 km/h for control and calcined bauxite pavement surfaces

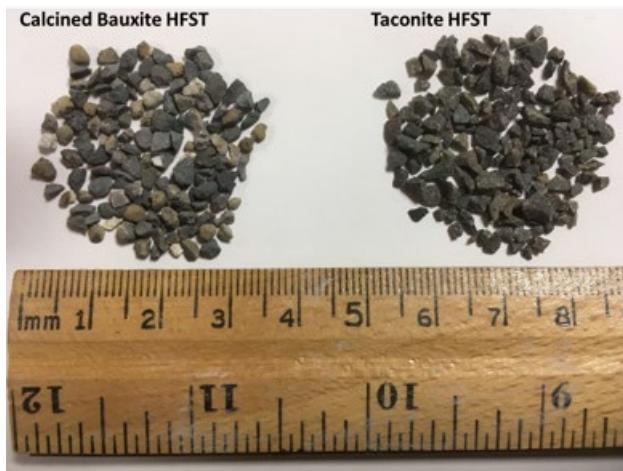
Figure 4.14. Comparison of calcined bauxite HFST aggregate (left) and taconite HFST aggregate (right)

Subsamples of both HFST aggregates were examined microscopically. Images showing the gross particle size and shape characteristics of both HFST aggregates are shown in Figure 4.14 and Figure 4.15. The inset images of Figure 4.15 provide a more detailed view of the respective morphologies of the calcined bauxite (A') and taconite aggregate (B') particles. Note that not all the calcined bauxite particles are

angular, and the amorphous, ceramic-like nature of the interior of one of the particles; whereas the taconite particles are uniformly angular (100% fractured faces), and individual mineral grain boundaries are visible.

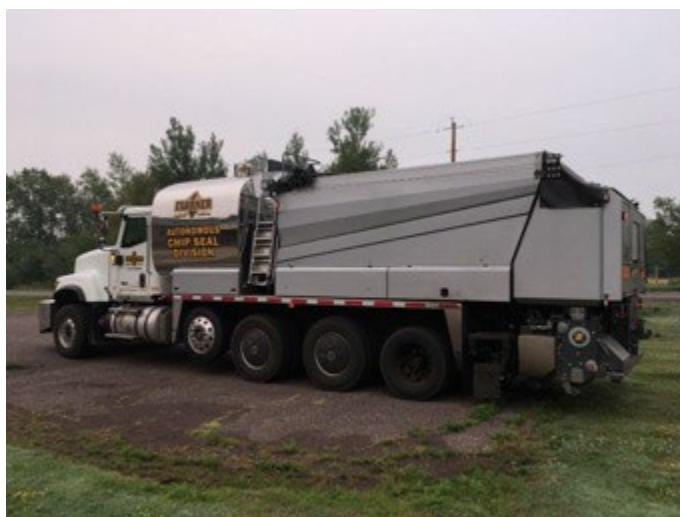
Figure 5.4. GSB Friction Seal chip spreader/distribution truck

The two GSB Friction Seal system test sections (cells) were installed in the morning of July 29. As described previously, the GSB Friction Seal system combines pavement preservation with friction enhancement, using a specialized chip spreader/distribution truck (Figure 5.4) that places the GSB liquid followed immediately by aggregate distribution. The system uses a narrower HFST-type aggregate gradation than micro surfacing does. The aggregate used in this system was taconite, donated by Optimal Aggregates LLC. Each sack contained approximately 3000 lbs. of aggregate.

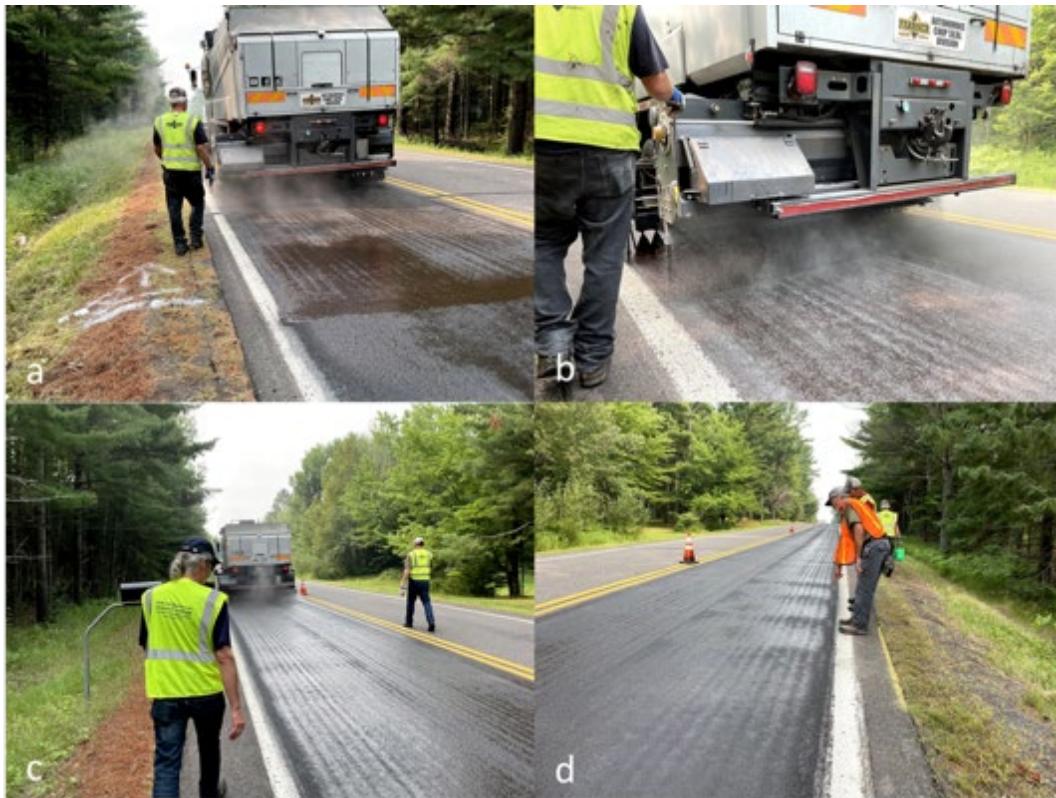
Figure 5.5. Installation of minus #8 Friction Seal: (a) start of installation; (b) close-up of spreader and deployment of GSB and aggregate; (c) freshly-installed; and (d) post-installation

Each test section took less than 5 minutes to install. Note the slightly heavier application of aggregate and liquid for Test Cell 2, compared to the standard Friction Seal application rate. A series of photos in Figure 5.5 shows the spreader/distribution truck and the deployment of the Friction Seal treatment. Additional photos and video were taken by the NRRI's Marketing Specialist, Jeremy Weizel, to document the GSB and HFST installations.

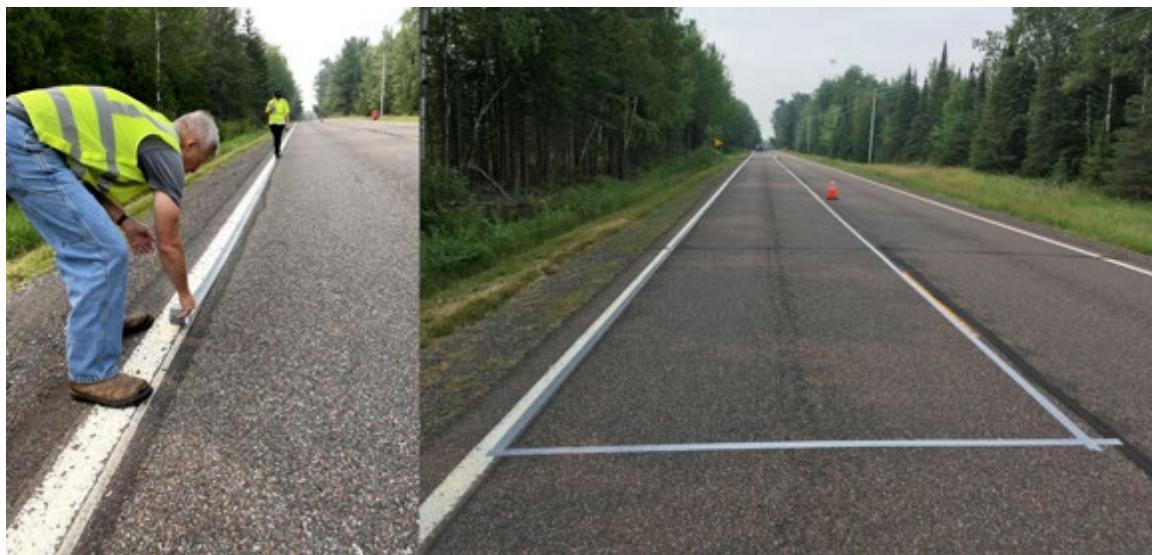
Figure 5.7. Taping of fog line prior to HFST installation (left); fully-taped lines (right)

The two HFST system test sections (cells) were installed in the afternoon of July 29, one using calcined bauxite friction aggregate and the other using taconite friction aggregate. The taconite HFST aggregate was again donated by Optimal Aggregates LLC. Duct tape was applied to the fog and center lines ahead of time to prevent the lines from being covered during the test section installations (Figure 5.7).

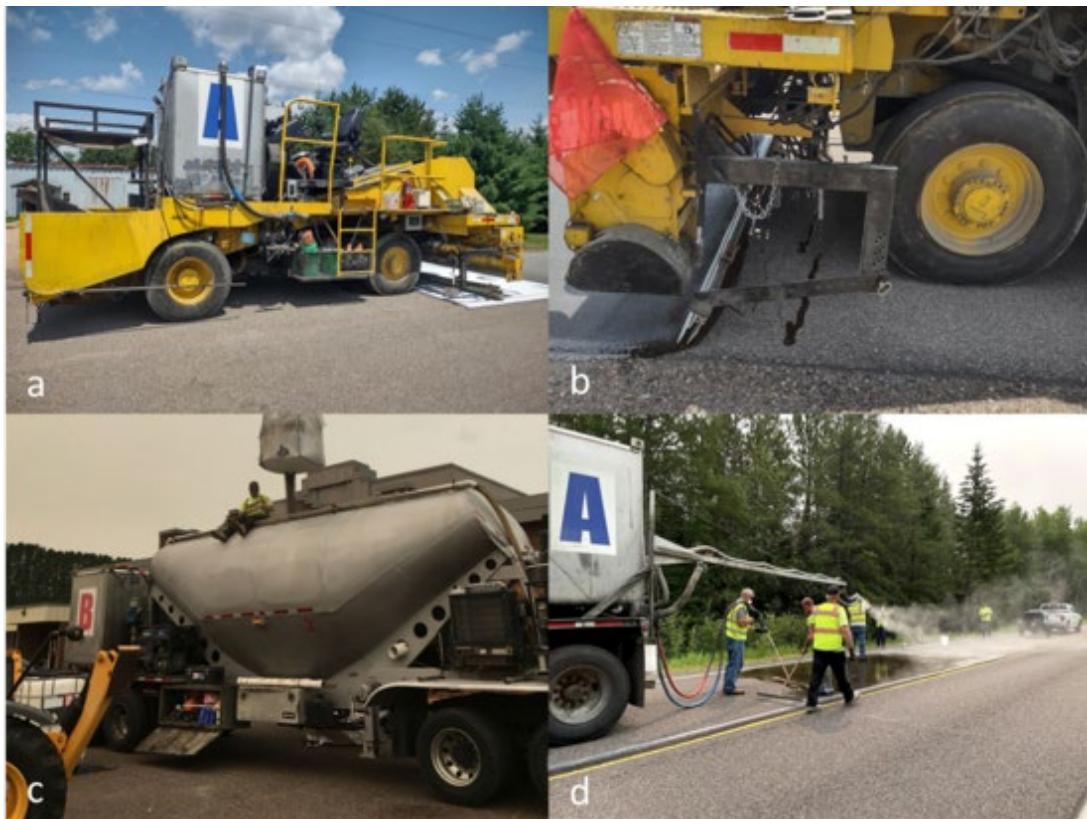
The HFST system can be installed using an automated or a non-automated high-friction rig (Figure 5.8a and Figure 5.8c, respectively). The automated rig was unavailable, so the non-automated method was used for the test section installations. As Figure 5.8b shows, the automated rig mixes and delivers the two-part epoxy resin from two separate tanks (marked "A" and "B") to the pavement while in moving mode, whereupon the resin is evenly spread with a lane-width "squeegee" at the rig's rear to which high friction aggregate is distributed and placed immediately. In contrast, the non-automated rig delivers the "A" and "B" resin components via the blue (component A) and red (component B) supply lines shown in Figure 5.8d to a mixing wand. Both resin components are combined at the nozzle end and are applied to the pavement. A worker follows with a hand-held squeegee to evenly spread the resin across the width of the lane. A final worker follows and applies the friction aggregate. The aggregate is delivered pneumatically from a hopper and broadcast to completely cover the resin at the specified application rate per square yard.

The non-automated method is more labor-intensive and thus slower. Each test section took approximately two hours to install (about twice the time of automated rig deployment), and its pneumatic aggregate delivery system likely generated more dust (Figure 5.8) than the automated rig would have, given their different mechanisms of resin and aggregate deployment. The NRRI's Environmental Health & Safety Manager, Jean Cranston, conducted respirable dust monitoring during the HFST test section installations; the results of her sampling work are presented in Chapter 6.

Figure 5.8. HFST equipment options: (a) automated HFST rig; (b) close up of resin and aggregate delivery end of automated HFST rig; (c) non-automated HFST rig showing loading of aggregate to hopper at project staging location; and (d) non-automated method for delivery and application of resin and aggregate from the non-automated HFST rig, showing installation of taconite HFST aggregate to Test Section 3. Images a and b courtesy of Fahrner Asphalt Sealers

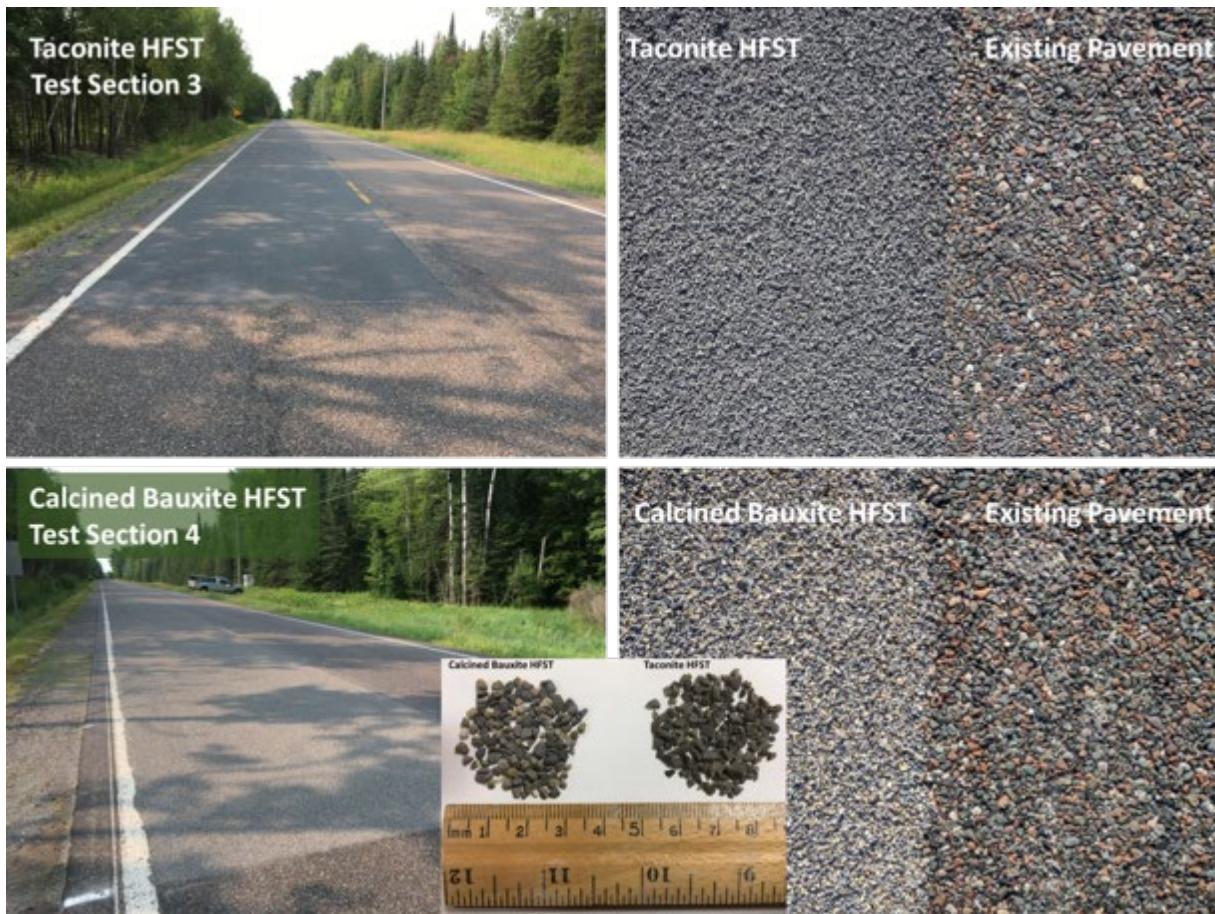
Figure 5.9. HFST test sections, post-installation: taconite test section, looking south (top left); close up of taconite HFST (top right); calcined bauxite test section, looking south (bottom left); close up of calcined bauxite HFST (bottom right); relative size of both aggregate types (inset image)

Figure 5.9 shows the post-installation appearance of both HFST test sections.

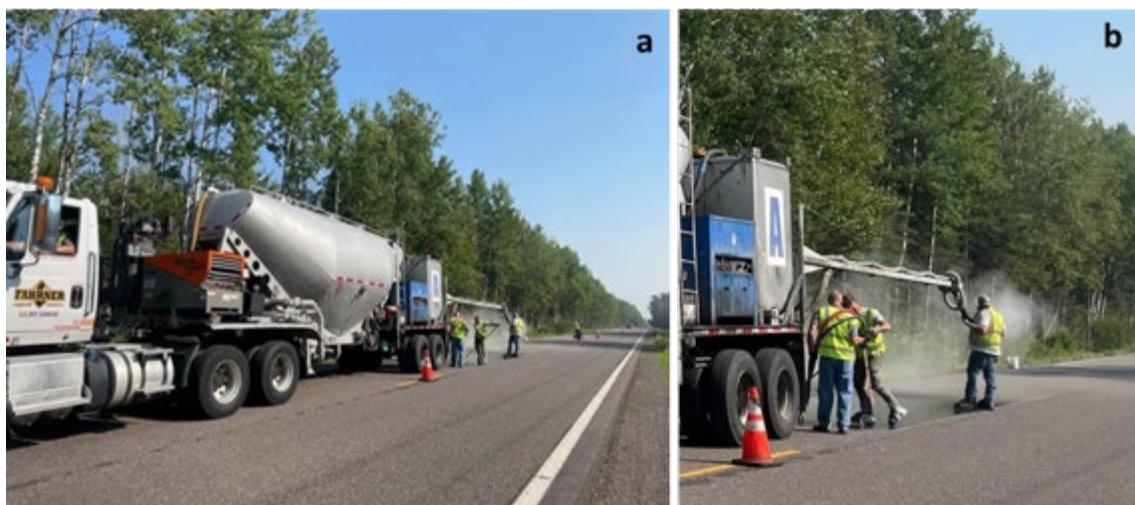
Figure 6.2. High friction rig (a); closeup of application hose (b) application process

Epoxy and aggregate were loaded separately into a Fahrner Asphalt high friction rig (Figure 6.2a). The aggregate was manually sprayed on top of the epoxy (Figure 6.2b). Air concentrations for Sample 1 were collected during the application of the tailings-based aggregate and air concentrations for Sample 2 were collected during application of the bauxite-based aggregate (refer to results).

As described in Project Task Report 5, The HFST system can be installed using an automated or a non-automated high-friction rig. The automated rig was unavailable, so the non-automated method was used for the test section installations. The non-automated rig delivers two resin components via supply lines to a mixing wand. Both resin components are combined at the nozzle end and are applied to the pavement. A worker follows with a hand-held squeegee to evenly spread the resin across the width of the lane. A final worker follows and applies the friction aggregate (Figure 6.4). The aggregate is delivered pneumatically from a hopper and broadcast to completely cover the resin at the specified application rate per square yard. The non-automated rig's pneumatic aggregate delivery system likely generated more dust than the automated rig would have.

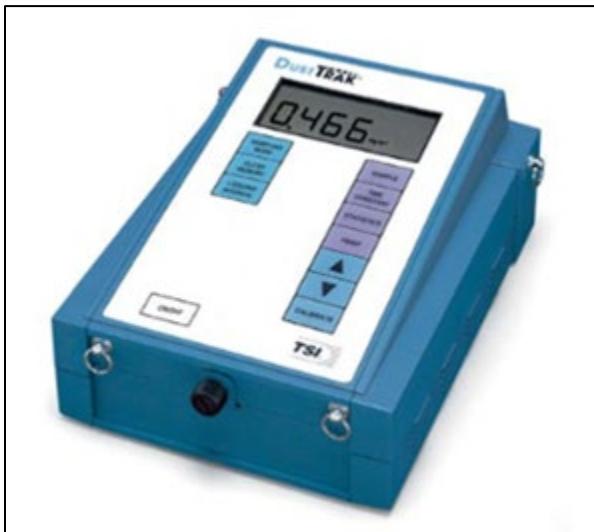
Figure 6.3. DustTrak Model 8520 (image source: TSI)

As calibrated (calibration date of March 2, 2021), a TSI, Inc. DustTrak (Model 8520) was used to evaluate the concentrations of inhalable dust during two separate applications (Figure 6.3). The Dust Trak measures particles using a laser photometer and light scattering technology. The data collection began approximately 15 minutes after each start-up to allow time for the equipment to warm up. An average aerosol concentration was recorded every minute for a total of 30 minutes.

A 10- μm inlet was used with the DustTrak so that results could be compared to hazardous occupational dust. Dust that is 10 μm or smaller in size is considered more of an occupational hazard than larger size particles as they have a greater potential to penetrate the thoracic and respirable areas of the respiratory tract.

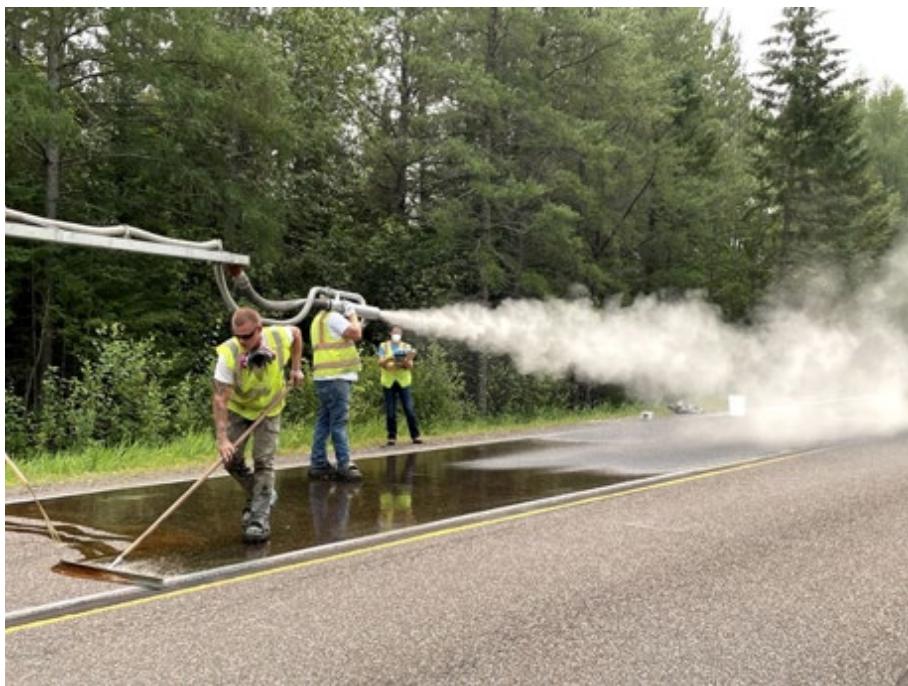
Figure 6.4. Dust monitoring by industrial hygienist upwind of HFST aggregate deployment.

An industrial hygienist walked along the shoulder of the road and moved with the mobile operation while holding DustTrak (Figure 6.4). The samples were collected 30-50 feet downwind of the application process (Figure 6.5). On the day of the sampling there was an air quality alert due to nearby forest fires. According to DustTrak, the average baseline aerosol concentration on the day of monitoring was 0.213 mg/m^3 . The temperature was 72 degrees Fahrenheit (22 degrees Celsius) with 11 mph (18 km/h) winds.

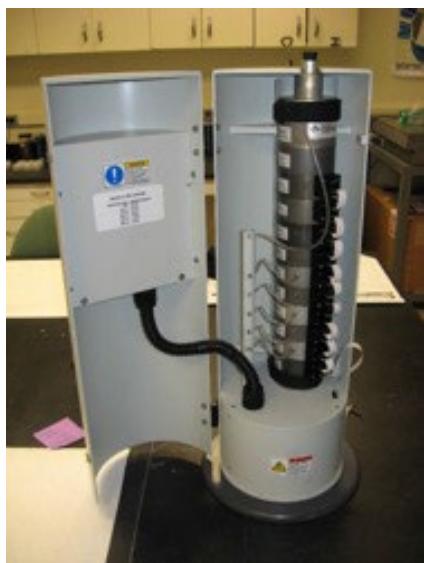
Figure 6.7. Micro-Orifice Uniform Deposit Impactor (MOUDI) (from: Monson Geerts et al., 2019)

As described by Monson Geerts et al. (2019), “The MOUDI is designed for precision, high-accuracy sampling. It operates at a flow rate of 30 L/min. and has 10 stages with aerodynamic diameter cut sizes ranging from 18 μm to 0.056 μm (Figure 6.7 and Figure 6.8). This size-fractionating of the aerosol particles allows for the designation of the PM into specific size classifications including PM1, PM2.5, and PM10, which is part of the characterization as well as important for assessing mass weight. Based on the aerodynamic diameter of particles and the MOUDI stage in which these particles are impacted, the size fractions can be related to general areas of the respiratory system that would be affected during breathing by particles of this size.”

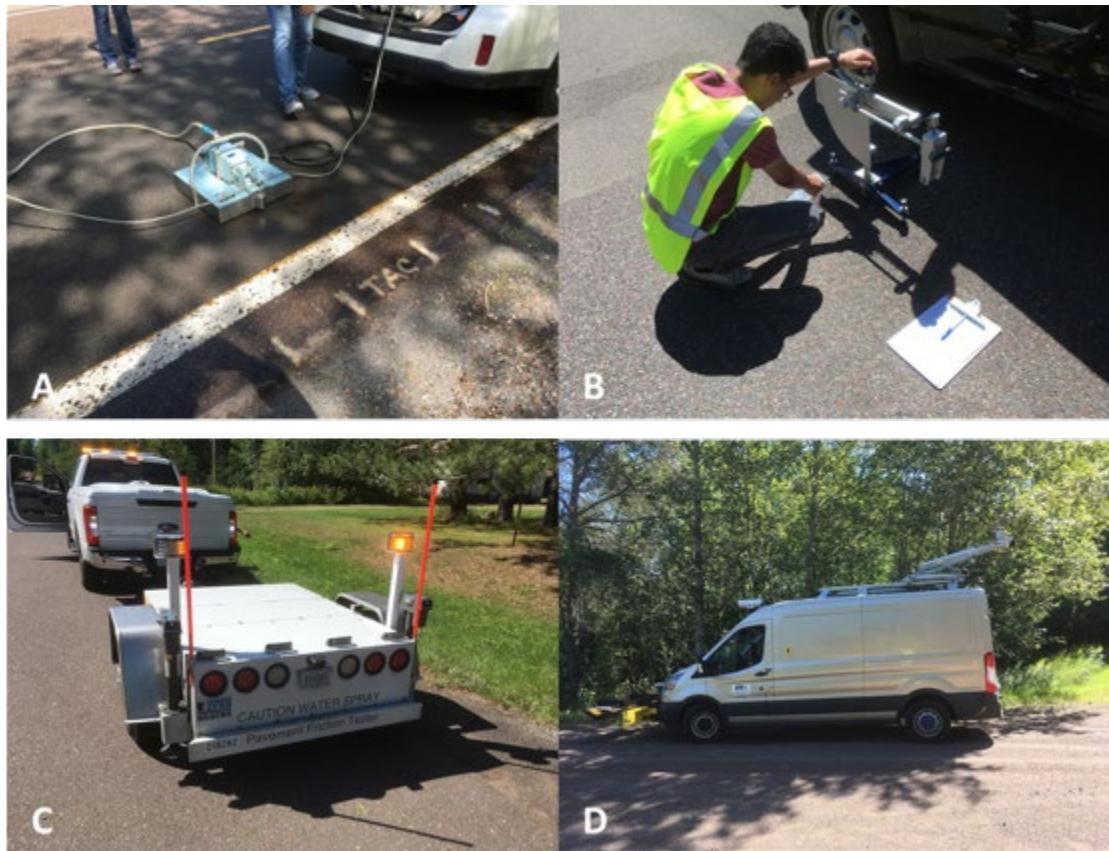
Figure 7.1. Data collection methods/equipment: A) Dynamic Friction Tester; B) British Pendulum; C) MnDOT's Locked-Wheel Pavement Friction Tester; and D) MnDOT's Road Doctor

Information and data collection began in August of 2021 to establish the post-installation test section (and control) baselines, using the DFT and BPT (August 5), MnDOT's Locked-Wheel Pavement Friction Tester (LWPFT) (August 17), and MnDOT's Road Doctor (August 11), see Figure 7.1.

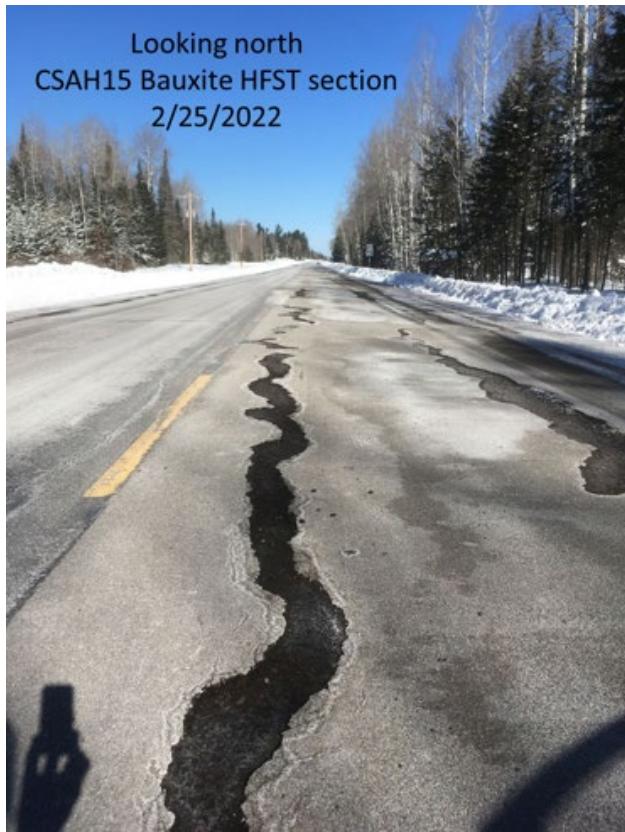
Figure 7.12. February 25, 2022, photo of distresses/losses in bauxite HFST test section

On February 25, 2022, the PI visited the project site and noted significant distress in the bauxite HFST section (Figure 7.12). It was speculated that – when combined with pre-existing weaknesses in the underlying chip sealed asphalt pavement (note the salt residue coincidental with the cracking in the adjacent southbound lane shown in Figure 7.13) – the epoxy bond was so strong that as a snowplow's blade passed over the very high friction bauxite aggregate, the blade was "grabbed", and the pulling/shear force exceeded the bond strength between the chipeal and the weaker pavement below. The failure also roughly coincided with the wheel path. Importantly, the HFST epoxy had *not* delaminated from the chipeal; rather, the chipeal had pulled completely away from the underlying asphalt pavement, exposing it as shown in Figure 7.14. The taconite HFST section exhibited similar (but less) distress.

On June 6, 2022, the HFST distresses showed little to no additional development from their February 25 state, even after an extended snow plowing season that ended in early May of 2022. This suggested the failures were probably related to (and exacerbated by) preexisting weaknesses in the underlying chip sealed pavement, making the pavement more susceptible to moisture infiltration and localized dilation (bulging?) caused by freezing early in the winter 2021-22 season and easier to "pluck" by snow plowing. Cores (Figure 7.15 and Figure 7.16) were collected by St. Louis County personnel and underwent further examination. Figure 7.17 is a close-up of a bauxite HFST core, showing the relative thicknesses of the HFST and underlying chipseal treatment. The HFST (epoxy/resin and aggregate) is about 3 to 4 mm thick; the chipseal layer is about 5 to 6 mm thick. In contrast, cores from the two GSB-based sections show the thinner nature of the treatment. Following coring, all holes were filled with the NRRI's rapid-setting repair compound (Figure 7.18); each achieved a drivable set in about 10 minutes.

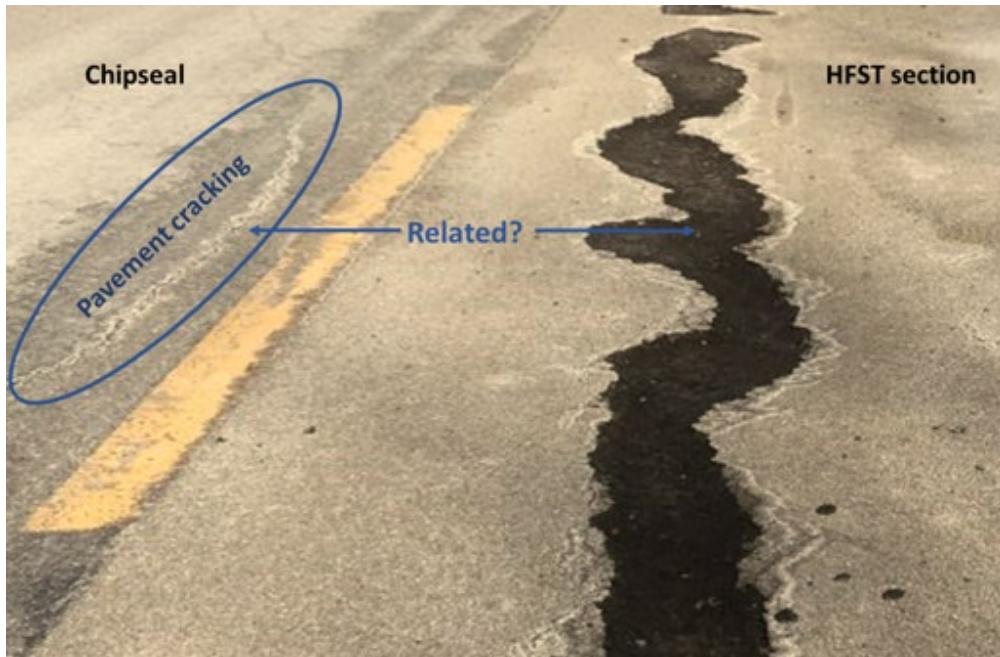
Figure 7.13. Photo showing potential relationship of pre-existing pavement cracking in "Control" pavement (left) to the losses in the HFST test section (right)

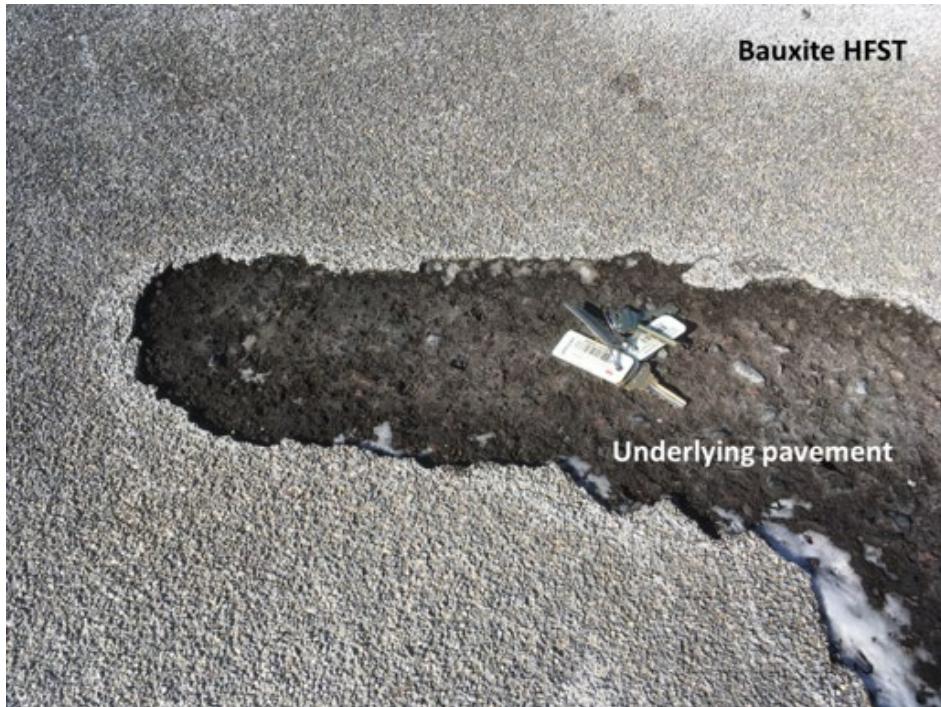
Figure 7.14. Photo showing complete exposure of underlying pavement where HFST loss occurred in the bauxite test section

A meeting between the project's PI, TL, and St. Louis County TAP representative at the time (Victor Lund) took place on March 7, 2022, to discuss these pavement distresses. Micro-milling the existing chipseal prior to the HFST installations had originally been planned, but the contractor said micro-milling was unnecessary based on their prior experience. Whether the decision not to micro-mill contributed to the distresses is uncertain. However, it was recommended that an analysis of failure be conducted to help identify the cause, including collecting cores of selected portions of the pavement. This analysis of failure began on June 6, 2022, during the project's third set of friction tests, and continued during a follow-up site visit on July 5.

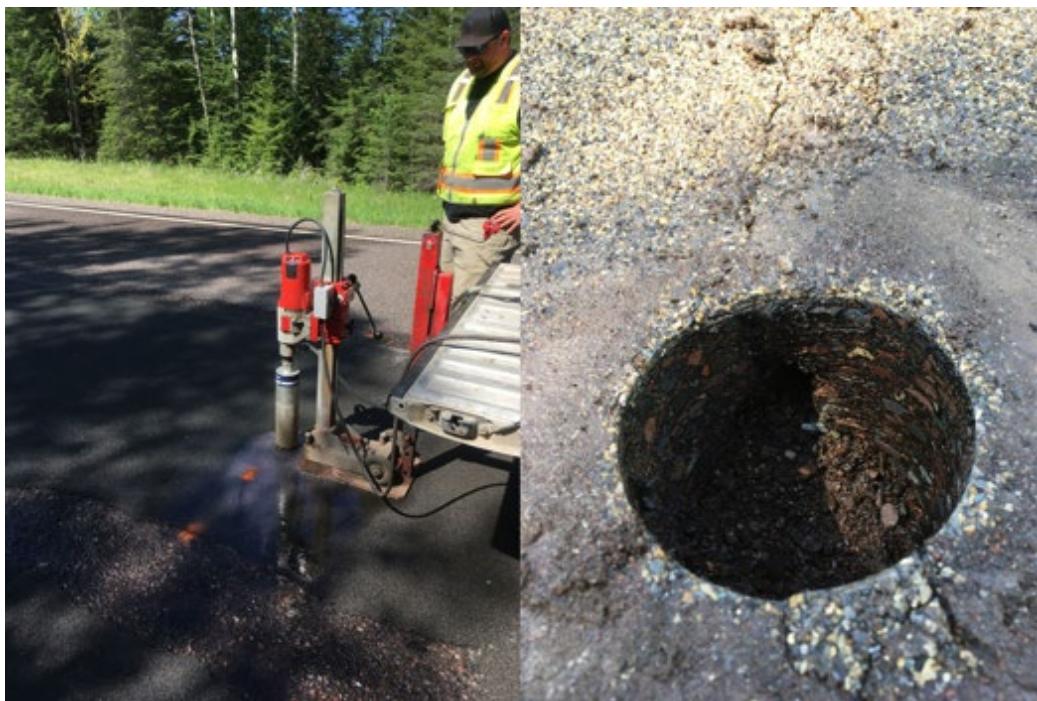
Figure 7.15. Collection of sample cores by St. Louis County personnel (left) and cored pavement (right)

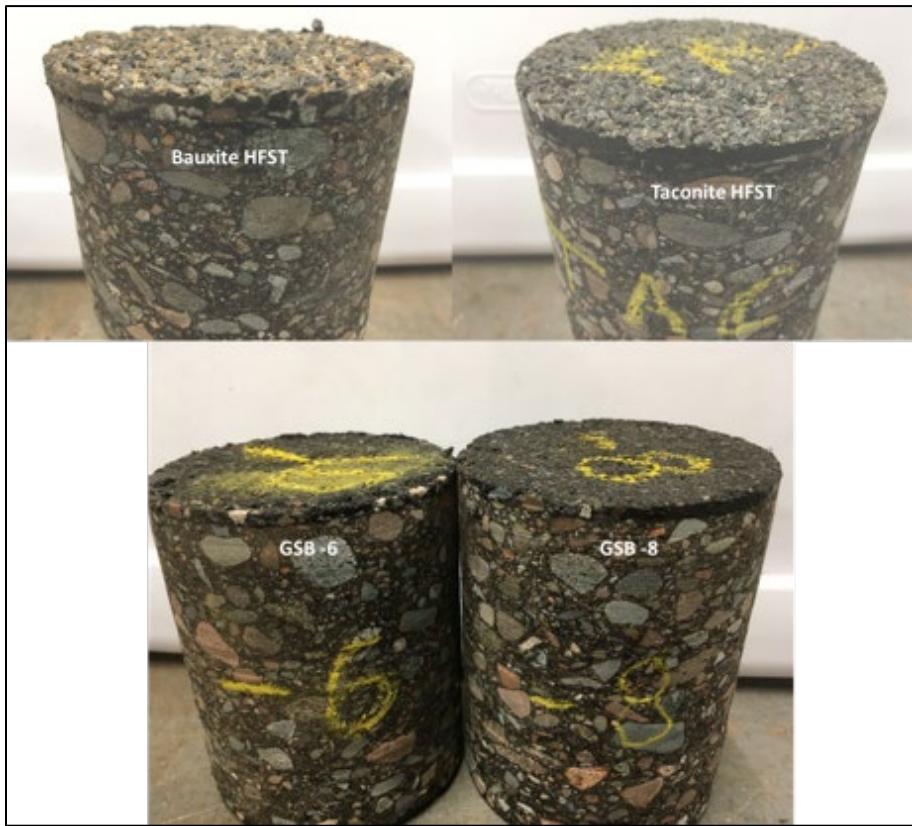
Figure 7.16. Cores collected from the four pavement treatment test sections

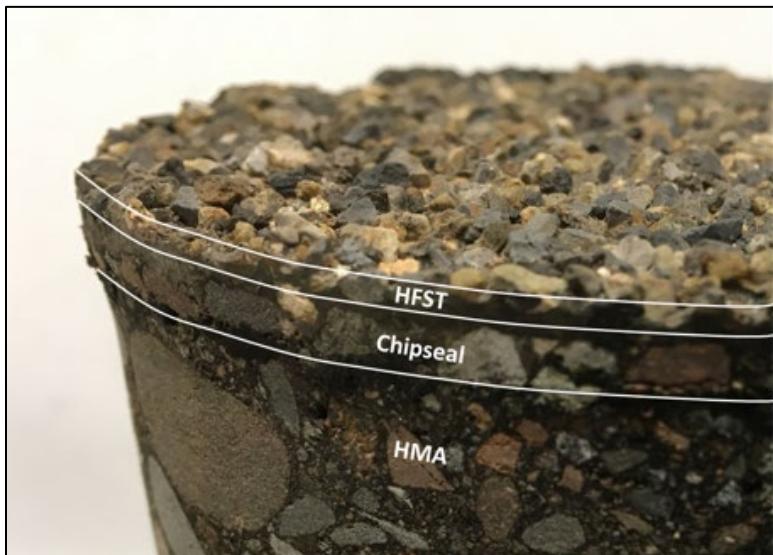
Figure 7.17. Close-up photo of bauxite HFST core, showing the relative thicknesses of the HFST and underlying chipseal treatment

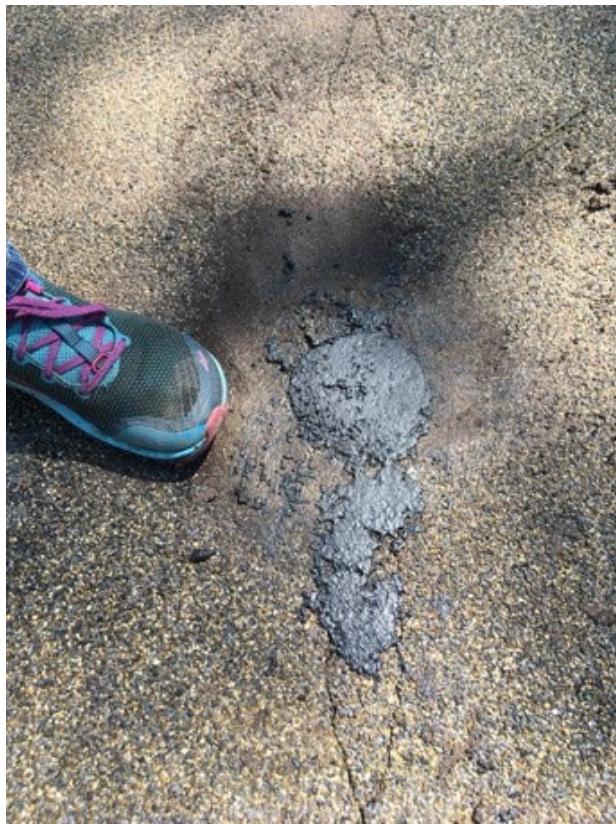
Figure 7.18. Core hole filled with the NRRI's rapid-setting repair compound
