Taconite As a Lower-Cost, Alternative High-Friction Surface Treatment to Calcined Bauxite for Low Volume Roads in Minnesota

June 2025

Research Project
Final Report 2025-41

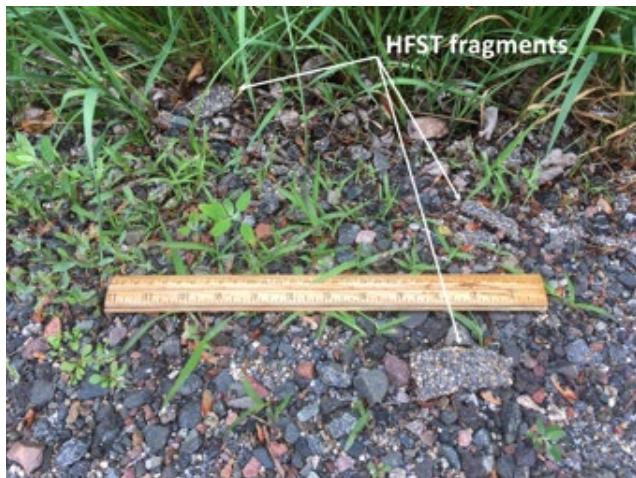
Figure 7.19. Photo of bauxite HFST fragments collected on July 5, 2022

As a follow-up, an additional site visit took place on Tuesday, July 5, 2022, to further study and document the HFST distresses. Fragments of snowplow “plucked” bauxite (Figure 7.19) and taconite HFSTs were found scattered along the shoulder, and several fragments were collected for closer examination (Figure 7.20). Their reverse side appearance, as well as that of the underlying pavement, suggest two mechanisms of failure: 1) at the interface between the chipseal and underlying HMA; and 2) within the HMA itself. Notably, the bond *between* the HFST and chipseal did not show any evidence of failure.

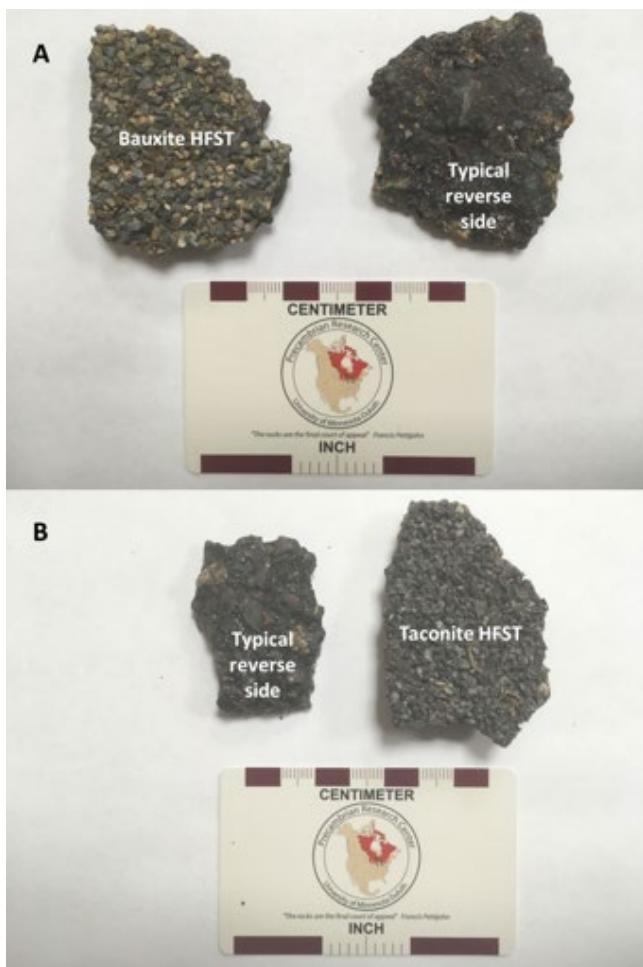
Figure 7.20. Representative fragments of snowplow “plucked” bauxite (A) and taconite (B) HFST

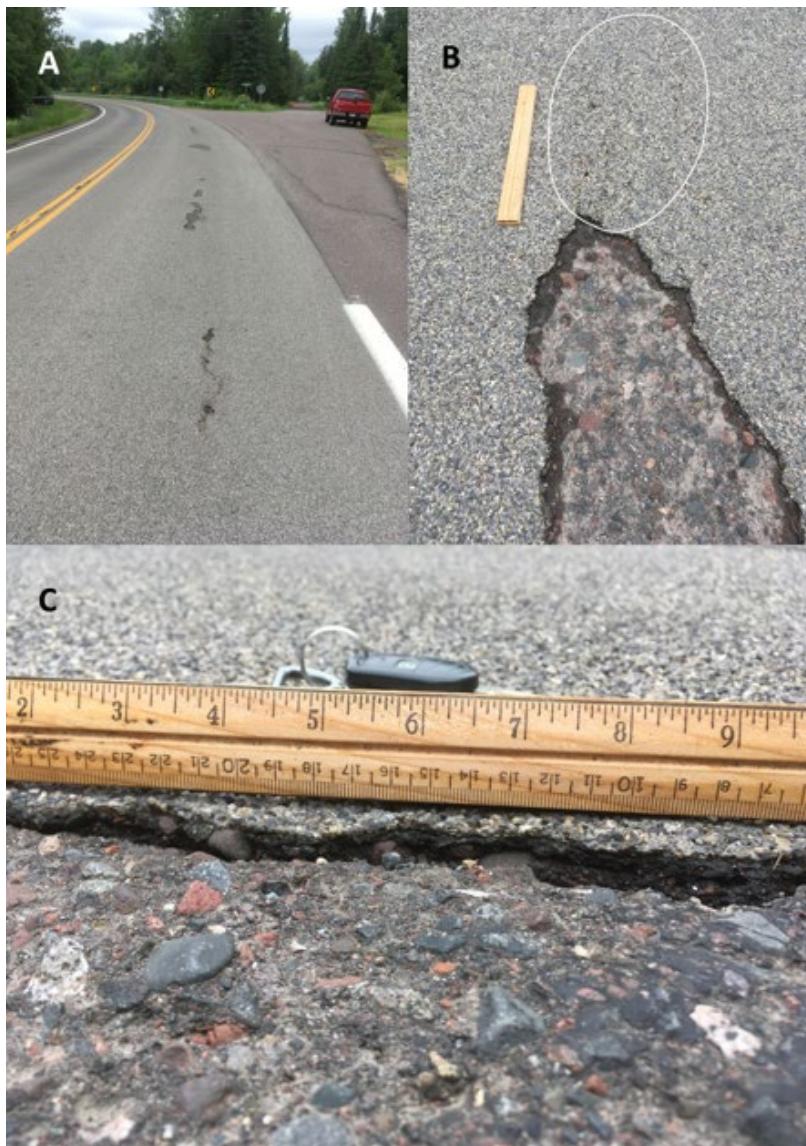
Figure 7.21. July 5, 2022, photos of losses in bauxite HFST installed in 2020: Looking south toward horizontal curve (A); closer view of HFST loss and visible faint cracks (B, circled); and close-up of underlying exposed asphalt pavement (C)

The bauxite HFST section installed for St. Louis County in 2020 (at the horizontal curve just to the south of the current project's test sections) was also examined on July 5. It exhibited similar distresses/losses (Figure 7.21) that were not noticed on February 25, 2022. Prior to this 2020 HFST installation, the existing chipseal *had* been micro-milled. Note that in Figure 7.21B, the faint cracks in the HFST coincide with and extend beyond the distress/loss (circled). This is another indication of a pre-existing condition (physical weakness) in the underlying pavement contributing to loss of HFST via reflective cracking.

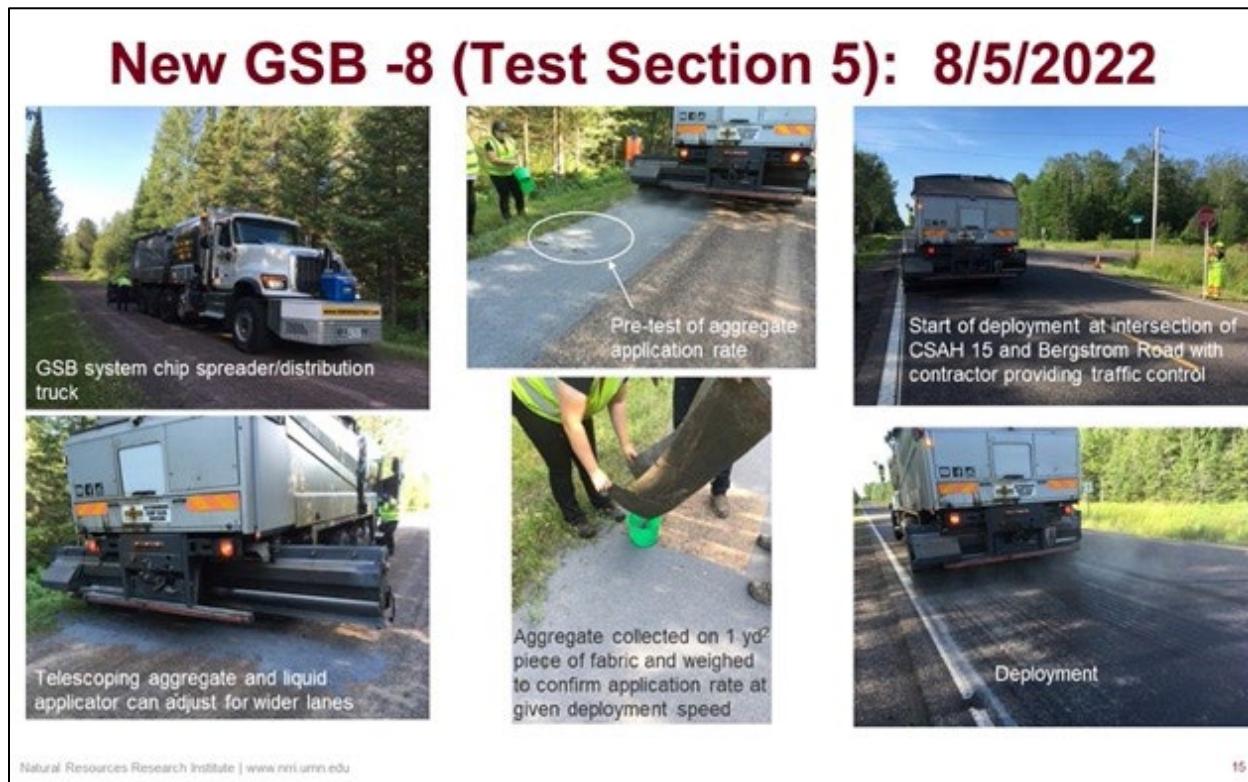
Figure 7.24. Installation of new GSB -8 (Test Section 5) on August 5, 2022

Figure 7.24 and Figure 7.25 show, respectively, August 5, 2022, Test Section 5 deployment and its updated liquid and aggregate application rate.

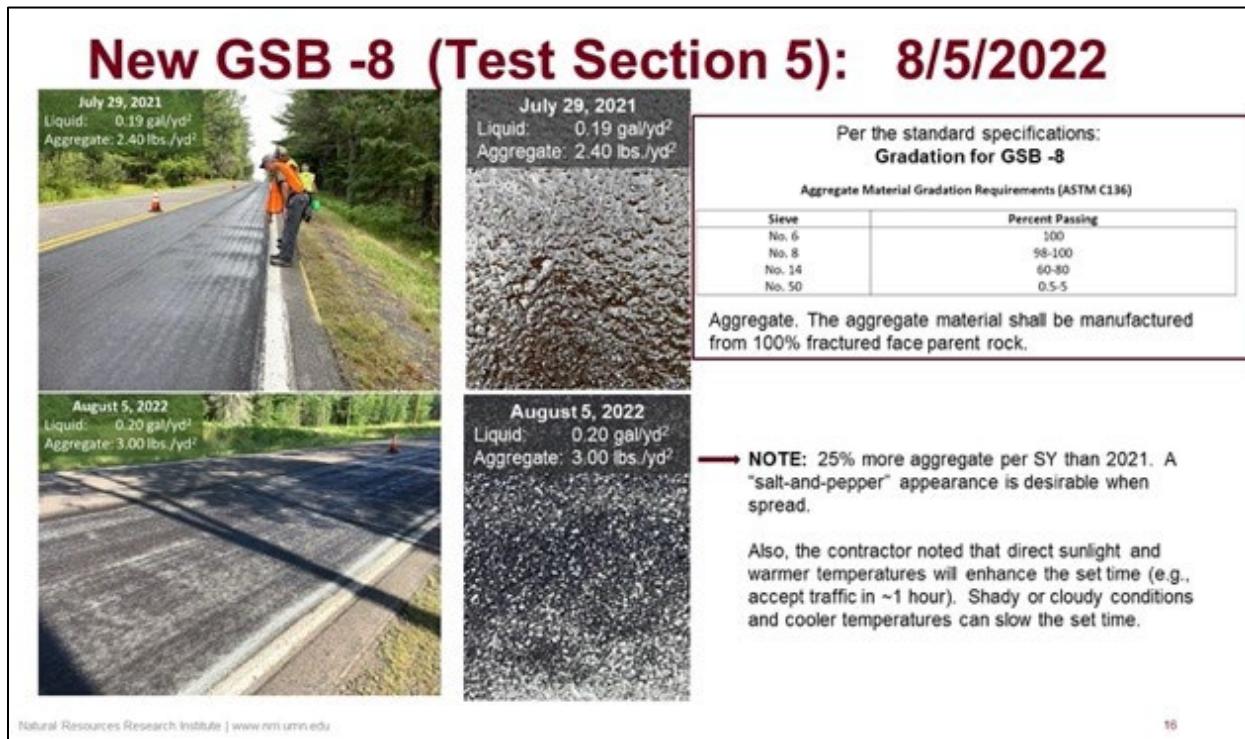
Figure 7.25. Liquid and aggregate application rate of new (2022) GSB-taconite test section compared to 2021 GSB-taconite test section

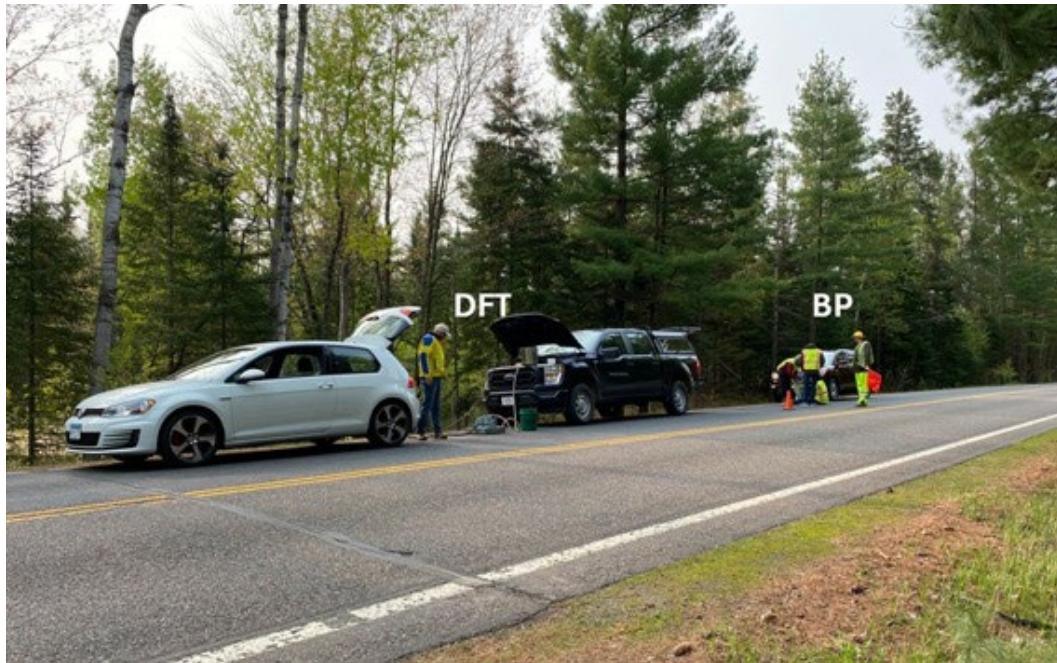
Figure 7.27. Typical DFT and BP setup, with traffic control

As usual, St. Louis County provided traffic control for DFT and BP testing (Figure 7.27). To maximize safety, all DFT and BP testing took place in the right half of the northbound lane (i.e., in the wheel path closest to the fog line) and between wheel paths in the center of the northbound lane). The project's final set of post-snowplowing DFT, BP, and LWPFT tests took place in Spring of 2025.

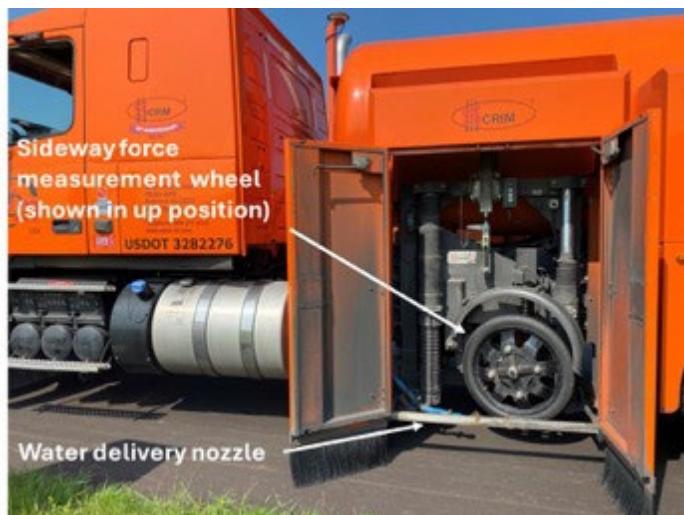
Figure 7.47. SCRIM sideway force measurement wheel and water delivery nozzle

The project team coordinated with WDM USA (hereafter referred to as WDM) to test its Sideway-force Coefficient Routine Investigation Machine (SCRIM) at the CSAH 15 Munger Shaw Road site on July 26, 2024. “Retros” (reflectors) were placed by WDM personnel at the beginning and end of each pavement section, which the SCRIM’s on-board sensor detected for geospatially pinpointing its position. To simulate a wet pavement, a calibrated flow of water was delivered by a nozzle ahead of the SCRIM’s sideway force measurement wheel (Figure 7.47).

As described by WDM Vice President Ryland Potter (personal communication, July 29, 2024), “The theoretical water film thickness is 0.5mm (which assumes the pavement surface is perfectly dense, smooth, and horizontal), so the flow rate is adjusted based on the speed of the vehicle to achieve the theoretical value. The actual water film thickness under the wheel will depend on the porosity, texture, and gradient of the pavement.”

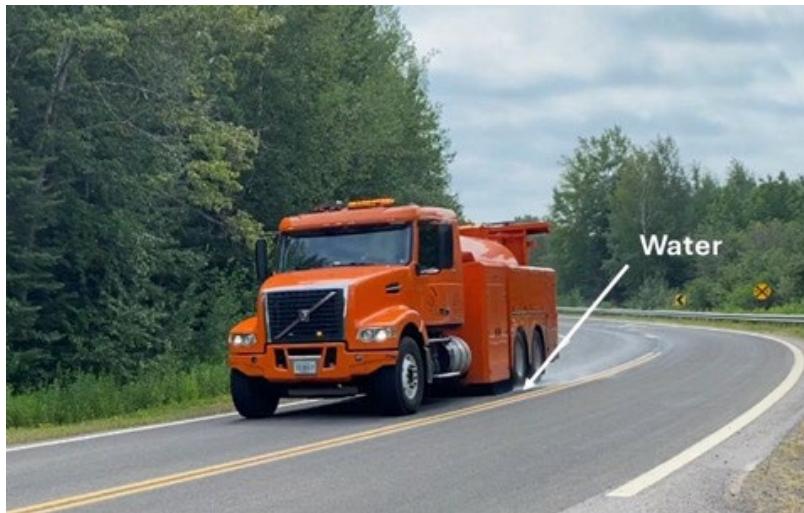
Figure 7.48. SCRIM in operation at the project test site on July 26, 2024

Figure 7.48 shows the SCRIM in operation at the project test site. Note the water being applied to the pavement surface.

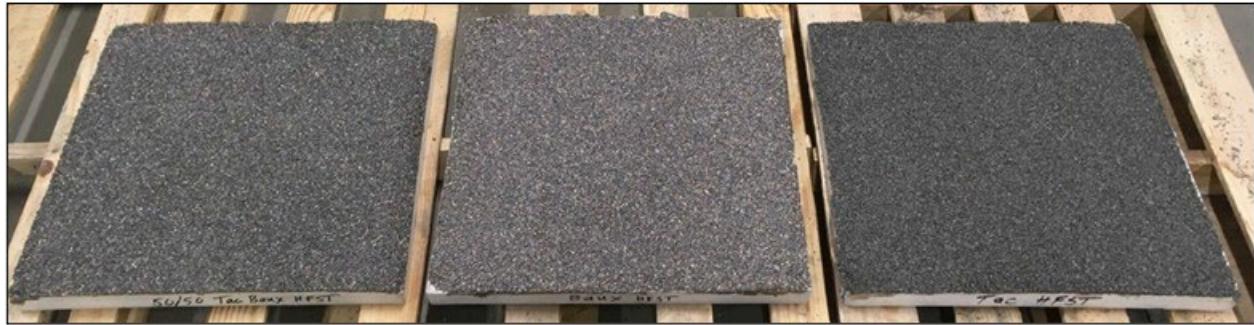
Figure D.1 shows the slabs prior to testing. The slabs shown in this figure contain the following surface treatments applied on three concrete tiles, from left to right, 50/50 blend of bauxite and taconite, 100% bauxite and 100% taconite.

Figure D.1. Test slabs with HFST application

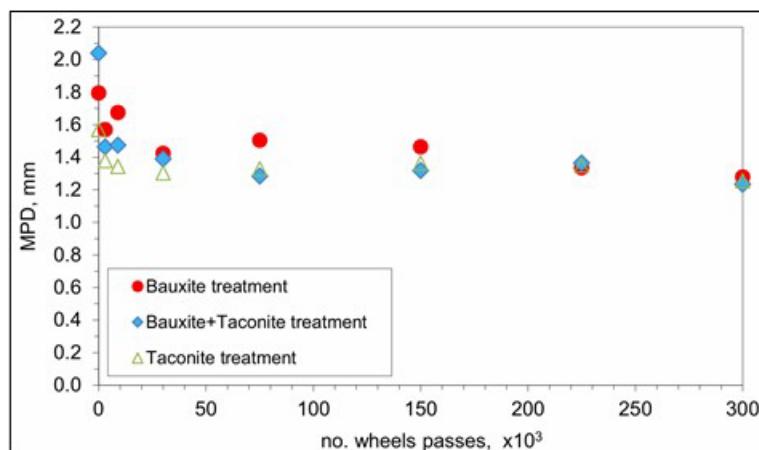
Figure D.4 Mean profile depth vs. wheel passes

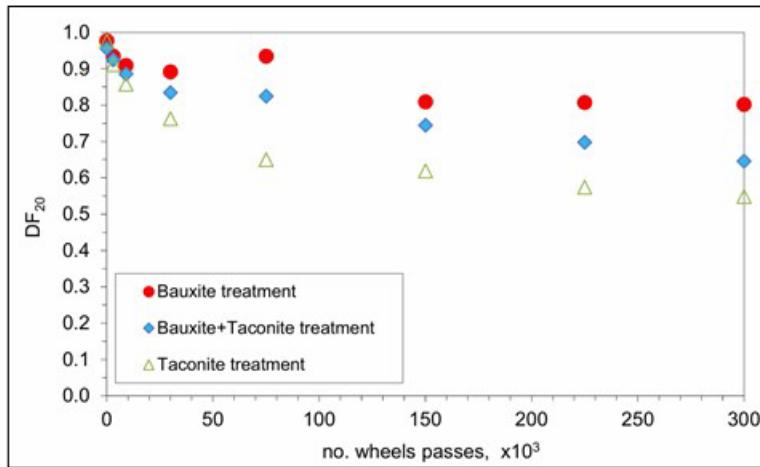
Figure D.5 DFT₂₀ vs. wheel passes

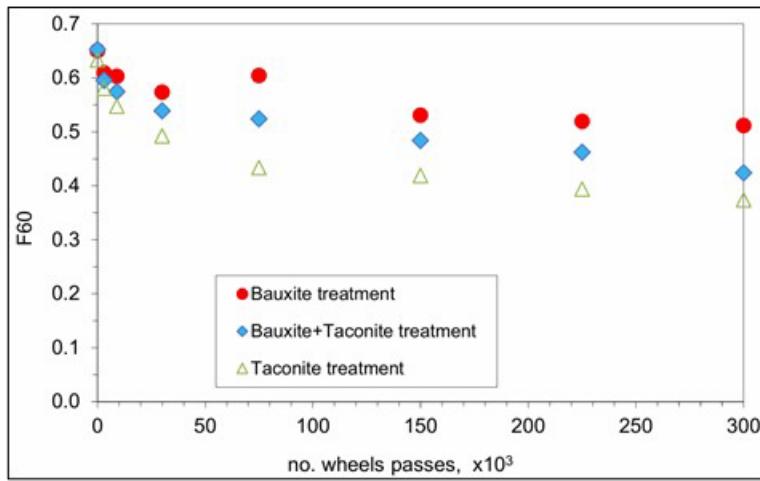
Figure D.6 F60 values vs. wheel passes

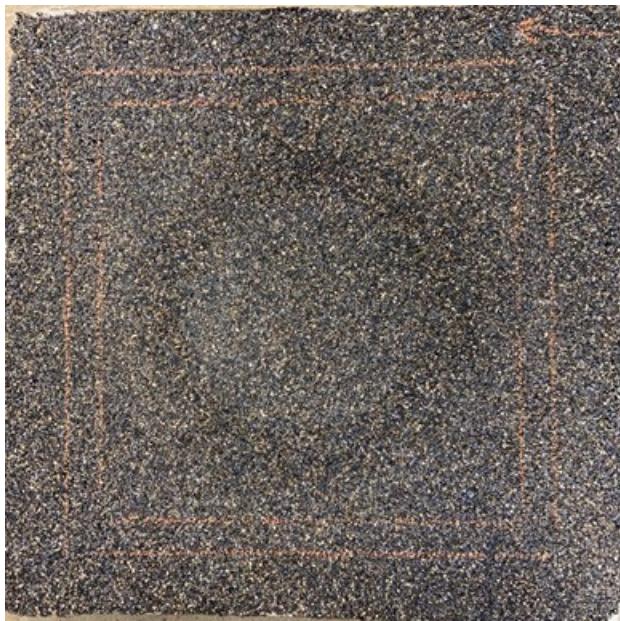
Figure D.7. 100% Bauxite-after testing

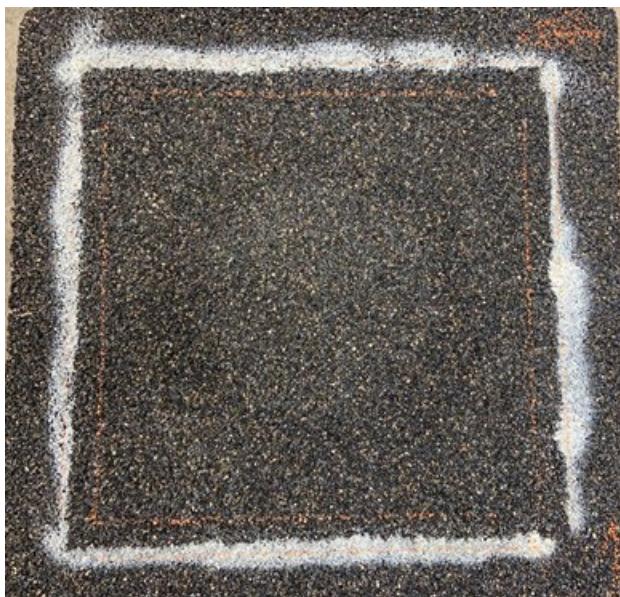
Figure D.8. 50/50 Bauxite + Taconite treatment-after testing

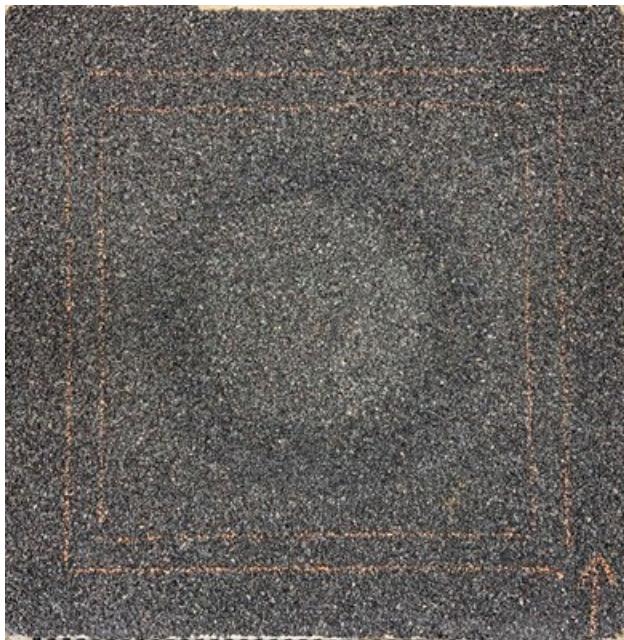
Figure D.9. 100% Taconite treatment-after testing
