FDOT Contract Number: BEC97

A Review of Protocols Used for Evaluating Defective Asphalt Materials and Pavements

Final Report-Deliverable 5

July 2024

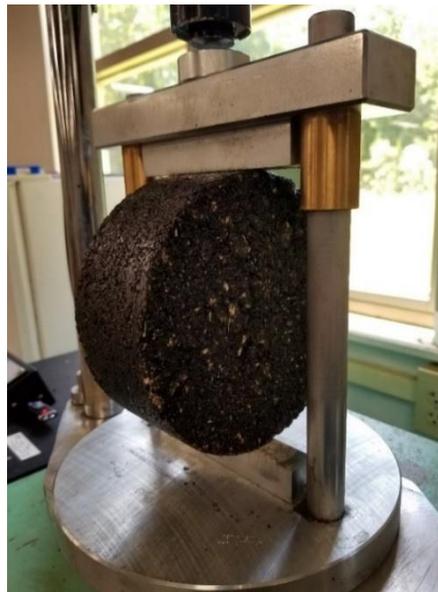
The HT-IDT test is being evaluated to quickly assess mixture rutting potential in a production setting where a rapid turnaround of results is necessary. The HT-IDT is performed using a standard Lottman breaking head (Figure 13) and any load press capable of loading the specimen at 50 mm/minute and measuring a peak load. A minimum of three specimens for this test were compacted in the SGC to 62 mm tall to the target density ± 0.5 percent for each testing condition. Specimens were conditioned in a water bath at 50°C for 1 hour before testing. The peak load and specimen dimensions are used to calculate each specimen's indirect tensile strength (ITS). A higher ITS is indicative of a more rutting resistant mixture. The ALDOT BMD Special Provision recommends a minimum ITS of 20 psi for mixtures with good rutting resistance (Yin and West, 2021).

Figure 13. High-Temperature Indirect Tensile Strength Test (HT-IDT)

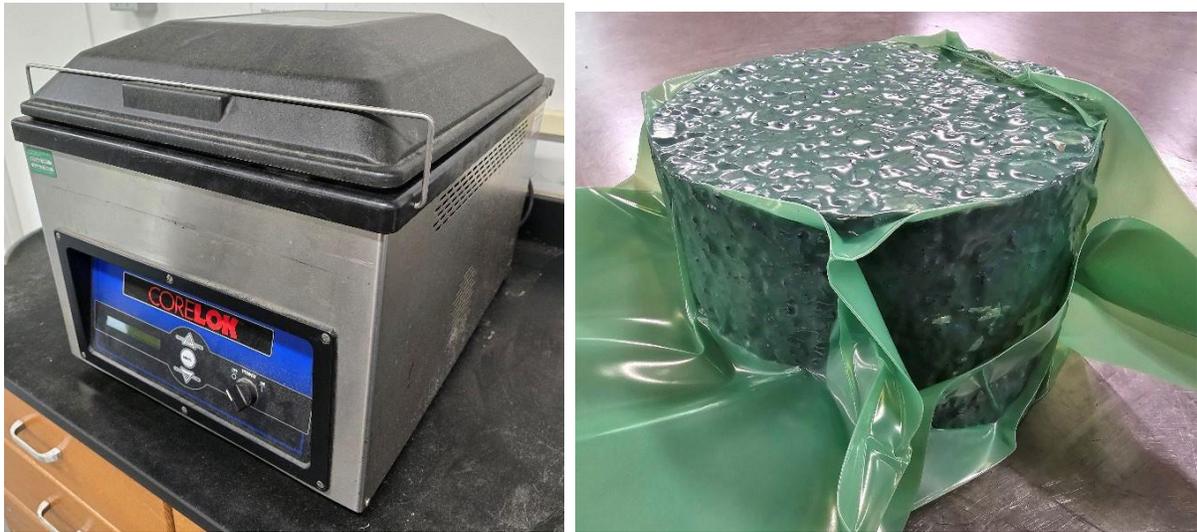
Figure 14. Vacuum Sealing Apparatus (left) and Vacuum-Sealed FC-5 Specimen (right)

The Cantabro test for FC-5 mixture durability was performed on the three FC-5 mix designs for this study by AASHTO T401-22. Three replicates compacted to N_{design} (50 gyrations) were tested for each gradation and AC combination for the three FC-5 mixtures. Before Cantabro testing, the air void content of each specimen was determined using the vacuum sealing method per AASHTO T331-23. The vacuum sealing apparatus used at NCAT, along with a photo of a specimen after vacuum sealing, are shown in Figure 14. NCHRP Report 877 *Performance-Based Mix Design of Porous Friction Courses* recommended an air void content of 15-20% for OGFC mixes determined with the vacuum sealing method (Watson et al., 2018).

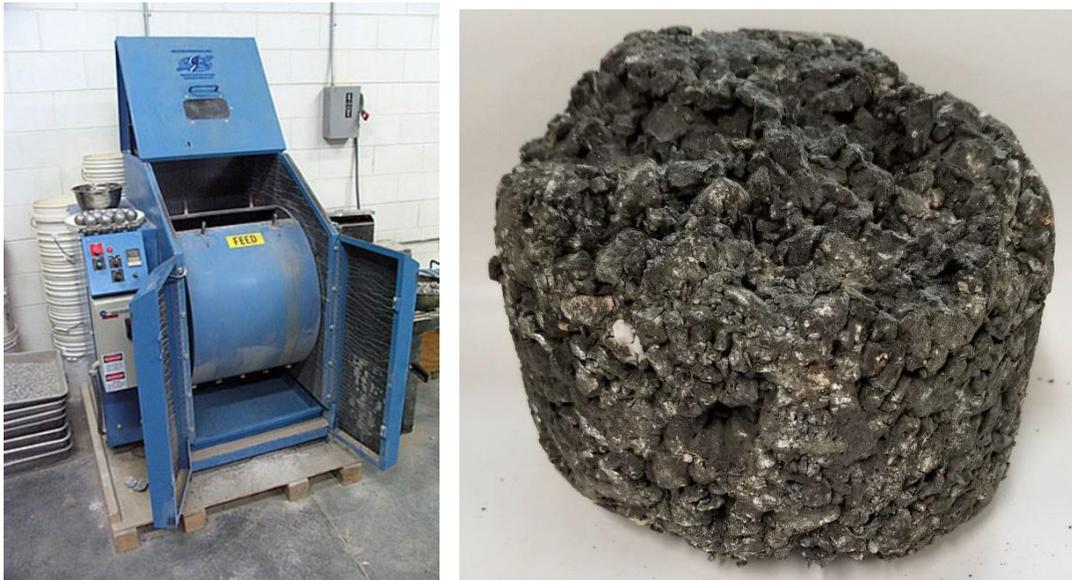
The specimens were conditioned in an environmental chamber for at least four hours at 25°C before Cantabro testing. Subsequently, each specimen was placed inside the Los Angeles Abrasion drum without the charge of steel spheres and subjected to 300 revolutions at a speed of 30 to 33 revolutions per minute. After the test, the largest portion of the remaining specimen was removed from the machine, and the weight was determined (Figure 15). The mass loss is calculated by taking the original mass minus the mass after testing and dividing it by the original mass. A maximum Cantabro mass loss of 20 percent on short-term aged specimens is commonly used for the design of open-graded or porous friction course mixes and is cited in the ASTM D7084 standard for the design of open-graded friction course mixtures.

Figure 15. Los Angeles Abrasion Machine Used for Cantabro Testing (left) and FC-5 Specimen after Cantabro Testing (right)

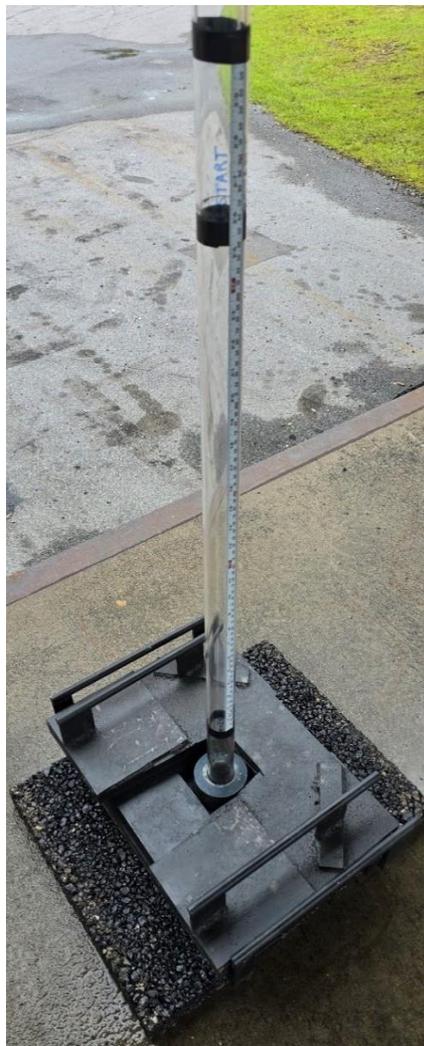
permeability of each slab was determined using a spreadsheet provided by FDOT. The coefficient of permeability (k) was calculated as a function of the slab thickness, the distance between the timing marks on the permeameter tube, and the time required for the water to travel between the tube markings.

It should be noted that all of the permeability readings taken using this method were extremely high. The field permeameter is typically used on continuous pavements with confined edges. When testing slabs sitting on top of a concrete pad, the edges of the slab were not confined. Hence, the water had very little distance to travel through the slab before being free to flow out of the slab. These issues were communicated with FDOT during testing, and the decision was made to proceed using this method for this study. However, it is recommended the permeability values in this report only be used as relative rankings within each mix rather than as definitive data regarding the permeability of a given mixture.

Figure 16. FDOT Permeameter with FC-5 Slab
