4. Title and Subtitle EVALUATION OF DESIGN ANALYSIS PROCEDURES AND ACCEPTANCE CRITERIA FOR ROADSIDE HARDWARE Volume IV. The Importance of the Occupant Risk Criteria				July 31, 1987																						
				6. Performing Organization Code 06-7321																						
7. Author(s) M. H. Ray, J. D. Michie, W. W. Hunter, J. S. Stutts				8. Performing Organization Report No.																						
9. Performing Organization Name and Address Southwest Research Institute 6220 Culebra Road, P.O. Drawer 28510 San Antonio, TX 78284				10. Work Unit No.																						
				11. Contract or Grant No. DTFH61-82-C-00086																						
12. Sponsoring Agency Name and Address Safety Design Division FEDERAL HIGHWAY ADMINISTRATION 6300 Georgetown Pike McLean, VA 22101-2296				13. Type of Report and Period Covered Final Report October 1982 - August 1987																						
				14. Sponsoring Agency Code																						
15. Supplementary Notes FHWA Contract Manager: Martin Hargrave (HSR-20)																										
16. Abstract <p>This research was conducted to identify and investigate aspects of NCHRP Report 230 which require additional technical research. This report deals with

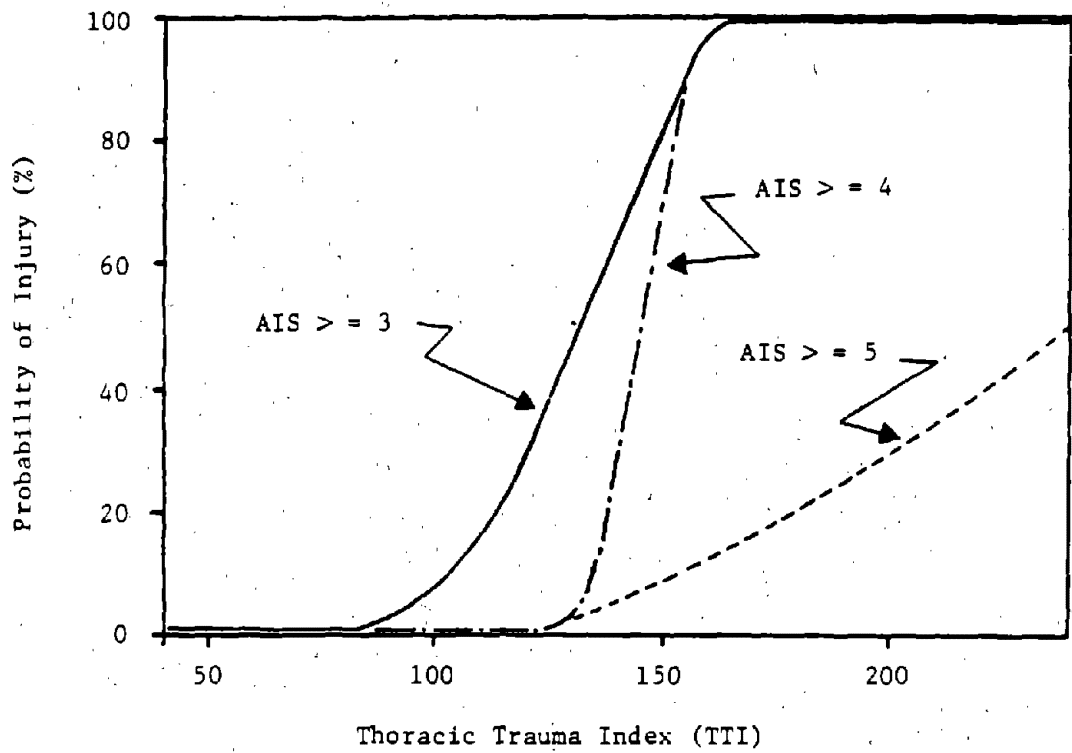
Another injury measure better suited to side impacts is the Thoracic Trauma Index (TTI). Eppinger, et al⁽⁵⁾ developed a family of curves which relate the TTI to the probability of sustaining a given level of injury. This relationship is shown in figure 3 and the TTI is defined by the following equation.

Figure 3. Probability of injury versus TTI. (4)

Even at a vehicle lateral acceleration of -18.6 g's and an occupant impact velocity of 24.9 fps (7.6 m/s), the probability of a hypothetical 41-year old 165-lb (74.9-kg) occupant (TTI = 113) sustaining an AIS of 3 or greater is only 0.16, and the probability of sustaining an AIS of 4 or greater is nil as shown in figure 3. The probability of severe injury (AIS >=4) is very remote for this occupant even under impact conditions which are generally considered to be severe.

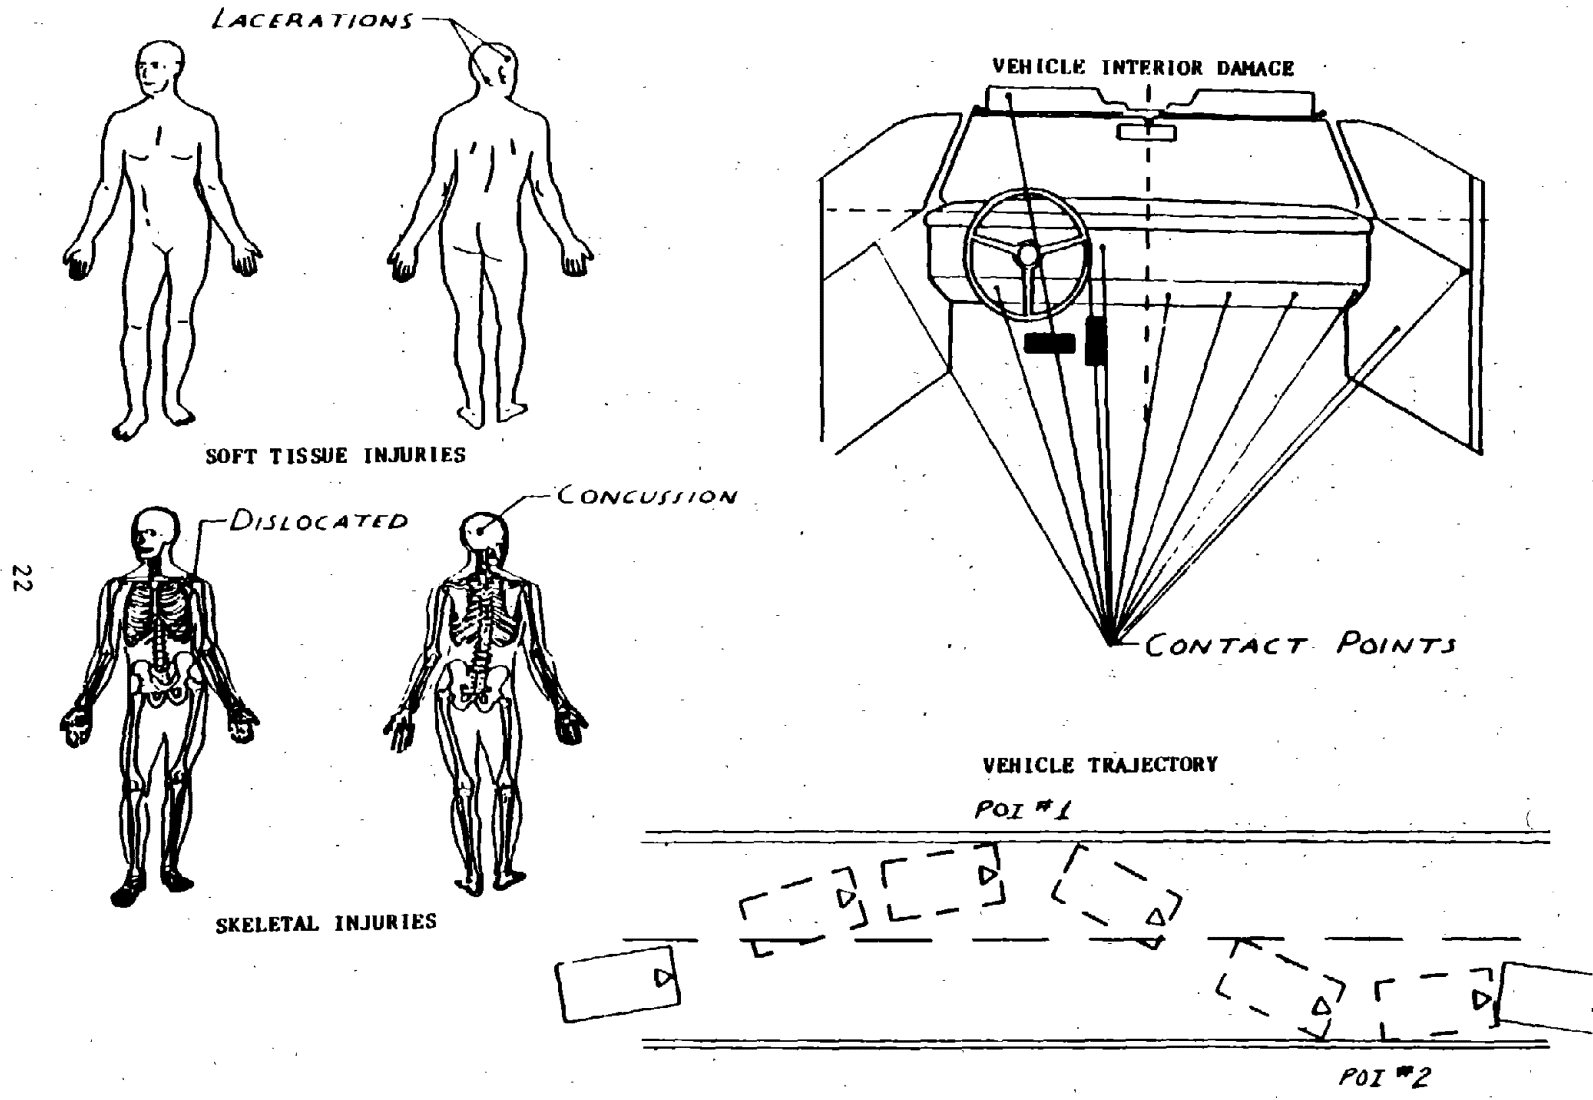
Figure 4. Typical accident reconstruction summary sheet, Case NASS 82-02-078V.

reconstruction process therefore involved determining the speed and angle for 2 or 3 collisions. The vehicle deformation energy was calculated using the damage analysis portion of CRASH3⁽⁸⁾, barrier deformation energy was estimated using BARRIER VII,⁽⁹⁾ and energy dissipated by tire-ground friction during the trajectory was estimated by hand analysis methods. By proceeding from the last event to the first and summing all the energies of vehicle and barrier deformation with the energies lost through tire-ground friction and braking a reliable estimate of the impact speed can be produced.

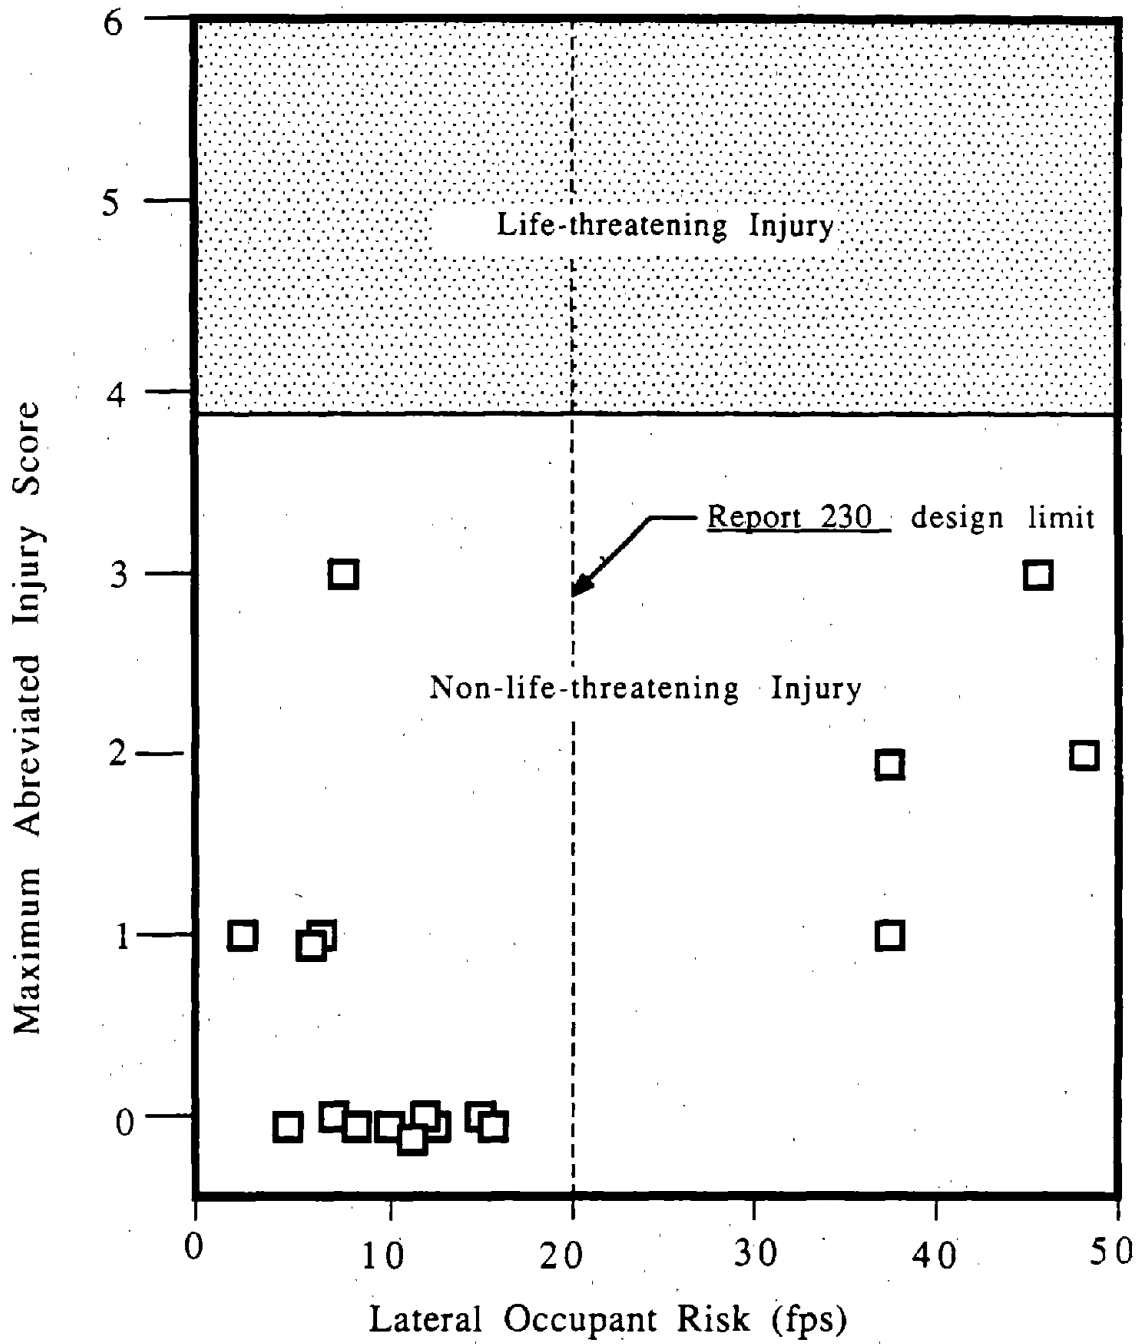
Figure 5. Occupant injury vs the lateral occupant risk factor.

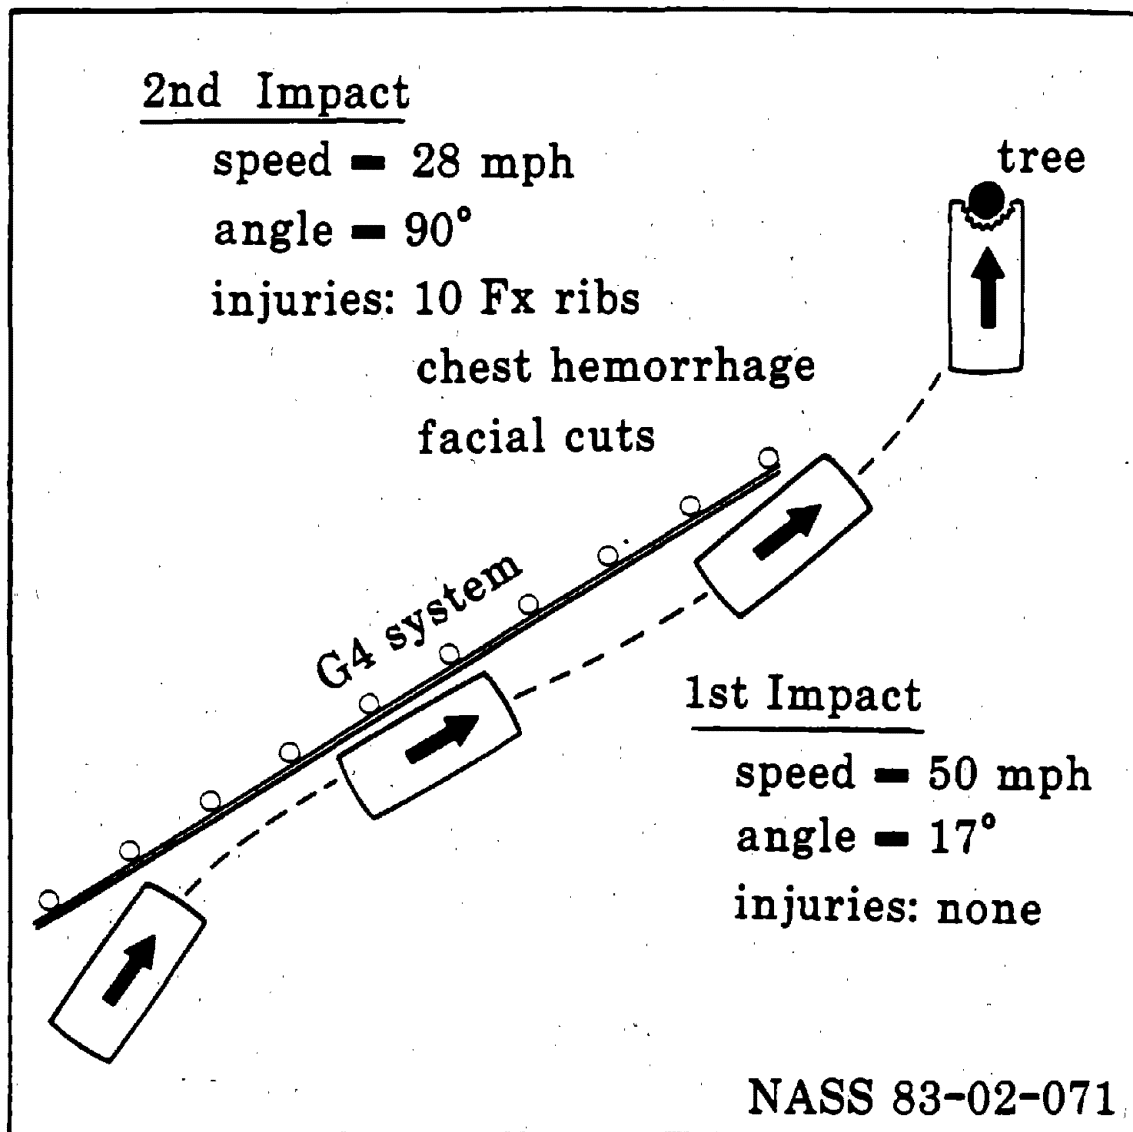
Figure 6. Example of a multiple impact accident case.

In more than 80 percent of the cases summarized in table 7, the vehicle struck another roadside object after being successfully redirected from the first collision. For all of the vehicle occupants that experienced secondary impacts, the MAIS was greater in the second impact than the first, sometimes by a large margin. For example figure 6 summarizes NASS case 83-02-071T. After the first barrier impact the occupant had sustained no injuries. After the vehicle was redirected, however, it collided with a tree; the MAIS for the second collision was 3. Often, in the cases summarized in table 6, the occupant sustained no injuries during the first redirection only to become involved with another, much more serious subsequent collision. Clearly, redirection into other roadside features poses a serious hazard to vehicle

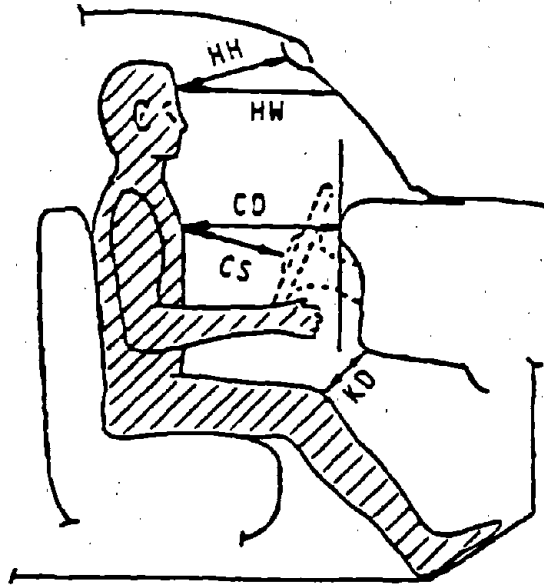
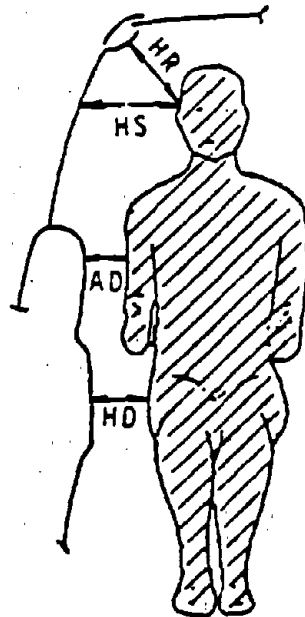
Figure 9. Occupant clearance dimensions.
(Taken from memo prepared by NHTSA Office of Vehicle Research.)

- HS - HEAD TO SIDE WINDOW - Horizontal distance from side of head (just above ear) to point on window (or pillar) immediately to the side of subject.
- CD - CHEST TO DASH - Horizontal distance from chest (near sternum) to vertical line tangent to dashpanel immediately in front of subject.
- CS - CHEST TO STEERING WHEEL - Distance from chest (near sternum) to hub of steering wheel for a subject seated in driver's position.
- AD - ARM TO DOOR - Horizontal distance from midpoint of upper arm to door (or other) surface immediately to side of subject.
- HD - HIP TO DOOR - Horizontal distance from hip (H-point) to door (or other) surface immediately to the side of subject.
- KD - KNEES TO DASH - Shortest distance from knees to lower dashpanel immediately in front of subject.

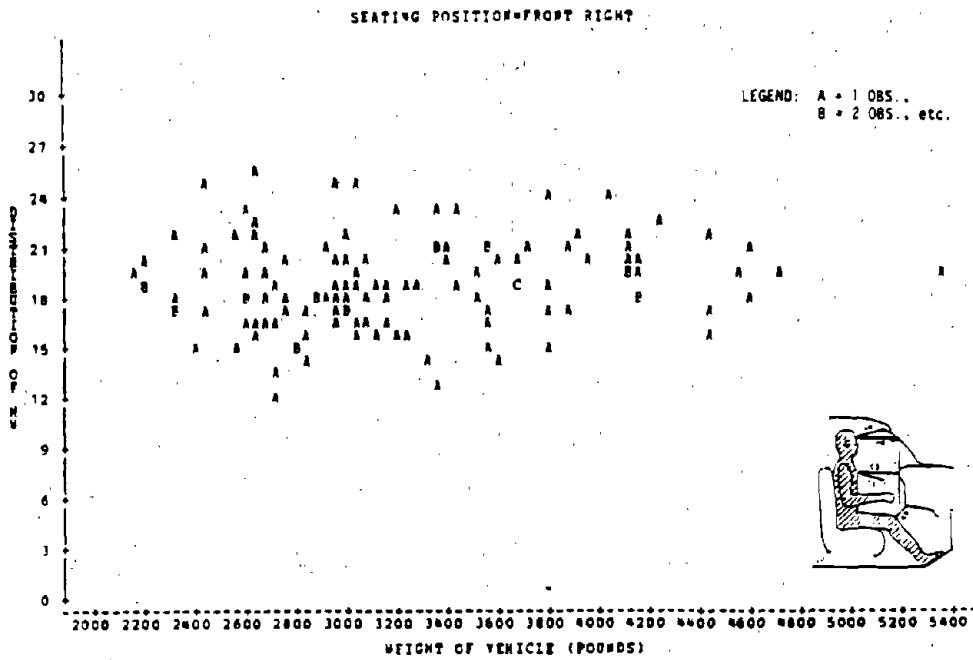
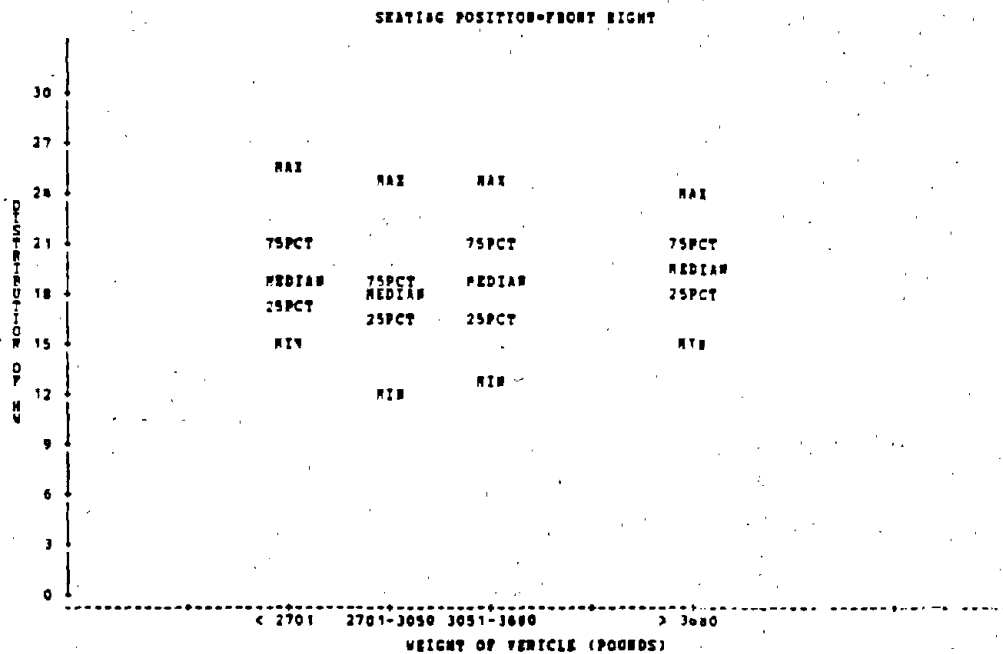
Figure 10. Head to windshield (HW) for right front passenger.

Figure 10 is a plot of the head to windshield (HW) dimension by the vehicle weight categories for the right front passenger and is typical of the remaining figures. For each weight category, the distribution of the HW dimension is reflected by the following points:

An examination of figure 10 shows only modest variation of HW within the various descriptors noted above. For example, the median values for all weight groups range between approximately 17.5-19.5 inches (44.5-49.5 cm). The largest value of HW is about 26 inches (66.0 cm) and occurs in the < 2701 lb (1226-kg) weight group. The smallest value of HW is about 12 inches (30.5 cm) and occurs in the 2701-3050 lb (1226-1385 kg) weight group.

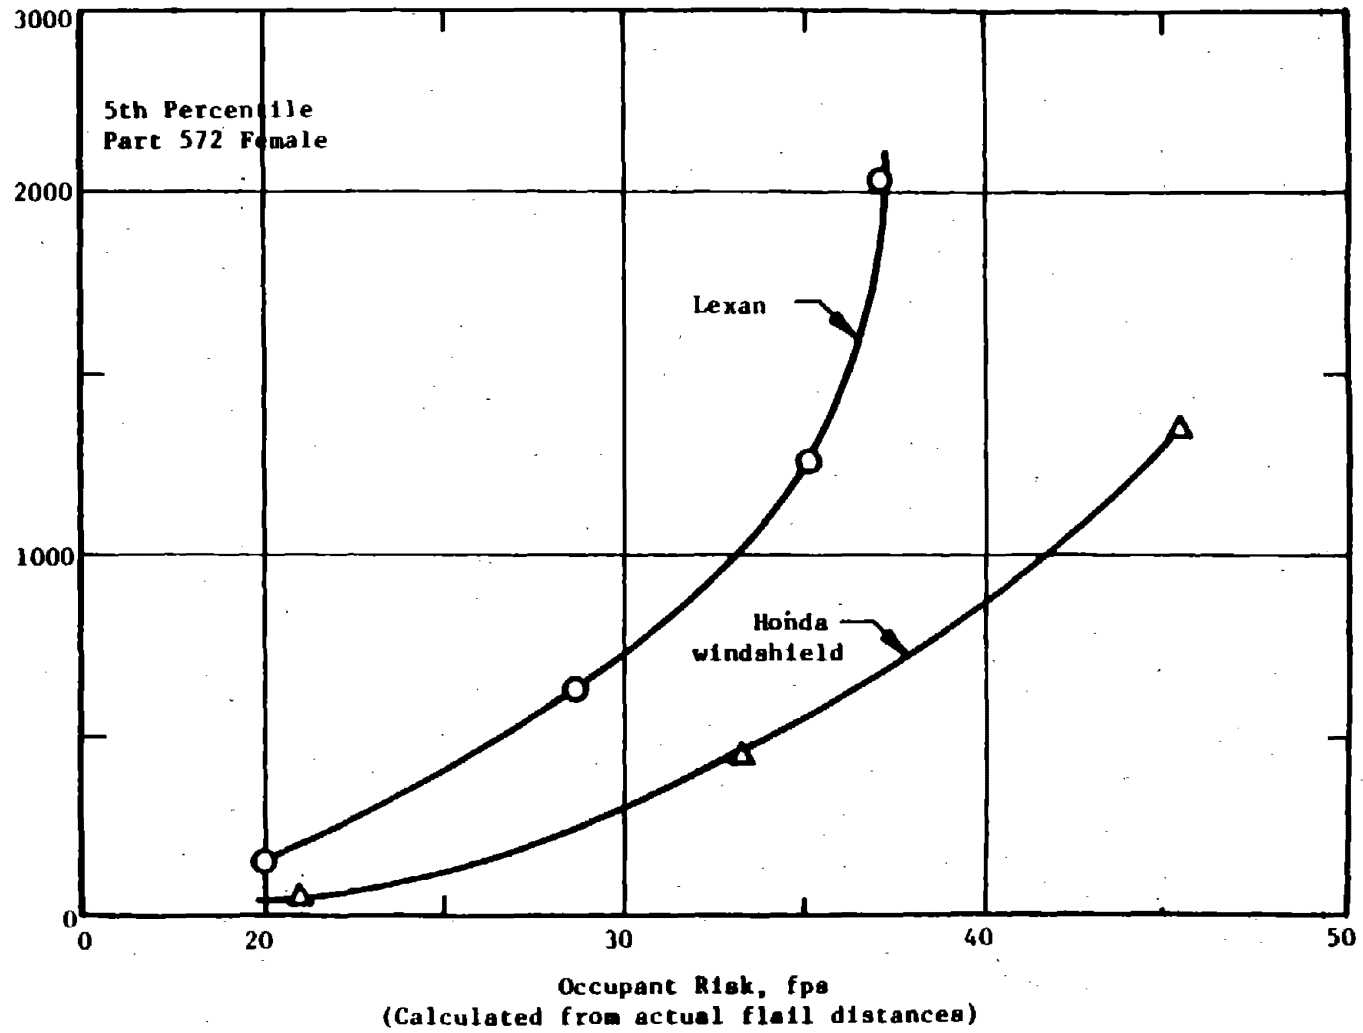
Figure 34. Plot of HIC vs occupant.

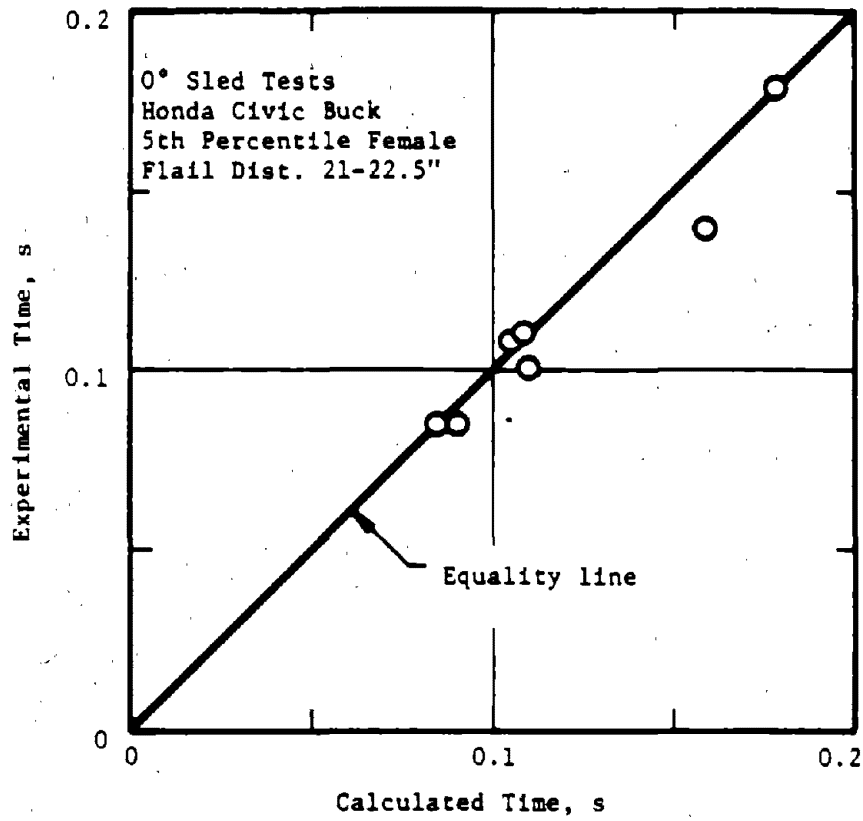
Figure 35. Comparison of experimental to computed time of head/windshield impact.

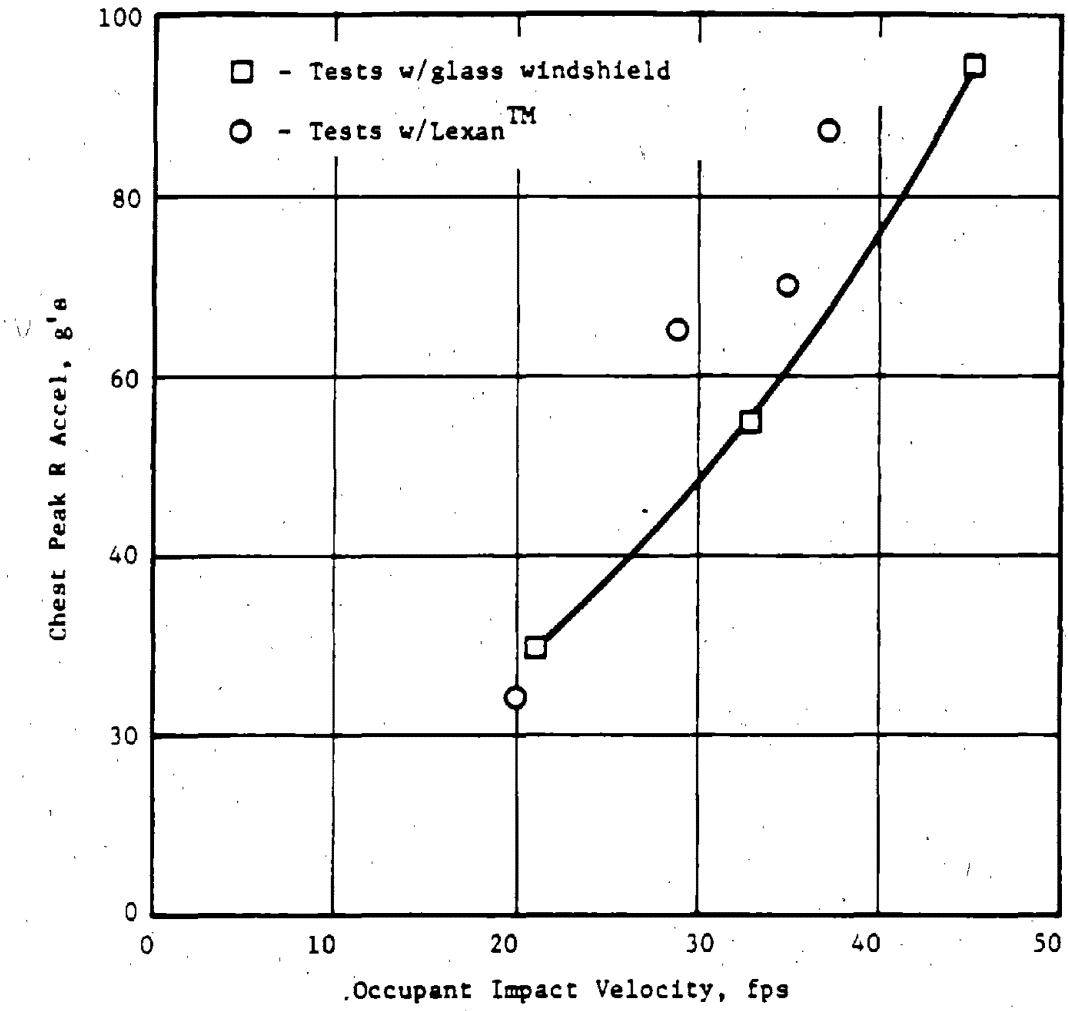
Figure 36. Dummy chest accelerations as a function of occupant to dash impact velocity.

- The occupant moves as a free body allowing the head to impact the windshield first. This is evidenced by the sequential photographs of figures 28 and 30 and by the plot shown in figure 35 of calculated impact times vs experimental times. Apparently there is a small amount of friction between the passenger seat and dummy, allowing the dummy to rotate slightly and initial contact by the head to occur first, even though the chest-to-dash distance was less than head-to-windshield distance.
- Occupant chest resultant accelerations exceed FMVSS 208 60-g limit for occupant impact velocity of 35 fps (10.7 m/s) and greater. A curve is extended through the points connecting the glass windshield tests in figure 36.
