HEAVY VEHICLE MEDIAN BARRIER

Contract No. DTFH61-84-C-00052

Texas Transportation Institute
The Texas A&M University System

March 1986

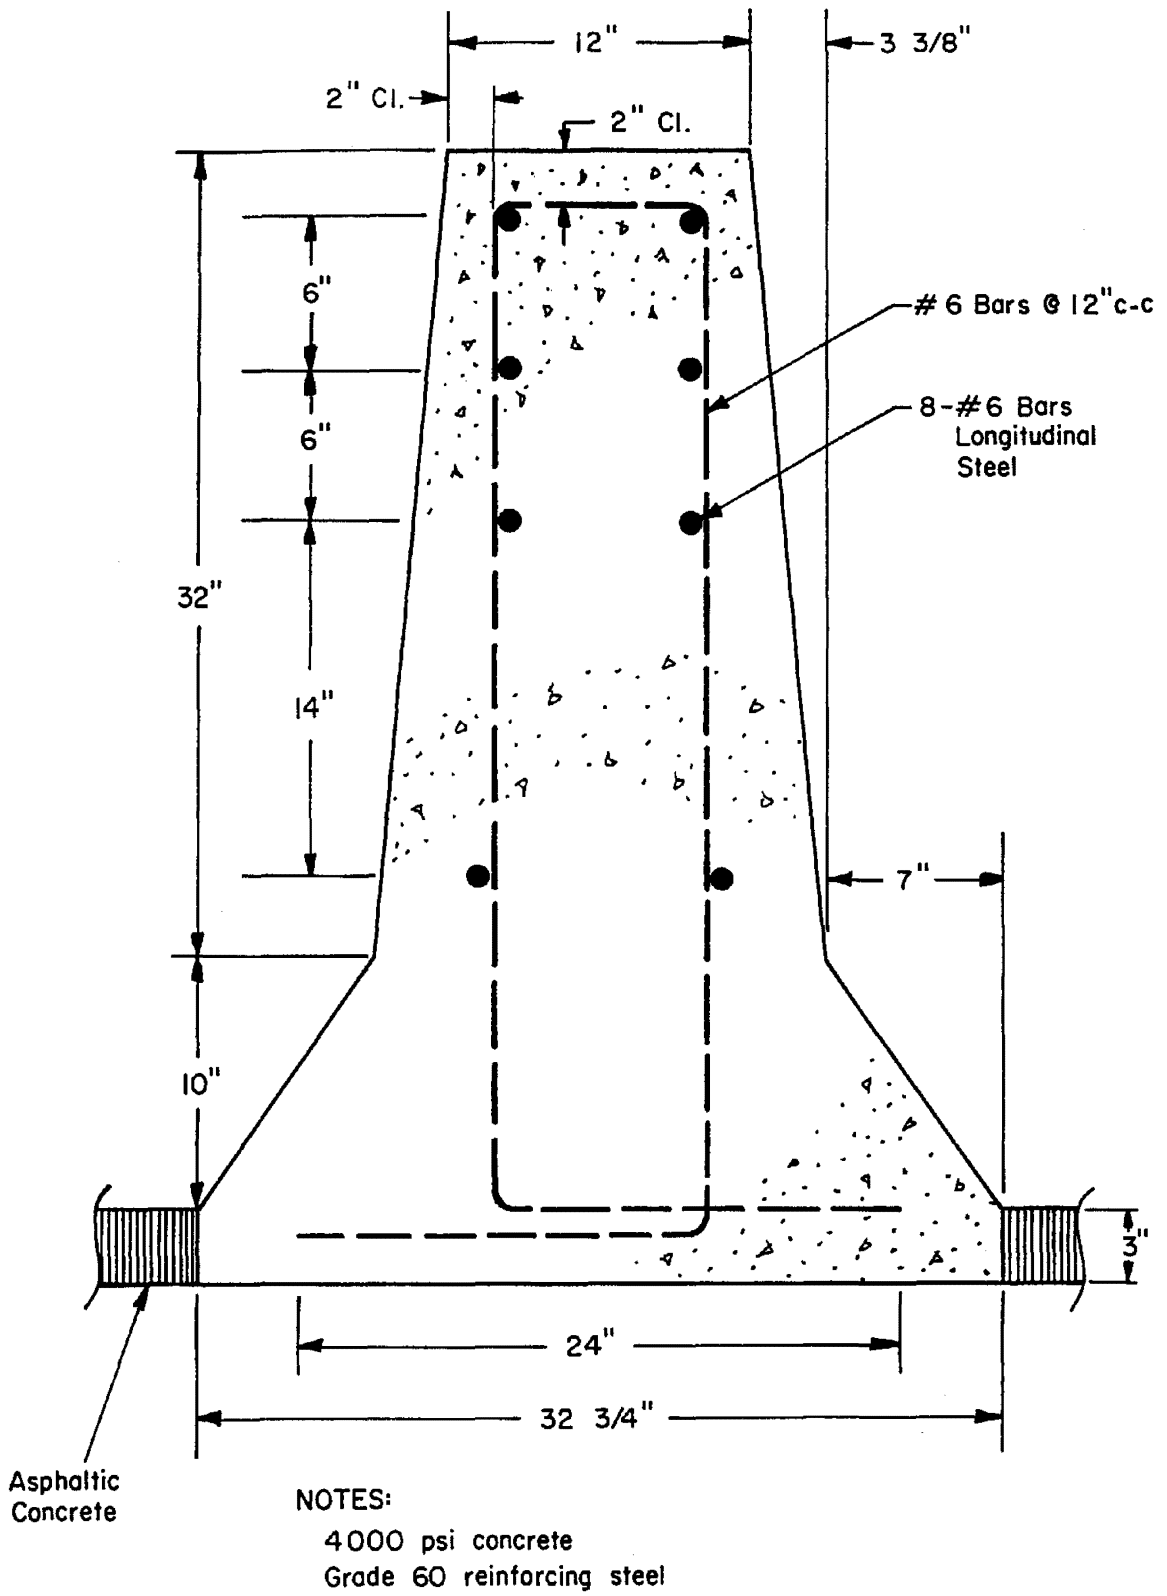
Figure 1. Cross section of test barrier.

For the strength analyses of the barrier, a rectangular cross section of 45 in x 16.5 in was assumed. This provided an area of 742 in². The assumed failure modes were:

- Barrier sliding laterally being resisted by the asphalt against the 3 in vertical face.

- Torsional movement of the barrier resulting from a segment in the impact area rotating about a longitudinal axis with the torsional load being resisted by the upstream and downstream portions of the barrier.
- Overturning of a finite length of barrier (inertia of the barrier was ignored).

The HVMB is a reinforced concrete section derived from the MB5 concrete safety shape (New Jersey profile) median barrier. The slopes of the barrier face were the same as the MB5 (see figure 1). However, the upper face was increased from 19 to 32 in. The lower vertical face remained at 3 in but differed from the MB5 design in that the vertical face was embedded in asphalt as shown in figure 1. These modifications increased the effective height of the barrier to 42 in. This height helps limit the roll of heavy vehicles and allows visibility across the median for police and emergency vehicles.

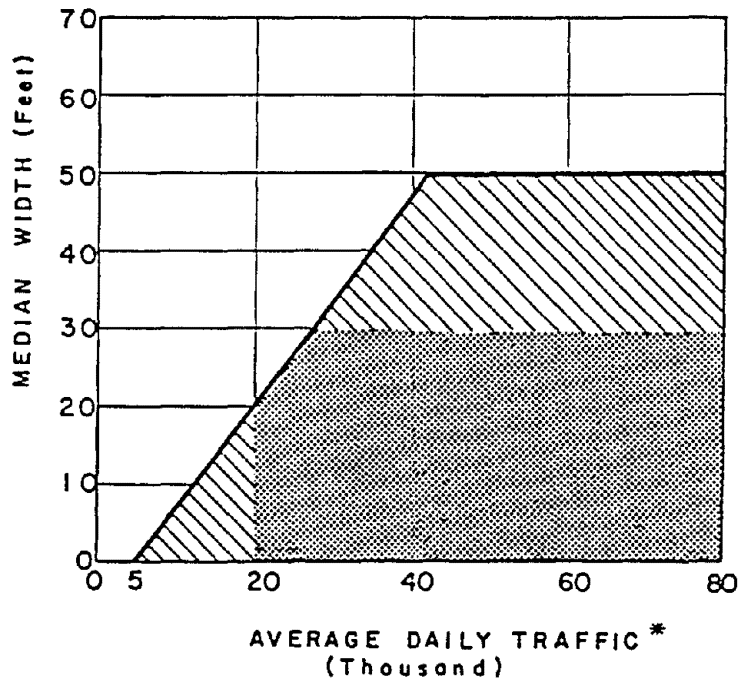
The 1977 AASHTO Barrier Guide procedure for Median Barrier Warrants could be used to select a Heavy Vehicle Median Barrier.⁽⁸⁾ Figure 8 is for all median barriers. In cases where trucks are crossing the median, the same curve could be used to warrant use of the HVMB.

* Based on a 5-year projection

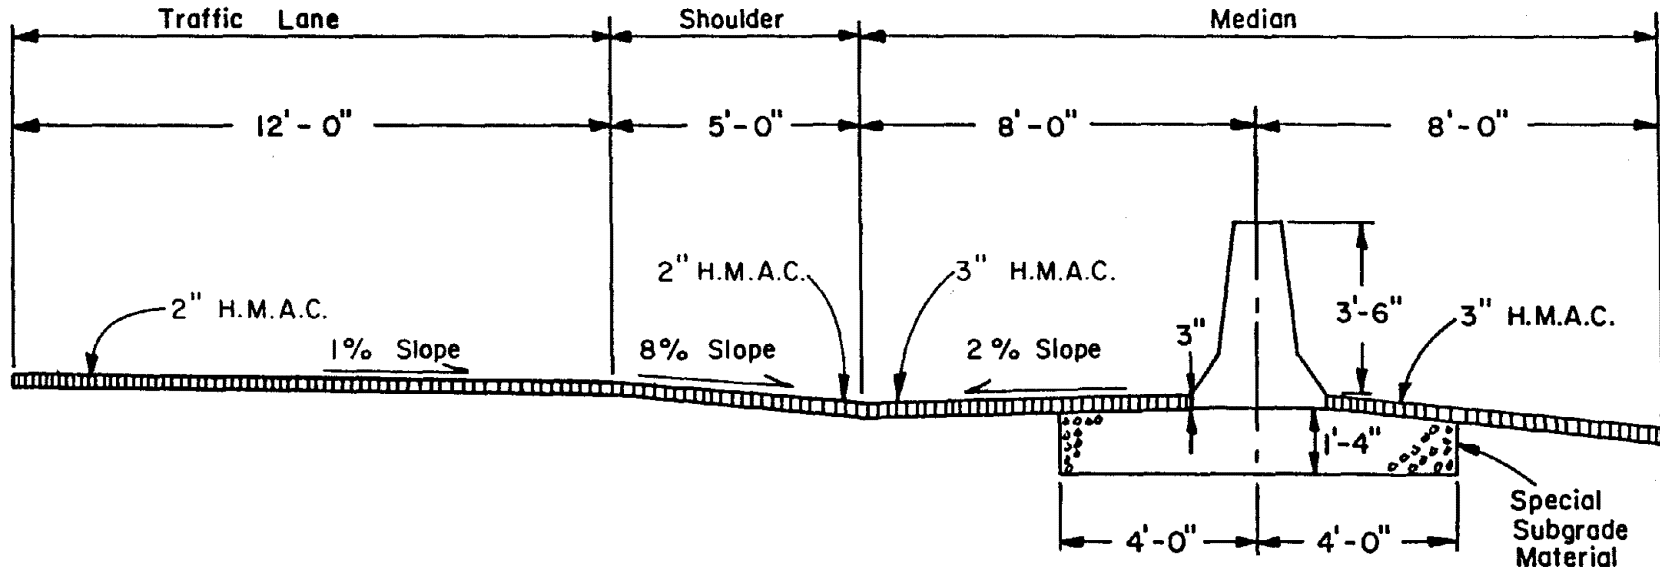
Figure 11. Cross section of test barrier installation.

H.M.A.C. - Hot Mix Asphaltic Concrete

Special Subgrade Material - Red sandy clay
subgrade material with a maximum
dry density (AASHTO T180) of 126.0 lb/ft³

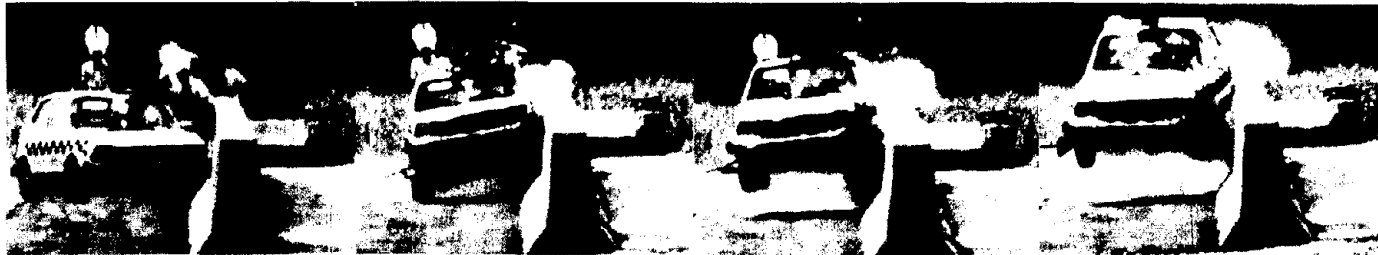
Test No.	1-1	Impact Speed.	100.7 km/h (62.6 mi/h)
Date	7-12-82	Impact Angle.	15.0 degrees
Rail	Continuous Mod. Safety Shape	Exit Speed.	91.3 km/h (56.8 mi/h)
Length of Installation . .	76.0 m (250.0 ft)	Exit Angle.	5.0 degrees
Vehicle.	1979 Honda CVCC	Vehicle Accelerations (Max. 0.050 sec Avg.)	
Vehicle Weight		Longitudinal.	-4.6 g
Test Inertia	843 kg (1860 lb)	Lateral	-8.3 g
Gross Static	993 kg (2190 lb)	Occupant Impact Velocity	
Vehicle Damage Classification		Longitudinal.	3.8 m/s (12.4 fps)
TAD--11LFQ4 SAE--11LFEW6		Lateral	5.2 m/s (17.1 fps)
Dummy Restraints		Occupant Ridedown Accelerations	
Driver	No Restraint	Longitudinal.	-2.3 g
Passenger.	Lap & Shoulder Belt	Lateral	-7.9 g

Following impact the vehicle rode up the face of the barrier and became airborne. The vehicle was in a nose down attitude with the front wheels steered to the right when it lost contact with the barrier. When the vehicle returned to the pavement it rolled and came to rest upright.

A summary of the results of this test is shown in figure 12. The roll behavior exhibited by the small vehicle was not acceptable according to performance standards set forth in NCHRP Report 230.⁽⁵⁾ Upon further study, it was determined that the prototype roadway cross section, which was not level, contributed to the roll of the vehicle.

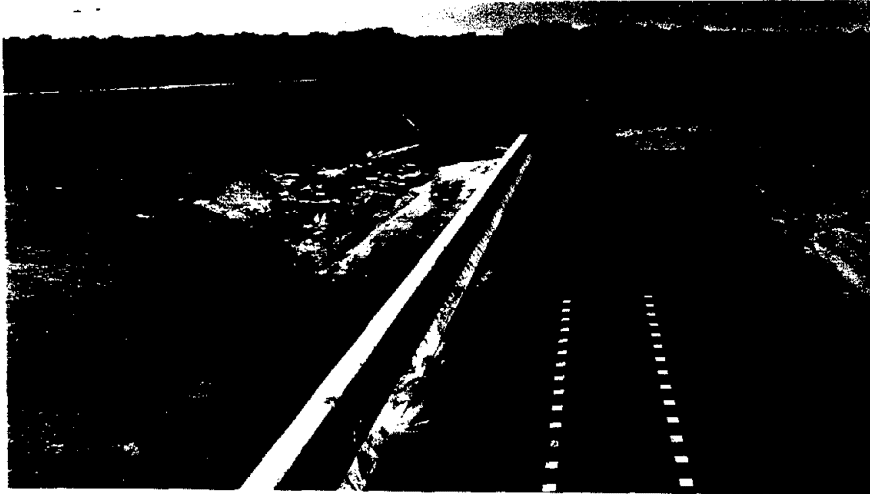
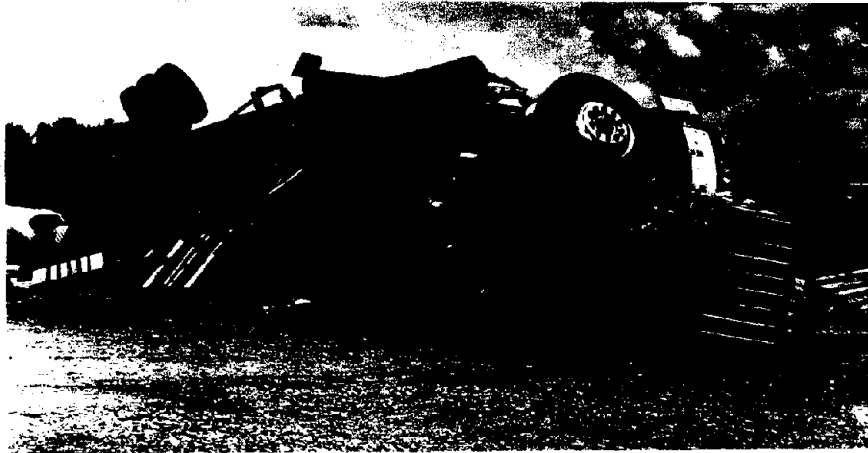
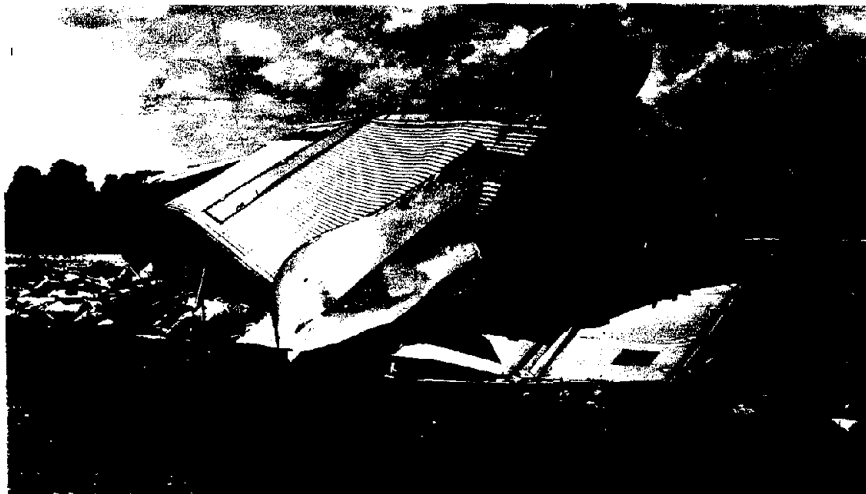
Figure 13. Vehicle after test 1-2.

The tractor was contained and redirected; however, the trailer rolled and extended approximately 21 ft onto the opposite side of the barrier. After careful study of test results it was determined that the positioning of the ballast in the trailer represented an extreme case, which contributed to excessive movement of the trailer into the opposite side of the barrier. This unacceptable behavior led to a second series of tests. The results of these tests are discussed in the next section of this report.

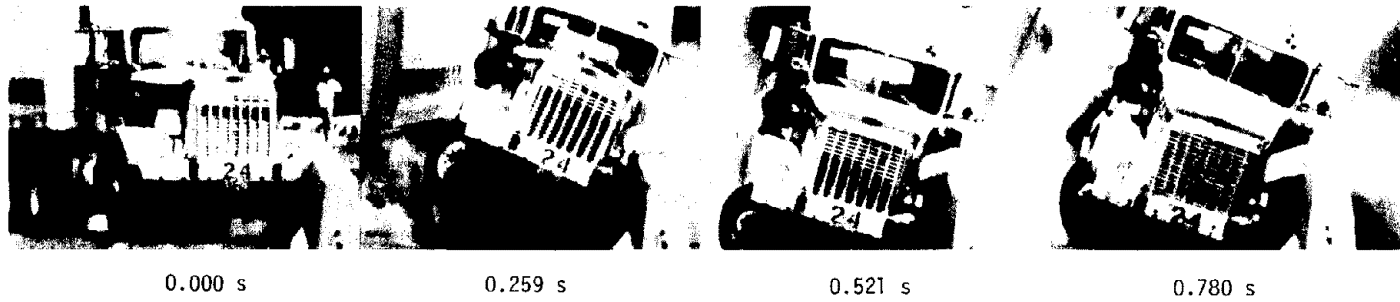
Figure 14. Summary of data for test 1-2.

Test No.	1-2	Impact Speed.	85.0 km/h (52.8 mi/h)
Date	7-14-82	Impact Angle.	16.0 degrees
Rail	Continuous Mod. Safety Shape	Vehicle Accelerations (Max. 0.050 sec Avg.)	
Length of Installation	76.0 m (250.0 ft)	Longitudinal.	-2.3 g
Vehicle.	Autocar	Lateral	-11.4 g
	Tractor-Trailer	Dummy Restriants	
Vehicle Weight		Driver (only)	Lap Belt
Test Inertia	13,971 kg (30,800 lb)		
Gross Static	36,479 kg (80,420 lb)

The barrier received minor damage and there was no measurable deflection. A summary of results is shown in figure 14.

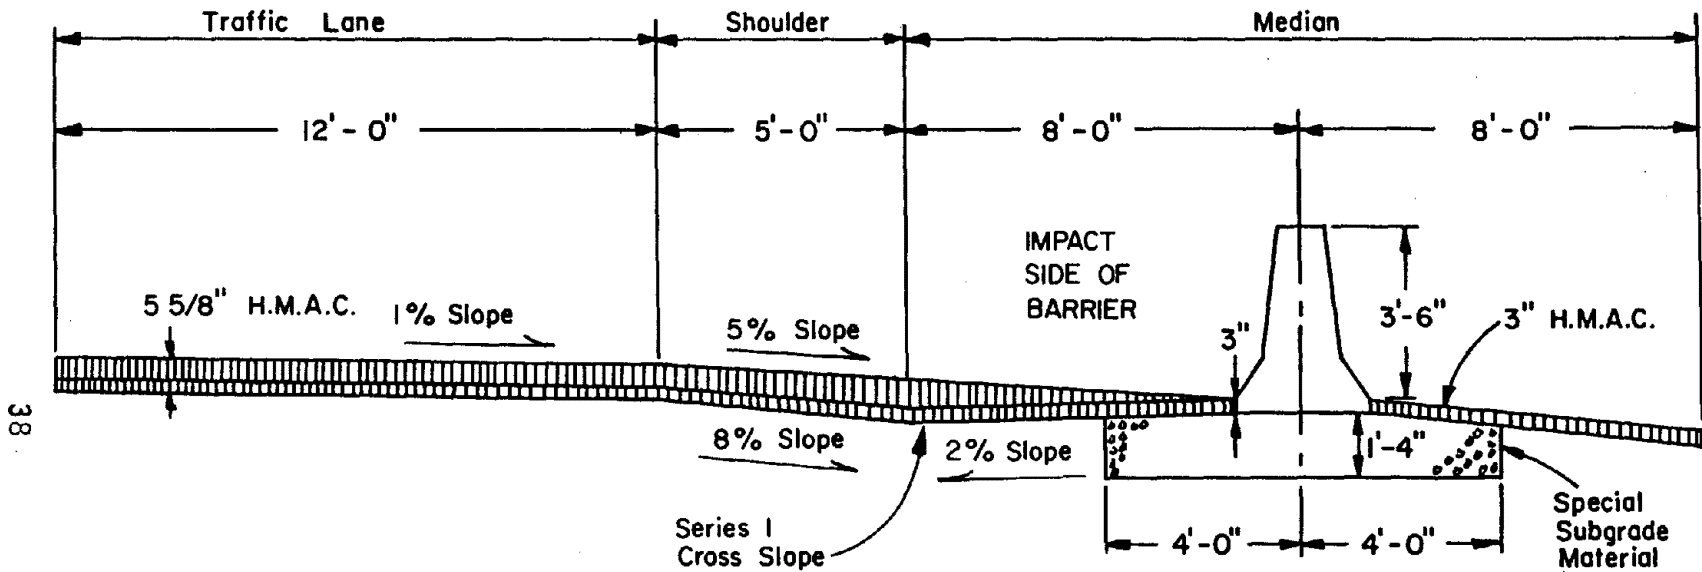
Figure 15. Cross section of test barrier installation showing modified roadway cross section (test series 2).

H.M.A.C. - Hot Mix Asphaltic Concrete

Special Subgrade Material - Red sandy clay
subgrade material with a maximum
dry density (AASHTO T180) of 126.0 lb/ft³

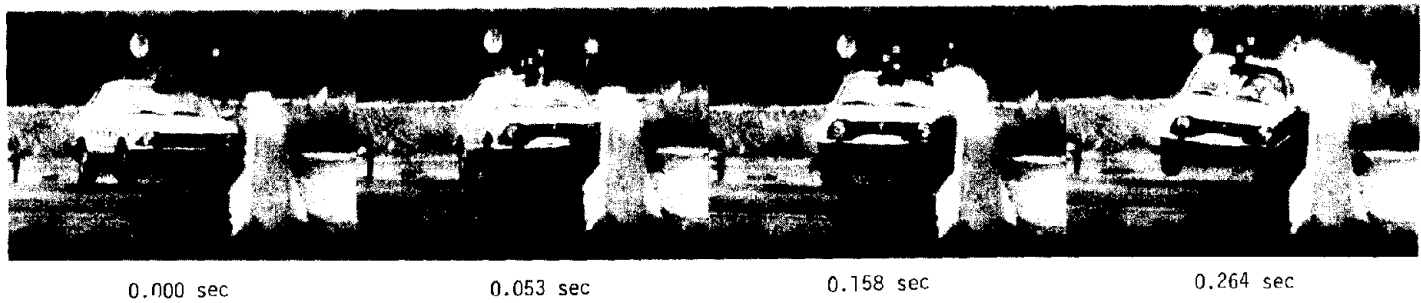
Test No.	4798-1	Impact Speed.	59.9 mi/h (96.4 km/h)
Date	4/20/83	Impact Angle.	14.5 degrees
Rail	Continuous Mod. Safety Shape	Exit Speed.	55.3 mi/h (89.0 km/h)
Length of Installation	250 ft (76 m)	Exit Angle.	2.5 degrees
Rail Deflection		Vehicle Accelerations	
Permanent	0 ft (0 m)	(Max. 0.050 sec Avg)	
Maximum	0 ft (0 m)	Longitudinal	-4.6 g
Vehicle.	1977 Honda Civic	Lateral	-10.0 g
Vehicle Weight		Vertical	3.0 g
Test Inertia.	1783 lb (809 kg)	Resultant.	11.3 g
Gross Static.	2118 lb (962 kg)	Occupant Impact Velocity	
Vehicle Damage Classification		Longitudinal	12.5 fps (3.8 m/s)
TAD	11-LFQ-3	Lateral	19.7 fps (6.0 m/s)
SAE	11FLEK1 11LDES2	Occupant Ridedown Accelerations	
		Longitudinal	-1.0 g
		Lateral	-13.9 g

The vehicle collided with the barrier at 59.9 mi/h and an approach angle of 14.5 degrees. The vehicle rode up the face of the barrier approximately 6 in, was redirected and lost contact with the barrier at a maximum roll angle of 10 degrees. The vehicle remained upright and relatively stable as it left the test area. A summary of data is shown in figure 16. Both the vehicle and barrier received minor damage.

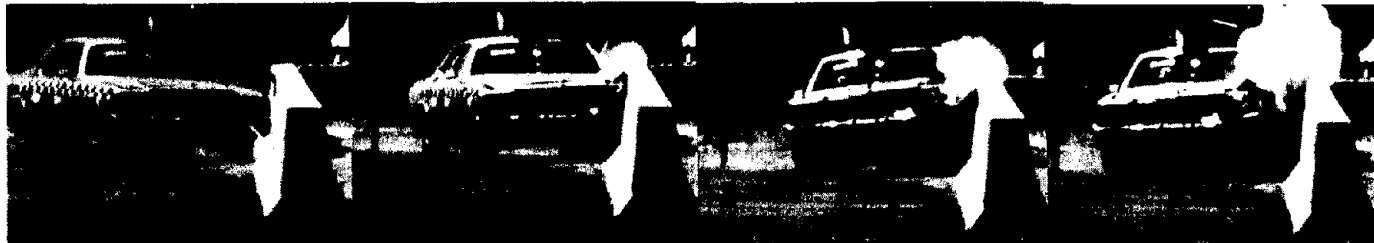
Figure 17. Summary of data for test 2-2.

Test No.	4798-3	Impact Speed.	58.6 mi/h (94.3 km/h)
Date	5/24/83	Impact Angle.	16.5 degrees
Rail	Continuous Mod. Safety Shape	Exit Speed.	49.1 mi/h (79.0 km/h)
Length of Installation	250 ft (76 m)	Exit Angle.	5.0 degrees
Rail Deflection		Vehicle Accelerations	
Permanent	0 ft (0 m)	(Max. 0.050 sec Avg)	
Maximum	0 ft (0 m)	Longitudinal	-4.2 g
Vehicle.	1977 Plymouth	Lateral.	-7.9 g
Vehicle Weight		Vertical	1.8 g
Test Inertia.	4520 lb (2052 kg)	Resultant.	8.6 g
Gross Static.	4880 lb (2216 kg)	Occupant Impact Velocity	
Vehicle Damage Classification		Longitudinal	10.4 fps (3.2 m/s)
TAD	11-LFQ-4	Lateral.	18.2 fps (5.6 m/s)
SAE	11FLEK2 11LDES2	Occupant Ridedown Accelerations	
		Longitudinal	-2.4 g
		Lateral.	-7.0 g

The vehicle impacted the barrier at 58.6 mi/h and an approach angle of 16.5 degrees. Shortly after impact, the left front wheel rode up the face of the barrier approximately 5 in. The other wheels remained in contact with the pavement surface. The vehicle was smoothly redirected and was stable when it left the barrier. The barrier and vehicle received minor damage. A summary of the results of this test are presented in figure 17.
