Traffic Control Device Analysis, Testing, and Evaluation Program: FY 2025 Activities

Technical Report 0-7198-R2

TEXAS A&M TRANSPORTATION INSTITUTE
COLLEGE STATION, TEXAS

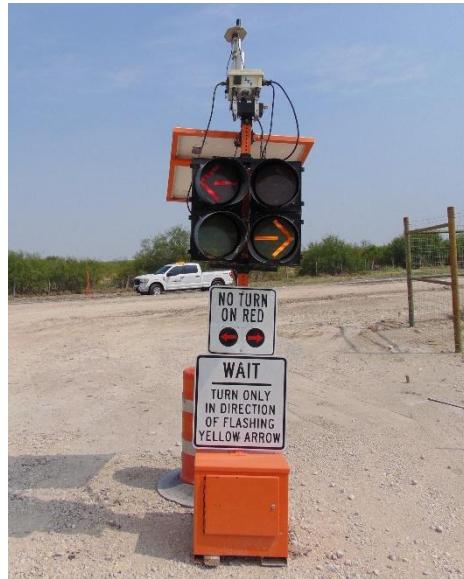
design for this project was the four-head stacked DAD, which included two 12-inch steady red arrow indications and two 12-inch flashing yellow indications. The steady red arrows indicated which direction a driver could not turn, while the flashing yellow arrows indicated which direction a driver could turn. During the all-red phase, both steady red arrows were illuminated. Since the four-section stacked DAD displayed steady red arrow indications, a modified R10-11 sign was included with a second supplemental sign (WAIT TURN ONLY IN DIRECTION OF FLASHING YELLOW ARROW) (see Figure 1).

Figure 1. Four-Section Stacked DAD Deployed on FM 2688 at D9.

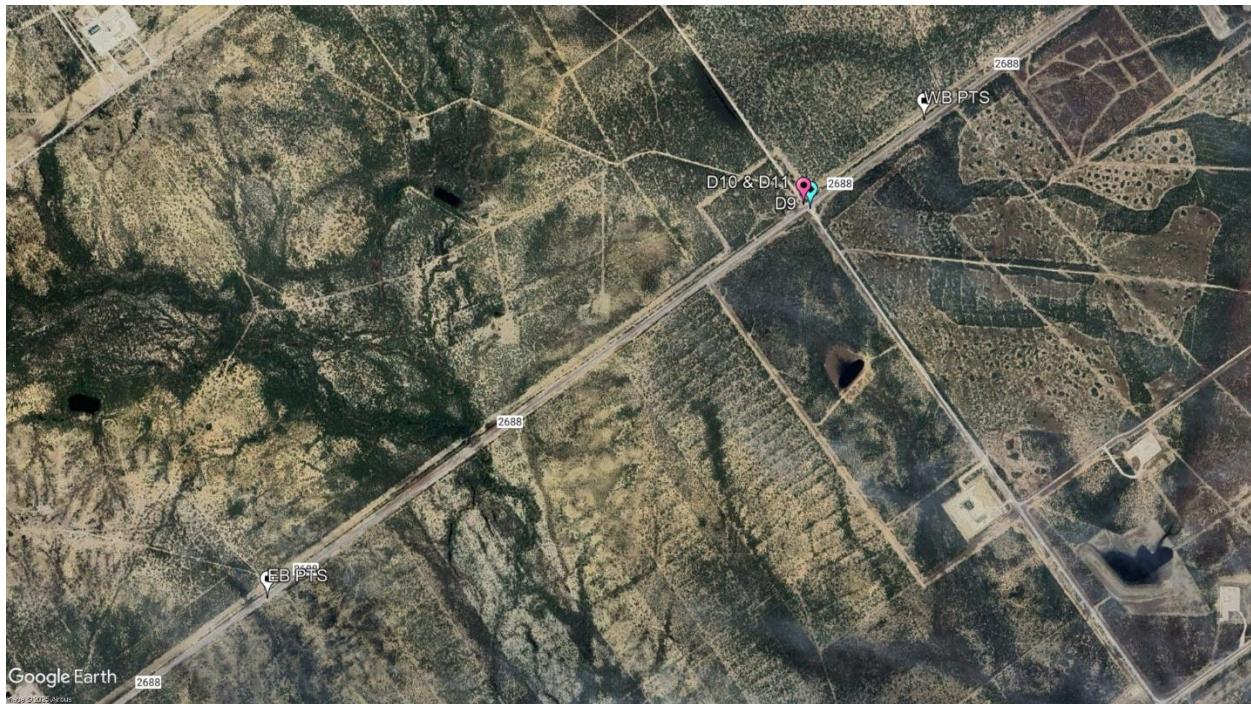
Figure 2 shows the section of roadway under construction in June 2024. The one-lane section was approximately 1.7 miles long and controlled by PTSs (see white pins with squares in Figure 2). DADs were used at two locations for three driveways, with one of the DADs serving two of those driveways (see pink pins with circle and aqua pin with diamond in Figure 2). The three driveways provided access to oil and gas operations, as well as industry and businesses. TTI collected data at D9 (aqua pin with diamond in Figure 2), which had highly variable cycle times for both eastbound and westbound, but overall, both cycles averaged approximately 4 minutes and 36 seconds. The average red time was 3 minutes and 53 seconds, and the average green time was 43 seconds.

Figure 2. Project 9 FM 2688 June 2024 One-Lane Study Section.

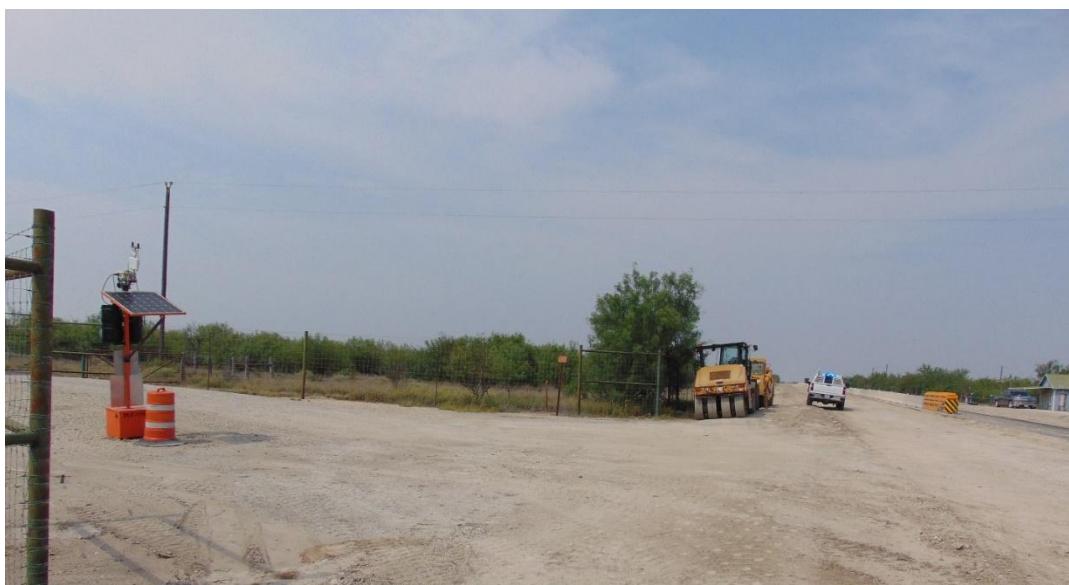
On June 4–6, 2024, TTI researchers observed traffic approaching FM 2688 from D9. The driveway was located approximately 0.3 miles from the westbound PTS and approximately 1.4 miles from the eastbound PTS. Although D9 was located near the westbound PTS, drivers approaching FM 2866 from D9 could not see the westbound PTS. At D9, the DAD was located on the nearside of the intersection, and construction was occurring in the eastbound lane (see Figure 3). Data collection began at 11:06 a.m. on Tuesday and ended at 10:05 a.m. on Thursday.

Figure 3. DAD at D9 Looking Westbound.

Over the 46 hours, 52 minutes, and 24 seconds of data collection at D9, 17 vehicles arrived at the DAD, and 15 of those vehicles (88.2 percent) did not comply with the DAD. Of those 15 violations, 10 (67 percent) were related to joining the queue, four (27 percent) were related to “jumping” the left flashing yellow arrow to get ahead of the main lane traffic queue, and one (6 percent) was a flashing yellow arrow violation. Overall, the violation rate for this site was 2.45 violations per 100 stop cycles (15 violations divided by 613 stop cycles multiplied by 100).

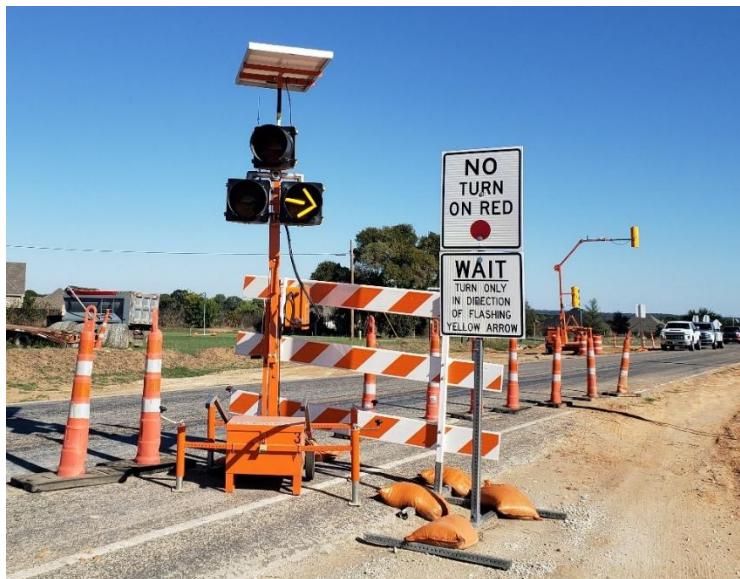
Project 15 involved the rehabilitation of existing sections of FM 730 in Wise County from SH 114 in Boyd, Texas, to just south of the intersection of FM 730 with CR 4384 (approximately 3.5 miles). The DAD design for this project was the three-section doghouse design, which includes two 12-inch flashing yellow indications, a single 12-inch solid red indication, a R10-11a sign, and a second supplemental sign (WAIT TURN ONLY IN DIRECTION OF FLASHING YELLOW ARROW) (see Figure 4).

Figure 4. Three-Section Doghouse DAD Deployed on FM 730 at D18.

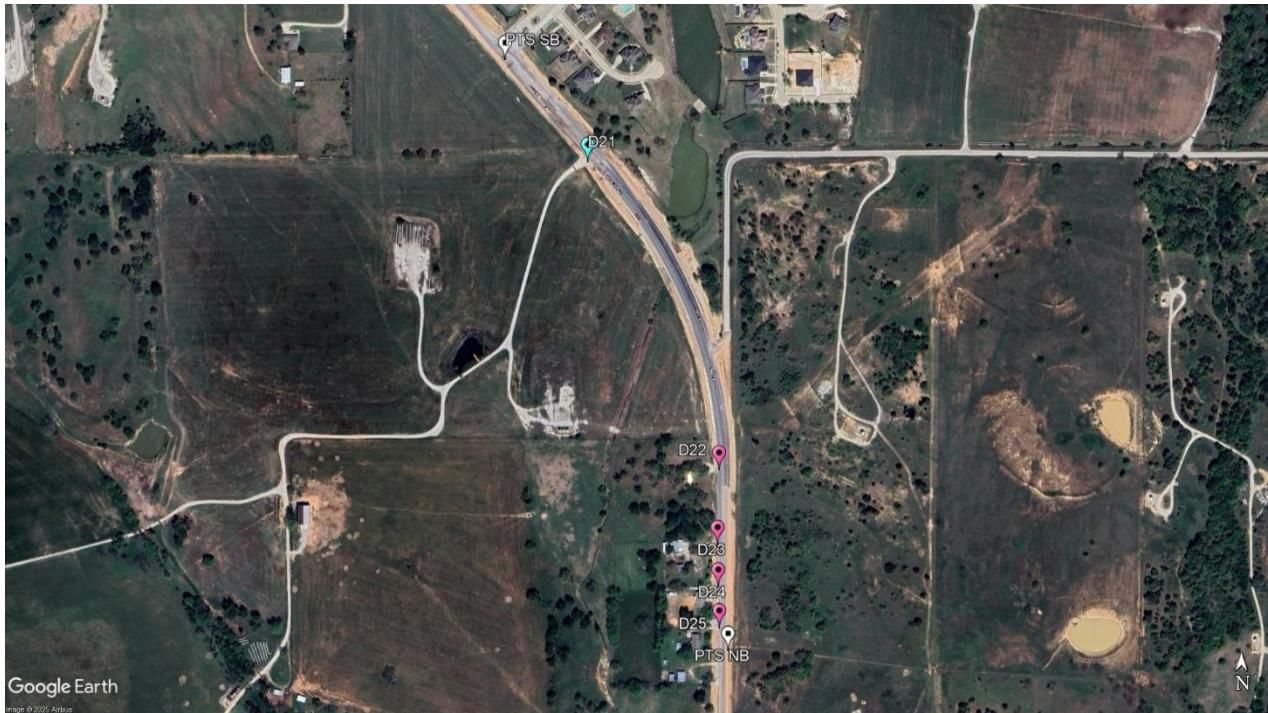
TTI researchers collected data at two different DADs (D21 and D18) in July and September 2024, respectively. Figure 5 shows the section of roadway under construction in July 2024 and the location of D21 (see aqua pin with diamond). The one-lane section was controlled by PTSs and was approximately 0.54 miles (see white pins with squares in Figure 5). This section included five DADs deployed at five private driveways (see pink pins with circles and aqua pin with diamond in Figure 5). Four of the driveways served residences (see pink pins with circles in Figure 5). The DAD deployed at D21 served a driveway that led to multiple oil and gas pads (see aqua pin with diamond in Figure 5). The intersection of FM 730 and CR 4460, in the middle of the one-way section, was closed and CR 4460 traffic was detoured. For the D21 DAD, the eastbound and westbound cycle times were approximately the same at 2 minutes and 4 seconds. The red time was 1 minute and 20 seconds, while the green time was 44 seconds.

Figure 5. Project 15 FM 730 July 2024 One-Lane Study Section.

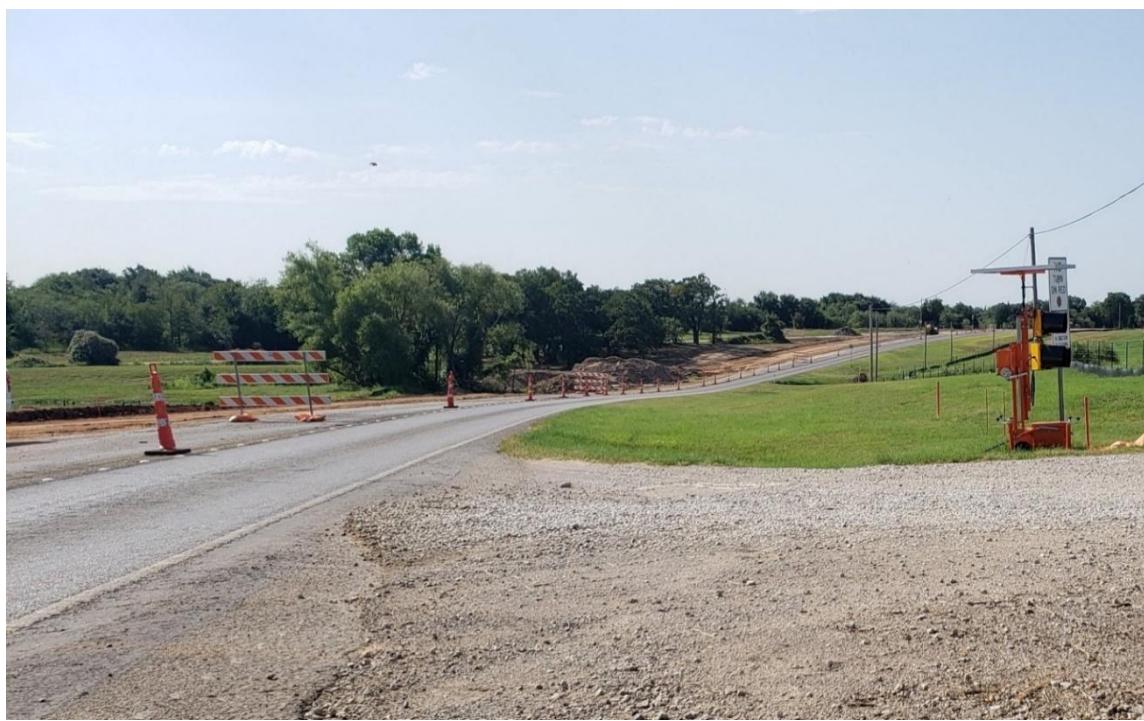
nearside of the driveway, and construction was occurring in the northbound lane (see Figure 6). Data collection began at 10:24 a.m. on Tuesday and ended at 10:09 a.m. on Thursday.

Figure 6. DAD at D21 Looking Southbound.

Over 47 hours and 44 minutes of data were collected at D21 on FM 730. During this time, six vehicles arrived at the DAD. Only one driver (17 percent) did not comply with the DAD, and this was due to a red violation (i.e. the driver turned on red in the opposite direction of

subsequent/next flashing yellow arrow), which was considered an unsafe driving action. Overall, the violation rate for this site was 0.07 violations per 100 stop cycles (1 violation divided by 1,357 stop cycles multiplied by 100).

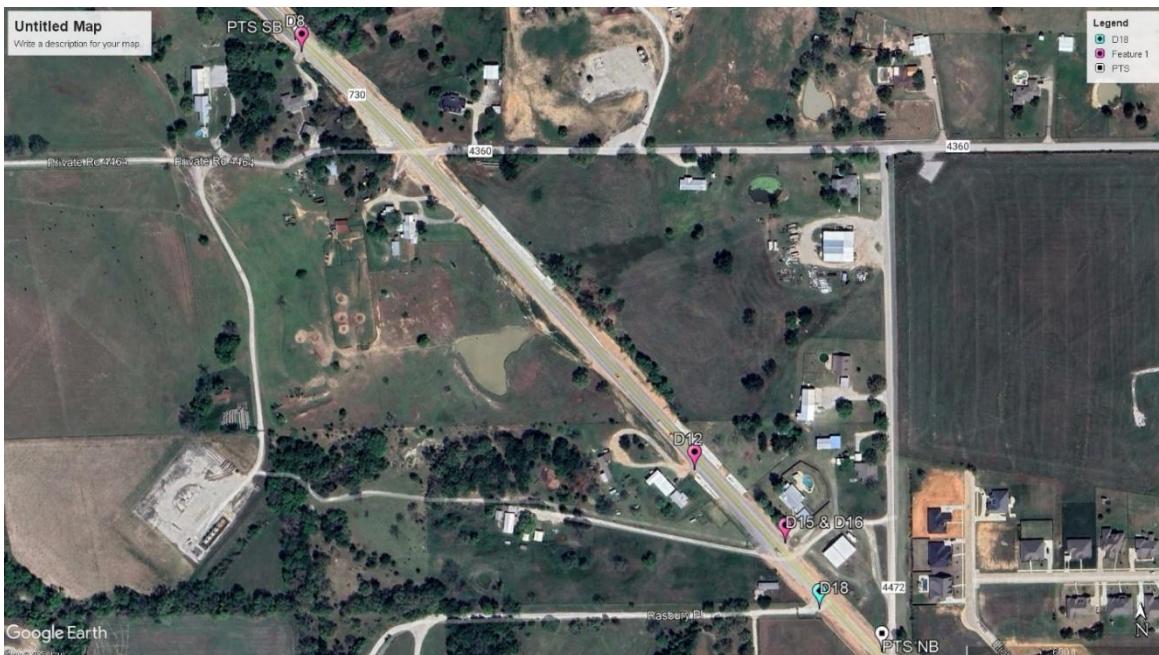
Figure 7 shows the section of roadway under construction in September 2024 and the location of D18 (see aqua pin with diamond). The one-lane section was controlled by PTSs and was approximately 0.48 miles (see white pins with squares in Figure 7). This section included four DADs deployed at four private driveways (see pink pins with circles and aqua pin with diamond in Figure 7). The DAD deployed at D18 served a driveway that led to multiple oil and gas pads and private residences. The intersection of FM 730 and CR 4360, in the middle of the one-way section, was closed and CR 4360 traffic was detoured. For the D18 DAD, the eastbound and westbound cycle times were approximately the same at 2 minutes and 4 seconds. The red time was 1 minute and 20 seconds, while the green time was 44 seconds.

Figure 7. Project 15 FM 730 September 2024 One-Lane Study Section.

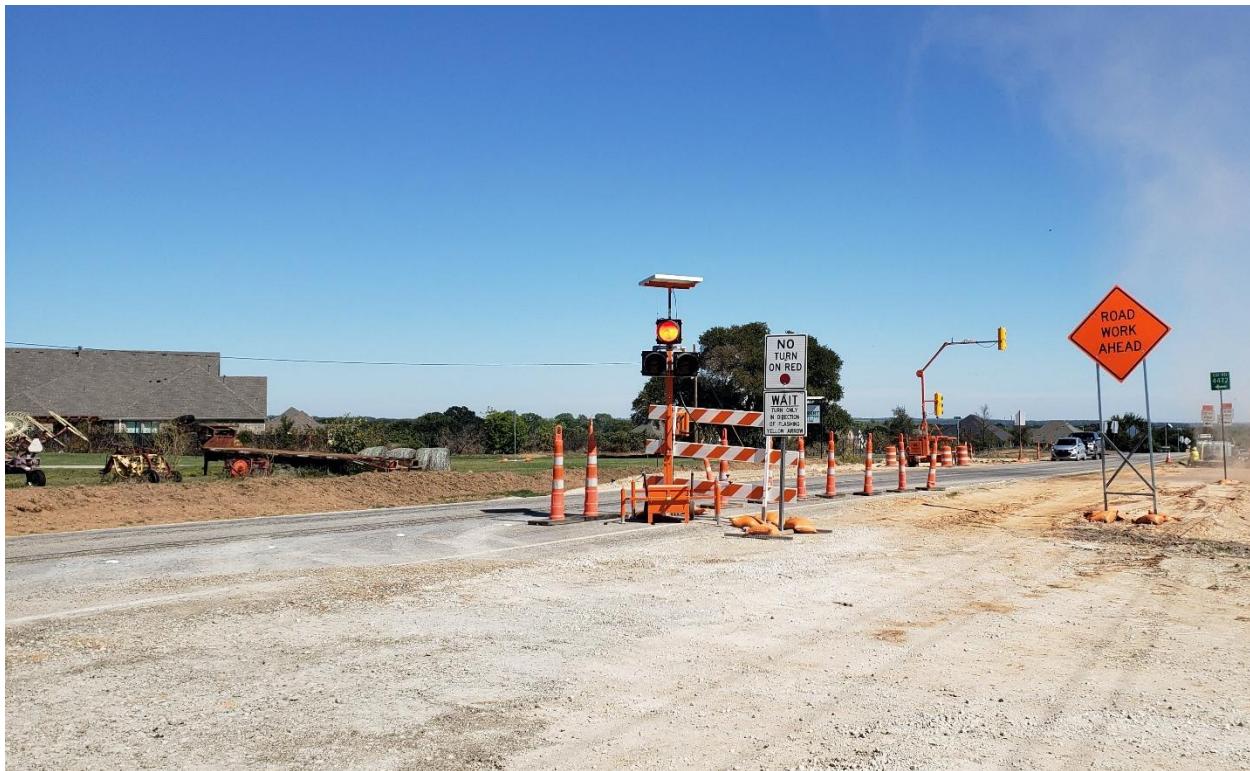
On September 24–26, 2024, TTI researchers observed traffic approaching FM 730 from D18. The driveway was located approximately 2,328 feet from the southbound PTS and approximately 235 feet from the northbound PTS. Vehicles entering FM 730 from D18 could clearly see the northbound PTS and any queue that might be associated with it. At D18, the DAD was located on the nearside of the driveway, and construction was occurring in the southbound lane (see Figure 8). Data collection began at 1:40 p.m. on Tuesday and ended at 4:27 p.m. on Thursday.

Figure 8. DAD at D18 Looking Southbound.

Over 50 hours and 46 minutes of data were collected at D18 on FM 730. During this time, 55 vehicles arrived at the DAD. Twenty-eight vehicles (51 percent) did not comply. However, at least 17 of those vehicles were construction-related vehicles with an additional four vehicles potentially being construction-related. Of these 28 violations, 10 (36 percent) were related to “jumping” the flashing yellow arrow, six (21 percent) were related to flashing yellow arrow violations (turning in opposite direction of FYA), and 12 (43 percent) were related to red violations. All the violations may have been attributed to the proximity of the DAD to the northbound PTS, which allowed vehicles at D18 to very clearly see if main lane traffic was coming from the northbound direction (see Figure 8). In addition, a concrete barrier was used to separate the closed lane (work area) from the open travel lane. The end of the concrete barrier terminated at D18, which led to construction workers often using this driveway as an exit from the work area (see Figure 16). Overall, the violation rate for this site was 1.83 violations per 100 stop cycles (28 violations divided by 1,529 stop cycles multiplied by 100).

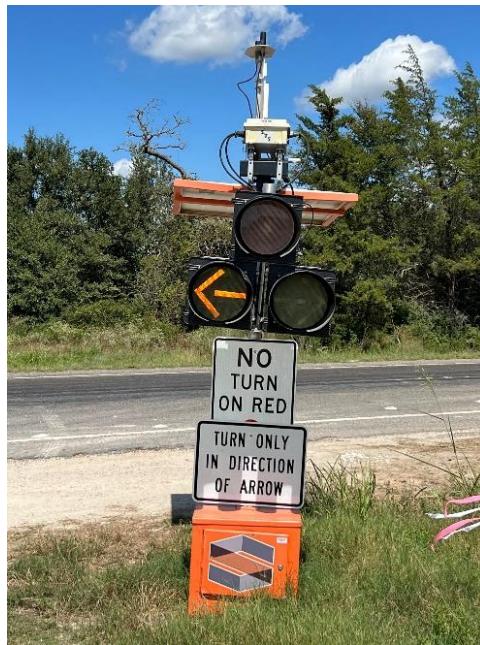
Project 16 entailed a bridge replacement taking place at a section of FM 46 that intersects with Cedar Creek in Franklin County just southeast of Franklin, Texas. The work zone and one-lane section spanned the bridge plus additional space around the bridge for an approximate total length of 0.2 miles. The DAD design for this project was the three-section doghouse, which included two 12-inch flashing yellow indications, a single 12-inch solid red indication, a R10-11a sign, and a second supplemental sign (TURN ONLY IN DIRECTION OF ARROW) (see Figure 9). However, the red ball graphic on the R10-11a sign was covered by the second supplemental sign (see Figure 9).

Figure 9. DAD at D1.

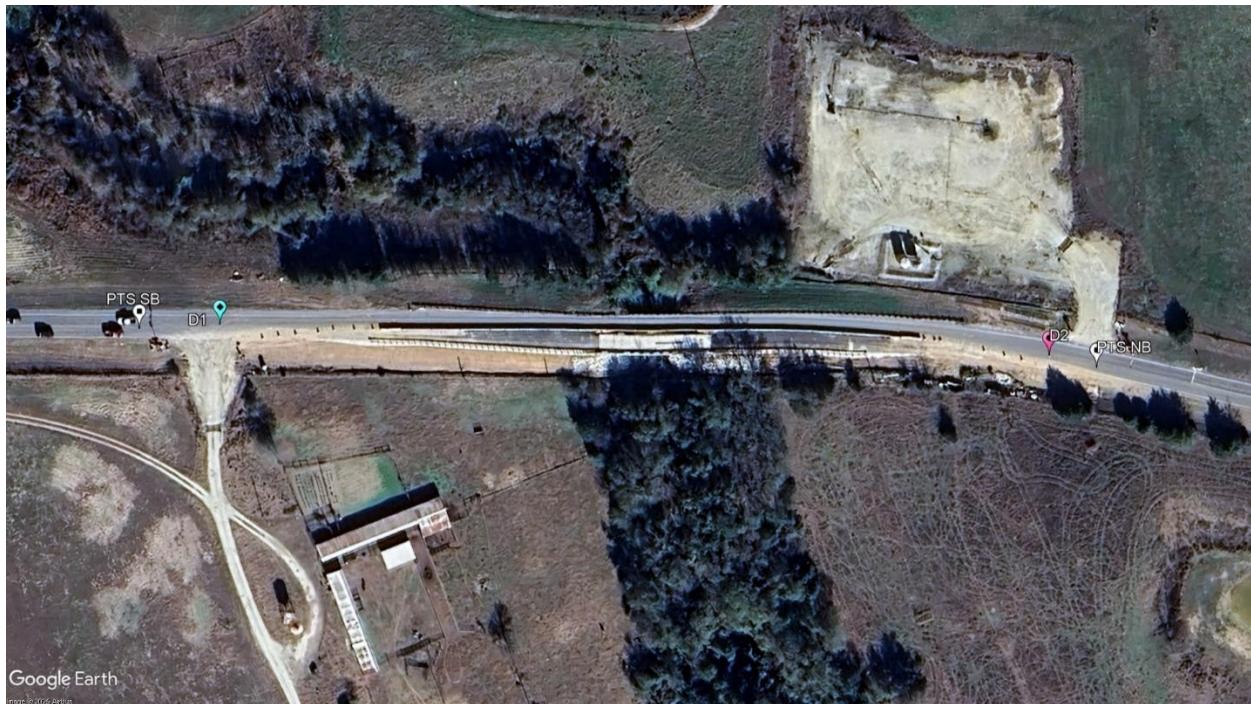
Figure 10 shows the section of roadway under construction in September 2024. The one-lane section was controlled by PTSs and was approximately 955 feet long (see white pins with squares in Figure 10). Two DADs were used for this project, one on each side of the bridge (see pink pin with circle and aqua pin with diamond in Figure 10). The DAD deployed at the southern end of the bridge (D2) provided access to a single oil pad, while the DAD deployed on the northern end of the bridge (D1) serviced multiple oil pads and residences. TTI collected data at D1 (see aqua pin with diamond in Figure 10), and the northbound and southbound cycle times were both approximately 1 minute and 8 seconds. The average red time was approximately 39 seconds, and the average green time was approximately 30 seconds.

Figure 10. Project 16 FM 46 September 2024 One-Lane Study Section.

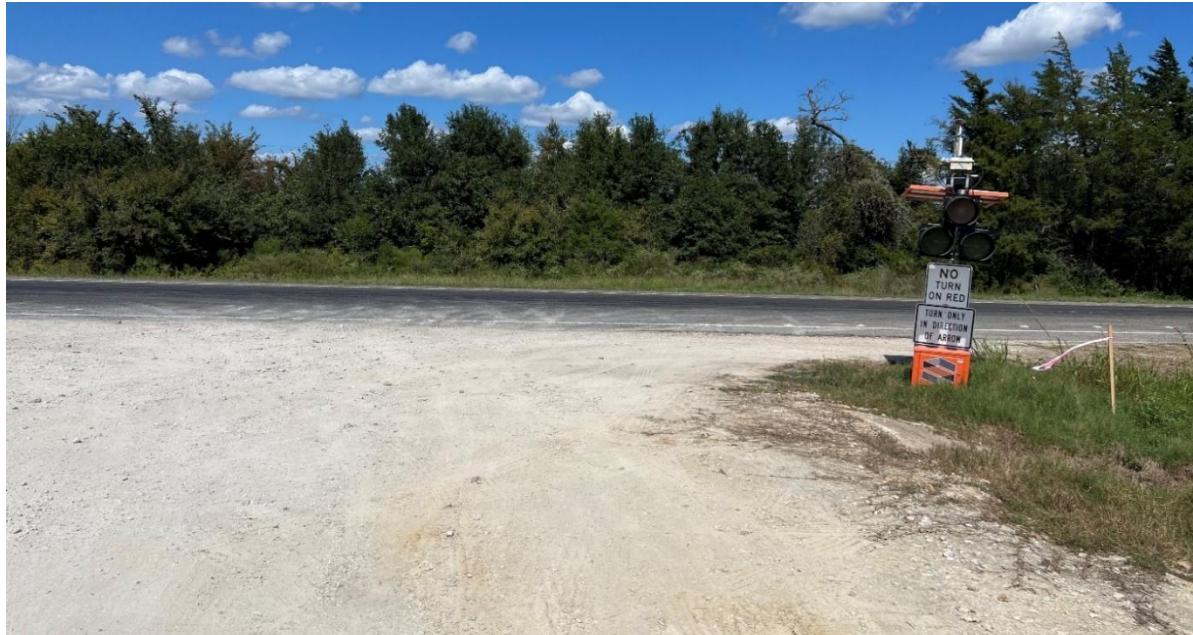
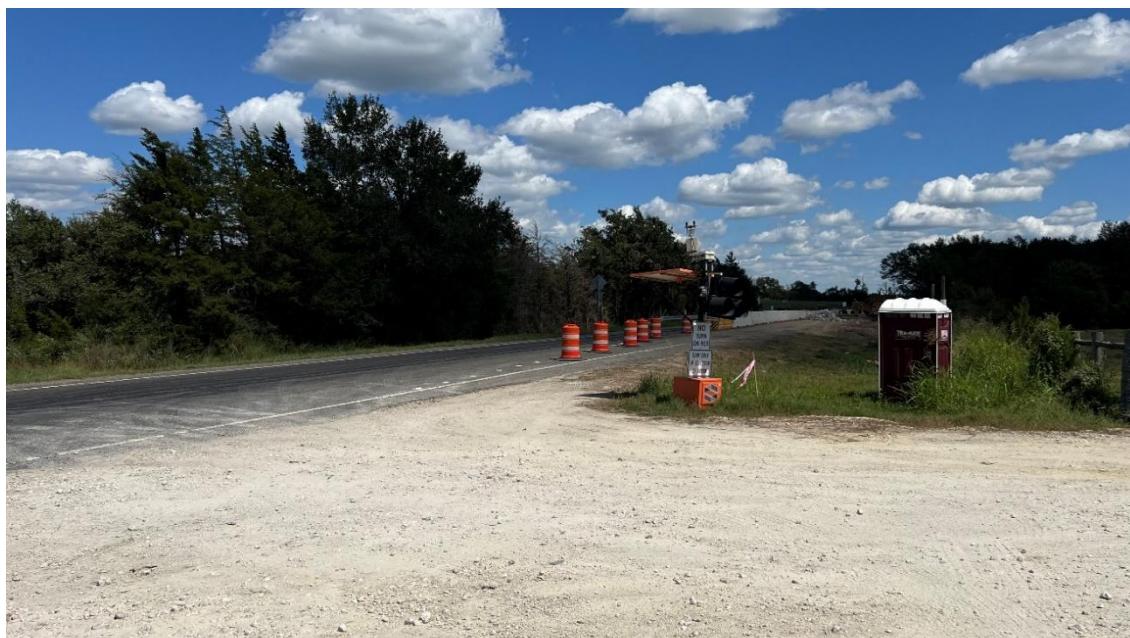
southbound lane (see Figure 11 and Figure 12). Vehicles entering FM 46 from D1 could see the southbound PTS and associated queue (if present) with ease due to the proximity of the PTS in relation to the driveway. However, vehicles entering FM 46 from D1 could not see the northbound PTS due to the presence of vegetation and a slight horizontal curve in the southbound direction on the south side of the bridge. Data collection began at 2:15 p.m. on Tuesday and ended at 2:08 p.m. on Thursday.

Figure 11. DAD at D1 from Approaching Traffic Viewpoint.

Figure 12. DAD at D1 Looking Southbound.

Over the 47 hours and 53 minutes of data collection that occurred at FM 46, 13 vehicles arrived at the DAD. Seven drivers (54 percent) did not comply with the DAD. Out of the seven violations that did occur, five (71 percent) were drivers “jumping” the flashing yellow arrows either in anticipation of the next phase and/or to get ahead of the main lane traffic queue. Of the five jumping violations, three of them involved the driver turning left and two of them involved the driver turning right. These violations might be explained by the proximity of the DAD to the PTS, and while these types of maneuvers were considered violations, they were not considered an unsafe driving action.

The remaining two violations (29 percent) were due to drivers that turned on red in the opposite direction of the subsequent flashing yellow arrow (i.e., turning in the direction of oncoming traffic). Both violations were drivers turning left on red when the next phase was a flashing yellow right arrow. These violations may have been influenced by the proximity of the DAD to the southbound PTS, which allowed vehicles at D1 to very clearly see if main lane traffic was coming from the southbound direction (see Figure 10). Overall, the violation rate for this site was 0.27 violations per 100 stop cycles (7 violations divided by 2,570 stop cycles multiplied by 100).

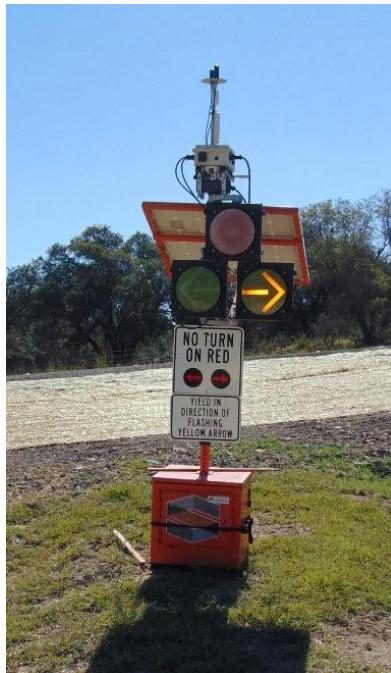
Project 25 involved several safety improvement projects along a north-south stretch of RM 1376 in Kendall County from RM 473 to 0.8 miles south of Upper Sisterdale Road (approximately 3 miles). TTI began discussions with TxDOT staff and the contractor in April 2024 but were unable to collect data until September 2024 during Phase 4 of the project. The DAD design used for this project was the three-section doghouse, which included two 12-inch flashing yellow indications, a single 12-inch solid red indication, a modified R10-11 sign, and a second supplemental sign (YIELD IN DIRECTION OF FLASHING YELLOW ARROW) (see Figure 13).

Figure 13. DAD Deployed on RM 1376 at D3.

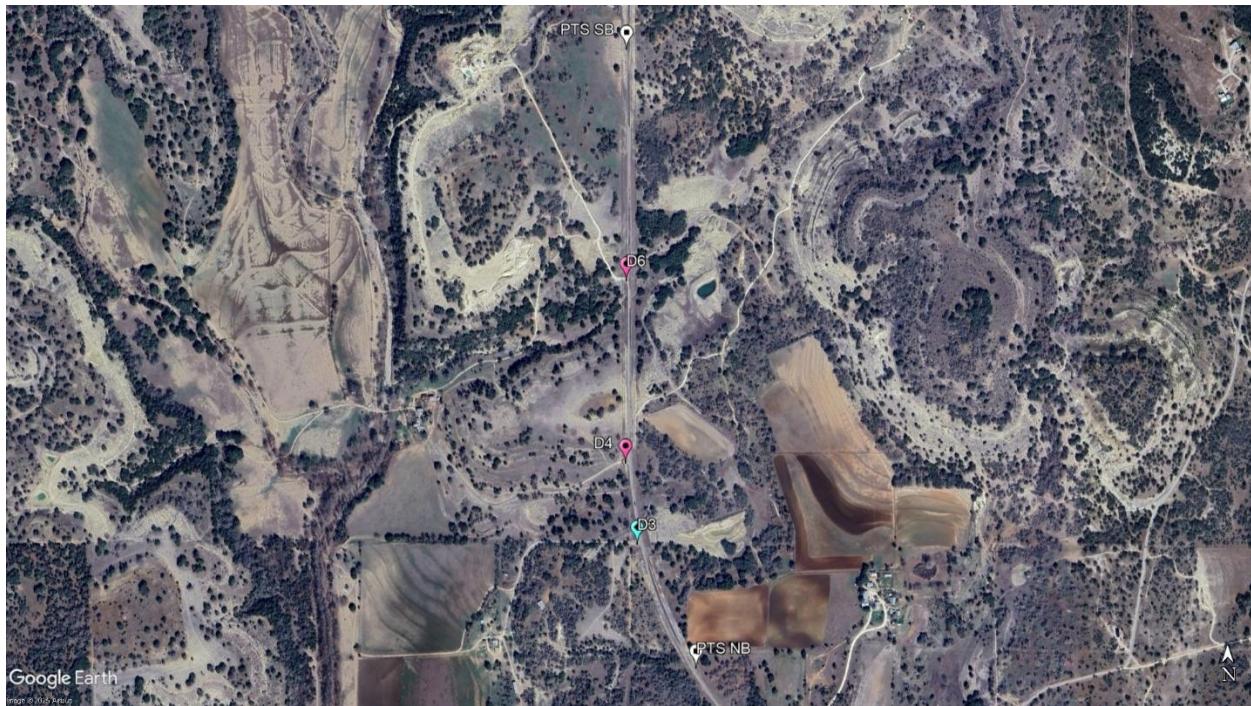
Figure 14 shows the section of roadway under construction in September 2024. The one-lane section was approximately 1 mile long and controlled by PTSs (see white pins with squares in Figure 14). Three DADs were used at three driveways, all serving private residences (see pink pins with circles and aqua pin with diamond in Figure 14). TTI collected data at the southernmost DAD (D3) (see aqua pin with diamond in Figure 14). High variability was present in the cycle times both for the southbound and northbound cycles. On average, a total cycle lasted approximately 3 minutes and 26 seconds. The average red time was approximately 2 minutes and 52 seconds, while average green time was 29 seconds.

Figure 14. Project 25 RM 1376 September 2024 One-Lane Study Section.

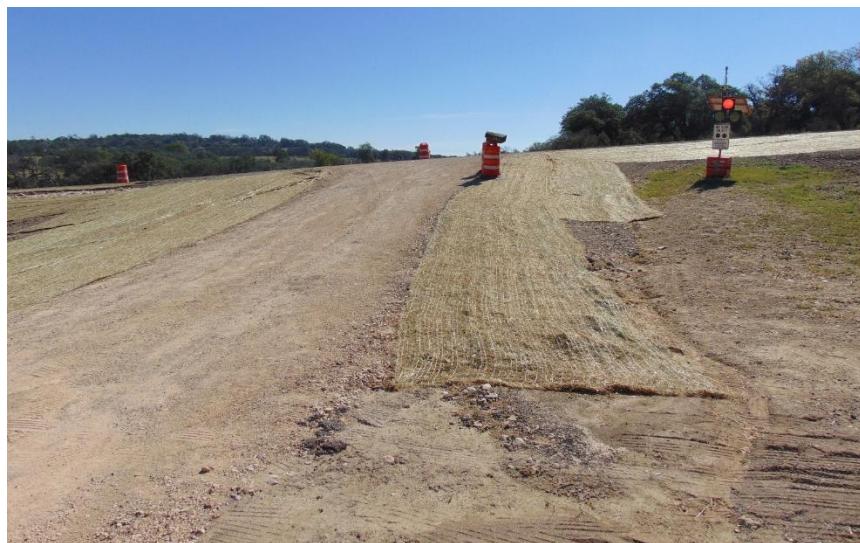
On September 10–12, 2024, TTI researchers observed traffic approaching RM 1376 from D3. The driveway was located approximately 0.25 miles from the northbound PTS and approximately 0.75 miles from the southbound PTS. Vehicles entering RM 1376 from the driveway could not see either PTS due to horizontal curvature, vegetation, and distance from the driveway to either PTS. At D3, the DAD was located on the nearside of the driveway's intersection with RM 1376, and construction was occurring in the southbound lane (see Figure 15). Data collection began at 10:42 a.m. on Tuesday and ended at 6:14 a.m. on Thursday.

Figure 15. DAD at D3 from Approaching Traffic Viewpoint.

Over the 43 hours and 28 minutes of data collection at RM 1376, nine vehicles arrived at the DAD, with four drivers not complying with the DAD (44 percent). All four violations were drivers “jumping” the left flashing yellow arrow to get ahead of the main lane traffic queue. While these types of maneuvers were considered violations, they were not considered an unsafe driving action. Overall, the violation rate for this site was 0.54 violations per 100 stop cycles (4 violations divided by 746 stop cycles multiplied by 100).

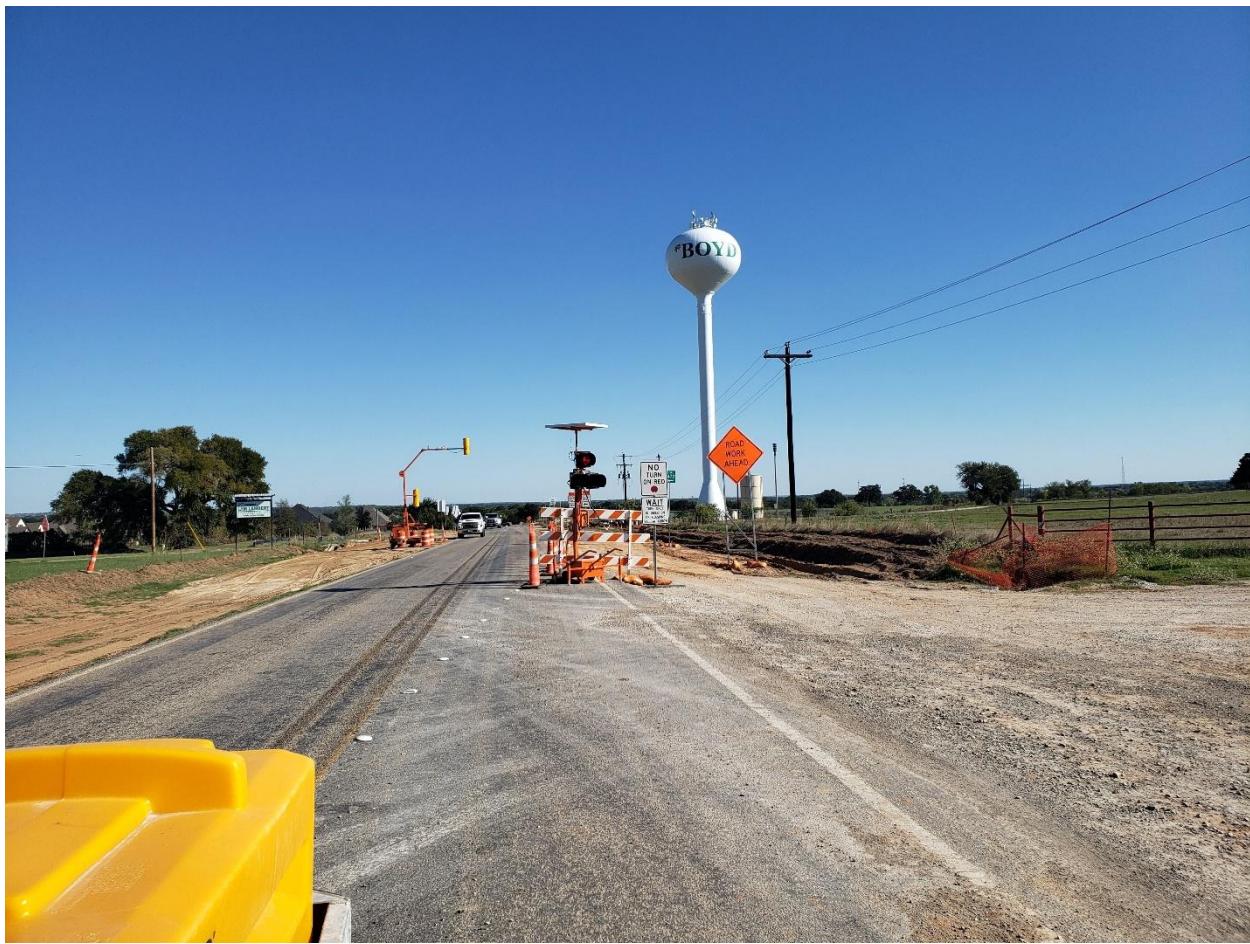
Figure 16. End of Concrete Barrier and DAD at D18 Looking Southbound.

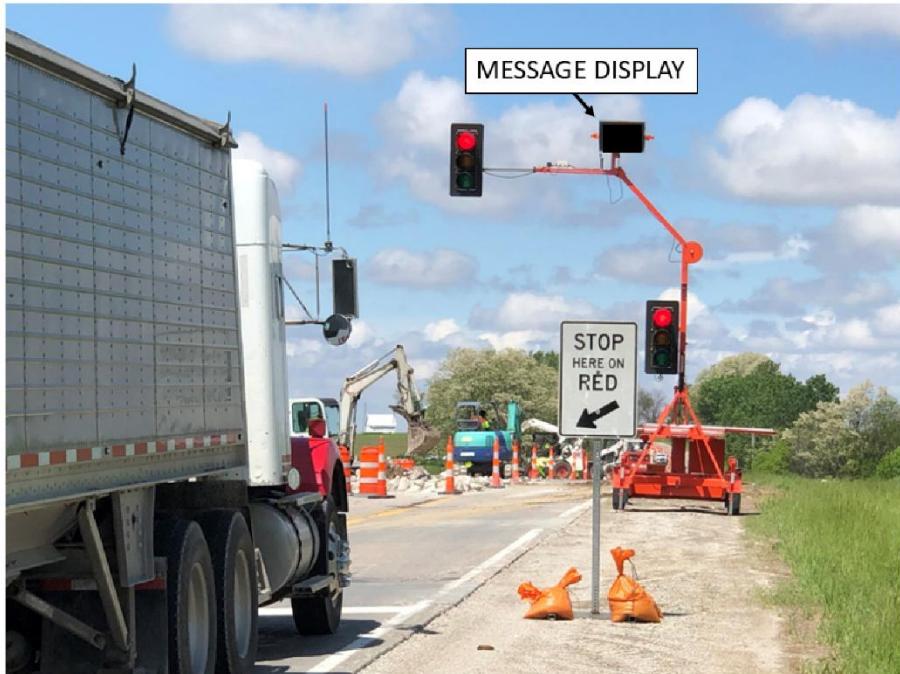
Participants who met the requirements and decided to participate were advanced to an explanation screen that showed a PTS with a wait time display board attached (see Figure 23). Text positioned above the image highlighted the message board on top of the signal as the focus of the study.

Please review the image below. It shows an approach to a portable traffic signal that is alternating one-way traffic on a two-lane roadway that is under construction. In addition to the signal, there is a message display that may provide additional information to you. During this survey, you will be asked a few questions about your interpretation of messages that may appear on the display.

Figure 23. Study Explanatory Screen.

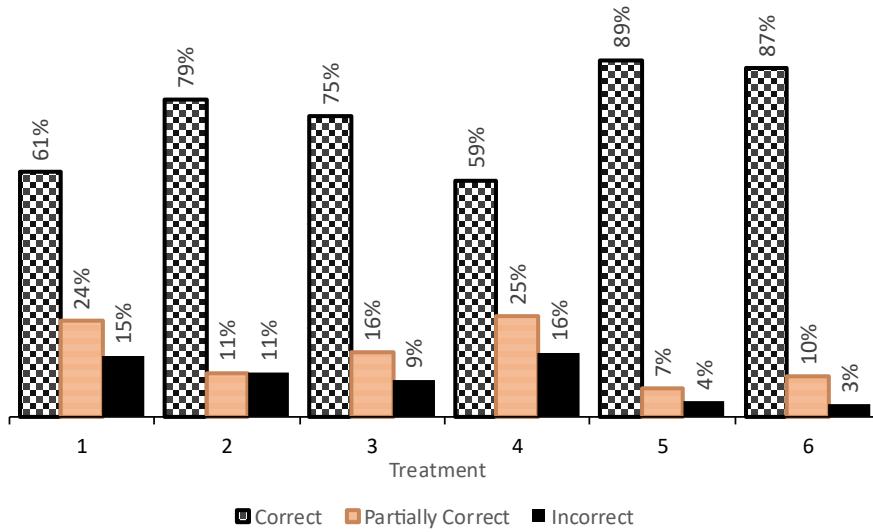
Figure 24 presents driver understanding of the wait time display alternatives. All the treatment alternatives were well understood, with 84 to 97 percent of participant responses correct or partially correct, exceeding the commonly used 85 percent threshold for acceptable comprehension. The percentages of completely correct responses for treatments that counted down second-by-second (Treatments 2, 5, and 6) were also found to not differ significantly from the 85 percent threshold. Likewise, Treatment 3 that counted down minute-by-minute (which participants saw the number change while they were viewing the display) was also well interpreted. Conversely, the percent of completely correct responses for Treatment 1 and Treatment 4, which did not have numerals counting down in their displays, were significantly lower than the 85 percent threshold. Clearly, the ability of participants to see numerals in the display decreasing over time provides a strong indication that the display represents a countdown and is usually associated with the red signal indication.

Figure 24. Participant Interpretations of the Meaning of the Wait Time Display.

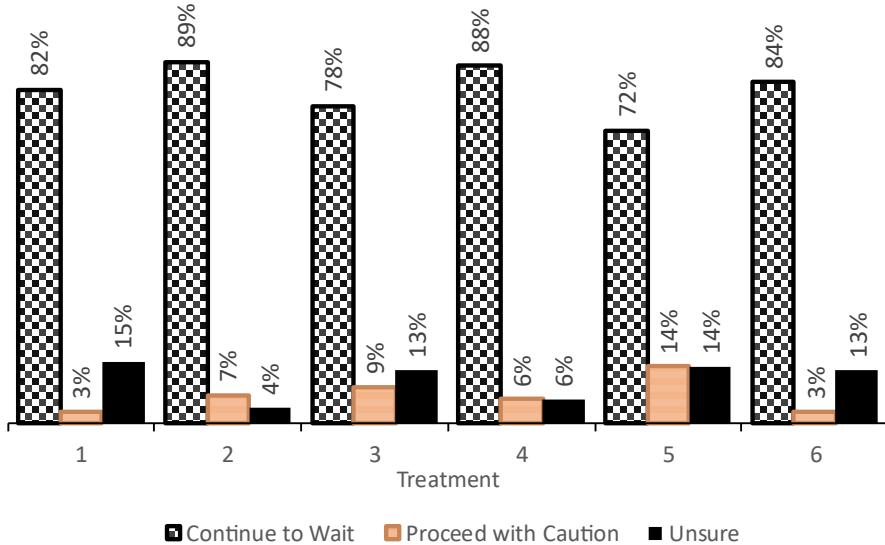
Participant responses to the question concerning the appropriate action to take if the wait time display counted down to zero but a red indication was still showing are presented in Figure 25. Overall, most participants correctly indicated that they would continue to wait until the signal turned green (none of the “continue to wait” percentages differed significantly from the 85 percent acceptable threshold value). However, over one-quarter (28 percent) of participants viewing Treatment 5 indicated that they would either proceed with caution into the work zone or were unsure what to do if the wait time indication displayed a zero while the red signal indication was still showing. Similarly, 22 percent of participants viewing Treatment 3 responded the same way. When those participants were asked why they would proceed with caution or were unsure what to do if the wait time display was at zero but the signal indication was still red, all of them stated that the signal could be malfunctioning. These participants apparently assumed that since the wait time display was actively counting down, it must be operating correctly rather than the signal itself.

Although very few participants (3 percent) viewing Treatment 1 or Treatment 6 indicated they would proceed with caution, 15 percent and 13 percent of the participants viewing those treatments, respectively, were unsure what they would do in that situation. The researchers hypothesize that this question may have confused participants viewing Treatment 1 since it displayed a static number (WAIT UP TO 3 MIN) that did not change. It is unclear why participants viewing Treatment 6 were unsure since none of them entered an explanation in the survey.

Figure 25. Participant Responses to Question About Proper Action to Take If Wait Time Display Reaches Zero and Signal Indication Is Still Red.

Interestingly, only 11 percent of participants viewing Treatment 2 indicated that they would proceed with caution or were unsure what to do, even though the wait time display for that treatment also included a minutes:seconds message that counted down second by second. Researchers hypothesize that the WAIT statement included in the display may have heightened participants' wariness about the display and resulted in a higher percentage of "continue to wait" responses. Conversely, while only 12 percent of participants viewing Treatment 4 said they would proceed with caution or were unsure what to do, researchers hypothesized that this was due more to the fact that several participants did not associate the decreasing bar display as a traffic signal countdown and so only considered how they would respond to the red indication when answering that question.

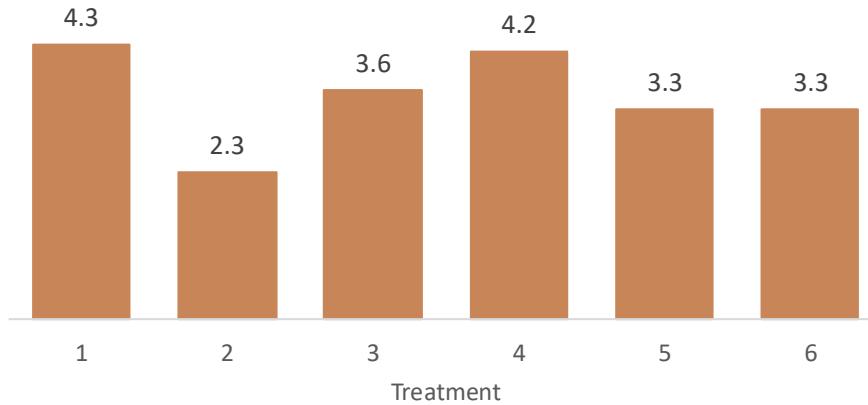
Figure 26. Average Treatment Ratings by Participants (1 = Best, 6 = Worst).

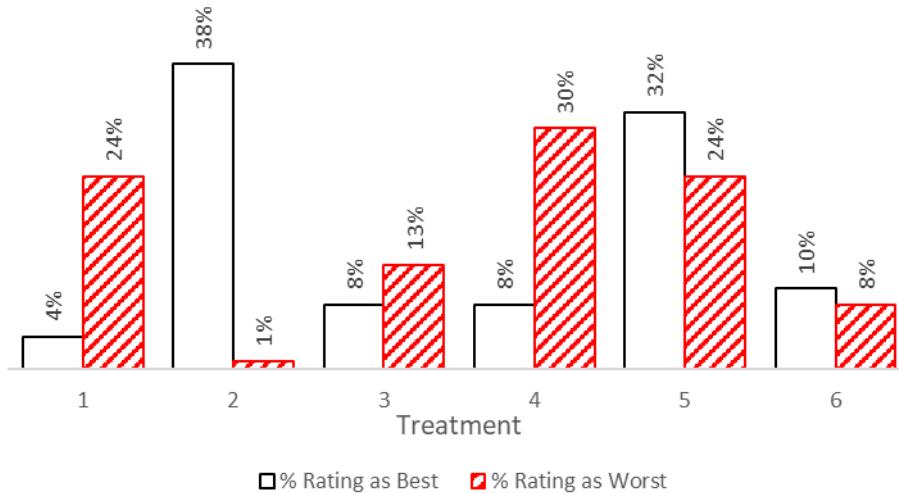
The percentage of participants ranking each treatment as best or as worst is provided in Figure 27. Treatments 1, 4, and 5 received the greatest percentage of "worst" rankings, whereas Treatments 2 and 5 received the greatest percentage of "best" rankings. The lack of a changing time on Treatment 1 was cited as a main reason by several participants for ranking it worst (e.g., "no real time information, I have no idea if the light just changed or how long you will be waiting"). Several participants noted that the use of a decreasing bar to indicate the wait time in

Treatment 4 was not intuitive but rather confusing. The fact that it did not present a specific time was also cited as reasons for ranking it as worst.

Figure 27. Percent of Participants Rating Each Treatment as “Best” or “Worst.”

Interestingly, Treatment 5 received significant numbers of both “best” and “worst” rankings, indicating that participants were highly opinionated regarding that treatment. Some of the reasons offered by participants for rating this treatment as best or worst are shown in Table 6. Whereas some participants focused on the larger font that this type of display allows (since no text is included in the display) as the reason for their preference, other participants perceived the simple numerical display as possibly confusing, especially since it lacked context. The fact that Treatment 5 only displayed seconds rather than minutes:seconds was disconcerting for some of the participants.
