## Detailed Modeling of the Train-to-Train Impact Test

# Rail Passenger Equipment Impact Tests

#### DOT/FRA/ORD-07/20

13. ABSTRACT (Maximum 200 words) This report describes the results of a finite element-based analysis of the train-to-train impact test conducted at the Federal Railroad Administration's Transportation Technology Center in Pueblo, CO, on January 31, 2002. The ABAQUS/Explicit dynamic finite element code was used to simulate the first 0.5 second (s) of the collision. The primary objective of this program was to extend the use of finite element-based models for simulating the crush of train structures to include vehicle-to-vehicle interactions.			
A subset of the data collected during the test was first selected as a basis for comparison with model predictions. A finite element model of the train was then developed. This model includes detailed representations of the end structures of the cab car and the locomotive, and coarser representations of the back of these vehicle bodies and the trucks of the cab car. Connections between the cab car body and trucks were modeled to allow for lift of the body during the collision. Trailing vehicles and vehicle-to-vehicle conne

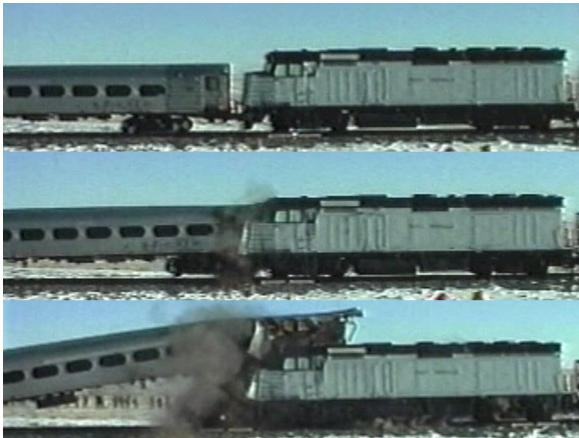
Figure 1. Schematic of the Full-Scale Train-to-Train Collision

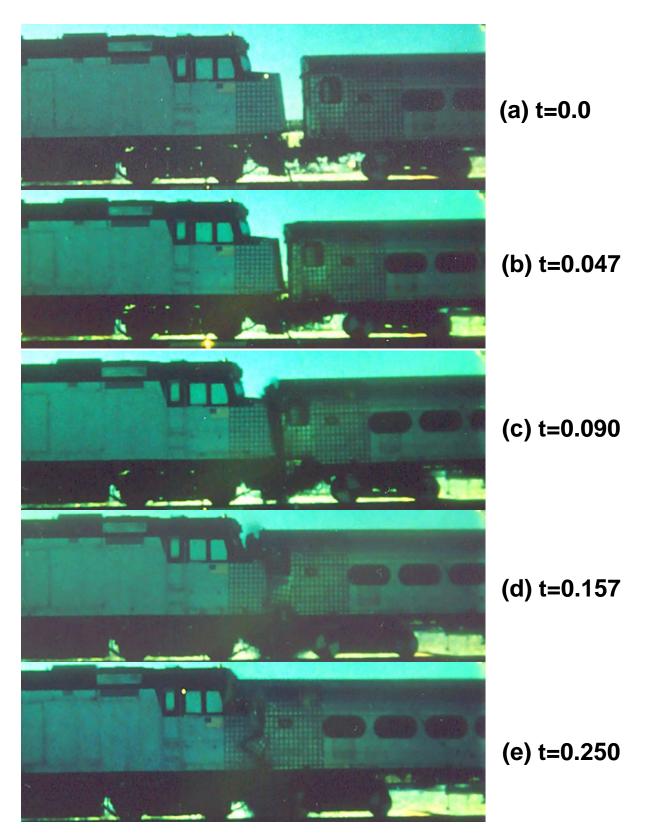
Video stills showing a side view of the forward ends of the colliding vehicles were captured at several instances over the first 0.25 s of the collision (7.6 ft or 2.3 m of crush). Two sequences of images (one from each side of the impact point) were captured from high-speed video, as shown in Figures 4 and 5. These images clearly show the forward motion of the cab car and the slight backward motion of the locomotive.

Figure 4. Sequence of Crush Over the First 0.25 s of the Collision (West Side View)

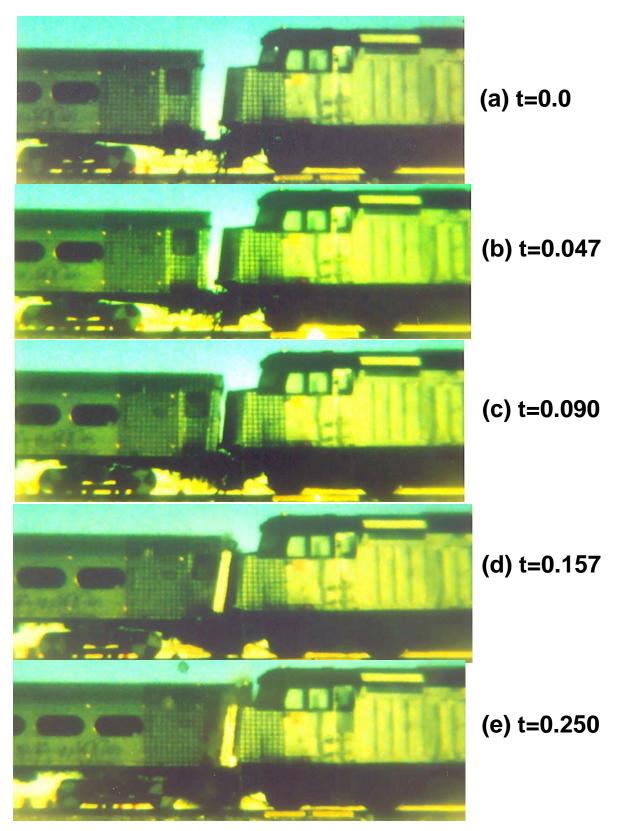
Figure 5. Sequence of Crush Over the First 0.25 s of the Collision (East Side View)

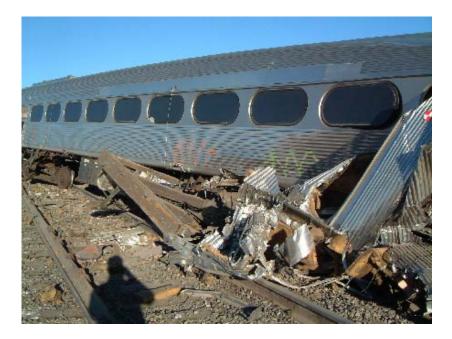
Figure 6 shows a more detailed view of the cab car after the test (compare with Figure 3). The end frame and the underframe have been completely torn away from the superstructure of the car, and the entire car has moved off to the left of the track (looking in the direction of moving train travel). The end frame can be seen in Figure 6 lying on the left rail of the track, close to the location of initial impact. Figure 7 shows a close up of the left collision post (again looking in the direction of moving train travel); the front face of which is down toward the ground in the photograph. The position of the end frame on the track indicates that it remained in contact with the hood of the locomotive during most of the crush.

Figure 6. End Frame is Lying Face Down Over the Left Rail, Oriented Approximately 90° with Respect to the Track

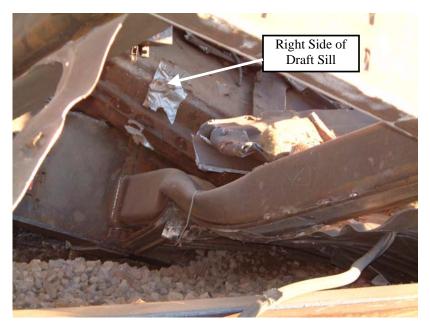
Figure 7. Left Collision Post: Front of Post is Facing Down and the End of Draft Sill Is Lying Just on Top of It

An image of the lower end of the cab car collision posts (Figure 42) indicates that the damage to the posts is similar in mode and location to that shown in Figure 7. It appears, however, that the local deformation is more severe in the model. The test damage may be less severe because the local forces on the collision post are relieved through fracture of other components (such as the anticlimber). It could also be less severe simply because the interaction of the end frame with the anticlimber is different because of the manner in which the draft sill deforms and fractures.

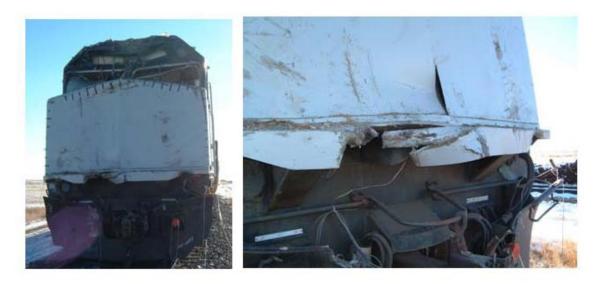
Figure 8 shows the front surface of the standing locomotive following the test. A large dent that is approximately 16 in (406 mm) is to the left of the centerline of the locomotive. It appears that this dent corresponds to the dent in the collision post (Figure 7). Substantially smaller dents exist on both the right side of the locomotive and the right collision post of the cab car (not shown). This can be explained if the cab car end frame shifted a few inches to the right as the cab car coupler draft pocket crushed. As illustrated in Figure 9, the large dent on the locomotive short hood is approximately 3 or 4 in (76 to 102 mm) closer to its centerline than one would expect if the cab car and locomotive centerlines had been coincident; the original distance between each cab car collision post and the cab car centerline was 19 in (483 mm). The angled profile (in plan view) of the locomotive anticlimber/hood would then cause the left cab car collision post to be struck first, as indicated in Figure 9, and this could then cause enough damage and weakening in the draft sill to result in a lower force impact on the right collision post. The damaged coupler pocket in the locomotive, as shown in Figure 10, provides further evidence for a shift to the right.

Figure 8. Views of Locomotive After the Test

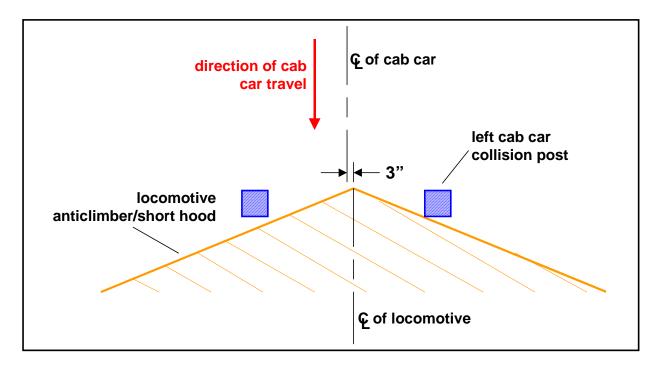
Figure 9. Illustration of a Possible Mode by which the Cab Car Collision Posts Collided with the Locomotive Anticlimber/Hood

Figure 9 also shows the imprint of the cab car end frame on the hood, from which it can be deduced that there was some counterclockwise rotation of the end frame about the longitudinal axis as initial deformation occurred. The end frame also appears to have rotated about a transverse horizontal axis as the bottom of the end frame was pushed inward and the end frame tilted to conform to the tilted profile of the locomotive (as is evident in Figures 4 and 5). The counterclockwise rotation may have been caused by the longitudinal load on the left collision post, which would have a component in the plane of the end frame once the end frame began to pitch. Such a component of load would tend to twist the end frame counterclockwise. (Finite element results presented in Section 4.1 also show twisting and suggest that the end frame may not be very resistant to twist.)

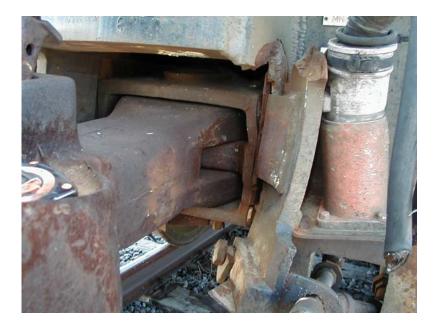
Figure 10. Damaged Coupler Pocket of the Locomotive

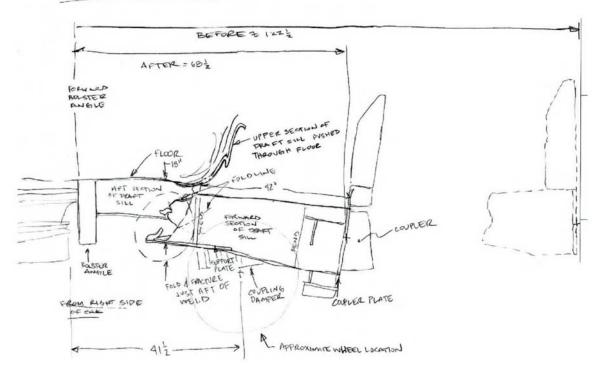
#### Figure 12. Sketches of the Damaged Draft Sill from the One-Car Test, Side View

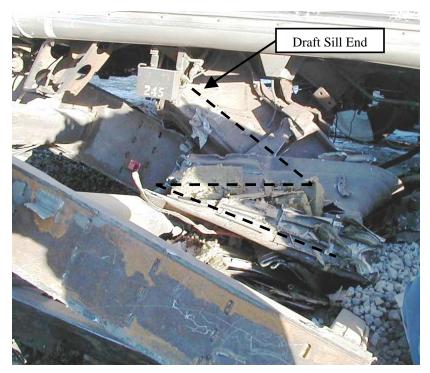
Figure 13. Photograph of Deformed Draft Sill (Dashed Line Shows Bent Shape of the Draft Sill)

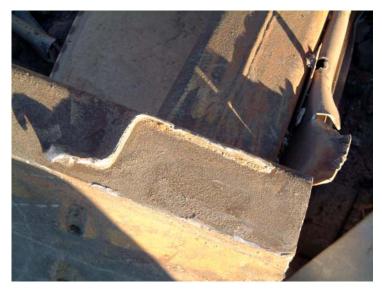
Finally, Figure 14 shows that the connection between the roof rails and the end frame fractured at some point on the collision.

Figure 14. Location at which Roof Rail Was Connected to Left, Rear Side of Antitelescoping Plate

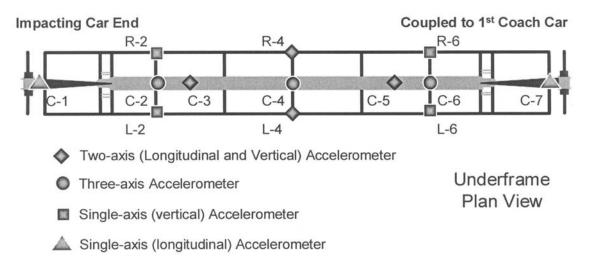
Vehicle motion data were derived from two sources: accelerometers and high-speed film. For the test, each vehicle was outfitted with a number of accelerometers. Figure 15 shows the arrangement of accelerometers on the cab car. The other vehicles had fewer accelerometers installed to adequately provide redundant measurements for the longitudinal motions of the vehicles. Accelerometer arrangement schematics for all vehicles can be found in [8].

Figure 15. Schematic Showing Layout of Accelerometers for the Cab Car

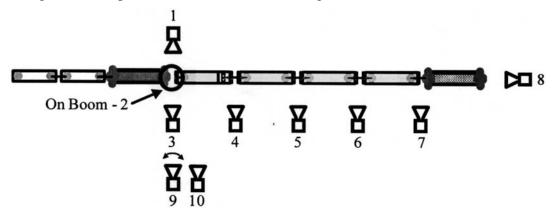
Figure 16. Schematic Showing Layout of High-Speed Cameras

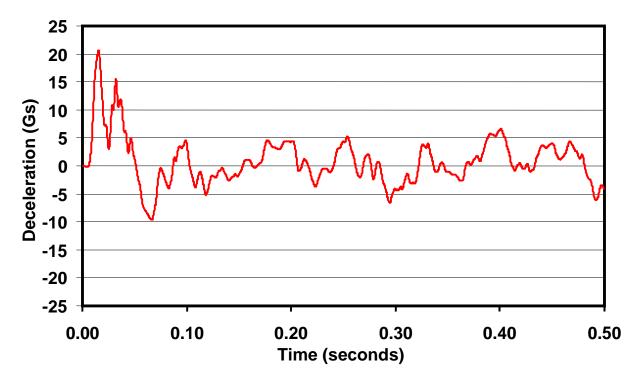
The following plots, Figures 17-30, represent each of the time histories (motions and forces) selected for comparison to the model. In Figure 17, the longitudinal deceleration of the cab car exhibits an initial peak acceleration of approximately 20 G after 0.02 s. A second, smaller peak of approximately 15 G occurs at 0.04 s, followed by a negative (positive acceleration) peak of approximately 10 G at 0.07 s. Over the remainder of the first 0.5 s, the acceleration levels vary within the range of  $\pm$  6 G.

Figure 17. Measured Longitudinal Deceleration of the Cab Car

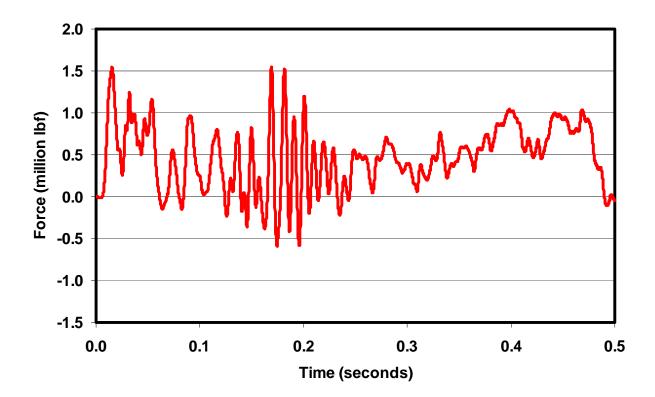
- Forward calculation: The force at the collision point is equal to the sum of the masses of the individual vehicles from the moving consist multiplied by their respective longitudinal accelerations (negated).
- Backward calculation: The force at the collision point is equal to the sum of the masses of the individual vehicles from the standing consist multiplied by their respective longitudinal accelerations.

Figure 31. Collision Force-Time History

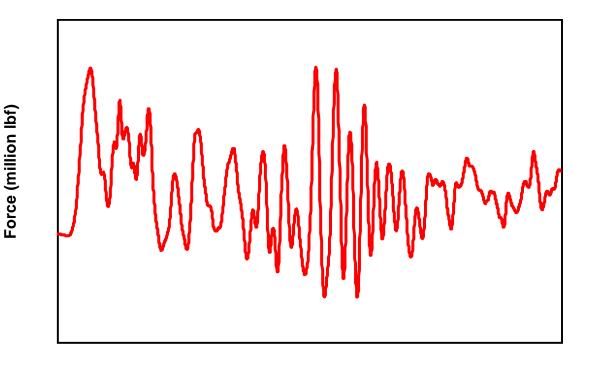
Collision force versus crush displacement curves were generated by cross-plotting force timehistory data versus the time-history of the relative longitudinal displacement of the cab car and the standing locomotive. Figure 32 shows the collision force (forward estimate) versus crush curve. Because of the significant forces transmitted from the trailing vehicles (see Section 2.4), the force levels remain quite high over the first 0.5 s of the collision.

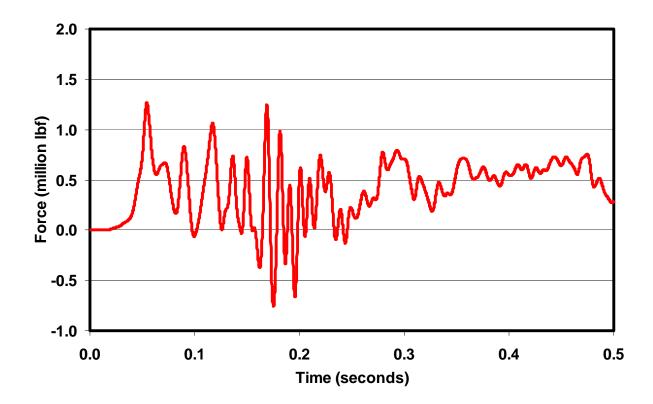
Figures 33 and 34 show the trailing vehicle force-time histories for the moving and standing consists, respectively. Note the delay in the initial peak force relative to the time that it occurred at the collision point (see Figure 31). In the train-to-train crash test, the trailing force has a significant effect on the collision force, as compared to the forward force (see Figures 31 and 32). Since no trailing cars are in the single car test, this force is absent in the single car test.

Figure 33. Trailing Force at Rear of Cab Car

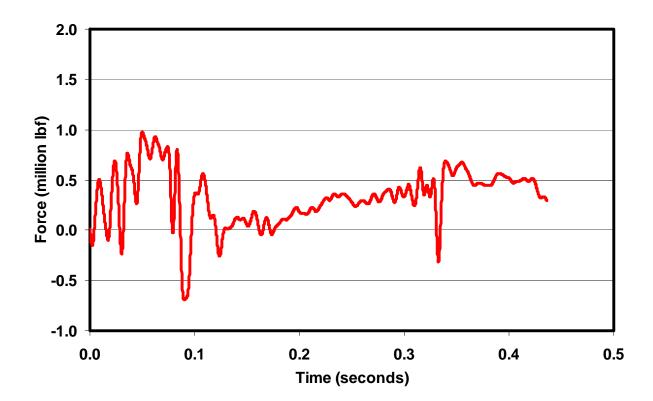
Figure 34. Trailing Force at Rear of Standing Locomotive

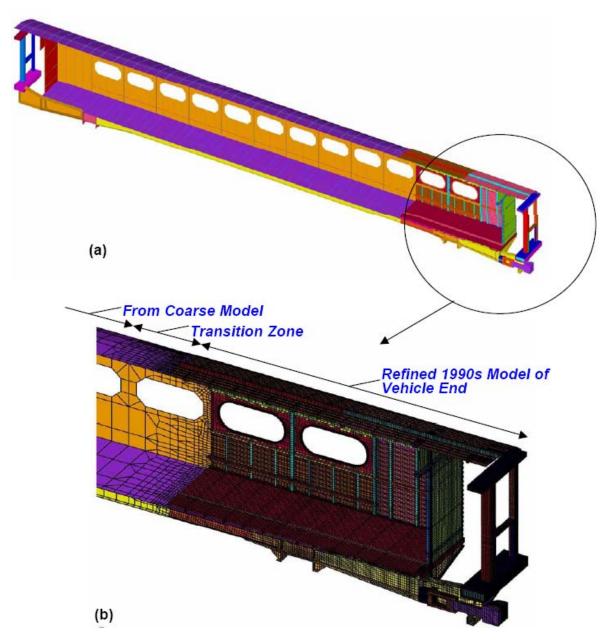
The model for the cab car body was, in part, derived from models that had been developed in prior programs. As a starting point, a model was used specifically for analysis of a representative 1990s car body [3, 6]. This model features a detailed discretization of the front 20 ft (6.1 m) or so of the cab car, using a characteristic element length of approximately 1.5 in (38.1 mm). A model was then added to characterize the rear-most 60 ft (18 m) or so of the vehicle. To minimize the number of elements, this part of the vehicle was modeled in much less detail, with a characteristic element length of approximately 15 in (381 mm). A mesh transition zone about 4 ft (1.2 m) in length was developed to link the refined and coarse parts of the mesh. Figure 35 shows the mesh for the cab car. The mesh consists of approximately 125,000 shell elements, with 118,000 of these representing the more refined forward end of the cab.

Figure 35. Finite Element Mesh for the Cab Car (a) the Entire Car (b) the Detailed Forward End

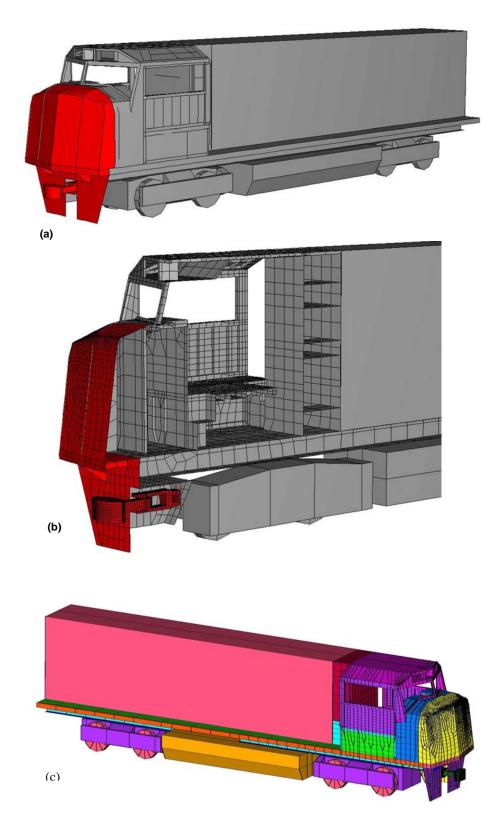
In a like manner, the mesh for the locomotive was derived from a previous model of the cab for a Electro-Motive Diesel, Inc. (EMD) locomotive [7]. Detailed representations were added for the short hood, collision posts, anticlimber, draft pocket, and draft gear based upon drawings for the F40PH locomotive. In addition, simplified representations were added for the underframe, engine, trucks, and fuel tank. Since the damage to the locomotive was limited to the very front of the vehicle, most of the vehicle was modeled as a single rigid body. This simplification allows this part of the mesh to be represented by a single node, having the correct mass and inertia properties, greatly decreasing the solution time for the model. In the analysis, this rigid body was confined to move only in the axial direction. The mass of the locomotive matched that of the locomotive used in the test. Figure 36 shows the mesh for the locomotive. It consists of approximately 16,000 elements, of which about 7,000 are deformable elements.

Figure 36. Finite Element Mesh for the Locomotive (a) the Entire Car, Mesh Hidden; (b) the Detailed Cab Interior; (c) the Entire Car, Mesh Visible

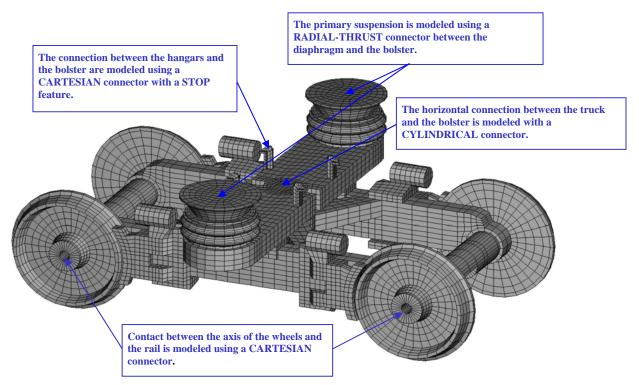
The cab car trucks were modeled as rigid bodies connected to the underframe of the cab car body through the use of ABAQUS connector elements. The structure of the truck was derived from a model developed in a previous study [6]. Figure 37 shows the mesh for the truck. This figure shows the location of the connector elements.

Figure 37. Finite Element Mesh for the Truck with Connector Elements Indicated

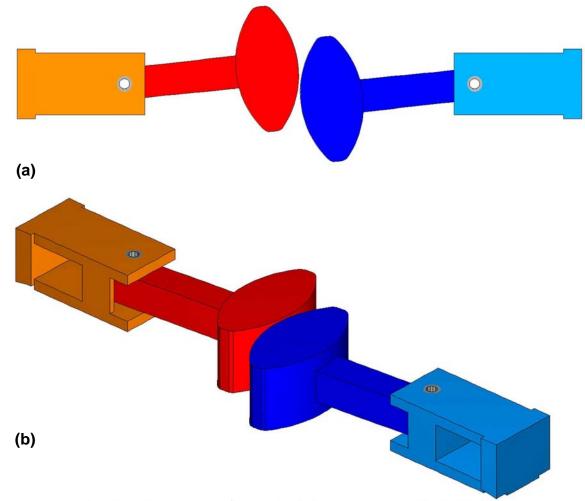
Models for cab car and standing locomotive couplers were modified to better represent their impact and subsequent motions. The representation of the connection between the coupler shank and the yoke was enhanced so that axial force transmission and coupler rotation could be modeled. This was done by explicitly modeling a rigid-pinned connection between the yoke and the coupler shank (see Figure 38). In addition, the respective couplers were each defined to have curved heads that allow them to collide and transmit longitudinal forces but also have them rotate past one another without locking together. An initial angular offset of 5 degrees was imposed on the initial configuration of each of the couplers to promote preferential rotational motion.

Figure 38. Finite Element Model for the Colliding Couplers (a) Plan View (b) Isometric View

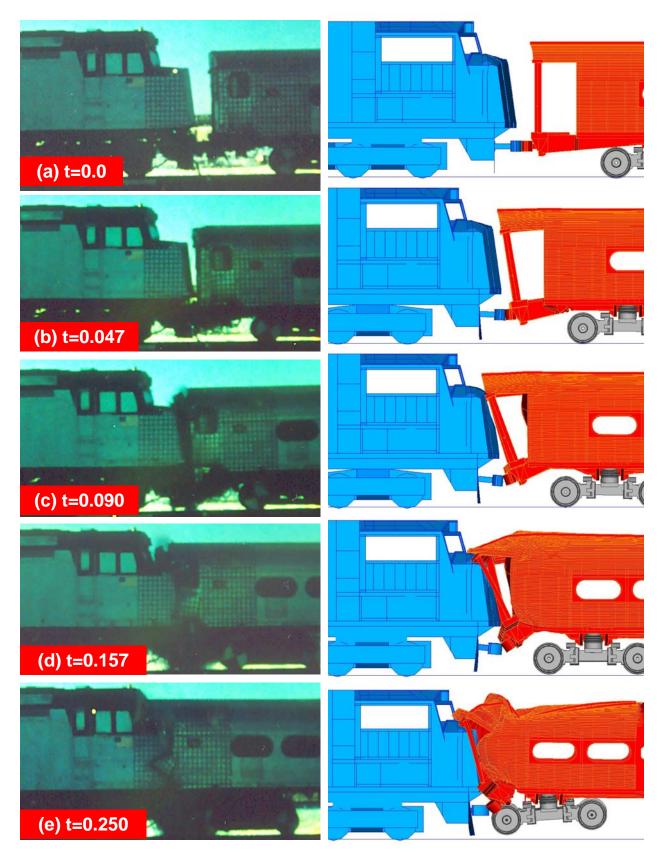
test. In the test, the draft gear appears to bend downward from a single plastic hinge point near the forward truck wheel. In the model, two plastic hinge points are formed above the forward wheel, so that the middle of the draft gear actually bends upward. These differences in deformation mode could easily be attributable to small differences between the characteristics of the model draft sill and the actual draft sill. This is particularly true when one considers the large extent of fracture that occurred in the draft sill.

Figure 39. Comparison of Model and Test Results: Collision Sequence

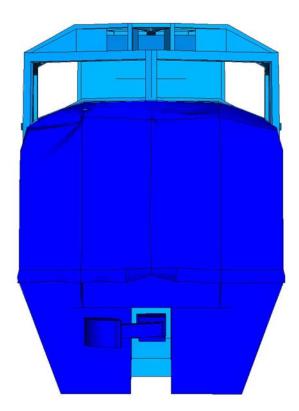
The predicted damage to the front of the locomotive is generally consistent with the damage that occurred in the test. Figure 40 shows the deformed locomotive model end after 0.6 s. The predicted damage to the upper front face of the short hood is very consistent with the test results, as is the sideways motion of the coupler. The coupler moves in a direction that is opposite the direction that it moved in the test. This is a result of the choice for the direction of the initial angular offset that was imposed on the model couplers (Figure 24). Since the remainder of the model is symmetric, offsetting the couplers in the opposite direction would have reproduced the actual motion of the coupler.

The damage that occurs in the anticlimber also appears to be consistent with the test results. As indicated in Figure 40, the model anticlimber experiences damage in two locations—one near the center of the locomotive and one more toward the left side. It is clear that this damage arises due to collision of the collision posts of the cab car. In fact, if one examines the sequence of images shown in Figure 41 in which the collision posts of the cab car are superimposed onto the locomotive, it is clear that the collision posts and, for that matter the entire end frame, roll during the collision.

Figure 40. Model Prediction for Deformation of Standing Locomotive Front End After 0.6 s (Deformable Structure Indicated in Dark Blue)

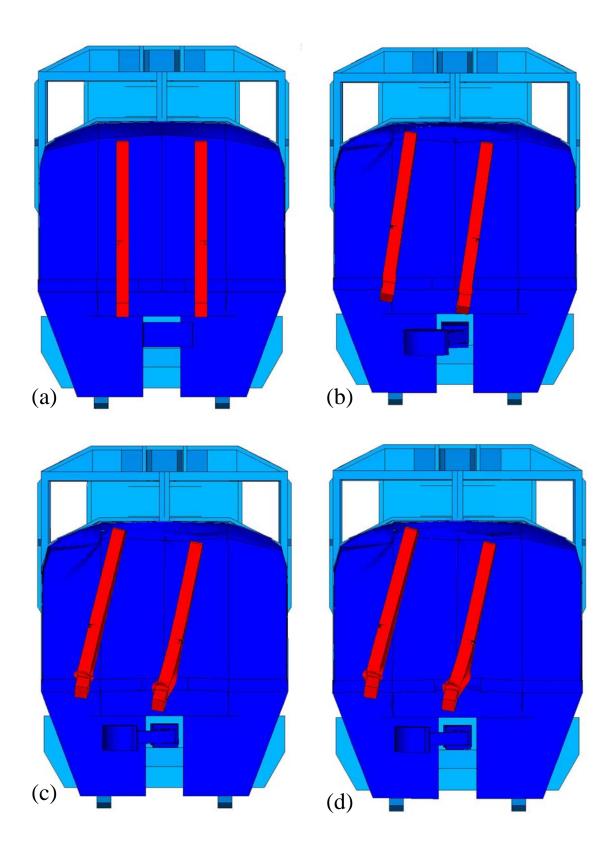
Figure 41. Sequence of Images Showing Deformation of Collision Posts onto the Short Hood of the Standing Locomotive (a) 0.0 s, (b) 0.156 s, (c) 0.3 s, (d) 0.6 s

Figure 41(d) shows that the damage to the anticlimber matches up very nicely with the motion of the collision posts. Moreover, it appears that the lateral shift and the angular rotation of the collision posts are consistent with the post-mortem evidence illustrated in Figures 8 and 9. It appears that much of the rotation occurs early in the collision. After 0.156 s (Figure 41(b)), the collision posts have rotated about 8 degrees from vertical. After 0.3 s (Figure 41(c)), the rotation has increased to approximately 11 degrees; after 0.6 s, it has increased to only about 12 degrees.

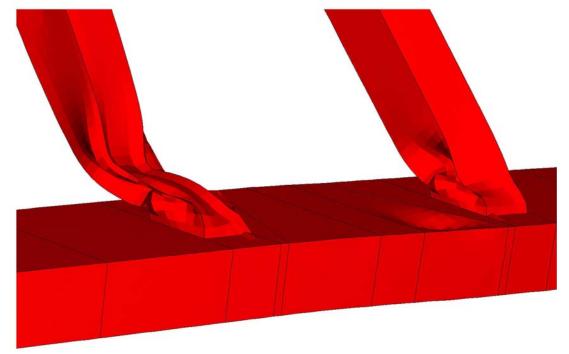
Figure 42. A Closeup of the Model Collision Posts After 0.6 s

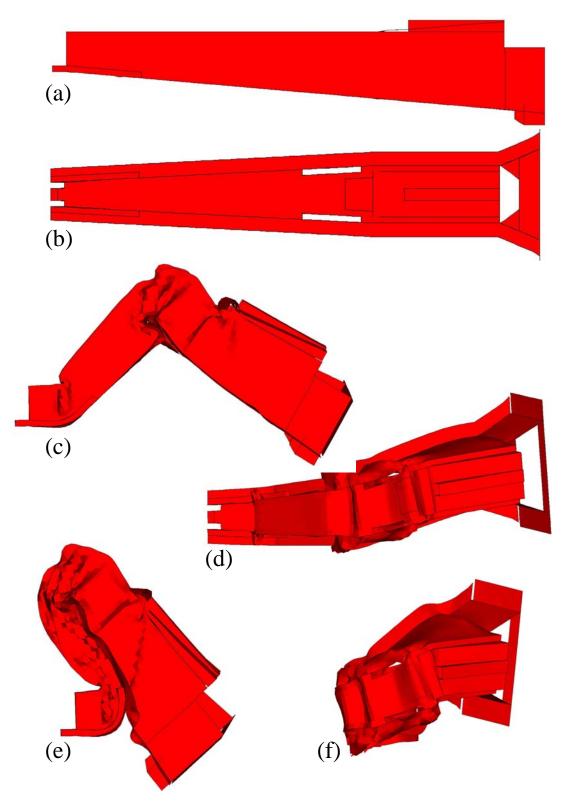
Finally, one can compare the test and model with respect to damage to the draft sill. Figure 43 shows a sequence of images that illustrate the evolution of damage in the draft sill. In comparison to Figure 13, it is clear that the model captures both the severe deformation of the draft sill and its tendency to fold into a Z-shape. Due to the extreme levels of deformation, it is difficult to surmise the exact deformation pattern in the demolished draft sill, but it appears that the folding may have occurred primarily in a horizontal plane. In contrast, it appears that, in the model collision, the folding occurs primarily (but not entirely) in a vertical plane.

Figure 43. Sequence of Images Showing Deformation of the Cab Car Draft Sill (a) Undeformed Side View; (b) Undeformed, Top View; (c) 0.156 s, Side View; (d) 0.156 s, Top View; (e) 0.3 s, Side View; (f) 0.3 s, Top View

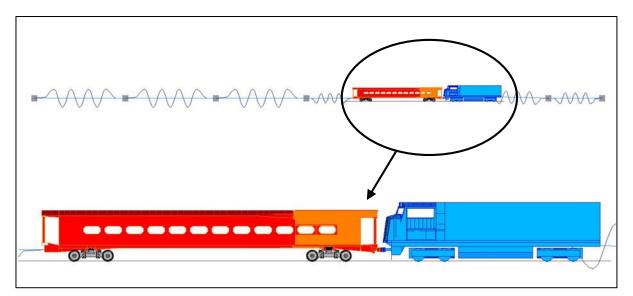
In order to produce meaningful comparisons to test results, model predictions of acceleration were also filtered using SAE J211/CFC 60. SAE filtering can be done within the ABAQUS/Viewer post-processing program. Appendix A presents plots showing comparisons between model and test results for each of the selected time histories (motions and forces). Figure 44 shows a visual representation of the complete finite element model. The cab car-led consist is comprised of a detailed model of the cab car and a series of springs representing the trailing cars. The locomotive consist is comprised of a detailed model of a detailed model of the locomotive and a series of springs representing the ballast cars.

Figure 44. Complete Finite Element Model of the Cab Car-Led Train with the Standing Locomotive-Led Train

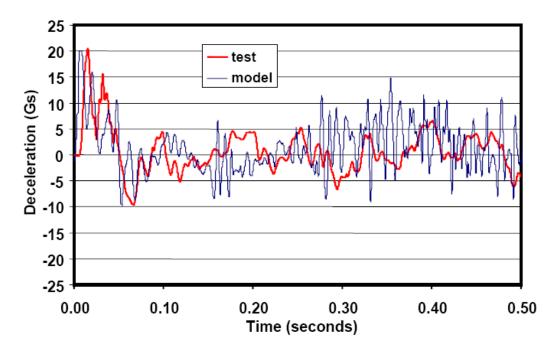
Figure 45 shows a comparison of the filtered longitudinal deceleration time histories for the cab car. In general, the model follows the trend of the test data over this 0.5-second interval. It captures the peak deceleration of about 20 G quite well, though the timing appears to be off by a few milliseconds. This may simply be due to a shift in the time of impact recorded in the test or slack in the colliding couplers. The model also captures the 10 G negative deceleration (positive acceleration) that occurs at 0.07 s. After about 0.3 s, the model-predicted accelerations rise above the test data. This is an indication that the model is not picking up the extent of fracture that is occurring during this time period. As noted in Section 3, the model restricts failure to the draft sill only; clearly, as evidenced by Figure 2, extensive fracture is occurring elsewhere in the end frame by this time. Plots for the cab car longitudinal, vertical, and lateral accelerations; velocities; and displacement motions (Figures 46-51) are also included.

Figure 45. Comparison of Test and Model: Longitudinal Acceleration of Cab Car

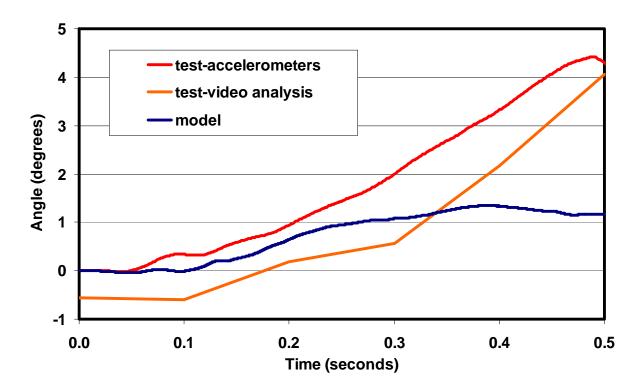
Figure 52 compares the pitch angle that develops during the collision. The results shown in the figure indicate that the model captures the climb of the forward end of the cab car over the first 0.2 s or so of the collision but not after that. In the model, the entire cab car appears to become trapped on the short hood of the locomotive, limiting further upward motion; whereas, in the test, the superstructure of the cab car appears to have torn away from the underframe and continued to climb. To capture the behavior exhibited in the test, more careful attention must be paid to modeling the details of the connections between the cab car superstructure and the underframe.

Figure 52. Comparison of Test and Model: Pitch Angle of Cab Car

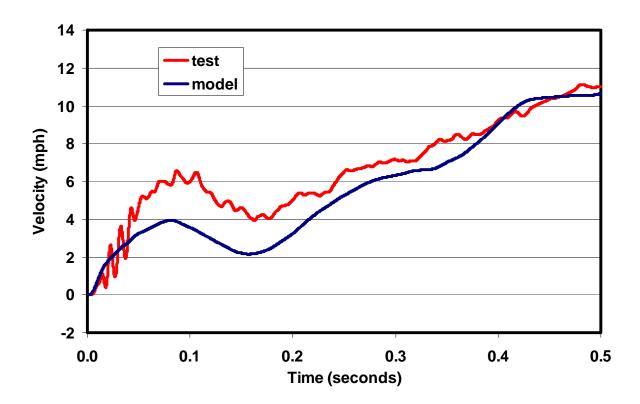
As noted in Chapter 2, the accelerometer on the locomotive had problems associated with vibration due to loose engine mounts. For this reason, the accelerometer data are noisy and do not lend themselves to comparisons with model predictions. The longitudinal velocity data, which are still considered to be valid, are compared with model predictions in Figure 53. The results indicate that the shape of the velocity history is captured but that its magnitude is underestimated by approximately 50 percent. Model predictions for the longitudinal displacement of the locomotive (Figure 54) seem to be more consistent with video data, indicating that the accelerometer-derived velocity estimation may be overestimating the actual test velocity.

Figure 53. Comparison of Test and Model: Longitudinal Velocity of Locomotive

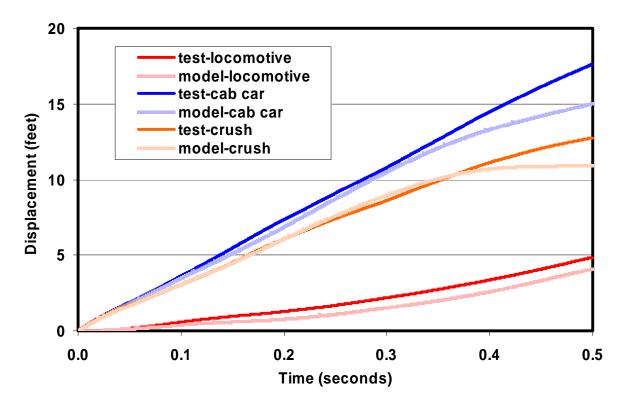
Subtracting the longitudinal displacement time history of the cab car from that of the standing locomotive provides an indication of the crush displacement time history. Figure 55 shows a comparison of cab car, locomotive, and crush (cab car minus locomotive) displacements versus time. As is evident in this figure, the model and test crush displacements compare quite favorably over the first 0.25 s or so. After this time, the respective curves begin to deviate from one another as the model loses accuracy due to the significant extent of fracture that arises, which the model does not accurately capture. The extensive fracture lowers the resistance of the cab car structure, therefore promoting additional displacement with time.

Figure 55. Comparison of Test and Model: Longitudinal Displacement of Locomotive, Cab Car, and Crush

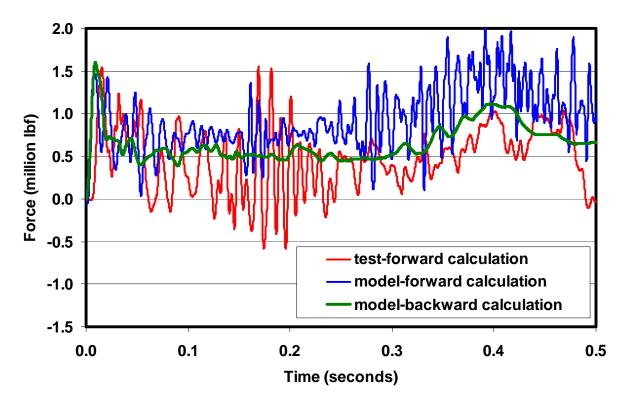
Figure 56. Comparison of Test and Model: Collision Force

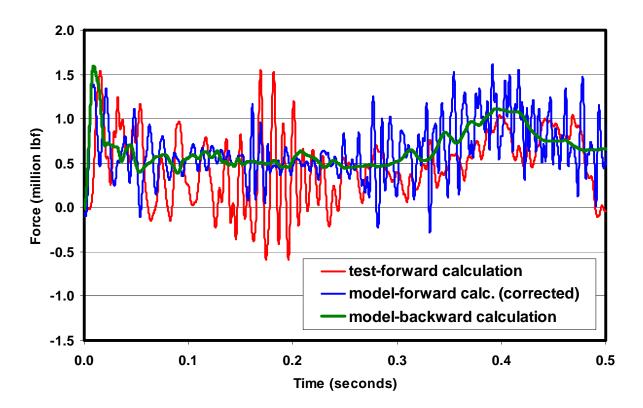
Further investigation indicates that using the acceleration at a single nodal location produces noise in the force prediction but does not significantly affect the trend of the data. However, it turns out that the impulse to the ground is significant. Correcting the force calculation by subtracting the ground's reaction force (Figure 57) results in a better comparison between the forward calculation and the test data, as well as more consistency between the forward and backward force estimates of the model.

Figure 57. Comparison of Test and Model: Collision Force (Corrected)

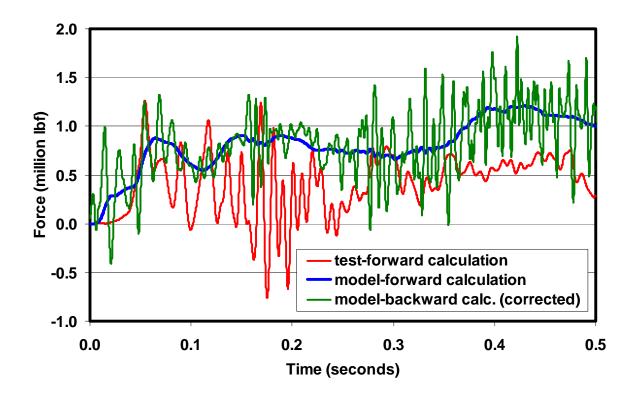
Figure 58 compares model and test results for the cab car trailing vehicle force time history. Of particular interest for this study is the large magnitude of the trailing force acting on the cab car. In comparison to a single-vehicle collision, the trailing force clearly has a significant effect on the collision force. It appears from Figure 58 that the magnitude of the model-predicted trailing vehicle force on the cab car is higher on average than the values derived from the test data, even over the first 0.25 s of the collision. This indicates that the values used for the stiffness and damping characteristics of the trailing vehicle connections may need to be modified.

Figure 58. Comparison of Test and Model: Moving Consist—Trailing Vehicle Forces (Corrected)

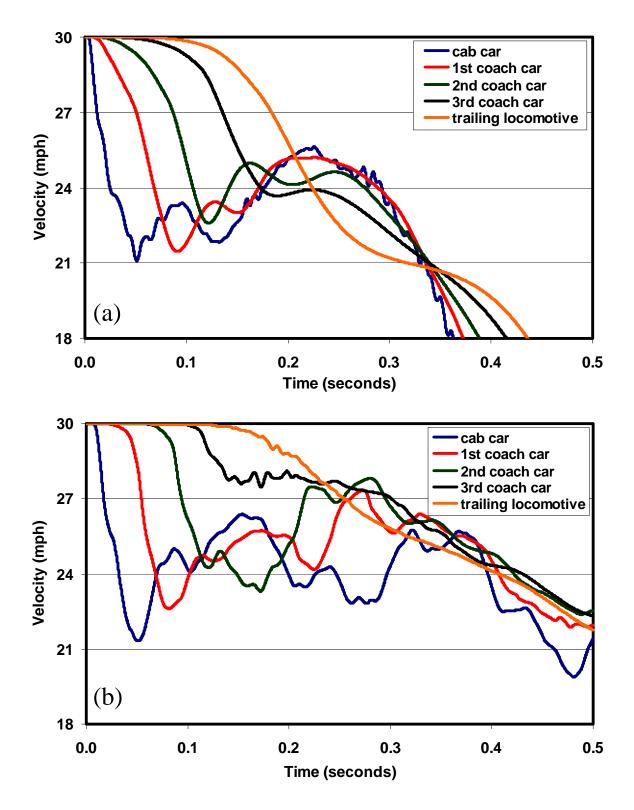
Figure 59. Comparison of Test and Model: Moving Consist—Moving Consist Vehicle Velocities (a) Test (b) Model

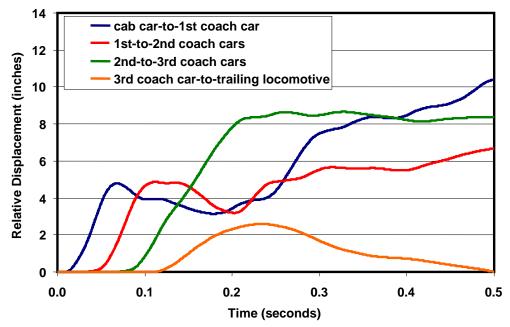
This discrepancy can likely be mitigated to some extent by adjusting the stiffness parameters for the model connectors. (Corrections of this sort can be made only through either examination of post-test data or careful characterization of conditions prior to the test.) In any event, it is clear that collision and trailing forces are sensitive to these parameters.

Figure 60. Test Data—Moving Consist Relative Vehicle Displacements

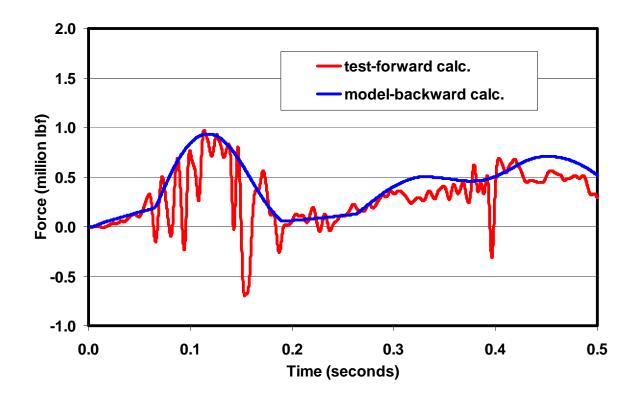
In contrast to the results for the moving consist, the trailing force on the standing locomotive (Figure 61) seems to be well captured by the simplified model of its trailing vehicles and vehicle-to-vehicle connections.

Figure 61. Comparison of Test and Model: Standing Consist—Trailing Vehicle Forces
