1. Report No. FHWA/TX-05/0-4701-1	2. Government Accession No.	3. Recipient's Catalog No.	
4. Title and Subtitle EVALUATION OF TRAFFIC CONTROL DEVICES: FIRST YEAR ACTIVITIES		5. Report Date October 2004	6. Performing Organization Code

EVALUATION OF TRAFFIC CONTROL DEVICES: FIRST YEAR ACTIVITIES

Report 0-4701-1
Project 0-4701

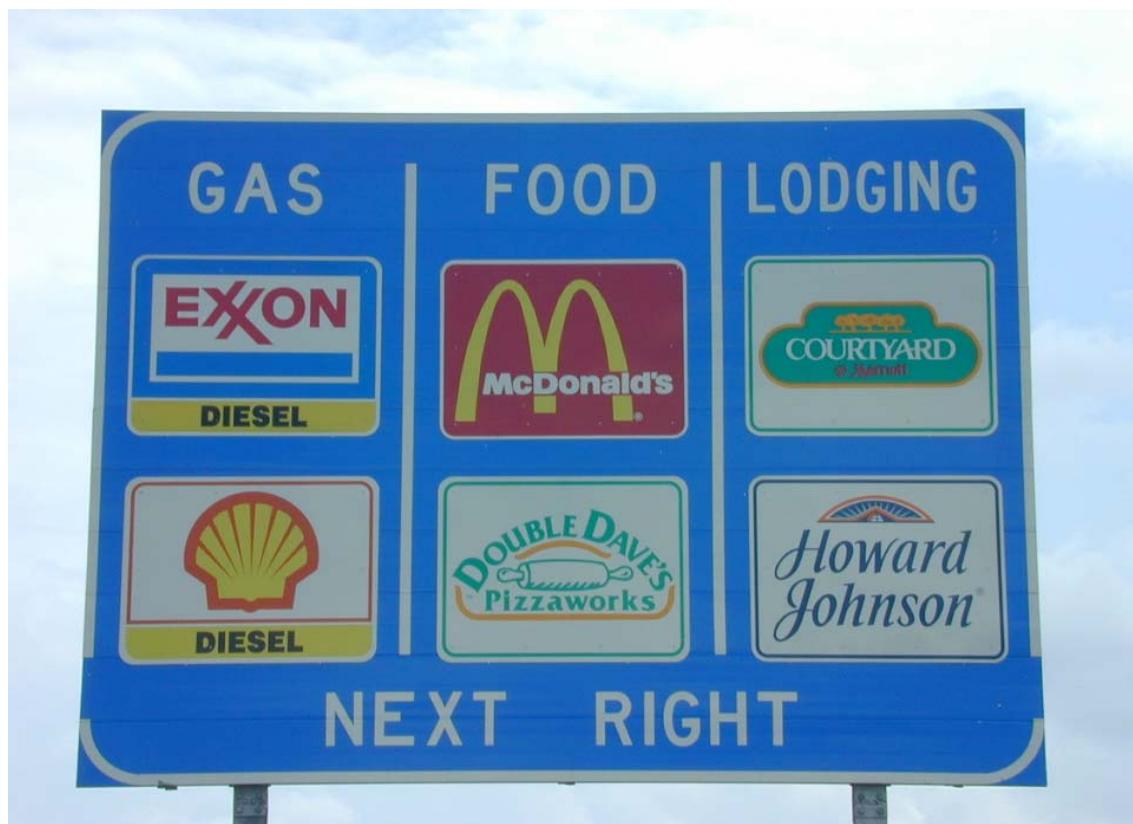
Specific service signs are large guide signs with a blue background that provide information to motorists about services available near a particular interchange exit. Graphic images or word messages (business logos) are used to represent a particular business on the sign. For this reason, specific service signs are commonly referred to as logo signs. The *Texas Manual on Uniform Traffic Control Devices* (TxMUTCD) defines specific service signs as “guide signs that provide road users with business identification and directional information for eligible services” (1). These signs may be used on any class of highway but are primarily used on interstates and freeways in advance of interchanges. Logo signs in Texas are used to inform the driver of specific services provided at an exit that the driver may need such as food, gas, lodging, and camping. In addition to the four categories described in the TxMUTCD, the national MUTCD also allows logos for some special attractions (2). Figure 2-1 shows an example of a logo sign with gas, food, and lodging logos.

Figure 2-1. Specific Service Sign—Three Service Categories and Six Logo Panels.

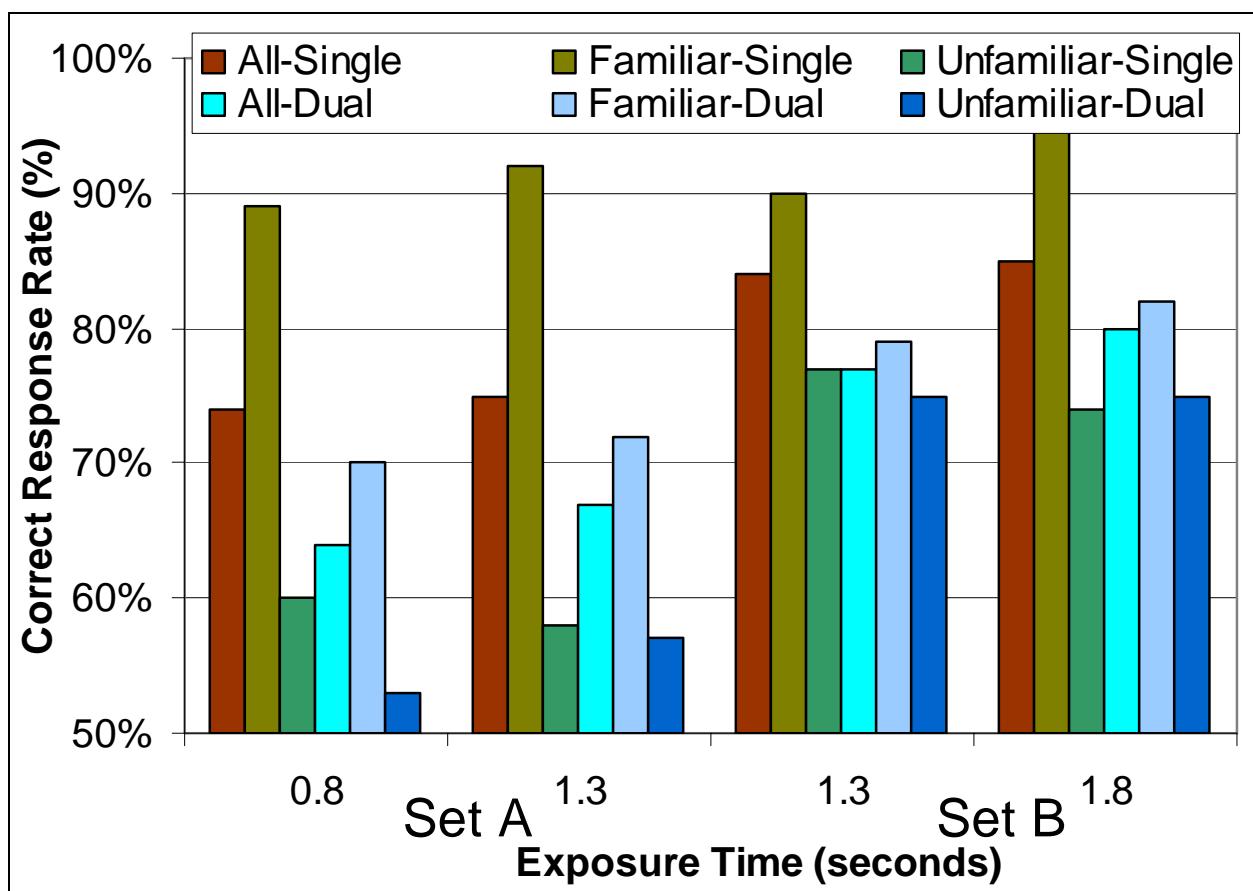
Figure 2-6. Graphical Representation of Survey Results.

The overall results for the two survey sets are shown in [Table 2-2](#). [Appendix 1-B](#) presents the results for individual questions. As can be observed from the data in the table, there are significant differences in response rates for the familiar and unfamiliar logos. The differences between single and dual logo response rates are somewhat hidden when viewed within the context of the total data set. [Figure 2-6](#) presents a graphical presentation of the data in [Table 2-2](#).

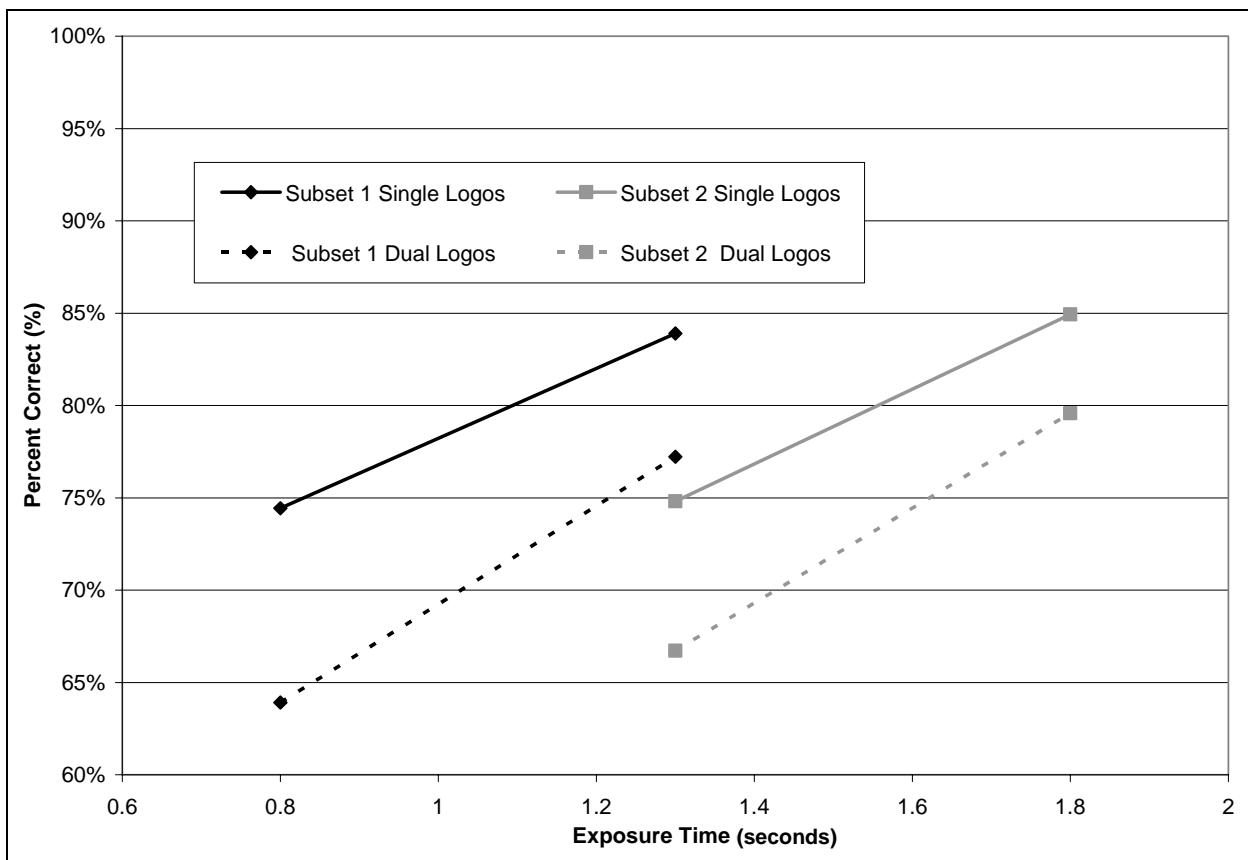
Since there was a significant difference between the correct response rates at 1.3 seconds between Survey Sets A and B, the proportions at the three different time periods cannot be compared. However, the questions at 0.8 seconds for Survey Set A and the questions at 1.3 seconds for Survey Set B were the same, and the example question showed the demographic samples were comparable. The same is true for the questions at 1.3 seconds in Survey Set A and the questions at 1.8 seconds in Survey Set B. [Figure 2-7](#) shows a graphical representation comparing the single and dual logo correct response rates for Subset 1 and Subset 2. Correct response rates for dual logos are represented by dashed lines, and correct response rates for single logos are represented by solid lines. The major point to notice from this figure is that at the differences for correct response rates between single and dual logos decreases as the time exposure increases.

Figure 2-7. Comparison of Proportions Correct between Dual and Single Logos for Subsets 1 and 2.

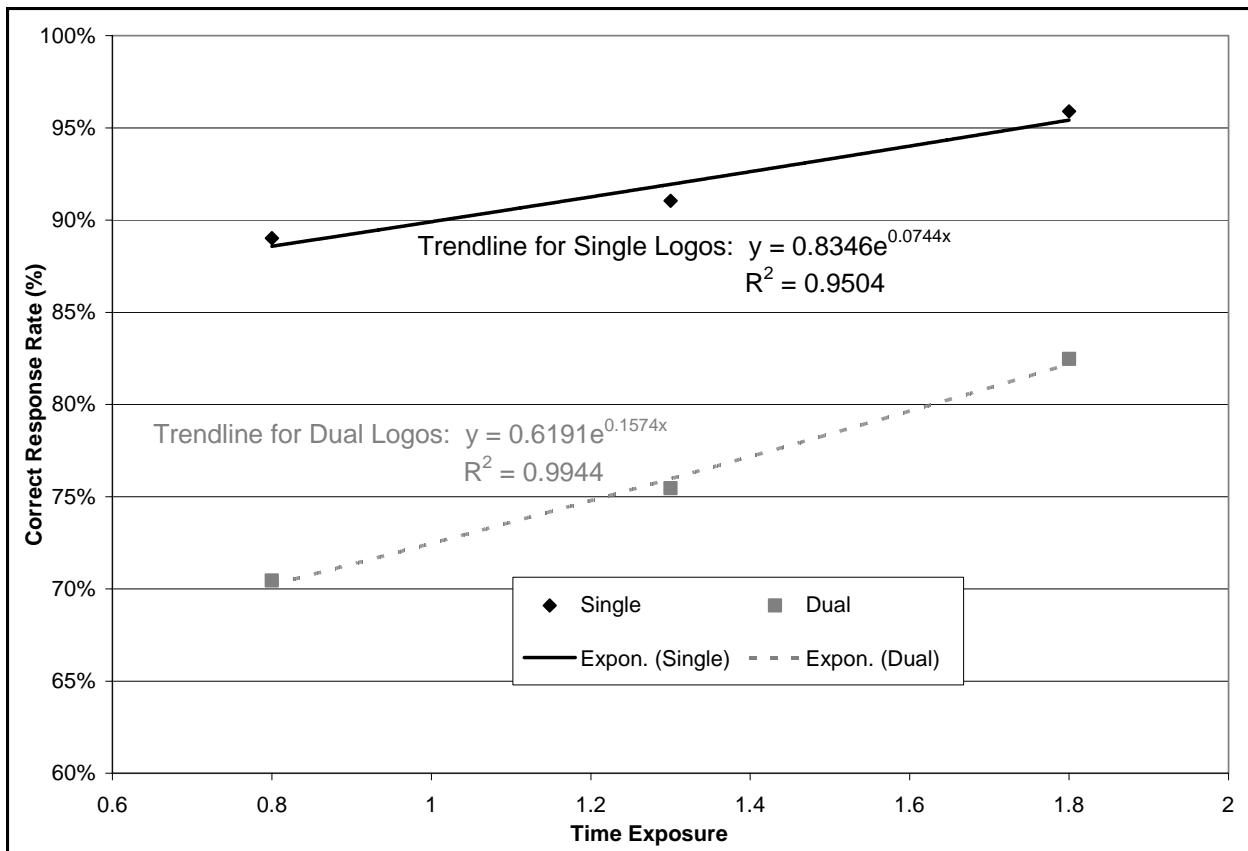
As shown in [Figure 2-8](#), trendlines were generated for single and dual familiar logo data. It can be seen that the difference in correct response rates for single and dual logos decreases as the time exposure increases. The trendlines were extended to solve for the time exposure at which the correct response rates were equal. This time exposure represents the amount of time necessary for the proportion of familiar dual logos recognized to equal the proportion of familiar single logos recognized. The time exposure for which the two trendlines have equal correct response rates was 3.6 seconds, which correlated to a percent correct of 109 percent. However, it is not possible to have a correct response rate over 100 percent. This indicates that using the trendlines to predict response rates as a function of exposure time may not provide accurate results.

Figure 2-8. Comparisons of Proportions Correct between Single Logos and Dual Logos for Familiar Data.

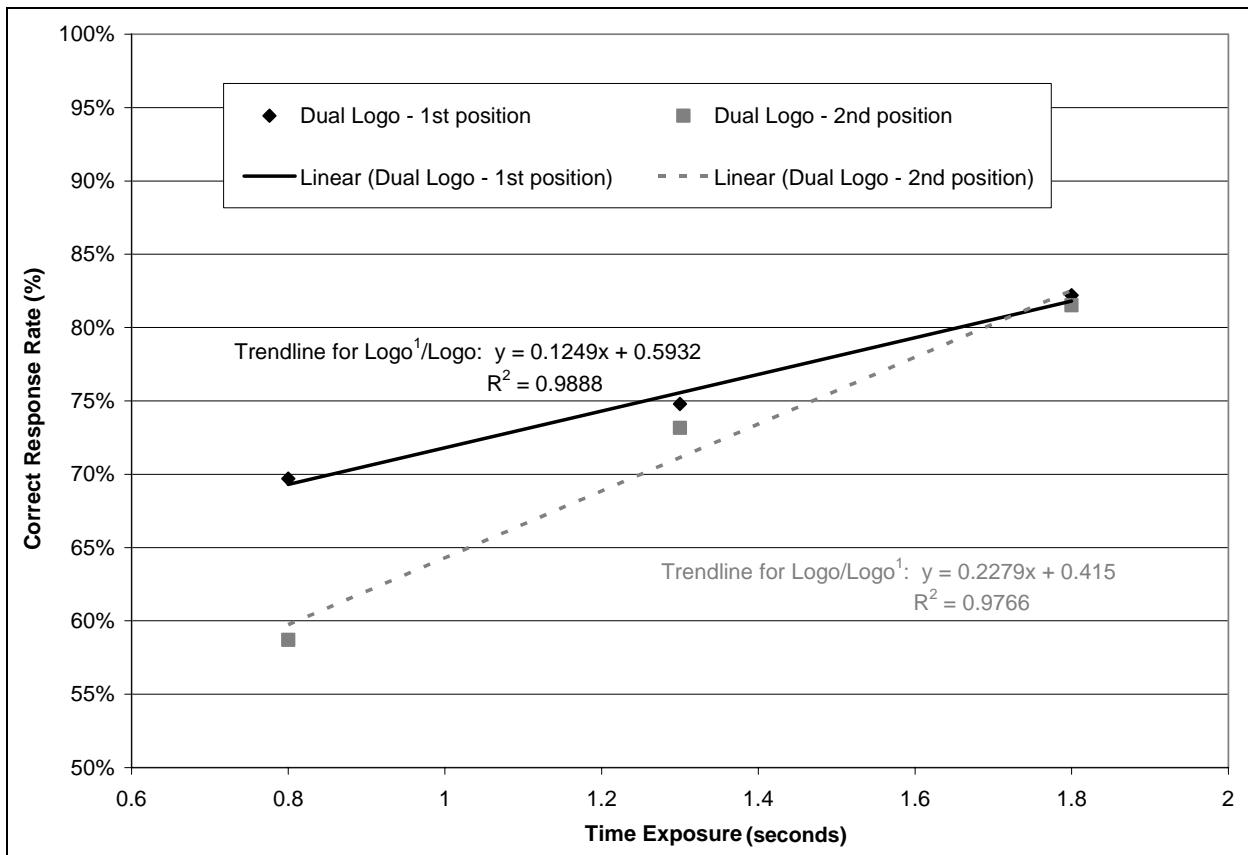
Chi-Square analysis, indicates that there is no reason to prevent the use of dual category dual logos.

Figure 2-9. Comparing Proportions Correct for Dual Logos in Different Categories.

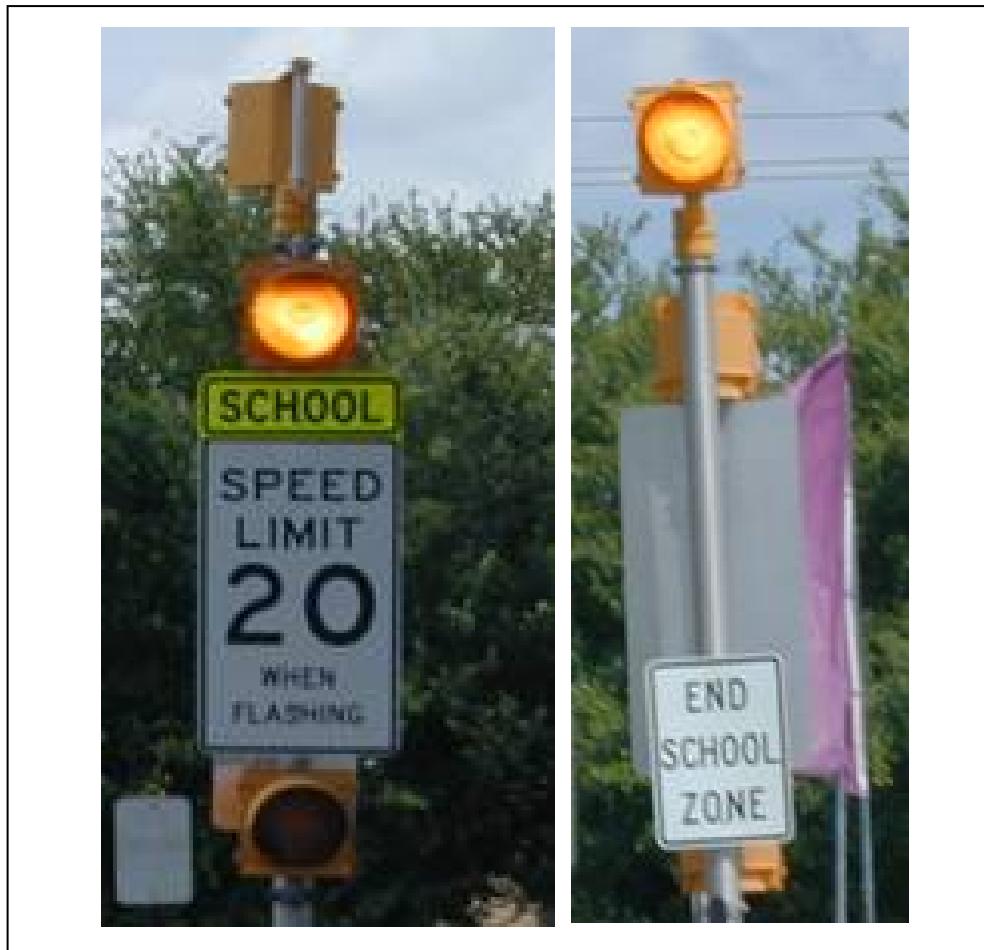
School Speed Limit sign assembly. The front and back of such an installation is pictured in [Figure 3-1](#). Each beacon was aimed in a rear-facing manner towards traffic already in the school zone. The flashing rate was identical to the front-facing beacons—approximately 1 flash per second. The rear-facing beacons were mounted on the left side of the street (as opposed to the right side) to utilize the power source from the existing front-facing beacons. Because power is already provided to the assembly, the only additional cost is that associated with the installation of the rear-facing beacon and the End School Zone sign. Because the rear-facing beacon and associated sign are located on the left side of the roadway, there should be an End School Zone or Speed Limit sign on the right side of the roadway although this sign installation will not have the rear-facing beacon.

Figure 3-1. Rear-Facing Beacon Installation.

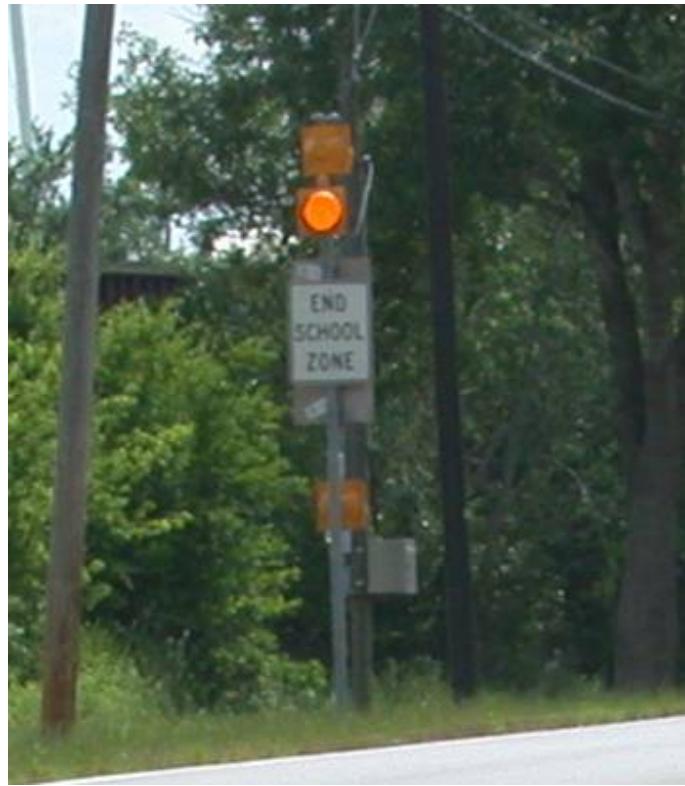
Site 1 is located on US 79 in Thorndale, Texas. The school zone is 2675 ft long, and a signalized intersection is located within the boundaries of the school zone. Traveling west, the signalized intersection is located about 1825 ft from the end of the school zone. An RFB and End School Zone sign were installed on the rear side of the east-facing school zone beacon and school zone speed limit sign. [Figure 3-2](#) shows a closeup of the RFB and End School Zone sign on US 79. The cross section at this location consists of five lanes with two lanes in each direction and a two-way left-turn lane (TWLTL). The speed limit on the road is 45 mph when the school zone is not active. [Figure 3-3](#) is a picture taken from the westbound lanes to illustrate what the driver sees when exiting the school zone. The school zone is active Monday through Friday (when school is in session) from 7:15 to 8:45 am and from 2:30 to 4:15 pm. The school zone speed limit is 30 mph. The school zone is active for an unusually long period of time in both the morning and the afternoon because there are four different schools within the zone—an elementary school, a middle school, a high school, and a small private school.

Figure 3-2. Site 1—Thorndale Schools, Closeup of RFB.

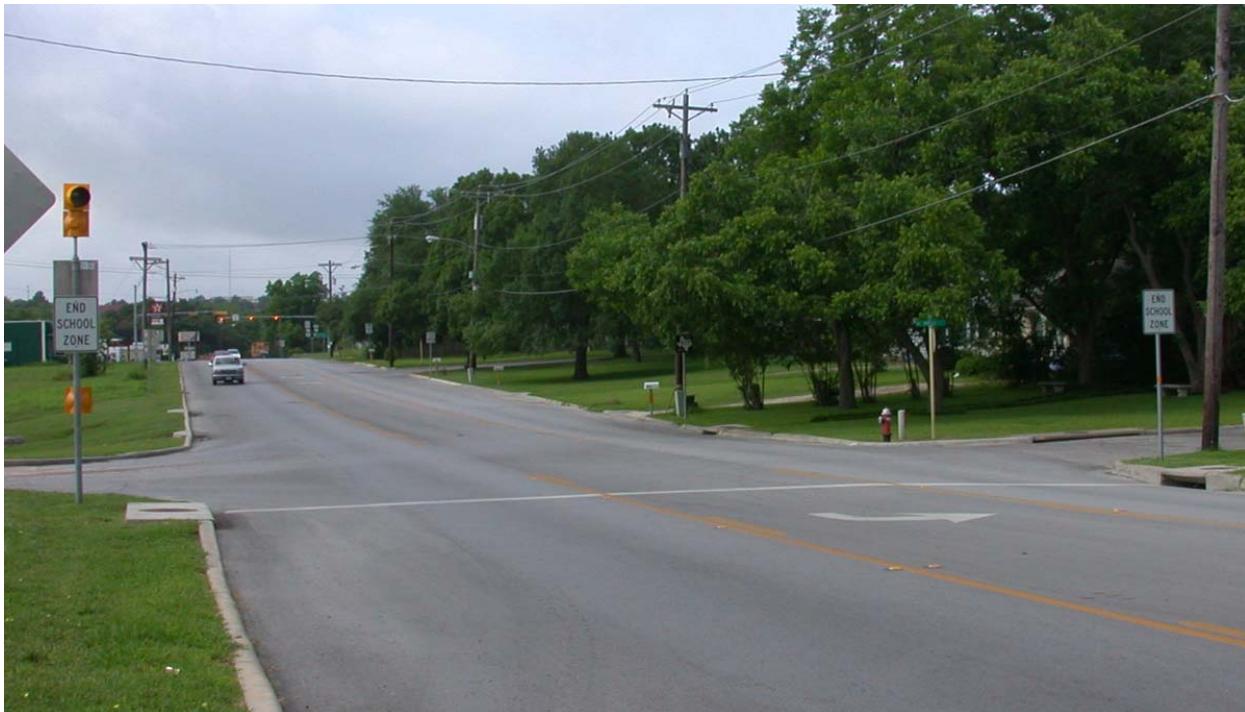
Site 2 is another school zone with a signalized intersection within its boundaries. Site 2 is located in Brenham, Texas, on Business 36 (North Park Street) and runs adjacent to the Brenham High School campus. Site 2 is about 1800 ft long. The intersection is located about 1000 ft from the end of the school zone traveling southbound. The cross section at this location consists of three lanes—one lane in each direction and one TWLTL. The school zone is active between 7:45 and 8:45 am and between 3:30 and 4:30 pm. [Figure 3-4](#) shows the RFB at Site 2.

Figure 3-4. Site 2—Brenham High School, School Zone with a Signalized Intersection.

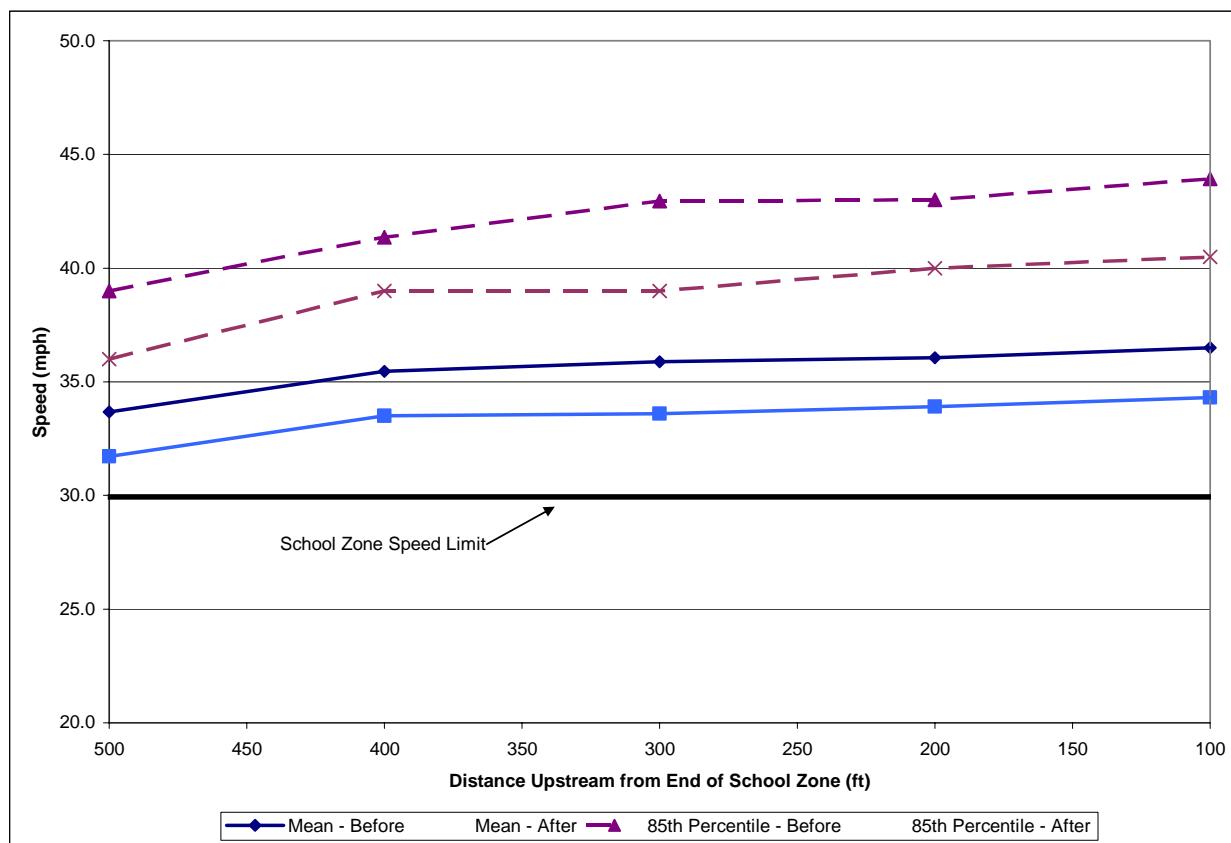
In most cases, the standard deviation of speed was also reduced after installation of the treatment. The reduction was small, on the order of 0.6-0.7 mph, but statistically significant.

Figure 3-7. Site 1—Mean and 85th Percentile School Zone Speeds before and after Rear-Facing Beacon Installation.

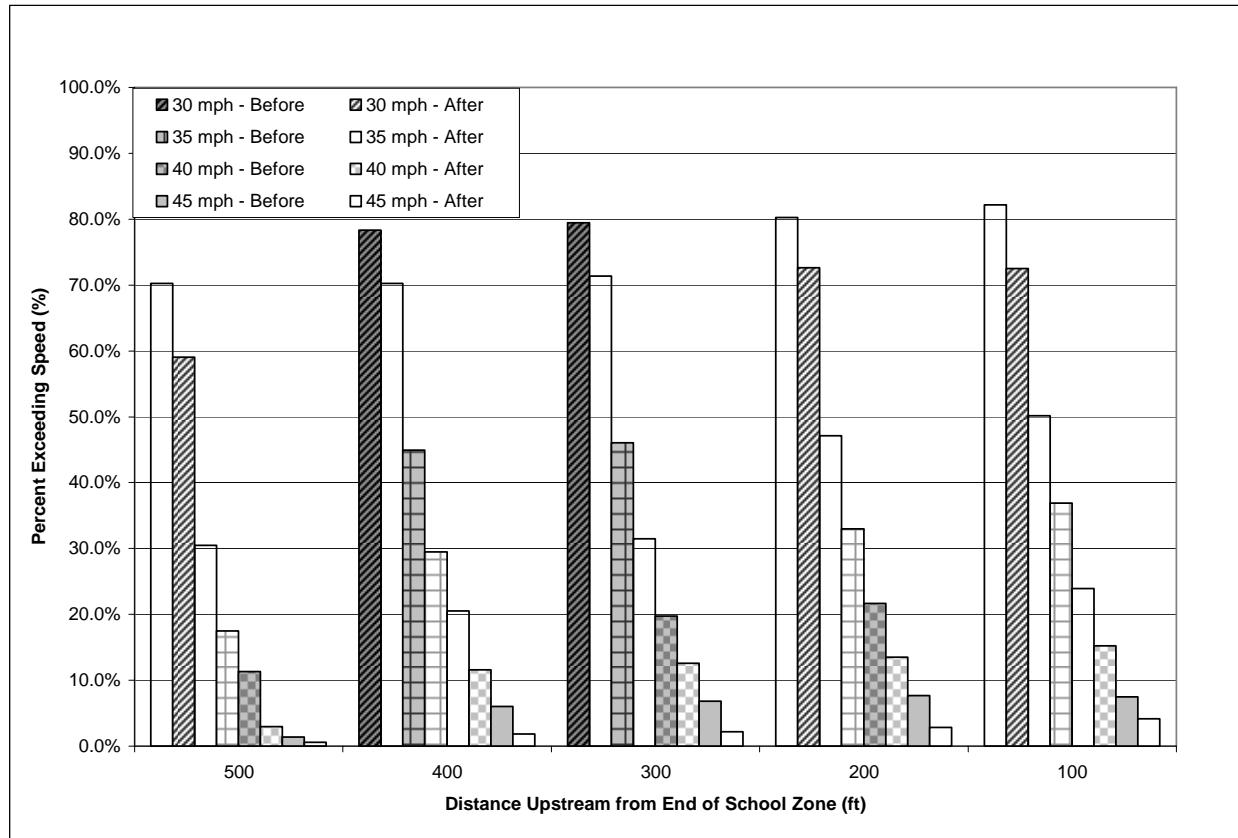
[Table 3-4](#) shows that the percent exceeding the speed limit (30 mph), 5 mph over the speed limit (35 mph), and 10 mph over the speed limit (40 mph) was significantly reduced at all five distances. The percent of vehicles exceeding 15 mph over the speed limit (45 mph) was significantly reduced at 400, 300, and 200 ft in advance of the rear-facing beacon. At 500 ft and 100 ft in advance of the rear-facing beacon, the percent exceeding 15 mph over the speed limit was lower in the after study, but the difference was not statistically significant. [Figure 3-8](#) illustrates the differences found at the various speed thresholds between the percent of vehicles exceeding these thresholds in the before study and the percent of vehicles exceeding these thresholds in the after study.

Figure 3-8. Site 1—Percent of Vehicles Exceeding Various Speed Thresholds before and after Rear-Facing Beacon Installation.

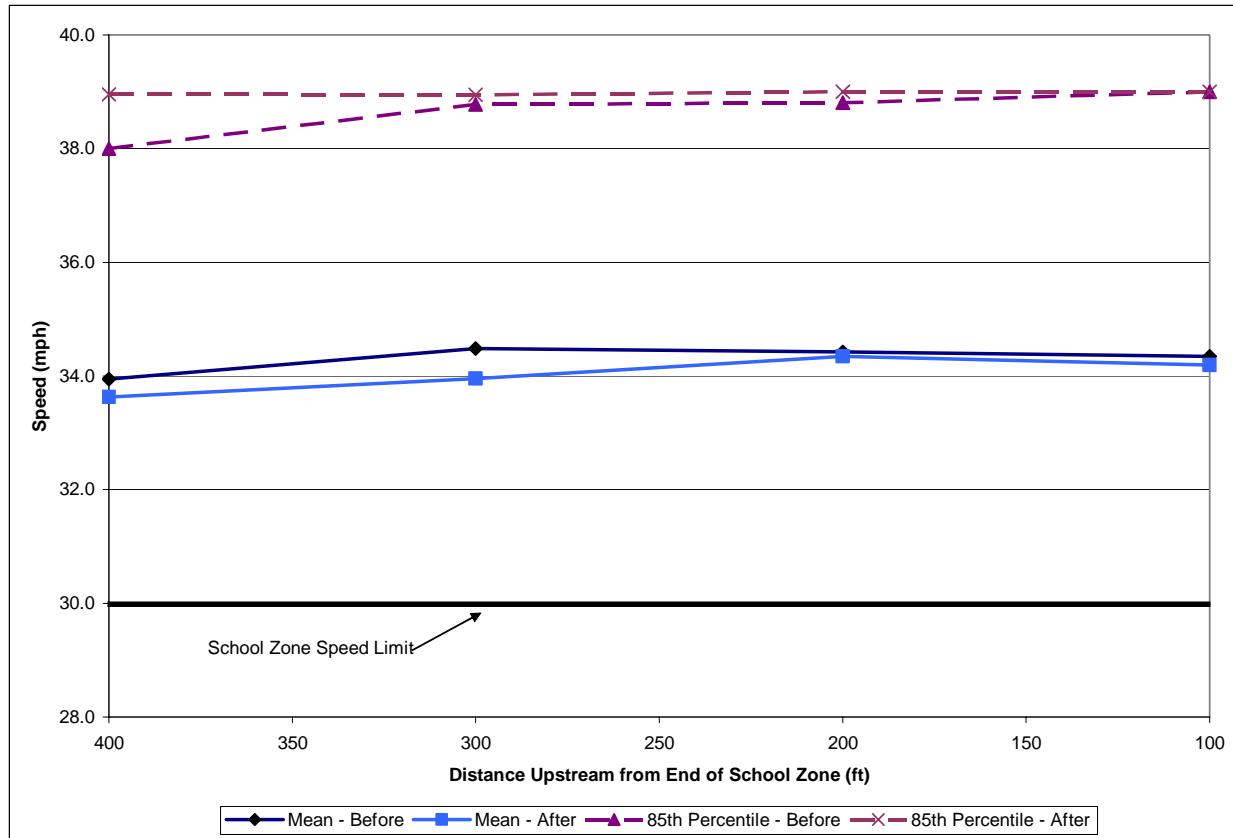
The fact that a significant difference was found for the control data weakens any conclusions researchers can draw from the results of the analyses performed on the data collected while the school zone was active. However, t-tests and F-tests were performed on these data as well. Again, data were only collected during the morning when the school zone was active. The sample size for the data collected while the school zone was active was slightly larger; 63 samples were collected in the before study, and 97 samples were collected in the after study. The t-test indicated at each distance (400, 300, 200, and 100 ft in advance of the RFB) that there was no significant difference between the average speeds traveled in the before study and the average speeds traveled in the after study. [Table 3-5](#) shows the average speeds, 85th percentile speeds, and standard deviation of the data collected during the active school zone. There were no significant differences found at any location between the before and after studies for average speeds or standard deviations. This indicates that the treatment had no effect on traffic speeds. The control data indicated that traffic was traveling about 2 mph slower in the after study while the school zone was not active, so one might expect the after speeds to be slower during the active school zone as well. The sample size is smaller than desirable, and that could influence the results. The data indicate that the treatment did not have any effect on average speeds or the variance of speeds at this site. The 85th percentile speeds were also the same at 300, 200, and 100 ft away from the RFB and within 1 mph at 400 ft from the RFB. [Figure 3-9](#) shows the mean and 85th percentile speeds in a graphical format.

Figure 3-9. Site 2—Mean and 85th Percentile School Zone Speeds before and after Rear-Facing Beacon Installation.

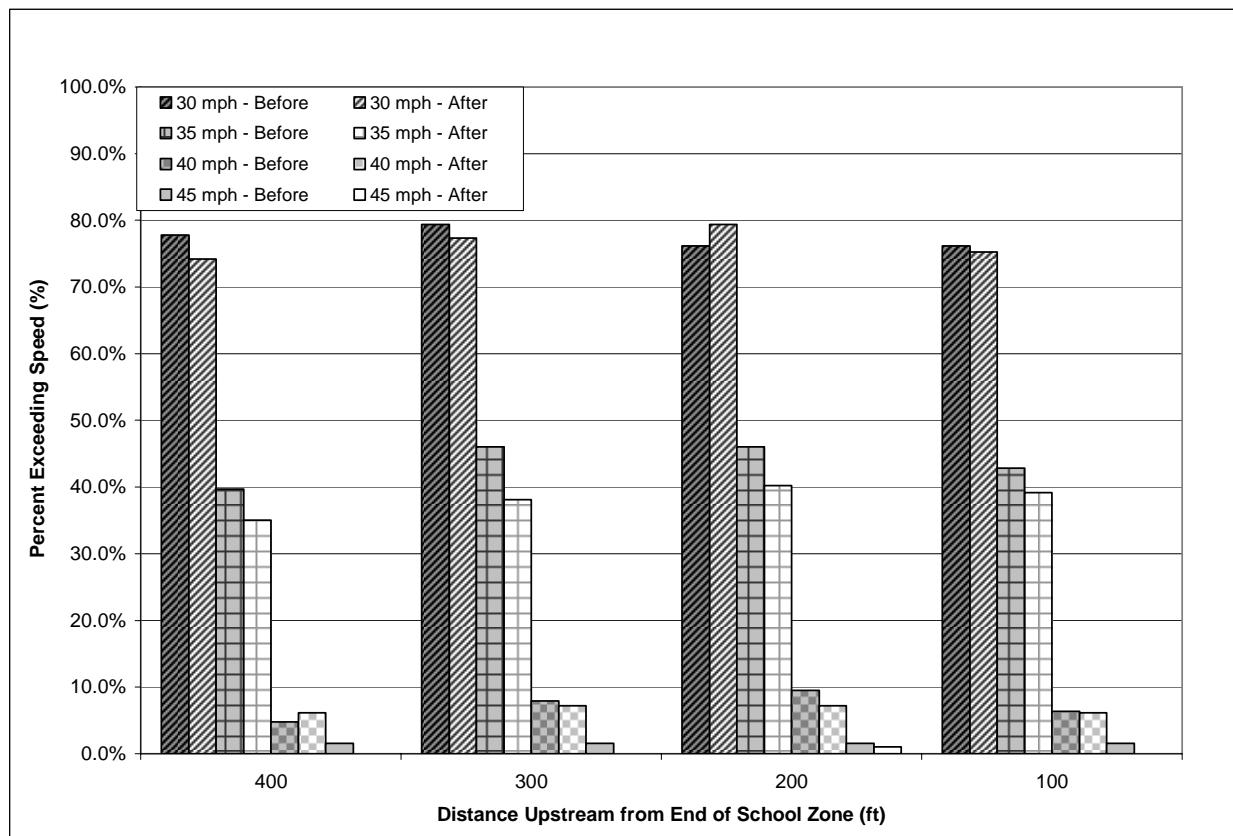
Z-test were also performed on the data collected at this site. No significant differences were detected in the number of vehicles exceeding the speed limit at this site when the school zone was not active. Thus z-tests were then performed at the thresholds mentioned previously. Again, no significant differences were found at any of the speed thresholds for any distance from the rear-facing beacon treatment. [Table 3-6](#) lists the percentage of vehicles exceeding the various thresholds for both the before and after study. [Figure 3-10](#) shows a graphical representation of the data.

Figure 3-10. Site 2—Percent of Vehicles Exceeding Various Speed Thresholds before and after Rear-Facing Beacon Installation.

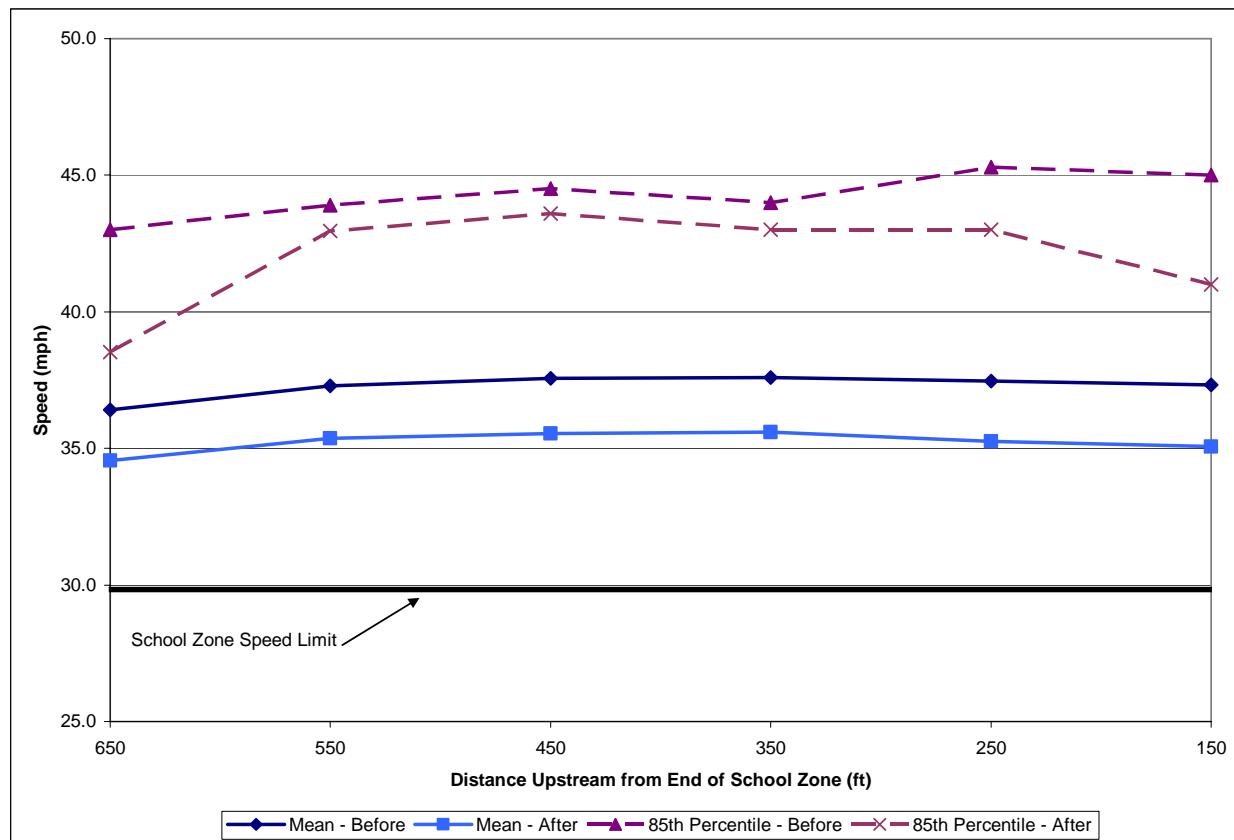
Figure 3-11. Site 3—Mean and 85th Percentile School Zone Speeds before and after Rear-Facing Beacon Installation.

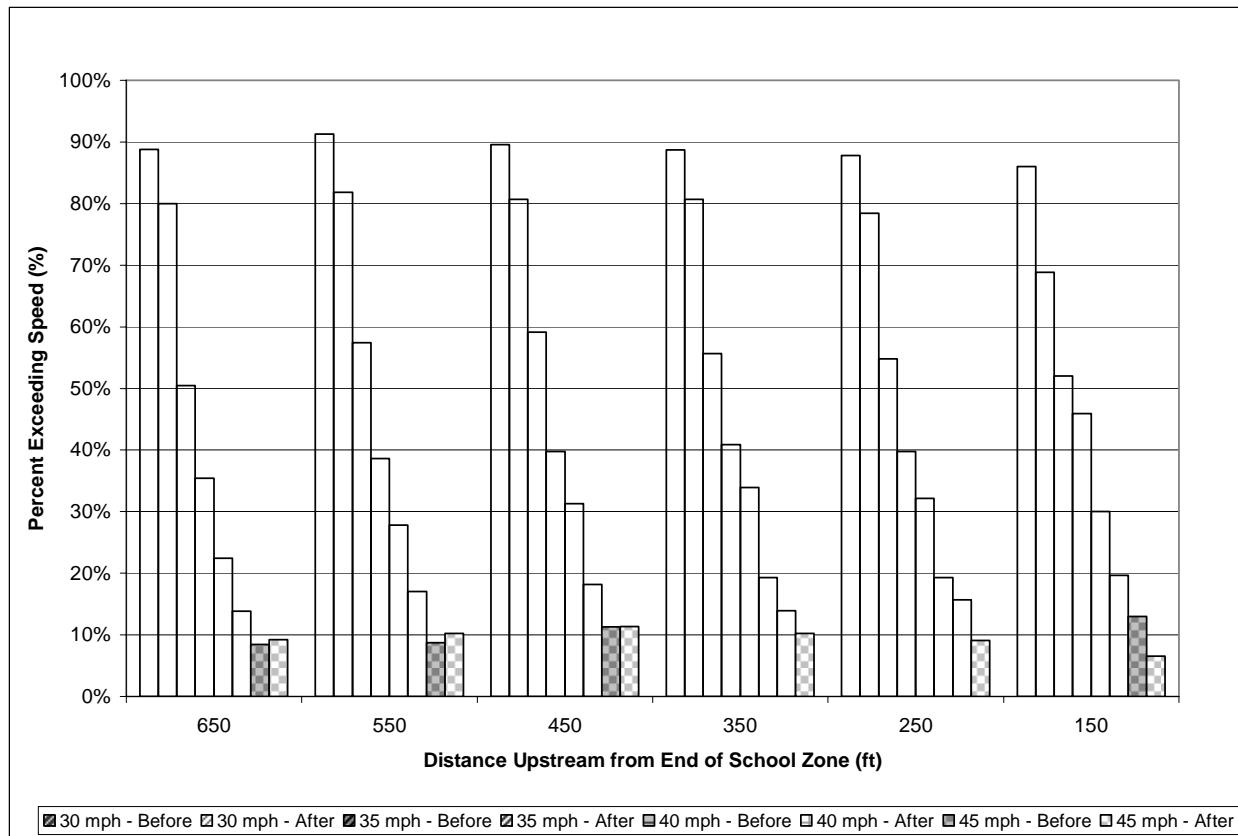
Significant differences were found between the percent of vehicles exceeding the speed limit, 5 mph over the speed limit, and 10 mph over the speed limit for the active school zone data. The difference between the percent of vehicles exceeding the speed limit in the after study was significantly lower than the percent of vehicles exceeding the speed limit in the before study at 550 and 150 ft in advance of the rear-facing beacon. At 5 mph over the speed limit (35 mph) a significant difference was seen at 550, 450, 350, and 250 ft in advance of the rear-facing beacon, and at 10 mph over the speed limit the percent of vehicles exceeding 40 mph was significantly lower at 450, 350, and 250 ft in advance of the rear-facing beacon. [Table 3-8](#) shows the results for the percent of vehicles exceeding various threshold speeds, and [Figure 3-12](#) is a graphical illustration of the results.

Figure 3-12. Site 3—Percent of Vehicles Exceeding Various Speed Thresholds before and after Rear-Facing Beacon Installation.

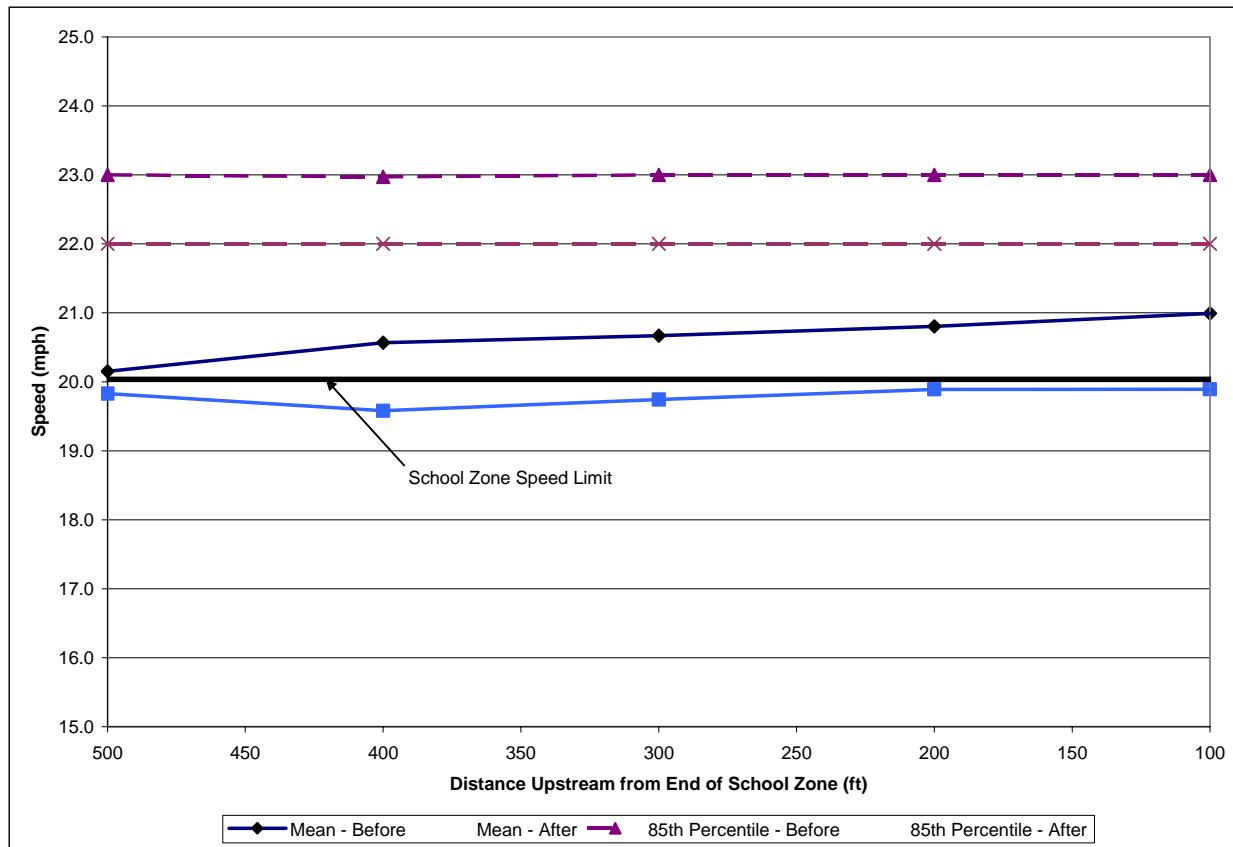
Figure 3-13. Site 4—Mean and 85th Percentile School Zone Speeds before and after Rear-Facing Beacon Installation.

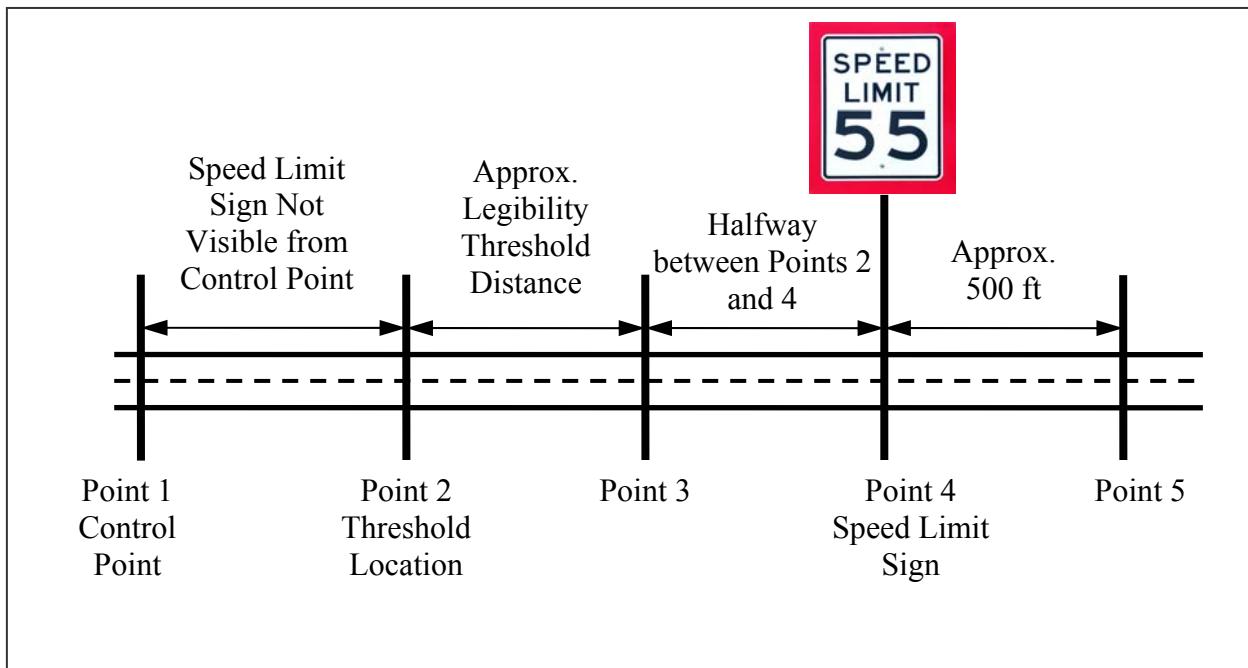
Figure 4-7. Spot Speed Data Collection Locations.

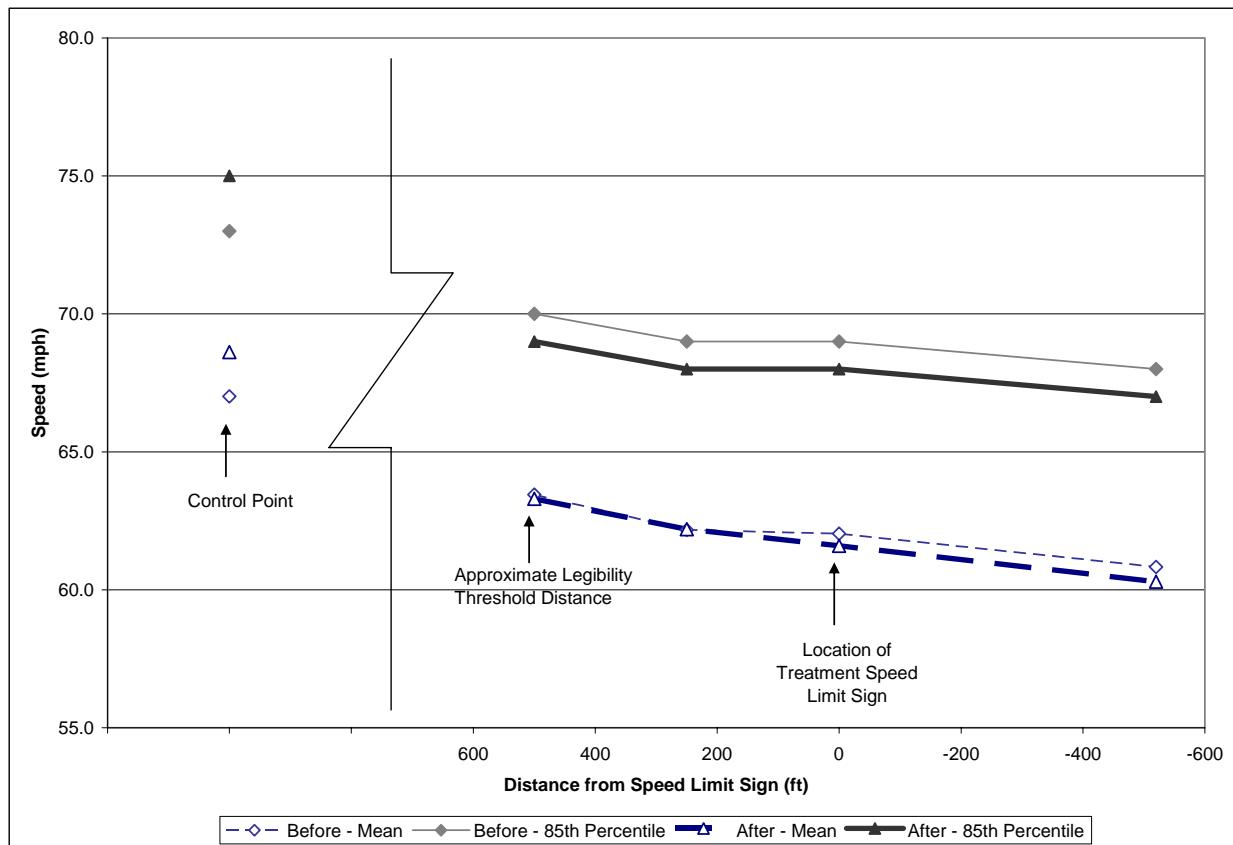
Figure 4-15 is a graphical representation of the average and 85th percentile speeds at each point. A consistent reduction in the 85th percentile speeds of about 1 mph is seen. As mentioned previously no statistical tests were performed directly on the 85th percentile speeds. Smaller reductions are also seen in the average speed as well. Though the mean speed reductions are small, it is important to remember that the upstream speed was higher during the after study. An analysis of the mean deceleration speeds may better quantify the effect of the red border in this case.

Figure 4-15. FM 60, Snook—Mean and 85th Percentile Speeds before and after Red Border Installation, Passenger Vehicles, Night Data Only.

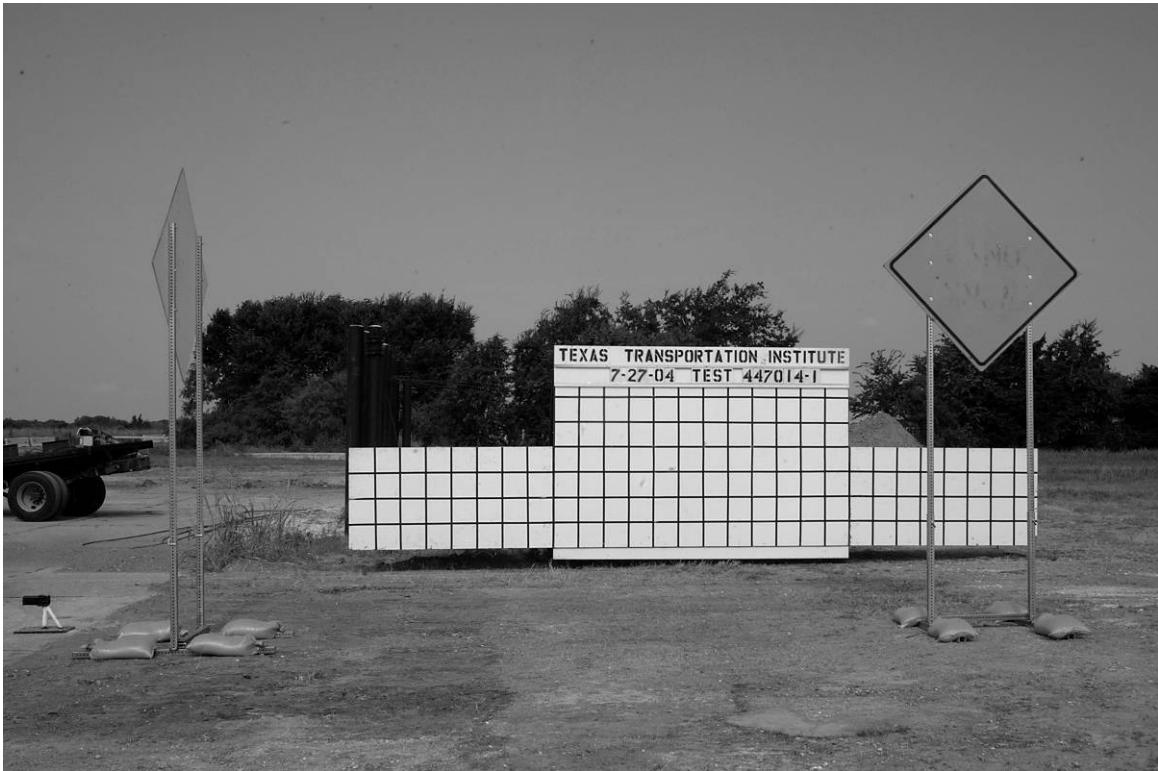
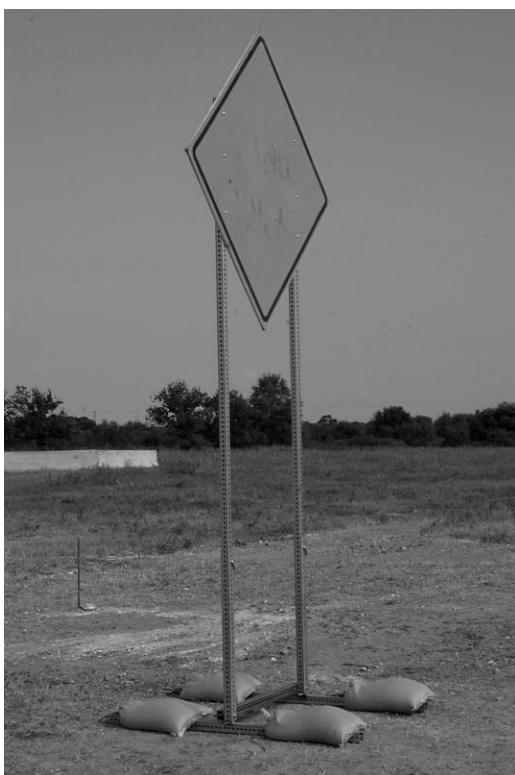
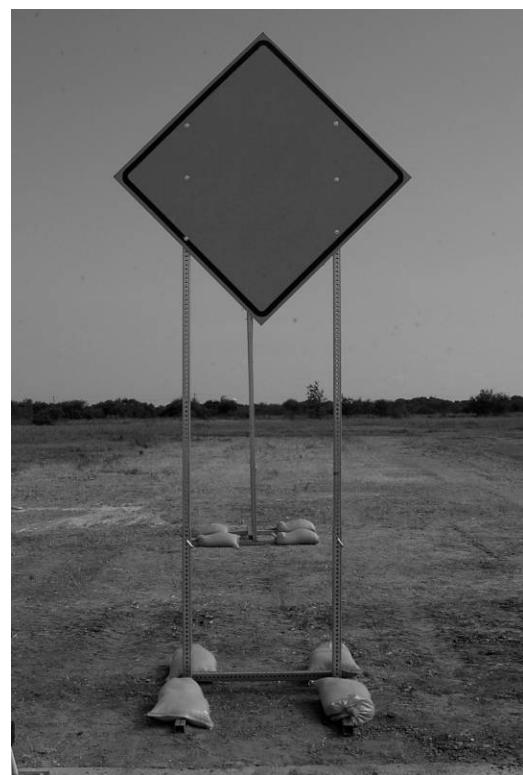
Figure 5-1. Sign Supports Used for Test.
