1. Report No. FHWA/TX-05/0-4701-1	2. Government Accession No.	3. Recipient's Catalog No.	
4. Title and Subtitle EVALUATION OF TRAFFIC CONTROL DEVICES: FIRST YEAR ACTIVITIES		5. Report Date October 2004	6. Performing Organization Code

EVALUATION OF TRAFFIC CONTROL DEVICES: FIRST YEAR ACTIVITIES

Report 0-4701-1
Project 0-4701

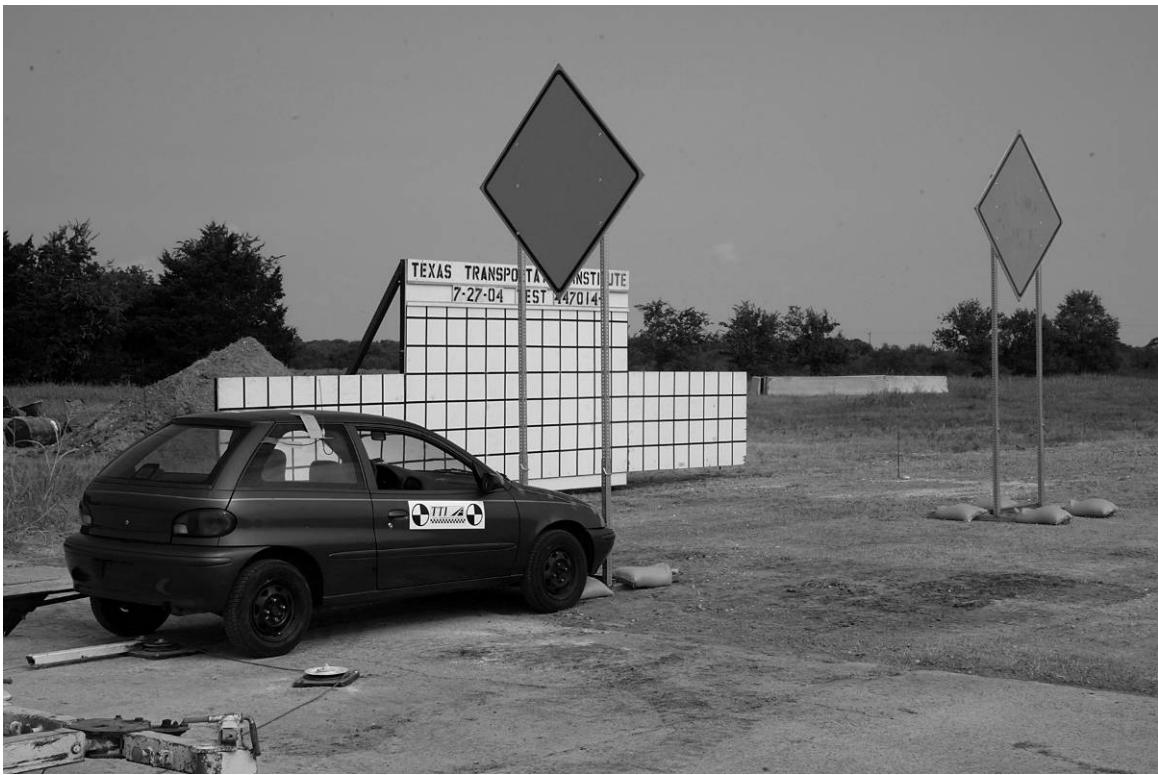
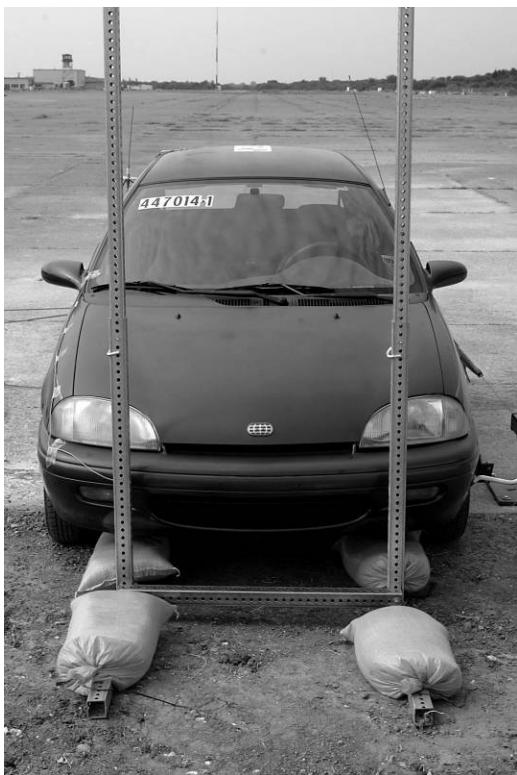
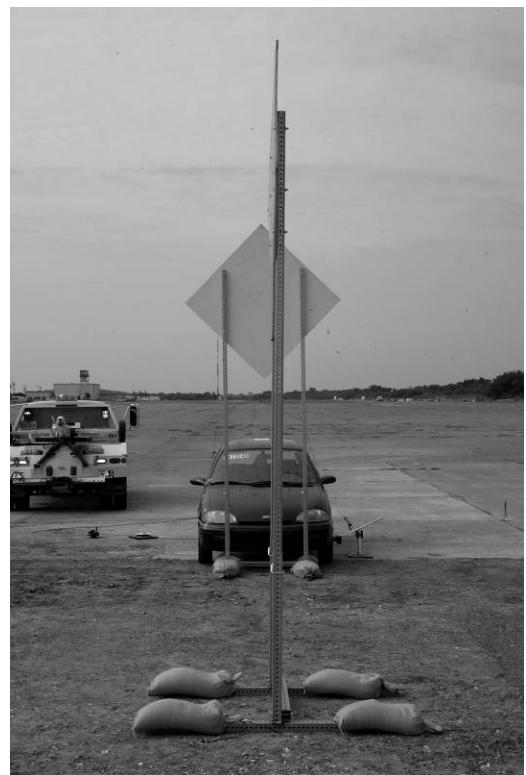
A 1997 Geo Metro, shown in Figures 5-2 and 5-3, was used for the crash test. Test inertia weight of the vehicle was 1,918 lb (871 kg), and gross static mass was 2,092 lb (950 kg). The height to the lower edge of the vehicle's front bumper was 15.7 inches (400 mm), and the height to the upper edge of the front bumper was 20.7 inches (525 mm). The vehicle was directed into the installation using the cable reverse tow and guidance system, and was released to be free-wheeling and unrestrained just prior to impact.

Figure 5-2. Vehicle and Support Geometrics before Test.

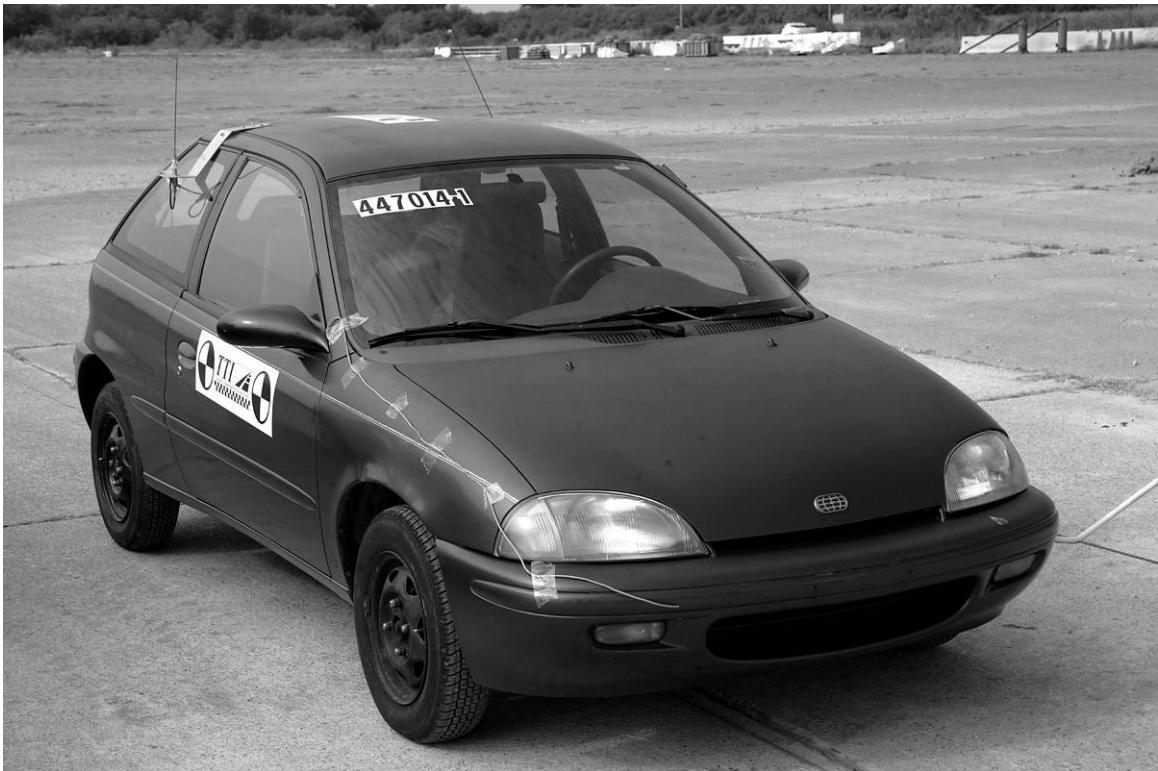
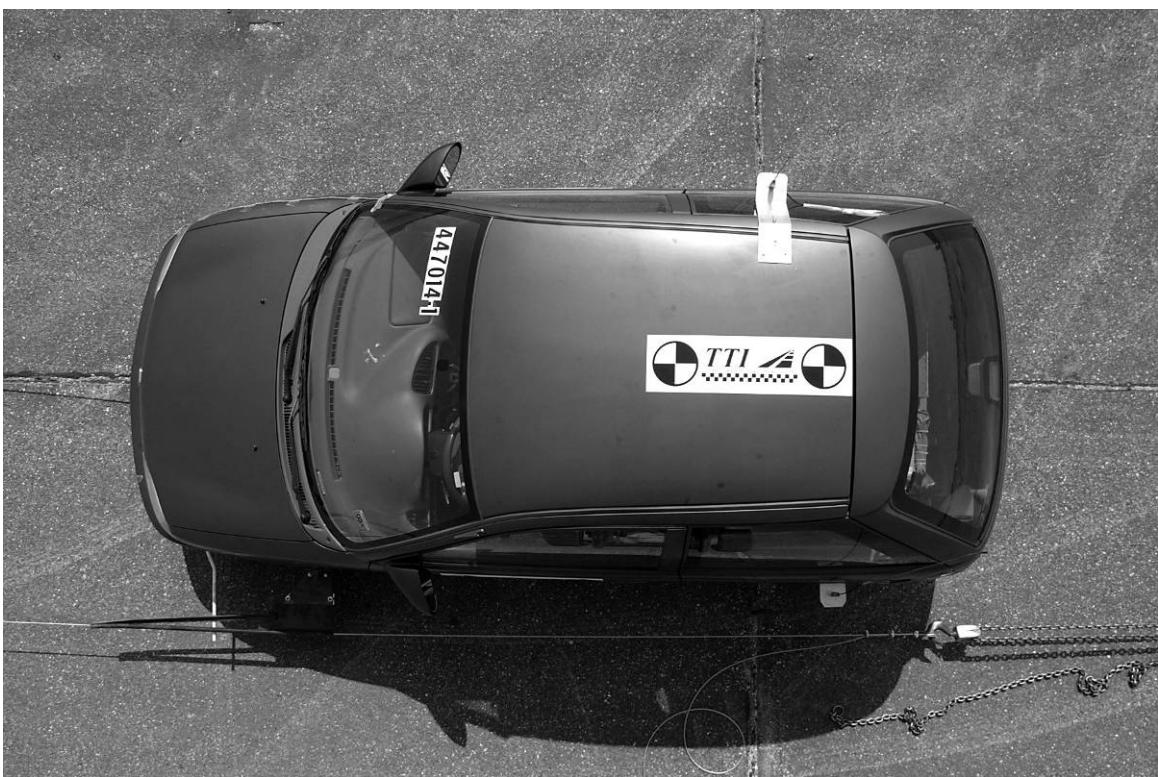
Figure 5-3. Vehicle before Test.

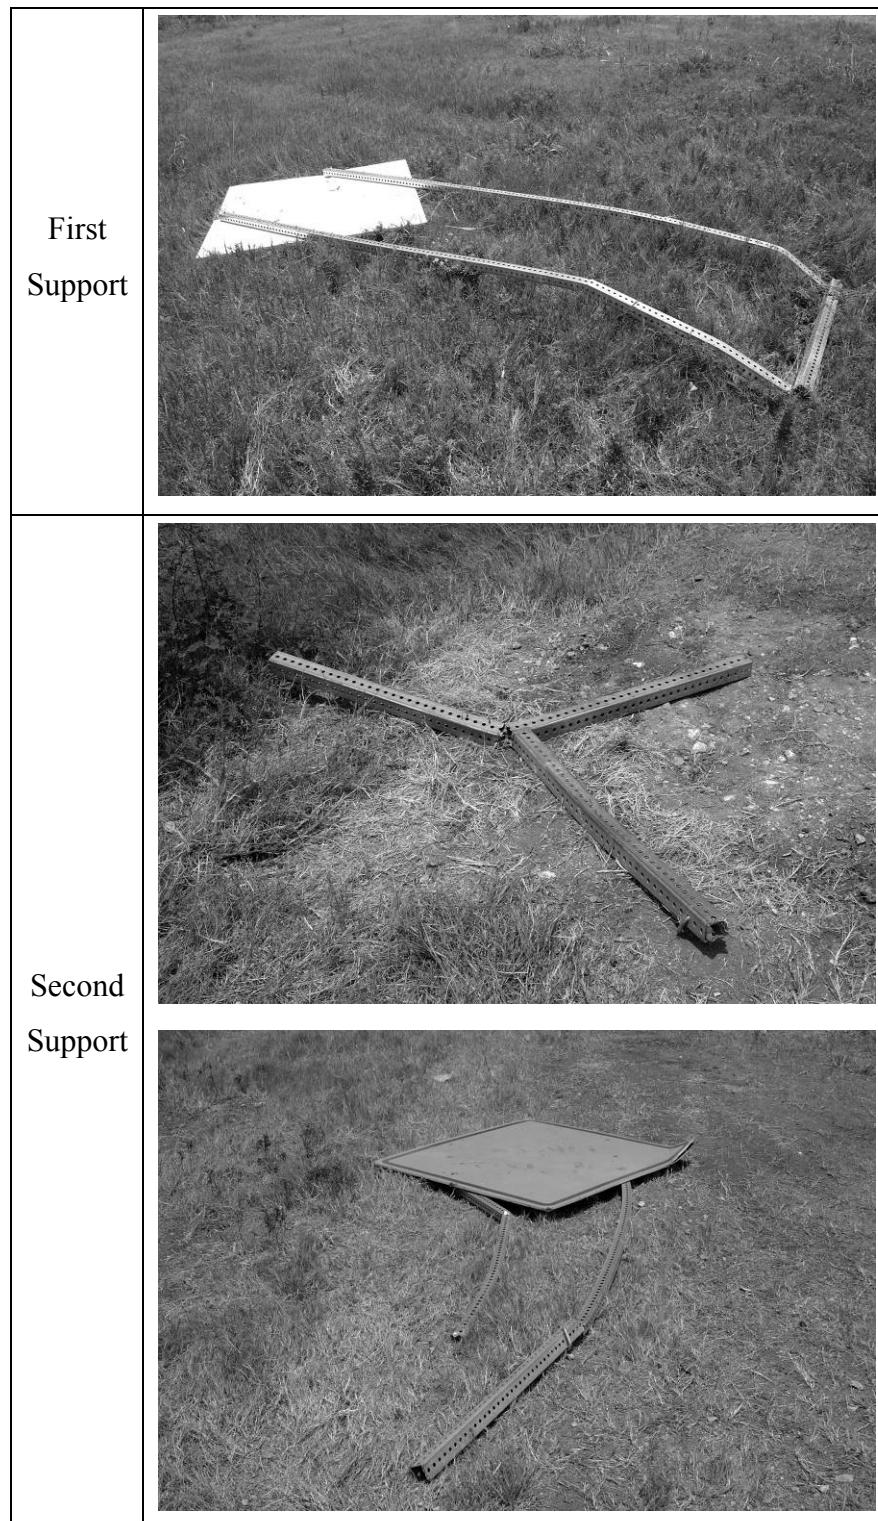
Figure 5-4. Supports after Test.

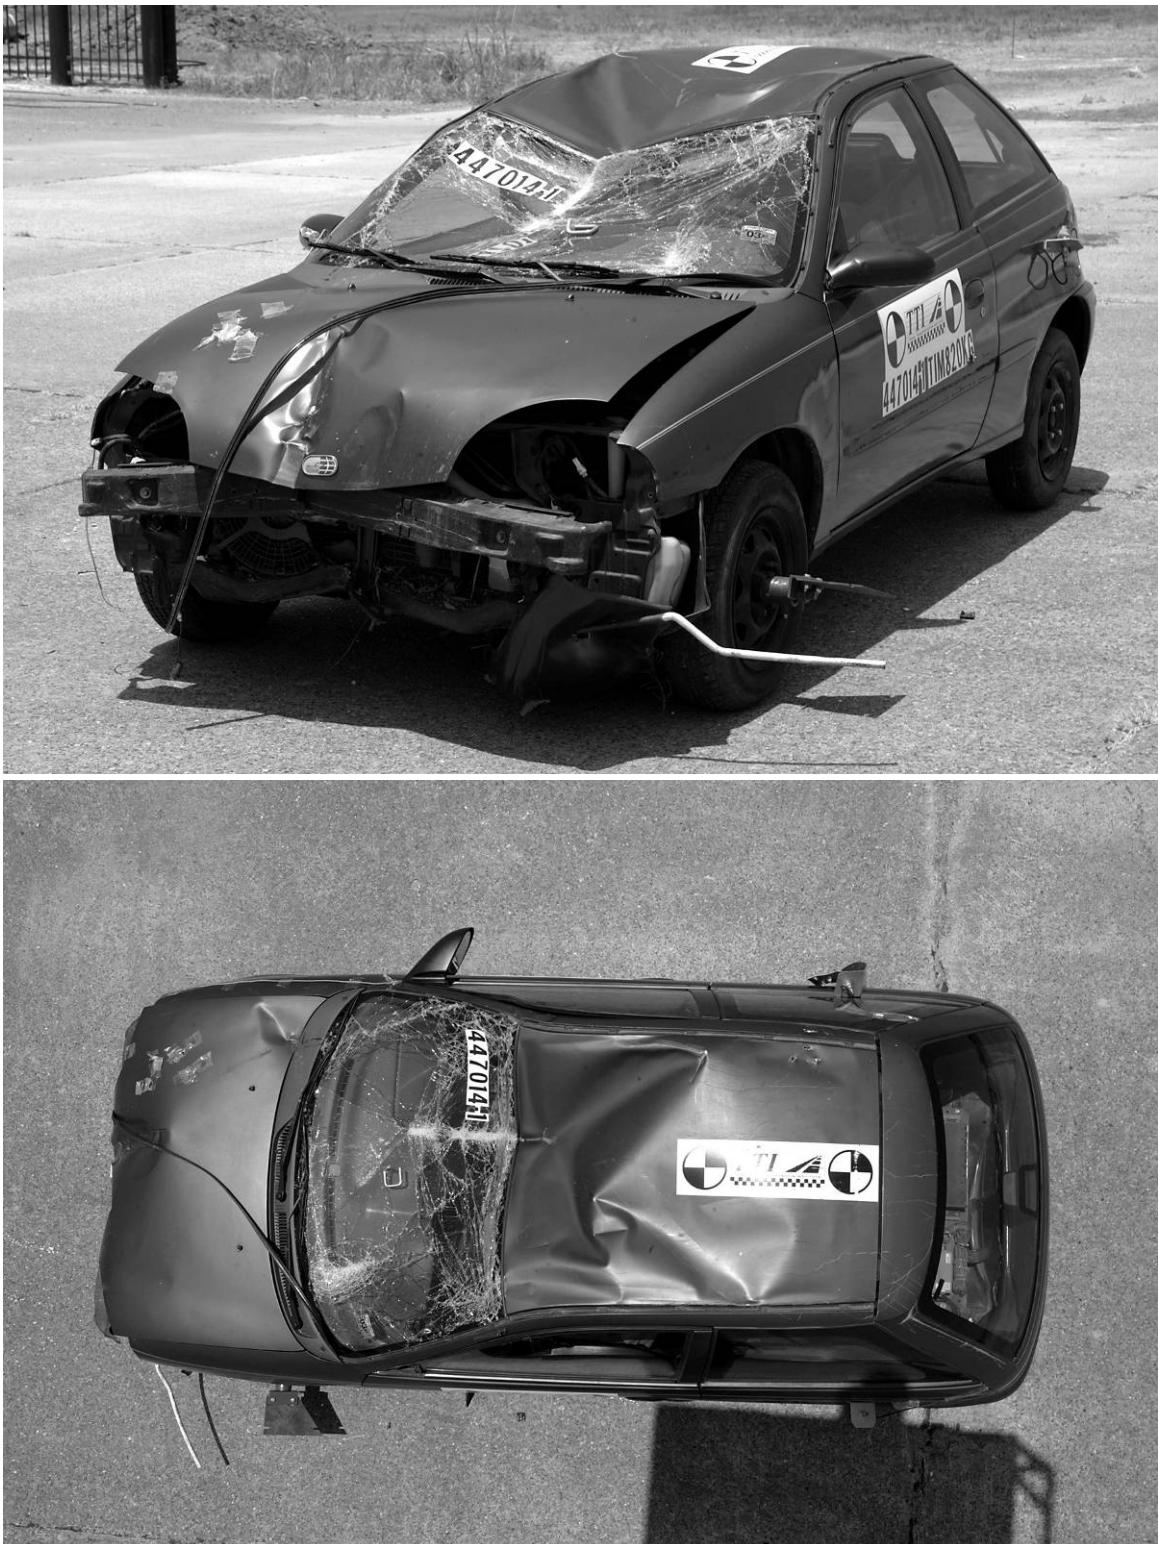
Figure 5-5. Vehicle after Test.

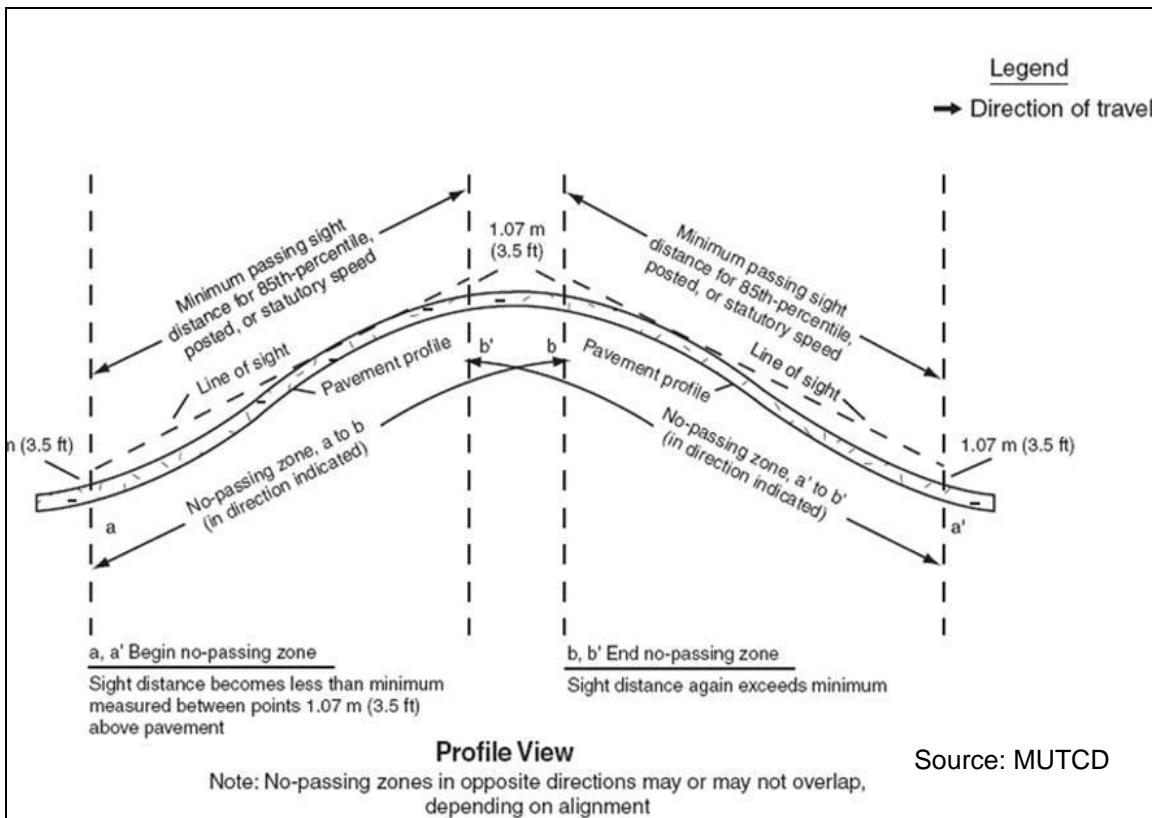
Figure 7-1. Locating No-Passing Zones on a Vertical Curve.

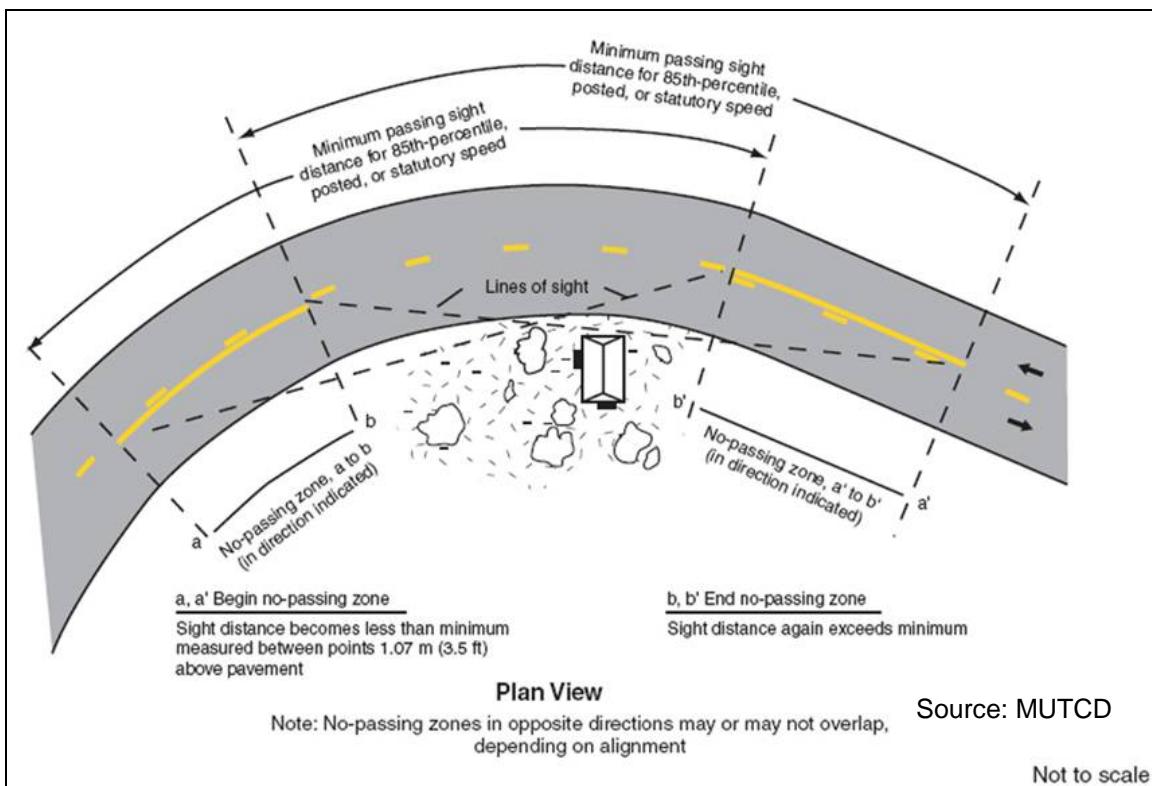
Figure 7-2. Locating No-Passing Zones on a Horizontal Curve.

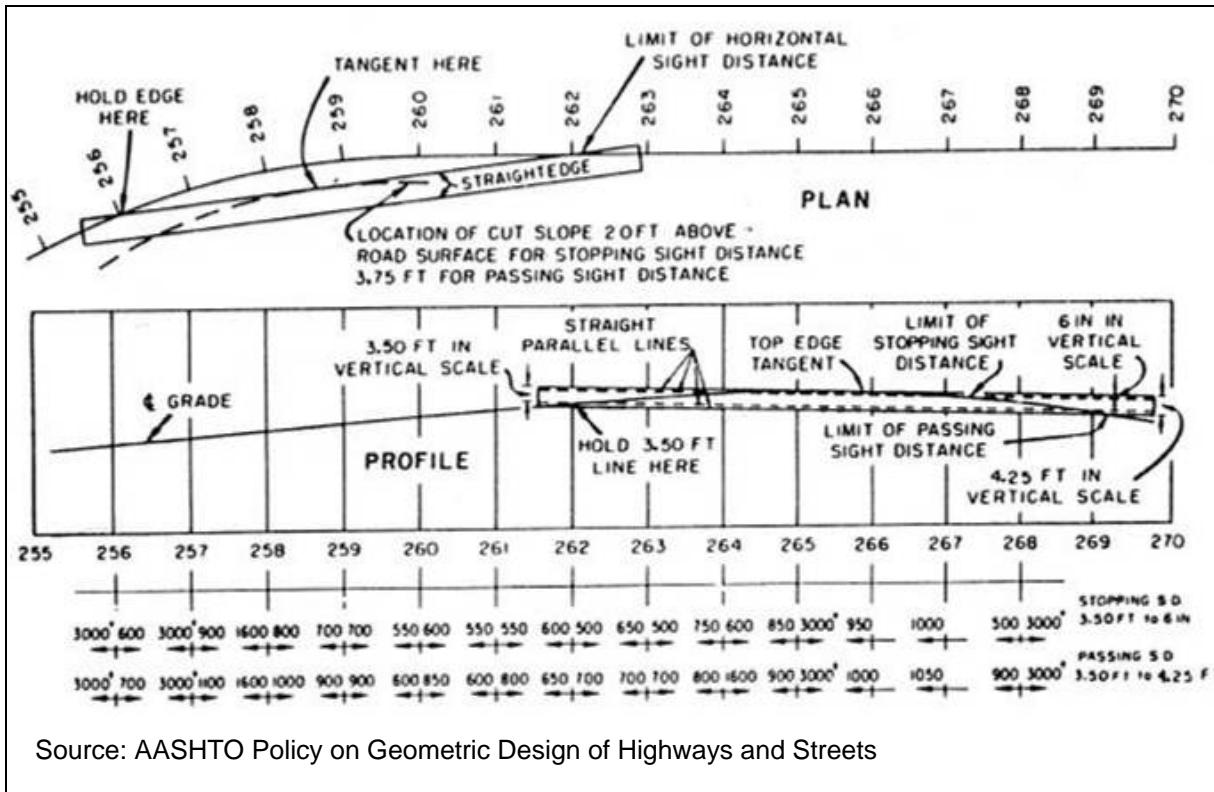
Figure 7-3. AASHTO Method for Scaling and Recording Sight Distance on Plans.
