1. Report No. FHWA/TX-06/0-4728-2	2. Government Accession No.	3. Recipient's Catalog No.	
4. Title and Subtitle AN ASSESSMENT OF VARIOUS RUMBLE STRIP DESIGNS AND PAVEMENT MARKING APPLICATIONS FOR CROSSWALKS AND WORK ZONES		5. Report Date October 2005	6. Performing Organization Code

14. Sponsoring Agency Code			
15. Supplementary Notes Project performed in cooperation with the Texas Department of Transportation and the Federal Highway Administration. Project Title: Evaluation of New RRPM and Marking Applications URL: http://tti.tamu.edu/documents/0-4728-2.pdf

**AN ASSESSMENT OF VARIOUS RUMBLE STRIP DESIGNS AND
PAVEMENT MARKING APPLICATIONS FOR CROSSWALKS AND
WORK ZONES**

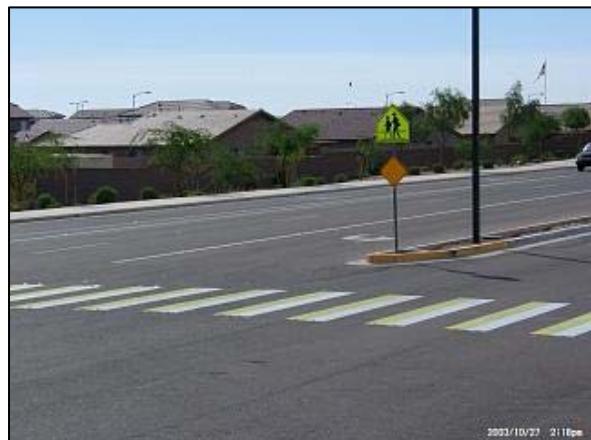
A. Full View.

B. Close-up.

Figure 3. Variation of YG and White Continental Crosswalk Used by the City of Goodyear.

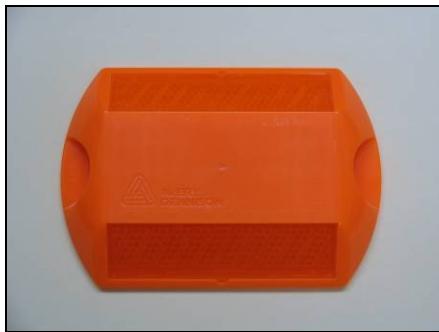
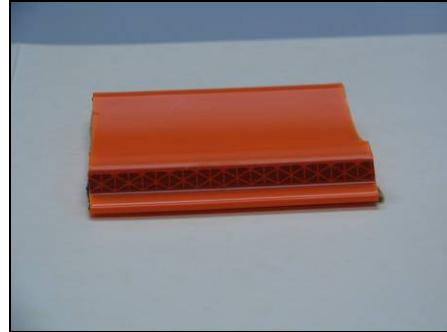
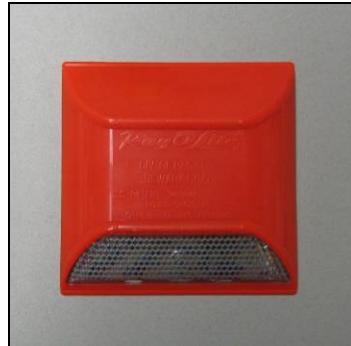
Figure 6. Fluorescent Orange RRPMs.

1a. Avery Dennison Product.

1b. Filtrona Extrusion Product.

1c. Rayolite Product.

Three manufacturers currently make fluorescent orange RRPMs: Avery Dennison, Filtrona Extrusion (Davidson Traffic Control Products), and Rayolite®. Researchers contacted all three manufacturers and received samples of their fluorescent orange RRPMs (Figure 6). After reviewing the samples and discussions with the manufacturers and TxDOT, researchers decided to only include the Avery Dennison and Filtrona Extrusion fluorescent orange RRPMs

in the color recognition study. Henceforth, the Avery Dennison and Filtrona Extrusion fluorescent orange RRPMs are referred to as Type 1 and Type 2 fluorescent orange RRPMs, respectively.

Under all conditions, the Type 1 fluorescent orange RRPMs were incorrectly identified as red by only one subject (8 percent). In contrast, the Type 2 fluorescent orange RRPMs were mistaken for red RRPMs by six subjects (50 percent).

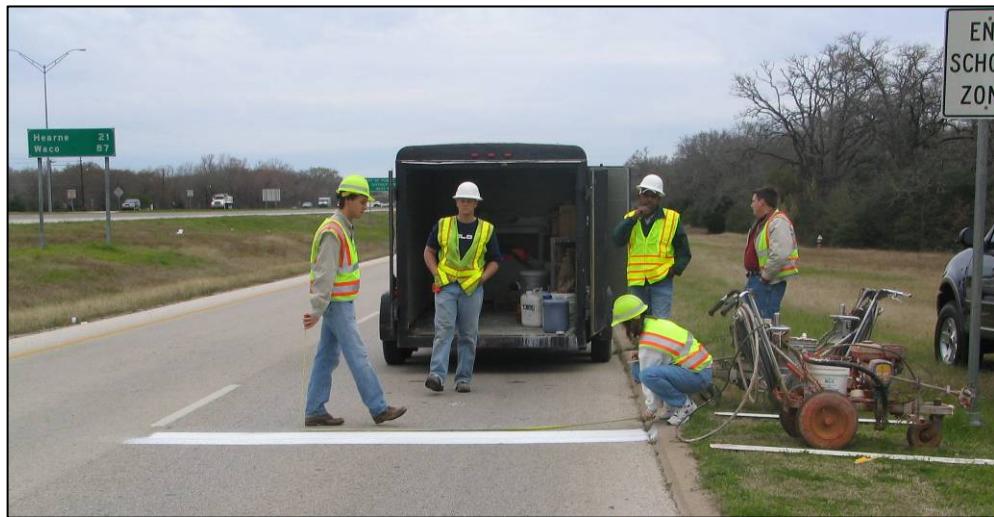
a) Stop Bar.

b) End School Zone.

Figure 18. Applications of “Removable” Paint on Frontage Road of State Highway 6.

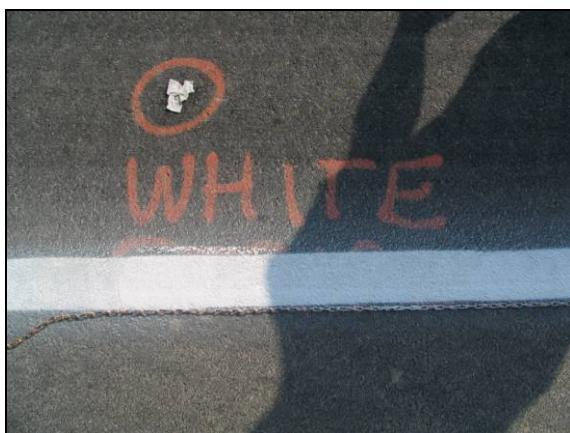
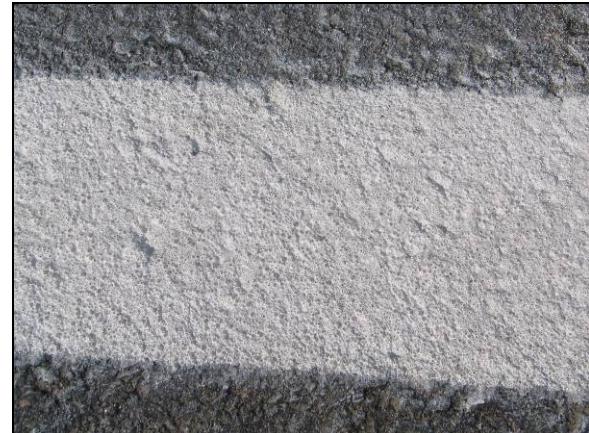
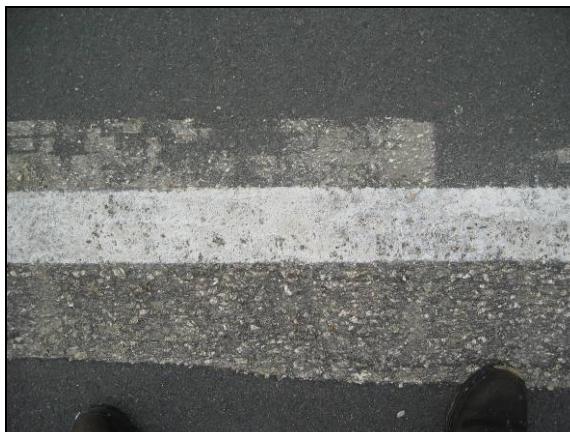
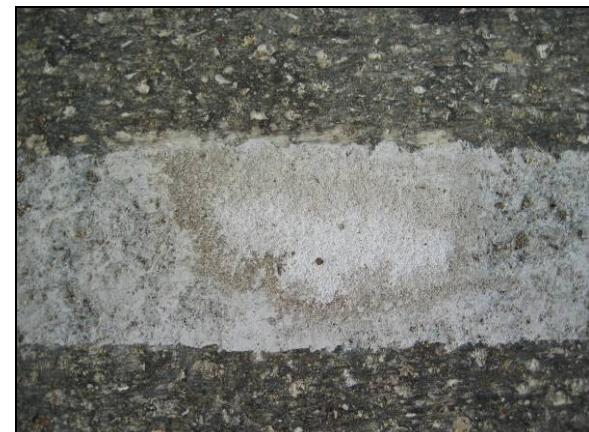
Figure 21. Comparison of Two “Removable” Paint Installations on Texas Avenue.

a) First Installation.

b) First Installation – Close-Up.

c) Second Installation.

d) Second Installation – Close-Up.

Based on the field experiences with the second white “removable” paint, researchers consulted the manufacturers, and they developed a third white “removable” paint that was less viscous. In June 2005, researchers applied 200 ft of this third white “removable” paint (edge line and lane lines) in a work zone on Texas Avenue in College Station, Texas (five-lane major arterial), with a self-propelled pavement marking applicator. Again the roadway surface was asphalt, and Type II beads were used. However, one week later a subcontractor applied thermoplastic pavement markings over the “removable” paint test section. The thermoplastic edge line markings were eradicated with a milling machine and the “removable” paint reapplied; however, the second application of the “removable” paint was not indicative of an ideal installation. As shown in [Figure 21](#), the second installation resulted in a less consistent marking.

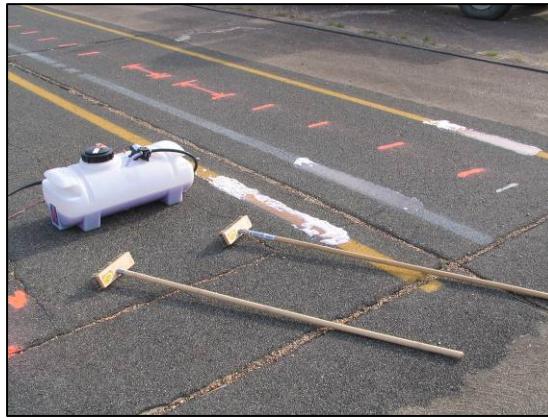
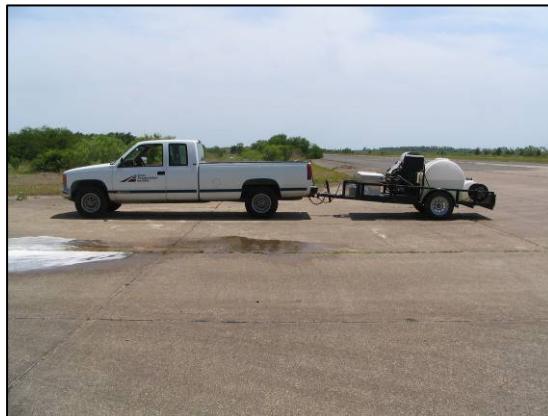
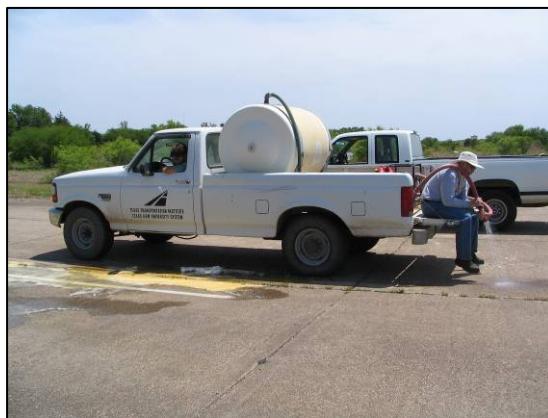
Figure 24. Equipment Used During the Removal Testing.

a) Motorized Spray Rig and Brooms.

b) High-Pressure Sprayer.

c) Low-Pressure Sprayer.

[Figure 24](#) shows the equipment used during the removal testing. The remover was applied with a small motorized spray rig (60 psi), and push brooms were used to agitate the surface (when desired). A motorized high-pressure sprayer (3000 psi) and motorized low-pressure sprayer (less than 60 psi) were used to apply water in order to remove the paint and rinse the roadway surface, respectively.

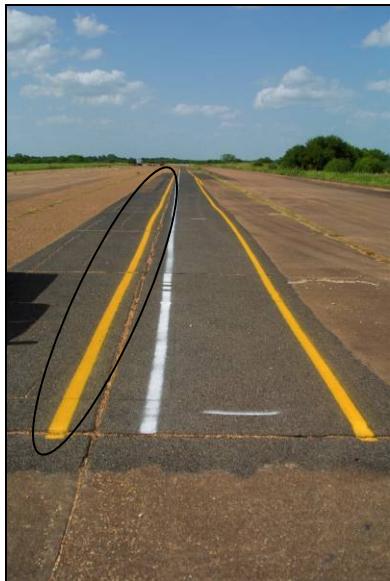
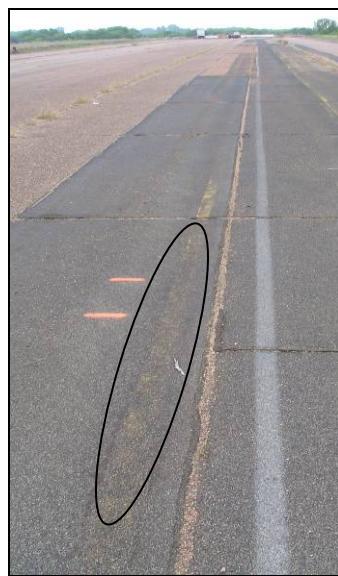
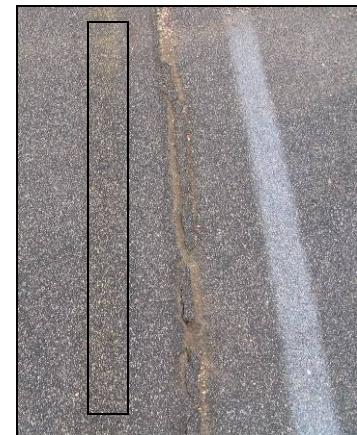
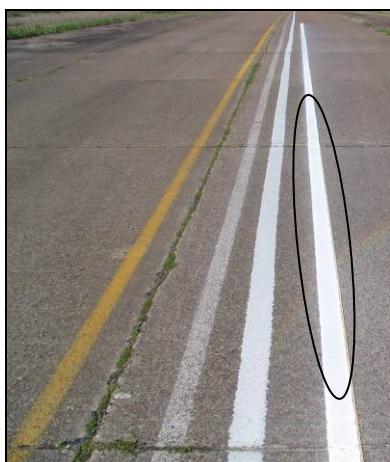
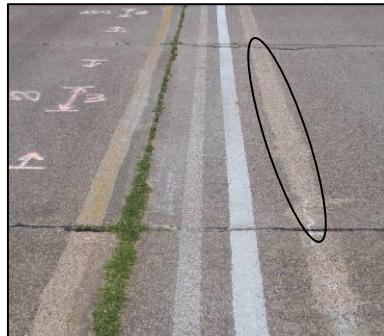
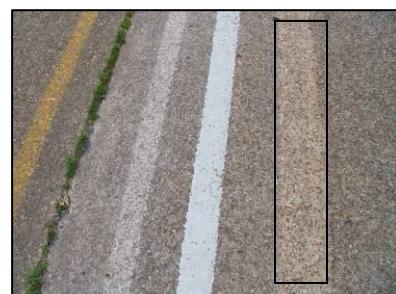
Figure 25. Results of the Removal Testing.

a) Yellow Markings Prior to Removal.

b) Yellow Markings After Removal.

c) Yellow Markings After Removal – Close-Up.

d) White Markings Prior to Removal.

e) White Markings After Removal.^a

f) White Markings After Removal – Close-Up.^a

^a The mark on the pavement in the highlighted area is not left over “removable” paint. The high-pressure water rinse cleaned the concrete as it removed the paint leaving behind the appearance of a marking.

For most of the trials, 90 to 100 percent of the “removable” paint markings were removed. [Figure 25](#) shows two examples of the removal results (yellow on asphalt and white on concrete). The following are answers to the previously posed questions:

- Once the remover is applied a chemical breakdown of the paint starts to occur. The remover works best if it is allowed to work for at least 5 minutes, with 10 minutes preferred.
- Agitation is not needed as it did not improve the effectiveness of the remover. Agitation only smeared the clumped removed paint all over the roadway surface.
- A high-pressure water rinse is needed to help break up the removed paint from the surface. A high-pressure water rinse alone (no remover) does not remove the paint.

- A low-pressure water rinse cannot be used in place of a high-pressure water rinse. The low-pressure water rinse does remove some of the paint, but it is not as effective as the high-pressure water rinse.

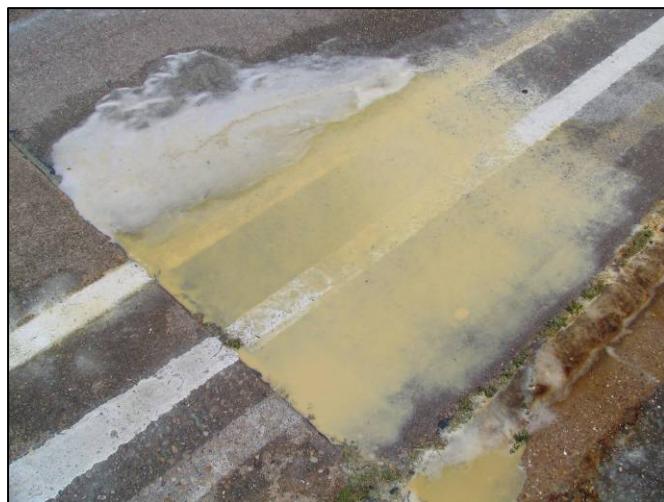
- After the liquid mixture dried on the pavement, researchers noticed that the paint residue was left behind on the surface. (Prior to drying the paint residue was suspended in the liquid mixture.) Based on limited testing of a new remover product received from the manufacturer, it appears that this issue has been corrected (i.e., the paint is now dissolved by the remover).

Figure 26. Liquid Mixture Remaining after Removal.

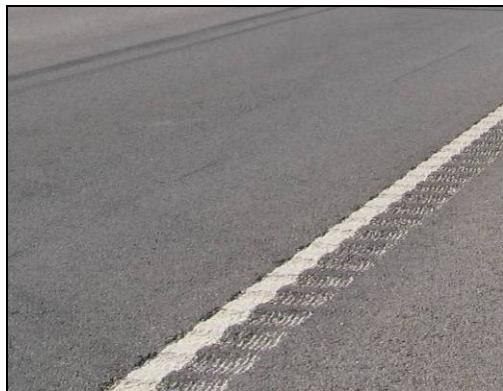
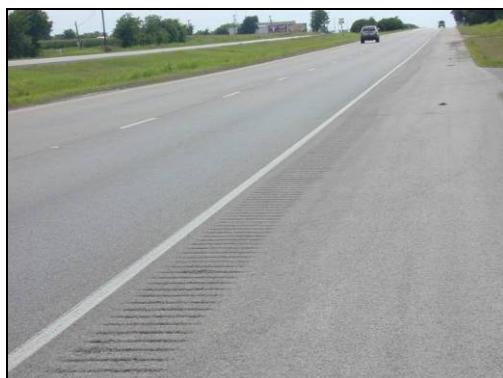
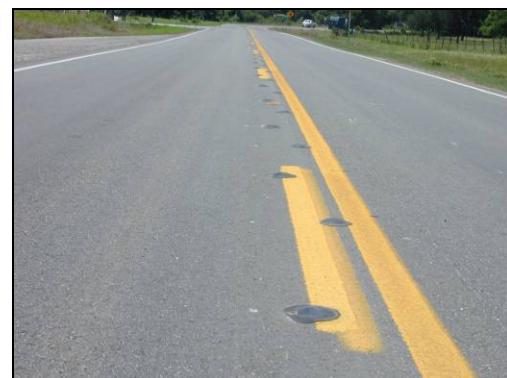
the milled strips (35). Metal forms are used to install what could be termed “rolled” rumble strips in new concrete.

a) Milled.

b) Raised (Profile).

c) Rolled.

d) Raised (Button).

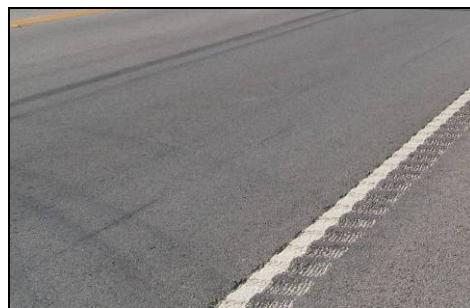
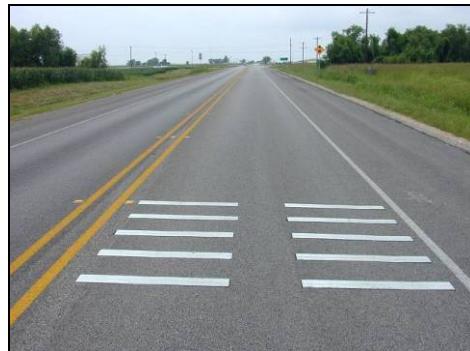
Figure 28. Types of Rumble Strips.

b) ERSs (a form of SRSs).

d) TRSs.

As shown in Figure 28, rumble strips are placed at different locations along the roadway to alert drivers to various changes in the roadway environment. These include the following:

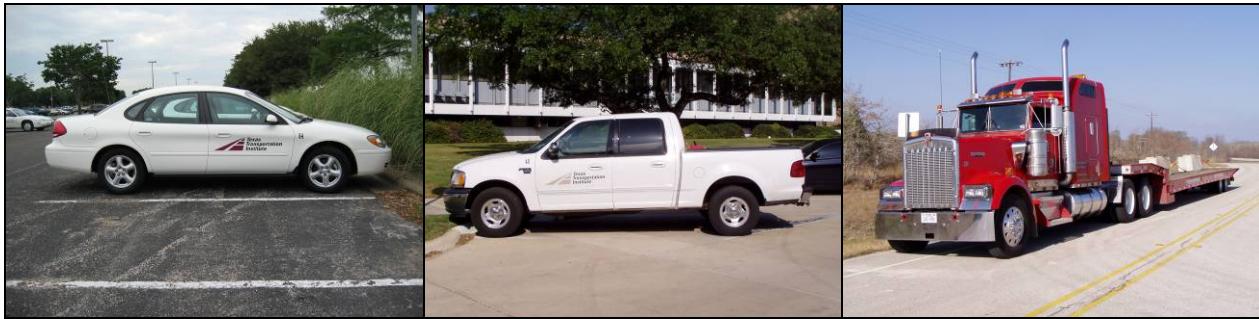
Sound and vibration measurements were recorded from the perspective of the driver. Sound was measured at shoulder level on the driver's right side (nearest to the center of the vehicle), and vibration was measured from a piece of metal attached directly to the floor of the vehicle (usually the bottom of the driver's seat). The data logging equipment and a researcher were located in the passenger seat. [Figure 33](#) is a depiction of the setup of the data collection equipment in the $\frac{1}{2}$ ton truck. A similar setup was used for the other two vehicles.

a) 2003 Ford Taurus.

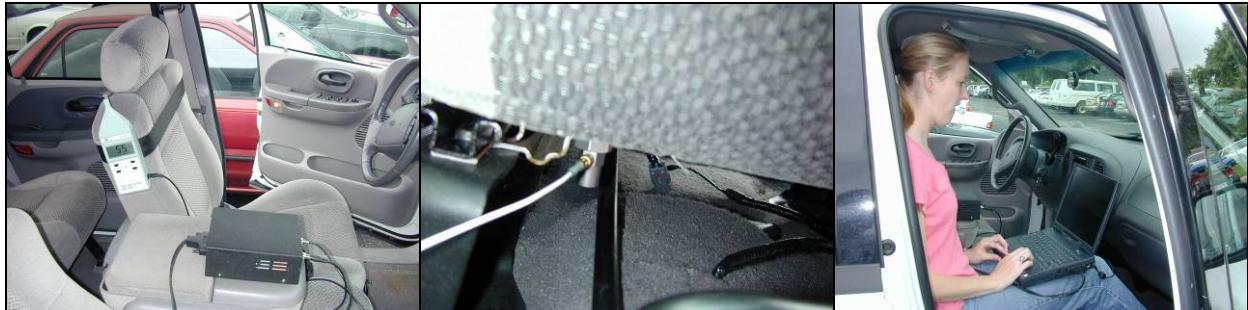
a) Sound Meter.

b) Vibration Sensor.

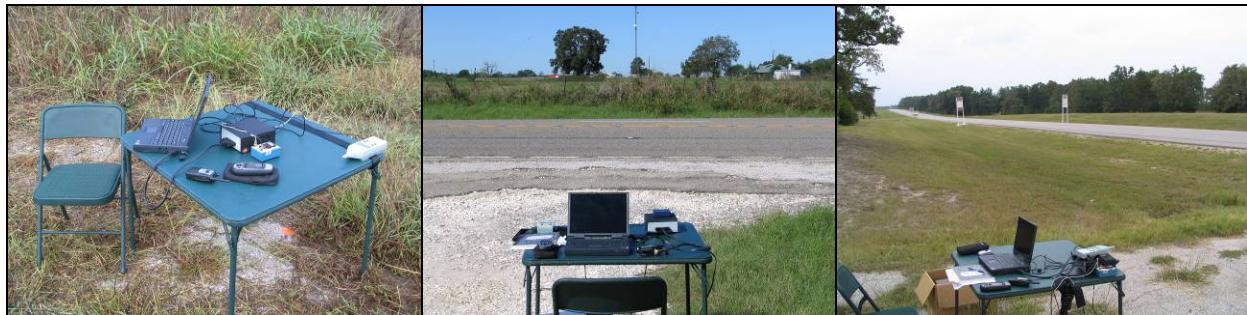
Figure 34. Outside Equipment Setup.

a) Equipment Setup. b) Centerline Measurements. c) Shoulder Measurements.

In order to quantify the impact of vehicle contact with rumble strips on the surrounding environment, sound measurements were recorded from the perspective of a pedestrian on the side of the road adjacent to the rumble strips. The sound measuring device and the data logging equipment were placed on a small, collapsible table set up 50 ft from the outside edge of rumble strip applications. [Figure 34](#) is a picture of the standard equipment setup for collecting outside sound data. The outside sound measurements were collected for the sedan and commercial

vehicle. The sedan was driven at 55 and 70 mph along the test roads provided that the speed limit was at least 70 mph. Again, for safety reasons the commercial vehicle was only driven at 55 mph.
