# US 160 Dry Creek Wildlife Study

**Technical Report Documentation Page**

| 4. Title and Subtitle<br><br>US 160 DRY CREEK WILDLIFE STUDY | | 5. Report Date<br>August 2021 | |

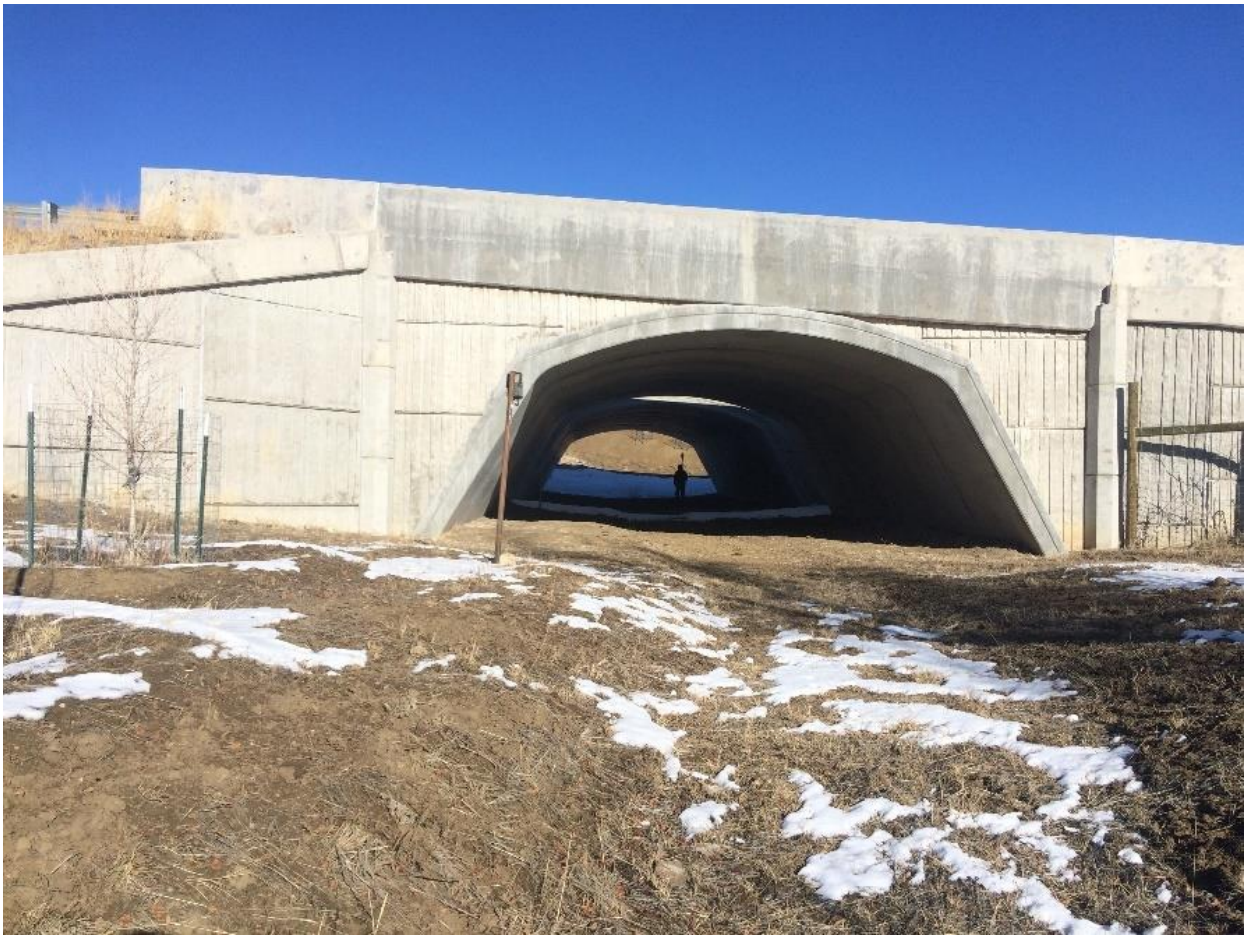
**Figure 3. Monitored Wildlife Crossing Structure US 160 MP 97.42. The Monitoring Camera and Post at the South Entrance are in the Foreground. Cameras Faced the Entrances.**

The wildlife crossing structure was an underpass, and consisted of two concrete arches, each 13 feet high by 39 feet wide. The north arch was approximately 70 feet long and the south arch was approximately 52 feet long. The median opening between the arches was approximately 13 feet long (Figure 3). Total length was approximately 135 feet.

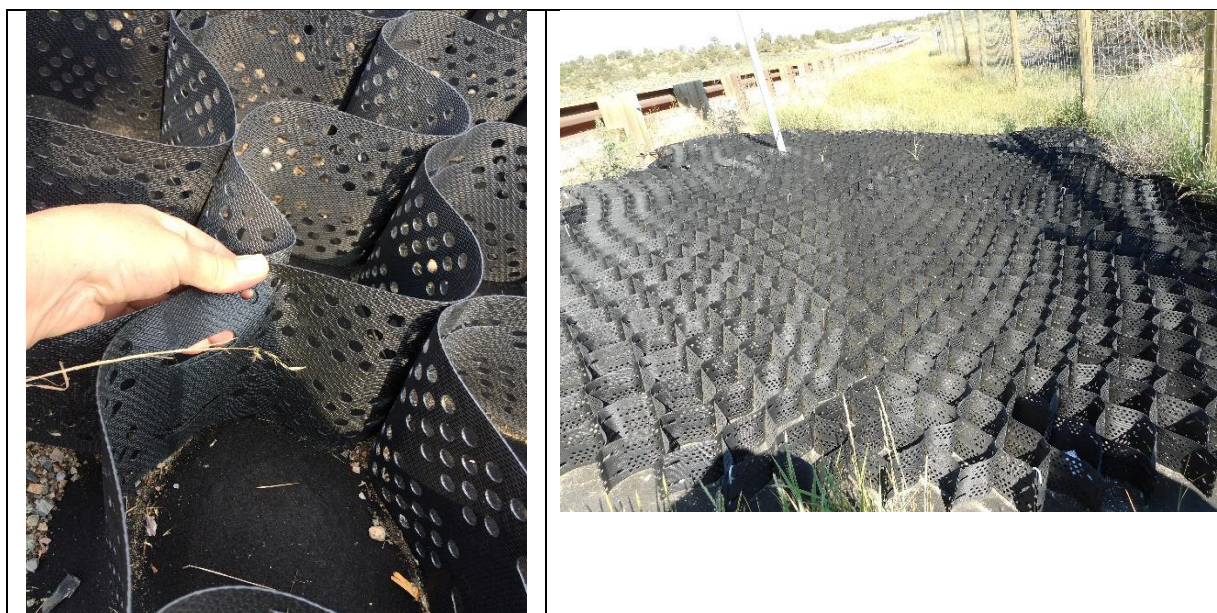
**Figure 4. The EnviroGrid® Geocell Up Close (left), and In-Place at the East Fence End.**

The EnviroGrid® Geocell was a flexible plastic material typically placed to prevent soil erosion. It was approximately six inches high, with leaf-shaped cells approximately eight inches by six inches (Figure 3). It was placed between the east fence end and the guard rail on both the north and south rights-of-way. The area of each treatment was approximately 10 feet by 30 feet.

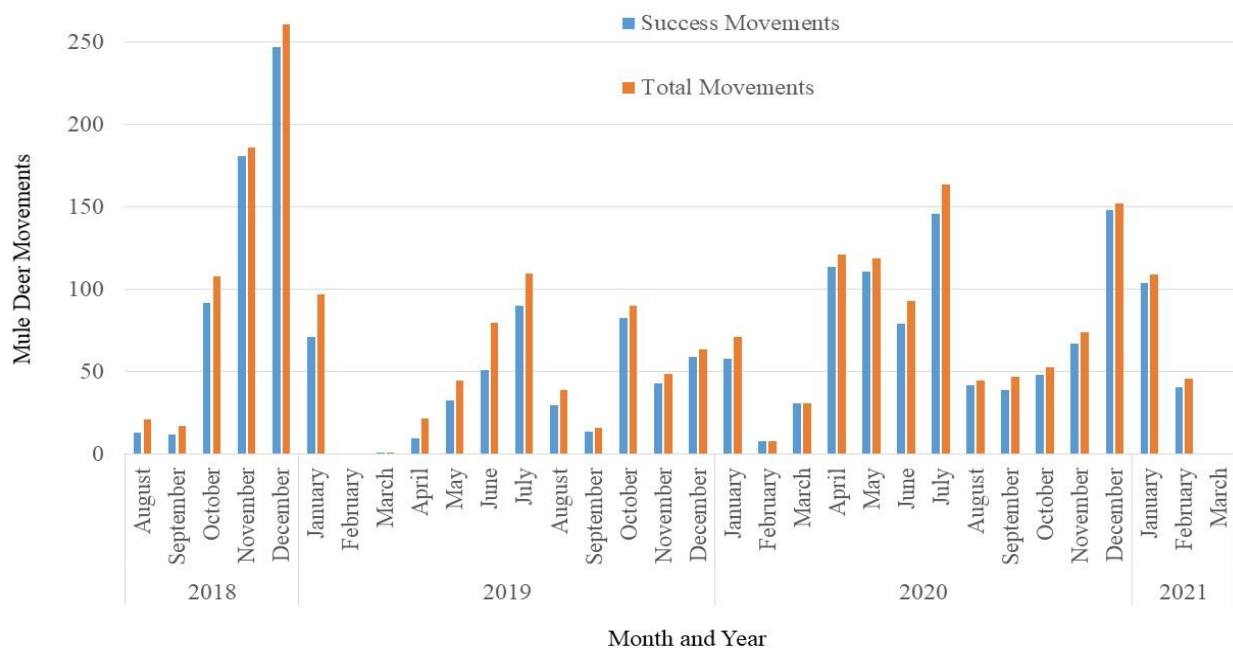
**Figure 5. Monthly Mule Deer Success Movements and Total Movements at the Wildlife Crossing Structure, US 160 MP 97.42.**

was 2.2, and the Abundance was 2.5. Monthly mule deer Success movements and Total movements are presented in Figure 5. Monthly mule deer movements peaked in Spring and Fall. Success movements through the wildlife crossing structure were also made by the following species: gray fox (3), red fox (2), squirrel (4), rabbit (11), badger (4), raccoon (2), domestic cat (10), and coyote (3). Elk movements were not recorded by the Structure Cameras at the entrances to the wildlife crossing structure.

From August 14, 2018 through March 12, 2021 (934 camera days) there were 2,339 mule deer Total movements at the wildlife crossing structure and 2,066 mule deer Success movements through the wildlife crossing structure. The mule deer Success Rate was 88 percent, the Success per Camera Day

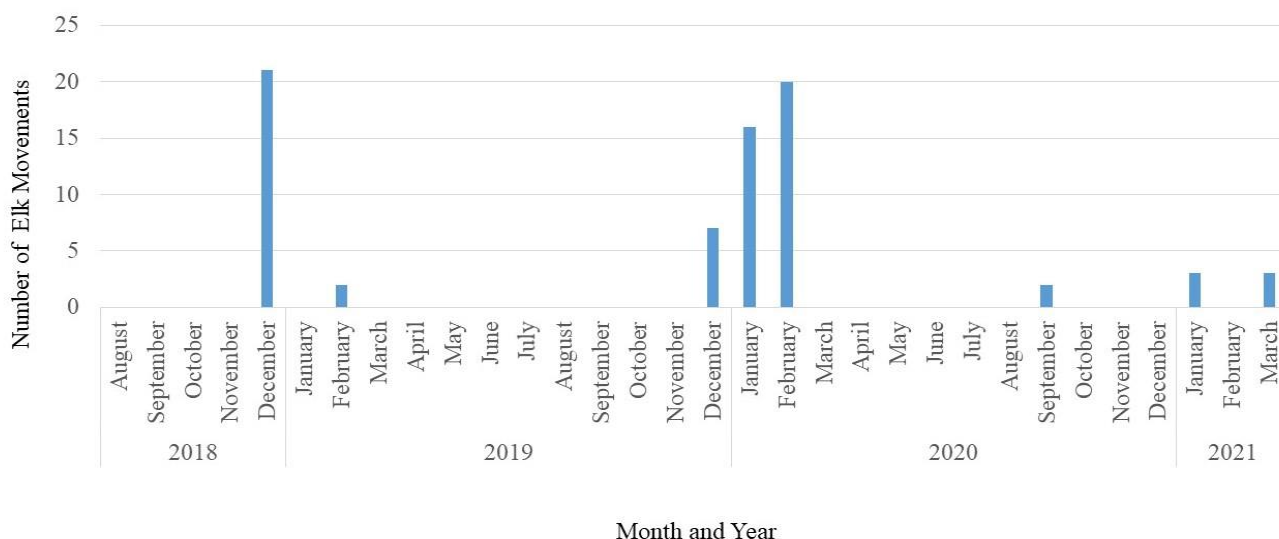
**Figure 6. Monthly Elk Movements at the Wild Camera on the North Right-of-Way Fence, on the North Side of the Wildlife Crossing Structure, US 160 Mile Post 97.42.**

The Wild Camera, at the north right-of-way fence on the north side of the wildlife crossing structure, from August 14, 2018 through March 12, 2021 (914 camera days), recorded: 74 elk movements, 39 coyote movements, 12 rabbit/hare movements, three fox movements, three domestic cat movements, and 12 domestic dog movements. Monthly elk movements at the Wild Camera are presented in Figure 6.

Elk were not recorded by the Structure Cameras during the study. However, 74 elk movements were recorded just 130 feet from the structure at the Wild Camera. The elk recorded by the Wild Camera did not move toward or attempt to utilize the wildlife crossing structure. During the winter of 2020-2021, approximately 15 elk moved south over US 160 about one-quarter mile east of the mitigation (B. Weinmeister, personal communication). During pre-construction of the mitigation (2010-2015), two WVC crashes with elk were reported, one at MP 96.06 in 2015 and one at MP 96.2 in 2013. Two WVC crashes with elk were reported during post-construction (2016-2020), one at MP 98.5 and one

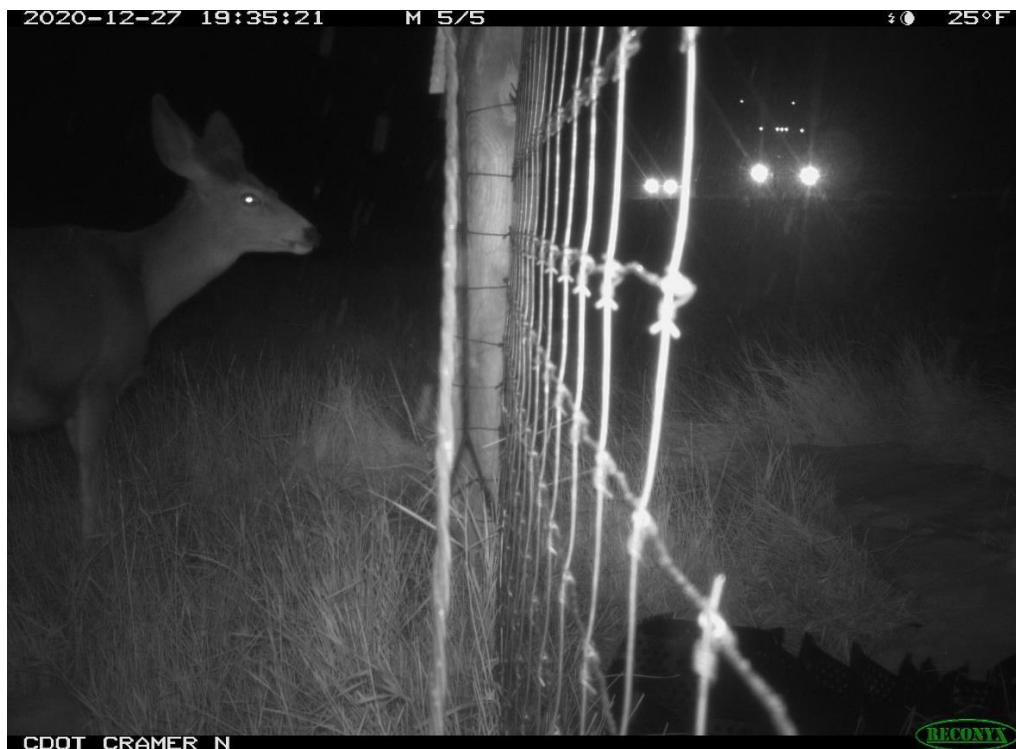
Mule deer success movement over US 160 at the EnviroGrid® Geocell treatment, north fence-end camera, non-interactive movement.

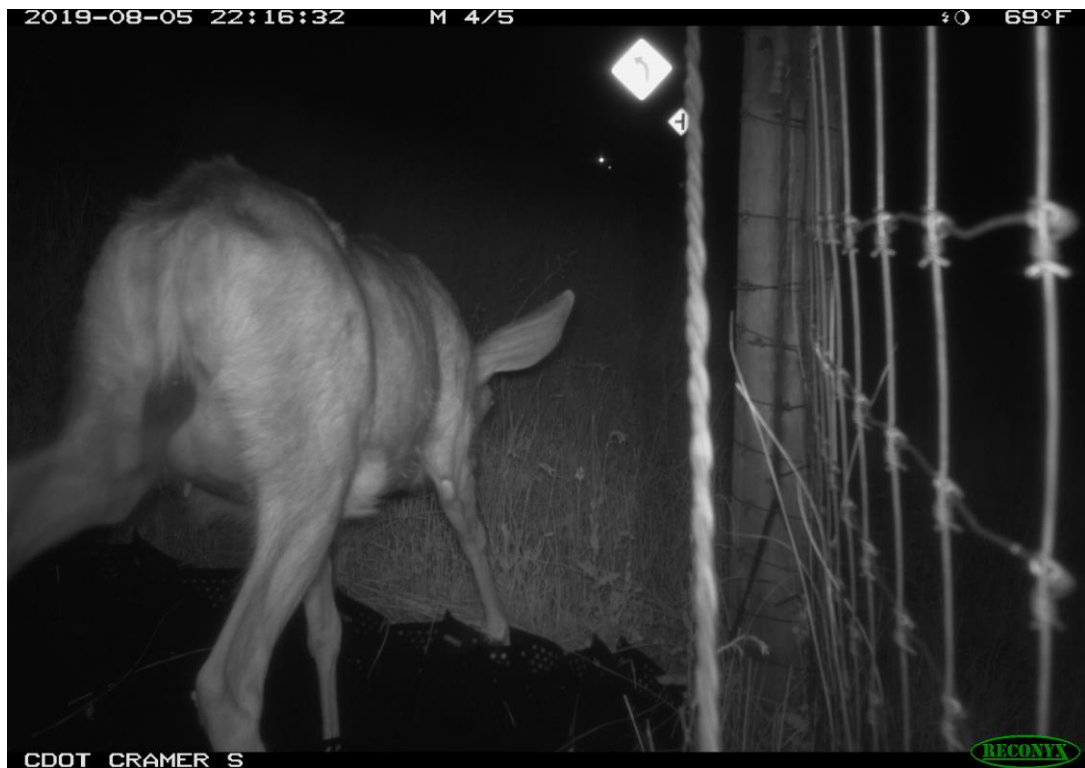
A mule walking over the EnviroGrid treatment to escape the Right-of-Way fenced area.

Mule deer escaped from the fenced mitigated area by moving from west to east over the EnviroGrid® Geocell treatments on four occasions (three escape movements at the north EnviroGrid® Geocell and one escape movement at the south EnviroGrid® Geocell).
