**THE EFFECTS OF INCIDENTS ON CONCURRENT FLOW  
HIGH OCCUPANCY VEHICLE LANE DELAY  
ON IH-635 (LBJ FREEWAY) IN DALLAS, TEXAS**

Report 0-4740-2  
Project Number 0-4740  
Project Title: Improved Quantification of  
High Occupancy Vehicle (HOV) Lane Delay Savings

TEXAS TRANSPORTATION INSTITUTE  
The Texas A&M University System  
College Station, Texas 77843-3135

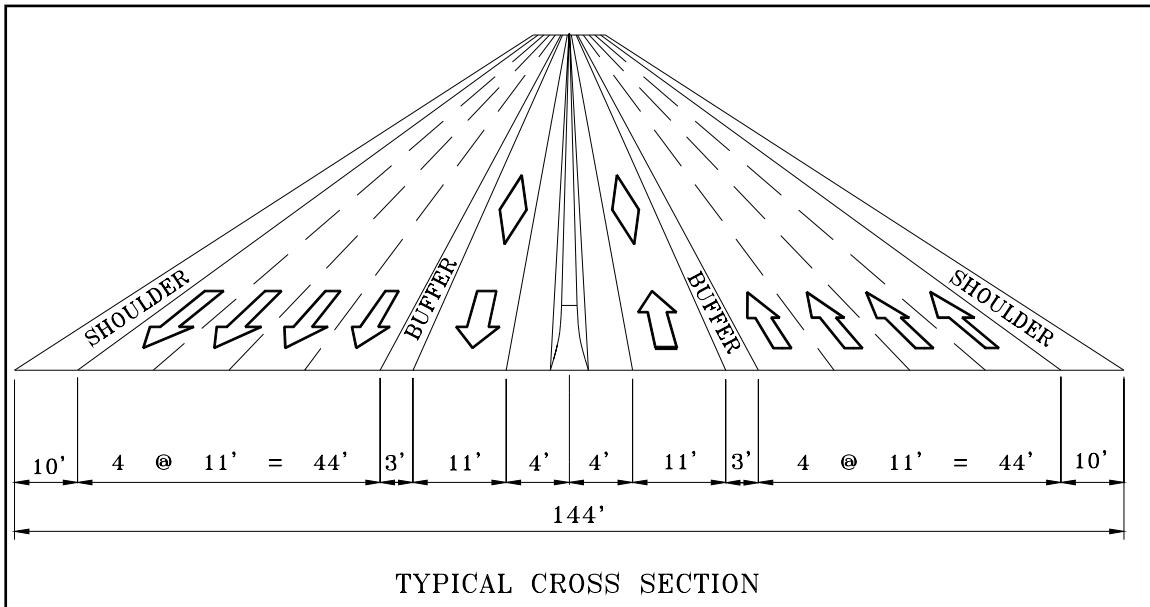
**Figure 1. IH-635 (LBJ Freeway) Cross Section between Josey Lane and Coit Road.**

The IH-635 HOV lanes opened in March 1997 and were some of the first of their kind in Texas. The HOV lanes were retrofitted into the existing freeway corridor by narrowing the general-purpose lanes to 11 feet and converting the inside shoulder into an 11-foot HOV lane for both directions of the freeway. Each HOV lane is separated from the general-purpose lanes with a buffer area indicated by painted solid white stripes. This buffer area has a maximum width of 3 feet. Intermediate ingress/egress is possible at locations where the painted buffer changes to a single skip stripe. [Figures 1 and 2](#) show the typical cross section of the facility between Josey Lane and Coit Road, which encompasses most of the facility east of IH-35E (Stemmons Freeway).

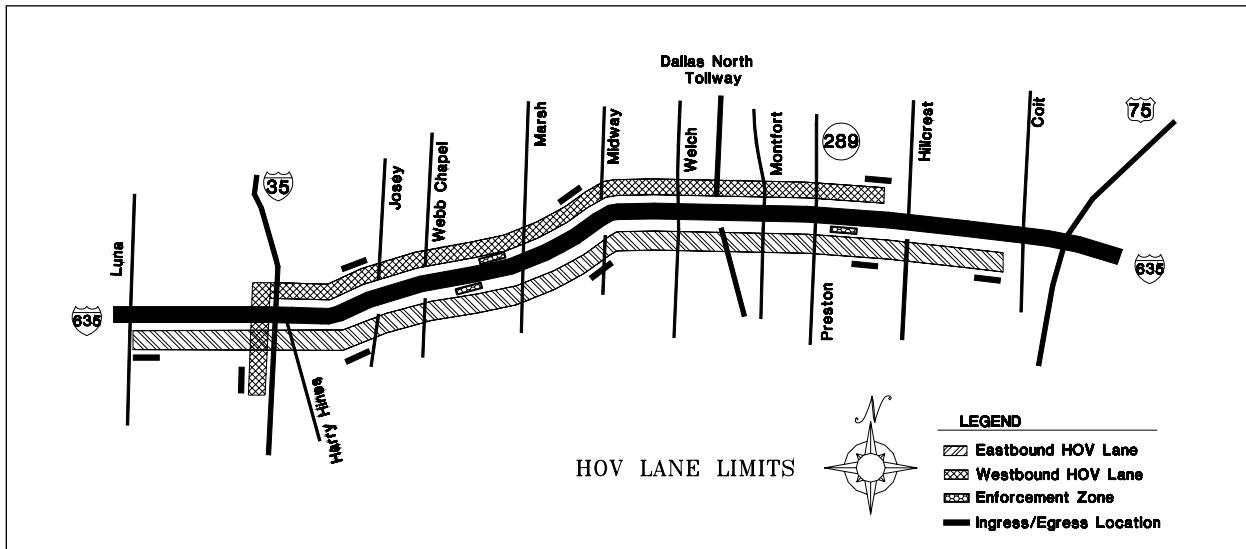
**Figure 3. IH-635 (LBJ Freeway) HOV Lane Features.**

Since opening, the HOV lanes have provided service to 2+ occupant vehicles 24 hours per day in both directions. The cost to construct the IH-635 HOV lanes was \$16.3 million in 1996 dollars (5). Figure 3 shows basic features of the corridor including access locations and vehicle occupancy enforcement zones.

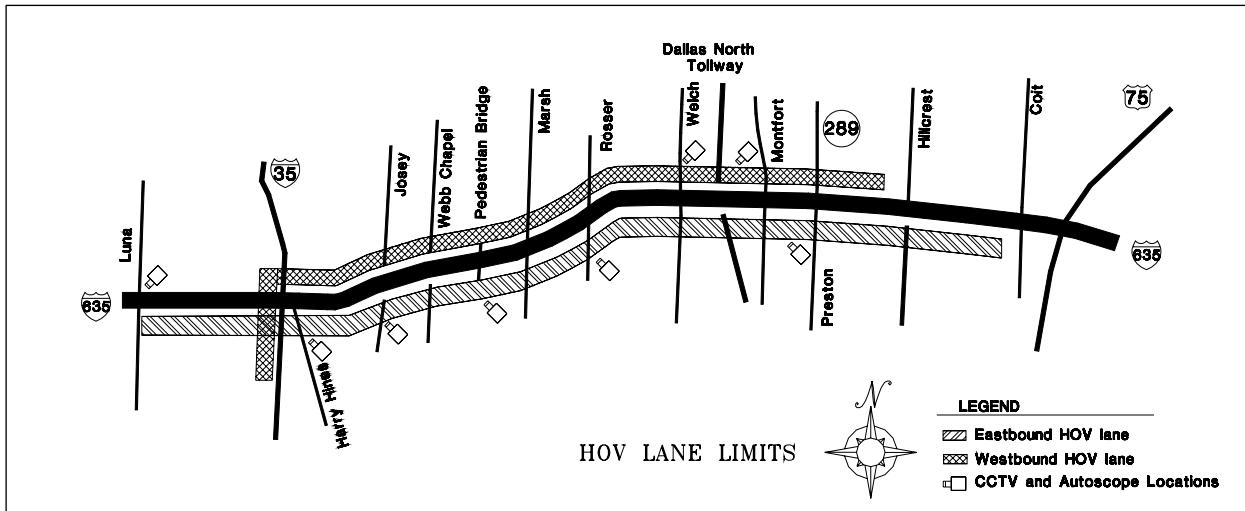
**Figure 4. IH-635 (LBJ Freeway) CCTV Camera and Autoscope Locations.**

Figure 4 shows the locations of these cameras with their identifying names of Luna, Harry Hines, Josey, Pedestrian Bridge, Rosser, Welch, Montfort, or Preston. These location names are referred to multiple times throughout the remainder of this report.

TxDOT also monitors traffic characteristics of various corridors using a video image detection system (VIDS), known as Autoscope (9). The Autoscope system uses equipment setup to look over a section of highway and detect various types of traffic data over certain time intervals. This system can detect and record corridor vehicle volumes and vehicle speeds for each of the individual travel lanes or for multiple lanes combined. The Autoscope equipment is in the same location as the CCTV cameras as indicated in Figure 4 above.

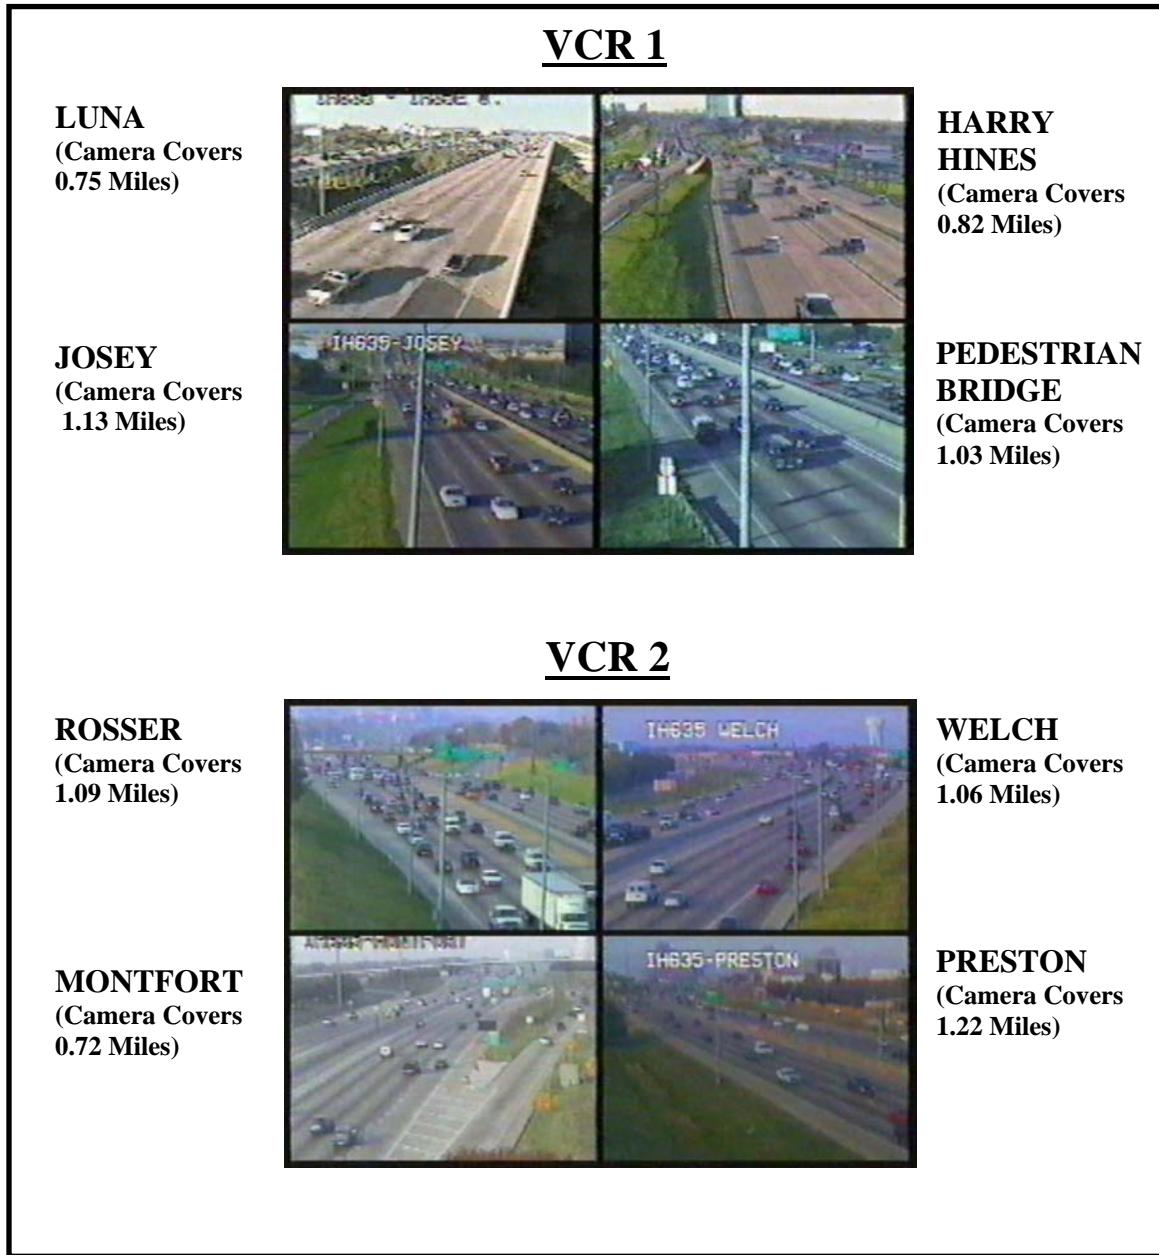
**Figure 5. DalTrans Camera Views.**

Visual confirmation of incidents along the IH-635 corridor was achieved by using the eight different camera views of CCTV from DalTrans on the weekdays over the 5-month period from September 2003 through January 2004. As noted earlier, the camera views used are designated as Luna, Harry Hines, Josey, Pedestrian Bridge, Rosser, Welch, Montfort, and Preston. The eight views were recorded using two videocassette recorders, four views per VCR in a quad-screen format, during the AM and PM peak periods as shown in [Figure 5](#). The AM peak period was from 6:00 AM to 9:00 AM and the PM peak period was from 4:00 PM to 7:00 PM. The two VCRs were kept in the DalTrans electronic equipment room for the duration of the data collection period. No weekend data were recorded or required given the scope of the research effort.

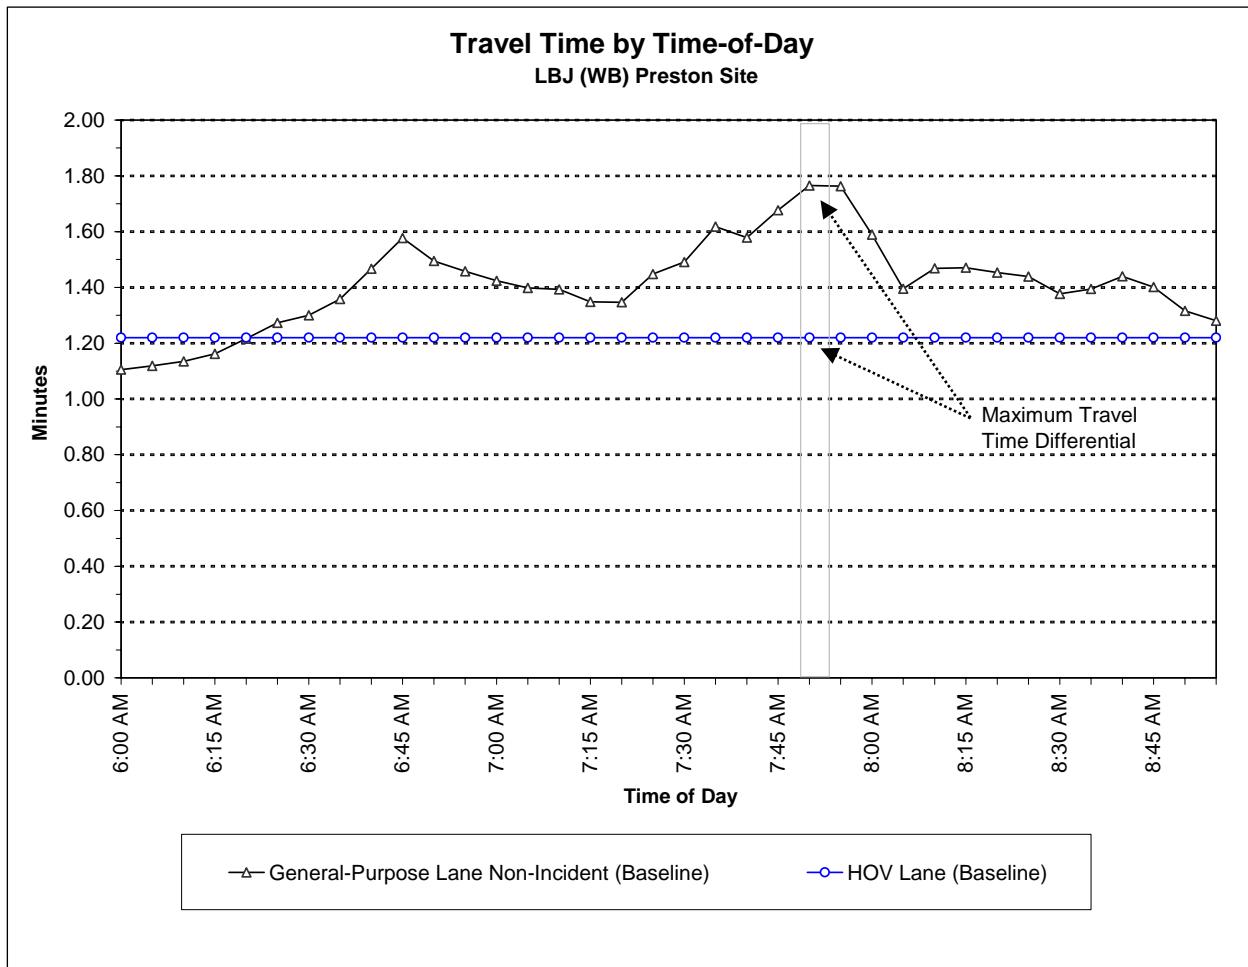
**Figure 6. Baseline Delay.**

On incident-free days, the speed on the HOV lanes is expected to remain relatively stable throughout the peak period. Historical data indicate that the HOV lane is usually moving around 60 mph (6). This speed is converted to travel time and represented on the graph as simply a constant travel time with which to compare to the general-purpose lane travel times. On the graph, for a particular time period, the difference between the line for general-purpose lanes travel time and the line for the HOV lane travel time represents the typical travel time savings available to HOV lane users on incident-free days for that particular location. For instance, an HOV lane user can expect to save a maximum of approximately 0.6 minute or 36 seconds over a 1.22-mile section near Preston in the westbound direction at 7:45 AM on a typical non-incident day for that 5-minute time increment.

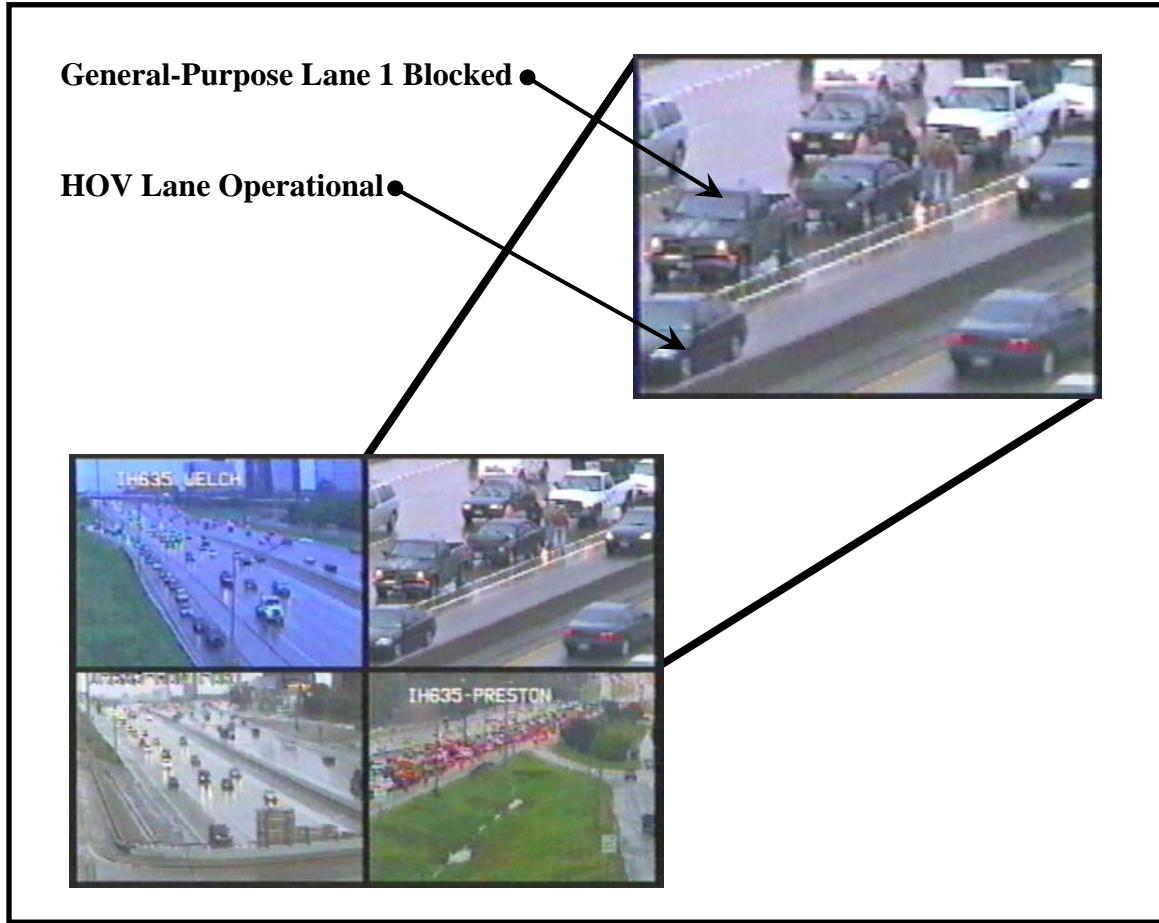
**Figure 7. Incident Blocking General-Purpose Lane Only.**

The increased delay due to incidents on the general-purpose lanes equates to increased travel time savings for HOV lane users that are unaffected by the incident. This is due to the decreased speeds on the general-purpose lanes while the HOV lane speeds remain relatively unchanged. By including the data for decreased general-purpose lane speeds on the baseline graph, the research team was able to visualize and better understand the impact of incidents with respect to travel time in the corridor. Figure 7 shows a typical general-purpose lane incident that does not affect the operation of the HOV lane as seen from the DalTrans cameras.

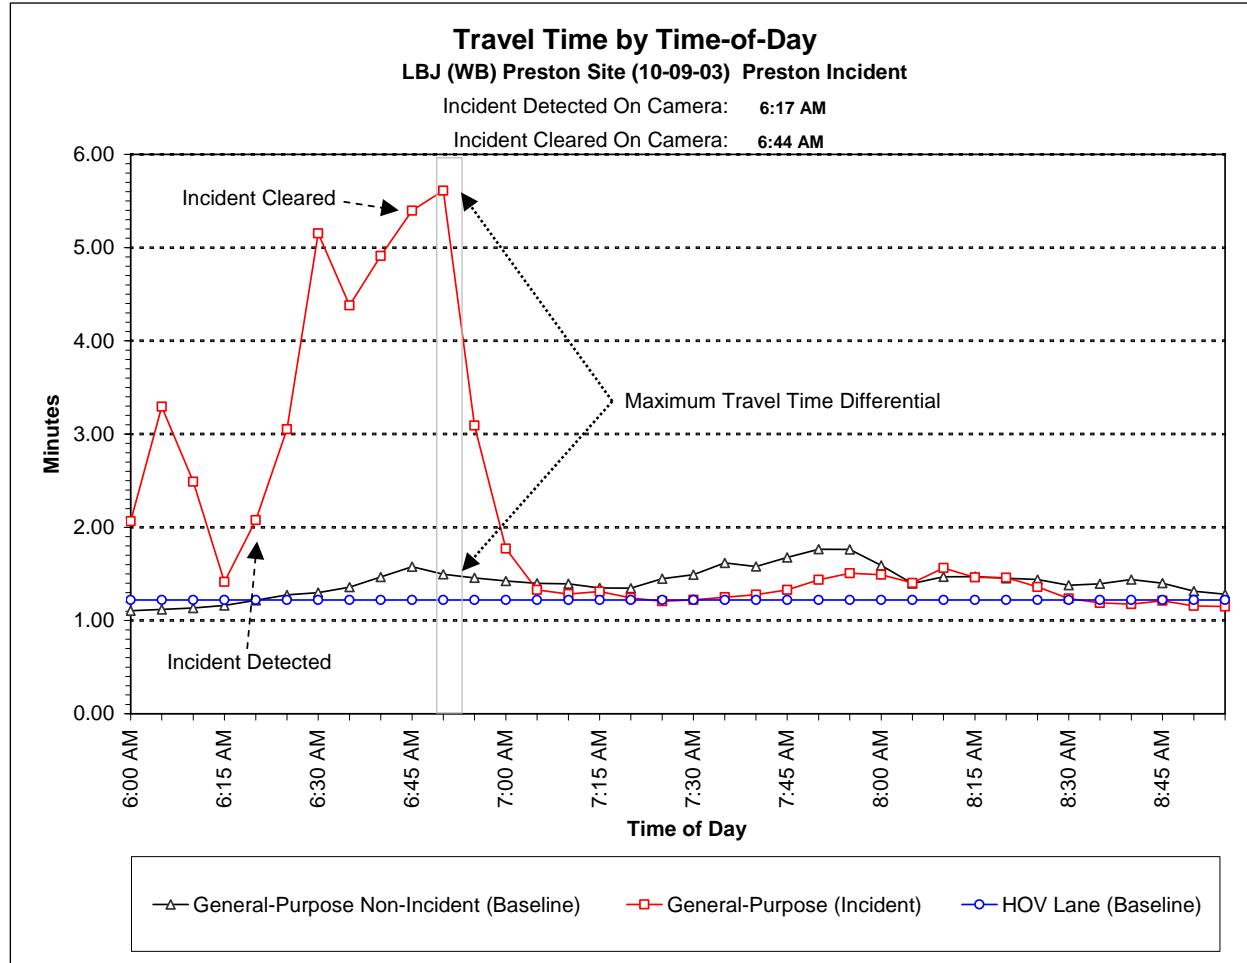
**Figure 8. Incident Causing General-Purpose Lanes Delay.**

The highest peak on the general-purpose lane incident data represents the greatest slow down in speeds and the longest travel times. The difference in the peak and the corresponding data point on the line representing typical non-incident general-purpose lane conditions gives the

additional delay on the general-purpose lanes during an incident. For this example, this equates to an additional 4.2-minutes travel time savings westbound at Preston at 6:50 AM for the HOV lane users during that 5-minute time increment.

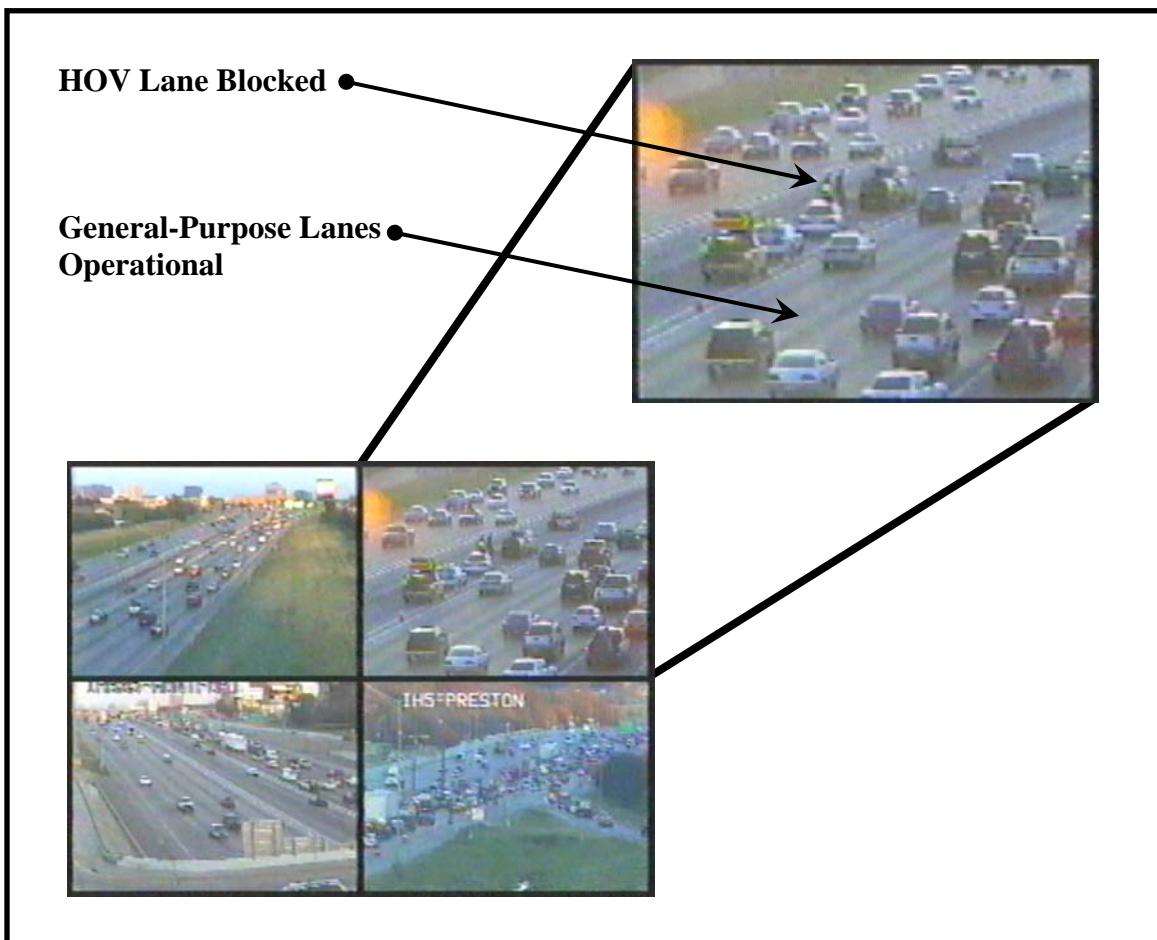
**Figure 9. Incident Blocking HOV Lane.**

designated as Lane 1, which is immediately adjacent to the HOV lane (4). Not only are many crashes occurring in Lane 1, it appears that emergency vehicles will purposely block Lane 1 and the HOV lane to provide a safe haven to work the crash when responding to incidents that are only blocking Lane 1. In these cases, the users of the HOV lane do not gain additional travel time benefits due to an incident occurring in the general-purpose lanes. The HOV lane users are affected adversely by having to merge back into the now extremely congested general-purpose lanes; thus, they lose the travel time benefits as well as the trip reliability, which are two of the primary goals of implementing HOV lanes. Obviously, incidents that occur on the HOV lane adversely affect the users by the same reasoning to a lesser degree. However, the HOV lane is actually blocked due to the incident itself and not due to positioning of emergency response vehicles. [Figure 9](#) shows a typical HOV lane incident as seen from the DalTrans cameras.

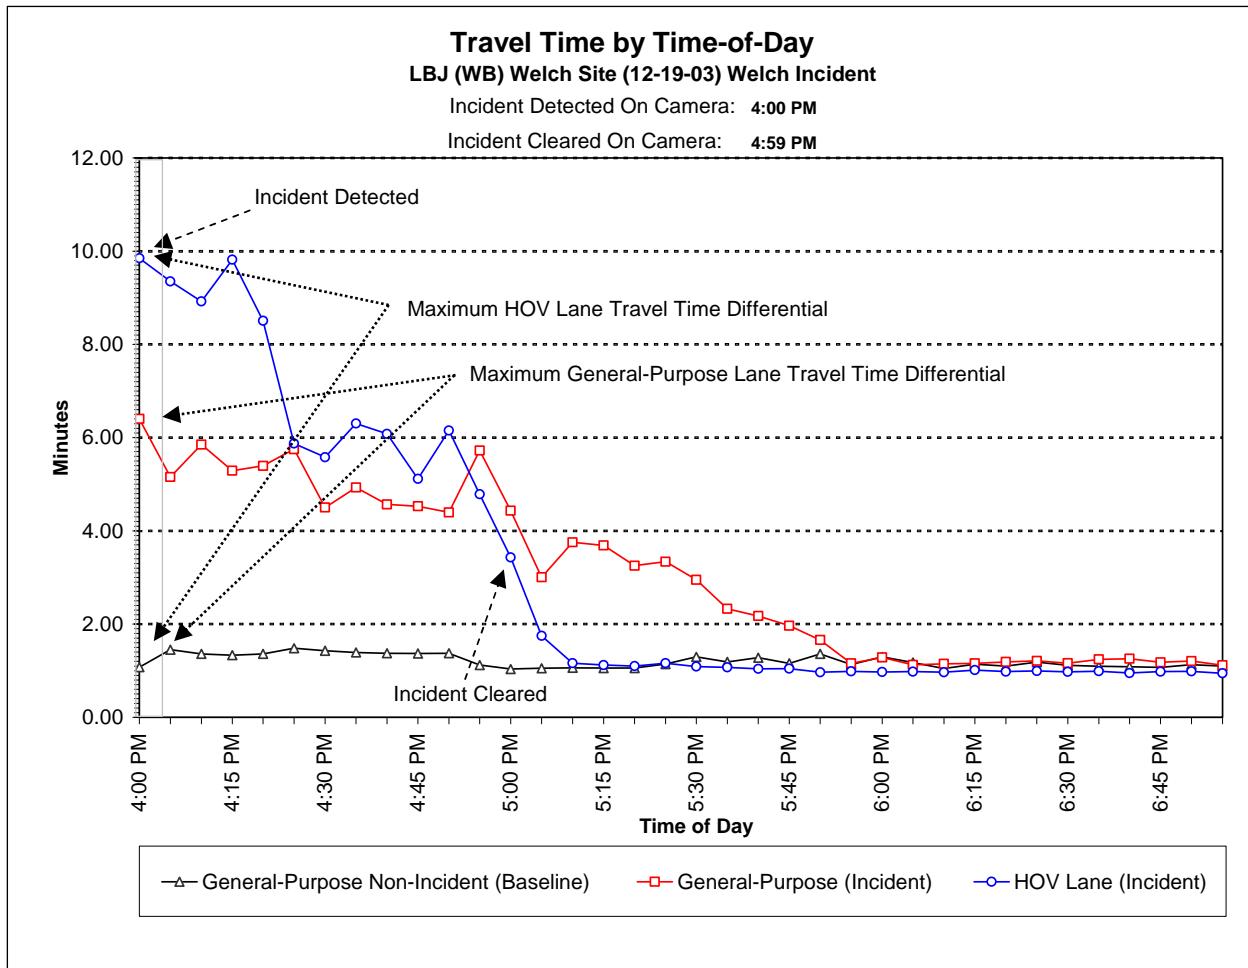
**Figure 10. Incident Causing HOV Lane and General-Purpose Lanes Delay.**

Figure 10 graphically represents data for a typical example of an incident on the HOV lane and the impact on speeds and travel time on the HOV lane and the general-purpose lanes as compared to the typical non-incident day. DalTrans personnel visually detected the incident at 4:00 PM through the CCTV cameras at the Welch location. Since the video recording of the corridor always began in the afternoon at 4:00 PM, the incident had been in place for an undetermined amount of time. Since the HOV lane was blocked, the speeds quickly dropped and the travel time increased for both the HOV lane and the general-purpose lanes as shown on the graph. The incident was cleared at 4:59 PM. The HOV lane travel time returned to normal and speeds were back to free flow by about 5:10 PM, and the general-purpose lanes travel time returned and speeds were free flow by about 5:55 PM.

For this incident, the HOV lane speeds are lower and travel times are shown to be longer than even the general-purpose lanes. In this case, the highest peak on the HOV lane incident data represents the greatest slow down in speeds and the highest travel times. The difference in the peak and the typical HOV lane speeds and travel time gives the maximum delay to HOV lane users at this camera location. As shown previously in Section 4.3.2, the highest peak on the general-purpose lane incident data represents the greatest slow down in speeds and the longest travel times. The difference in the peak and the corresponding data point on the line representing typical non-incident general-purpose lane conditions gives the additional delay on the general-purpose lanes during an incident.

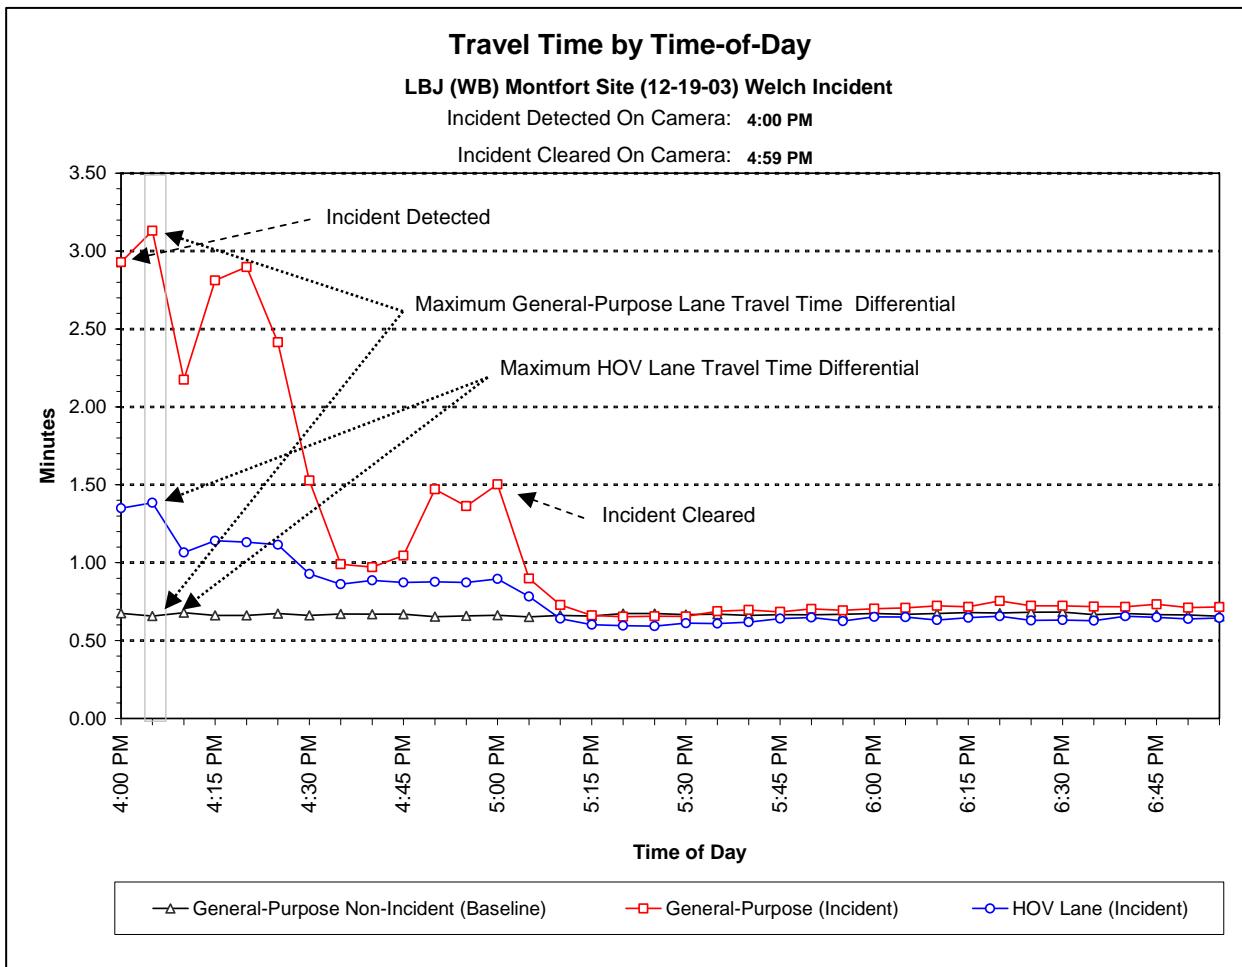
**Figure 11. Delay Upstream of Incident – One Mile (Approximately).**

Figure 11 shows data graphically at the Montfort location approximately 1 mile upstream of the Welch incident blocking the HOV lane that was presented previously in Section 4.4.2. Again, this incident was visually detected by the CCTV cameras at the Welch location by DalTrans personnel at 4:00 PM and the incident was cleared at 4:59 PM. At the upstream Montfort location, the HOV lane shows some adverse affects of the incident. However, the users of the HOV lane are still obtaining speed and travel time benefits over that of the general-purpose lanes.

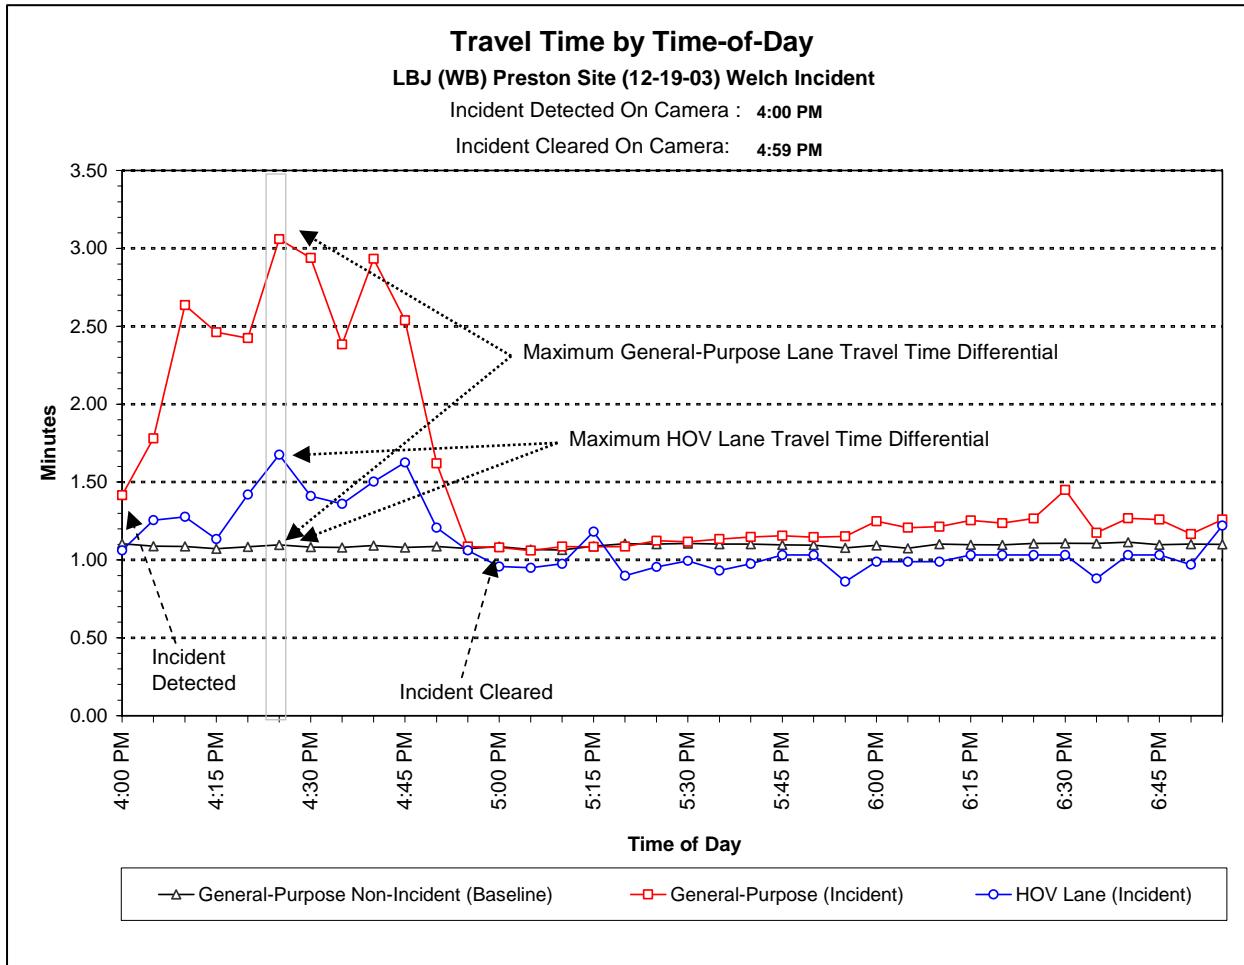
**Figure 12. Delay Upstream of Incident – Two Miles (Approximately).**

Figure 12 shows data graphically for the Preston location approximately 2 miles upstream of the Welch incident blocking the HOV lane. Again, the HOV lane speed and travel time is

showing effects of the downstream incident. However, the users of the HOV lane are still getting measurable travel time benefits over that of the general-purpose lanes.

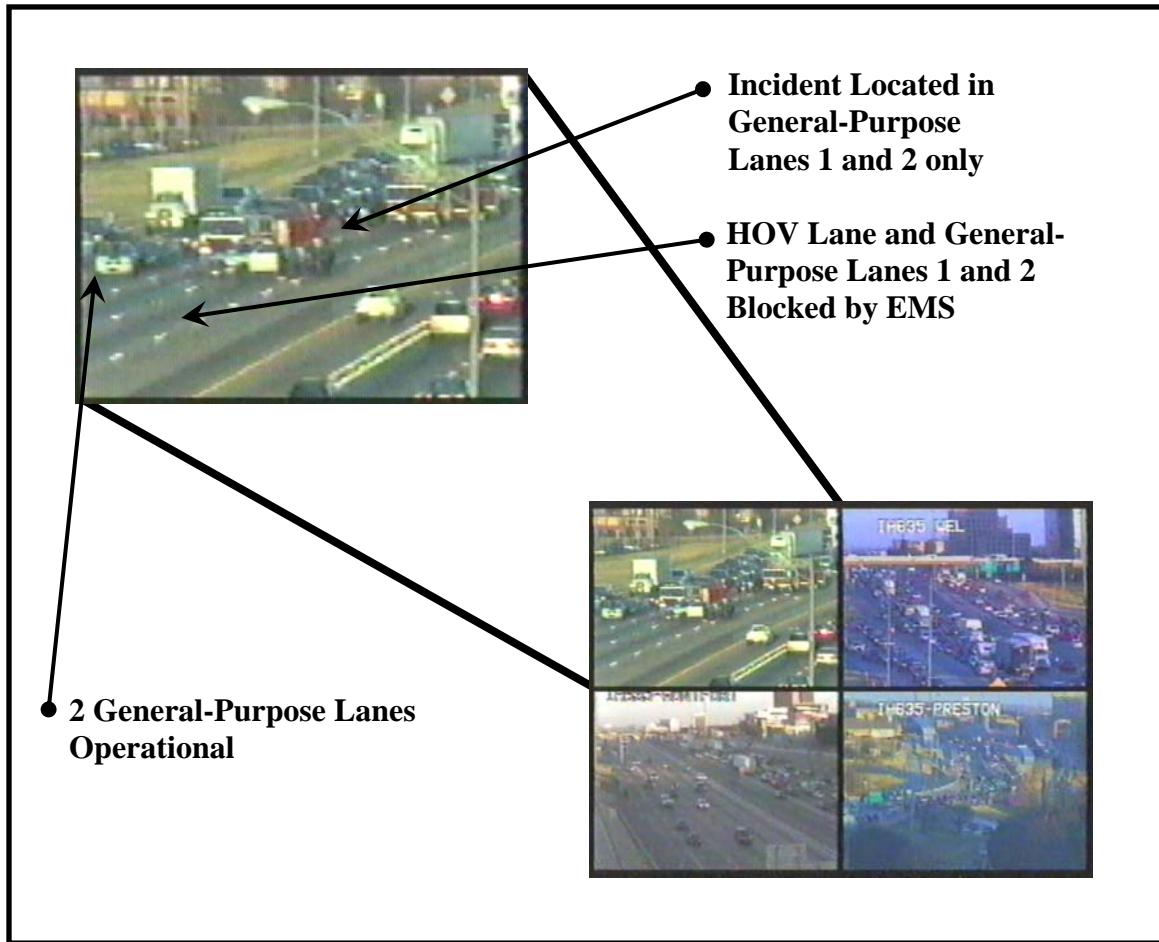
**Figure 13. Closing HOV Lane Unnecessarily.**

[Figure 13](#) shows an incident blocking Lane 1, immediately adjacent to the HOV lane, and Lane 2 of the general-purpose lanes. With only these two lanes blocked, general-purpose Lane 3 and Lane 4 continued to be operational. In addition, the HOV lane continued to be operational, thereby offering additional travel time savings to the users. This additional travel time savings could be as much as 10 minutes per HOV lane vehicle as shown in Section 4.6.1. Upon arrival of emergency vehicles, the HOV lane was closed due to the angled positioning of a ladder fire truck. In this case, it would seem that the HOV lane was closed unnecessarily.

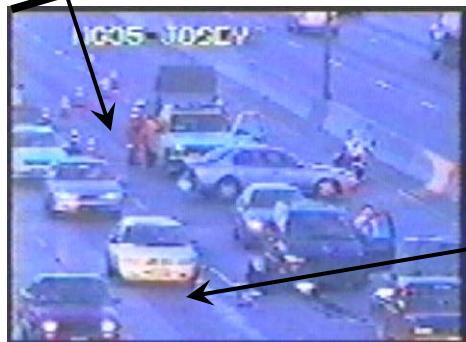
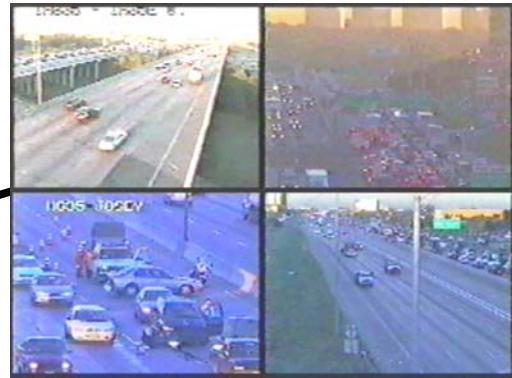
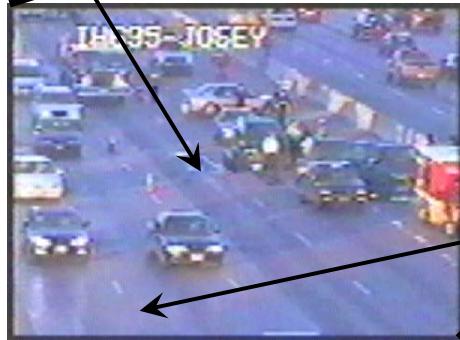
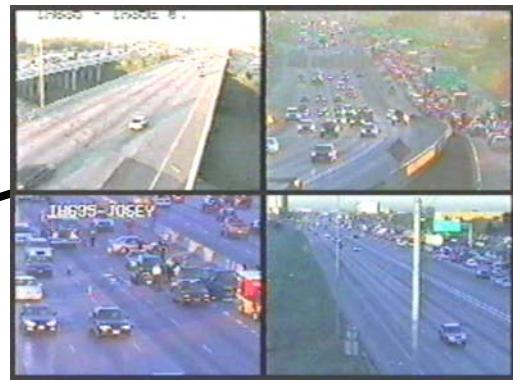
Figure 14. Taking Additional General-Purpose Lanes Unnecessarily.

Figure 14 shows an incident blocking both Lane 1 of the general-purpose lanes and the HOV lane. Lanes 2, 3, and 4 of the general-purpose lanes remain operational even after arrival of the TxDOT Courtesy Patrol. The Courtesy Patrol truck with its electronic arrow board in operation is positioned immediately behind the incident. Courtesy Patrol personnel set out orange traffic cones to channel traffic past the incident. When an ambulance arrives at the scene, it is positioned immediately in front of the incident and does not cause any additional disruption of the general-purpose lanes operation. However, upon arrival of the fire truck, it is positioned in a way that blocks Lane 2 of the general-purpose lanes. In this case, it would seem that an additional travel lane was taken away unnecessarily.

HOV Lane and  
General-Purpose Lane 1  
Blocked by Courtesy Patrol

3 General-Purpose Lanes  
Operational

HOV Lane and  
General-Purpose Lanes 1 and 2  
Blocked by EMS

2 General-Purpose Lanes  
Operational
