I-25 South Gap Work Zone Performance Measures Report

1. Report No. CDOT-2020-16	2. Government Accession No.	3. Recipient's Catalog No.	
4. Title and Subtitle I-25 GAP WORK ZONE PERFORMANCE MEASURES REPORT		5. Report Date May 2020

EXECUTIVE SUMMARY

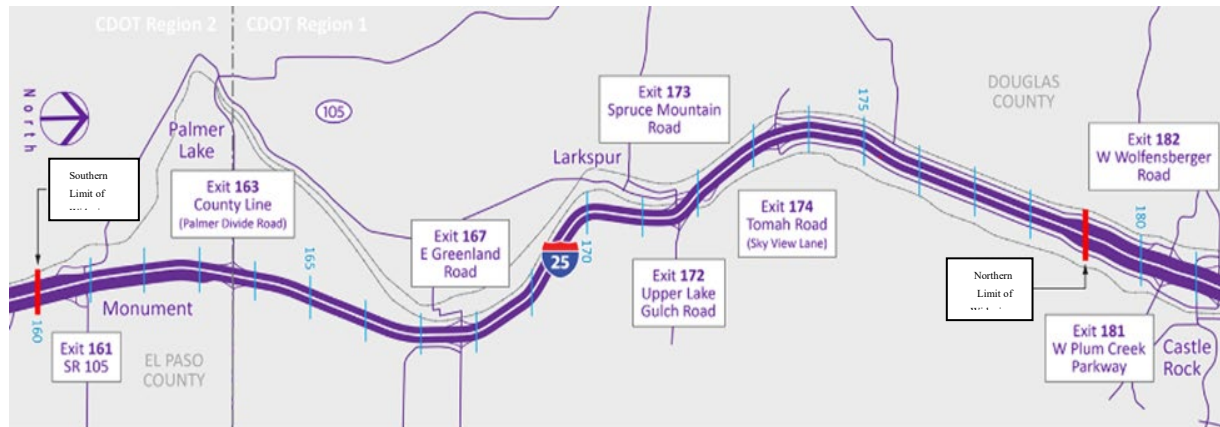
Figure ES- 1. I-25 Gap Project Area

With the integration of these measures, CDOT has improved the effectiveness of the mitigation team in an effort to better serve the public. The I-25 Gap construction project was initiated September 2018 and extends from mile marker 161 to 182 as illustrated in **Figure ES-1**.

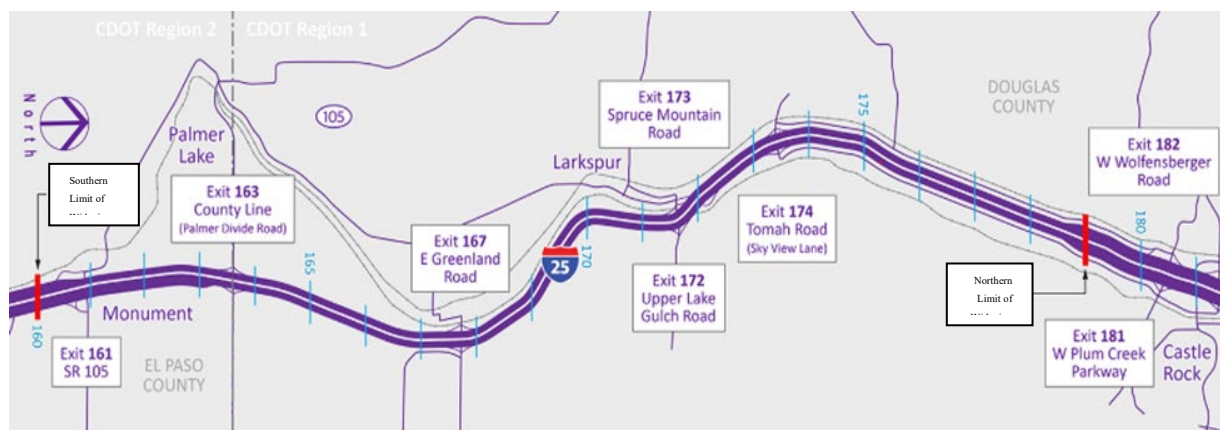
Figure 1. I-25 Gap Project Area

With the integration of these measures, CDOT has improved the effectiveness of the mitigation team in an effort to better serve the public. Construction activities on the I-25 Gap construction project was initiated September 2018 and extends from mile marker 161 to 182 as illustrated in **Figure 1**.

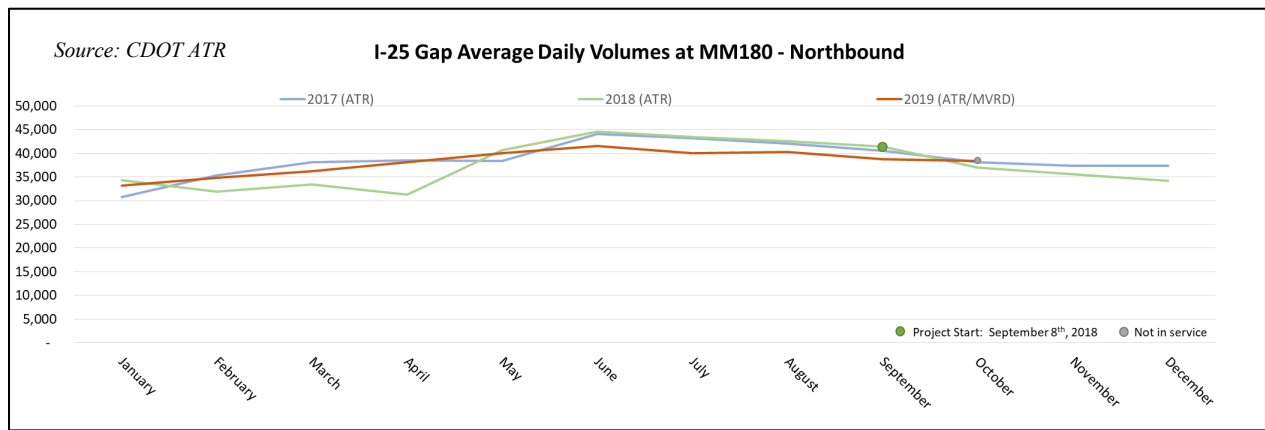
Figure 2. Northbound I-25 Gap Average Daily Volume

The volume data associated with the ATR and MVRD devices from mile marker 180 is graphically presented from 2017-2019. **Figures 2 and 3** display the northbound and southbound volumes, respectively. Overall, this analysis reveals uniform traffic volumes during the length of the evaluation period indicating that the corridor is continuing to serve the same number of users during construction compared to before construction began. **Appendix A** contains the ADT summary tables used to prepare the calculations.

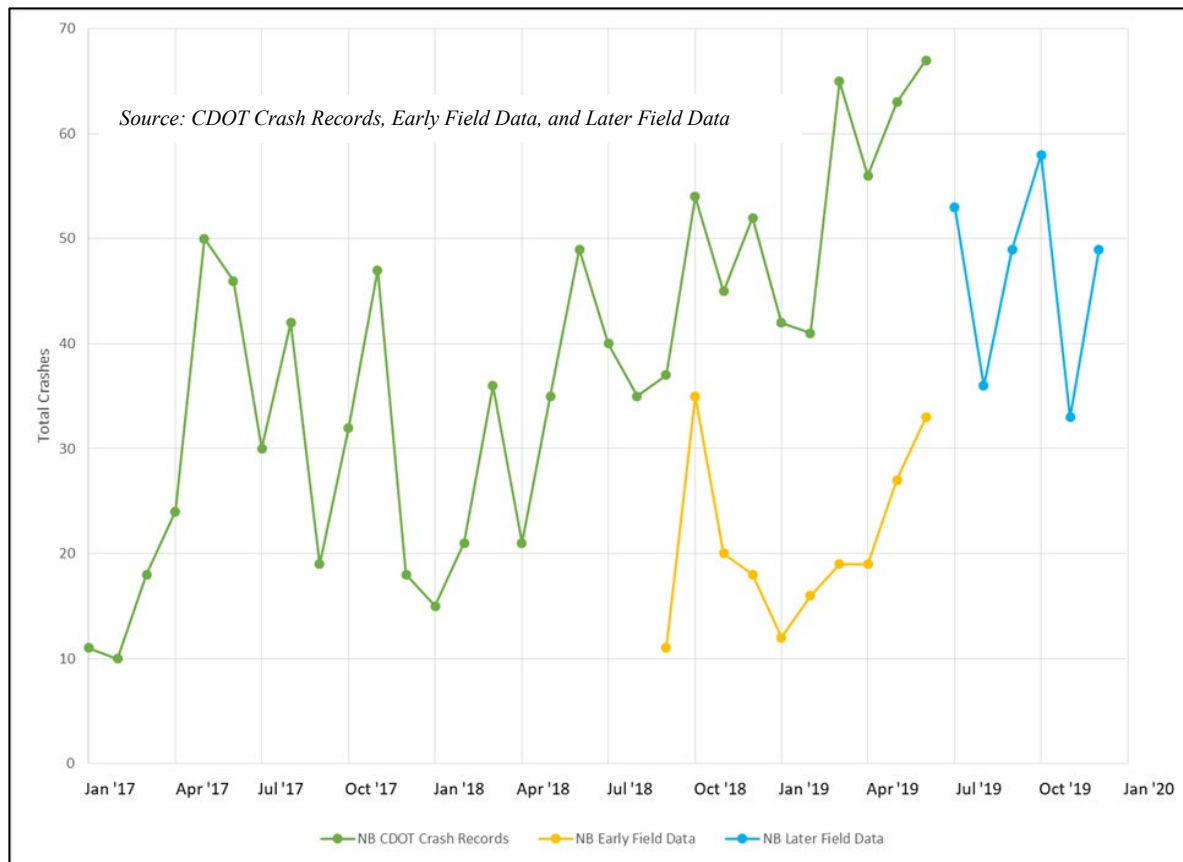
Figure 5. Northbound Crash Dataset Comparison

To understand the completeness and accuracy of the Early Field Data and Later Field Data a comparison was completed using graphical representations of each of these datasets by direction. **Figures 5** and **6** compare the northbound and southbound data, respectively.

Examination of these data sources reveals that the Early Field Data follows a similar trend as the CDOT Crash Records trends but contains under 50% of the total crashes occurring on the corridor. Starting in July 2019, with the Later Field Data there is clearly an increased number of crashes being identified, but unfortunately CDOT Crash Records were not available for the same time period during our analysis, and therefore, it cannot be known whether changes to the POC staffing and hours have begun to capture the total number of crashes.

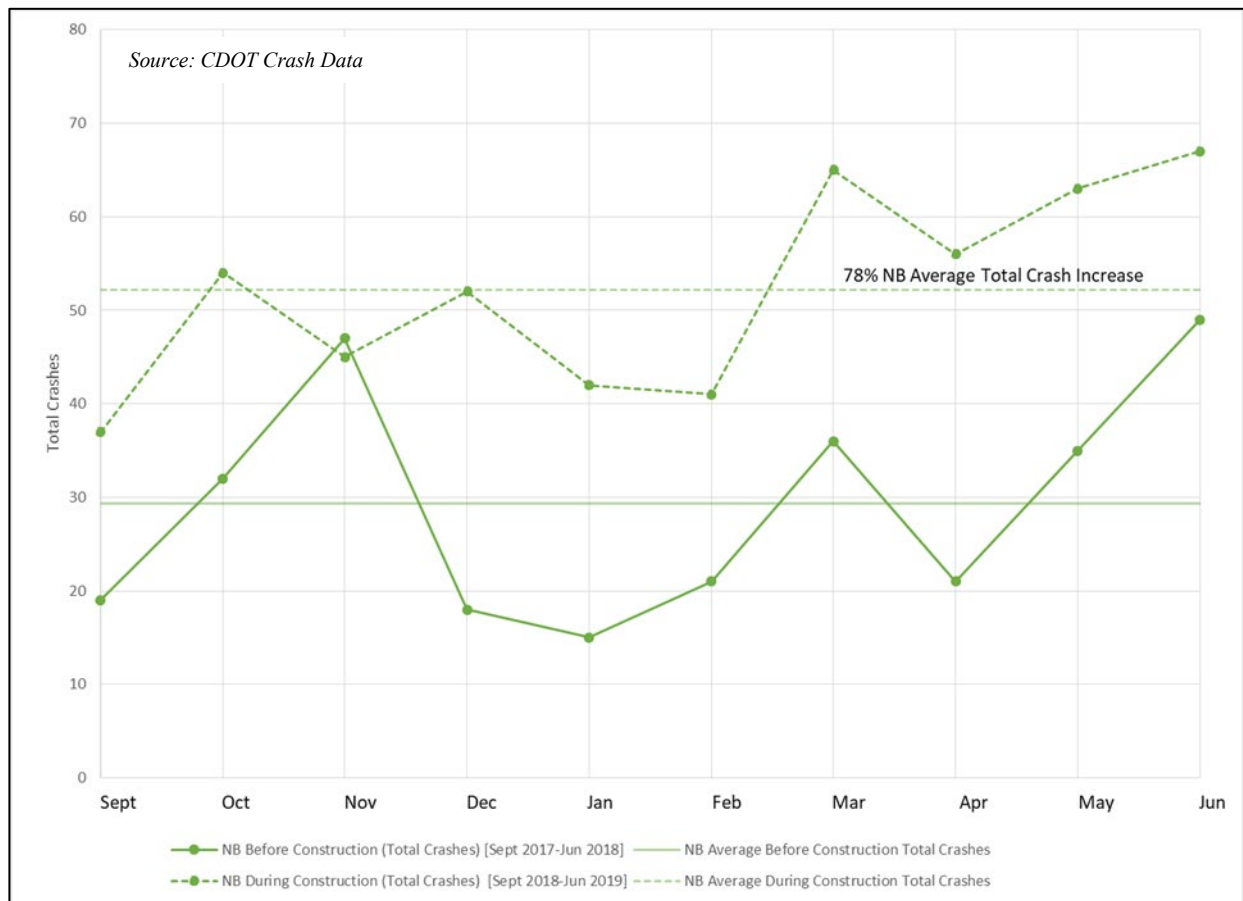
Figure 7. Northbound Total Crash Analysis

Figure 7 provides the northbound direction comparison for the ten months period. An average crash rate has also been calculated before and during construction, which reveals an average crash rate increase of 78% between the two periods. No fatal crashes were recorded in the northbound direction during the study period.
