# STATE HIGHWAY 9 WILDLIFE CROSSINGS MONITORING – YEAR 4 PROGRESS REPORT

Study Number 115.01

March 2020

Report to the Colorado Department of Transportation  
Applied Research and Innovation Branch

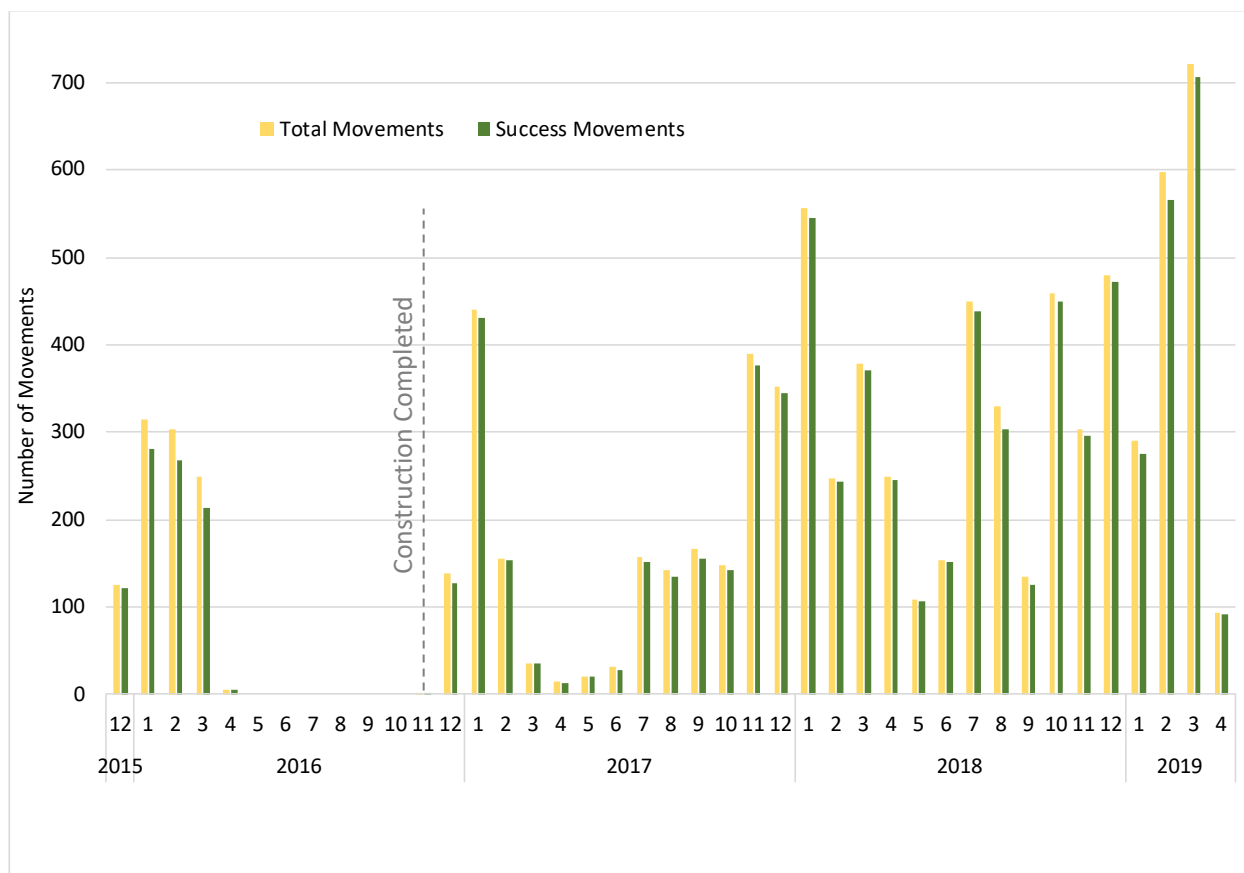
*Figure 10.* Mule deer total movements and success movements by month and year at the Harsha Gulch Underpass (MP 131.6) from December 2015 through April 2019. Note y-axis scale is 0 – 700.

Mule deer total movements and success movements by month at the Harsha Gulch Underpass are presented in Figure 10. Winter movements increased each year at this structure with the highest activity recorded in January 2018. The lack of mule deer activity during the non-winter months of 2016 is attributed to ongoing construction activities at this location. Mule deer movements remained high through much of Winter 2018-19, with the largest peak in the months of February and March. The total number of mule deer success movements at this location since construction was completed was 7,500. The number of annual success movements by calendar year was: 121 (2015, December only); 899 (2016); 1,984 (2017); 3,748 (2018); and 1,640 (2019, January through April only). After Phase 2 construction was complete, success rates remained relatively stable (97-98%).

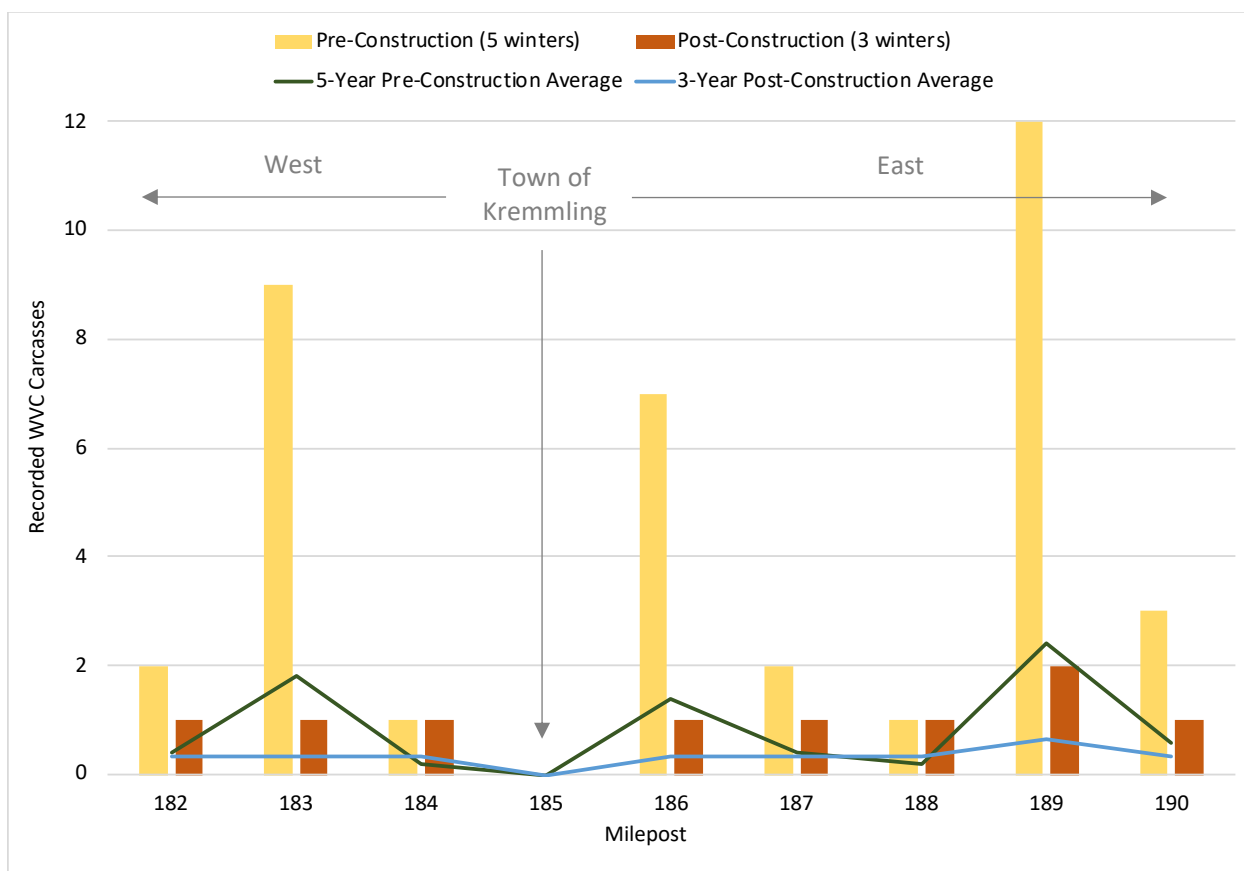
Figure 27. Ungulate carcass counts recorded by CDOT Maintenance on US 40 east and west of Kremmling (MP 185) for five winters prior to mitigation construction and three winters post-construction. The 5-year pre-construction winter average was calculated for each one-mile segment.

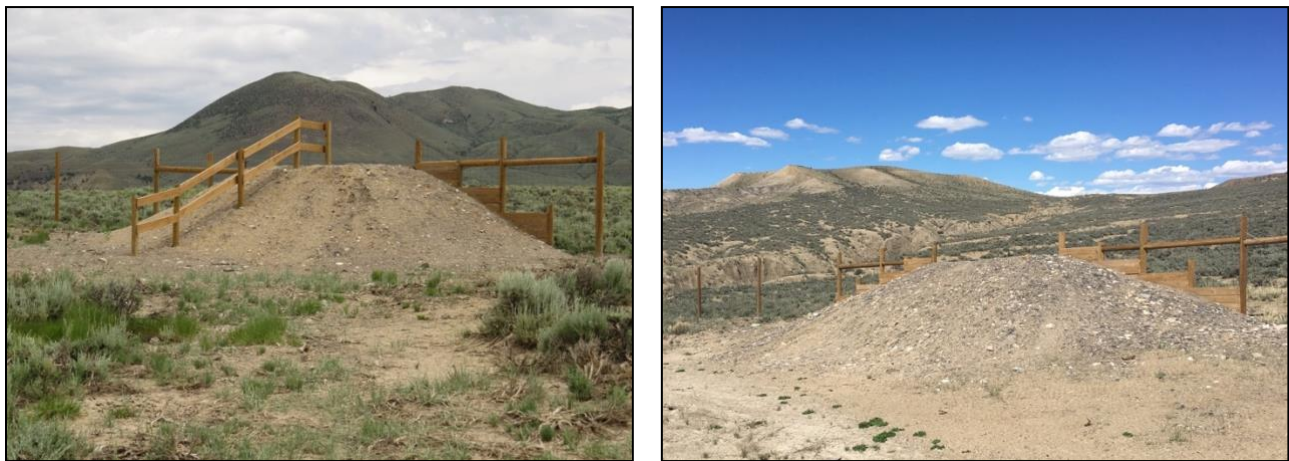
*Figure A-2. Example of an escape ramp with a 2:1 slope with perpendicular rail fence (left) and a ramp with a 3:1 slope with no rail fence (right).*
