2+1 ROAD WITH BARRIER

Evaluation of the Feasibility of Deployment of Swedish 2+1 Road with Barrier in Colorado

1. Report No. CDOT-2020-05	2. Government Accession No.	3. Recipient's Catalog No.	
4. Title and Subtitle 2+1 ROAD WITH BARRIER Evaluation of the Feasibility of Deployment of Swedish 2+1 Road with Barrier in Colorado		5. Report Date April 2020

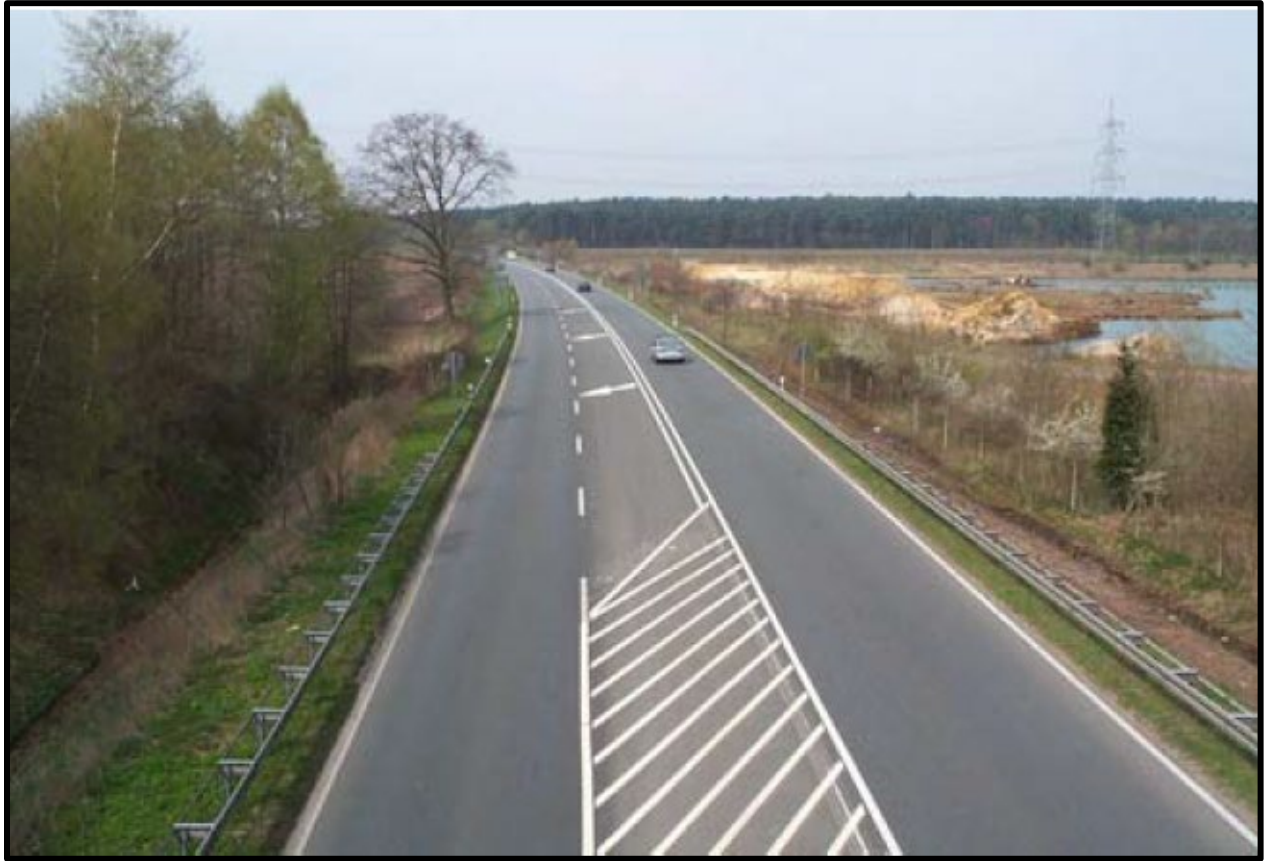
Figure 2: 2+1 Road in Germany

marking also warn vehicles in the passing lane that they must merge right. 2+1 is considered the optimum roadway type for 8,000-22,000 vpd. Observed volume as high as 30,000 vpd. 2+1 roads are safer than two-lane roads, or four-lane undivided roads. The minimum length for a 2+1 road is 4km (2.5 miles). The narrow shoulders associated with the 2+1 road (0.25m (10 inches) in Germany) can be problematic for maintenance, breakdowns and crashed vehicles. A typical lane drop (critical) transition on a German 2+1 road is shown in **Figure 2**.

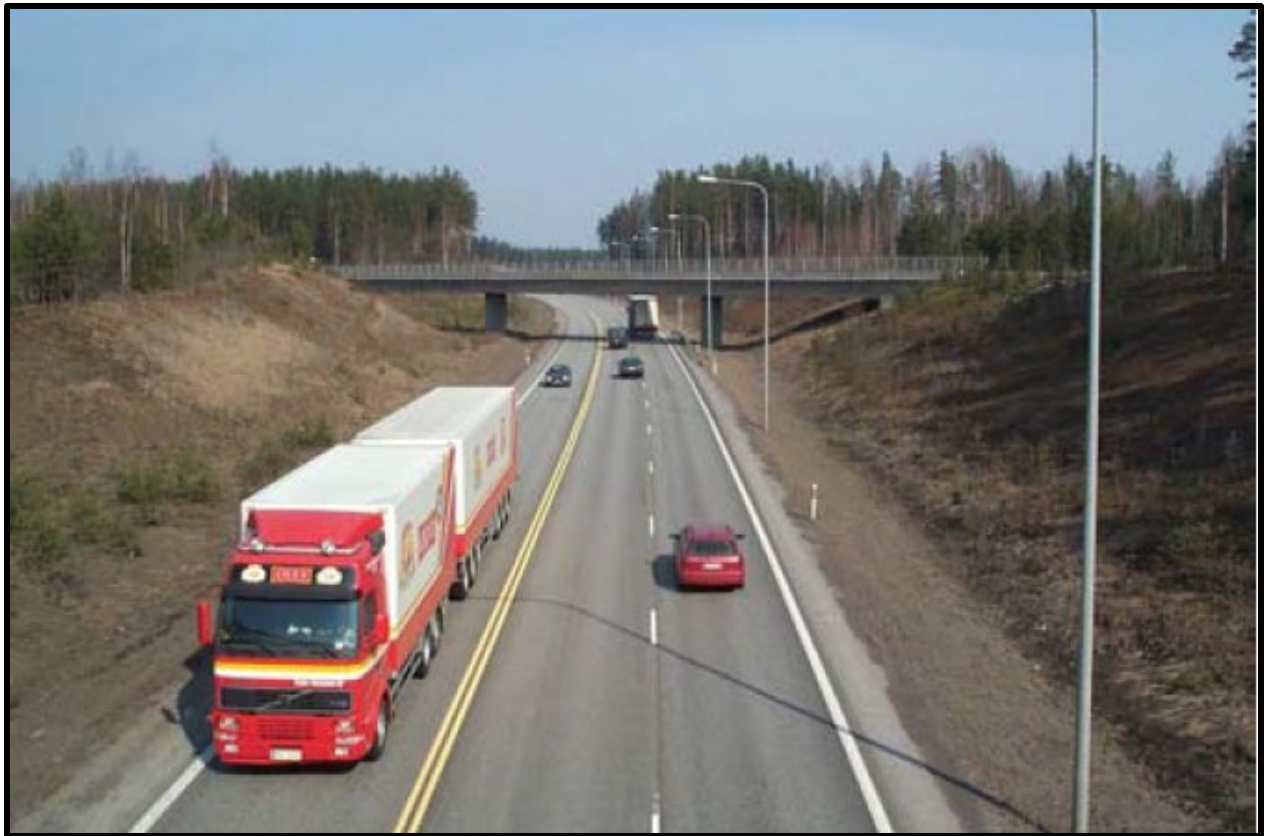
Figure 3: 2+1 Road in Finland

1.5 km long. Advance warning signs are posted on both sides 400m (1,300 ft) ahead of the lane drop and again 50m (160 ft) ahead of the lane drop. Speed limit is 100 km/h (62 mph) for cars and 80 km/h (50 mph) for trucks. Finland has found 2+1 not much safer than ordinary 2-lane, with high head-on frequency, thus the plan to add median cable. A typical section of Finish 2+1 Road is shown in **Figure 3**.

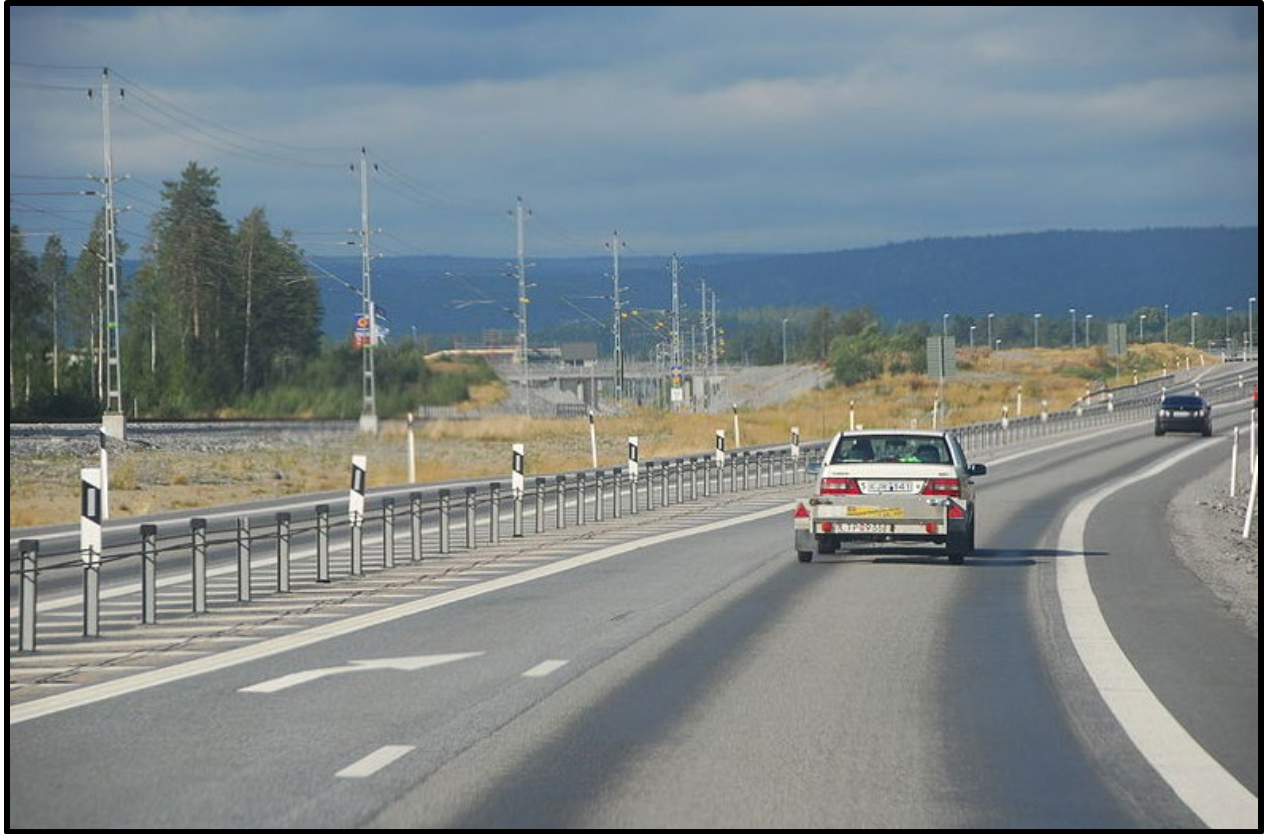
Figure 4: 2+1 Road in Sweden, at Critical Transition

SWEDEN: 2+1 roads in Sweden use cable barrier in a flush median, typically with a 1.5m (5 ft) median width. Critical transition tapers are 150m (500 feet) (about 43:1). The tapers are back-to-back with a total transition length of 300m (1,000 feet). Non-critical transitions tapers are 50m (165 feet) (about 14:1) with a total transition length of 100m (330 feet). The 2+1 section transitions to conventional 2-lane at locations with significant side road traffic or access density. Permanent openings in the median barrier, allowing for emergency/maintenance turn arounds, are located in all non-critical transition locations. Provisions for opening barrier are included in critical transition locations (at the widest point). Passing lanes are provided at least every 2km (1.2 mi). Passing zone length is variable, indicated by sign at beginning of passing lane. Advance warning signs are posted on both sides 400m (1,300 ft) ahead of the lane drop and again 50m ahead of the lane drop. Pavement marking merge arrows also alert passing drivers that they need to merge right. Delineation reflectors are incorporated in the median barrier at 100m (330 ft) spacing, decreasing to 10m (33 ft) spacing in critical transitions. The crown is located on the actual roadway centerline (thus within, but to the left of the center of the passing lane), this has not been found to cause any problems. Sweden has found 2+1 roads with barrier to be much safer than 2-lane roads, with safety very comparable to four-lane divided motorways with center barriers. 2+1 roads easily carry up to 1400-1600 vph in one direction – traffic in the opposite direction is not a factor. The speed limit is 90km/h (55 mph). A typical lane drop (critical) transition on a Swedish 2+1 road is shown in **Figure 4**.

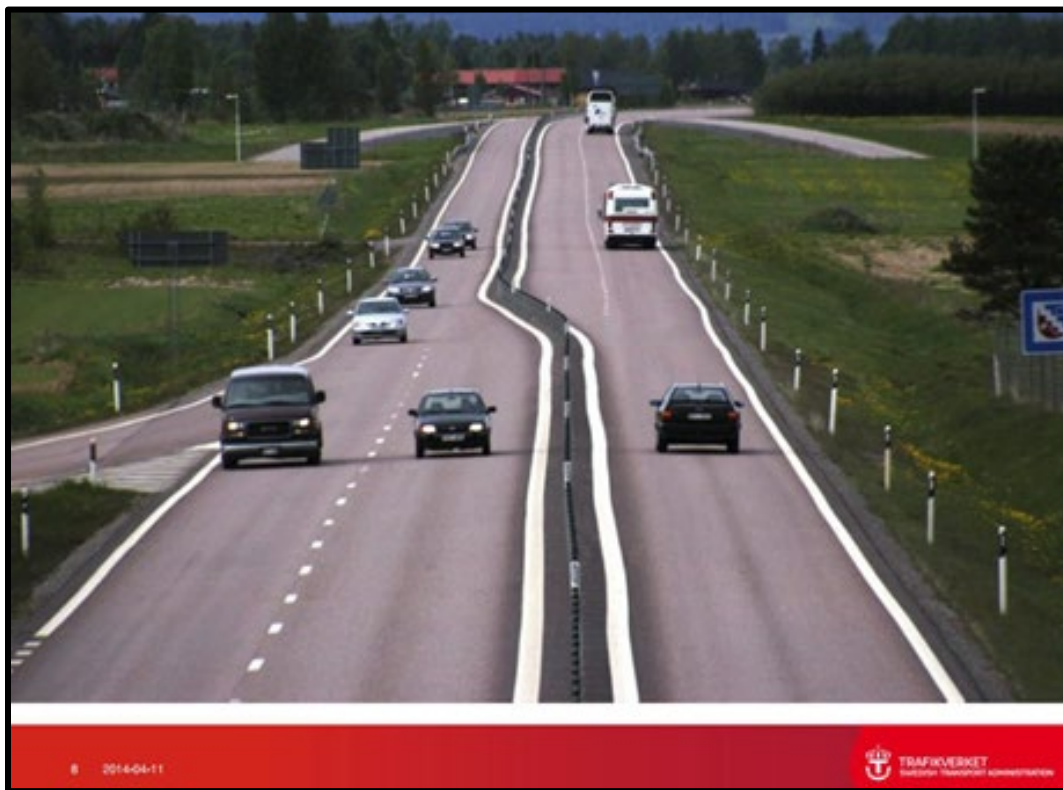
Figure 6: Example 2+1 Road with Barrier

Observational before and after studies conducted in Sweden over more than 20 years, show that **a 75% crash reduction in fatalities and a 50% reduction in injuries** can be expected.^{3,4,5}. In addition to reducing head-on and sideswipe-opposite crashes Swedish 2+1 Section with Barrier is also effective in reducing higher severity roadway departure crashes such as overturning and fixed object collisions. **Figure 6** shows a photograph of an operating location in Sweden.

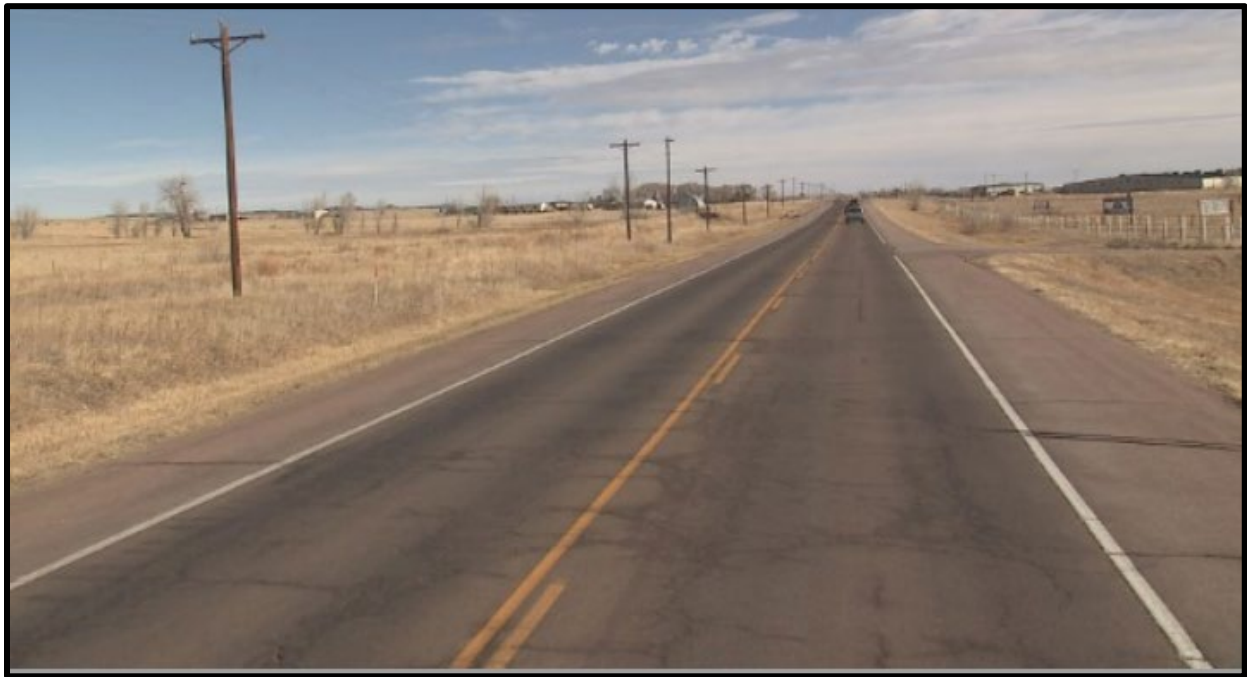
Figure 8: SH 24, MP 321.00 to 325.50 Typical View

SITE CONDITIONS SH 24 is classified as an Urban Principal Arterial from MP 321.00 to MP 322.53 and a Rural Principal Arterial from MP 322.54 to MP 325.50, however it is of a rural character throughout the study section. SH 24 is primarily a 2-lane undivided highway facility with 12-foot lanes and 8-foot shoulders in the study section, but has two widened areas in the vicinity

Figure 8 shows a typical section of SH 24 within project limits.

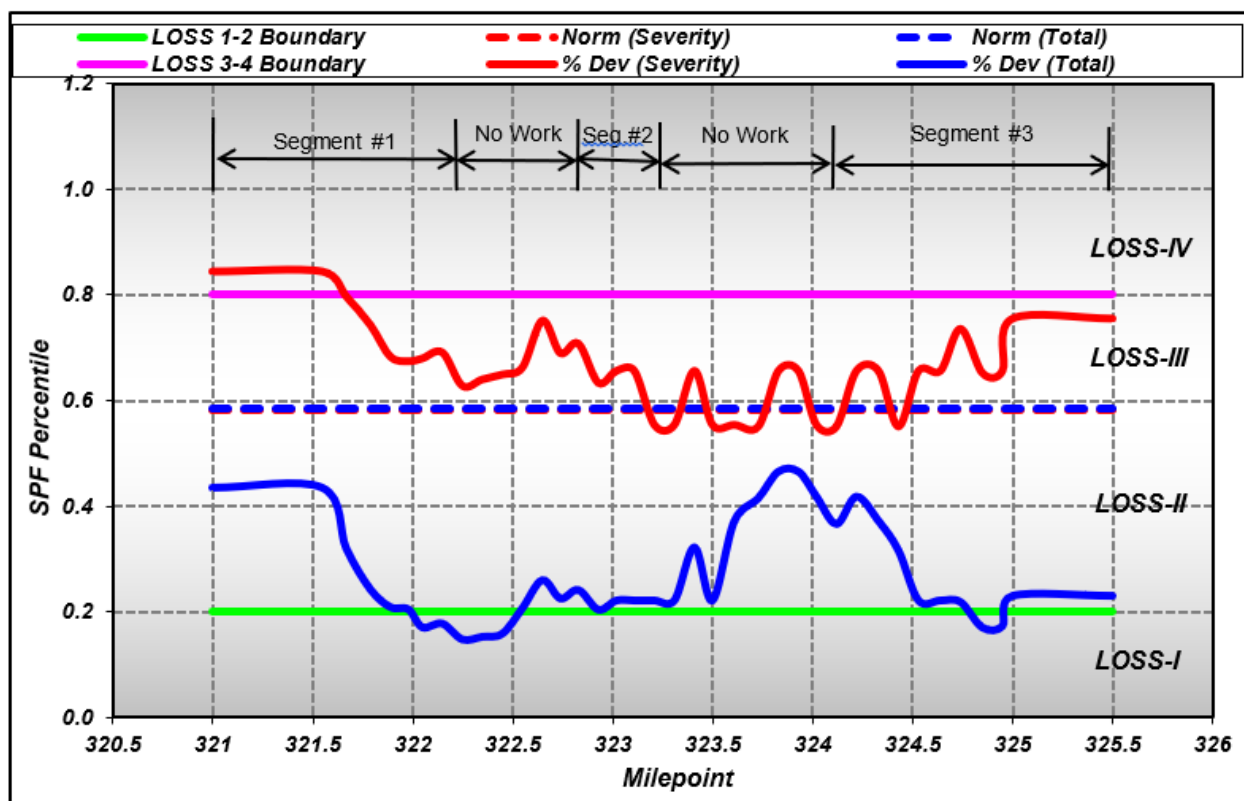
Figure 9: Corridor SPF for SH 024G MP 321.00 to 325.50

SAFETY PERFORMANCE ANALYSIS AND DIAGNOSTIC EXAMINATION The chart in **Figure 9** shows the corridor SPF for the study section with the three work segments and two no-work segments identified. As the chart shows, the study section is performing worse in terms of the severity of crashes than the overall number of crashes. This is seen by the fact the line for the severity SPF plots higher than the frequency line throughout the length of the plot. It is mostly in category LOSS-III in the work segments, but is in the LOSS-IV category through the first 6/10 or so of a mile suggesting a relatively high potential for reduction of severe crashes.

Figure 9 shows segment safety performance from the total crash frequency stand point. It shows that all three segments perform in the LOSS-II category in terms of total crash frequency, suggesting a low potential for a significant reduction in total number of crashes.

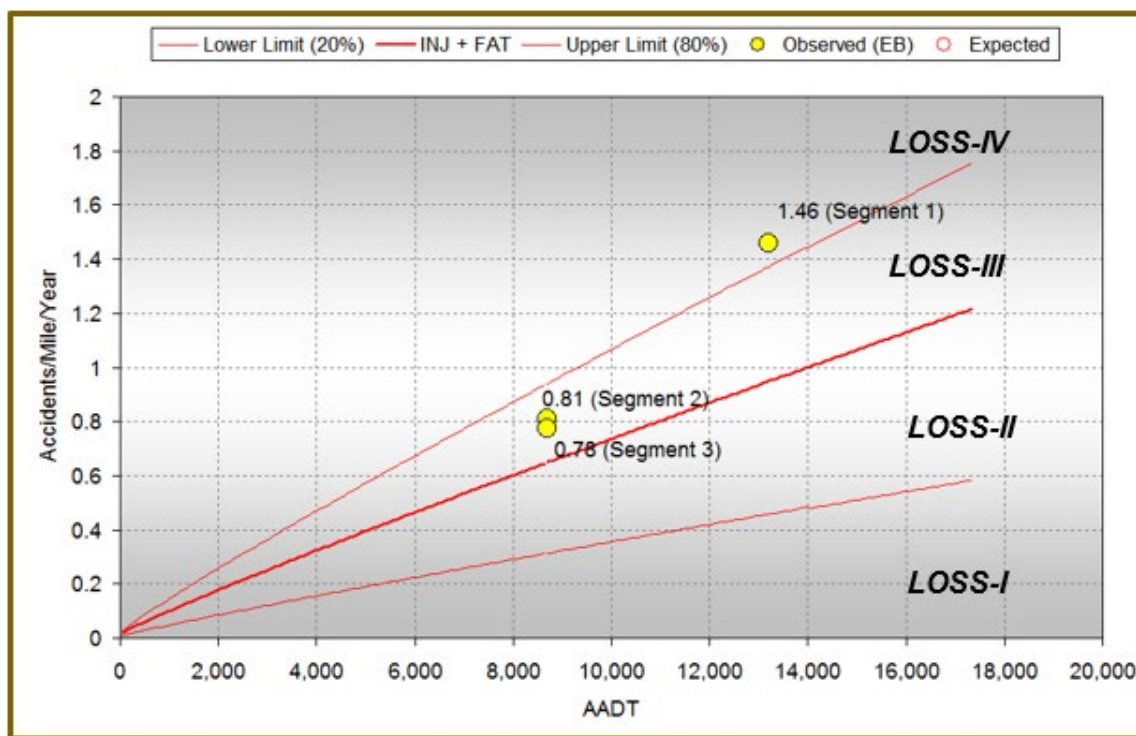
Figure 11: EB Corrected SPF for Injury and Fatal Crashes

Figure 11 represents segment safety performance from the standpoint of severity and considers injury and fatal crashes only. It shows all three segments perform in LOSS-III and LOSS-IV category in terms of severity, suggesting moderate to high potential for reduction of crashes involving bodily injury.

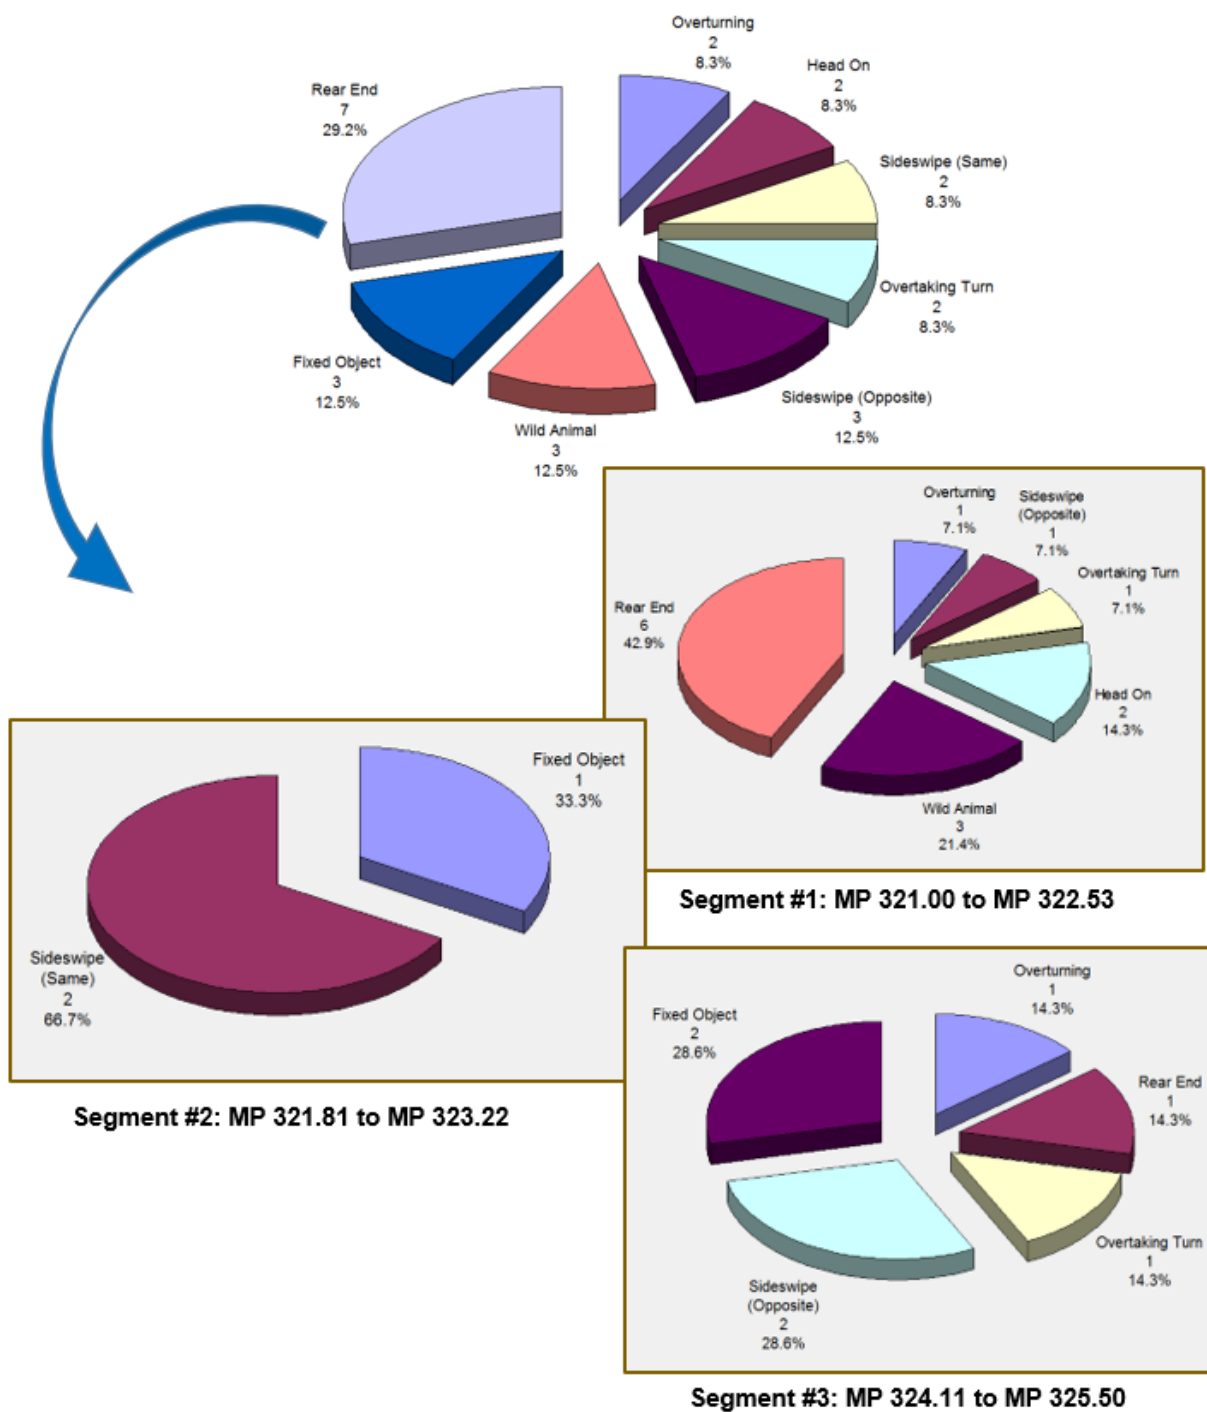
Figure 12: Crash Type Distribution SH 024G MP 321.00 – 325.50

The overall distribution by crash types within the study limits, with breakdowns for each of the three subsections, is provided in **Figure 12**. As with the previous crash related summaries, these depict only the non-intersection related crashes. As the chart for overall crashes shows, Rear End crashes were the most common, representing 29% of all crashes, but otherwise the types of crashes are spread relatively evenly amongst seven other different crash types. It is noted that the Overtaking Turn crashes were not intersection related as one would typically expect for this crash type, but were resulted when vehicles were attempting to make U-turns on the highway.

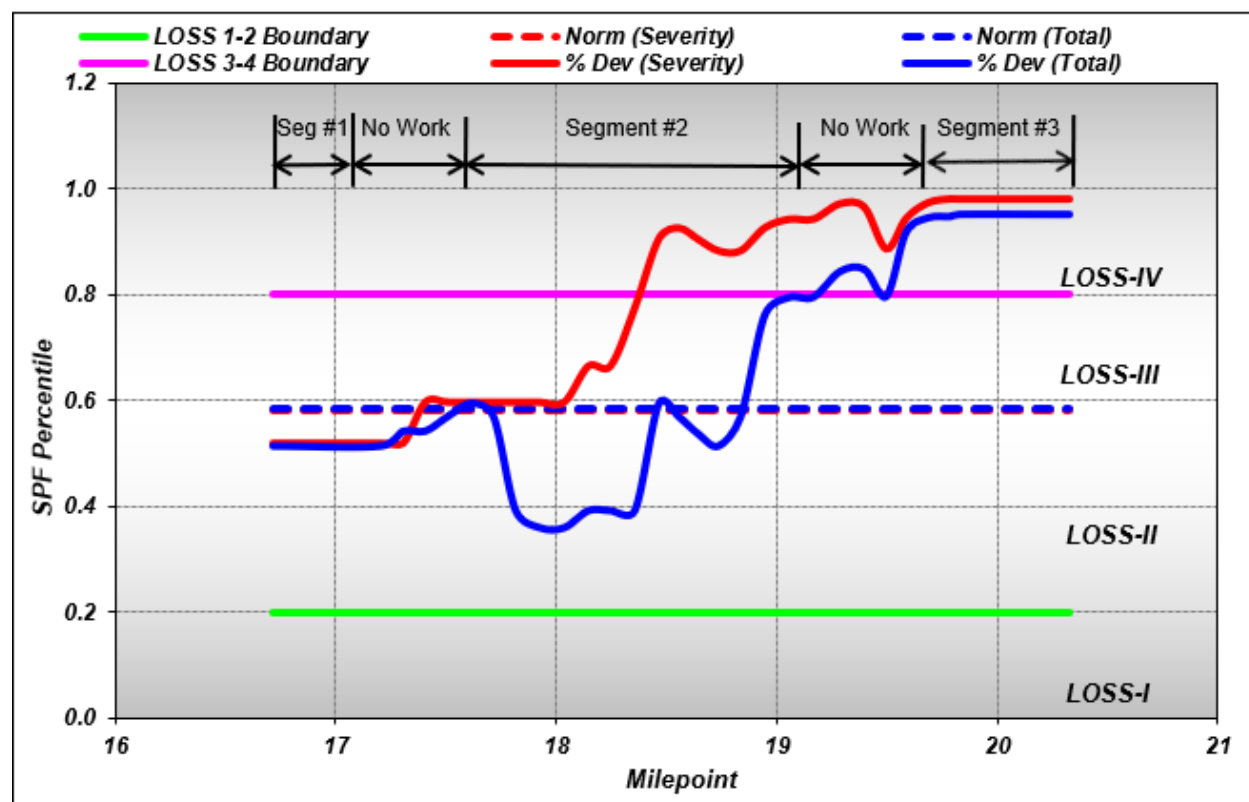
Figure 15: Corridor SPF for SH 030A MP 16.72 to 20.33

performs at LOSS-IV throughout both in terms of frequency and severity suggesting a high potential for crash reduction in that stretch.

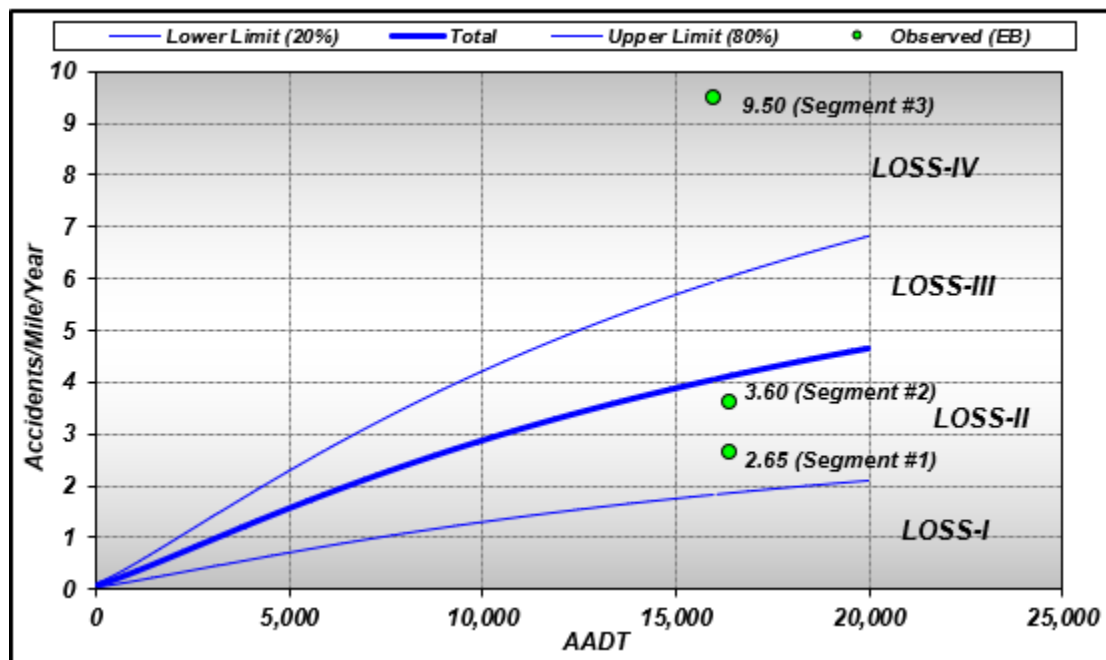
Figure 16: EB Corrected SPF for Total Crashes

Figure 16 shows segment safety performance from the total crash frequency stand point. It shows that segments #1 and #2 perform in the LOSS-II category in terms of total crash frequency, suggesting a low potential for a significant reduction in total number of crashes. However, segment #3 is performing well into the LOSS-IV category suggesting a high potential for reducing the number of crashes.

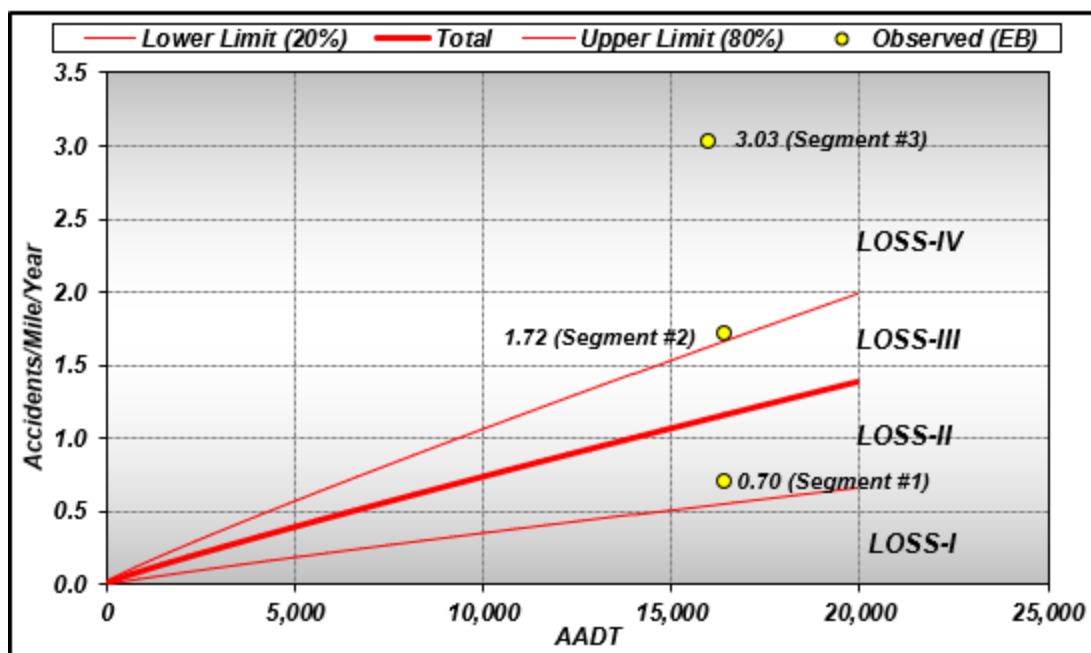
Figure 17: EB Corrected SPF for Injury and Fatal Crashes

Figure 17 represents segment safety performance from the stand point of severity and considers injury and fatal crashes only. It shows that segments #2 and #3 perform in LOSS-IV category in terms of severity, suggesting moderate to high potential for reduction of crashes involving bodily injury. Segment #1 is performing in the Loss-II category indicating a relatively low potential for severe crash reduction.

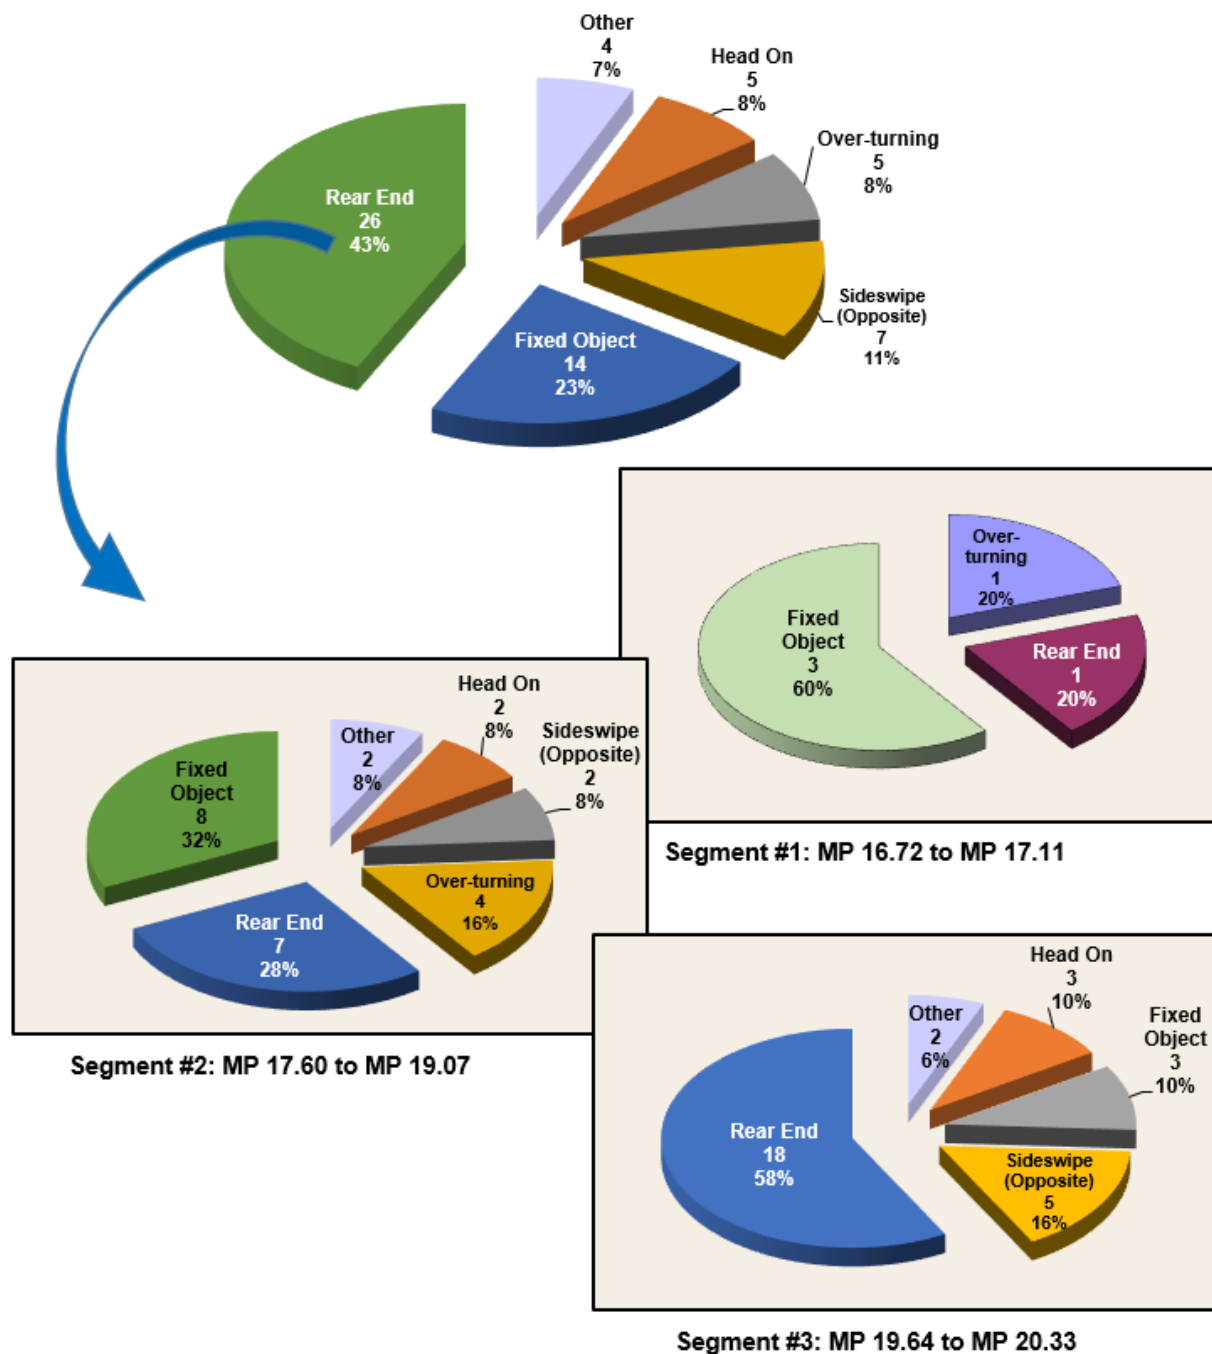
Figure 18: Crash Type Distribution SH 030A MP 16.72 – 20.33

The overall distribution by crash types within the study limits, with breakdowns for each of the three subsections, is provided in **Figure 18**. As with the previous crash related summaries, these depict only the non-intersection related crashes. As the chart for overall crashes shows, Rear End crashes were the most common, representing 43% of all crashes. Fixed Object crashes were the second most common crash type representing 23% of all crashes. The other relatively common crash types were Opposite Side Sideswipes comprising 11% of the crashes, with Overturning and Head Ons each comprising 8%. The four “Other” types of crashes shown in the chart were one Same Direction Sideswipe, one Overtaking Turn, one Parked Motor Vehicle and one crash involving spilled cargo on the roadway.

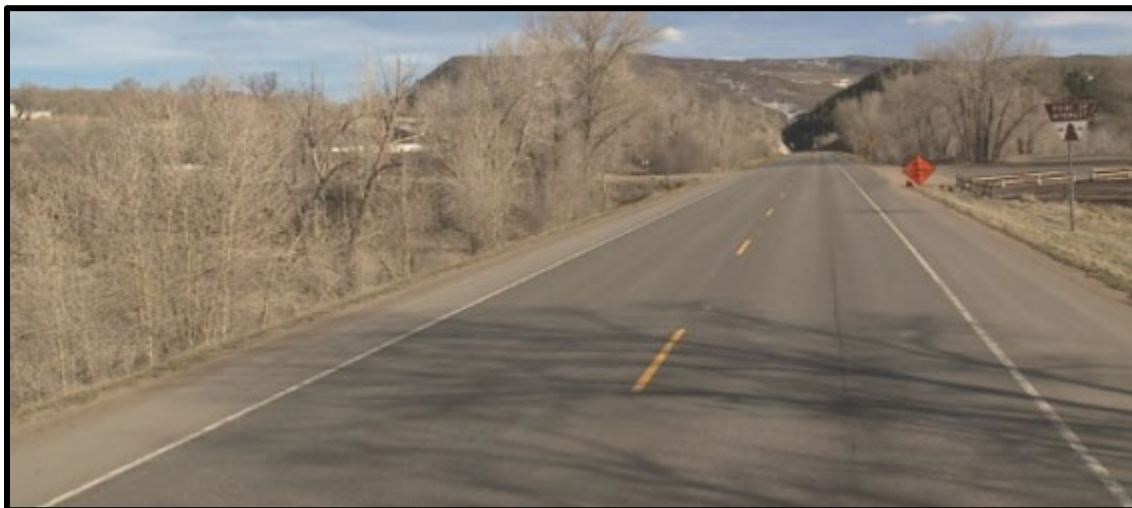
Figure 20: SH 040A Typical Cross Section

Figures 20 and **21** are typical views of SH 40 within project limits. The photo in **Figure 20**, showing one of the milder portions of the study section, was taken from the OTIS photo log at approximately MP 114.3 and the photo in **Figure 21**, showing the rock cut on the left and downslope on the right, was taken at approximately MP 115.30.

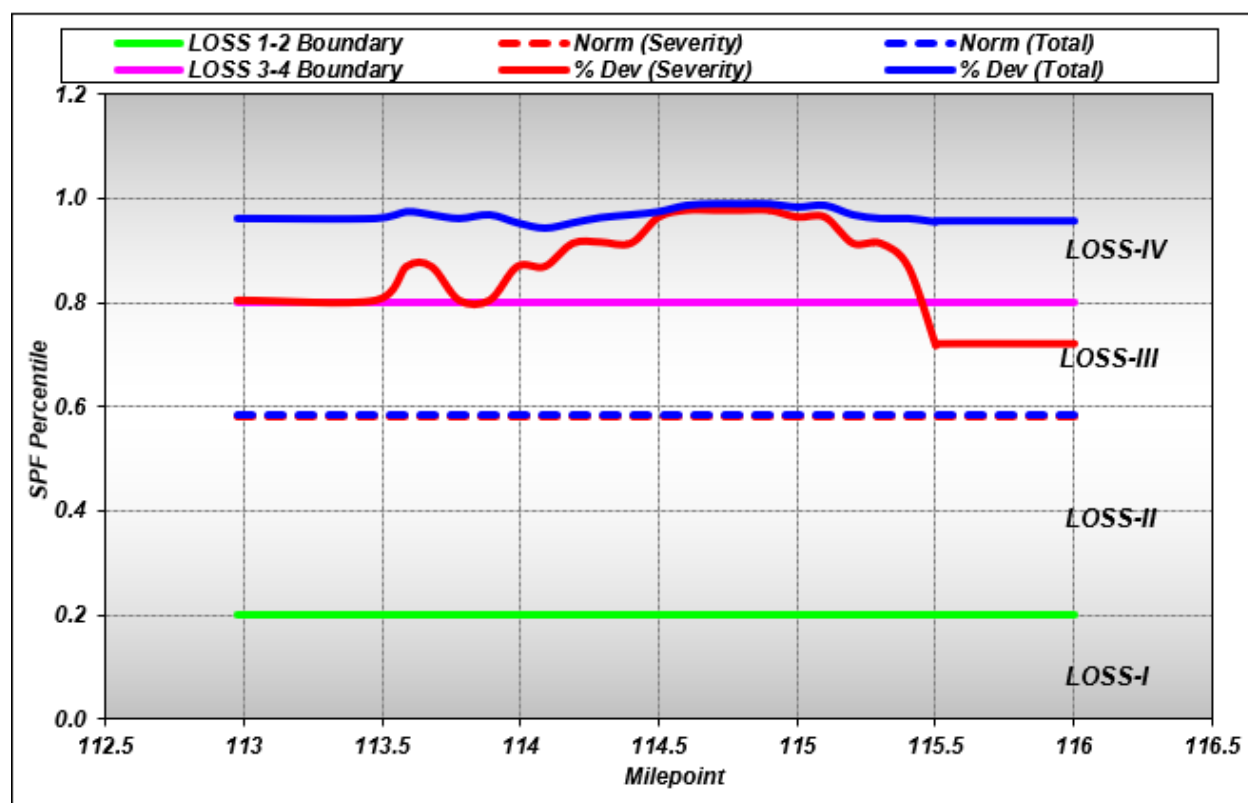
**Figure 22: Corridor SPF for SH 040A MP 112.98 to 116.00**

SAFETY PERFORMANCE ANALYSIS AND DIAGNOSTIC EXAMINATION The chart in **Figure 22** shows the corridor SPF for the study section. As the chart shows the entire study section is performing the LOSS-IV category throughout the study section in terms of crash frequency and throughout all but the last ½ mile in terms of crash severity, suggesting high potential for accident reduction in both categories.

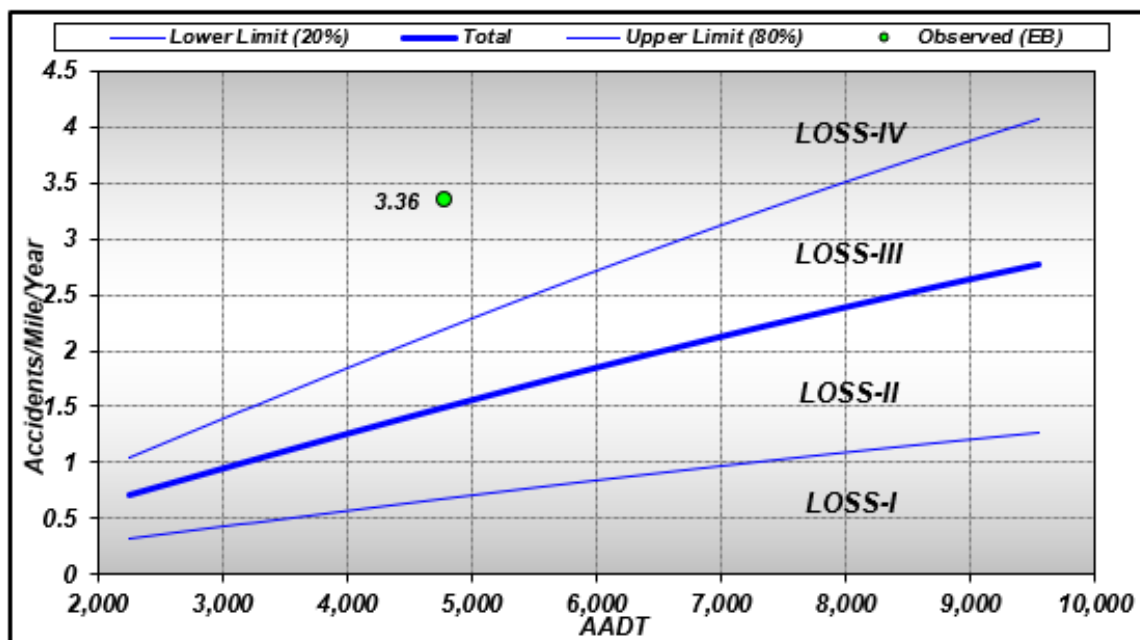
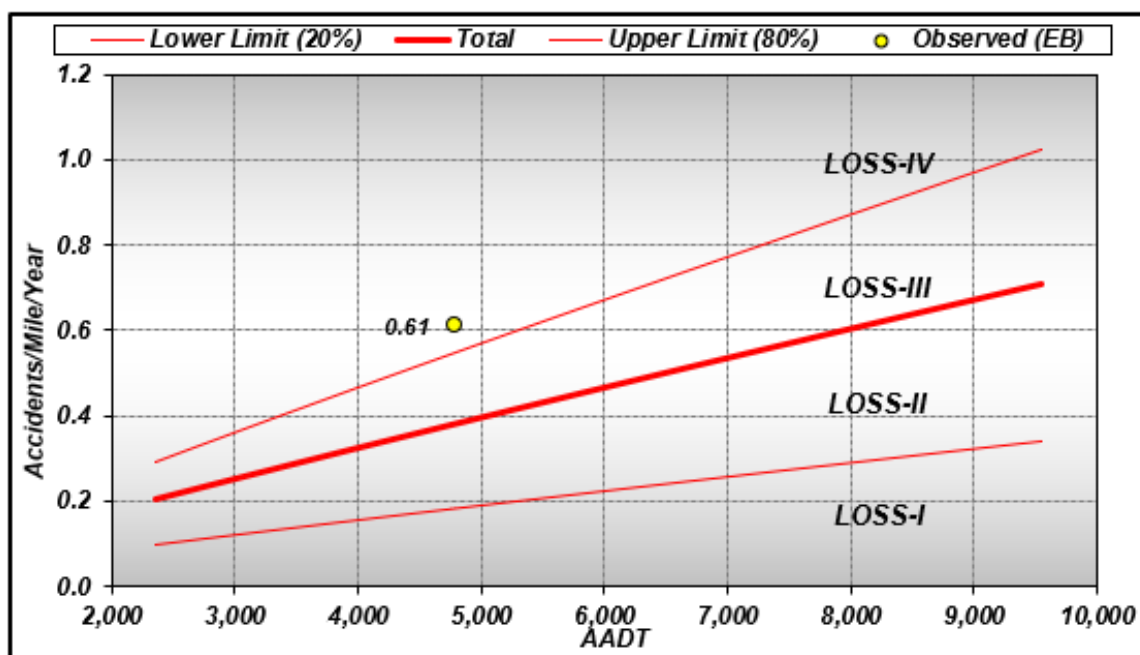
Figures 23 and 24 represent EB corrected segment safety performance analysis of SH 040A within the study limits. **Figure 19** shows segment safety performance from the total crash frequency stand point and **Figure 20** represents segment safety performance from the stand point of severity and considers injury and fatal crashes only. Both charts show that the study section overall is performing in the LOSS-IV category, suggesting a high potential for a significant reduction in total number of crashes as well as the number of injury related crashes.

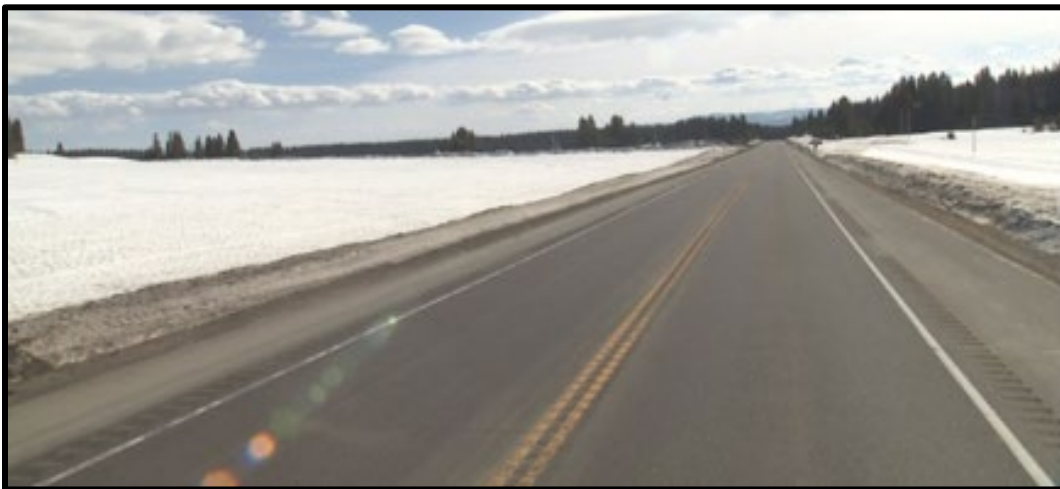
Figure 27: SH 040A MP 152.50 Typical Cross Section

Figures 27 and 28 show typical sections of SH 40 within project limits. **Figure 27** shows a 2-lane location that is typical for most of the study section and **Figure 28** shows the section with the westbound passing lane at about MP 153.06.

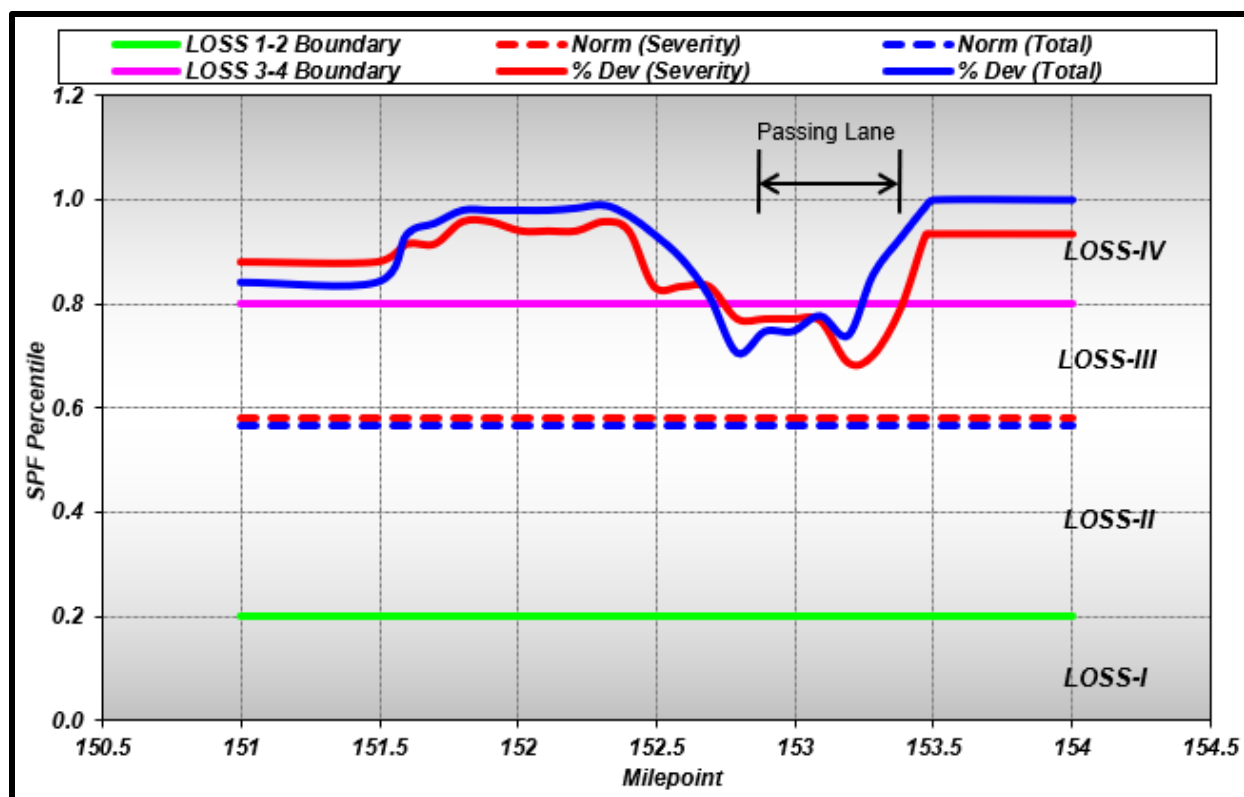
Figure 29: Corridor SPF for SH 040A MP 151.00 to 154.00

SAFETY PERFORMANCE ANALYSIS AND DIAGNOSTIC EXAMINATION The chart in **Figure 29** shows the corridor SPF for the study section. As the chart shows the entire study section is performing at the LOSS-III and LOSS-IV category for both frequency and severity of crashes suggesting high potential for reduction in both categories. The chart also shows that the LOSS appears to improve upon encountering the westbound passing lane.

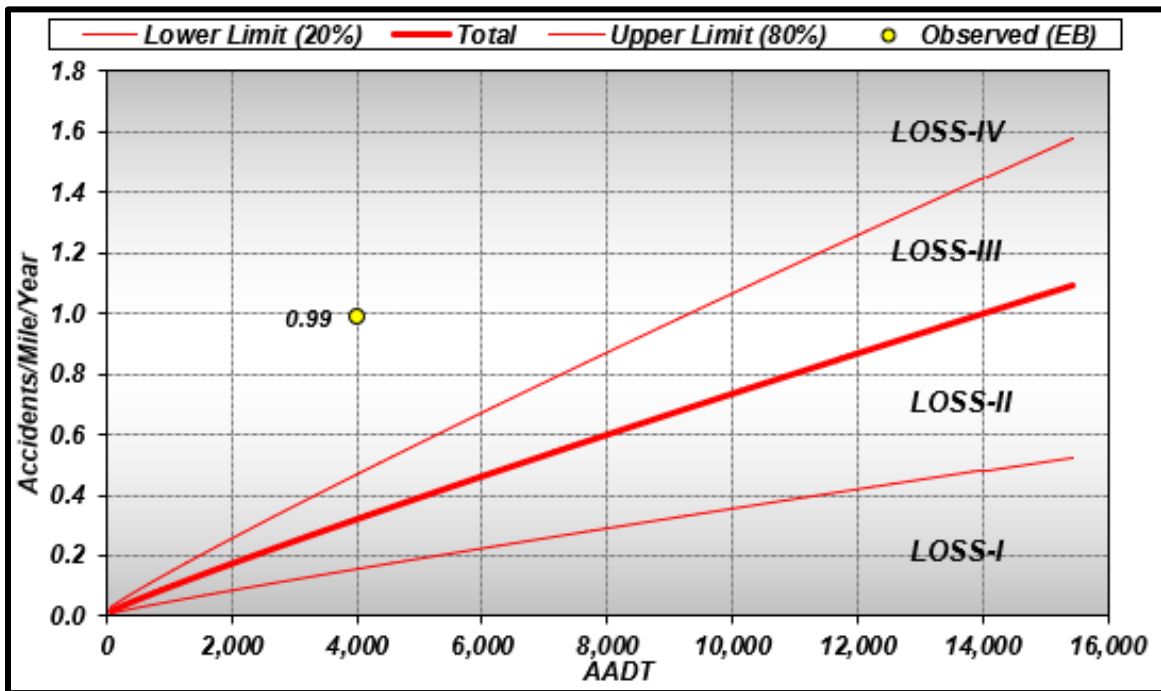
Figure 31: EB Corrected SPF for Injury and Fatal Crashes

Figure 31 represents segment safety performance from the stand point of severity and considers injury and fatal crashes only. It shows that the study section performs in the LOSS-IV category in terms of severity as well, suggesting high potential for reduction of crashes involving bodily injury.

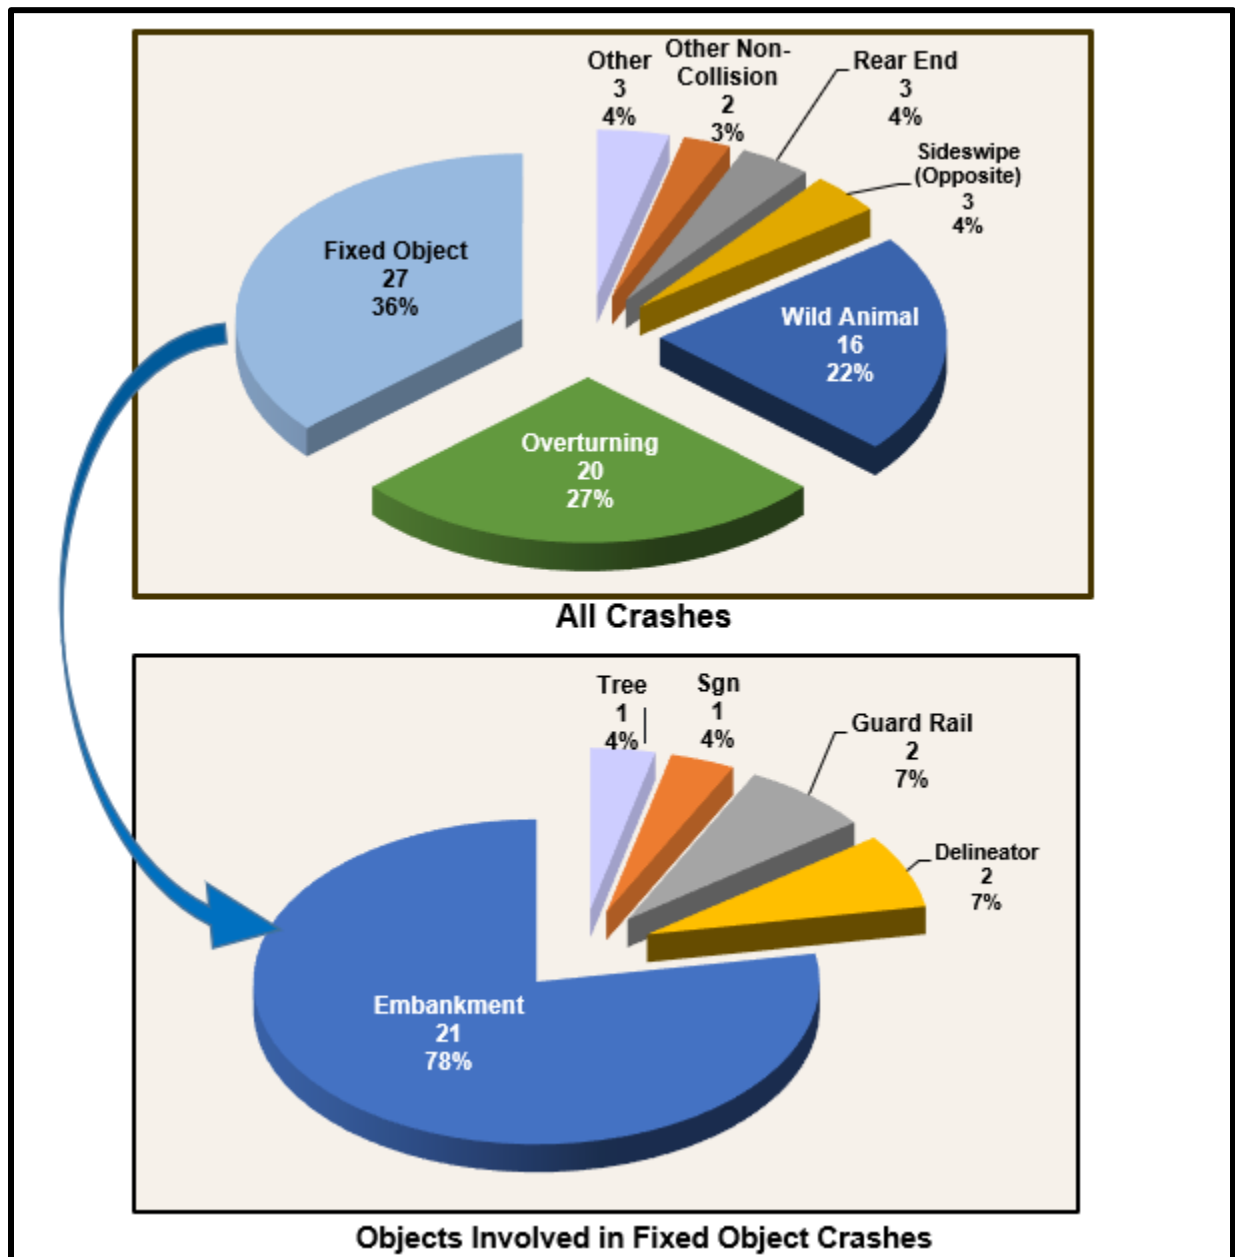
Figure 32: Crash Type Distribution SH 040A MP 151.00 to 154.00

the most common, representing 36% of all crashes. The lower chart in **Figure 32** shows a breakdown of the objects that were involved in those crashes, showing that Embankment was the predominant object accounting for 78% of those crashes. Overturning crashes were the second most common crash type representing 27% of all crashes, and Wild Animals were the third most common type accounting for 22%. All other crash types were relatively infrequent.

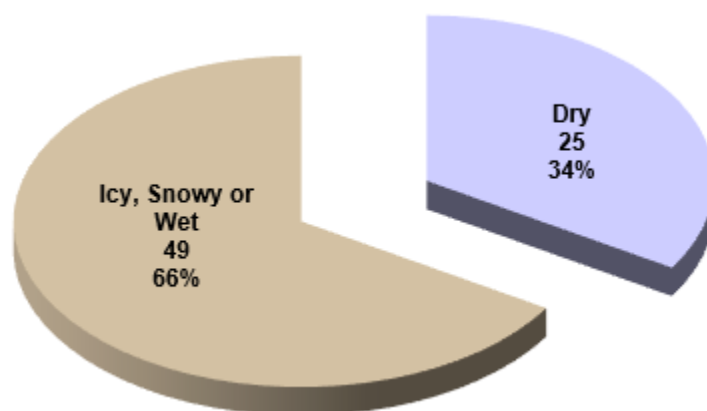
Figure 33: Distribution of Crashes by Road Condition SH 040A MP 151.00 to 154.00

The chart in **Figure 33** shows a breakdown of the 74 accidents by the condition of the roadway. As the chart shows, about two thirds, or 66%, of all accidents occurred when the road was icy, snowy or wet. The statewide average for this type of facility is for about 28% of all crashes to occur under during these road conditions.
