2+1 ROAD WITH BARRIER

Evaluation of the Feasibility of Deployment of Swedish 2+1 Road with Barrier in Colorado

1. Report No. CDOT-2020-05	2. Government Accession No.	3. Recipient's Catalog No.	
4. Title and Subtitle 2+1 ROAD WITH BARRIER Evaluation of the Feasibility of Deployment of Swedish 2+1 Road with Barrier in Colorado		5. Report Date April 2020

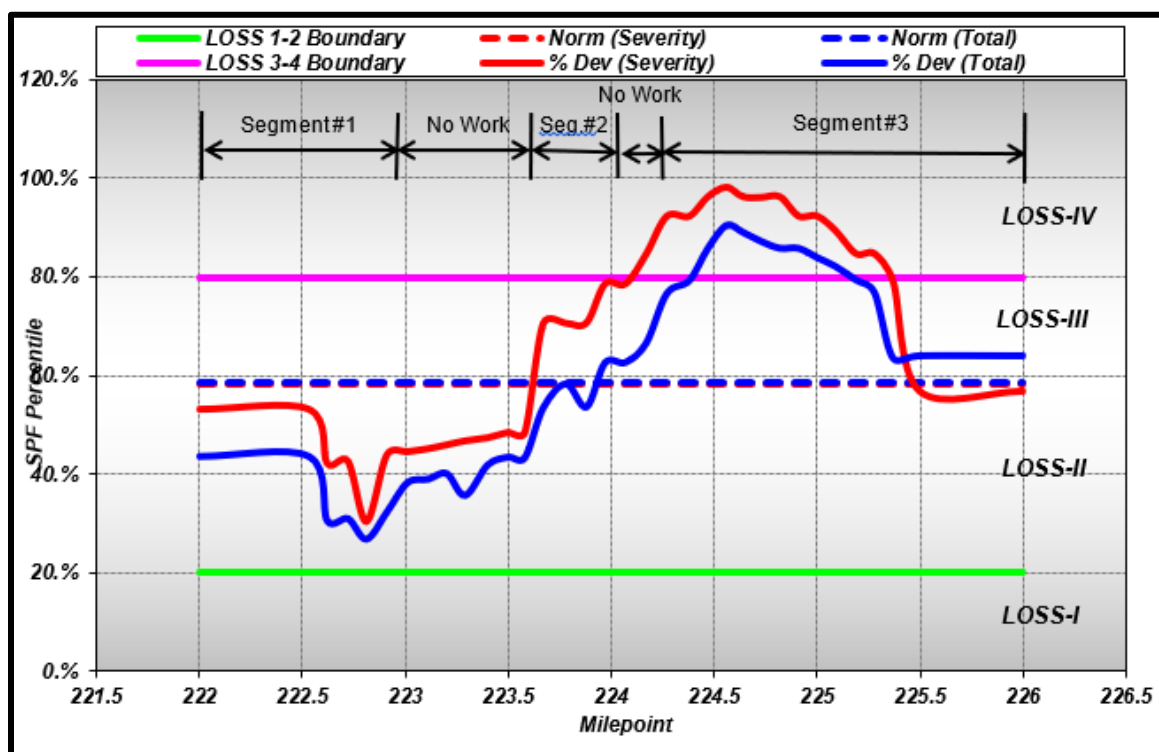
Figure 36: Corridor SPF for SH 040A MP 222.00 to 226.00

SAFETY PERFORMANCE ANALYSIS AND DIAGNOSTIC EXAMINATION The chart in **Figure 36** shows the corridor SPF for the study section with the three work segments and two no-work segments identified. As the chart shows much of Segment #3 is performing the LOSS-IV category suggesting high potential for accident reduction.

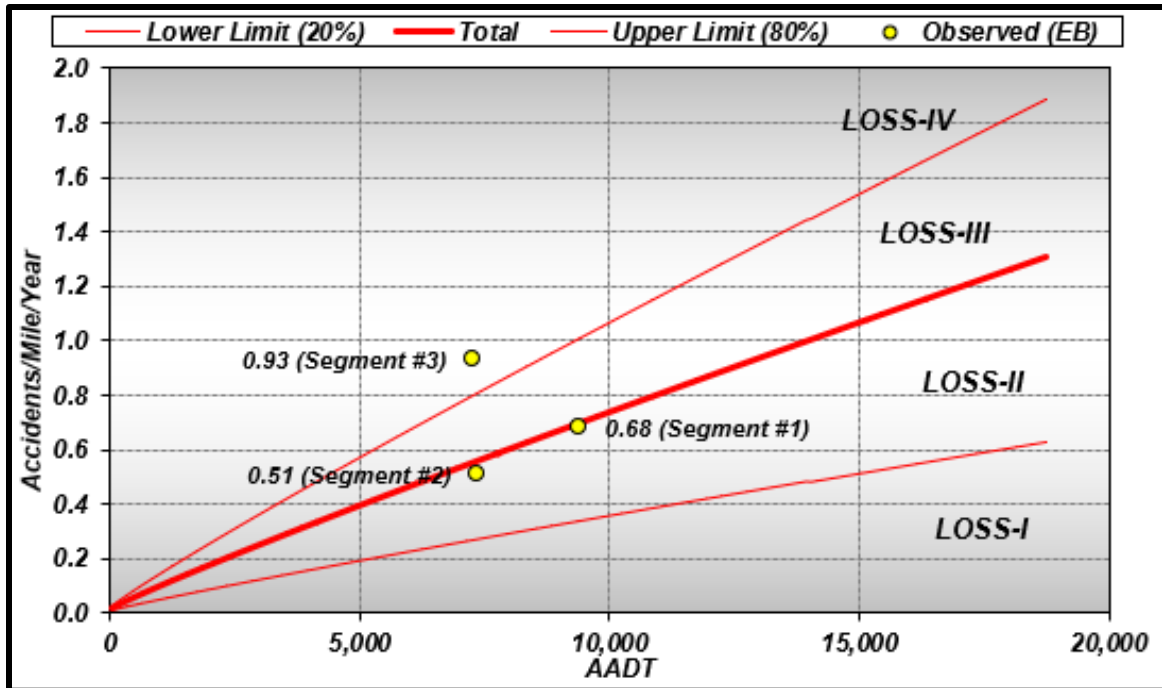
Figure 38: EB Corrected SPF for Injury and Fatal Crashes

Figure 38 represents segment safety performance from the stand point of severity and considers injury and fatal crashes only. It shows that the study section is performing in very close to the norm for Segments #1 and #2, and in the LOSS-IV category for Segment #3 in terms of severe crash frequency, suggesting a high potential for a significant reduction in severe crashes in Segment #3 and a somewhat lower potential in Segments #1 and #2.

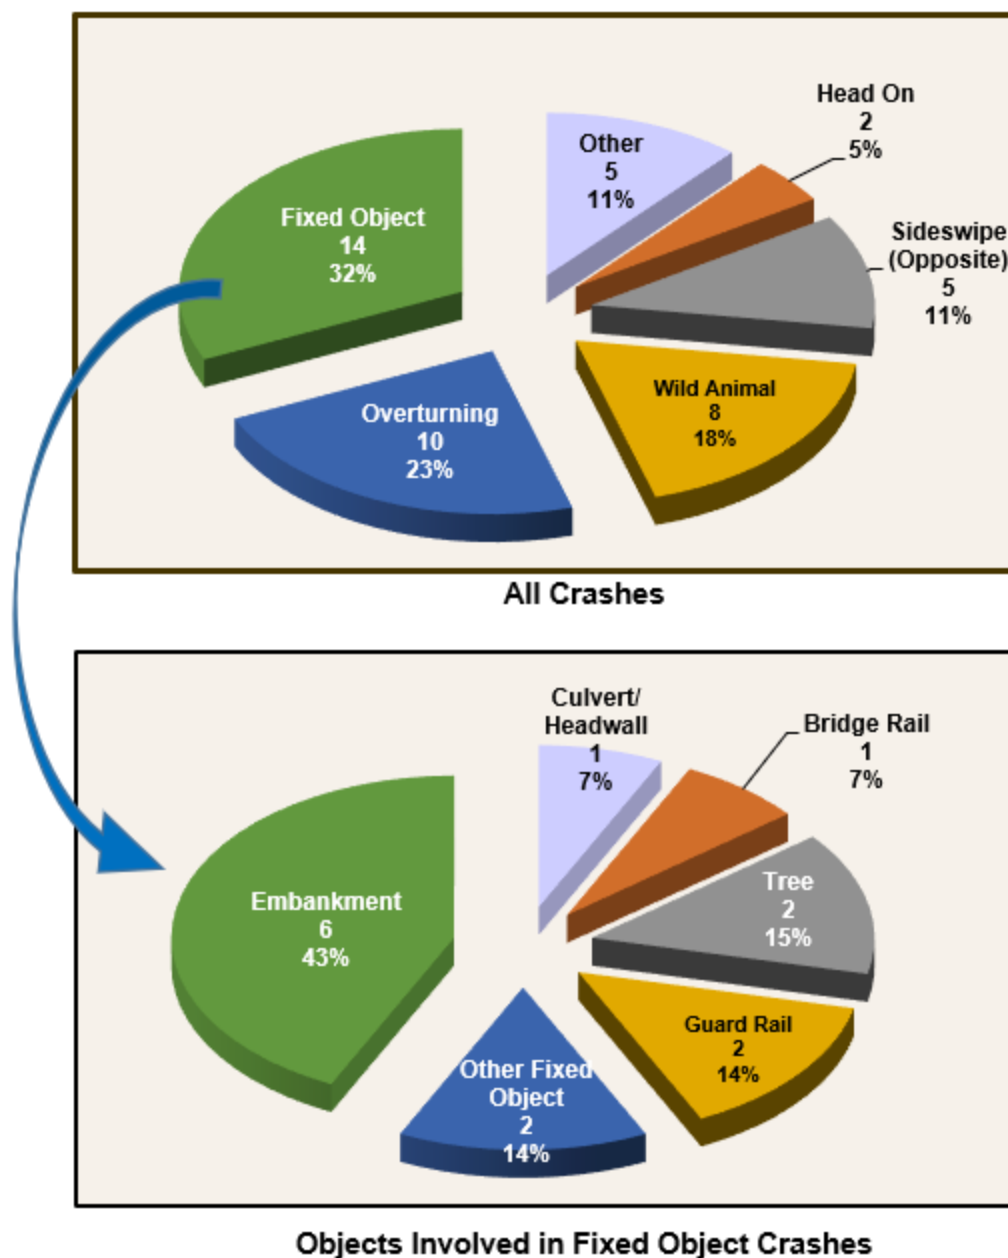
Figure 39: Crash Type Distribution SH 040A MP 222.00 – 226.00

Types of Crashes The overall distribution by crash type for all non-intersection related crashes within the study limits is provided in **Figure 39**. As the chart shows, Fixed Object crashes were the most common, representing 32% of all crashes. The lower chart in **Figure 39** shows a breakdown of the objects that were involved in those crashes, showing that Embankment was the most common object accounting for 43% of those crashes. Overturning crashes were the second most common crash type representing 23% of all crashes, Wild Animals were the third most common type accounting for 18%, and Opposite Direction Sideswipes were the fourth most common type accounting for 11% of the crashes. All other crash types were relatively infrequent but it is perhaps worth noting that two (2) head on crashes occurred which accounted for three (3) of the 18 injuries.

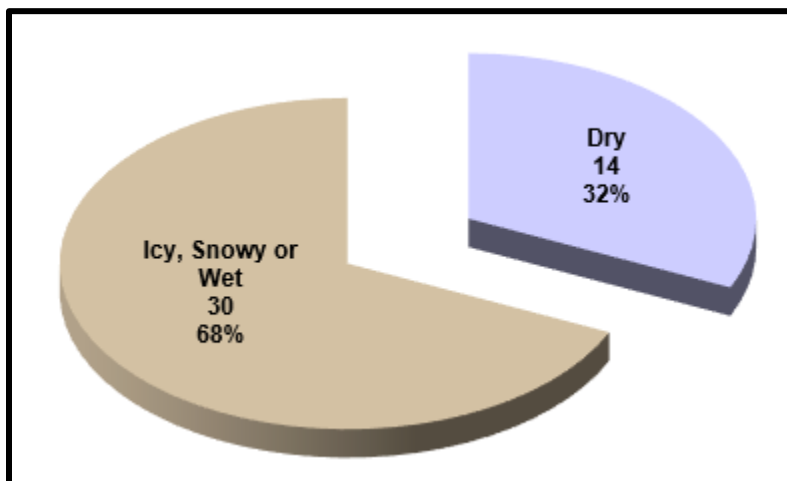
Figure 40: Distribution of Crashes by Road Conditions SH 040A MP 222.00 – 226.00

these road conditions. This higher frequency is likely due in most part to the high elevation of this location, which results in snow and ice persisting on the road for longer durations than at most lower elevations. However, the combination of this prevalence and the more frequent multi-vehicle collisions suggests that the separation between oncoming traffic provided by the Swedish 2+1 design could be particularly beneficial in this area in terms of reducing the number of severe crash types.

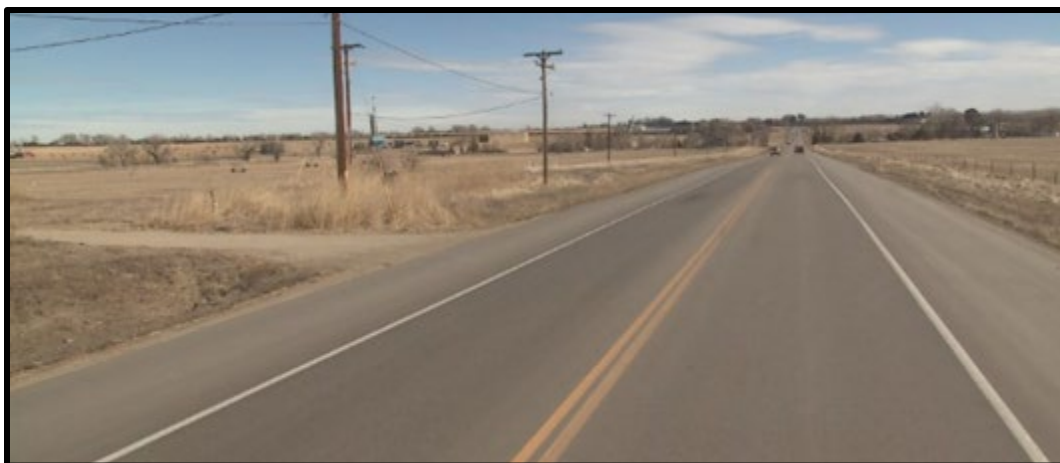
Figure 42: SH 066B MP 40.50 – Typical Cross Section

Figure 42 is a typical view of the roadway cross sections within study limits. This photo was taken from the OTIS photo log on SH 066B at approximately MP 40.50. The side road shown on the left is fairly typical of the many minor side roads that will be discussed later.

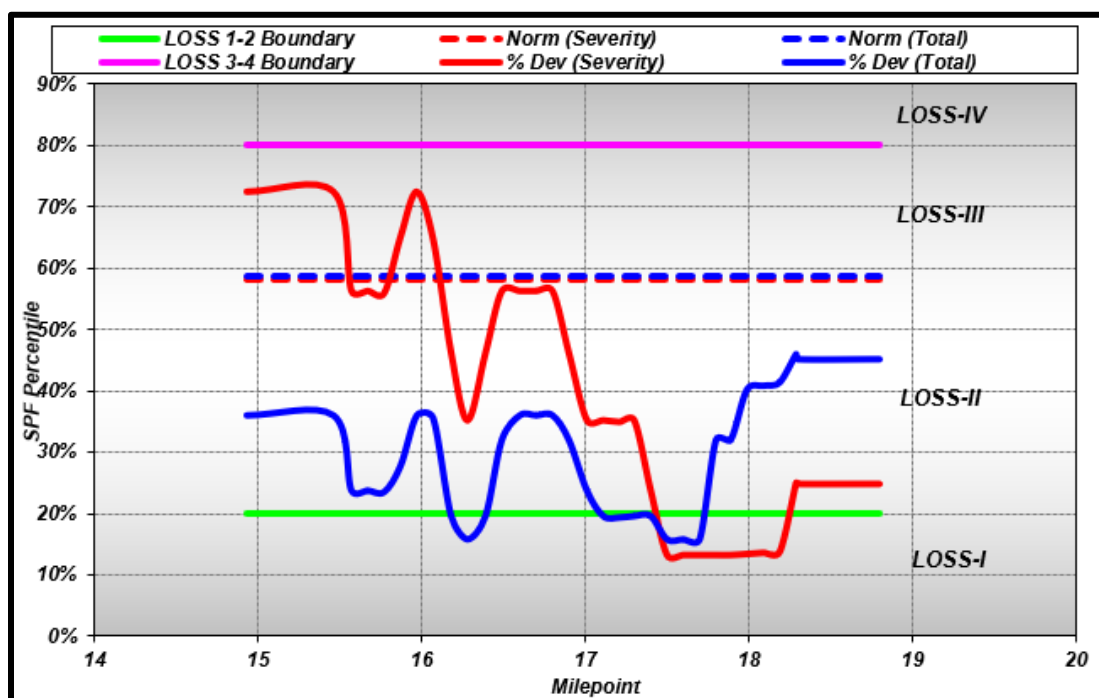
Figure 43 Corridor SPF for SH 052A

SAFETY PERFORMANCE ANALYSIS AND DIAGNOSTIC EXAMINATION The chart in **Figure 43** shows the corridor SPF for the SH 052A portion of the study section. As the chart shows the study section is performing in the LOSS-III in terms of severity for most of the first mile suggesting moderate potential for a reduction in severe crashes through that stretch. Otherwise, SH 052A is performing at LOSS-II and even dropping into LOSS-I suggesting relatively low potential for accident reduction in both categories.

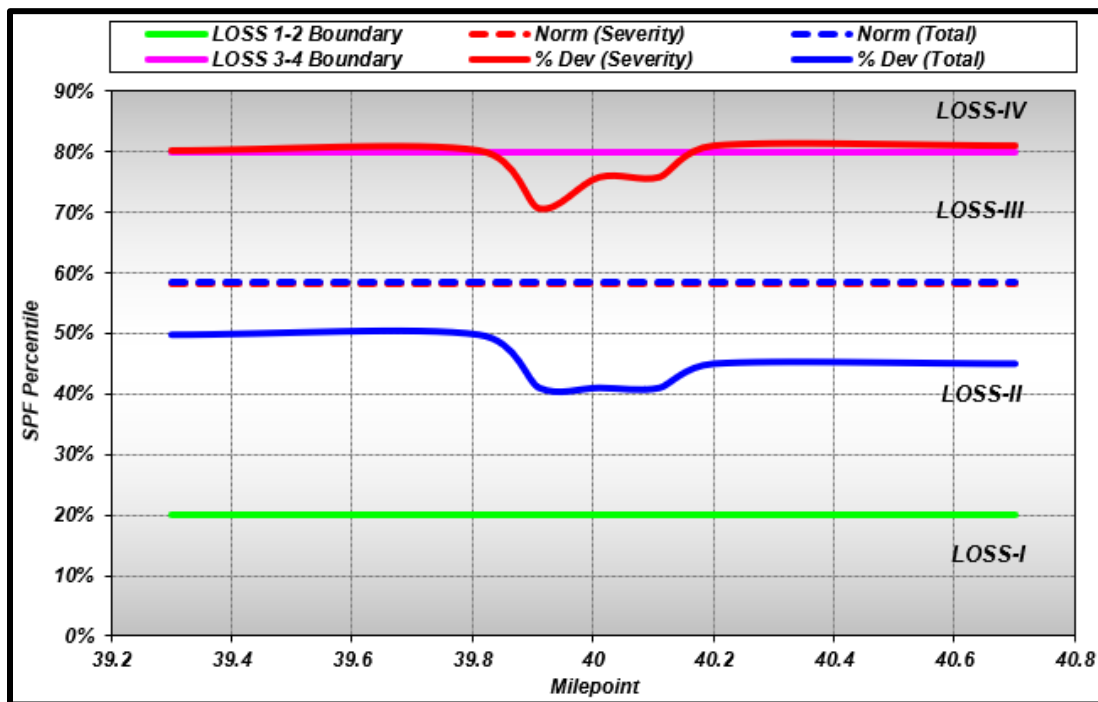
Figure 44: Corridor SPF for SH 066B

The chart in **Figure 44** shows the corridor SPF for the SH 066B portion of the study section. As the chart shows SH 066B is performing near the boundary of LOSS-III and LOSS-IV in terms of severity through most of the study section suggesting a relatively high potential for a reduction in severe crashes through the stretch. In terms of crash frequency, it is performing at LOSS-II throughout suggesting relatively low potential for a significant reduction in total number of crashes.

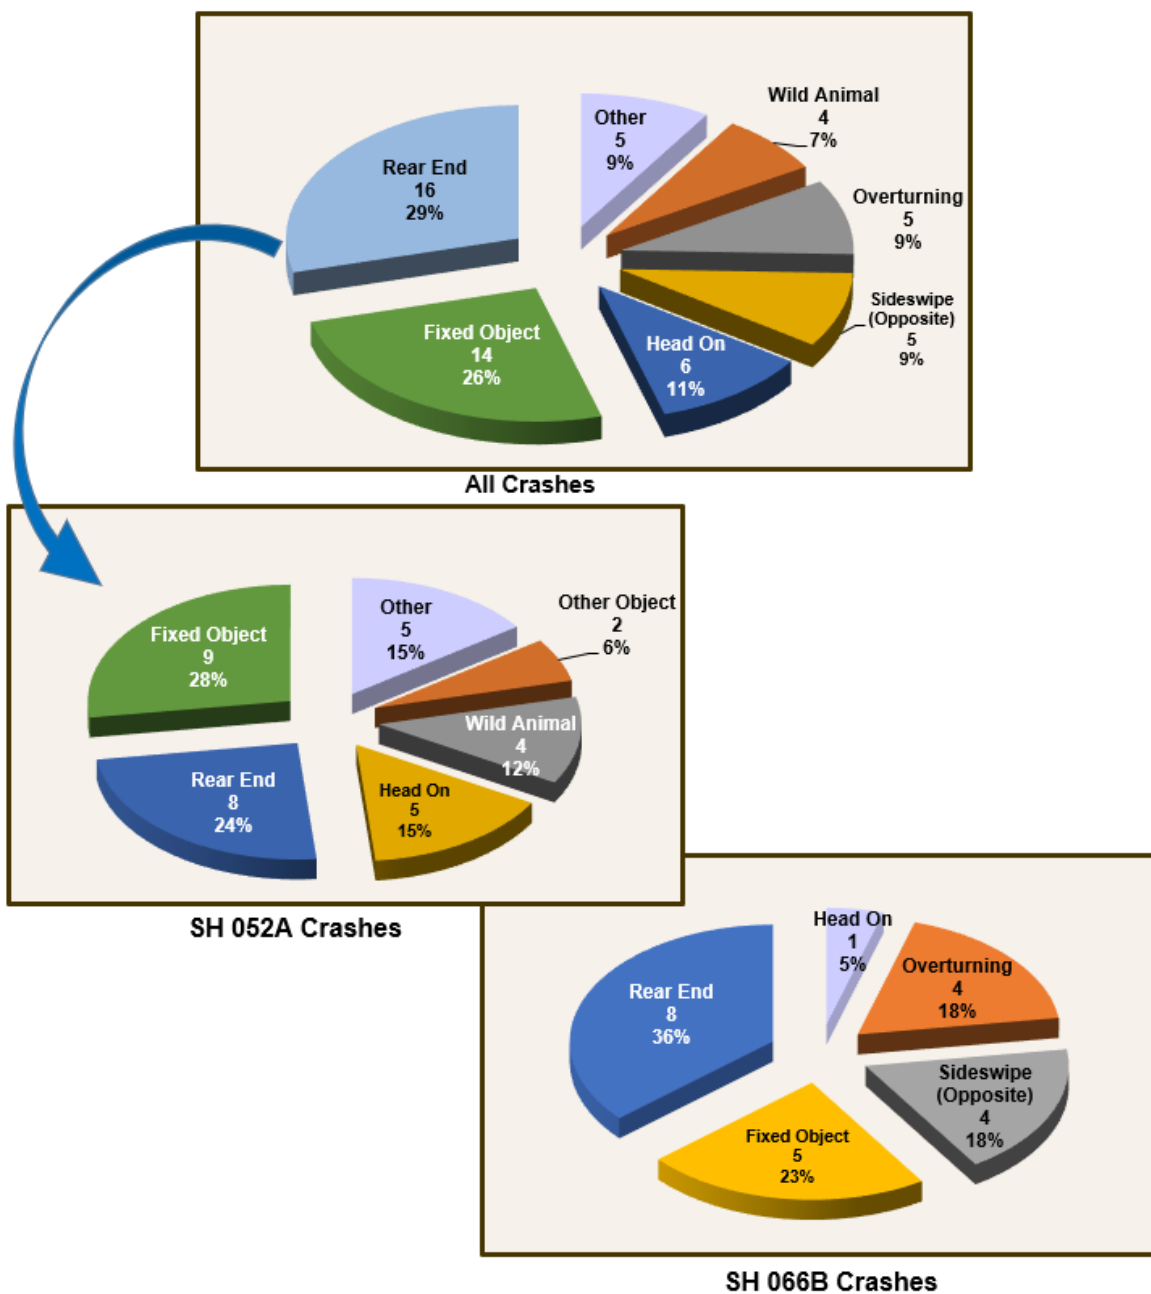
Figure 47: Crash Type Distribution, SH 052A MP 14.93 – 18.80 and SH 066B MP 39.30 – 40.70

the chart shows, Rear End crashes were the most common, representing 29% of all crashes. Fixed Object crashes were the second most common crash type representing 26% of all crashes followed by Head Ons (11%), Opposite Side Sideswipes (9%) and Overturning (9%). Wild Animal and other miscellaneous type made up the remaining 16% of crashes.

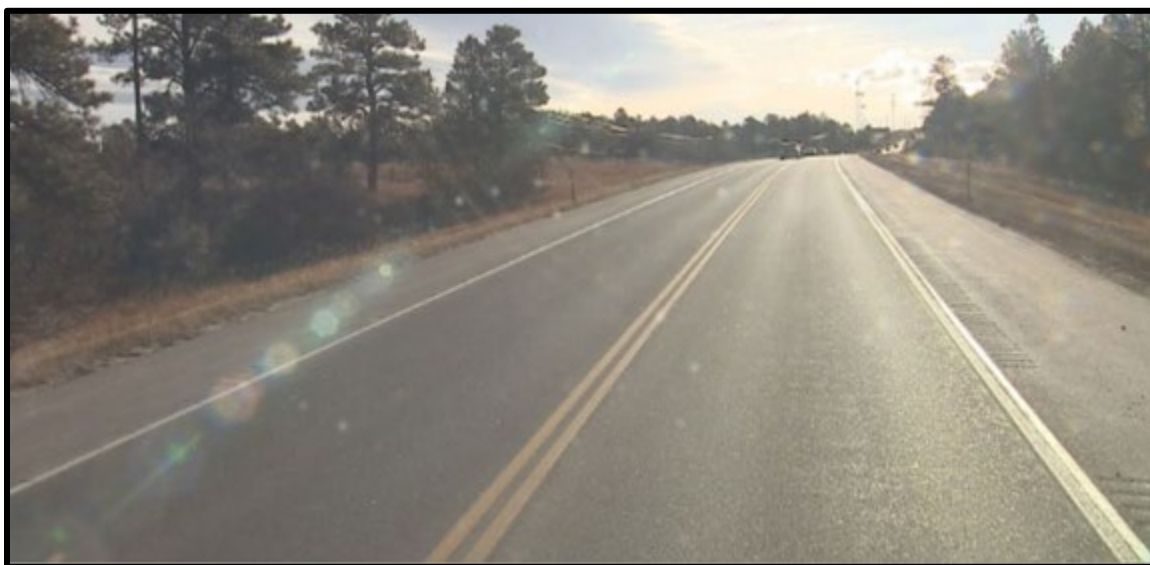
**Figure 49: SH 086A MP 10.60 – Typical Cross Section**

Figure 49 shows a typical section of SH 086A within project limits.

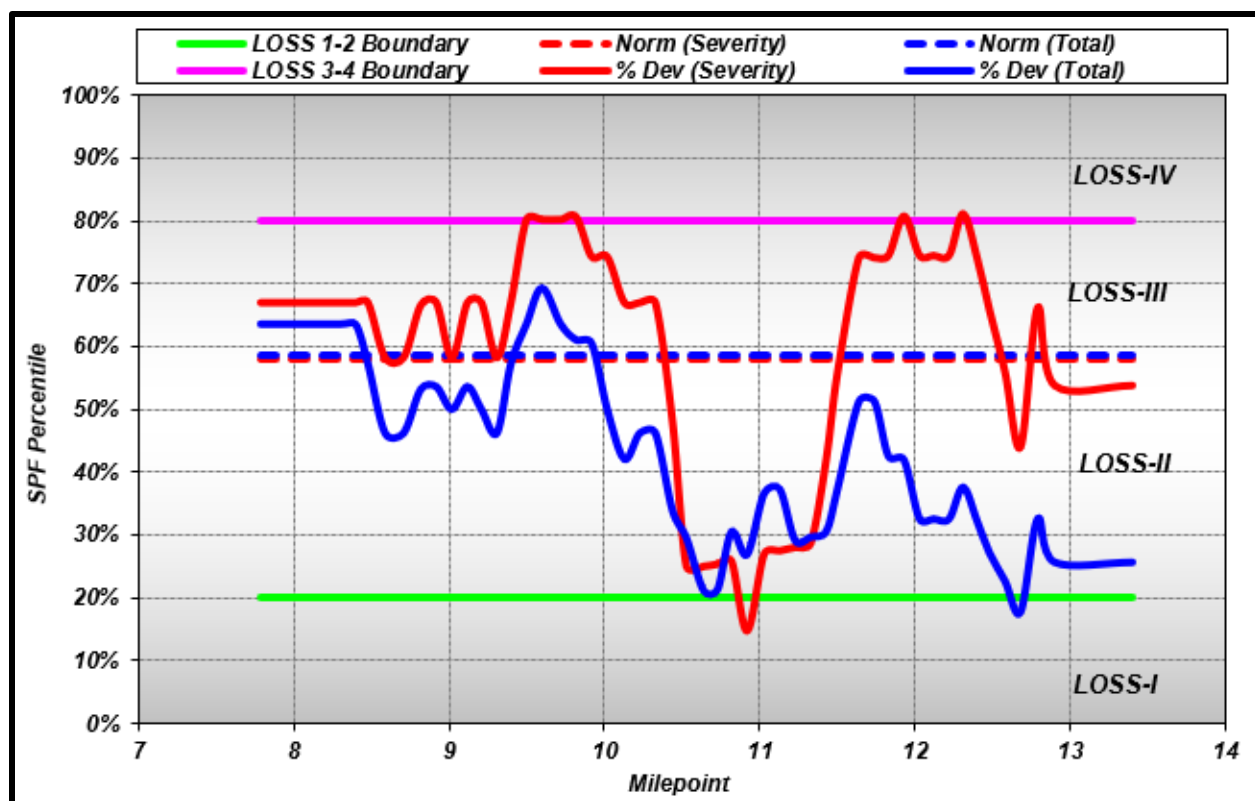
Figure 50: Corridor SPF for SH 086A

SAFETY PERFORMANCE ANALYSIS AND DIAGNOSTIC EXAMINATION The chart in **Figure 50** shows the corridor SPF for the study section. The chart shows that the study section is performing at the LOSS-II and LOSS-III category for both frequency and severity of crashes for almost all of the study section suggesting moderate potential for reduction in both categories. The LOSS for severity of crashes is higher than the LOSS for frequency of crashes suggesting somewhat higher potential for reduction of crashes resulting in bodily injury.

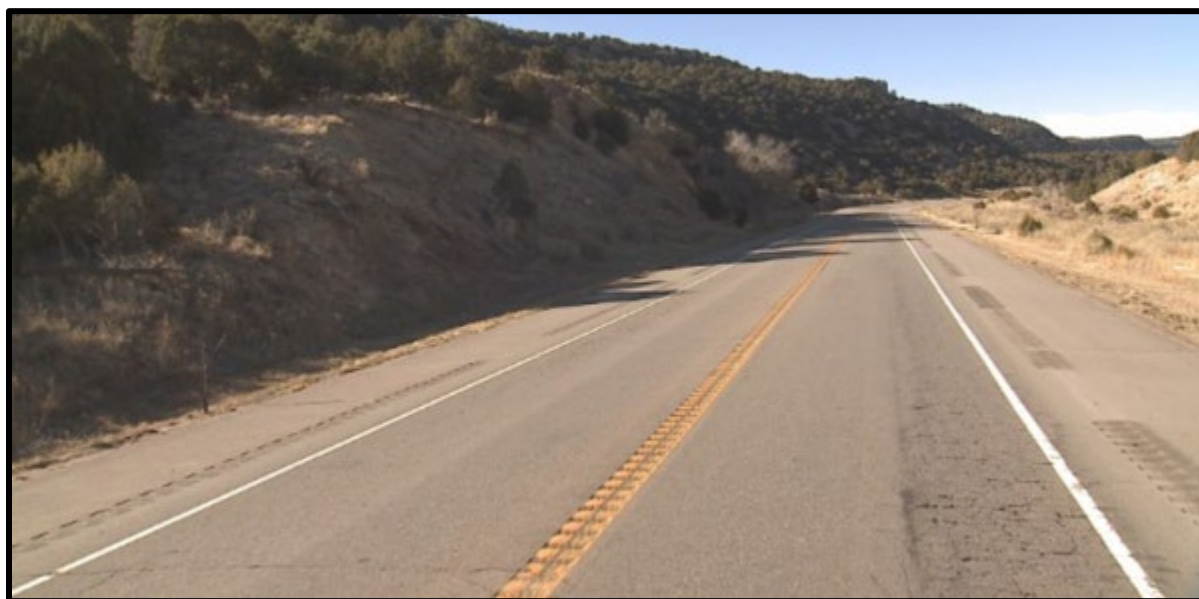
Figure 55: SH 115A MP 22.04 – Typical Cross Section

Figure 55 is a typical view of SH 115A within project limits, taken at approximately MP 22.04.

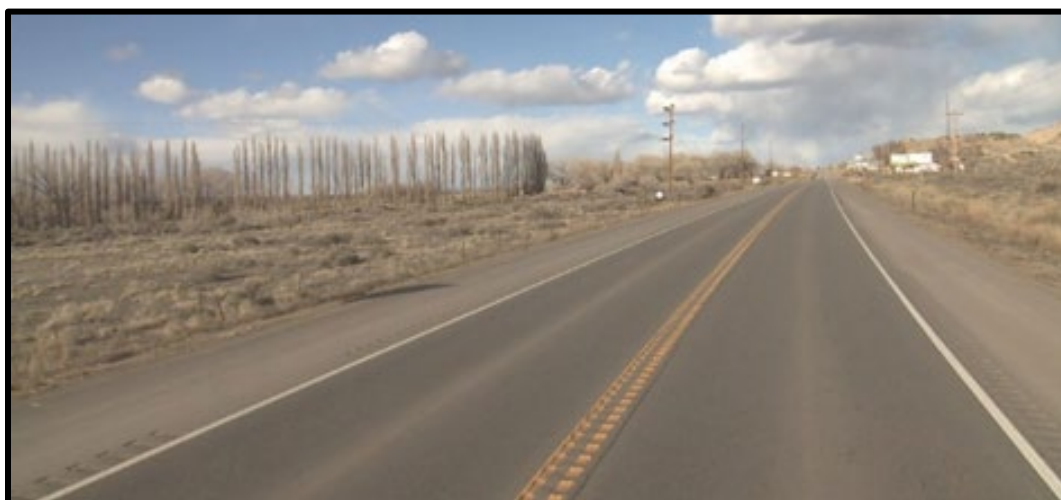
**Figure 61: SH 160A MP 27.50 – Typical Cross Section**

Figure 61 is a typical view of SH 160 within project limits, taken at approximately MP 27.50.

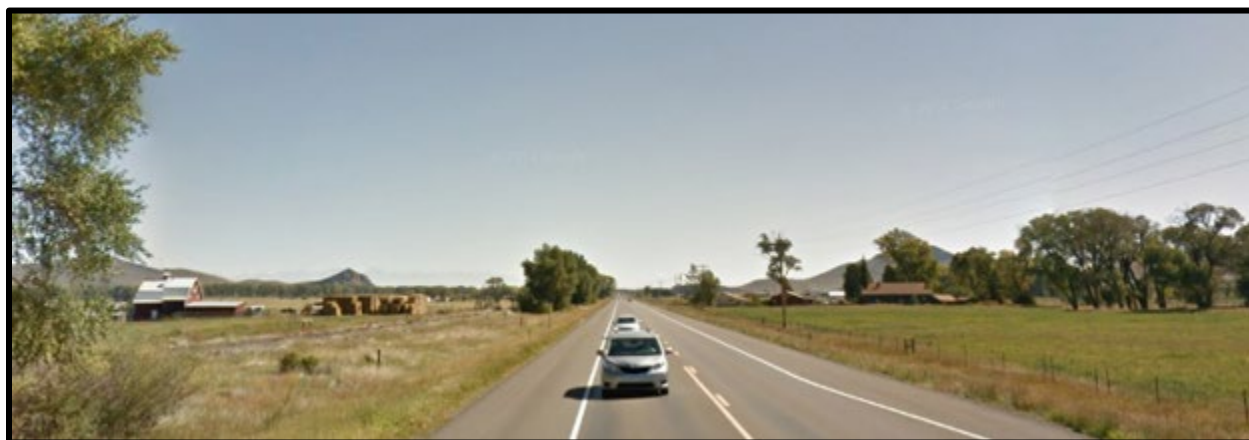
Figure 67: SH 160A MP 199.20 – Typical Cross Section

Figure 67 is a typical view of SH 160A within project limits taken at approximately MP 199.20 showing the generally flat nature of the surrounding terrain.

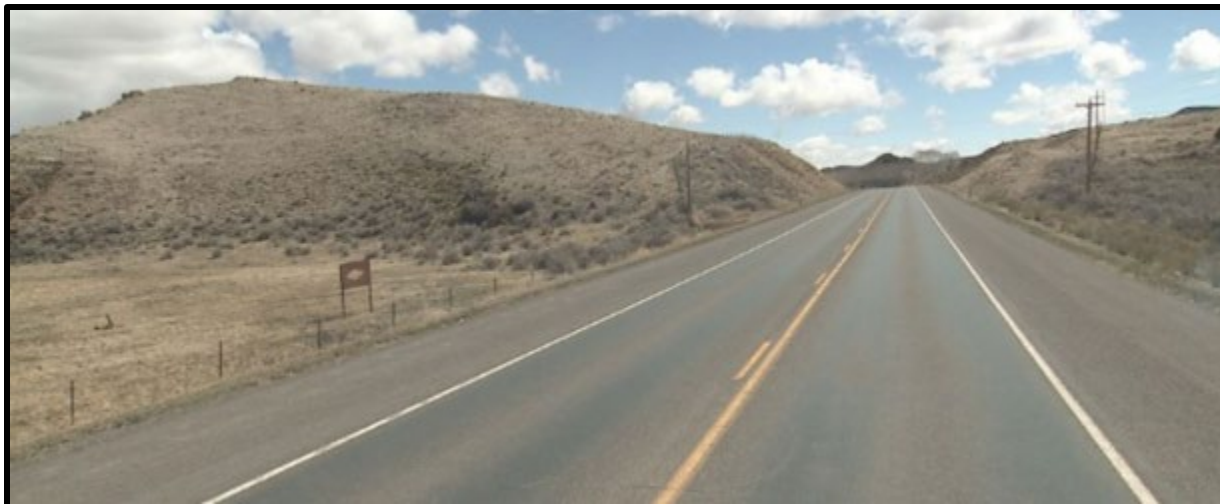
Figure 68: SH 160A MP 198.50 – Cross Section at Cut

Figure 68 is a view of SH 160A at approximately MP 198.50 showing the cut section described above. This is the only place within the project limits in significant cut or fill and the only place where the grade was estimated to exceed 1%.

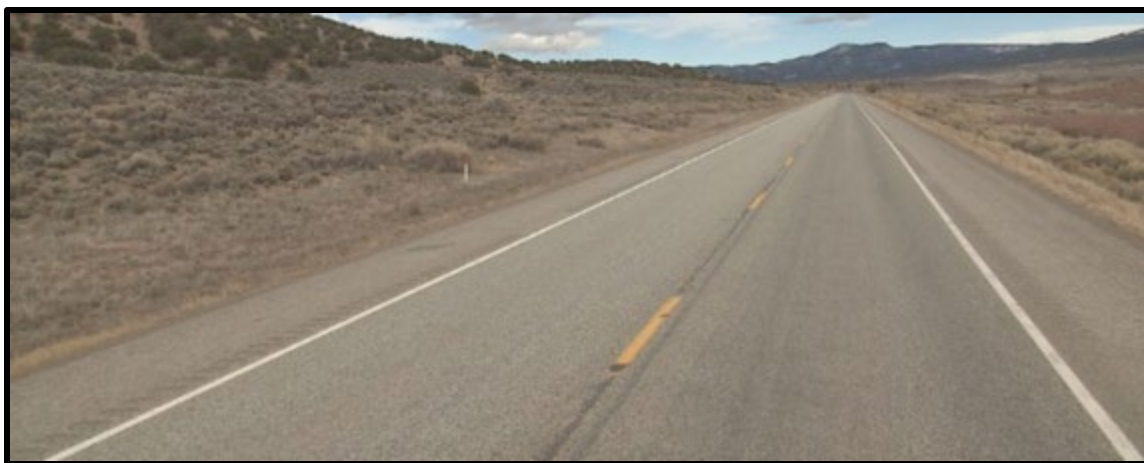
Figure 75: SH 160A MP 259.60 – Typical Cross Section

Figure 75 is a typical view of SH 160 within project limits.

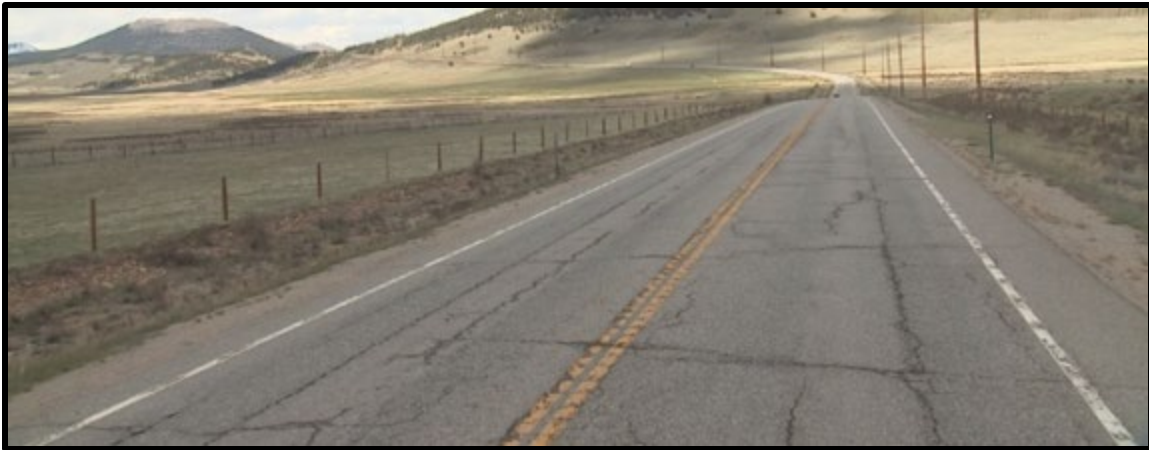
Figure 81: SH 285D MP 185.20 – Typical 2-Lane Cross Section

Figures 81 and **82** are typical views of SH 285 within project limits. The photo in **Figure 91**, showing a section in the 2-lane portion of the study section, and the photo in **Figure 82**, showing a section in the 3-lane portion of the study section. Both photos show the worn centerline rumble strips.
