# Capacity Prediction of Repaired and Unrepaired Bridge Beams with Deteriorated Ends

**FINAL REPORT – SEPTEMBER 2025**

**Western Michigan University**

## Final Report (2022 - 2025)

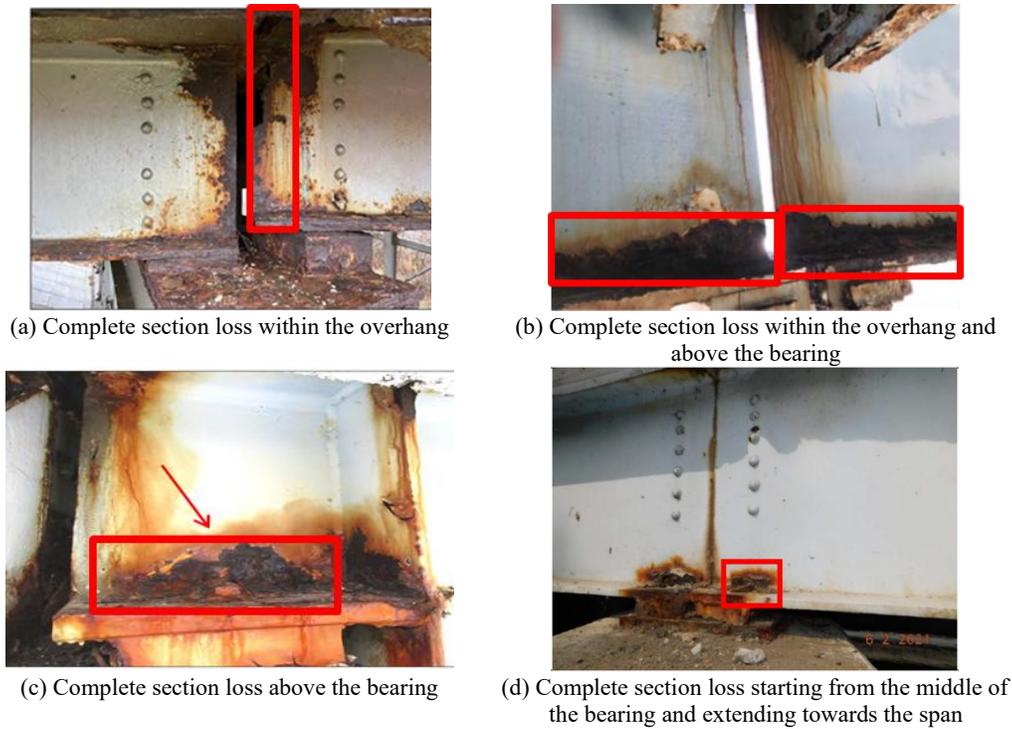
**Figure 7-12. Hole configurations documented during bridge inspection.**

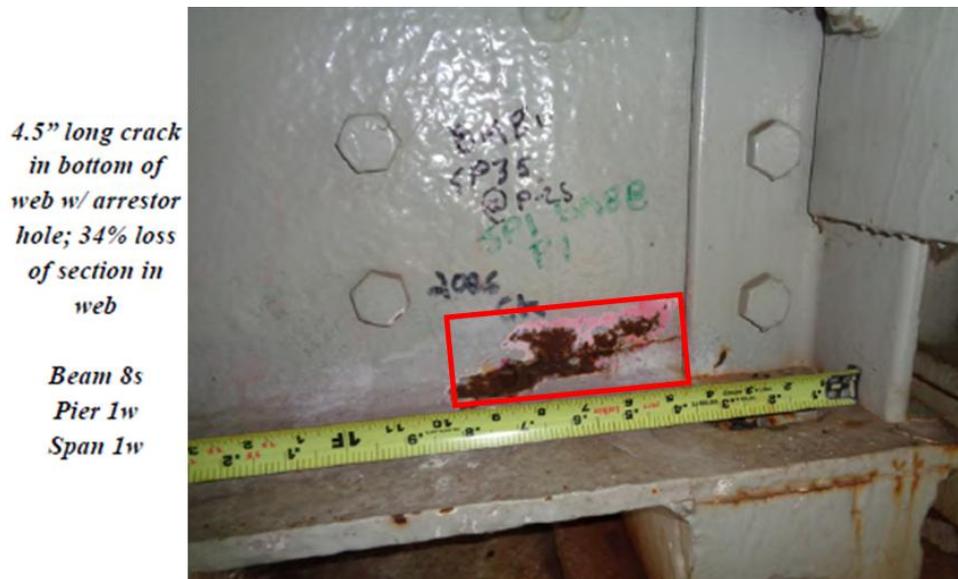
Figure 8-2. Beam end with a 4.5 in. long crack (STR 10907).

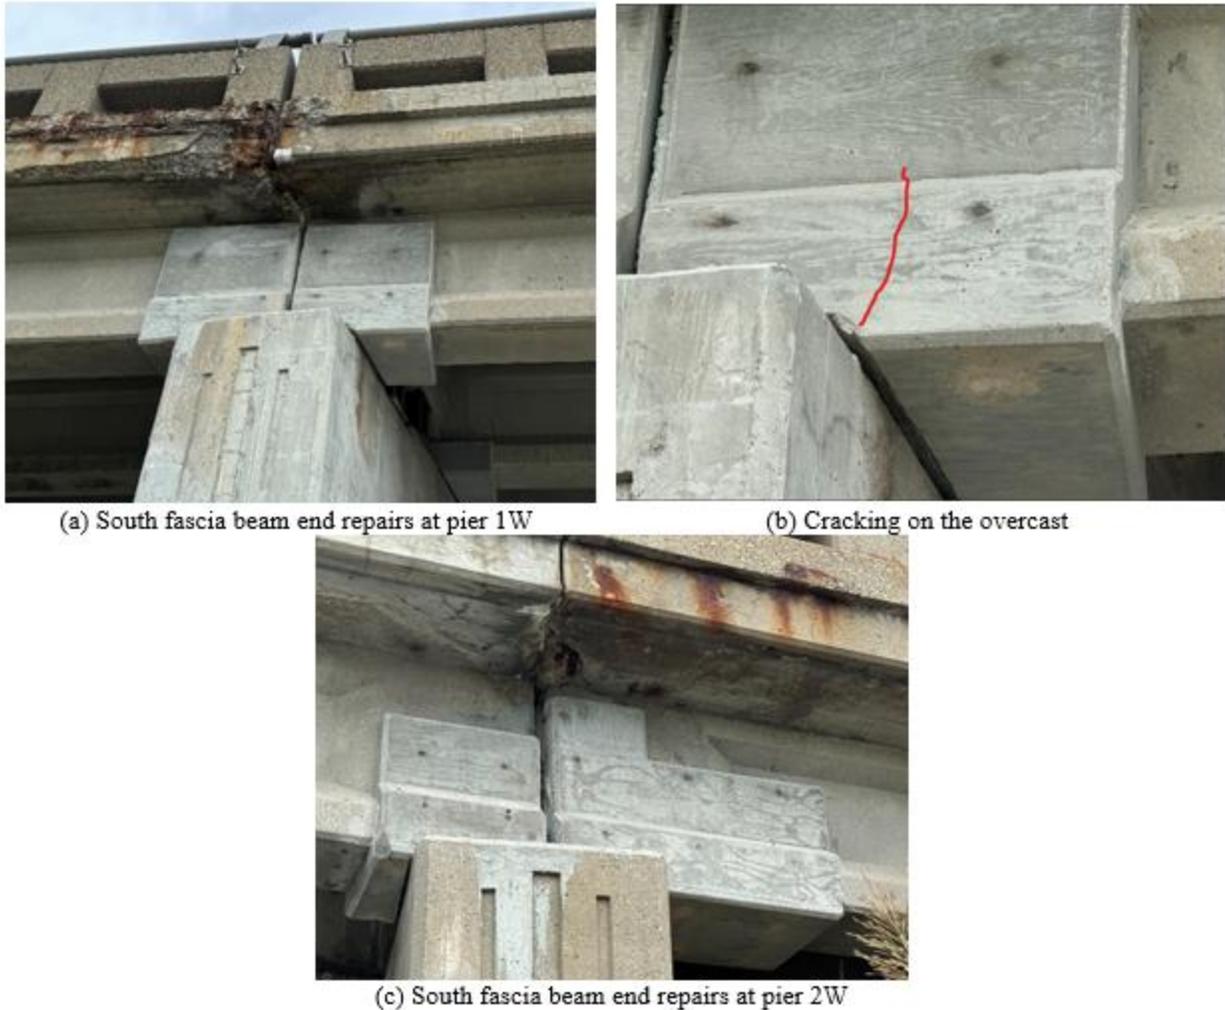
**Figure D-33. The condition of the south fascia beam repairs at pier 1w and 2w.**

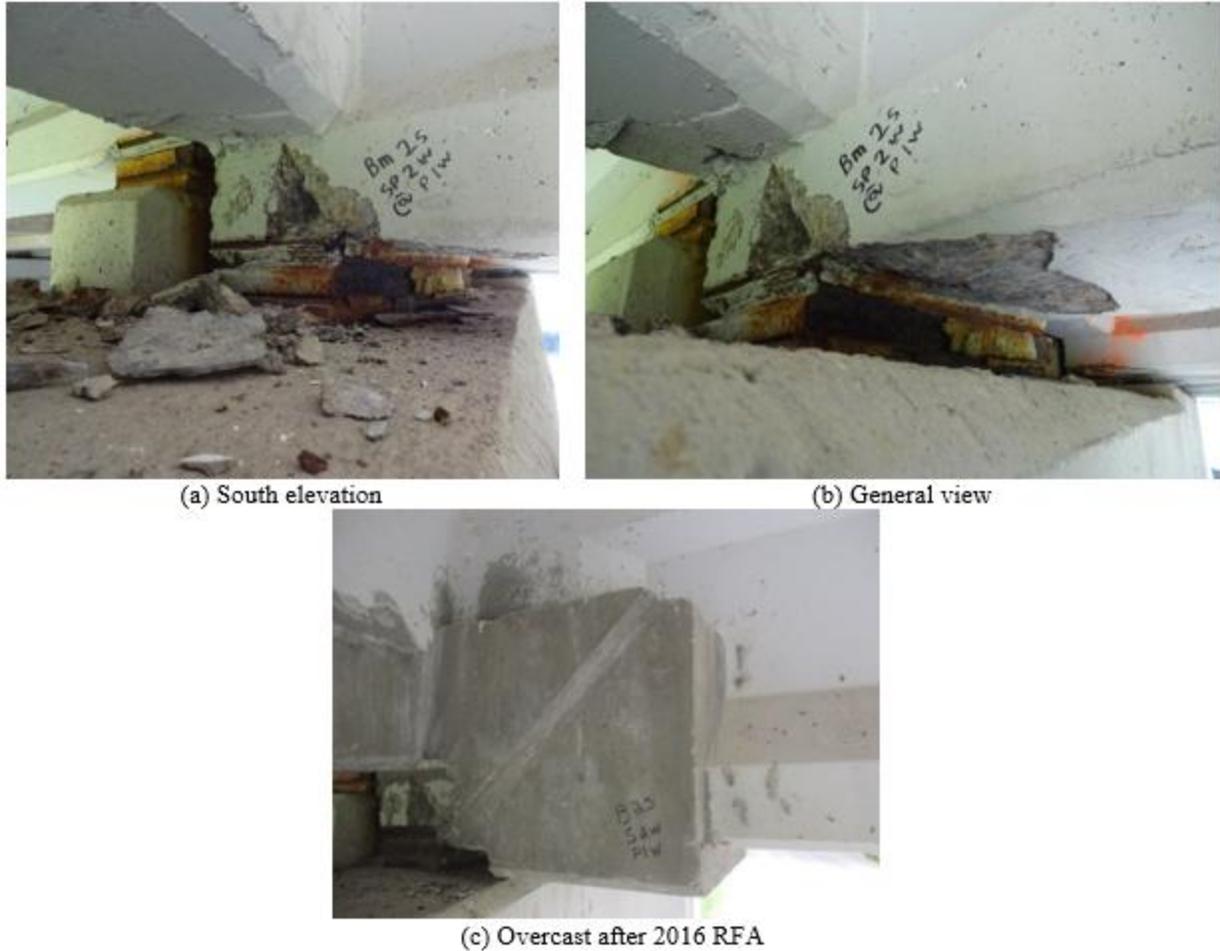
**Figure D-62. The condition of beam 2s in span 2w at pier 1w as of 06/09/2016 and the subsequent repair of the beam end.**

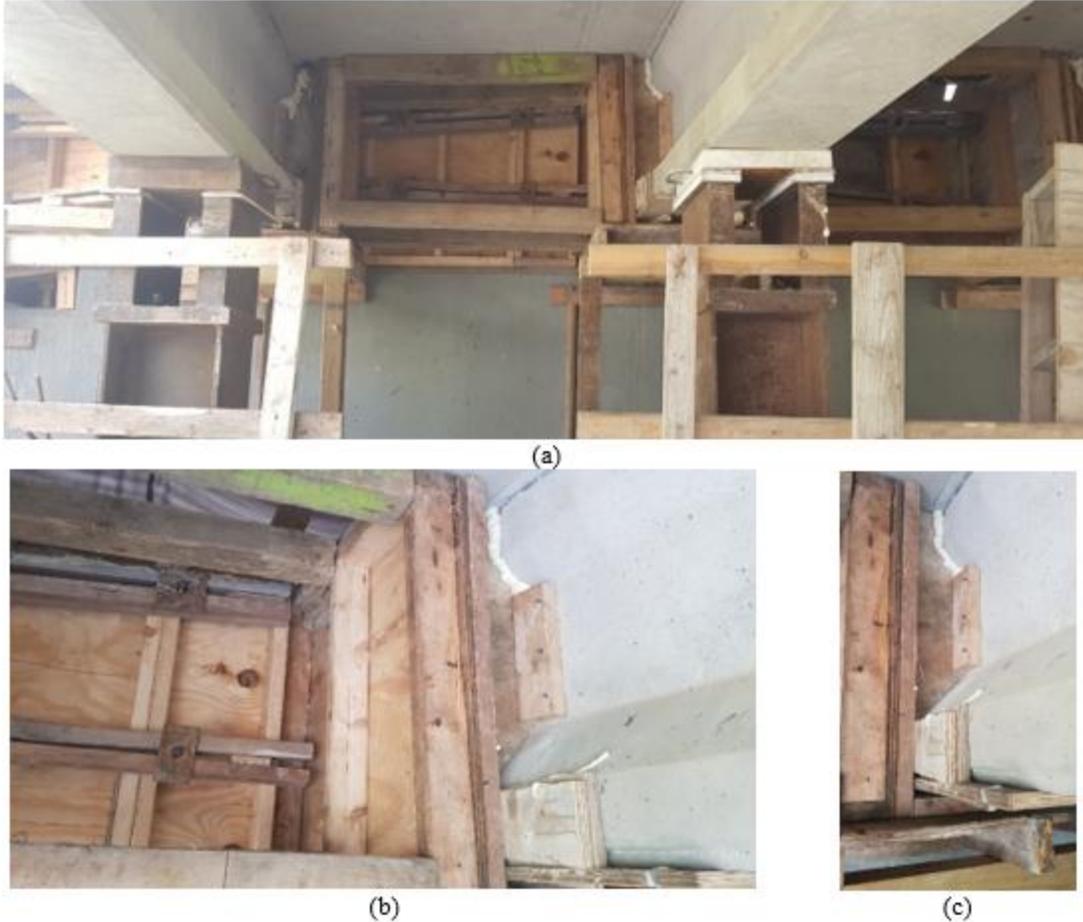
**Figure F-14. Formwork for an interior beam end overcast with an end diaphragm.**
