**DOT/FAA/TC-26/5**

# **AIA Recommendations for Ultrasound Inspection of New- Make Turbine Engine, Life-Limited Rotating Parts**

January 2026

Final report

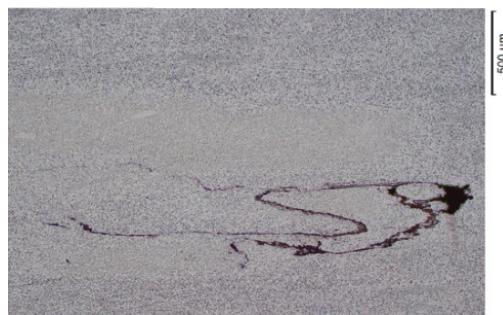
A region of segregation, typically characterized by a reduced content of the hardening element and an oxide layer (OCNC) surrounding the segregated volume. After etching, these regions typically appear whiter than the surrounding material (matrix) and depending on thermomechanical processing conditions, may show an area of grain coarsening. Voided areas may form at the boundary between the dirty zone and the matrix. Figure 2.3 is a metallographic image of a DWS found in ring-rolled forging.

**Figure 2.3 . Dirty White Spot (DWS).**

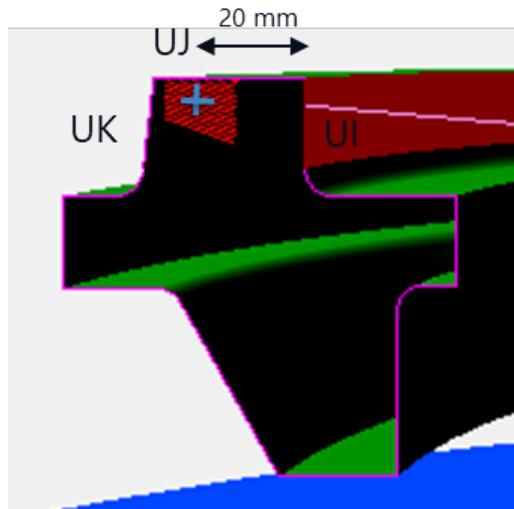
One OEM identified Disk 5 as having an indication of interest, located as shown in Figure 3.18. The cross marks the location of the indication, and the relevant scan regions of the disk are labeled as UI, UJ, and UK. The C-scan image of the indication is presented in Figure 3.19 C-scan images of the Disk 5 indication from surface UI using a 0-deg longitudinal surface focusing using 10 MHz probe C-scan images of the Disk 5 indication from surface UI using a 0-deg longitudinal surface focusing using 10 MHz probe. The parameters used for the planned C-scans are detailed in Table 3.15.

**Figure 3.18** Disk 5 with relevant UT scan regions UI, UJ, and UK, showing an indication at the approximate location marked by the blue cross.
