# **Determining Layer Thickness and Understanding Moisture Related Damage of State-Owned Roads Using GPR and Capturing Such in a GIS-Based Inventory**

## **Final Report August 2024**

**Principal Investigator:** Christopher D.P. Baxter, Ph.D., P.E.  
Professor, Departments of Ocean/Civil and Environmental Engineering

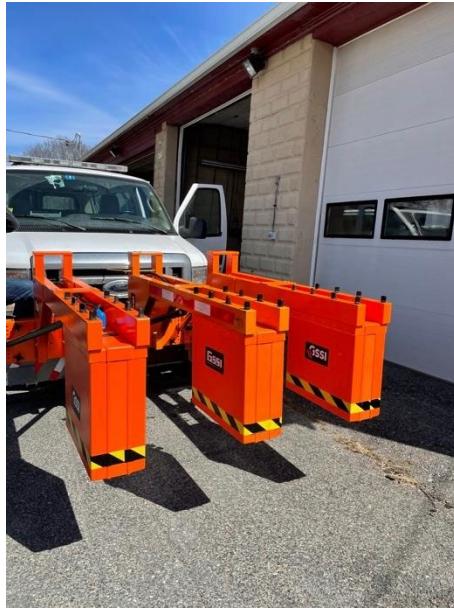
Figure 2: Three, 2 GHz antennas installed on the front of the RIDOT van

The physical setup of the Roadscan system included mounting one (SIR 20) or three (SIR 30) 2 GHz antennas onto the front of a RIDOT owned van as shown in Figure 2. Availability drove the choice of which system would be used on a particular day. The Roadscan-devoted laptop (with the data collection software) and data acquisition units (SIR 20/SIR 30) were mounted in the interior of the RIDOT van and connected to the antenna control cables, power supply, and GPS. The GPS hardware was located on the top, back-center of the van. To ensure accurate coordinates would be collected, the coordinates of the GPS hardware in relation to each mounted antenna were inputted into the laptop. Additionally, filters were applied to each antenna to remove noise that would hinder the visibility of the data file.

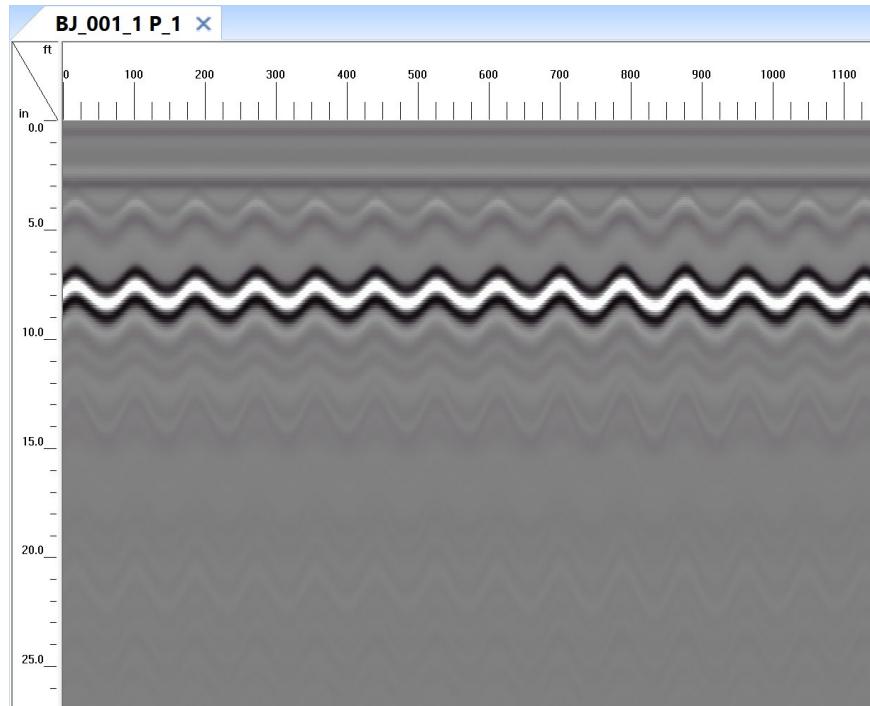
Figure 3: Raw Metal Plate File

The first file collected using the Roadscan is null. The second is a metal plate file. This file is used to remove the bouncing effects in the data because of the van not traveling over an even surface, and to calibrate the data so that time ‘zero’ is at the roadway’s surface. This file was collected by placing a metal plate under one of the antennas, and collecting data in time mode for a few seconds, while a person jumps up and down on the van’s bumper. This is usually completed in a parking lot near the roadway of interest. An example of the raw metal plate file can be seen in Figure 3 below.

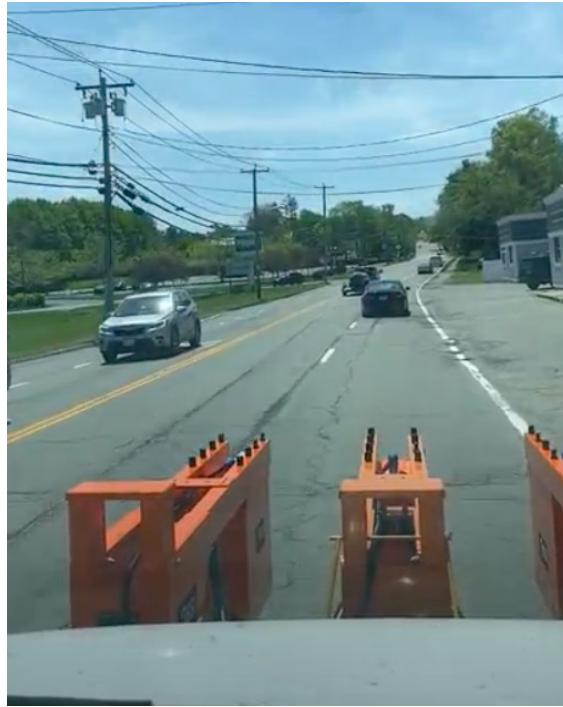
Figure 4: Snapshot of video from East Main Road data collection

Once the metal plate file was collected, data collection from the roadway of interest began using the Roadscan-devoted laptop with the preinstalled data collection software. Data was collected from an entire road (from start to finish) or a pre-established segment of road. If the Roadscan SIR 20 with one antenna was used, data would be collected from each antenna mounting location, from each lane. These locations equate to the right wheel path, left wheel path and the center of the roadway. If the Roadscan SIR 30 with three antennas was used, data would be collected from all three mounting locations at the same time (Figure 4), from each lane (Figure 5). Once data collection was complete, the data was transferred from the laptop to an external USB drive for further processing, analysis and visualization.

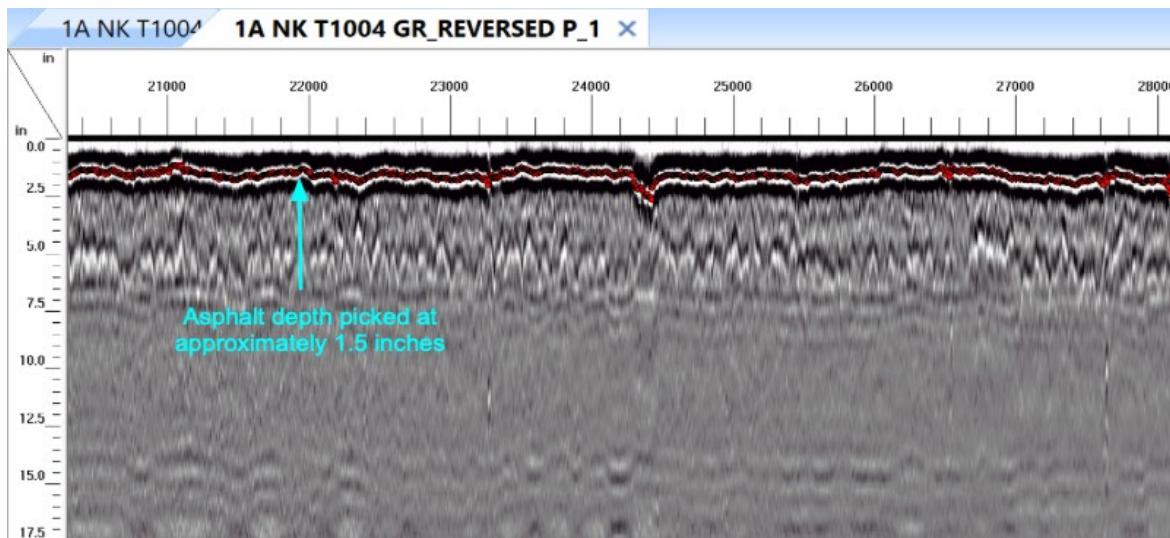
Figure 6: Calibrated B-Scan Collected from Route 1A

All the raw data was post-processed using GSSI's RadaN software. Post-processing steps included removing gain and using the metal plate file to perform a calibration. At this stage of analysis, one can visually estimate the pavement thickness by observing the reflections of the B-scan. The points located at the estimated layer depth can be manually selected in RadaN, as shown in Figure 6. These selected points were then exported to a .CSV file. The exported information associated with the selected points includes: file name, distance (from data collection starting point), amplitude of the return signal, depth, and dielectric. For some sites, the estimated pavement depths from RadaN were compared with actual, measured pavement depths from cores that were collected from strategic locations along the roadway.

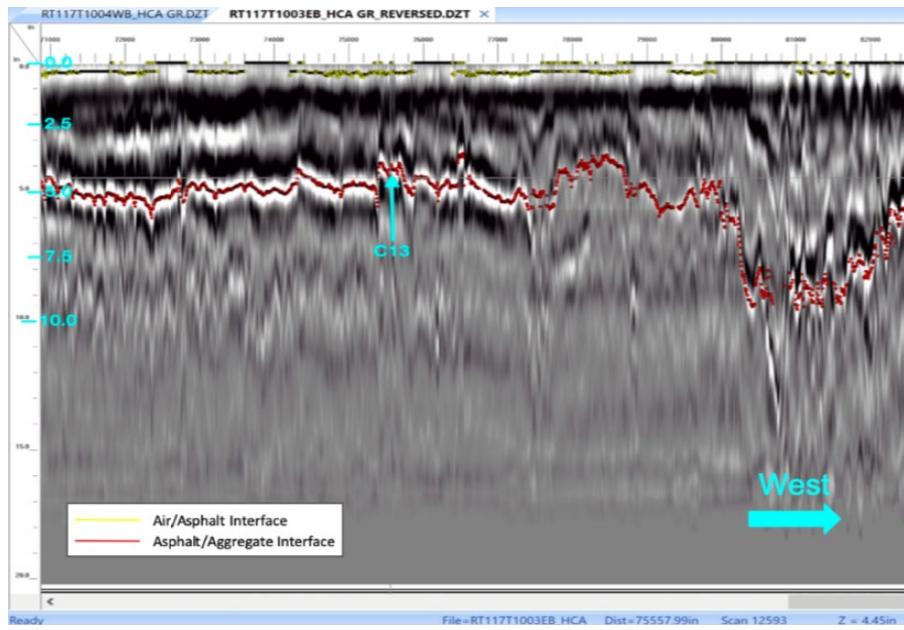
Figure 9: Example of picked Radan file consisting of a road section with areas of composite and non-composite base

After the files were calibrated in Radan, the roadway's surface and the bottom of the asphalt were manually 'picked' as layers in Radan. For this site, the RIDOT was interested in the pavement depth and the identification of any composite sections. The surface layer is picked in yellow and the bottom of the asphalt layer is picked in red, as shown in Figure 9. A CSV file was outputted from Radan to include the depth and dielectric constant of each 'pick' in each layer. When picking the bottom layer, it was discovered that the road consists of both a composite and non-composite base. In Figure 9, the composite section of the road is shown as the red layer with the bright reflection from approximately 71,000 inches to 77,400 inches. A section of the road with a non-composite base is shown as the red layer with a duller reflection after 77,400 inches.

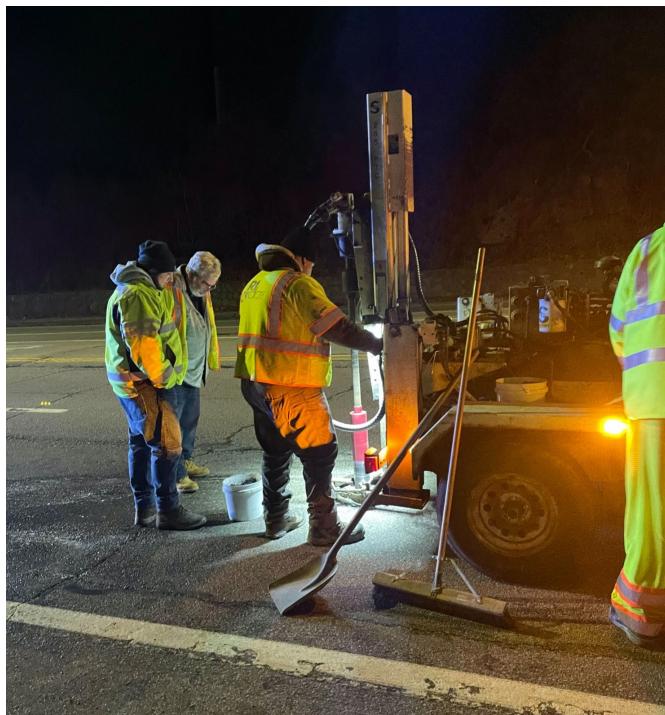
Figure 10: RIDOT taking core of Route 117

Once the radar data was preliminarily analyzed, strategic locations with varying reflection depth and brightness were selected for coring, as well as locations of consistent depth and brightness. Coring was performed by the RIDOT as shown in Figure 10. The core locations were marked with road paint along Route 117 for the coring crew. Cores 1 through 15 were collected from the eastbound lane and cores 16 through 23 from the westbound lane.

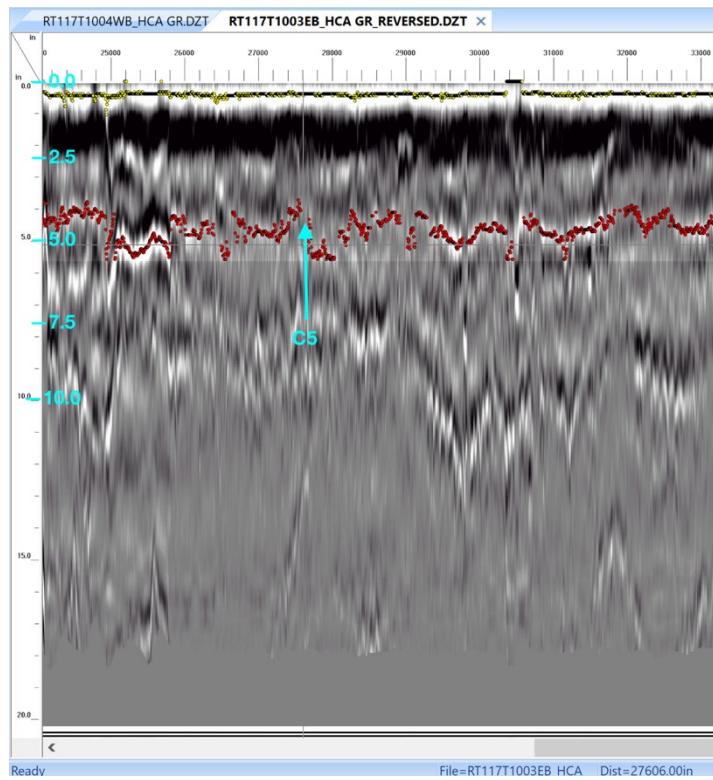
Figure 11: Core 5 approximate location shown in Radar

As an example, the GPR image corresponding to core 5 (C5) is shown in Figure 11. The surface of the road corresponding to the same core location, shown in Figure 12, exhibits both longitudinal and transverse cracking. The estimated (per GPR) asphalt thickness of 4.5 inches at this location was confirmed by measuring the actual core thickness, which was about 4.6 inches. The actual core is displayed in Figures 13 and 14. As a second example, the GPR image corresponding to core 4 (C4) is shown in Figure 15. The surface of the road corresponding to the same location, shown in Figure 16, appears to be in good condition, having a smooth surface with no cracking. The estimated asphalt thickness of 5 inches at this location was confirmed by measuring the actual core thickness, equal to 5 inches. This measurement is displayed in Figure 17.

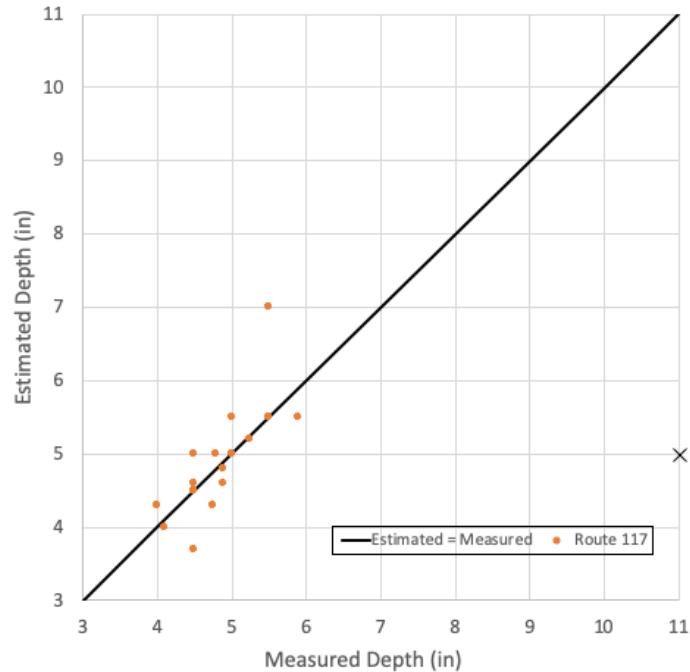
Figure 18: Comparing the estimated and measured depth of Route 117 cores

A comparison of the estimated asphalt thicknesses (via GPR data) versus the actual thickness measured from the collected cores is displayed in Figure 18. The estimated and measured data had a percent error of 4.8%. The outlier, represented with an "X", was not included in the percent error calculation.

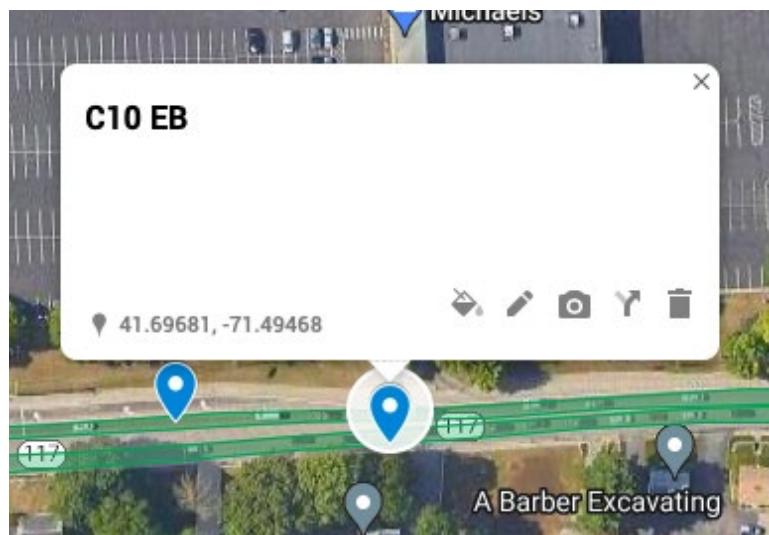
Figure 19: Example of the Google Map showing the core number, road direction, and GPS coordinates

Google Maps was used for a visual display of core locations, asphalt thickness, areas potentially underlain by concrete, and dielectric constant of the roadway's surface. This is illustrated in Figures 19-21. In terms of asphalt thickness, green represented a section of asphalt with a thickness between 4.5" and 5.5", as shown in Figure 20. Also, the color black represents a section potentially underlain by concrete, and the bridge deck. In terms of the dielectric constant, there was significantly more variability in comparison to the thickness. Therefore, only sections of high dielectric and varying dielectric were displayed. The areas of high dielectric, being above 12, are shown in red, while the areas of inconsistent dielectric are shown in yellow. The sections with no color have consistent dielectric values close to the normalized value of 1 (normalized to the roadway's average dielectric constant). This is depicted in Figure 21. It can also be noted that the sections with the yellow or red color represent areas of old pavement, while the sections with no color represent new pavement. This coincides with the concept that newer pavement will have more consistent dielectric constants, while older or damaged pavement will likely have high or variable dielectric constants.

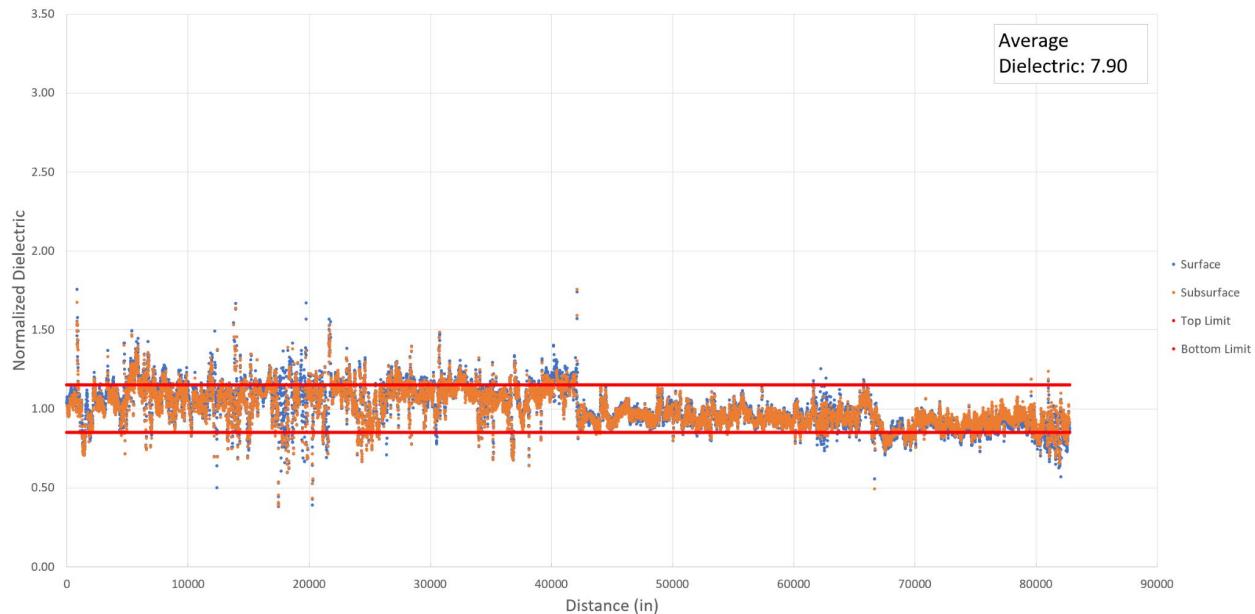
Figure 22: Route 117 Eastbound Dielectric Constants

A further analysis comparing the dielectric values of the roadway's surface and bottom of the asphalt layer (as directly outputted from Radan) was performed. Figure 22 displays the dielectrics of the eastbound lane. The surface dielectric values are shown in blue, and the bottom of the asphalt layer in orange, which appear to be the same values. Additionally, the red lines represent suggested limits that may be considered when determining locations of damage via dielectric values. These limits were determined by normalizing the dielectric values to the average for the entire roadway and then calculating +/- 15% from 1.0. As a result, the graph shows how far each value of surface dielectric constant strays from the average dielectric

constant of the roadway. This analysis was more-so used for the next roadway discussed because it is obvious that the beginning portion of the eastbound lane is old, damaged pavement which transitions to new pavement at about 40,250 ft. This is indicated by the portion of the graph before 40,250 ft being much more variable than the latter, more consistent, portion of the graph. The same analysis for the westbound lane was performed and are displayed in Figure 23.

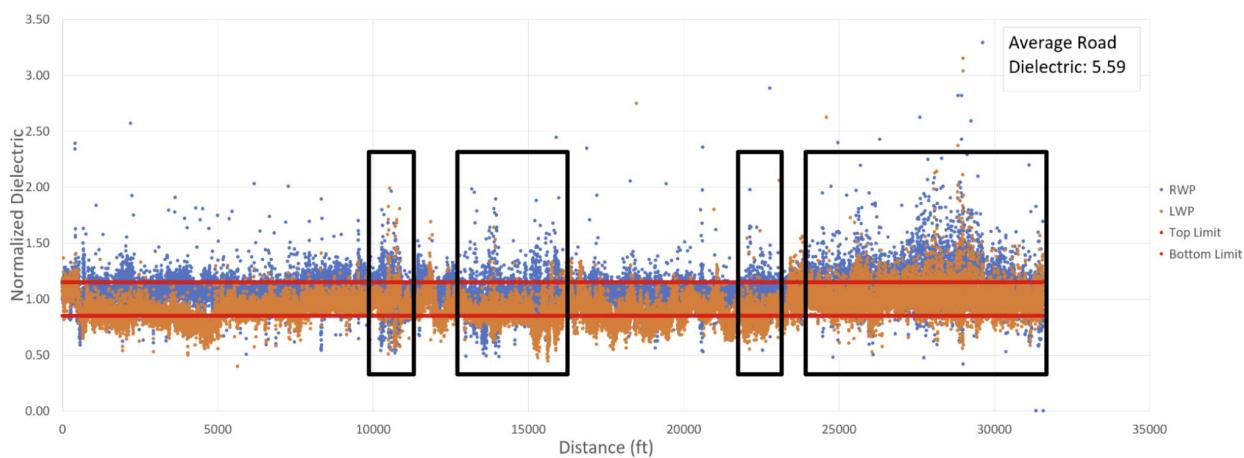
Figure 26: East Main Road surface dielectrics in each wheel path going Southbound

Figure 26 shows the surface dielectric values collected from each wheel path in the southbound left lane (lane 1). The dielectric values were normalized to the average dielectric (5.59) of this roadway. The red lines indicate the boundaries of +15% and -15% of the normalized dielectric. Areas on the graph that have clusters of dielectrics that stray outside of these red lines are indicated by the black rectangles. When viewing the surface of the roadway at these locations, it's clearly damaged. For example, Figure 27 is a Google Earth image showing the section of road that corresponds to the dielectric values in the first black rectangle at approximately 10500 feet from the graph's origin, in Figure 26. This further suggests that damaged areas will likely have higher dielectrics.

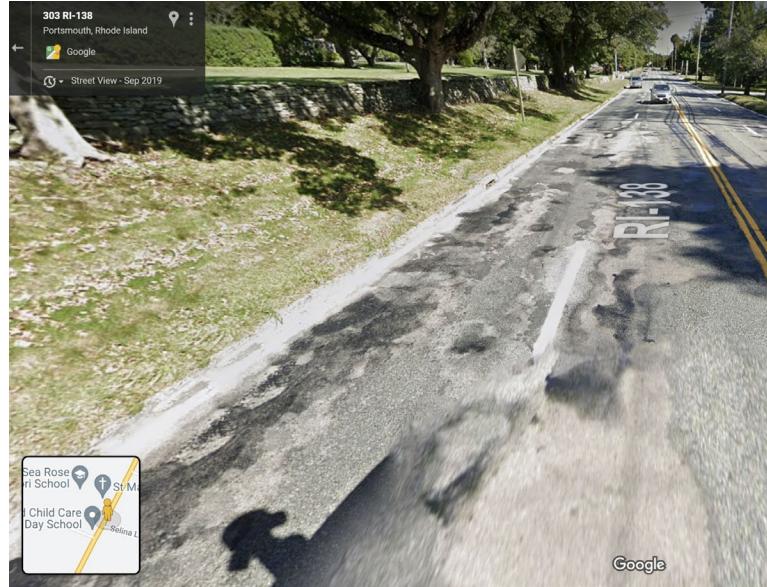
Figure 27: East Main Road surface photo from Google Street View of East Main Road Southbound lane 2

Since the limits of data collection encompassed approximately 6.5 miles of roadway, a variety of road conditions were encountered. Areas where clusters of both high and low dielectrics were highlighted on the variable dielectric map created using Google Maps. These areas were found to correlate with poor surface conditions. Only the surface dielectrics (outputted directly from Radan) were analyzed since they appeared to be the same as the bottom of the asphalt, as shown and discussed in the previous section.

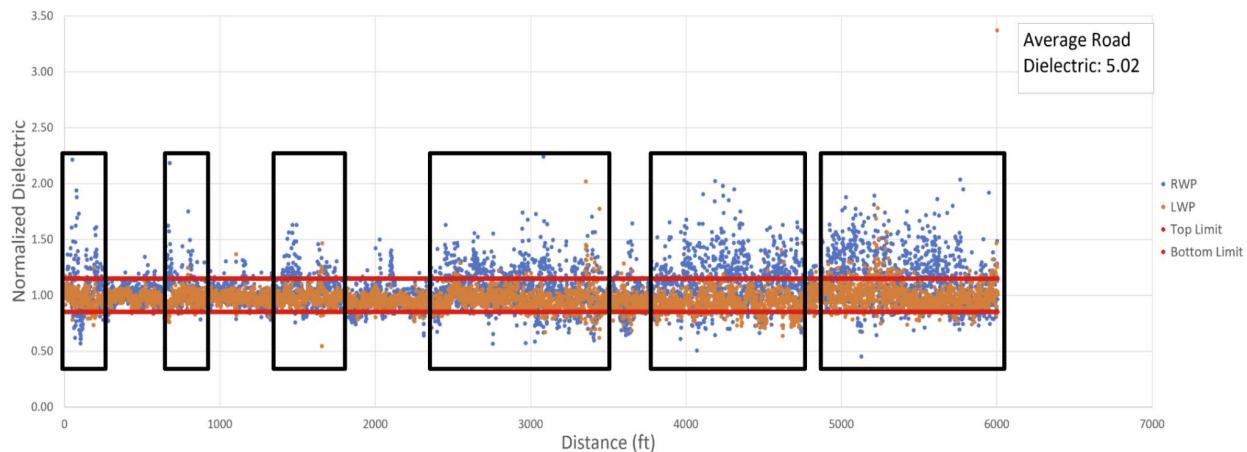
Figure 30: South of Commons Road surface dielectrics in each wheel path going Southbound

The presence of water can be identified where there are areas of high dielectrics. The dielectric values along this road were normalized to the road's average dielectric of 5.02, as shown in Figure 30. This figure shows the surface dielectrics collected from each wheel path in the southbound lane. It can be seen in Figure 30 that the right wheel path has consistently higher dielectrics than the left wheel path. It is hypothesized that this could be due to the crown of the road causing more water to collect in the right wheel path resulting in more damage to this portion of the road (See Figure 31). Clusters of dielectric values that are not within 15% of the

average dielectric value for this roadway are shown in the black rectangles. It was suspected that the high water table could be the cause of the high dielectrics along the road. Although the dielectric values along this road weren't incredibly higher than the other roads studied, the high groundwater table could still be a contributing factor. Further observance after a rain event, and data collection during the wet spring season would be valuable to further conclusions.
