Report No. FHWA-RD-79-146

THE FEASIBILITY OF ACCOMMODATING PHYSICALLY HANDICAPPED INDIVIDUALS ON PEDESTRIAN OVER AND UNDERCROSSING STRUCTURES

September 1980
Final Report

Prepared for
FEDERAL HIGHWAY ADMINISTRATION
Offices of Research & Development
Environmental Division
Washington, D.C. 20590

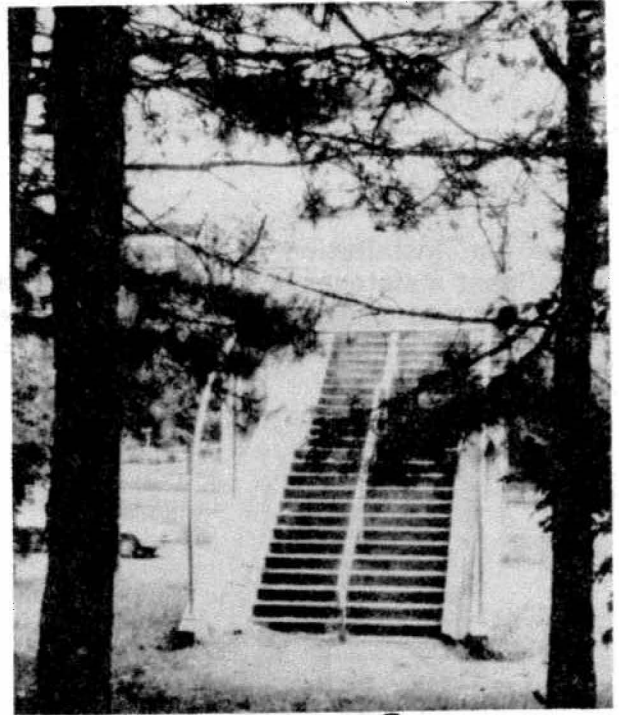
Stairs only on Approach to Overcrossing: Straight Flight; Space for Ramp on Three Sides.

In this situation, only stairs have been provided at the approach to the overcrossing. Space within which to construct ramps exists on three sides - in front and on either side of the straight flight of stairs.

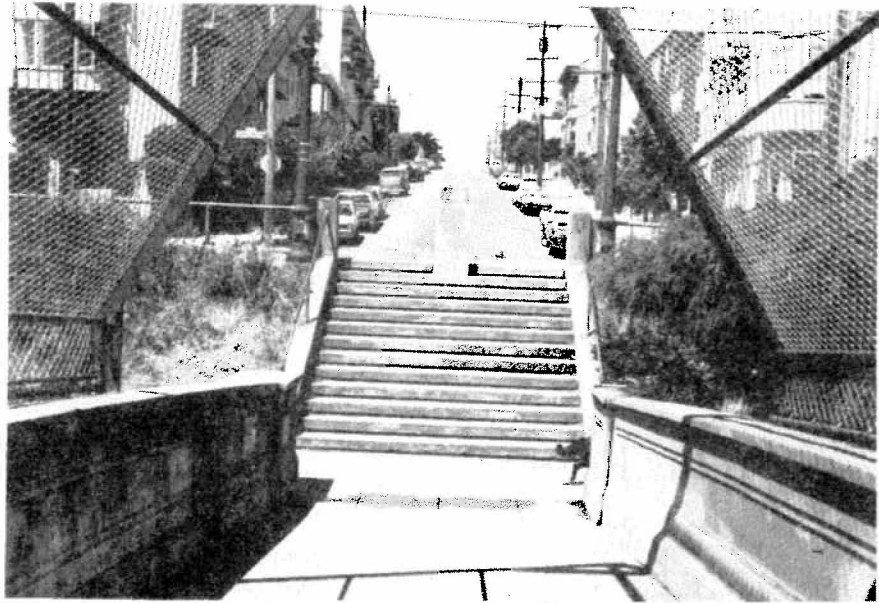
Stairs only on Approach to Overcrossing: Straight Flight; Space for Ramp on Both Sides Only.

Like Problem No. 3, only stairs have been provided for access to this overcrossing. However, because the sidewalk and street meets the top of the stairs, there is space for a ramp on either side of the stairs only.

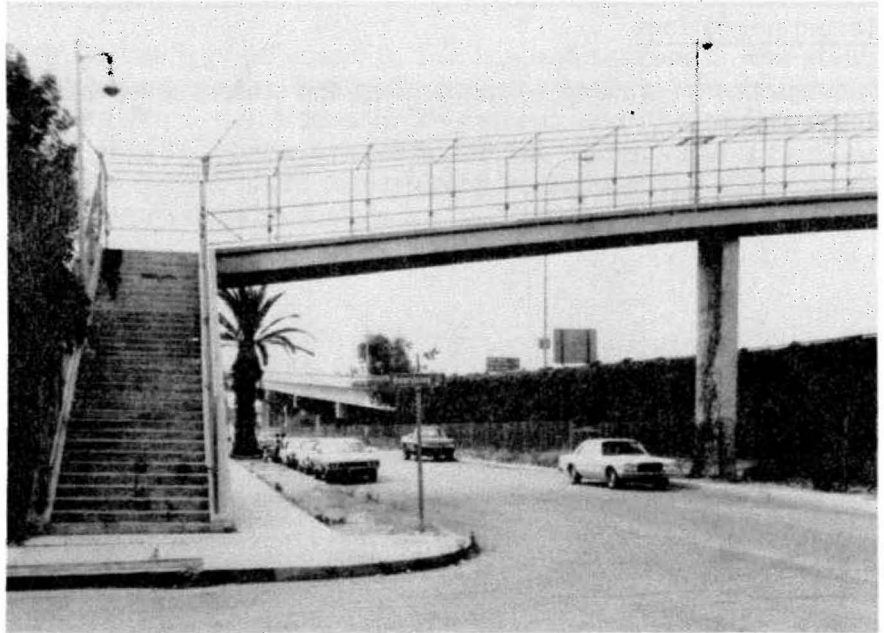
Stairs only on Approach to Overcrossing: Straight Flight; Space for Ramp on one End and one Side.

In this situation as in Access Barriers 3 and 4, a straight flight of stairs is the only available access to the overcrossing. However, because of the two intersecting streets, space to build a ramp is restricted to the side away from the street, and the end behind the stairs.

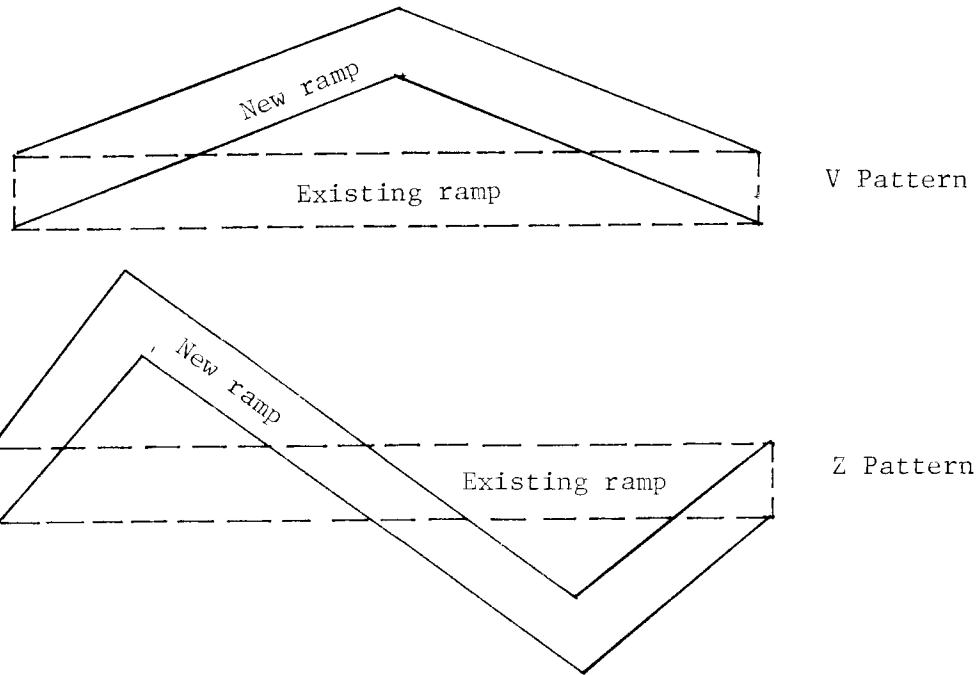
Construction of a new ramp allows a choice of alignments which utilize the original beginning and ending points. Rest areas can be constructed within the ramp and handrails will be required for ramps exceeding 5 percent grade. V or Z pattern alignments would result where beginning and ending points remain constant with the original design. A more direct alignment could be used where usage patterns can be served more directly.

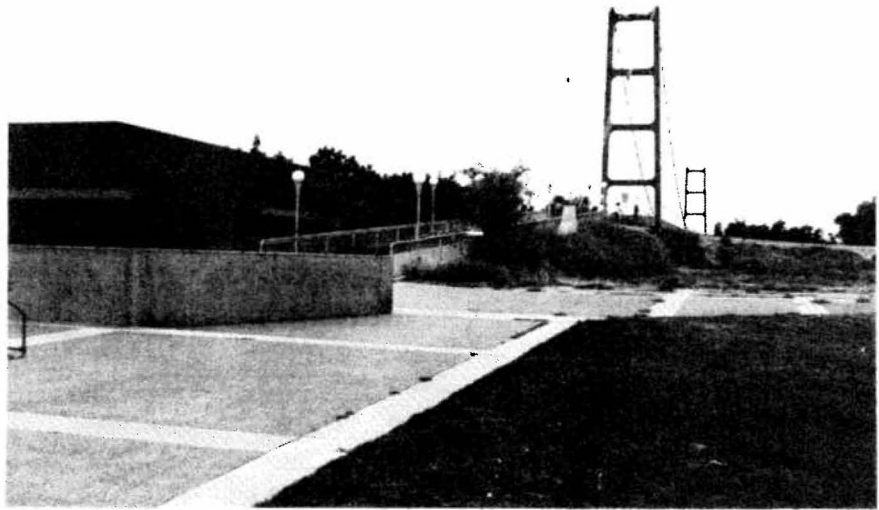
Ramps on Approach too Long (not too Steep).

Alternative No. 2 - overlaying the existing ramp to create rest areas is the cheapest solution and its disadvantages are not considered to be so great as to rule it out. Therefore, this solution is recommended over the others.

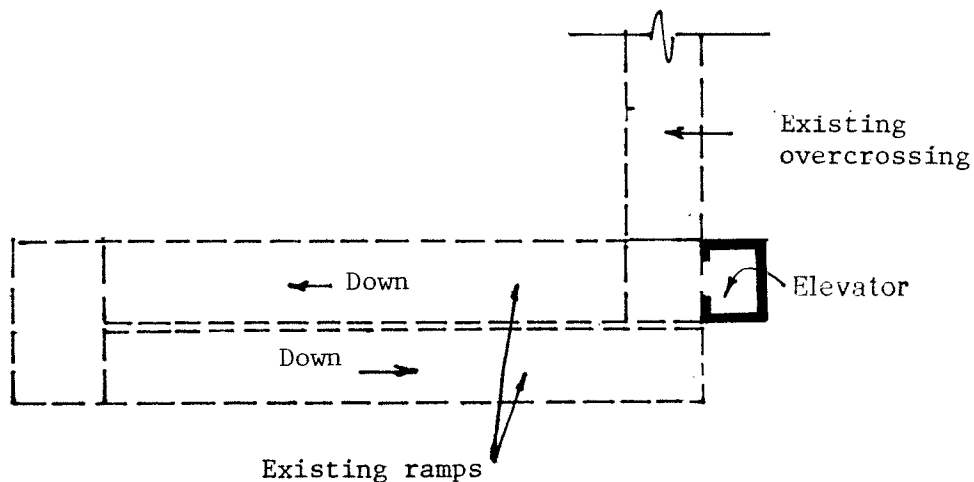
Installation of an elevator provides a direct connection between the top and bottom of the ramps. This solution is practical only where problems of vandalism and security do not immediately rule it out as a possibility.

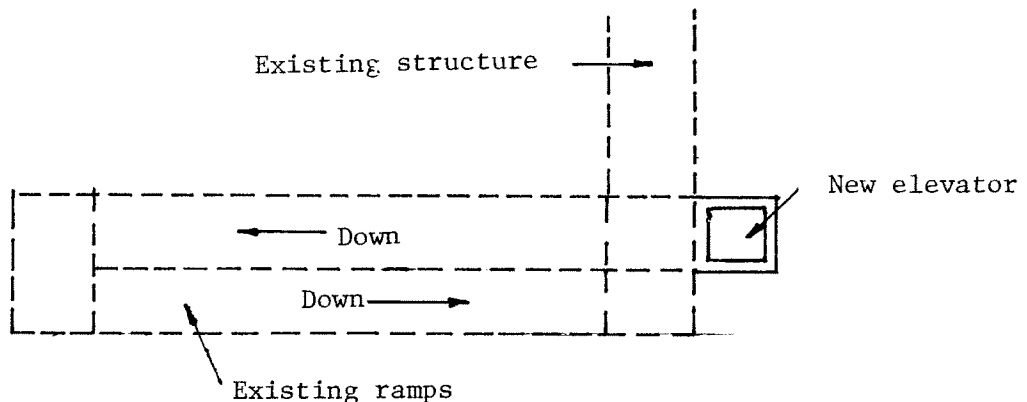
Installation of an elevator provides a direct connection between the top and bottom of the ramps. This solution is practical only where problems of vandalism and security do not immediately rule it out as a possibility. This might include areas such as a school, downtown shopping area, etc.

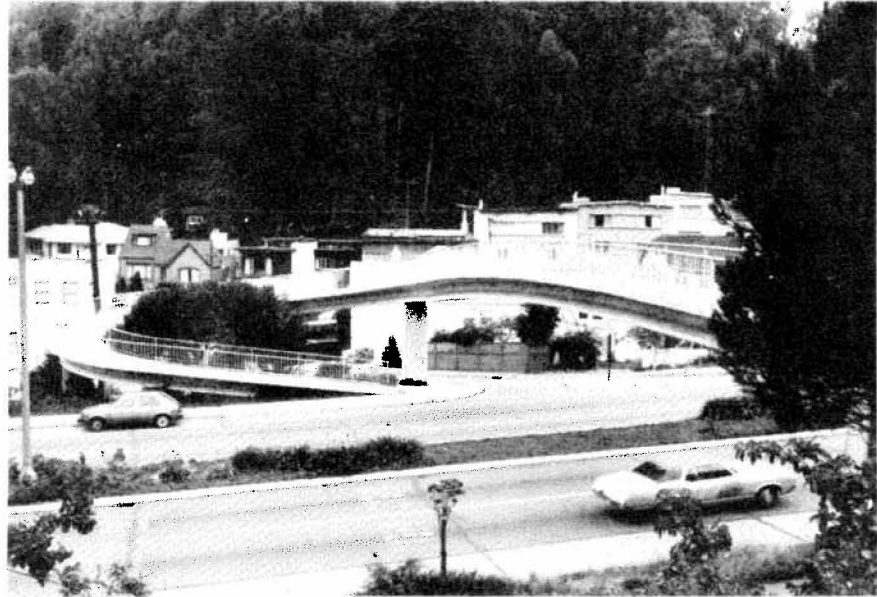
Ramped walkway across structure too long.

This problem defines a situation in which the structure ramps but no landings (at 30' intervals) have been provided.
