**Assessment and optimization of double CT bridge girder sections with  
longitudinal precast decks**

**Final Project Report**

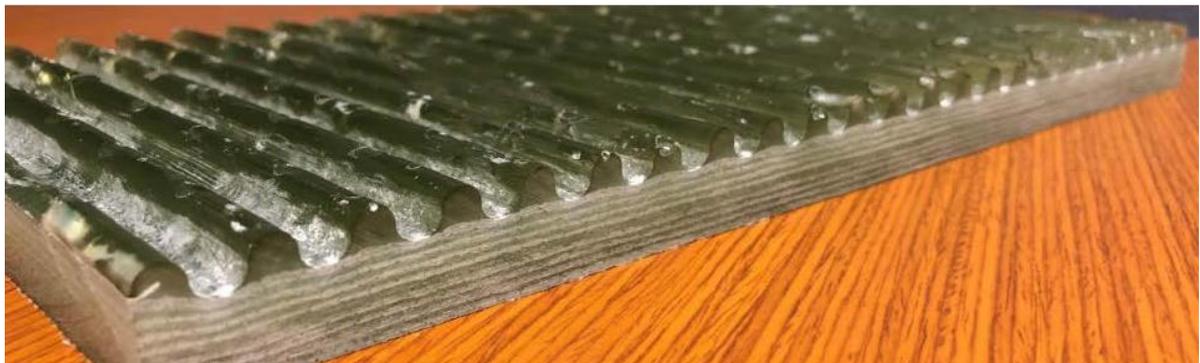
**Figure 2: Ridged FRP Shear Connection**

To maintain composite action between the girder and partial precast deck, the double CT girder uses a novel shear connection developed previously by the University of Maine [1, 2]. This connection system, seen in Figure 2, uses sinusoidal ridges cast into the girder's FRP upper flanges, which are copied into the deck as it is poured. These interlocking ridges provide a continuous shear key between the components, with uplift forces resisted by discrete shear connectors (similar to shear studs in conventional steel-concrete composite construction or to the reinforcement protruding from prestressed girders and cast into the deck). This connection has been investigated in the past with promising results [1-3] prompting additional investigation and development. In this portion of the project, focus was placed upon the elements providing clamping force rather than the FRP-concrete connection itself. Specifically, FRP threaded rods are investigated as possible clamping elements and stainless steel rods are reevaluated. These elements have the potential to provide adequate clamping load to the connection, while also reducing or eliminating the effects of corrosion inherent when using mild or carbon steel components. Elimination of corrosion damage can potentially improve a structure's overall durability and greatly reduce maintenance demands.

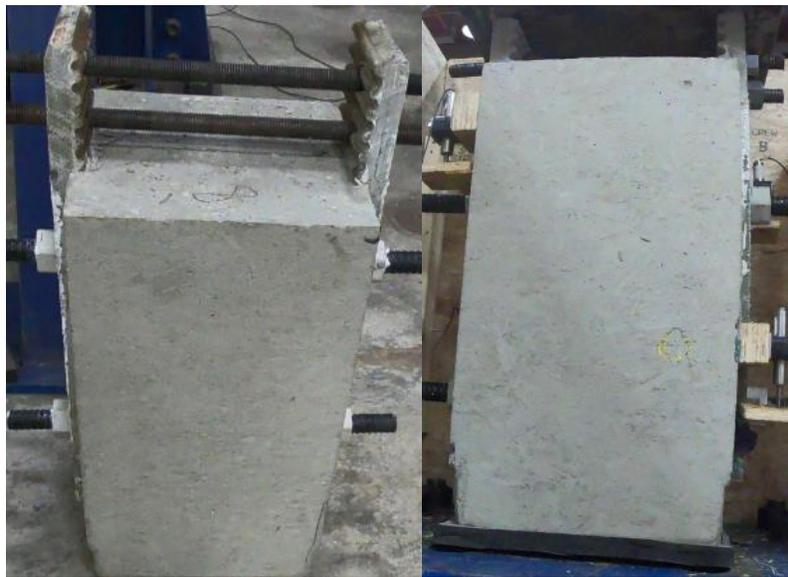
**Figure 3: Precast, FRP Rod Specimens (from left to right: Specimen 1, 2)**

A total of five shear push-out specimens were cast for testing under fatigue and/or strength-level loading. These were initially divided into two types, each designed to test a different alteration to the original ridged shear connector concept. Three specimens, Specimens 1, 2, and 5, were planned to be cast to test the use of 1 1/8" diameter, non-pretensioned FRP threaded rods to apply clamping force to the connection. The rods, furnished by GBolt to AIT Manufacturing, are characterized by their light weight and high tensile strength. FRP Nuts were used to clamp together the FRP plates and concrete, but, in contrast to previous studies [1-3], were only tightened hand-tight, as opposed to being tightened to a specific pretensioning torque. These specimens were additionally designed to emulate a precast concrete deck connection, as would be present on a double-T CT girder bridge. As such, they were cast by American Concrete Industries (ACInd), a local precaster, using a high early strength concrete mix. Photos of Specimens 1 and 2 can be seen in Figure 3.

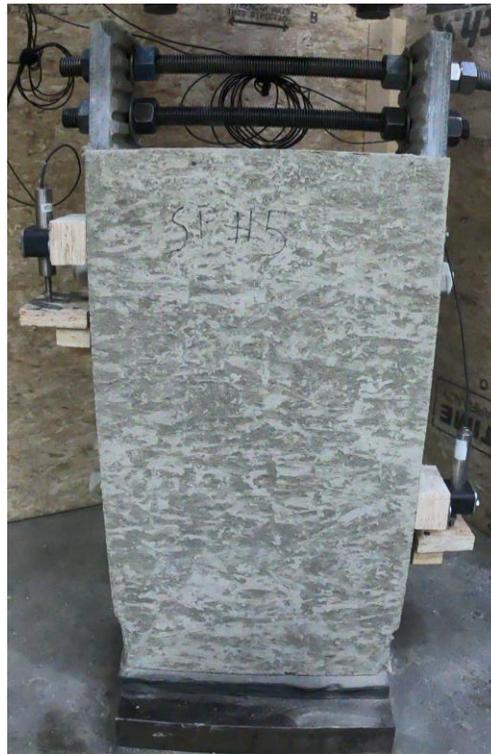
**Figure 4: Specimen 5**

Specimen 5 as a non-fatigue-tested control specimen for assessment of strength or stiffness degradation due to fatiguing. It was not until after having tested Specimen 5 to failure that the changes were communicated. Therefore, conclusions regarding fatigue degradation cannot be readily made for the unaltered specimens, and only limited conclusions can be drawn from the results of tests performed on Specimen 5.

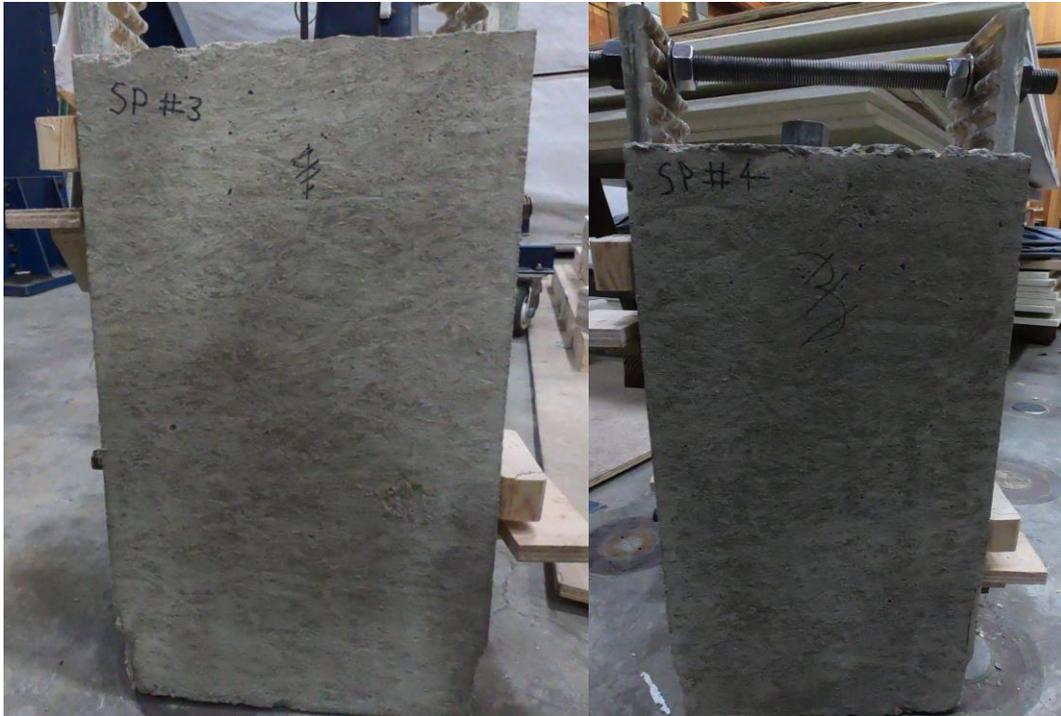
**Figure 5: Cast-in-Place, Stainless Steel Rod Specimens (from left to right: Specimen 3, 4)**

The remaining two specimens (Specimens 3 and 4) were cast to emulate the potential connection details of a small, single or double CT girder bridge with a cast-in-place deck. These specimens used relatively small diameter (1 in. and  $\frac{3}{4}$  in. for Specimens 3 and 4, respectively), non-pretensioned 18-8 stainless steel rods with end nuts to apply clamping. To emulate the properties of a cast-in-place deck, concrete was cast concurrently with the deck of an actual, single CT girder bridge, the Hampden Grist-Mill Bridge (HGMB) in Hampden, Maine, with concrete from the same batch. This concrete mix was more conventional than the concrete from which the other three specimens were cast, having a lower (4,000 psi) design compressive strength and less-than-ideal curing conditions. It should be noted that, as the bridge's deck was cast in early December, admixtures were included to account for cold-weather curing. These specimens can be seen in Figure 5.

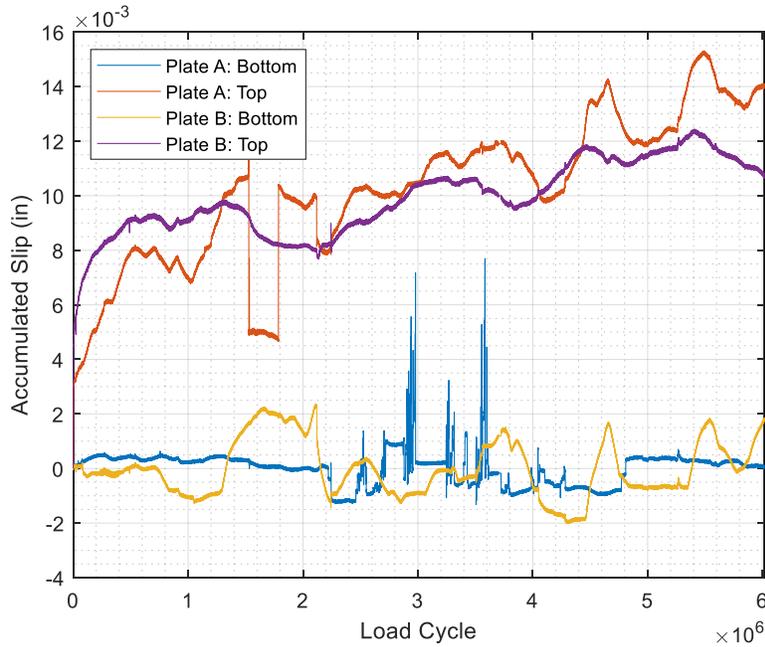
**Figure 6: Specimen 1 - Apparent Slip Accumulated over Fatigue Testing**

Fatigue testing of specimen 1 began on September 22, 2020 and 6 million load cycles were applied without failure. Figure 6 presents the apparent slips recorded over the course of testing. A few observations can be made from these recorded data. First, the maximum recorded slips are of similar magnitude to those recorded in the previous study [1, 3] for fatigue specimens using pretensioned 18-8 stainless steel rods to maintain clamping between concrete and FRP. However, in these previous tests smaller fatigue loads were applied, suggesting that these FRP rods may be adequate in this application. However, the FRP rod recorded slips are larger than the slips recorded for specimens in [1, 3] that used pretensioned Grade 5 bolts to apply clamping force under slightly higher loads. A second observation is that, from the positive slope of the slips recorded at the tops of the FRP plates, it appears that the repeated loading caused some cumulative damage of either the concrete, FRP plates, FRP rods, or some combination which increased over time. Finally, it can be seen that the slips recorded at the top of the plates were much higher than those recorded at the bottoms. Although it is possible that the tops slipped much more than the bottom, it should be

noted that during testing, it was observed that the applied load tended to cause bowing in the top portions of the FRP plates from lack of lateral support. This movement may have been detected by the LVDTs and was thus mistakenly interpreted as relative slip.

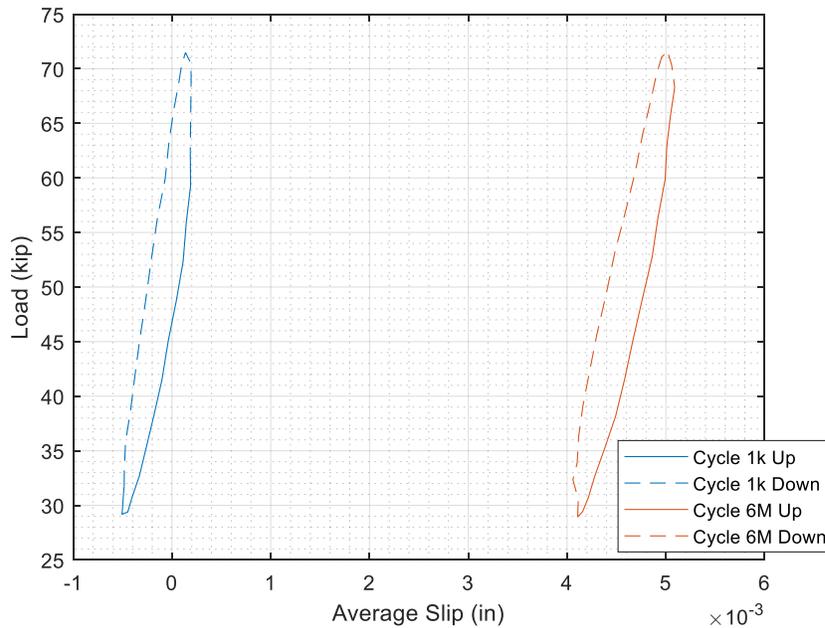
**Figure 7: Specimen 1 – Average Load-Slip Behavior at Beginning and End of Fatigue Testing**

To identify possible damage to, or loss of load-slip performance in Specimen 1 over the course of testing, its recorded slips were averaged across the four LVDTs at the beginning and end of testing and plotted. Figure 7 shows the averaged slip measured over the course of the one-thousandth and six-millionth load-cycles. As can be seen, the average load-slip response increased somewhat throughout the test. This is likely a combination of the increase in slip identified previously, and minor damage accumulated over the test. Regardless, the shape remained constant from the beginning to end of the test. The response to loading and unloading is about the same, with little increase in hysteresis after 6,000,000 cycles.

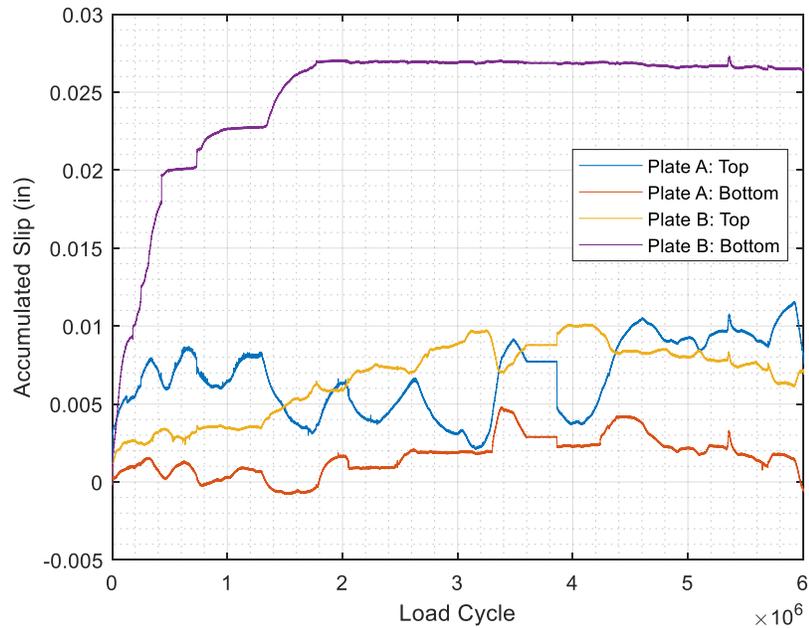
**Figure 8: Specimen 2 - Apparent Slip Accumulated over Fatigue Testing**

Fatigue testing of specimen 2, which duplicated the materials and geometry of Specimen 1, began on October 19, 2020 and the specimen withstood 6 million load cycles without failure. To prevent the bowing effect observed at the top of the plates on Specimen 1, two sets of threaded rod were inserted into the holes at the top of the FRP plates, with a nut and washer on either side of each plate. Figure 8 presents the apparent slips recorded over the course of testing. As is immediately apparent, from the onset of fatigue loading, the LVDT at the bottom of Plate B recorded apparent slips that were exceptionally high relative to the other LVDTs and relative to Specimen 1. Upon inspection of the specimen, it was discovered that the FRP nut closest to this LVDT had a crack extending from the outer surface to the inner thread as seen in Figure 9. It is unknown if the crack developed during specimen assembly or during the curing of the structural adhesive applied to prevent nut loosening. In either case, the crack may have limited the amount of clamping force the nut applied to the panel, thereby causing more slip. It can also be seen in Figure 8 that the slips recorded by the other LVDTs were smaller than those recorded at the top of Specimen 1, and similar to those recorded in previous tests [1, 3]. This suggests that the additional hardware provided at the plate tops prevented the bowing behavior observed from Specimen 1, reducing the amount of non-slip movement to be recorded and falsely interpreted as slip.

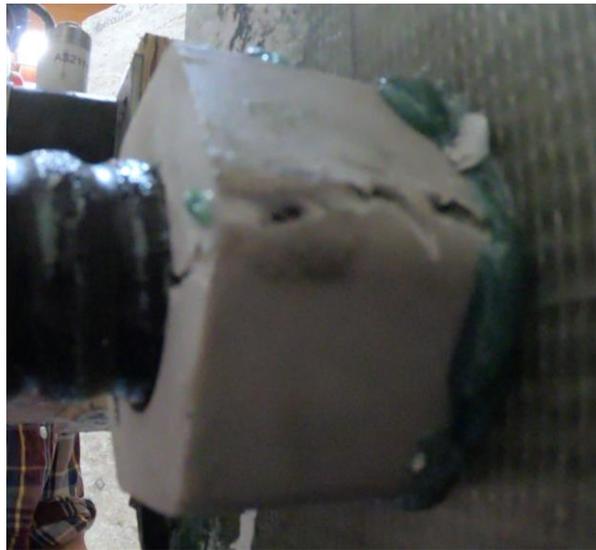
**Figure 9: Specimen 2 – Crack in Plate B, Bottom FRP Nut**

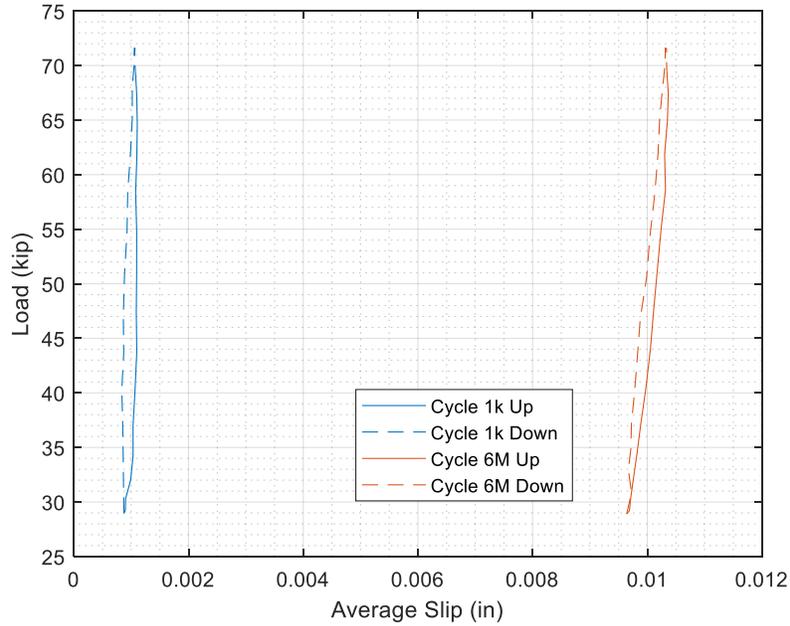
**Figure 10: Specimen 2 – Average Load-Slip Behavior at Beginning and End of Fatigue Testing – Cracked Nut Data Included**

The average load-slip behavior of Specimen 2 was again extracted to track any changes in behavior over the course of fatigue cycling. The behavior was identified twice; once in Figure 10 with the data from the bottom of Plate B included, and once in Figure 11 with these data omitted. Both Figure 10 and 11 show that Specimen 2 experienced some loss of stiffness between the beginning and end of the test, observable as a slight rotation of the load-unload path between the one-thousandth and six-millionth load-cycles. This indicates that the specimen underwent a small amount of damage, resulting in a loss of stiffness. This may be due to the reduced participation by

the bottom part of Plate B to slip resistance caused by reduced clamping force. However, minimal hysteretic response (seen as an increase in recorded slip during loading relative to unloading) was recorded.

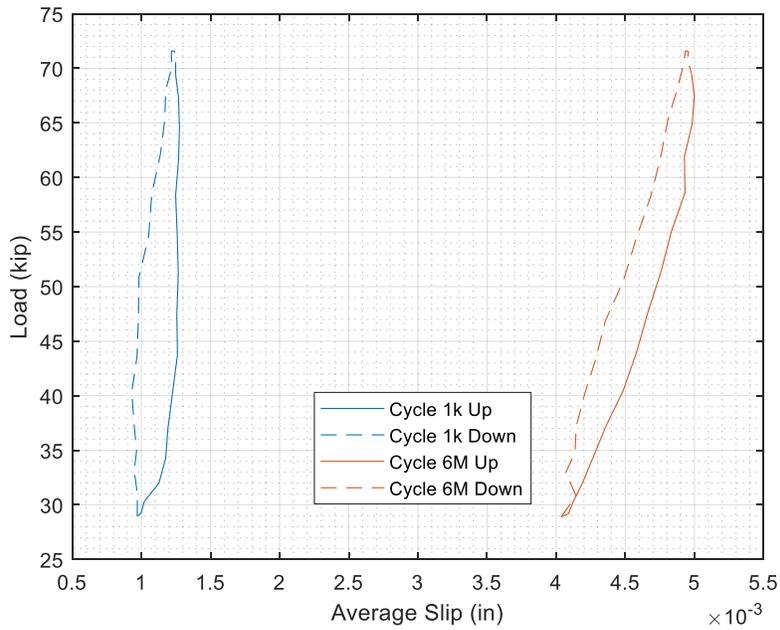
**Figure 11: Specimen 2 – Average Load-Slip Behavior at Beginning and End of Fatigue Testing – Cracked Nut Data Omitted**

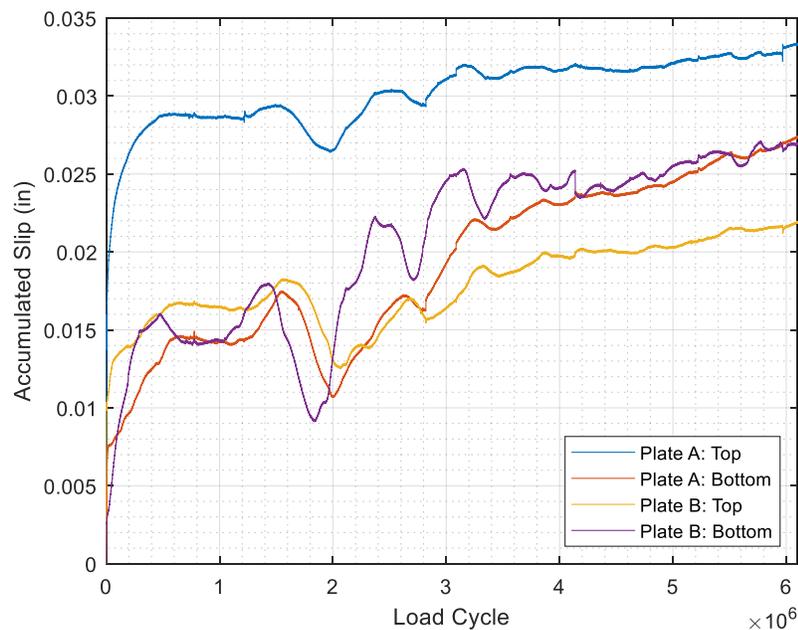
**Figure 12: Specimen 3 - Apparent Slip Accumulated over Fatigue Testing**

Specimen 3 began fatigue testing on December 18, 2020 and was able to withstand 6 million load cycles without failure. The accumulated slip recorded during this test by all LVDTs was dominated by a large initial slip (0.015 in – 0.029 in.) accumulated within the first 750,000 load cycles with a much less drastic accumulation thereafter. This can be seen in Figure 12, which presents the apparent slips recorded over the course of testing. Inspection of the specimen after fatiguing did not reveal an apparent source of this large, initial slip. However, the differences between this specimen and the previous two may reveal some possibilities. First, at the onset of testing the concrete comprising the specimen was relatively young, being cast only 10 days prior. Assuming that concrete reaches its “full” cure at 28 days, the specimen had not fully cured until it had been subjected to more than 4 million load cycles. Therefore, this large, initial slip may have been a function of the concrete’s immaturity leading to reduced stiffness. This is further evidenced by the fact that, as seen later, Specimen 4 did not exhibit this large accumulation of slip at the onset of fatiguing, despite using identical concrete cast at the same time and using smaller shear connectors to apply clamping load. It should also be noted that, after the large, initial accumulation, the specimen’s recorded slip seemed to stabilize until around 1,800,000 load-cycles, after which slip decreased rapidly, was regained, and then increased gradually for the remainder of testing. This may indicate the onset, and then development of minor damage to the connection.

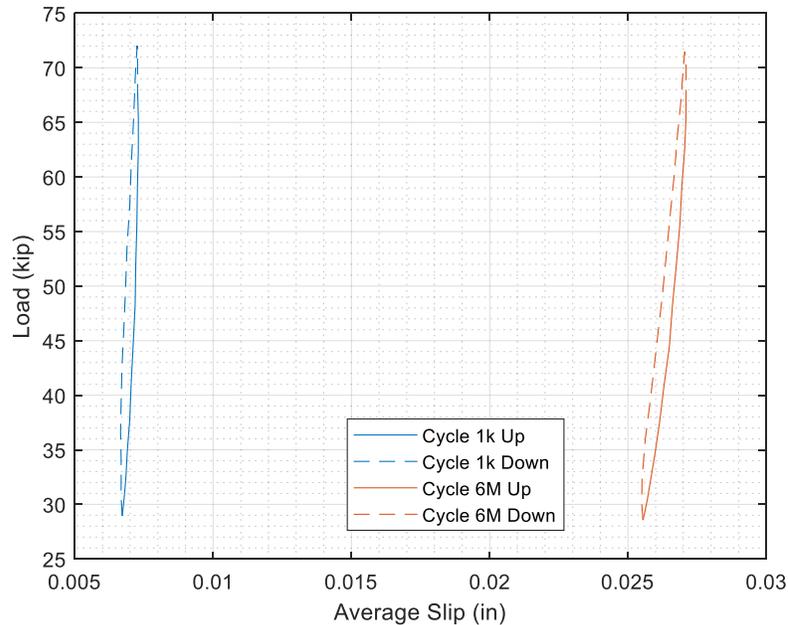
**Figure 13: Specimen 3 – Average Load-Slip Behavior at Beginning and End of Fatigue Testing**

This can be seen as the large shift in the specimen’s load-slip response between 1,000 and 1,000,000 cycles, which has been included here as well. Additionally, the difference between slips at maximum and minimum load increased by a small amount, visible as a clockwise rotation of the load-slip curve and indicating a small decrease in stiffness. Finally, very little load-unload hysteresis was accumulated, as indicated by an insignificant widening of the space between loading and unloading curves at the one-thousandth and six-millionth load-cycles. These factors combine to indicate that only a small degree of damage was incurred over the course of fatiguing.

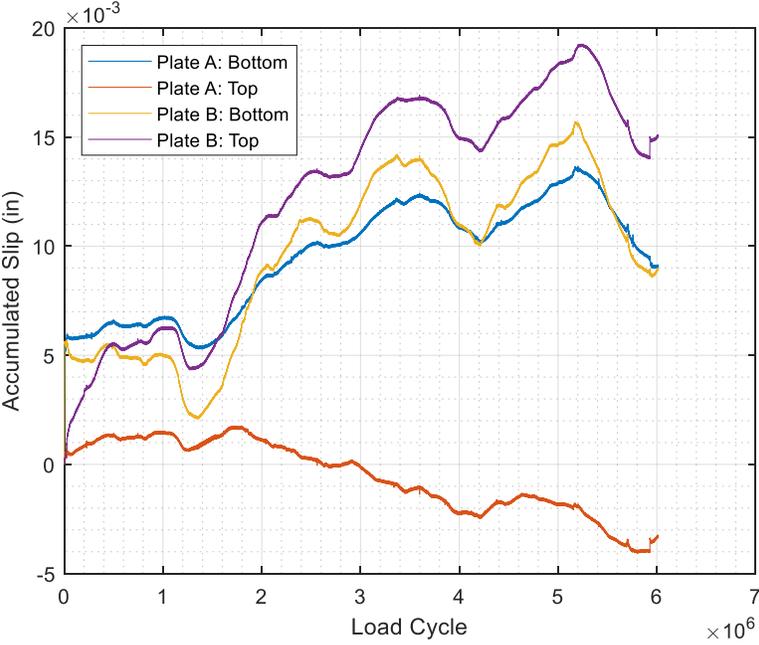
**Figure 14: Specimen 4 - Apparent Slip Accumulated over Fatigue Testing**

Specimen 4 began fatigue testing on January 12, 2021 and withstood the full 6 million load-cycles without failure. As seen in Figure 14, accumulated slip was initially relatively small, remaining less than 0.01 in. until around 1,800,000 load cycles. At around 1,300,000 cycles, the slips recorded at the bottom of Plate A and throughout Plate B increased rapidly, stabilizing at around 3,500,000 cycles. Notably however, the slip recorded at the top of Plate A did not display this behavior, remaining stable until around 1,700,000 cycles when it began to decrease gradually, finishing with a small net-negative accumulated slip. This behavior indicates a smaller movement of the plate at this location relative to the concrete after being fatigued than at the onset. The area around the sensor did not display any visible evidence of significant changes that would lead to this behavior, making speculation on the cause difficult. One possible cause of this behavior is a gradual work-hardening of the stainless steel stud near this sensor. Due to the stud’s relatively small cross-sectional area relative to previous specimen, localized strain could possibly have

caused strain hardening over time, eliciting a stiffer response and less slip. Another possibility is gradual slip of the LVDT itself in its mounting, leading to erroneous readings.

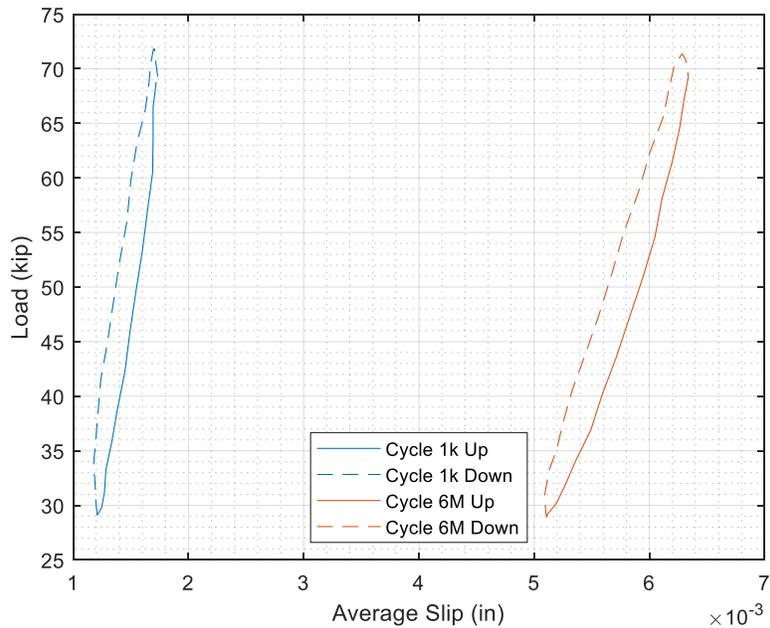
**Figure 15: Specimen 4 – Average Load-Slip Behavior at Beginning and End of Fatigue Testing**

Figure 15 presents Specimen 4’s average load-slip behavior over the course of fatiguing. In contrast to Specimen 3, which saw a quite large increase in average slip response, Specimen 4 did not see a very large increase, aligning more with Specimens 1 and 2. This provides further evidence that the large slips measured at the beginning of testing Specimen 3 may be due in part to concrete immaturity. The change in load-slip behavior over testing, as presented in Figure 15 is somewhat misleading, as the decrease in recorded slip at the top of Plate A pulls down the average slip at 6 million load-cycles. However, it is still evident that little hysteretic change can be observed, and that the loss of stiffness over testing (as indicated by the rotation of the load-slip curve) was small.

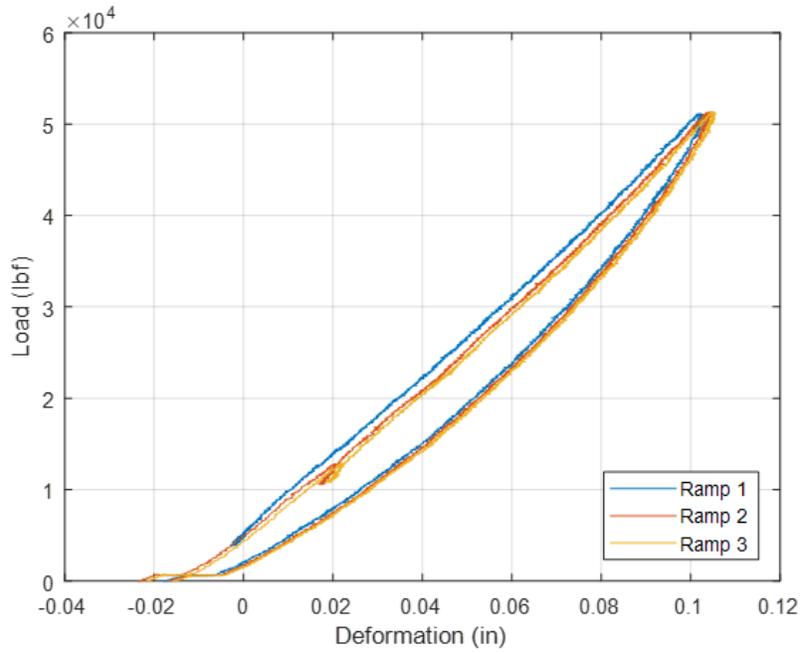
**Figure 16: Specimen 1 – Service-Load Stiffness Testing**

speculation can be made. For instance, this may have been caused by a small amount of damage incurred during the first load ramp or from time-dependent deformation recovery of the neoprene pad placed beneath specimens during testing. In either case, the average stiffnesses of Specimens 1 and 2 were 460,000 lbf/in and 445,000 lbf/in respectively.

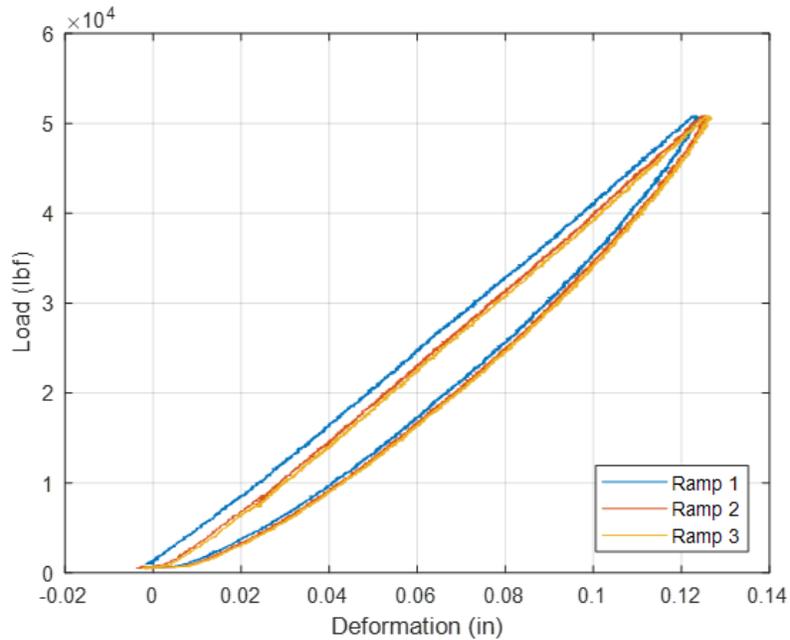
**Figure 17: Specimen 2 – Service-Load Stiffness Testing**

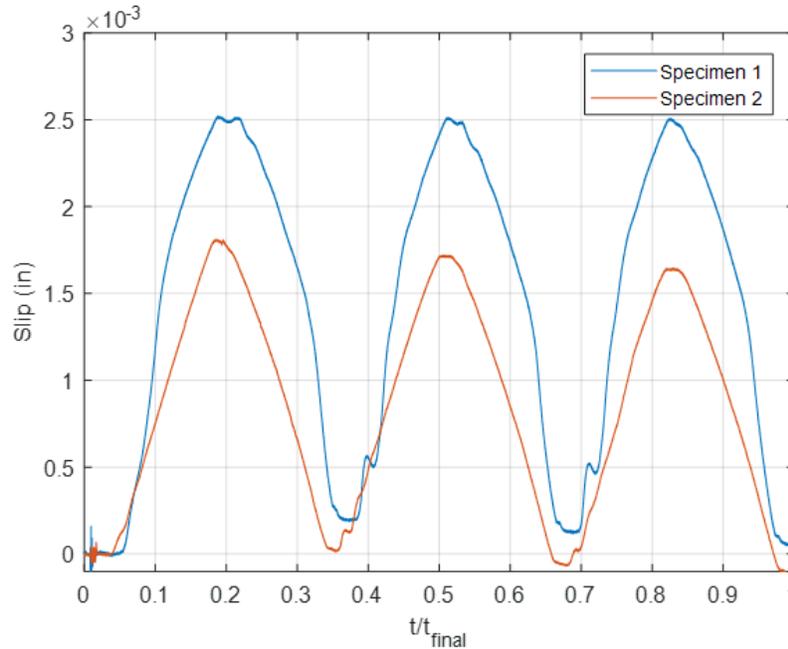
**Figure 18: Specimens 1 & 2 – Average Slip Data**

Some additional information can be gleaned from the slip measured between FRP plates and concrete over the course of stiffness testing. These were averaged across the four LVDT's attached to each specimen and are plotted in Figure 18 for both specimens. As can be seen, the maximum and minimum recorded slips were roughly constant, accounting for a slight zero-drift in the LVDT readings. Additionally, the slips recorded during unloading were reasonably similar to those recorded during loading. This would seem to indicate linear slip behavior, suggesting that the slight nonlinearity observed from the load-displacement plots is not due to the specimens themselves, and rather comes from external sources such as time-dependent neoprene decompression.

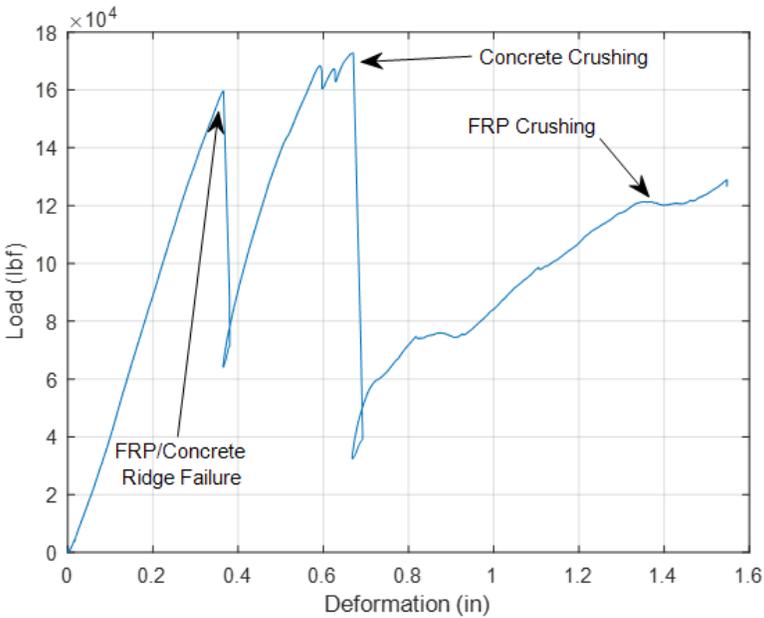
**Figure 19: Specimen 1 – Ultimate-Load Strength Testing**

Figures 19 and 20 present the load-deformation curves recorded during failure testing of Specimens 1 and 2, respectively. As with specimens tested to failure as part of previous studies [1-3], the ultimate behavior of these specimens was characterized by an initial, roughly linear load-deformation response up to failure. For both these specimens, initial failure was due to crushing of the concrete block with significant cracking and spalling, usually around top or bottom corners. As seen in Figure 20, the failure of Specimen 2 at around 172,300 lbf led to an immediate drop in load, after which little additional load was carried. However, the initial failure of Specimen 1 at around 159,400 lbf led to an immediate drop in load which was recovered and surpassed, with secondary failure occurring under a load of around 172,700 lbf, which is close to the failure load of Specimen 2. It is possible that at the initial failure, some of the FRP and/or concrete ridged in the connection experienced shear failure (due to concrete porosity, lack of fiber penetration, etc.). After this, the remaining intact connection components were able to carry the additional load until concrete crushing had occurred. This crushing failure can be seen in Figures 21 and 22 for

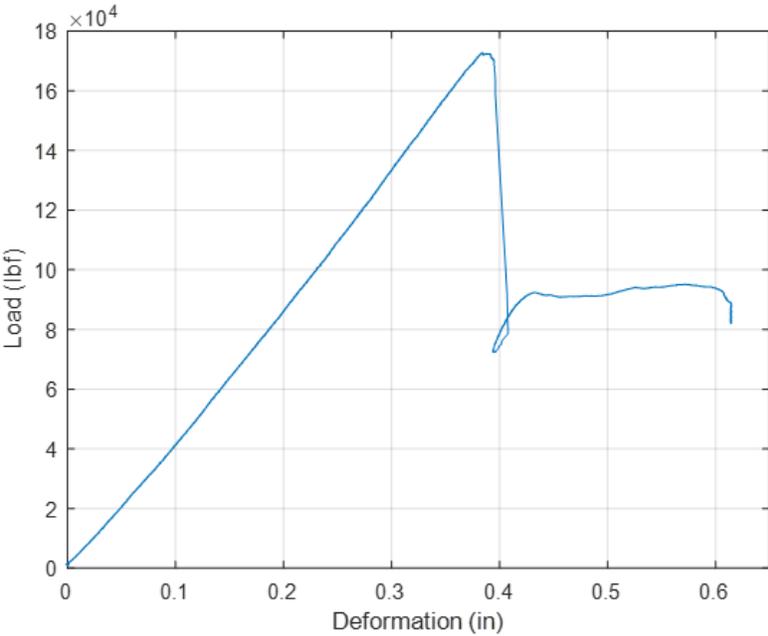
**Figure 20: Specimen 2 – Ultimate-Load Strength Testing**

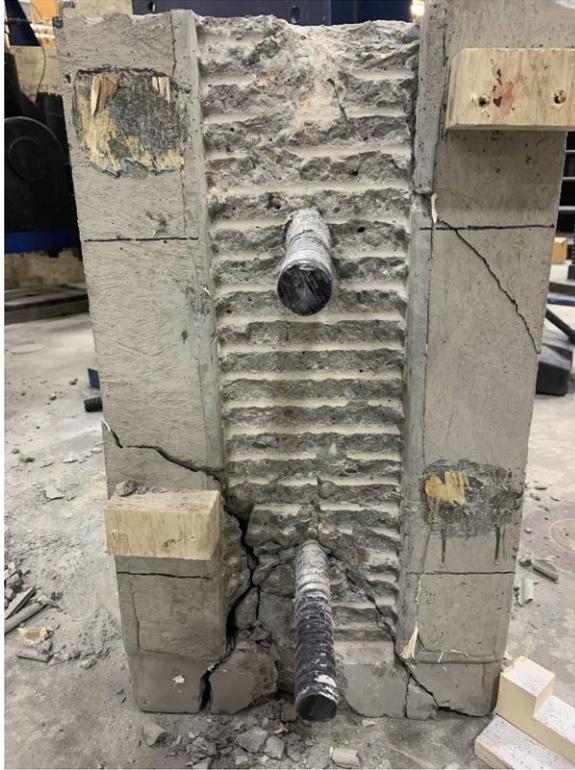
**Figure 21: Specimen 1 – Concrete Crushing Failure**

Specimens 1 and 2, respectively. It can be assumed that during crushing failure, shear failure of the concrete ridges also occurred, as can be seen in Figures 21 and 22.

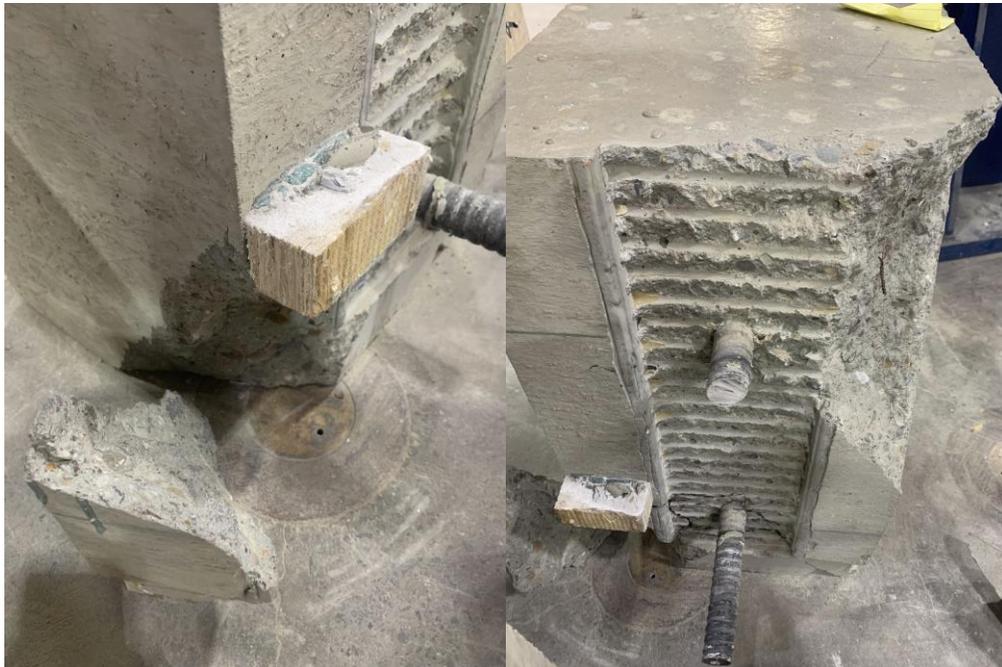
**Figure 22: Specimen 2 – Concrete Crushing Failures**

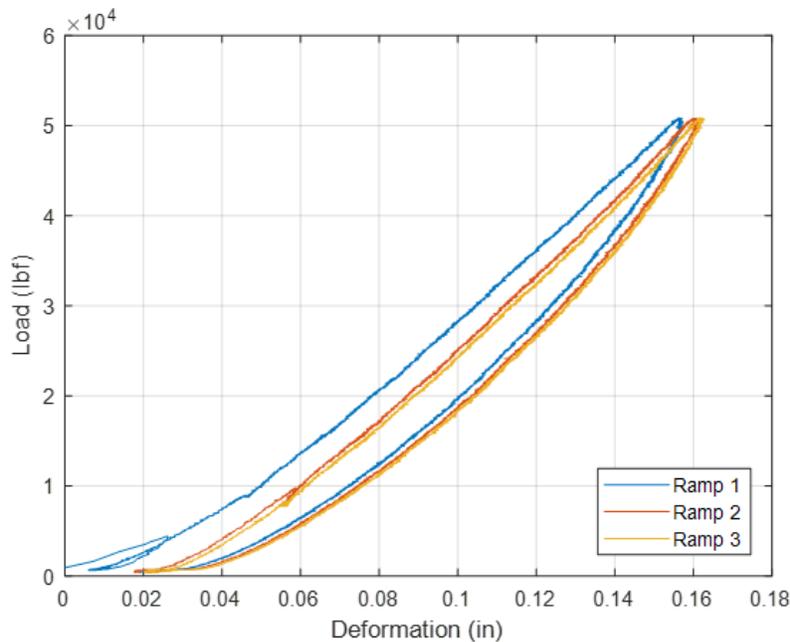
**Figure 23: Specimen 3 – Service-Load Stiffness Testing**

Figures 23 and 24 present the results of stiffness testing of Specimens 3 and 4, respectively. Similar to Specimens 1 and 2, the load-deformation response of Specimens 3 and 4 during stiffness testing was characterized by roughly linear response during loading and nonlinear response during unloading. Additionally, the responses during load ramps 2 and 3 were again similar to one another, with the response during the first ramp being slightly shifted. These similarities to the behavior from Specimens 1 and 2 suggests that the linearity of Specimens 3 and 4 is also affected by a factor outside of the specimen itself. The average calculated stiffnesses were 399,000 lbf/in. and 405,000 lbf/in. for Specimens 3 and 4, respectively. These are somewhat more compliant than Specimens 1 and 2, which is reasonable considering their lower concrete compressive strengths (correlating to lower concrete elastic moduli [4]).

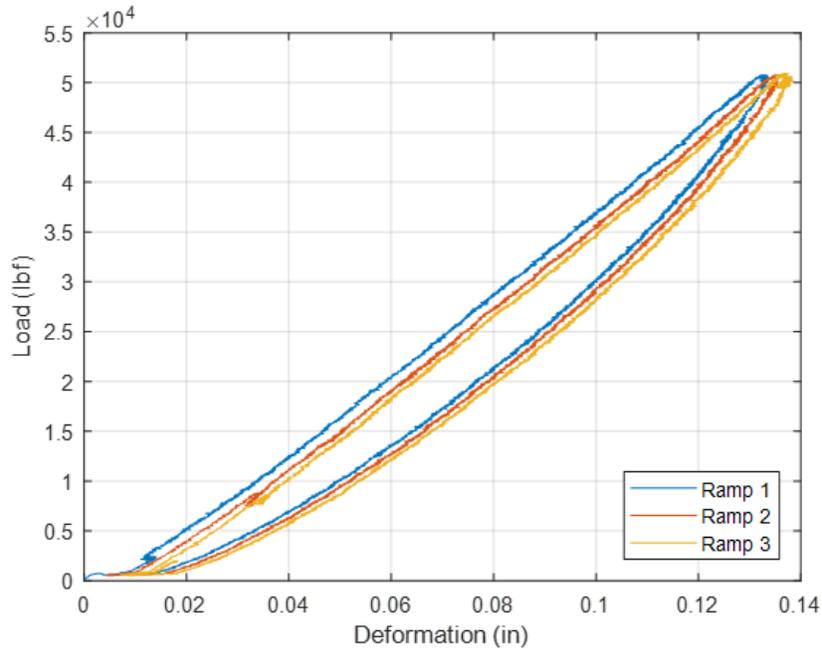
**Figure 24: Specimen 4 – Service-Load Stiffness Testing**

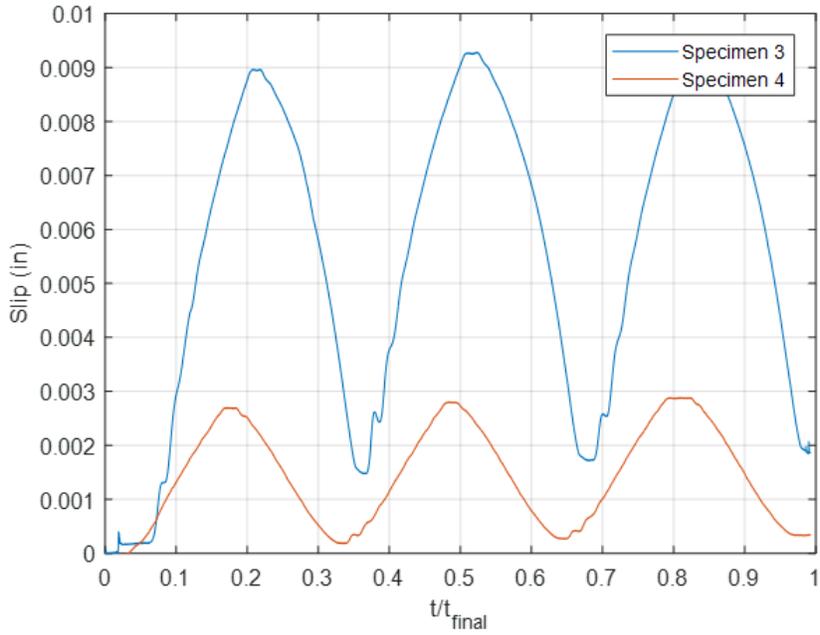
**Figure 25: Specimens 3 & 4 – Average Slip Data**

Figure 25 presents the average slips recorded during stiffness testing of Specimens 3 and 4. As can be seen, these specimens behaved similarly to Specimens 1 and 2, with the magnitudes of maximum and minimum slips recorded staying roughly stable across subsequent load ramps, and similar loading and unloading behavior. However, Specimen 3 experienced much greater average slips than did any of the other specimens. This is consistent with the results of fatigue testing, wherein Specimen 3 exhibited the largest final slips of any fatigued specimen. The reasons for this are not immediately apparent, as this specimen did not have any outwardly visible differences from other specimens and had a nearly identical stiffness to Specimen 4.

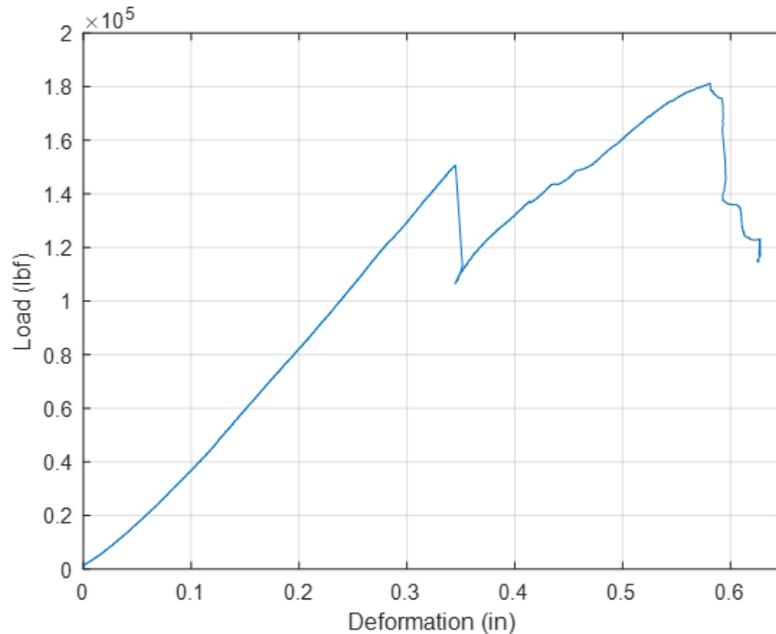
**Figure 26: Specimen 3 – Ultimate-Load Strength Testing**

Figure 26 presents the load-deformation response of Specimen 3 during failure testing. As with the previous specimens, this Specimen’s behavior was initially characterized by a roughly linear regime. However, after this initial, linear regime, it exhibited behavior that differed from the previous two. Specimen 3 experienced a significant loss in load carried at a load of around 150,600 lbf. After this drop, it was able to sustain additional load surpassing its initial failure point until experiencing a full loss of marginal load capacity at around 180,900 lbf. This secondary load-path is less stiff, and is characterized by significant nonlinearity.

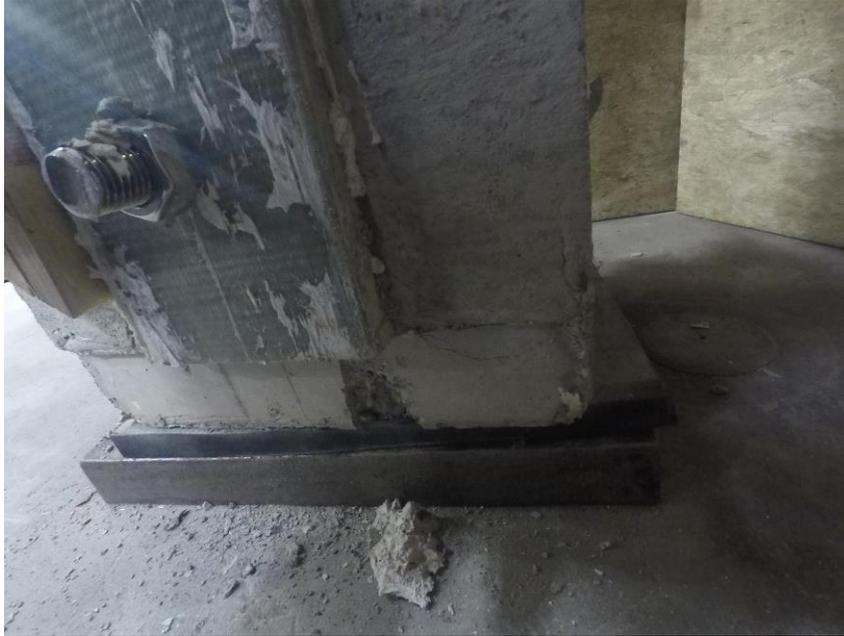
**Figure 27: Specimen 3 – Minor Concrete Spalling**

Examination of Specimen 3 did not reveal the concrete compressive failure characteristic of the first two specimens, with only a small portion of the bottom of the block spalling from the main block, as seen in Figure 27. However, as seen in Figure 28, one of the FRP plates under the actuator’s load-head experienced significant crushing and delamination. During removal of the FRP plates from the concrete block, it was observed that the stainless steel studs were in direct bearing with the plates, making removal difficult, and that nearly all of the ridges cast into the concrete block had experienced shear failure. From these observations, the specimen’s progression of failure can be hypothesized. At the initial failure point (150,600 lbf), the connection’s concrete ridges began to fail in shear, causing the stainless studs to be loaded by direct bearing. These then began to yield (accompanied by the shear failure of additional ridges), as evidenced by the nonlinearity of the secondary load-path. It is unclear whether the final drop in load was due to concrete compressive failure (Figure 27) or FRP crushing (Figure 28). However, as they occurred on opposite sides of the Specimen, it is possible that one led to the other as a loss of stiffness on one side of the Specimen led to additional load being taken by the other, which exceeded its corresponding capacity.

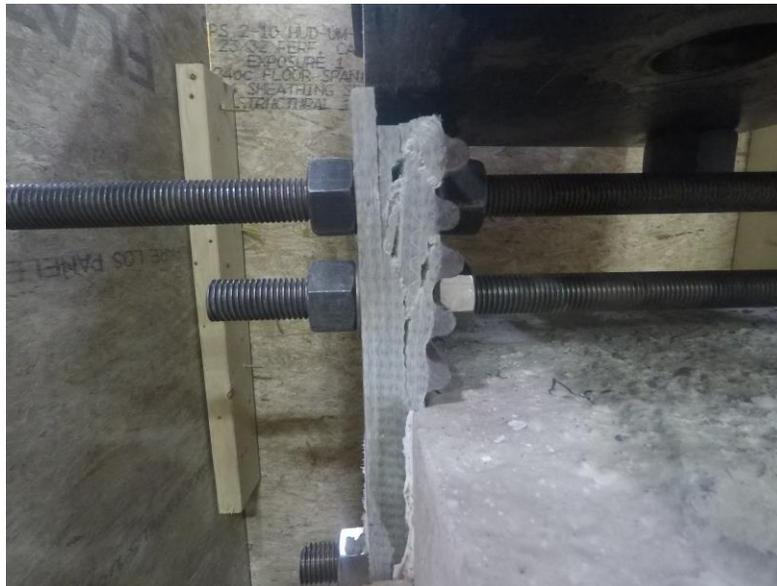
**Figure 28: Specimen 3 – FRP Crushing**

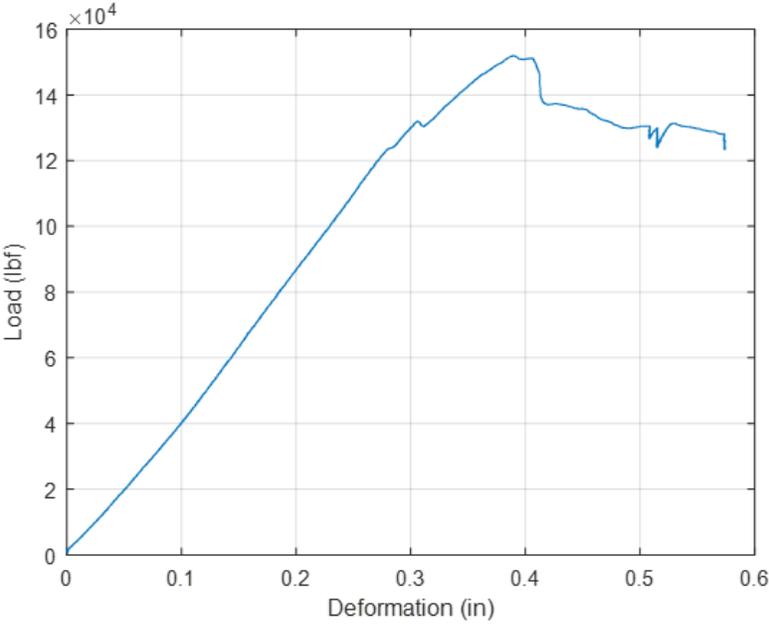
**Figure 29: Specimen 4 – Ultimate-Load Strength Testing**

Figure 29 presents the load and deformation data recorded from Specimen 4 during failure testing. Behavior was roughly linear up to a load of around 123,700 lbf, after which the specimen experienced some mild softening. Peak load occurred at around 150,800 lbf, which was followed by a moderate loss of load and inability to recover or carry additional load. Investigation of the failed specimen revealed that the initial softening was likely due to concrete ridge shear failure, as can be seen in Figure 30. The drop in load after peak is likely due to a concrete crushing failure

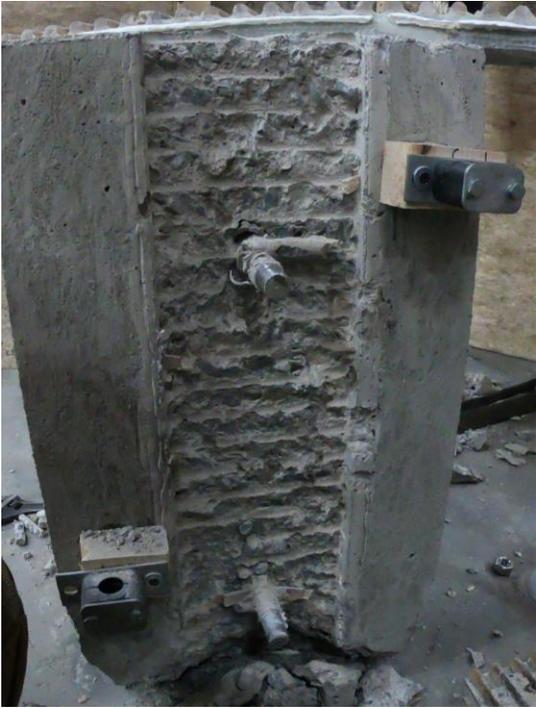
**Figure 30: Specimen 4 – Concrete Ridge Shear Failure and Spalling**

(visible from a large spall at the specimen's bottom in Figure 30) which was followed by stud yielding and pullout, visible in Figure 31.

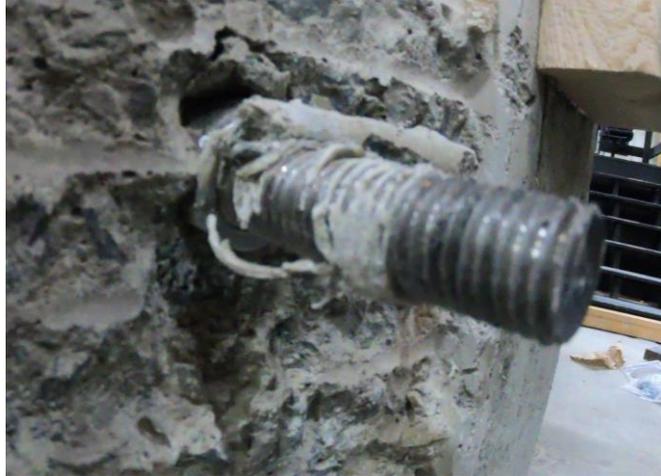
**Figure 31: Specimen 4 – Stainless Stud Yielding and Pullout**

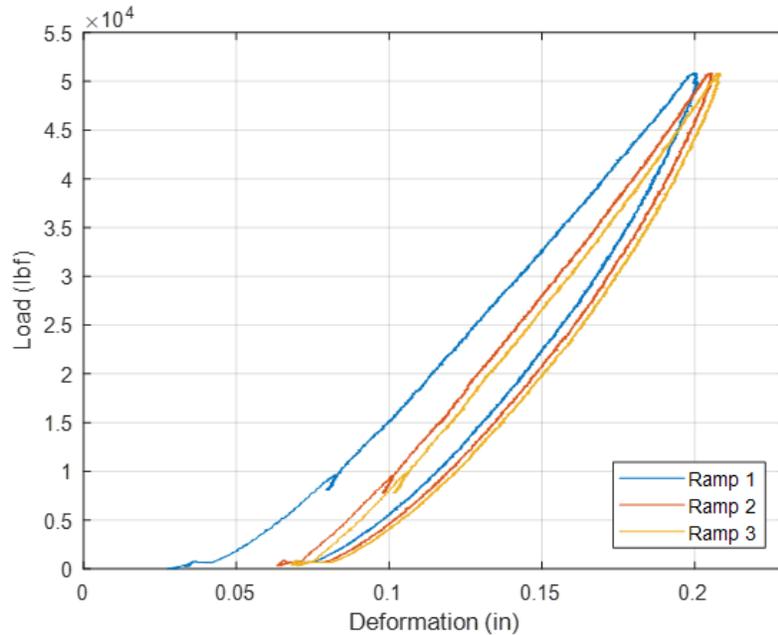
**Figure 32: Specimen 4 – Service-Load Stiffness Testing**

Figure 32 presents the results of stiffness testing performed on Specimen 5. This specimen's load-deformation behavior was qualitatively similar to that of the previous specimens. Its response during loading cycles was roughly linear, while its response during unloading was nonlinear and displayed some hysteretic deformation. In addition, the response during the second and third load ramps were stiffer and slightly offset from the first. As noted in Table 2, on average Specimen 5's stiffness (386,000 lbf/in.) was around 85% that of Specimens 1 and 2. However, this difference in stiffness is reasonable considering Specimen 5's lower compressive strength. As shown in Table 3, on the day of testing, concrete cylinders cast concurrently with Specimens 1 and 2 exhibited an average compressive strength of 12,100 psi, compared with Specimen 5's 8,220 psi. Using AASHTO's [4] formula for concrete elastic modulus (a function of compressive strength), the ratio of Specimen 5's concrete elastic modulus to that of Specimens 1 and 2 is around 82.4%, close to the measured 85% for the specimens as a whole. This suggests that, for service-level loading, the connection's stiffness is not highly dependent on ridge quality, but rather depends more highly on concrete stiffness.

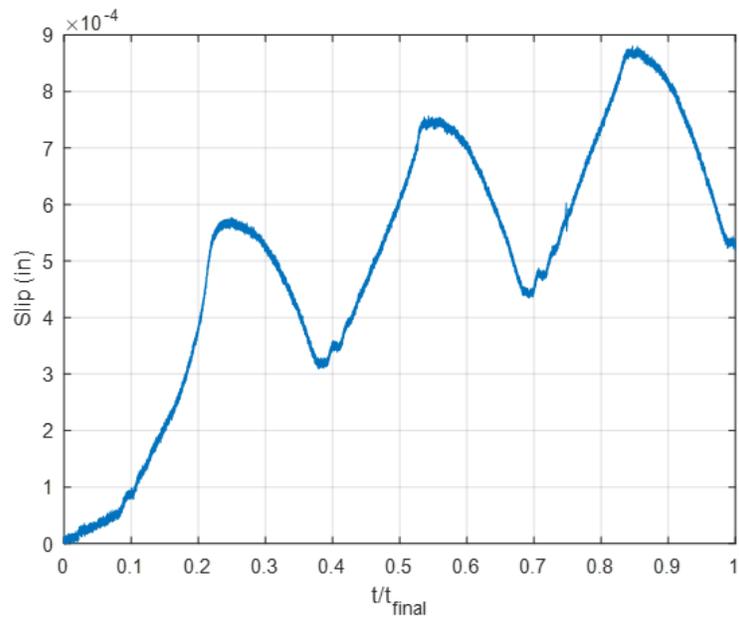
**Figure 33: Specimen 5 – Average Slip Data**

Additional differences between the stiffness test behavior of Specimen 5 and the previous, fatigue tested specimens can be seen in Figure 33, which presents the average slips between concrete and FRP plates recorded during stiffness testing. In contrast to previous specimens, a significant amount of irrecoverable slip was incurred during each load ramp. This can be seen as the slip not returning to near-zero after load is removed. This behavior is consistent across both FRP plates at both the top and bottom, as seen in Figure 34. Both Figures 33 and 34 also display significant asymmetry between the slips recorded during loading and unloading, as well as a decreased signal-to-noise ratio in recorded slip as compared with previous specimens. This behavior is possibly due to the specimen being in its “virgin” state, not having been significantly loaded under previous fatigue testing. It is plausible that this irrecoverable slip, load-unload asymmetry, and noisy signal were also characteristic of the other specimens during their first fatigue cycles as imperfections in connections and tolerance gaps were taken up in a “wear-in” period. This is further evidenced by the large amount of slip each previous specimen accumulated early in fatigue testing (see Figures 6, 8, 12, and 14).
