**Assessment and optimization of double CT bridge girder sections with  
longitudinal precast decks**

**Final Project Report**

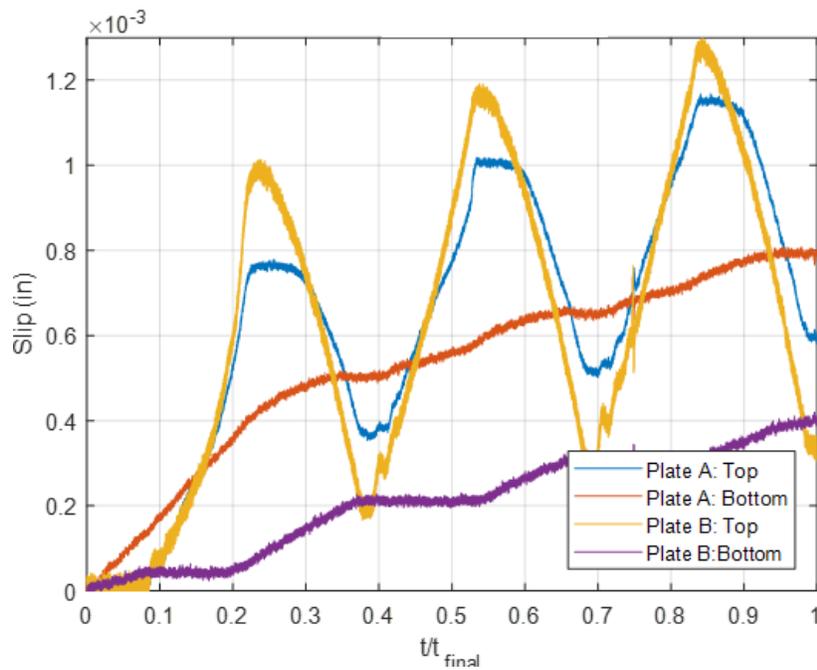
**Figure 34: Specimen 5– All Slip Data**

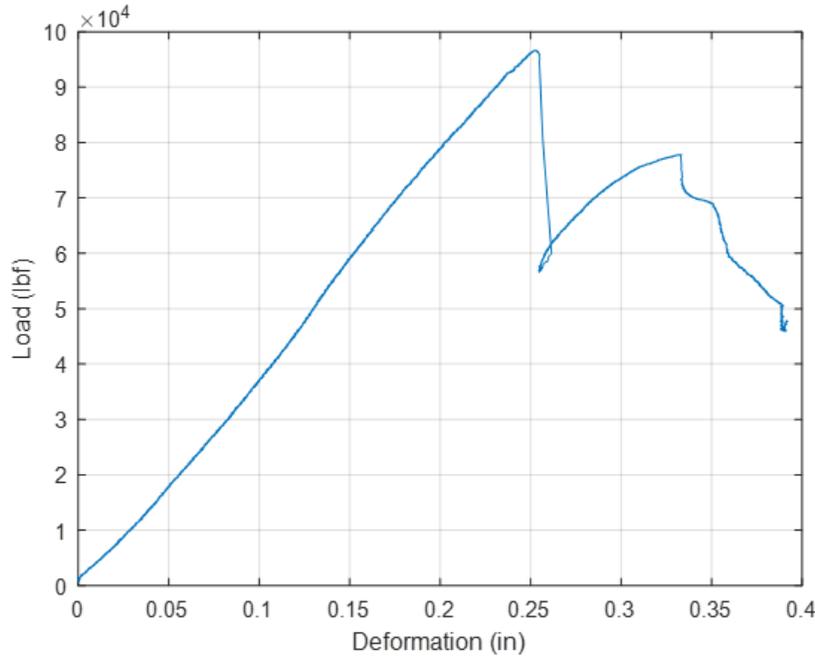
**Figure 35: Specimen 5 – Ultimate-Load Strength Testing**

Figure 35 presents Specimen 5’s load-deformation response during failure testing. As can be seen, the specimen’s response is qualitatively very similar to previous specimens (especially Specimens 1 and 2), with an initial, linear range up to a well-defined failure point. After this point a significant amount of load was dropped with some recovered during a nonlinear, softening phase

and a final point at which no additional load can be carried. Quantitatively, Specimen 5 failed at a load of 96,600 lbf, a 40% reduction from Specimen 1 and a 44% reduction from Specimen 2. This reduction in failure load is reasonable considering the loss of ridge interlock resulting from shaving the height of the initial FRP ridges, as well as the specimen's lower concrete strength.

Inspection of Specimen 5's FRP-concrete interface after testing provides some additional insight into the possible series of events leading to complete failure. The damage sustained by the two interfaces, by both the concrete and FRP, was quite different. Side A (shown in Figure 36) sustained heavy damage, with all of the positive concrete ridges (and in fact some of the negative ridges as well) experiencing shear failure, and significant bearing damage occurring at the stud-holes in the FRP. Contrary to this, Side B (shown in Figure 37) experienced much less concrete damage and no visible FRP bearing damage. It can be hypothesized that most of the concrete damage from Side A occurred around the peak loading, which led to the immediate drop in load seen in Figure 35. After this, much of the additional load was shed to Side B, with the majority of load carried by Side A resulting from the FRP bearing directly on the studs. From there, the concrete ridges on Side B began to fail progressively, leading to the softening seen in Figure 35 after peak load.

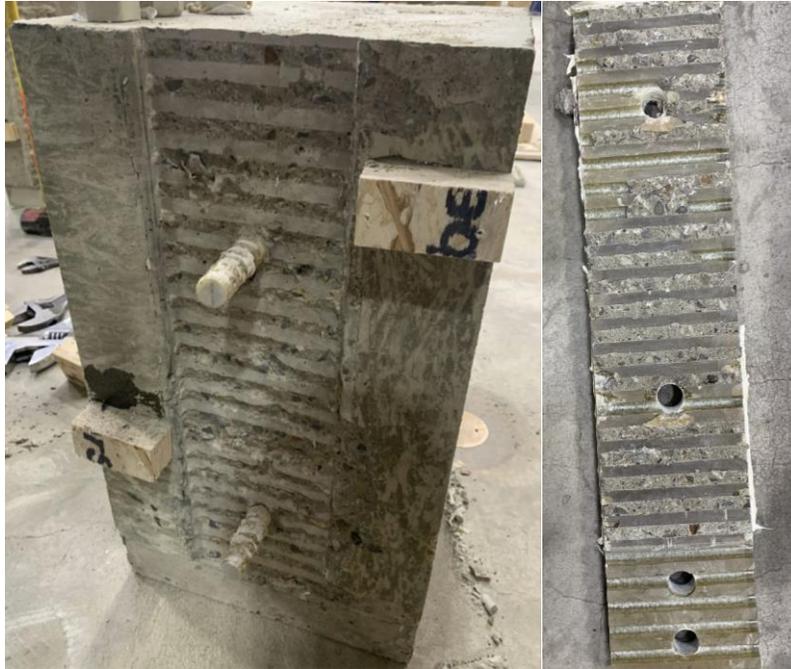
**Figure 36: Specimen 5 – Side A Heavy Damage (Left: Concrete, Right: FRP)**

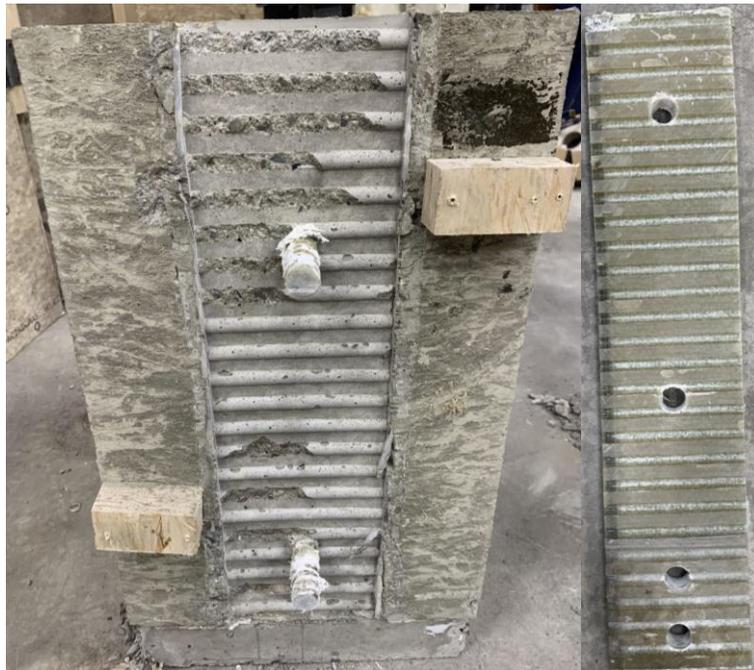
**Figure 37: Specimen 5 – Side B Moderate Damage (Left: Concrete, Right: FRP)**

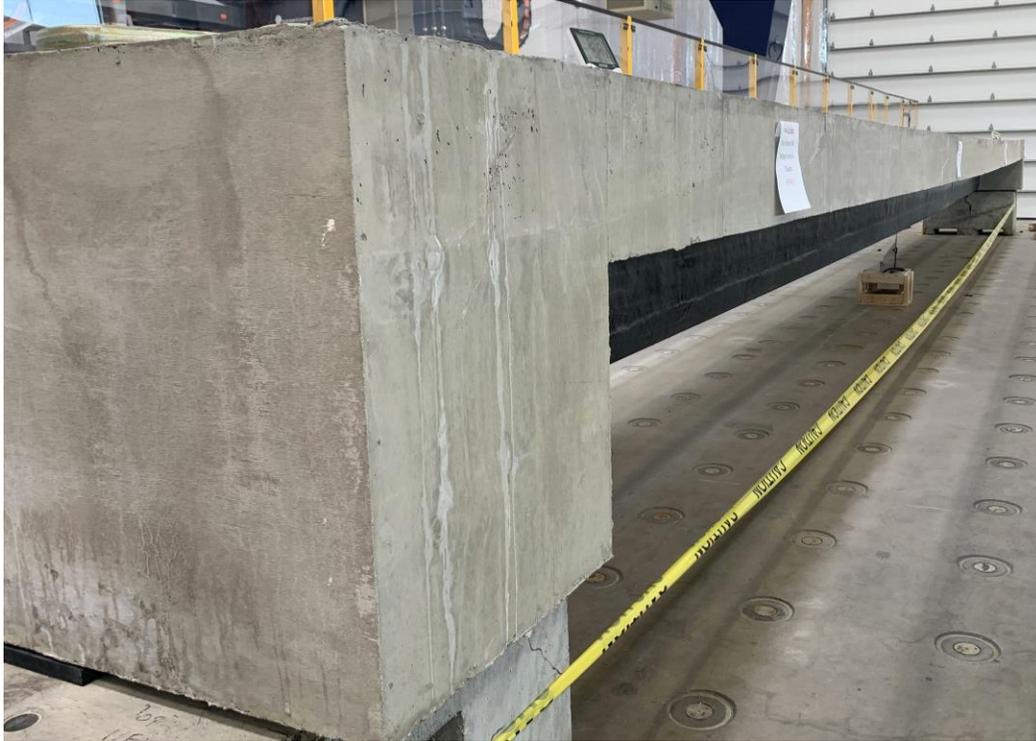
**Figure 38: UTC-1 Creep Girder Specimen**

It is well known that FRP and concrete exhibit visco-elastic behavior over time leading to the phenomenon we know as creep, an increase in deflection over time under a constant state of stress [6-8]. Additionally, other composite FRP-concrete sections used as the main structural members of bridges are subject to creep deflection and rupture, with these limit states addressed in design [9]. It can therefore be safely assumed that the double CT girder would likely display creep behavior and that this behavior must be both understood and accounted for in design. As a first step in gaining this understanding, UMaine tested one half of a double CT girder section (a full double CT girder cut length-wise and consisting of one FRP girder, and both the lower, precast, and upper, cast-in-place deck sections within the girder's tributary width) under its own weight in creep. An image of the creep girder specimen, hereafter referred to as "UTC-1", can be seen in Figure 38. This test simulates a CT girder, which, after having been manufactured, was fully supported until its upper deck section had fully cured, after which supports were removed and no further dead loads or sources of stiffness introduced.

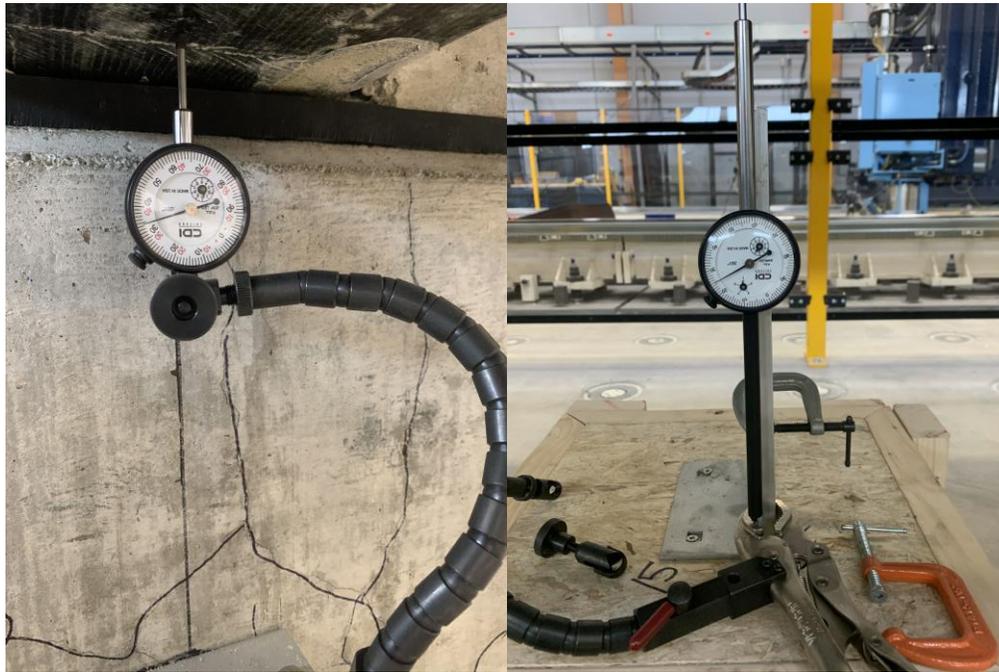
**Figure 39: Deflection Measuring Dial Indicators**

reduced to 4 measurements per day for an additional 2 days, 3 measurement per day for an additional 4 days, and finally 2 measurements per day thereafter. Measurements were taken on weekdays only and only during lab business hours. The final measurement was taken on September 20, 2021, giving a total measurement period of 215 days. In addition to deflections, each measurement also included ambient lab temperature and humidity with a portable thermometer/humidity sensor, and surface temperature of the girder and concrete around the areas of the dial indicators using an infrared thermometer.

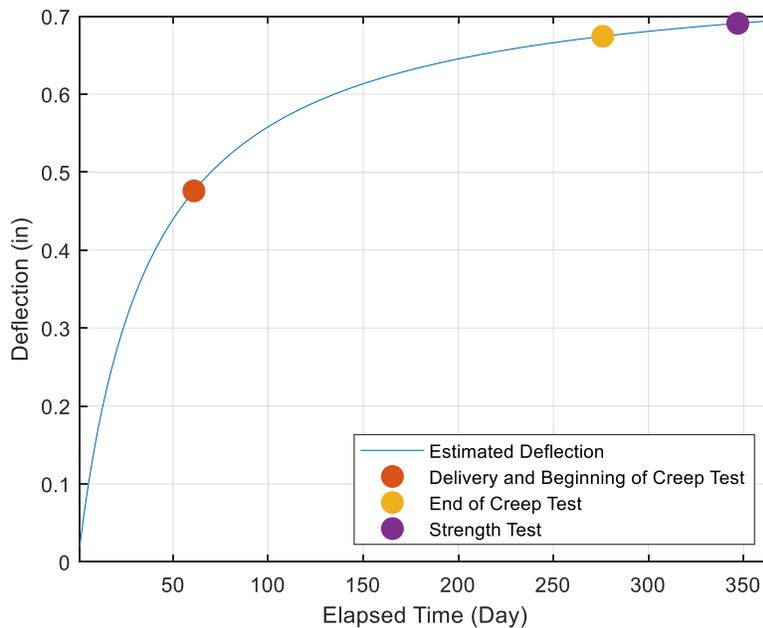
**Figure 40: Estimated Shrinkage Deflection**

As an additional point of comparison, the specimen's approximate shrinkage deflection was computed for elapsed times of one day to one year after casting. These can be seen plotted in Figure 40 with key dates in testing noted. To estimate these deflections, uniform shrinkage strain in the concrete at each time-step was estimated per AASHTO [4] in Equation 1, where  $\varepsilon_{sh}$  is the estimated uniform shrinkage strain in the deck at a particular time after casting and  $k_s$ ,  $k_{hs}$ ,  $k_f$ , and  $k_{td}$  are empirical factors accounting for the deck's shape, the ambient humidity, the concrete's initial strength, and the elapsed time, respectively. To ensure plane sections, the shrinkage strain and a nonuniform strain distribution causing internal stresses ( $\varepsilon_\sigma$ ) were summed and equated to the sum of an axial ( $\varepsilon_a$ ) and bending ( $\varepsilon_\phi$ ) strain in Equation 2. By enforcing moment equilibrium, the curvature was found through Equation 3, in which  $A_c$  is the cross-sectional area of the concrete,  $\bar{y}$  is the composite centroidal height,  $y_c$  is the height of the concrete centroid, and  $I_T$  is the transformed moment of inertia for the composite section. Separately, the curvature was taken as the second derivative of the deflection caused by shrinkage and integrated twice to obtain an expression for the deflection as seen in Equations 4 and 5 in which  $v$  is shrinkage displacement of the girder at a position  $x$  along its span length  $L$ . By substituting Equation 3 into Equation 5 and setting the position at midspan ( $x = L/2$ ), a straightforward estimation of midspan deflection from shrinkage could be obtained.

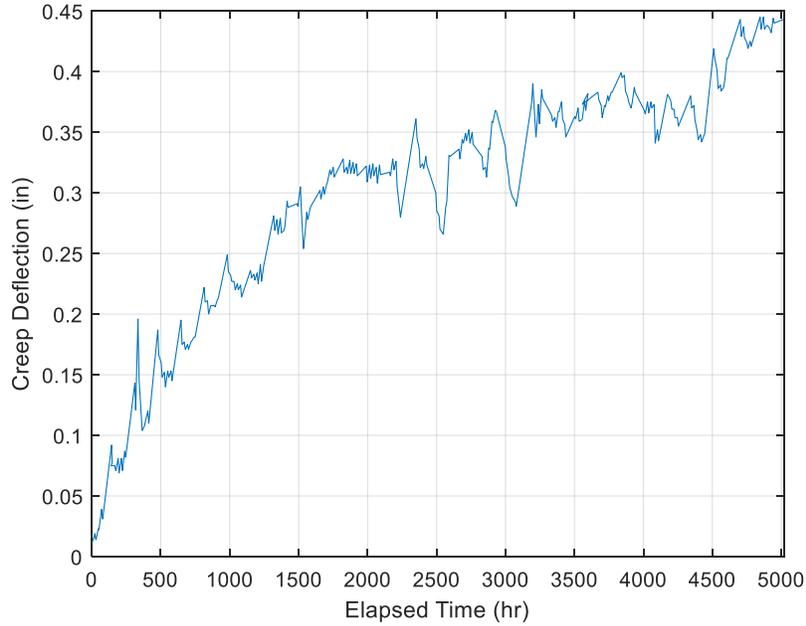
**Figure 41: Recorded Creep Deflection**

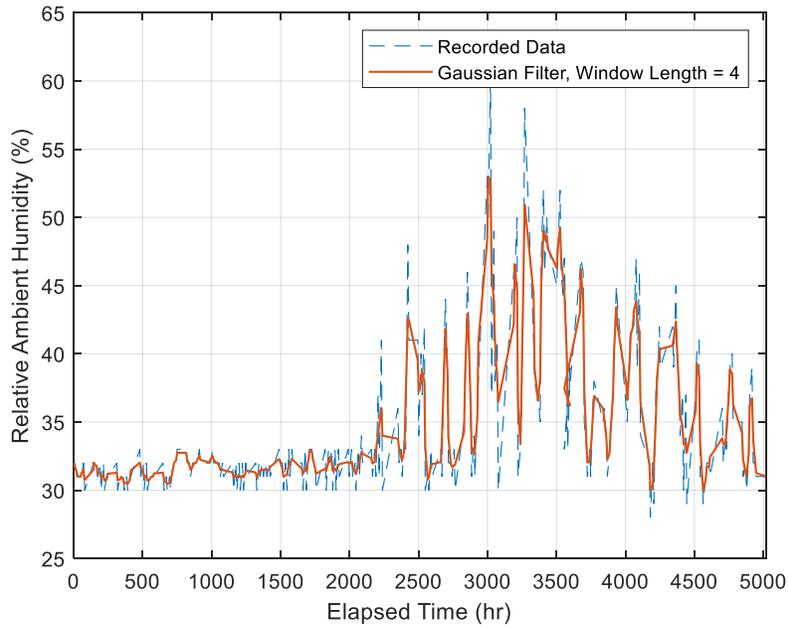
**Figure 42: Recorded OWL Relative Humidity**

and temperature were recorded to investigate their possible effects on creep. These are presented in Figures 42 and 43, respectively both as raw measurement data and clarified with a Gaussian moving average filter, window length of 4.

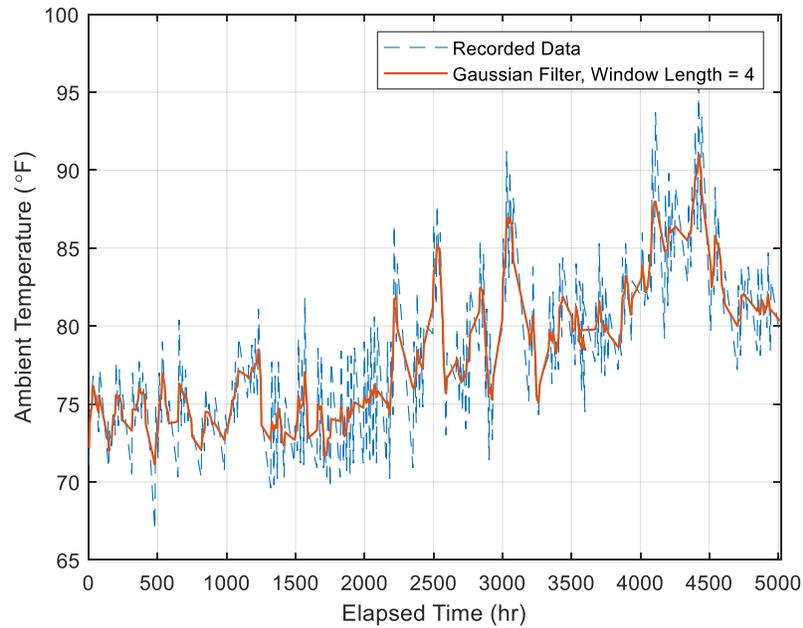
**Figure 43: Recorded OWL Temperature**

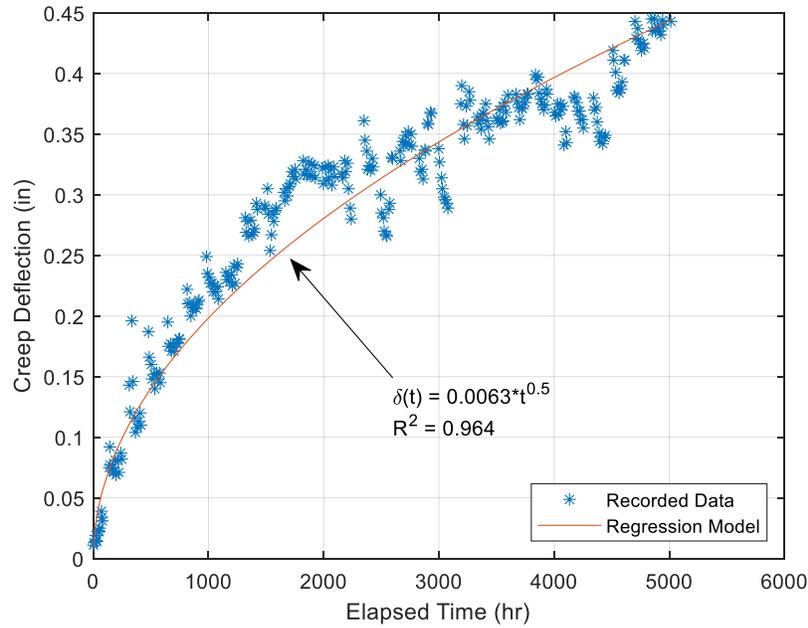
**Figure 44: Comparison of Recorded Creep Deflection and Regression Model Prediction**

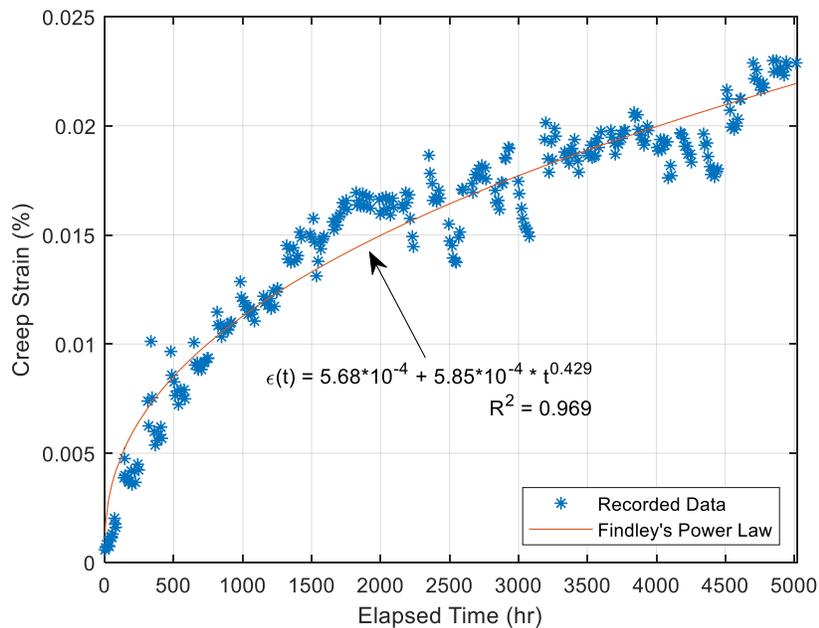
**Figure 45: Comparison of Recorded Creep Strain and Regression Model Prediction**

strain of  $0.022\% \approx 220 \mu\epsilon$ , or about 2.4% of the average strain at failure of the carbon bottom flange of  $9180 \mu\epsilon$  observed in the beam test reported by Davids et al. [13].

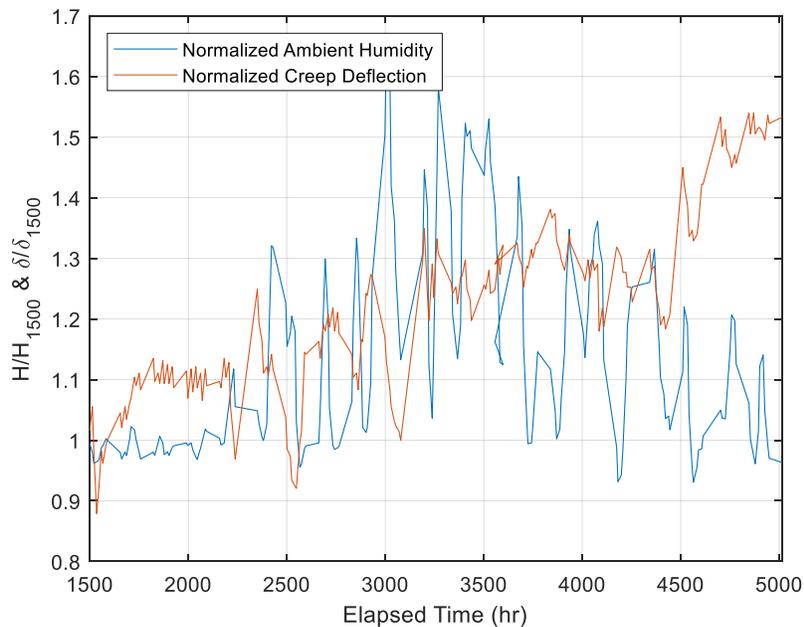
**Figure 46: Variation in Creep and Humidity**

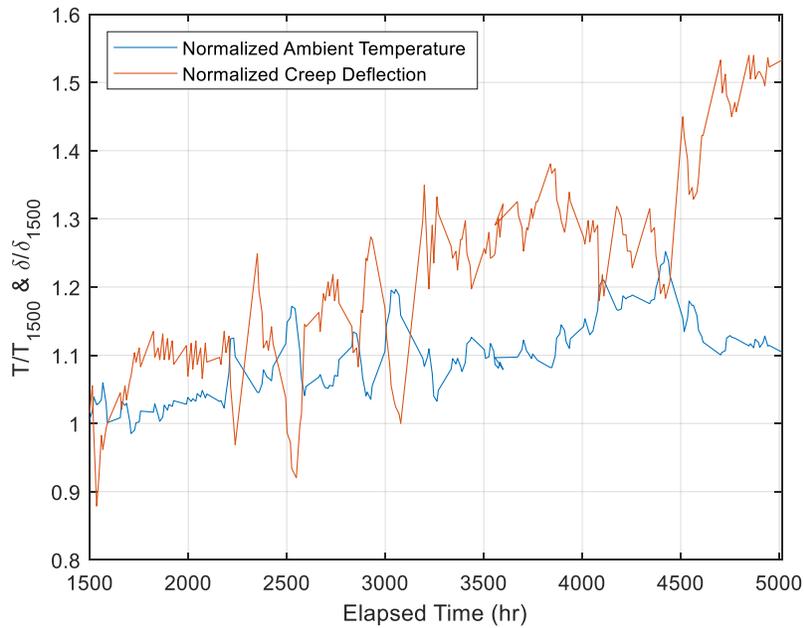
**Figure 47: Variation in Creep and Temperature**

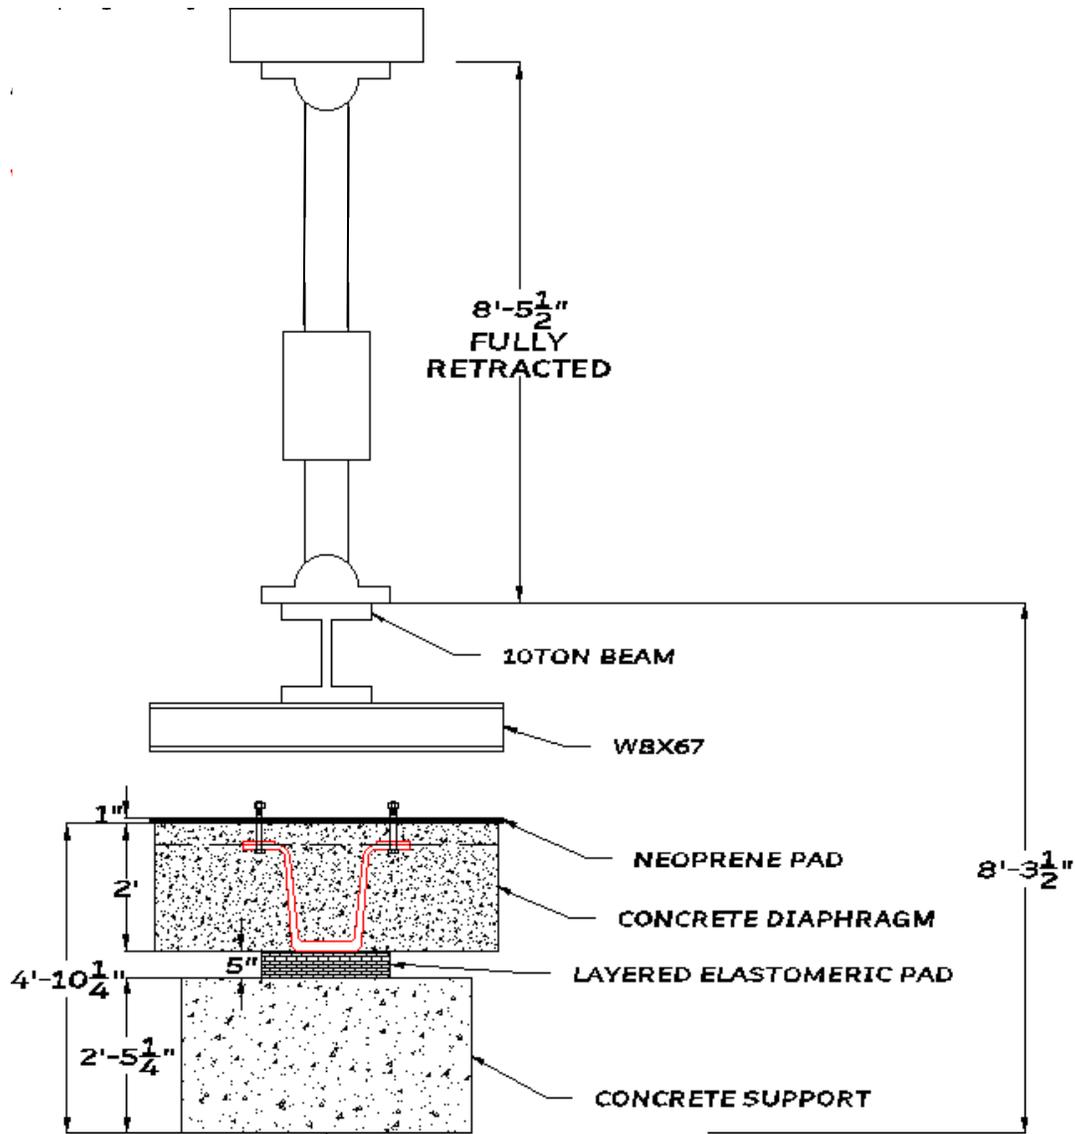
Figure 49: Test Configuration – End Elevation

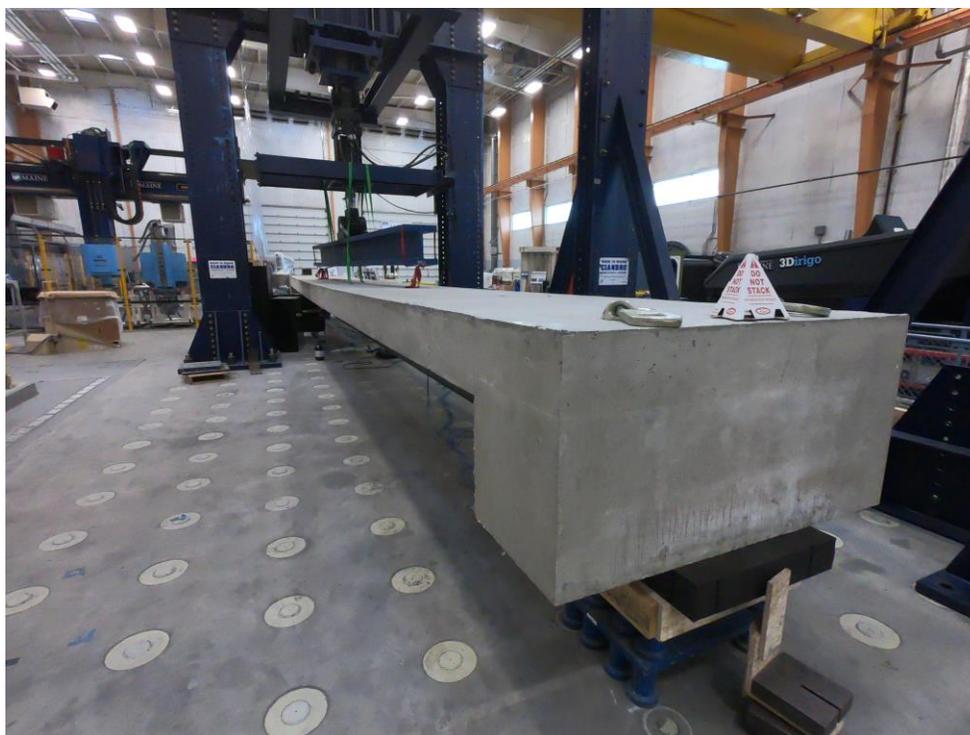
Figure 50: UTC-1 in Test Configuration

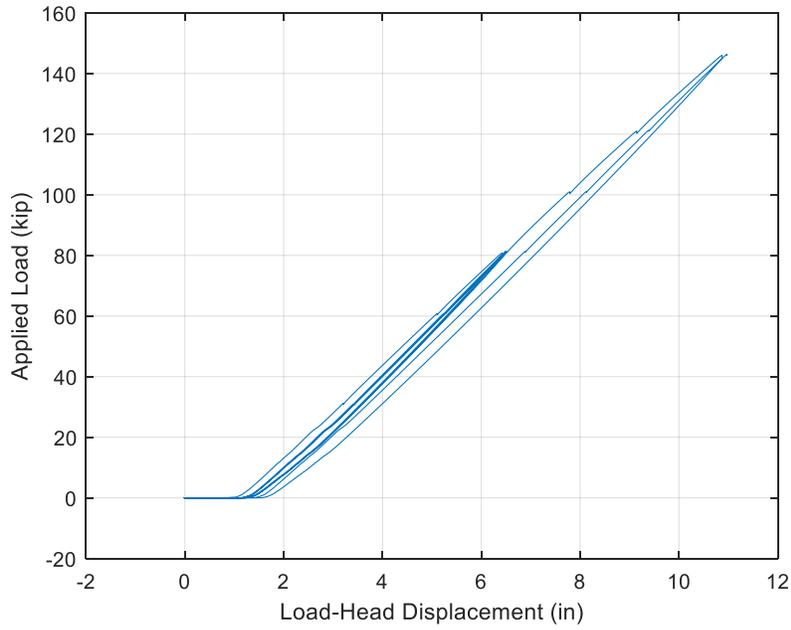
Figure 51: UTC-1 Service & Strength Load-Displacement Behavior

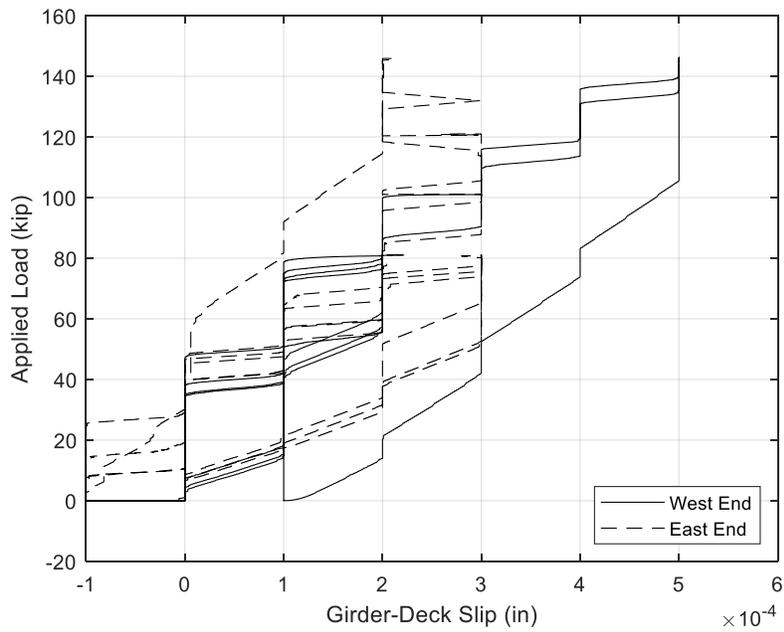
Figure 52: UTC-1 Service & Strength Deck Slip

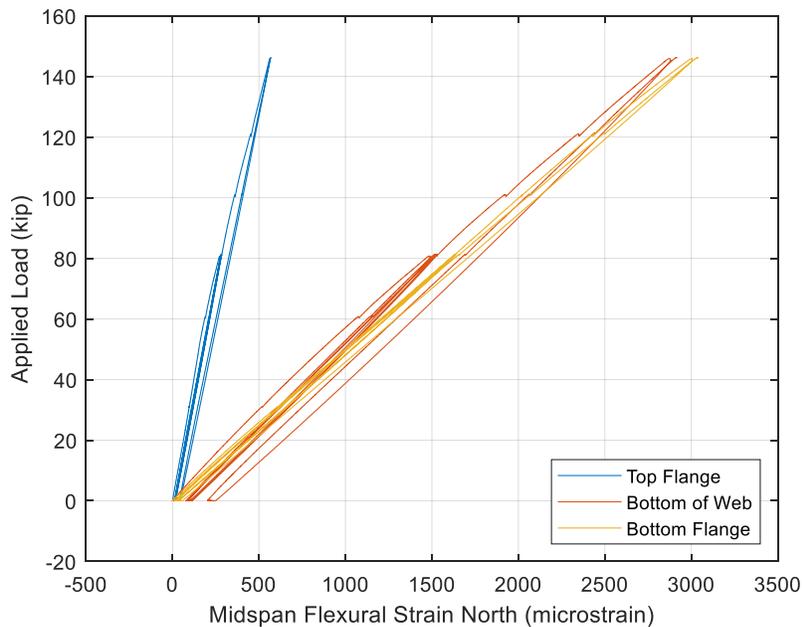
Figure 53: UTC-1 Service & Strength North Face Longitudinal Strain

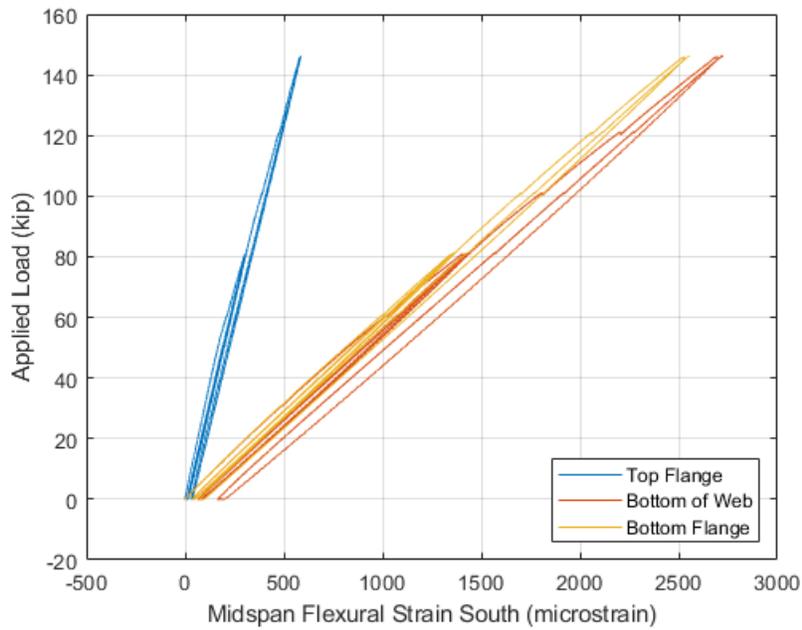
Figure 54: UTC-1 Service & Strength South Face Longitudinal Strain

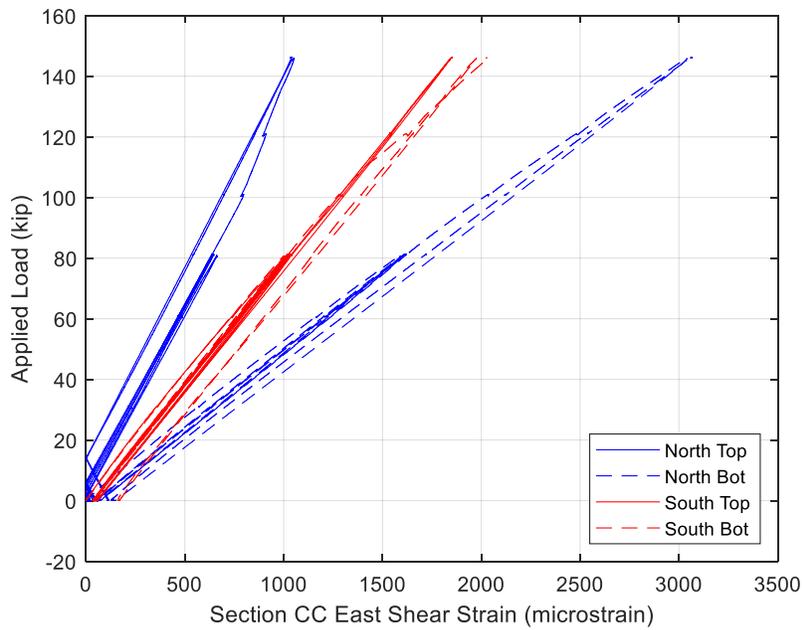
Figure 55: UTC-1 Service & Strength Shear Strain 6 in. from Support

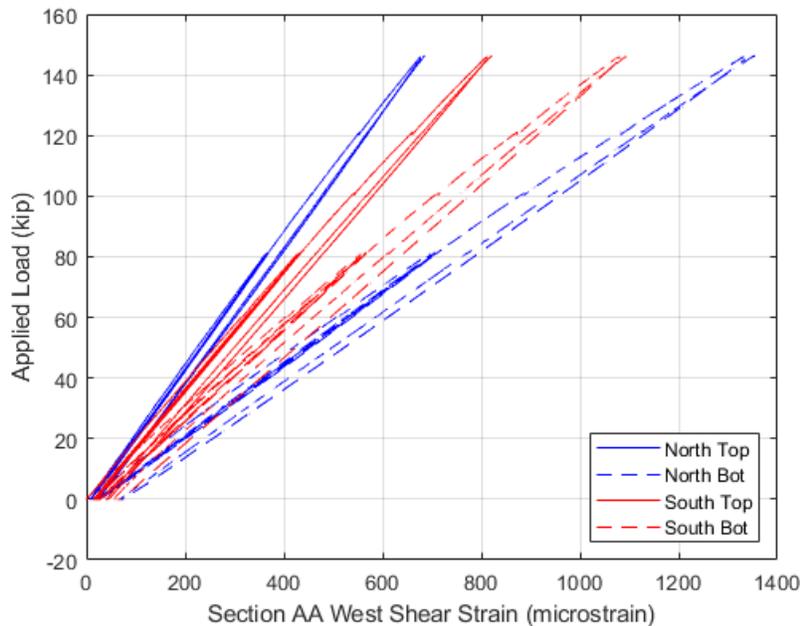
Figure 56: UTC-1 Service & Strength Shear Strain 8 ft from Support

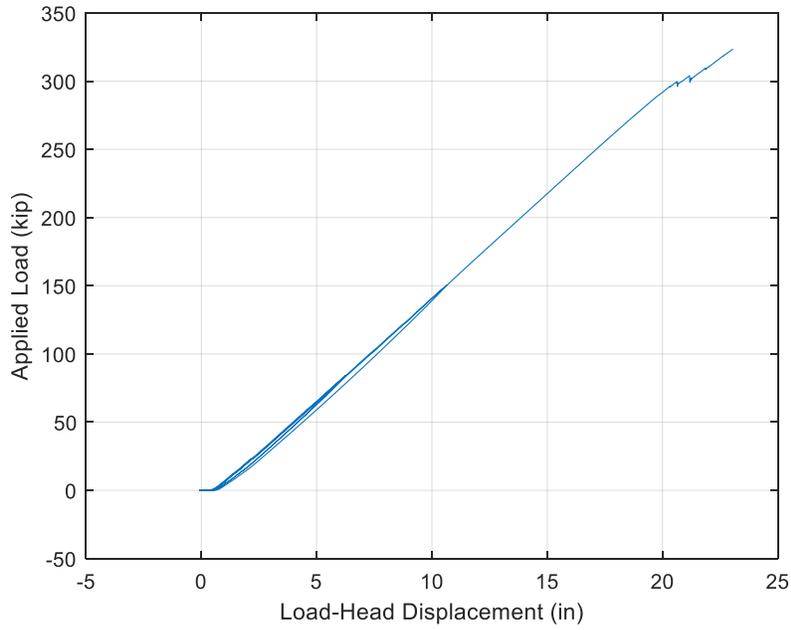
Figure 57: UTC-1 Ultimate Load-Displacement Behaviors

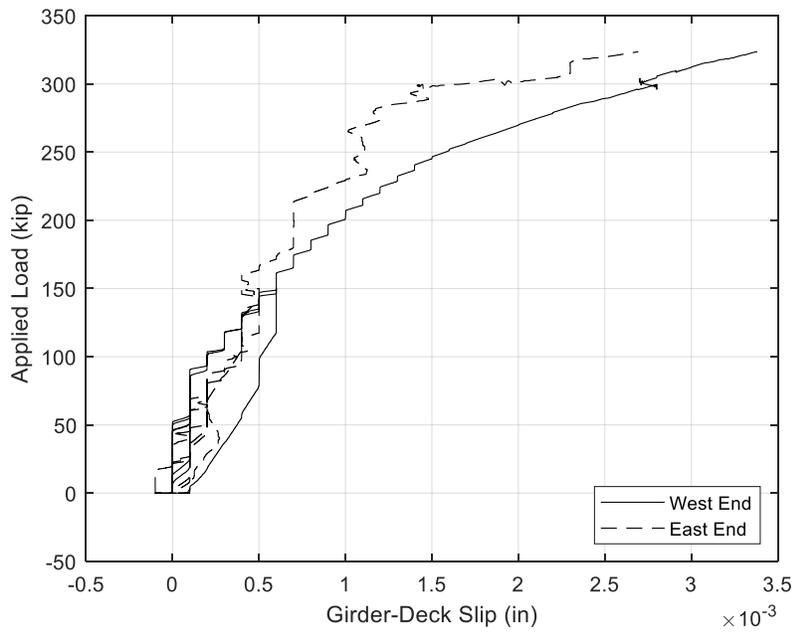
Figure 58: UTC-1 Ultimate Deck Slip

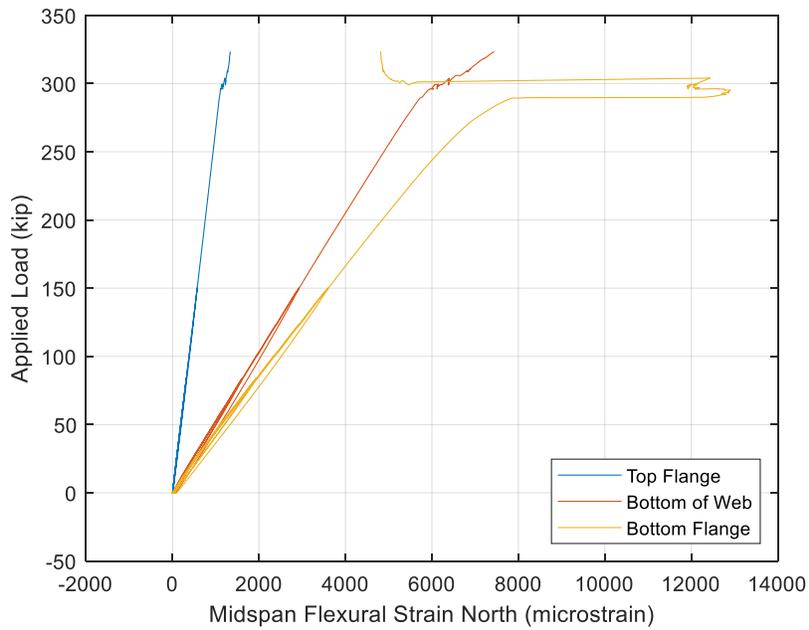
Figure 59: UTC-1 Ultimate North Longitudinal Strain

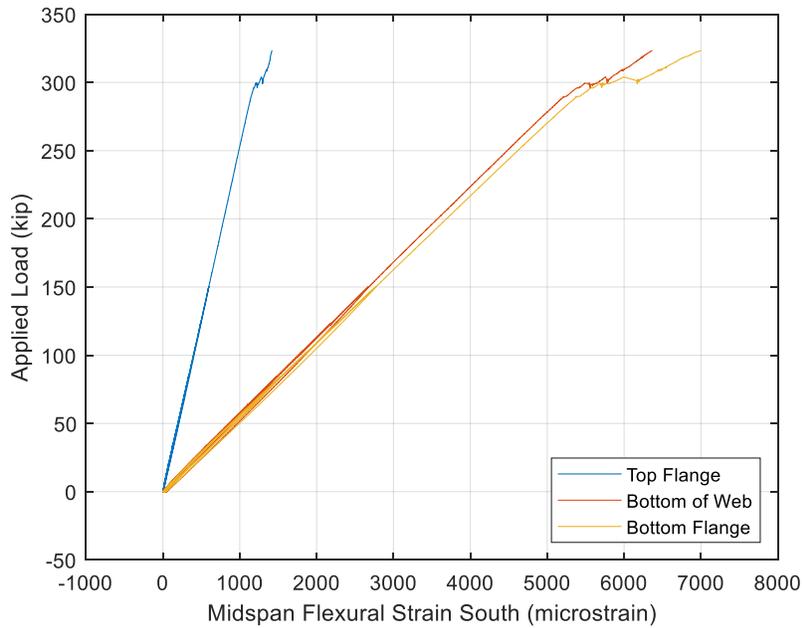
Figure 60: UTC-1 Ultimate South Longitudinal Strain

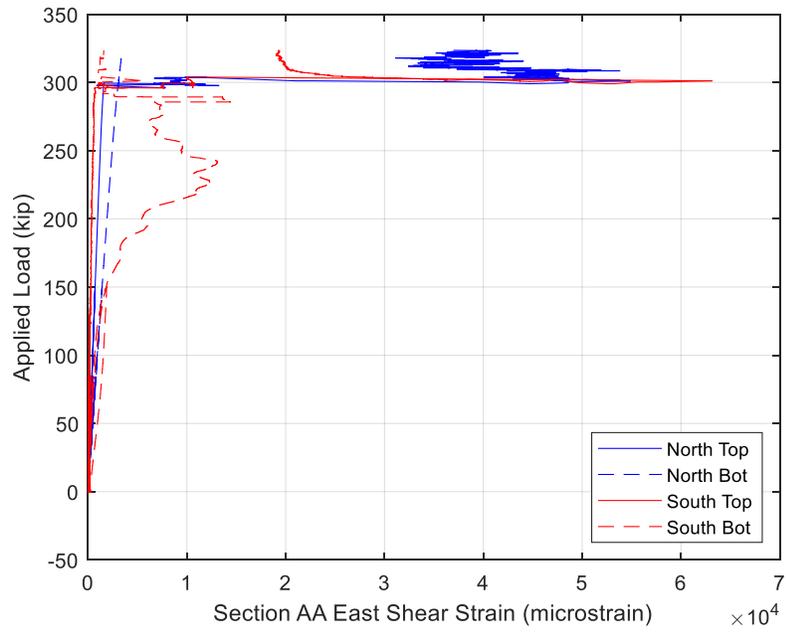
Figure 61: UTC-1 Ultimate Shear Strain 6 in. from East Support

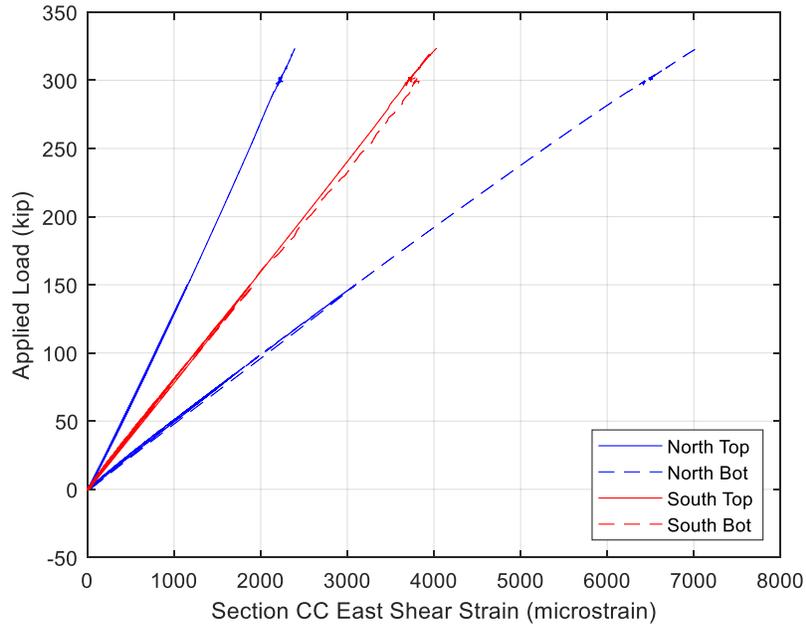
Figure 62: UTC-1 Ultimate Shear Strain 8 ft from East Support

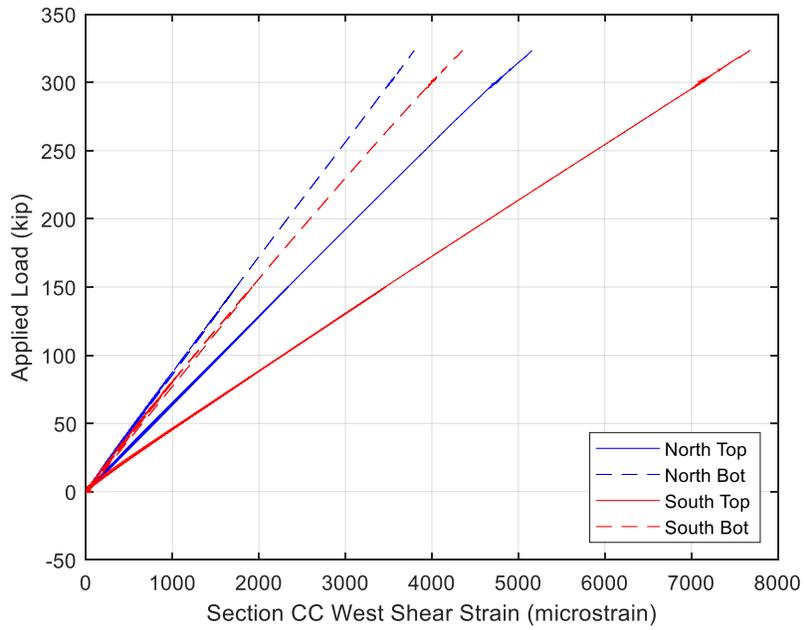
Figure 63: UTC-1 Ultimate Shear Strain 8 ft from West Support

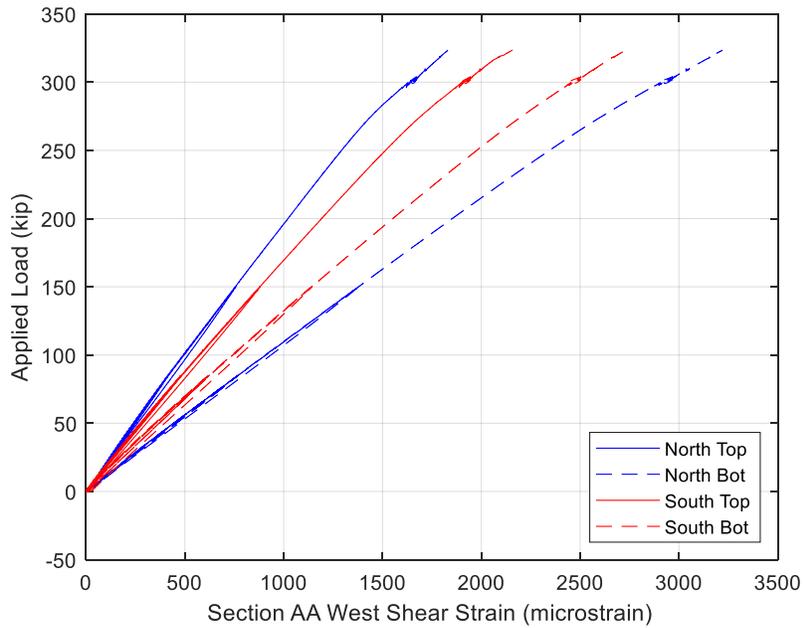
Figure 64: UTC-1 Ultimate Shear Strain 6 in. from West Support

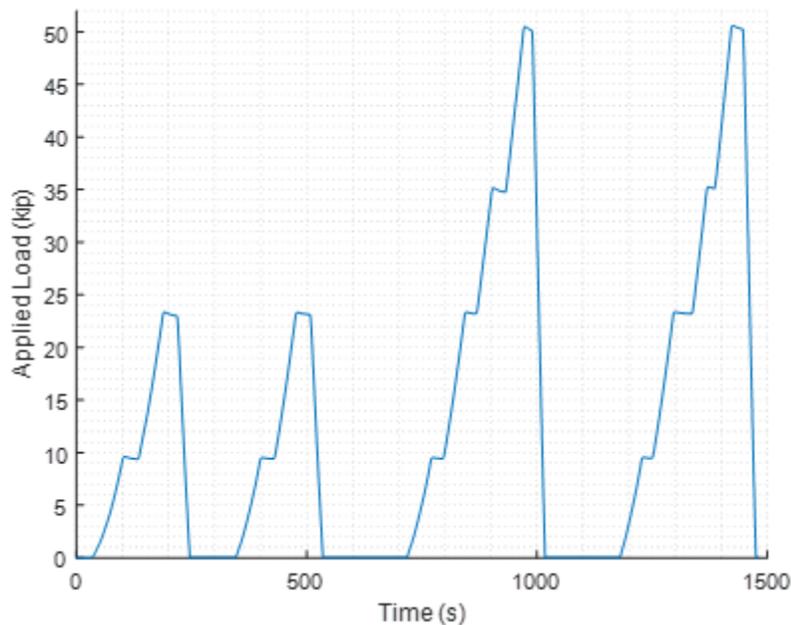
Figure 65: UTC-2 Construction Loads Test Sequence

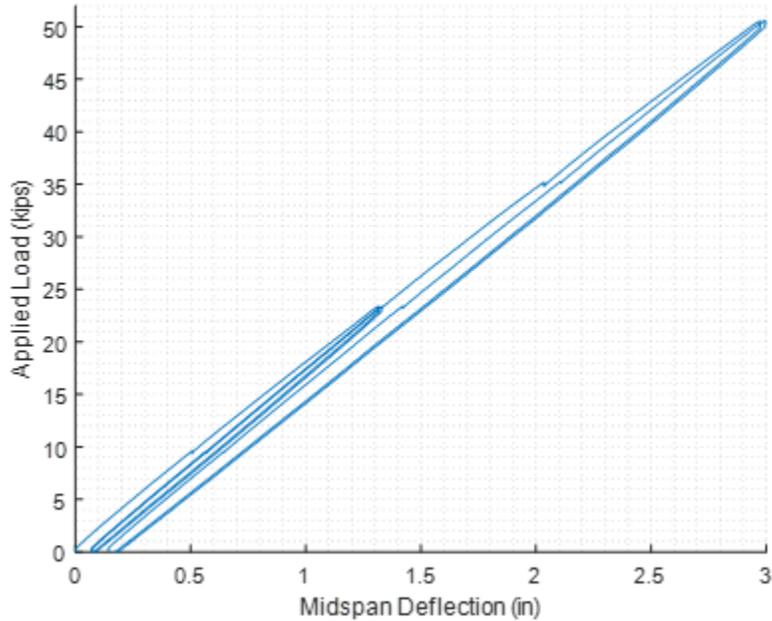
Figure 66: UTC-2 Applied Load vs. Deflection at Midspan

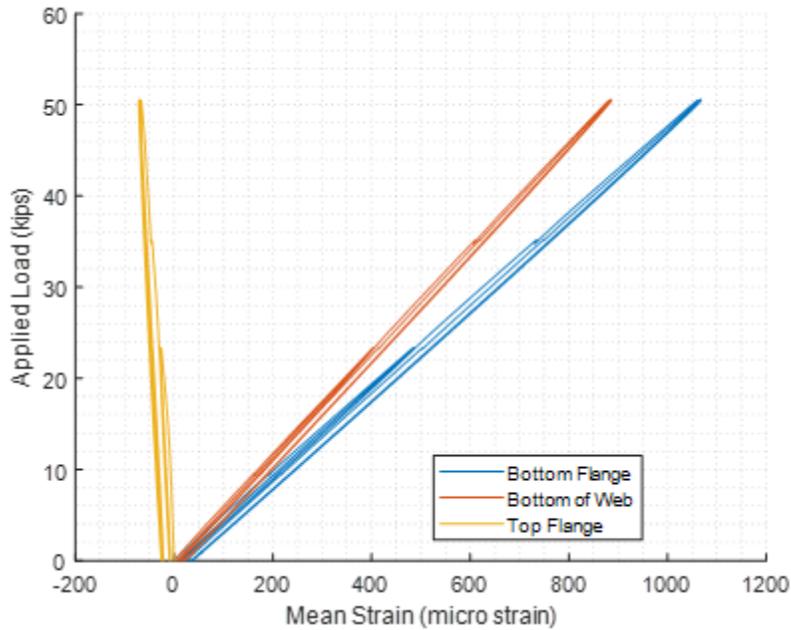
Figure 67: UTC-2 Applied Load vs. Midspan Strain\_

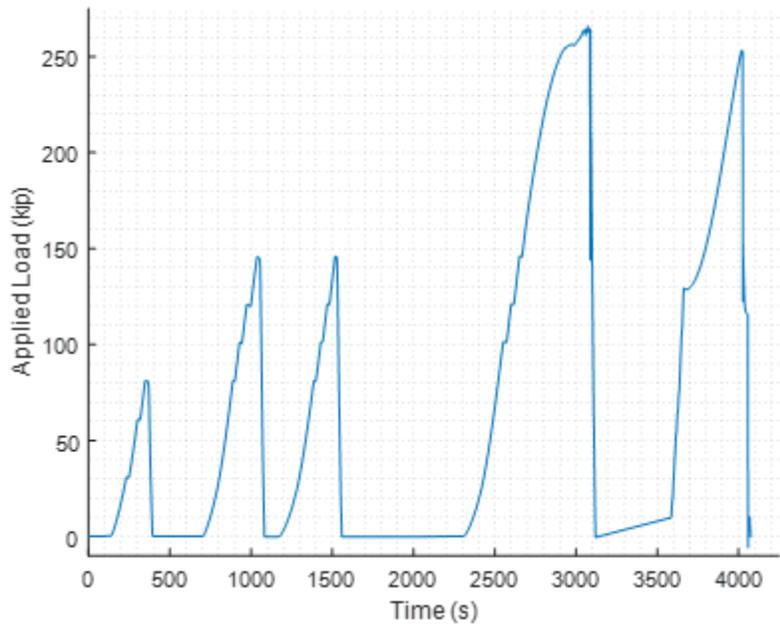
Figure 68: UTC-2 Service, Strength I, and Failure Load Sequencing

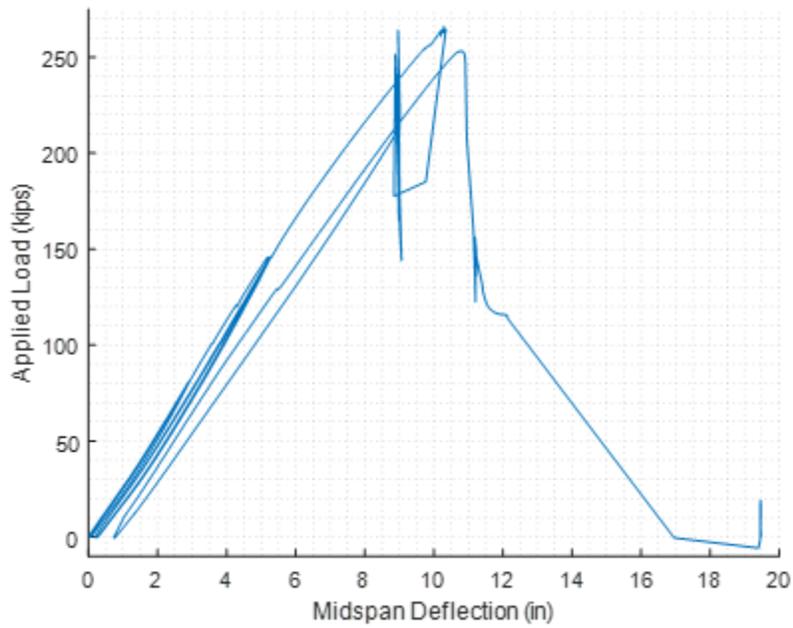
Figure 69: UTC-2 Applied Load vs. Deflection at Midspan

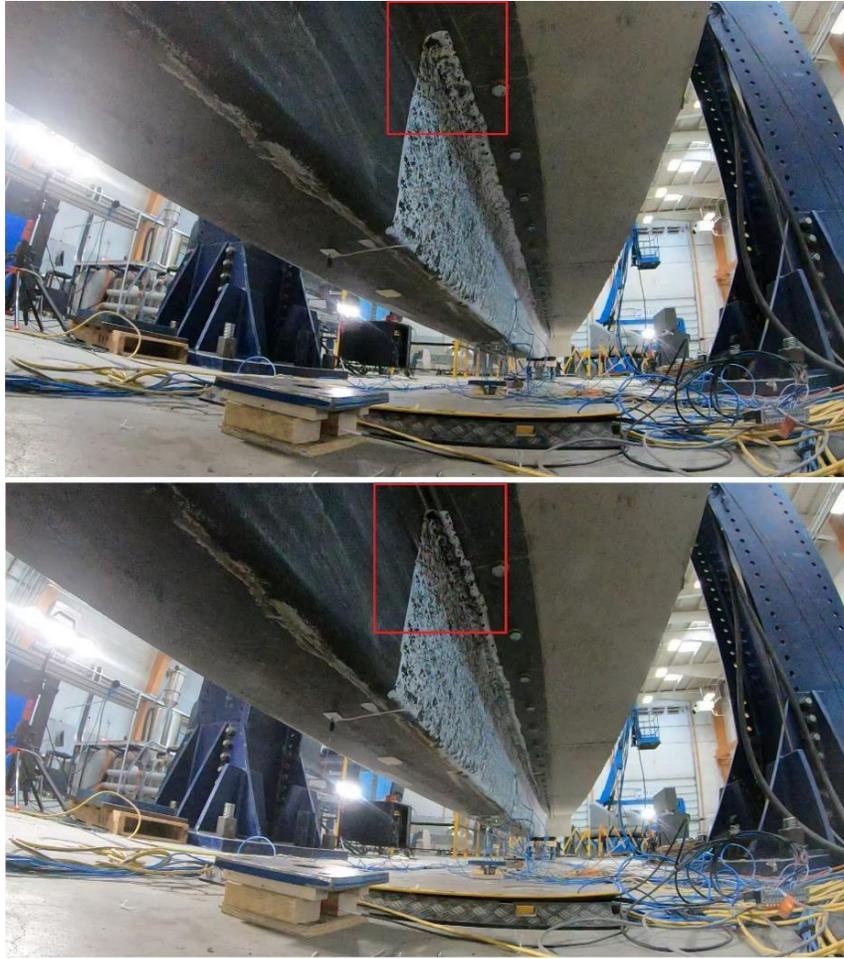
Figure 70: Before (Top) and after (Bottom) Pictures of Failure at 264 kips

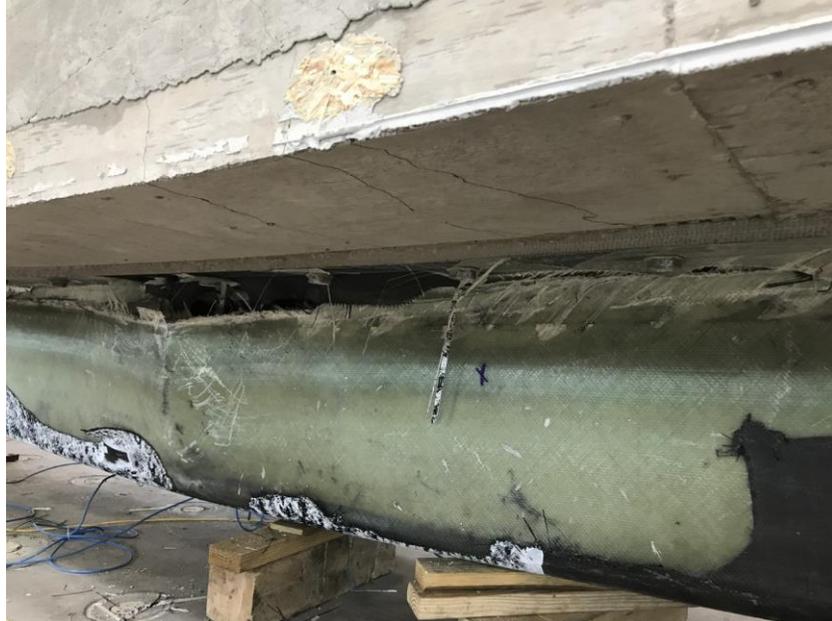
Figure 71: UTC-2 After the 253 kip Failure Load
