**Assessment and optimization of double CT bridge girder sections with  
longitudinal precast decks**

**Final Project Report**

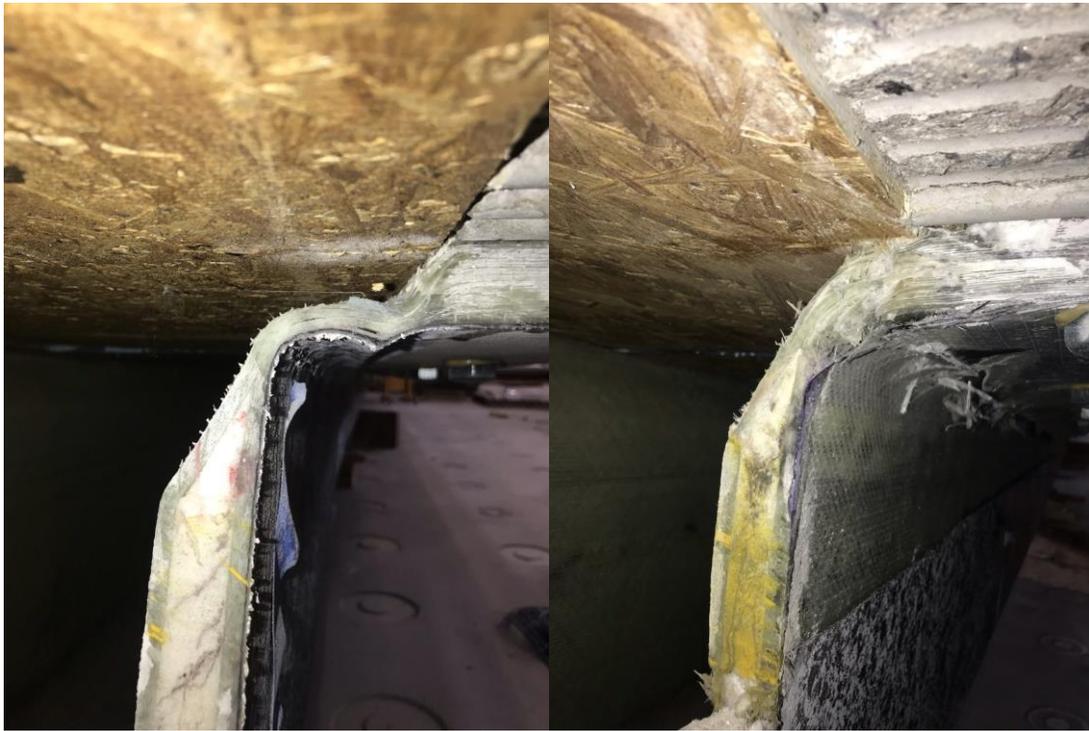
Figure 72: Top Flange Radius Buckling (Left) and Delamination (Right)
