FINAL REPORT ~ FHWA-OK-26-01

# EFFECTIVENESS OF MAGNESIUM- ALUMINO-LIQUID PHOSPHATE-BASED CONCRETE AS A REPAIR MATERIAL

Department of Civil, Environmental & Architectural Engineering  
The University of Kansas  
Lawrence, Kansas

October 2025

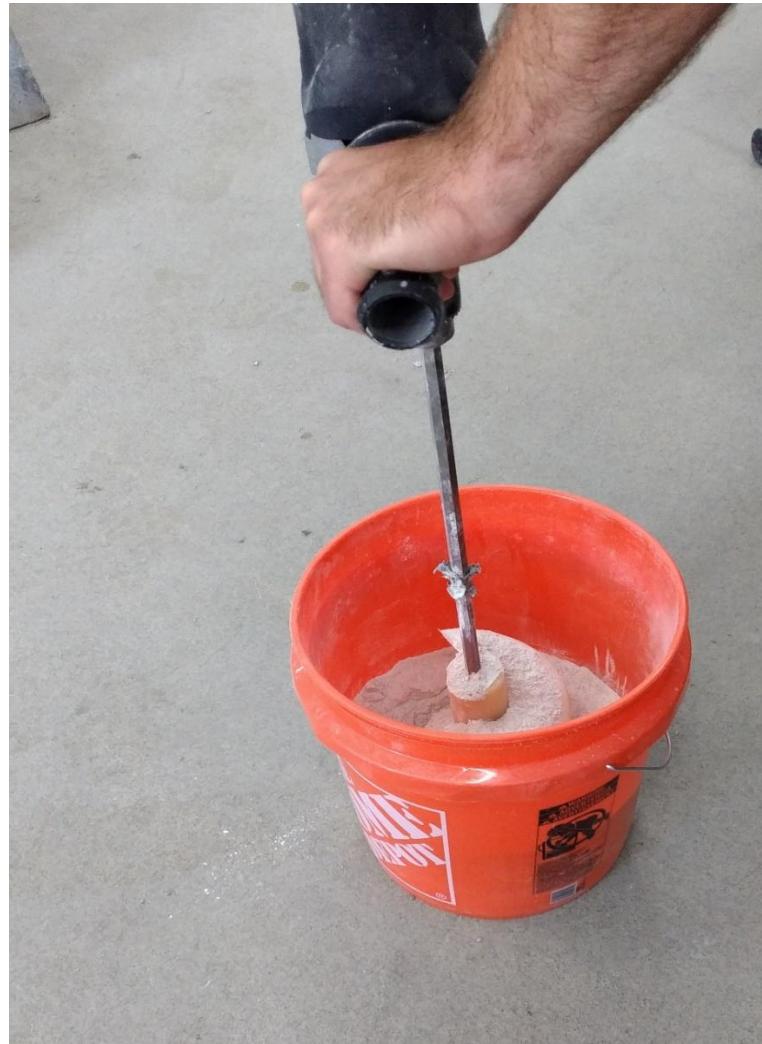
**Figure 2.1:** Mixing material in a 5-gallon bucket and drill-mounted mixer

Following the manufacturer's recommendations, MALP-E, MALP-NE, MKP, and MKP-VO were mixed in a 5-gallon plastic bucket using a drill-mounted augur mixer for one minute, as shown in Figure 2.1. For MALP-E, the activator was added first, followed by Endure and, finally, the dry material. A comparable procedure was employed for MALP-NE, without Endure. For MKP, water is added to the bucket first, followed by Endure, and the dry material. A similar procedure is followed for MKP-VO.

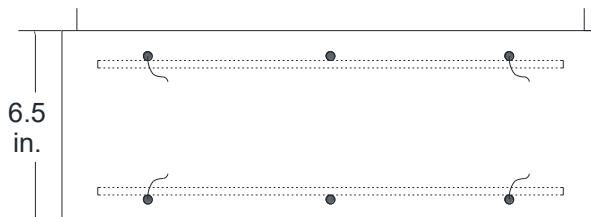
**Figure 2.4:** Top (a) and Side (b) View of Field Test Specimens for Monolithic-MALP Field Test Specimen

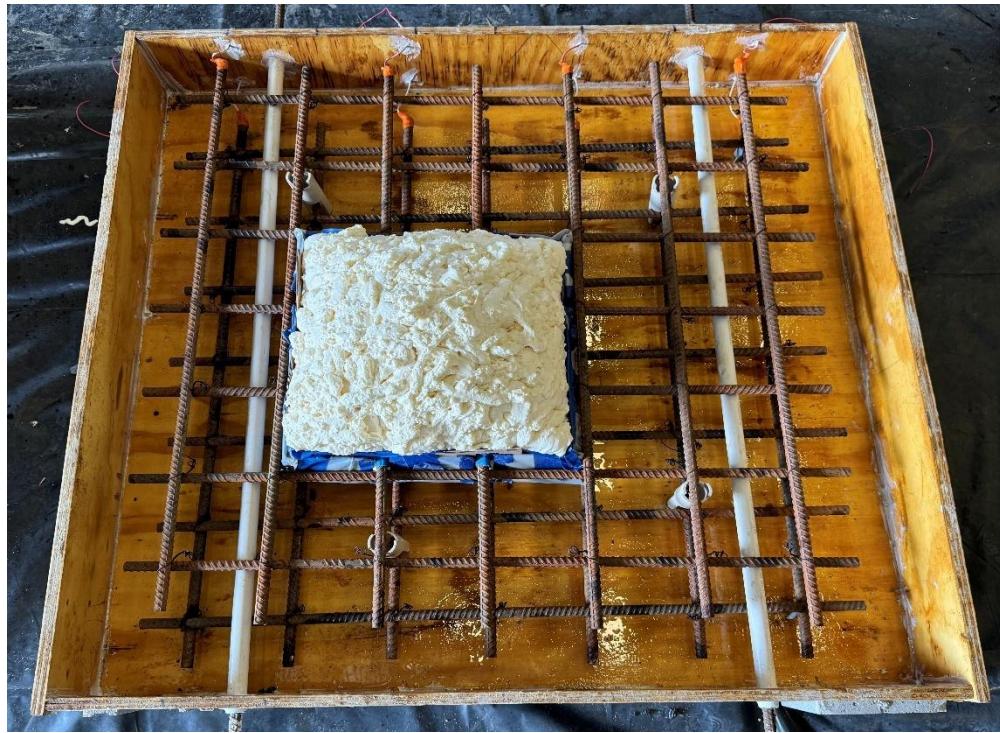
**Figure 2.6:** Form and reinforcing steel for MALP/Conv field test specimen showing the foam block-out used so that the edges of the repair patch aligned directly above the reinforcement (specimens with "A" in title) before casting

Figures 2.6 through 2.10 show the FTS specimen forms with the reinforcing steel and, where used, foam block-outs for regions in which MALP is used to simulate a repair prior to casting. To place the foam block-out 18 in.  $\times$  18 in.  $\times$  3 in. cardboard boxes were prepared and covered with plastic sheets to prevent water absorption from the concrete. Each cardboard box was then placed between the reinforcement, as shown in Figures 2.6 and 2.7. The reinforcement inside the box was covered with tape to protect it from contact with the foam material. The foam block-out was poured into the box one day before casting to allow it to set properly.

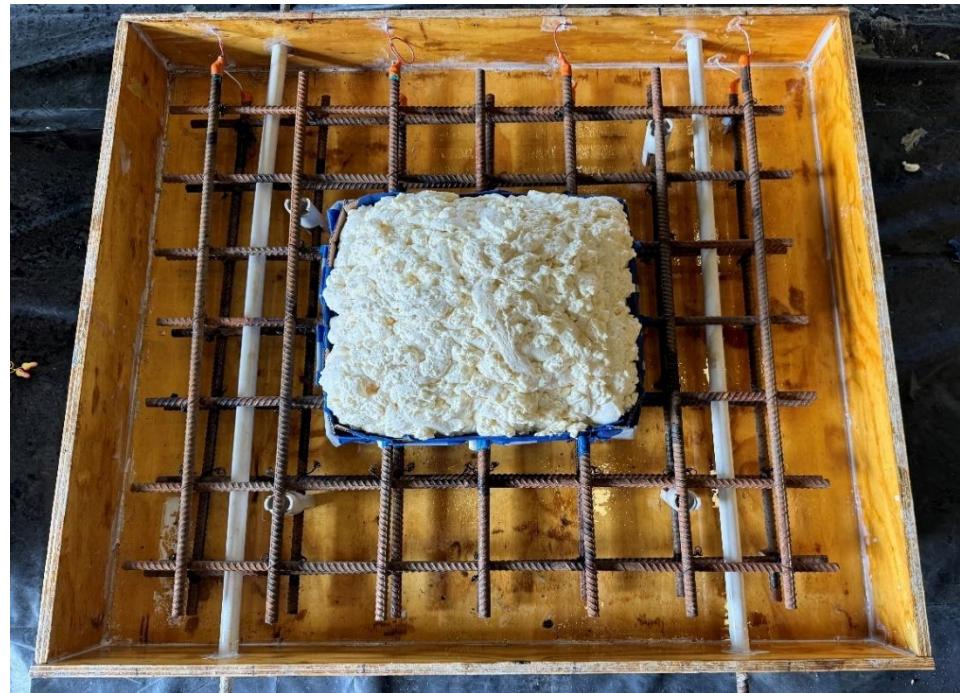
**Figure 2.7:** Form and reinforcing steel for MALP/Conv field test specimen showing the foam block-out used so that the edges of the repair patch aligned between reinforcing bars (specimens with "B" in title) before casting

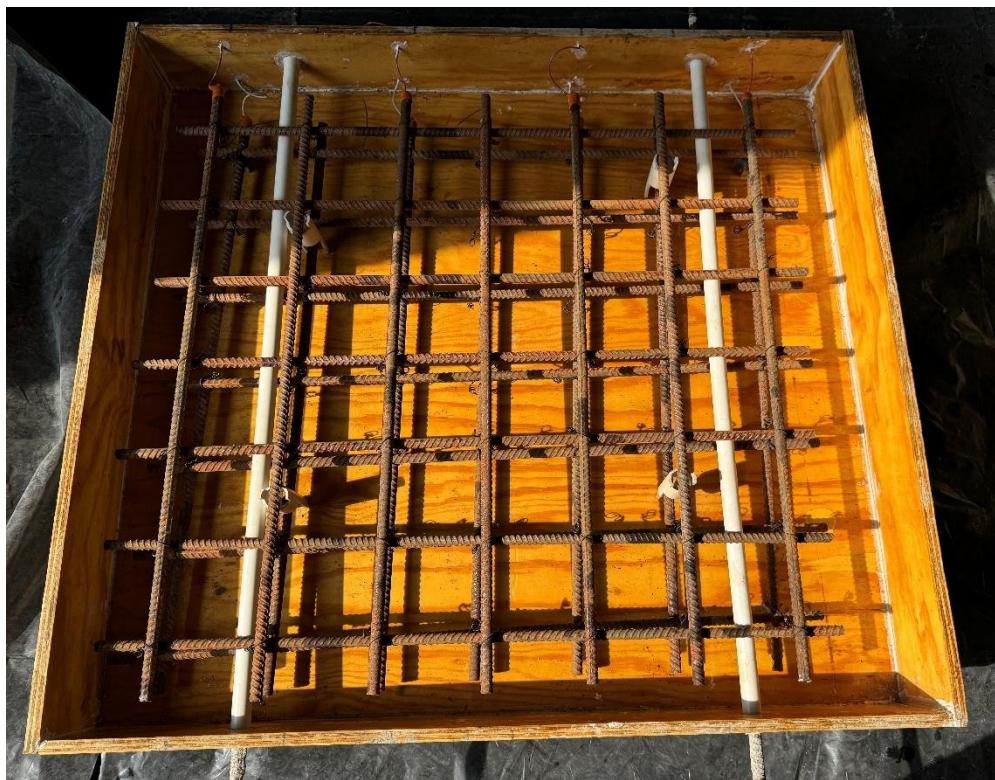
**Figure 2.9:** Form and reinforcing steel for field test specimen containing conventional concrete without MALP and without simulated cracks before casting

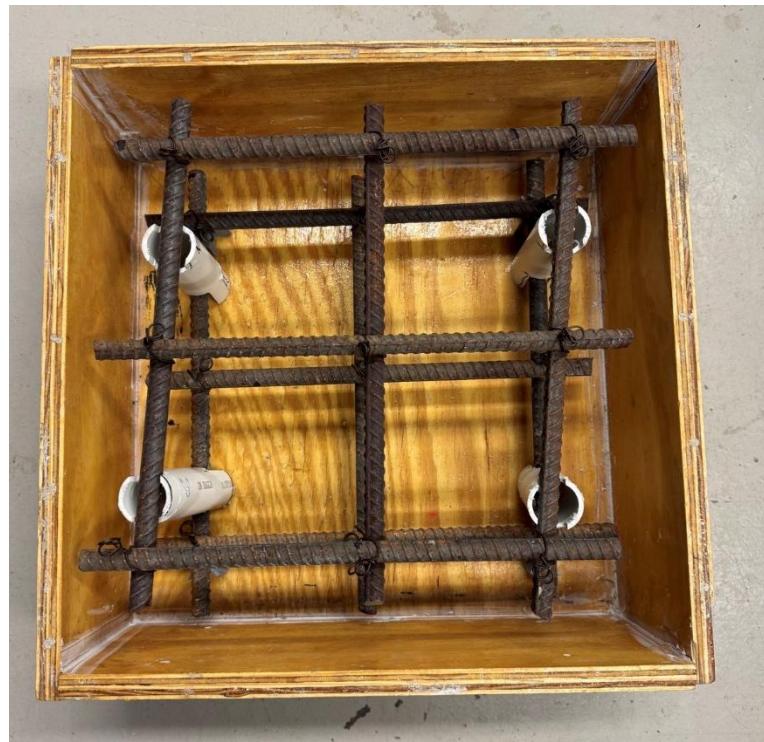
**Figure 2.10:** Form and reinforcing steel for field test specimen containing MALP before casting

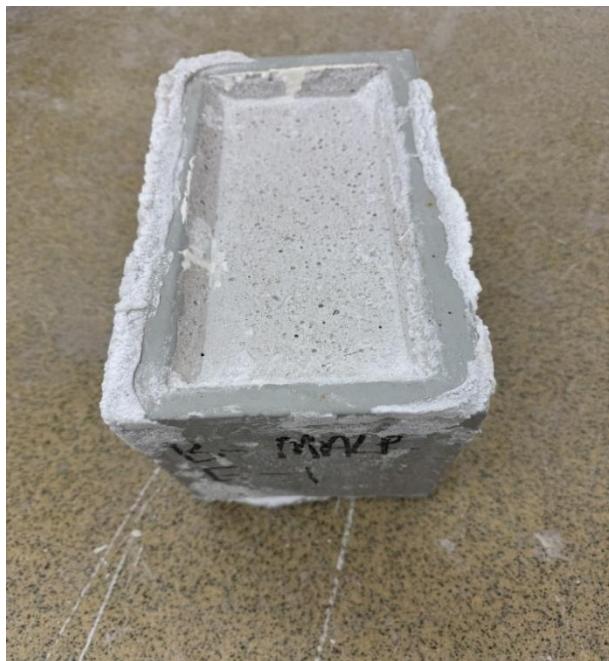
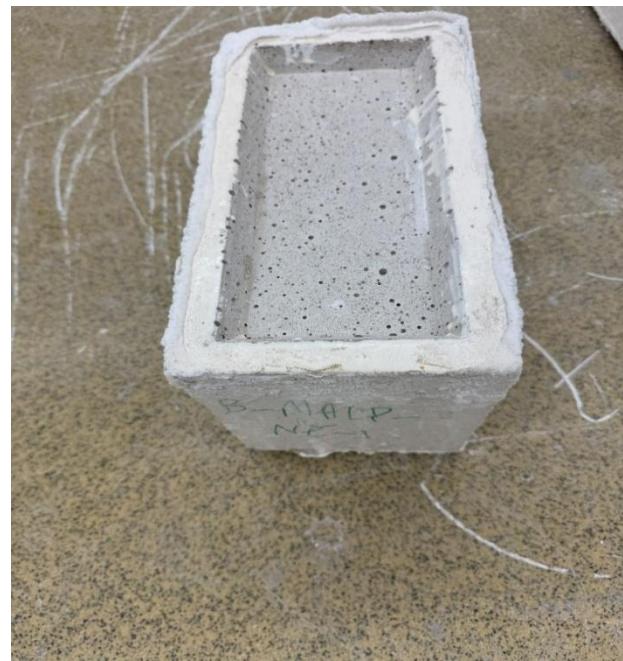
**Figure 3.5a –** MALP beam specimen with Endure (MALP-E)

**Figure 3.5b –** MALP beam specimen without Endure (MALP-NE)

**Figure 3.5 –** MALP beam specimens with and without Endure at 96 weeks

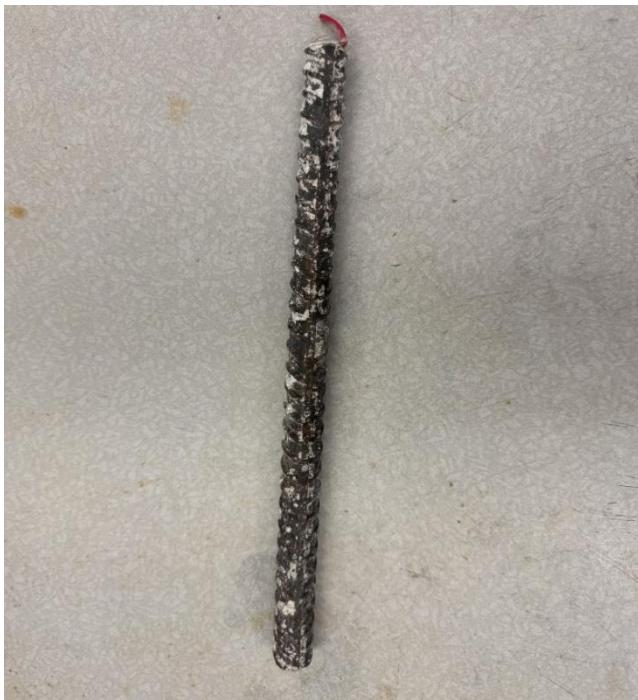
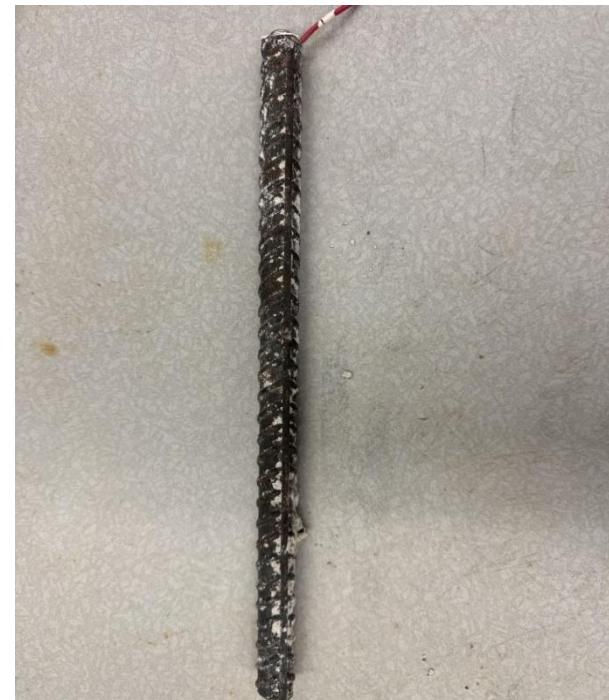
**Figure 3.6a** – Upper steel bar from MALP beam specimens with Endure

**Figure 3.6b** – Upper steel bar from MALP beam specimens without Endure

**Figure 3.6** – Top mat steel bars from MALP beam specimens with and without Endure at 96 weeks

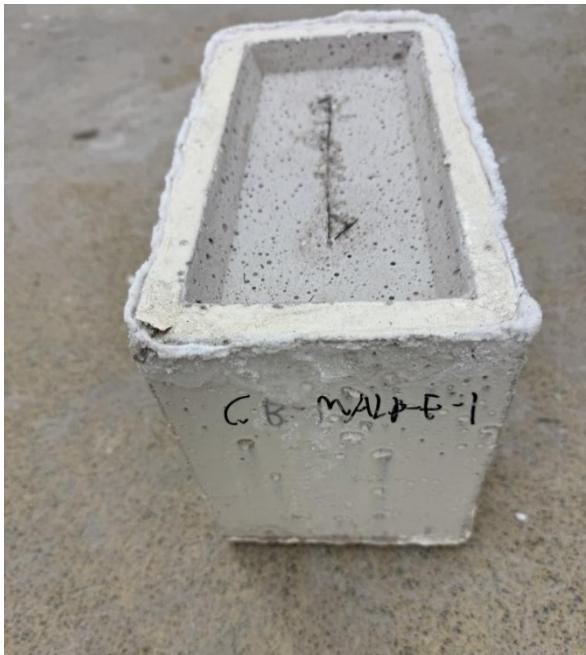
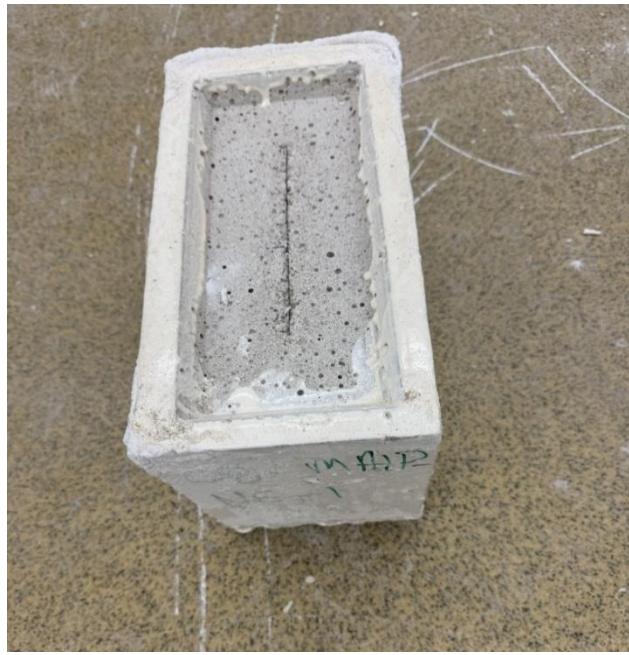
**Figure 3.7a** – MALP cracked beam specimen with Endure

**Figure 3.7b** – MALP cracked beam specimen without Endure

**Figure 3.7** – Cracked beam specimens with and without Endure at 96 weeks

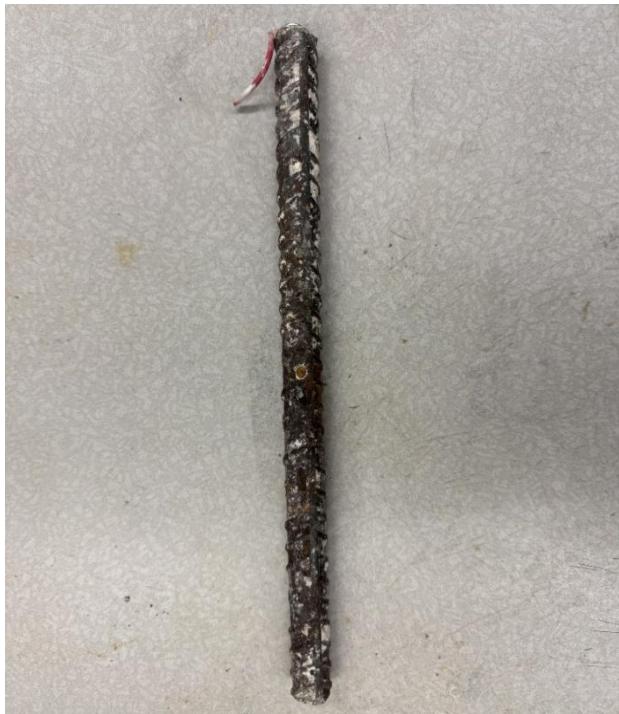
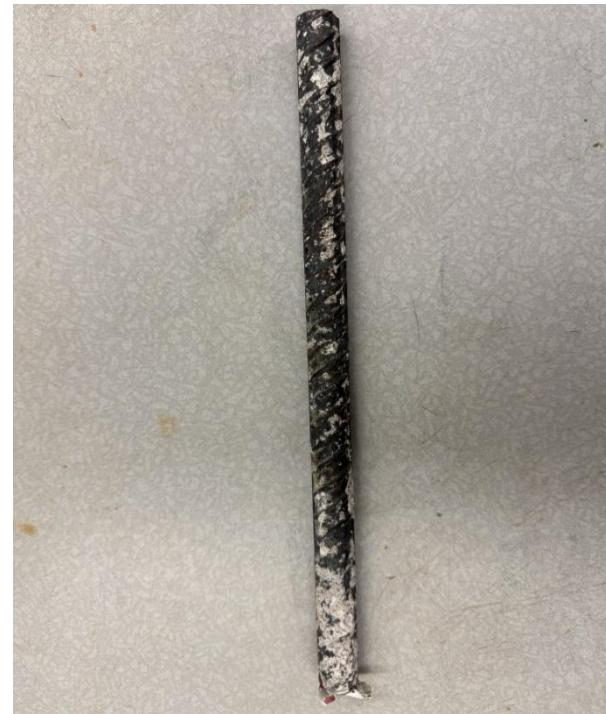
**Figure 3.8a** – Upper steel bar from MALP cracked beam specimens with Endure

**Figure 3.8b** – Upper steel bar from MALP cracked beam specimens without Endure

**Figure 3.8** – Top mat steel bars from MALP cracked beam specimens with and without Endure at 96 weeks

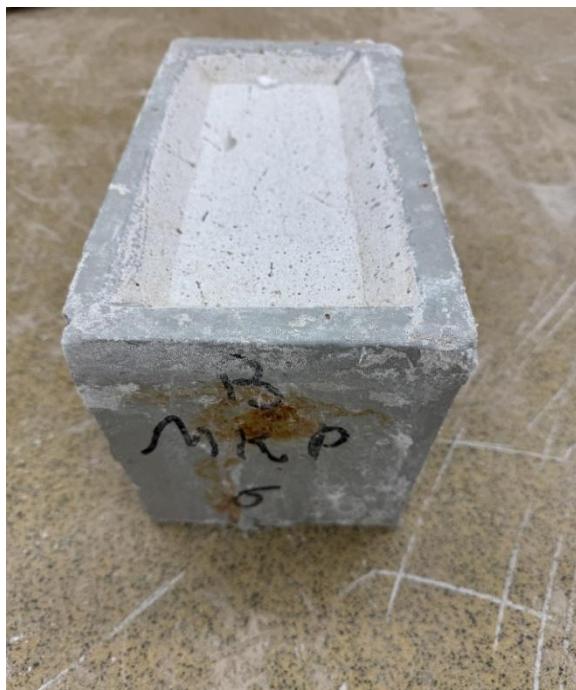
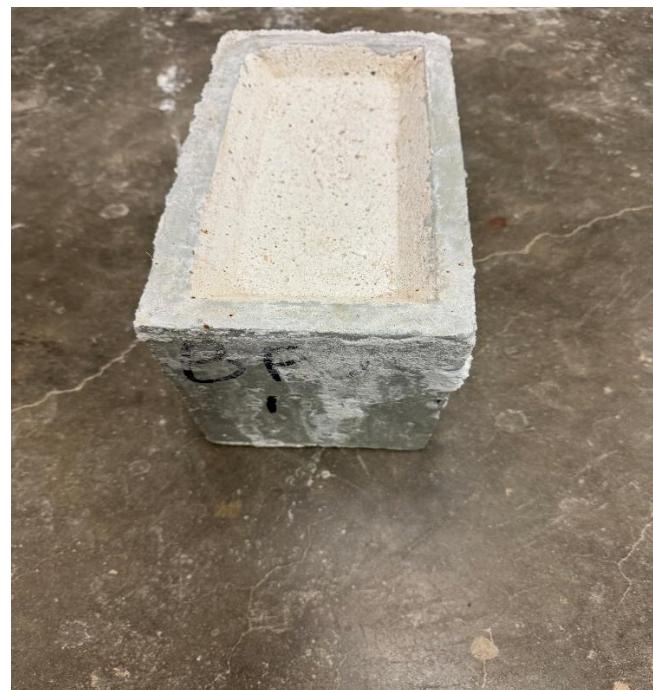
**Figure 3.9a** – MKP beam specimen

**Figure 3.9b** – MKP-VO beam specimen

**Figure 3.9** – MKP and MKP-VO beam specimens at 96 weeks

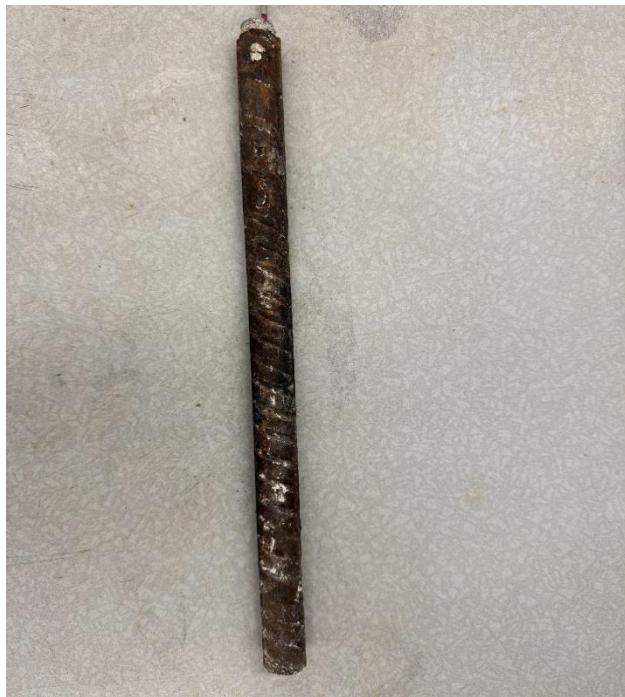
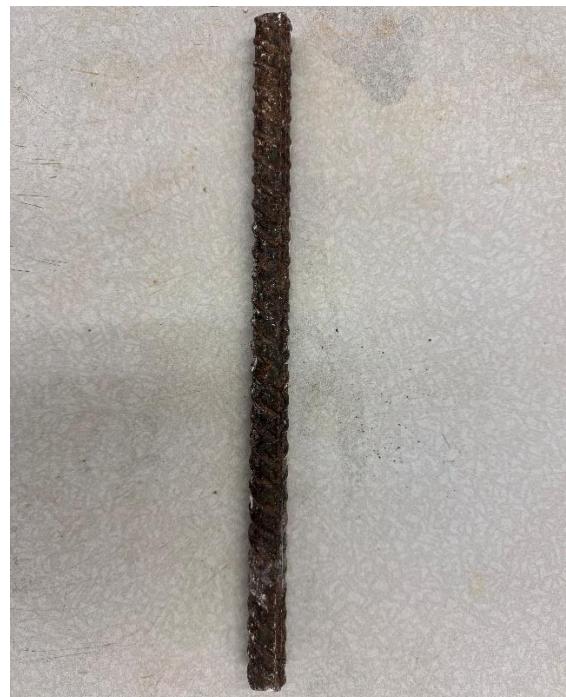
**Figure 3.10a** – Upper steel bar from MKP beam specimen

**Figure 3.10b** – Upper steel bar from MKP-VO beam specimen

**Figure 3.10** – Top mat steel bars from MKP and MKP-VO beam specimens at 96 weeks

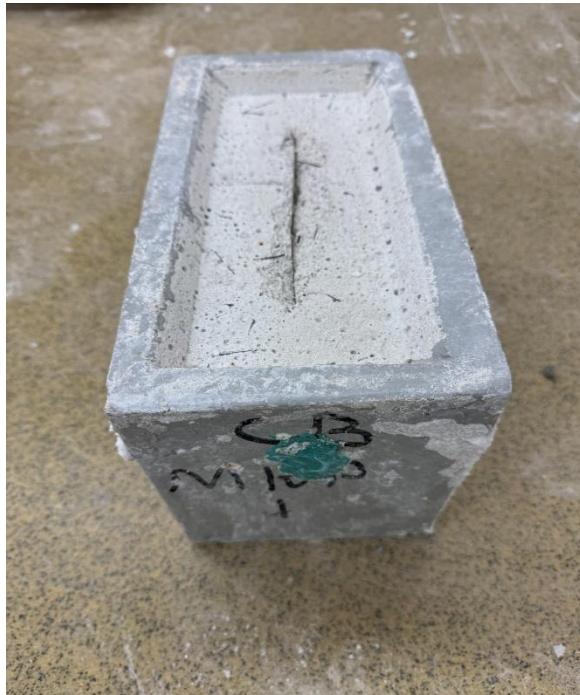
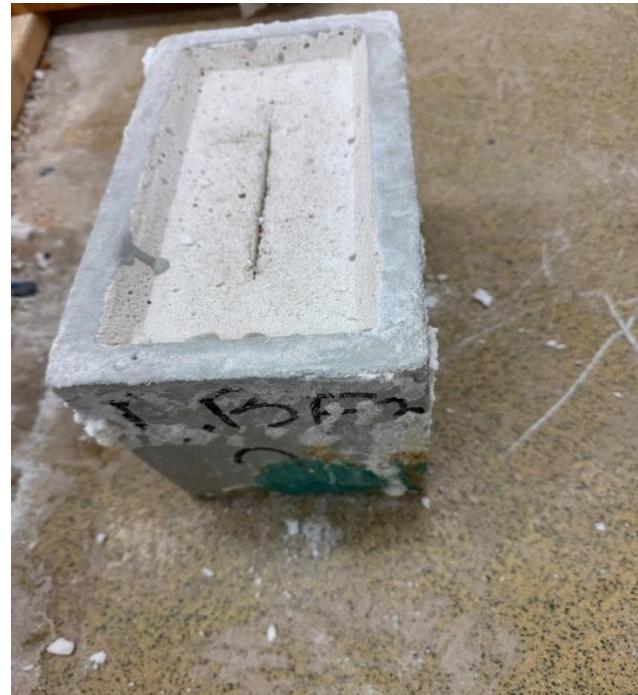
**Figure 3.11a** – MKP cracked beam specimen

**Figure 3.11b** – MKP-VO cracked beam specimen

**Figure 3.11** – MKP and MKP-VO cracked beam specimens at 96 weeks

Figure 3.11 shows cracked beam specimens containing MKP and MKP-VO after 96 weeks of exposure, and Figure 3.12 shows the upper steel bars from these specimens. Corrosion products were observed on the exterior surfaces at the cracks of both MKP and MKP-VO specimens (Figures 3.11a and 3.11b). In the bars in the MKP specimens, the corrosion products rust were spread over wider areas, whereas in the MKP-VO specimens, corrosion was restricted to smaller, localized spots (Figure 3.12). Overall, the results and autopsy images demonstrate that MKP-VO concrete was more protective than MKP concrete in the cracked beam specimens, but less so than MALP-E or MALP-NE.

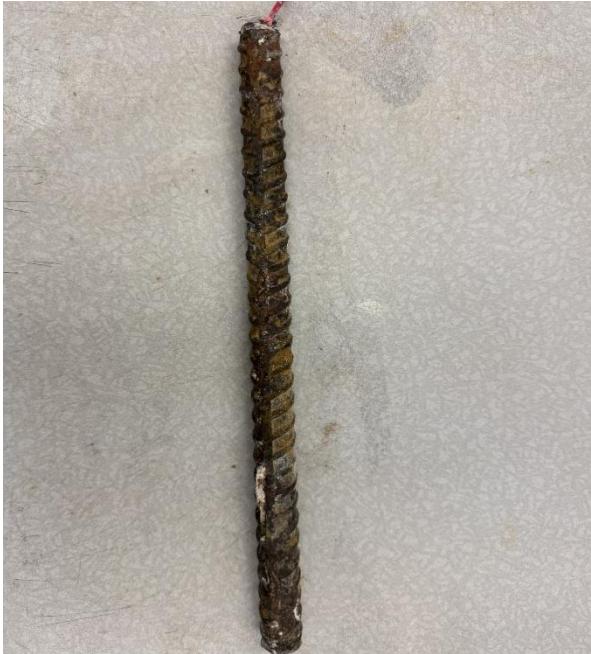
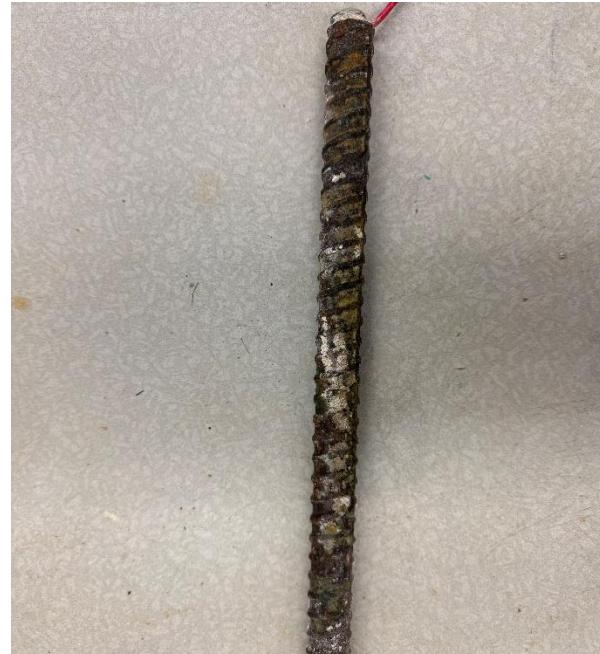
**Figure 3.12a** – Upper steel bar from MKP cracked beam specimen

**Figure 3.12b** – Upper steel bar from MKP-VO cracked beam specimen

**Figure 3.12** – Top mat steel bars from MKP and MKP-VO cracked beam specimens at 96 weeks

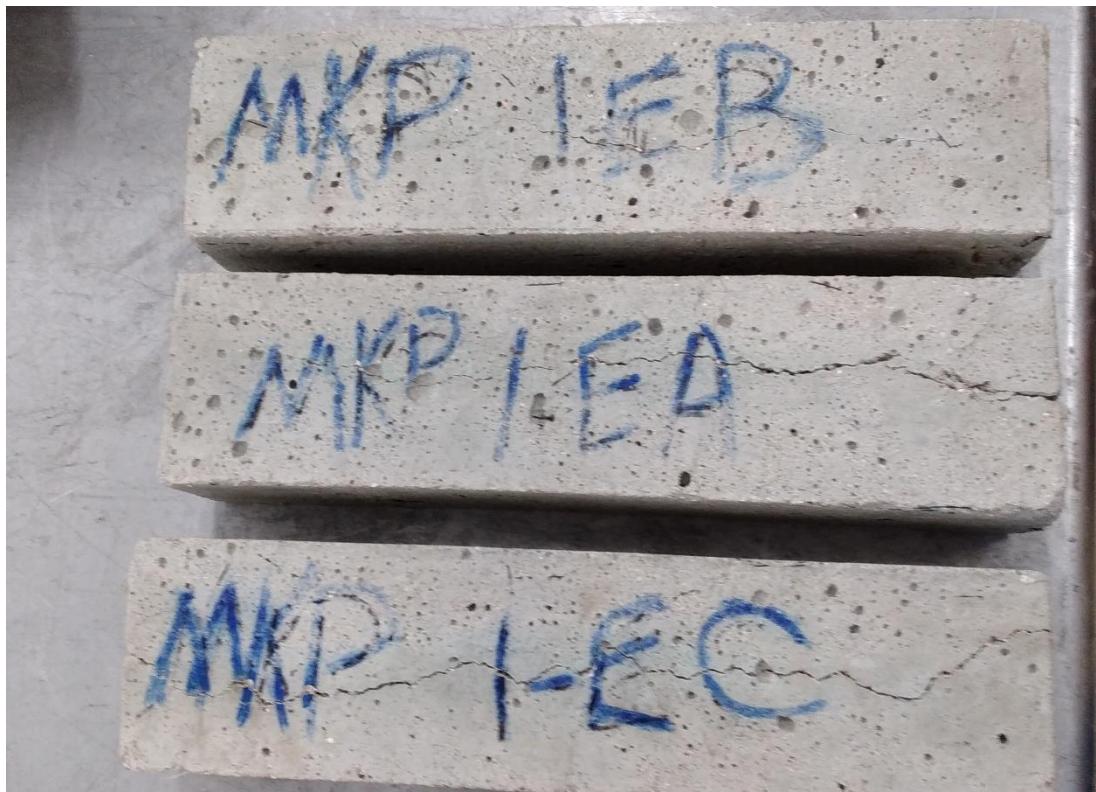
**Figure 3.17-** Three MKP specimens after 864 cycles (Procedure B) in freeze-thaw testing
