# Prediction and Prevention of Bridge Performance Degradation due to Corrosion, Material Loss, and Microstructural Changes

**Final Report**  
**September 2025**

**Principal Investigator:** Lesley Frame, Associate Professor  
Department of Materials Science and Engineering, University of Connecticut, Storrs, CT

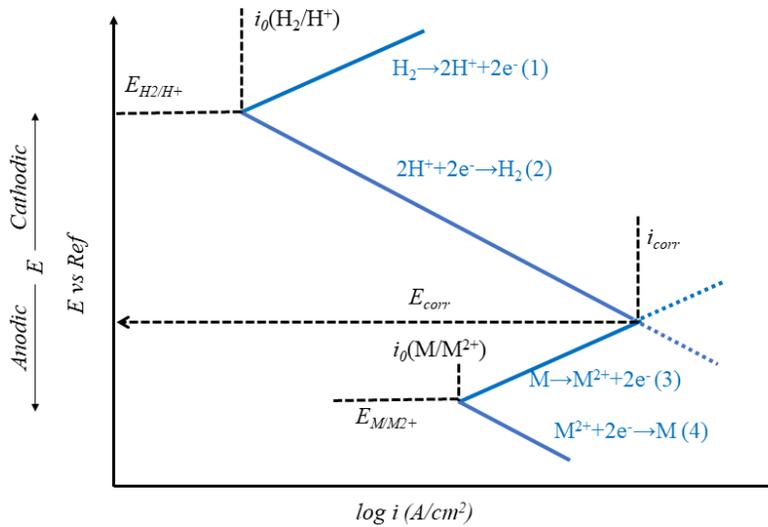
*Figure 1. Schematic of anodic and cathodic polarization and the half-cell reactions for metal M in acid solution (Adapted from Jones, 1992)*

When metal M corroding, half-cell reaction of anodic (3) and cathodic reactions (2) occurs simultaneously until the reaction reach to  $E_{\text{corr}}$ . The intermediate point  $E_{\text{corr}}$  is referred to as corrosion potential or mixed potential for the cell. Similarly, *Figure 2* describes the polarization in a galvanic couple between corroding metals M (cathode, green line) and N (anode, red line) [16]. Due to mixed potential theory, total anodic and cathodic polarization shifted to noble (positive) value and the corrosion rate is increased followed by orange line. In case of galvanic couples between two corroding metals M and N, the couples corrosion potential ( $E_{\text{couple}}$ ) will be determined between  $E_{\text{corr}(M)}$  and  $E_{\text{corr}(N)}$ . The corrosion rate of more anodic metal, N will be increased, and corrosion rate of more cathodic metal, M will be decreased. For example, galvanic couple of Zn and Cu, more anodic metal Zn will be corroded more than Cu, which is more noble metal, and  $E_{\text{couple}}$  will be determined between  $-0.76\text{V}(E_{\text{corr}(\text{Zn})})$  and  $0.34\text{V}(E_{\text{corr}(\text{Cu})})$ . Galvanic corrosion occurs between completely different metals such Zn and Cu as above, but galvanic corrosion occurs between different grades of steels.

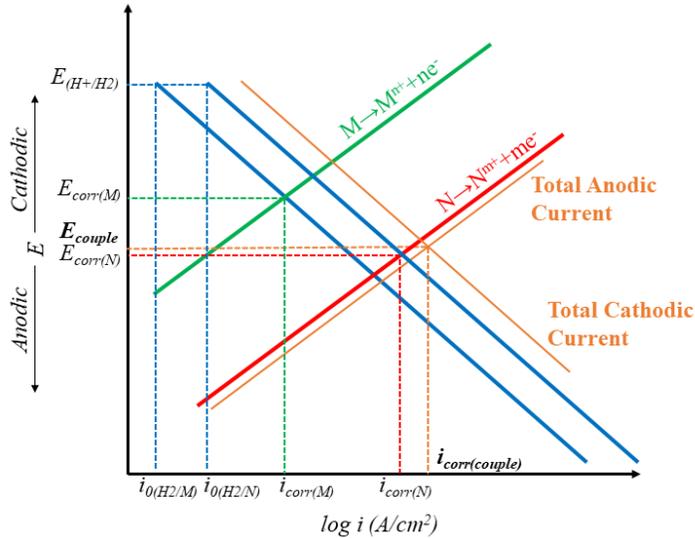
Figure 2. Polarization in a galvanic couple between corroding metals M and N (Adapted from Jones, 1992)

According to J. Zhang et al, and Groshek & Hebdon, galvanic couple between ASTM A1010 steel (stainless steel) and ASTM A325 steel (weathering steel) accelerates corrosion of weathering steel up to 1.65 times [17][18][19]. Since alloying elements contribute to increase or decrease corrosion potential of steels, galvanic corrosion can occur incidentally, especially during bridge steel repair.

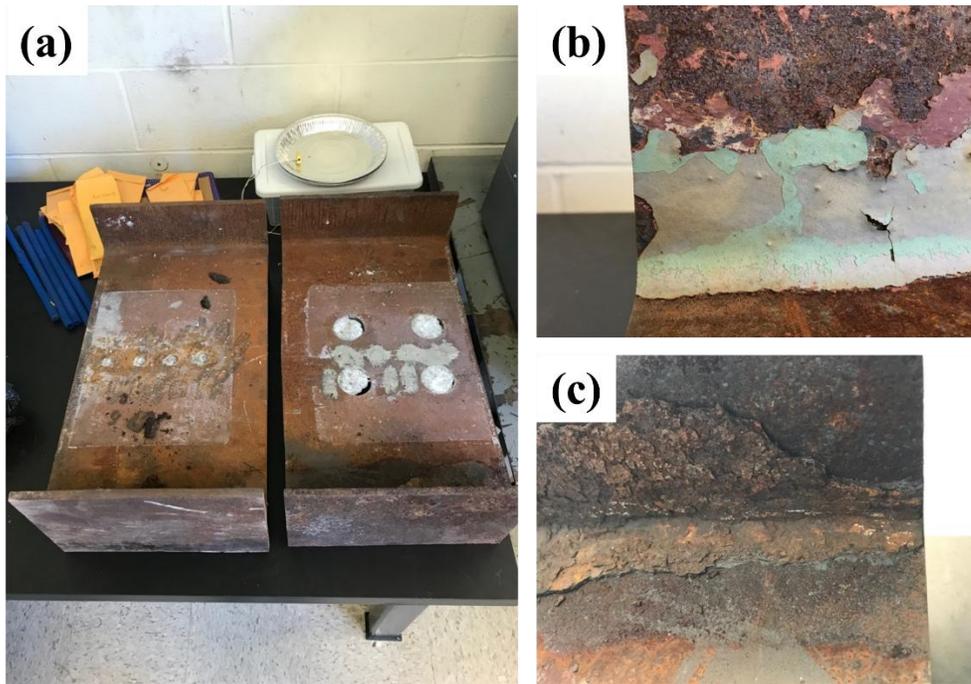
Figure 3. (a) Two I-beam sections collected from the Q-Bridge. (b) One I-beam had paint at one corner and (c) the other I-beam had thick compact corrosion in one corner.

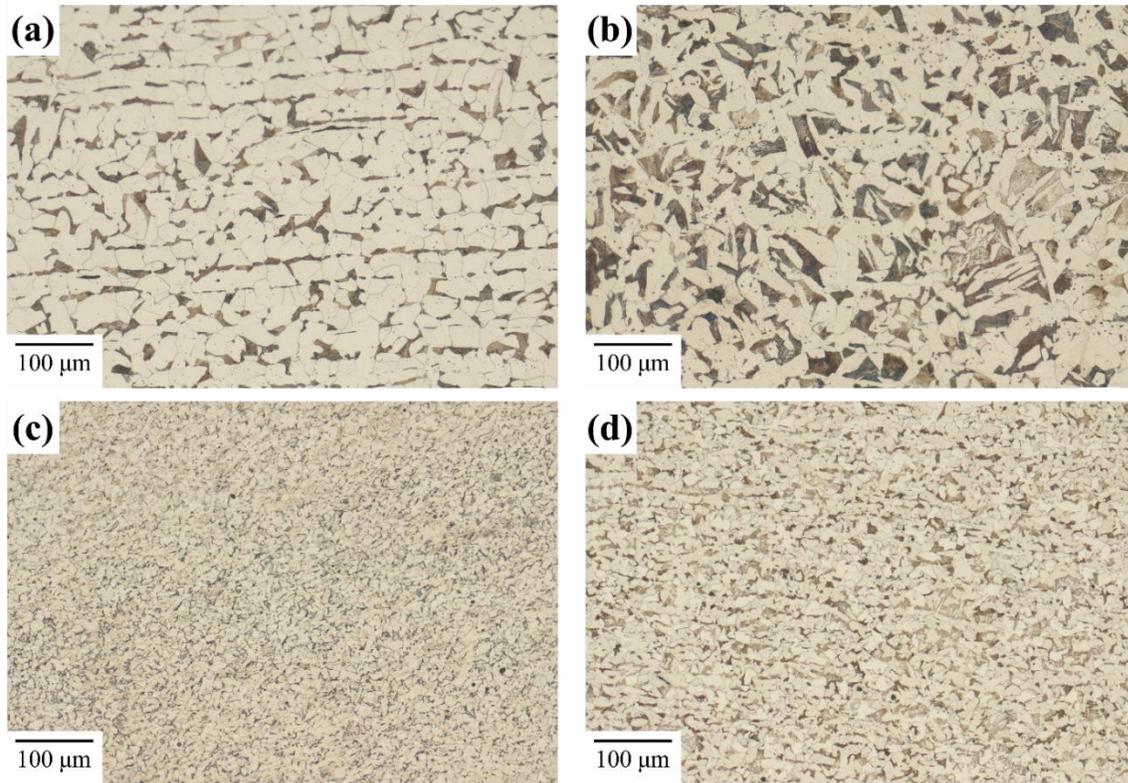
Figure 4 Microstructure of (a) Q-Bridge, (b) A7, (c) A36 and (d) A588 after 30 seconds etching with 2% Nital solution

To utilize the equation, it is assumed that dark portion of the image is pearlite, and the bright portion of the image is ferrite. The method has a limitation that different types of inclusion like MnS, carbides might be included in the pearlite fraction. It is also difficult to measure Si content using ICP-OES because the system employs a quartz tubing system, which interferes with the detection of Si in the samples.

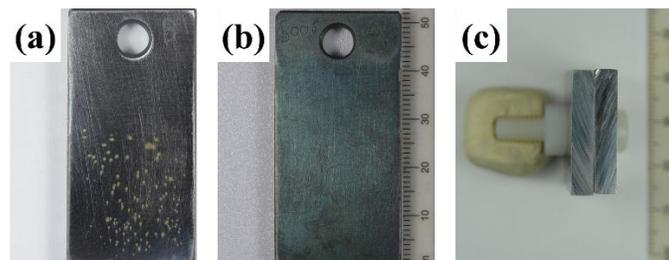
Figure 5. (a) Polished Q-Bridge coupon, (b) Oxidized Q-Bridge coupon, and (c) galvanic coupling of A588 (left) and A36 (right)

Prior oxide on the surface of the samples was removed using 800 grits SiC grinding papers. For the galvanic coupling of A36 and A588, both steels were cut to 25 mm x 25 mm x 5 mm coupons with a hole at center as shown in *Figure 5*. The 3 mm diameter nylon screw were tightened to connect the two materials electrically

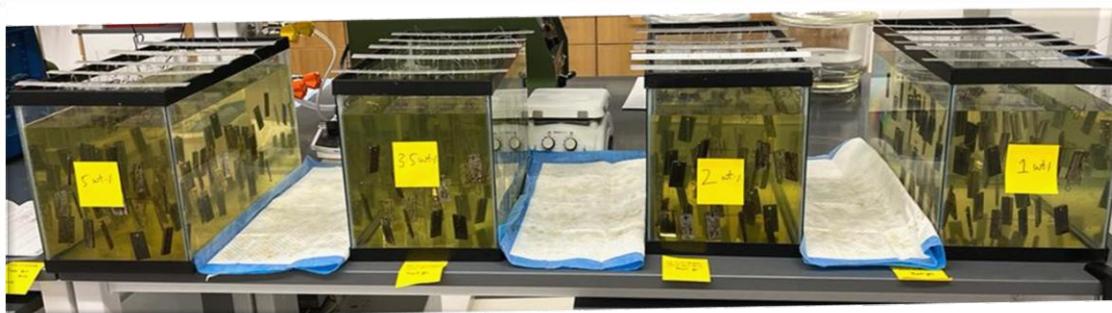
Figure 6. Wet/dry cycle set up for this study

In this study, 400 wet/dry cycles were performed with the testing parameters detailed in *Table 3*. Each wet/dry cycle consisted of wetting the sample in corresponding salt solution for 15 minutes, followed by drying in a convective environment generated by a stand fan for 1 hour. The Wet/dry cycles set up is shown in *Figure 6*. Sample batches were collected at 100, 200, 300 and 400 cycles for analysis. A flow chart describing the sequence of testing and characterization is depicted in *Figure 7*.

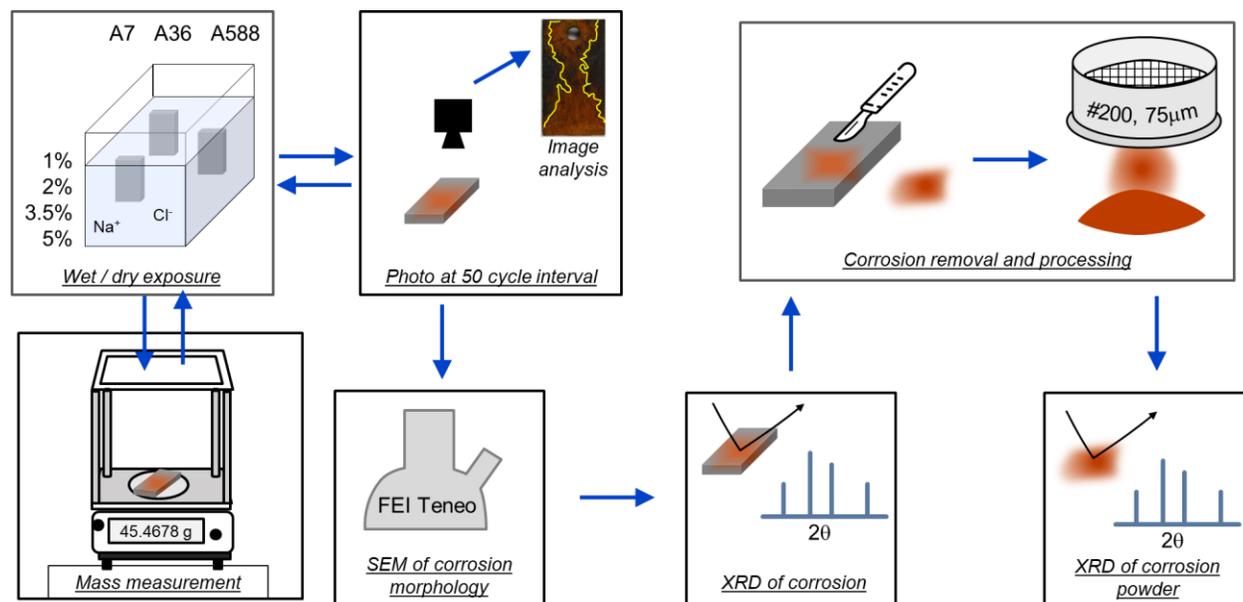
Figure 7. Flow chart showing the sequence of testing and characterization of steel samples

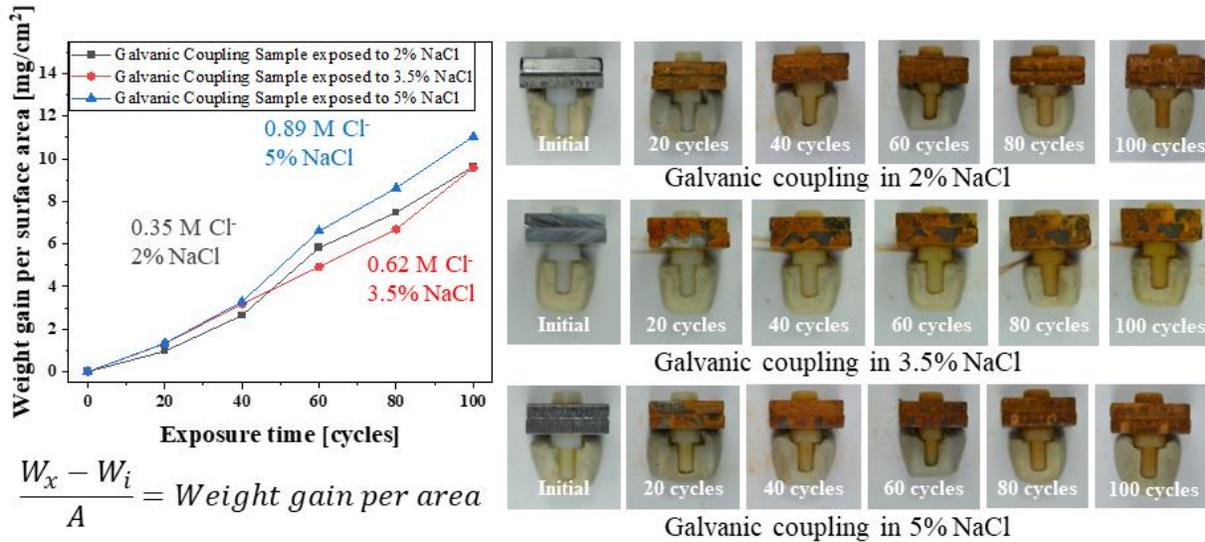
Figure 8. Weight gain per surface area of galvanic coupling between A36 and A588 steel coupons during the 200 cycles of accelerated corrosion testing in 2%, 3.5%, 5% NaCl and corrosion progression of galvanic coupling during the accelerated corrosion testing

From the initial stage, the weight change depending on  $[Cl^-]$  is not distinguishable, but the difference between weight change became clear after 40 cycles. After 40 cycles, the highest  $[Cl^-]$  5% NaCl shows the highest weight gain, and 2% NaCl followed by 3.5% NaCl. Originally, the higher  $[Cl^-]$  is expected the more weight gain, but weight gain of 2% NaCl and 3.5% NaCl galvanic coupling do not follow the expectation. Although weight change at 2% NaCl is higher than that of 3.5% NaCl after 40 cycles, weight gain of 3.5% NaCl increases greater than 2% NaCl after 80 cycles. To collect clear variation of weight change in different solutions, additional cycles could be beneficial, but after 60 cycles, outside and facing side of the all the samples covered by corrosion products uniformly. Compared to weight gain of single materials (A7, A36 and A588 steel), weight gain of galvanic coupling is almost twice higher than single materials which represents galvanic coupling results in rapid corrosion progression.

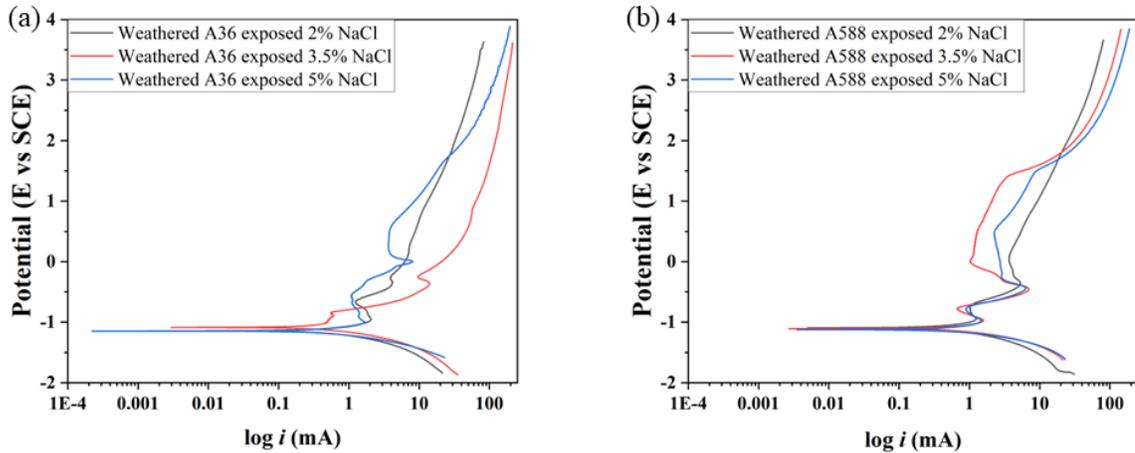
Figure 9. Potentiodynamic polarization curve of (a) weathered A36 in 2%, 3.5%, and 5% NaCl and (b) weathered A588 in 2%, 3.5%, and 5% NaCl

To mimic field bridges samples, electrochemical performance of weathered surface condition of A36 and A588 was analyzed using PDP shown in Figure 9. The corresponding electrochemical parameter calculated using Tafel fitting and  $R_p$  fitting listed in Table 4. Electrochemical parameters calculated from potentiodynamic polarization curve of weathered A36 in 2%, 3.5%, and 5% NaCl and weathered A588 in 2%, 3.5%, and 5% NaCl using Tafel fitting and  $R_p$  fitting.

Although corrosion rate of A36 steel is higher than corrosion rates of A588 steel, corrosion rate of weathered A36 steel is slightly lower than weathered A588 steel. Because weathered surface has various FeOOHs with Fe<sub>3</sub>O<sub>4</sub>, weathered surface of A588 steel is expedited to build additional layer of FeOOH on top of the surface. Corrosion rates of weathered A36 steel are 226 mpy (2% NaCl), 261 mpy (3.5% NaCl), and 344 mpy (5% NaCl), and corrosion rate of weathered A588 steel are 211 mpy (2% NaCl), 312 mpy (3.5% NaCl), and 406 mpy (5% NaCl). Although the corrosion rate of A36 is lower than that of A588, corrosion resistance is highly affected by the layer formed on the surface as well as the corrosion rate. To analyze corrosion performance of the weathered steel, Primary Passivation Potential ( $E_{pp}$ ) and Transpassive Potential ( $E_{trans}$ ) is measured.  $E_{pp}$  and  $E_{trans}$  of weathered A588 steel is higher than  $E_{pp}$  and  $E_{trans}$  of A36 steel because formation of surface layer protects the steel, and the surface layer prevents pitting formation.  $E_{pp}$  decreases and  $E_{trans}$  increases along with the [Cl<sup>-</sup>] increasing shown in Figure 10.

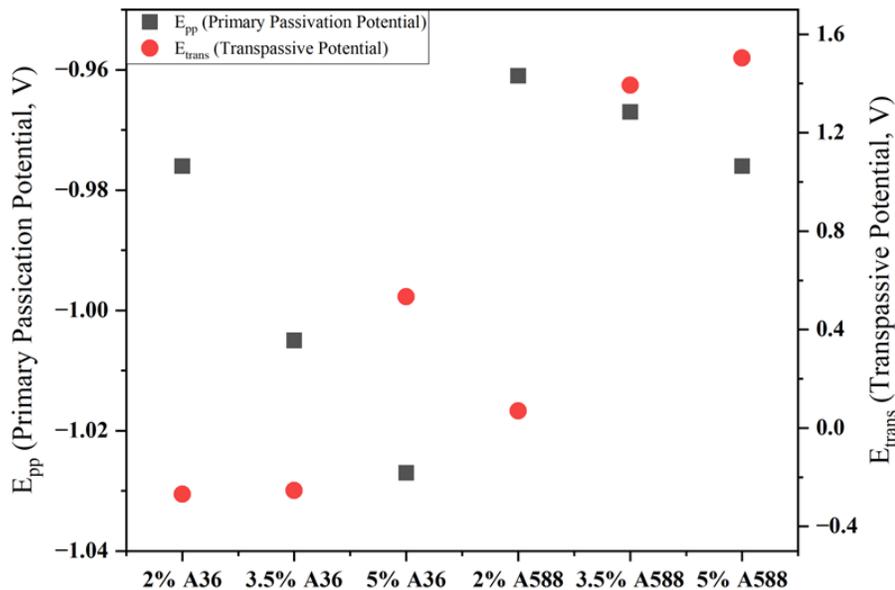
Figure 10. Primary passivation potential (left-gray) and transpassive potential (right-red) change inside of galvanic coupling in 2%, 3.5%, and 5% NaCl

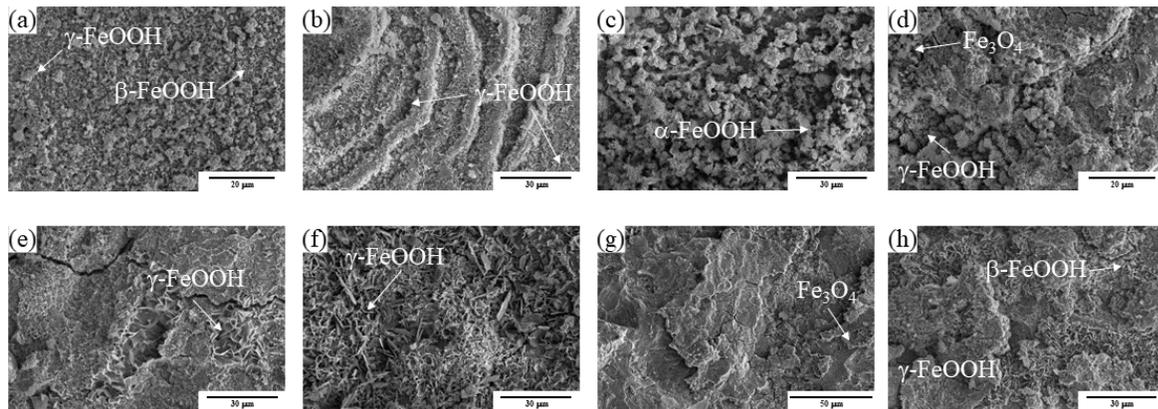
*Figure 11. Microstructure of (a)-(d) A36 side of galvanic coupling surface and (e)-(h) A588 side of galvanic coupling surface in 2% NaCl*

Microstructures of different types of iron hydroxides on the surface could be distinguishable through SEM image shown in *Figure 11* to *Figure 13*, and the figures shows facing side of galvanic coupling. Typical shape of  $\alpha$ -FeOOH is either relatively small cotton balls or fine plates, and  $\beta$ -FeOOH looks like either cigar-shaped or relative large rosette, and  $\gamma$ -FeOOH is flake or needle shape (Morcillo et al., 2011). Galvanic coupling in 2% NaCl shows various types of FeOOHs, and typical shape of  $\gamma$ -FeOOH (flake type) is widespread for both A36 steel and A588 steel, and it is distinct in *Figure 12* (b) and (f).

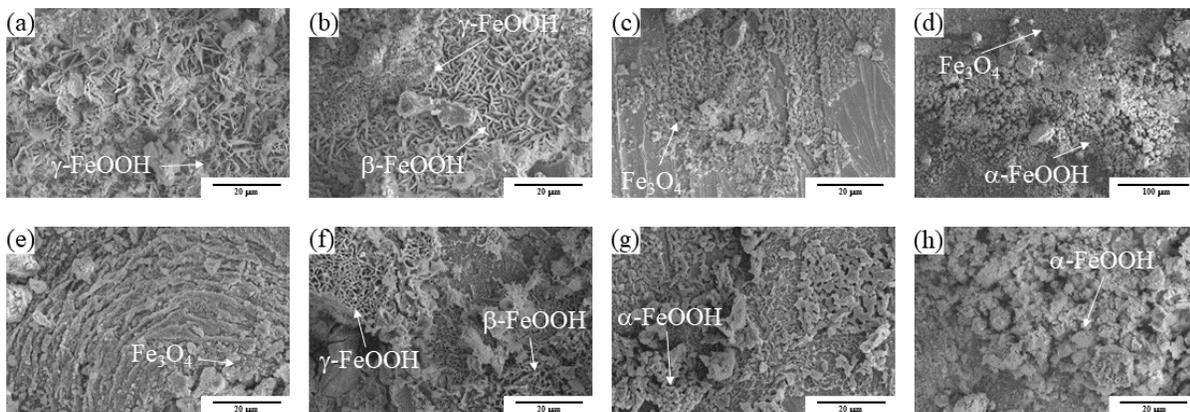
*Figure 12. Microstructure of (a)-(d) A36 side of galvanic coupling surface and (e)-(h) A588 side of galvanic coupling surface in 3.5% NaCl*

Compared to 2% NaCl exposure, galvanic coupling formed more  $\alpha$ -FeOOH and  $\beta$ -FeOOH in 3.5% NaCl with some of  $\gamma$ -FeOOH as well. Cotton ball type of  $\alpha$ -FeOOH is recognizable in *Figure 12* (d) and (h), as well as cigar type of  $\beta$ -FeOOH is identified in *Figure 12* (b) and (f). Certainly, since 3.5% NaCl is more corrosive environment, extra  $\beta$ -FeOOH observation is possible in 3.5% NaCl galvanic couple.

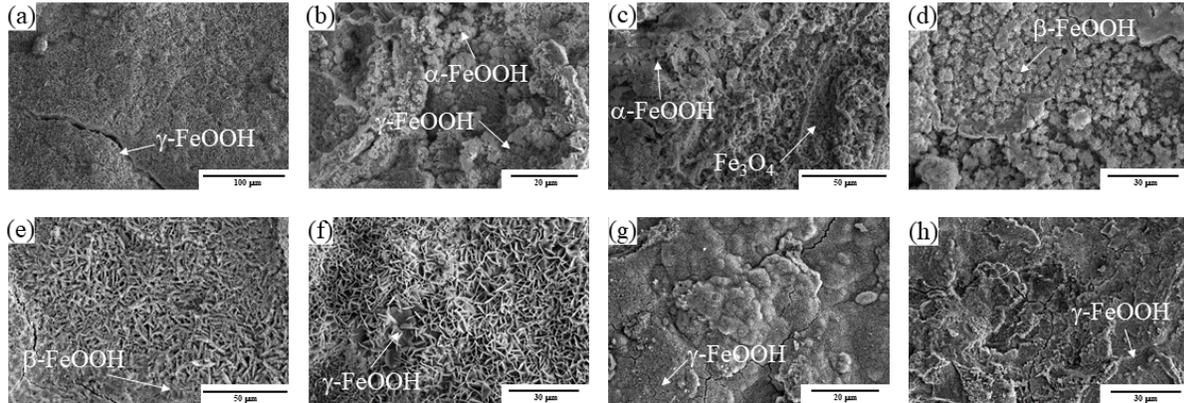
Figure 13. Microstructure of (a)-(d) A36 side of galvanic coupling surface and (e)-(h) A588 side of galvanic coupling surface in 5% NaCl

Although 5% NaCl is expected to discover more  $\beta$ -FeOOH than any other conditions, various combinations of phases appeared rather than  $\beta$ -FeOOH dominant microstructure. From the A36 side of galvanic coupling in 5% NaCl, relatively small size of ball type  $\alpha$ -FeOOH (Figure 13 (b)), rosette type of  $\beta$ -FeOOH (Figure 13(d)), and flake type of  $\gamma$ -FeOOH (Figure 13 (a)) is noticeable. On the other hands, A588 steel side, cigar type of  $\beta$ -FeOOH (Figure 13(e)), and flake type of  $\gamma$ -FeOOH (Figure 13(f)) is observed on the surface.

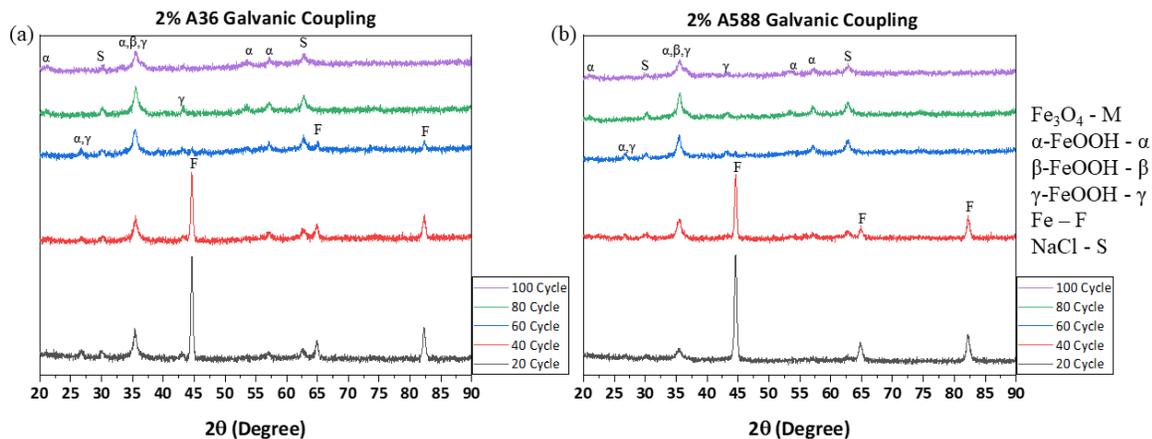
Figure 14. XRD patterns of (a) A36 side of galvanic coupling surface and (b) A588 side of galvanic coupling in 2% NaCl during the accelerated corrosion testing

In addition to surface morphology, semi in-situ XRD was conducted every 20 cycles to track change of phases and quantity of phases. Although the peaks of the patterns are getting ambiguous over the cycles due to formation of unidentifiable phase,  $\alpha$ -FeOOH,  $\beta$ -FeOOH, and  $\gamma$ -FeOOH are still major phases of most of the patterns. Because corrosion products mixed up in the interface between galvanic coupling of A36 steel and A588 steel, general scans in different solution does not show much difference as shown in Figure 14 to Figure 16.

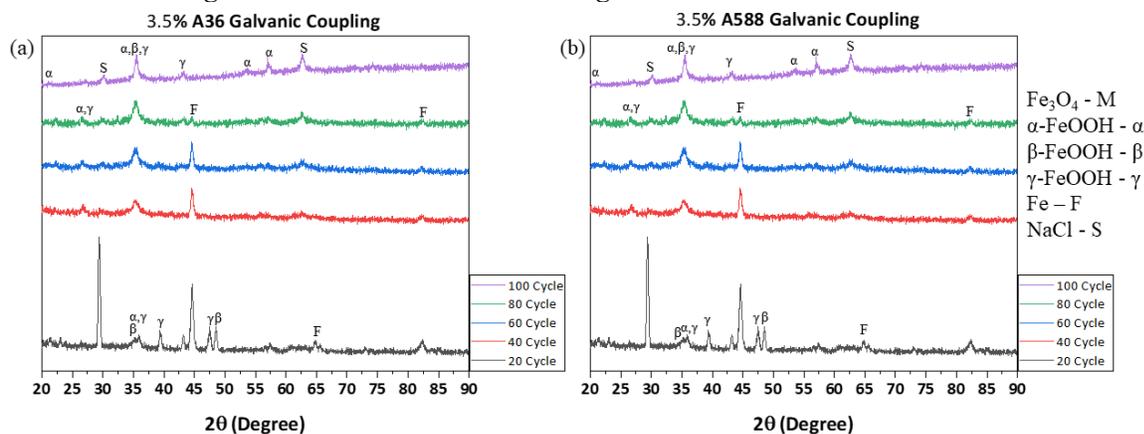
Figure 15. XRD patterns of (a) A36 side of galvanic coupling surface and (b) A588 side of galvanic coupling in 3.5% NaCl during the accelerated corrosion testing

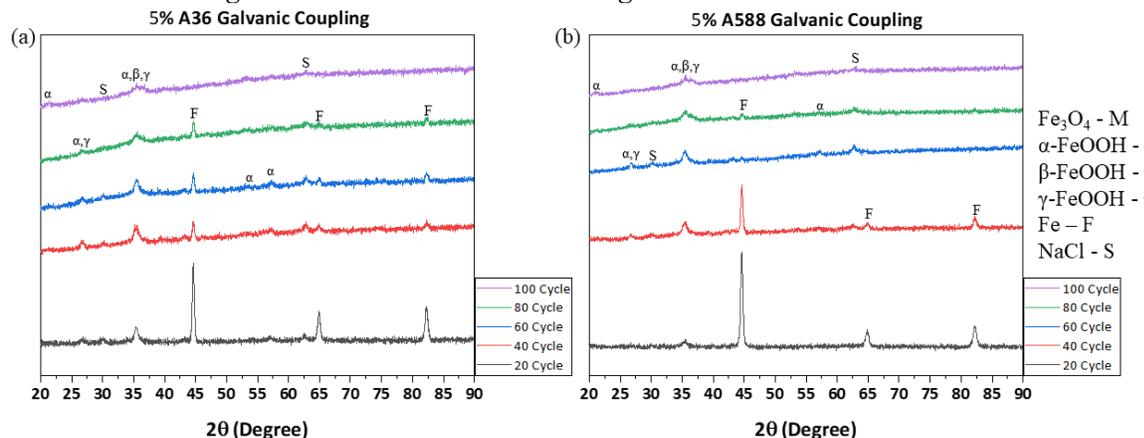
Figure 16. XRD patterns of (a) A36 side of galvanic coupling surface and (b) A588 side of galvanic coupling in 5% NaCl during the accelerated corrosion testing

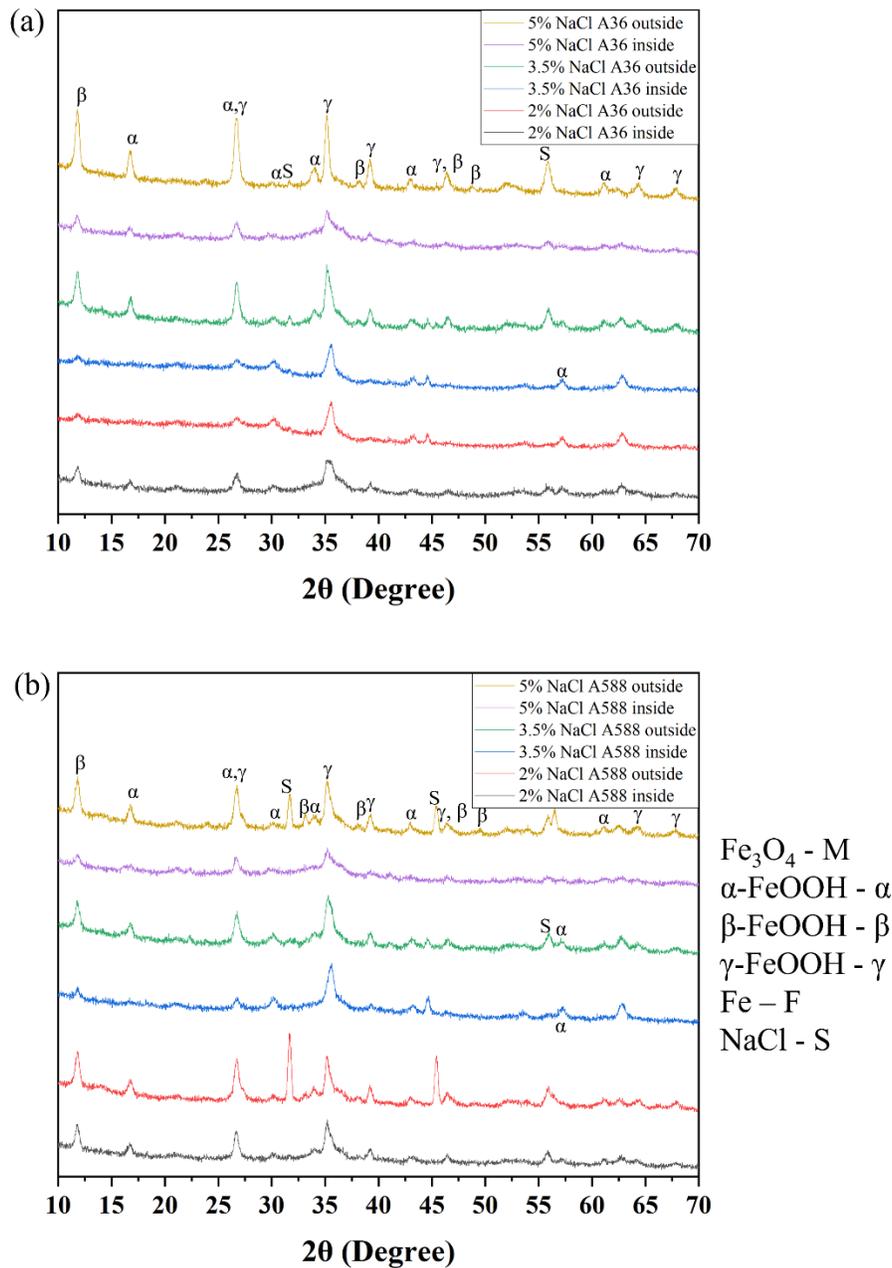
Figure 17. Focused XRD patterns of inside and outside (a) A36 side and (b) A588 side of galvanic coupling after 100 cycles in 2%, 3.5%, 5% NaCl

Up to 100 cycles of all the galvanic coupling is classified as active corrosion since PAI<sub>β</sub> is higher than 0.5, and the deterioration inspection value increases as corrosion progresses. To analyze the quantity of phase and calculate PAI precisely, focused XRD scan was carried out for 100 cycles exposed galvanic couplings as shown in *Figure 17*.

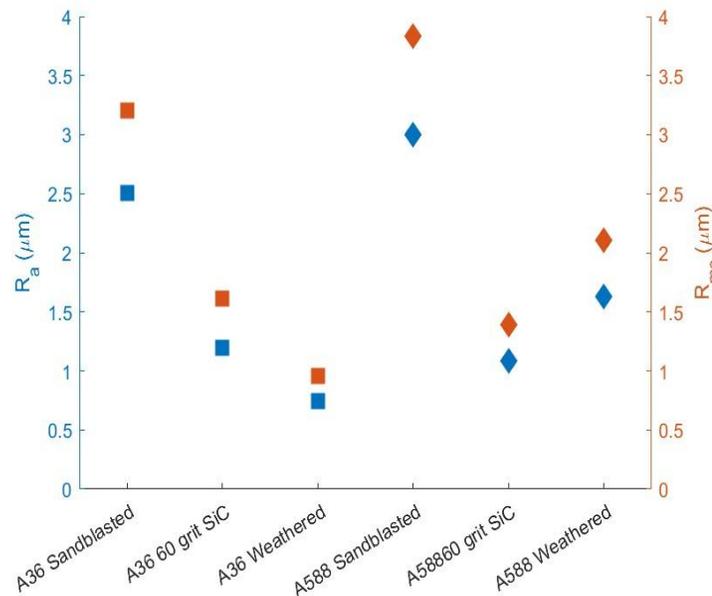
Figure 18. Roughness average for all samples

Before the electrochemical testing, surface roughness of weathered, sandblasted, and 60 grit SiC ground A36 and A588 steel were measured using Zygo New View 5000. Four spots were selected randomly, and root mean square ( $R_{ms}$ ) and average roughness ( $R_a$ ) are measured based on the height difference are shown in *Figure 18*. Surface residual stresses of weathered and sandblasted A36 and A588 steel were measured using 116.2° peak with young's modulus of 200 GPa, and Poisson's ratio of 0.26. Compressive residual stress is present for both weathered and sandblasted steel as listed in *Table 9* and the stress value increased in the A36 steel after sandblasting from 406 MPa to 583 MPa, so the sandblasting process contributed to increase both surface roughness and compressive residual stress. The  $R_a$  of the sandblasted A588 steel is 2.999  $\mu\text{m}$  which is roughly twice as high as that of the  $R_a$  of weathered A588 steel: 1.632  $\mu\text{m}$ . Although sandblasting increases  $R_a$  of the A588 steel, sandblasting does not apply surface compressive residual stress to the A588 steel. The corrosion behavior of A588 steel after sandblasting is affected not by surface residual stress, but by surface roughness changing.

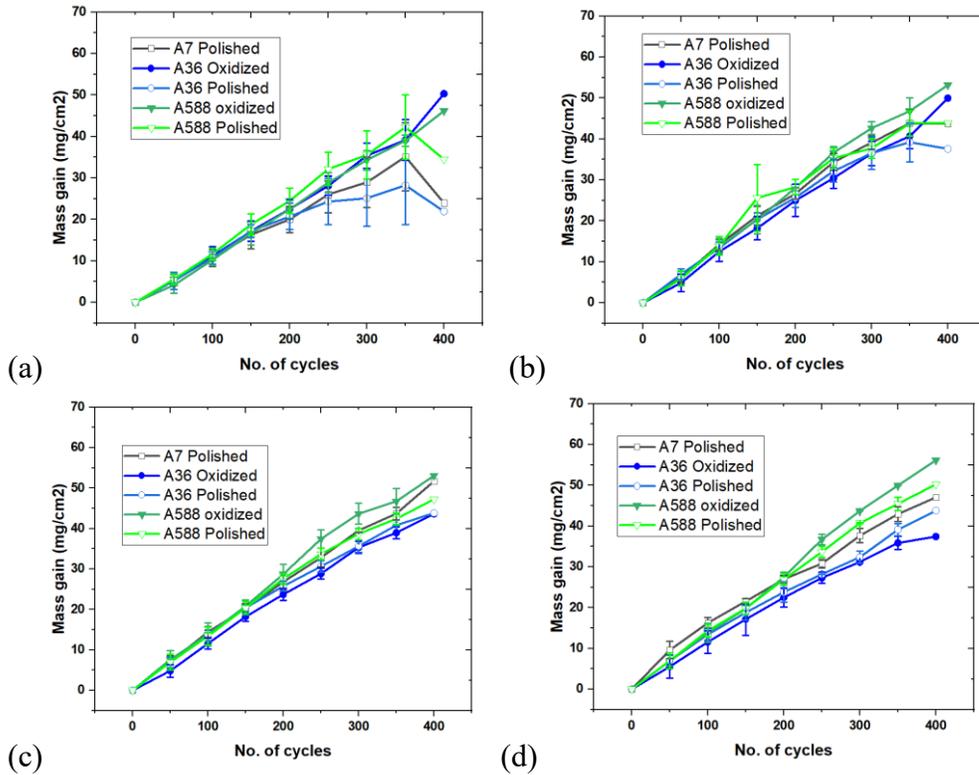
Figure 19. Mass gain results of (a) 1 wt.% NaCl (b) 2 wt.% NaCl (c) 3.5 wt.% NaCl (d) 5 wt.% NaCl

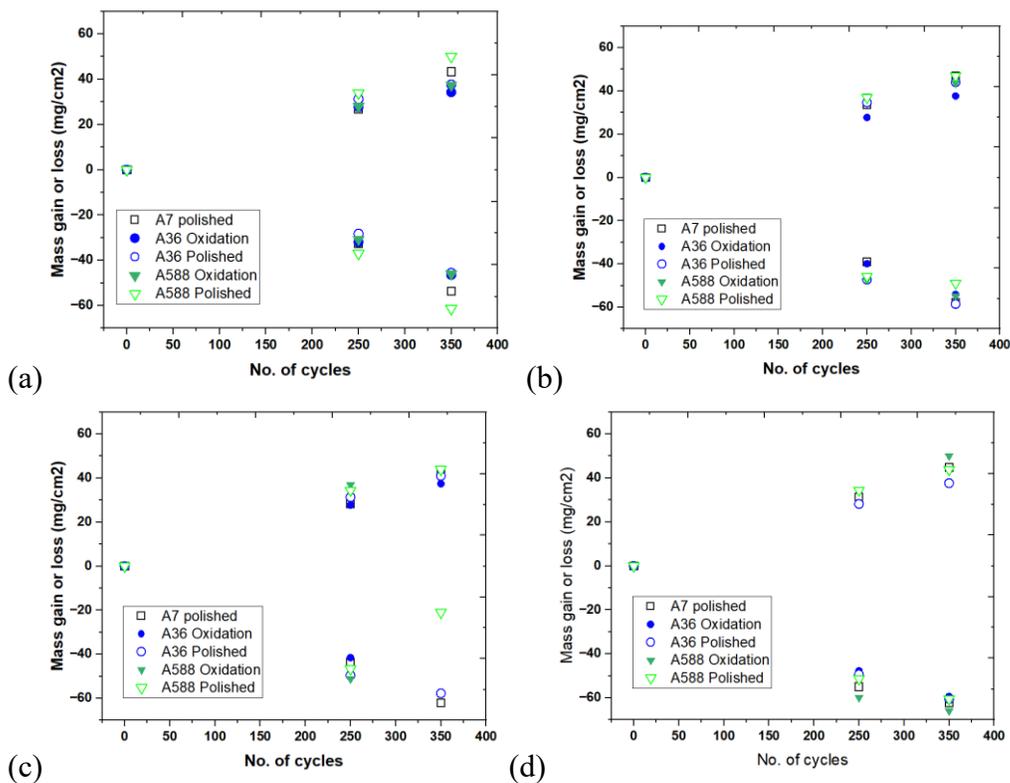
Figure 20. Results of the 250 and 350 cycles coupon mass with corrosion product removed

Samples were also weighed with corrosion product removed by careful scraping of the surfaces. *Figure 20* shows the results of the coupon mass gained per unit surface area in comparison with coupon mass loss when the corrosion product was removed.

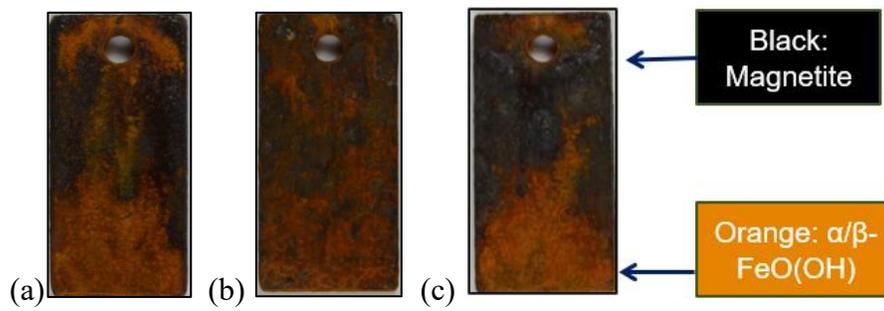
Figure 21. Macro images after 400 cycles of wet/dry testing in (a) A36 oxidized 1 wt% (b) A36 polished 5 wt% (c) A588 Oxidized 2 wt%

There were two major regions on the corroded sample surfaces as illustrated in the macro photographs (Figure 21 through Figure 23). The black-colored region is primarily magnetite, and the orange-colored region is a mixture of iron hydroxide phases (e.g.,  $\alpha$ ,  $\beta$ -FeO(OH, Cl), or  $\gamma$ ). Figure 21 shows images of A36 oxidized condition 1 wt% NaCl, A588 oxidized condition 1 wt% NaCl, and A36 Polished condition 5 wt% NaCl removed samples after 400 cycles. The images show that the magnetite forms at the upper portions of the sample, but the iron hydroxide phases dominate near the bottom. This is likely due to the accumulation of NaCl in the lower portions of the sample. The accumulation happens due to the diffusion of NaCl along the dripping electrolyte solution during drying. Higher amounts of NaCl starts to accumulate at the lower portions as the solution continues to drip. The formation of hydroxide phases at the lower portions suggests that it could be due to the accumulation of NaCl at the lower portions of the sample.

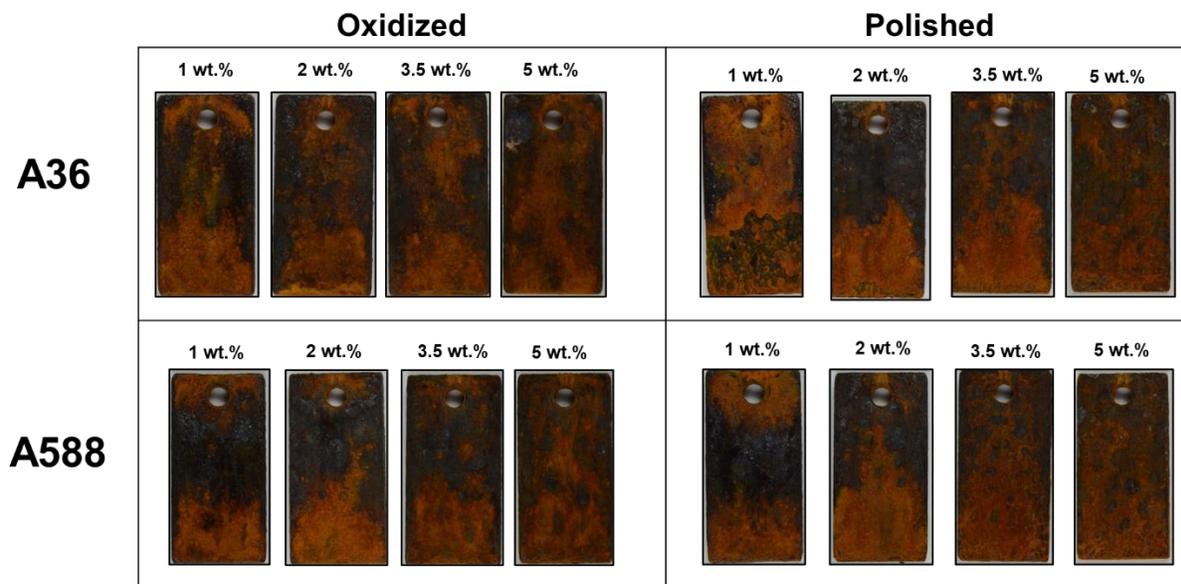
Figure 22. Macro images after 400 cycles of wet/dry testing in A36, A588, oxidized and polished conditions.

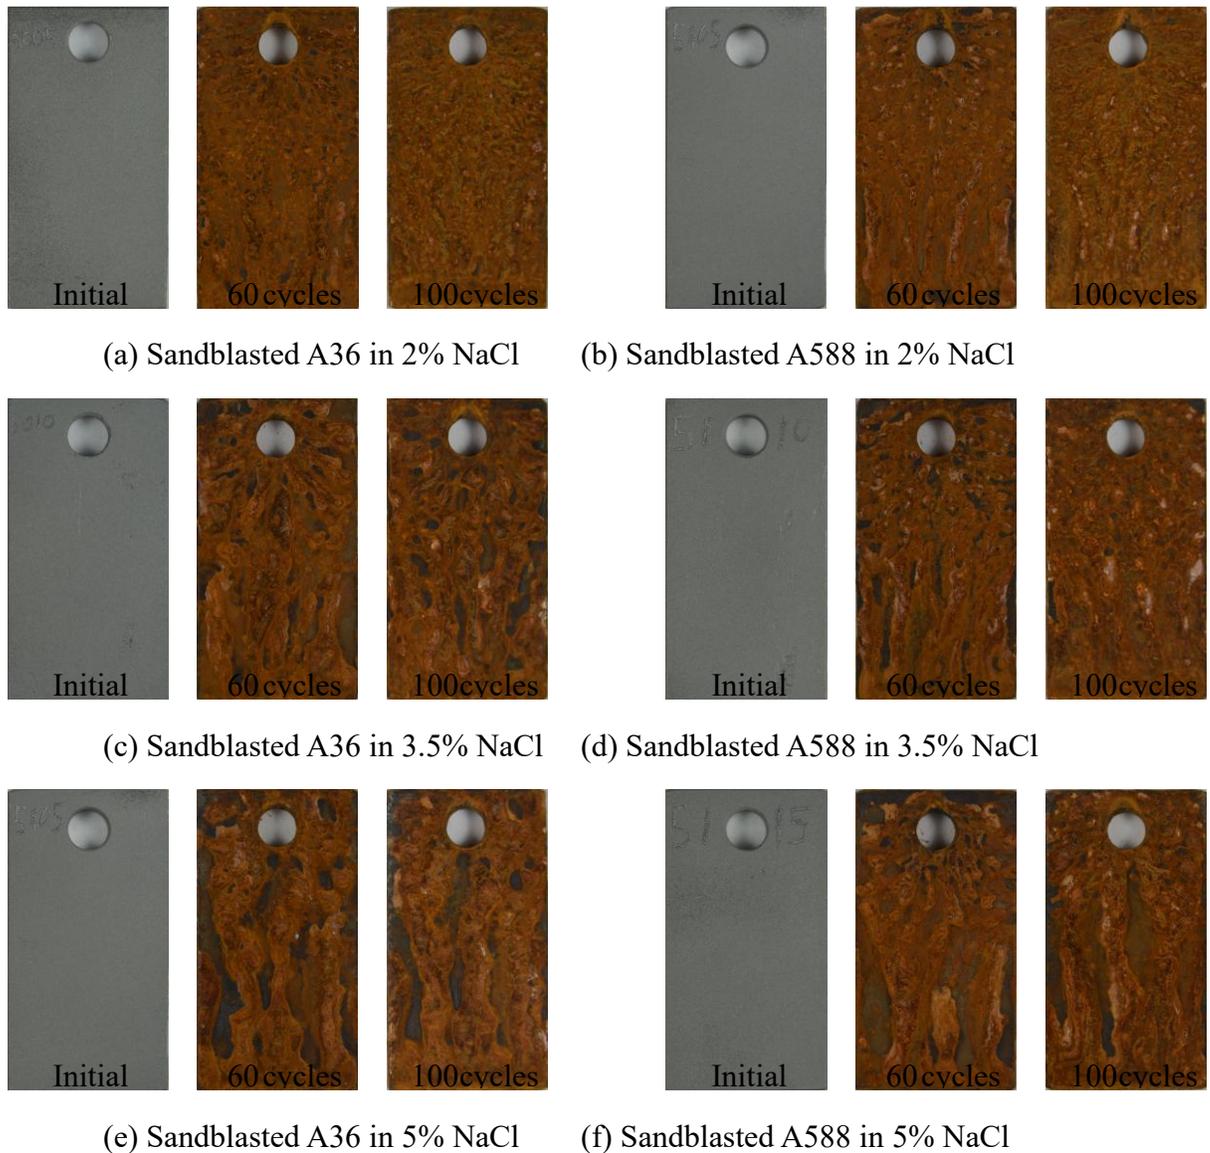
Figure 23. Images of sandblasted coupons in the initial condition and after 100 cycles.

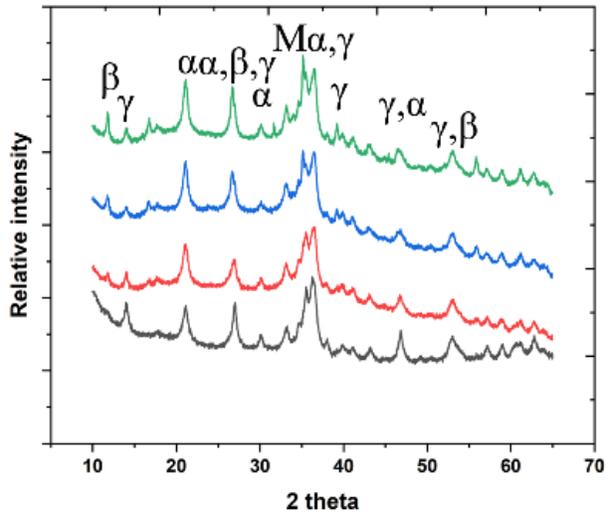
Figure 24. XRD scan of A7-Polished sample at 400 cycles and, Akageneite ( $\beta$ -FeO(OH), Cl) (Top to bottom: Green: 5% NaCl, Blue: 3.5 wt.% NaCl, Red: 2 wt.% NaCl, Black: 1 wt.% NaCl)

XRD results confirm that the presence of the compounds goethite ( $\alpha$ -FeOOH), akageneite ( $\beta$ -FeO(OH, Cl)), lepidocrocite ( $\gamma$ -FeOOH) and magnetite ( $\text{Fe}_3\text{O}_4$ ) in every test coupon after 400 cycles (Figure 24). Relative intensity ratio (RIR) results are shown in Figure 25 for all 400 cycle samples, and the data reveal a trend of uniform growth of corrosion products with the increase in the NaCl concentration. The formation of  $\beta$ -FeO(OH, Cl) can be seen to be significant after 300 wet/dry cycles.

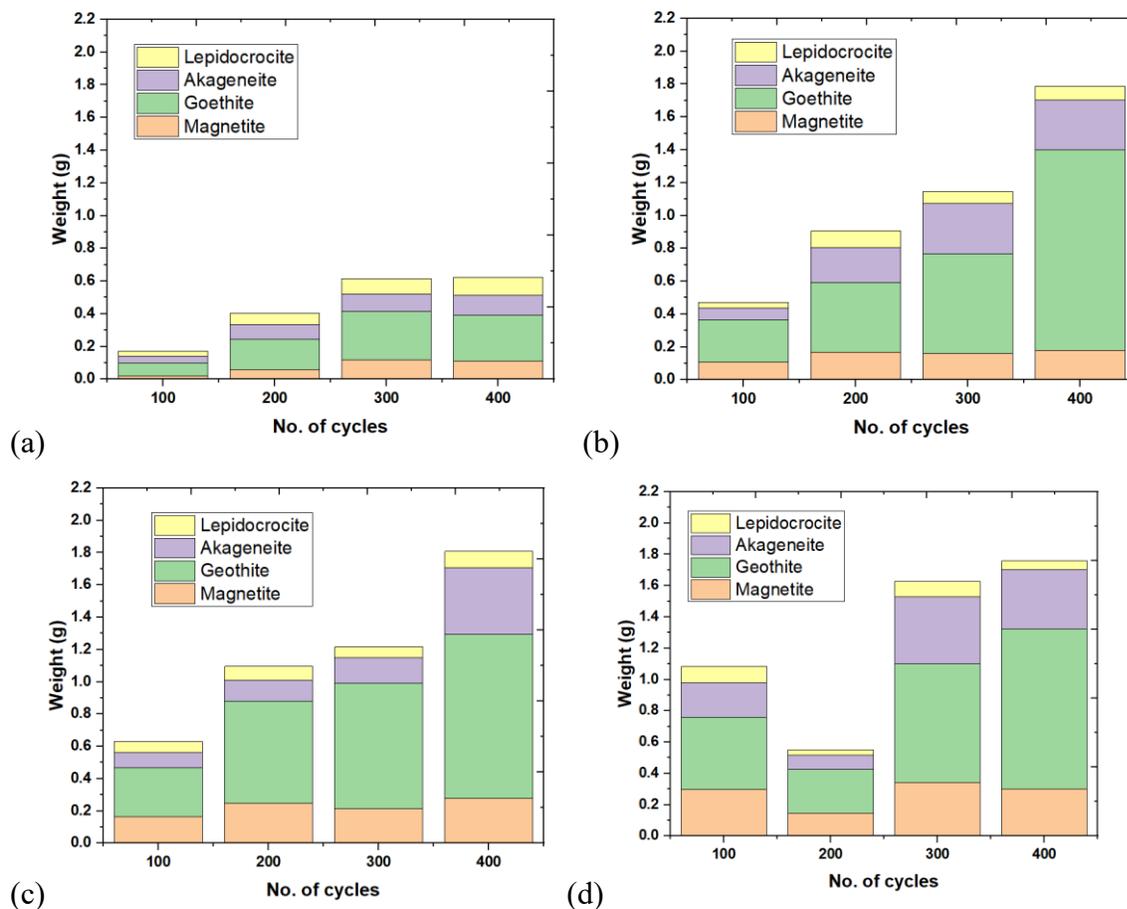
Figure 25. RIR analysis results of A7 steel sample polished condition corrosion powders after 400 cycles (a) 1 wt.% NaCl, (b) 2 wt.% NaCl, (c) 3.5 wt.% NaCl, and (d) 5 wt.% NaCl

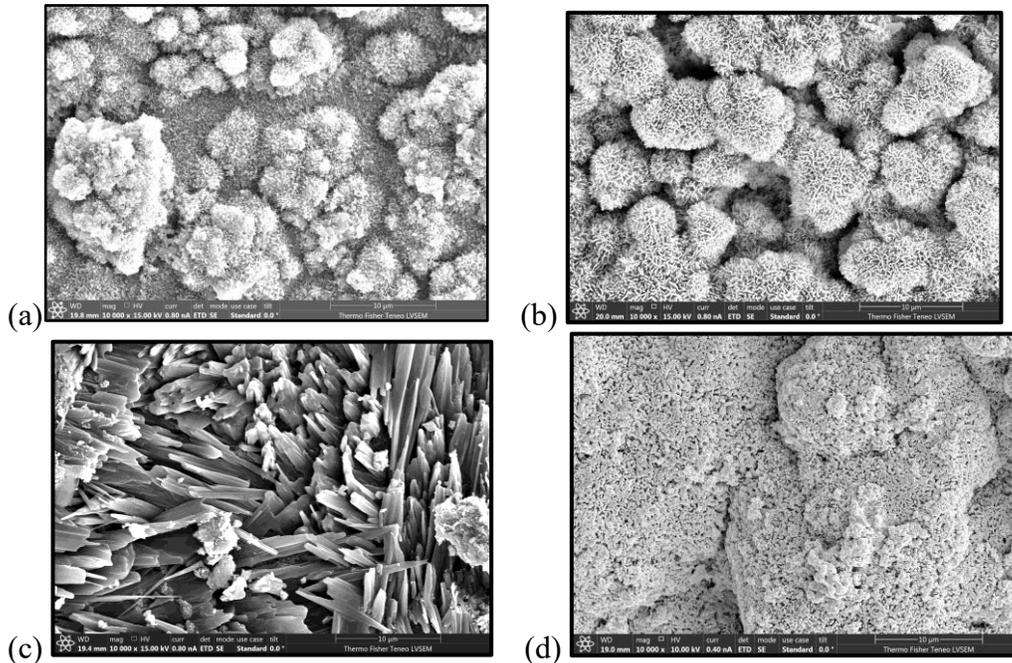
*Figure 26. Compounds identified in SEM imaging (a) Goethite ( $\alpha$ -FeOOH) (A3-Oxidized – 5 wt.% NaCl) (b) Akageneite ( $\beta$ -FeO(OH, Cl)) (A7-Polished-1 wt.% NaCl) (c) Lepidocrocite ( $\gamma$ -FeOOH) (A36-Oxidized-5 wt.% NaCl), and (d) Magnetite ( $\text{Fe}_3\text{O}_4$ ) (A36-Polished-5 wt.% NaCl)*

The presence of the iron corrosion product phases identified with XRD are confirmed through SEM imaging. Goethite ( $\alpha$ -FeOOH) forms in a cotton ball morphology with a secondary features of fine whisker shape. Akageneite ( $\beta$ -FeO(OH, Cl)) forms in a cotton ball morphology with secondary features of thick dendrite or cigar shaped structure. Whereas lepidocrocite ( $\gamma$ -FeOOH) forms in flake or rosette shaped morphology with needle or spike shaped secondary features, and magnetite ( $\text{Fe}_3\text{O}_4$ ) forms in compact cotton ball morphology. *Figure 26* confirms the presence of all the four oxides in the corrosion products of the bridge steel samples.

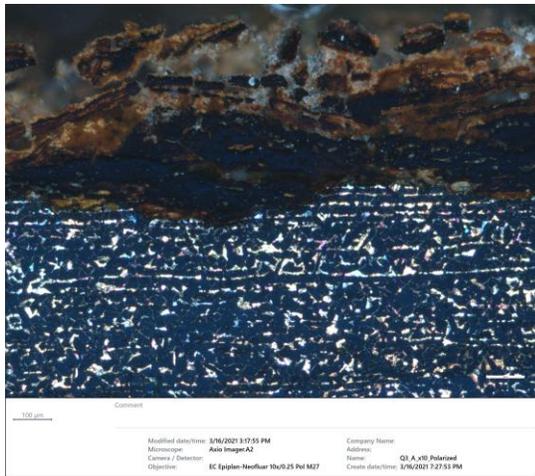
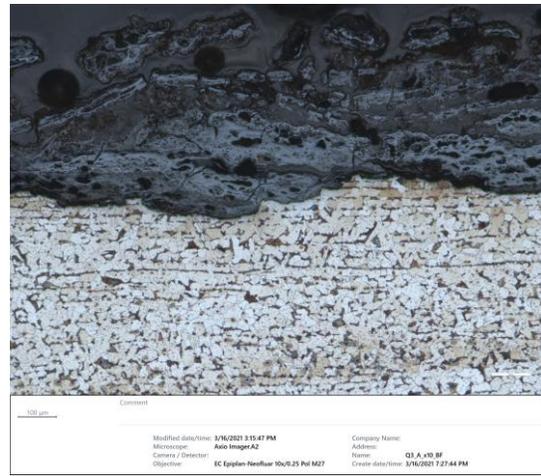
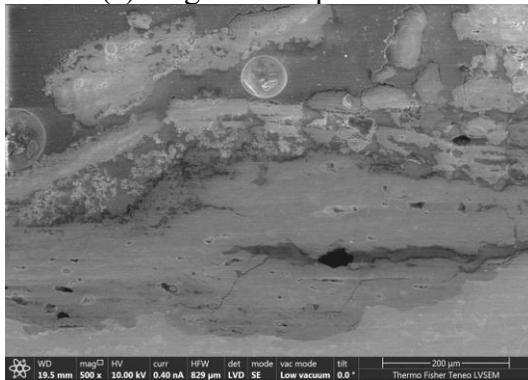
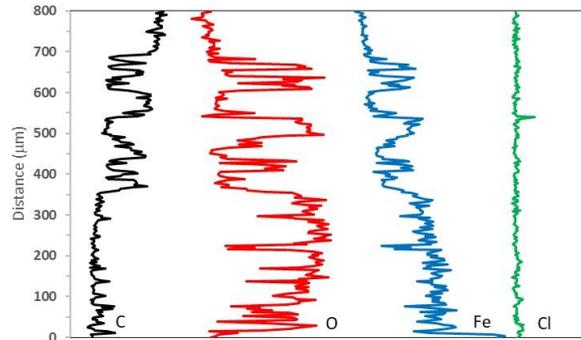
(a) Bright field optical

(b) Polarized Optical

(c) Secondary Electron SEM

(d) EDS line scan

*Figure 27* Polished Q-bridge sample exposed to 3.5% NaCl for 200 Cycles with steel and corrosion layer shown. (a) Brightfield optical image and (b) polarized optical image with the white box showing the locations for the SEM image. (c) Secondary electron SEM image with the red line indicating the location of the EDS line scan, and (d) is the EDS line scan result showing relative amounts of the detected elements along the scan location.

difference in steel corrosion. PLM images of polished Q-Bridge in 3.5% NaCl shown in *Figure 27* (b) and oxidized Q-Bridge in 3.5% NaCl shown in *Figure 28* (b) is highly correlated to component analysis. The corrosion products mainly consist of three different colors which are light brown region (akaganeite), dark gray region (magnetite), and dark brown region (lepidocrocite and goethite). In the middle of the corrosion layer usually filled with gray and dark brown whereas outer surface and interface between the corrosion layer and the steel matrix shows bright or light brown color. The cross-polarized image is supported by EDS results shown in *Figure 27* (d) and *Figure 28* (d). According to EDS results for 3.5% NaCl exposed Q-Bridge, Fe content is stable throughout the corrosion products, but O contents steadily decreased toward surface to the matrix, and the trend is more evident in *Figure 27* (d). Akaganeite forms on the outer surface and denser and more stable phase lepidocrocite, goethite, and magnetite forms in the middle of the corrosion layer due to abundant O flows in the middle of the layer during the accelerated corrosion testing.

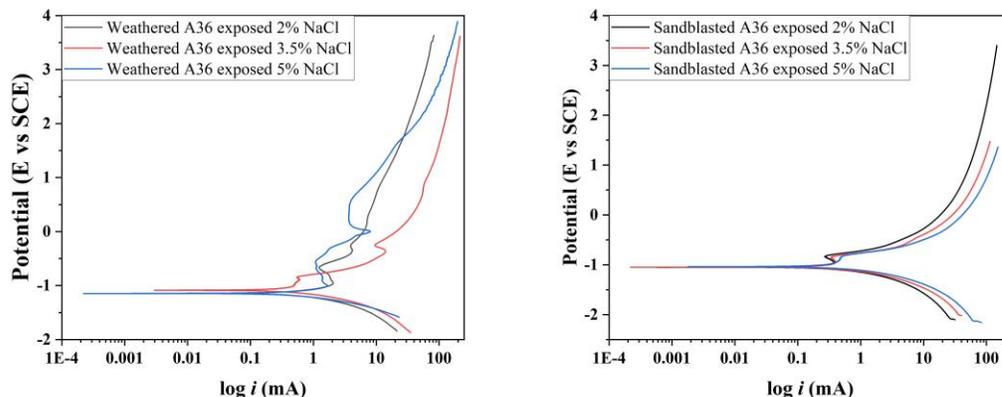
*Figure 29. Potentiodynamic polarization curve of (a) weathered A36 in 2%, 3.5%, 5% NaCl and (b) sandblasted A36 in 2%, 3.5%, 5% NaCl*

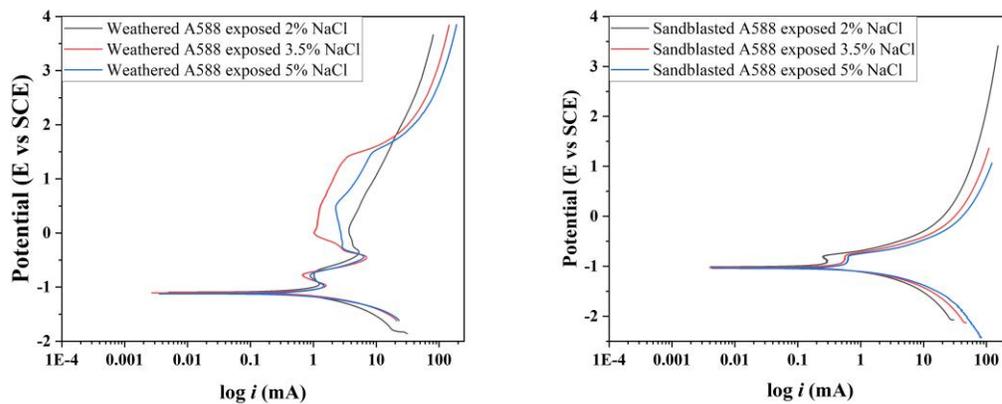
Figure 30. Potentiodynamic polarization curve of (a) weathered A588 in 2%, 3.5%, 5% NaCl and (b) sandblasted A588 in 2%, 3.5%, 5% NaCl
