# Prediction and Prevention of Bridge Performance Degradation due to Corrosion, Material Loss, and Microstructural Changes

**Final Report**  
**September 2025**

**Principal Investigator:** Lesley Frame, Associate Professor  
Department of Materials Science and Engineering, University of Connecticut, Storrs, CT

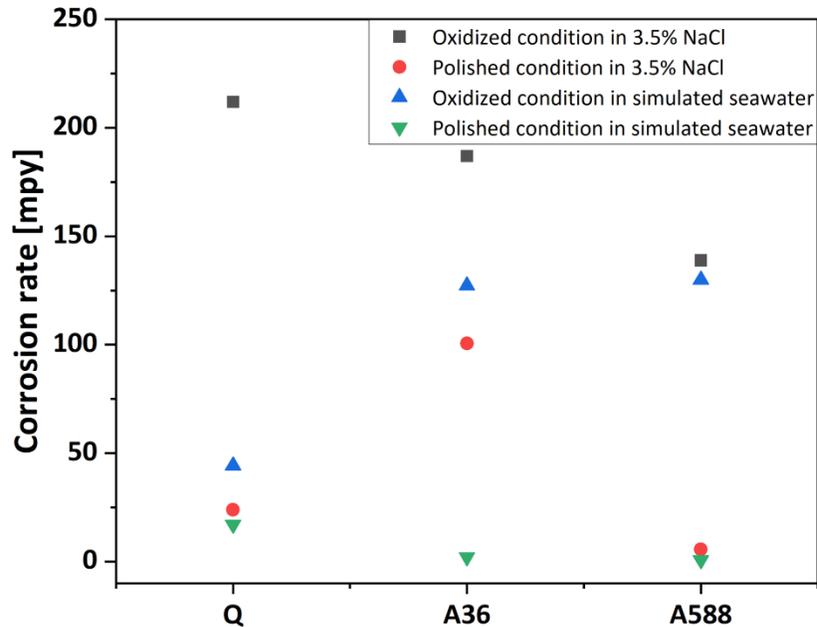
Figure 31. Corrosion rate of the steel depending on the surface condition and the  $[Cl^-]$
