COLORADO
Department of Transportation

CDOT Office of Applied Research

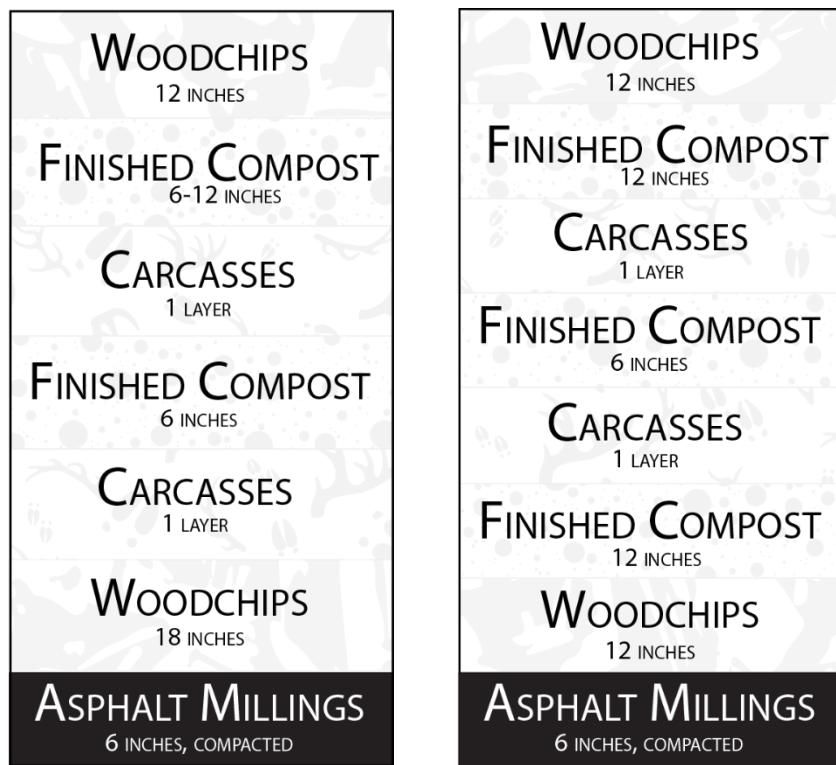
Compost piles are comprised of carbon and nitrogen-based components. Carbon acts as the bulking agent, moisture absorber, and microbe food (e.g., sawdust, woodchips, clippings, etc.), and nitrogen provides the microbes with proteins, amino acids, and enzymes for growth (carcasses). Finished compost is also used to inoculate new compost piles with the appropriate microbe community. The physical construction or “build” of the compost pile includes a combination of these elements in layers, the depths of which vary by the season to account for changes in ambient air temperature surrounding the pile. Maintaining pile temperatures is key to achieving overall decomposition and pathogen reduction, and the pile should be constructed accordingly. The main difference between pile builds is an additional layer of finished compost near the bottom of the pile, and varying depths of finished compost and woodchips at the top and bottom of the pile. Figure 1 depicts an example layout of summer and winter pile builds.

Figure 1. Example compost summer pile build (left) and compost winter pile build (right)

Composting activities at the pilot project site started in Fall of 2021; therefore, the piles were initially built to winter specifications. Starting in May 2022, the summer build was used for piles A2, C2, and D1, before moving back to the winter build for Pile A3 in December 2022.

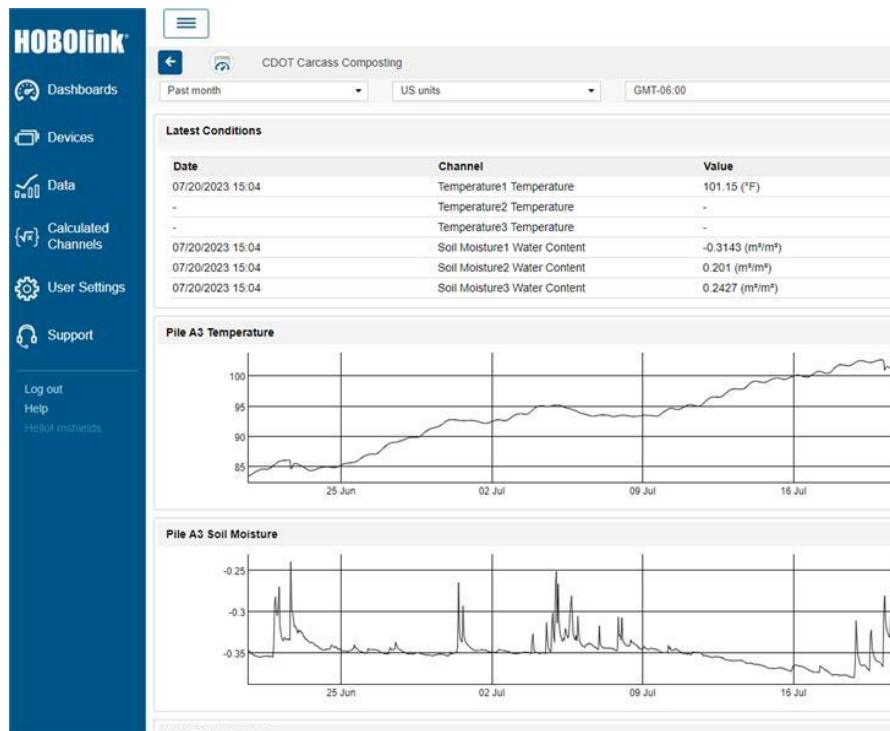
Quantitative data collected for each pile included daily temperature and soil moisture measurements. The project team deployed two methods for collecting quantitative data in this remote setting. First, temperature and soil moisture probes (manual probes) were set to face the trail camera which would then record pile conditions via photos, which were then transcribed manually. Secondly, part of the way through the study, a wireless, cellular-enabled datalogger system was installed onsite that automatically collected temperature and soil moisture data via sensors. The data from the sensors transmitted wirelessly to the cellular-enabled datalogger, which uploaded the data to a dashboard hosted online (viewable at any time and depicted in Figure 2). Both methods collected data at an interval of one day or less. The data captured was then analyzed by the project team to determine when pile actions should occur, such as turning a pile once temperatures have peaked and then lowered.

Figure 2. Example of automated data collection dashboard using Hobo data loggers

The third method considered, and the second used onsite, included the purchase and deployment of an Onset Datalogger system. This method was deployed to help combat lack of availability and participation from the CDOT maintenance crew for monitoring pile conditions. The Onset setup consisted of a centralized datalogger box that wirelessly connected to temperature and soil moisture sensors in each pile. Hourly readings were captured and cellularly transmitted to an online portal where data could be viewed and downloaded. These sensors were deployed alongside the manual-read probes for comparison. The probes associated with the datalogger did not have an effective insertion device, so CORVUS contracted Weld-Wright Fabricators to build an insertion guide rod for each pile that would hold both the temperature and soil moisture sensor on a single insertion rod, with protective plating above the sensors for the insertion process (see attached photolog).

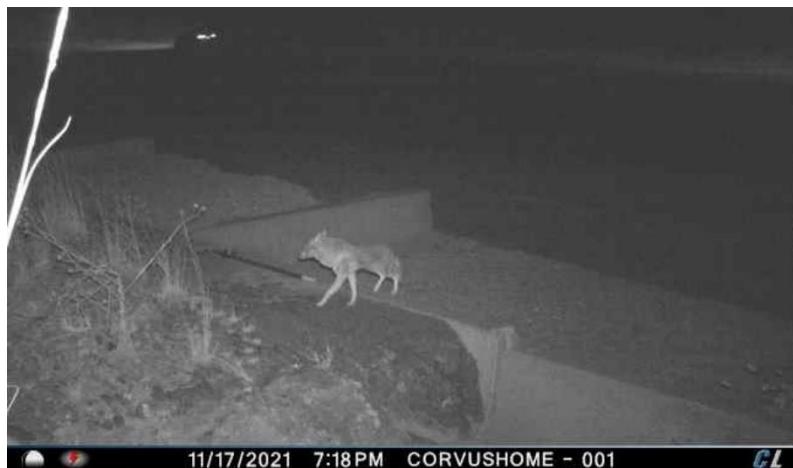
Figure 4. Coyote visiting the site at the beginning of the project.

The main negative environmental condition encountered by the project was the continued presence of scavengers. Earlier in the project, larger scavengers (coyote) were observed accessing uncovered carcasses or portions of carcasses and pulling them out of the pile. This led to bones and half-decomposed bits of carcass scattered outside of the jersey barriers, which will attract additional scavengers, exacerbating the problem. To combat this, the project team reviewed photos more frequently to identify uncovered carcasses sooner, and fewer large pieces of carcass were pulled out of the pile.
