FINAL REPORT ~ FHWA-OK-12-07

# EFFECT OF Y-CRACKING ON CRCP PERFORMANCE

OKLAHOMA STATE UNIVERSITY  
CIVIL AND ENVIRONMENTAL ENGINEERING  
KANSAS STATE UNIVERSITY  
CIVIL AND ENVIRONMENTAL ENGINEERING

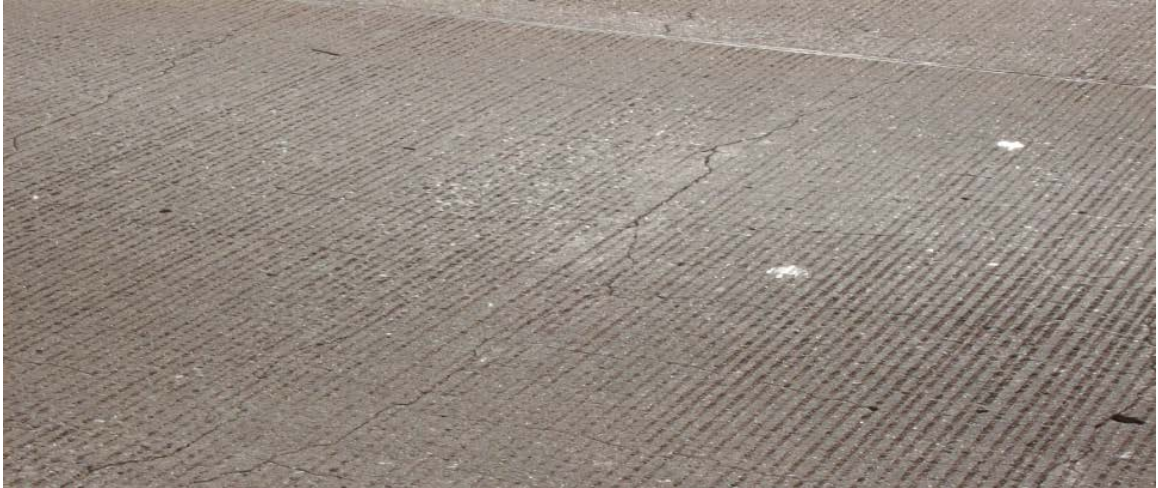
**Figure A.2 Photo shows transverse cracks with inter-connecting longitudinal cracks.**

The southbound lane of his project had several more distresses and failures than the north bound lane. The southbound lane had several large areas of map cracking as seen in Figure A.2. The lane also exhibited multiple Y-cracks, or transverse cracks with several branching cracks, shown in Figure A.3 below.

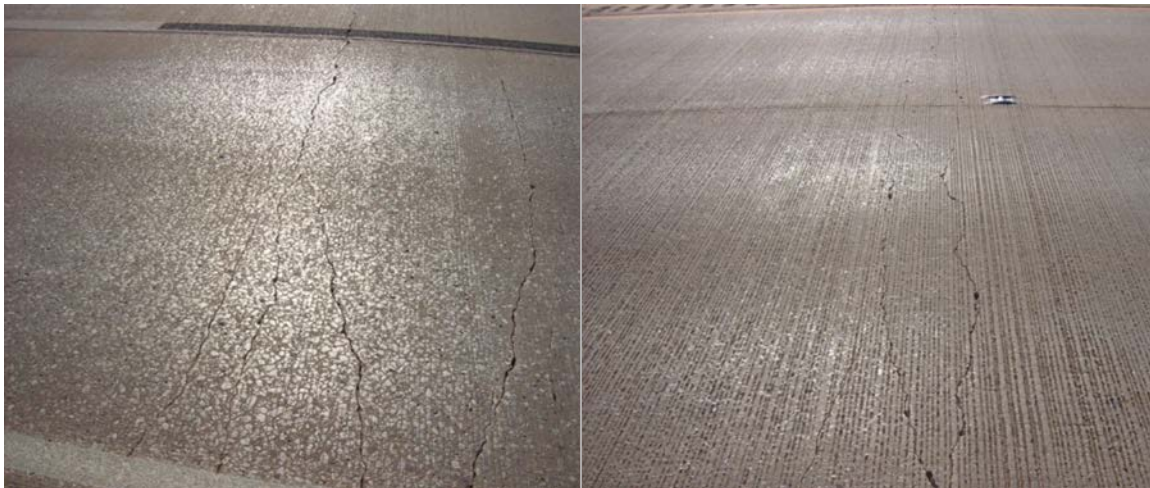
**Figure A.3 Photo shows Y-cracks with multiple branches**

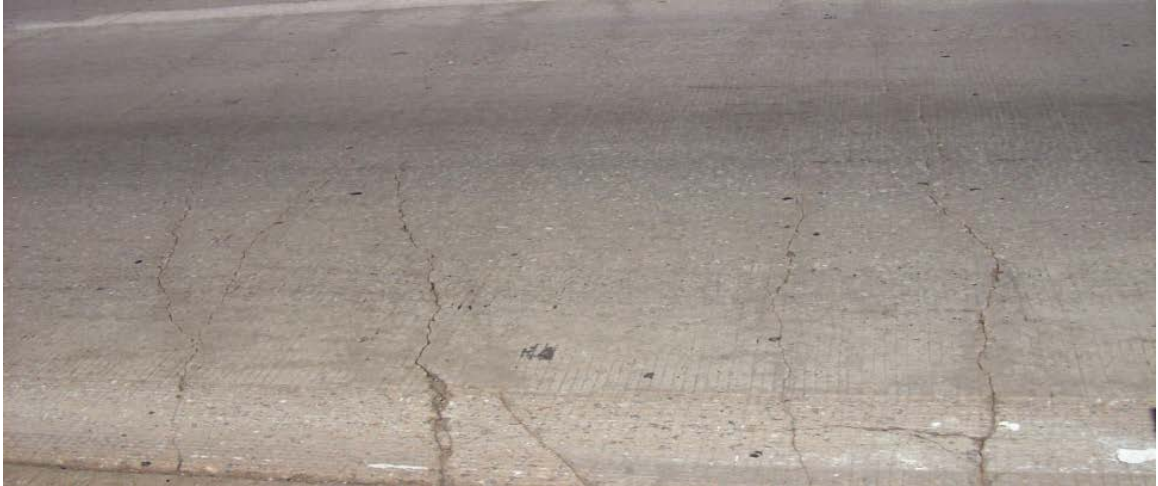
**Figure A.7 Closely spaced transverse connected by longitudinal cracks**

The northbound lane of this project had isolated areas of heavy Y-cracking and closely spaced transverse cracks connected by longitudinal cracks (see Figure A.7). It was noted that the crack width seemed to be very small, with a crack spacing of eight to ten feet between clusters of cracks.

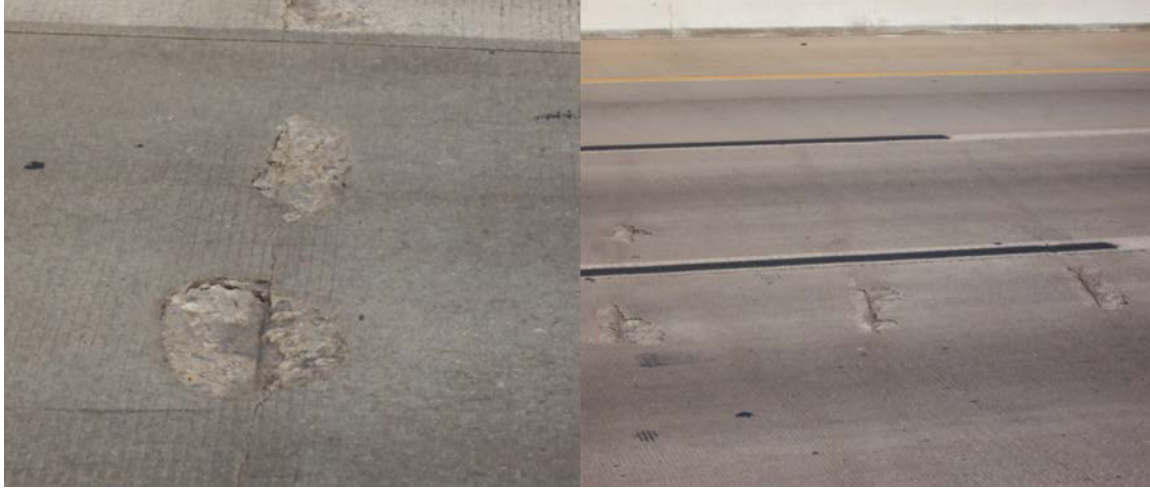
**Figure A.8 Distresses in ODOT's region of concern**

Before the project was inspected, ODOT commented that they had a particular concern within mileposts 124.1 and 124.2. Figures A.8 and A.9 show the distresses in this particular region. The transverse steel in this region appears to be high in the pavement, leaving only  $\frac{3}{4}$ -1 inch of concrete cover over the bar. It was also noted that the transverse steel in this region does not appear to be perpendicular to the direction of traffic. Chris Westlund, an ODOT employee, said that the steel on this project was placed with a machine during the paving process and he recalled that the machine was having problems. Nevertheless, the distresses in this section of pavement seemed to be caused by inadequate steel cover and not related to Y-cracking, or any other cracking patterns. None of the distresses caused by the transverse steel have been patched in the northbound lane. The northbound lane also exhibited several stretches where the road surface was extremely worn. The tines in the wheel paths were barely visible. Several stretches of pavement had to be skipped while performing the visual inspection due to exits, entrances, and barrier walls not providing a shoulder to conduct the inspection.

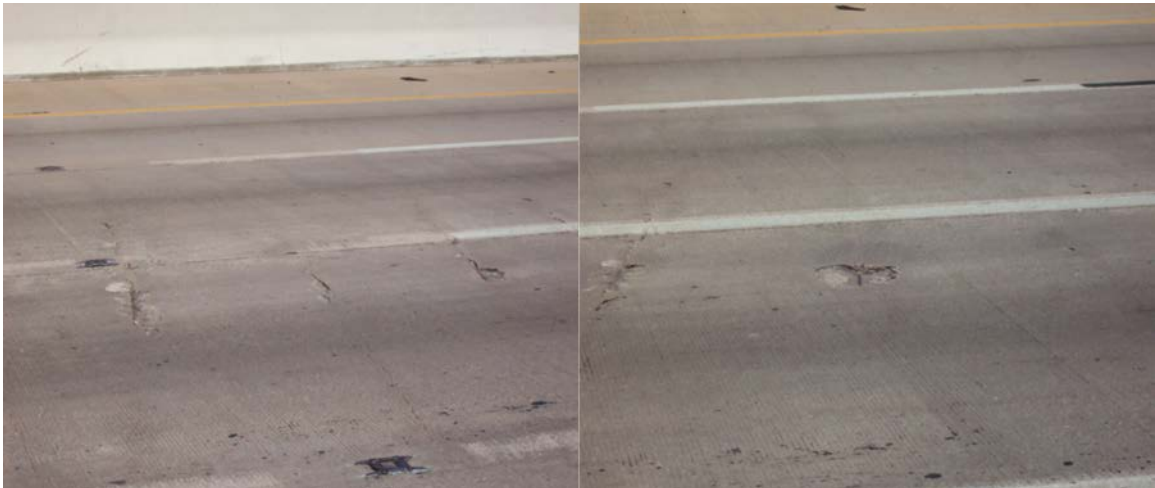
**Figure A.9 More distresses in ODOT's region of concern**

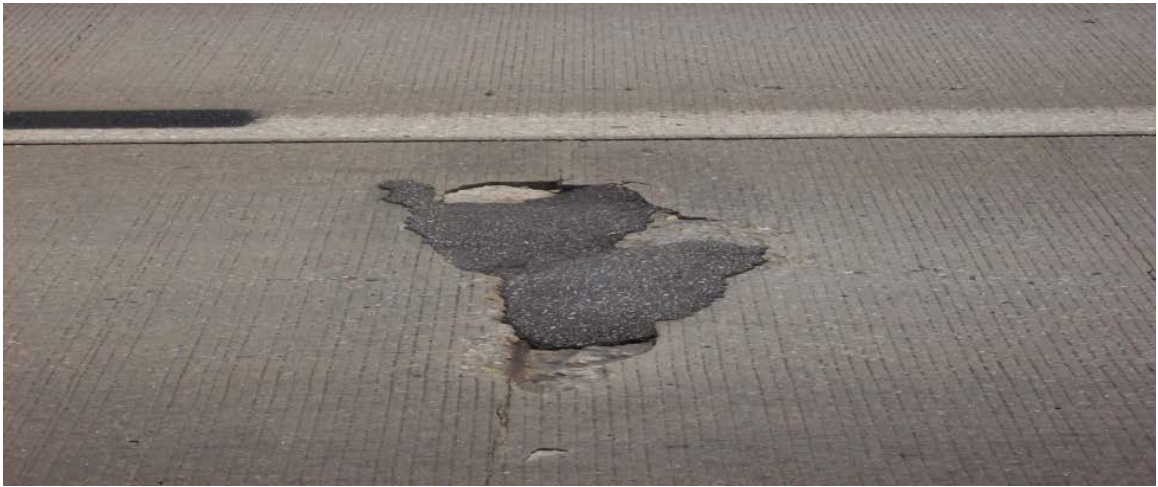
**Figure A.10 AC patch over a distress with exposed transverse steel**

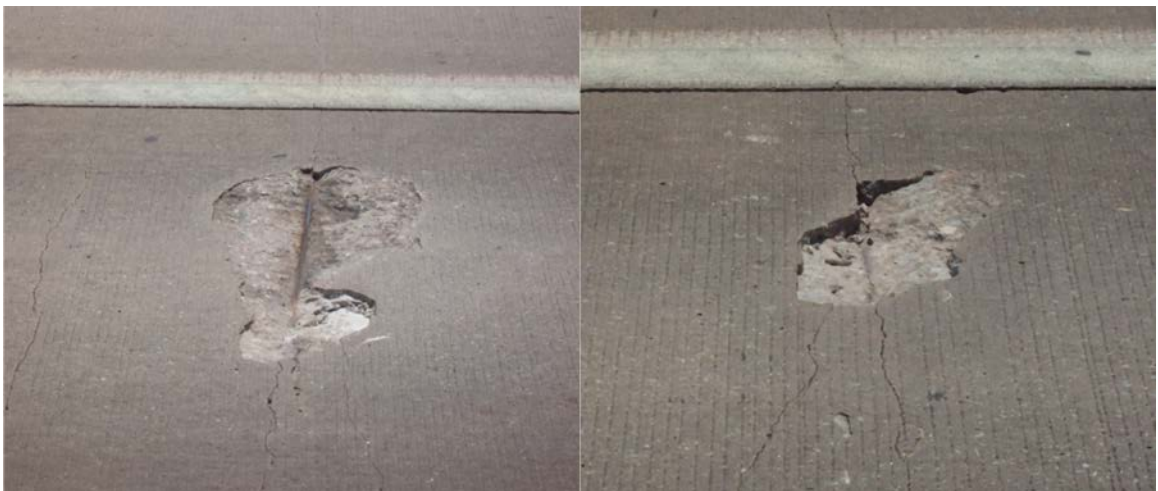
**Figure A.11 Possible Y-crack over shallow transverse steel**

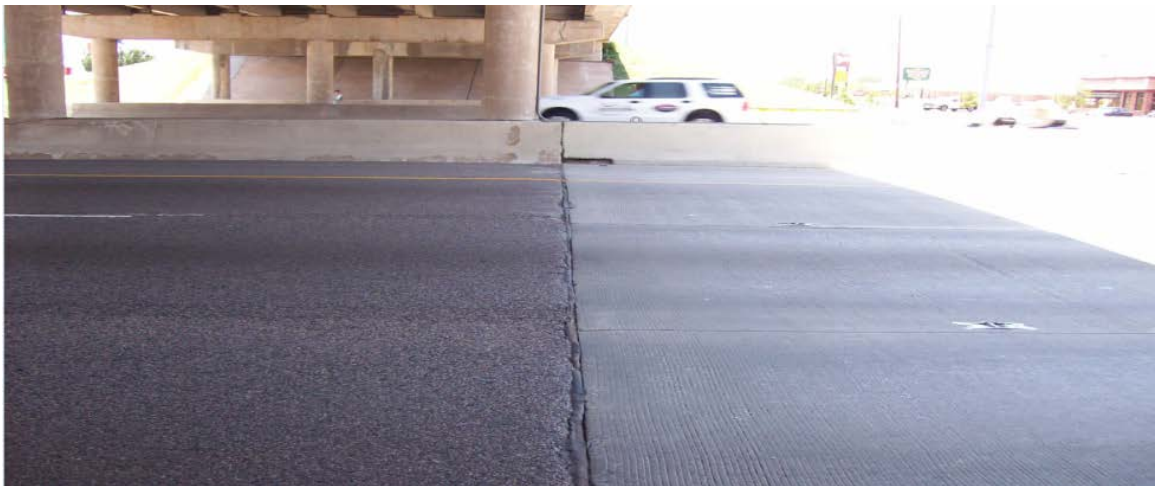
**Figure A.13 Joint at the Southern end of North bound lane**

The northbound lane of the project was more accessible which allowed the full length of the pavement to be viewed. The inspection began at the joint on the southern end of the project (Figure A.13). It was noted that the pavement had no cracks for the first forty-two feet, and then displayed a long crack spacing of approximately fifteen feet. Then cracks slowly became closer, reaching a spacing of three to four feet. Overall, the northbound lane, like the southbound lane, was in good shape with no patches or punchouts recorded.

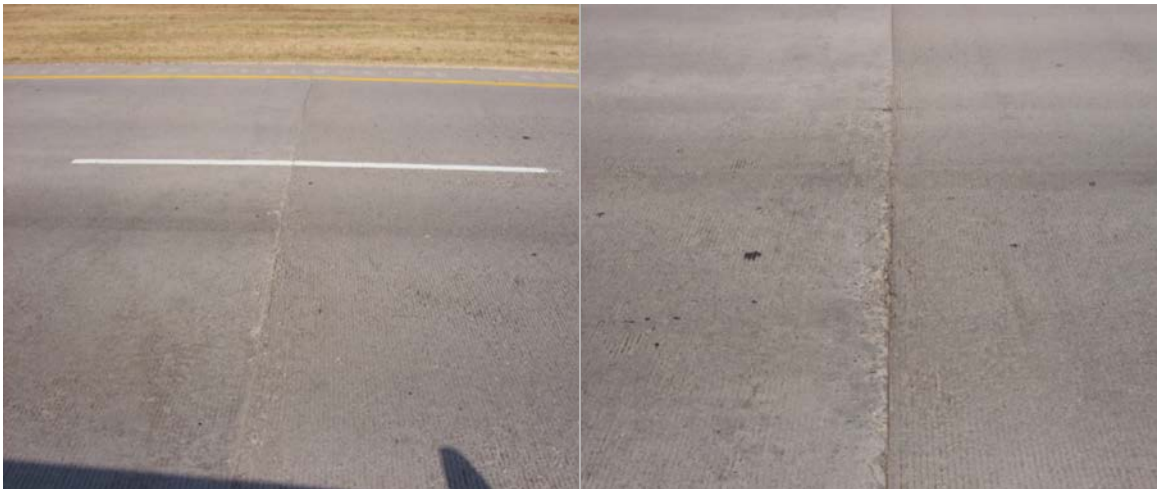
**Figure A.16 Two construction joints displaying signs of spalling**

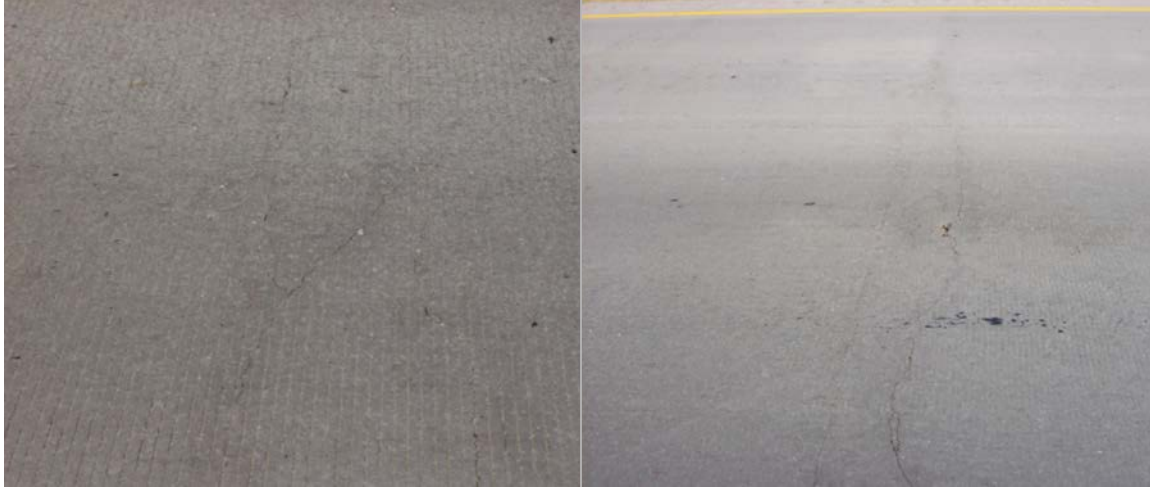
**Figure A.17 (Left) Y-crack located in the region; (right) two close transverse cracks showing distress**

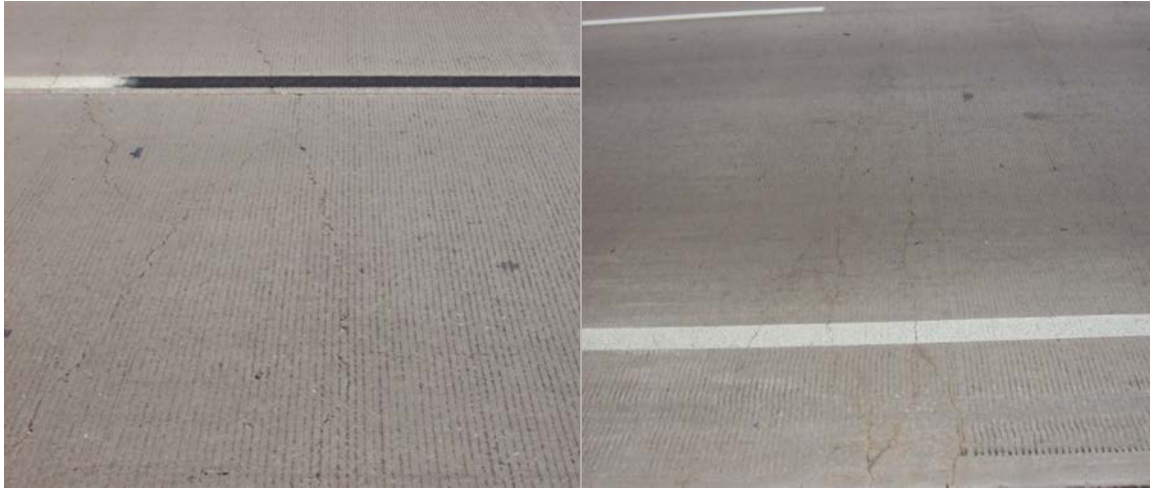
**Figure A.19 Two different forms of Y-cracking**

The southbound inspection began at a bridge approach joint 0.16 miles north of mile post 29. The first 0.64 miles inspected were part of the project IMY-35-1(145)029. This area of pavement displayed a low number of Y-cracks. The south bound lane appeared to be more worn than the northbound lane, and its appearance was not as glossy. The southbound lane of the original project of interest displayed various forms of Y-cracking as seen in Figure A.19. However no patches or punchouts were documented.

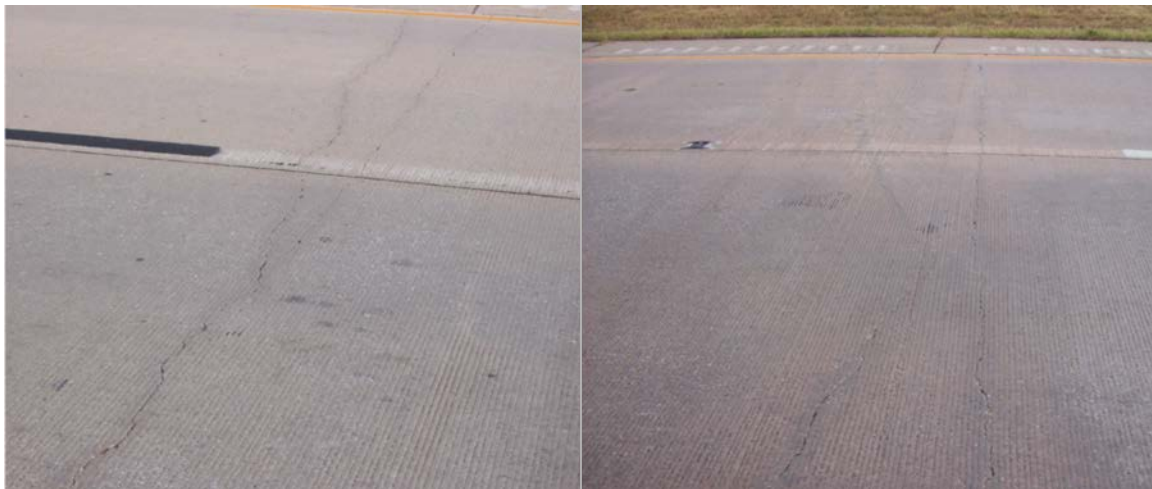
**Figure A.22 Two different types of Y-cracks found in the area**

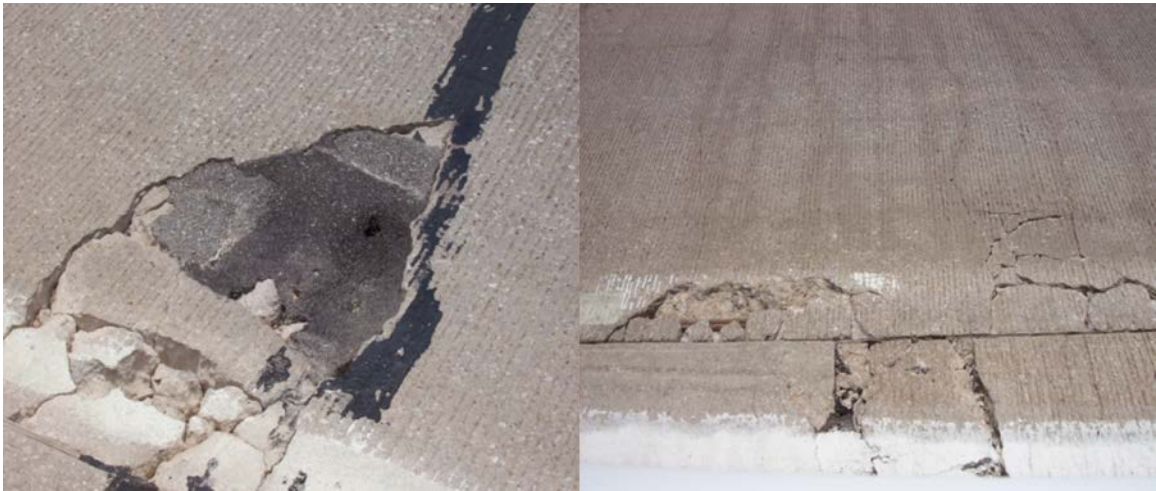
**Figure A.30 (left) Y-crack breaking up, (right) distress caused by close transverse cracking**

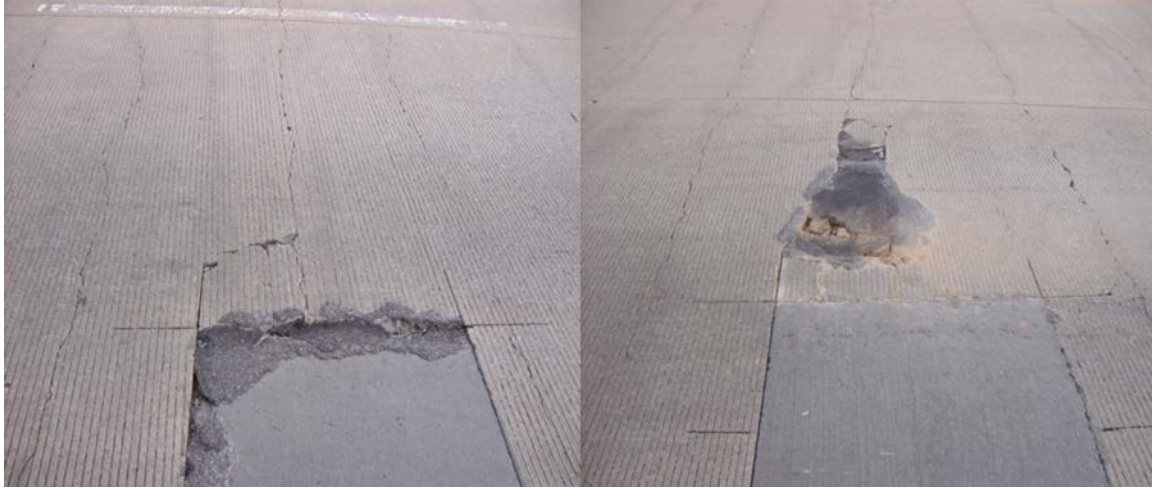
**Figure A.32 Small patch with distress developing close by**

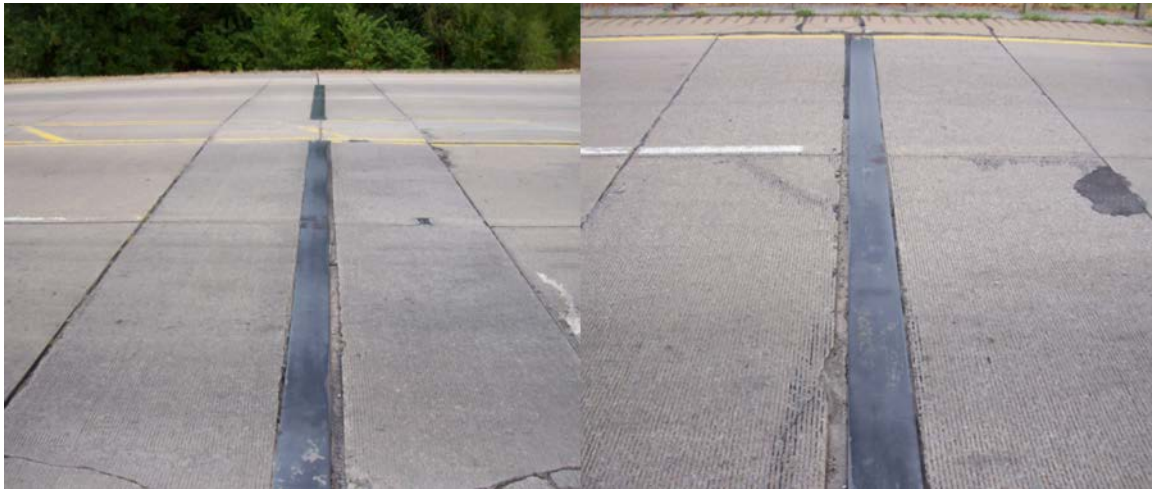
**Figure A.33 Terminal joints showing signs of spalling**

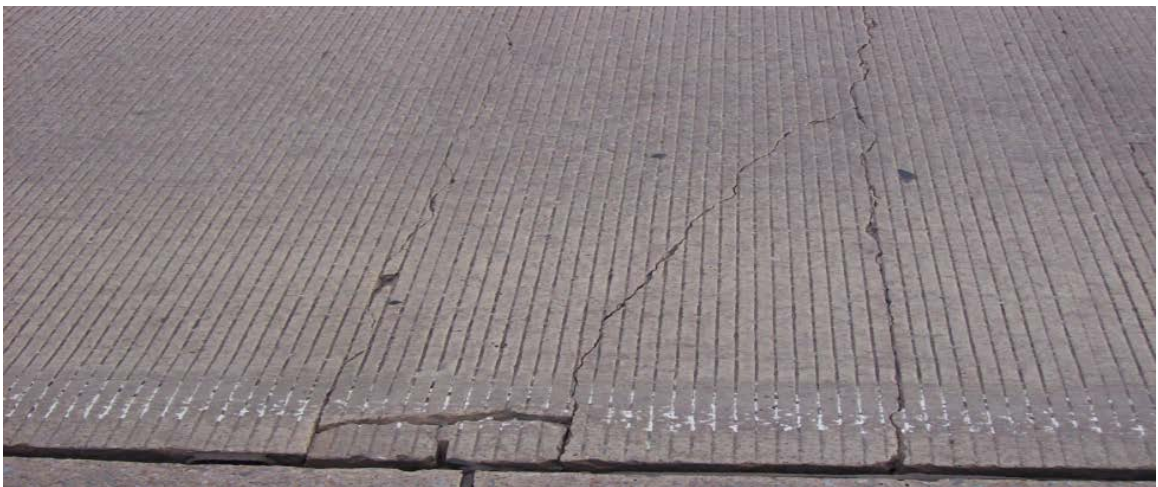
**Figure A.35 Typical Y-crack for the area**

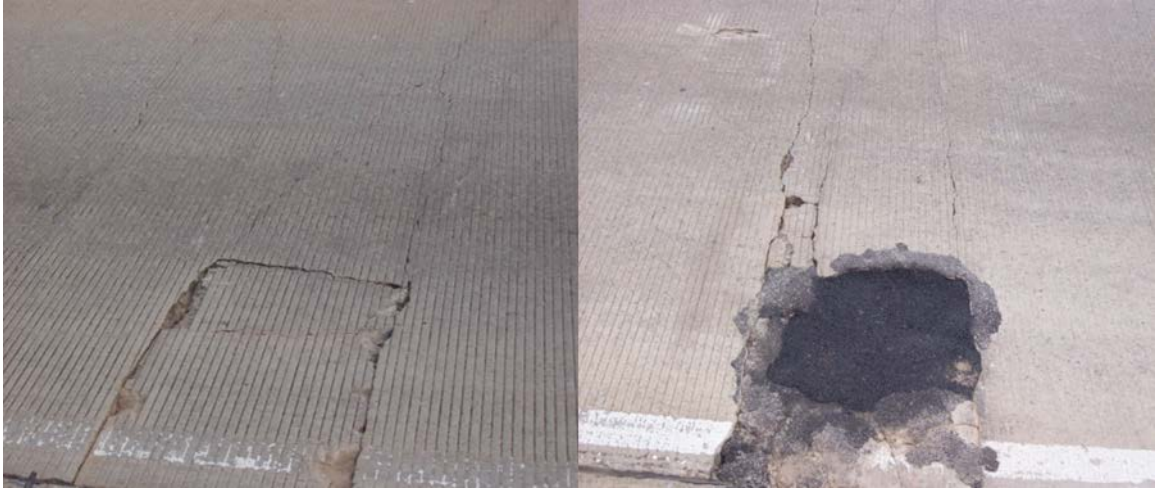
**Figure A.36 Y-cracks leading to punch-out and eventually failure**

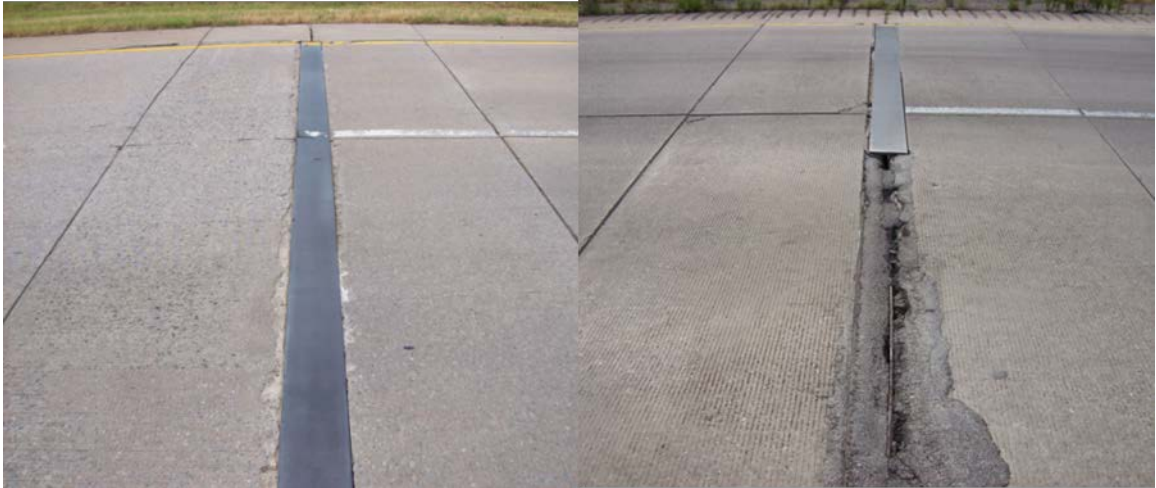
**Figure A.37 Terminal joints showing distress**

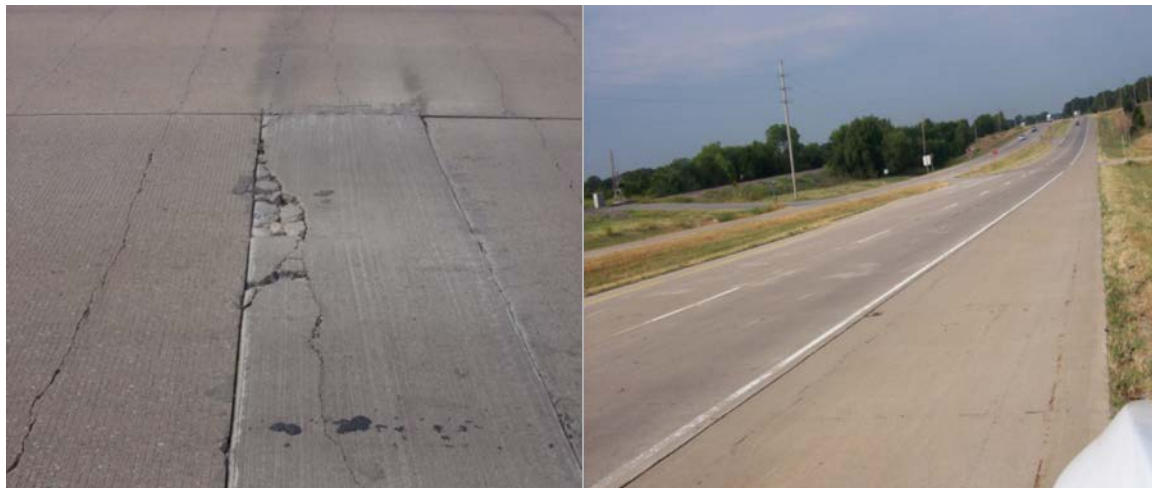
**Figure A. 38 (left) patch showing signs of distress (right) area of road where crack survey was taken.**

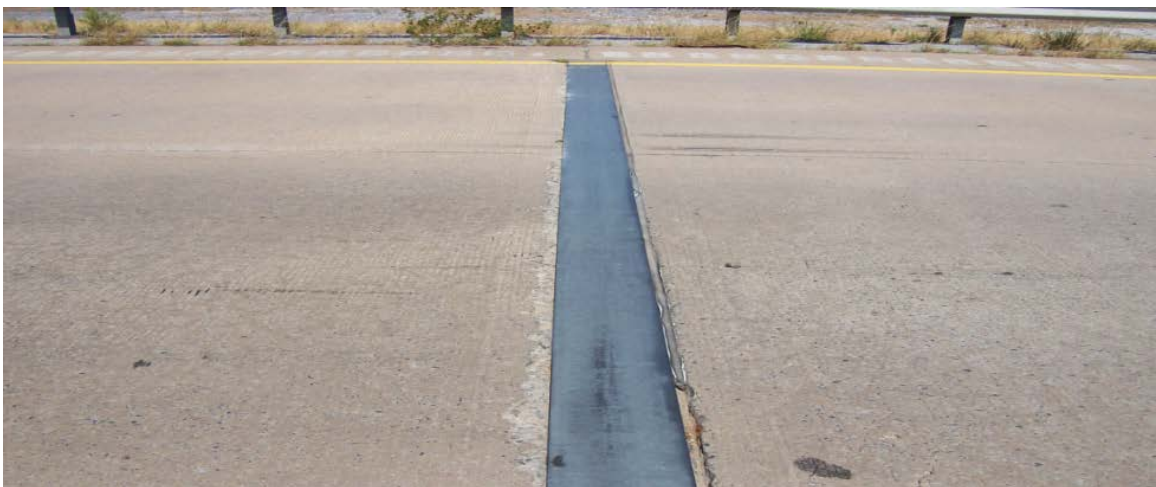
**Figure A.39 Spalled terminal joint with worn roadway surface**

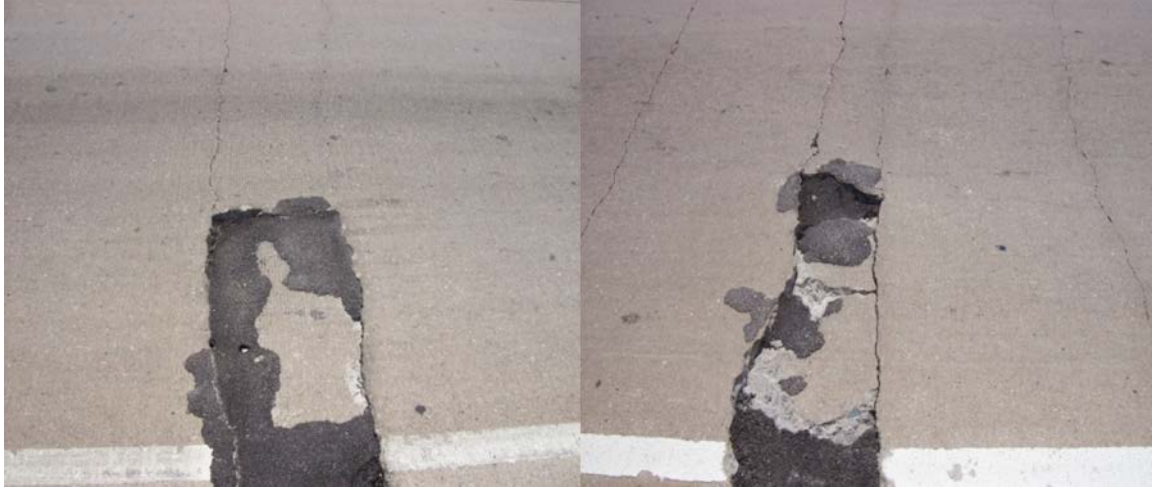
Figure A.45 Transverse cracks intersected by longitudinal cracks

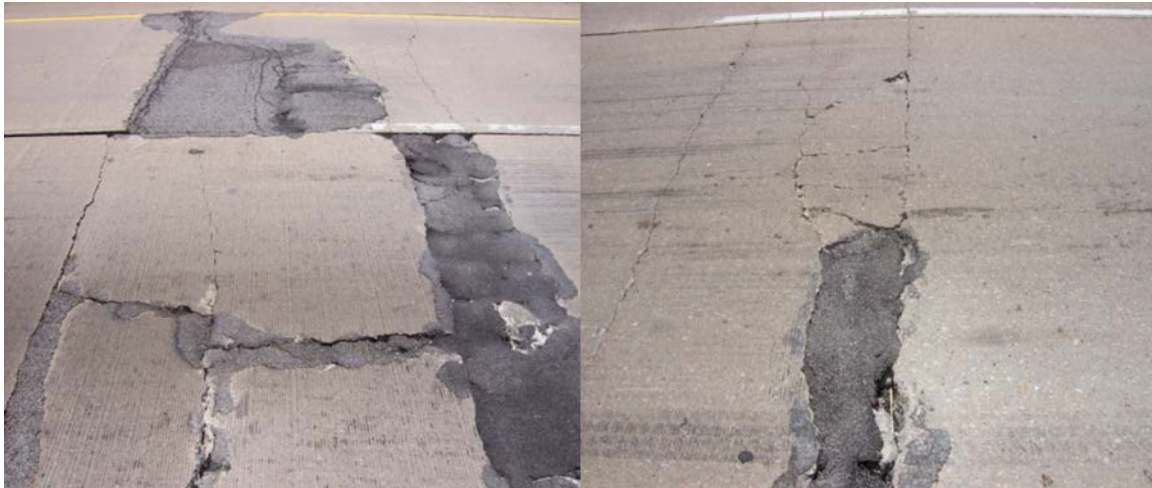
**Figure A.46 Transverse cracks intersected by longitudinal cracks**

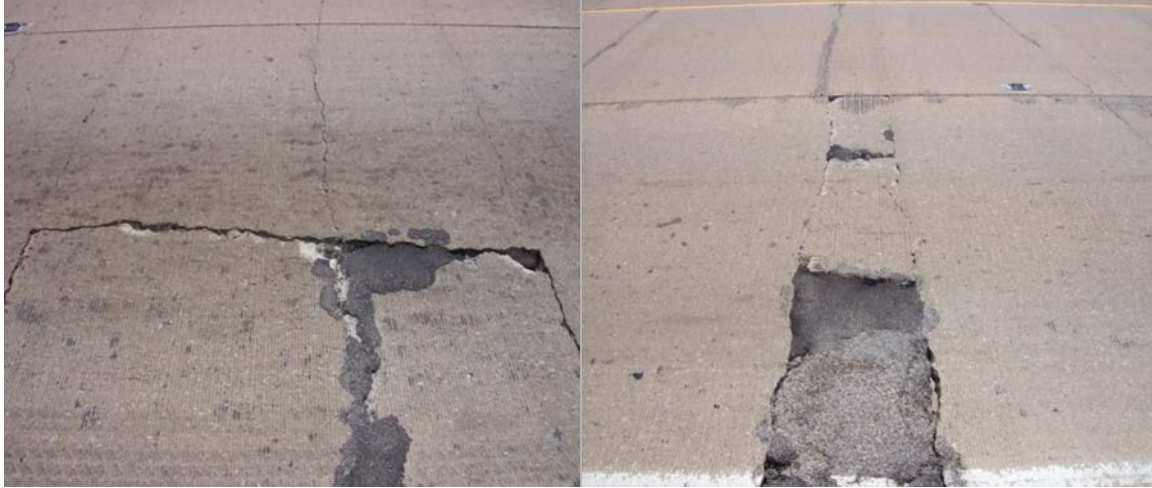
**Figure A.47 Transverse cracks intersected by longitudinal cracks**

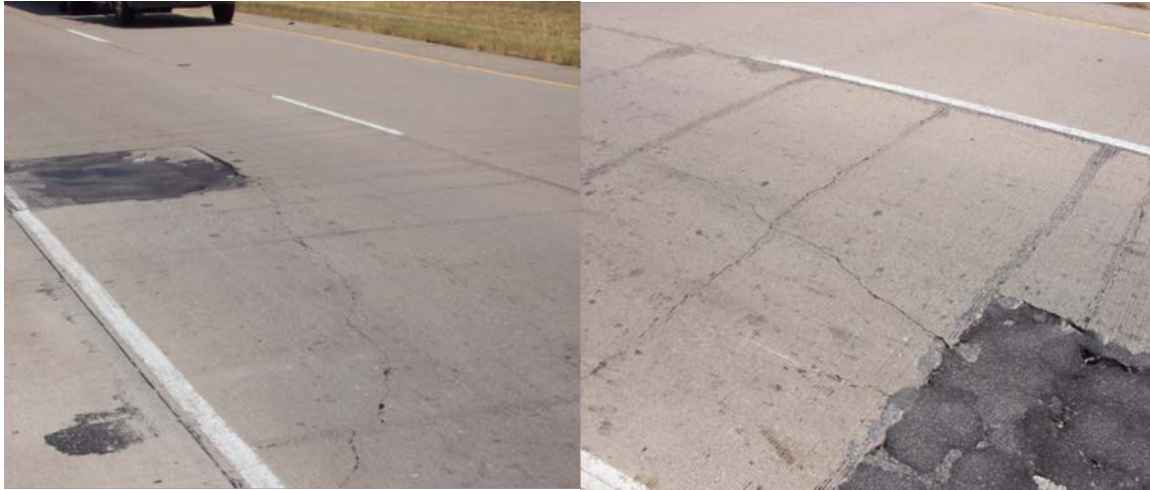
**Figure A.49 Multiple transverse cracks intersected by a longitudinal crack**

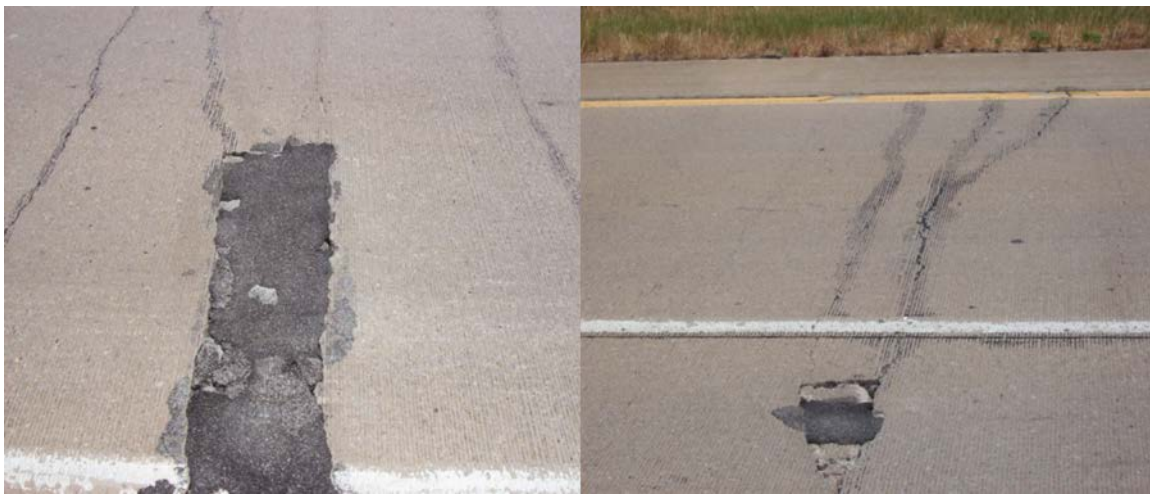
**Figure A.50 Patches that appear to be the result of a failed Y-crack**

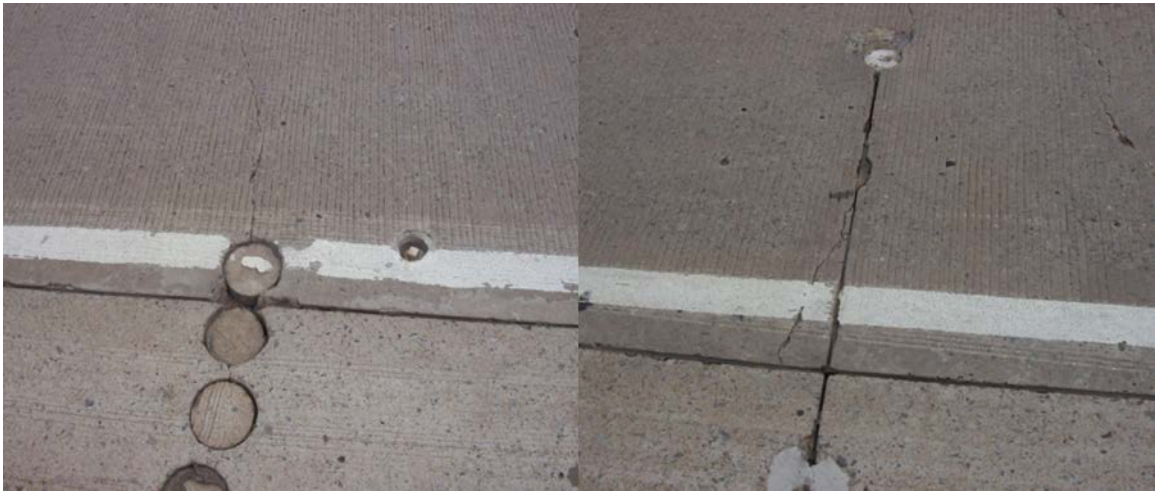
**Figure A.58 (left) cores taken from shoulder, (right) core with censor wire extending to shoulder**

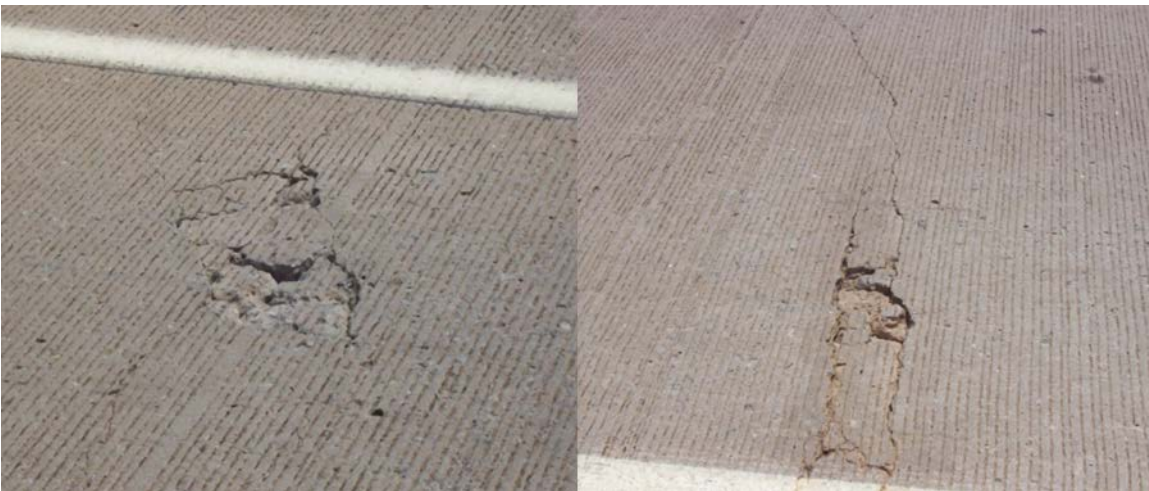
**A.60 (left) Two closely spaced transverse cracks, (right) Y-crack developing into a punch-out**

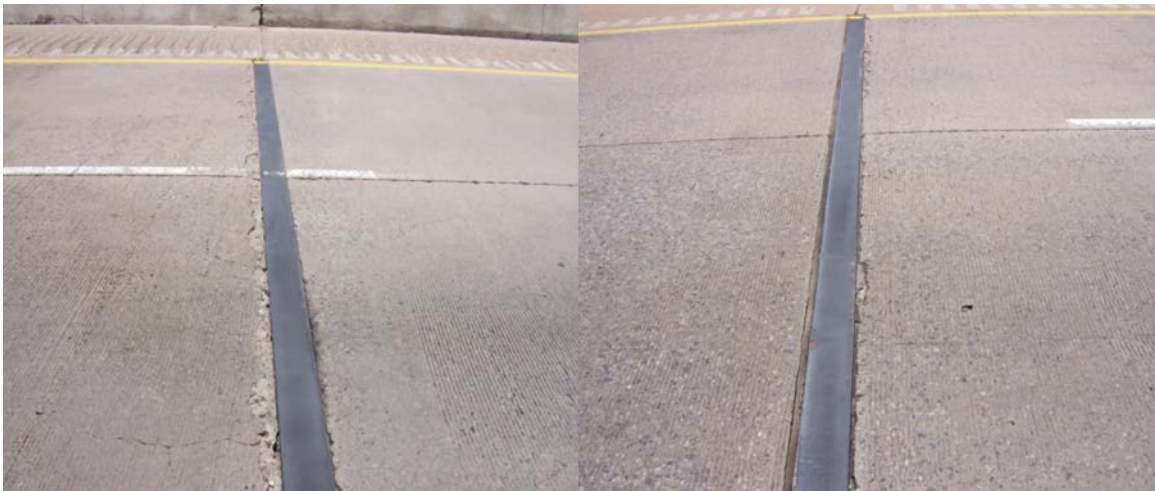
**Figure A.66 Terminal joints at project beginning and end**

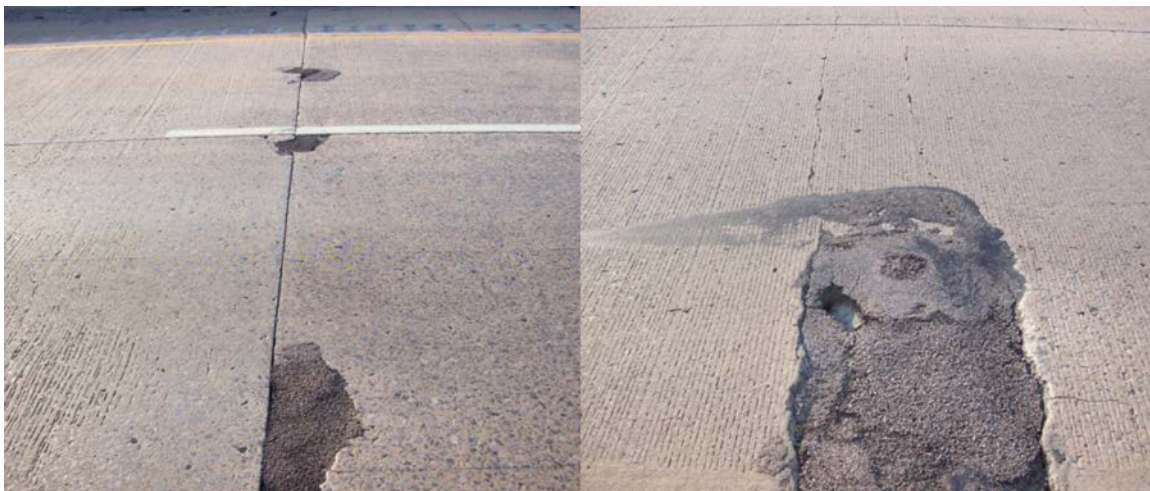
**Figure A.68 Patches in the southbound lane**

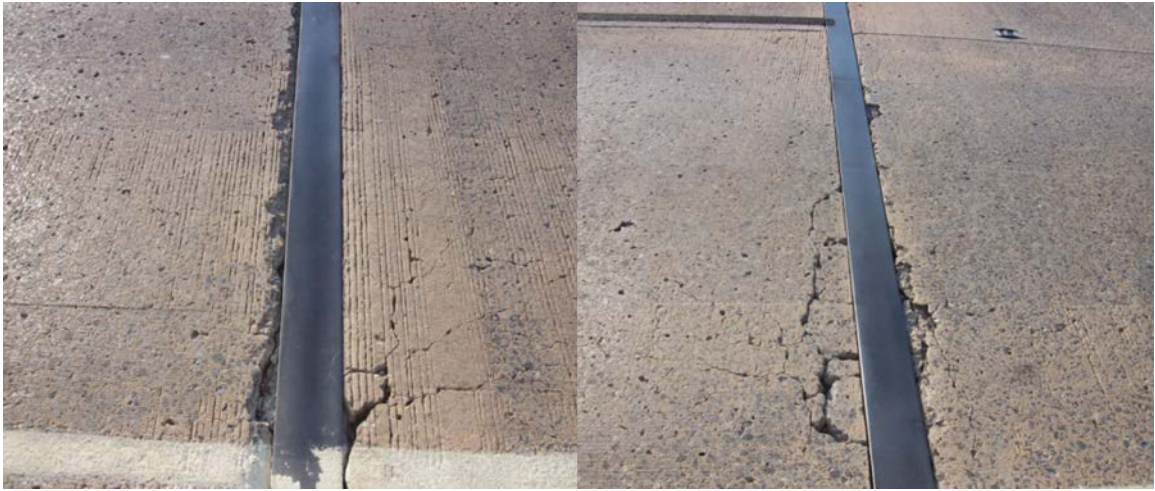
**Figure A.69 Terminal joints at the beginning and end of the project**

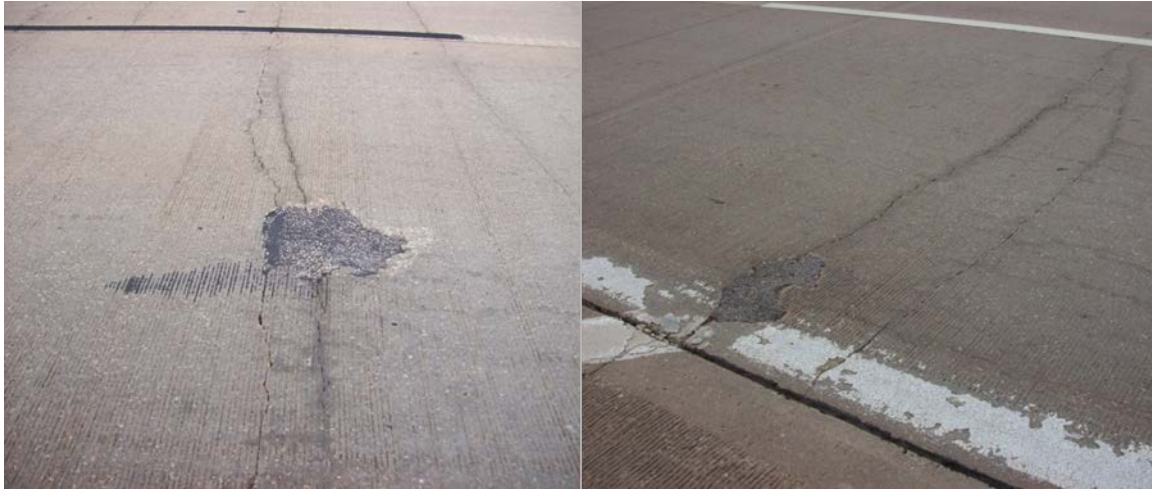
**Figure A.71 Meandering cracks with small patches stopping just short of a “Y” intersection**

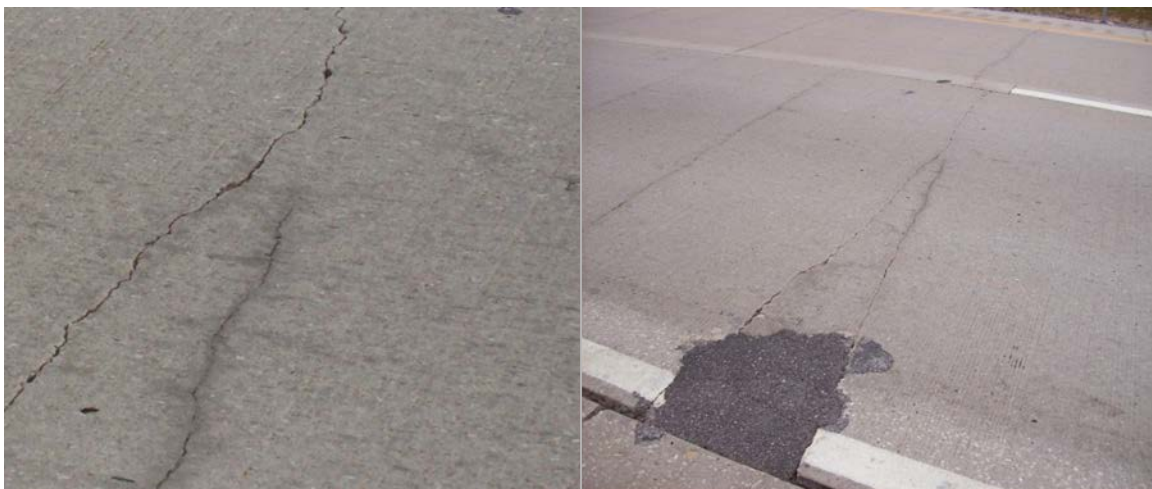
**Figure A.72 A transverse crack stopping just short of a “Y” intersection with another transverse crack.**

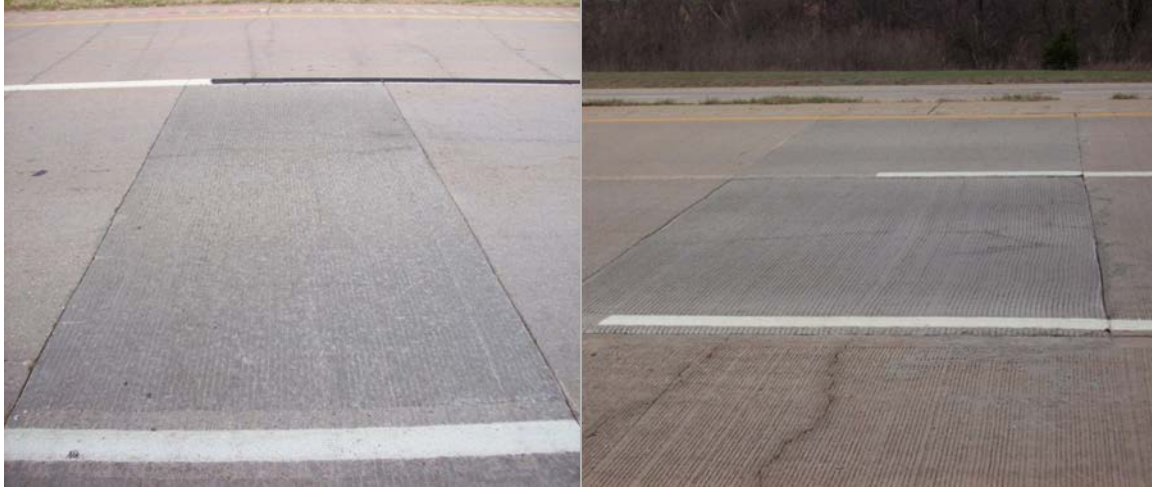
**Figure A.74 Patches with longitudinal cracking**

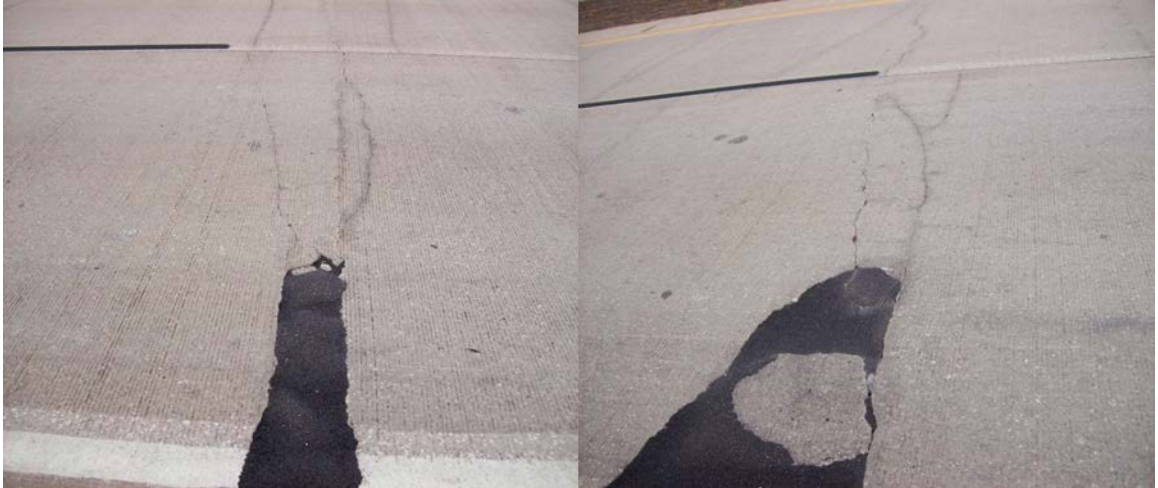
**Figure A.76 Punchouts/ patches forming near Y-cracks**

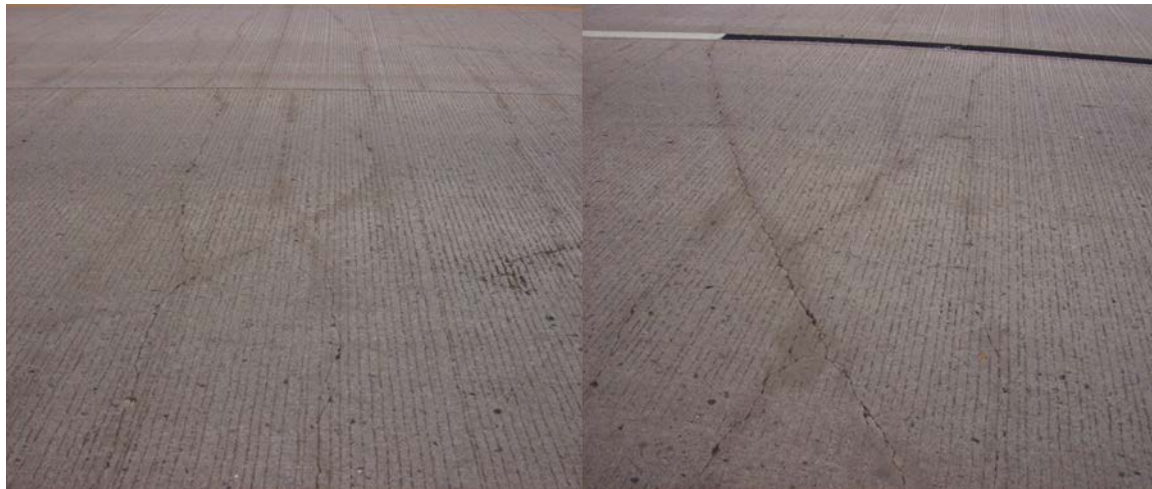
**Figure A.92 Typical Y-cracks seen in the East bound direction**
