pennsylvania
DEPARTMENT OF TRANSPORTATION

Bridge Deck Non-Destructive Evaluation Testing- Advanced Technology for Bridge Asset Management

FINAL REPORT
June 11, 2024

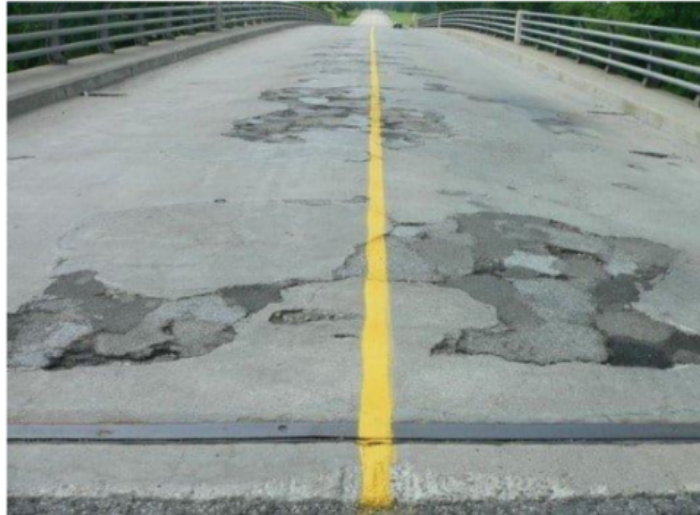
Figure 1 Significant Deterioration in a Concrete Bridge Deck [3]

Concrete bridge deck deterioration can be caused by cracking, scaling, spalling, delamination, alkali-aggregate reaction, sulfate attack, corrosion, and freezing and thawing. Additionally, harsh weather conditions and traffic can contribute to the degradation of bridges. Figure 1 shows a bridge deck with severe deterioration. This damage can eventually lead to irreparable degeneration of the deck as well as damage to the girders and substructure [1], [3].

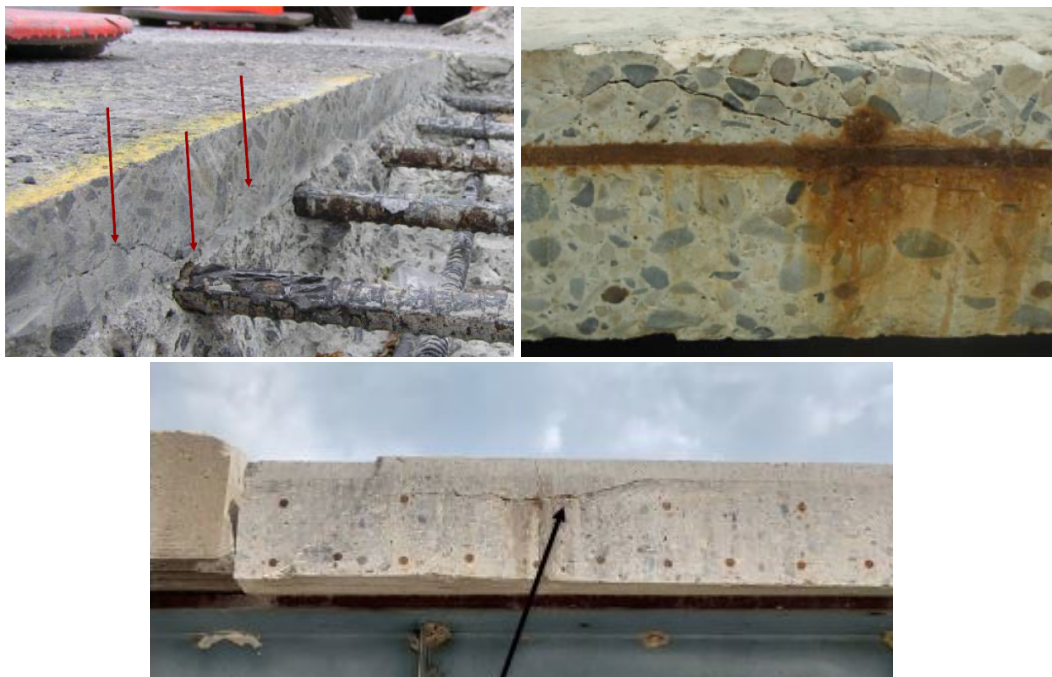
Figure 3 A slab with Naturally Occurring Delamination [6], [7], [8]

Horizontal cracking due to the expansion of corroded rebars is known as delamination, a serious deterioration issue in concrete bridge decks. This expansion can create subsurface cracks within the concrete, which may be confined to a small area or extend over a larger region. Delamination is typically not visible on the concrete surface. If timely repairs are not undertaken, corrosion will persist, causing the delamination to progress into open spalls, ultimately compromising the structural integrity of the deck.

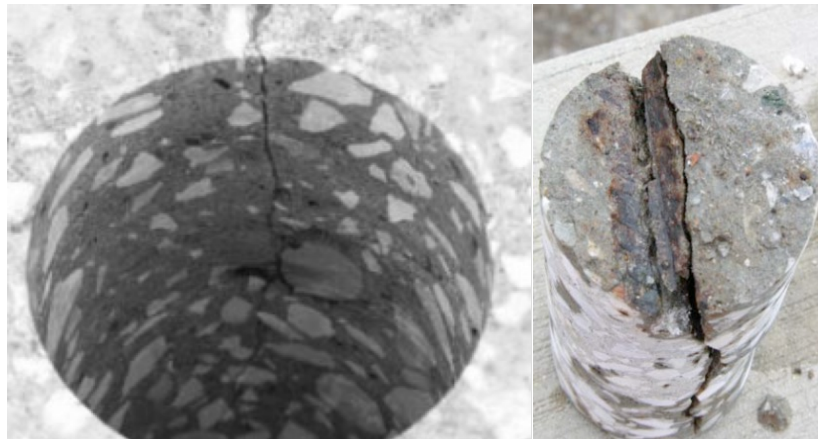
Figure 4 Vertical Cracking [6]

Vertical cracks in bridge decks can result from various factors, including rebar corrosion, plastic shrinkage, heat of hydration, ambient temperature, geometric constraints during concrete curing, traffic load, and cycles of freezing and thawing. These cracks can grow wider as the metal bars continue to rust (Figure 4).

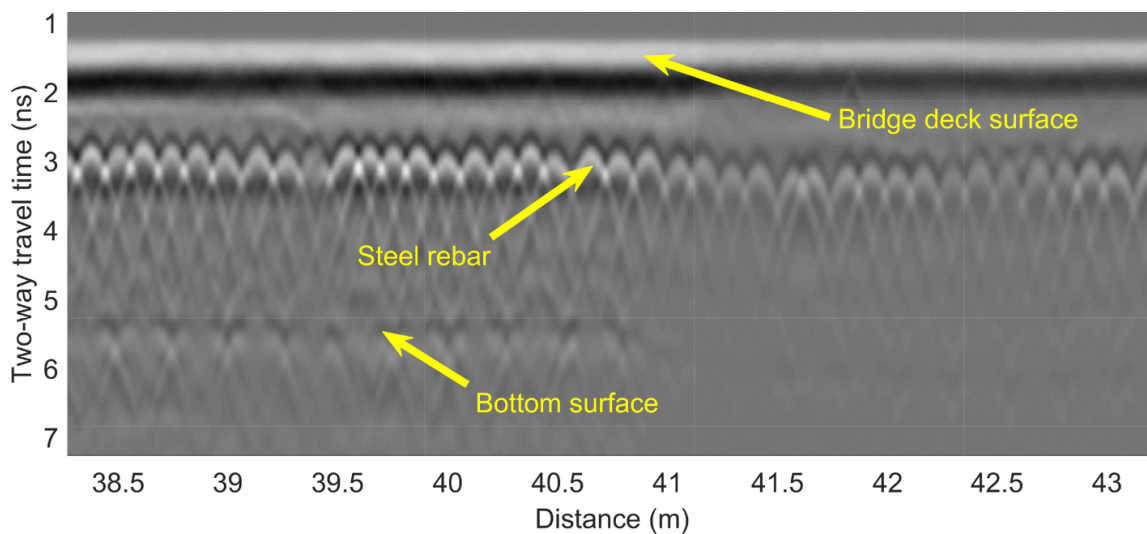
Figure 7 GPR Image of a Concrete Bridge Deck [20]

One of the most widely used electromagnetic techniques is ground penetrating radar (GPR), a recognized non-destructive evaluation technique with many applications. Figure 7 shows GPR image of a concrete bridge deck [17]. GPR provides an electromagnetic wave-reflection survey to assess in-depth characteristics of subsurface layers, including damages, voids, cracks, and corrosion, as well as steel rebar location [18] [19].

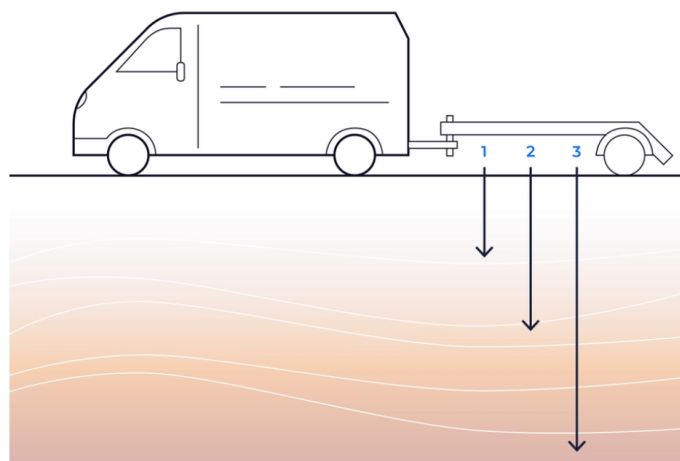
Figure 8 Three Antenna Arrays Sensor [26]

There are three antenna array types which are shown in Figure 8. Type 1 has outstanding resolution at shallow depths, securely records 3D data, and is used at high speeds for road, pavement, and railway inspection. Type 2 features high-resolution, near-surface 3D imaging with deep penetration for shallow and deep underground mapping and object detection, deck assessment, and utility mapping. Type 3 is used for exceptional depth capabilities and 3D imaging in harsh environments for mapping and detecting objects deep underground [26].

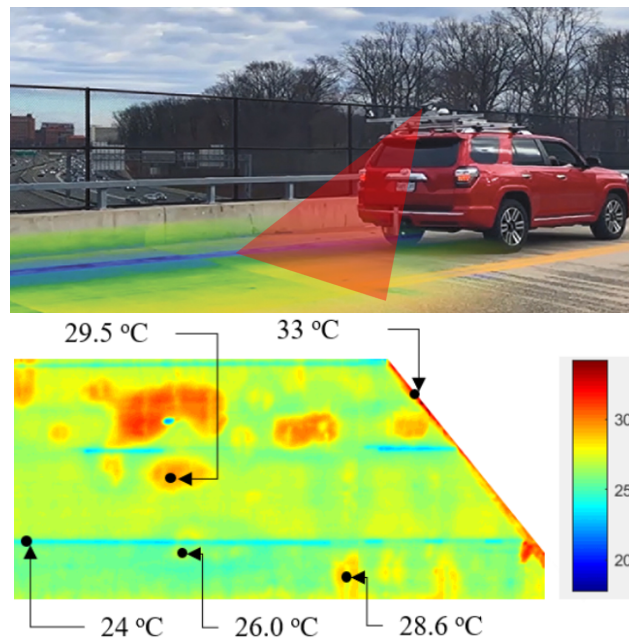
Figure 10 Infrared Thermographic Inspection of Bridge Decks [28], [29]

The principle behind using Infrared Thermography (IRT) for evaluating concrete bridges is based on the fact that subsurface defects, like delamination, interfere with the normal heat transfer through the concrete. During the day, as the sun and ambient heat raise the temperature of the concrete, the areas above these subsurface defects heat up more quickly compared to areas where the concrete remains intact. This results in the delaminated areas appearing as hot spots on the concrete surface when viewed through an infrared camera. Conversely, during the night when the ambient temperature drops, the concrete begins to cool down (Figure 10). The surface areas above the delaminations cool down more rapidly than the intact concrete, making these areas appear as cold spots relative to the undamaged concrete. This thermal behavior allows for the identification of subsurface defects by observing the temperature variations on the surface of the concrete structure. By capturing these thermal images at different times of the day, engineers can accurately pinpoint the locations of delaminations and other defects, facilitating timely maintenance and repairs to ensure the structural integrity of the bridge [27], [2].

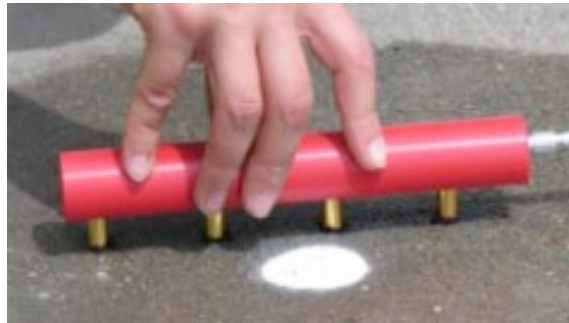
Figure 11 Resistivity Test [6]

There are two primary methods for electro-chemical evaluation in concrete structures: Electro-Resistivity (ER) and Half-Cell Potential (HCP) evaluation. Electro-Resistivity (ER) techniques, as illustrated in Figure 11, are utilized to detect moisture content and structural defects such as cracks. The moisture level in concrete is a critical indicator of its corrosion state, as electrical conduction within concrete predominantly occurs through electrolytic current flow via the open pore system. In regions where the concrete is damaged or cracked, increased porosity creates preferred pathways for fluid and ion movement, exacerbating corrosion processes. Thus, areas with higher electrical resistivity indicate lower corrosion currents passing between the anodic and cathodic zones of the reinforcing steel, suggesting better structural integrity and less corrosion activity [2].

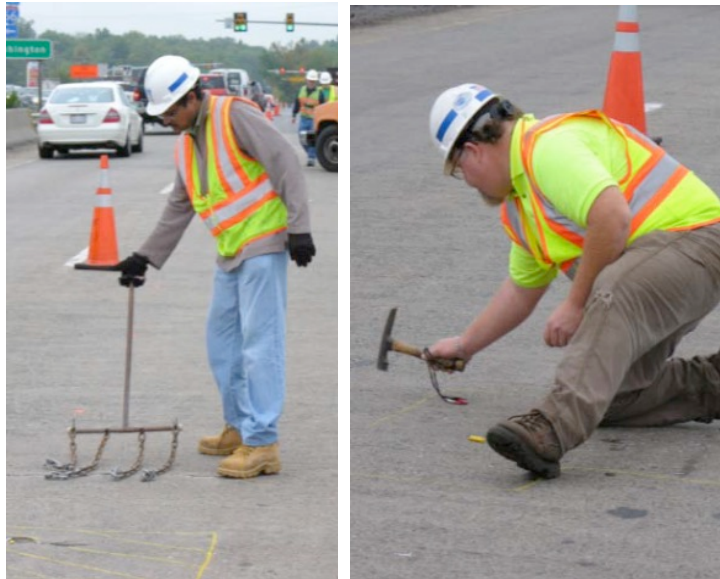
Figure 13 Chain Dragging and Hammer Sounding Technique [6]

Two major factors in concrete bridge damage are delamination and spalling. In these methods, which are the most frequent inspection procedures utilized by transportation agencies and other bridge owners for detecting delamination in concrete bridge decks, the inspector sets up the deck surfaces to grids, i.e., 5 ft by 5 ft. Then drags several lengths of heavy chain over the concrete surface of the entire bridge deck or hits it with a hammer. The sound changes from a clear ringing sound (sound deck) to a somewhat muted or hollow sound (delaminated deck), allowing for mapping the deck condition. Whenever a dull or hollow sound is heard, the area is outlined as damaged by marking this section with paint. These areas are marked and mapped for further evaluation (Figure 13). At the end of the test, the marked areas can be transferred to electronic format [32], [17].

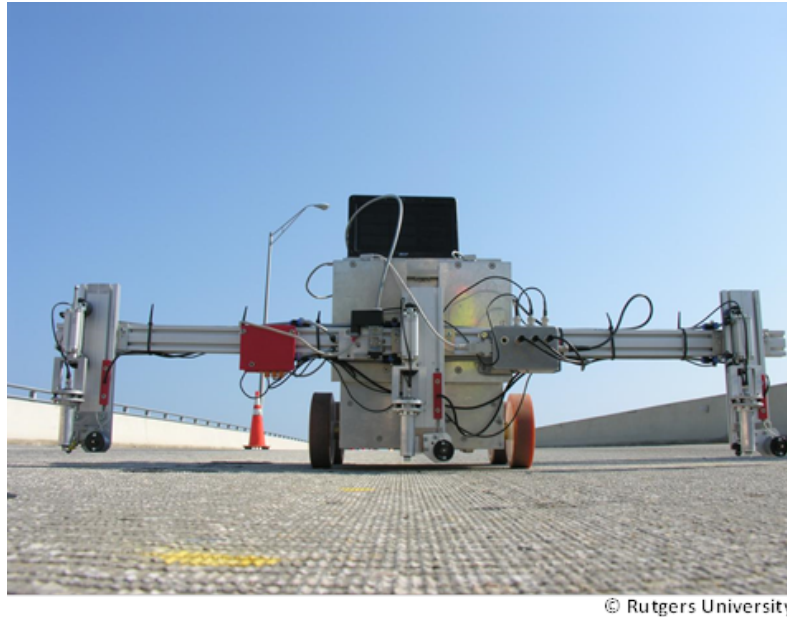
Figure 14 Impact Echo Equipment [39]

The Ultrasonic Pulse Echo (UPE) method is primarily used for detecting defects in concrete, with a particular focus on delamination. This method operates on the principle of striking the surface of the tested object with a low-frequency stress wave and measuring the response at a nearby location (Figure 14). By analyzing the frequency spectrum of the deck's response to an impact, the positions of reflectors, such as voids and delaminations in the concrete, can be identified. In a sound deck, the dominant reflector is typically found at the bottom of the deck, where there is a significant contrast in acoustic impedance between the concrete and the air. However, delaminated areas are detected as shallow reflectors. Other potential reflectors include voids, tendons, and supporting structural elements. Each NDT method, including UPE, has its own capabilities, drawbacks, limitations, and associated uncertainties in measurement and costs. For instance, while UPE can provide detailed information about internal defects, it is time-consuming and requires precise probe coupling on the surface. Additionally, the accuracy of UPE can be affected by various factors such as wave attenuation and surface roughness. To enhance evaluation and interpretation, some methods can be integrated (data fusion), combining their strengths to achieve more comprehensive assessments. Therefore, these methods should be strategically deployed based on the specific requirements and conditions of the inspection task [2].

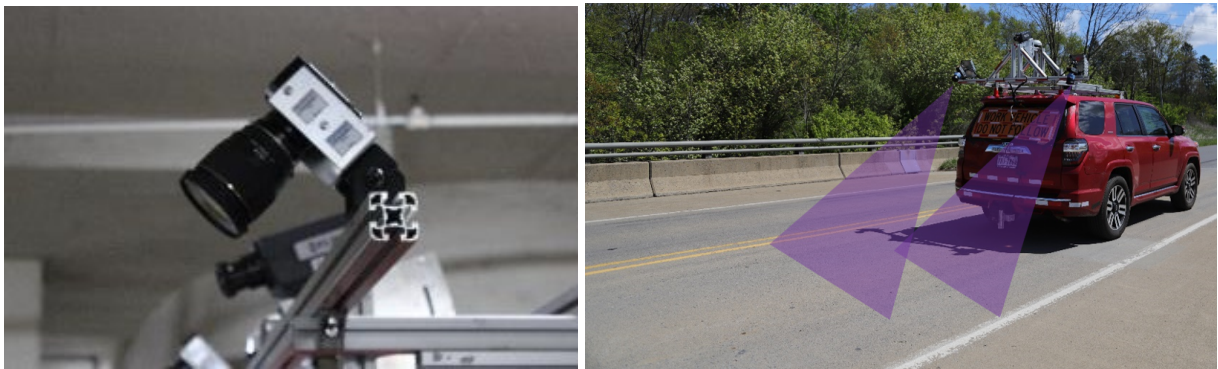
Figure 27 High Definition (HD) Visual Inspection [28]

The high-speed images obtained from bridges provided a high-resolution representation of the bridge surface, showing various surface features as well as the surface cracks. Visual digital images of the four bridges analyzed in Kuraves-Actis and AutoCAD software were combined to draw the existing cracks of each bridge. The results of surface imaging provided by both third-party companies for the four bridges are as follow:

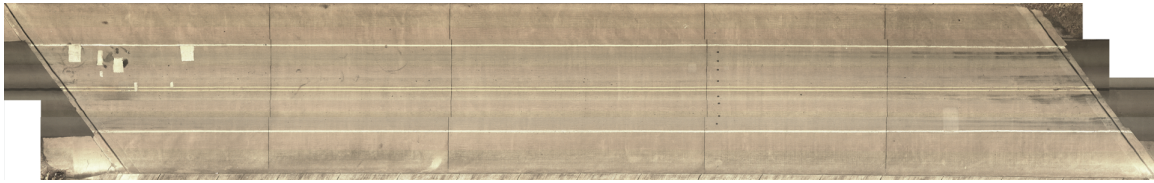
Figure 31 Overall View Images of Bridge Deck No. 22451

Figure 31 shows the digital imaging of bridge No. 22451:

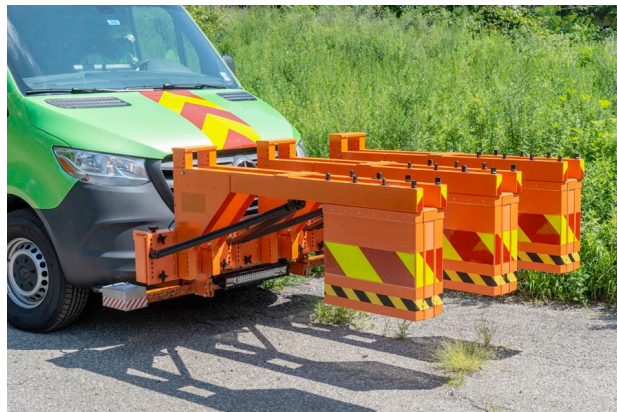
Figure 32 Ground Penetrating Radar System [40]

The technique provides images of the subsurface by using the electromagnetic spectrum in the microwave range between 10 MHz and 2.6 GHz. These signals are transmitted through the ground and reflect off subsurface structures based on their electrical permittivity. A receiving antenna records variations in the return signals, which the GPR device uses to generate images that generally indicate changes in electrical properties. GPR signals can be used to find a wide range of items, and this subsurface tool is most effective when there is a large difference between the electromagnetic property of the target and surrounding material. GPR device can be used to find corrosion, moisture, debonding, voids, and delamination. Figure 32 shows the GPR system used by Infratek Solutions Inc.

The GPR data was collected by NEXCO's partner¹ using a mobile ground-coupled antenna manufactured by Kontur (formerly 3D-Radar), the DXG1820 model. The system uses Step-Frequency SF Radar Technology, which utilizes a radar waveform that comprises a sequence of sine waves that progressively increase in frequency. Step frequency ground penetrating radar (SF-GPR) is a type of ground penetrating radar (GPR) that uses a stepped frequency signal to transmit electromagnetic

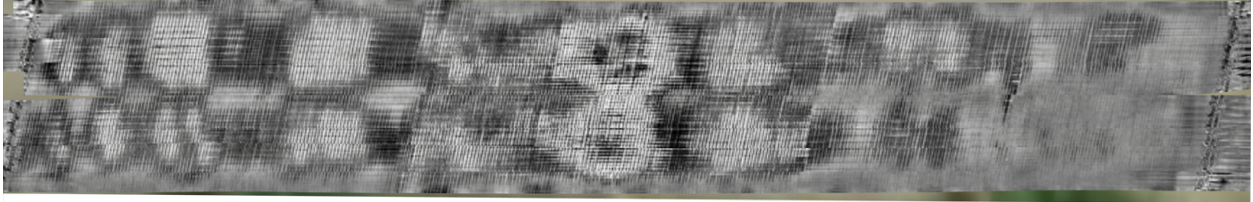
Figure 36 GPR Image Showing Top Steel Condition of Bridge Deck No. 22266

Figure 36 to Figure 38 show the top steel, bellow top steel condition, and cover thickness of the bridge deck No. 22266.

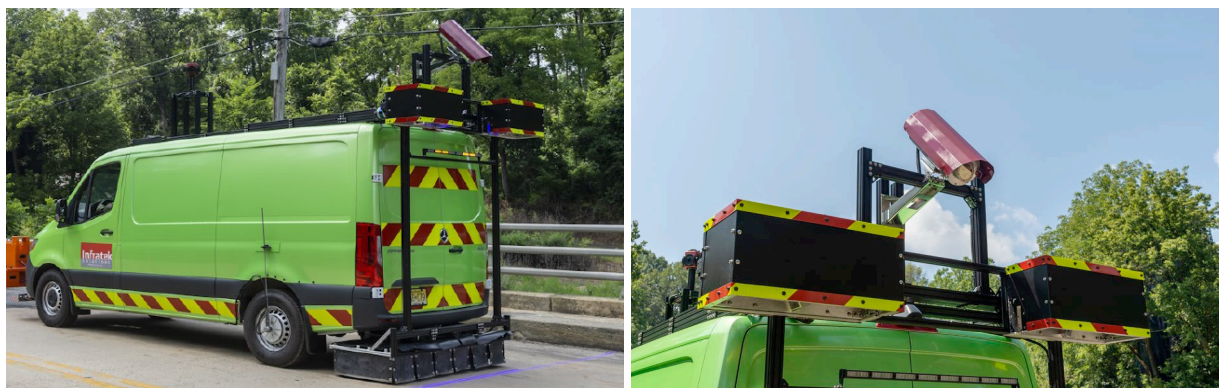
Figure 48 High Speed (HS) System Include Infrared Thermography (IRT) [40]

For IRT images, Infratek used a High Speed (HS) System, as shown in Figure 48.

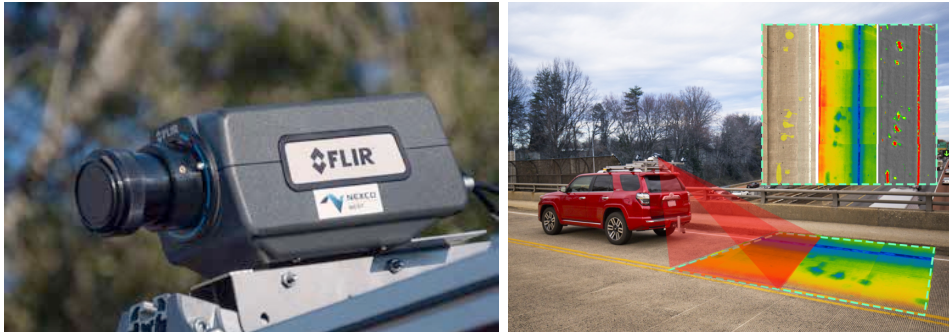
Figure 49 FLIR A6701sc Camera [43] and Deck Top Scanning System (DTSS) Include Infrared Thermography (IRT) [28] [44]

NEXCO used Deck Top Scanning System (DTSS) which is a high-speed data collection system (Figure 49). This system includes FLIR A6701sc infrared camera, a GPS unit, and a speedometer unit. Combined, these sensors identify sub-surface defects on roadways and bridge decks [28].

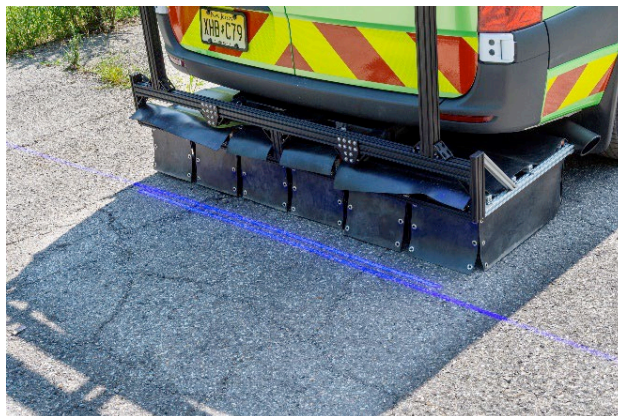
Figure 57 High Speed Sounding (Chain Dragging) [40]

Infratek used High-Speed Sounding (Chain Dragging) for the detection top cover dimension (Figure 57). When the chain passes over a delaminated area, where the top layer of concrete has separated from the underlying layers, the sound changes. This change is usually a hollow or duller sound compared to the crisp ring produced by intact concrete. The sound test was also done by PennDOT's Engineering District 11.

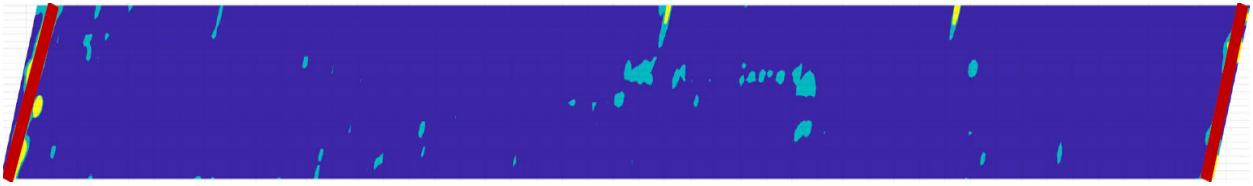
Figure 58 Contour Map of Sound Test of Bridge Deck No. 22266

Figure 58 shows the deck sounding result of the bridge deck No. 22266.

PennDOT's engineering district 11 reported no delamination found in bridge deck No. 22266.

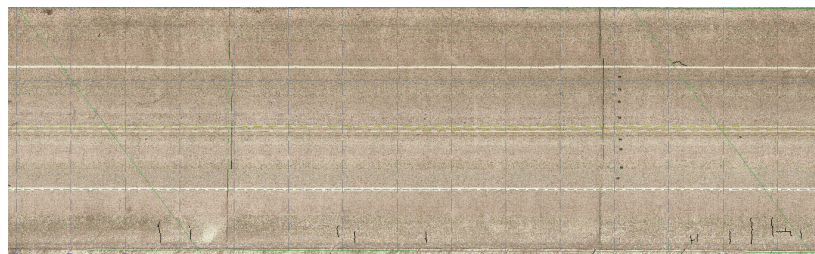
Figure 79 Existing Cracks on Bridge Deck No. 22451-Span 2

Figure 77 to Figure 80 show existing cracks of bridge deck No. 22451:

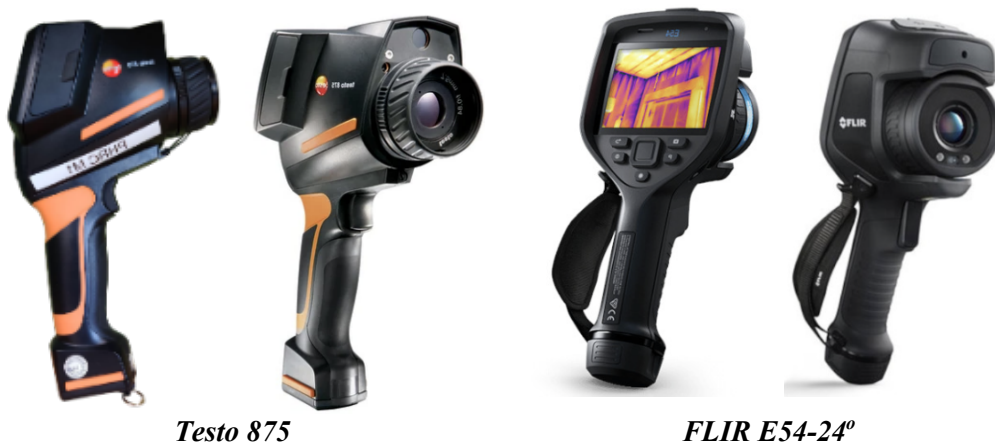
Figure 106 Testo 875 High-Resolution Thermal Imager

- IR Resolution: 160×120 pixels - While this resolution is lower than that of the FLIR E54-24, it remains effective for identifying significant thermal anomalies across the concrete specimens.
- Image Frequency: 30 Hz - Similar to the FLIR camera, this frequency supports the capture of fluid thermal videos, aiding in dynamic analysis.
- Thermal Sensitivity: < 50 mK @ 30°C (86°F) - This sensitivity level, though slightly lower than that of the FLIR E54-24°, still permits the detection of minor temperature variations that could indicate the presence of defects.
