**SCHOOL OF CIVIL AND  
ENVIRONMENTAL ENGINEERING  
OKLAHOMA STATE UNIVERSITY**

**INTERIM REPORT  
NO. 1:  
FIELD TESTS, ANALYSES,  
AND LABORATORY TESTS**

**FATIGUE ASSESSMENT OF BRIDGE MEMBERS  
BASED ON IN-SERVICE STRESSES**

**Report No. FHWA\OK-95(07)**

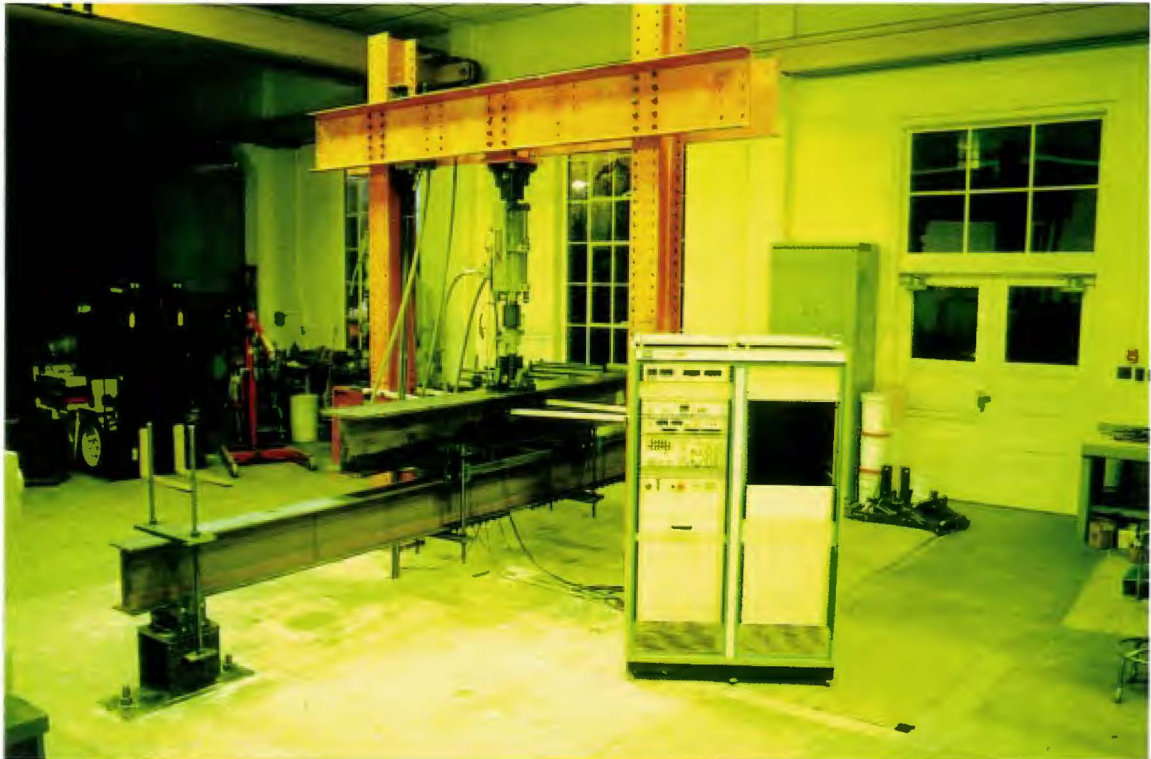
Figure 70. Test Setup

Before beginning the fatigue test on each specimen, a static load test was performed. These tests were performed while monitoring the strain gages along the tension flange of each specimen. For each static load test, the load was increased by increments of 5 to 10 kips up to a peak value. Once the peak value was reached, the load was decreased by increments of 5 to 10 kips. Strains were recorded for each increment of load and the corresponding stresses were calculated. To determine if the test specimen was properly aligned, the actual stresses occurring in the test specimen were compared to theoretical stresses, and the strains occurring on each side of the tension flange were compared to each other. If improper alignment was suspected, the test specimen was simply adjusted until favorable strains were measured.

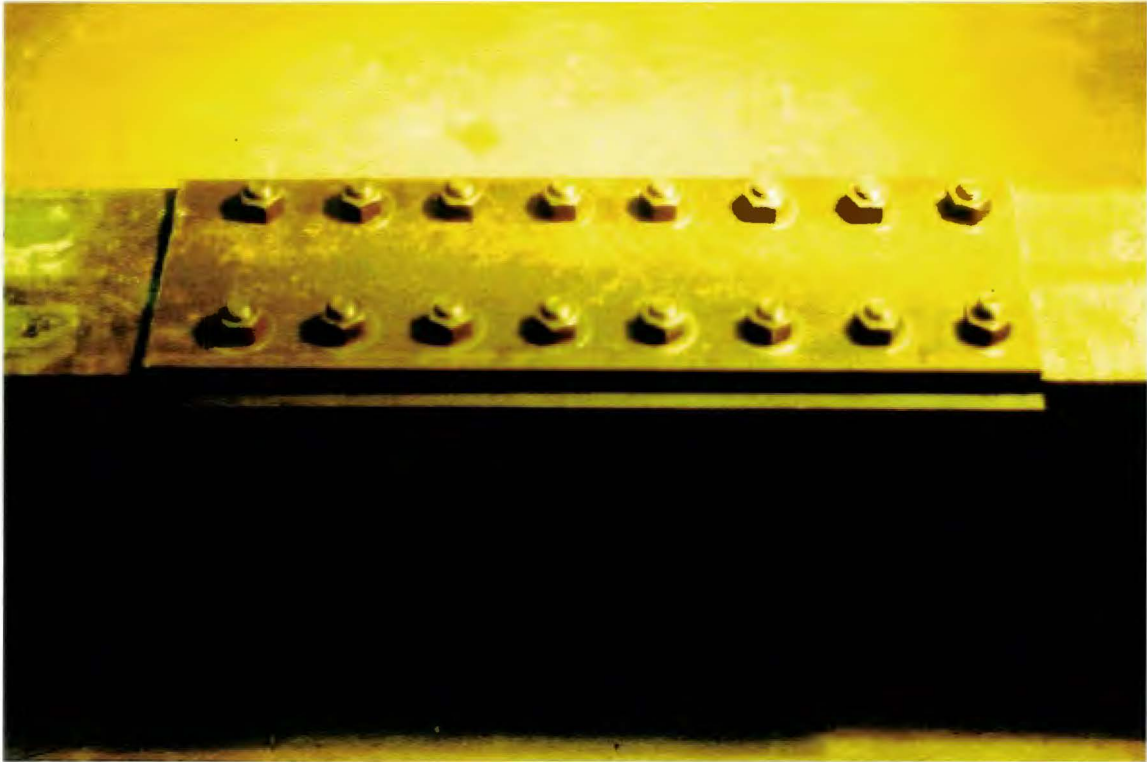
Figure 71. Splice Plate Detail

After failure, the cracked flange was repaired so that fatigue testing could be continued to obtain cracks at other stiffener locations. The repairs were accomplished by splicing across the cracked region. Splice plates with a thickness of 3/8-in. were bolted above and below the tension flange with 3/4-in. diameter A325 bolts. The bolts were accommodated by drilling holes through the tension flange and splice plates. Because of the nature of the fatigue loading, the splice plate details were designed as slip-critical connections requiring several bolts on each side of a crack. A typical splice plate detail is shown in Figure 71.
