1. Report No. ABC-UTC-2016-C6-FIU02-Final	2. Government Accession No.	3. Recipient's Catalog No.	
4. Title and Subtitle Comprehending the Structural Performance and Examining Potential Field Applications of Sileto, as a New Material		5. Report Date February 2026

Comprehending the Structural Performance and Examining Potential Field Applications of Sileto, as a New Material

Final Report

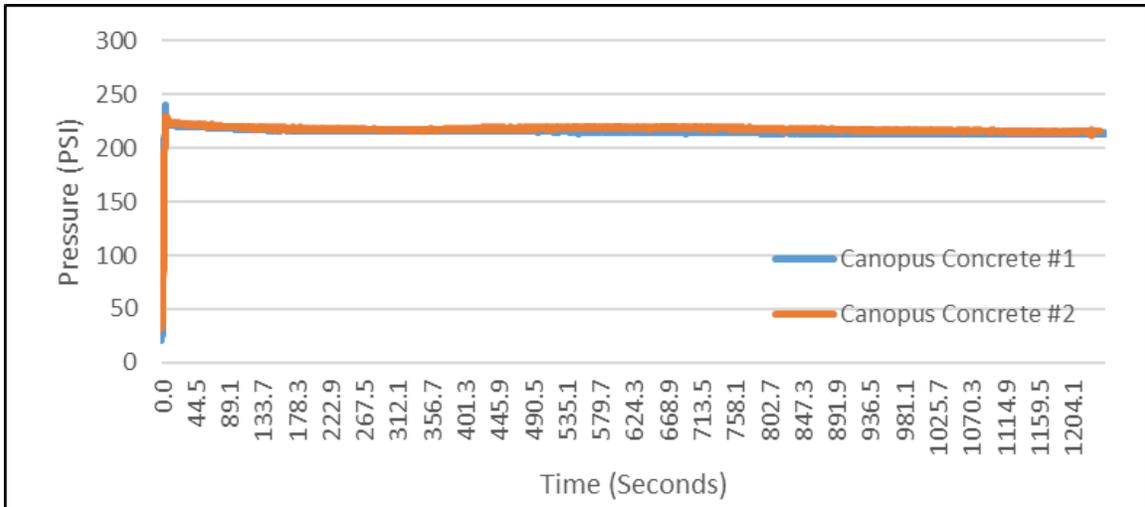
Figure 1 and Figure 2 show results of these tests for sileto materials. These results are in terms of applied pressure versus time. In this test the test cylinder made of Silto, on one end is subjected to water at a high pressure and pressure versus time is monitored. Ingress of water into test cylinder causes drop in the water pressure. Retaining the water pressure is an indication that material is durable, as water does not ingress into the test cylinder. In the tests, pressure was increased to about 250 psi and drop in pressure versus time is observed, as indicated in Figure 1 and Figure 2. More durable the material, the more steady the pressure versus time response is, after pressure reach its pick value. Figure 3 shows results of same tests on normal strength concrete and UHPC.

Figure 1. Durability test results for Sileto material (Canopus)

As observed from Figure 1 through Figure 3, Results of tests conducted on Sileto test cylinders are close to results obtained on UHPC and better than what is observed with normal strength concrete. As a result, it can be concluded that the preliminary work indicates that Sileto is a very durable material.

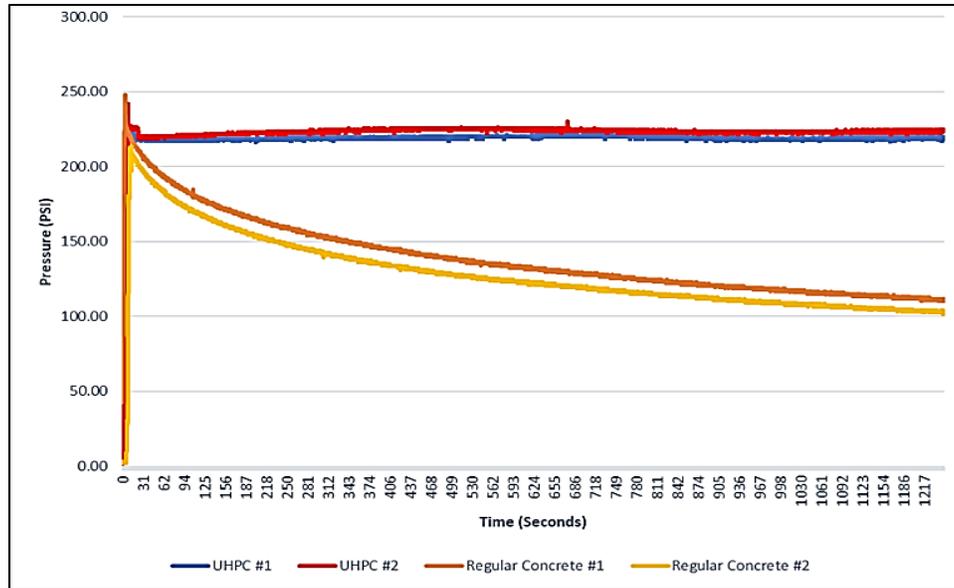
Figure 3. Durability test results for normal strength concrete and UHPC

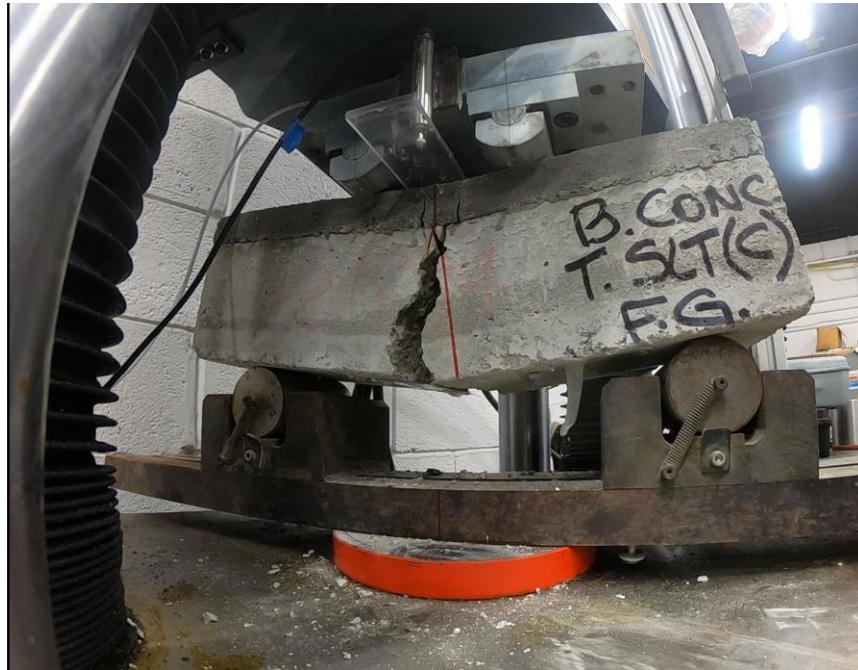
Failure Mode: Flexural Failure

Max Bending Moment Capacity: 719.7 N.M

Figure 6. Specimen #2 Failure

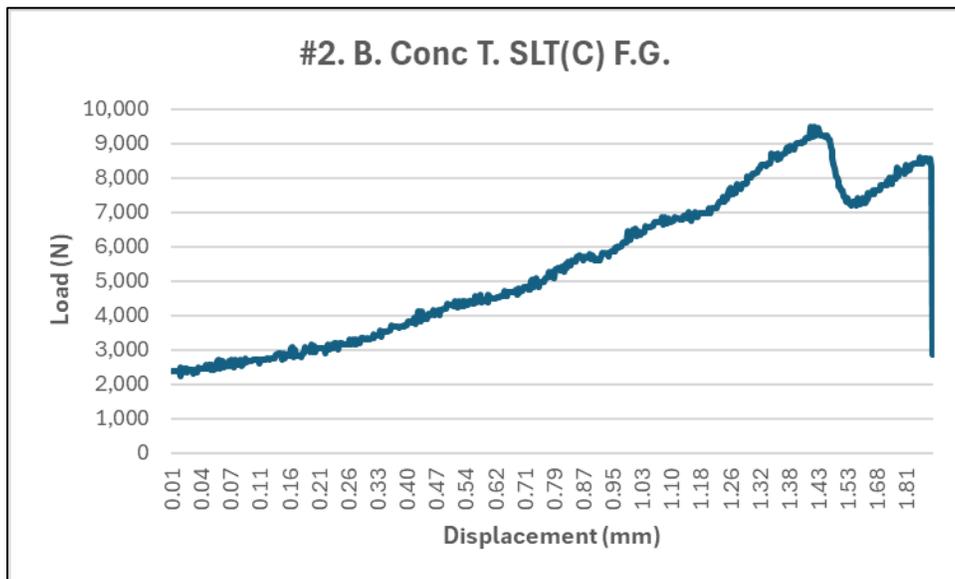
Max Load: 9,470 N

Figure 7. Specimen #2 Results

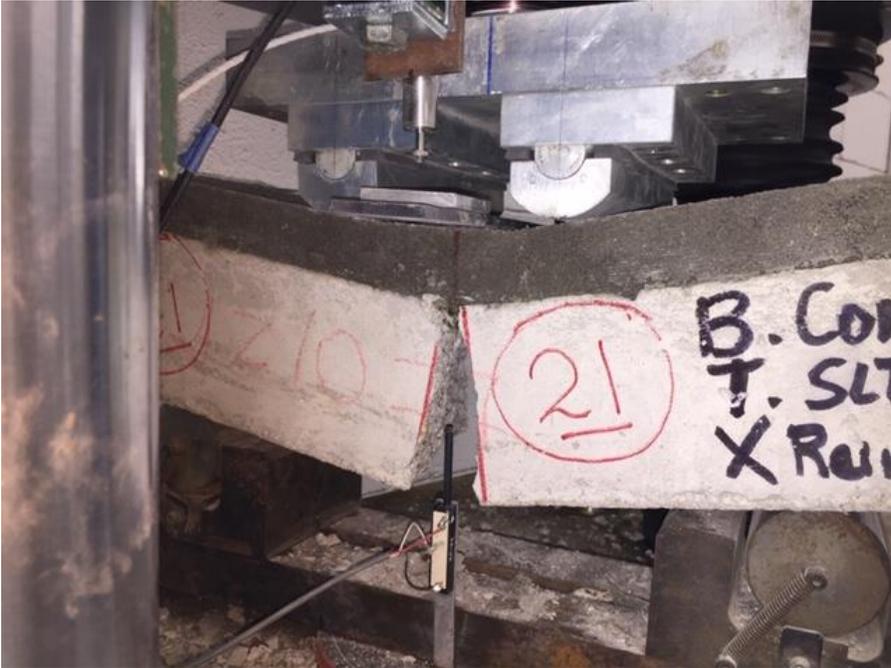
Failure Mode: Flexural Failure

Max Bending Moment Capacity: 1314.8 N.M

Figure 8. Specimen #21 Failure

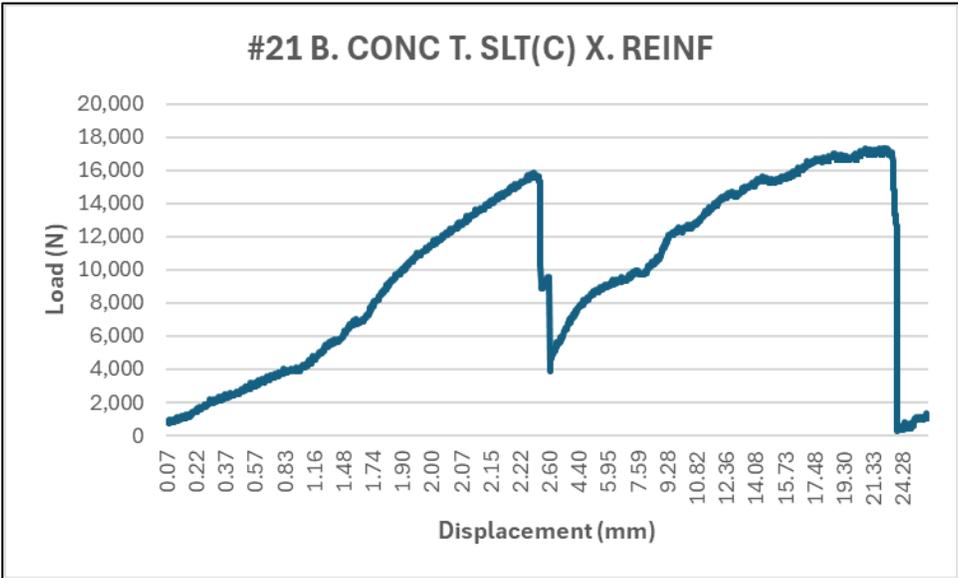
Figure 9. Specimen #21 Results

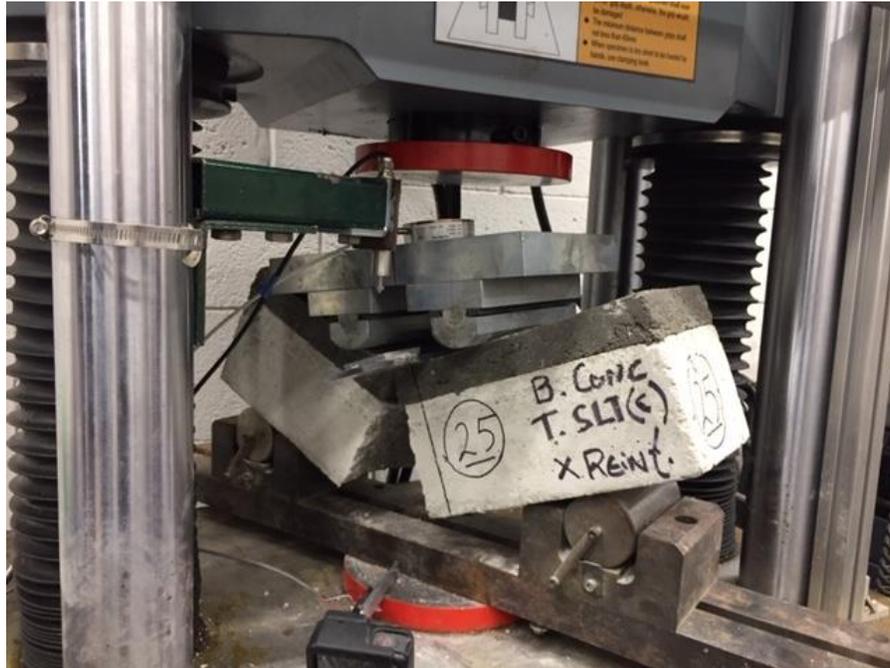
Failure Mode: Flexural Failure

Max Bending Moment Capacity: 961.2 N.M

Figure 10. Specimen #25 Failure

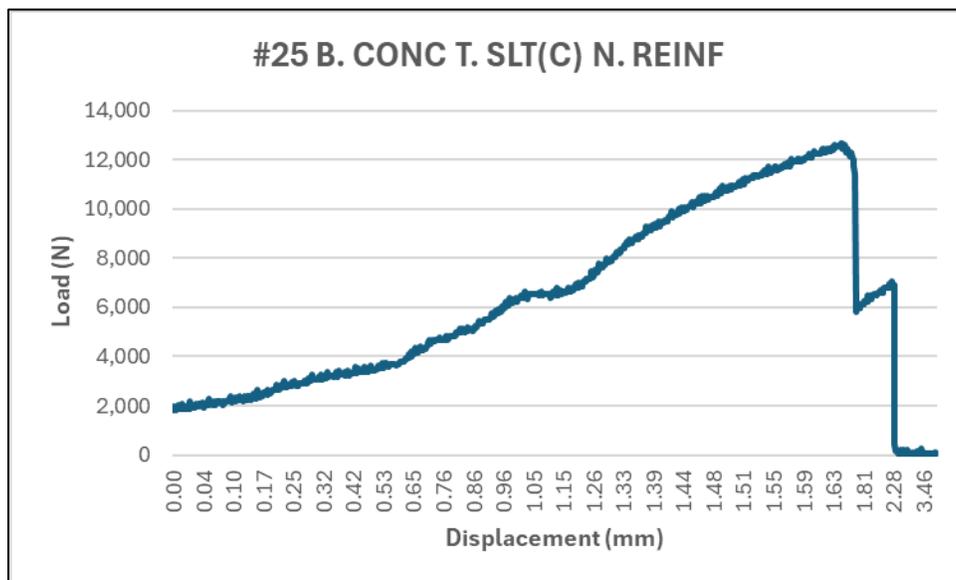
Figure 11. Specimen #25 Results

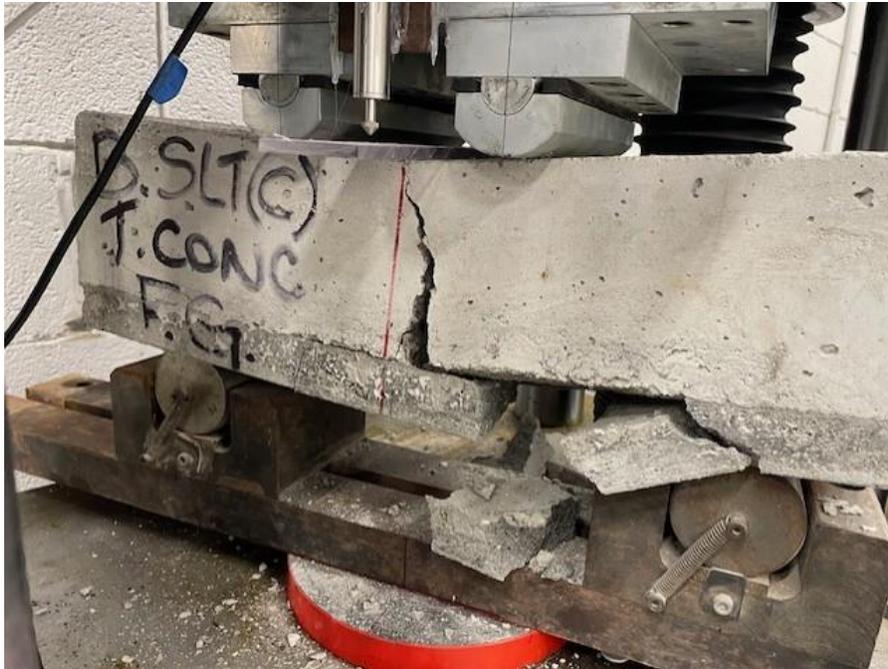
Failure Mode: Flexural Failure

Max Bending Moment Capacity: 4093.6 N.M

Figure 12. Specimen #3 Failure

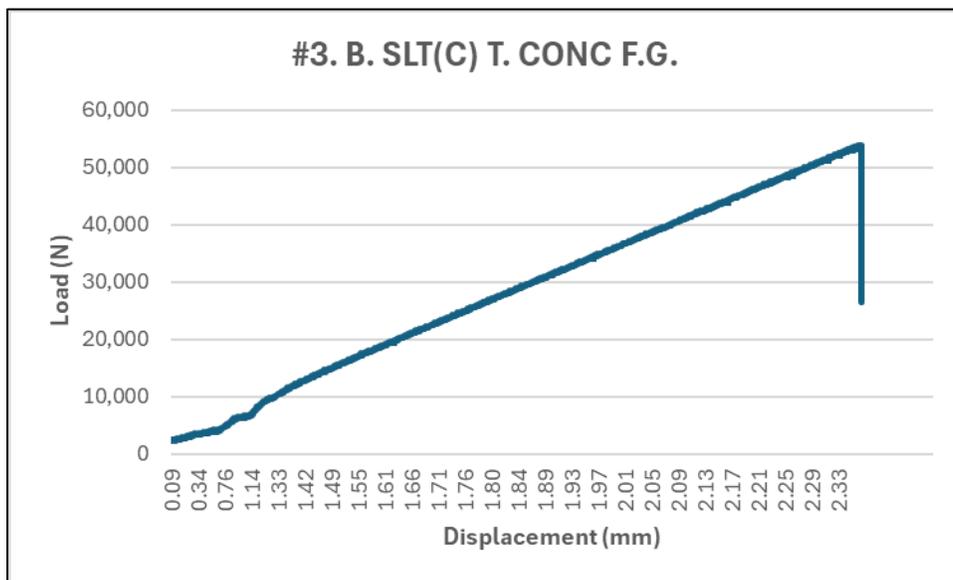
Figure 13. Specimen #3 Results

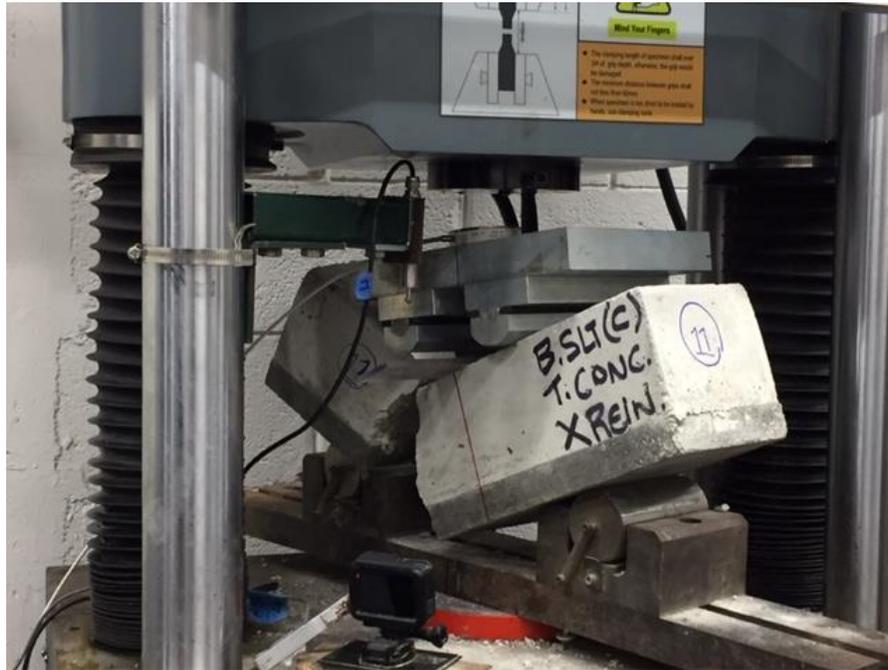
Failure Mode: Moment-Shear Failure

Max Shear Capacity: 31468.5 N

Figure 14. Specimen #11 Failure

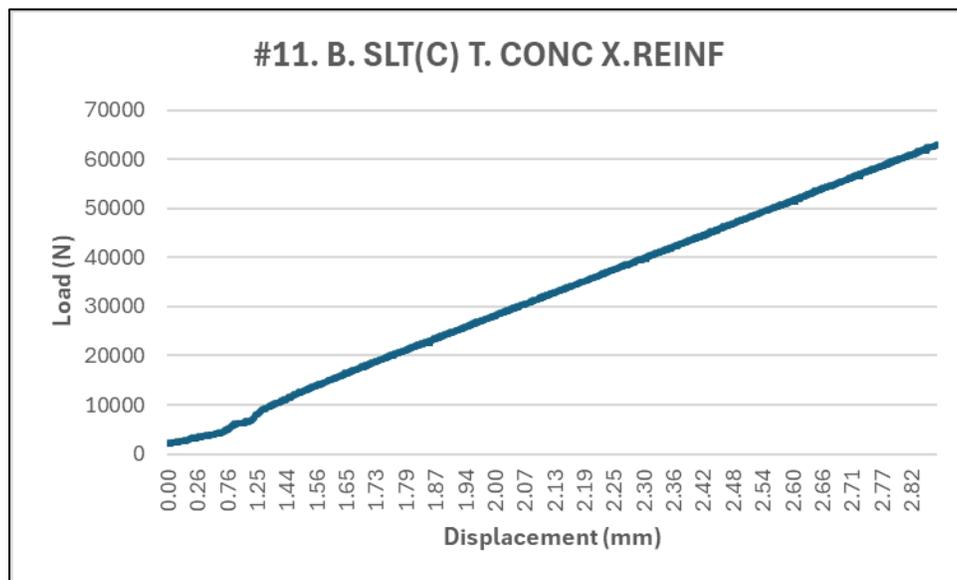
Figure 15. Specimen #11 Results

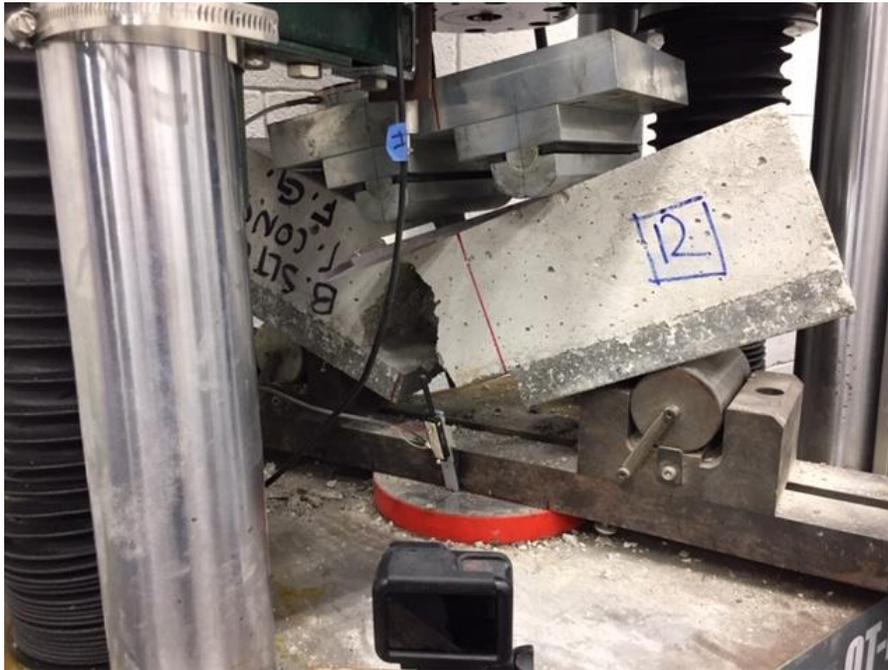
Failure Mode: Flexural Failure

Max Bending Moment Capacity: 4909.8 N.M

Figure 16. Specimen #12 Failure

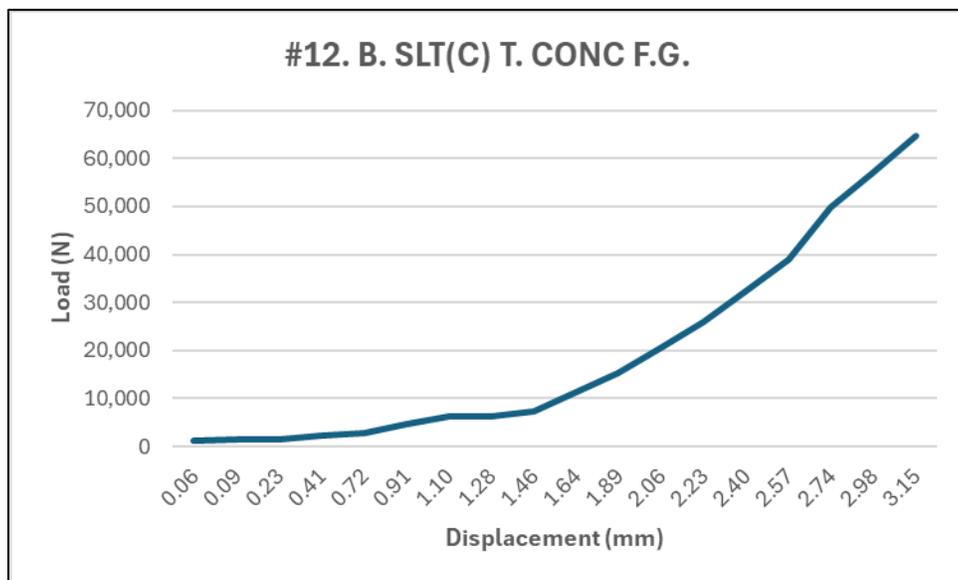
Figure 17. Specimen #12 Results

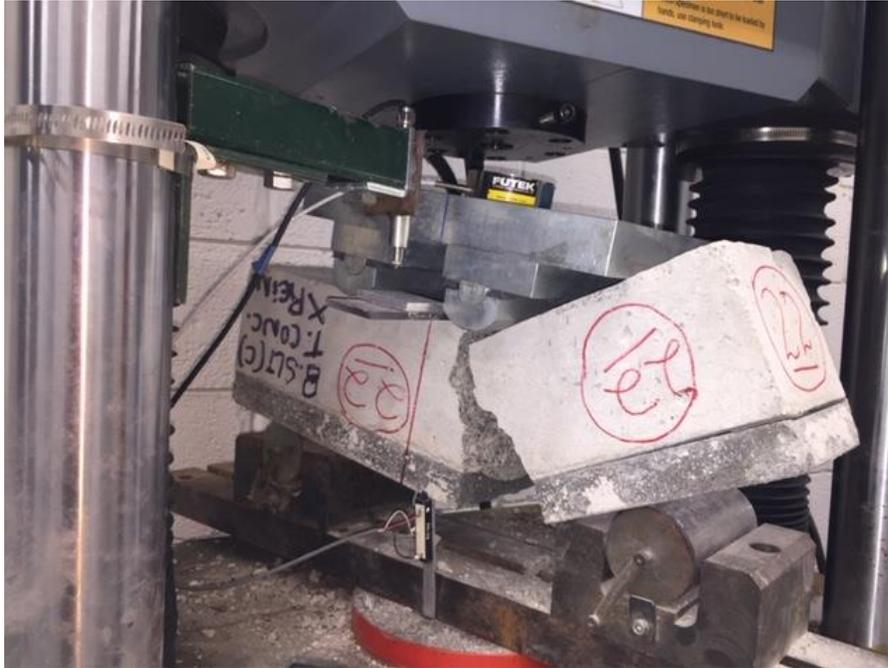
Failure Mode: Flexural Failure

Max Bending Moment Capacity: 3753.9 N.M

Figure 18. Specimen #22 Failure

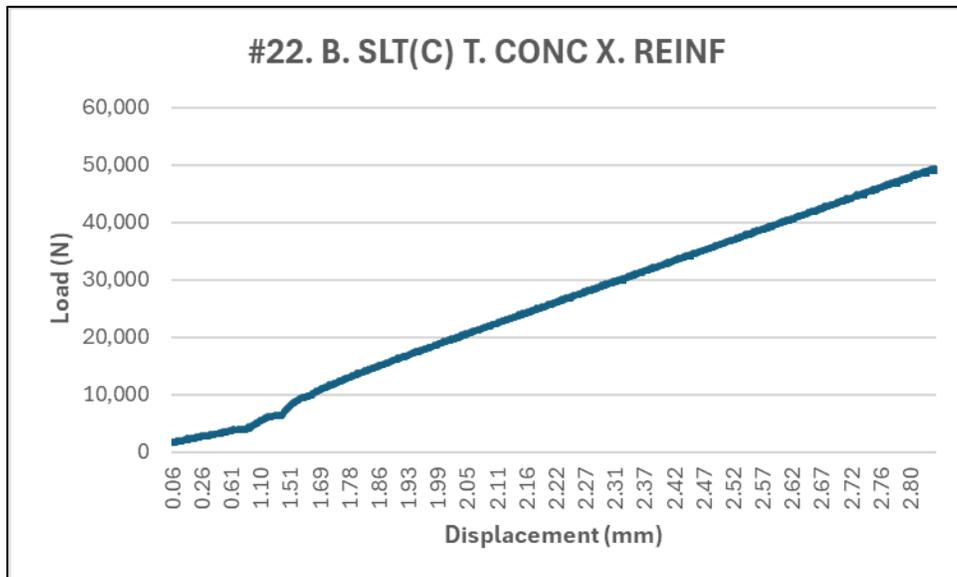
Figure 19. Specimen #22 Results

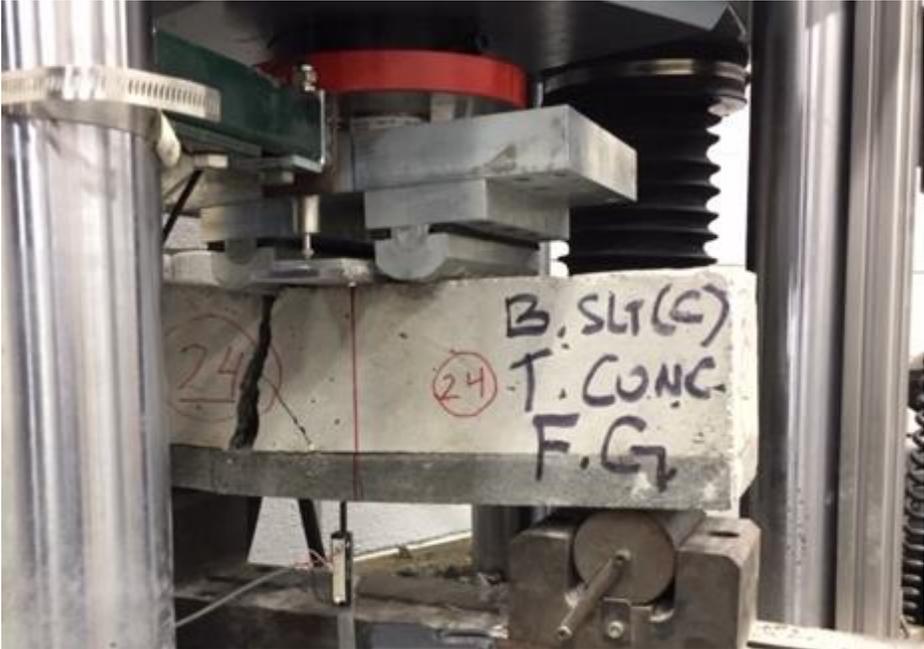
Failure Mode: Shear Moment Failure

Max Shear Capacity: 23900 N.M

Figure 20. Specimen #24 Failure

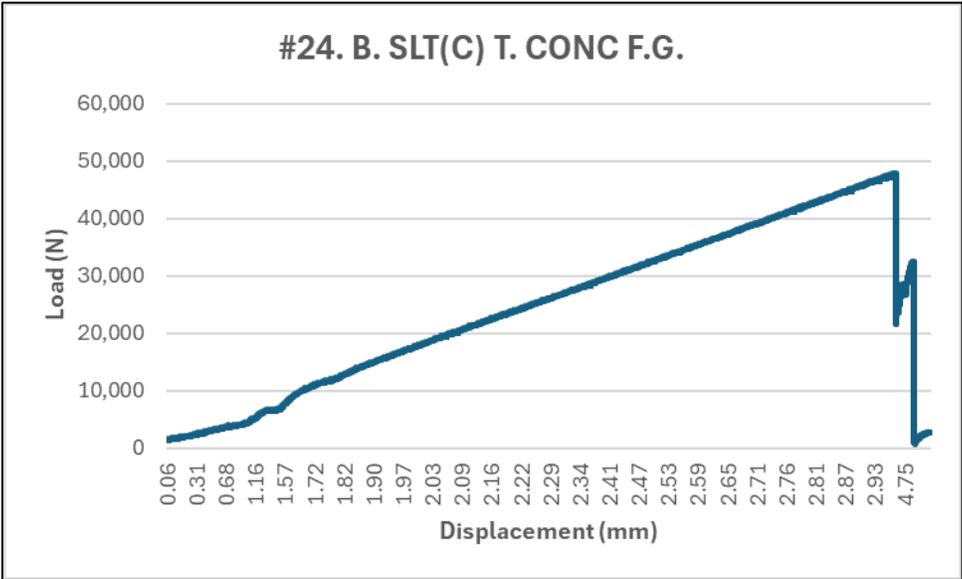
Figure 21. Specimen #24 Results

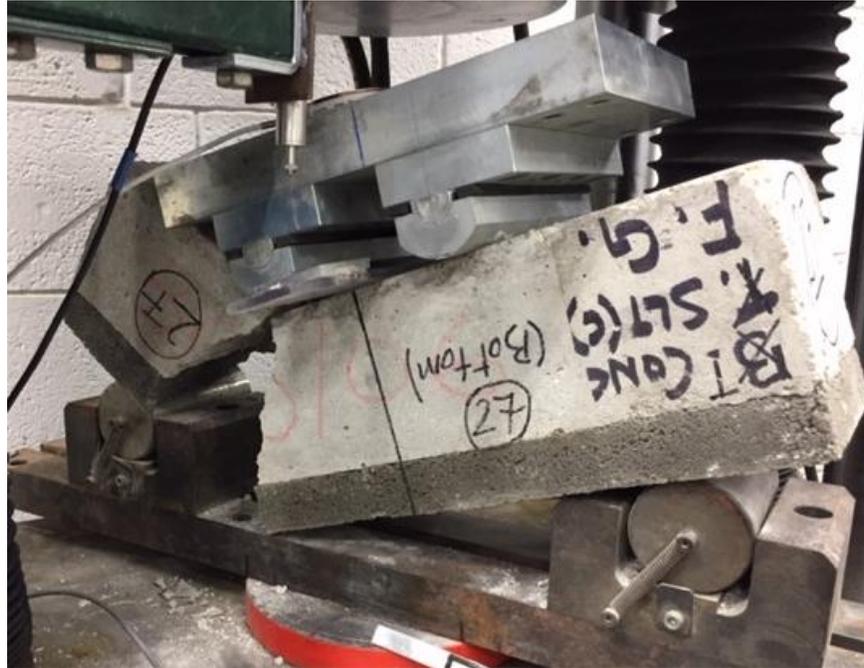
Failure Mode: Shear Moment Failure

Max Shear Capacity: 16916.5 N

Figure 22. Specimen #27 Failure

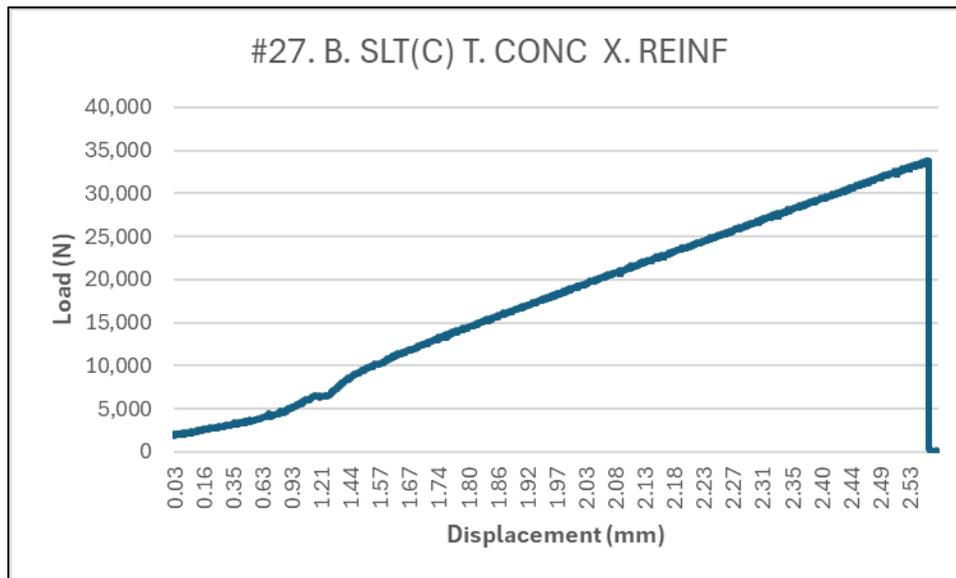
Figure 23. Specimen #27 Results

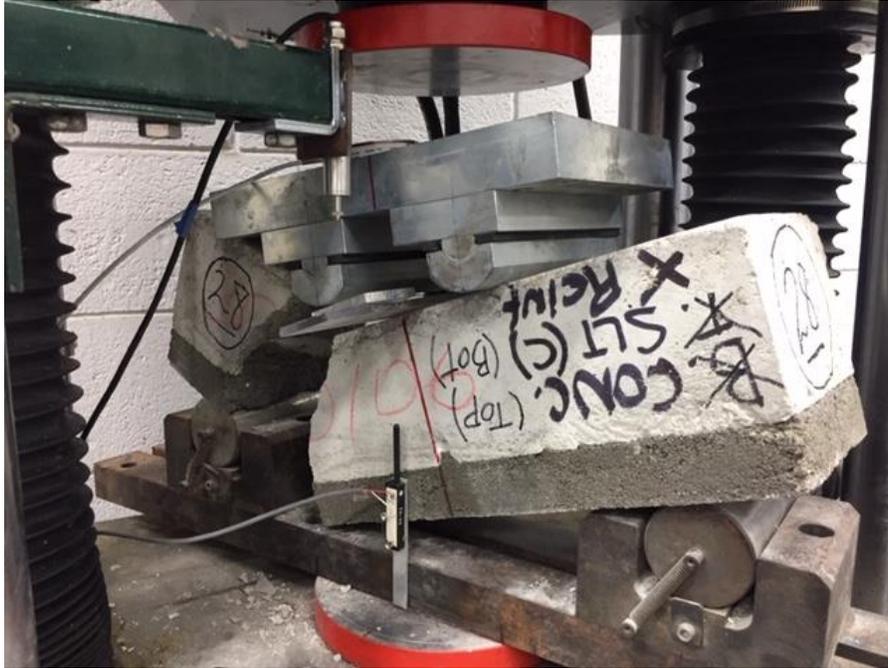
Failure Mode: Shear Moment Failure

Max Shear Capacity: 15181.5 N

Figure 24. Specimen #28 Failure

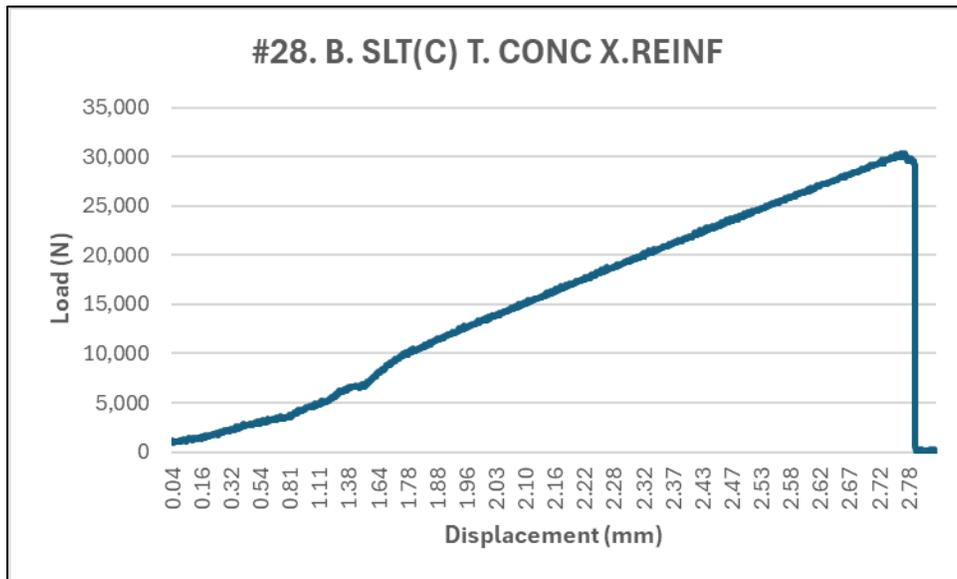
Figure 25. Specimen #28 Results

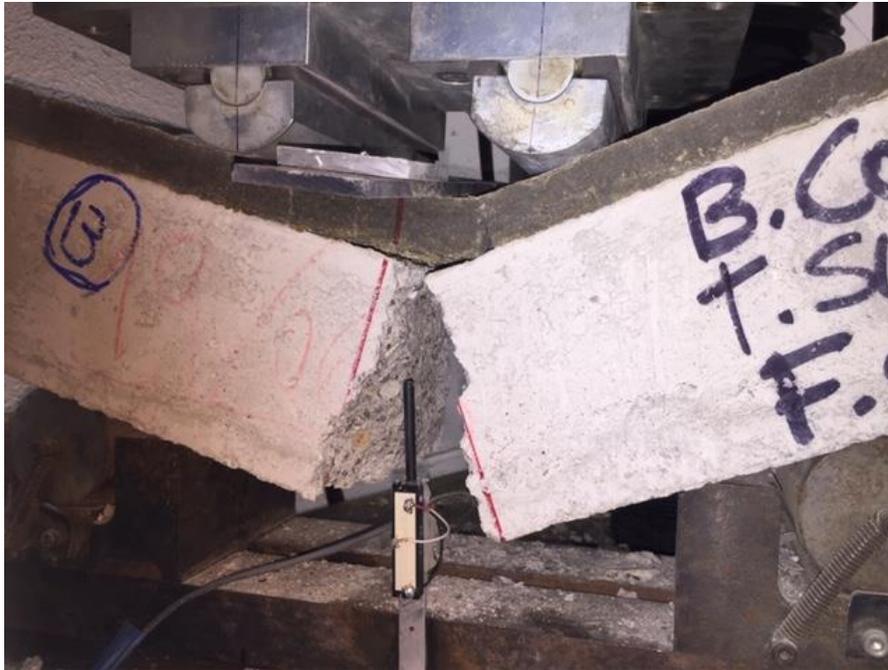
Failure Mode: Flexure Failure

Max Bending Moment Capacity: 1014.1 N.M

Figure 26. Specimen #13 Failure

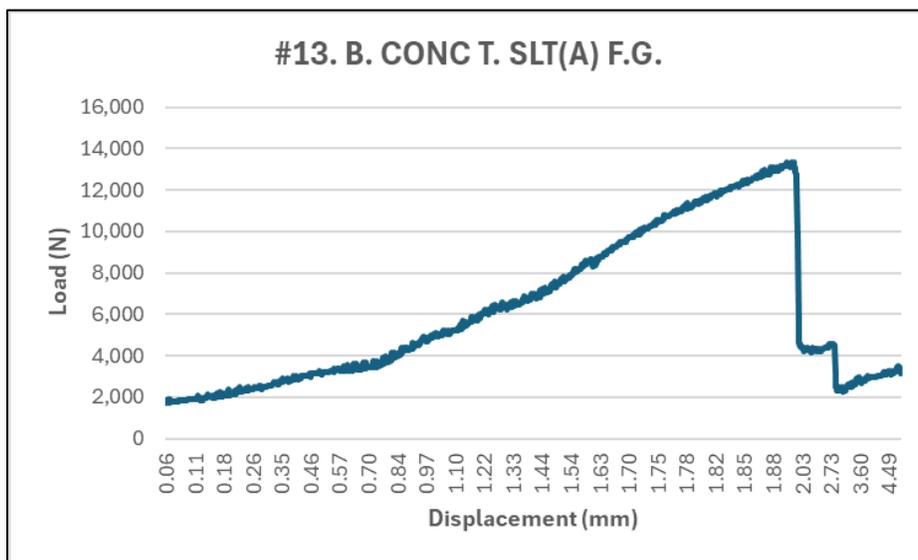
Figure 27. Specimen #13 Results

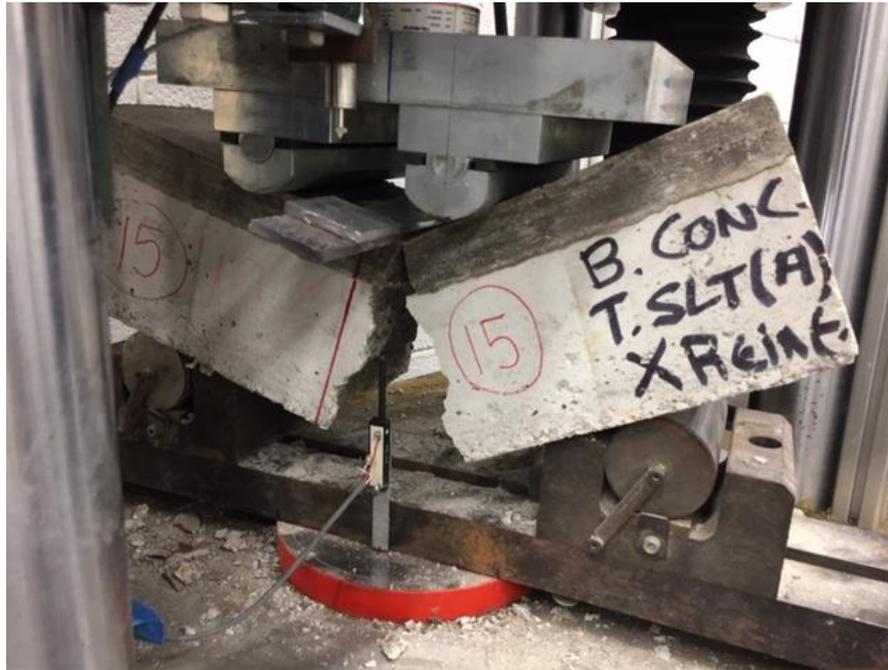
Failure Mode: Flexure Failure

Max Bending Moment Capacity: 596.8 N.M

Figure 28. Specimen #15 Failure

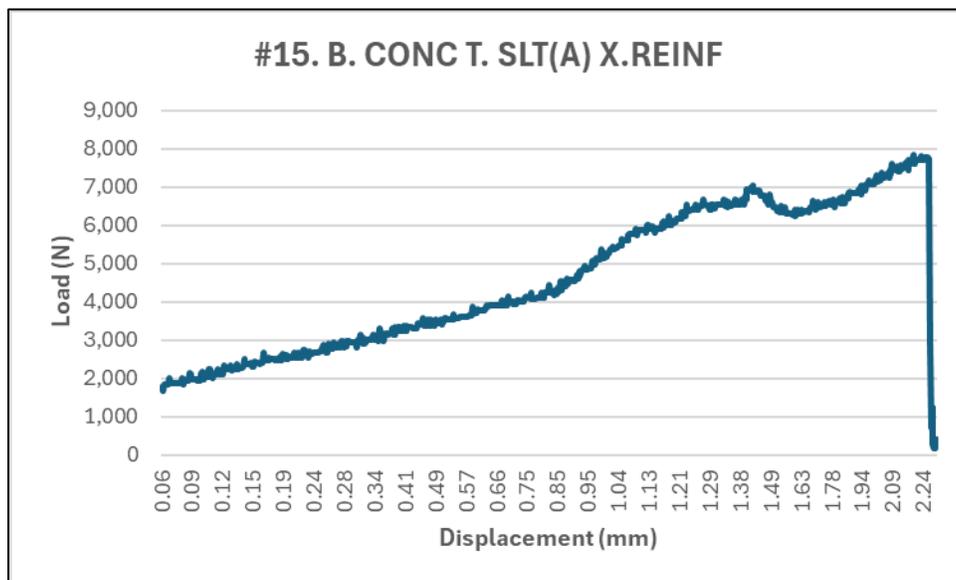
Figure 29. Specimen #15 Results

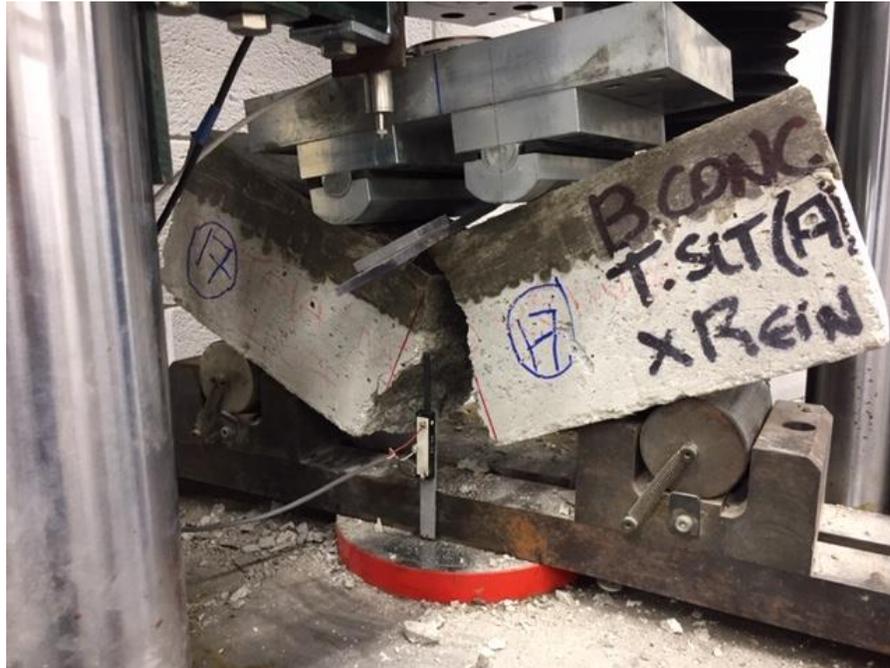
Failure Mode: Flexure Failure

Max Bending Moment Capacity: 1079.4 N.M

Figure 30. Specimen #17 Failure

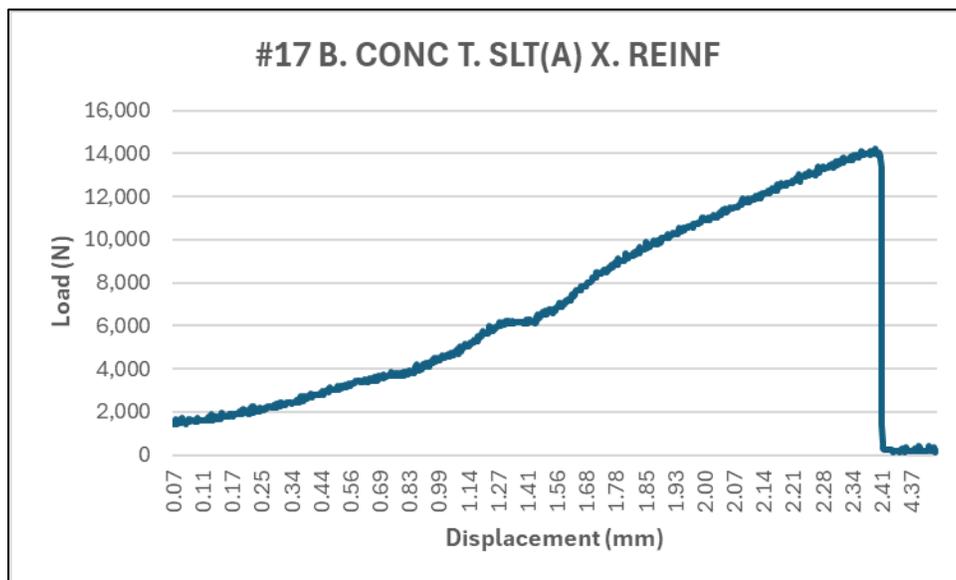
Figure 31. Specimen #17 Results

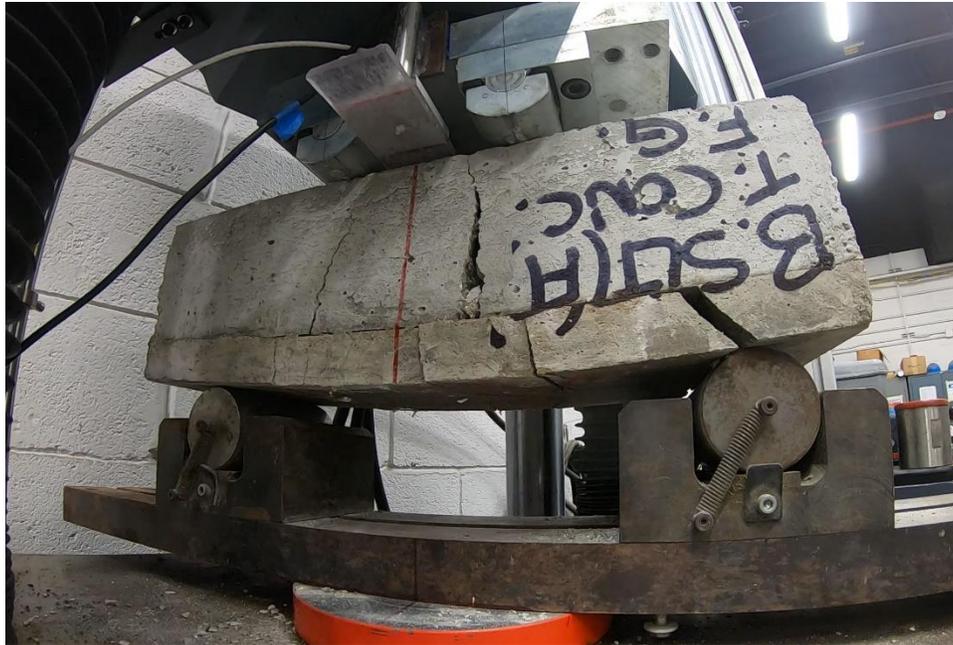
Failure Mode: Flexure Failure

Max Bending Moment Capacity: 5040.9 N.M

Figure 32. Specimen #5 Failure

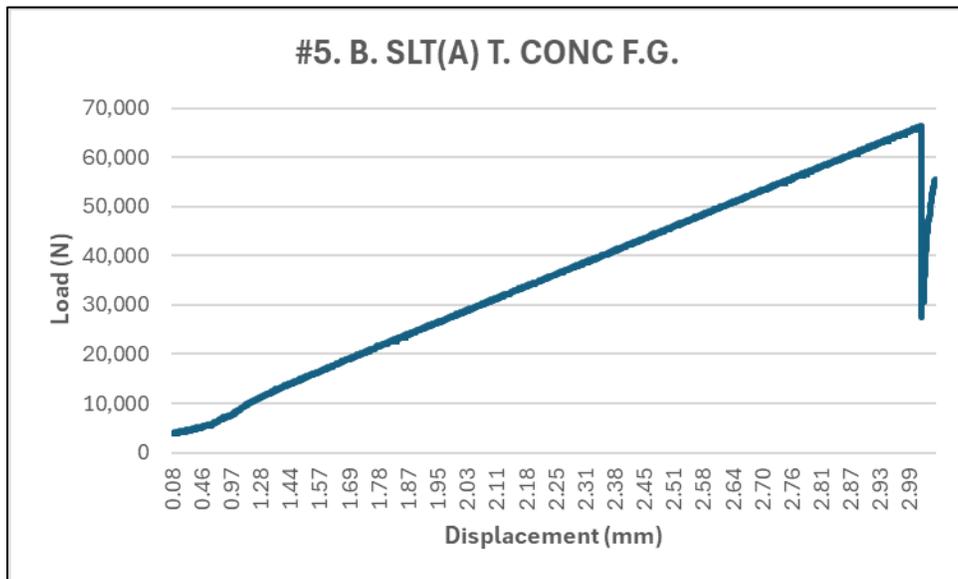
Figure 33. Specimen #5 Results

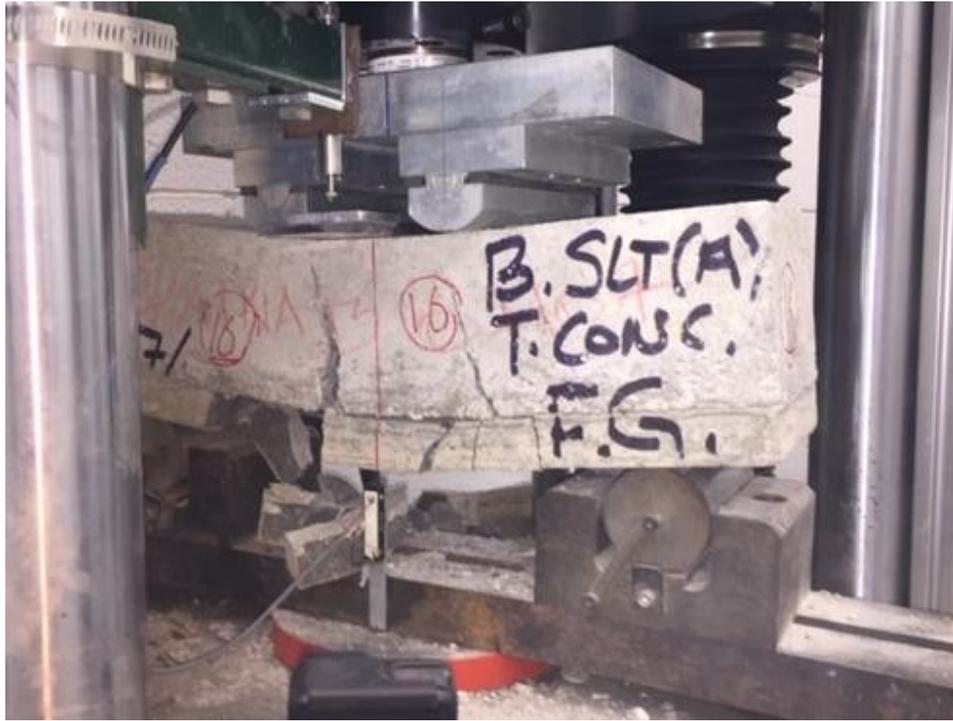
Failure Mode: Flexure Failure

Max Bending Moment Capacity: 4354.6 N.M

Figure 34. Specimen #16 Failure

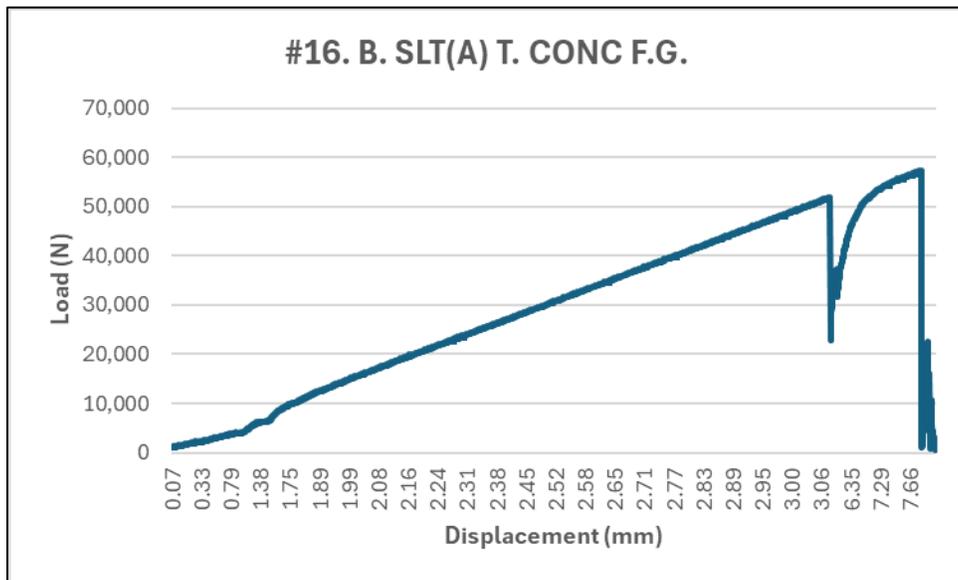
Figure 35. Specimen #16 Results

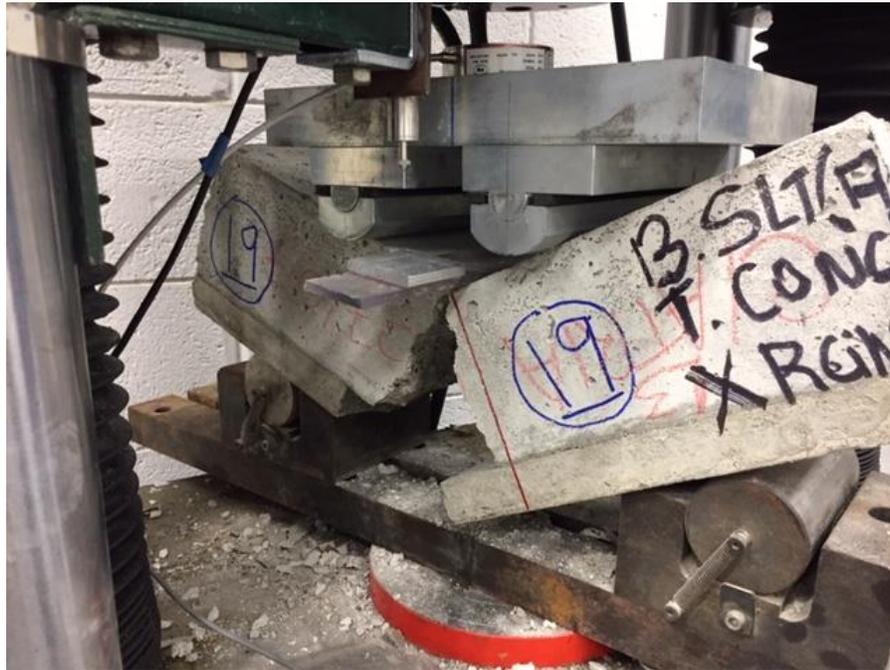
Failure Mode: Flexure Failure

Max Bending Moment Capacity: 3365.5 N.M

Figure 36. Specimen #19 Failure

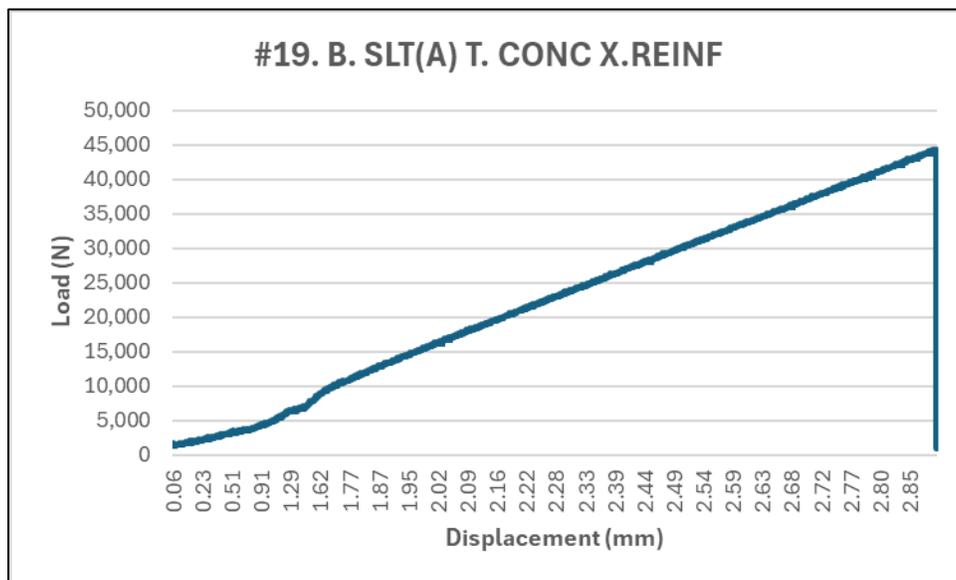
Figure 37. Specimen #19 Results

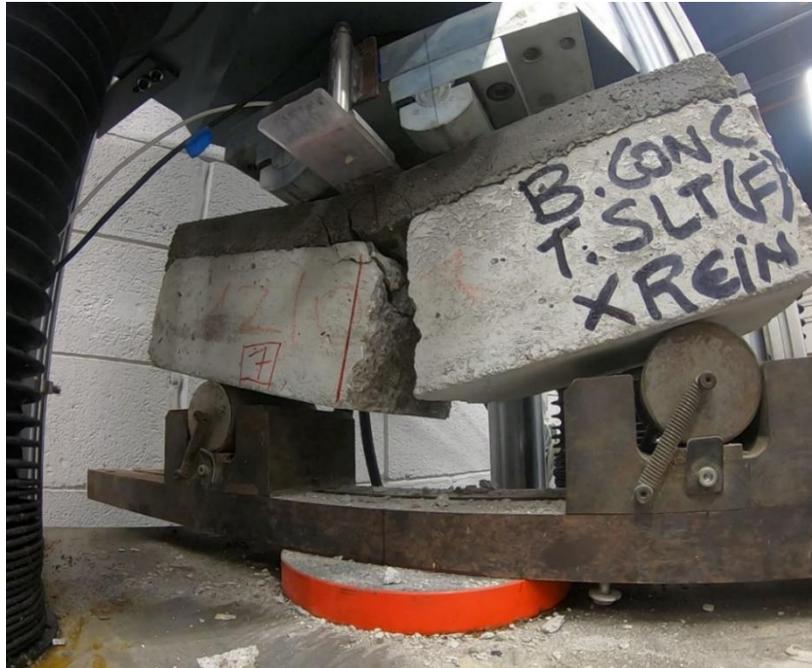
Failure Mode: Flexure Failure

Max Bending Moment Capacity: 1568.6 N.M

Figure 38. Specimen #7 Failure

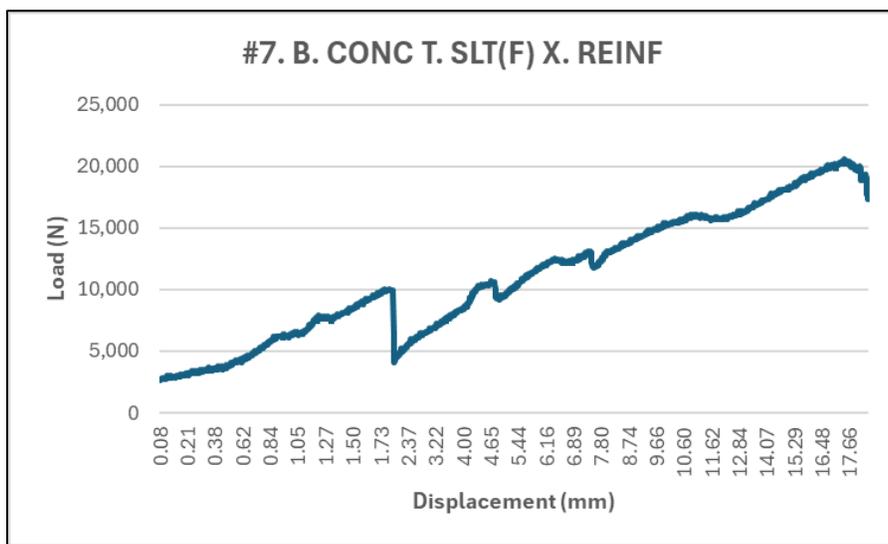
Figure 39. Specimen #7 Results

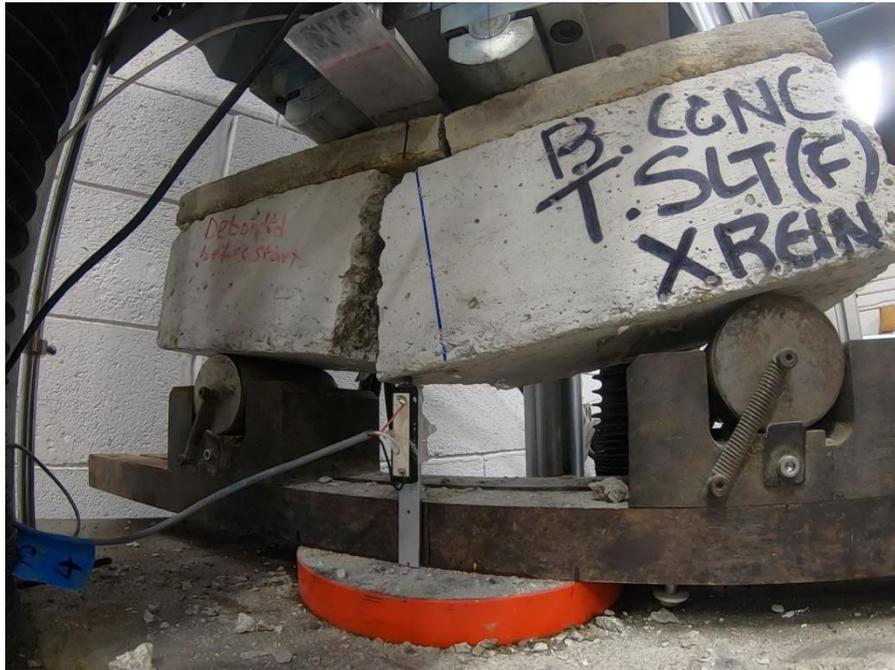
Failure Mode: Flexure Failure

Max Bending Moment Capacity: 1519.5 N.M

Figure 40. Specimen #10 Failure

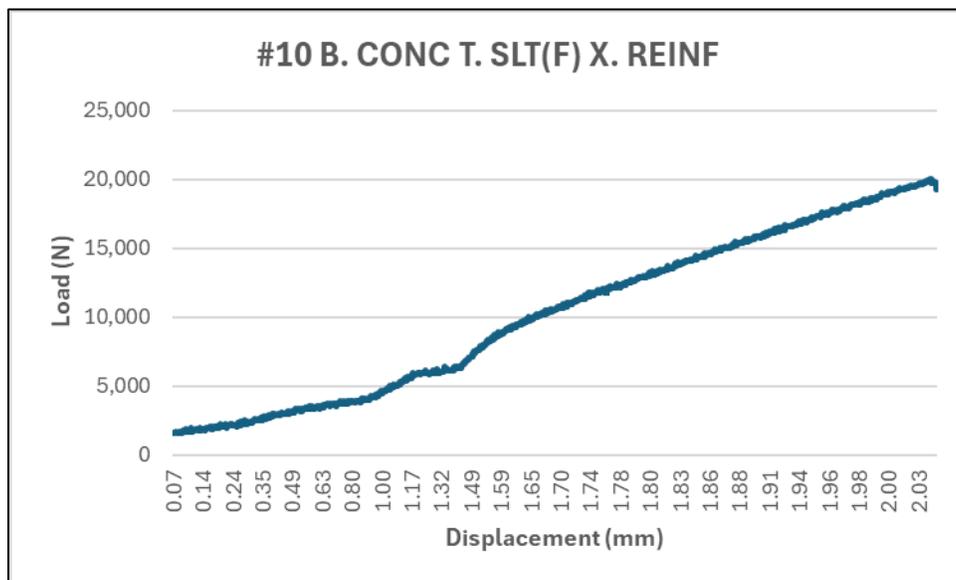
Figure 41. Specimen #10 Results
