1. Report No. ABC-UTC-2016-C6-FIU02-Final	2. Government Accession No.	3. Recipient's Catalog No.	
4. Title and Subtitle Comprehending the Structural Performance and Examining Potential Field Applications of Sileto, as a New Material		5. Report Date February 2026

Comprehending the Structural Performance and Examining Potential Field Applications of Sileto, as a New Material

Final Report

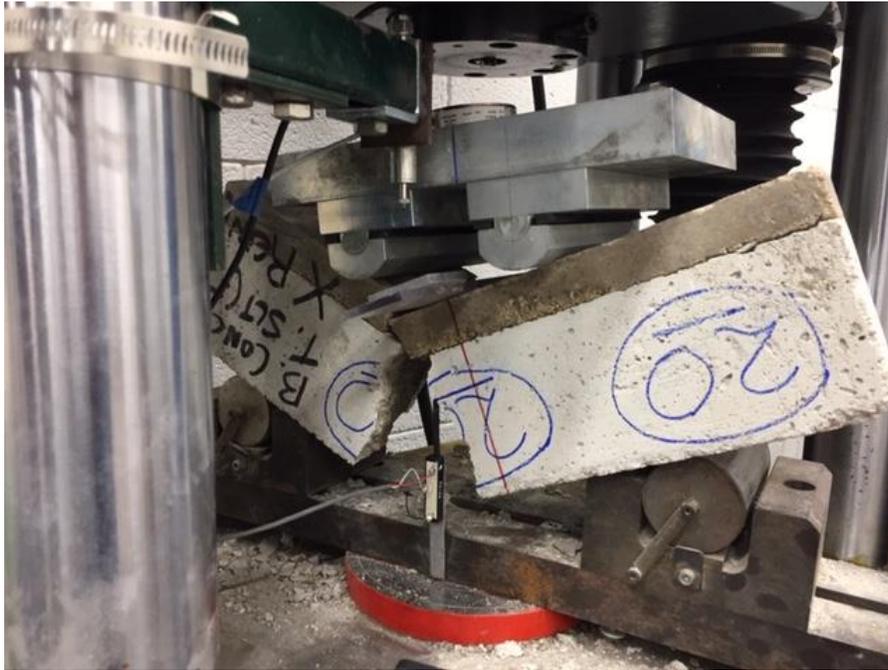
Failure Mode: Flexure Failure

Max Bending Moment Capacity: 802 N.M

Figure 42. Specimen #20 Failure

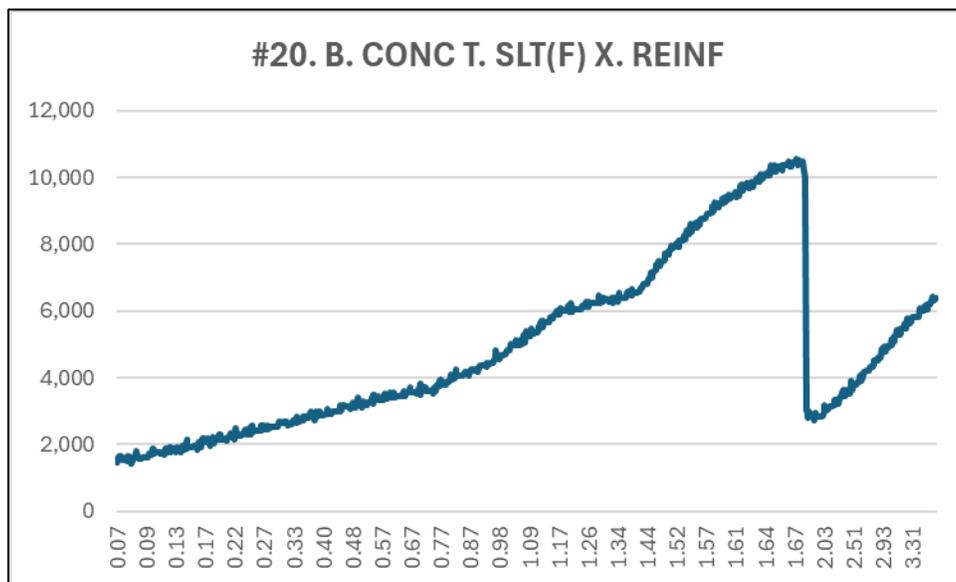
Figure 43. Specimen #20 Results

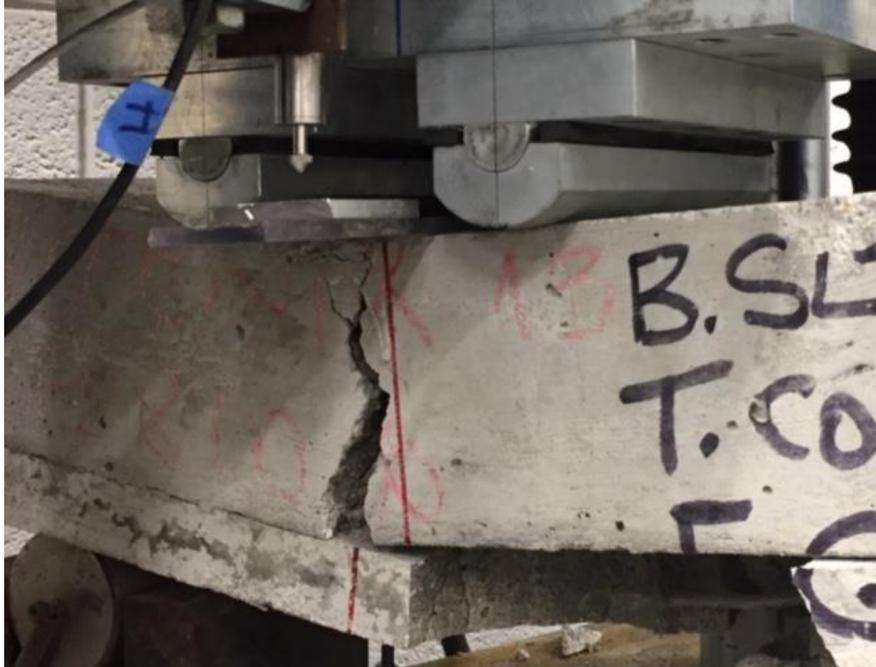
Failure Mode: Flexure Failure

Max Bending Moment Capacity: 5115.6 N.M

Figure 44. Specimen #9 Failure

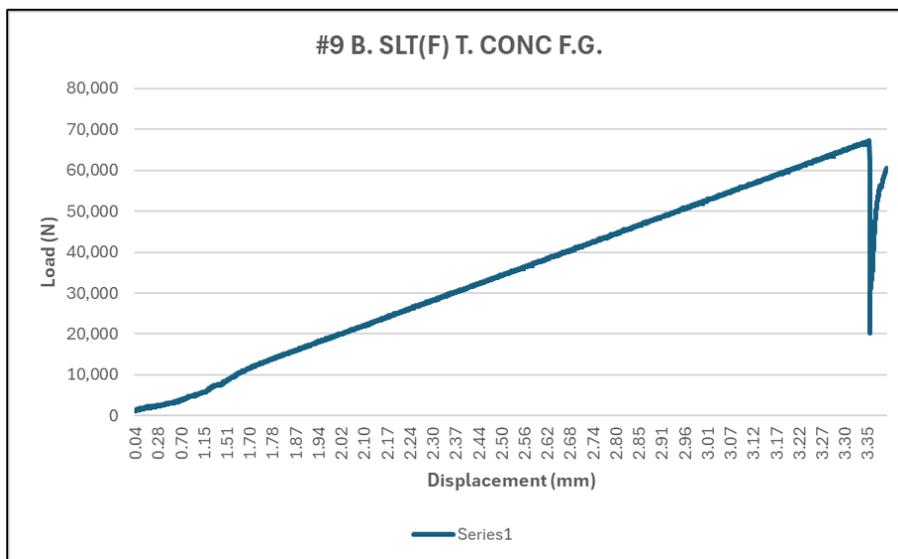
Figure 45. Specimen #9 Results

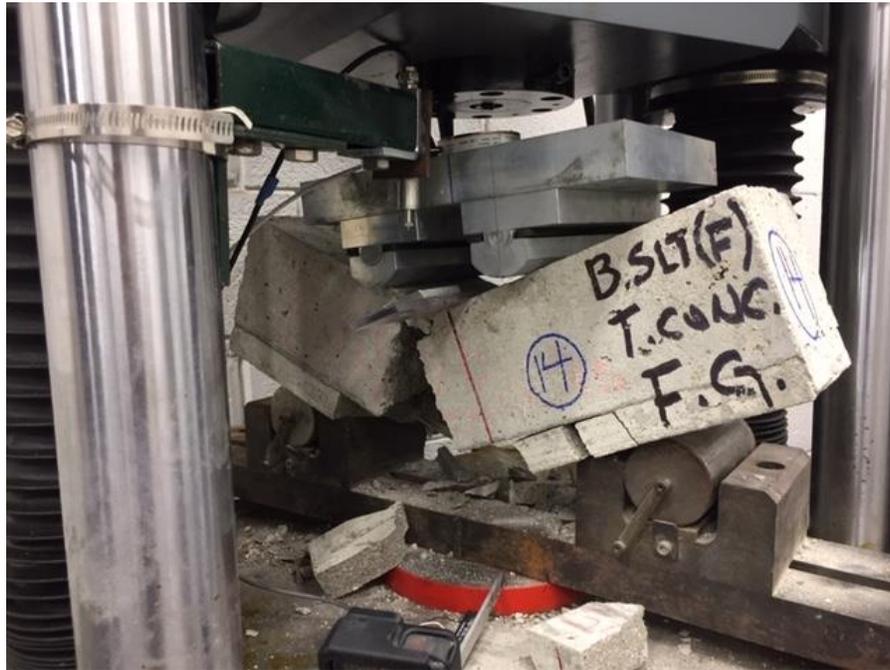
Failure Mode: Flexure Failure

Max Bending Moment Capacity: 5173.5 N.M

Figure 46. Specimen #14 Failure

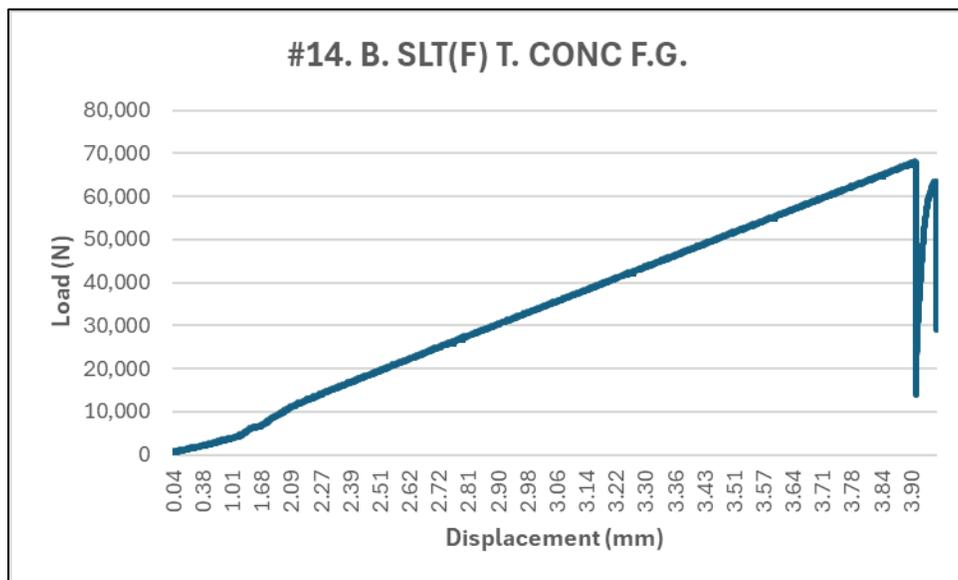
Figure 47. Specimen #14 Results

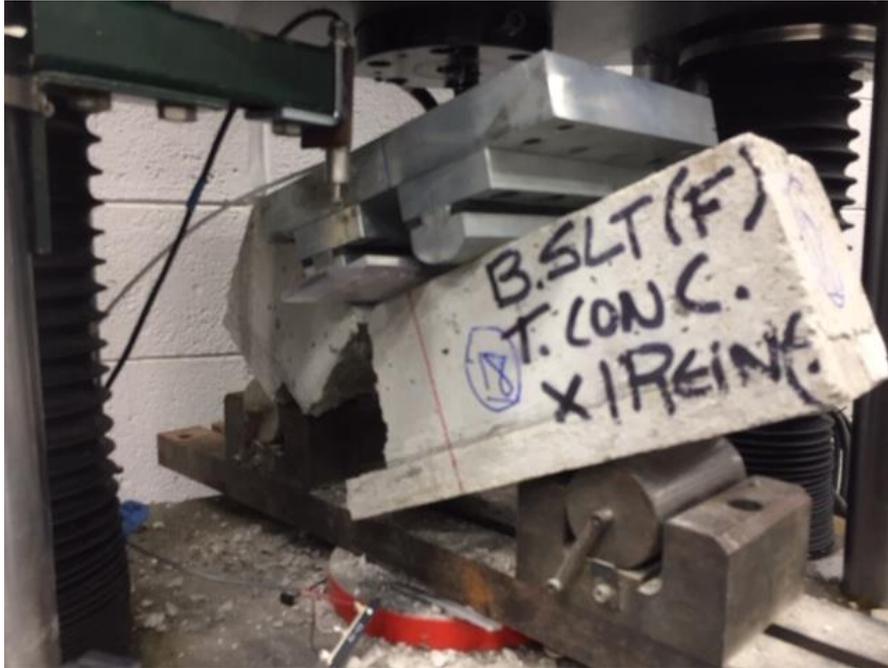
Failure Mode: Flexure Failure

Max Bending Moment Capacity: 2544.7 N.M

Figure 48. Specimen #18 Failure

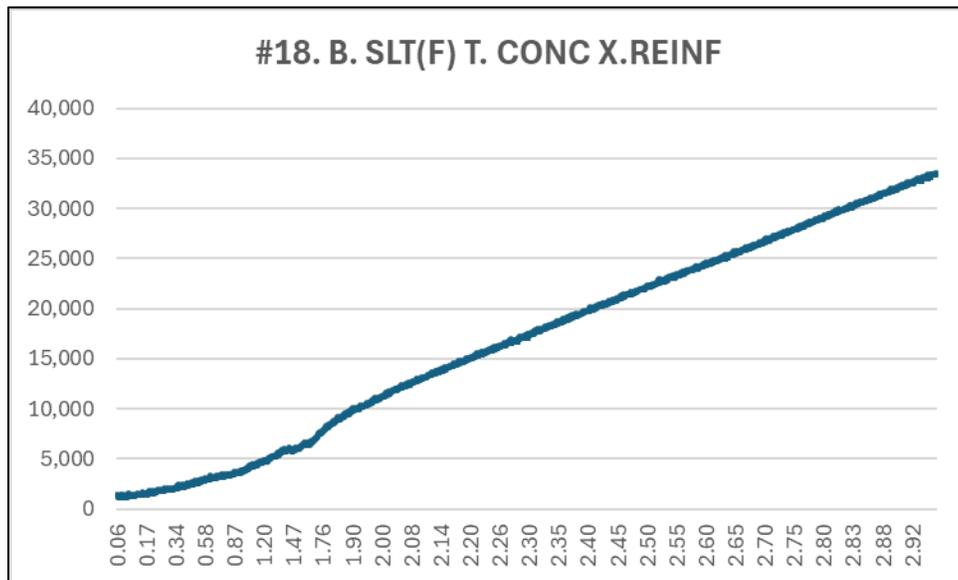
Figure 49. Specimen #18 Results

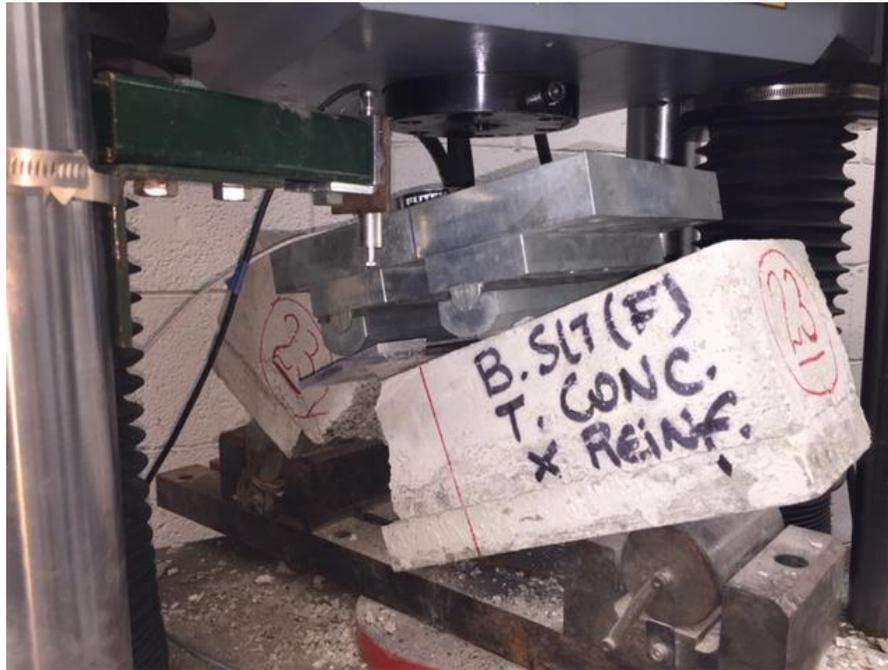
Failure Mode: Shear Moment Failure

Max Shear Capacity: 26045 N

Figure 50. Specimen #23 Failure

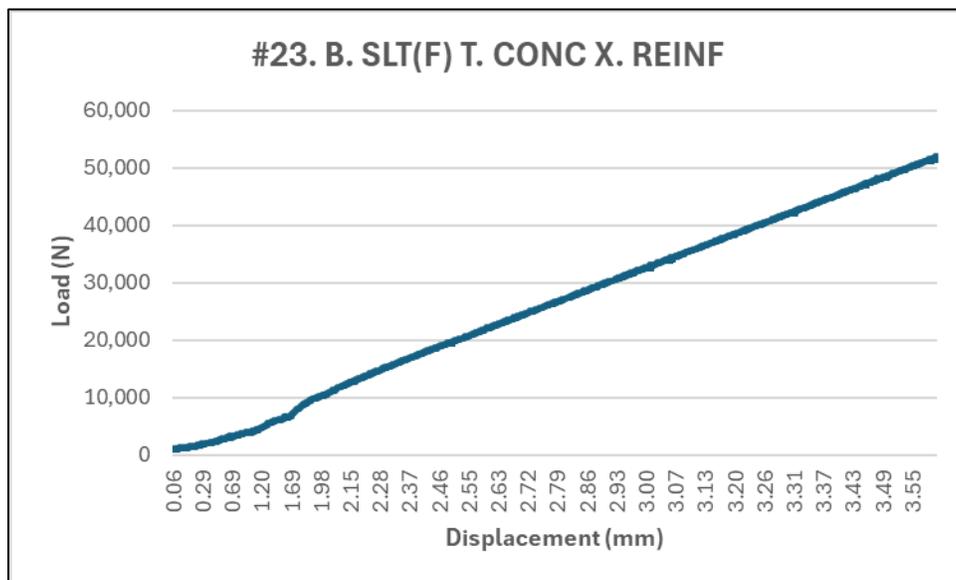
Figure 51. Specimen #23 Results

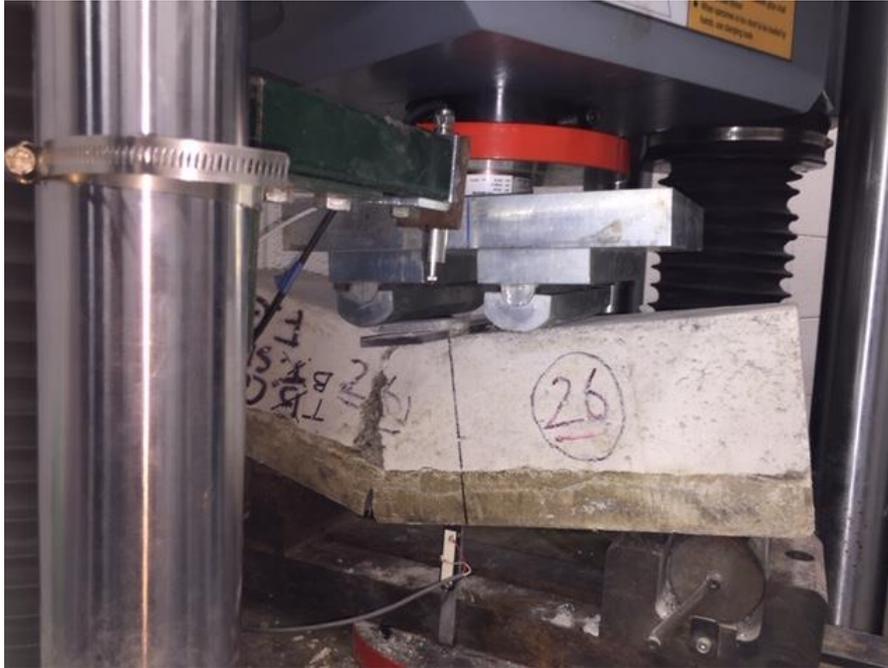
Failure Mode: Flexure Failure

Max Bending Moment Capacity: 1654.5 N.M

Figure 52. Specimen #26 Failure

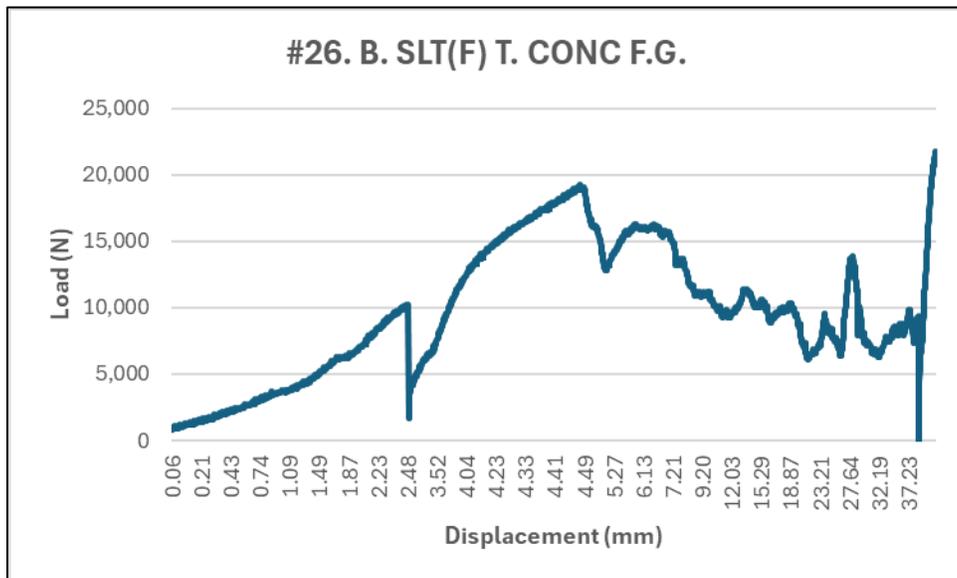
Figure 53. Specimen #26 Results

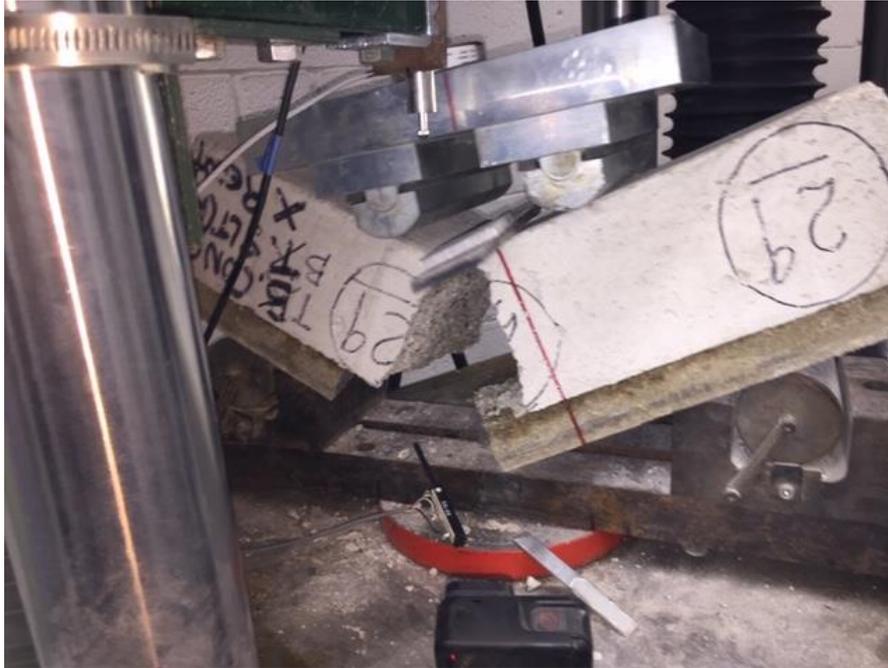
Failure Mode: Flexure Failure

Max Bending Moment Capacity: 1125.8 N.M

Figure 54. Specimen #29 Failure

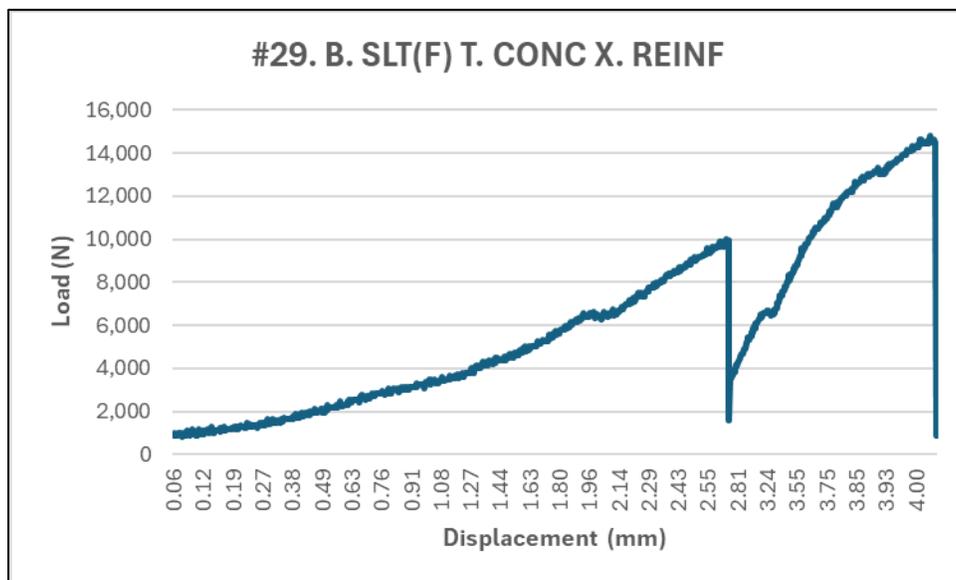
Figure 55. Specimen #29 Results

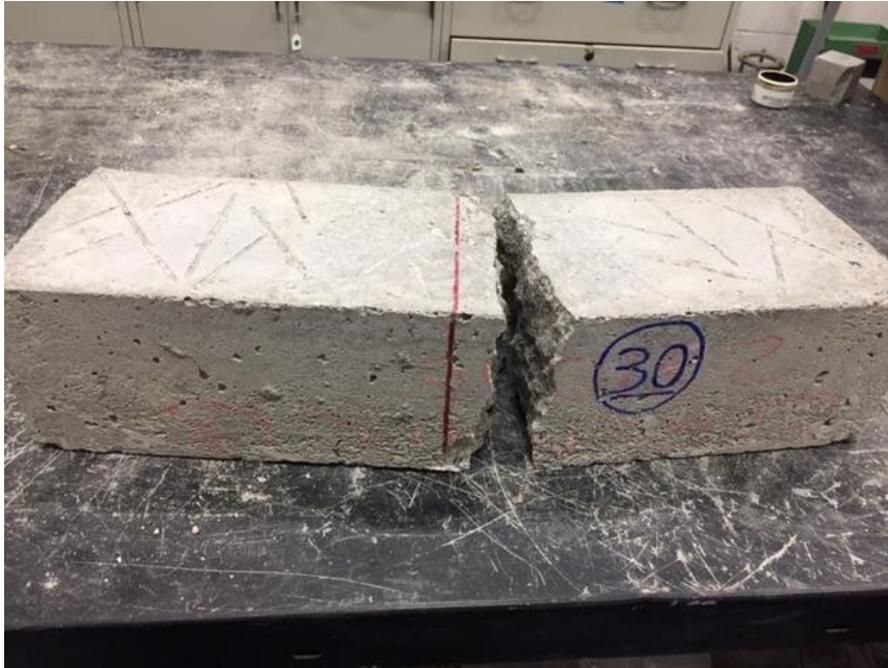
Failure Mode: Flexure Failure

Max Bending Moment Capacity: 948.3 N.M

Figure 56. Specimen #30 Failure

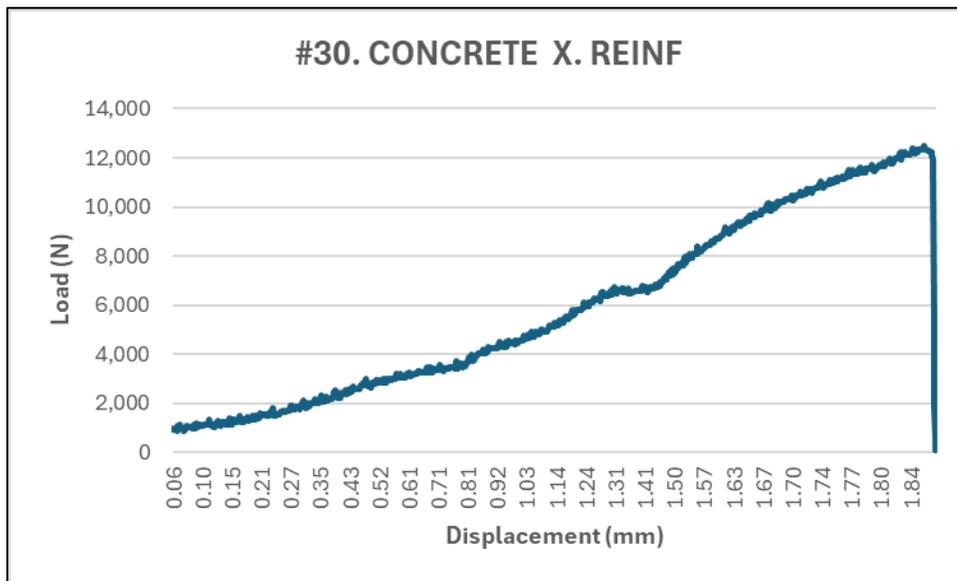
Figure 57. Specimen #30 Results

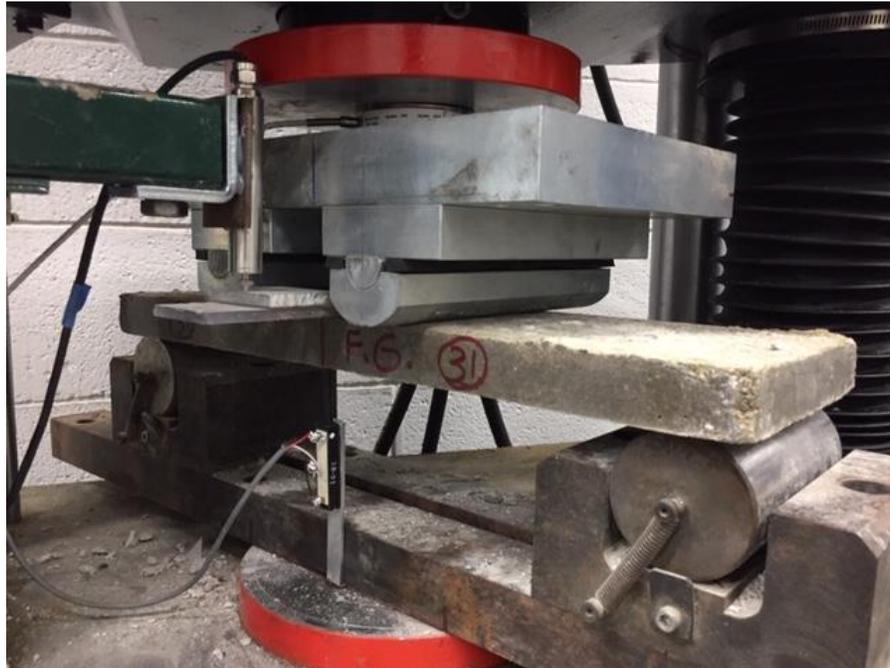
Failure Mode: Flexure Failure

Max Bending Moment Capacity: 361.5 N.M

Figure 58. Specimen #31 Failure

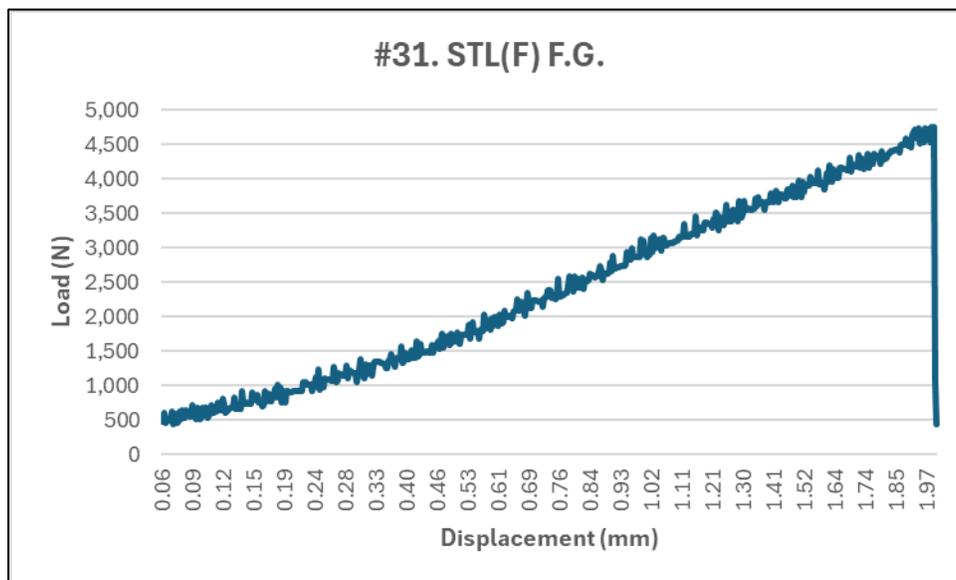
Figure 59. Specimen #31 Results

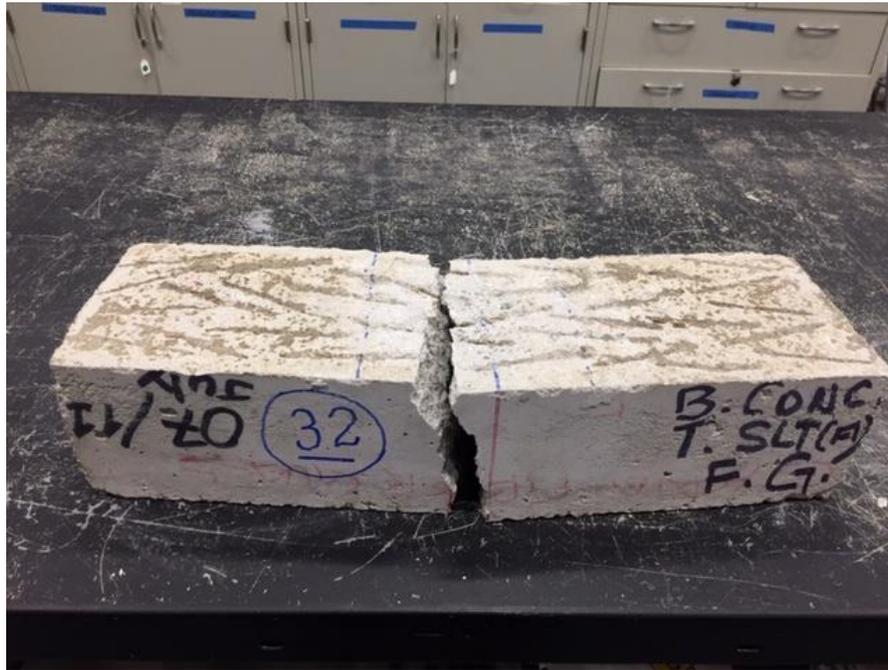
Failure Mode: Flexure Failure

Max Bending Moment Capacity: 827.6 N.M

Figure 60. Specimen #32 Failure

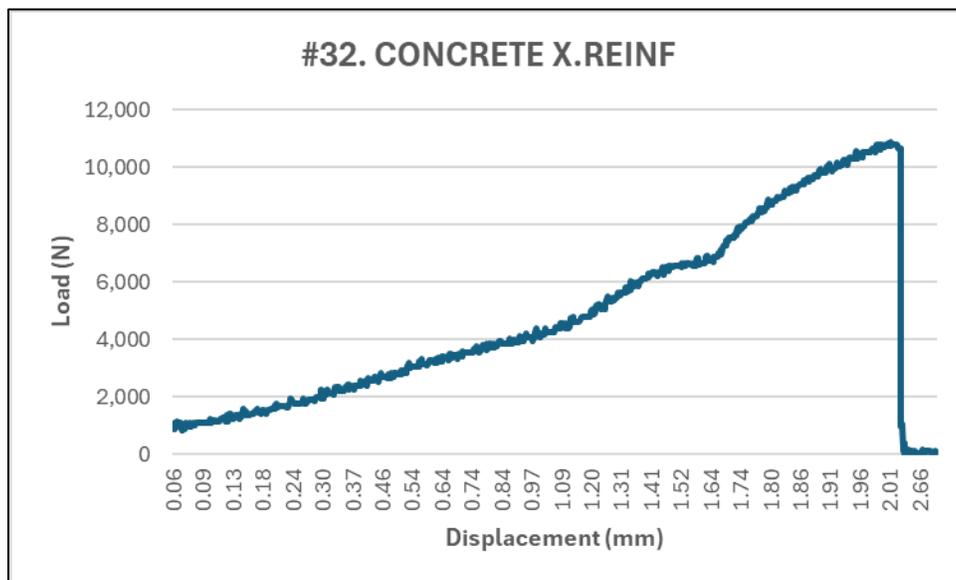
Figure 61. Specimen #32 Results

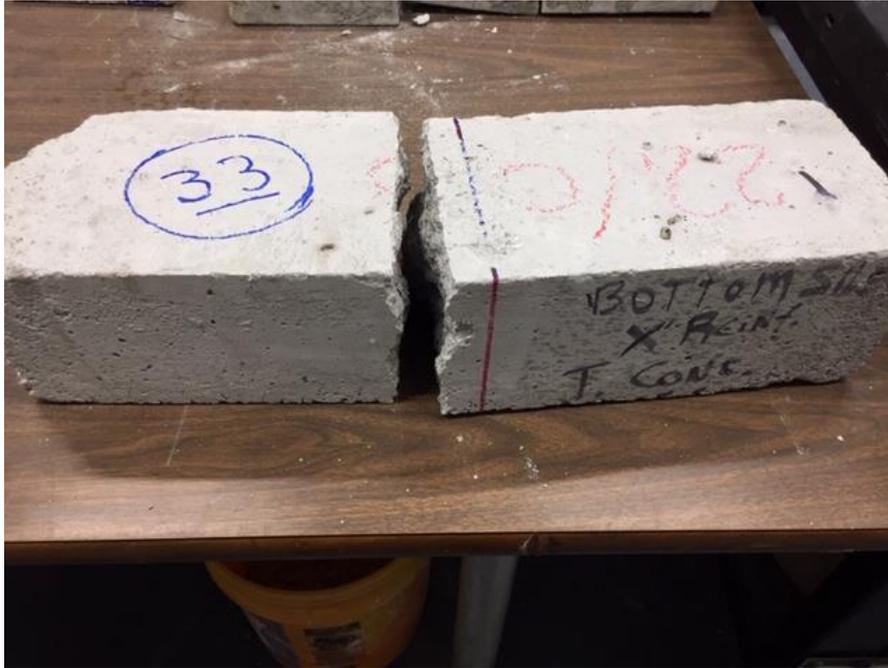
Failure Mode: Flexure Failure

Max Bending Moment Capacity: 633.8 N.M

Figure 62. Specimen #33 Failure

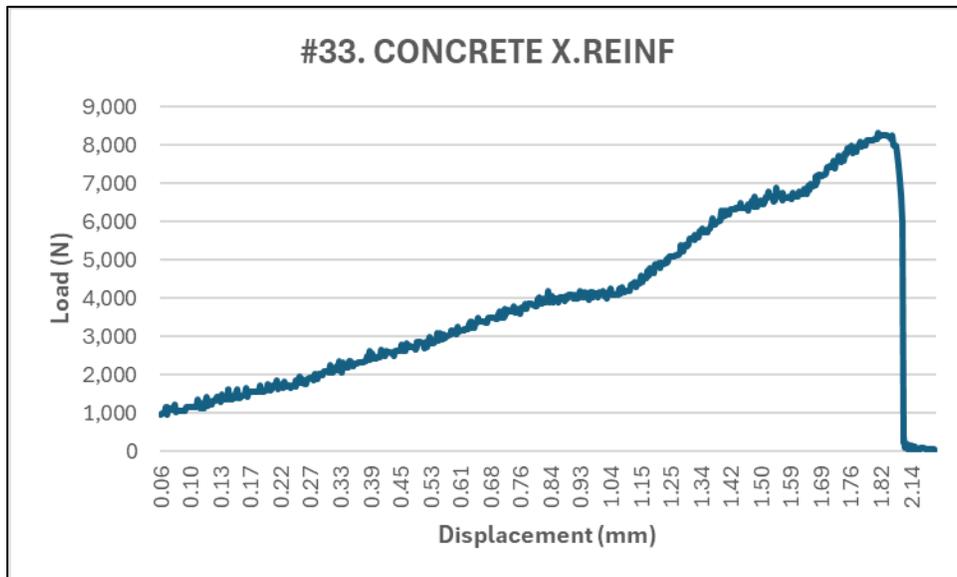
Figure 63. Specimen #33 Results

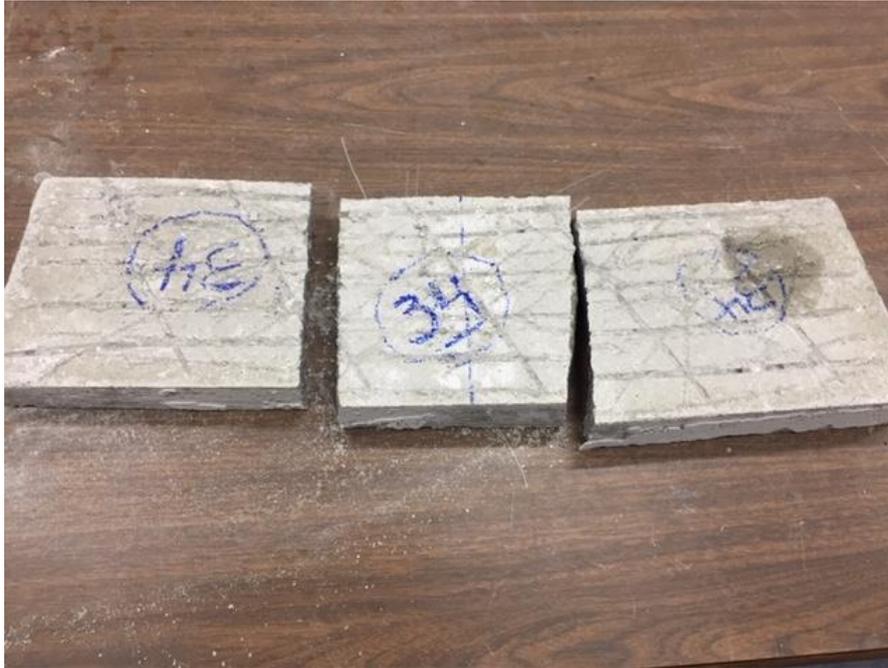
Failure Mode: Flexure Failure

Max Bending Moment Capacity: 416.5 N.M

Figure 64. Specimen #34 Failure

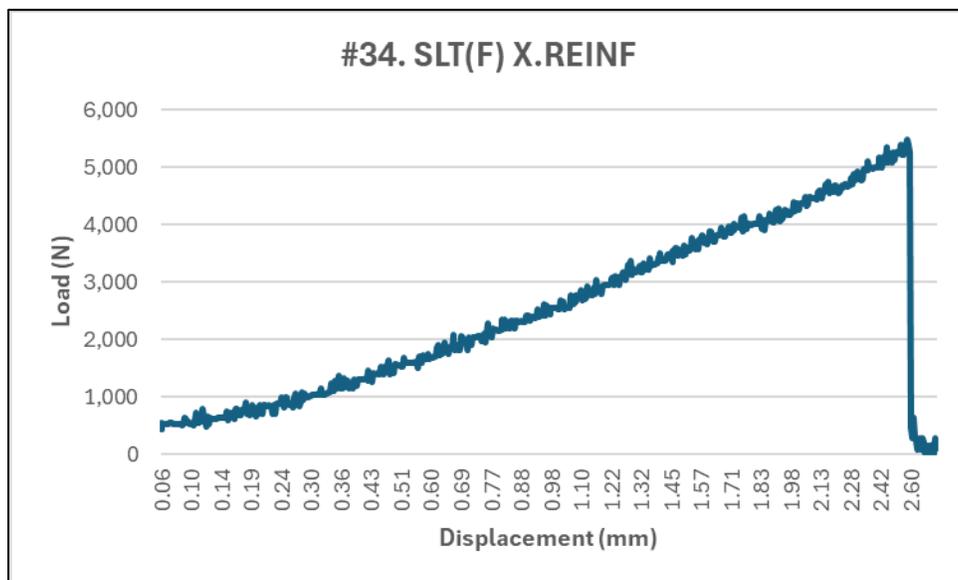
Figure 65. Specimen #34 Results

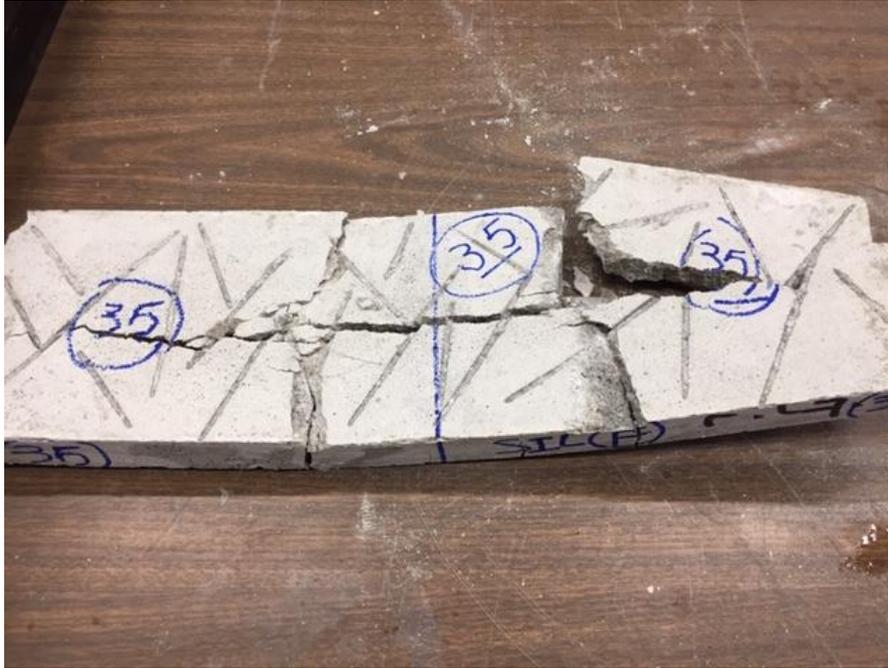
Failure Mode: Flexure Failure

Max Bending Moment Capacity: 562.6 N.M

Figure 66. Specimen #35 Failure

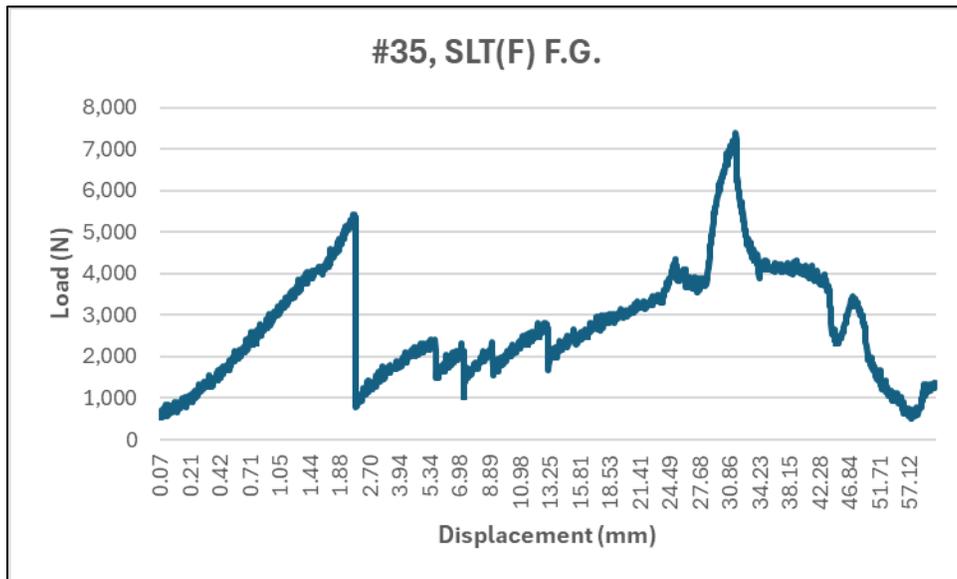
Figure 67. Specimen #35 Results

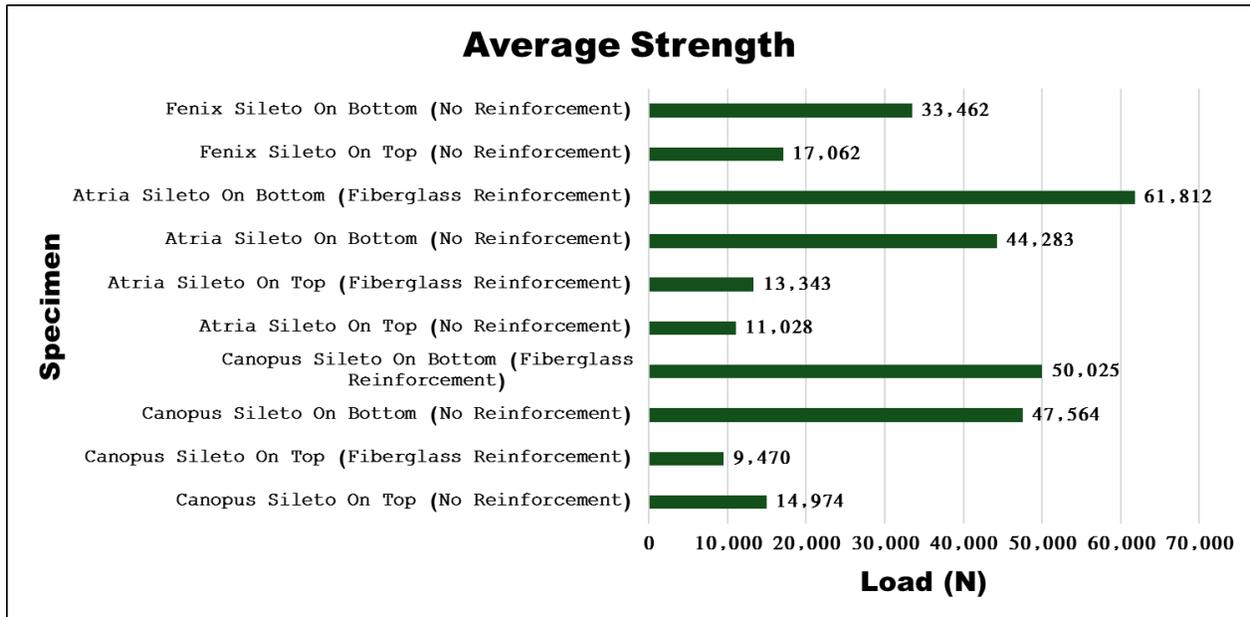
Figure 68 shows the average 4-point flexural strength results for the specimens that did not delaminate during shipping.

Figure 68. Average results from specimens that did not delaminate during shipping

Tests observations and results summarized in Figure 68 above, provides basis to make following conclusions, and recommendations:

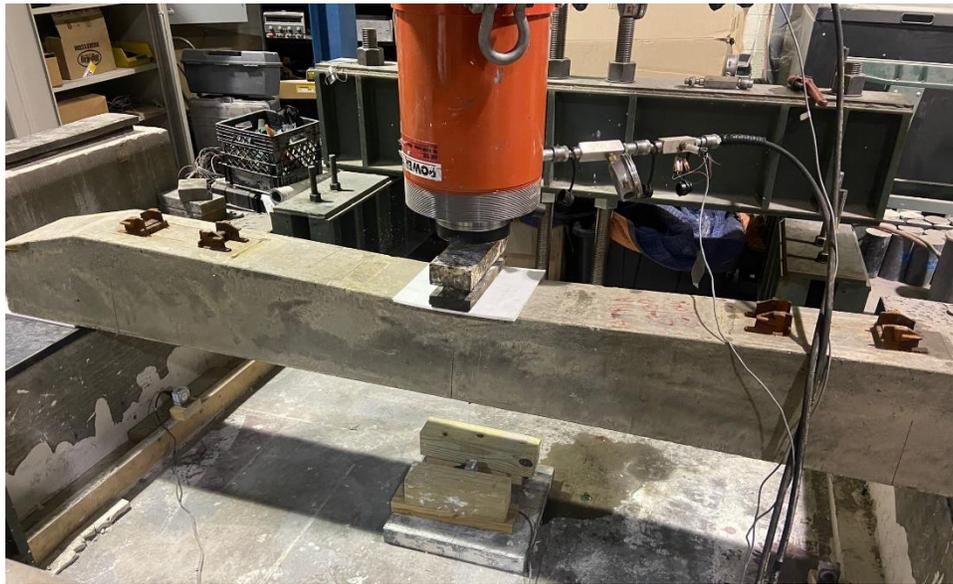
The 3-point flexural strength testing of the railroad tie shown in Figure 69. The railroad tie had dimensions of 280cm x 30cm x 30cm with a clear span between the two rigid supports of 225 cm. Each end of the tie was resting on a Teflon sheet during the test. The tie was also reinforced with fiberglass fibers. The specimen was loaded using a hydraulic ram. Load cells as well as pressure transducers were utilized to measure the applied load on the specimen. Deflection gages were used to measure the deflection of the specimen.

Figure 69. 3-Point Flexural Strength Testing of The Railroad Tie

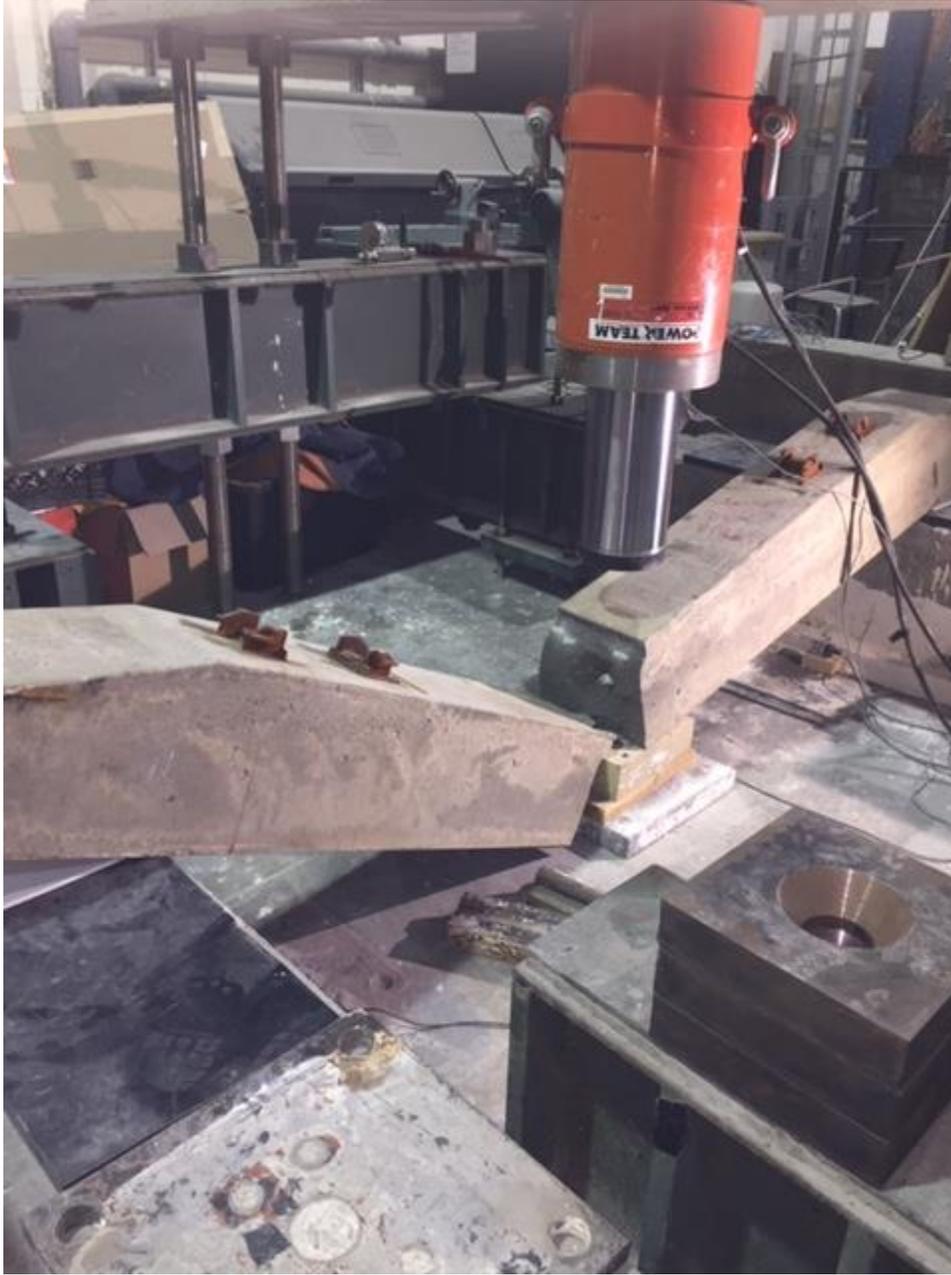
Figure 70. Railroad Tie Failure

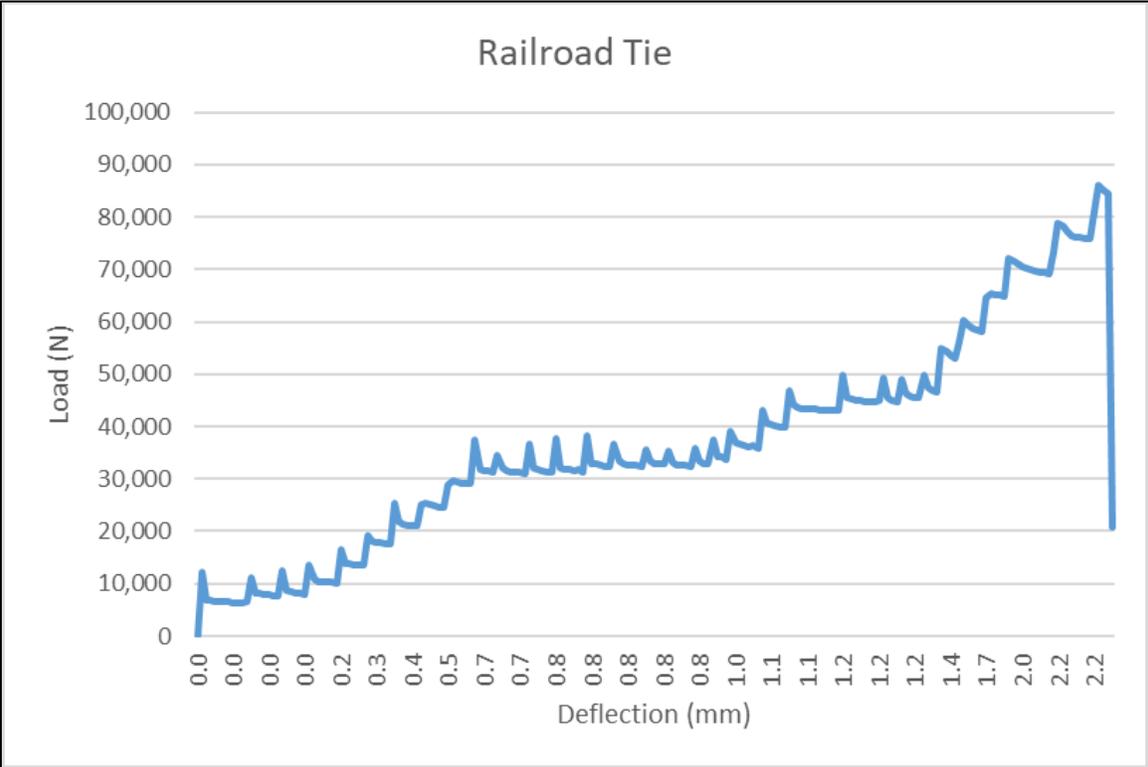
Max Load: 86,108 N

Figure 71. Railroad Tie Results

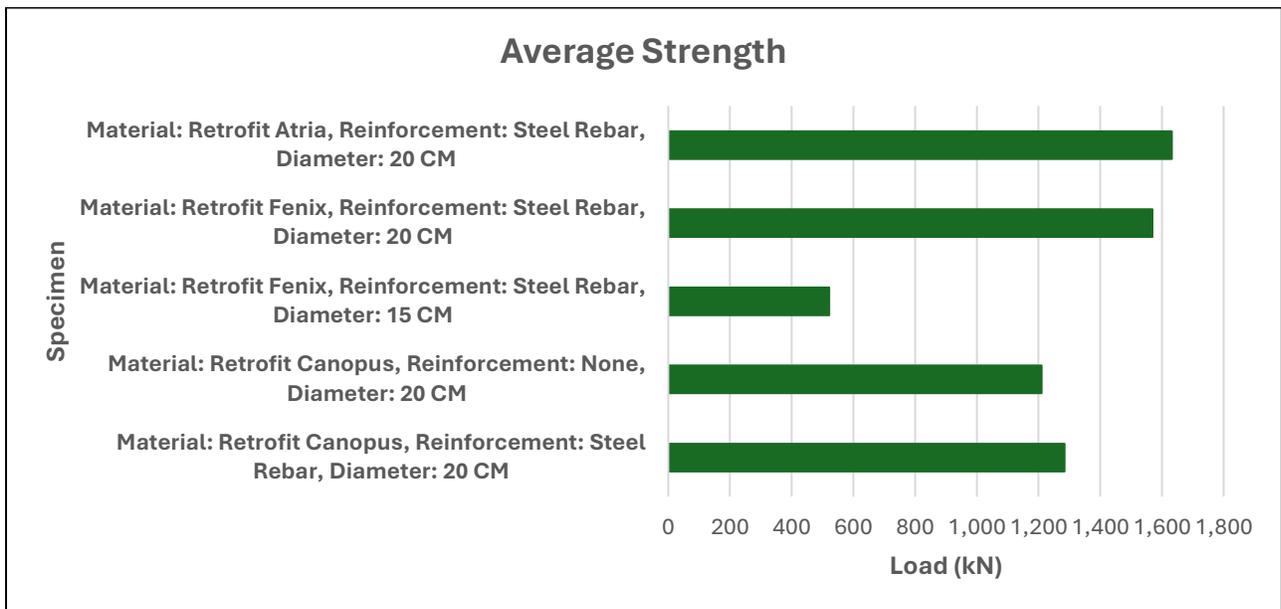
Figure 82. Average Compressive Strength of Cylindrical Columns

Concrete columns subjected to pure axial load, in general exhibit a very brittle failure mode. Same observation was observed during testing of the five test specimens described above. Based on the test observations, following tentative conclusions could be made:

- 1) Bond between Sileto and normal strength concrete columns, appeared to be very good.
- 2) Addition of longitudinal reinforcement resulted in relatively ductile mode of failure.

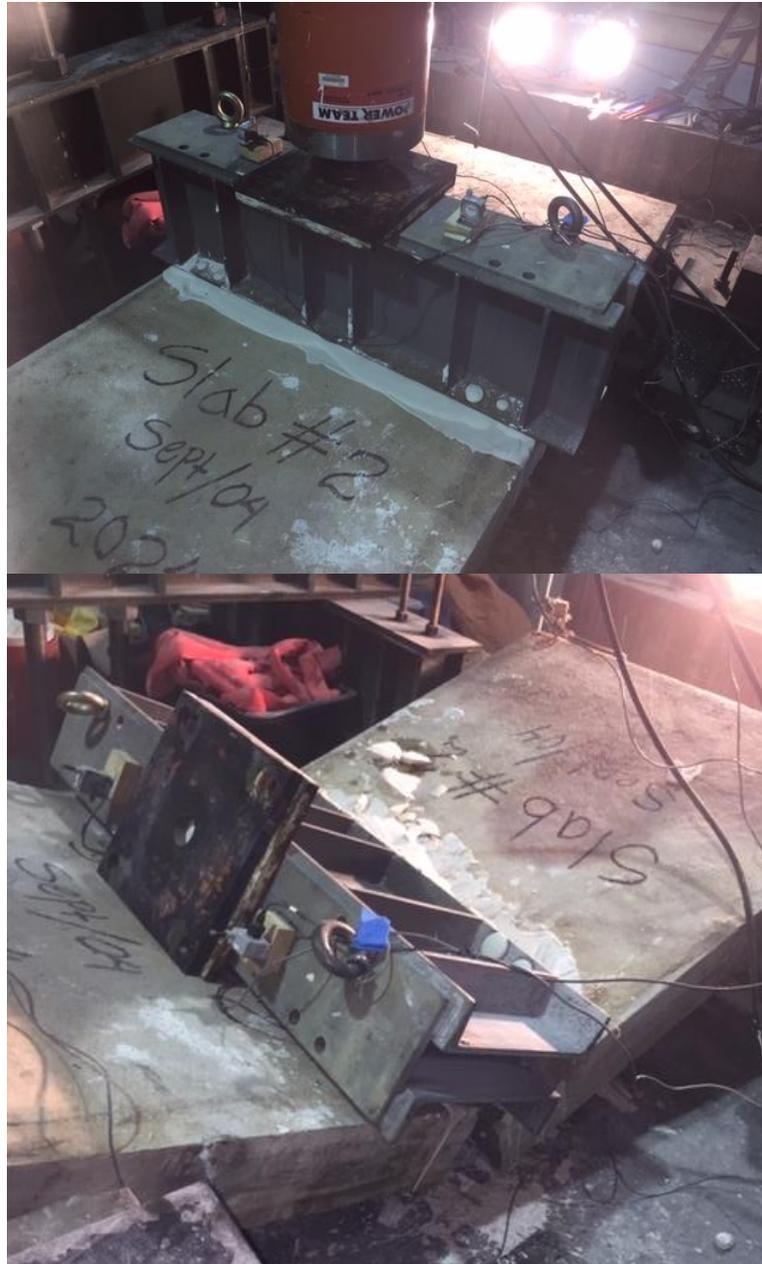
Figure 86. Slab #2 Testing

After test conclusion, it was observed that in slab #2 the fiberglass reinforcement were located exactly in the center of the slab (9.5 cm from the top edge of the slab as tested). However, in slab #1 the fibers were located 7.0 cm from the top edge of the slab as tested.
