# TERMINAL END JOINTS IN CONTINUOUSLY REINFORCED CONCRETE PAVEMENT

INTERIM REPORT

October, 1992

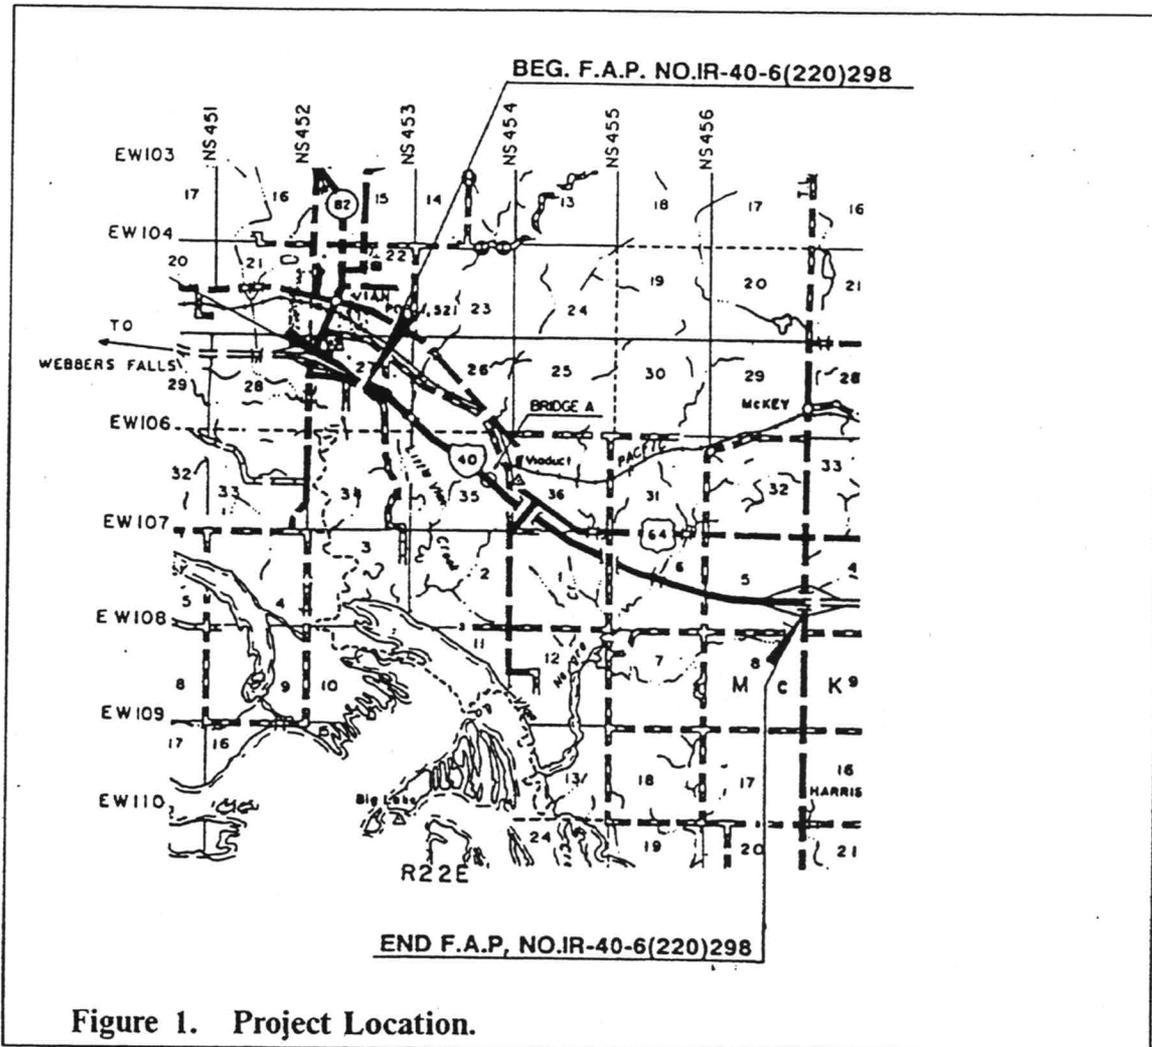
Figure 1. Project Location.

This project, Federal Aid Project Number IR-40-6(220), is located on I-40 in Sequoyah County in eastern Oklahoma. The project, a four lane divided highway, begins at SH-82 and extends east 5.2 miles (Figure 1) and has a design ADT of 10,500 with 31% truck traffic. The contract was awarded to Duit Construction Co., Inc., on May 1, 1989, at a cost of \$7.2 million. The project was completed in January 1991.

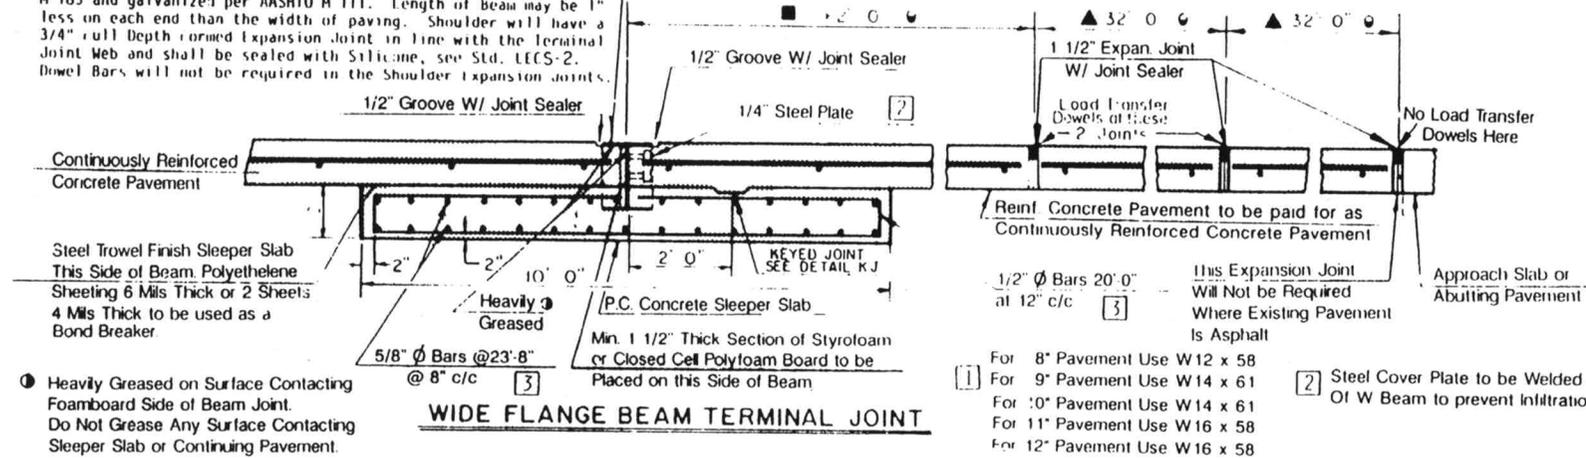
Figure 2. Standard Wide Flange Beam Terminal Joint.

1 Steel Beam W 14x61 @ 24" Long meeting the requirements of AASHTO M 183 and galvanized per AASHTO M 111. Length of beam may be 1" less on each end than the width of paving. Shoulder will have a 3/4" full Depth formed Expansion Joint in line with the terminal Joint Web and shall be sealed with Silicone, see Std. LECS-2. Dowel Bars will not be required in the Shoulder Expansion Joints.

Heavily Greased on Surface Contacting Foamboard Side of Beam Joint. Do Not Grease Any Surface Contacting Sleeper Slab or Continuing Pavement.

**WIDE FLANGE BEAM TERMINAL JOINT**

- 1 For 8" Pavement Use W 12 x 58
- For 9" Pavement Use W 14 x 61
- For 10" Pavement Use W 14 x 61
- For 11" Pavement Use W 16 x 58
- For 12" Pavement Use W 16 x 58

2 Steel Cover Plate to be Welded on each End of W Beam to prevent Infiltration of Material

The standard design calls for a wide flange beam joint to be placed 128 feet from a bridge approach/leave slab or abutting pavement (Figure 2). One 62 foot long reinforced concrete slab and two 32 foot long reinforced concrete slabs are placed between the wide flange beam joint and the existing pavement. The two intermediate joints incorporate dowels while the abutting joint does not.

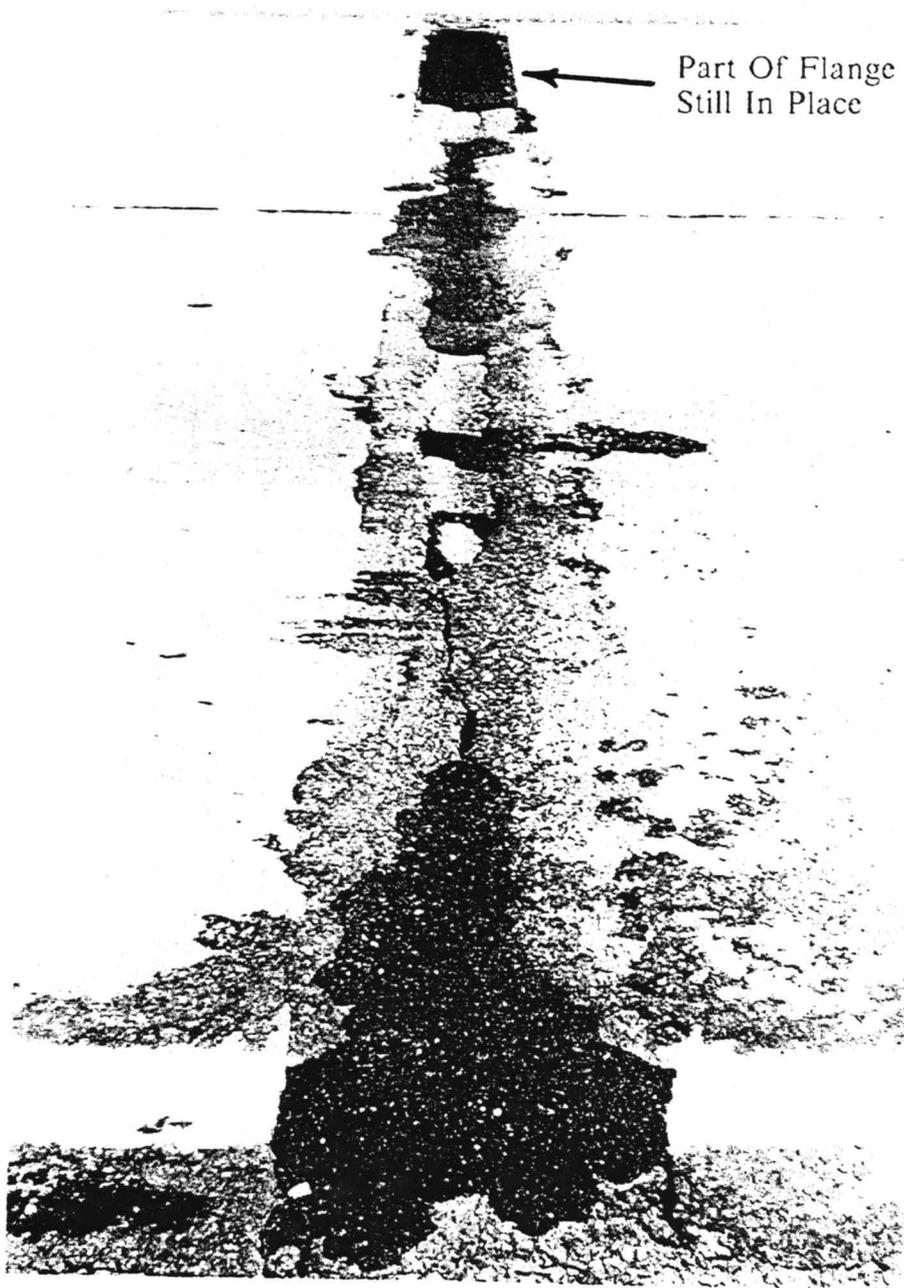
Figure 3. Failed Wide Flange Beam Terminal Joint.

Over the years, the wide flange beam joint has not maintained its integrity, as both the top and bottom flanges of the beam have broken during service. Once the beam fails, it becomes a maintenance problem and a safety concern to the traveling public (Figure 3).

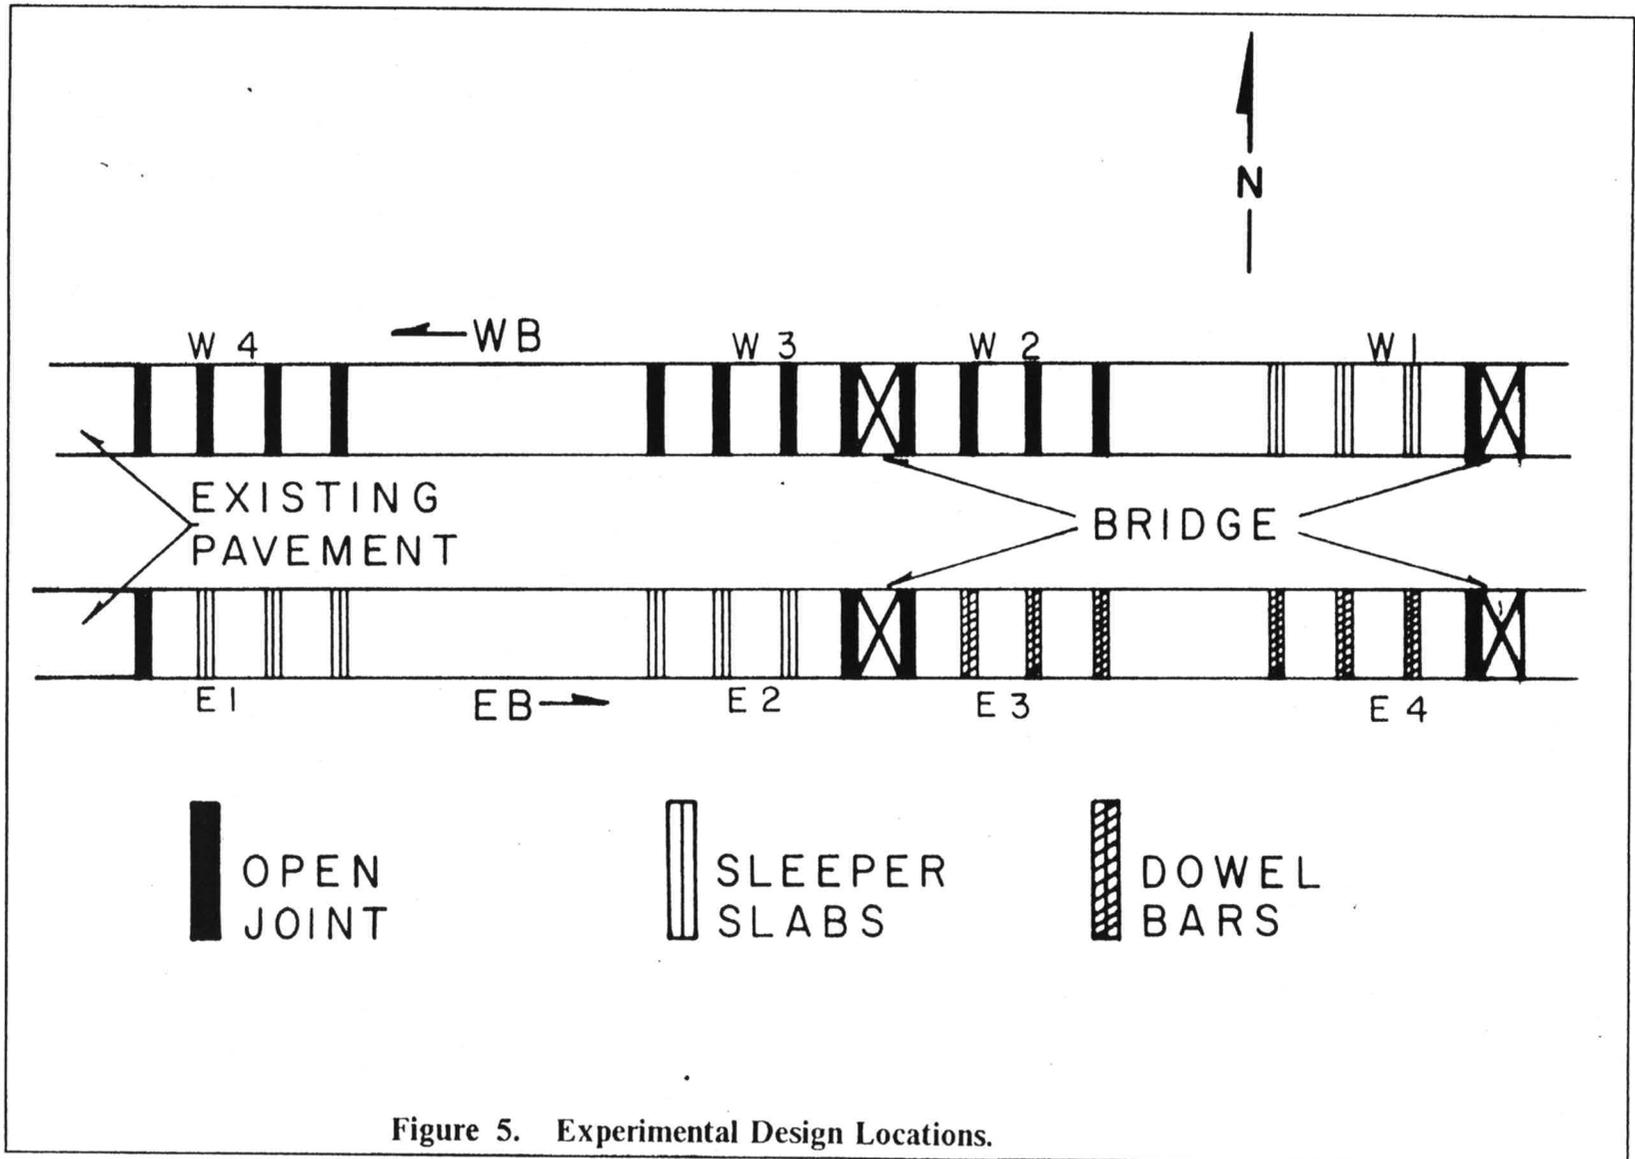
Figure 5. Experimental Design Locations.

Figure 5 shows a schematic layout of the project and locates the various joint designs. Each terminal will be classified according to the type of joint design used in the three non-abutting joints, as each location has the abutting joint as an open joint.

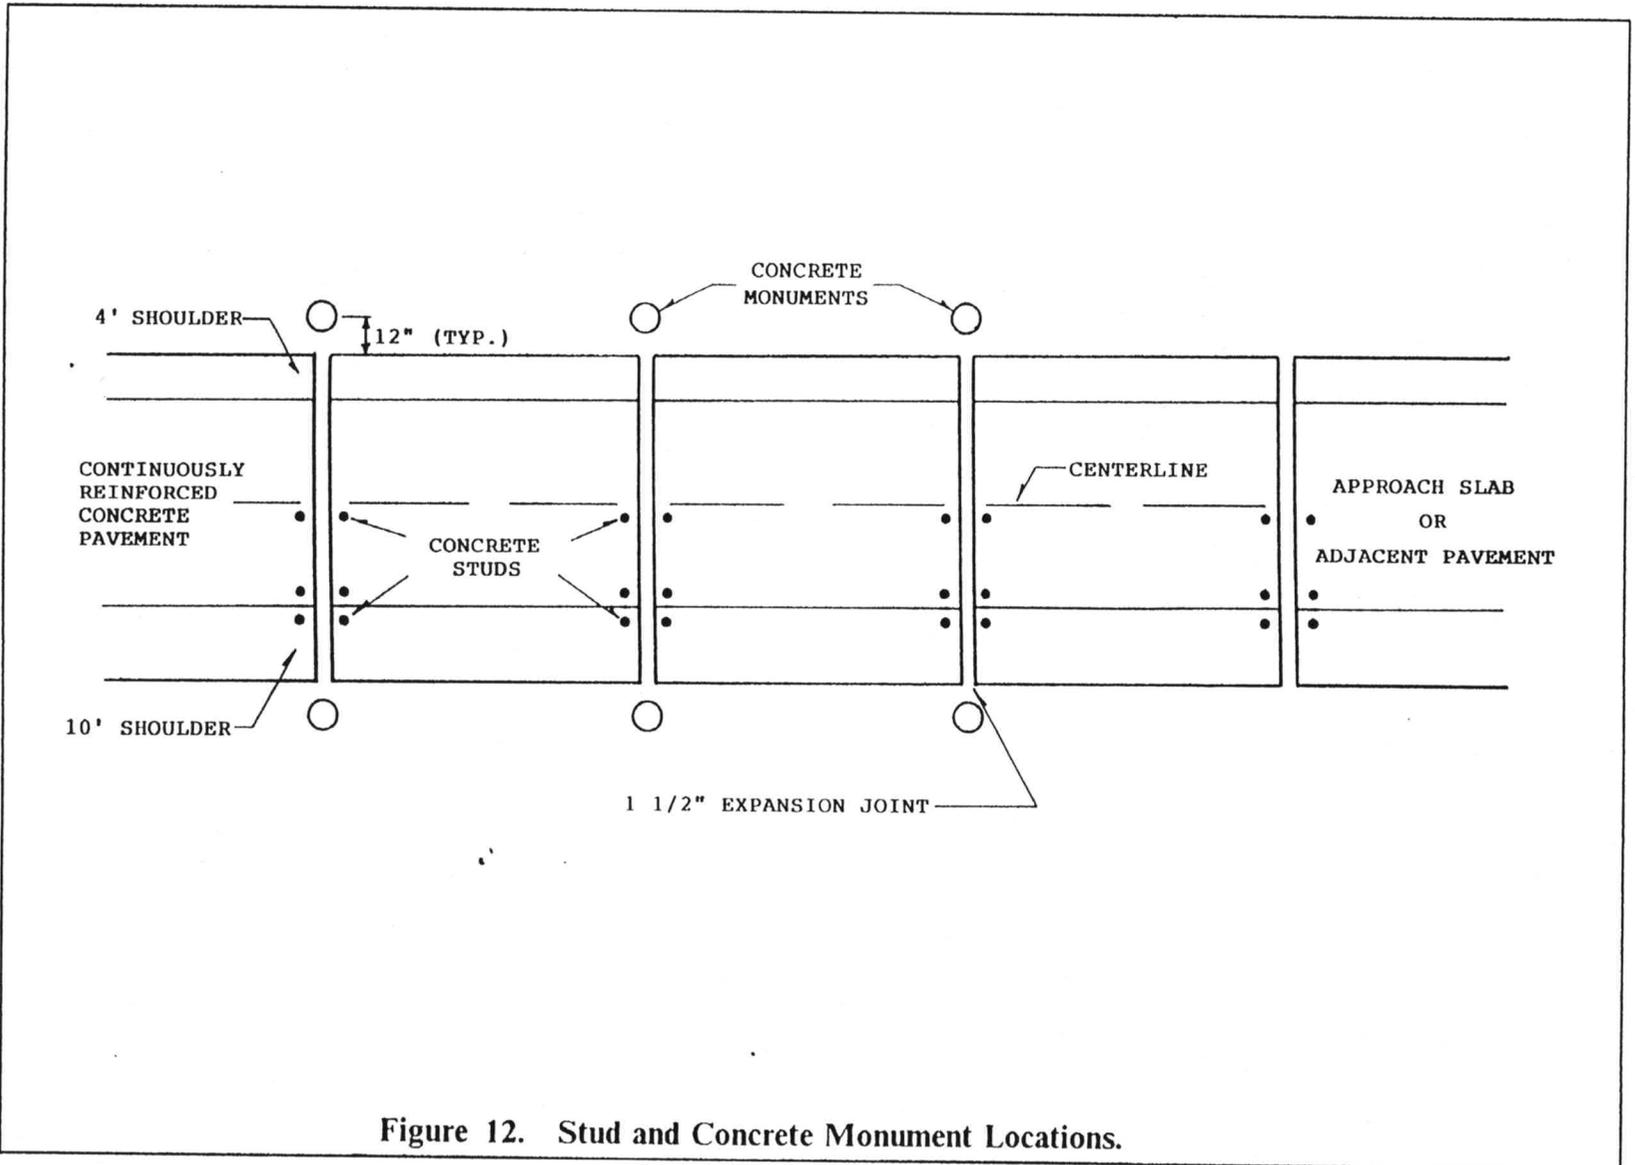
Figure 12. Stud and Concrete Monument Locations.

Six pavement studs were installed at each joint, approximately 3 inches x 3 inches from the pavement corner, to be used in conjunction with monitoring joint width movement as shown in Figure 12. Stud installations and initial measurements were performed in April 1990 in the westbound lanes and in December 1991 in the eastbound lanes. In both cases, the installations were made prior to any public traffic use of the new pavement.

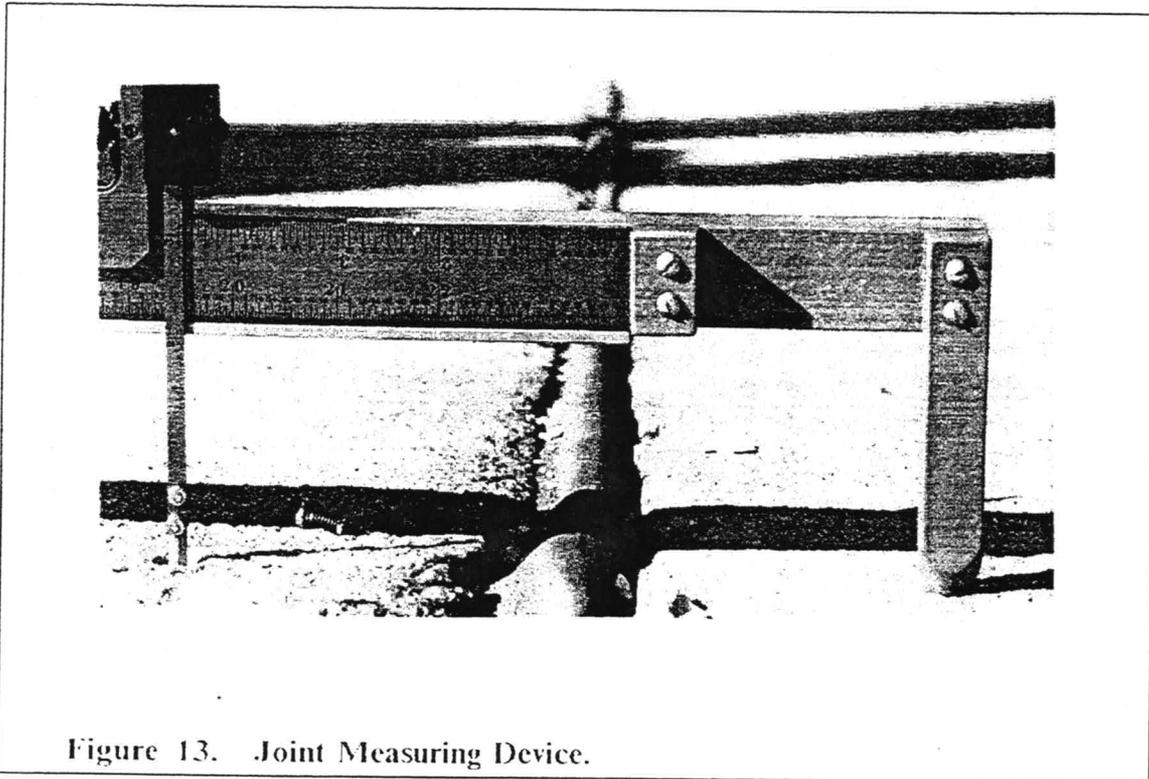
Figure 13. Joint Measuring Device.

A pavement joint monitoring device is used to perform the seasonal measurements of the pavement studs. This device has a measurement arm with a fixed end which can be placed into a stud location. A moveable pointer is placed over the longitudinally opposing stud and a measurement is made to the nearest 1/32nd of an inch (Figure 13). The measurement arm can be leveled, allowing for true horizontal measurements.

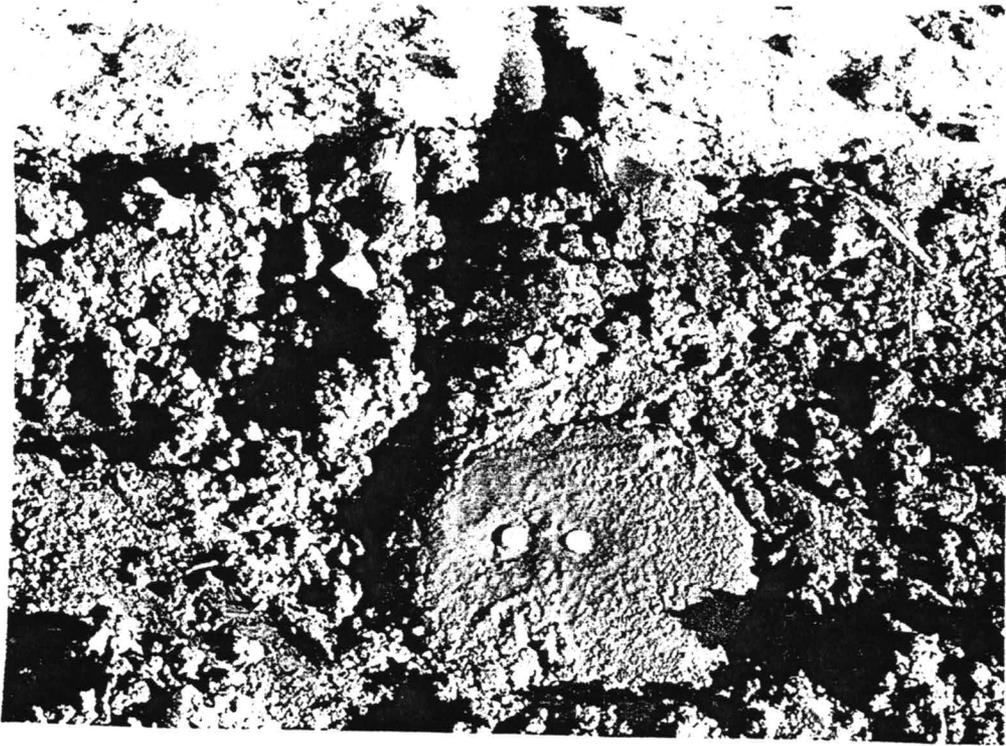
**Figure 14. Concrete Monument with PK Nails Set.**

The concrete monuments were centered on the joint and placed approximately 1 foot beyond the outside and inside shoulders (Figure 14). These locations were augered to a depth of 2 feet and filled with concrete. The monuments were formed using 6 inch diameter concrete cylinder molds with the bottom cut out. This provided a smooth rim to finish the concrete.

While the concrete was plastic, PK nails were placed in the monuments corresponding to each face of the joint. The PK nails were placed by using a stringline placed along each face of the joint, running from the corner adjacent to the centerline joint to the corner adjacent to the shoulder joint, for both the inside and outside shoulders.

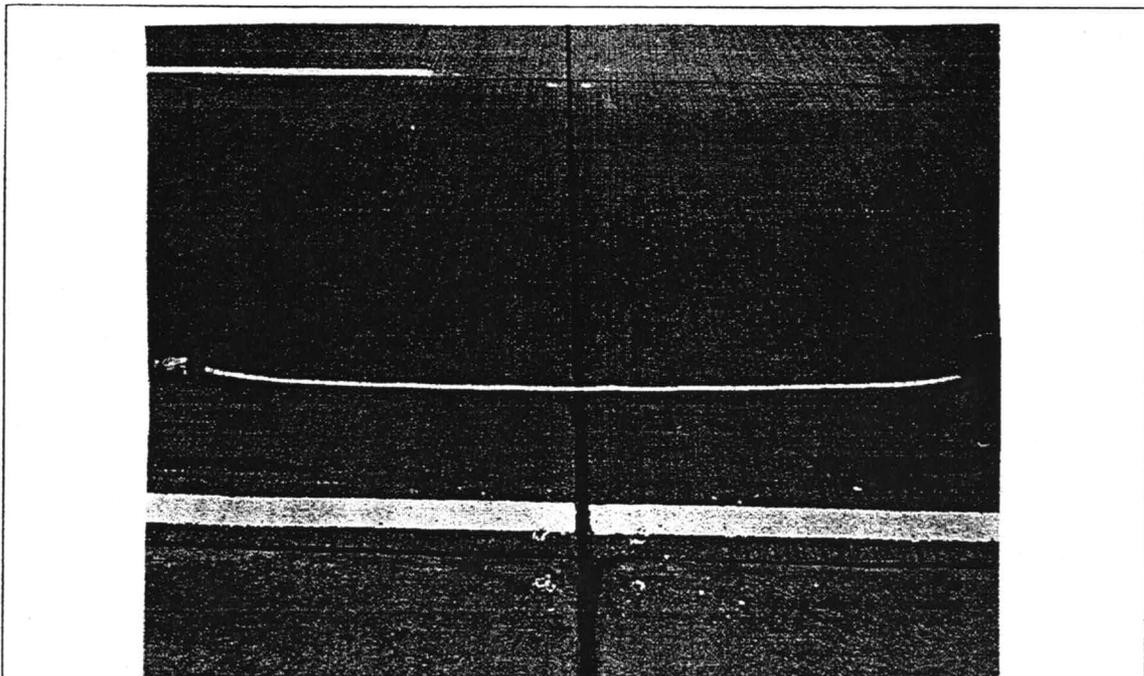
Figure 15. Reflective Cracks Above Sleeper Slab.

One area of interest is located at the end terminal joint of joint location E1 where two transverse cracks are located 2.5 feet from either side of the joint (Figure 15). This terminal joint system is a sleeper slab design. Both cracks extend across the total 24 foot pavement width and are approximately 1/8 inch in width. Each crack corresponds to the location of the sleeper slab located under the joint and extending 2.5 feet to each side of the joint. Construction records indicate that some of the plastic used as a bond breaker was rolled up, thus resulting in the pavement bonding to the sleeper slab.

These reflective cracks will probably cause maintenance problems in the near future. The midjoint M2 had a transverse crack 2 feet from the joint which may be attributed to bonding to the sleeper slab. Joint M1 and the abutting joint showed no signs of cracking above the sleeper slab. The other two sleeper slab locations (E2 and W1) showed no evidence of cracking above the sleeper slab.

The 1992 visual survey revealed certain distresses which will be monitored closely in the future. The reflective cracking above the sleeper slab at joint system E1 can be attributed to construction technique. If increased severity results in the joint being repaired, subsurface investigation will be performed to verify that the pavement had bonded to the sleeper slab at this location.

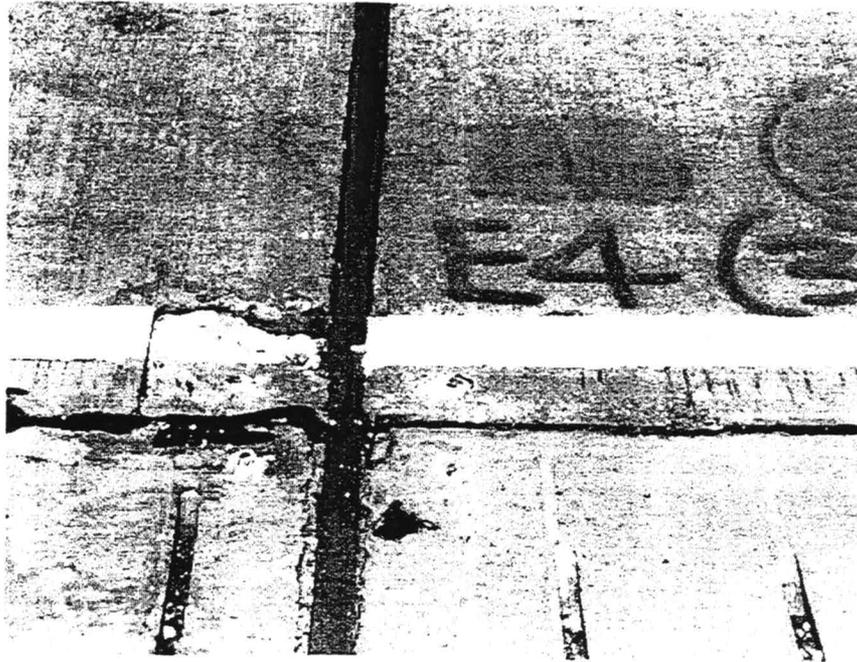
**Figure 16. Corner Punchout Above Dowel Bar.**

The second area of interest was located at terminal joint system E4 where two punchouts in joints M2 and the end joint exist. This terminal joint system is a dowel joint design. At joint M2 of this system there is a punchout section approximately 8 inches square (Figure 16). This punchout is located at the outside lane/shoulder interface and appears to have been patched during construction. This punchout will have to be replaced by maintenance personnel and the pavement stud will have to be replaced. This punchout appears to coincide with the location of the first dowel location next to the pavement shoulder. This joint system was difficult to construct due to the placement of steel and maneuvering the slipform paver around the dowels which were located at each joint.

A small corner spall developed at the end joint which is 10 inches long by 3 inches wide and is on the leave side of this joint and at the outside lane/shoulder interface. A pavement stud is in this spall area but appears to be firmly in place. It is difficult to determine if this spall is reflective of the dowel placement.

The punchouts found at dowel joint system E4 appear to be tied to the dowel placement nearest the pavement shoulder. Possibly the first dowel bar needs to be placed farther from the pavement edge to avoid the punchout. If these sections are repaired, an investigation will be performed to determine the relation between the repaired areas and the dowel spacing.

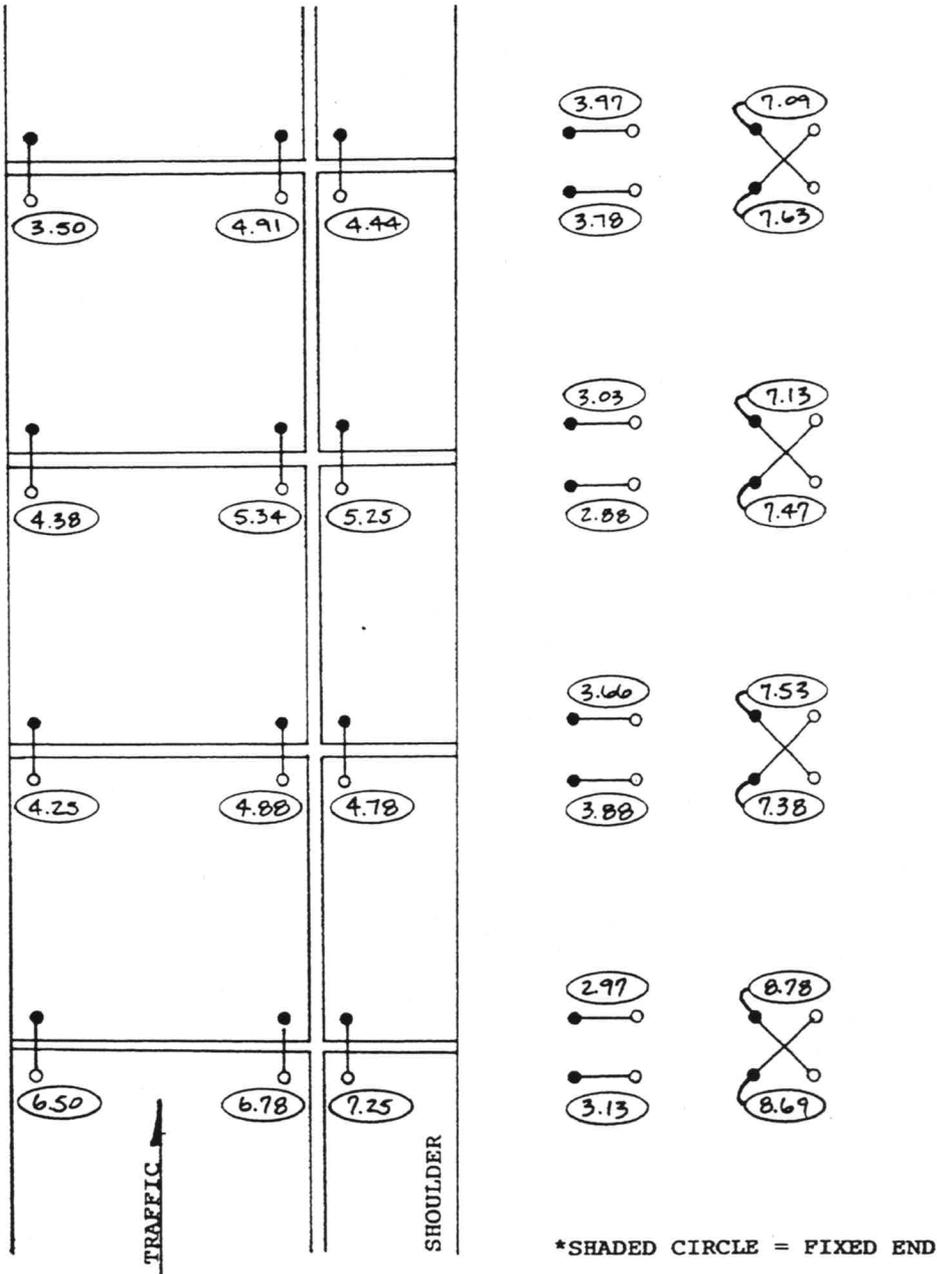
Figure 17. Field Data Sheet for Joint Measuring Device.

A pavement joint measuring device was used to perform the measurements between the pavement studs. Seven readings were recorded for each terminal joint location. These readings included the reading between the studs at the roadway centerline and all measurement combinations between the four studs on the right edge of the pavement and the shoulder. A sample field data sheet is shown in Figure 17 with all readings recorded in inches.

FIELD DATA SHEET

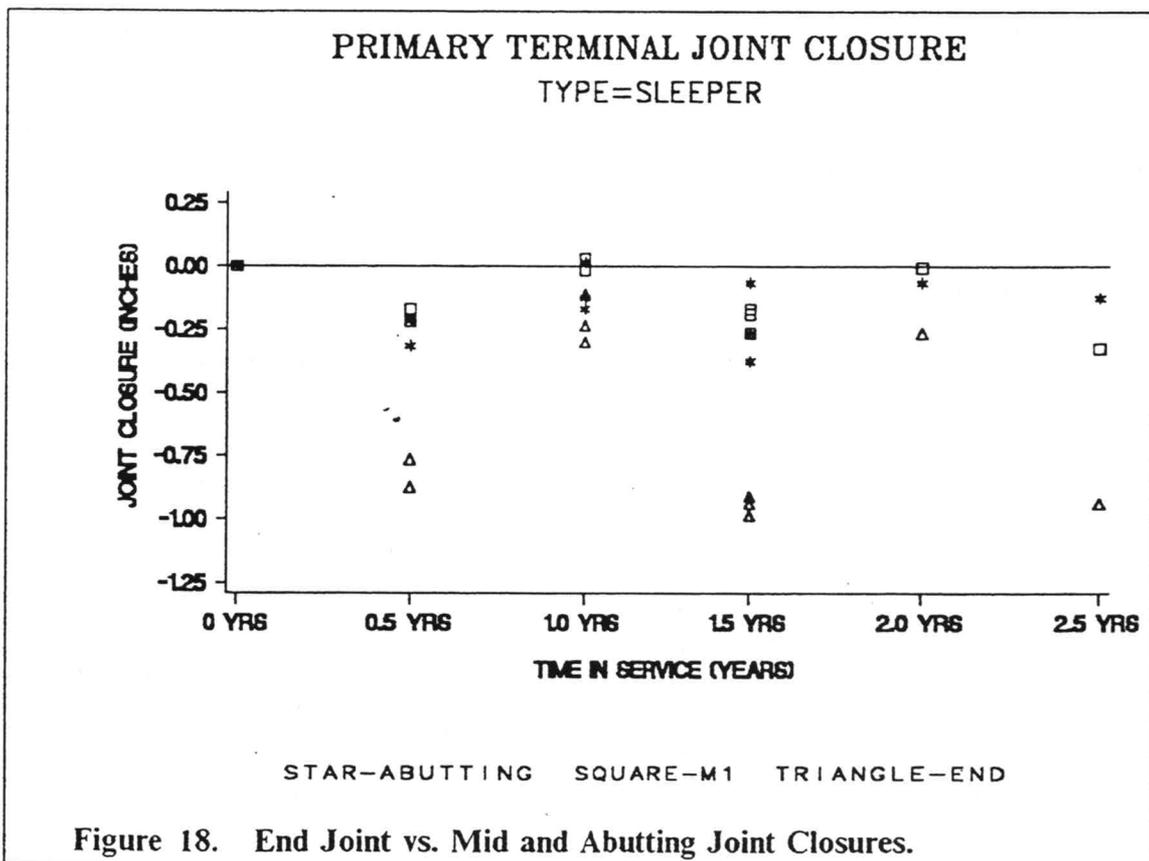
The end joints have had closures ranging from 0.55 inches to 1.14 inches. The midjoints (M1 and M2) and the abutting joints have had small closures compared to the end joints. Figure 18 illustrates the movement of the the sleeper joint system where the end joints move much more than the mid and abutting joints during the hot weather. Similar movements were seen for the open joint system and the dowel joint system.

It should be noted that the end joints did not return to their initial position during the cold weather cycle. This may be attributed to possible permanent creep. The mid and abutting joints nearly returned to their initial position during the cold weather cycles. The movements of the mid and abutting joints can be attributed to thermal expansion and contraction of the sixty foot terminal slabs.

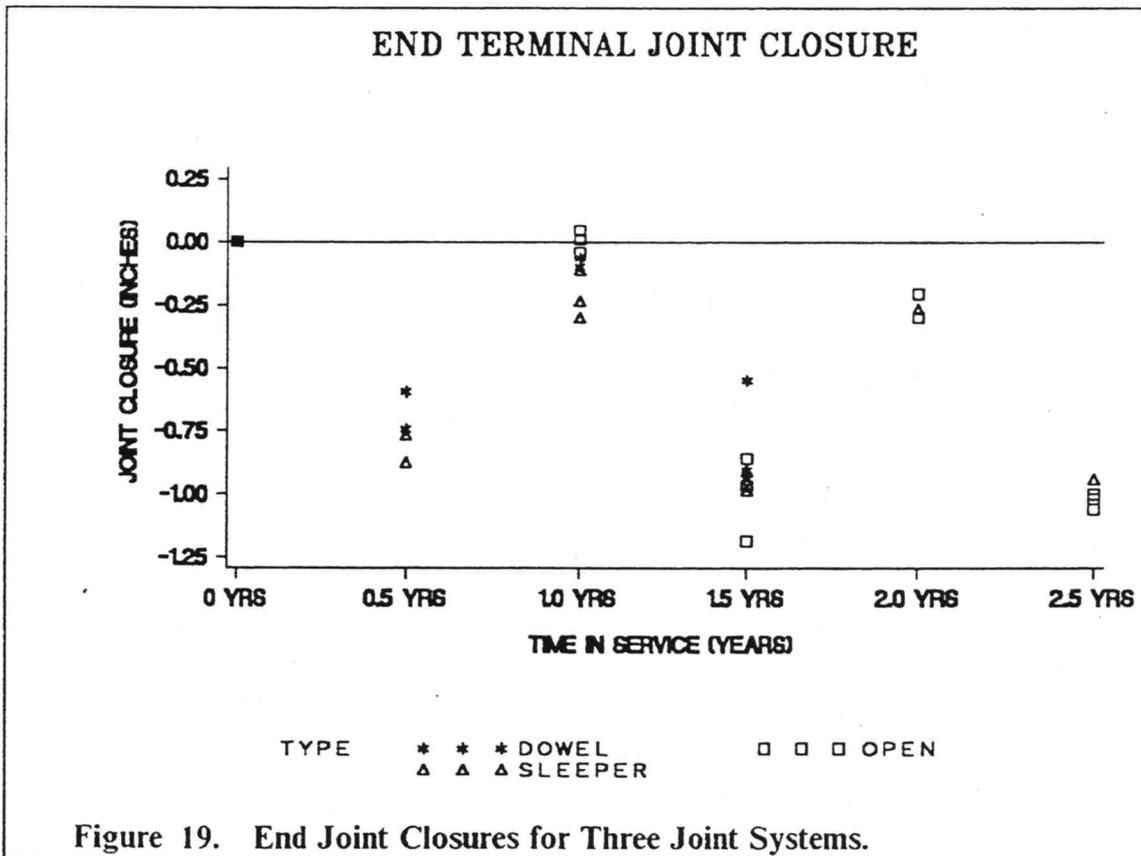
Figure 19 illustrates the difference in closures of the end joints of the three joint system designs. Figures 20, 21, and 22 illustrate the closures of the open, sleeper, and dowel system respectively.

The end terminal joint closures for the three different joint system designs were evaluated. The open joint system exhibited the most closure ranging from 0.77 inches to 1.14 inches. The sleeper system exhibited the the second most closure ranging from 0.76 inches to 0.98 inches. The dowel system had the least closure ranging from 0.52 inches to 0.82 inches.

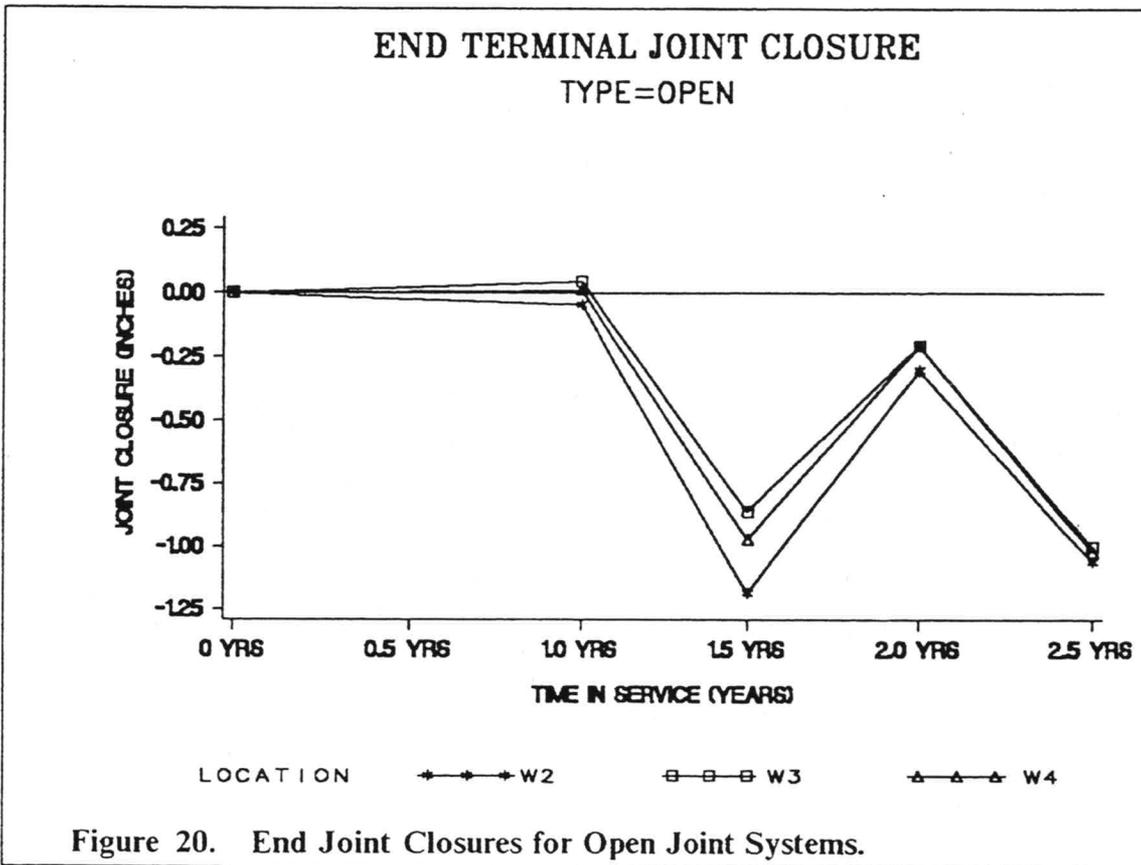
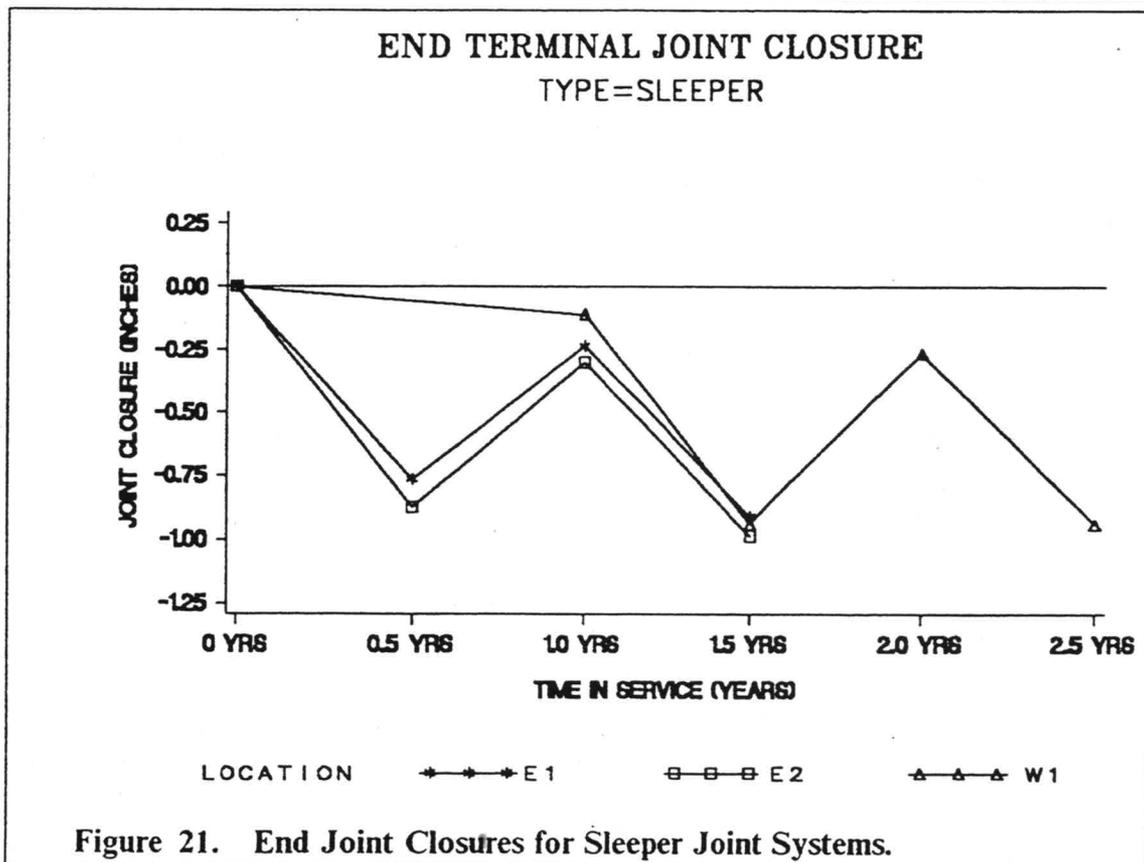
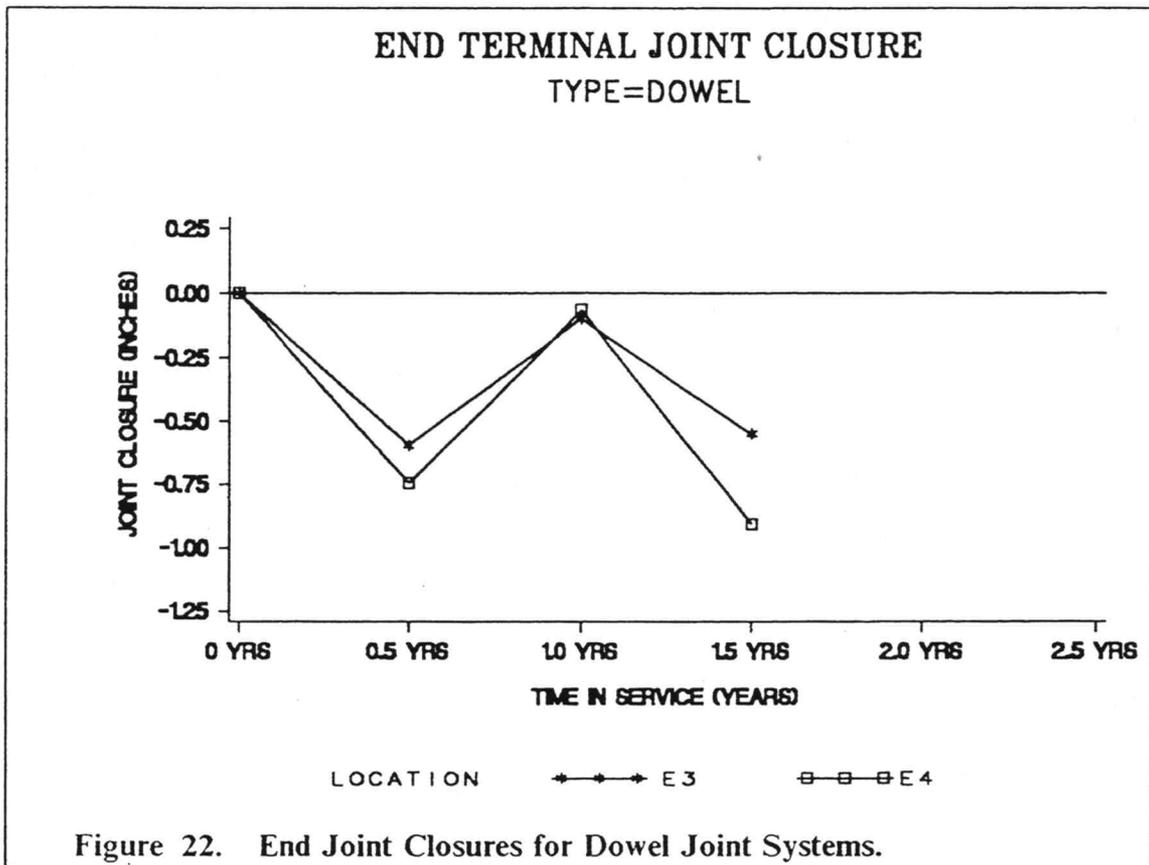
All joints exhibited a minimum closure of 0.50 inches from winter to summer. One joint of note was the end joint at W4 (open joint). In Summer 1991 it was observed to be closed shut with a joint closure of 1.14 inches while in Summer 1992 this joint had a closure of 1.01 inches.

The three joint systems are performing similarly in their expansion and contraction during the warm and cold weather cycles. Also, it should be noted that the Winter 1992 indicated that none of the end joints had returned to their initial open position.

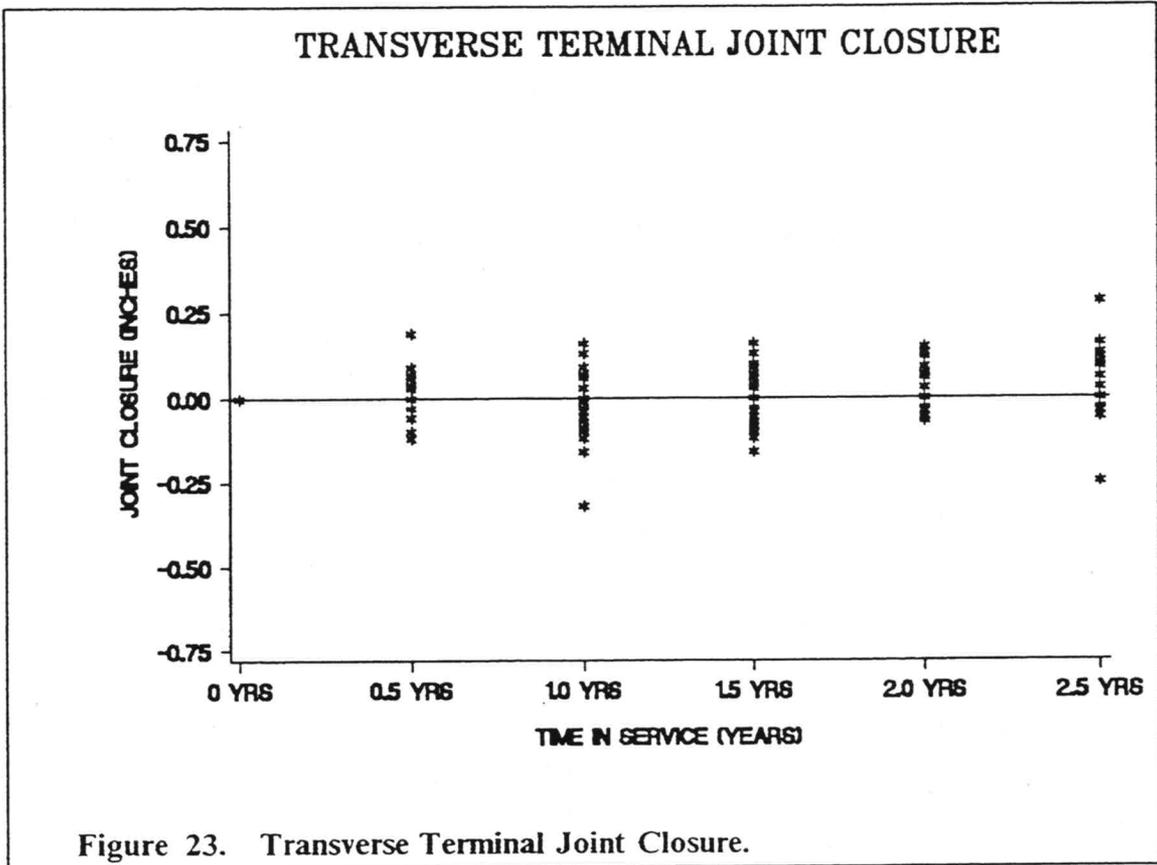
The stud measurements indicated minimal transverse movement between the CRCP pavement and the shoulder. These movements were mainly 0.05 inches to 0.10 inches which can be attributed to slab expansion or to test reading error. Figure 23 indicates the transverse movements for all of the joint systems.

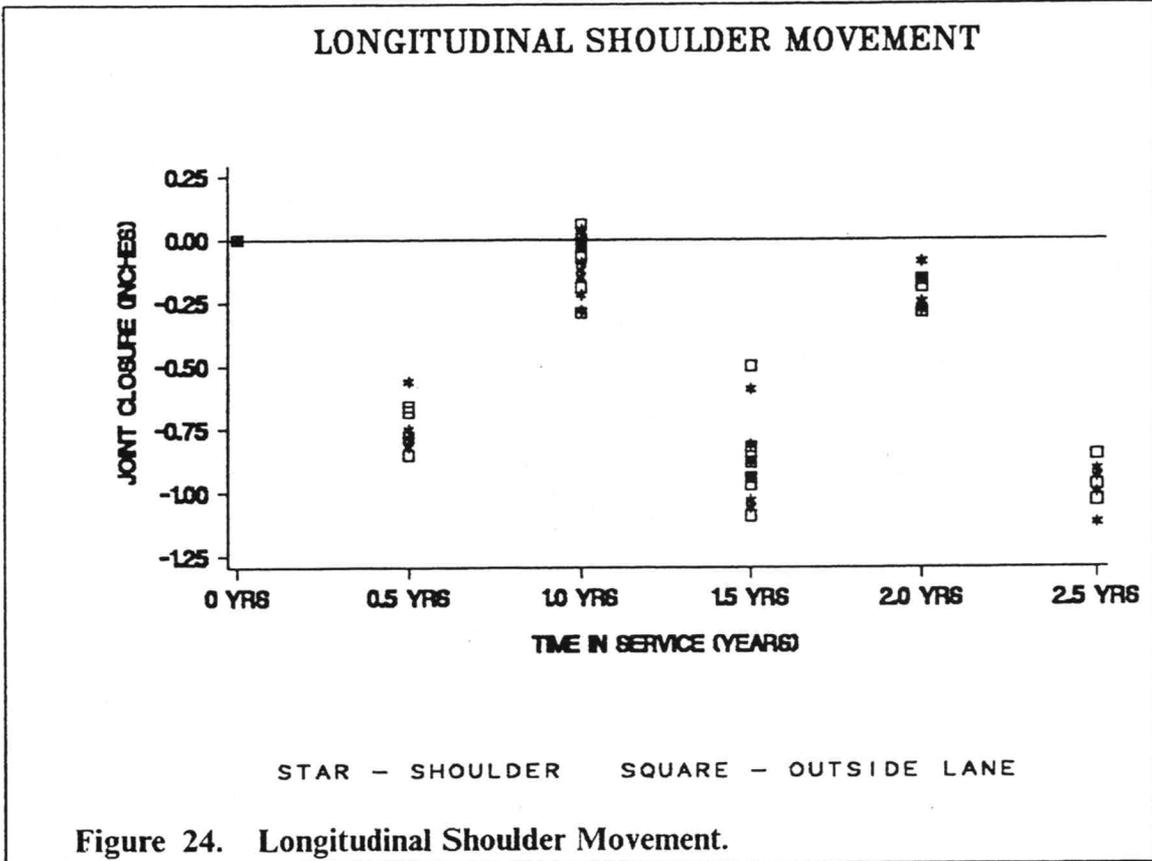
The stud measurements also indicated the shoulders are moving longitudinally with the CRCP pavement. This movement is indicated in Figure 24 for all of the joint systems. This movement was expected since the shoulders are tied to the pavement.
