**SCHOOL OF  
CIVIL ENGINEERING  
OKLAHOMA STATE UNIVERSITY**

PERFORMANCE OF EPOXY-COATED STEEL  
IN CONTINUOUSLY REINFORCED  
CONCRETE PAVEMENT

Report No. FHWA/OK 91(11)

August, 1991

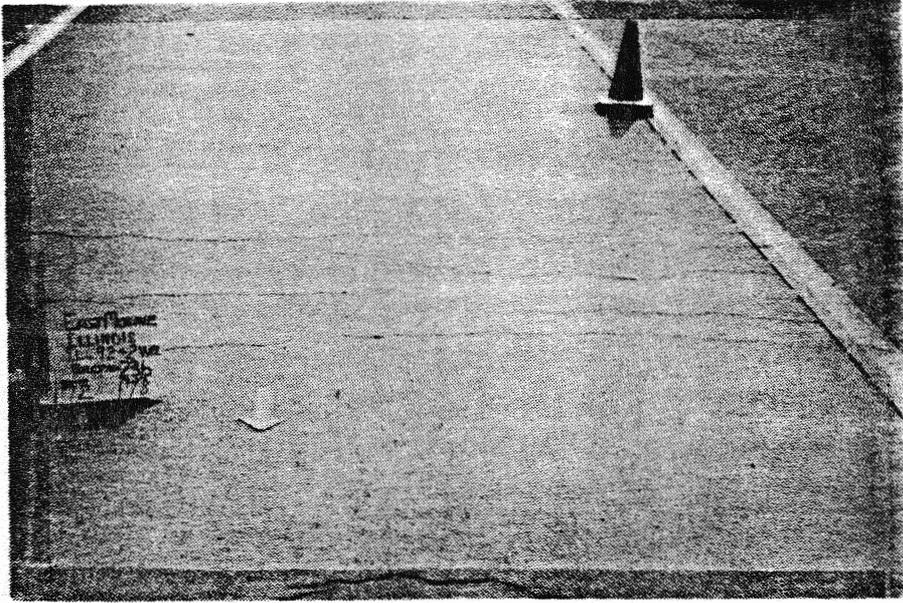
Figure 3. Minor Localized Cracking [28]

There are many factors which cause structural failures such as cracking, spalling, and pumping in reinforced pavements. Among these factors are temperature, type of subgrade and subbase, properties of concrete and percentage of steel. Construction season and early curing temperature are found to affect early crack development but not final cracking. Figures 3 through 11 [from Ref. 28] show various types of pavement failures.

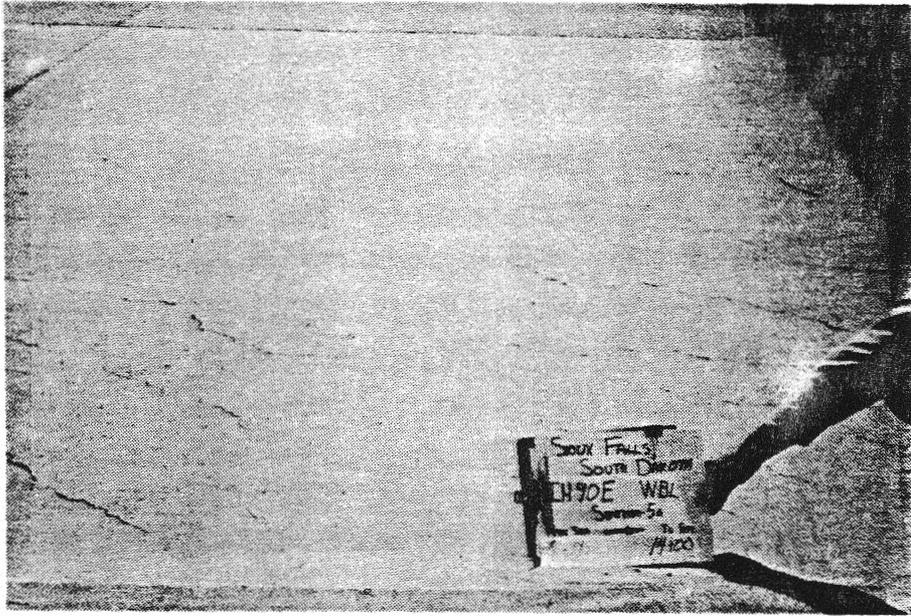
Figure 4. Severe Localized Cracking [28]

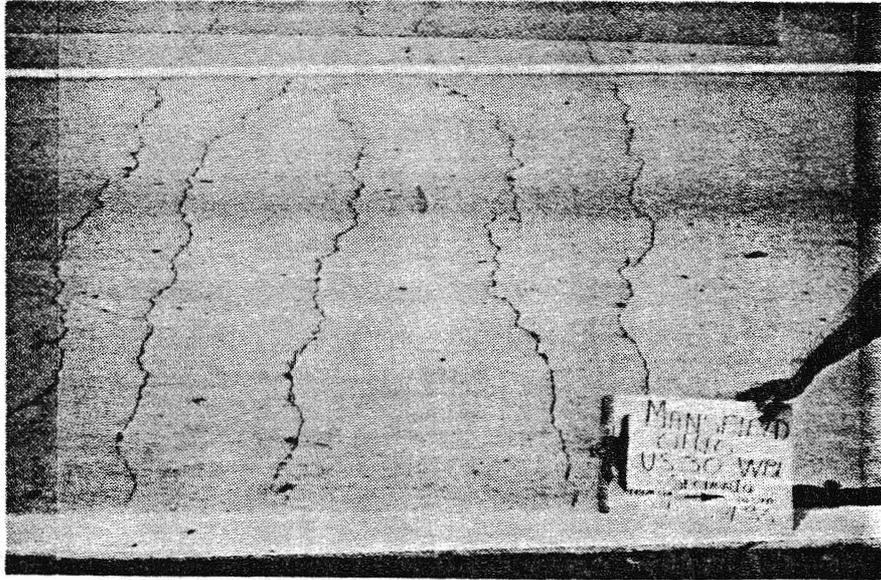
Figure 5. Severe Transverse Cracking [28]

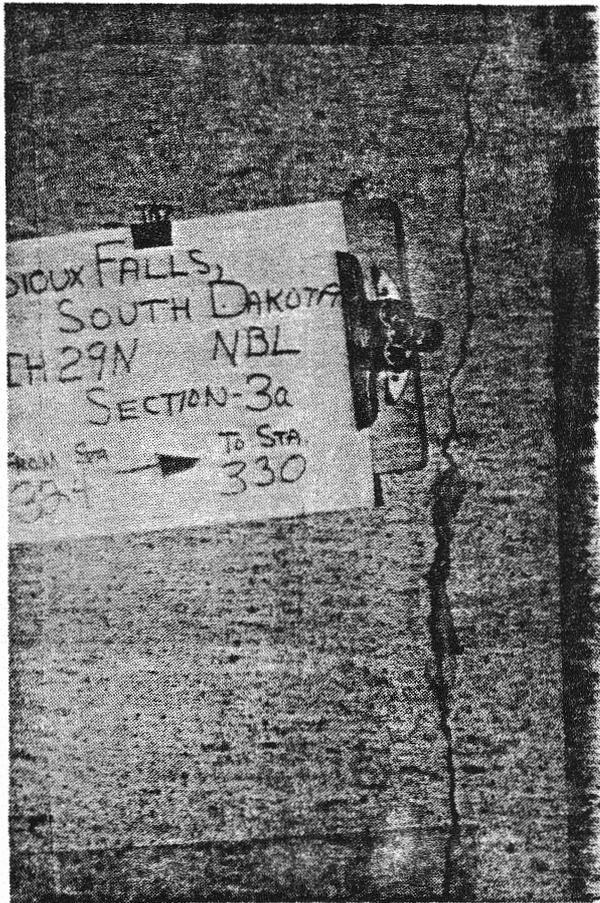
Figure 6. Minor Spalling [28]

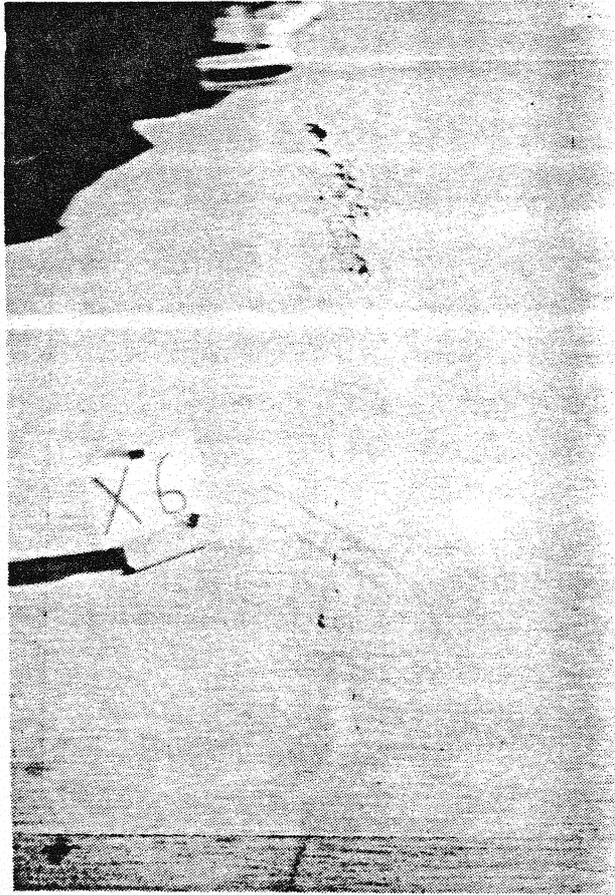
Figure 7. Severe Spalling [28]

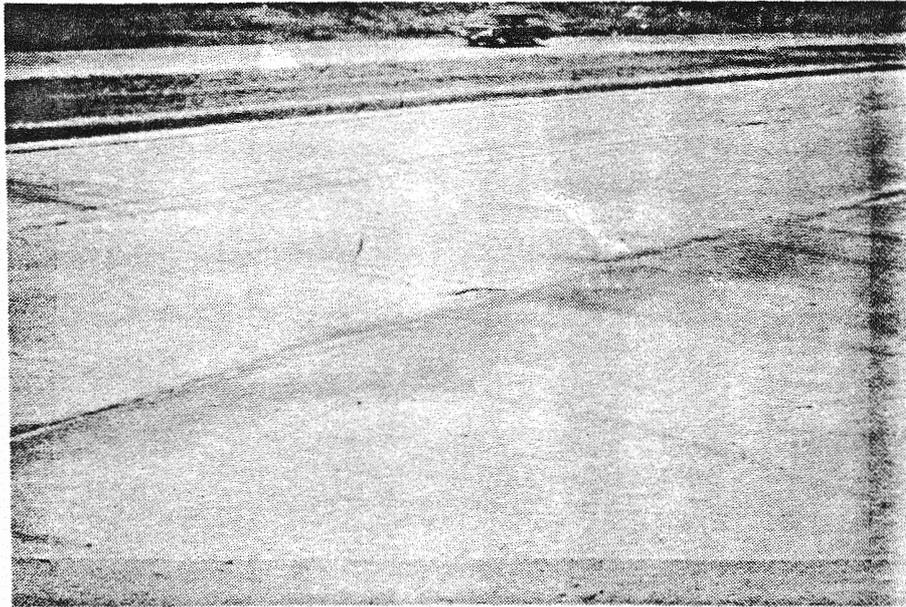
Figure 8. Minor Pumping [28]

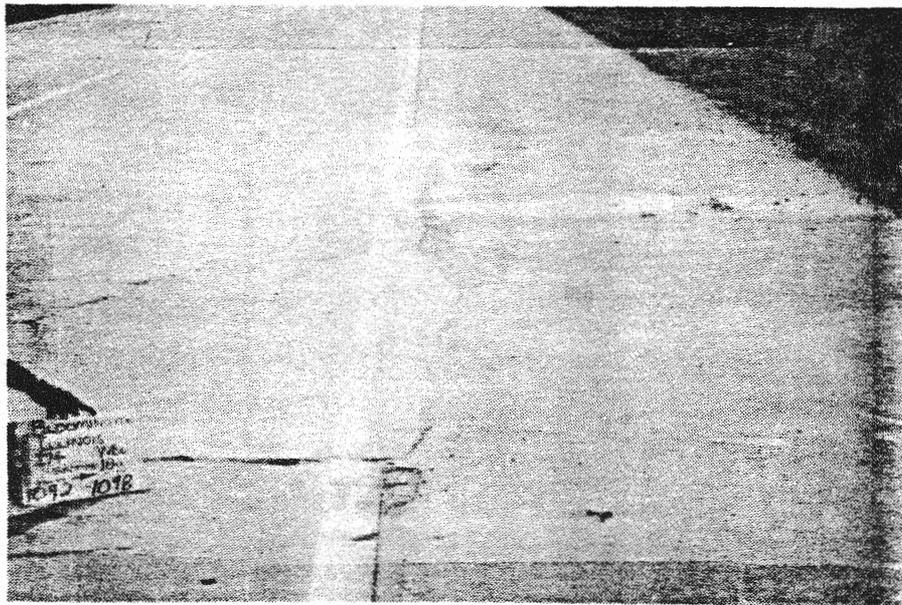
Figure 9. Severe Pumping [28]

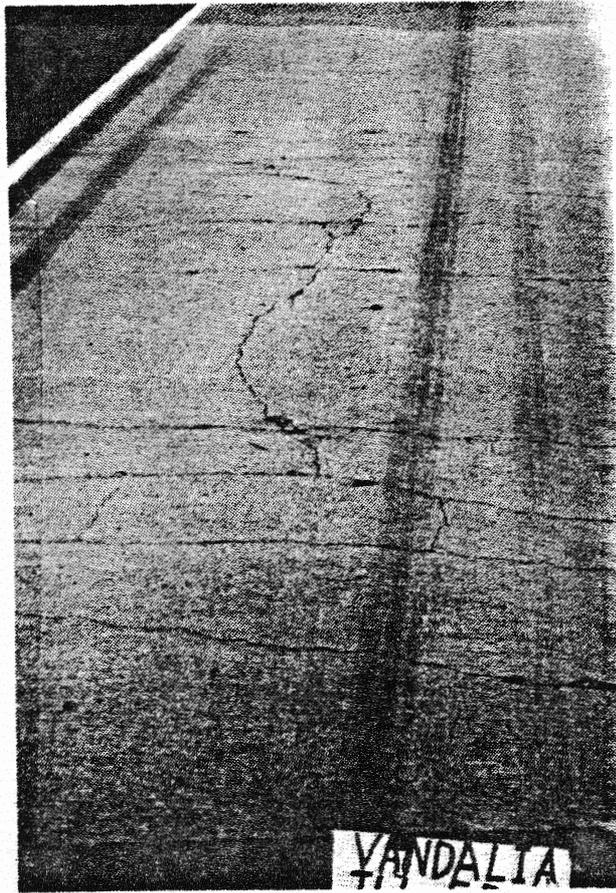
Figure 10. Minor Punchout [28]

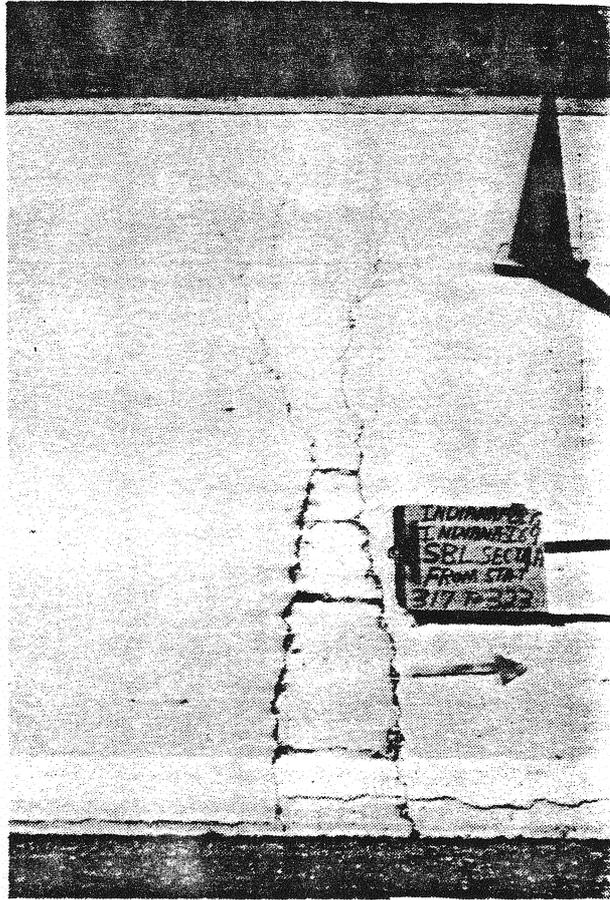
Figure 11. Severe Punchout [28]

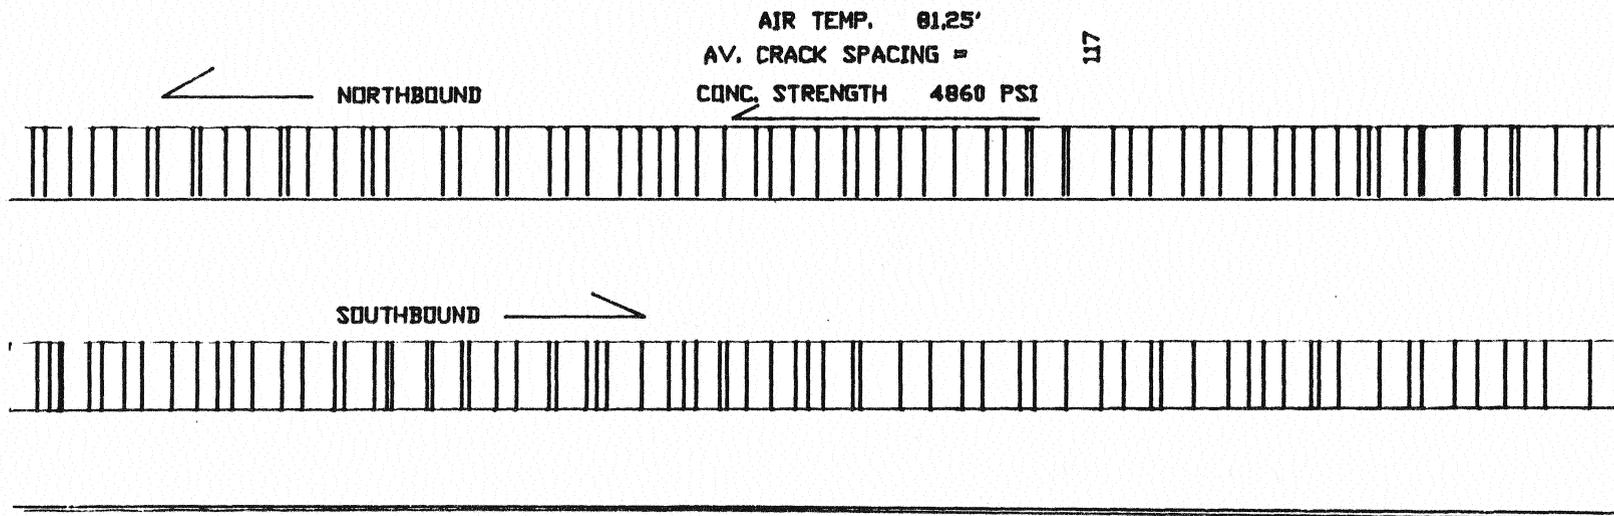
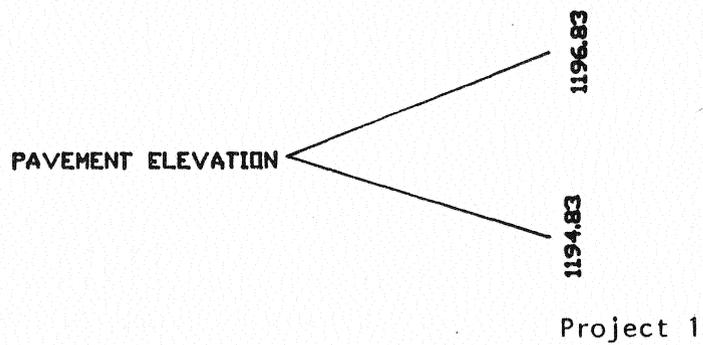
Figure 13. Typical 500-Ft Sections of Projects 1 and 2

AIR TEMP. = 74'  
AV. CRACK SPACING = 11.74'  
CONCRETE STRENGTH = 5400 PSI

AIR TEMP. = 95'  
AV. CRACK SPACING = 10.18'  
CONC. STRENGTH = 5390 PSI

Crack maps for typical 500-ft lengths of both projects are shown in Figure 13. The figure is based on the first crack survey. Regular spacing of cracks on Project 2 is due to the young age of the pavement. At the time of the first survey, most of the cracks in Project 2 originated at the end of transverse sawcuts made in unreinforced shoulders. In both projects, additional cracking occurred between the first and second surveys. Figure 14 shows typical cracks in the pavements.

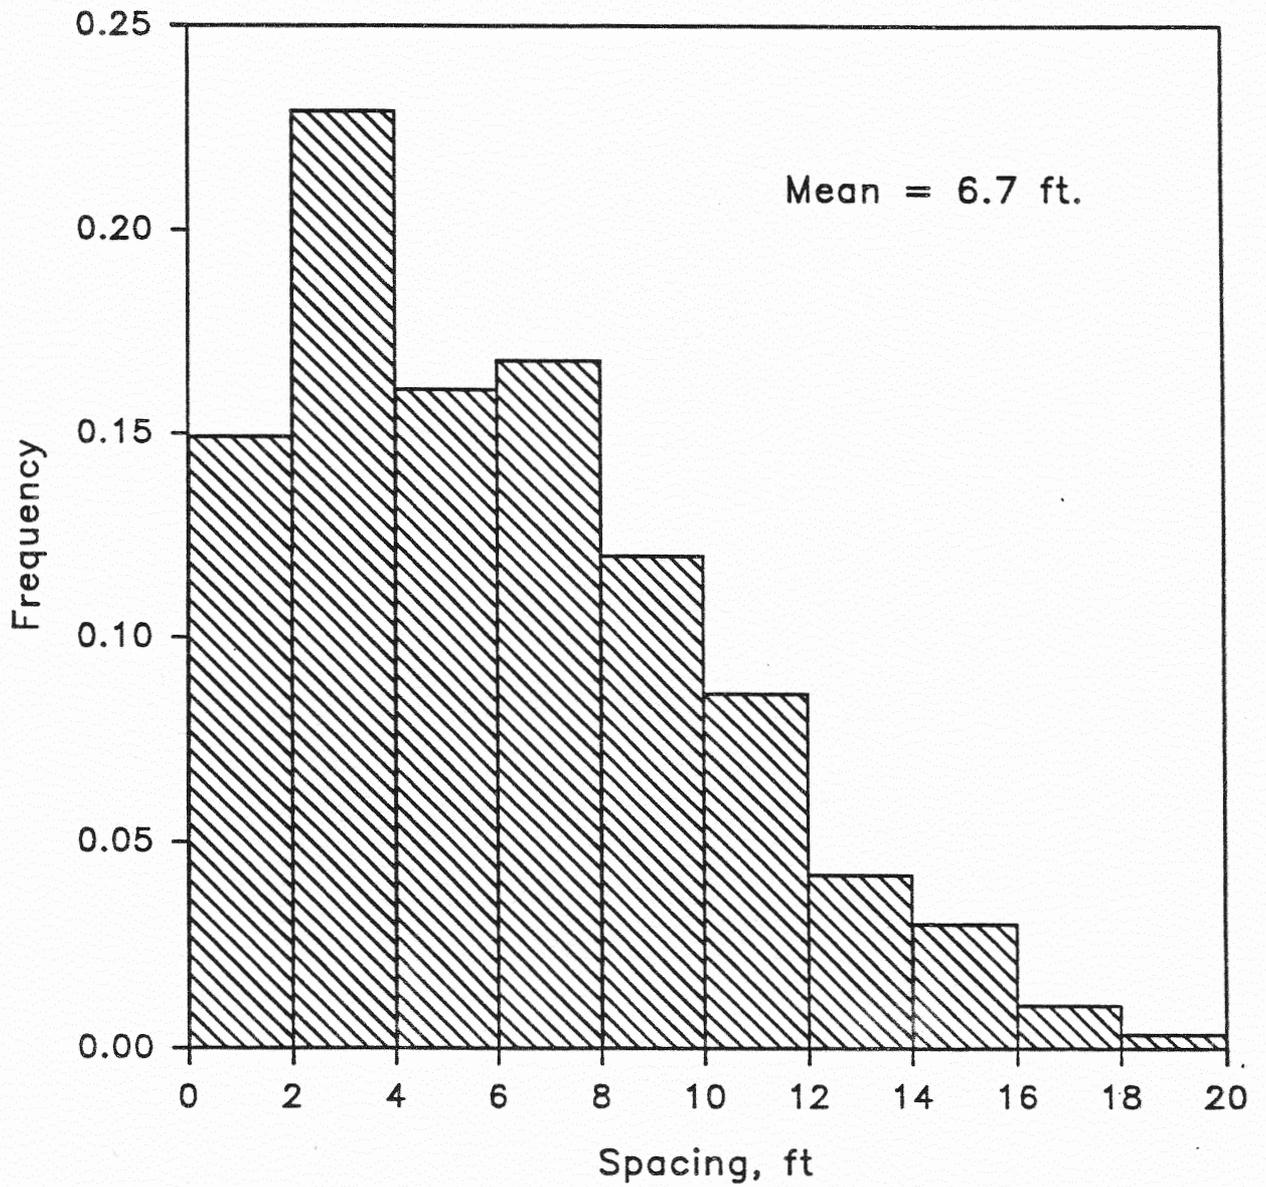
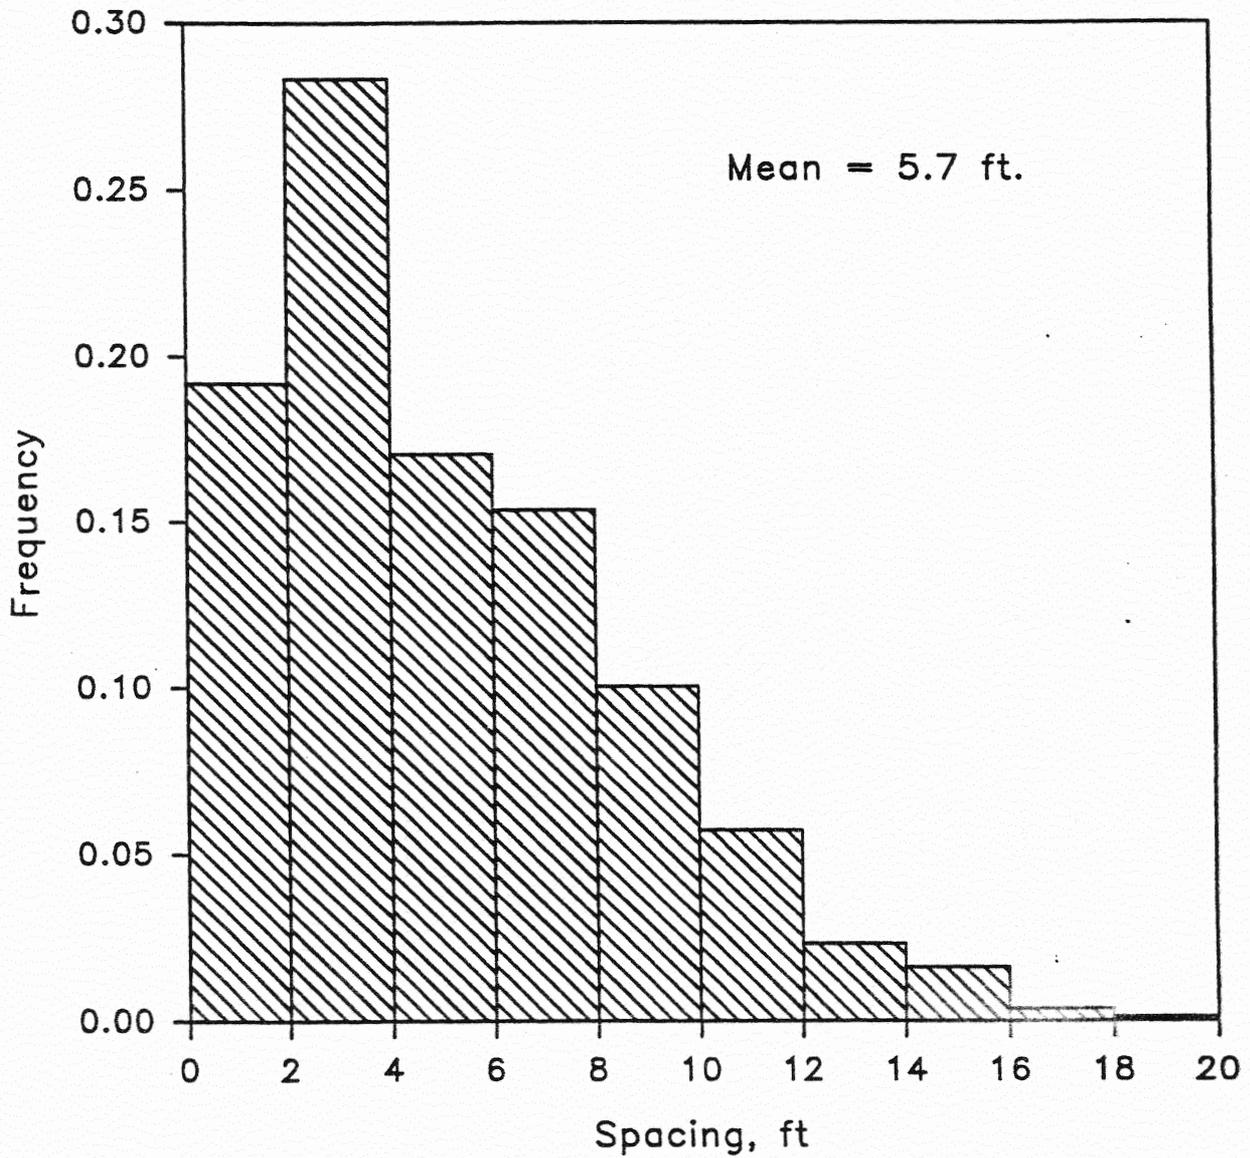
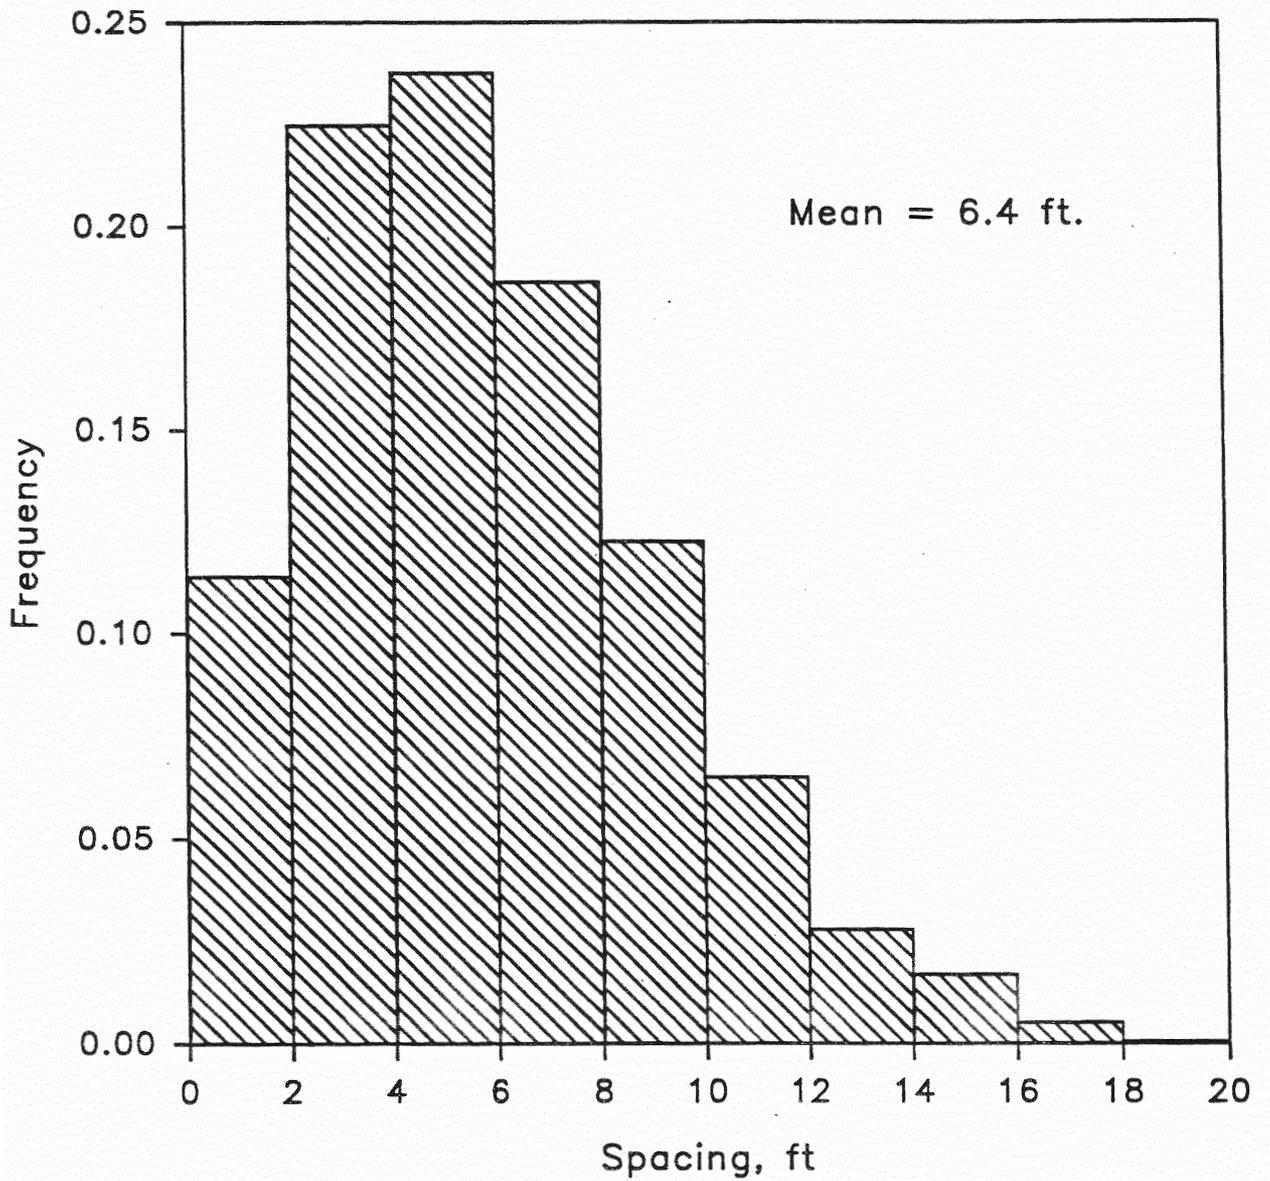
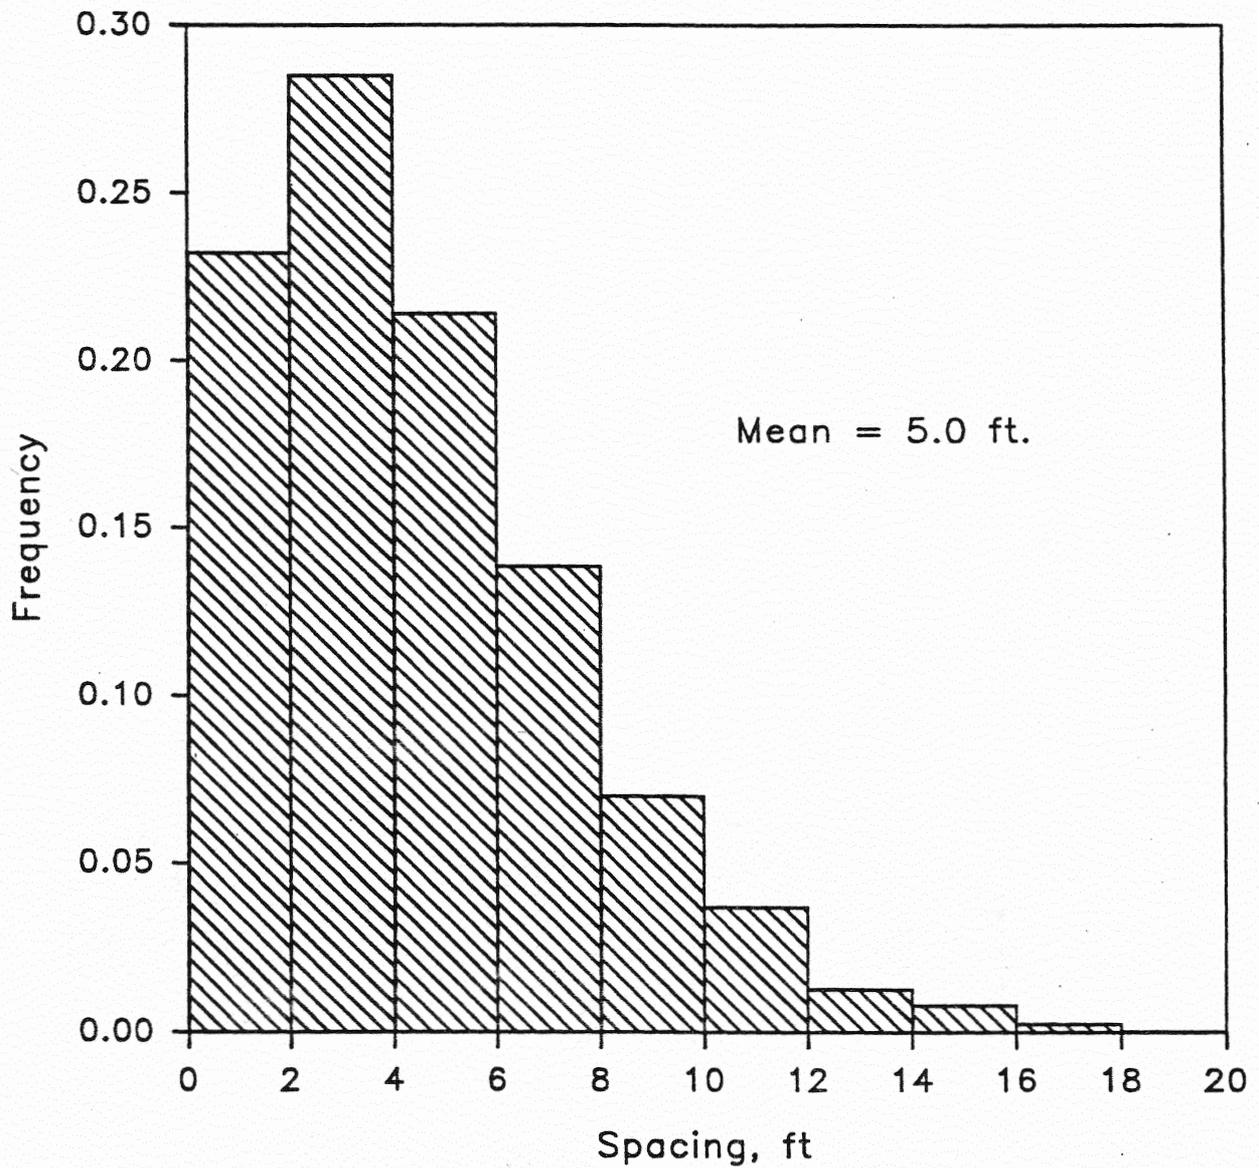
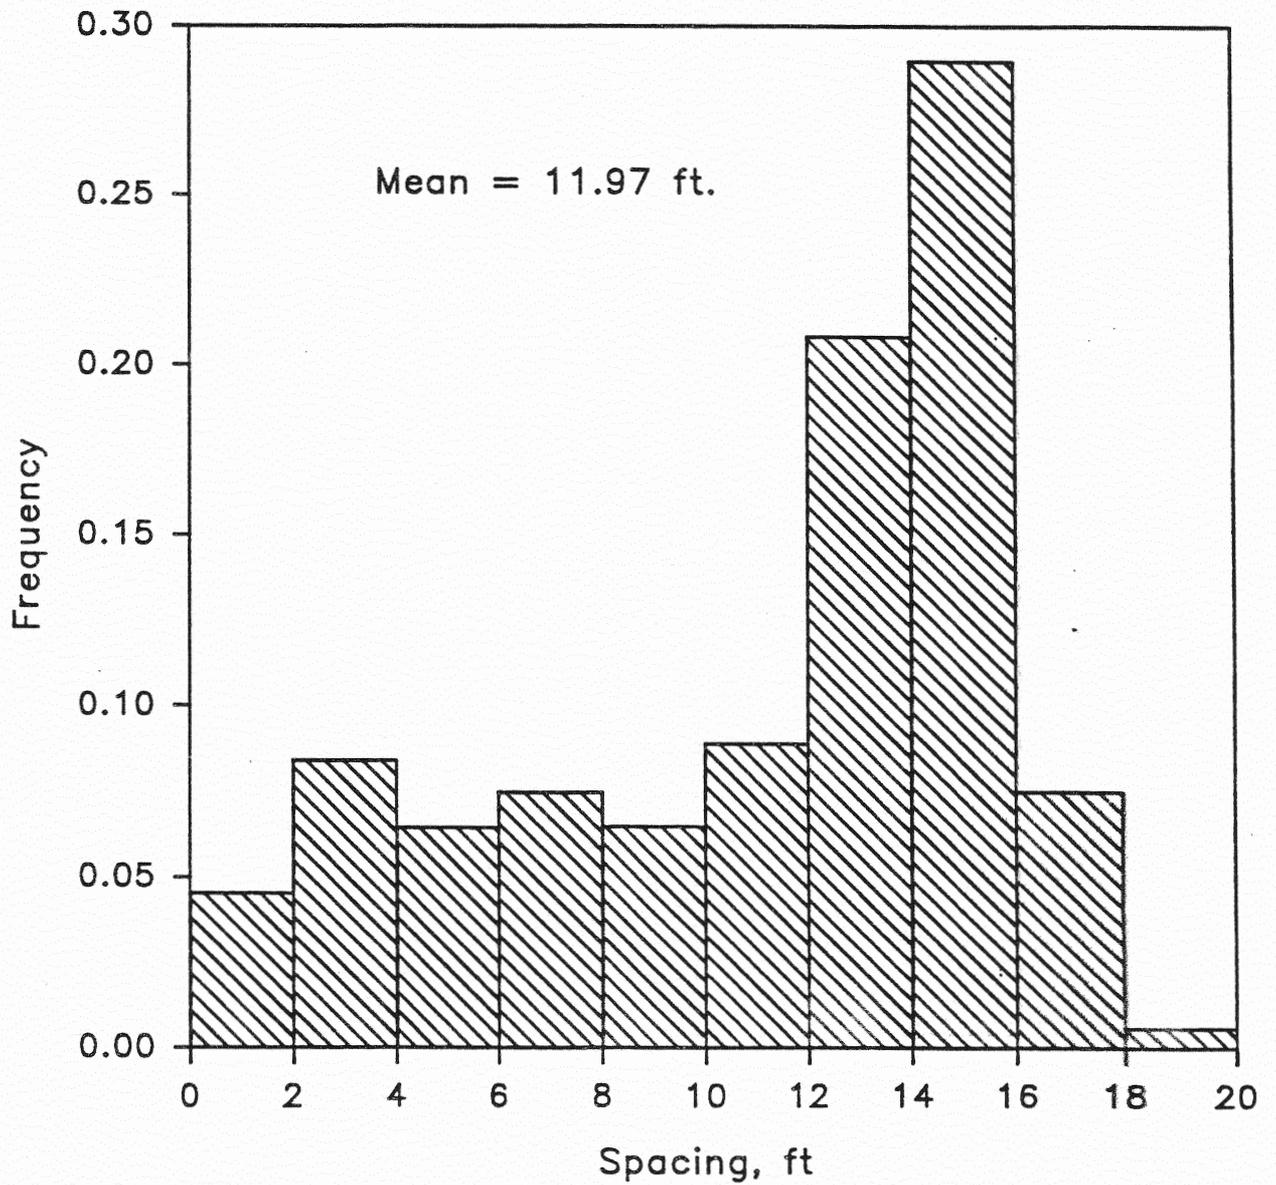
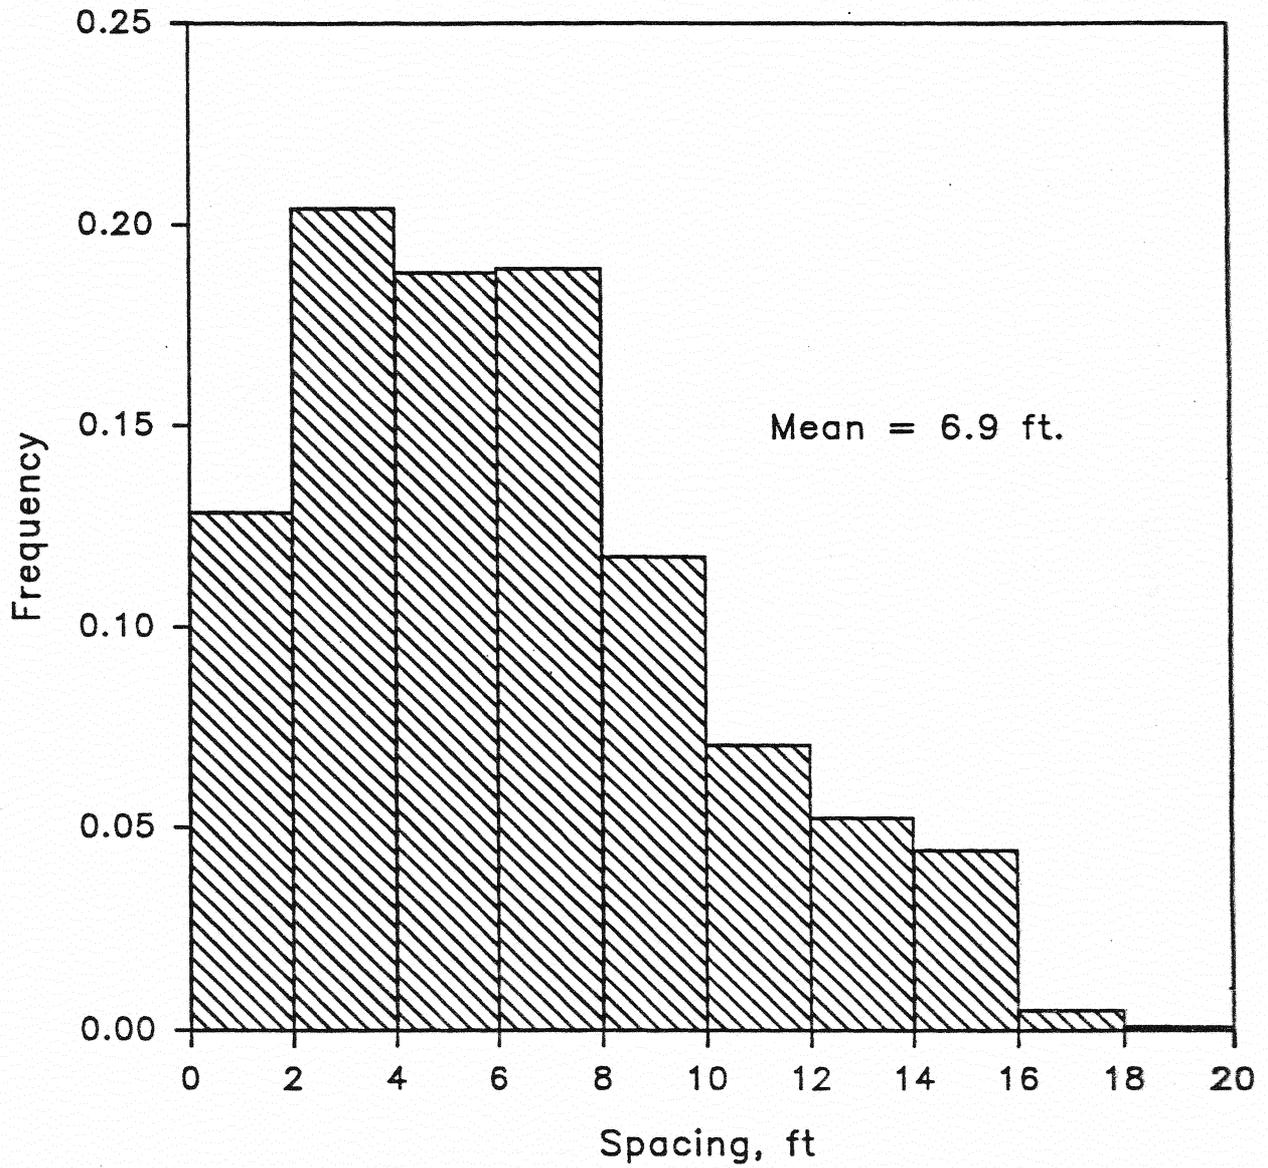
Figure 15. Histogram for Project 1, Northbound, First Survey

Figure 16. Histogram for Project 1, Northbound, Second Survey

Figure 17. Histogram for Project 1, Southbound, First Survey

Figure 18. Histogram for Project 1, Southbound, Second Survey

Figure 19. Histogram for Project 2, Northbound, First Survey

Figure 20. Histogram for Project 2, Northbound, Second Survey

Histograms of crack spacing for surveys one and two on north- and southbound lanes are shown in Figures 15 through 22. By comparing these figures it can be seen that (1) crack spacing decreases with time (that is, more cracks develop), and (2) average crack spacing for the northbound lanes (uncoated steel) is slightly greater than average spacing for the southbound lanes (epoxy-coated steel). A statistical analysis of the data from the second survey indicates that the average crack spacings for the north- and southbound lanes are different at the 5% significance level for Project 1 but not for Project 2. The independent t-test

Comparing the behaviors of CRCP with coated and uncoated steel at a more subjective level, it should be noted that the range of spacings is almost identical and that the spacing with the highest frequency is always in the 2- to 4-ft interval. The age of the pavement should also be considered when conclusions are drawn from the data. It is likely that cracking, especially for Project 2, has not stabilized. Finally, the comparison between north- and southbound lanes of Project 1 is further clouded by the fact that the steel percentage in the northbound lanes is less than in the southbound lanes.

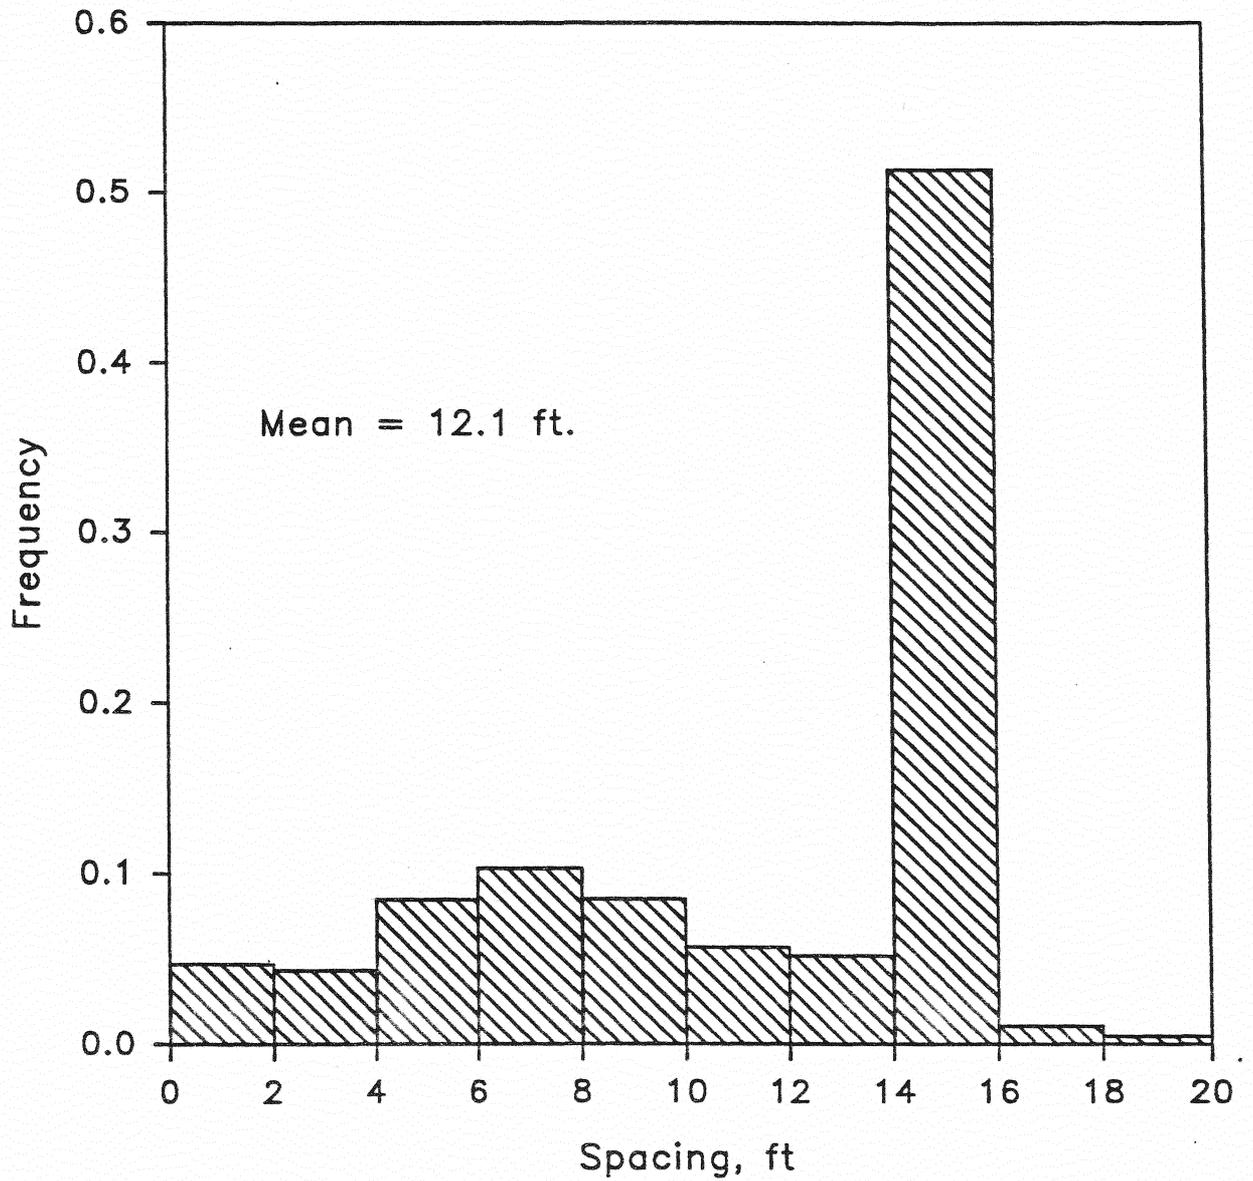
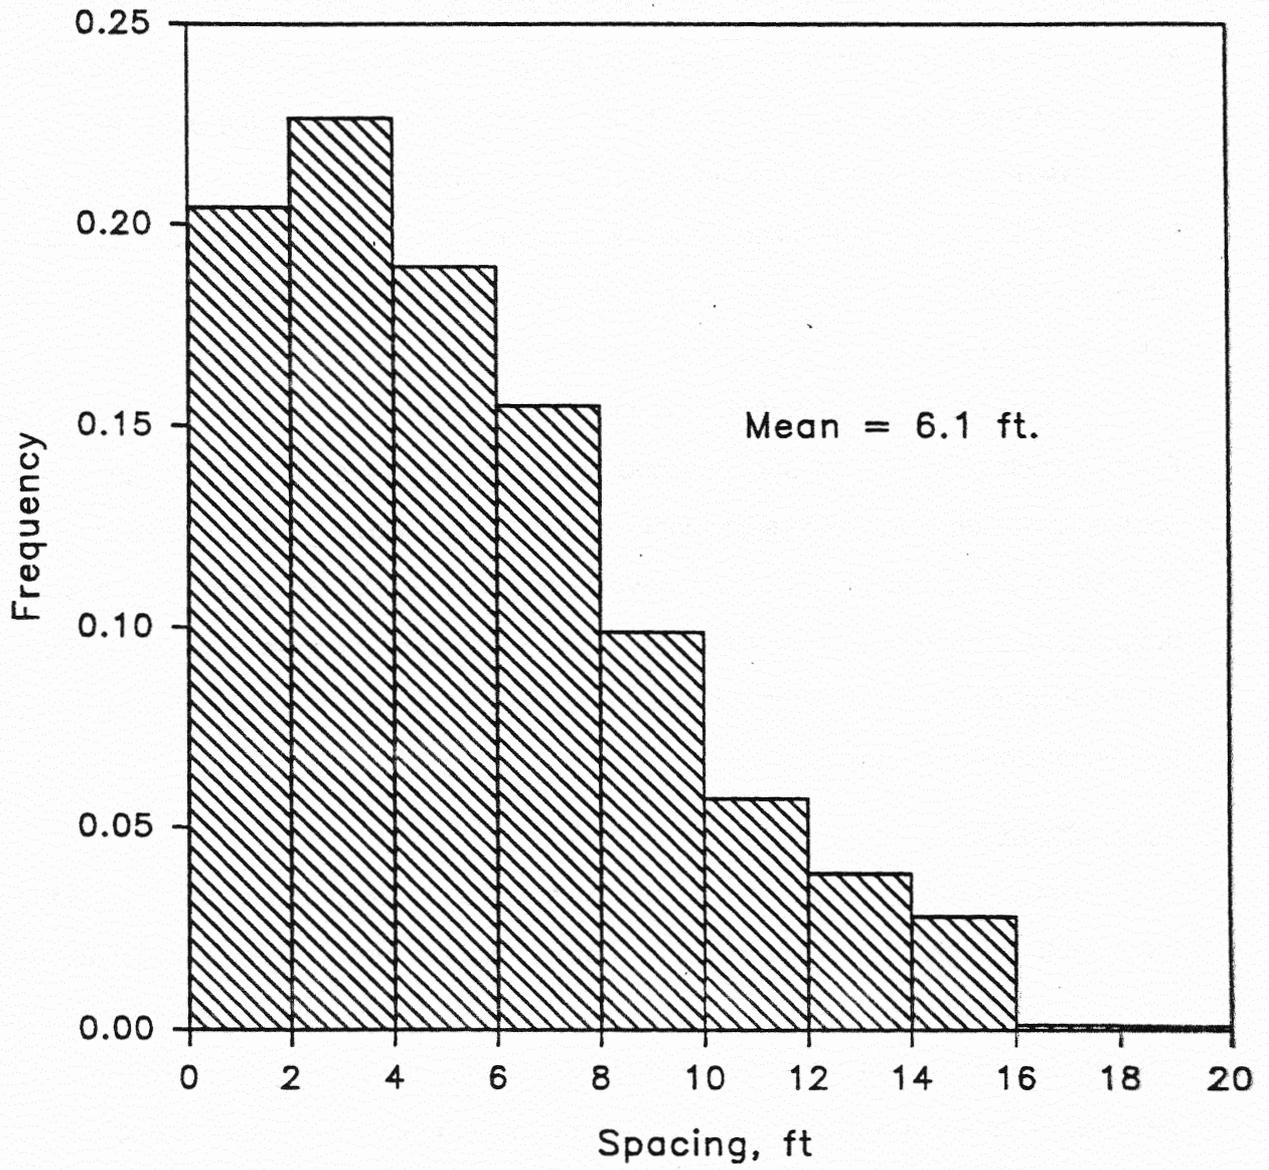
Figure 21. Histogram for Project 2, Southbound, First Survey

Figure 22. Histogram for Project 2, Southbound, Second Survey

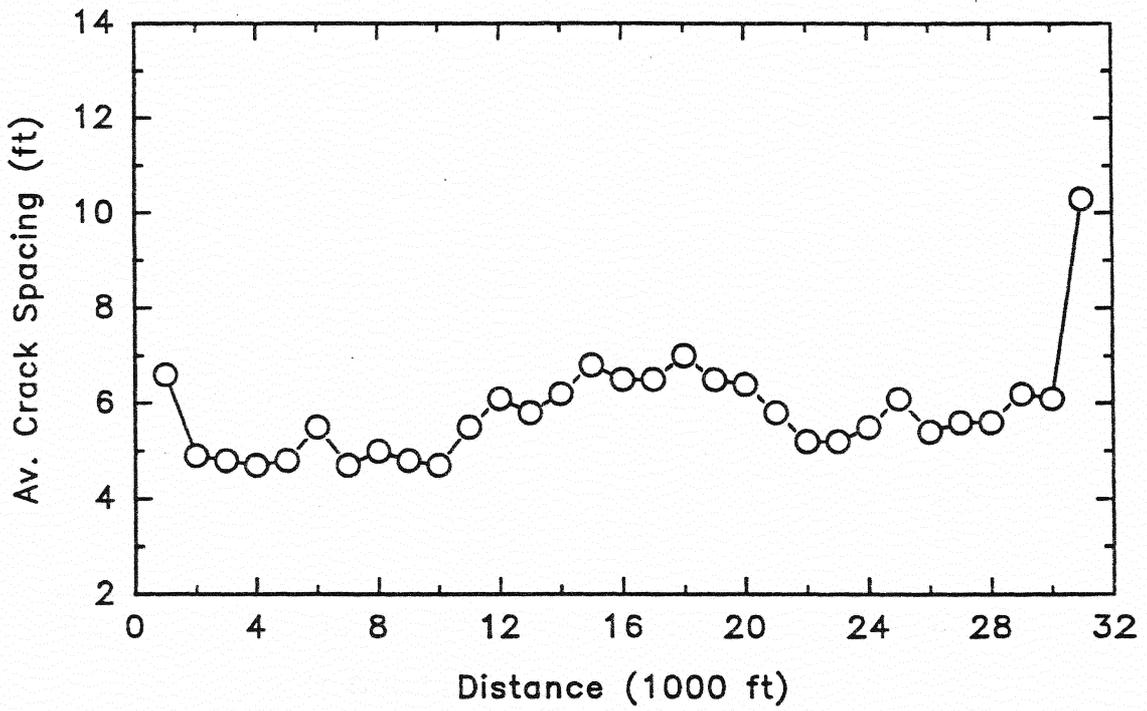
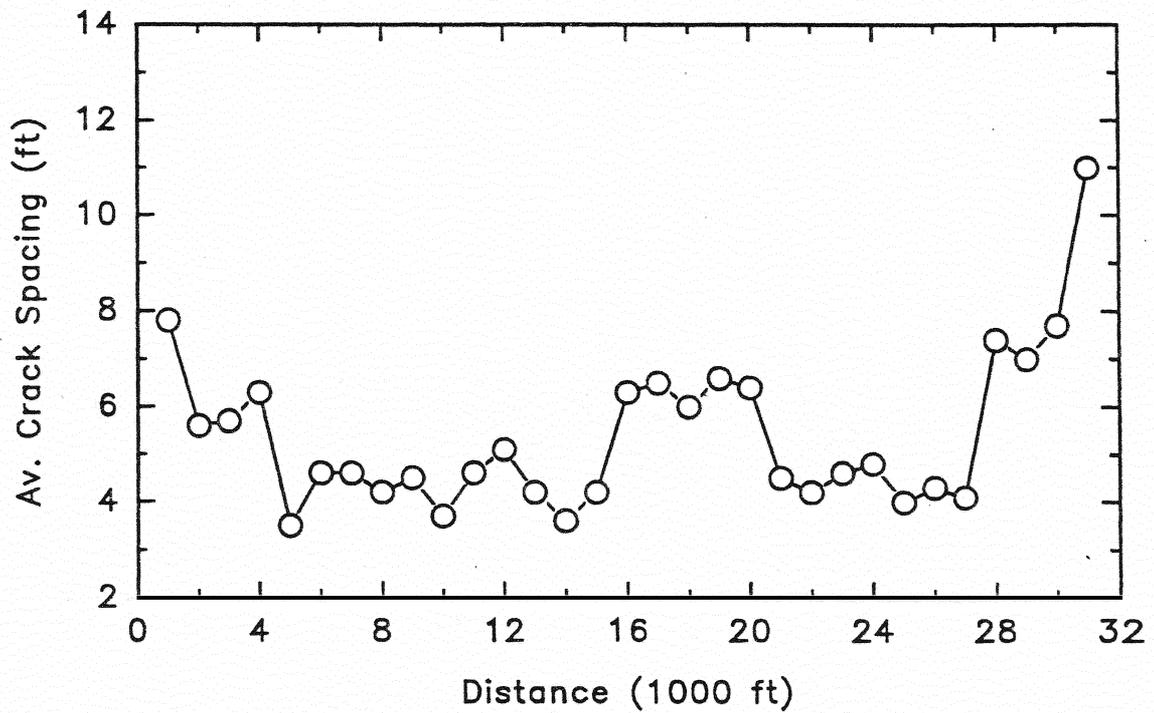
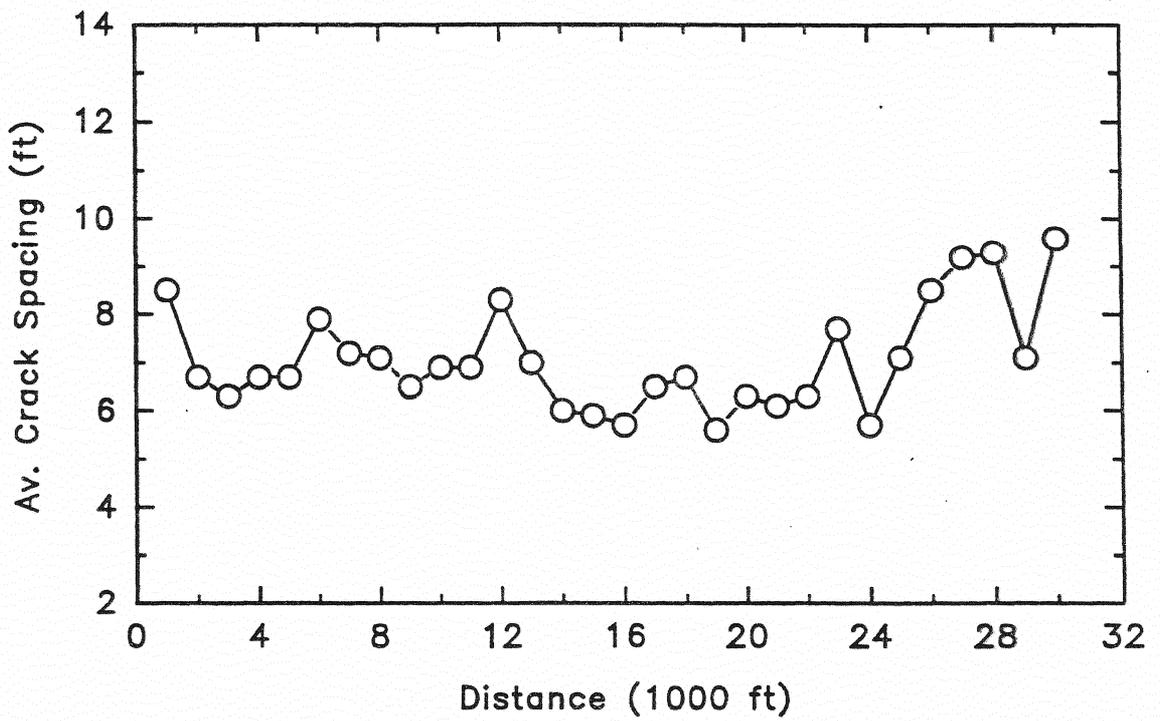
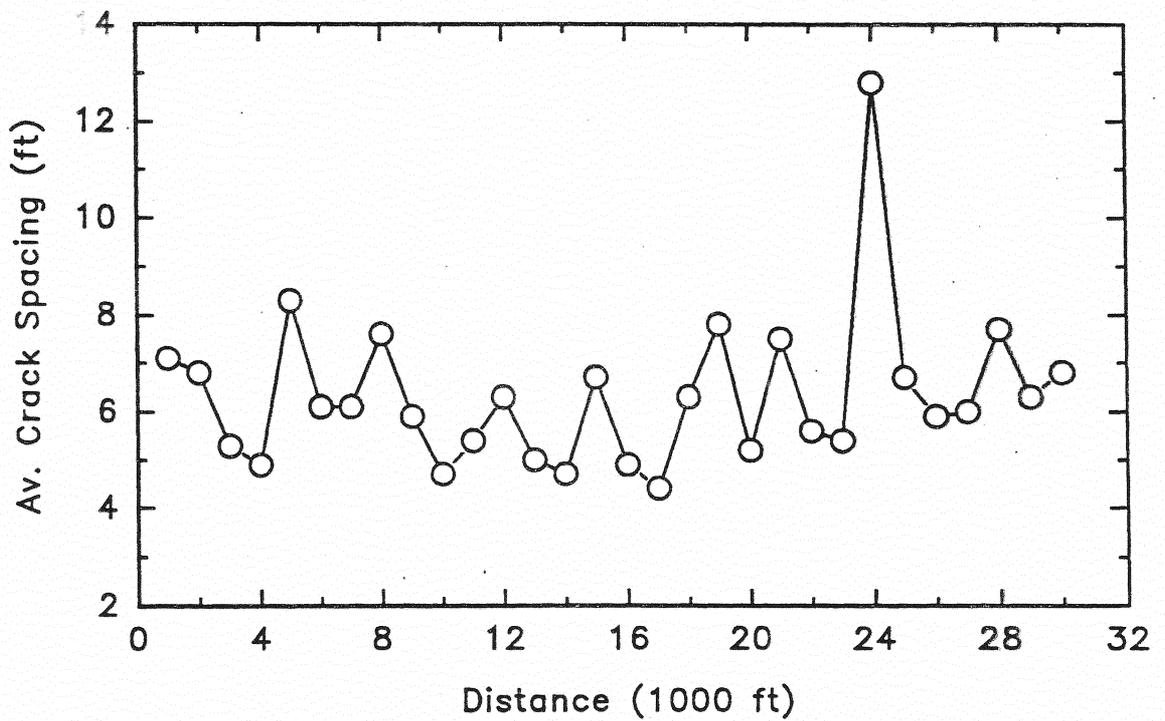
Figure 23. Effect of Distance From Terminal Point for Project 1, Northbound

Figure 24. Effect of Distance From Terminal Point for Project 1, Southbound

Figure 25. Effect of Distance From Terminal Point for Project 2, Northbound

Figure 26. Effect of Distance From Terminal Point for Project 2, Southbound

Average crack spacings were calculated for 1000-ft sections over the entire length of the pavements and plotted versus distance from a terminal point. The effect of distance from terminal points can be seen in Figures 23 through 26. Away from terminal points, crack spacing is relatively uniform. The very high value seen in Figure 26 away from the ends of the pavement is in the vicinity of a bridge where the pavement was also terminated. Near terminal points, crack spacing increases significantly. Such behavior near terminal points is due to a lack of fixity at these points and has been observed by others [4,13,21].

It can also be seen that crack spacing is more uniform for Project 1 than for Project 2. This can be attributed to the different ages of the pavements. Additional cracking between widely spaced cracks on Project 2 will occur with time to make the spacing more uniform. It is likely that cracking on Project 1 has nearly stabilized.
