**SCHOOL OF  
CIVIL ENGINEERING  
OKLAHOMA STATE UNIVERSITY**

PERFORMANCE OF EPOXY-COATED STEEL  
IN CONTINUOUSLY REINFORCED  
CONCRETE PAVEMENT

Report No. FHWA/OK 91(11)

August, 1991

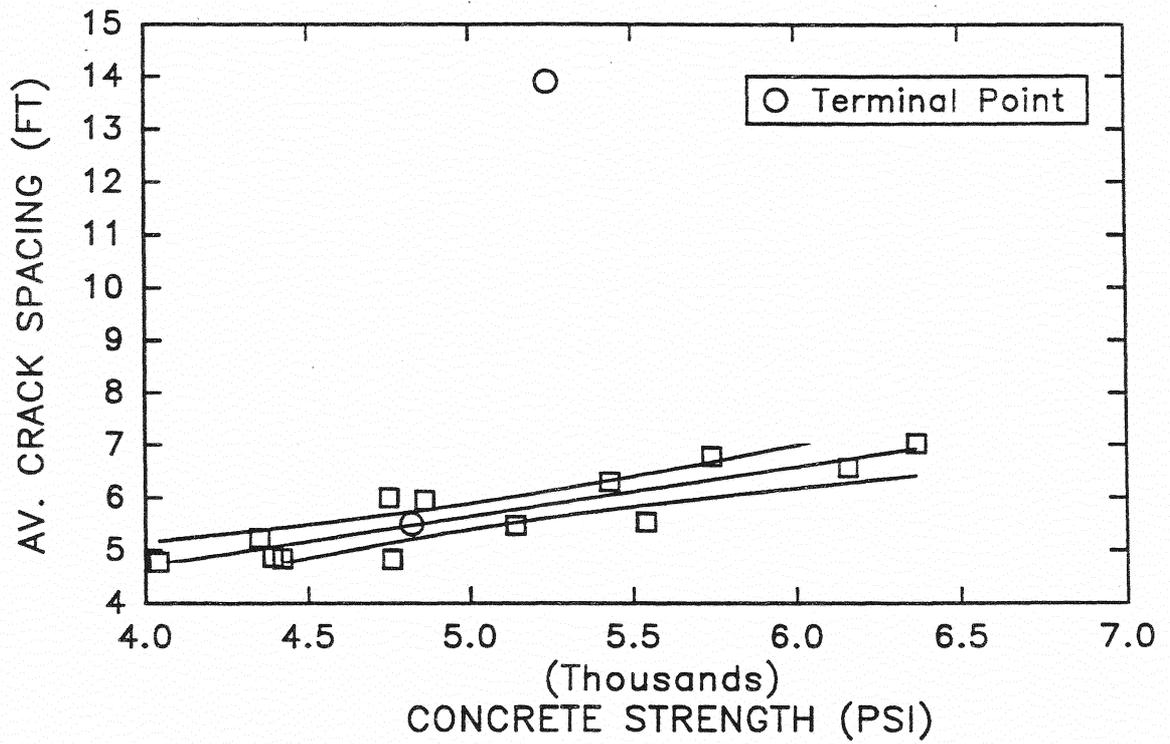
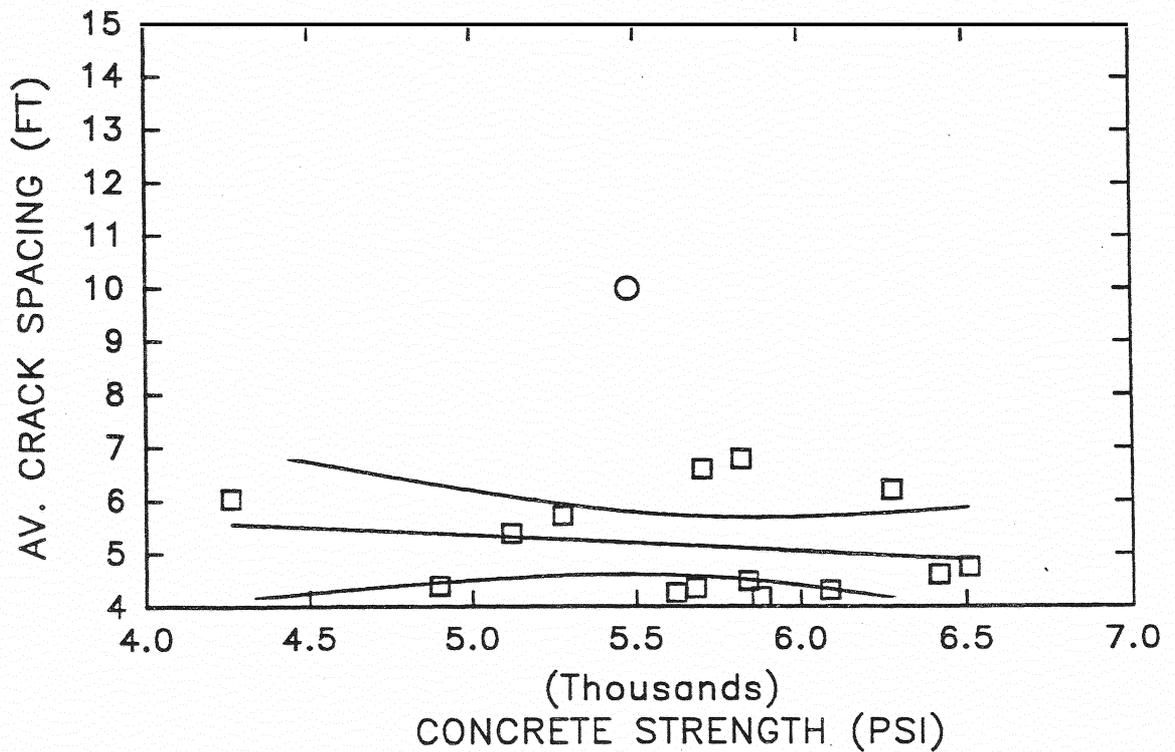
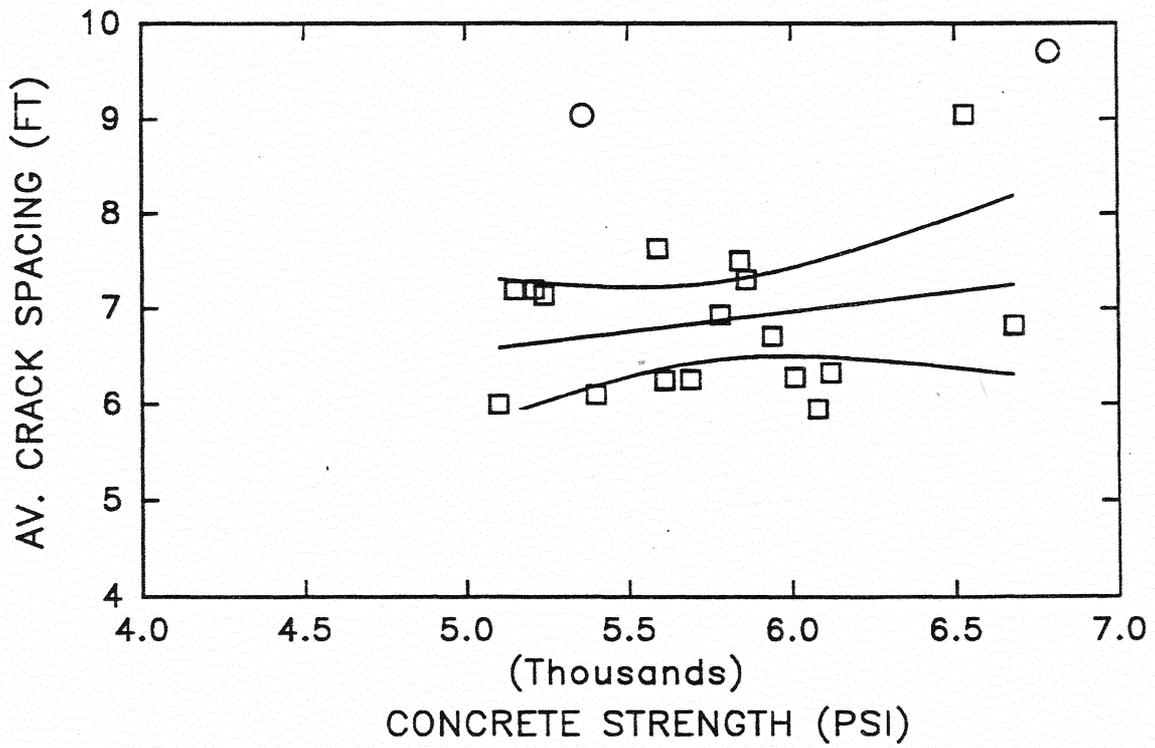
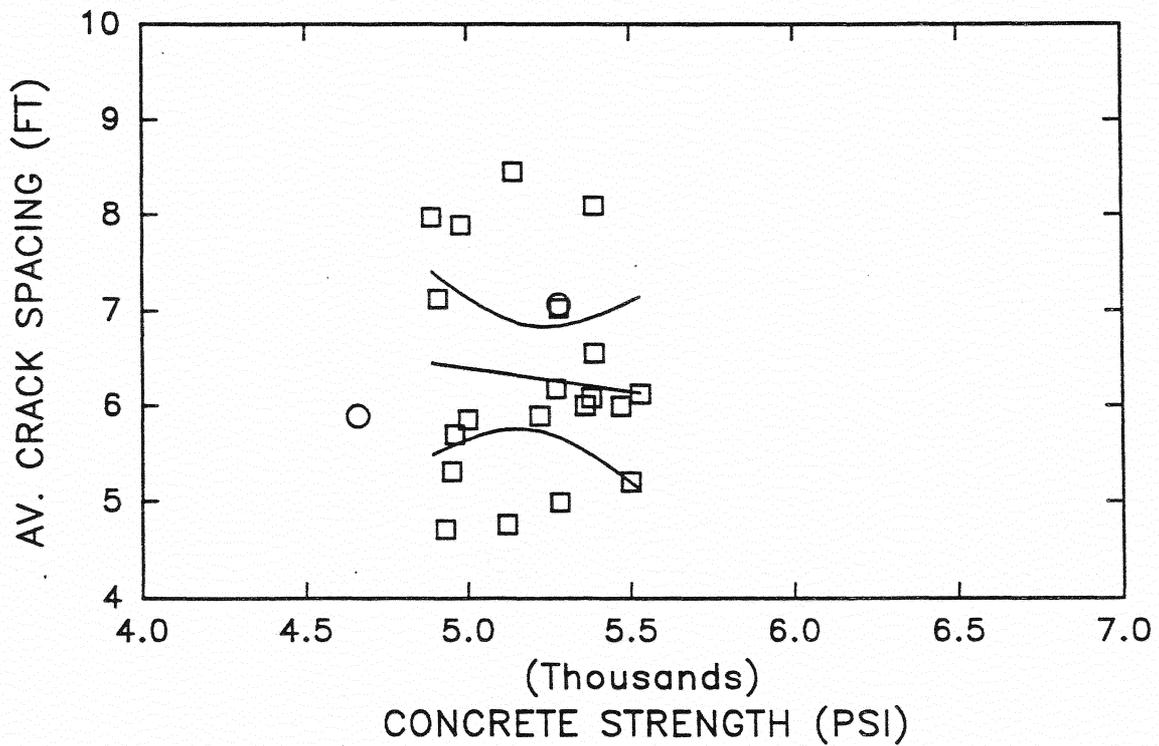
Figure 27. Effect of Concrete Strength for Project 1, Northbound

Figure 28. Effect of Concrete Strength for Project 1, Southbound

Figure 29. Effect of Concrete Strength for Project 2, Northbound

Figure 30. Effect of Concrete Strength for Project 2, Southbound

Average crack spacing versus concrete 28-day compressive strength is plotted in Figures 27 through 30. All data are plotted to the same vertical scale. Regression lines and 95% confidence limits are shown with the data. Terminal points are indicated by circles and are not included in the regression analyses. Considering the amount of scatter in the data and the fact that two of the regression lines have a positive slope and two have a negative slope, it must be concluded that the data do not provide evidence of a relationship between concrete strength and crack spacing. This conclusion is contrary to the findings of an earlier Texas study [49] in which it was concluded that an increase in concrete strength led to an increase in crack spacing.

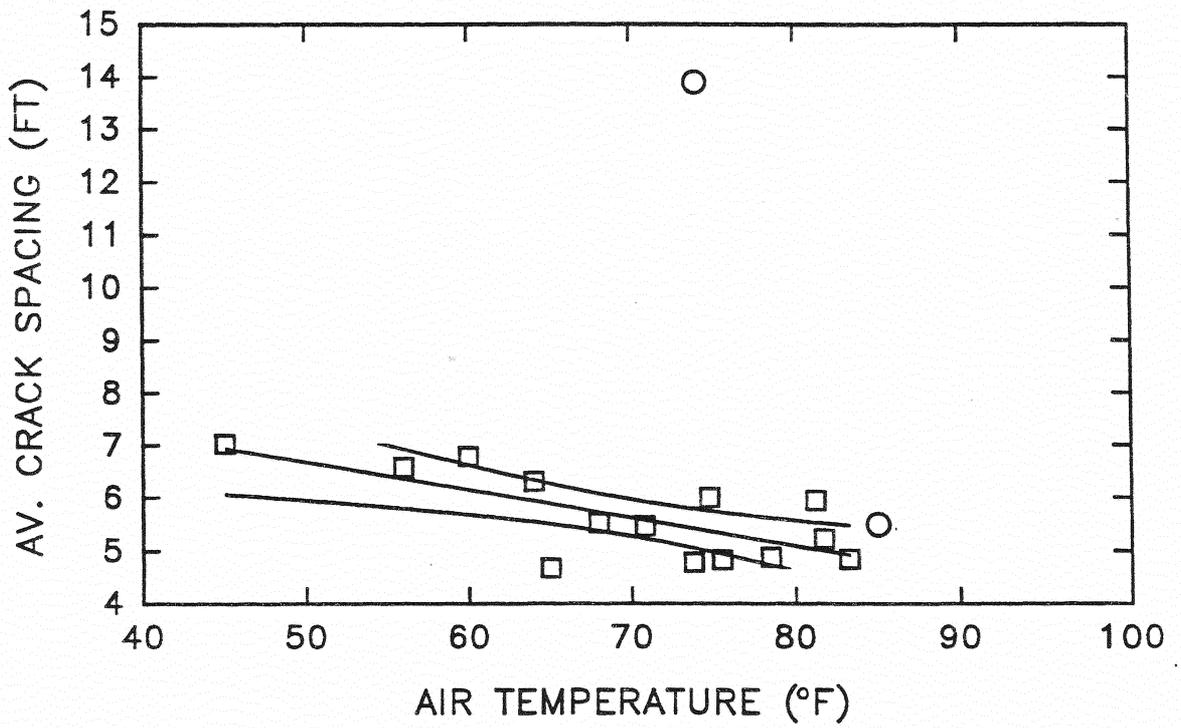
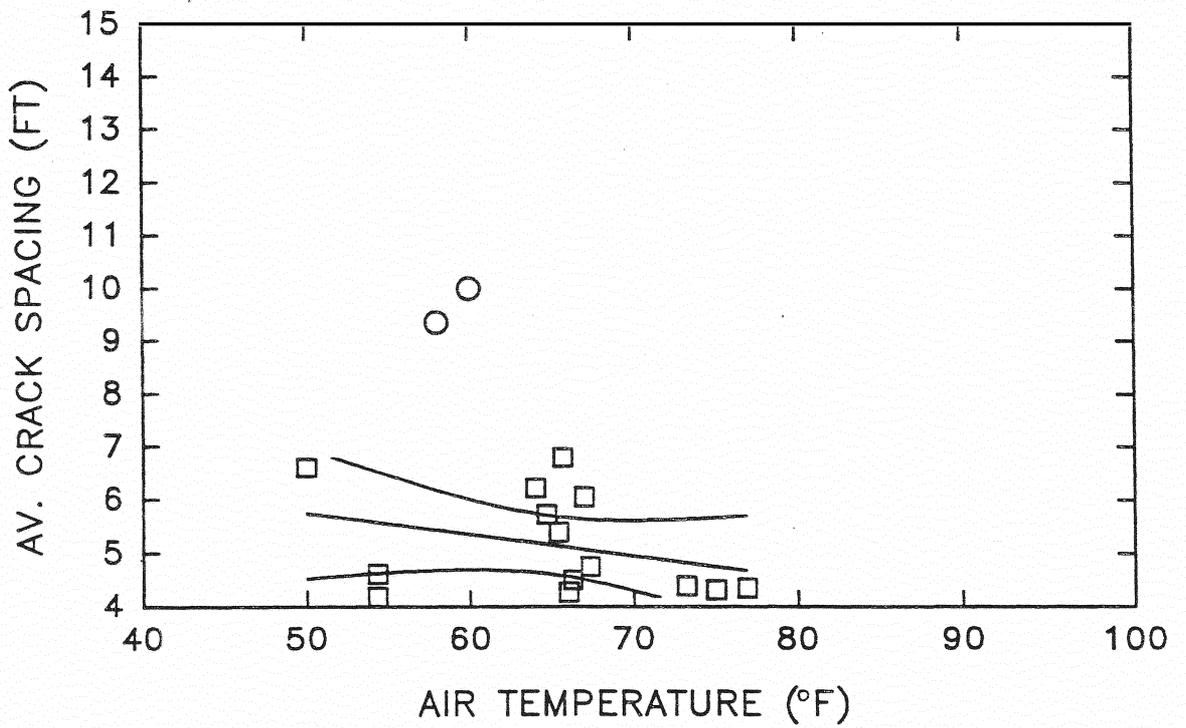
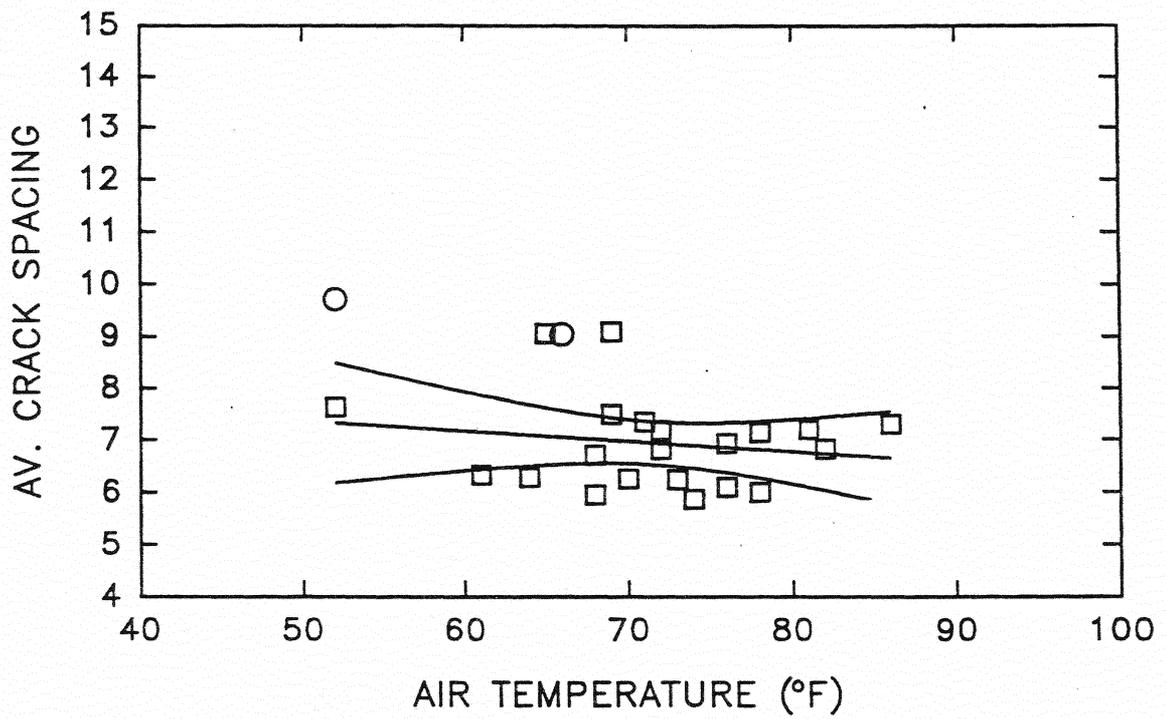
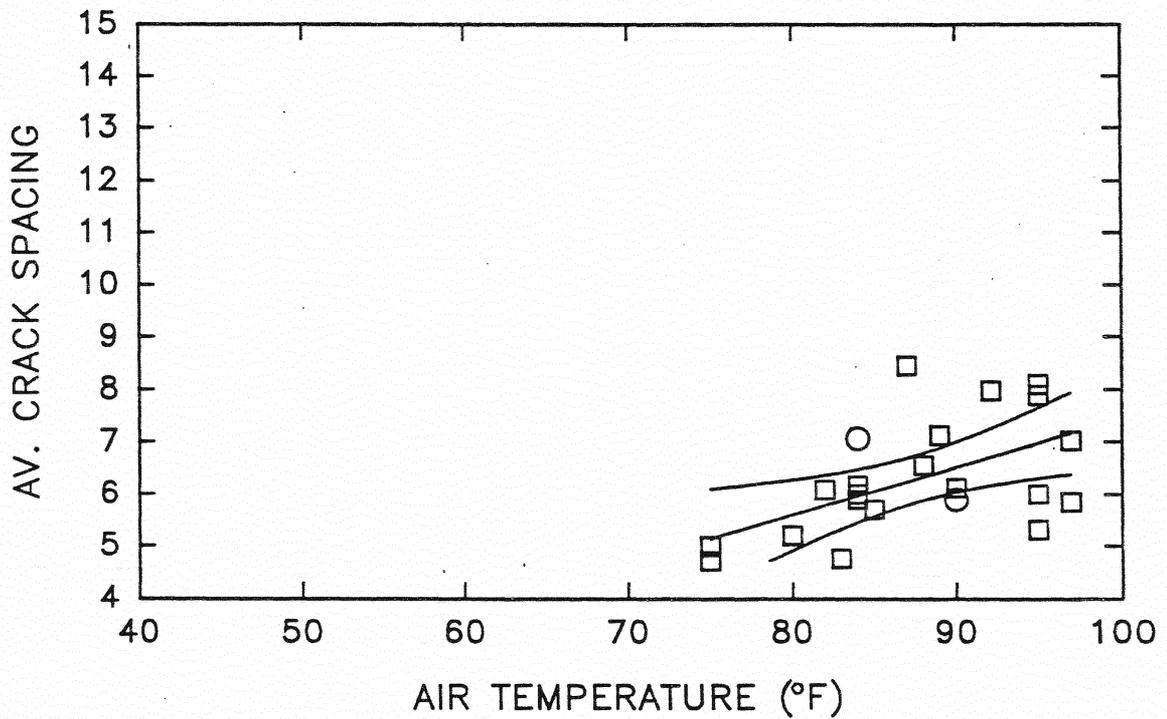
Figure 31. Effect of Air Temperature for Project 1, Northbound

Figure 32. Effect of Air Temperature for Project 1, Southbound

Figure 33. Effect of Air Temperature for Project 2, Northbound

Figure 34. Effect of Air Temperature for Project 2, Southbound

Average crack spacing versus air temperature at the time of placement is plotted in Figures 31 through 34. The format of the plot is the same as for concrete strength. In three of the four plots, average crack spacing decreases with increasing air temperature. This behavior is in agreement with an earlier Texas study [49]. In the single plot for which crack spacing increases with increasing temperature, temperatures were consistently higher than for the other three cases. The data from the Texas report covered a 60 to 90°F temperature range, similar to the data presented in Figures 31 through 33. This behavior suggests that the influence of air temperature on crack spacing cannot be modeled linearly.

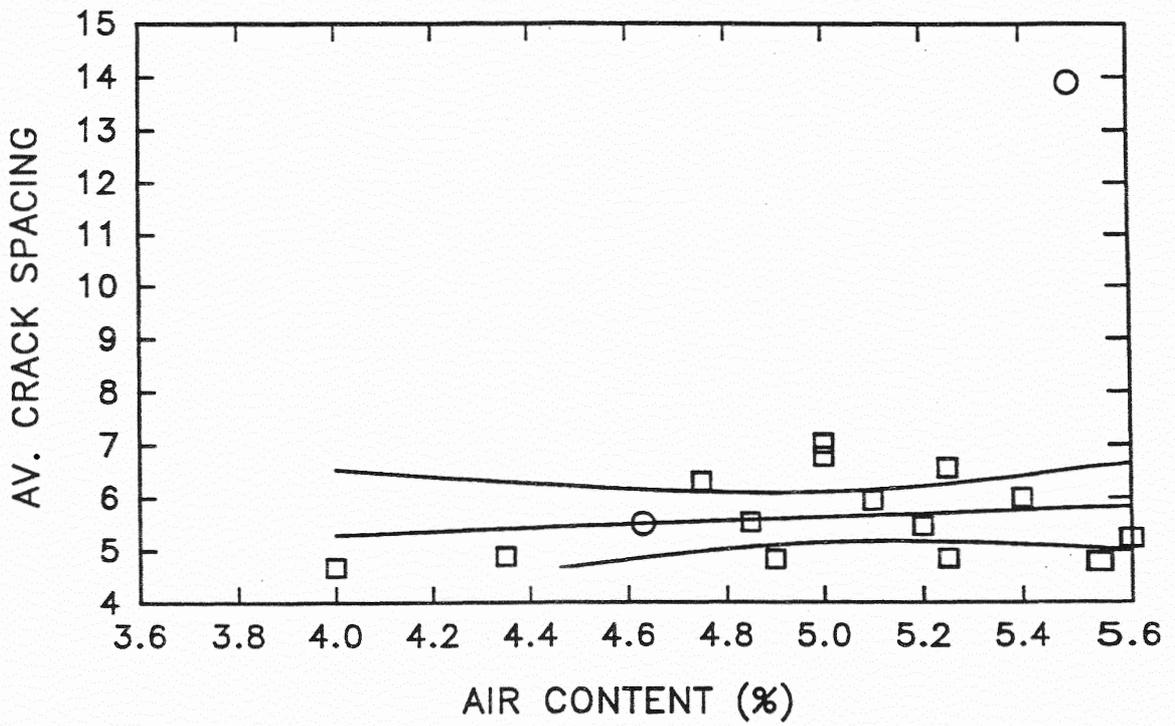
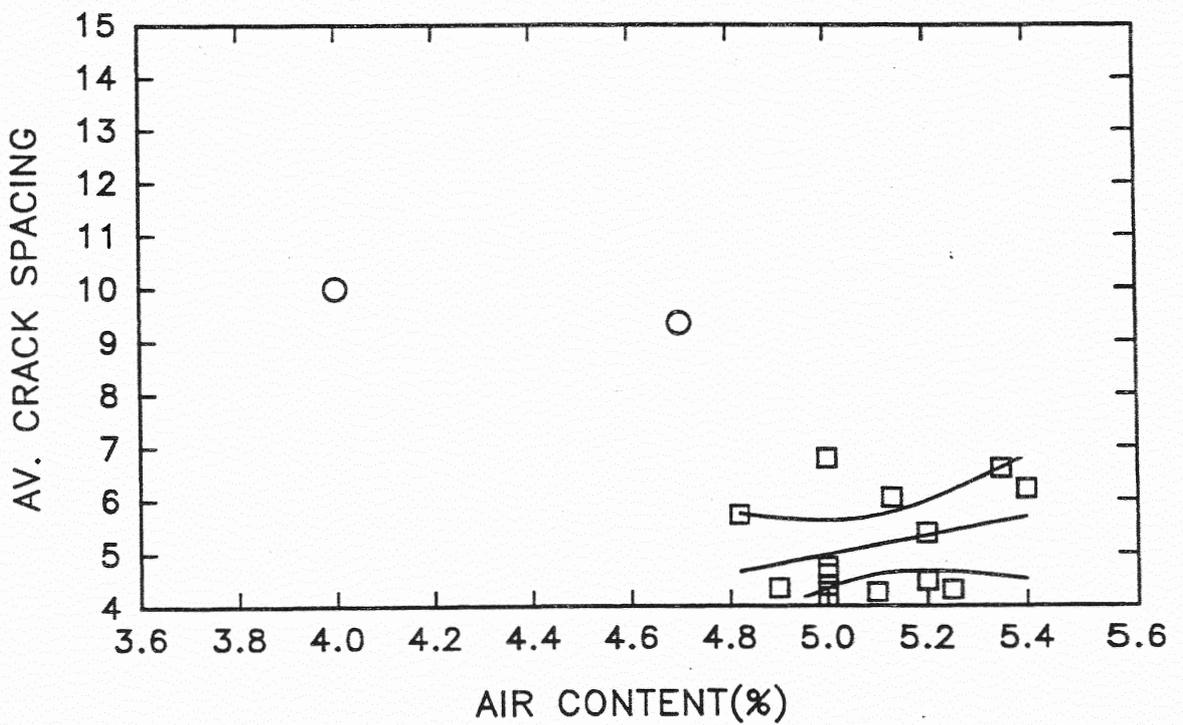
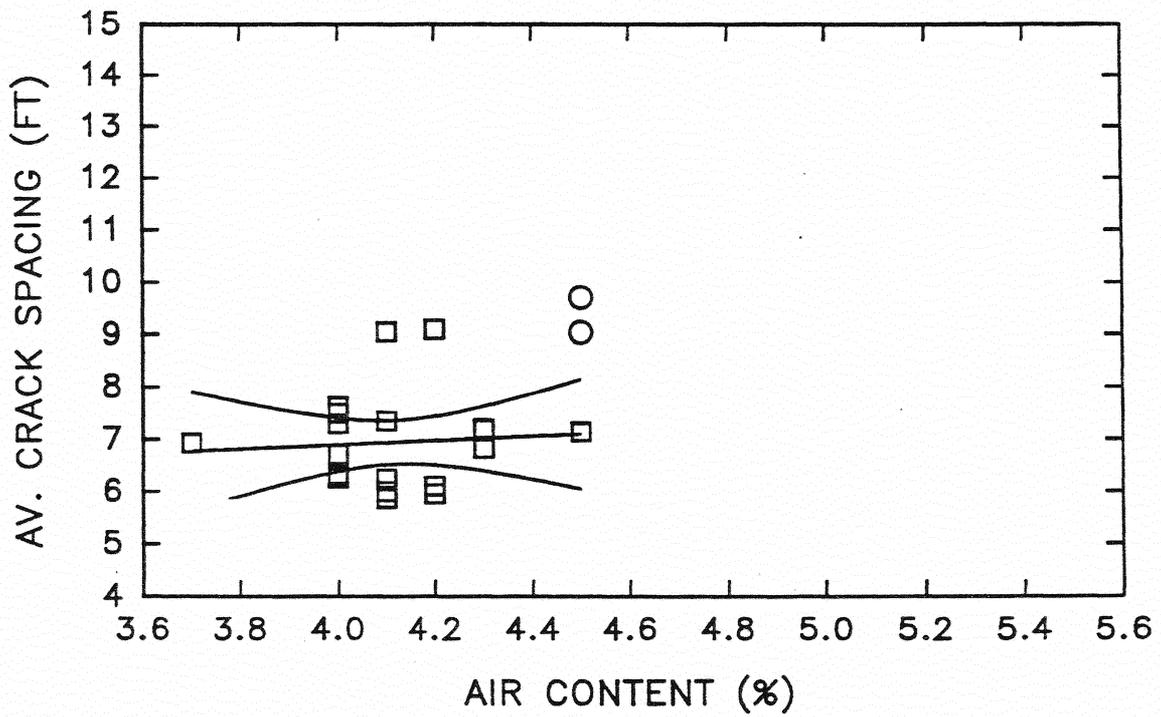
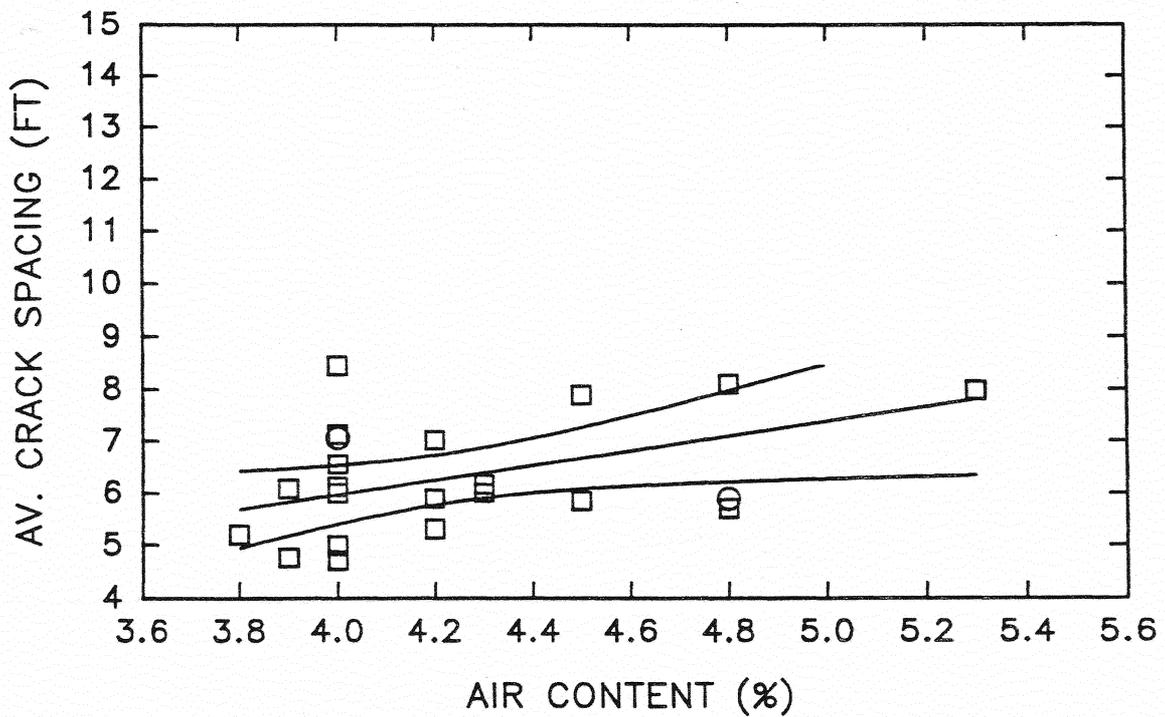
Figure 35. Effect of Air Content for Project 1, Northbound

Figure 36. Effect of Air Content for Project 1, Southbound

Figure 37. Effect of Air Content for Project 2, Northbound

Figure 38. Effect of Air Content for Project 2, Southbound

Average crack spacing versus concrete air content is plotted in Figures 35 through 38 in the same format as the preceding figures. The regression lines have positive slopes in all four plots, indicating a slight increase in average crack spacing with increasing air content. Independent confirmation of this behavior was not found.

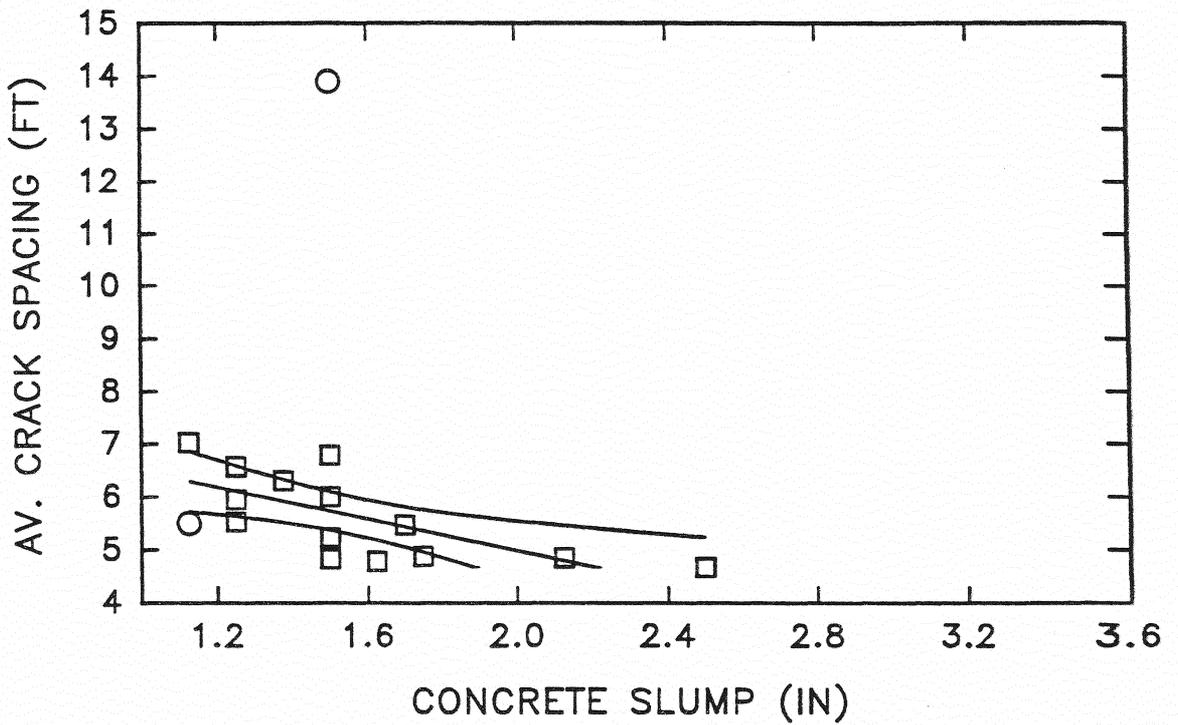
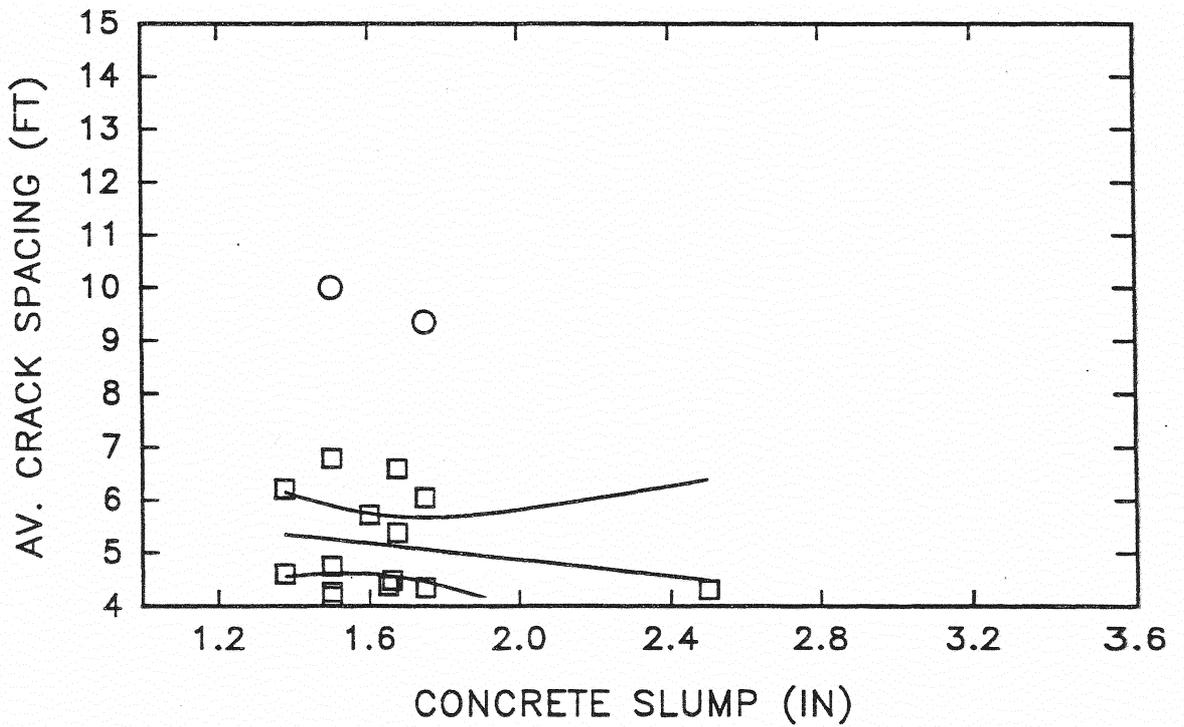
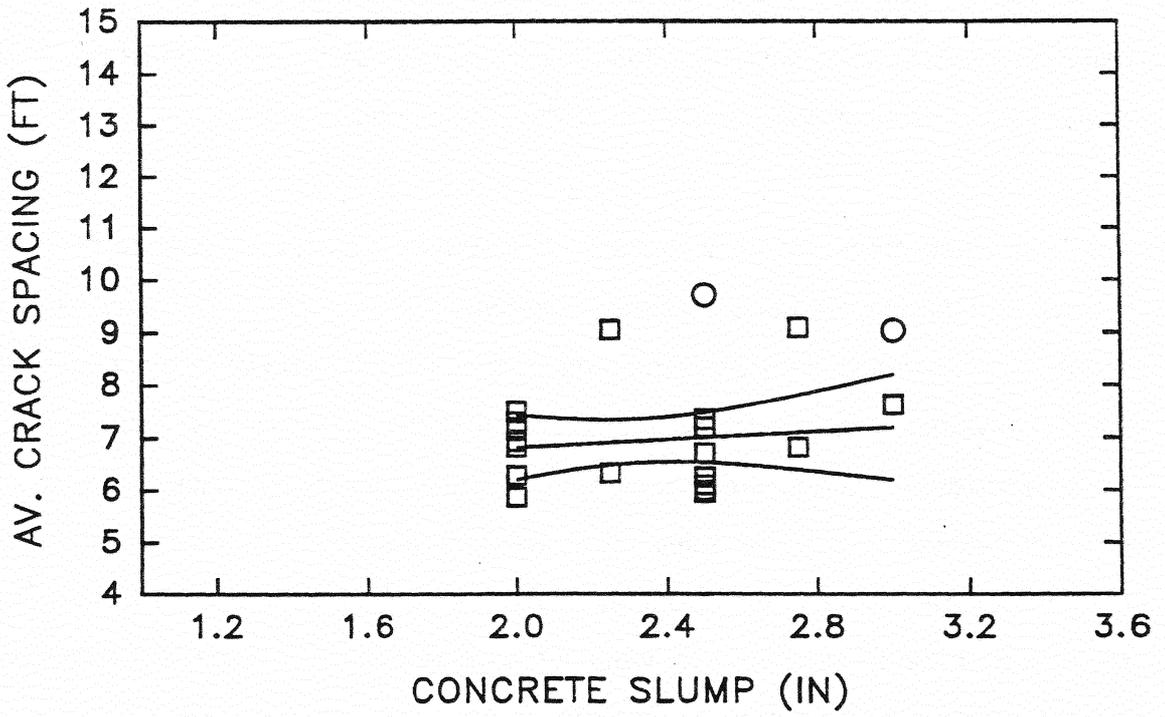
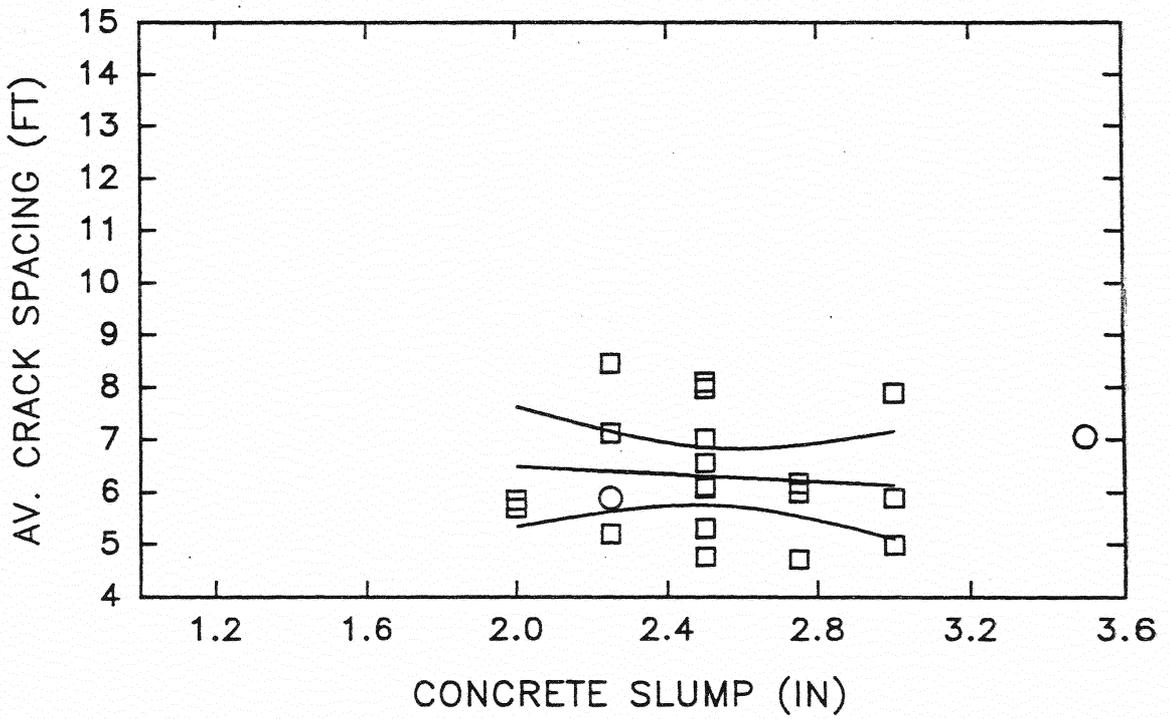
Figure 39. Effect of Slump for Project 1, Northbound

Figure 40. Effect of Slump for Project 1, Southbound

Figure 41. Effect of Slump for Project 2, Northbound

Figure 42. Effect of Slump for Project 2, Southbound

Average crack spacing versus slump is plotted in Figures 39 through 42. The slopes of the regression lines in three of the plots are negative and in one is positive. Considering the

scatter in the data along with the differences in the regression lines, it must be concluded that a relationship between crack spacing and slump is not indicated.

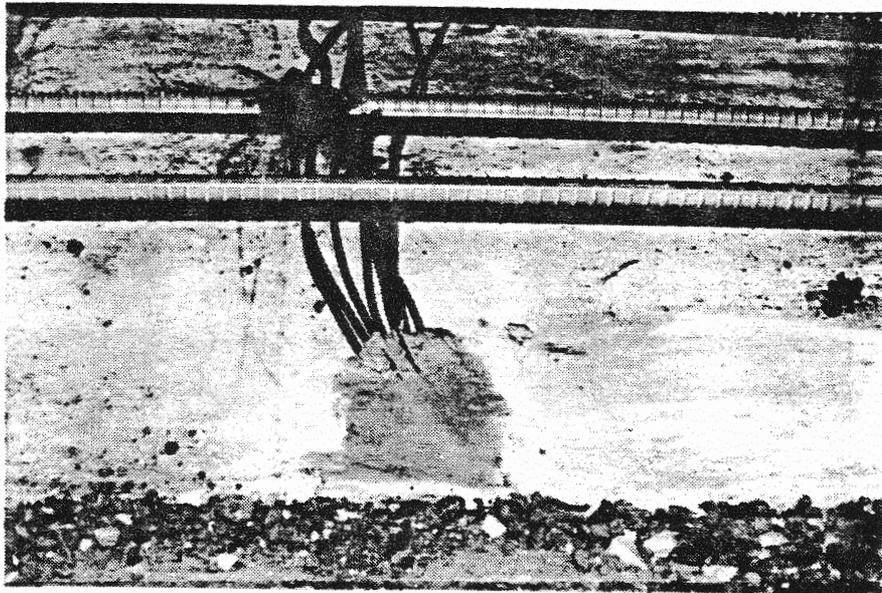
Figure 47. Copper Wires Carried Through the Ground

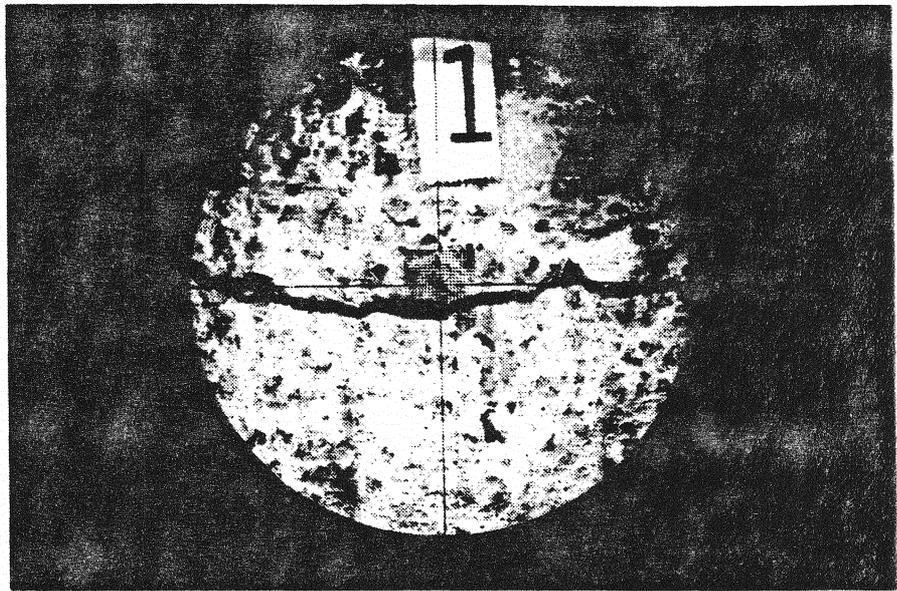
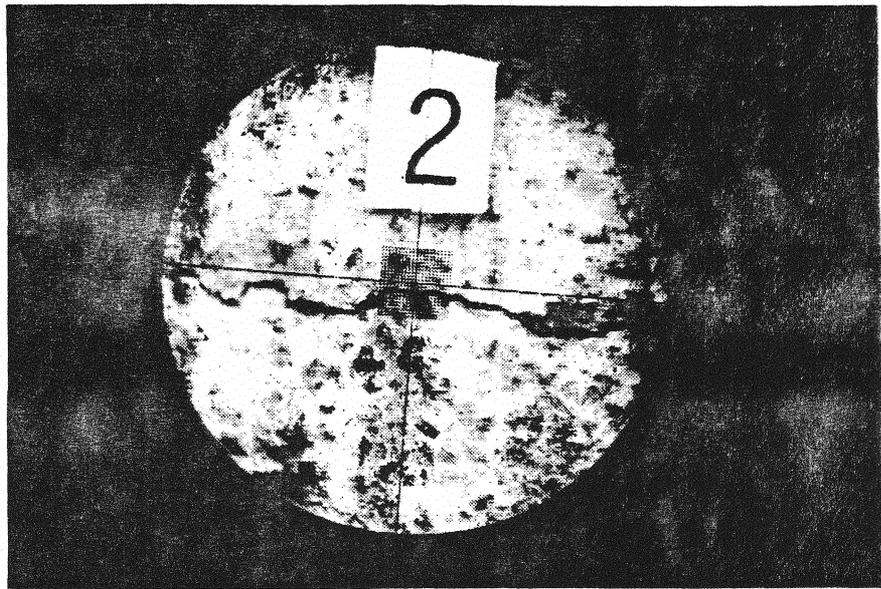
Figure 50. Cracks Photographed Using a Comparator

Crack widths were also measured from photographs taken through a comparator. Typical photographs are shown in Figure 50. The full width of the grid over the cracks is 2 mm. Crack widths as measured with the comparator were found to vary between 0.2 and 0.3 mm (0.008 and 0.012 in.).

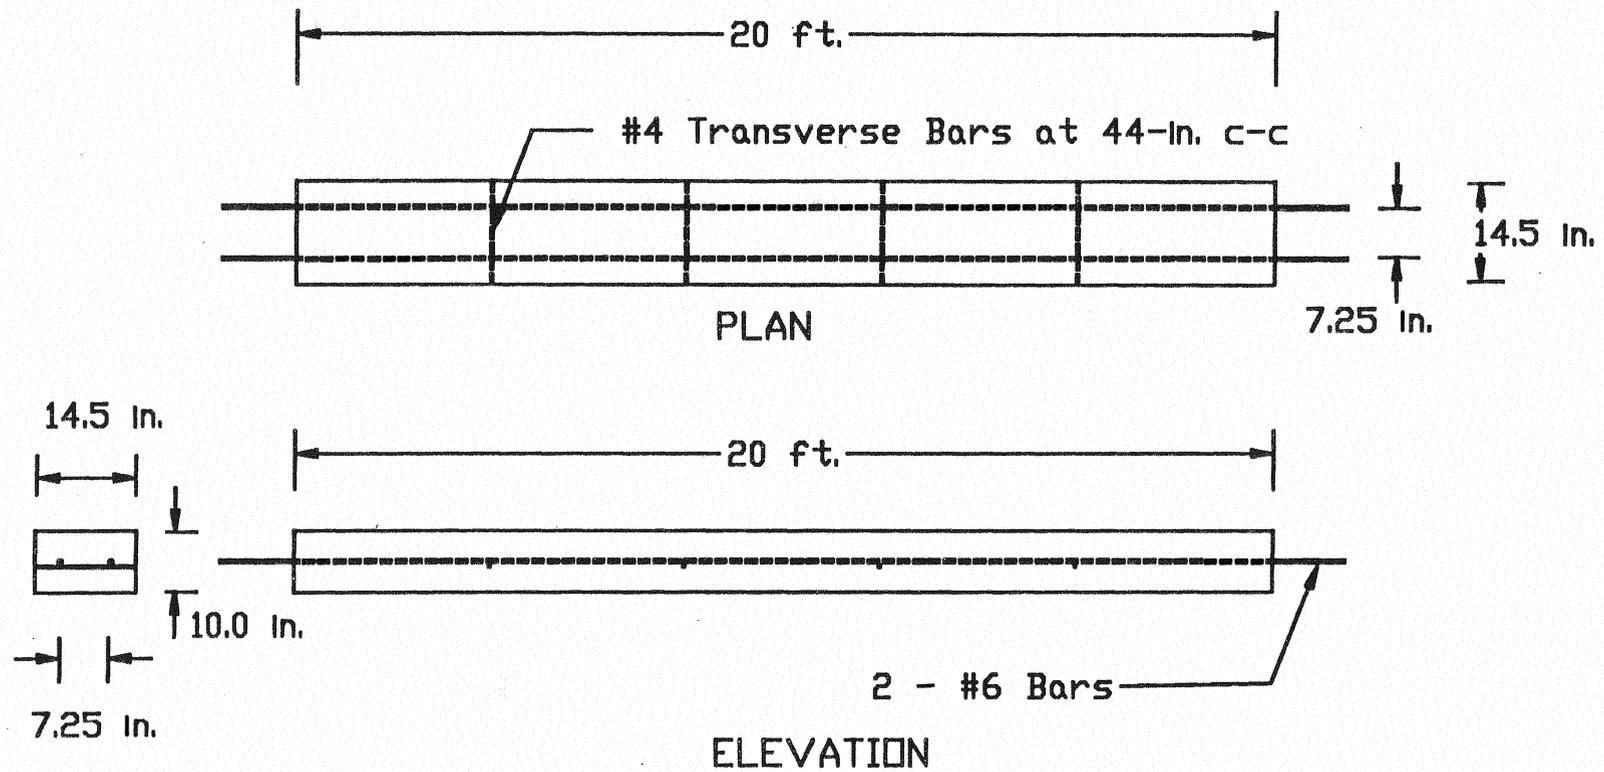
Figure 51. Slabs With 0.61% Reinforcement

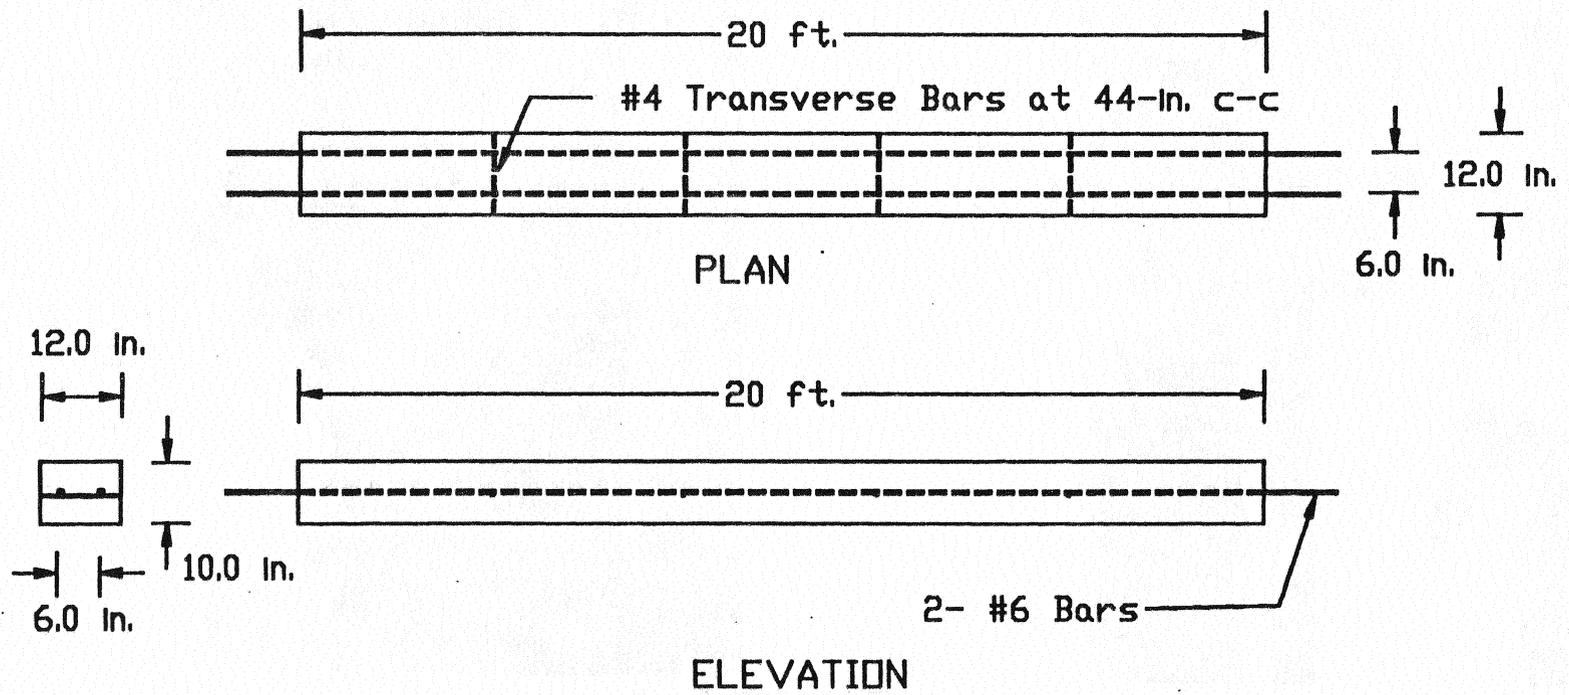
Figure 52. Slabs With 0.73% Reinforcement

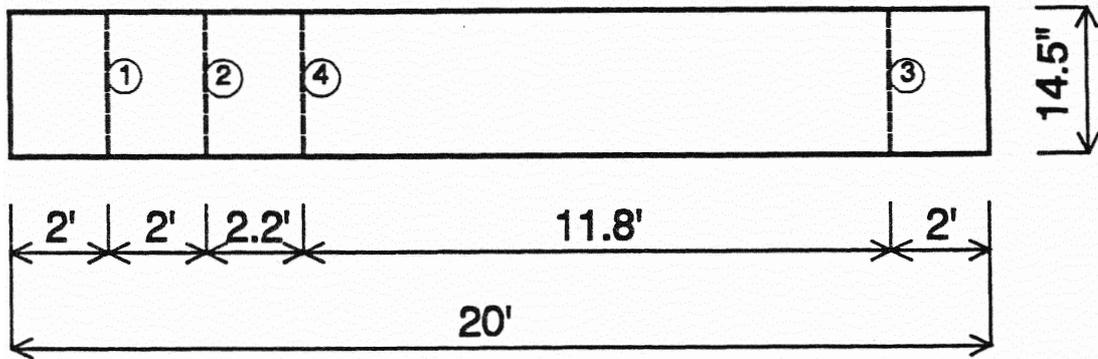
Plan View - Width of Slab Not to Scale

Figure 54. Crack Locations in Tensile Specimens, 0.61% Steel

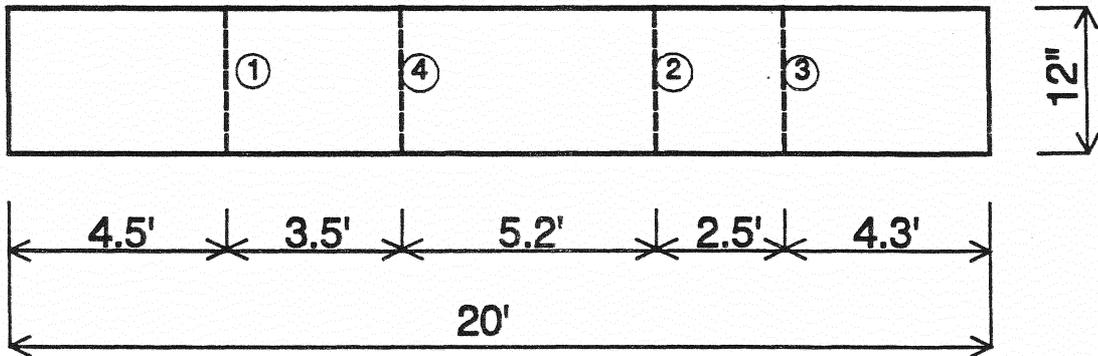
Plan View - Width of Slab Not to Scale

Figure 55. Crack Locations in Tensile Specimens, 0.73% Steel
