**SCHOOL OF  
CIVIL ENGINEERING  
OKLAHOMA STATE UNIVERSITY**

PERFORMANCE OF EPOXY-COATED STEEL  
IN CONTINUOUSLY REINFORCED  
CONCRETE PAVEMENT

Report No. FHWA/OK 91(11)

August, 1991

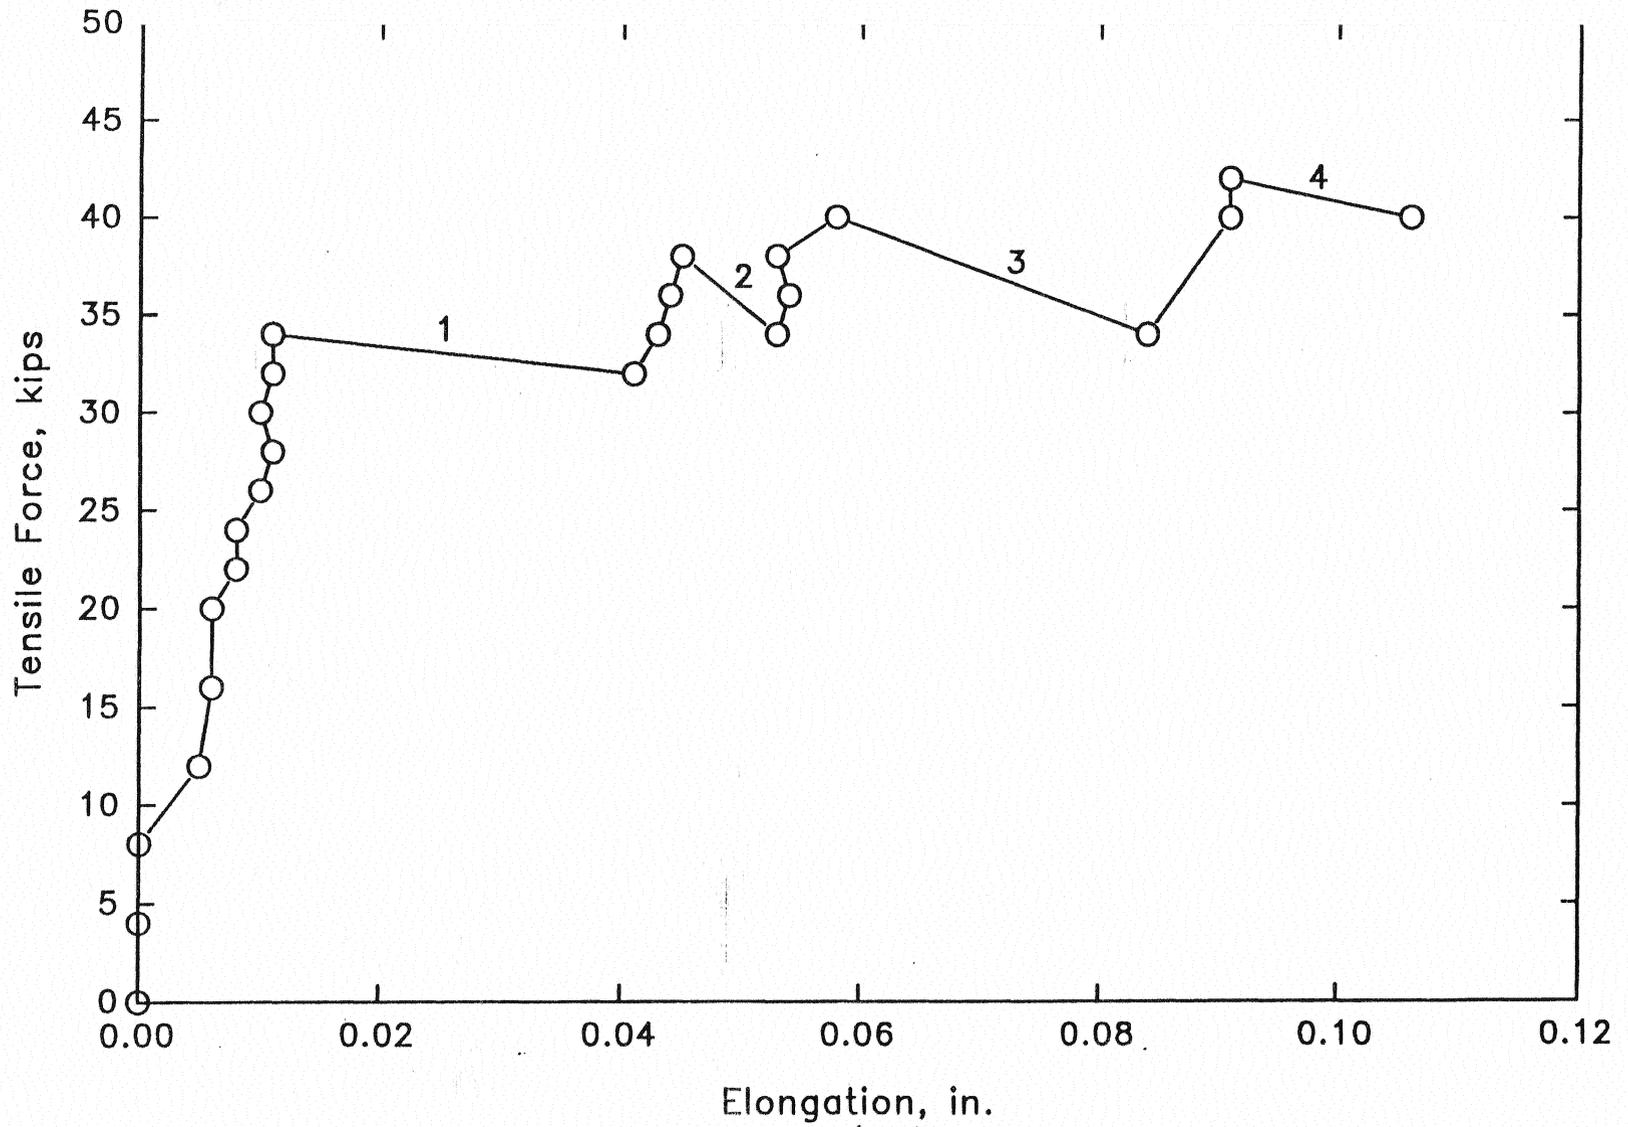
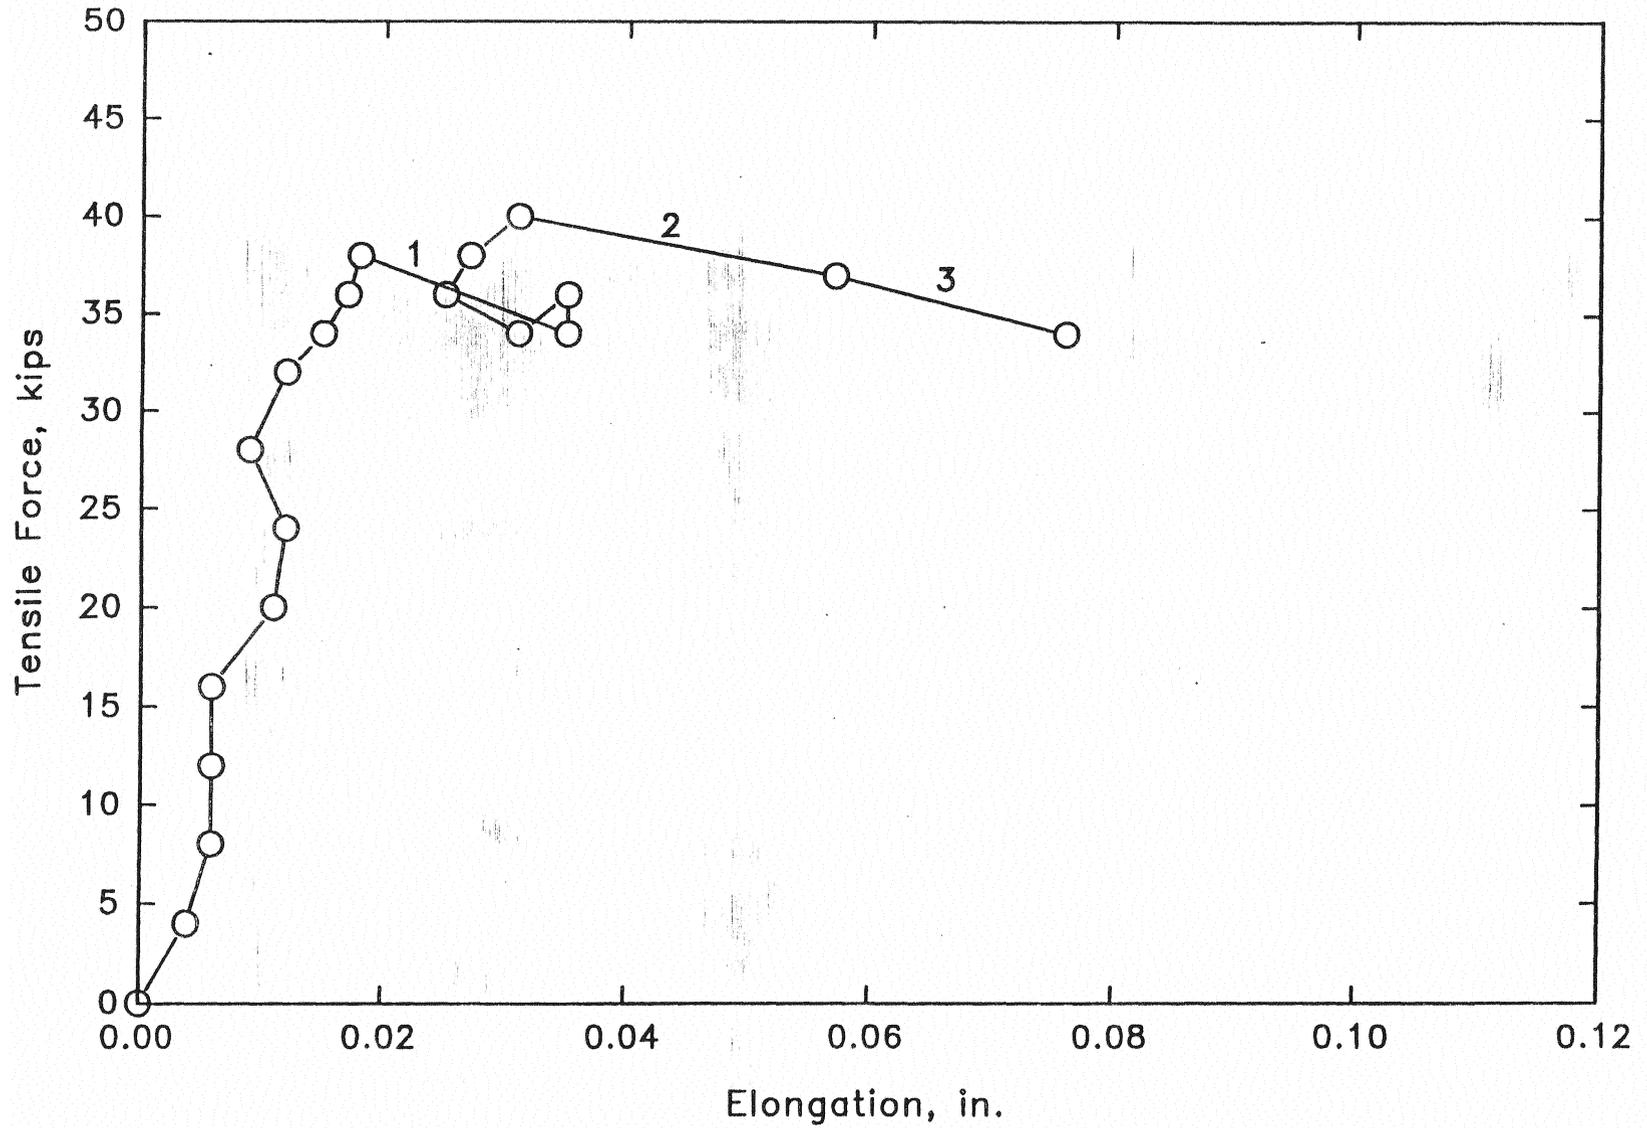
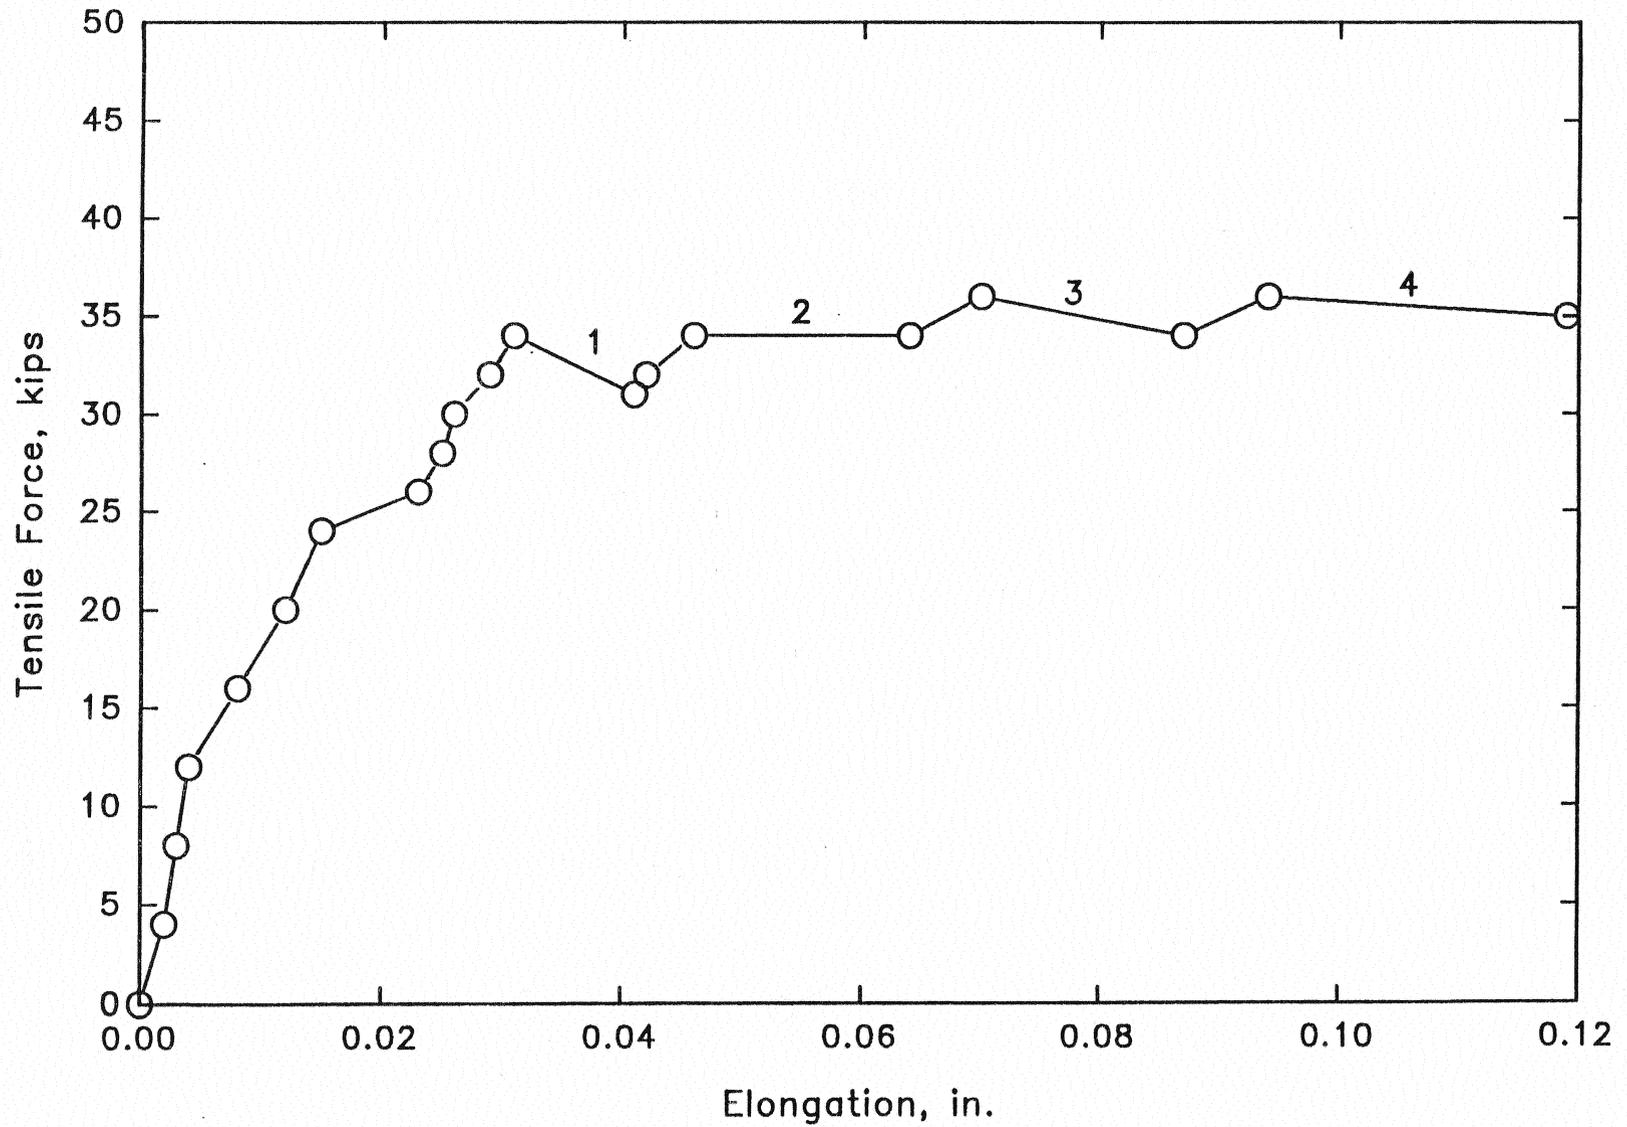
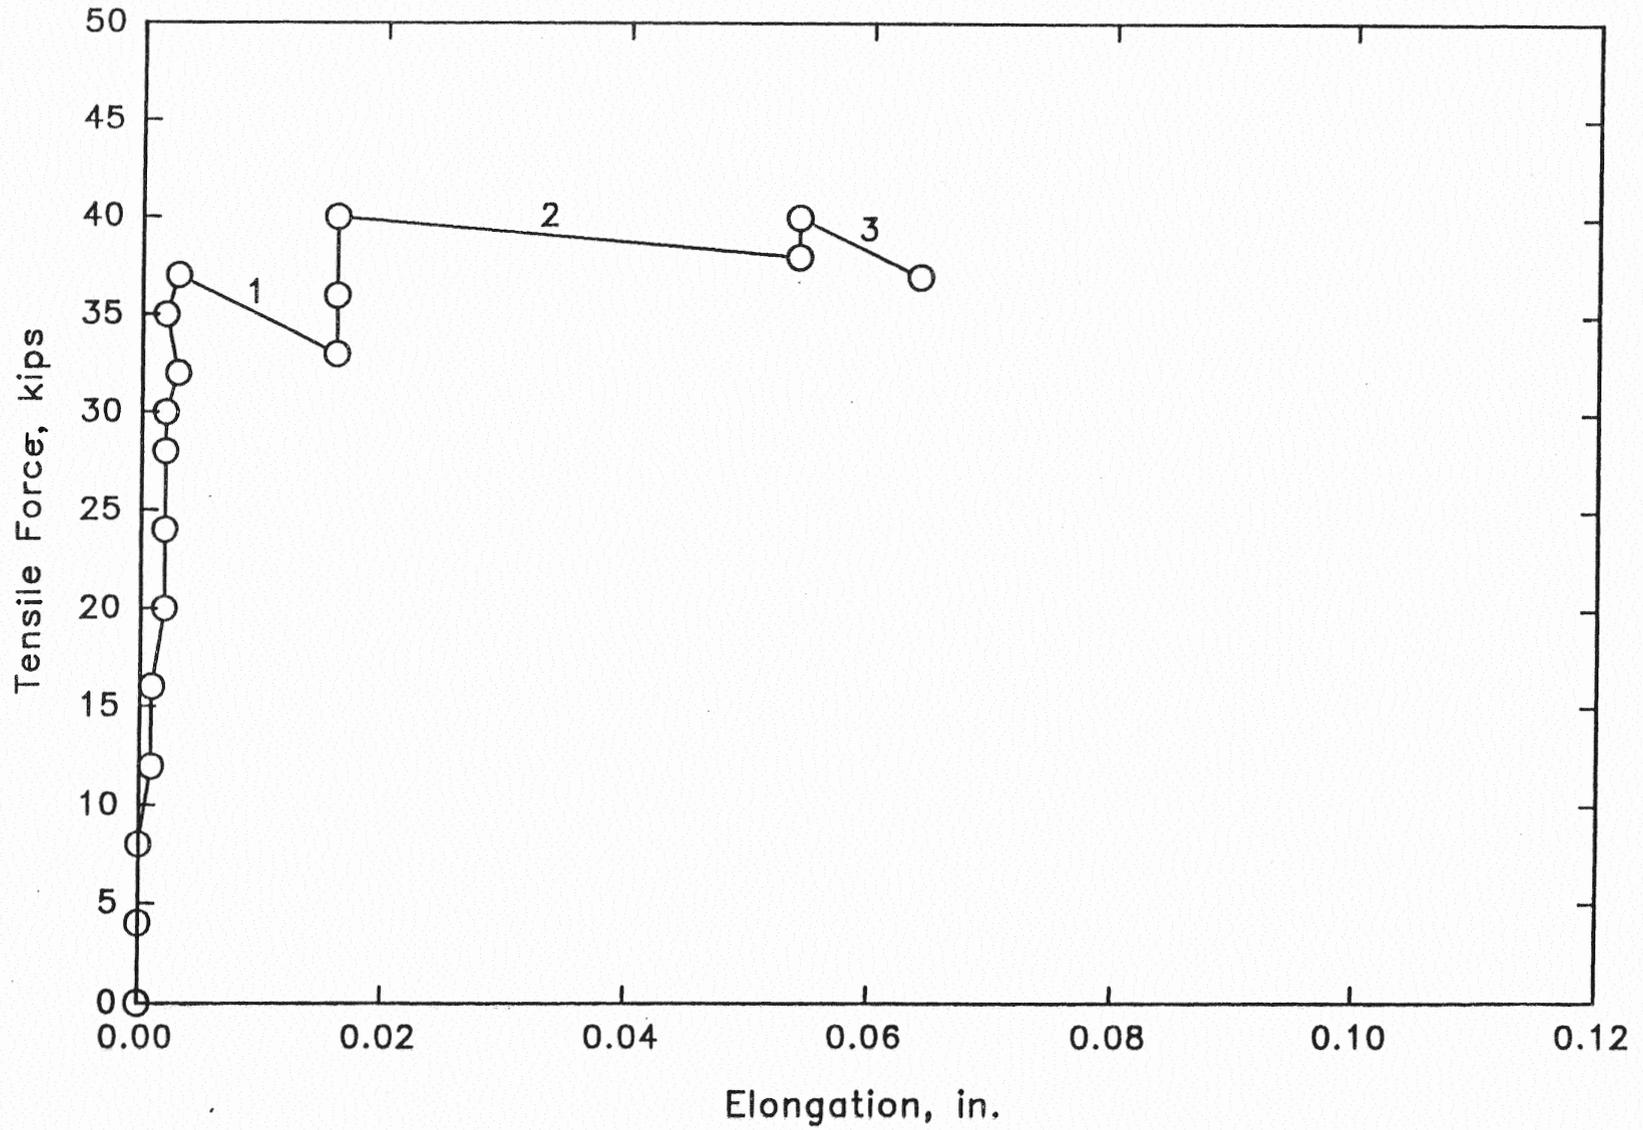
Figure 56. Tensile Test Results for Slab With 0.61% Uncoated Reinforcement

Figure 57. Tensile Test Results for Slab With 0.61% Coated Reinforcement

Figure 58. Tensile Test Results for Slab With 0.73% Uncoated Reinforcement

Figure 59. Tensile Test Results for Slab With 0.73% Coated Reinforcement

In Table 2, several of the key features of the plots in Figures 56 through 59 and the data from the comparator measurements are presented for comparison. In regard to crack width, the data do not indicate a significant difference between specimens constructed with uncoated

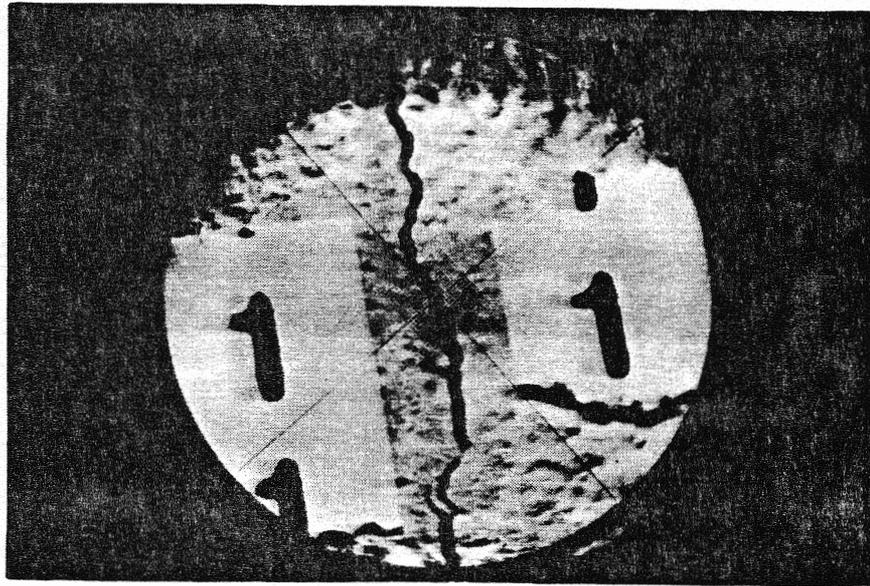
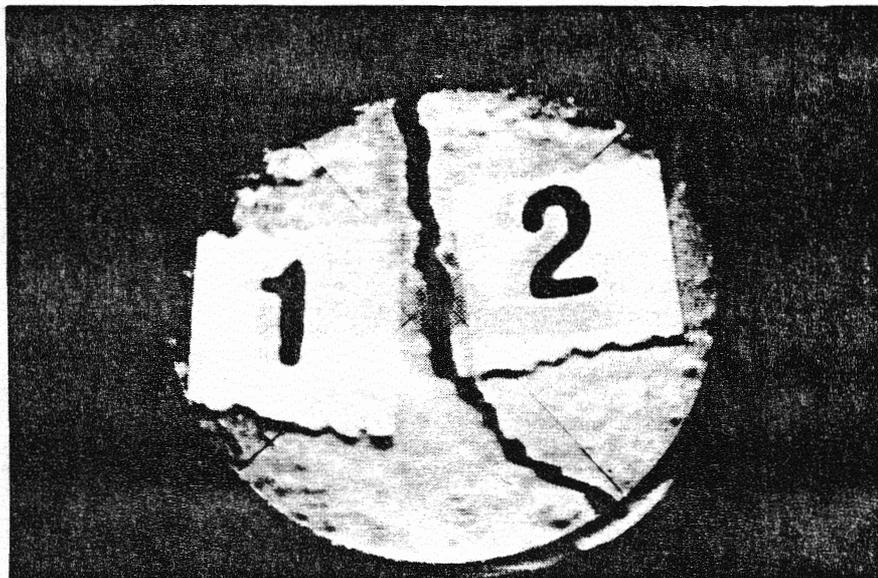
Crack Width = 0.27 mm

Crack Width = 0.39 mm

Average Crack Width = 0.36 mm

Figure 60. Typical Cracks Formed in Slab With  
0.61% Uncoated Reinforcement

In Figure 60 through 63, examples of photographs taken through the comparator are presented. The numbers on both sides of the cracks identify the slab number and the crack position. Photographs were taken at arbitrary locations along the length of the cracks. Crack widths were determined from the known width of the grid in the comparator, seen above the cracks.

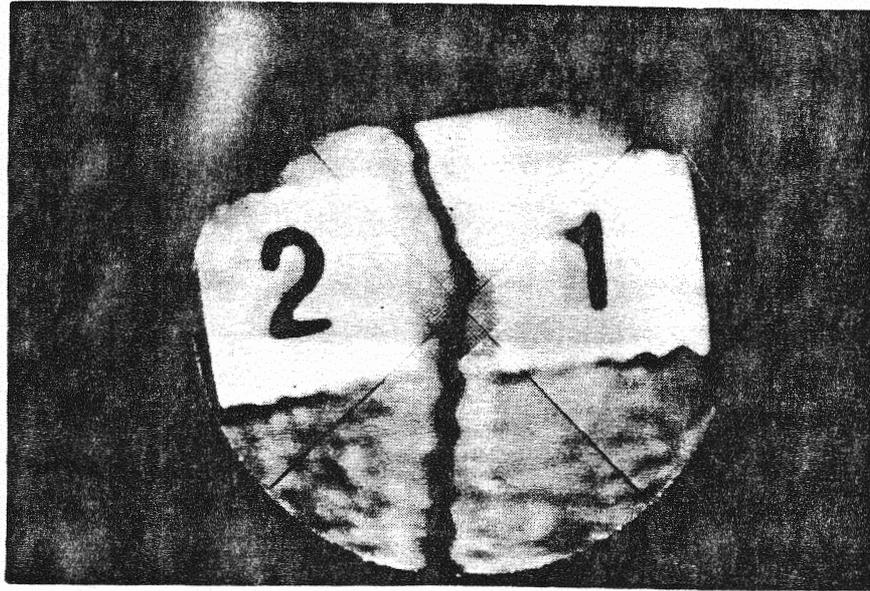
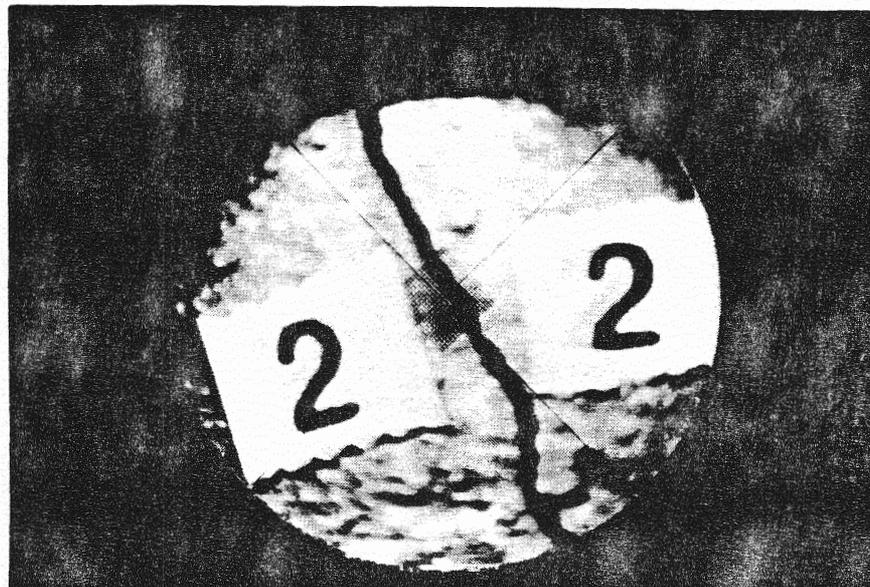
Crack Width = 0.27 mm

Crack Width = 0.32 mm

Average Crack Width = 0.24 mm

Figure 61. Typical Cracks Formed in Slab With  
0.61% Coated Reinforcement

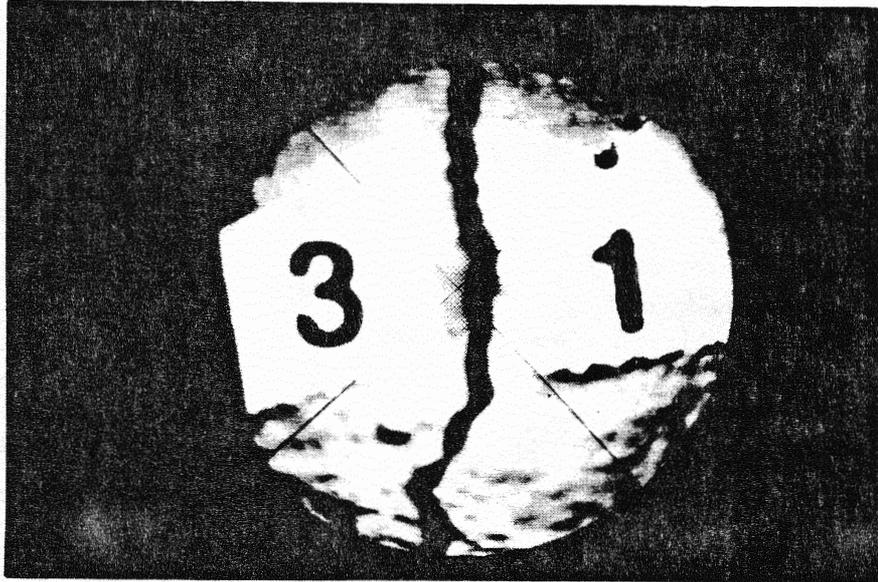
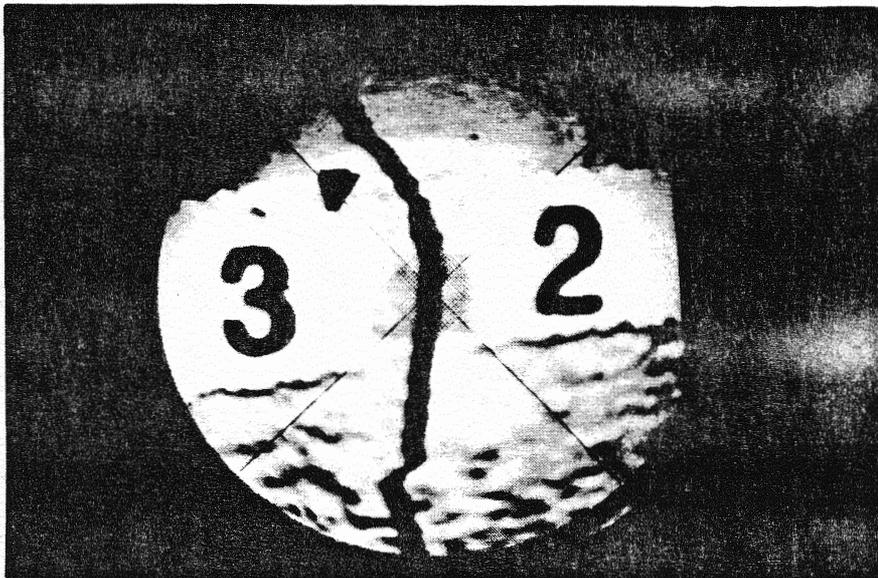
Crack Width = 0.53 mm

Crack Width = 0.30 mm

Average Crack Width = 0.36 mm

Figure 62. Typical Cracks Formed in Slab With  
0.73% Uncoated Reinforcement

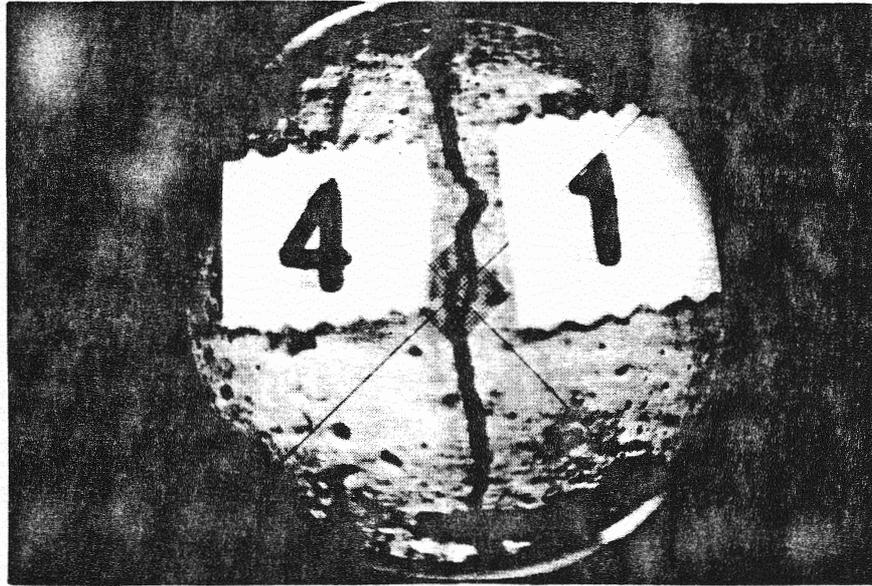
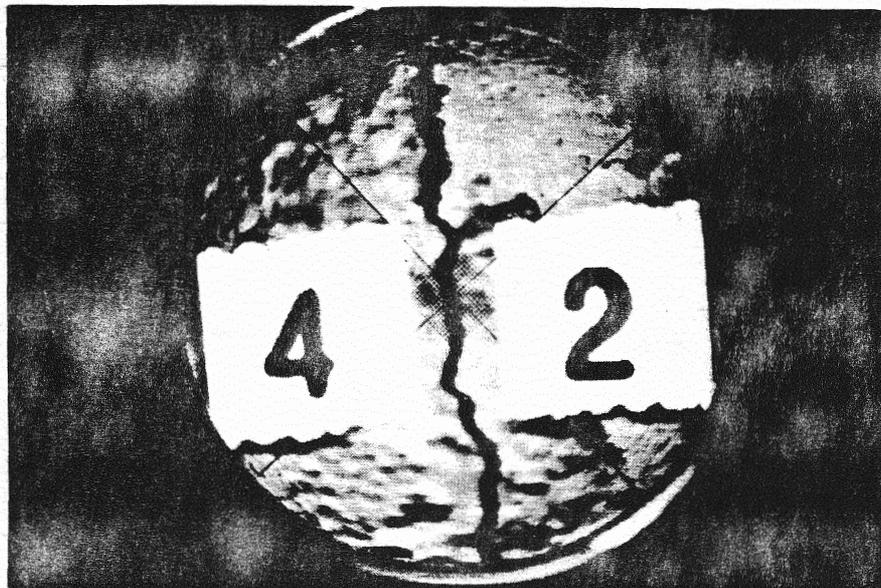
Crack Width = 0.31 mm

Crack Width = 0.27 mm

Average Crack Width = 0.26 mm
