# THE CONSTRUCTION OF A PYRAMENT BRIDGE DECK OVERLAY

## CONSTRUCTION REPORT

Under the Supervision  
of  
C. Dwight Hixon, P.E.  
Research & Development Engineer  
Research & Development Division  
Oklahoma Department of Transportation  
200 N.E. 21st Street, Room 2A2  
Oklahoma City, Oklahoma 73105

May, 1991

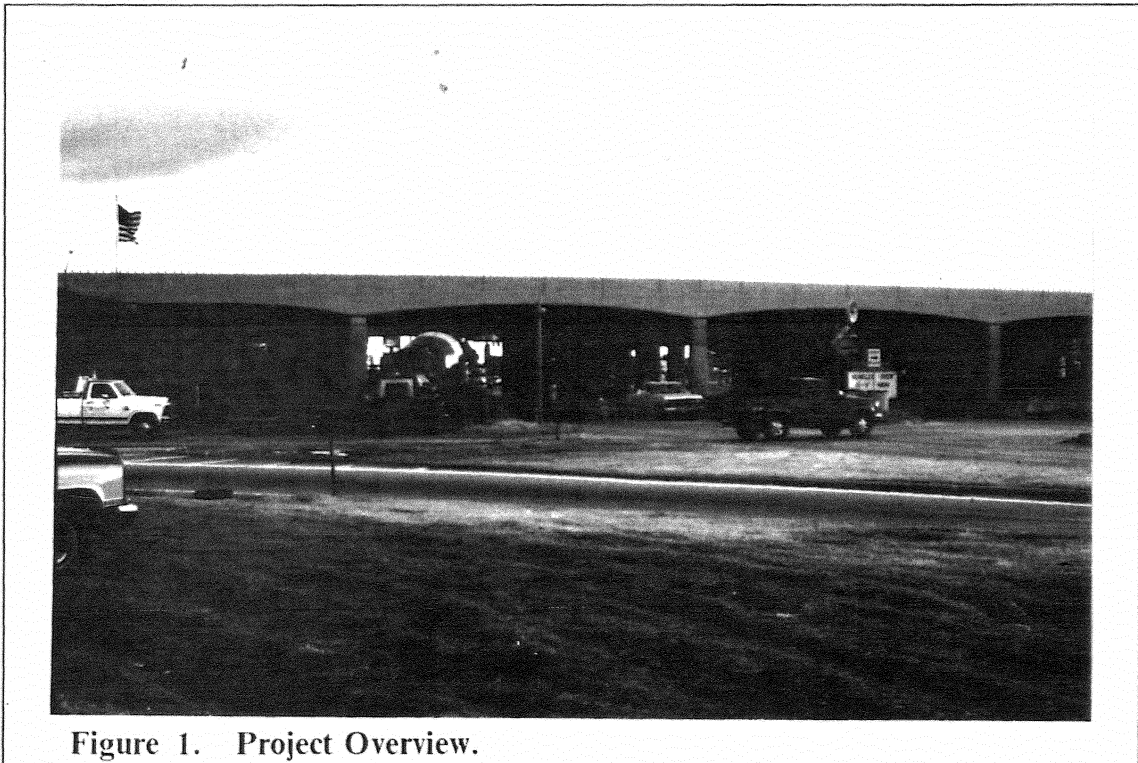
The project selected by the ODOT Bridge Division was an interstate rehabilitation project located on I-40 in Oklahoma City. The bridge is a slab span structure with four spans (38'-57'-57'-38') with a total bridge length of 187.5 feet. (Figure 1) The bridge was originally constructed in 1962 and at the time of rehabilitation it contained an asphalt overlay. The bridge is located in an urban area with an Average Daily Traffic (ADT) of 50,000. The project location is illustrated in Figure 2.

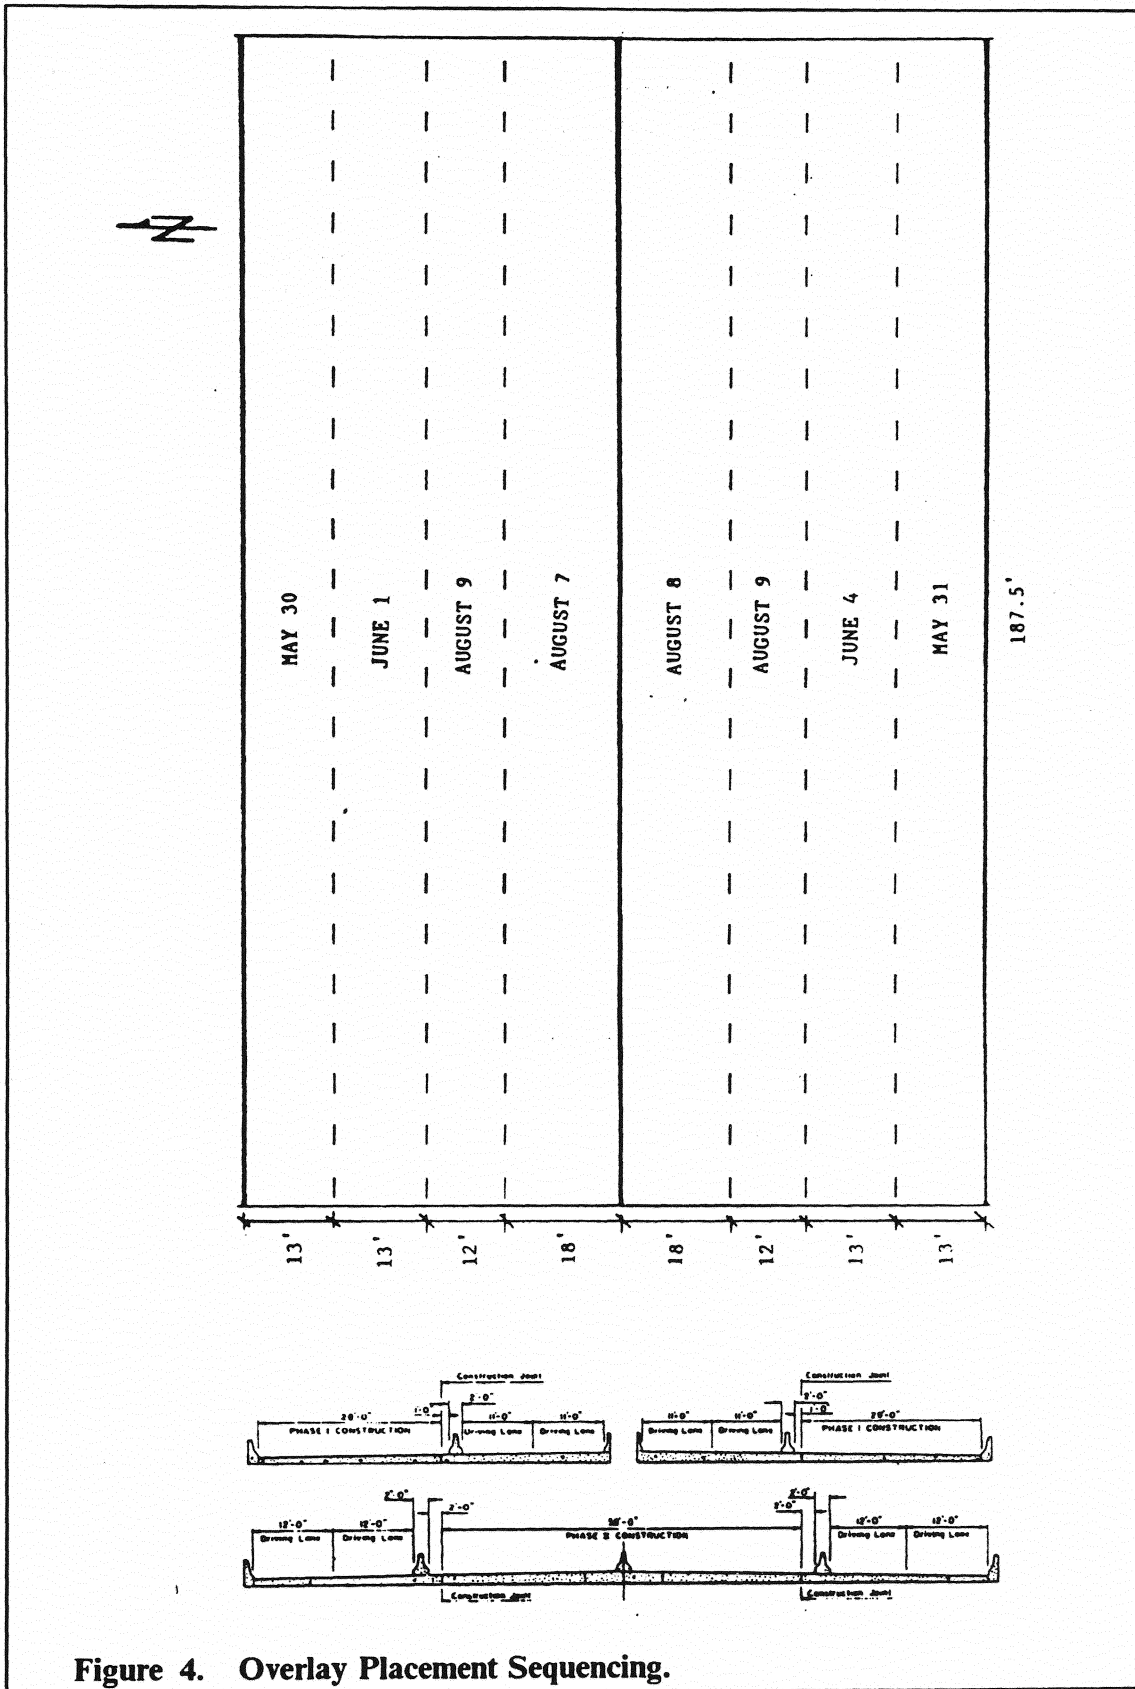
During the second phase traffic was maintained at two lanes each direction. The two lanes were diverted to the outside lanes where the new Pyrament overlay was in place. Upon completion of the widening, the Pyrament overlay was placed on the remainder of the structure. Figure 4 illustrates the the sequencing of each Pyrament overlay placement. The May and June placement dates were part of Phase I, while the August placement dates were part of Phase II.

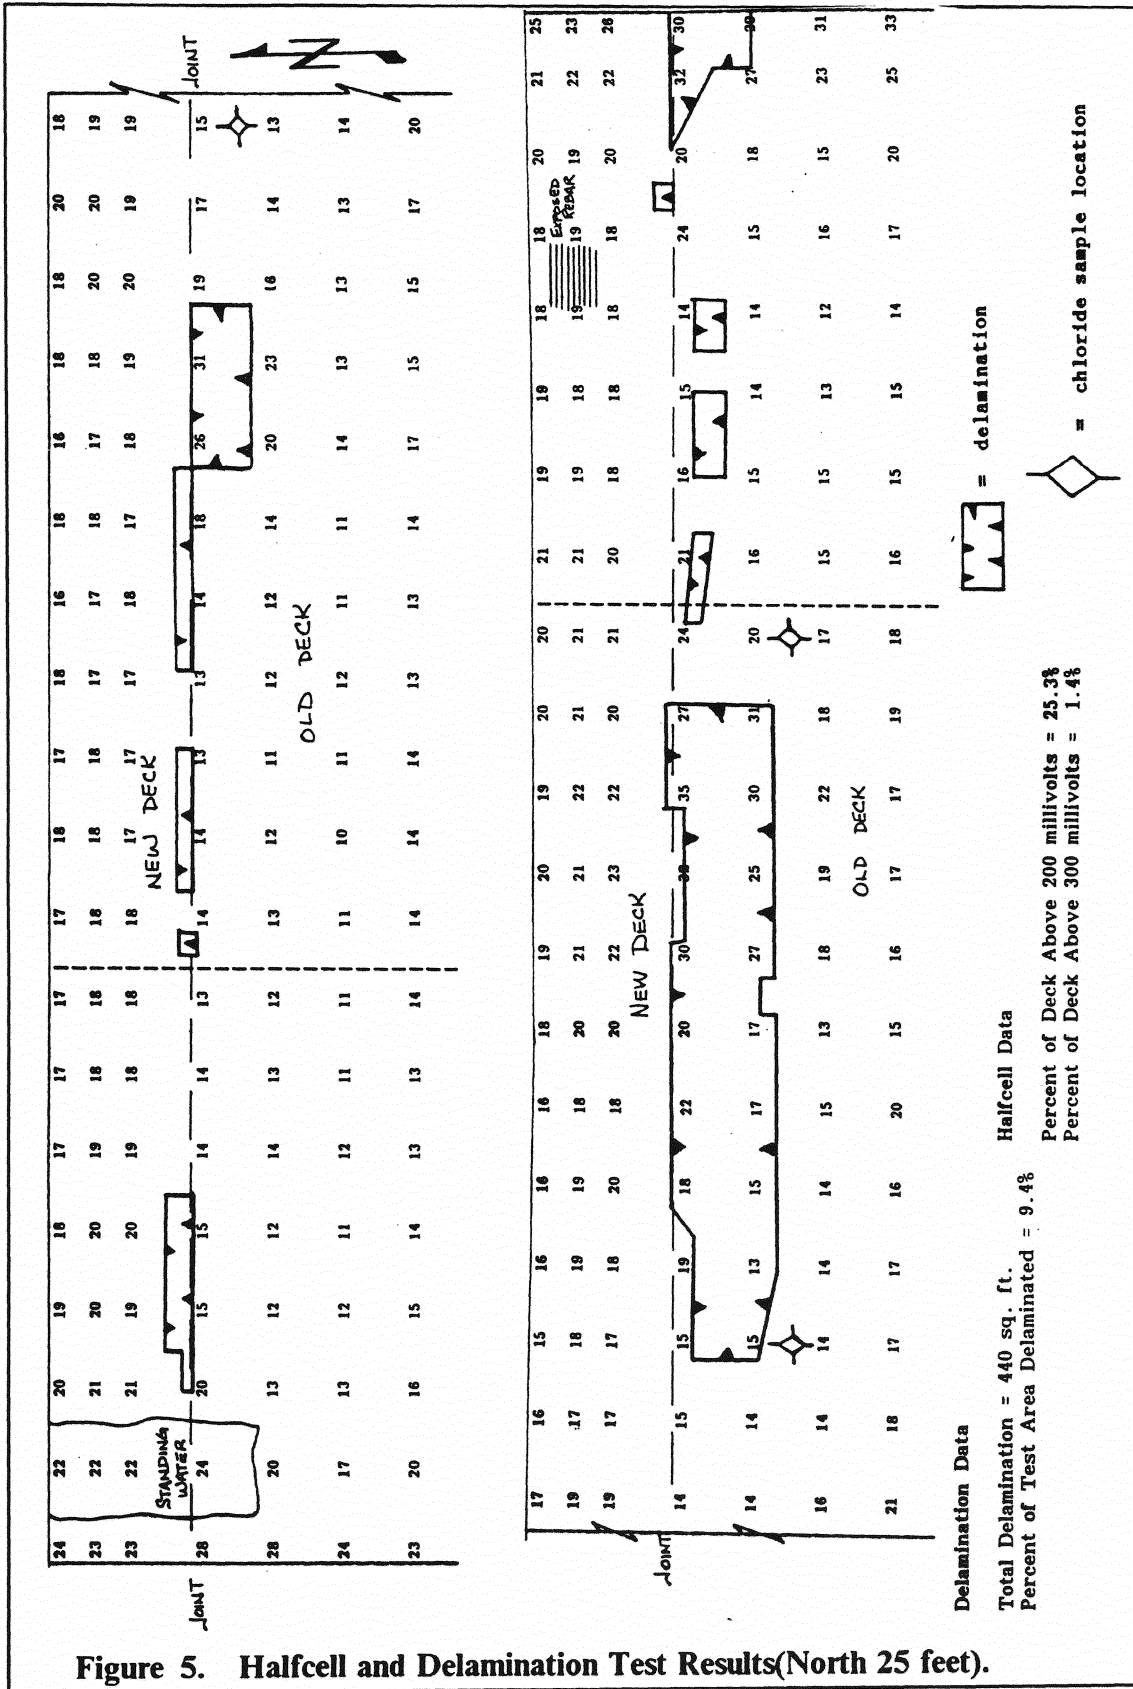
Figure 5. Halfcell and Delamination Test Results(North 25 feet).

Bridge deck testing was performed after the completion of scarification. The Research Division of ODOT performed halfcell testing (ASTM C-876), delamination (chain-drag) testing, and chloride content testing (AASHTO T260). The results of the tests were used to determine which areas of the bridge deck contained deteriorated concrete and required removal before the overlay placement. The areas of high halfcell potentials corresponded with areas of delamination and high chloride contents. The results of this testing are illustrated in Figures 5 and 6. Areas of delamination and high halfcell readings corresponded to areas of the deck where the old structures' gutterline existed. These were predictable because salt water from deicers tends to settle in the gutters of bridge decks. The result of salt water ponding in the gutters is the eventual corrosion of the reinforcing steel.

Total Delamination = 442 sq. ft.  
 Percent of Test Area Delaminated = 9.6%

Percent of Deck Above 200 millivolts = 66.5%  
 Percent of Deck Above 300 millivolts = 4.1%  
 Percent of Deck Above 350 millivolts = 1.1%  
 Percent of Deck Above 400 millivolts = 0.2%

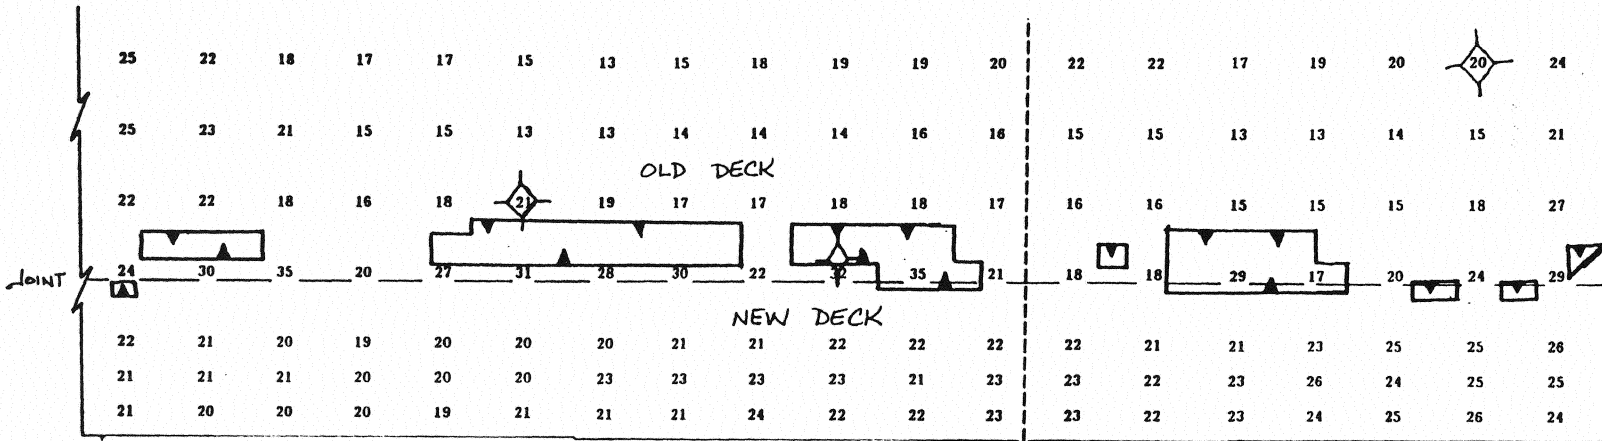
Figure 6. Halfcell and Delamination Test Results (South 25 feet).

Delamination Data

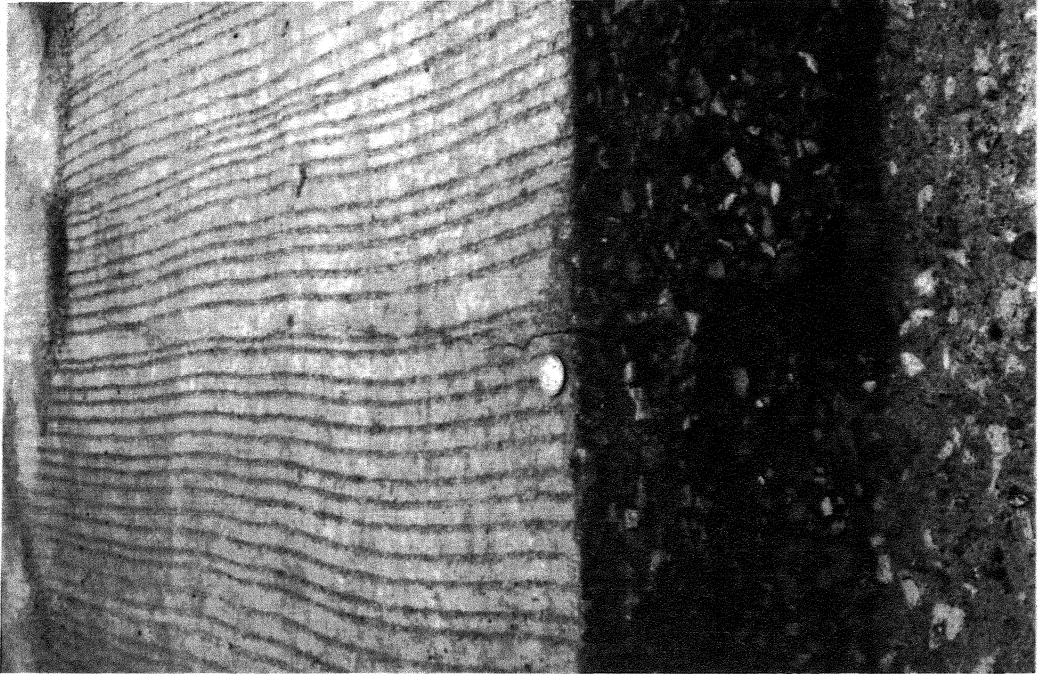
Figure 7. Full Depth Crack (24 Hours After Placement).

The above curing procedures were used during the Phase I portion of the project. At times the contractor was delayed in placing the cotton blankets. This resulted in the overlay setting up before the blankets were placed. The Phase I overlay developed severe shrinkage cracking 24 hours after placement. The cracks were Y-shaped in formation and some migrated to full depth (Figure 7). It was also noted portions of the overlay were not consolidated at the interface with the bridge deck. This was especially evident in areas where the overlay was greater than four inches thick.

The cracking problems in Phase I had to be addressed before Pyrament could be used in Phase II. It was discovered between phases that linseed had never been used on Pyrament as a curing agent. The manufacturer recommended a resin curing compound be used in Phase II. In addition to a resin compound, the wet blankets would be placed immediately behind the application of the resin compound.

The Phase II curing procedures included resin curing compound, fogging the surface with a light water mist, placement of burlap, cotton blankets, and plastic all kept in place for 24 hours. The fogging and placement of burlap were steps added by the contractor during construction. This resulted in maintaining a good finished surface since the burlap weight was less than that of the cotton. If the cotton blankets were placed directly on the wet concrete surface the tine finish could be disturbed.

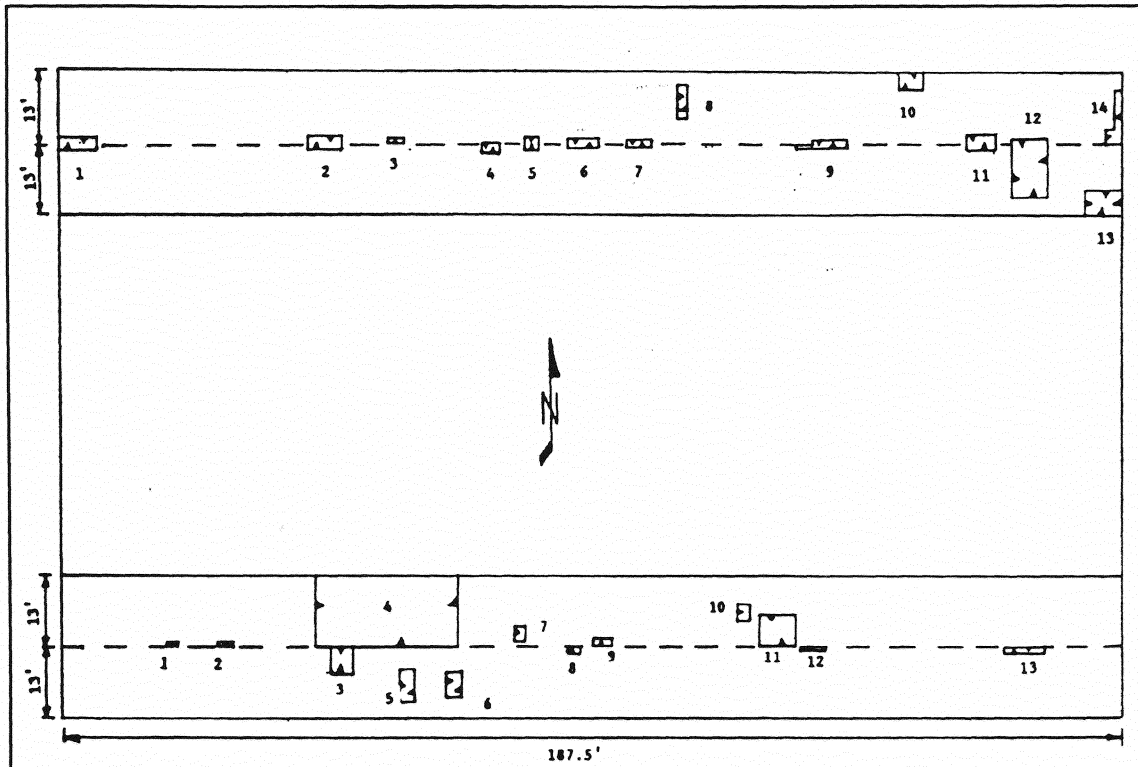
Figure 8. Repaired Area Locations.

The delamination survey indicated all delaminated areas were located in the Phase I portion of the overlay. This consisted of the northernmost 26 feet and the southernmost 26 feet of the bridge deck. The northernmost 26 feet contained 14 delaminated areas totalling 216 square feet. The southernmost 26 feet contained 13 delaminated areas totalling 478 square feet. The total delaminated area was 694 square feet which is 7% of the Phase I overlay or 3.2% of the entire bridge deck. The locations of the delaminated areas are illustrated in Figure 8. Photographs of the cracking are shown in Figures 9 and 10.

Each of the delaminated areas contained shrinkage cracks. Figure 8 indicates almost all of the delaminated areas were located along the longitudinal construction joints separating each days overlay placement. The construction joints are illustrated with a dashed line. The two construction joints were located in the old bridge deck gutter. There were many areas of concrete removal along the old gutter which resulted in the overlay being the thickest in these areas. As mentioned earlier in this report, the vibrating screeds of the finishing machine did not fully consolidate the overlay when depths were greater than four inches. Voids at the overlay/deck interface combined with the shrinkage cracks would cause problems in the future and needed to be removed.

DELIMITATIONS NORTHERN 26 FEET		
NUMBER	DIMENSIONS (FEET)	AREA (SQ. FT.)
1	7.0 x 2.0 =	14.00
2	6.0 x 2.2 =	13.20
3	3.5 x 1.3 =	4.55
4	2.8 x 1.5 =	4.20
5	2.8 x 2.3 =	6.44
6	5.6 x 1.7 =	9.52
7	4.7 x 1.2 =	5.64
8	1.7 x 7.2 =	12.24
9	3.0 x 0.8 =	2.40
	5.9 x 1.8 =	10.62
10	4.7 x 3.2 =	15.04
11	5.6 x 2.6 =	14.56
12	6.3 x 9.6 =	60.48
13	4.8 x 7.0 =	33.60
14	12.0 x 0.5 =	6.00
	2.3 x 1.5 =	3.45
TOTAL =		215.94

DELIMITATIONS SOUTHERN 26 FEET		
NUMBER	DIMENSIONS (FEET)	AREA (SQ. FT.)
1	1.5 x 0.9 =	1.35
2	3.4 x 1.0 =	3.40
3	5.3 x 4.7 =	24.91
4	24.7 x 13.3 =	328.51
5	2.7 x 6.8 =	18.36
6	2.8 x 5.6 =	15.68
7	2.8 x 2.5 =	7.00
8	2.4 x 2.3 =	5.52
9	3.5 x 1.8 =	6.30
10	2.7 x 3.0 =	8.10
11	7.3 x 6.3 =	45.99
12	4.0 x 0.8 =	3.20
13	7.6 x 1.3 =	9.88
TOTAL =		478.20

The delaminated areas indicated in Figure 8 were removed and replaced with Pyrament. A concrete saw was used to outline each area and jackhammers were used to remove the concrete. The delaminated areas were easily removed due to lack of consolidation and bonding at the bottom of the overlay. However, the contractor had difficulty removing areas just outside the delaminated areas which indicated there was excellent bonding and consolidation where there were no delaminations. Pyrament was placed in the removed areas and vibrated and finished by hand.

A number of shrinkage cracks were still present in the Phase I portion of the overlay. No delaminations were detected in these areas. ODOT wanted to take every precaution to seal the overlay to obtain longer service life. A methyl methacrylate sealer was used to seal each of the shrinkage cracks. Five sample cores were taken to ensure the methyl methacrylate was penetrating and sealing the cracks. The cores indicated the methyl methacrylate had penetrated the cracks to depths ranging from one to three inches.

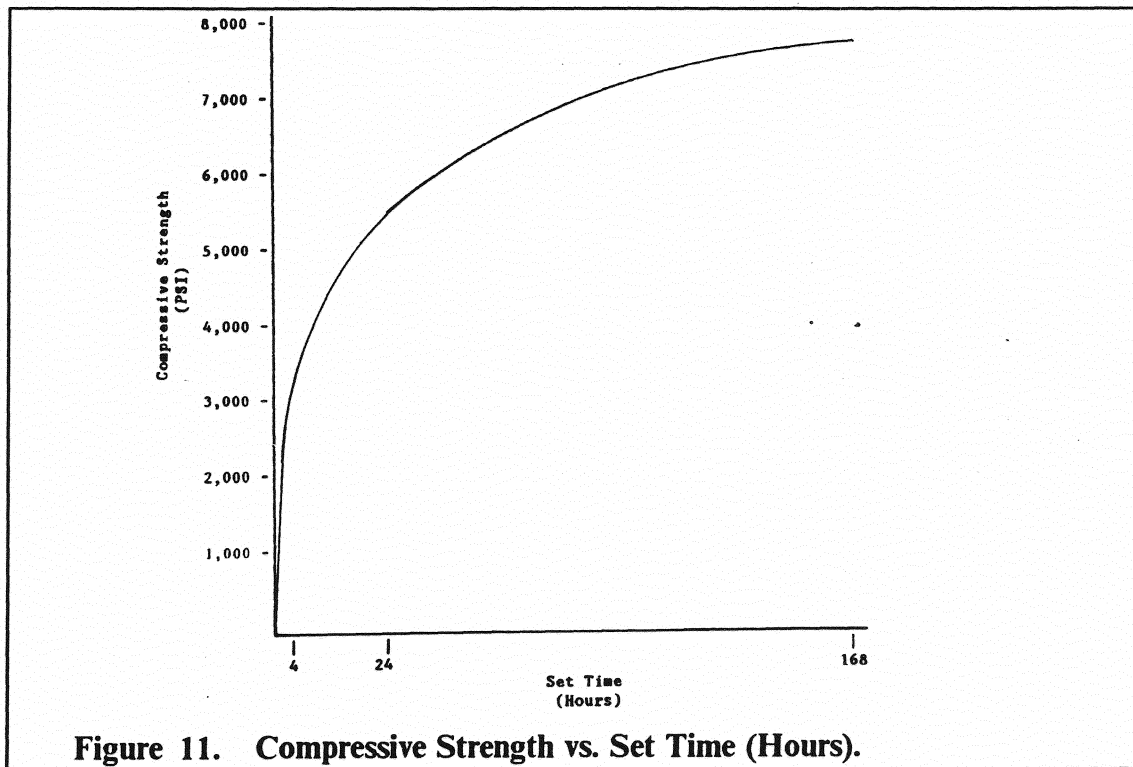
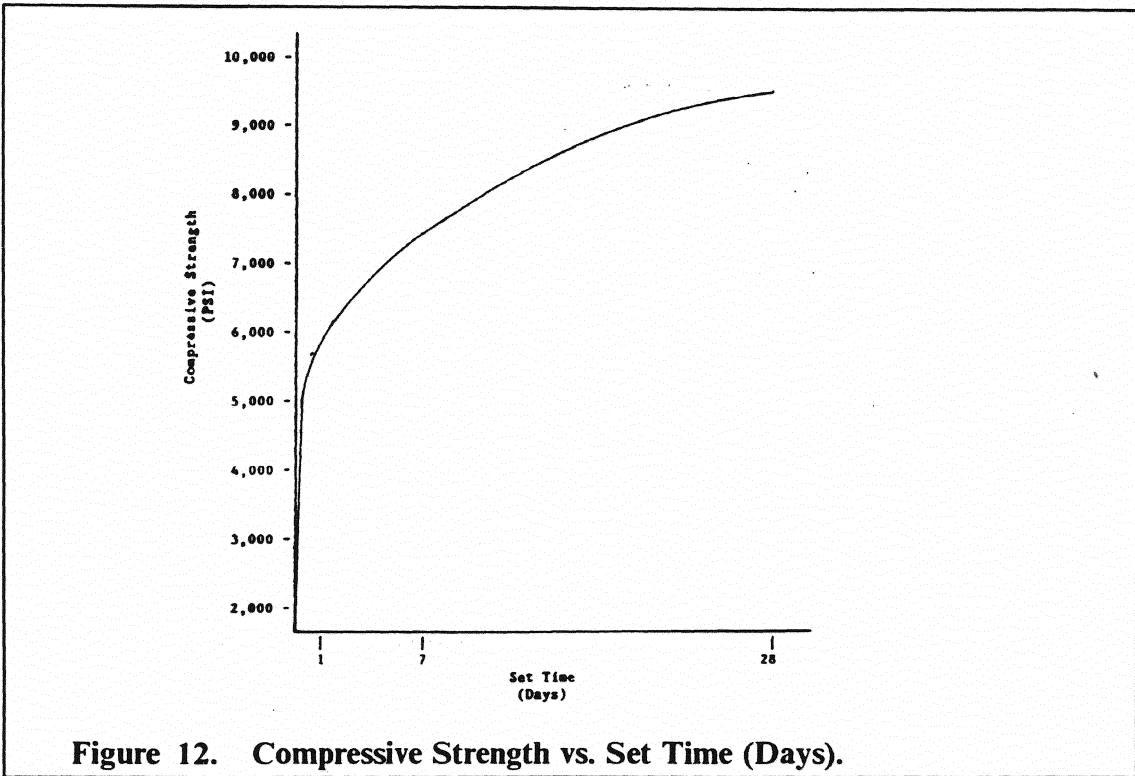
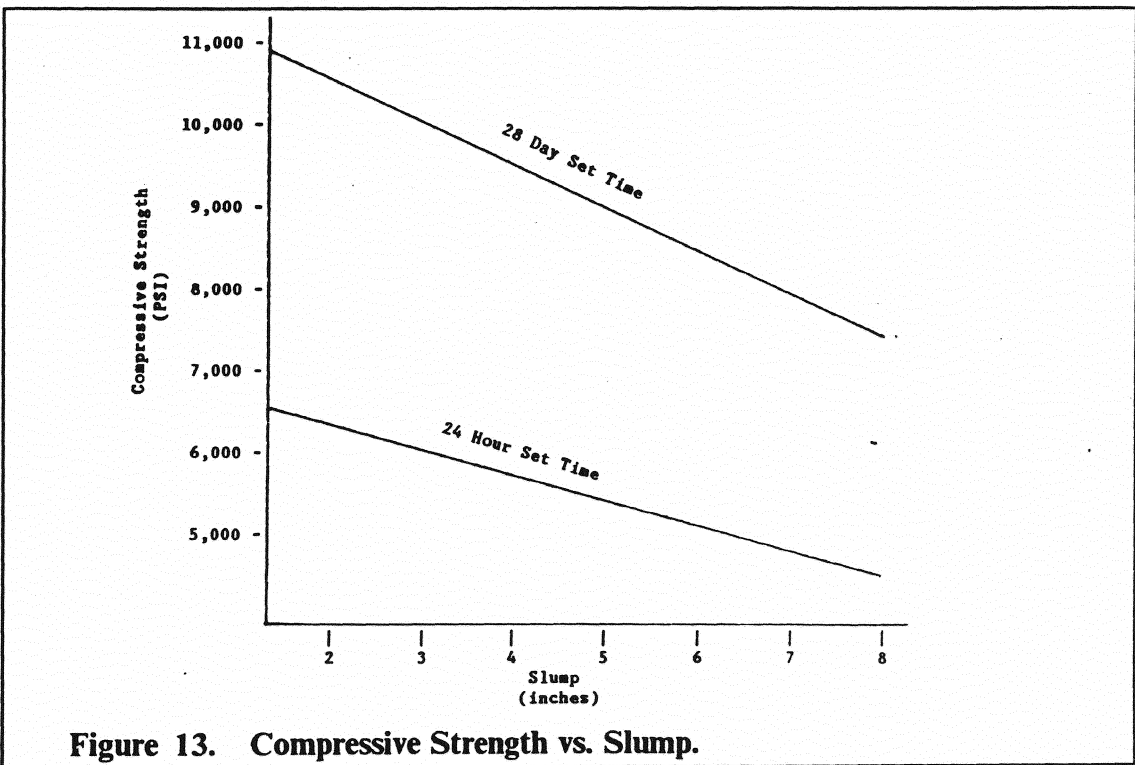
Compressive strength cylinders were made during the Pyrament overlay placement. The cylinders were tested at 4 hour, 24 hour, 7 day, and 28 day set times. The project specification required a minimum 4 hour compressive strength of 2500 psi and a minimum 28 day compressive strength of 8000 psi. The 4 hour compressive strengths ranged from 2550 psi to 3200 psi with an average of 2700 psi. The 28 day compressive strengths ranged from 7660 psi to 11,050 psi with an average of 9600 psi. The Pyrament compressive strengths over time are illustrated in Figures 11 and 12. The test cylinder results indicate the Pyrament obtained the necessary compressive strengths on this project.

Slump tests were performed on each concrete truckload in which cylinders were made. As expected, the compressive strength of Pyrament decreased as the slump increased. Figure 13 illustrates the relationship between slump and compressive strength for the Pyrament at 24 hour set time and at 28 day set time. The strength requirements were still easily met at the upper slump specification limit of six inches. Construction procedures were simplified when the Pyrament could be placed with five inch slump instead of a two inch slump.

The compressive strength of the Pyrament concrete exceeded the specification requirements of 2500 psi after 4 hours and 8000 psi after 28 days. This held true for slumps ranging from two to six inches. The compressive strength results indicate Pyrament overlays can be opened to traffic after 24 hours curing. This quality is beneficial for rapid urban interstate bridge deck rehabilitation.
