# **EVALUATION OF CAUSES OF EXCESSIVE SETTLEMENTS OF PAVEMENTS BEHIND BRIDGE ABUTMENTS AND THEIR REMEDIES— PHASE II**

By  
Joakim G. Laguros  
Musharraf Zaman  
Iqbal U. Mahmood

Office of Research Administration  
University of Oklahoma

**January 1990**

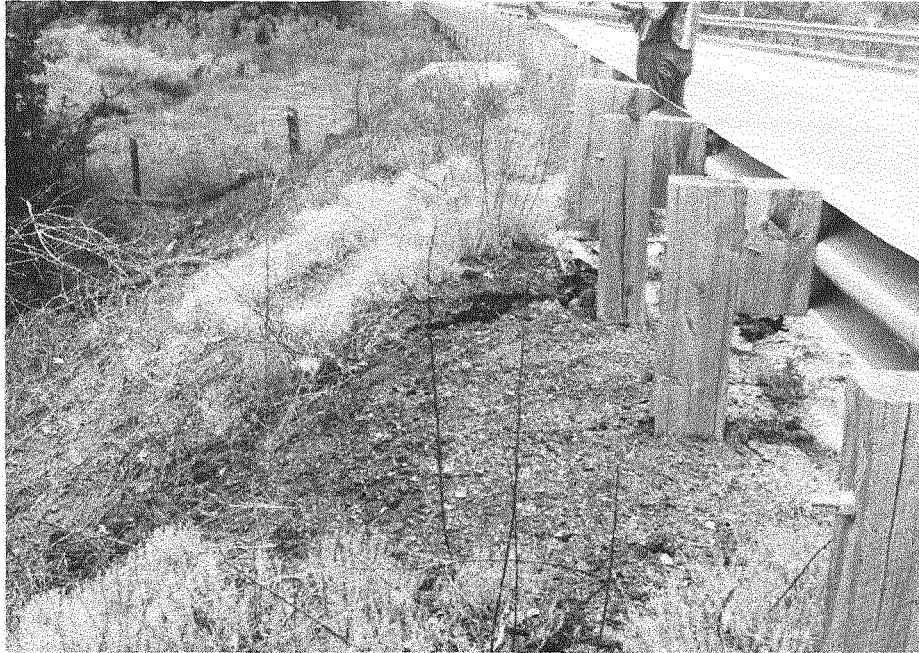
Fig. 2-2. Approach guardrail used during the period 1960-1980

The age of the bridge approach may be estimated by the types of approach guardrail, general condition of the bridge or bridge structure type. The guardrail shown in Fig. 2-1 was in use during 1930-1960. Figure 2-2 shows typical guardrails which were in use during 1960-1980 and the one shown in Fig. 2-3 has been in use since 1980. This will only give a broad idea about the age of the bridge approach. Depending upon the individual judgement, the estimated age might vary substantially. However, this inaccuracy may not be of any concern since the actual age of the bridge can be obtained from the ODOT Bridge Division records.

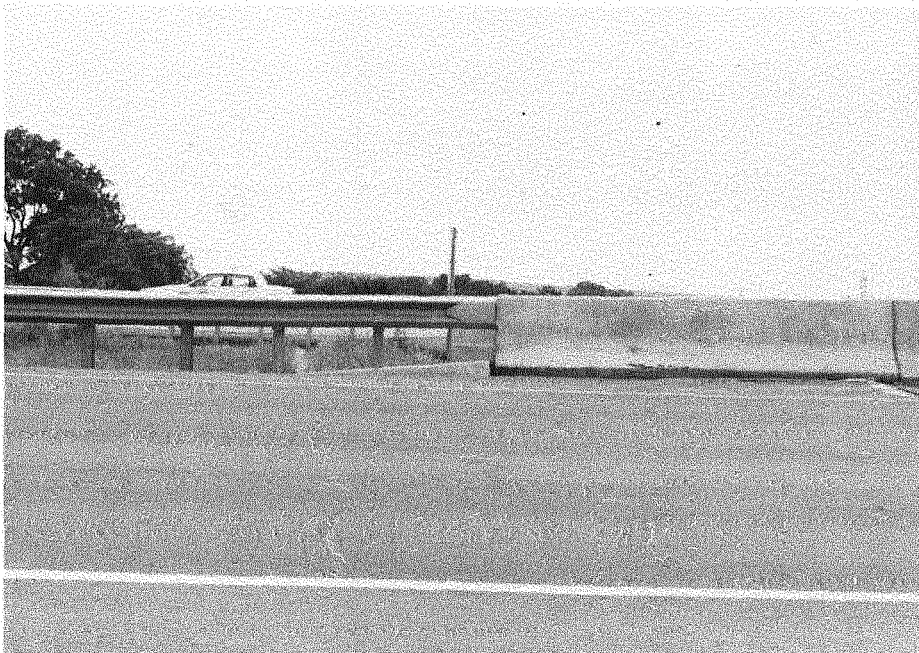
Fig. 2-3. Approach guardrail used since 1980

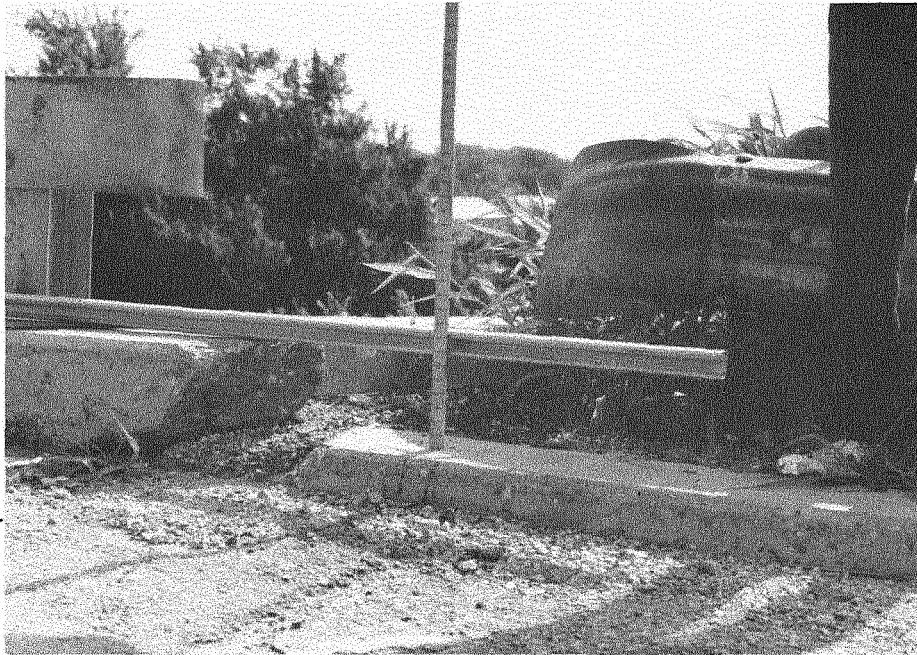
Fig. 2-4. Settlement estimate of bridge approach from the differential settlement of the curb

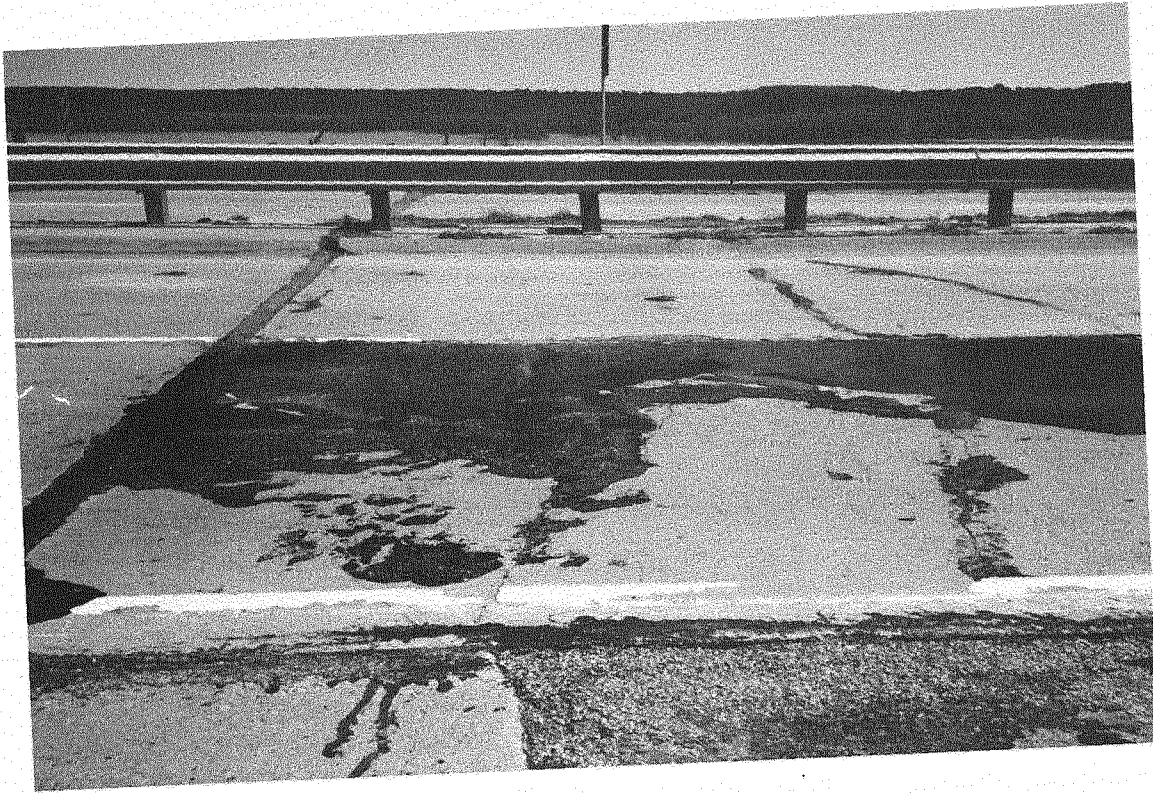
Surface roughness may be categorized as rough, moderately rough or smooth. This does not indicate the extent of settlement but rather gives an idea about the present condition of the riding surface. Hence an approach may have undergone excessive settlement but at the time of survey it may be smooth if appropriate maintenance measures were undertaken. An illustration of various types of roughness are shown in Figs. 2-6, 2-7 and 2-8.

Fig. 2-8. A rough bridge approach

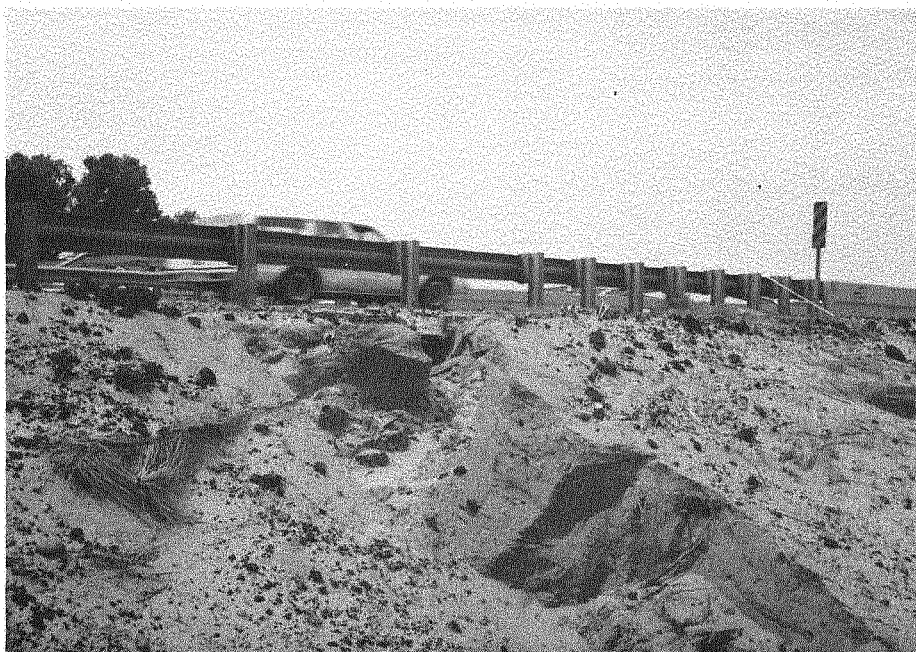
Embankment slope erosion aggravates the settlement problem. The slope near the abutment should be checked for evidence of erosion or settle-

ment. Figure 2-11 shows a severely eroded approach embankment slope.

Fig. 2-11. An approach embankment showing erosion

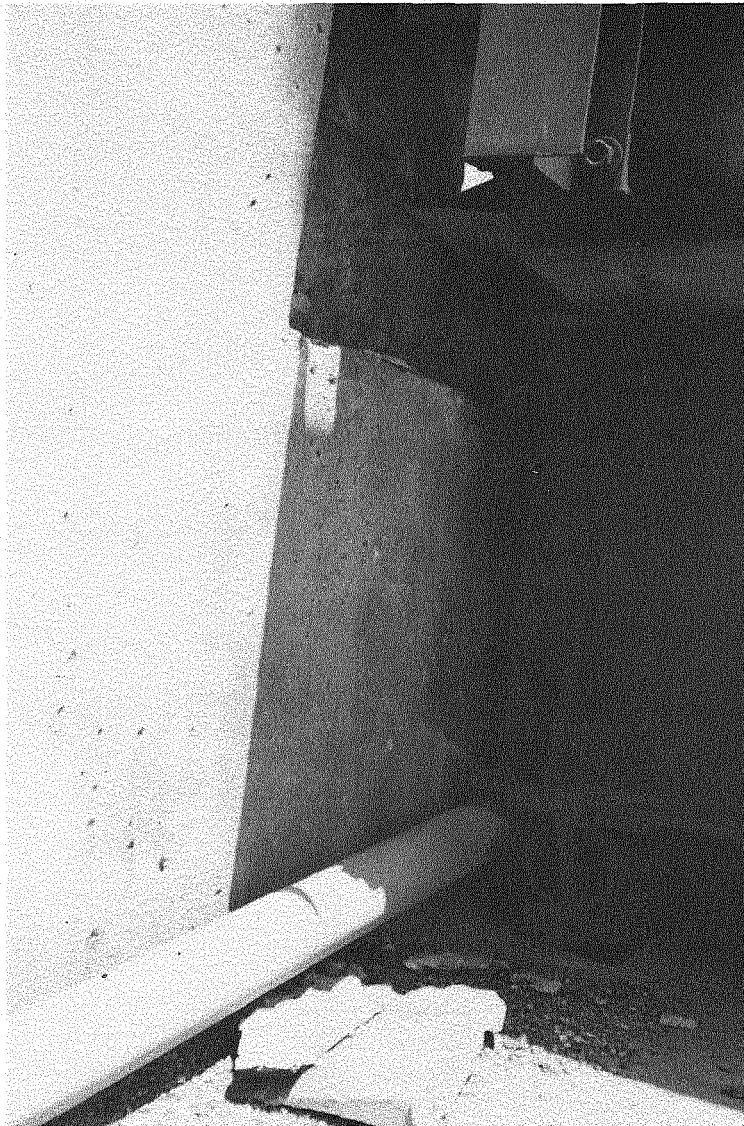
Fig. 2-13. Evidence of a minor movement of the abutment headwall

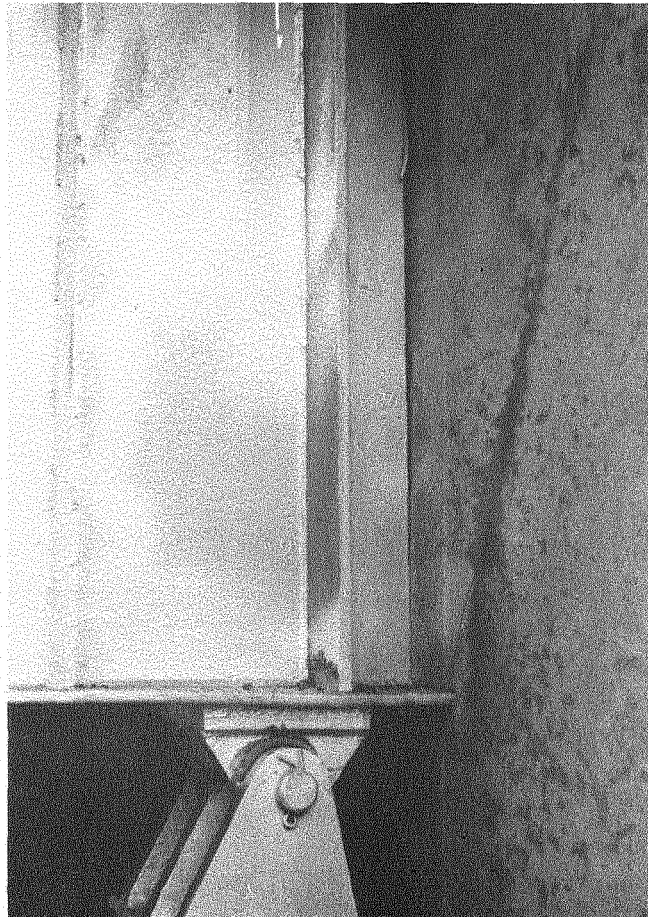
Fig. 2-15. Evidence of extensive movement of abutment headwall

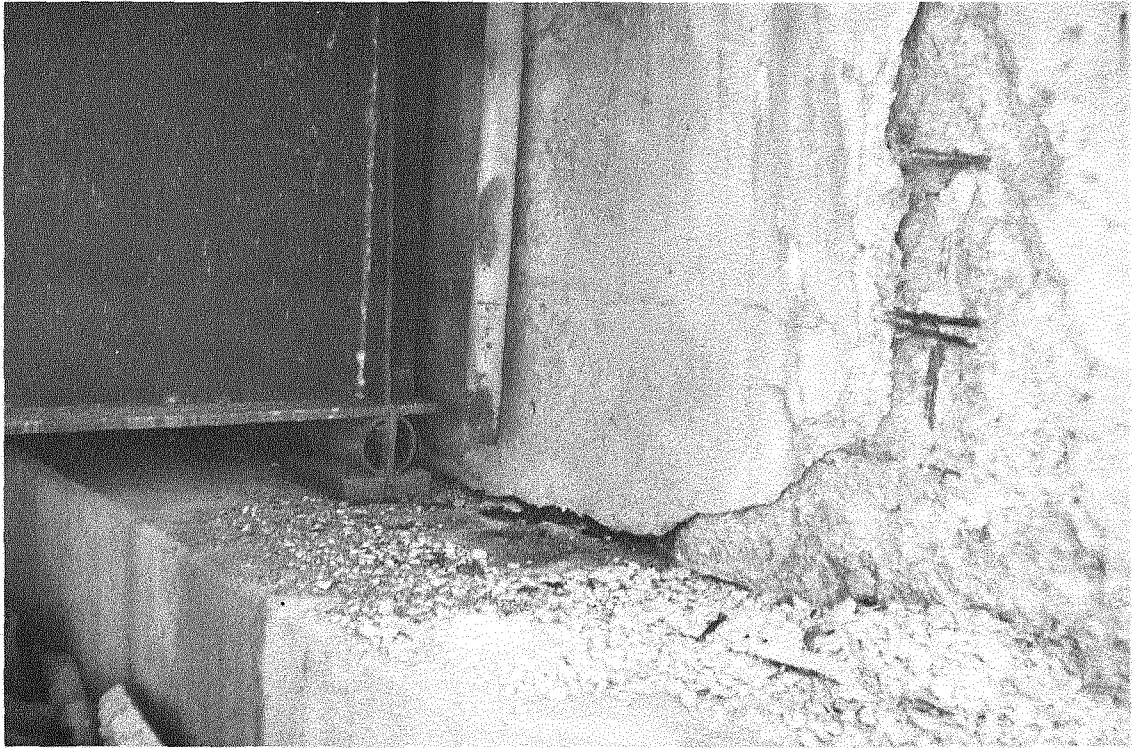
Fig. 2-19. Expansion device showing minor tilting

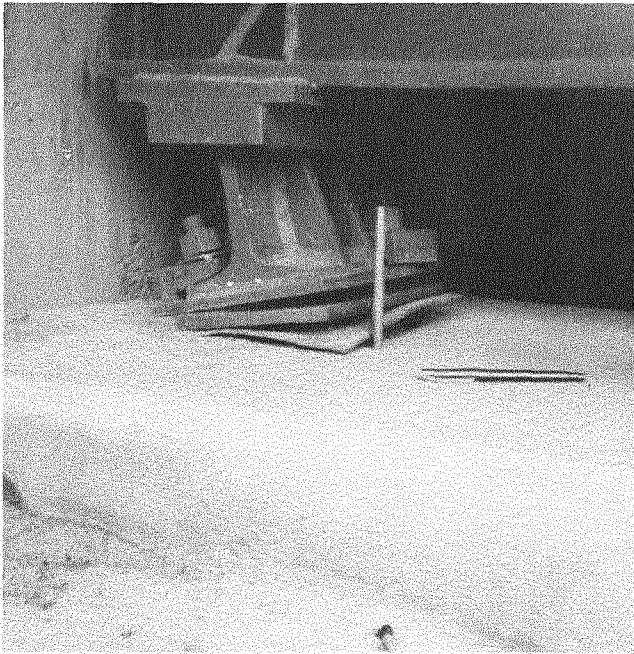
Fig. 2-21. Expansion device showing extensive tilting

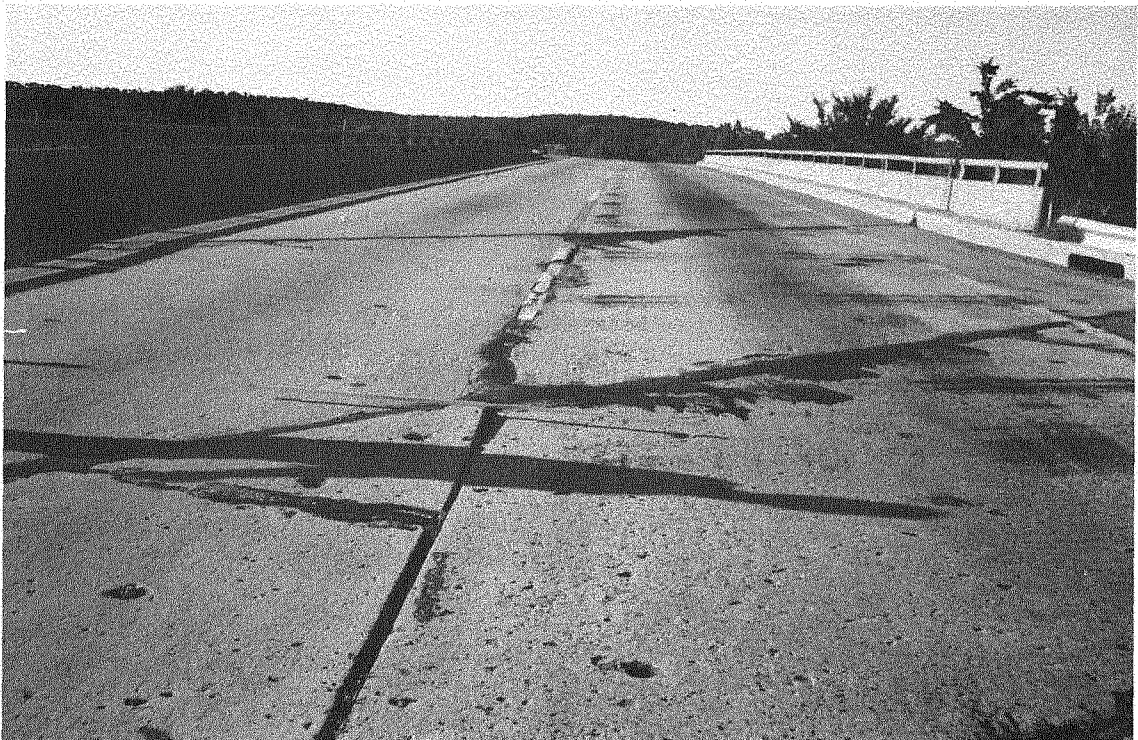
Fig. 2-22. Differential settlement between truck lane and nontruck lane

traffic flow. The degree of settlement in the right most lane should be compared to other lanes for evidence of influence of truck traffic on the settlement problem. Figure 2-22 shows the differential settlement between truck lane and nontruck lane.
