Test Report No. 441203-01

**DESIGN AND EVALUATION OF TRANSITION FOR TXDOT
MASH TEST LEVEL 4 (TL-4) GUARDRAIL SYSTEM**

Sponsored by
Texas Department of Transportation (TxDOT)

TEXAS A&M TRANSPORTATION INSTITUTE PROVING GROUND

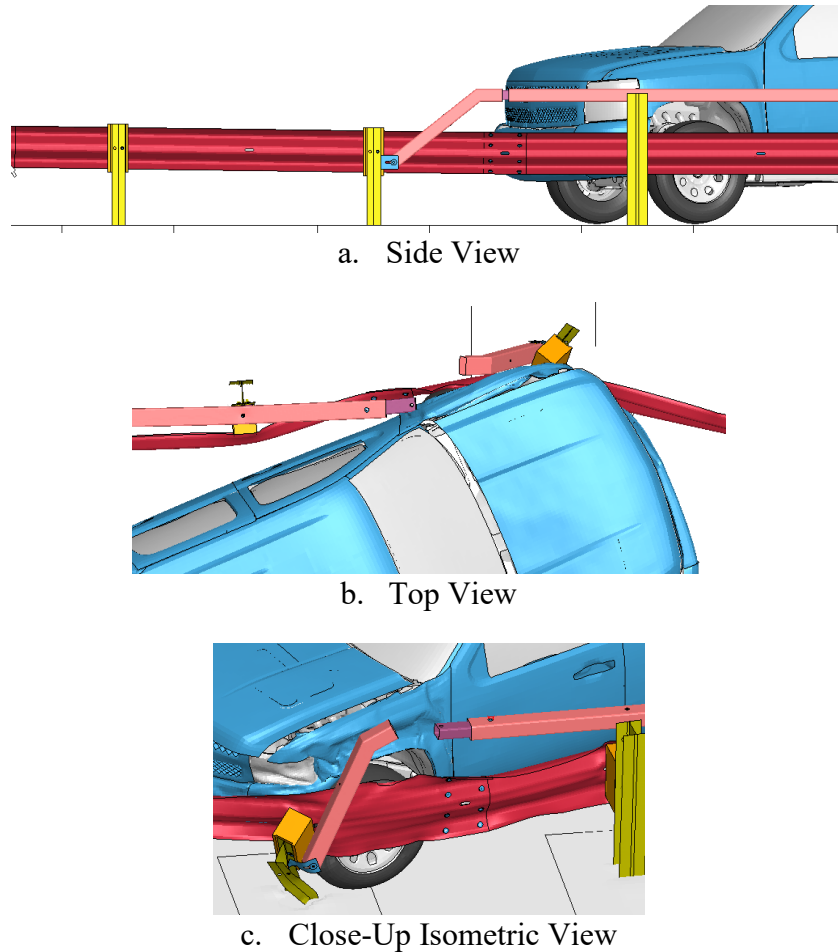
Figure 2.4. Reverse-Direction Pickup Truck Impact of the Shortened Turn-Down Rail Design.

The researchers then performed impact simulations of the modified Transition design (Figure 2.4) from the opposite direction of travel using *MASH* Test 3-21 impact conditions. Simulations were performed with the vehicle impacting the transition while traveling in the direction from the W-beam guardrail to the TL-4 guardrail. The researchers performed simulations at three different impact points (IPs), as shown in Figure 2.5. These impact points, IP1, IP2, and IP3, were 86 inches, 161 inches, and 236 inches upstream of the center of the splice between the top HSS rail and the turn-down rail, respectively. The purpose of performing simulations at multiple impact points was to determine the most critical impact location for crash testing.

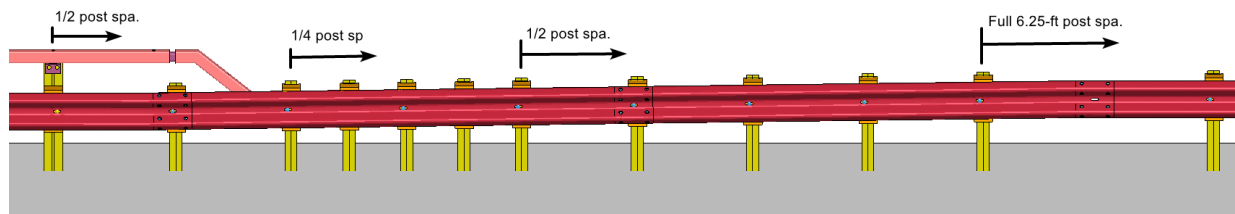
To stiffen the W-beam guardrail upstream of the TL-4 guardrail, the researchers added additional W6×9 posts, as shown in Figure 2.7. A post was added between the W6×25 TL-4 guardrail post and the W6×9 post to which the turn-down rail was attached. Upstream of this, four posts were positioned at quarter post spacing (i.e., 18.75-inch post spacing), followed by four posts at half post spacing (i.e., 37.5-inch post spacing), followed by the standard W-beam guardrail with full post spacing (i.e., 75-inch post spacing). By adding these posts at varying post spacings, the lateral stiffness of the Transition’s W-beam guardrail was increased upstream of the TL-4 guardrail.

Figure 2.7. Transition Design with Posts Installed at Quarter and Half Post Spacings.

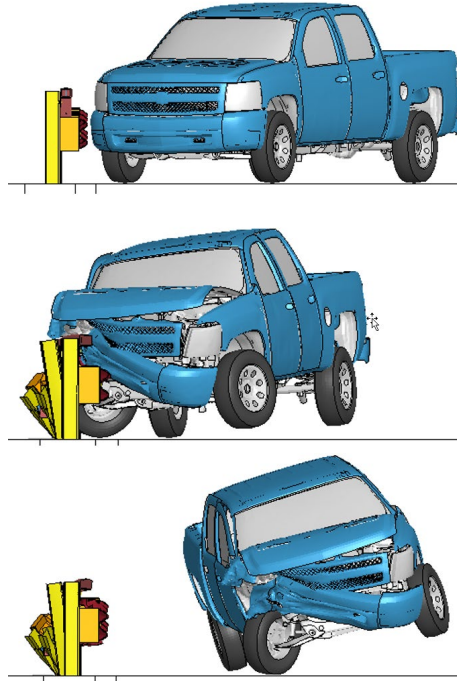
The researchers performed impact simulations with *MASH* Test 3-21 impact conditions at the three impact points used previously (Figure 2.5). Some key frames from the simulation results are presented in Figure 2.8 through Figure 2.10. Simulation results indicated that the vehicle was successfully contained and redirected for all the impact points.

Figure 2.8. Simulation at IP1 for Transition Design with Quarter and Half Post Spacings.

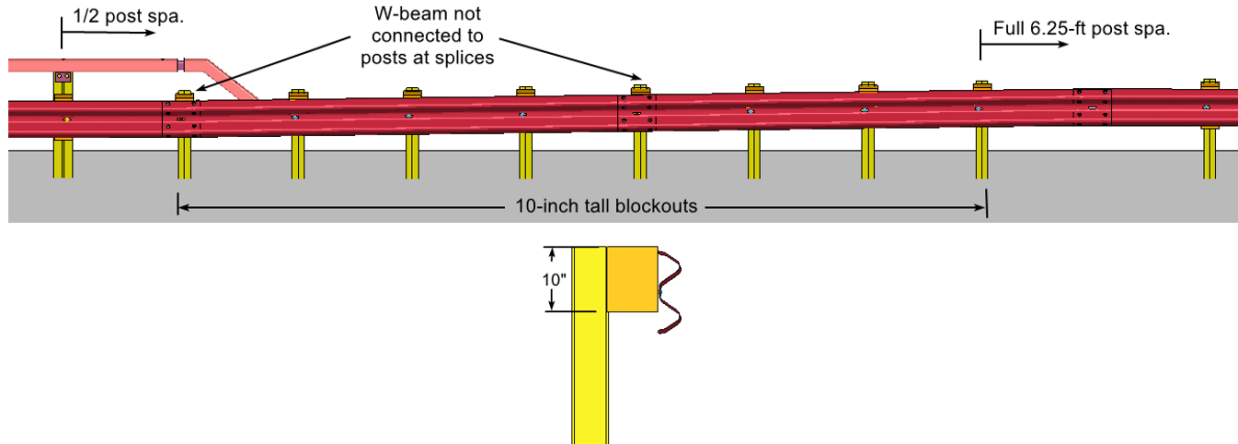
In addition to half post spacing of the Transition posts, the blockouts of these posts were 10 inches tall. The reduction in the blockout length was incorporated based on full-scale crash testing performed under another project at TTI (3). In that project, *MASH* Test 3-21 on a W-beam transition from full post spacing to half post spacing failed due to rail rupture. Another test was performed by reducing the height of the blockout from 14 inches to 10 inches (as shown in Figure 2.11). This prevented the rail from rupturing, and the transition passed *MASH* testing. The modified Transition design shown in Figure 2.11 incorporates the design features of the passed full post spacing to half post spacing transition. Successful testing of this Transition on the upstream end eliminated the need to evaluate it under this project.

Figure 2.11. Modified Transition Design with Half Post Spacing.

The researchers performed three impact simulations on the modified design shown in Figure 2.11. These simulations were performed using the impact points shown in Figure 2.5 with *MASH* Test 3-21 impact conditions. The results of these simulations are shown in Figure 2.12 through Figure 2.14. For all three impact simulations, the Transition system successfully contained and redirected the pickup truck.

Due to the successful containment and redirection of the vehicle in the simulation analyses, the researchers recommended performing the full-scale crash testing with the Transition design shown in Figure 2.11. The CIPs for *MASH* Test 3-21 and Test 3-20 were 86 inches and 104 inches, respectively, measured upstream of the center of the splice between the top HSS rail and turn-down rail.

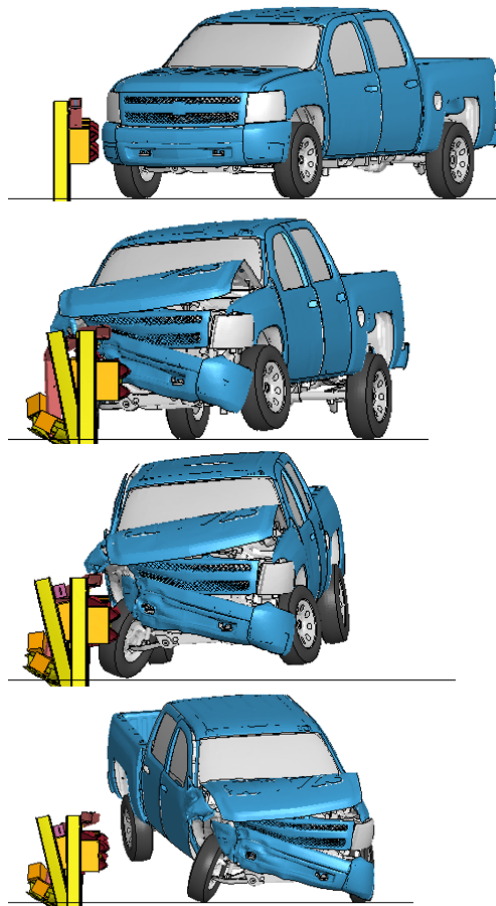
Figure 2.12. Simulation at IP1 for Transition Design with Half Post Spacing.

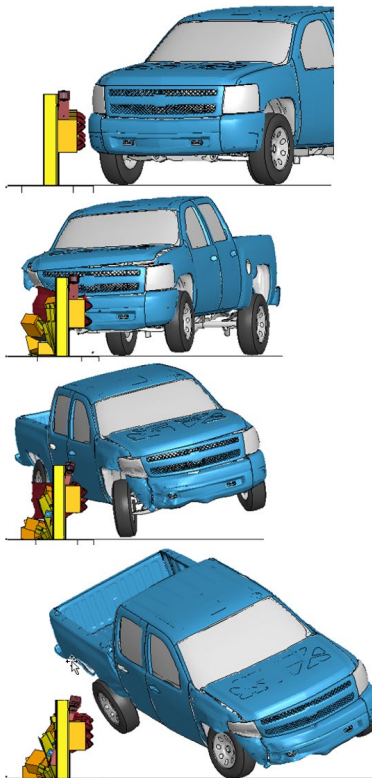
Figure 2.14. Simulation at IP3 for Transition Design with Half Post Spacing.

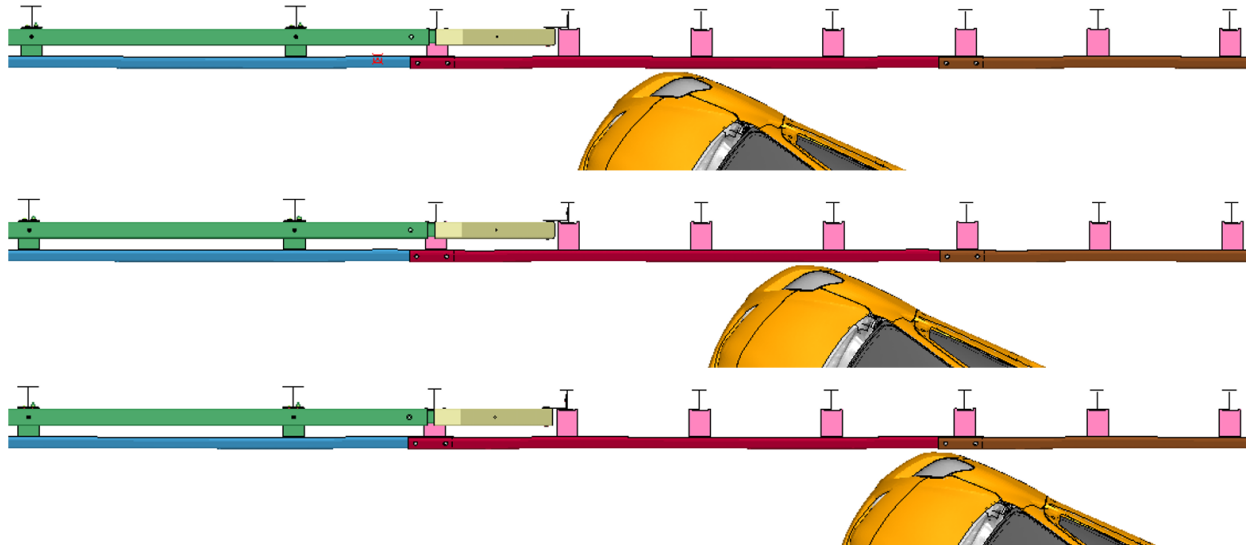
Since this system was simplified compared to the system with quarter and half post spacings, the researchers picked this design for further evaluation with the passenger car. The researchers performed three impact simulations using *MASH* Test 3-20 impact conditions (i.e., 2,420-lb small car, impacting at 62 mi/h and 25 degrees).

Figure 2.15. Impact Points for Test 3-20 Simulations (IP4 [top], IP5 [center], IP6 [bottom]).

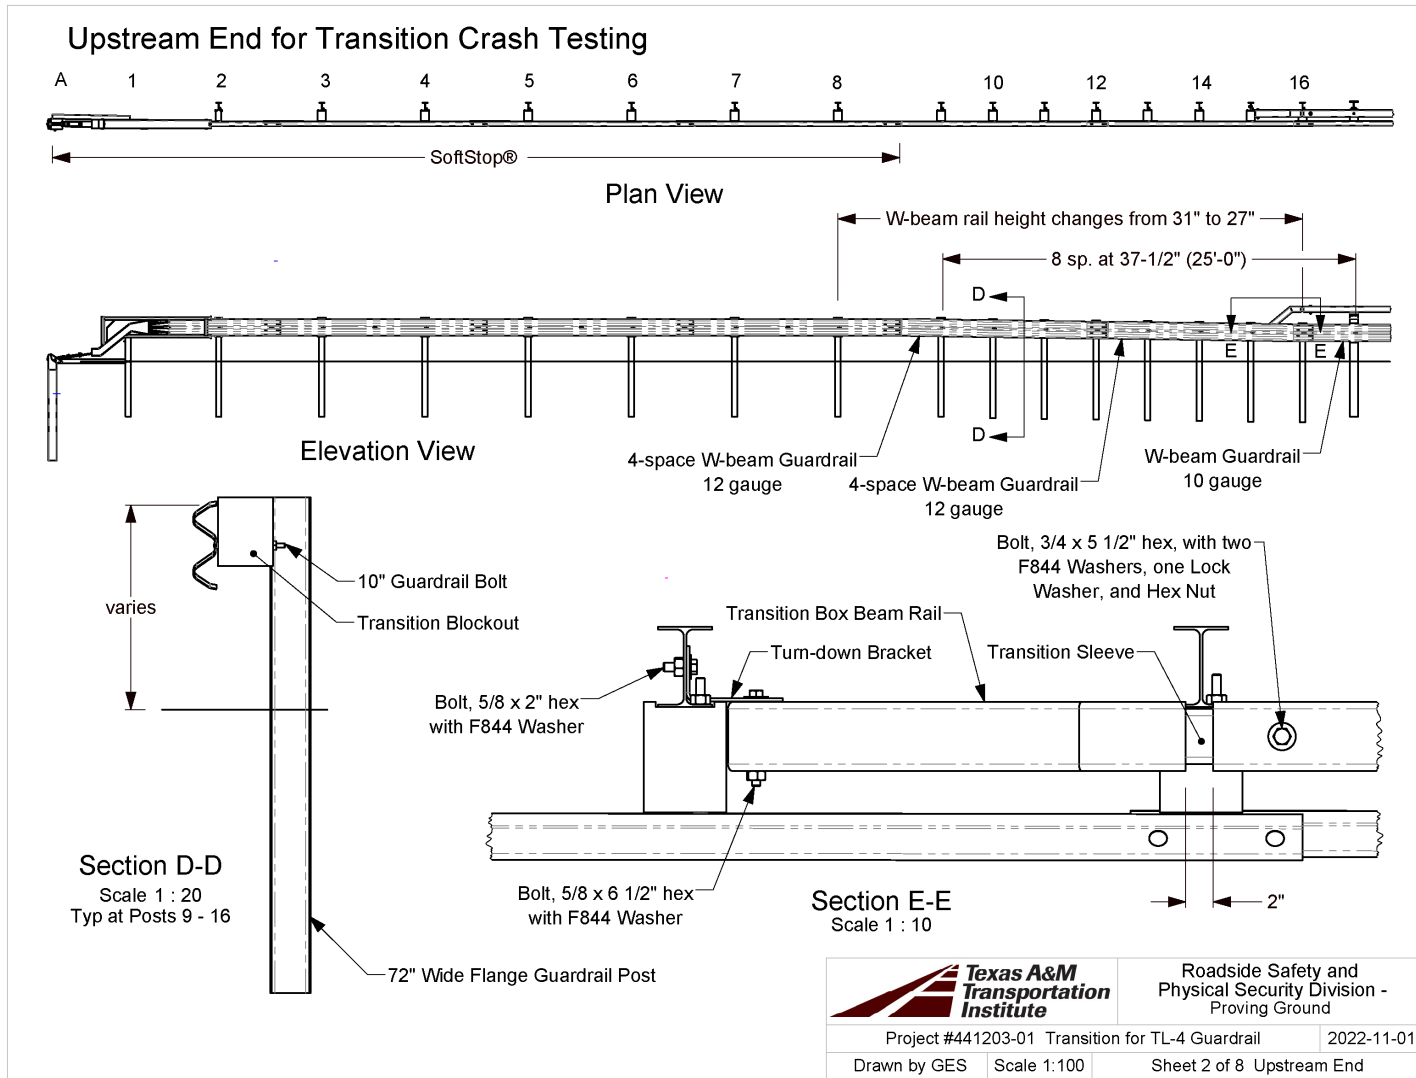
Figure 3.1. Details of Transition.

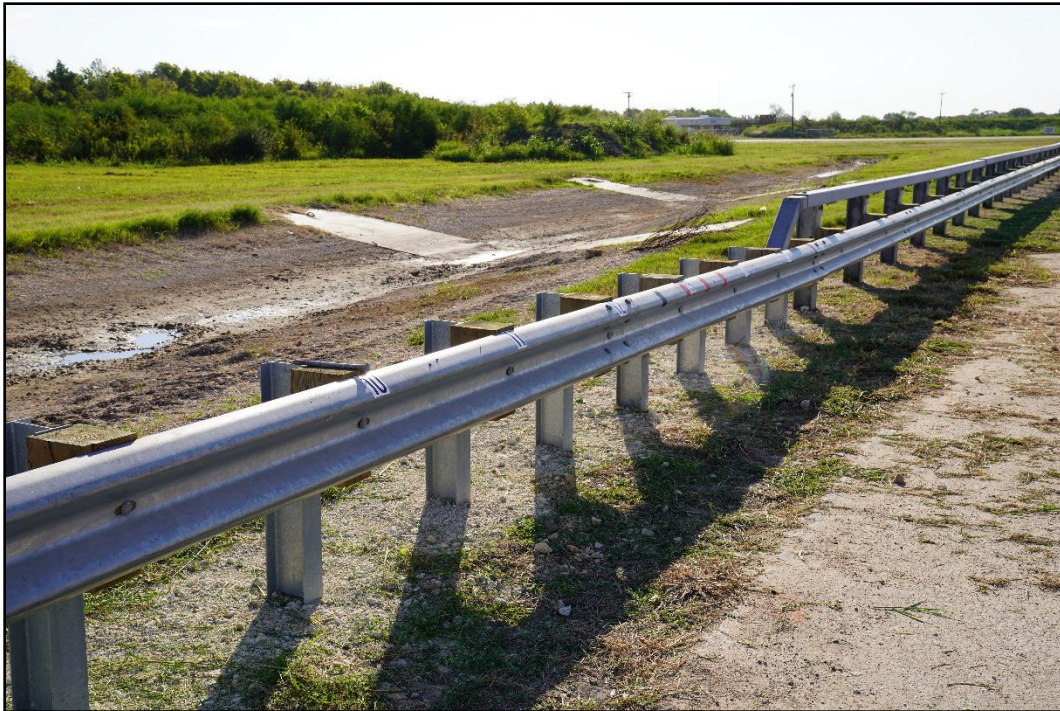
Figure 3.2. TL-4 Test Installation prior to Testing.

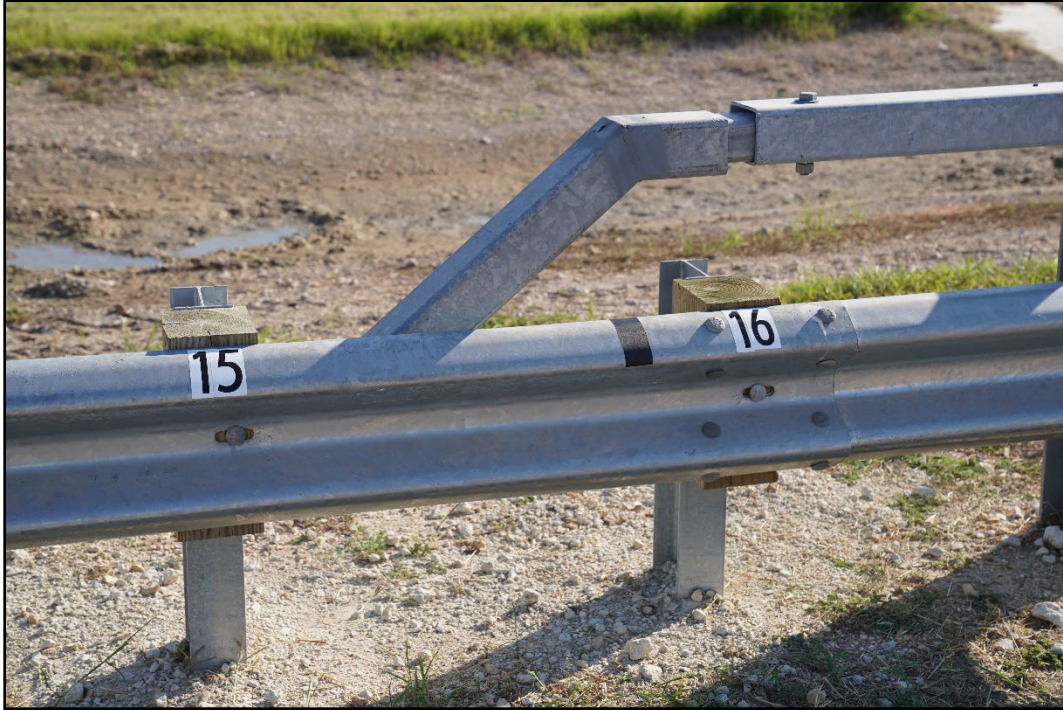
Figure 3.4. TL-4 Test Installation at the Transition Box Beam Rail prior to Testing.

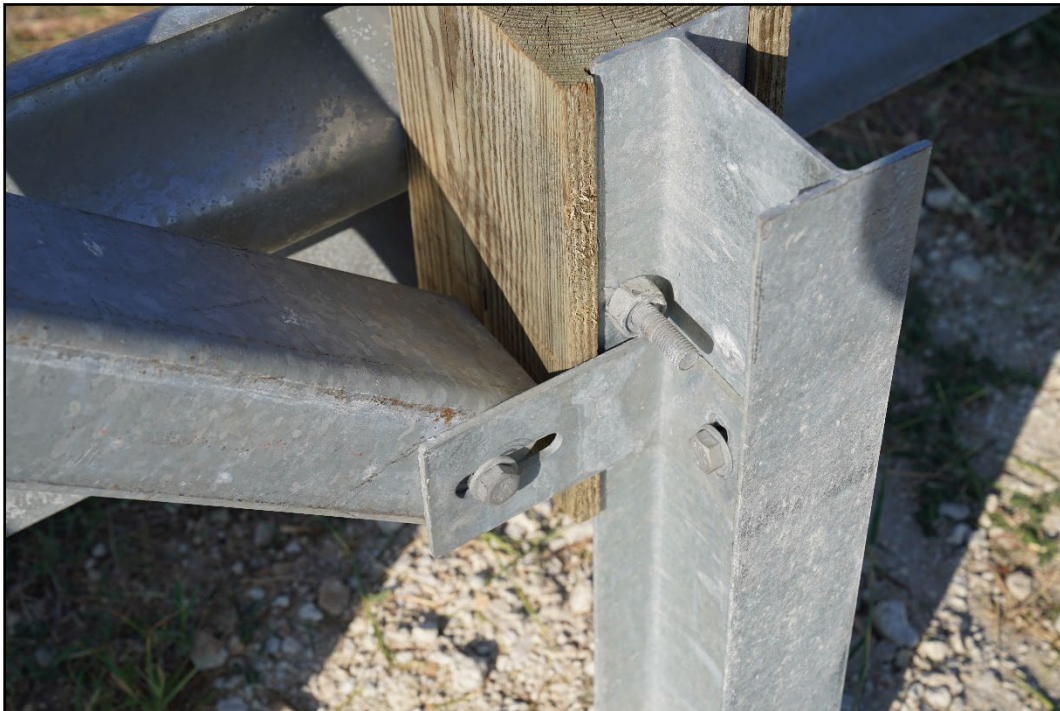
Figure 3.7. Transition Box Beam Rail Connection to Post 15 prior to Testing.

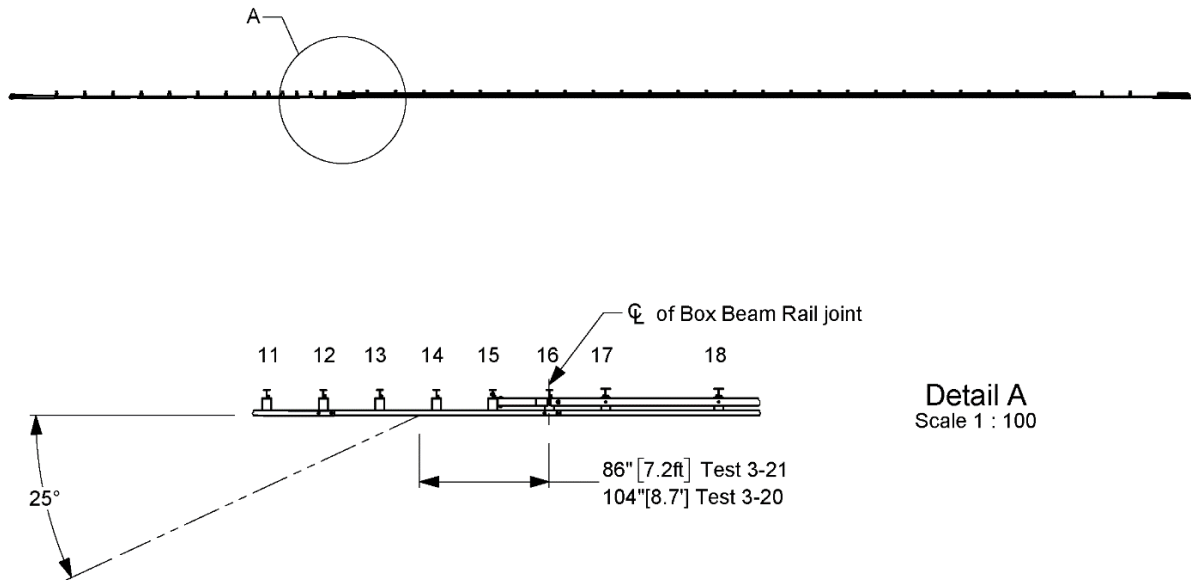
Table 4.1 shows the test conditions and evaluation criteria for *MASH* TL-3 for transitions for longitudinal barriers. The target CIPs for each test were determined using the simulation analyses presented in Chapter 2. Figure 4.1 shows the target CIPs for *MASH* Tests 3-20 and 3-21 on the Transition.

Figure 4.1. Target CIPs for *MASH* TL-3 Tests on TL-4 Guardrail Transition.

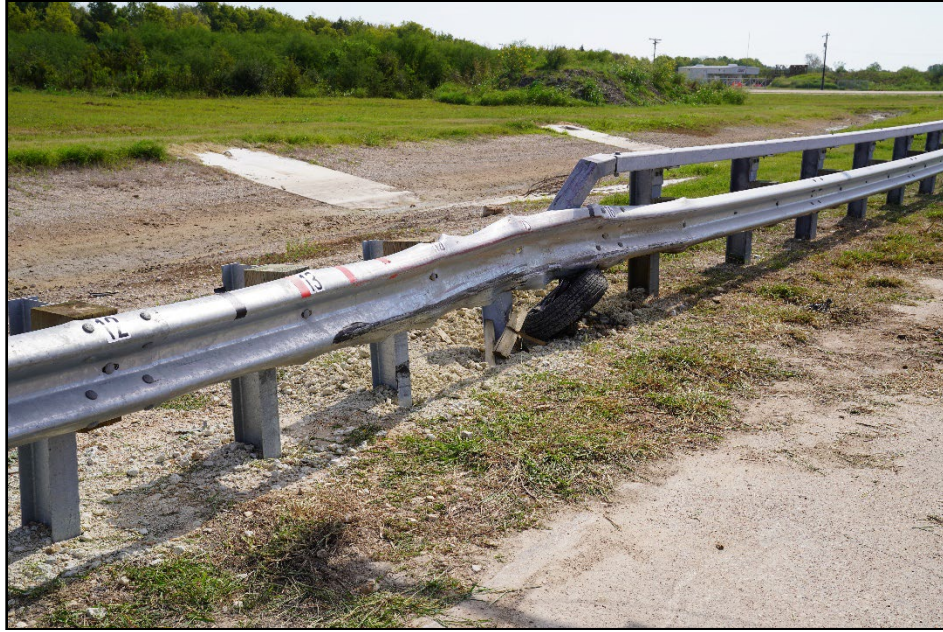
Figure 6.5. Transition after Test at Impact Location for Test 441203-01-1.

Table 6.6 and Table 6.7 describe the damage to the Transition. Figure 6.5 and Figure 6.6 show the damage to the Transition.

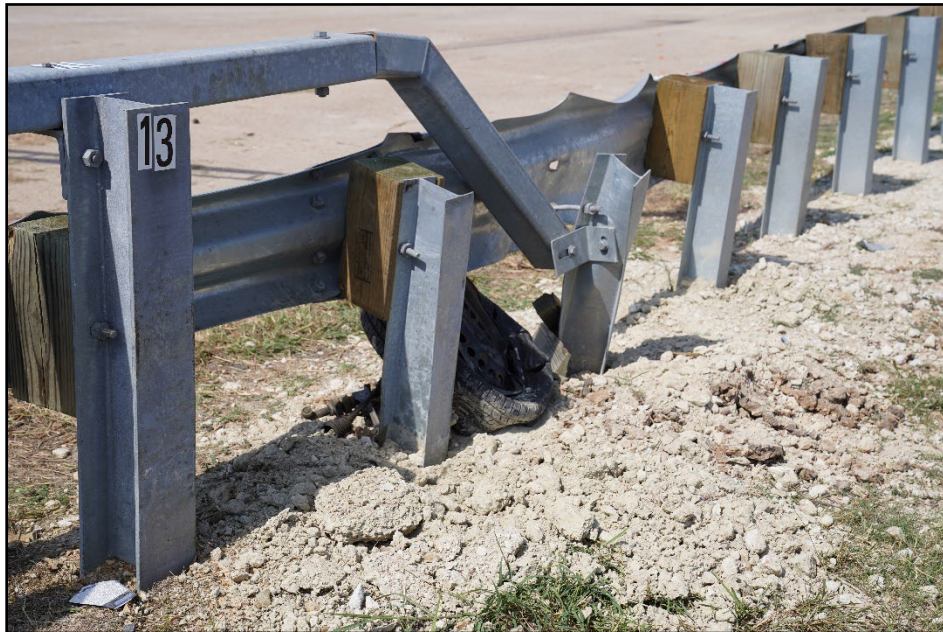
Figure 6.6. Transition after Test from the Field Side of the Installation for Test 441203-01-1.

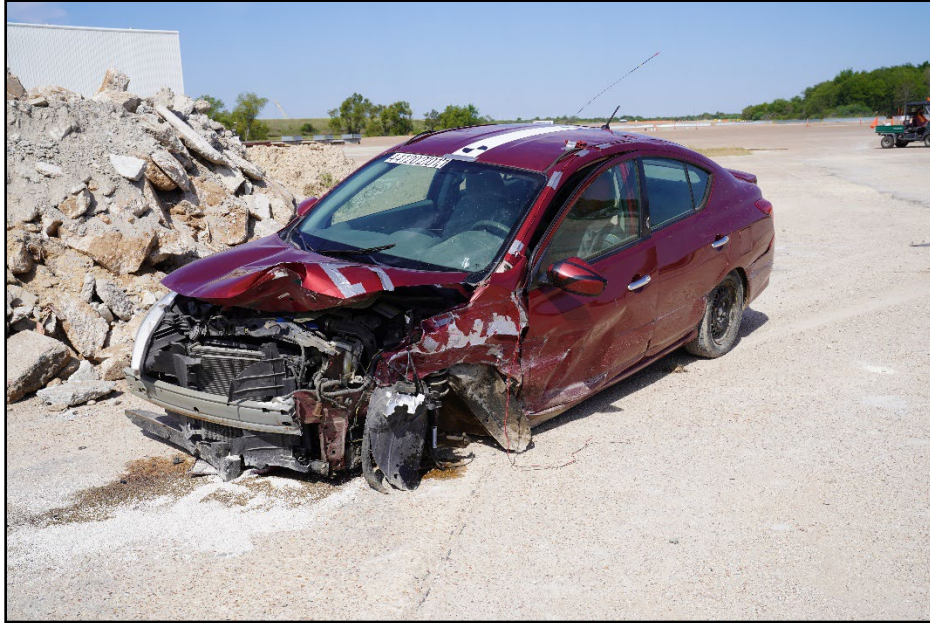
Figure 6.7. Impact Side of Test Vehicle after Test 441203-01-1.

Figure 6.7 and Figure 6.8 show the damage sustained by the vehicle. Figure 6.9 and Figure 6.10 show the interior of the test vehicle. Table 6.8 and Table 6.9 provide details on the occupant compartment deformation and exterior vehicle damage. Tables C.2 and C.3 in Appendix C.1 provide exterior crush and occupant compartment measurements.

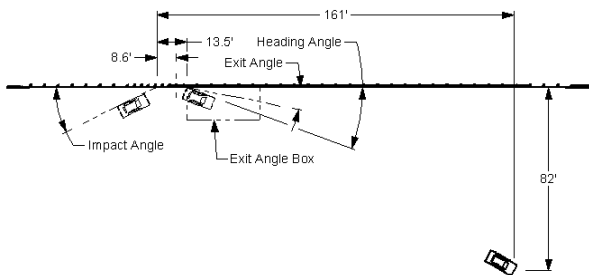
IMPACT CONDITIONS							
	Impact Speed (mi/h)	63.7						
	Impact Angle (deg)	25.8						
	Impact Location	8.6 ft upstream from centerline of joint in box beam rail at post 16						
Impact Severity (kip-ft)	62.4							
EXIT CONDITIONS								
Exit Speed (mi/h)	44.3

Trajectory/Heading Angle (deg)	11/20							
Exit Box Criteria	Vehicle did not meet the exit box criteria							
Stopping Distance	161 ft downstream 82 ft to the traffic side							
TEST ARTICLE DEFLECTIONS								
Dynamic (inches)	16.2							
Permanent (inches)	9							
Working Width/Height (inches)	36.6/19.4							
VEHICLE DAMAGE								
VDS	11LFQ5							
CDC	11FLEW4							
Max. Ext. Deformation	12							
Max Occupant Compartment Deformation	2.5 inches in the side panel							
OCCUPANT RISK VALUES								
Long. OIV (ft/s)	27.2	Long. Ridedown (g)	11.6	Max 50-ms Long. (g)	-13.3	Max Roll (deg)	11	
Lat. OIV (ft/s)	24.1	Lat. Ridedown (g)	14.5	Max 50-ms Lat. (g)	11.2	Max Pitch (deg)	6	
THIV (m/s)	10.8	ASI	1.6	Max 50-ms Vert. (g)	-2.9	Max Yaw (deg)	64

Figure 6.11. Summary of Results for MASH Test 3-20 on TL-4 Guardrail Transition.

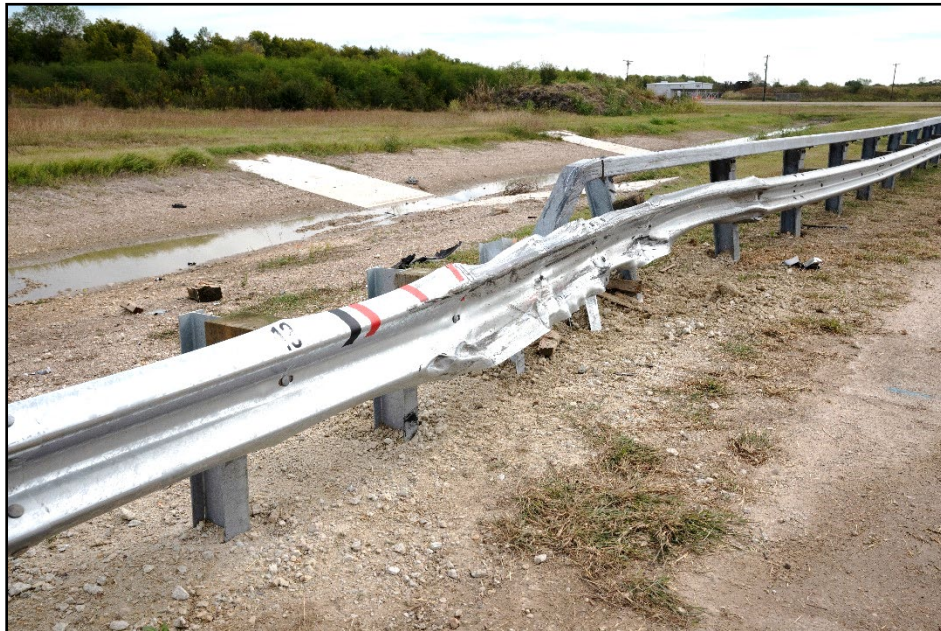
Figure 7.5. Transition at the Impact Location after Test 441203-01-2.

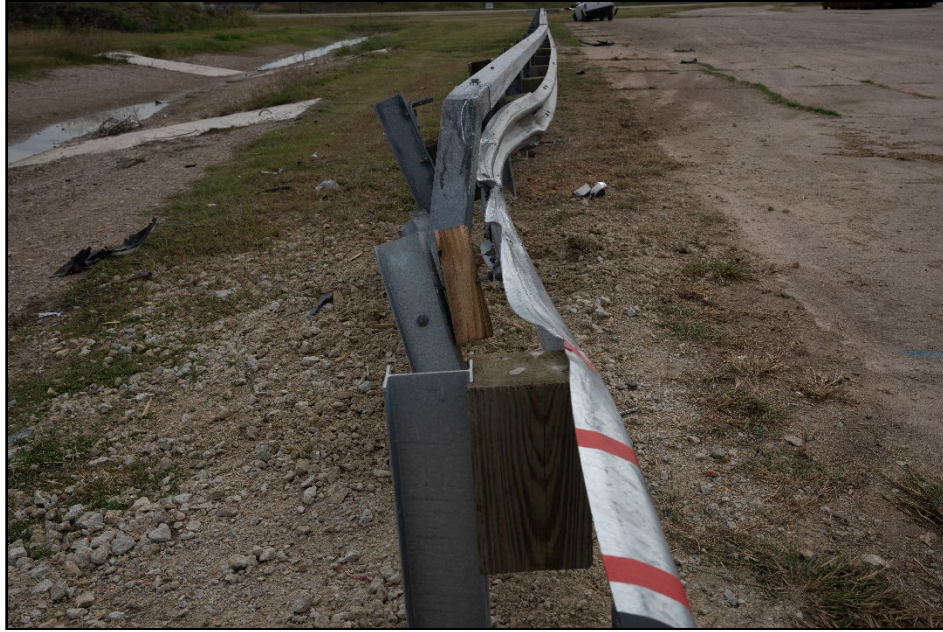
Figure 7.6. In-Line View with the Transition after the Impact for Test 441203-01-2.

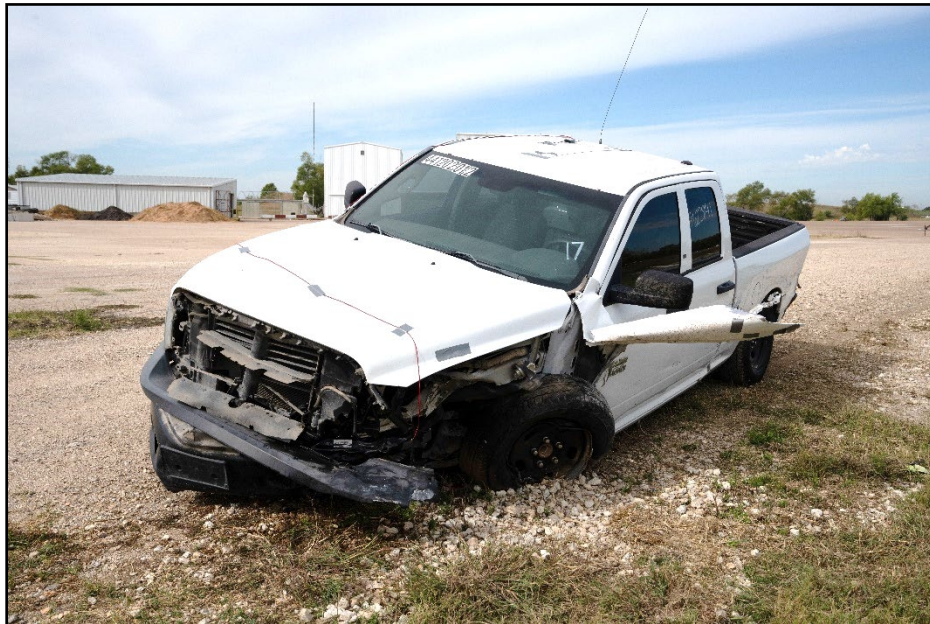
Figure 7.7. Impact Side of Test Vehicle after Test 441203-01-2.

Figure 7.7 and Figure 7.8 show the damage sustained by the vehicle. Figure 7.9 and Figure 7.10 show the interior of the test vehicle. Table 7.8 and Table 7.9 provide details on the occupant compartment deformation and exterior vehicle damage. Tables D.2 and D.3 in Appendix D.1 provide exterior crush and occupant compartment measurements.

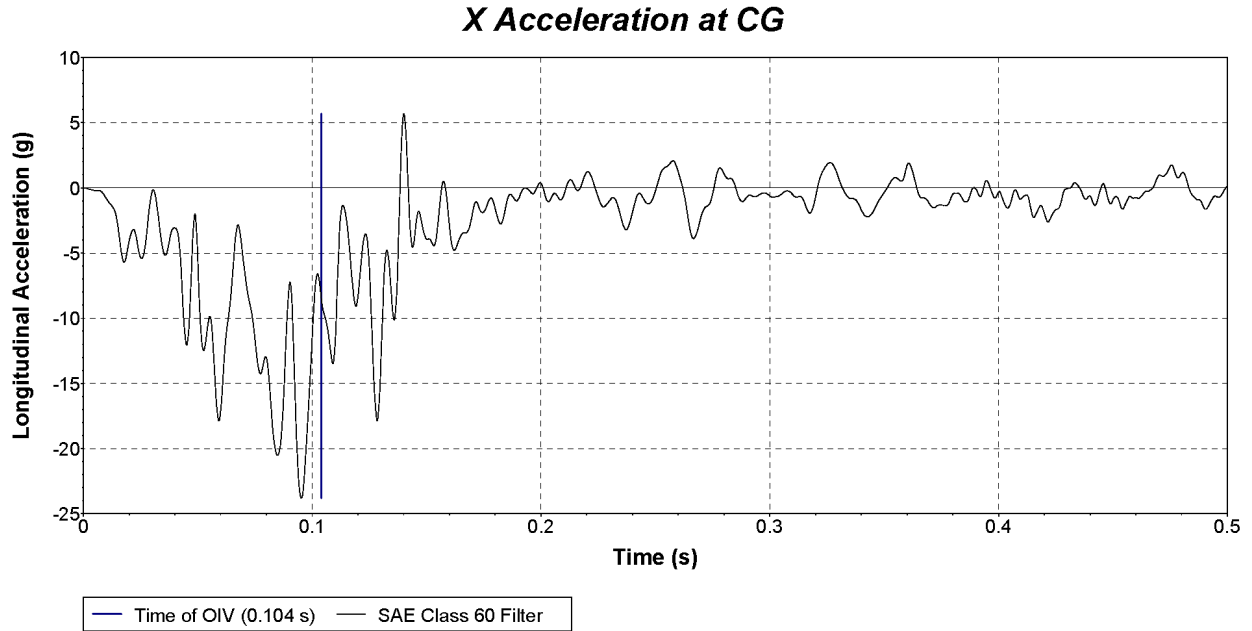
**Figure C.8. Vehicle Longitudinal Accelerometer Trace for Test 441203-01-1
(Accelerometer Located at Center of Gravity).**

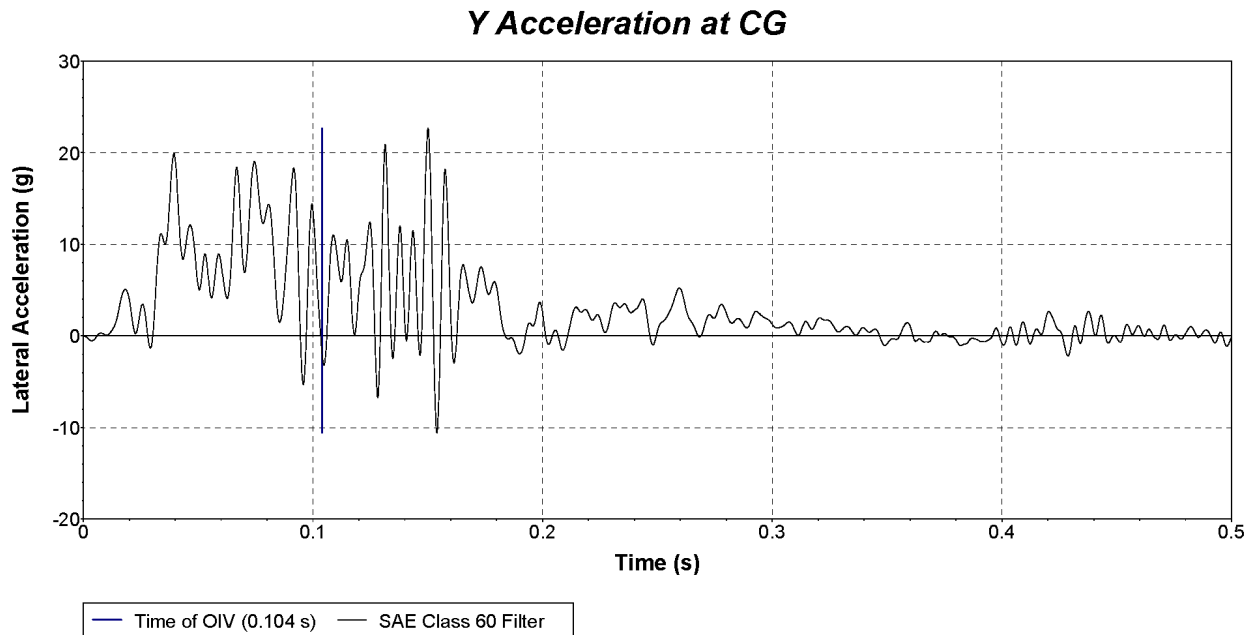
**Figure C.9. Vehicle Lateral Accelerometer Trace for Test 441203-01-1
(Accelerometer Located at Center of Gravity).**

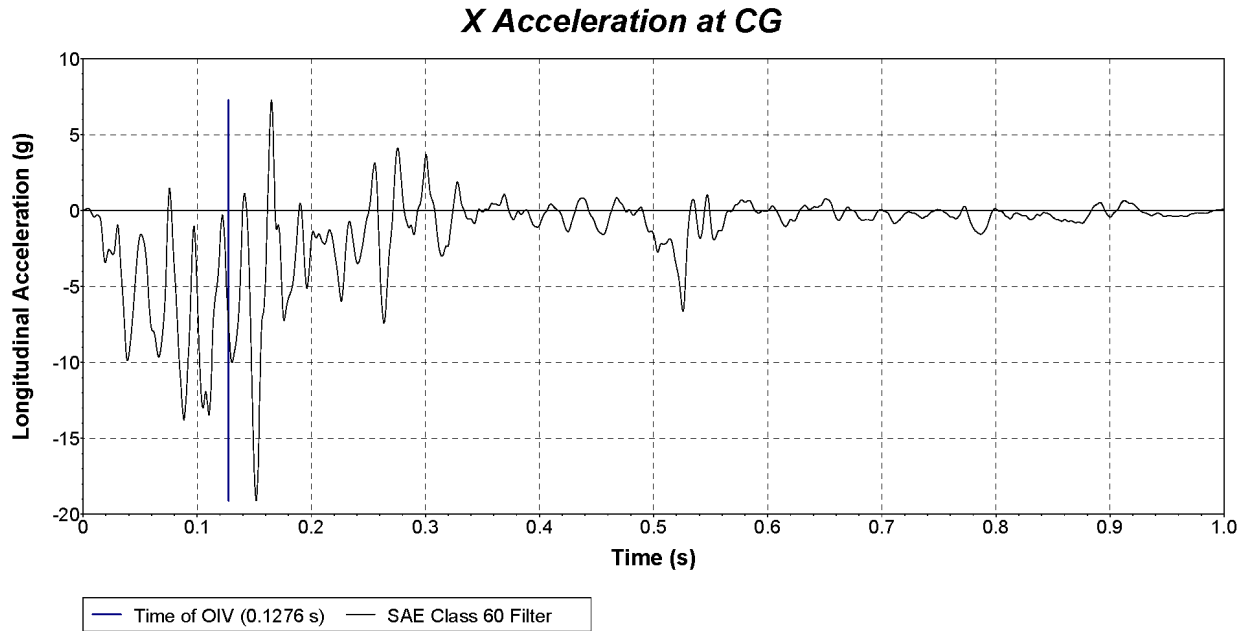
**Figure D.8. Vehicle Longitudinal Accelerometer Trace for Test 441203-01-2
(Accelerometer Located at Center of Gravity).**

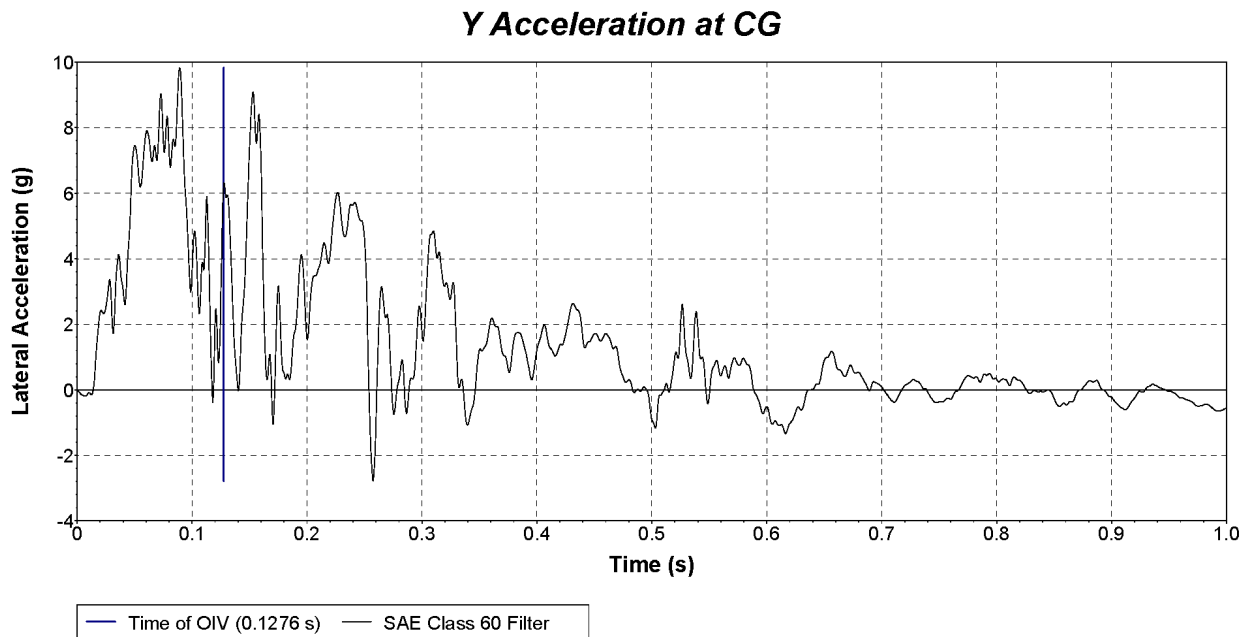
**Figure D.9. Vehicle Lateral Accelerometer Trace for Test 441203-01-2
(Accelerometer Located at Center of Gravity).**
