DISCARDED TIRES IN HIGHWAY CONSTRUCTION

PRECOATED AGGREGATE

KINGFISHER, OKLAHOMA

This constitutes an interim report of the construction procedures of Research Project 81-06-1, "Kingfisher County, Discarded Tires In Highway Construction". A study of the roadway was made to determine its condition prior to applying the surface treatment. The factors observed were climate, regional location, dominant soils, traffic and roadway history.

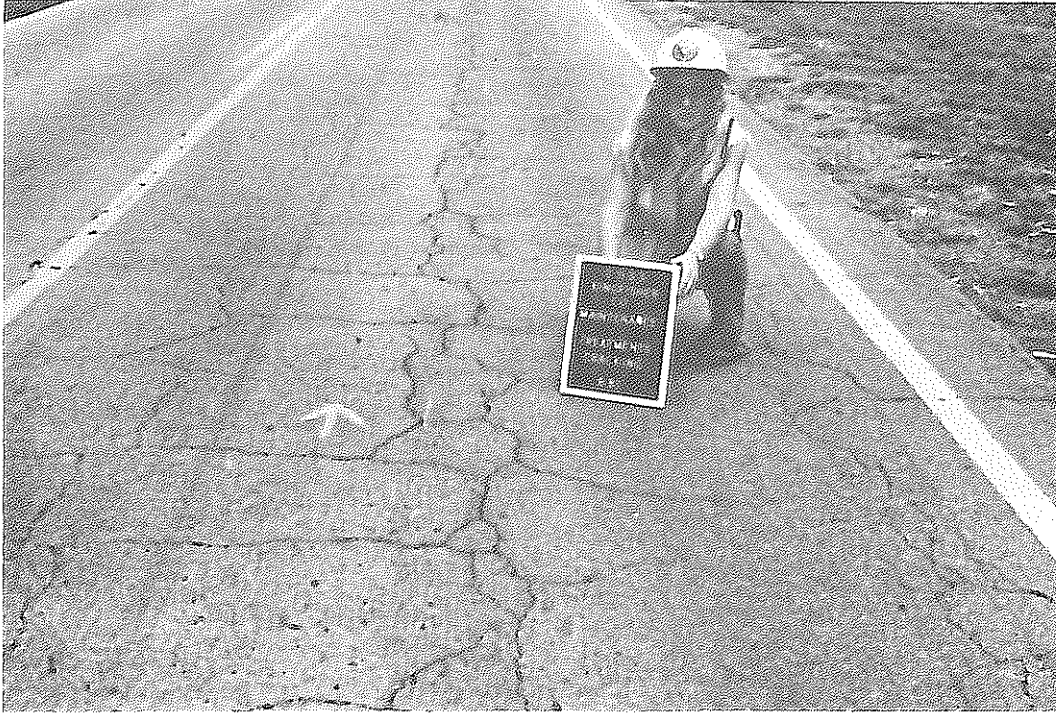
Figure 1A. The cracked condition of the surface prior to the Asphalt-Rubber treatment.

Division Four (Perry, Oklahoma) Engineers, coordinated with Research and Development Engineers to apply the second asphalt-rubber bituminous surface treatment on a highway that exhibited several surface condition problems. The 3.7 miles (6.0 km) of roadway chosen for treatment were located just east of the city of Kingfisher on State Highway 33. Most of this road showed signs of fatigue. It exhibited random block and alligator cracking with a one-half (0.8 km) mile section having a serious bleeding problem. Also, an occasional base failure was evident. Most have been repaired. See Figure 1 for an illustration of the surface problems.

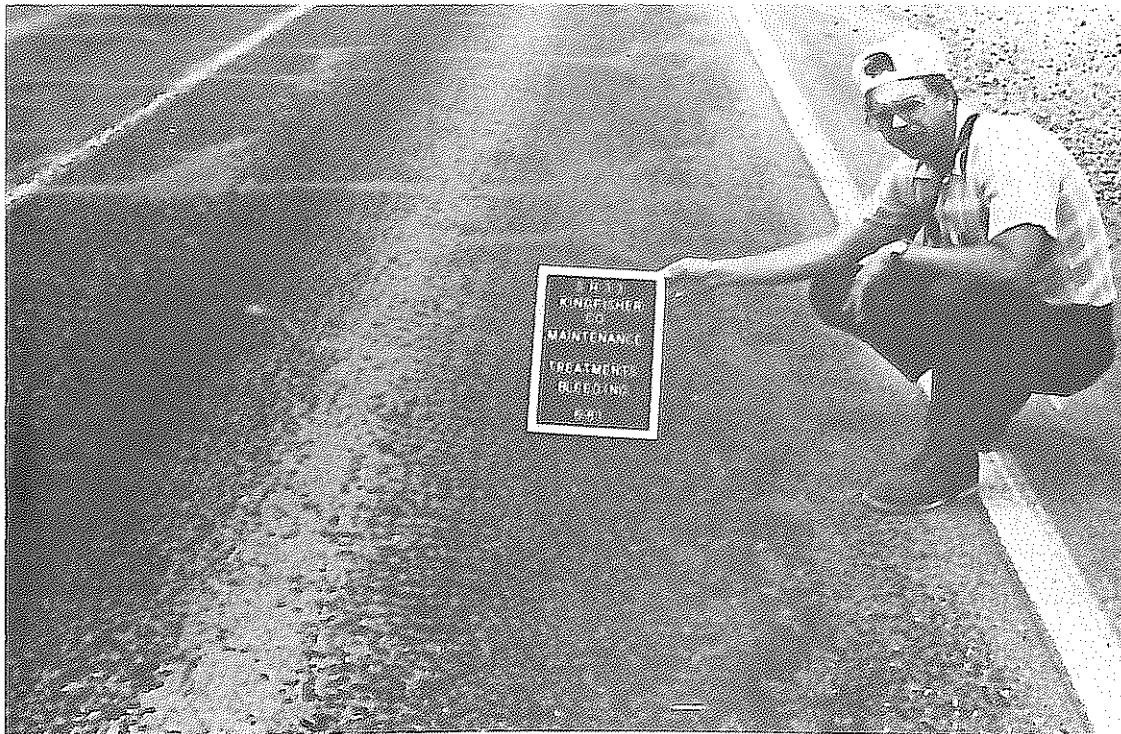
Figure 1B. The flushed condition of the surface prior to Asphalt-Rubber treatment.

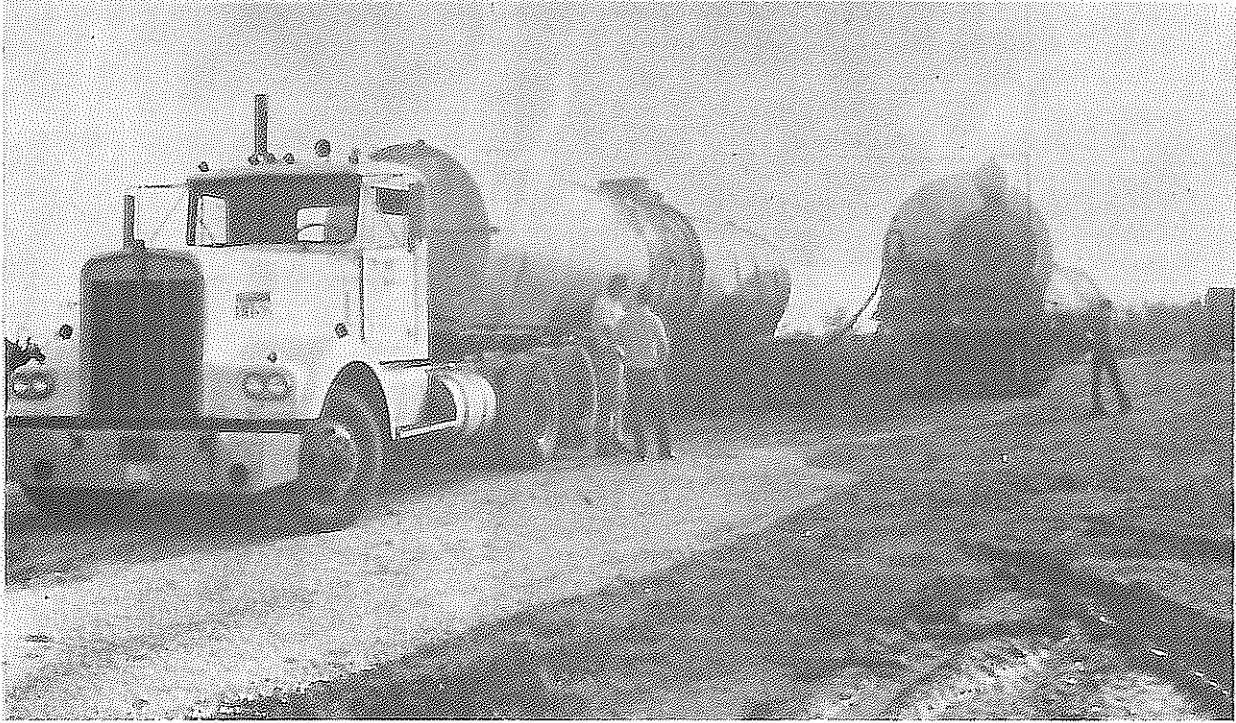
Figure 2. Filling the Asphalt Heat Tank with 85-100 per asphalt.

By September 16, 1981, all the equipment and material were mobilized on the job site. On the day of application, Sahuaro's heat tank was filled with 85-100 penetration grade asphalt. See Figure 2 for storage of liquid asphalt. It was connected to the mechanical blender that has an upper storage silo for the rubber and a lower mixing tank. Two diluent holding tanks were placed adjacent to the blending machine. Three specially modified distributor trucks with internal mixing paddles and furnace heaters were used.

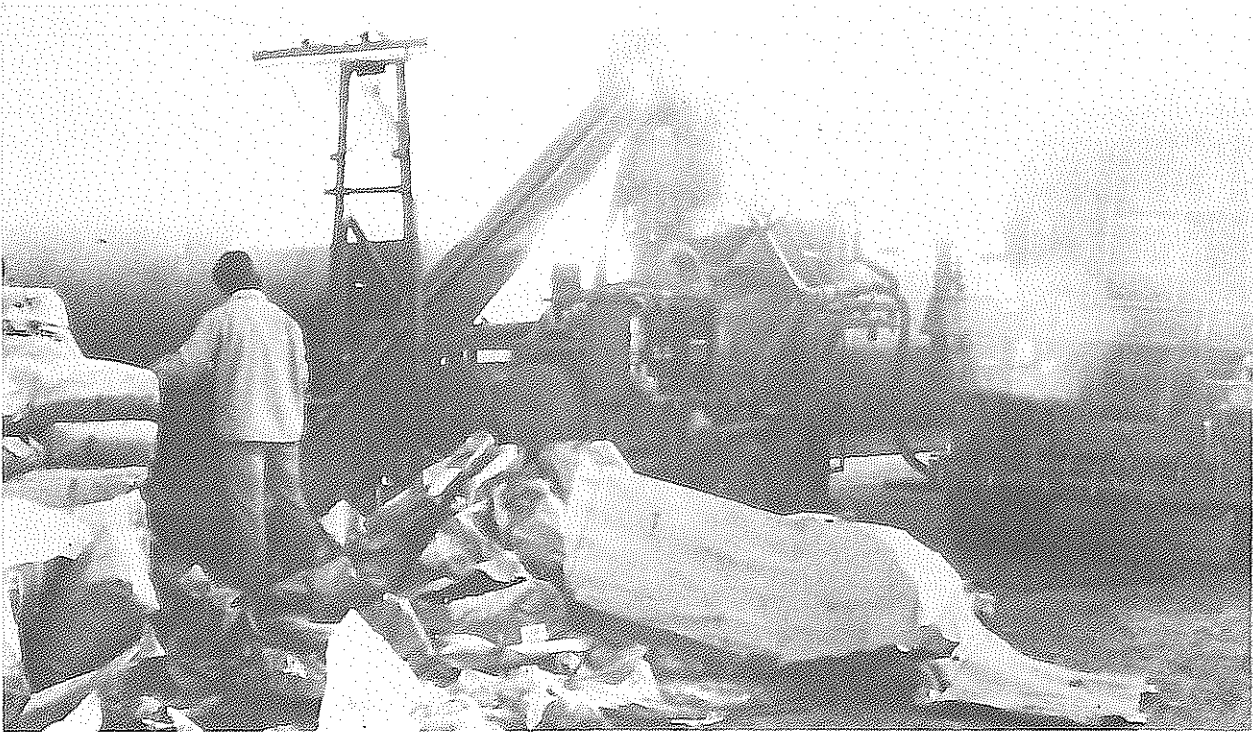
Figure 3. The blending of asphalt and rubber.

Pallets of bagged ground rubber were fork lifted to the front of the blending machine. There, the bags were broken and the granulated crumb rubber particles were conveyed to the storage silo atop the blending machine. The heated asphalt was pumped to the bottom of the blending machine and from there into the mixing tank. Then a specific quantity of rubber was fed into the mixing tank and blended with the asphalt for approximately one and one-half minutes at 425°F (218°C). The mixture was then pumped to the modified distributor truck that was connected to the blending machine. See Figure 3 for blending of asphalt and rubber.

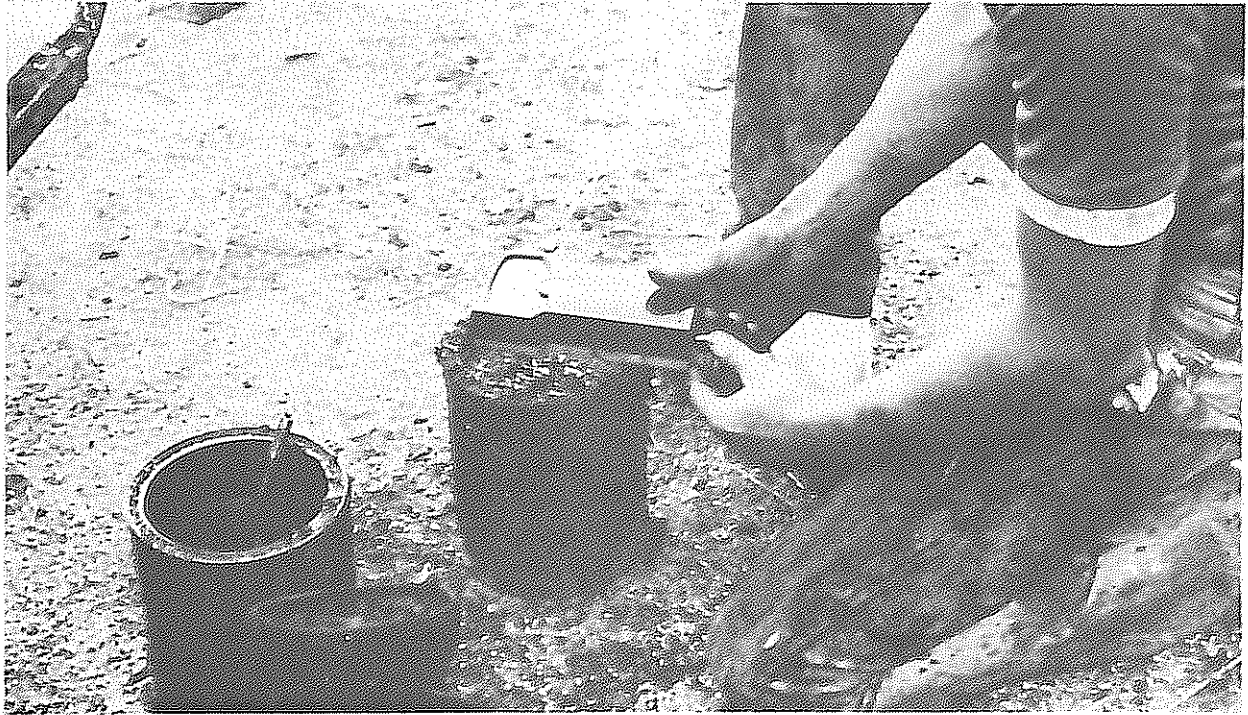
Figure 4. Final check with the hand Viscosity Instrument.

Sahuaro took a one gallon (3.8 liter) container and duplicated the design mixture as in the distributor truck tank. A hand viscosity meter was used on the design mixture as a final check before disconnection. See Figure 4 for Viscosity Instrument.

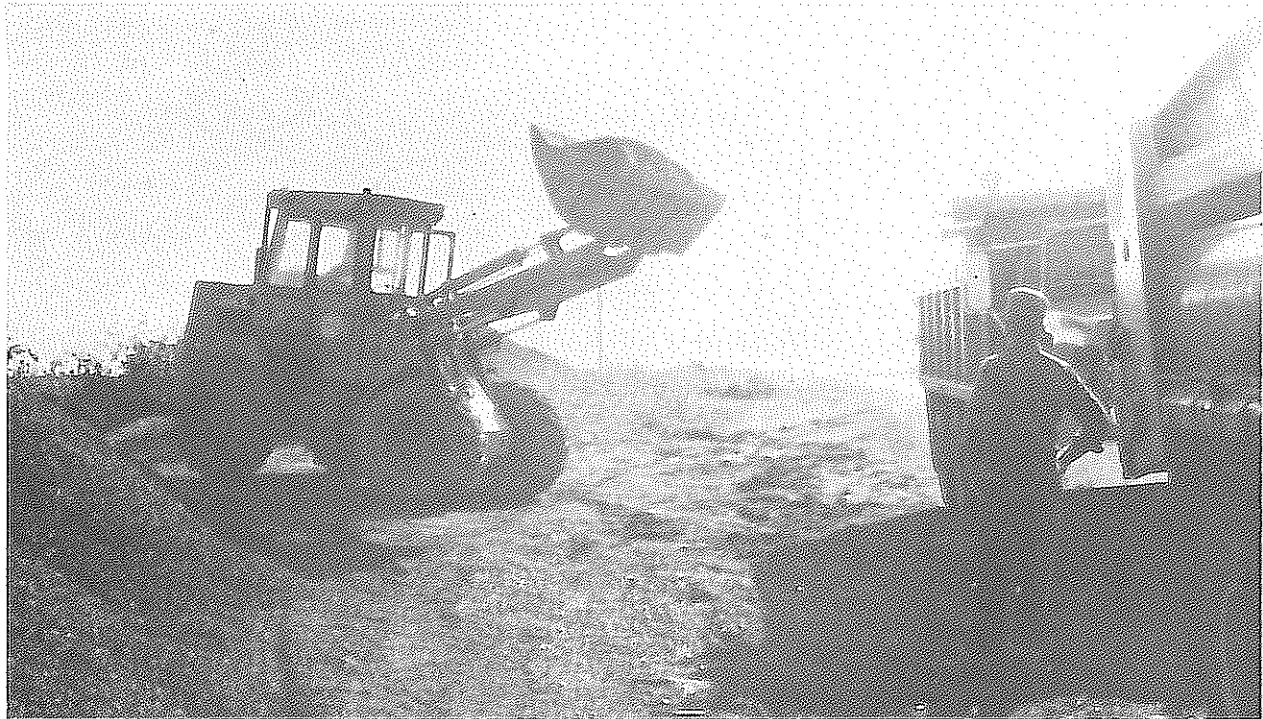
Figure 5. Loading the dump trucks with pre-coated aggregate.

While the traffic control was being set, the dump truck was being loaded with pre-coated aggregate. See Figure 5 for aggregate loading. Traffic control allowed enough time (about 15 minutes) for the tack coat to be applied to the roadway and to set. The tack was 1 part emulsion and 3 parts water and was applied at a rate of 0.1 gallons/yd<sup>2</sup> (0.45 l/m<sup>2</sup>).<sup>9</sup>

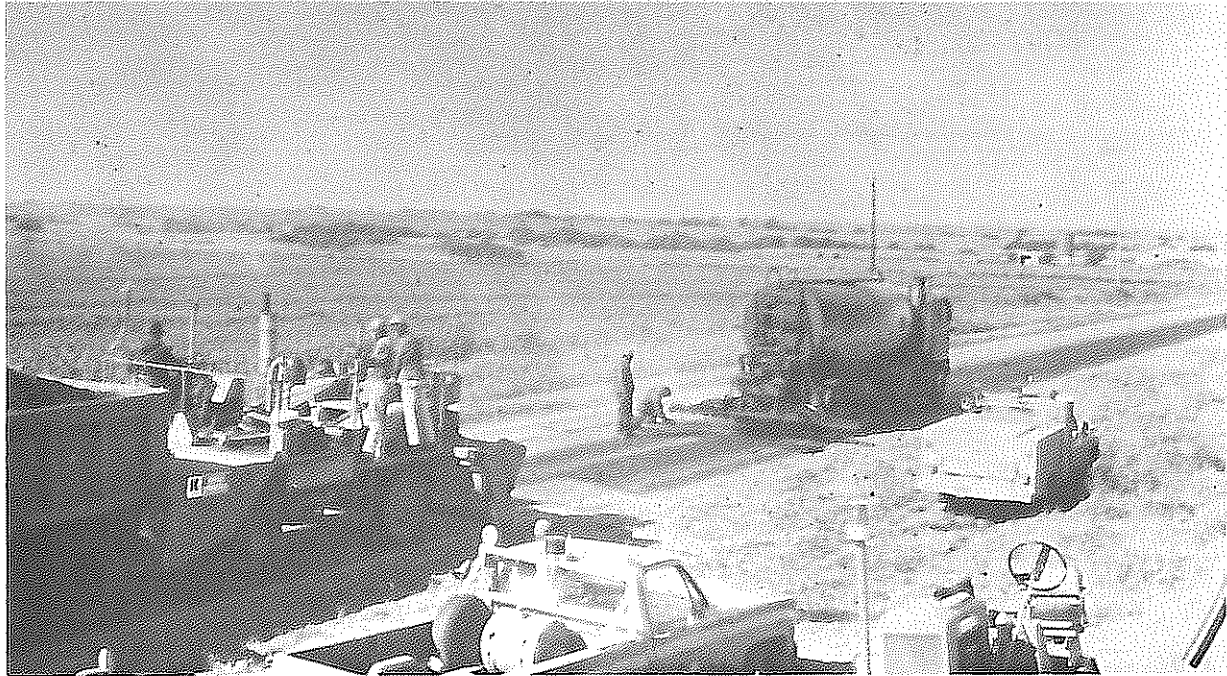
Figure 6. The arrangement of the chip sealing equipment on the roadway.

All the necessary equipment moved into place after the tack coat had set. See Figure 6 for the arrangement of the chip sealing equipment. The "chip seal" operation began.

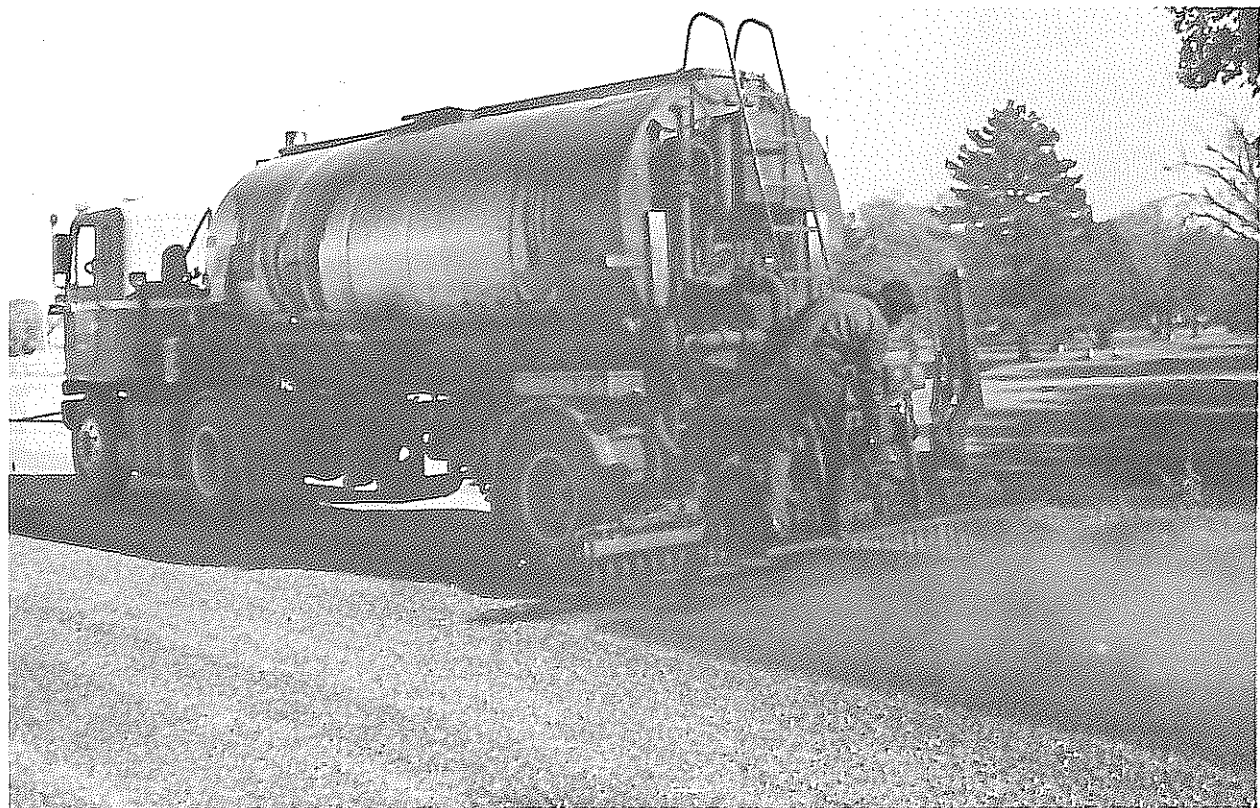
Figure 7. The application of asphalt-rubber by the modified distributor.

The specially modified distributor applied 0.54 gal/yd<sup>2</sup> (0.24 l/m<sup>2</sup>) of asphalt-rubber on the roadway for about 200 yd. (183 m). See Figure 7 for application of asphalt-rubber. The application rate was regulated from a control panel in the cab. See Figure 8 for panel control. The chip spreader was filled by a dump truck. The spreader would travel behind the distributor as closely as possible, releasing 40 lbs/yd<sup>2</sup> (22 kg/m<sup>2</sup>) of the aggregate. See Figure 9 for the placing of aggregate. Two, nine wheel pneumatic rollers would make two passes and the two static steel wheel rollers 5-8 ton and 8-12 ton (4.5 to 7.3 and 7.3 to 10.9 metric ton) would perform the final rolling. See Figure 10 for rolling procedures. Traffic would then be held off of the new surface for a minimum of 10 minutes.

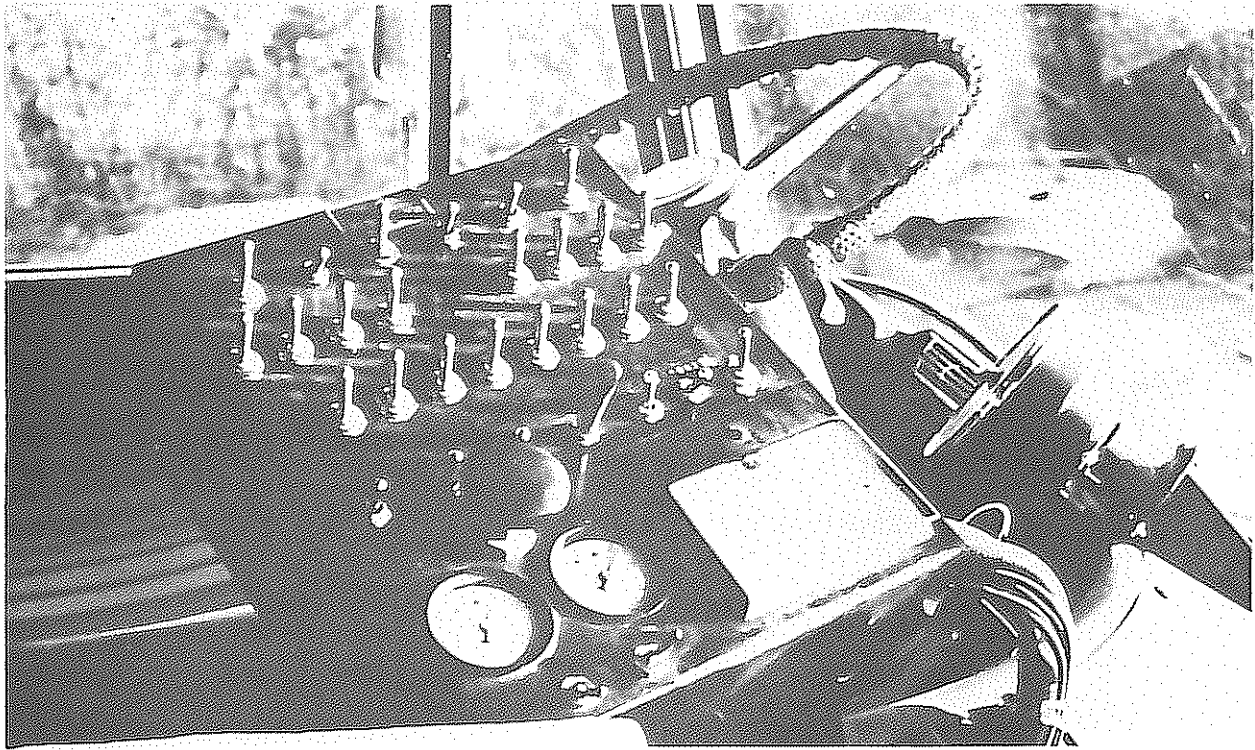
Figure 8. The control panel in the modified distributor truck.

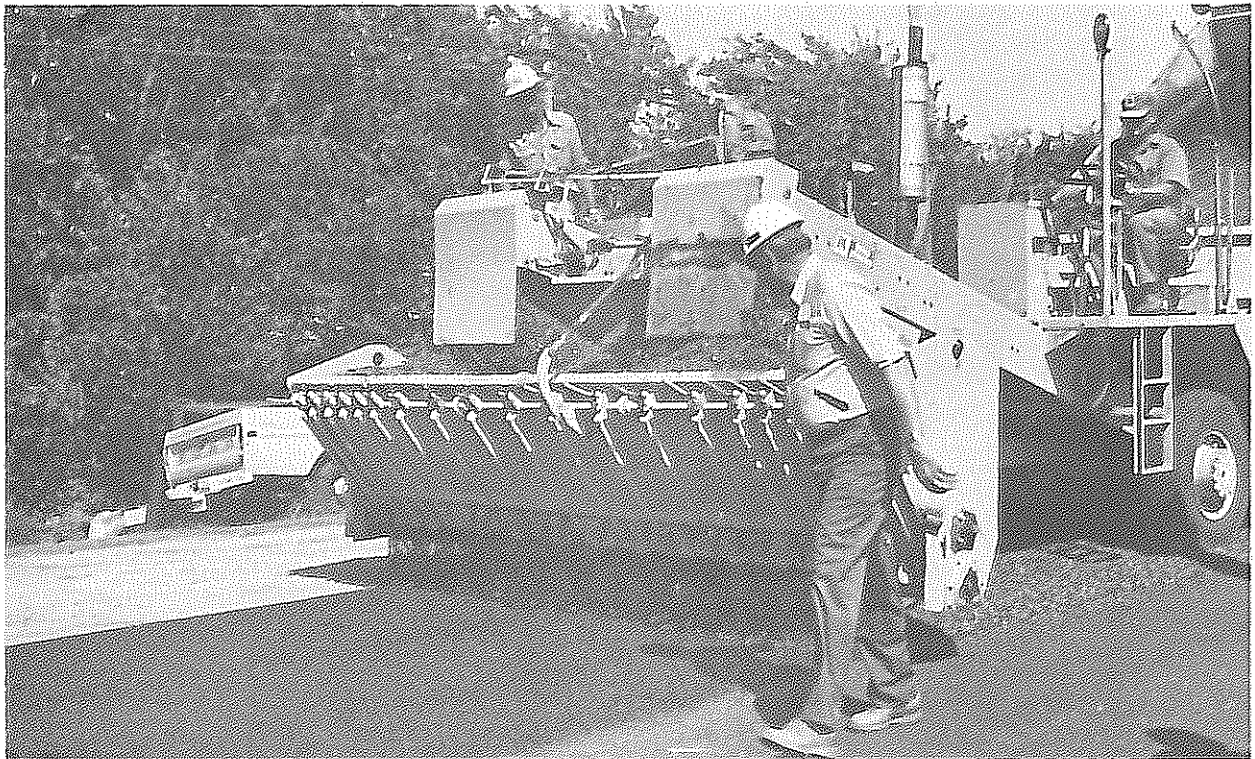
Figure 9. Placing of aggregate with the Chip Spreader.

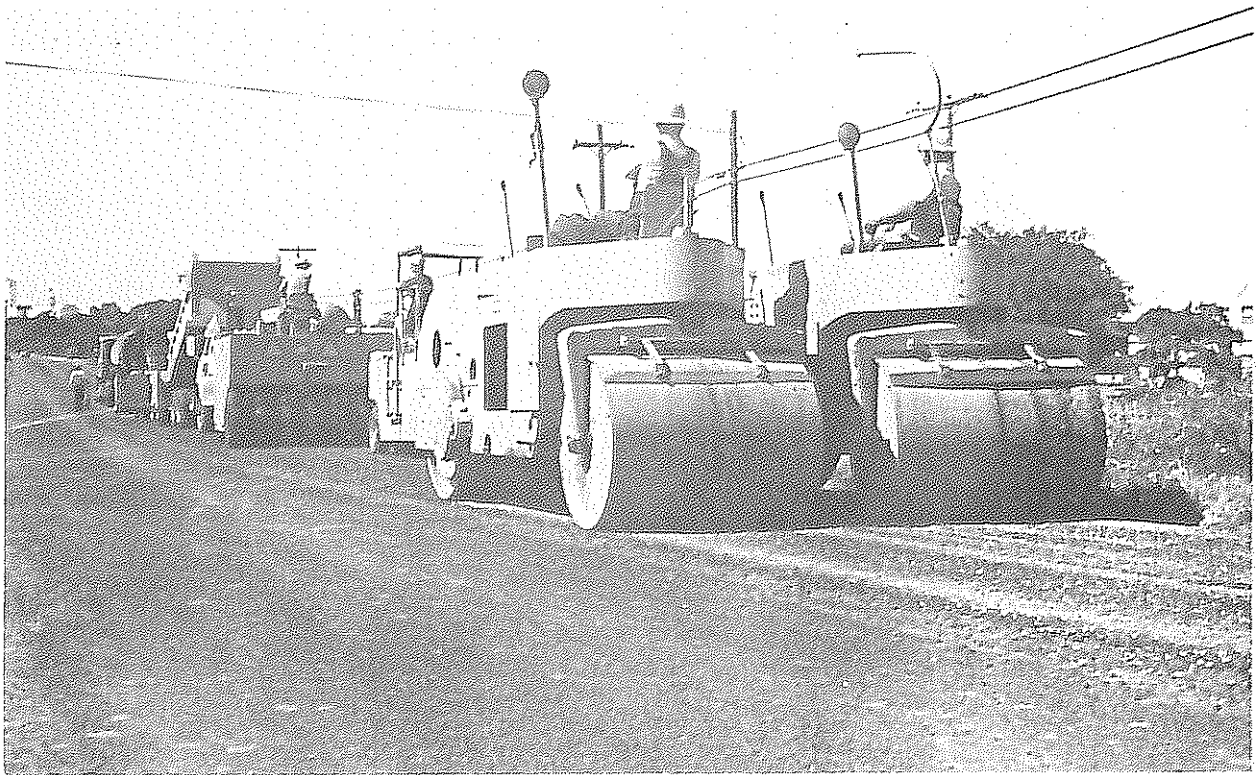
Figure 10. The rolling procedure required for proper aggregate embedment.

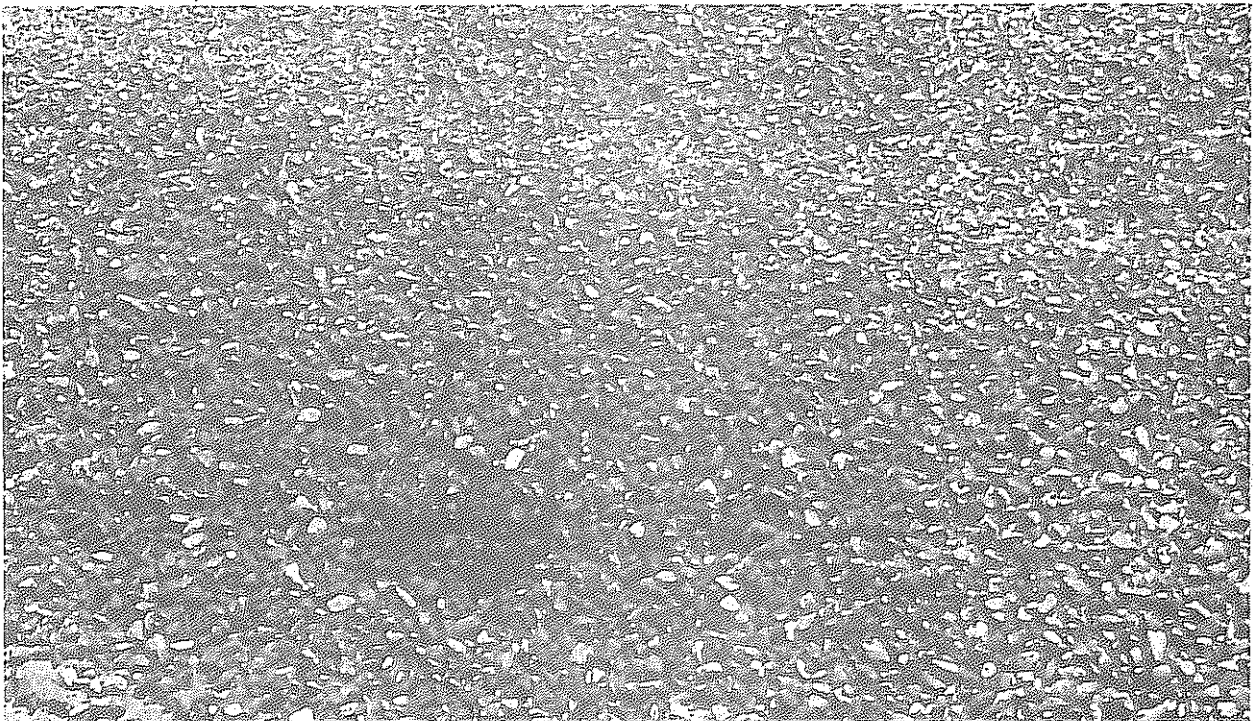
Figure 11. A new asphalt-rubber surface.

By the end of the second day with three miles completed, the pre-coated aggregate was exhausted. The remaining tonnage of asphalt-rubber binder was "chipped" with washed, non-coated aggregate that covered one full width mile. See Figure 11 for new Asphalt-Rubber surface.
