MoDOT Work Zone Speed Study

January 2026
Final Report

Project number TR202518
MoDOT Research Report number cmr 26-001

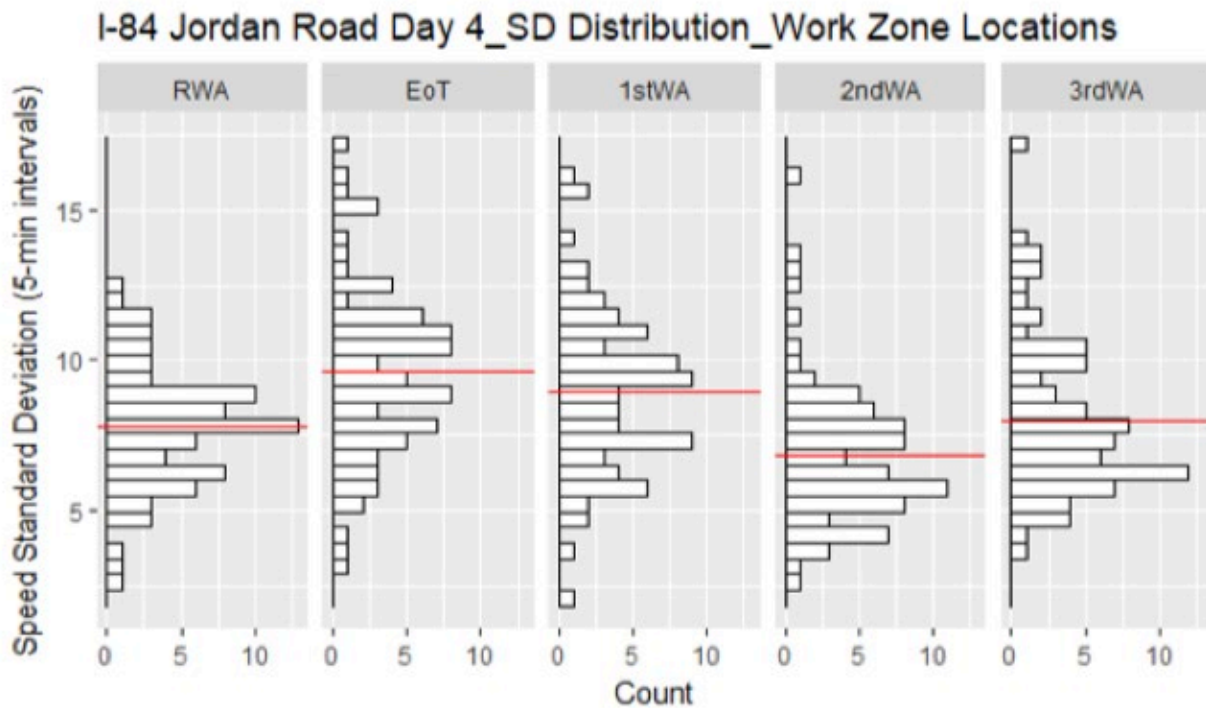
Figure 2-2. Example plot of 5-minute speed standard deviation distribution for Oregon (Gambatese and Jin 2021).

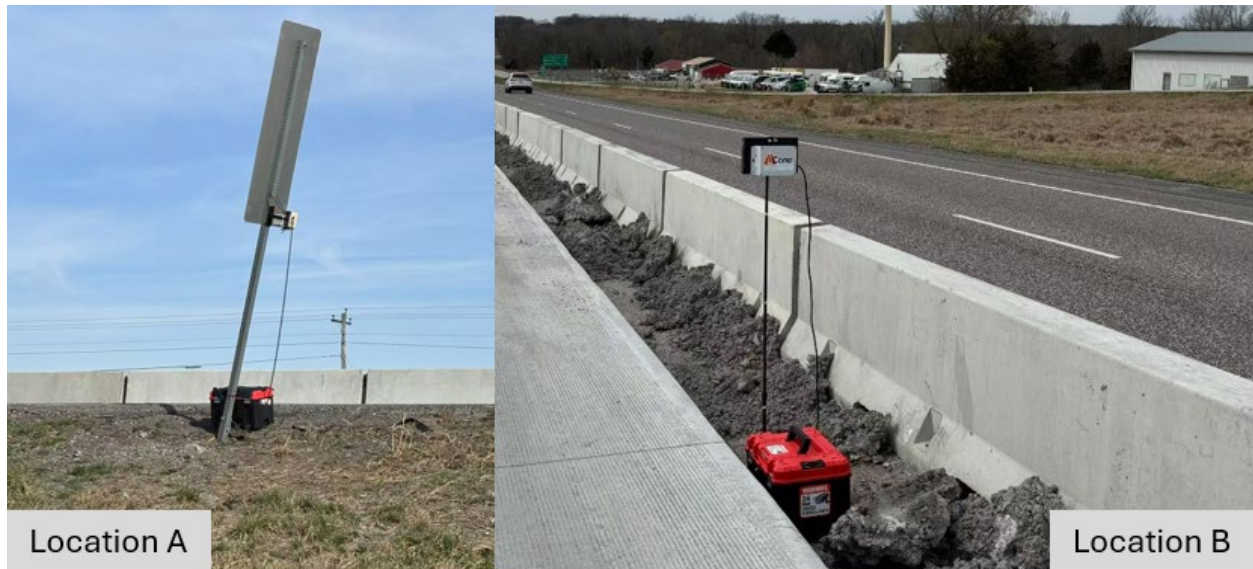
Figure 4-1. Sensor setup at the I-70 Kingdom City work zone.

Speed data were collected at two locations within the I-70 Kingdom City work zone using iCone Doppler radar sensors. At the Location A, the external battery was stolen during the monitoring period, resulting in a shortened dataset. As a result, valid data was obtained only on March 11, between 1:05 PM and 9:15 PM, covering 10,307 vehicles. Analysis of the collected data indicated an average speed of 62.13 mph, which exceeds the posted work zone speed limit (55 mph). The 85th percentile speed was 72.4 mph. In addition, 87.5% of vehicles (9,029 vehicles) were traveling above the posted speed limit, 37.8% (3,897 vehicles) exceeded the limit by more than 10 mph, and 3.3% (340 vehicles) exceeded the limit by more than 20 mph. These results indicate a high level of non-compliance with the temporary speed reduction within the monitored area. The speed distribution for Location A is shown in Figure 4-2.

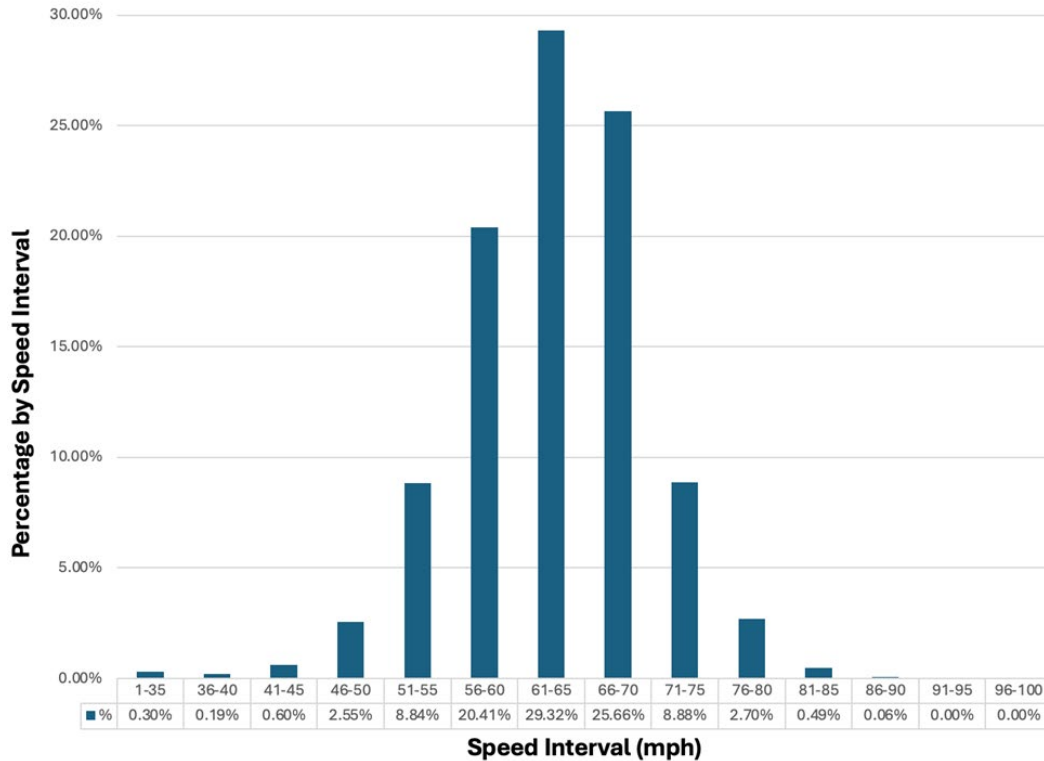
Figure 4-2 Speed distribution for Location A, I-70 Kingdom City.

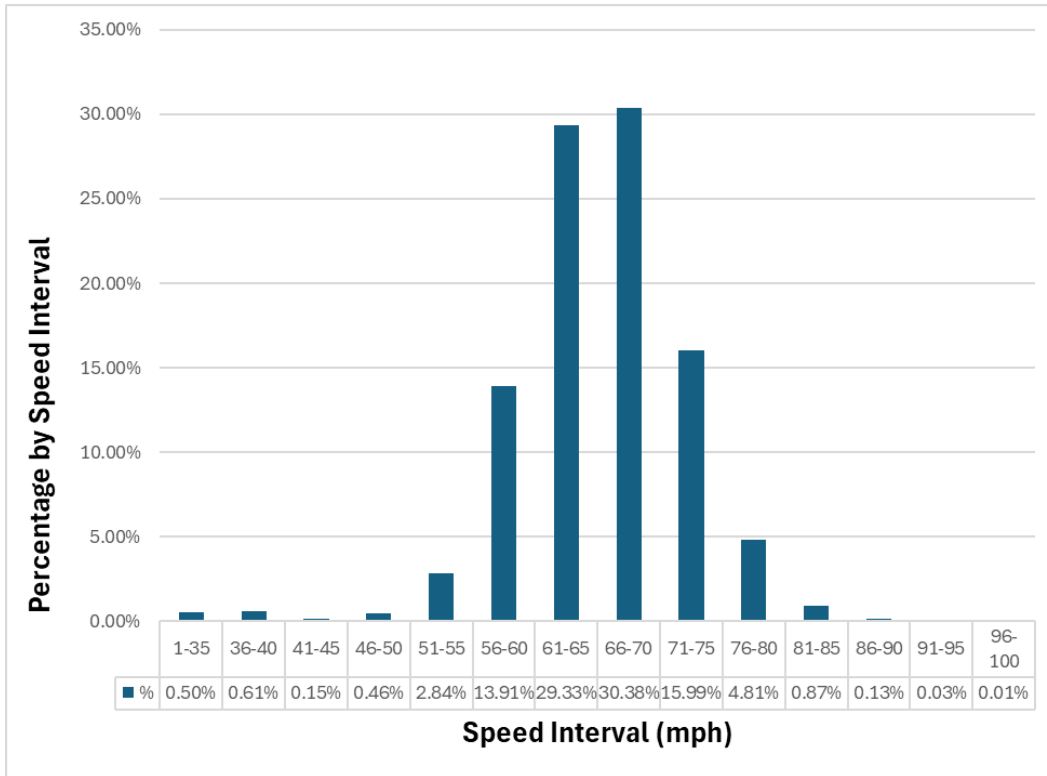
Figure 4-3 Speed distribution for Location B, I-70 Kingdom City.

At Location B, data were successfully collected on March 24, March 30, and April 2 through April 4, totaling approximately 52 hours of observation. During this period, a total of 59,288 vehicles were recorded, with an average speed of 64.54 mph and 85th percentile speed of 73.8 mph. The data show that 95.4% of drivers (56,572 vehicles) exceeded the work zone speed limit, 52.2% (30,960 vehicles) were traveling more than 10 mph above the limit, and 5.8% (3,438 vehicles) were traveling more than 20 mph over the limit. Similar to Location A, these findings reflect a consistent pattern of speed non-compliance. The speed distribution for Location B is shown in Figure 4-3.

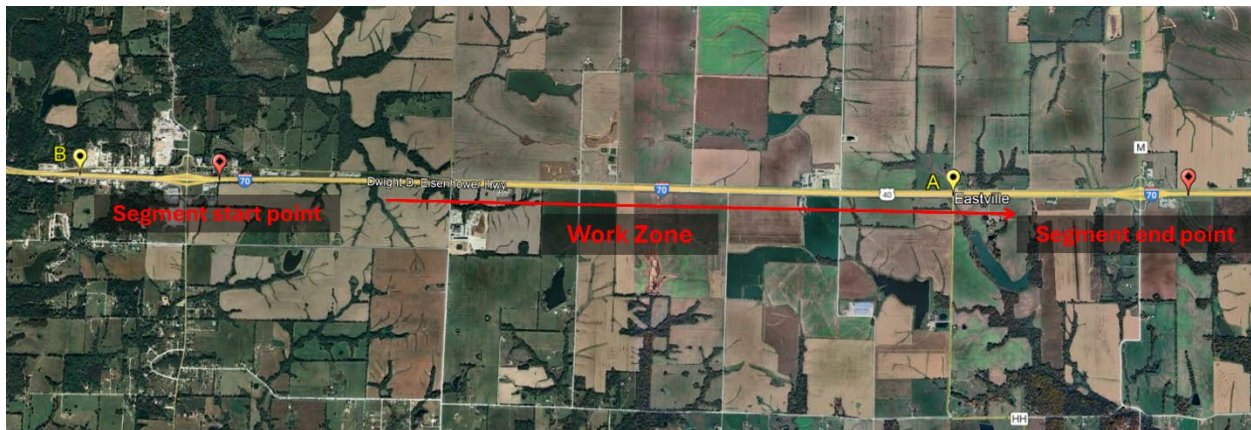
As shown in Figure 4-4, the limits of the HERE segment for I-70 Kingdom City encompassed both sensors. HERE data were extracted from March 11 to March 24, 2025 (same dates as sensors were in place) and from March 11 to March 24, 2024 (historical dates before the work zone installation).

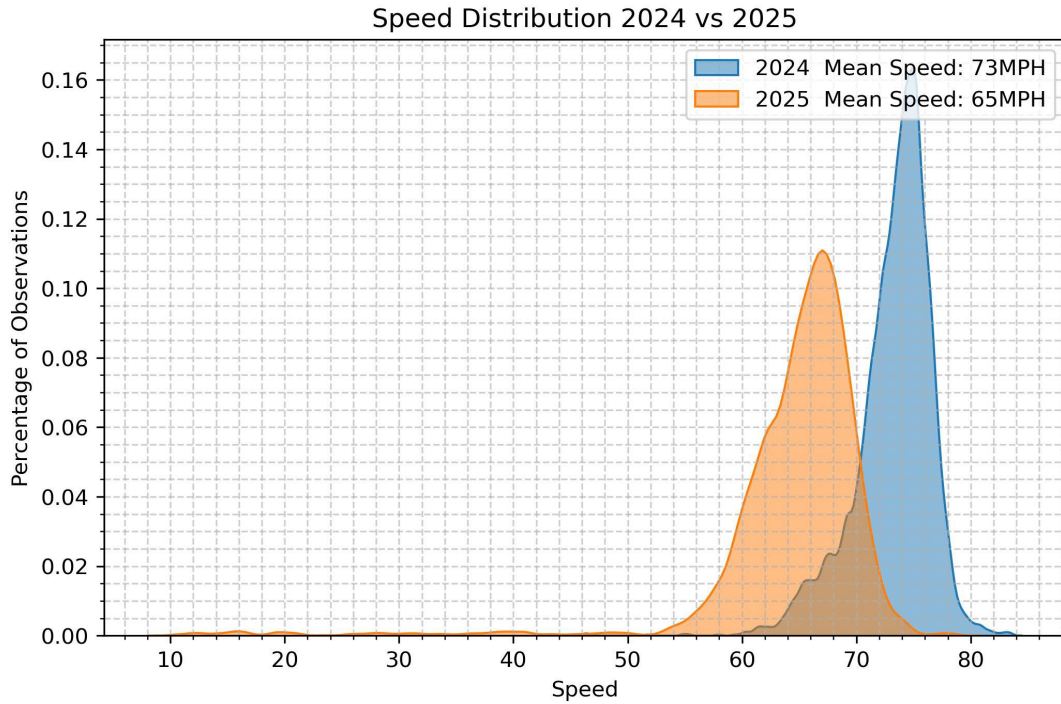
Figure 4-5. Speed distributions for 2024 and 2025 HERE data for I-70 Kingdom City.

The results for speed distribution are shown in Figure 4-5, and the cumulative speed distributions are shown in Figure 4-6. The results indicate that the mean speed in 2025 was 8 mph lower than the mean speed in 2024, while the standard deviation increased from 2.05 mph to 4.85 mph, reflecting both reduced average speeds and greater variability in 2025.

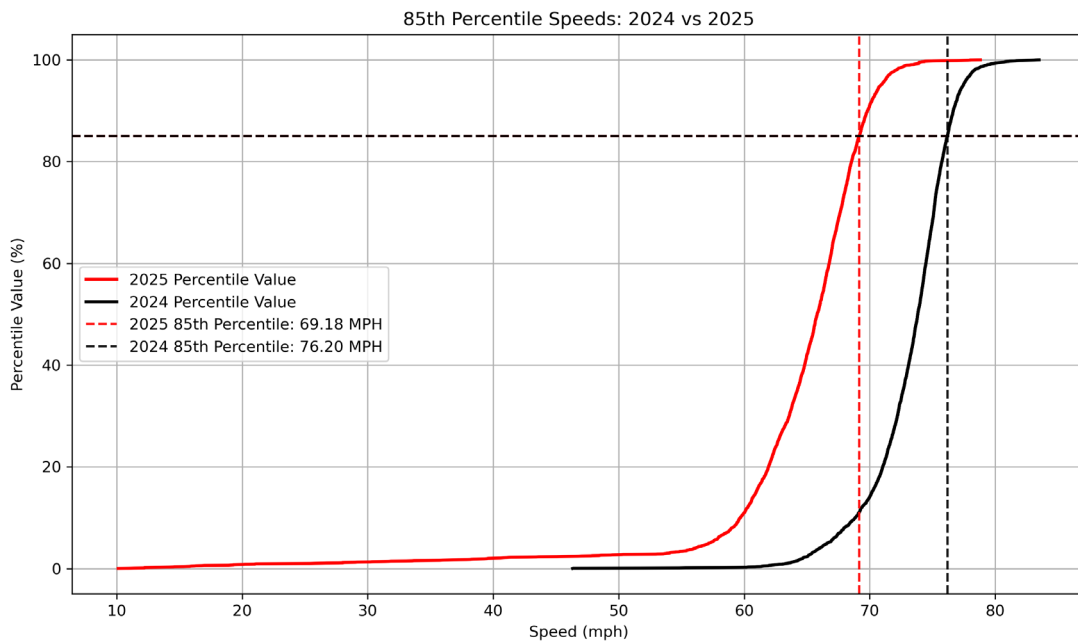
Figure 4-6. Cumulative speed distributions for 2024 and 2025 HERE data for I-70 Kingdom City.

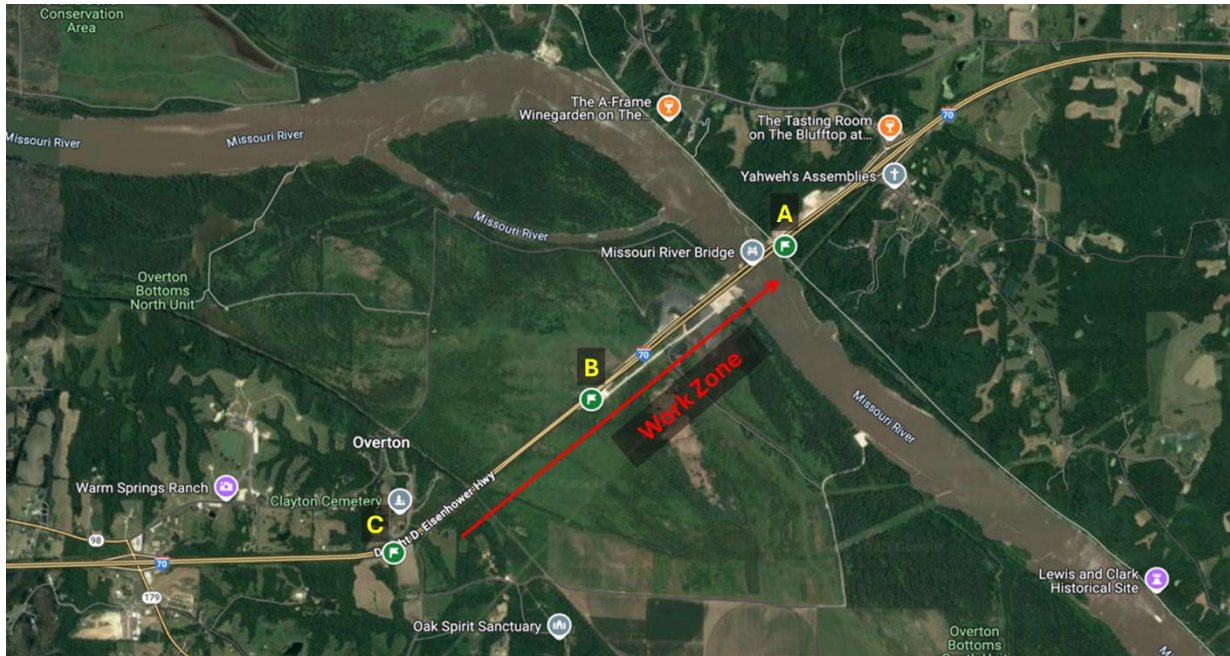
Figure 5-1. Sensor layout for I-70 Rocheport.

A total of three Armadillo traffic sensors were deployed to collect vehicle speed data within the I-70 Rocheport work zone. As shown in Figure 5-1, the sensors—designated as Locations A, B, and C—were installed along the eastbound direction within the active work zone limits. Location A near the downstream end, Location C was positioned near the upstream end of the monitored segment, and Location B approximately at the midpoint between them. The distance between Locations A and B was approximately 1.12 miles, and between Locations B and C was 1.12 miles, providing continuous coverage throughout the corridor. Figure 5-2 illustrates the Armadillo sensor mounted at Location B.

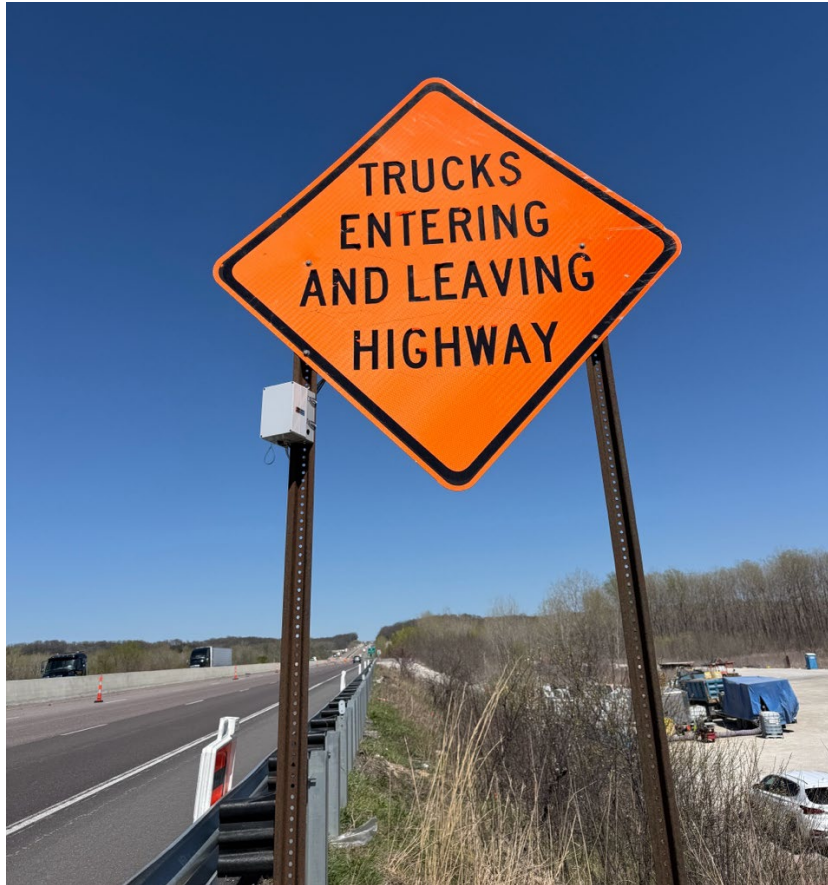
Figure 5-2. Sensor mounted at Location B for I-70 Rocheport.

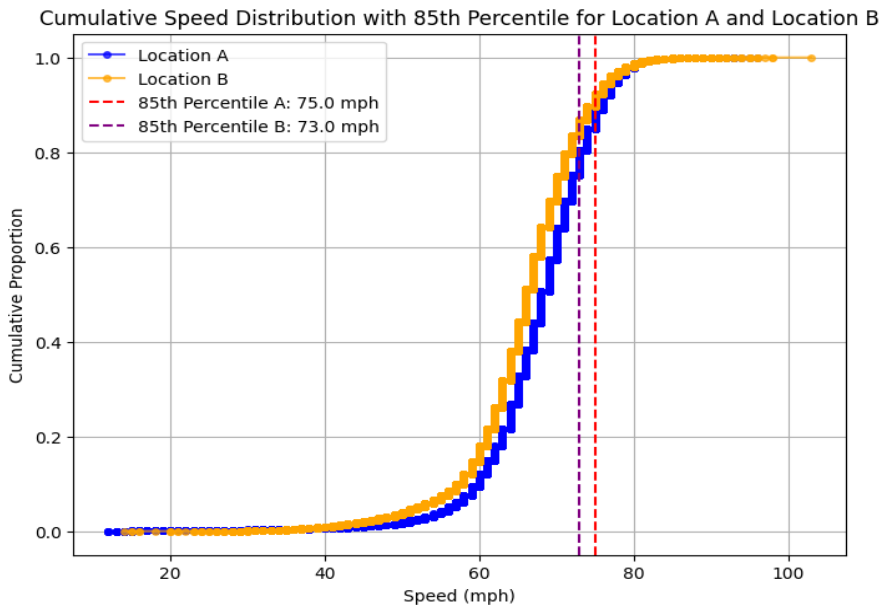
Figure 5-4. Cumulative speed distribution within the Two-Sensor Window for I-70 Rocheport.

Figure 5-3 and Figure 5-4 display the speed distribution and cumulative speed distribution in Two-Sensor Window, respectively. Both sites exhibited mean and 85th percentile speeds above the 60 mph limit, with Location B showing slightly higher values than Location A.

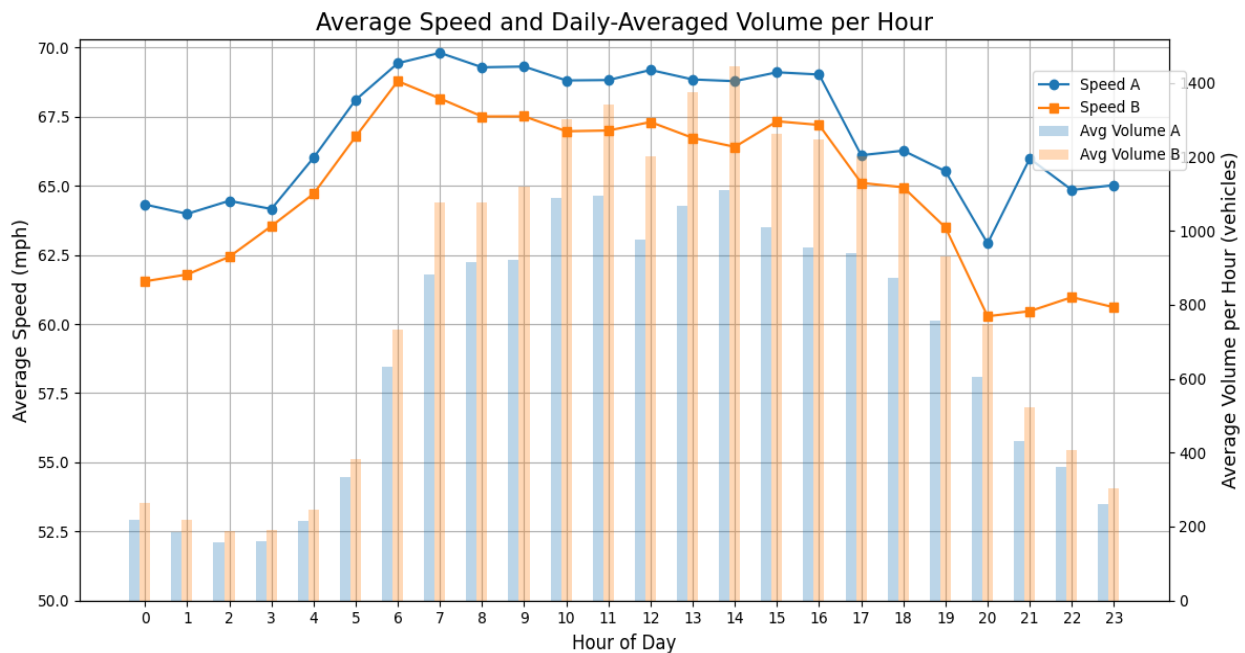
Figure 5-6. Average speed and volume by hour within the Two-Sensor Window for I-70 Rocheport.

Figure 5-6 illustrates the average speed and average volume by hour within the two-sensor window. As shown in the figure, during the early morning hours (12 AM–5 AM), volumes were low and average speeds remained moderate. As volumes increased sharply between 6 AM–8 AM, average speeds at both locations increased correspondingly, peaking near 70 mph and exceeding the 60-mph speed limit. Throughout the daytime (9 AM–4 PM), volumes remained high while average speeds stabilized at relatively elevated levels. In the evening (5 PM–8 PM), traffic volumes stayed high, but speeds declined, especially at downstream Location A, reflecting greater congestion effects compared to midpoint Location B.

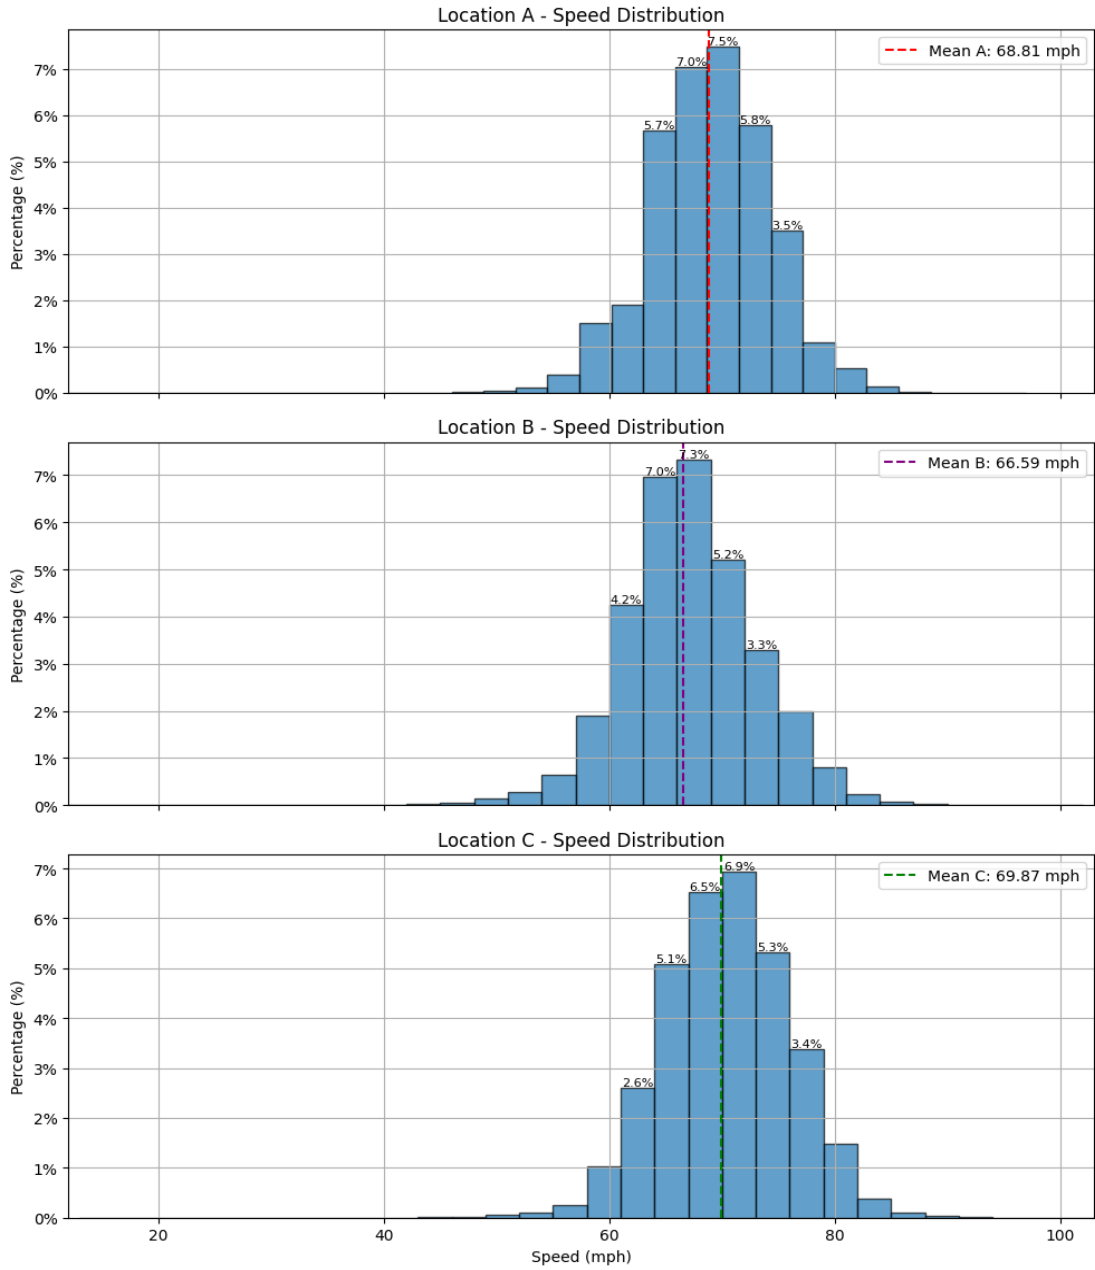
Figure 5-7. Speed distribution within the Three-Sensor Window for I-70 Rocheport.

Figure 5-7 and Figure 5-8 show the speed distribution and cumulative speed distribution in the Three-Sensor Window, respectively. Mean and 85th percentile speeds at all locations exceeded the posted 60-mph speed limit, with the highest values observed at upstream Location C and downstream Location A.

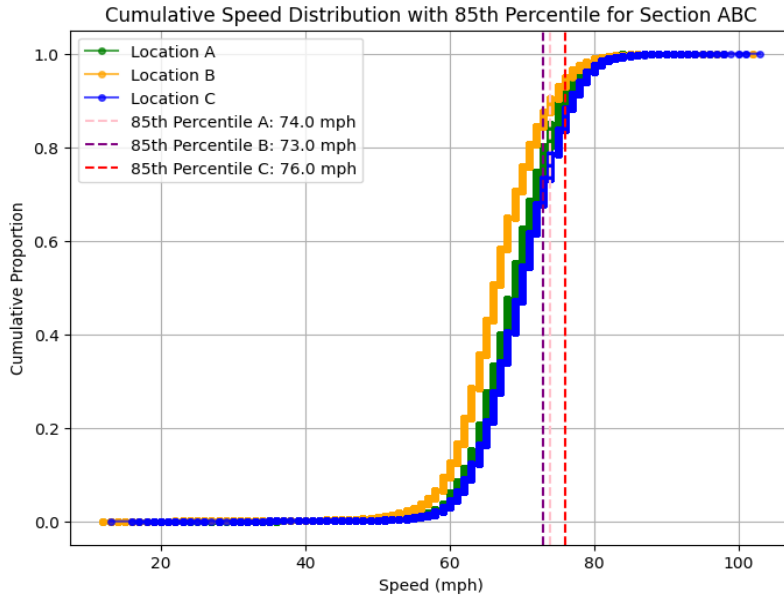
Figure 5-8. Cumulative speed distribution within the Three-Sensor Window for I-70 Rocheport.

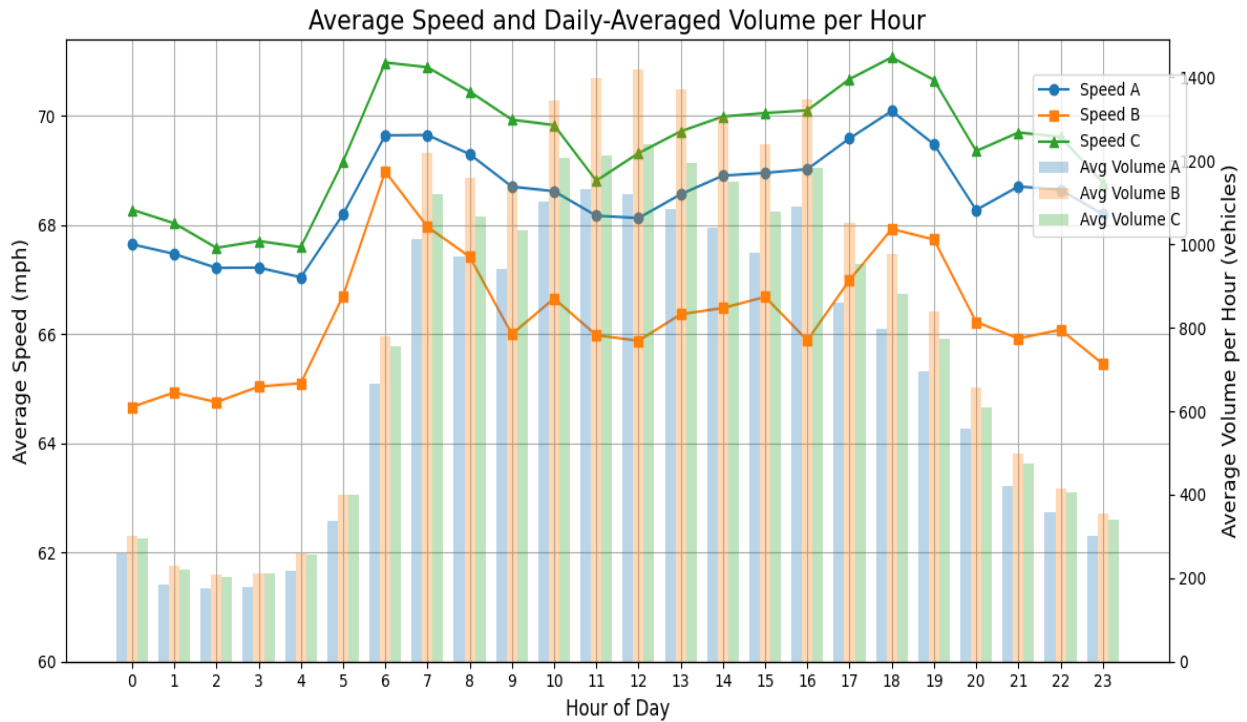
Figure 5-10. Average speed and volume by hour of the day within Three-Sensor Window.

upstream and downstream ends. In terms of traffic volume, all three locations followed similar temporal patterns, with flows increasing sharply from 6 AM, peaking between 10 AM–4 PM, and declining steadily in the evening. High volumes together with stable speeds during the daytime suggest that the work zone could handle heavy traffic without major speed reductions. However, the persistently lower speeds at Location B indicate localized flow constraints at the midpoint compared to the upstream and downstream ends.

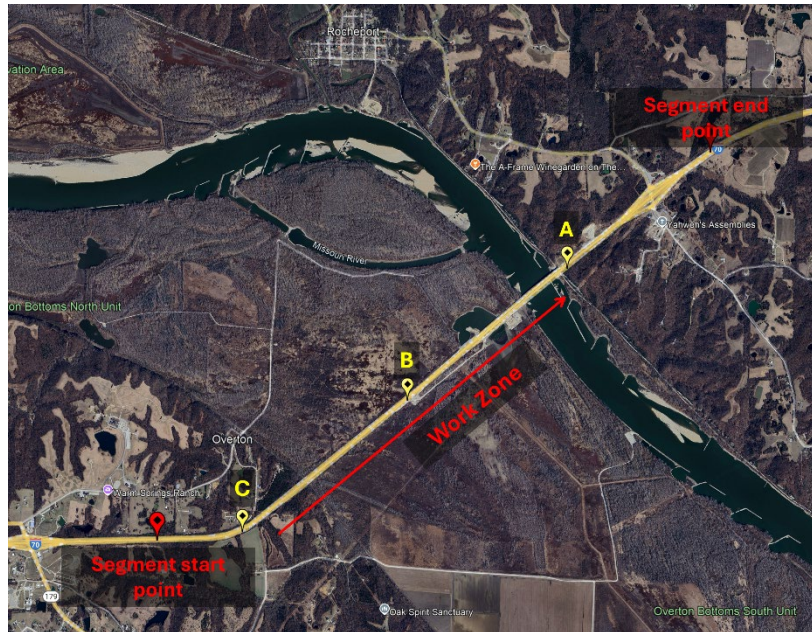
As shown in Figure 5-11, the limits of the HERE segment for I-70 Rocheport encompassed all three sensors. HERE data were extracted from April 15 to May 6, 2025 (same dates as sensors were in place) and from April 15 to May 6, 2022 (historical dates before the work zone was in place).

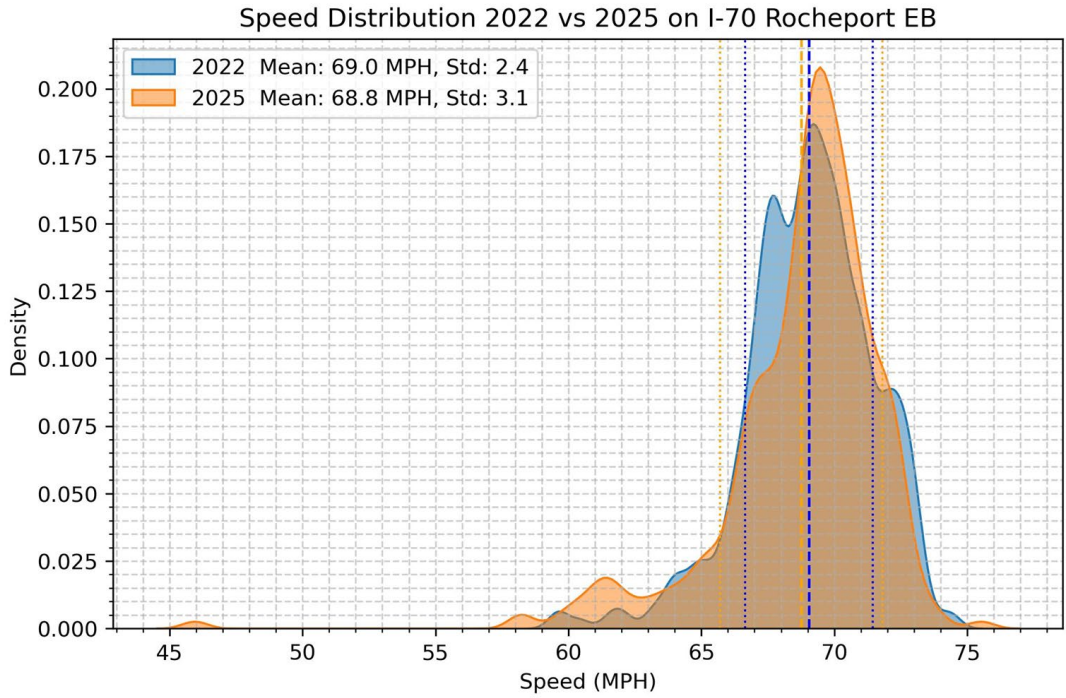
Figure 5-12. Speed distributions for 2022 and 2025 HERE data for I-70 Rocheport.

Three statistical tests were performed to evaluate speed characteristics between the work zone period (2025) and the non-work zone period (2022) using HERE data, including a t-test for average speed, an F-test for speed variability, and a quantile test for the 85th percentile speed. The test results are summarized in Table 5-19. In summary, construction activities at the I-70 Rocheport site did not lead to a statistically significant change in either average or 85th percentile speeds, indicating that overall and fast-driver speeds remained largely stable between the construction and non-work zone periods. However, the analysis revealed a marked increase in speed variability during construction, suggesting that while typical speeds were maintained, driving behavior became less consistent under work zone conditions.

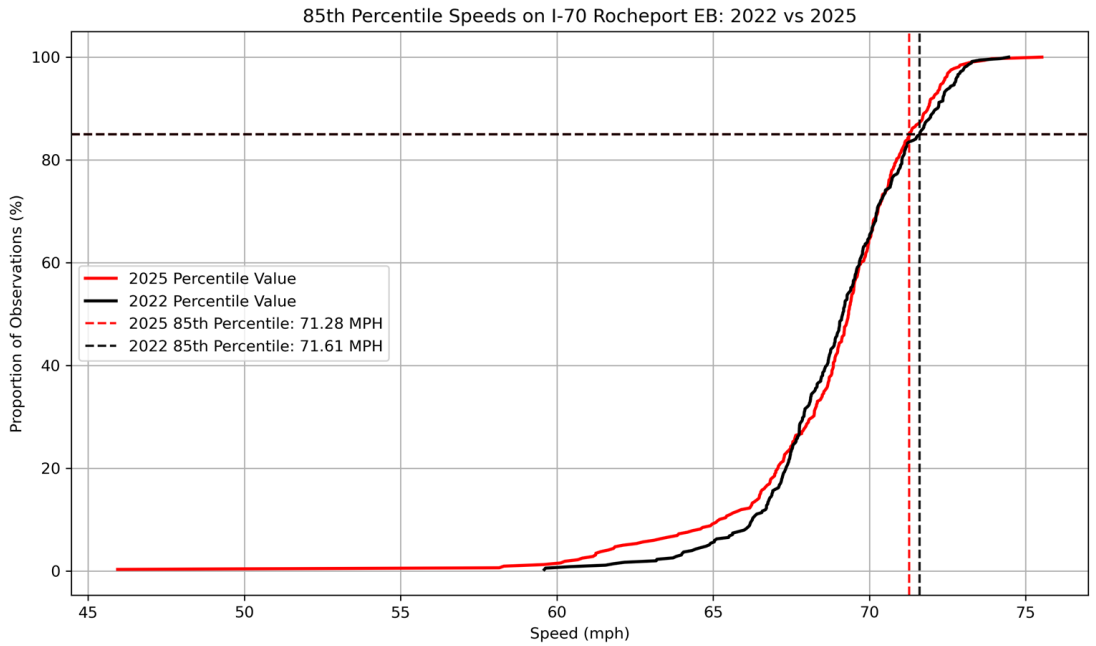
Figure 5-13. Cumulative speed distributions for 2022 and 2025 HERE data for I-70 Rocheport.

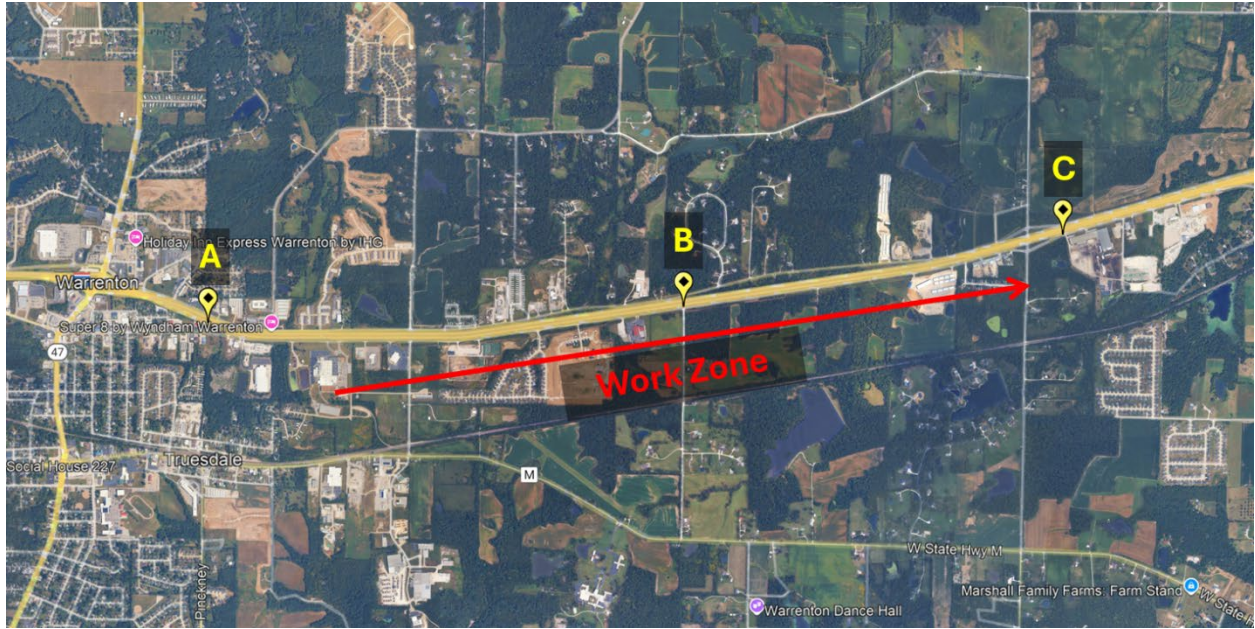
Figure 6-1. Sensor layout for I-70 Warrenton.

This study investigates traffic speed within the I-70 Warrenton work zone, where sensors were positioned at the upstream, midpoint, and downstream of the zone along the eastbound travel direction. As shown in Figure 6-1, all three sensors were placed within the zone, where Location A is situated at the upstream end, Location B is near the midpoint, and Location C close to the downstream end. The distance between Location A and Location B is approximately 1.5 miles, while the distance from Location B to Location C is about 1.8 miles. Figure 6-2 shows the sensor mounted at Location B.

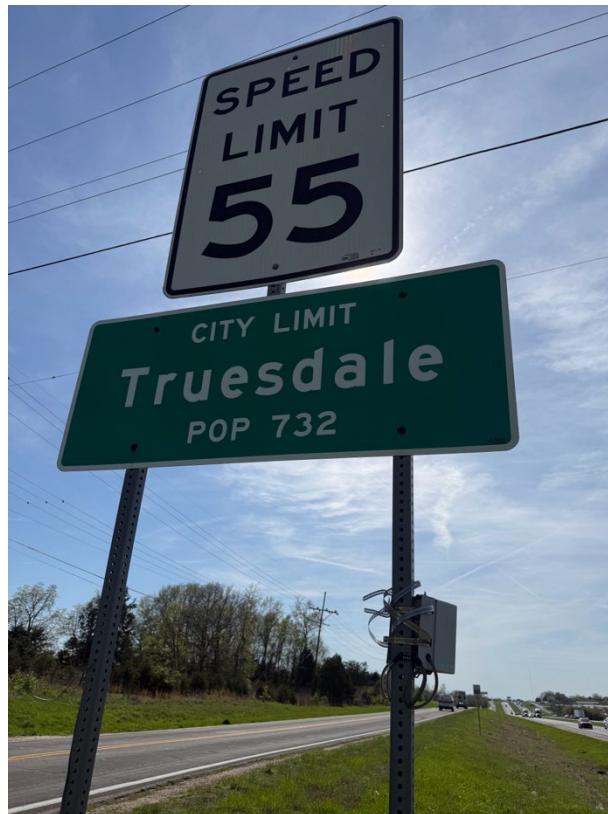
Figure 6-2. Sensor mounted at Location B for I-70 Warrenton.

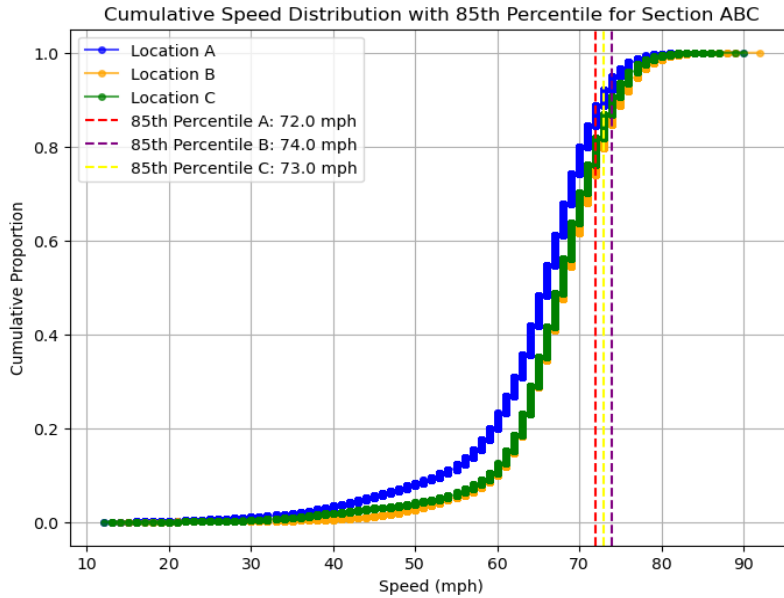
Figure 6-4. Cumulative speed distribution during non-work zone period for I-70 Warrenton.

Figure 6-3 and Figure 6-4 show the speed distribution and cumulative speed distribution during the non-work zone period, respectively. The 85th percentile speed exceeded the posted 70 mph limit at all locations, whereas the mean speed remained below 70 mph at each site. Among the three locations, Location B exhibited the highest mean and 85th percentile speeds, followed by Location C and then Location A.

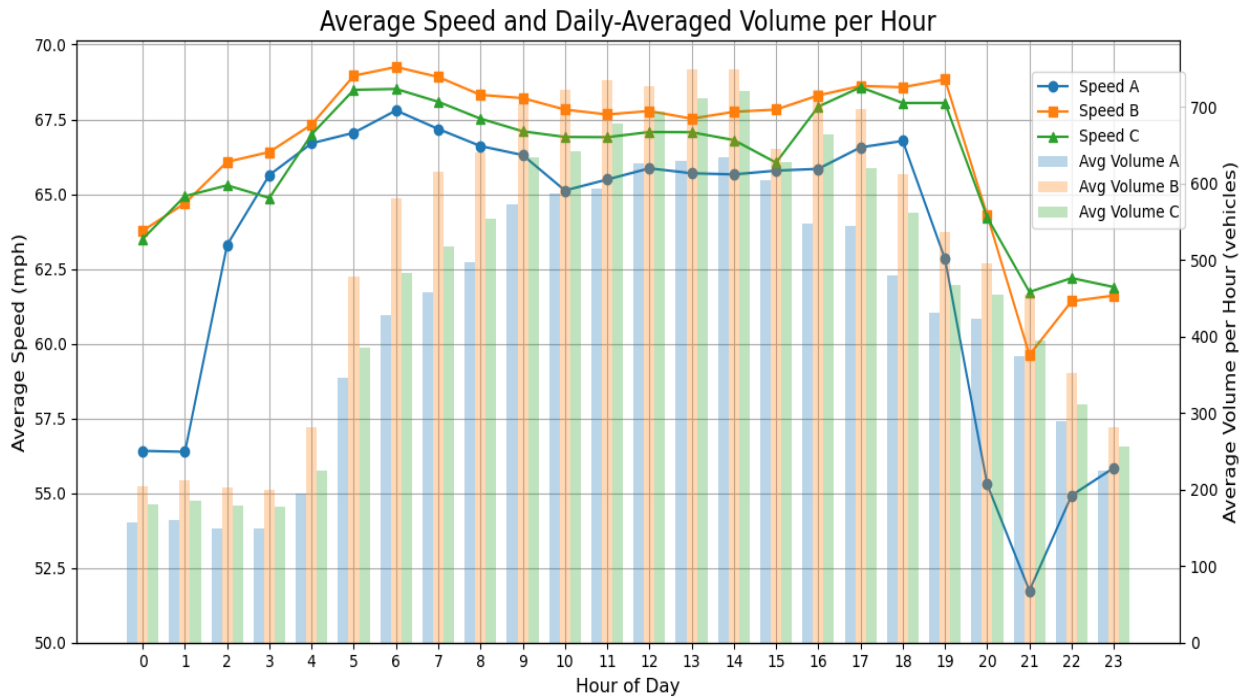
Figure 6-6. Average speed and volume by hour of the day during non-work zone period for I-70 Warrenton.

Location B exhibited the highest speeds, and Location C consistently fell between the other two, with values closer to those at Location B.

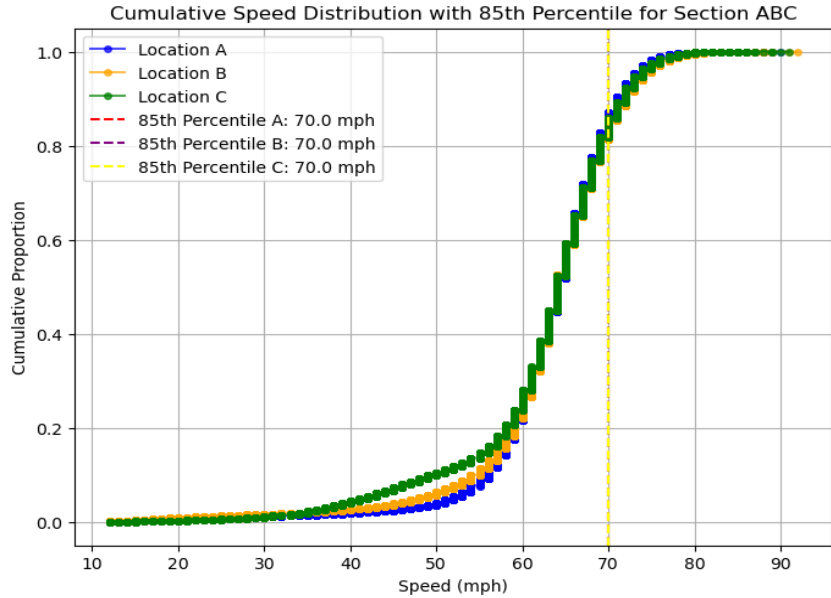
Figure 6-8. Cumulative speed distribution during work zone period for I-70 Warrenton.

Figure 6-7 and Figure 6-8 illustrate the speed distribution and cumulative speed distribution during the work zone period, respectively. Both locations recorded mean and 85th percentile speeds exceeding the posted 60 mph limit, with Location A showing the highest values, followed by Location B, while Location C exhibited the lowest.

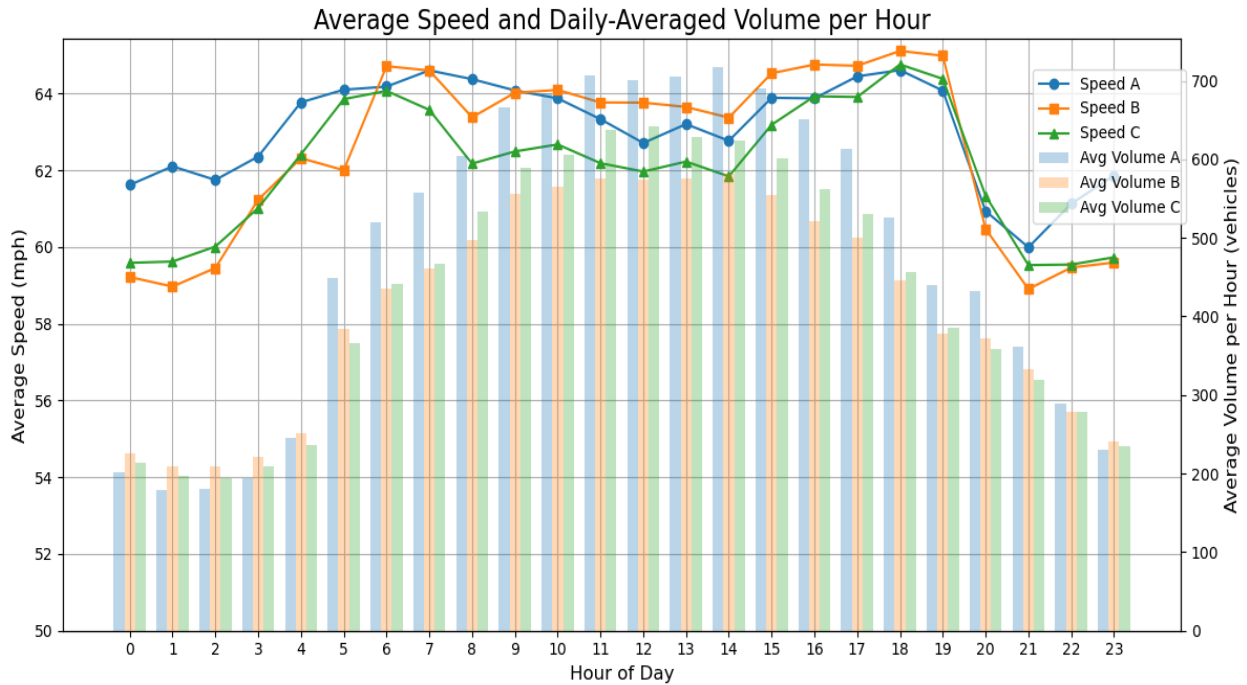
Figure 6-10. Average speed and volume by hour of the day during work zone period for I-70 Warrenton.

hours, experienced a moderate decrease as volumes increased during the daytime, and partially recovered during evening off-peak conditions. Across locations, speeds exhibited minor variations during construction, with Location C generally displaying slightly lower values, while Locations A and B showed comparable trends.

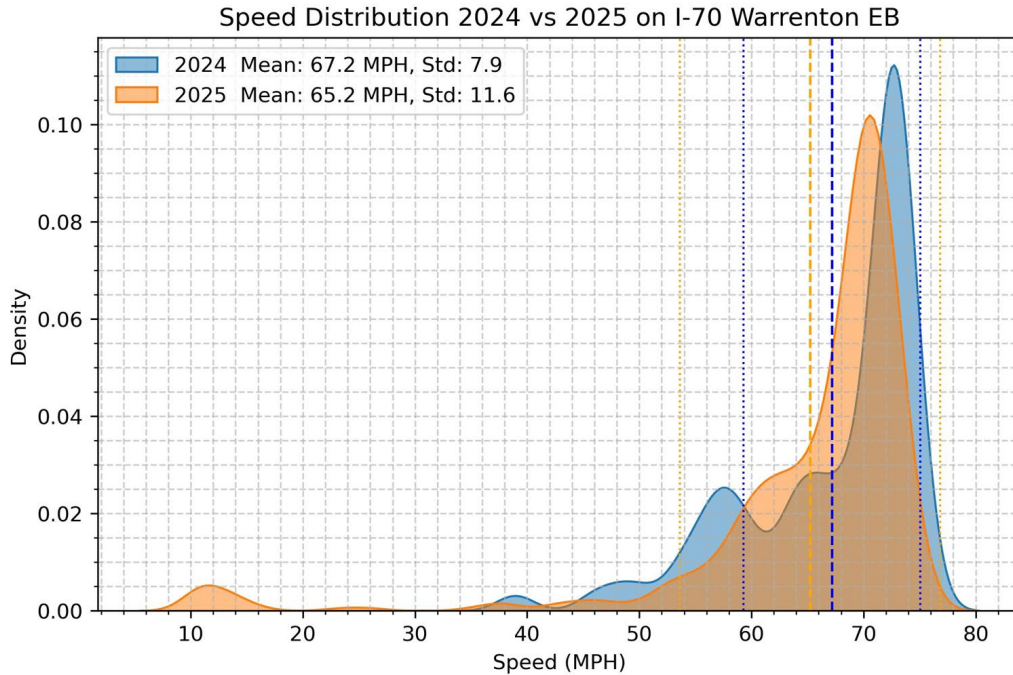
Figure 6-12. Speed distributions for 2024 and 2025 HERE data for I-70 Warrenton.

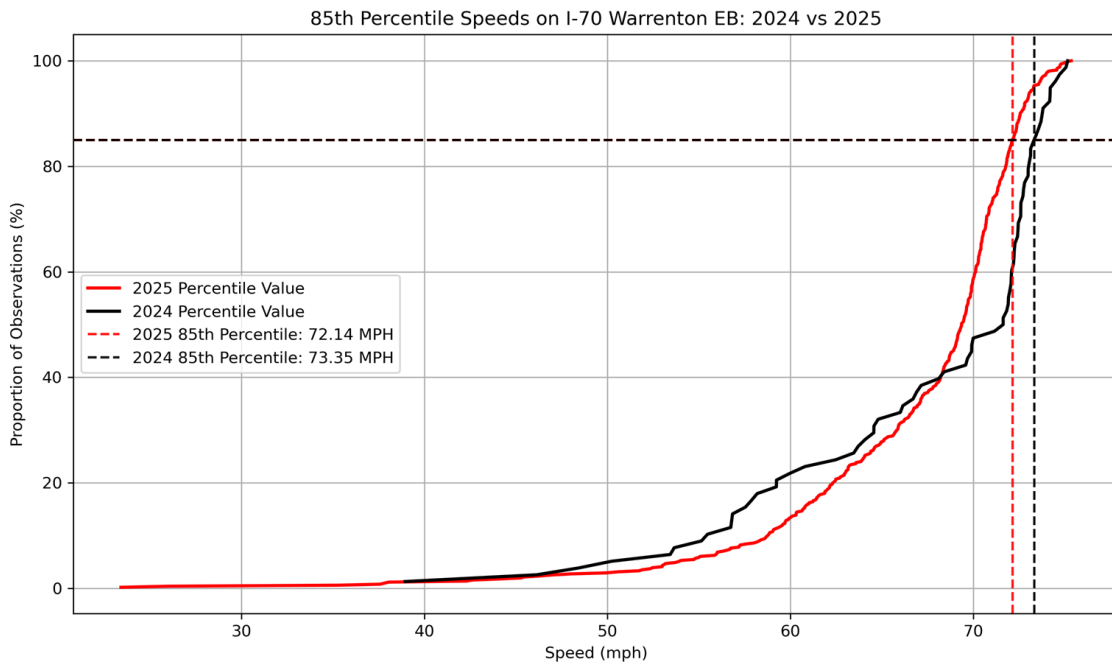
Figure 6-13. Cumulative speed distributions for 2024 and 2025 HERE data for I-70 Warrenton.

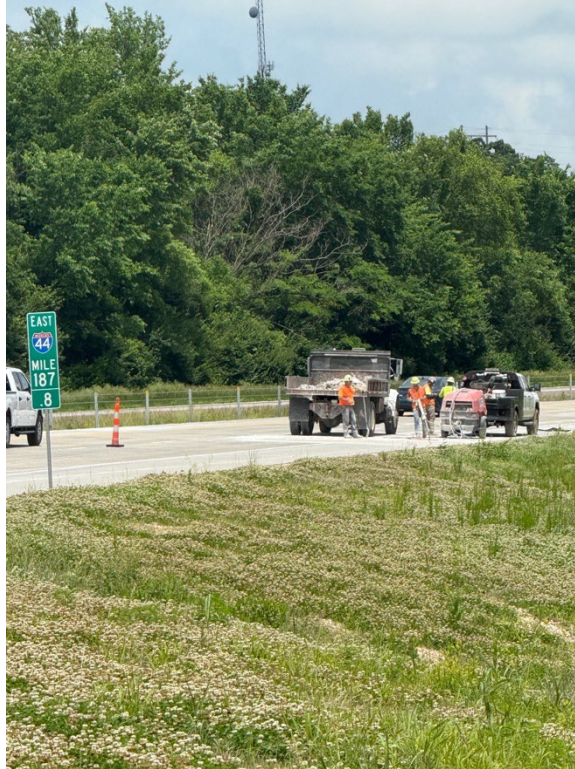
Figure 7-1. Workers and equipment in closed lane on I-44 near Rolla and St. James.

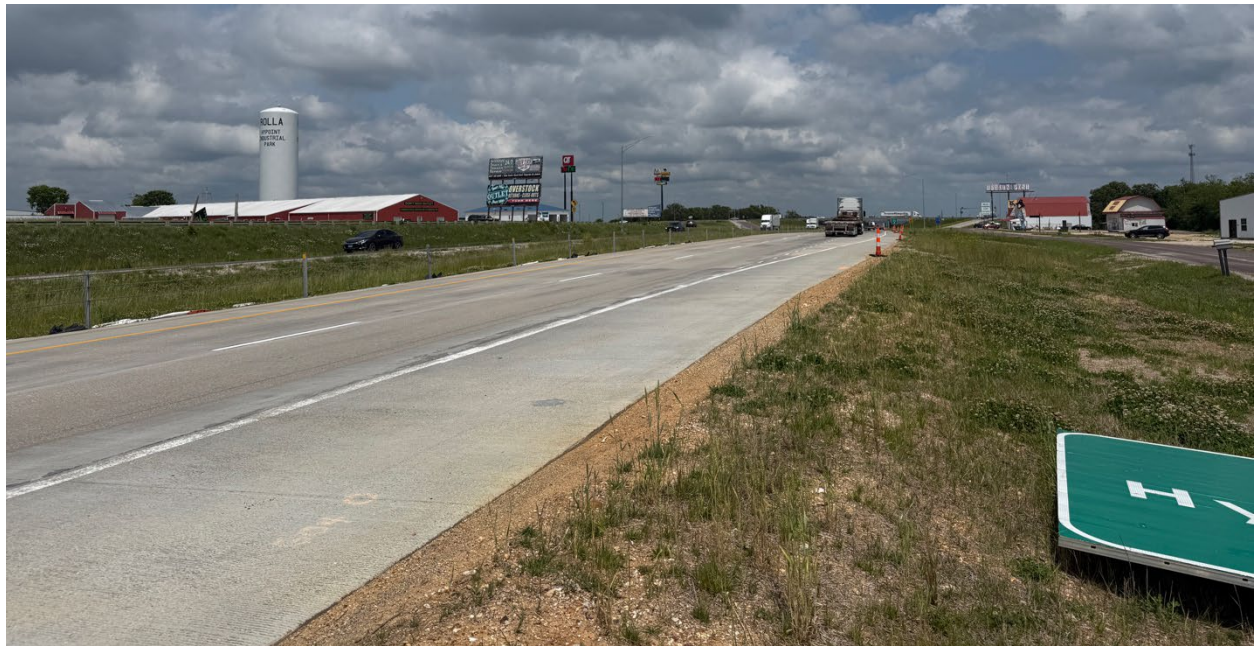
Figure 7-3. Downstream view from Location C on I-44 eastbound.

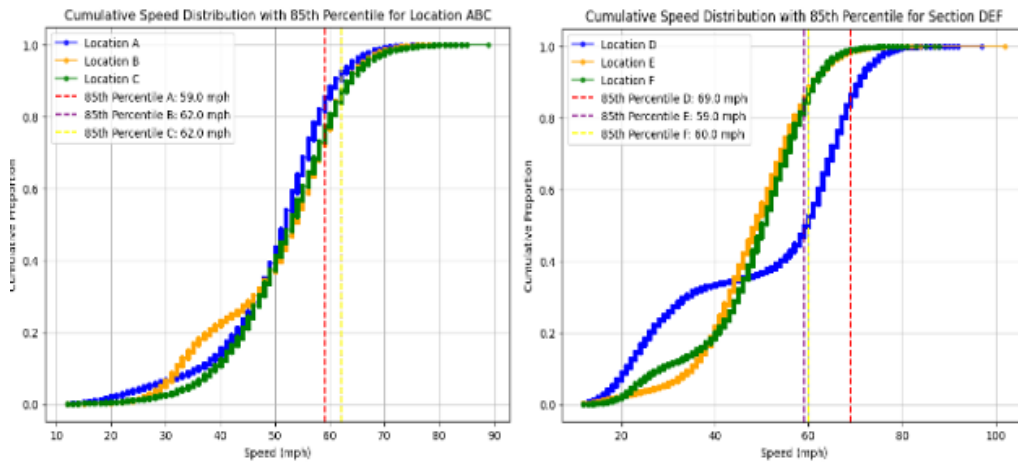
Figure 7-5. Cumulative speed distribution during work zone period for I-44 Rolla (left) and St. James (right).
