MoDOT Work Zone Speed Study

January 2026
Final Report

Project number TR202518
MoDOT Research Report number cmr 26-001

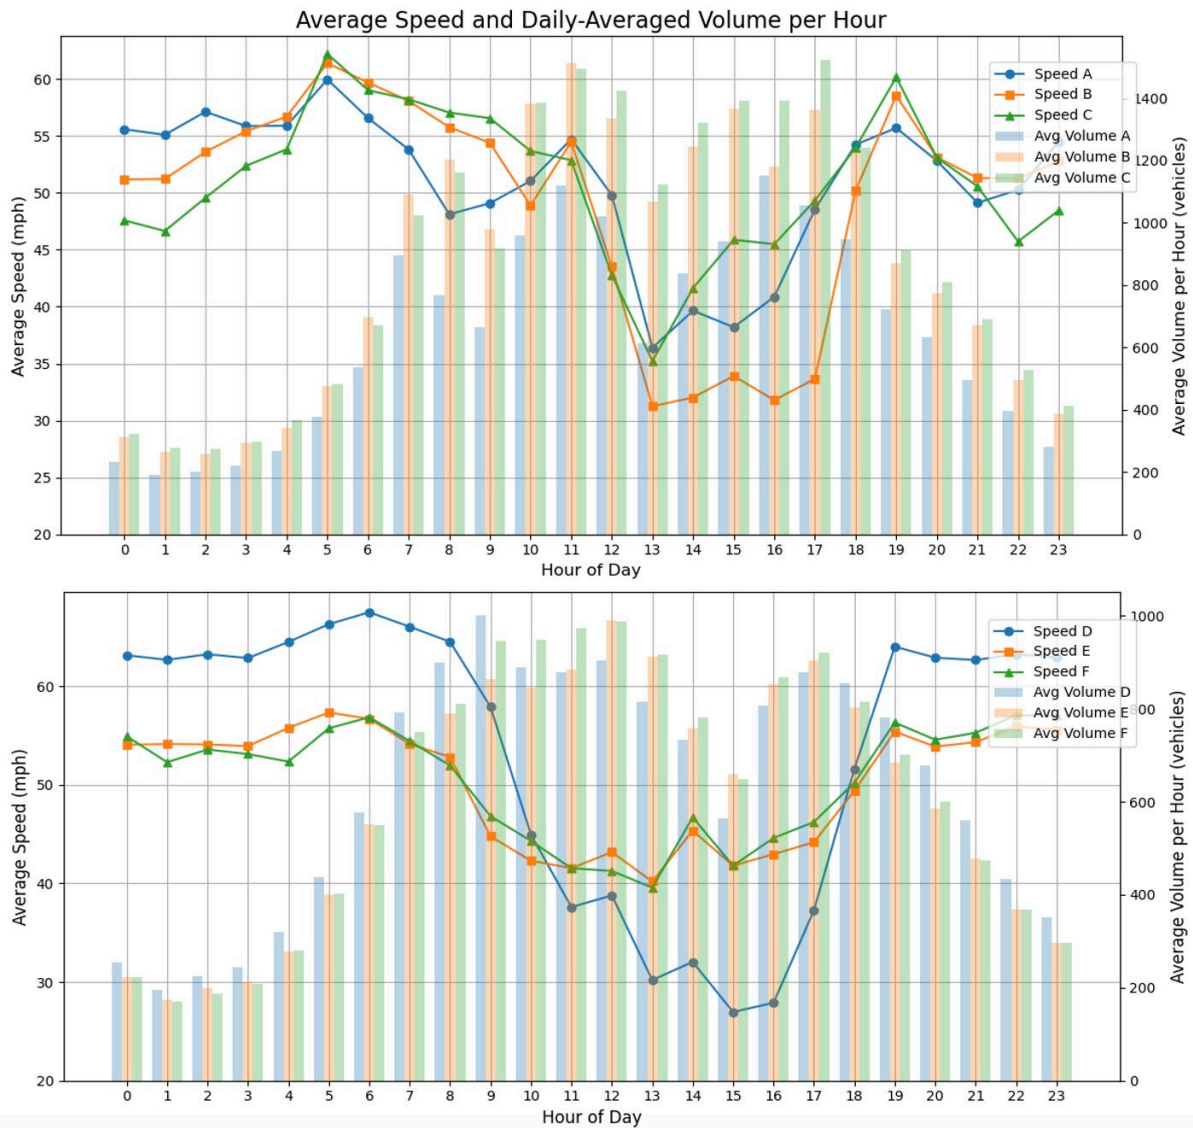
Figure 7-8. Average speed and volume by hour of the day during work zone period for I-44 Rolla (top) and St. James (bottom).

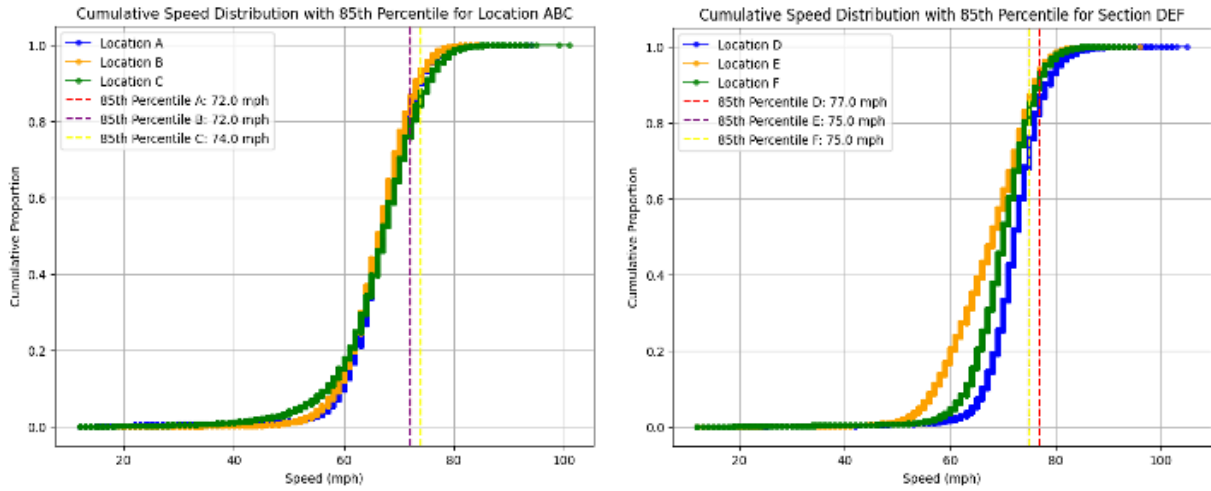
Figure 7-10. Cumulative speed distribution during non-work zone period for I-44 Rolla (left) and St. James (right).

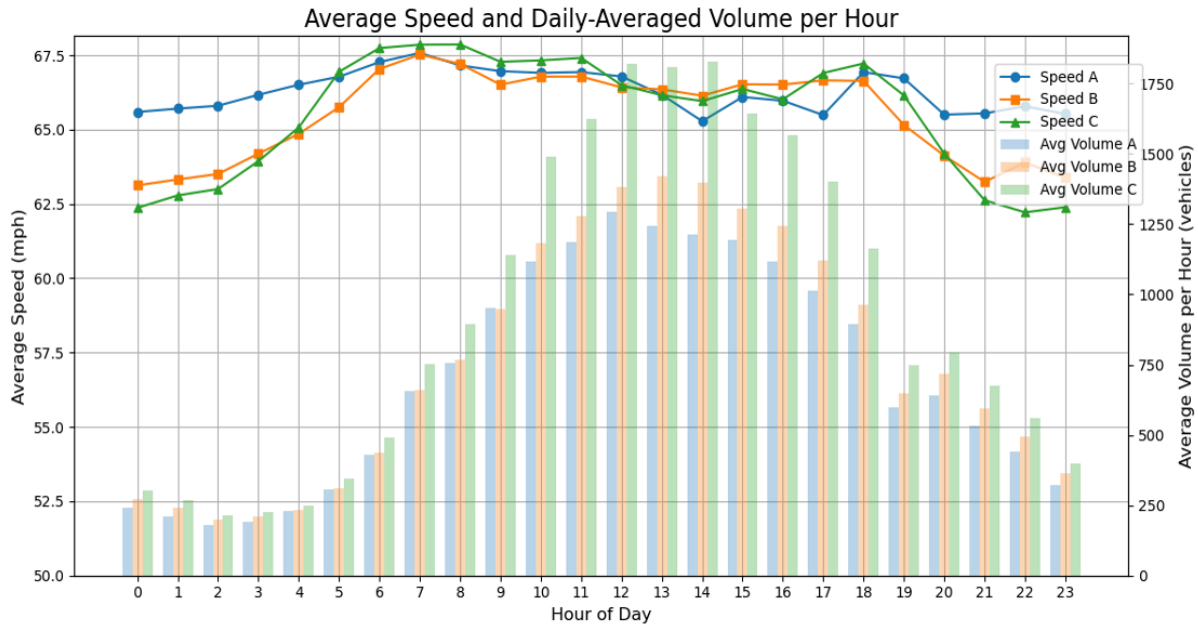
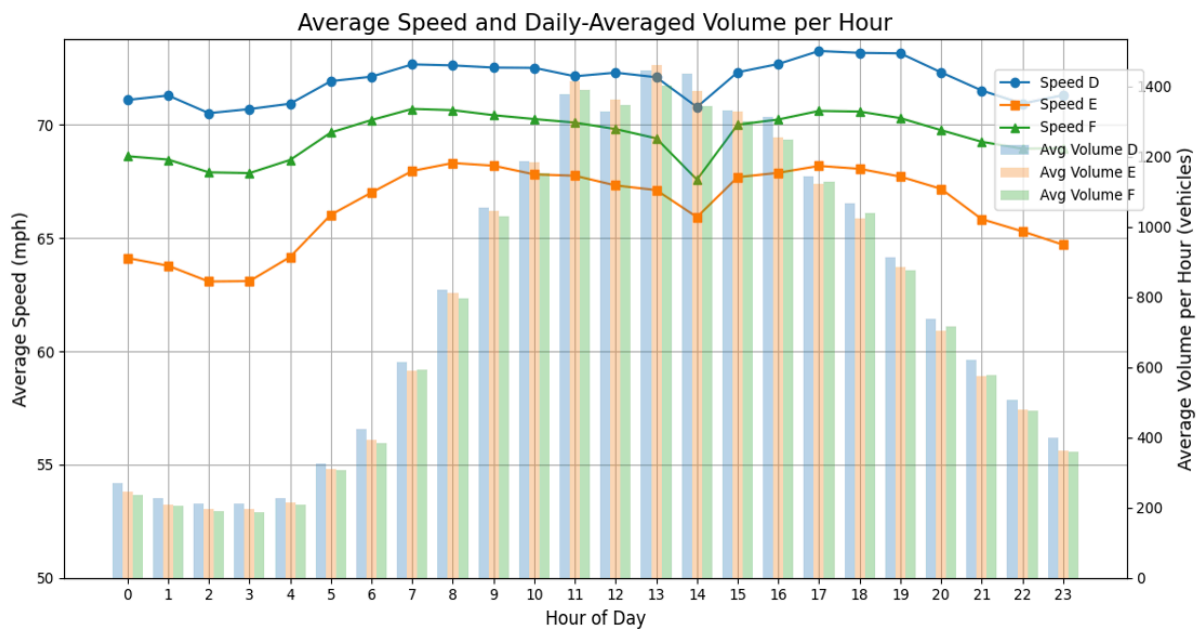
Figure 7-13. Average speed and volume by hour of the day during non-work zone period for I-44 Rolla (top) and St. James (bottom).

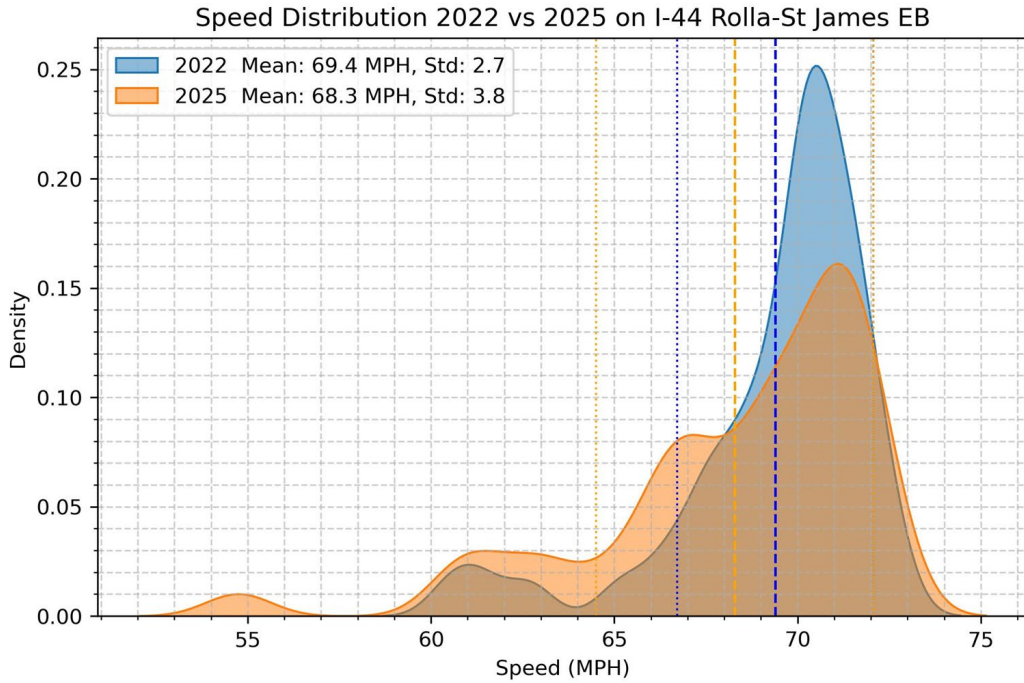
Figure 7-15. Speed distributions for 2022 and 2025 HERE data for I-44 Rolla/St. James.

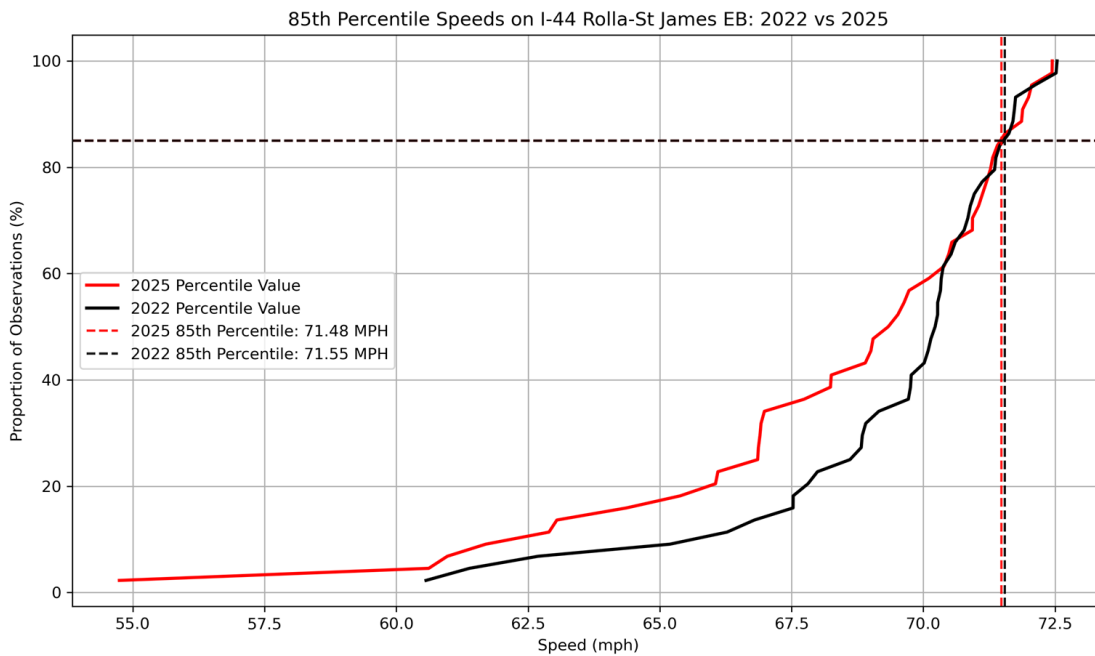
Figure 7-16. Cumulative speed distributions for 2022 and 2025 HERE data for I-44 Rolla/St. James.

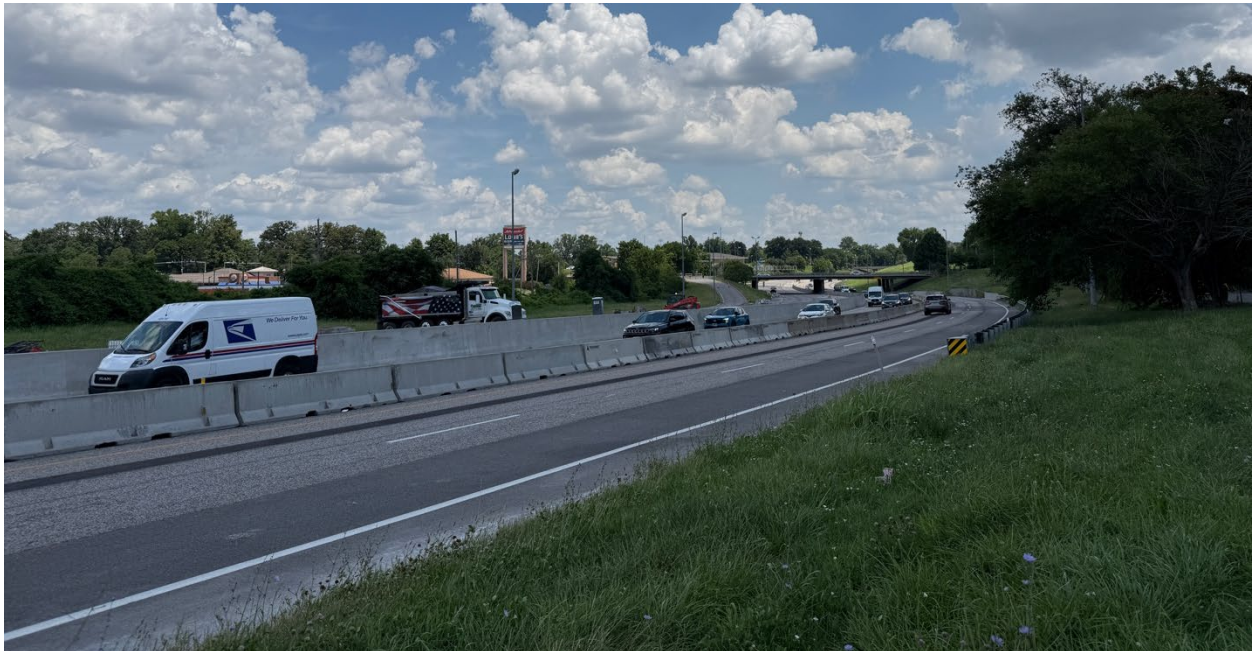
Figure 8-1. Two-way traffic separated by temporary barrier on I-55 in St. Louis.

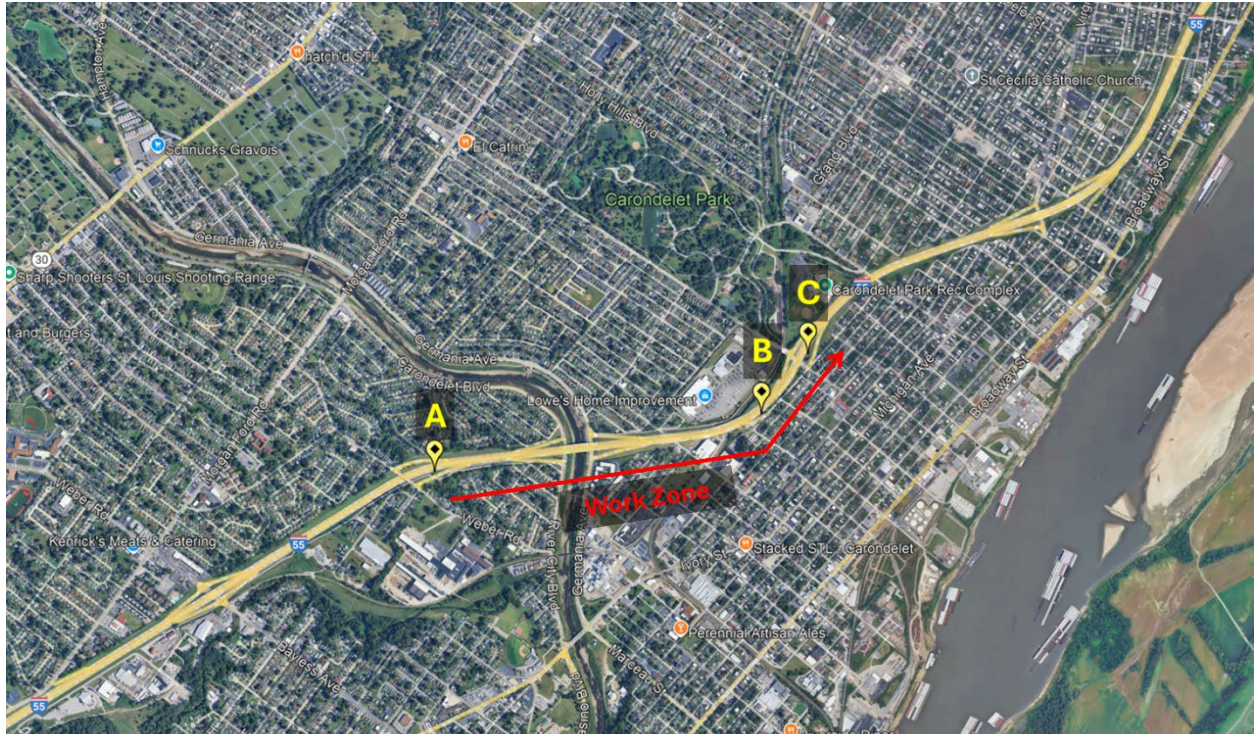
Figure 8-2. Sensor layout for I-55 St. Louis.

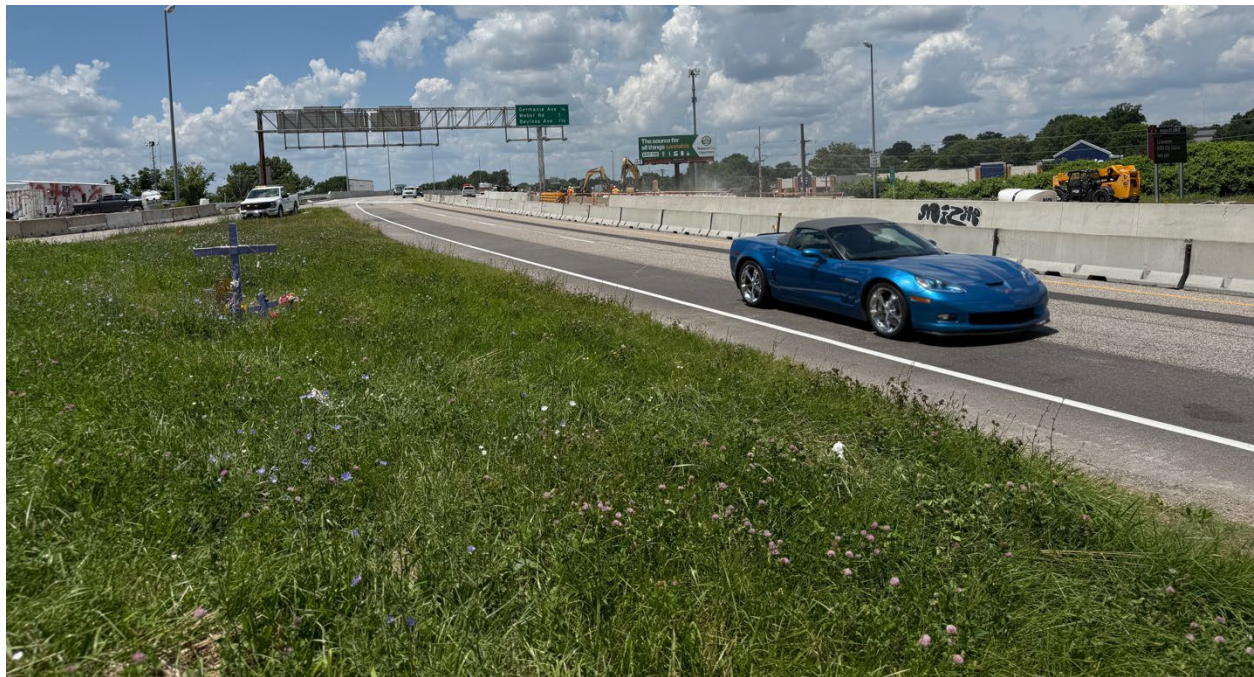
Figure 8-3. View of oncoming traffic at Location B for I-55 in St. Louis.

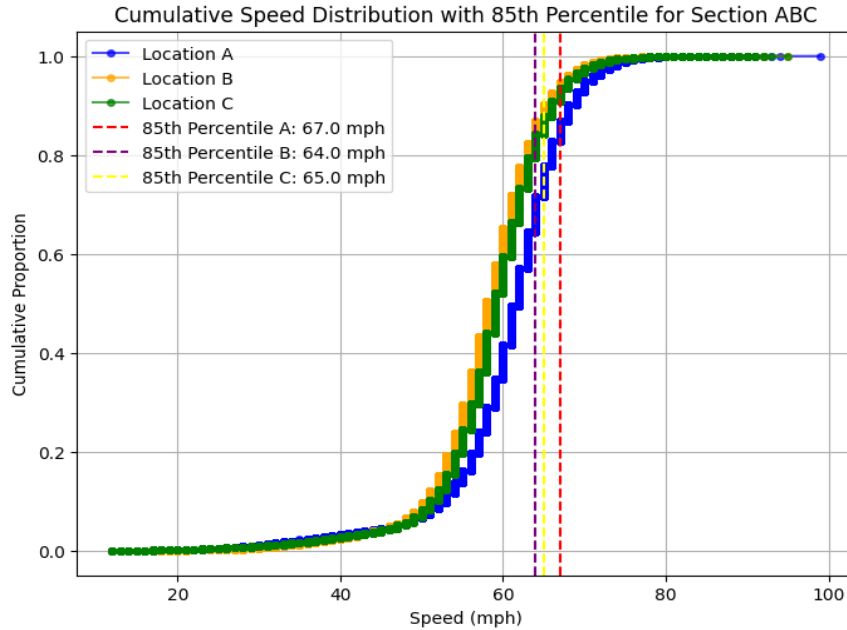
Figure 8-5. Cumulative speed distribution during active work period for I-55 St. Louis.

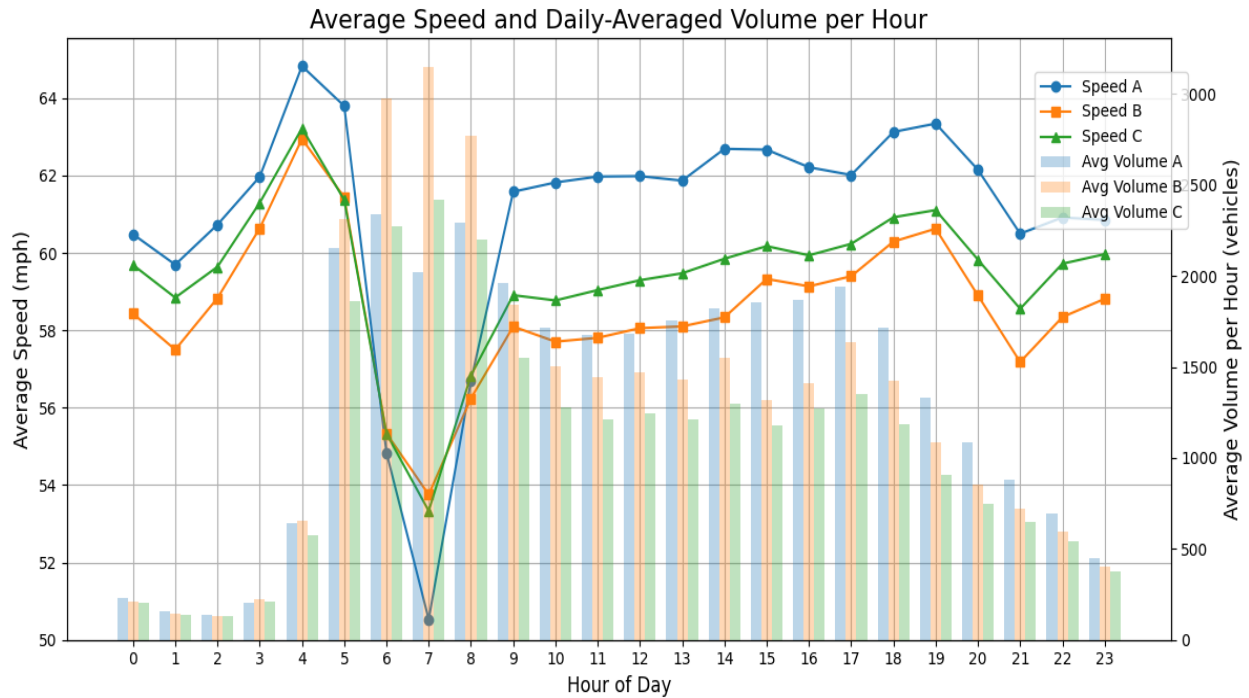
Figure 8-7. Average speed and volume by hour of the day during active work period for I-55 St. Louis.

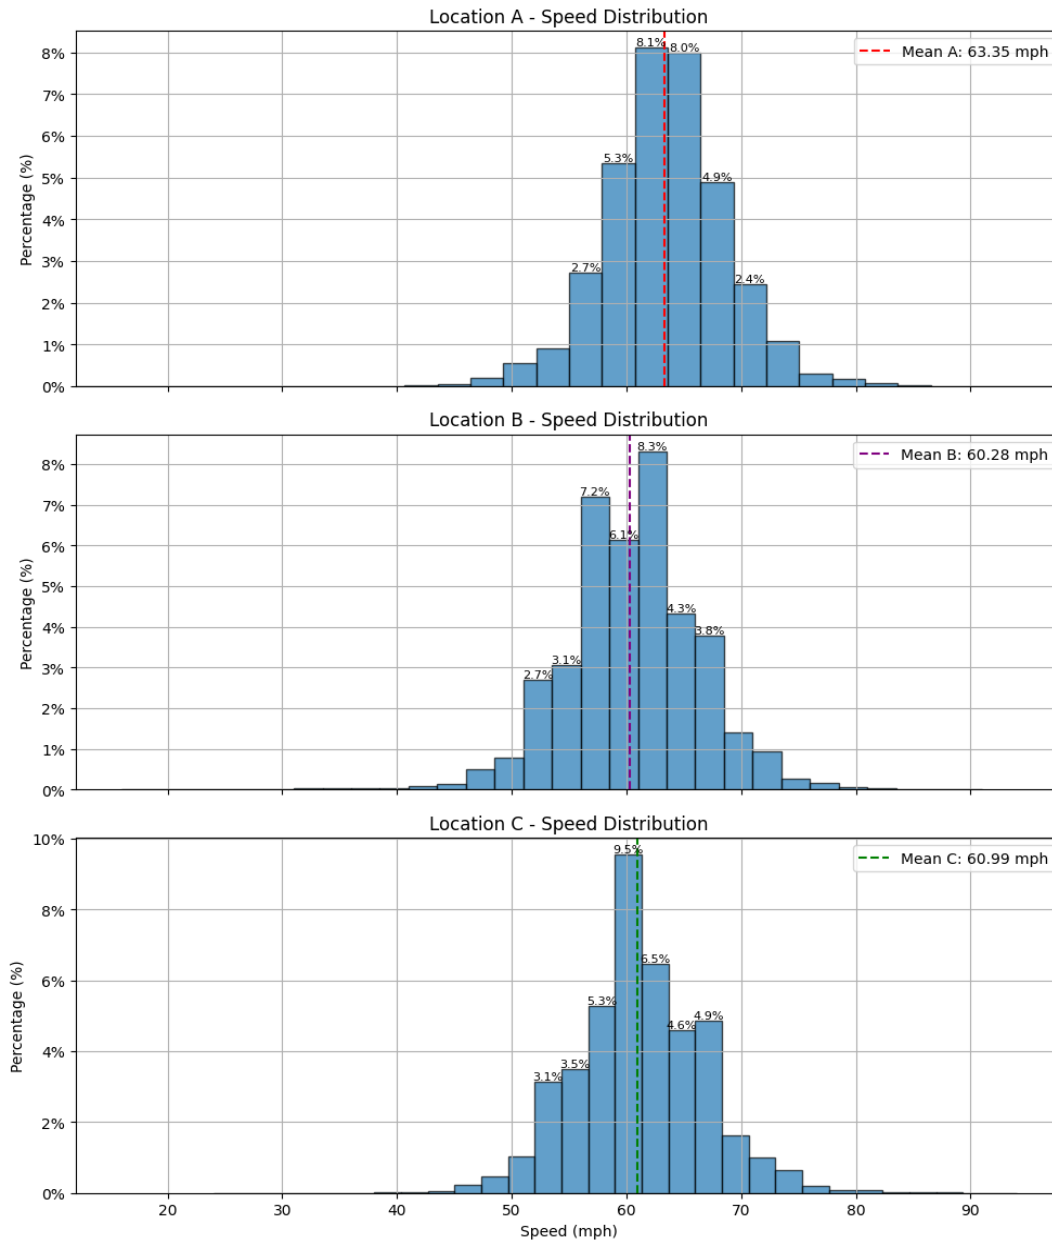
Figure 8-8. Speed distribution during non-active work period for I-55 St. Louis.

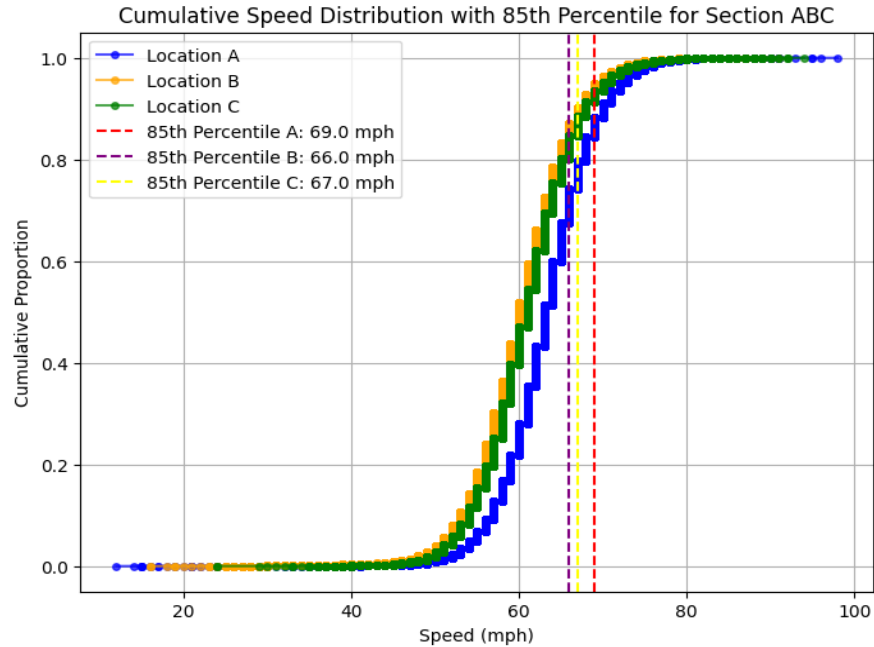
Figure 8-9. Cumulative speed distribution during non-active work period for I-55 St. Louis.

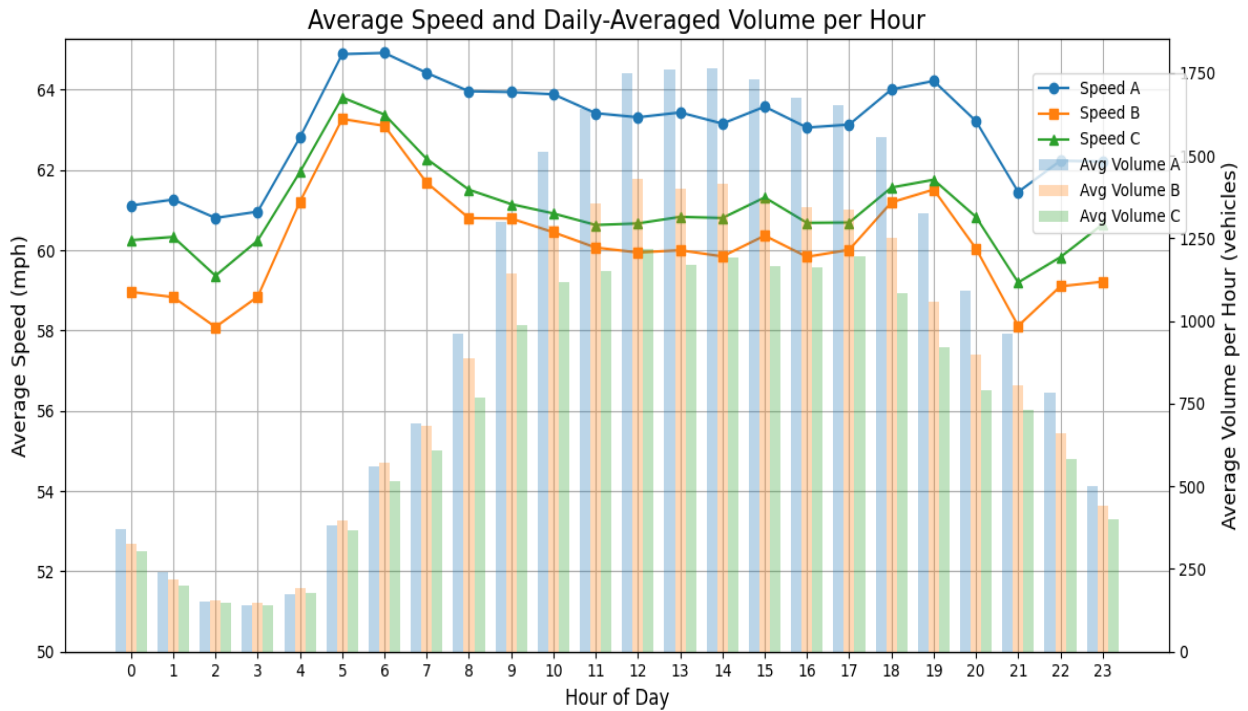
Figure 8-11. Average speed and volume by hour of the day during non-active work period for I-55 St. Louis.

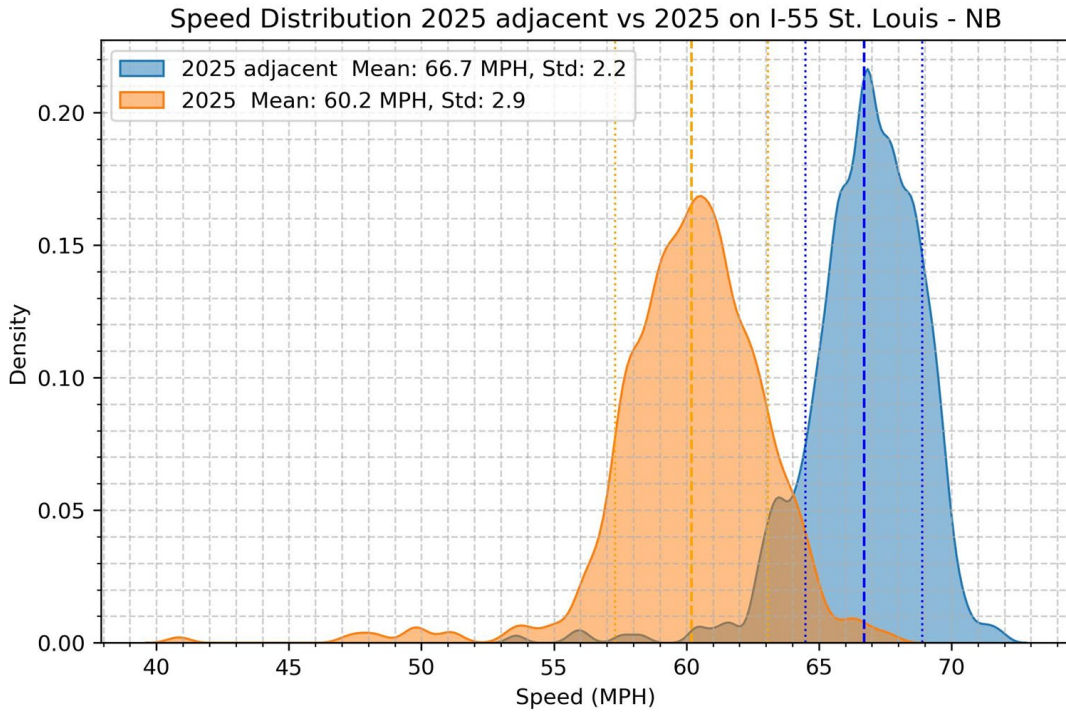
Figure 8-13. Speed distributions for HERE data for upstream (adjacent) and downstream (between sensors A and B) segments for I-55 St. Louis.

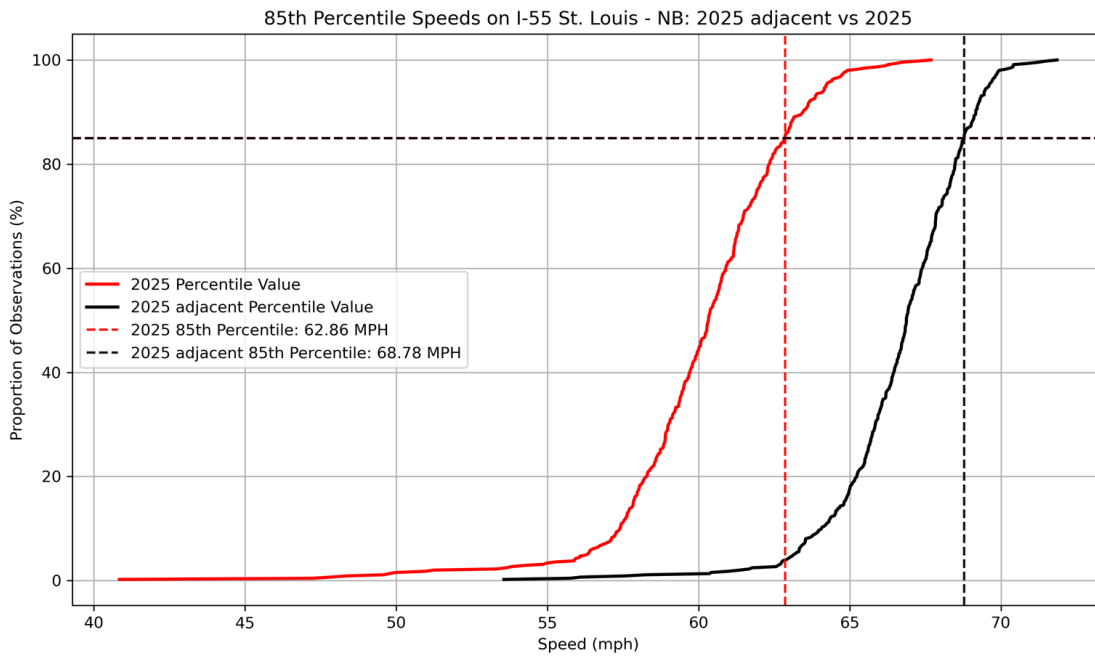
Figure 8-14. Speed distributions for HERE data for upstream (adjacent) and downstream (between sensors A and B) segments for I-55 St. Louis.
