GEORGIA DOT RESEARCH PROJECT 23-11

**ROADWAY RUNOFF IMPACTS TO TROUT
STREAMS STUDIES FOR MS4 PERMIT**

February 2026

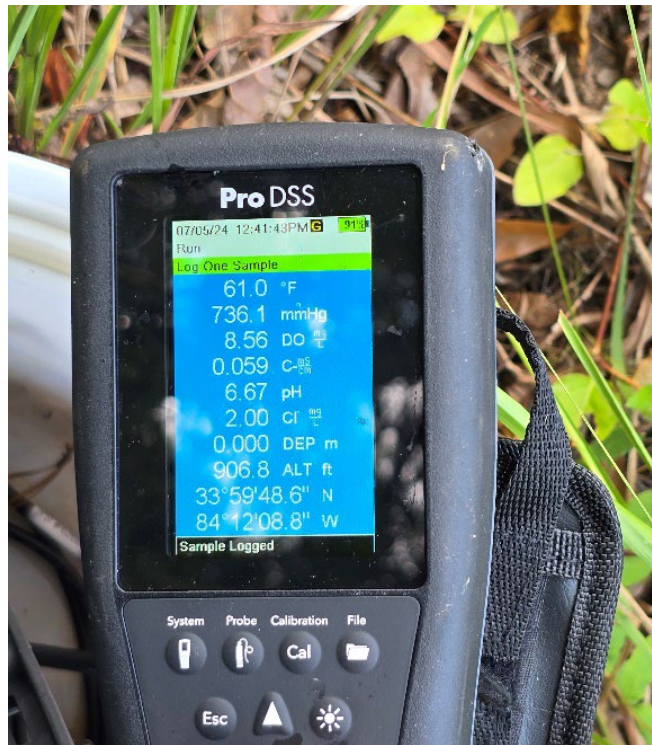
Figure 8. Photo. YSI® ProDSS Multiparameter Instrument Reading Screen

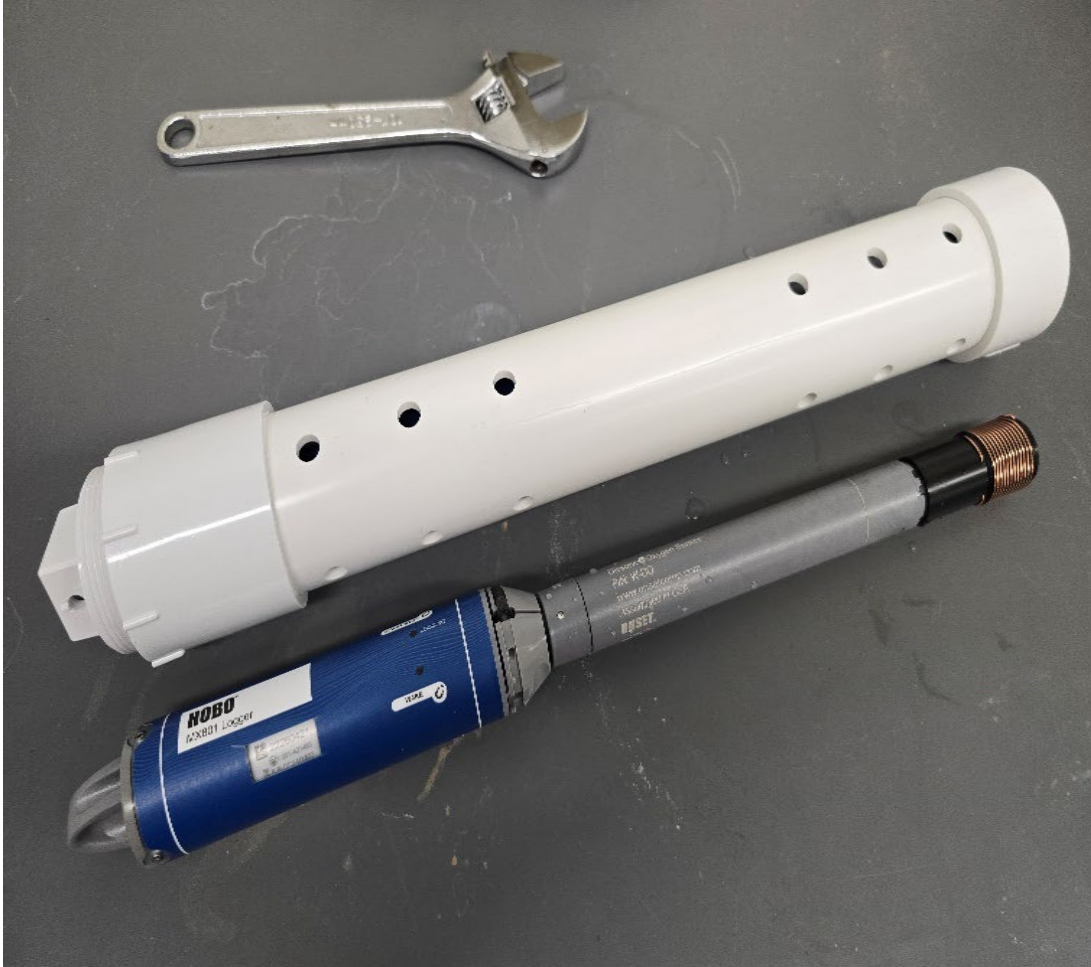
Figure 10. Photo. HOBO® Data Logger with DO/Temperature Sensor Attached and PVC Protective Housing

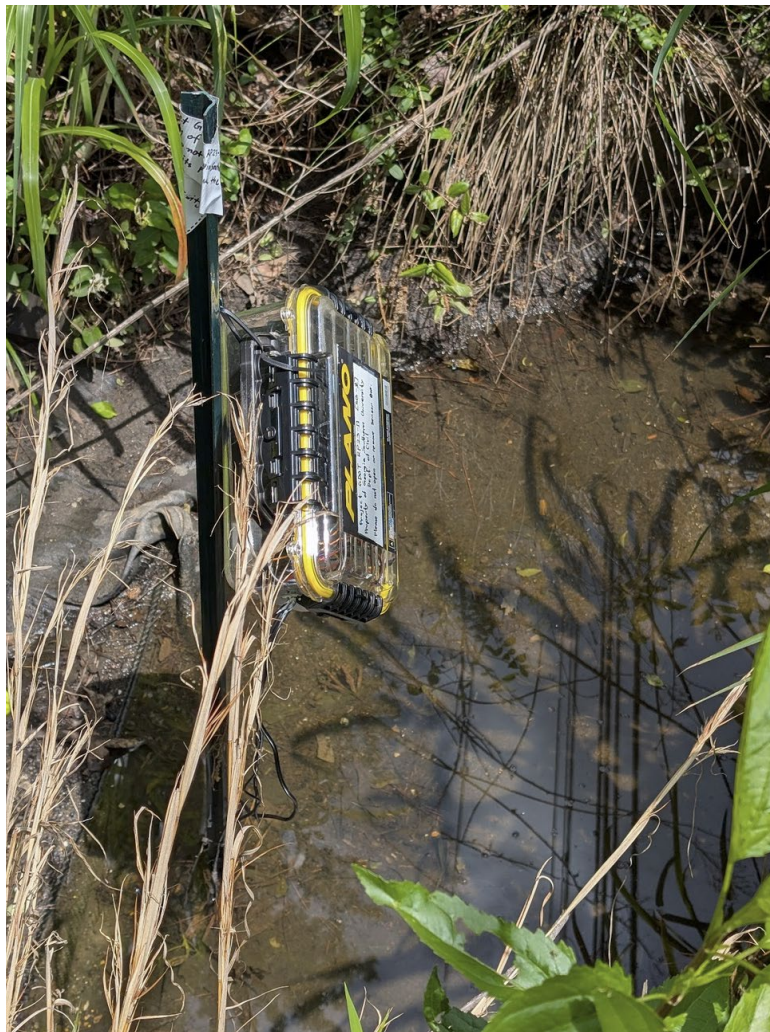
frequent data transmission failures. The constant reconnection attempts caused the hotspot to draw excessive power, fully discharging the 20,000 mAh battery within approximately 10 hours of operation. To extend operational longevity, the battery capacity was increased by 3.5 times (to 70,000 mAh), and a hotspot device with roughly three (3) times higher energy efficiency was adopted. These modifications improved total runtime to about 70 hours, though some variability in data continuity remained.

Figure 12. Photo. Deployed ESP32-based Remote Sensor System at Site 1 Outfall 2

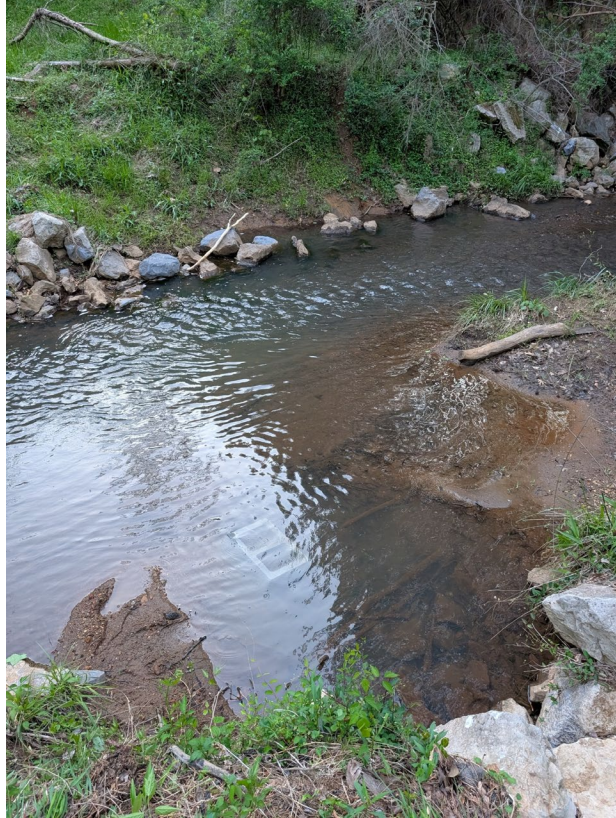
Powder Springs Creek's variable baseflow required adaptive mounting heights; therefore, adjustable stainless-steel clamps were used to reposition sensors seasonally to maintain optimal submergence.

Figure 17. Photo. Initial deployed placement of instream sensor concrete (CC) block at Site 2

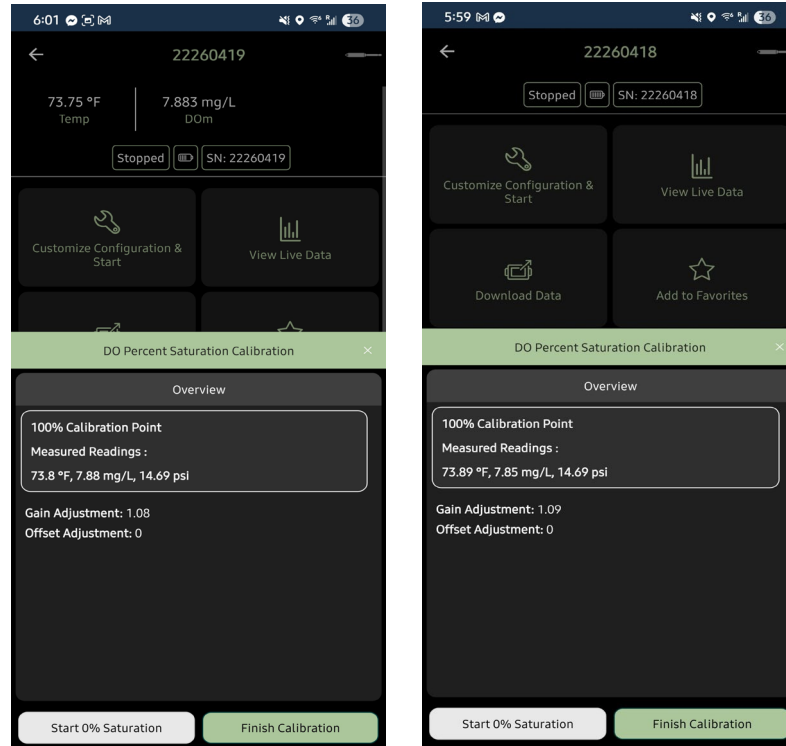
HOBO® MX-801 DO and temperature loggers were calibrated using the manufacturer’s optical DO calibration cap at 100-% oxygen condition and validated against YSI® readings in a stirred calibration tank at 73 ± 0.5 °F. Figure 20 below shows two (2) **HOBO® MX-801** DO sensors calibration screens at 100-% calibration point.

Figure 20. Photo. HOBO® MX-801 sensor calibration screen

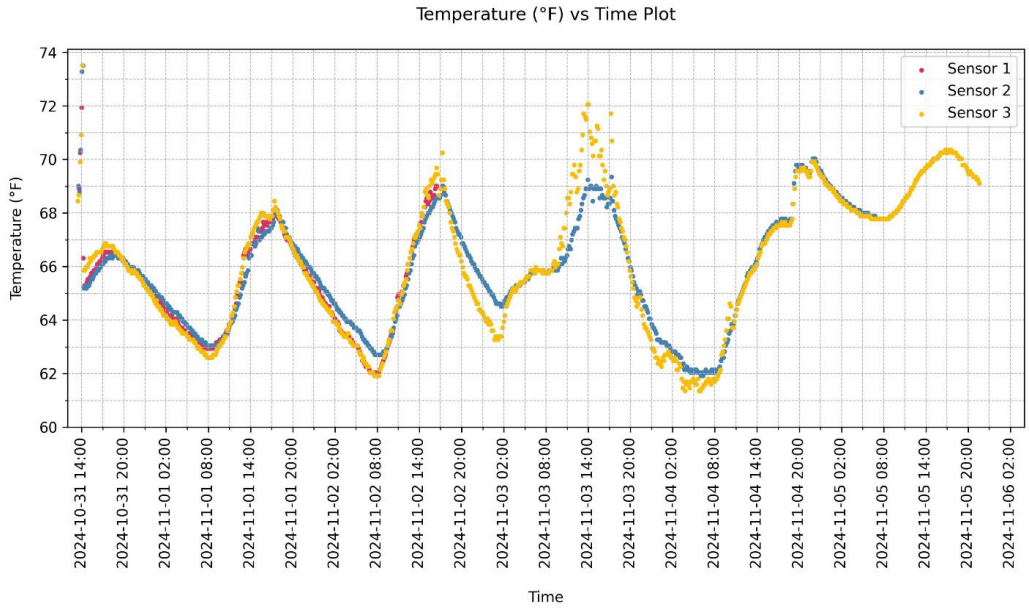
A series of controlled field tests were conducted to evaluate the performance of the ESP32-based remote sensor units under real-world environmental conditions. The first test, shown in Figure 25, involved three (3) sensors deployed simultaneously to record stream temperature variations over several diurnal cycles. All sensors demonstrated consistent temperature response trends, validating the system's basic temperature measurement capability. In the subsequent field trial (Figure 26), a fourth remote sensor was co-located with a YSI® ProDSS unit for calibration comparison. The temperature readings exhibited good agreement with the reference data, confirming acceptable accuracy for short-term deployments. However, as shown in Figure 27, the corresponding DO data revealed greater variability and intermittent gaps, reflecting the sensitivity of the low-cost galvanic DO probe to environmental fluctuations and calibration drift. Overall, the tests confirmed the system's potential for rapid, low-cost data collection, while also highlighting performance limitations that contributed to data variability.

Figure 25. Chart. Temperature vs Time plot for prototype Remote sensor performance comparison during first field deployment

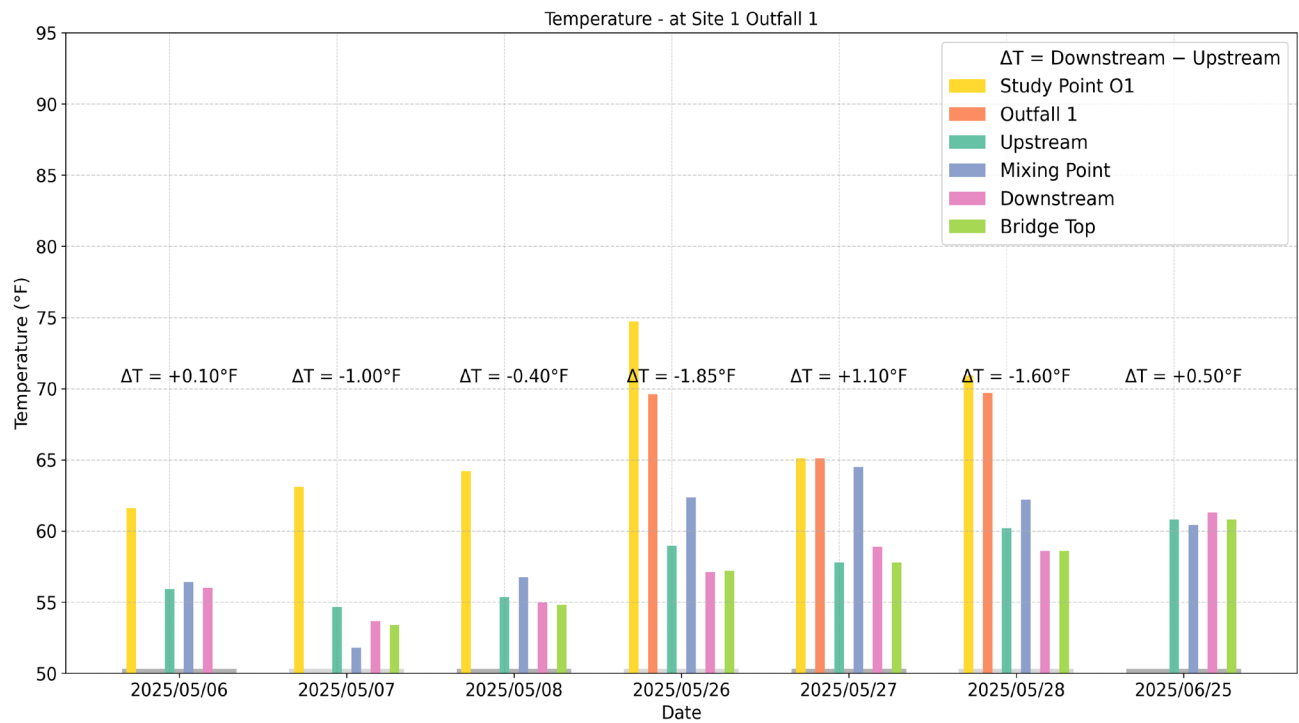
Figure 32. Chart. Temperature data collected at Site 1 Outfall 1 in 2025

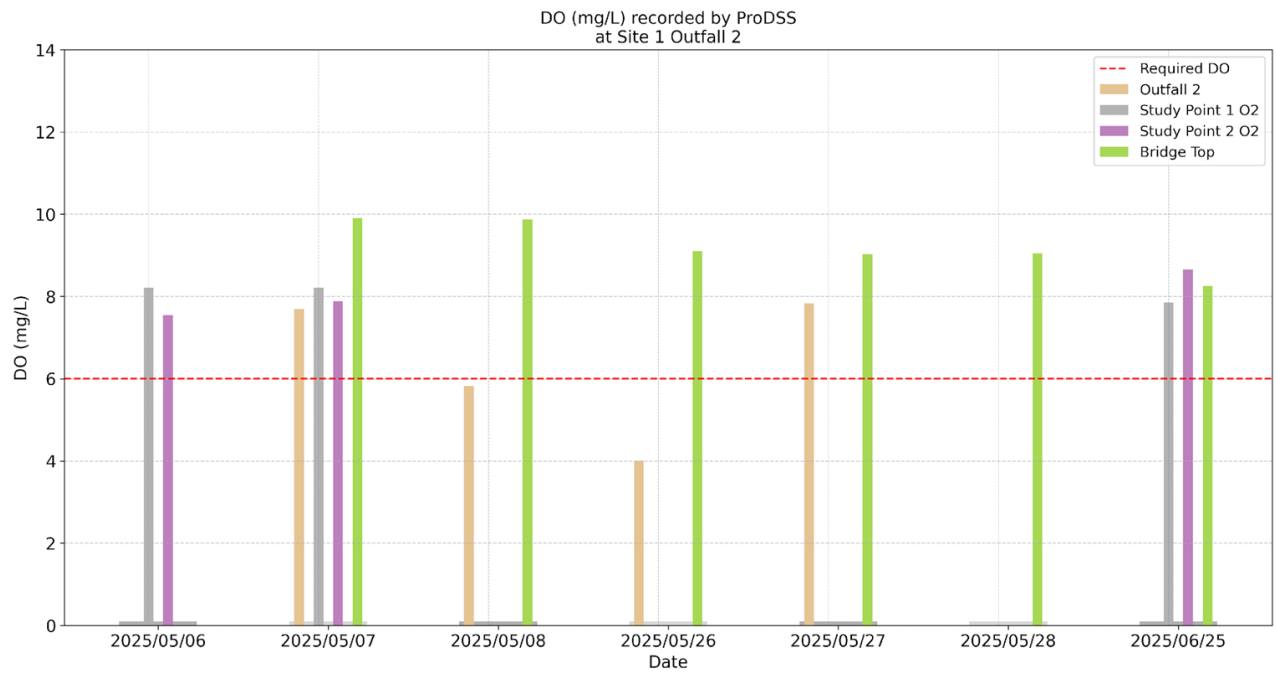
Figure 35. Chart. DO data collected at Site 1 Outfall 2 in 2025

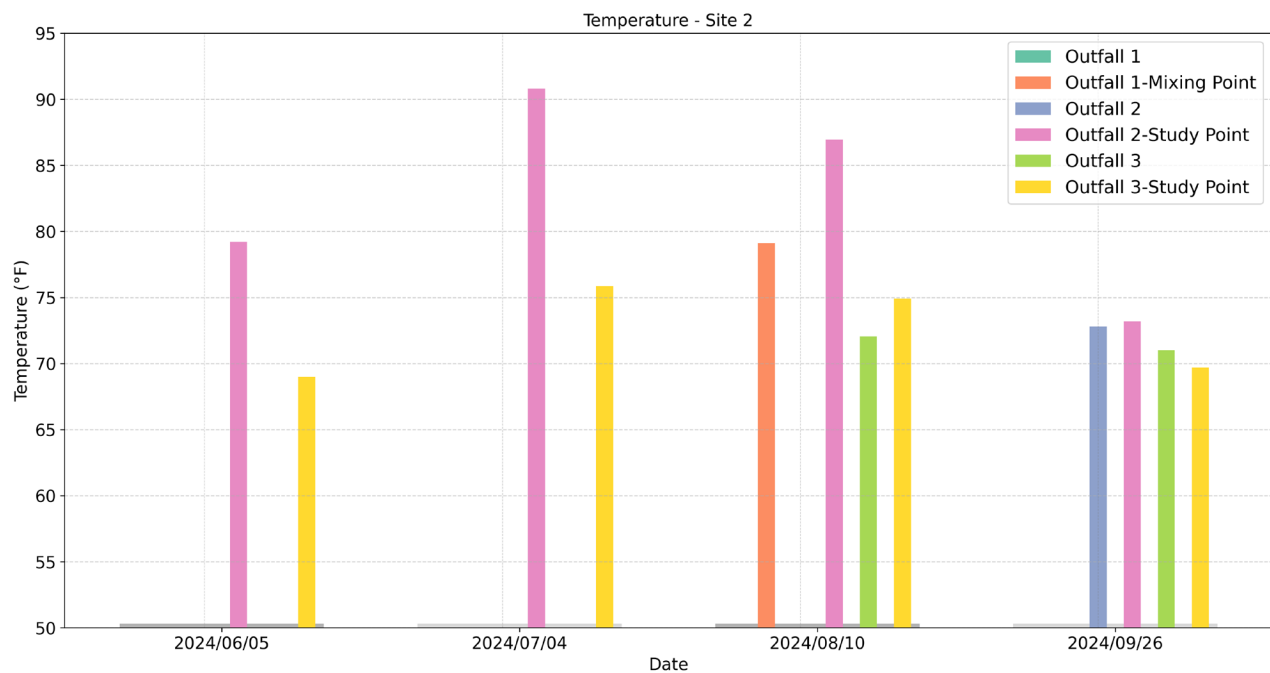
Figure 36. Chart. Temperature data collected at Site 2 in 2024

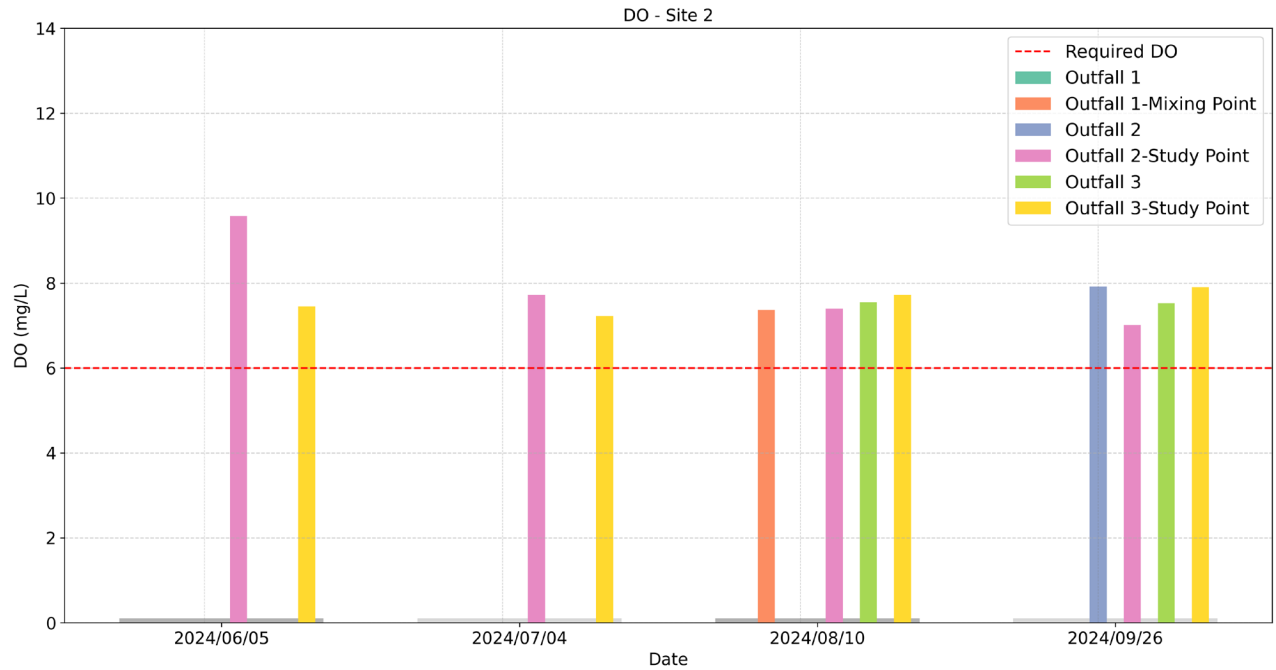
Figure 37. Chart. DO data collected at Site 2 in 2024

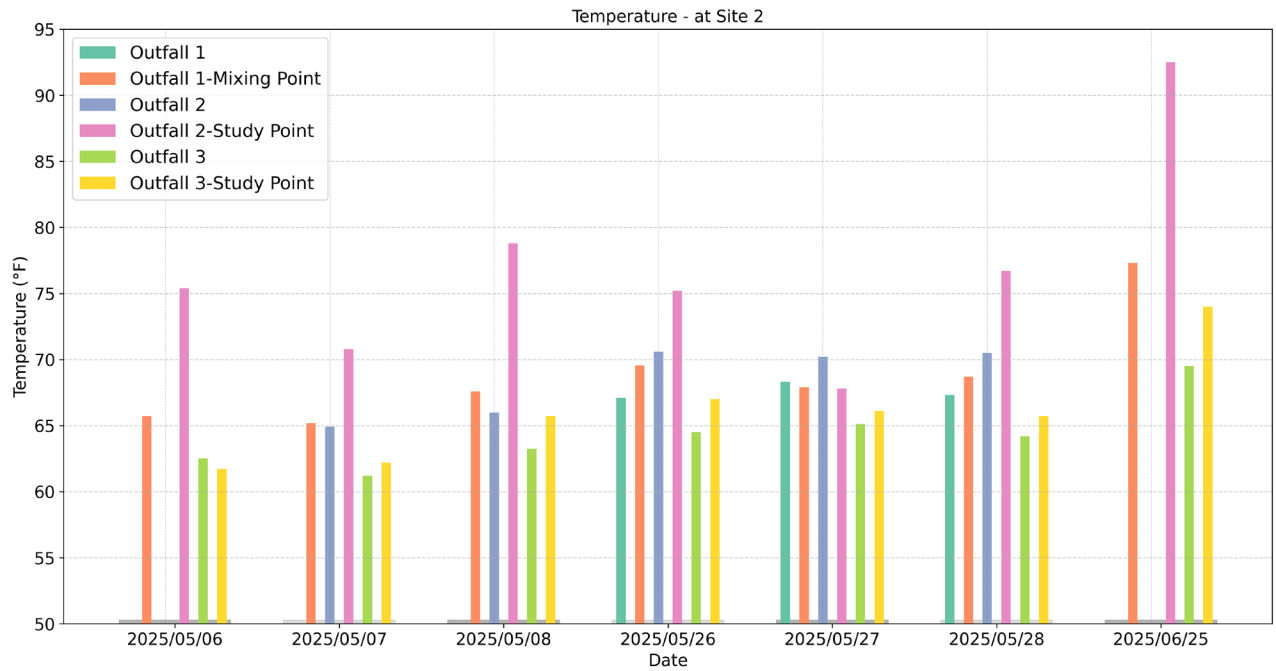
Figure 38. Chart. Temperature data collected at Site 2 in 2025

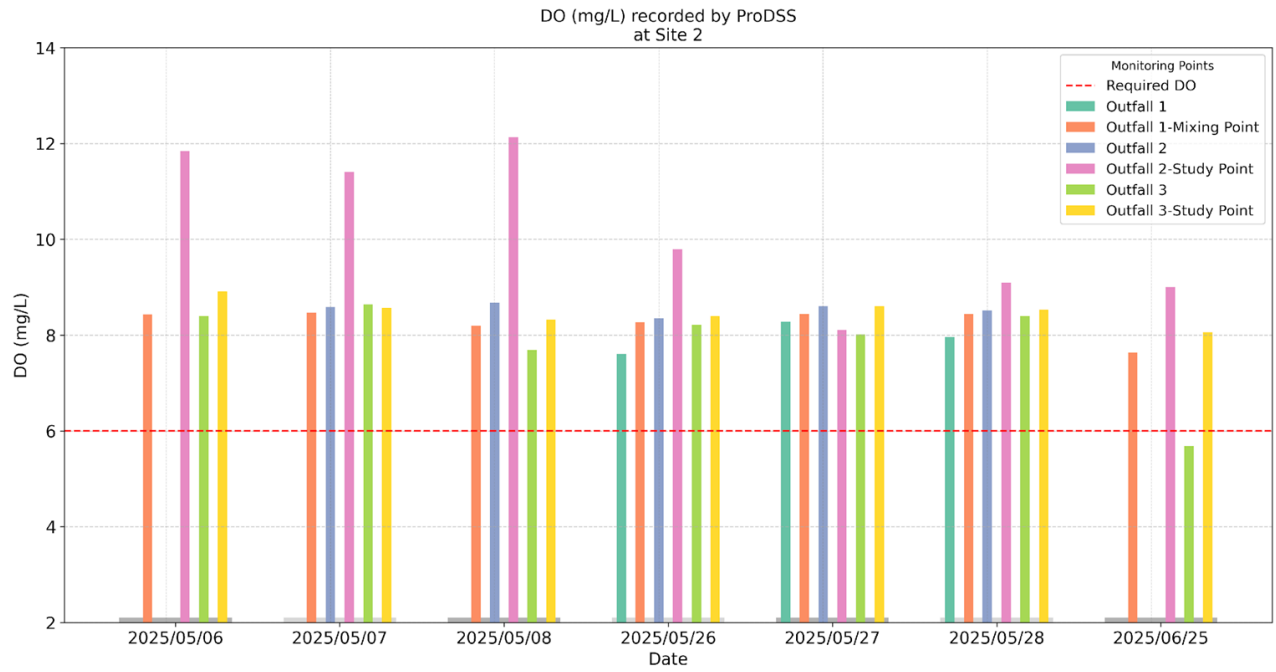
Figure 39. Chart. DO data collected at Site 2 in 2025

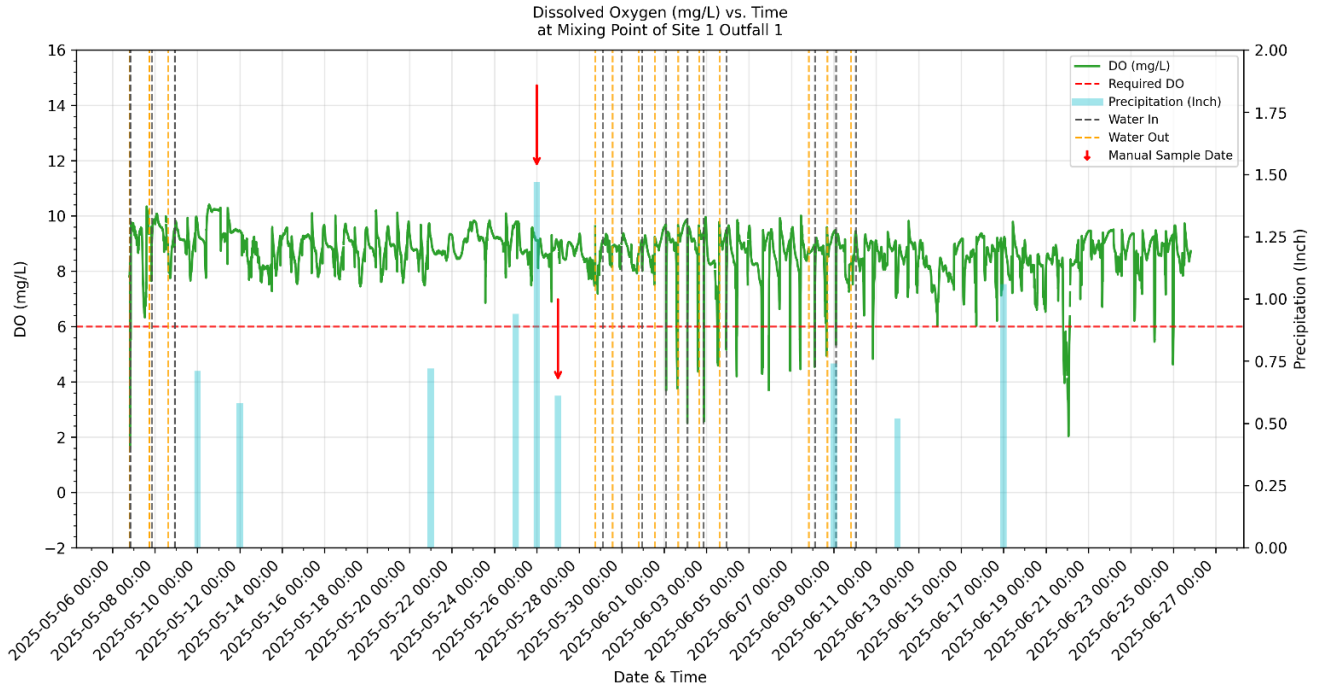
Figure 55. Chart. HOBO® DO vs Time plot with USGS daily Precipitation data (≥ 0.5 inch) at Mixing point of Outfall 1 from 2nd Quarter of 2025

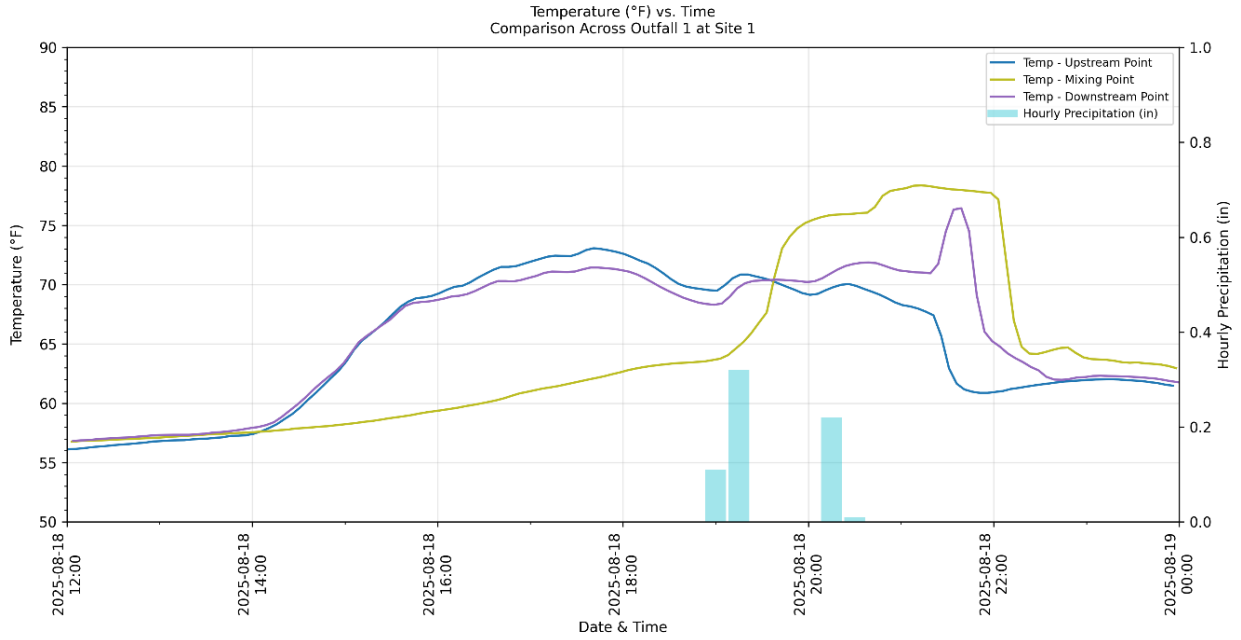
Figure 82. Chart. HOBO® Temperature change plot for comparison between Upstream-Mixing-Downstream points with USGS hourly precipitation data at Site 1 Outfall 1 for rainfall event from 8/18/2025

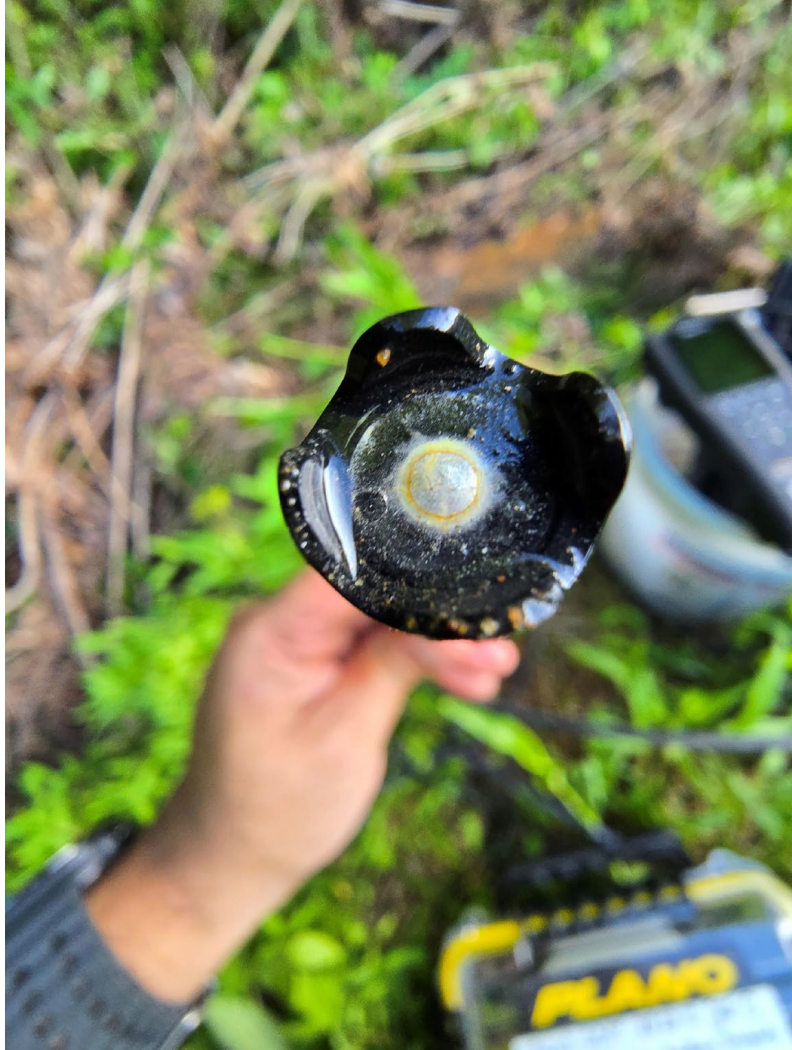
Figure 93. Photo. DFRobot® DO Sensor Cap Degraded by Fouling.
