GEORGIA DOT RESEARCH PROJECT 24-07

Final Report

**A COMPREHENSIVE GUIDELINE FOR
GDOT BRIDGES FIRE HAZARD ASSESSMENT**

February 2026

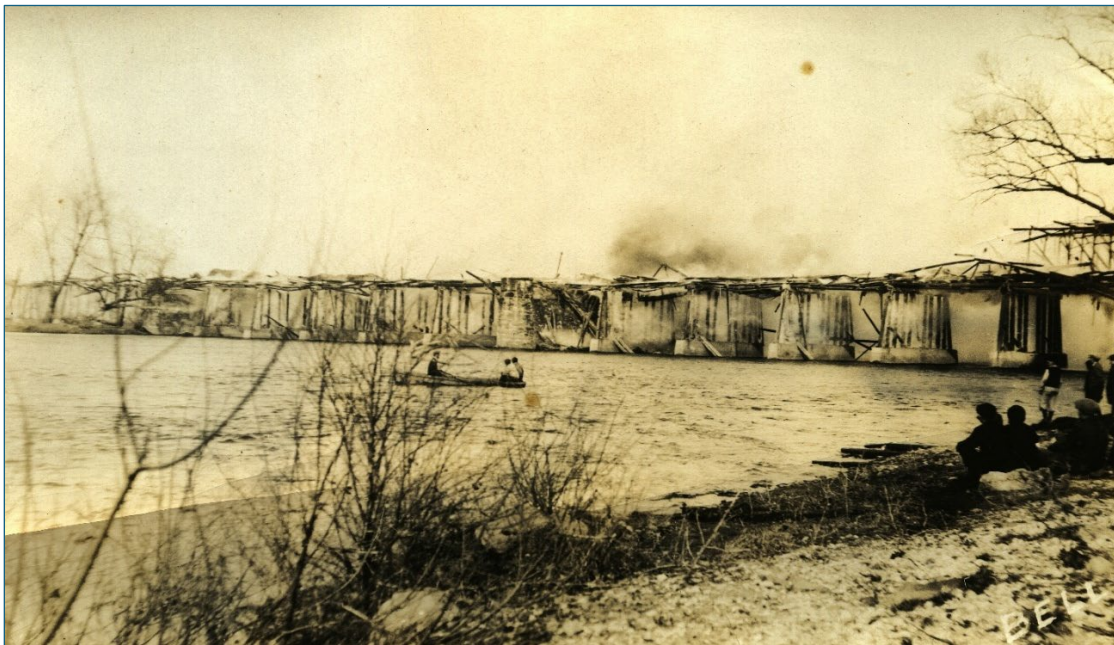
Figure 1. Photo. DeKalb Street Bridge post-fire.[66].

[64]. Later sources indicate that the fire resulted from petroleum products from automobiles that soaked into the timbers of the superstructure. Once the fire started, it was impossible to stop [63], [64]. The fire completely destroyed the timber superstructure (see figure 1).

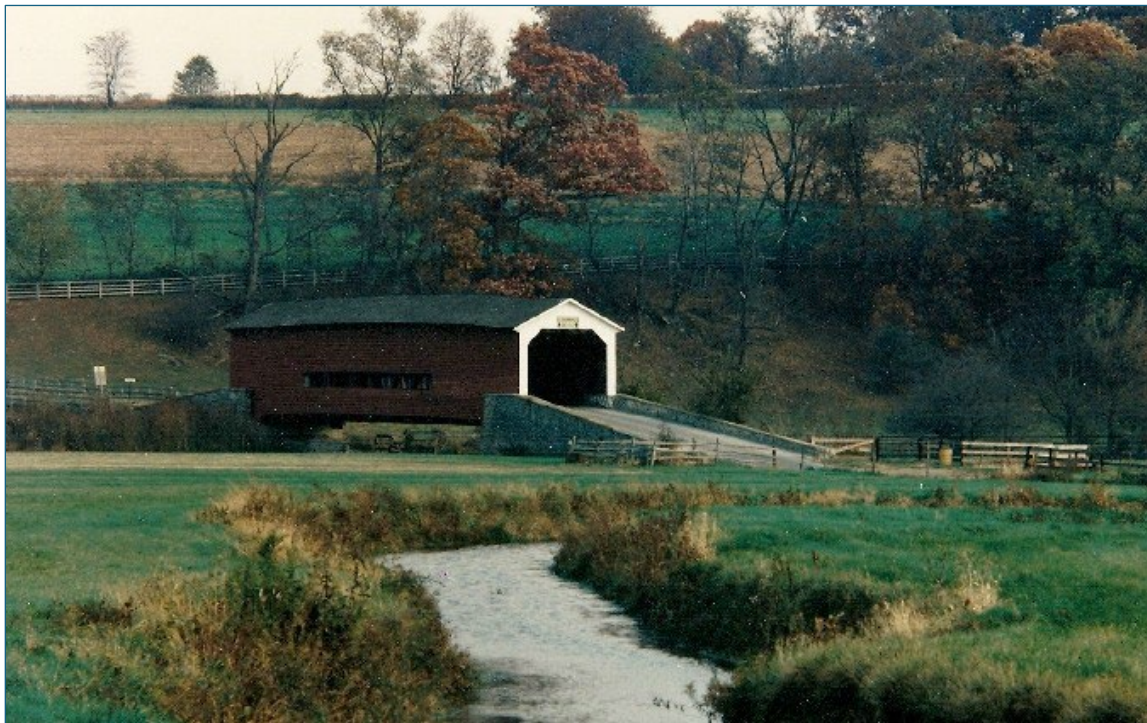
Figure 2. Photo. Bellbank Covered Bridge [71]; Photographed by Mr. John H. Ramsey, Jr.

to the region (see figure 2). It measured approximately 112 ft in length and served as a functional and cultural landmark during its lifetime [68], [69].

Prior to reconstruction, the structure sustained fire damage due to a lightning strike [67], [69]. Despite its age, the structure remained in service into the late 20th century, surviving public proposals for its demolition in the 1960s [67]. However, on March 19, 1979, the bridge was destroyed by a deliberate act of arson. Early investigations by local fire officials confirmed that a gasoline can was recovered amid the debris [70]. Efforts to rebuild the structure failed, and a steel beam structure was built in its place [69], [70].

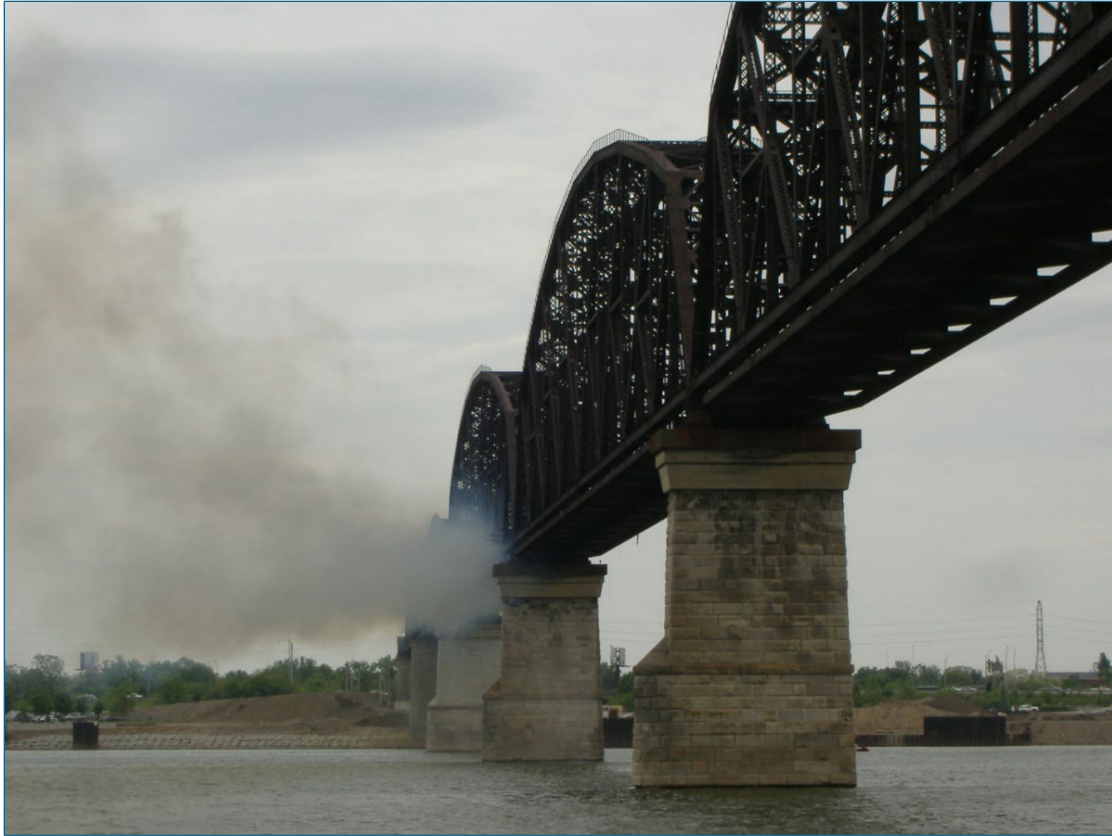
Figure 3. Photo. Big Four Bridge 2008 fire [76].

This point was underscored when another electrical fire struck the Big Four Bridge on May 7, 2008 (see figure 3) [72], [73], [74]. An electrical fault in a lighting system sparked a fire above the Ohio River [74]. Construction workers were attempting to replace the beacon lights on the bridge [75]. Once again, the fire spread along timber elements of the span that eventually fell into the Ohio River, causing a stop of all river traffic [73], [75]. Once again, only minor structural damage was reported to the steel truss, but many of the timbers were burned away according to photographic evidence [74].

The fact that no steel members needed replacement after either fire indicates that the Big Four Bridge's trusses had sufficient thermal mass and redundancy to avoid catastrophic failure in these events. Both incidents point to a broader hazard of electrical failures causing bridge fires.

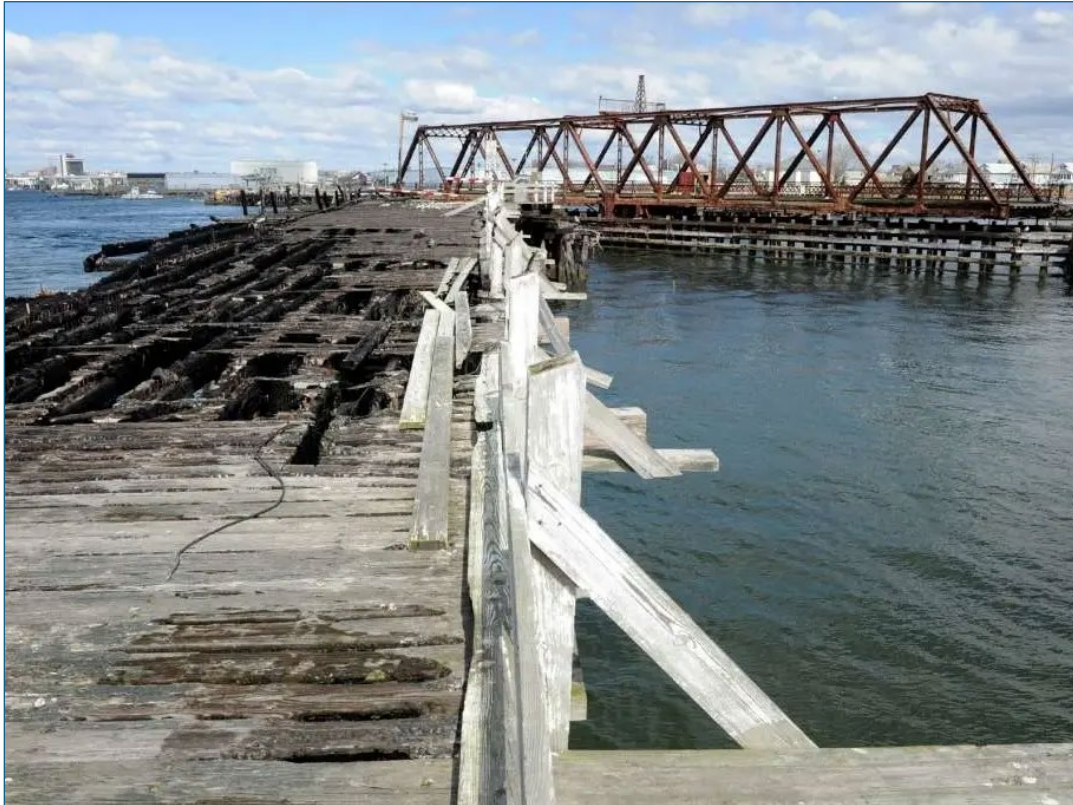
Figure 4. Photo. Pleasure Beach Bridge post-fire [78].

shows that the steel truss survived but the approach spans were destroyed and impassable (see figure 4). By the time the fire was out, the connection between Pleasure Beach and the mainland was severed, creating the “state’s largest ghost town” [77]. The Pleasure Beach Bridge demonstrates that relatively inconsequential ignition sources can lead to devastating results.

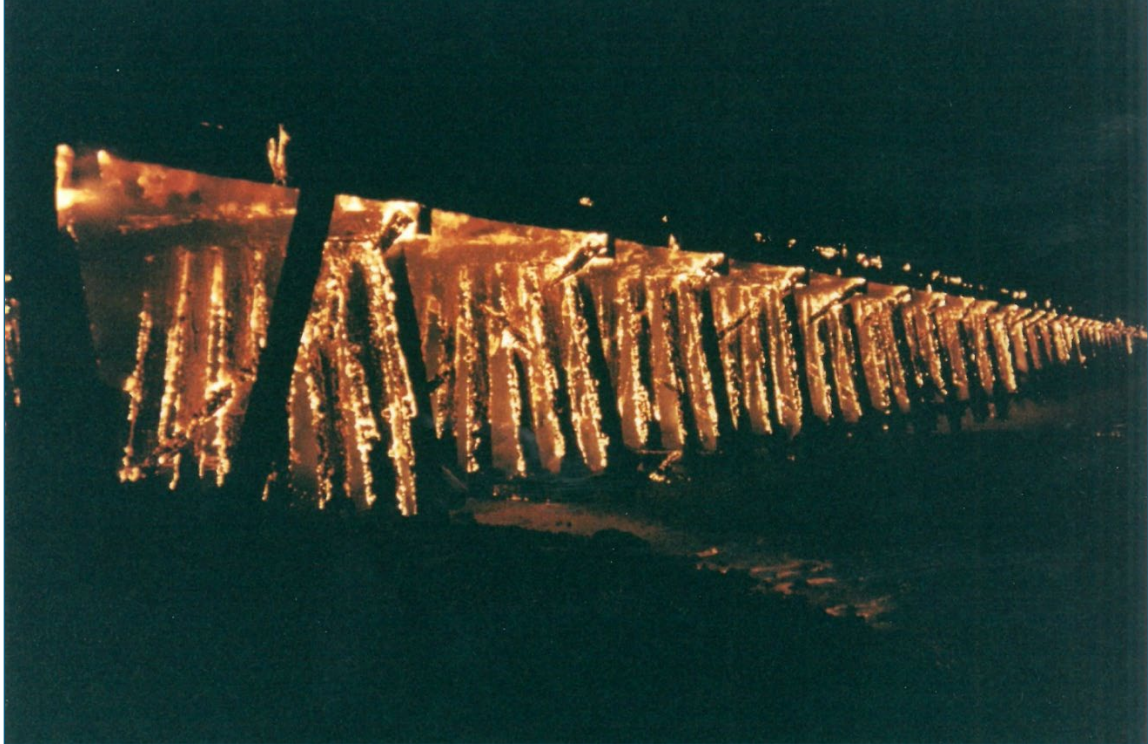
Figure 5. Photo. Dumbarton Rail Bridge fire [84].

At approximately 7 p.m. on January 3, 1998, locals in Menlo Park, California, reported flames on the abandoned western trestle of the Dumbarton Rail Bridge [85], [87]. A fire crew from Menlo Park responded in the middle of a rainstorm, arriving to discover a 1,750-ft section of the western portion of the bridge engulfed in flames [84], [85], [87]. Winds carried the toxic smoke from the fire, severely reducing visibility near the structure and closing a nearby highway for approximately 6 h [84], [85], [87]. The intense blaze destroyed the creosote-soaked timber structure despite the storm (see figure 5) [84], [85]. It took nearly 18 h before the fire department declared the fire under control [85]. Even then, pockets of fire smoldered in the collapsed piles and had to be removed later [85]. Large sections of the abandoned structure fell into the bay during the fire, and charred railroad ties were seen floating on the water [87]. Although arson was suspected, an official cause of the fire was never determined [84], [87].

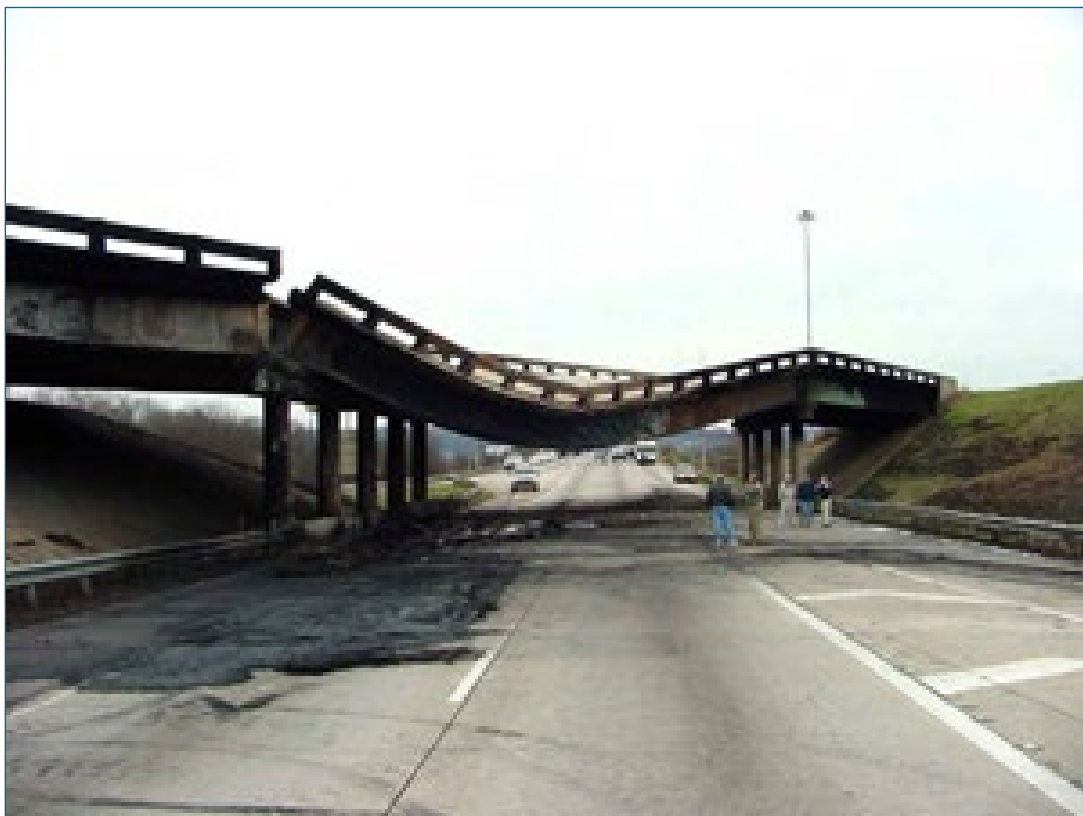
Figure 6. Photo. Malfunction Junction 2002 post-fire [94].

The burning fuel compromised the steel superstructure of the overpass, causing the girders to experience up to 10 ft of deflection, threatening the stability of the whole structure (see

figure 6) [34], [91]. Authorities immediately closed the interchange. In the days that followed, crews demolished the ramp and hauled away about 5,000 yd³ of debris, along with 200 tons of steel [91]. Engineers fast-tracked a replacement bridge; the interchange was reopened to traffic in only 37 days [93]. The swift reconstruction was hailed for its fast pace [92].

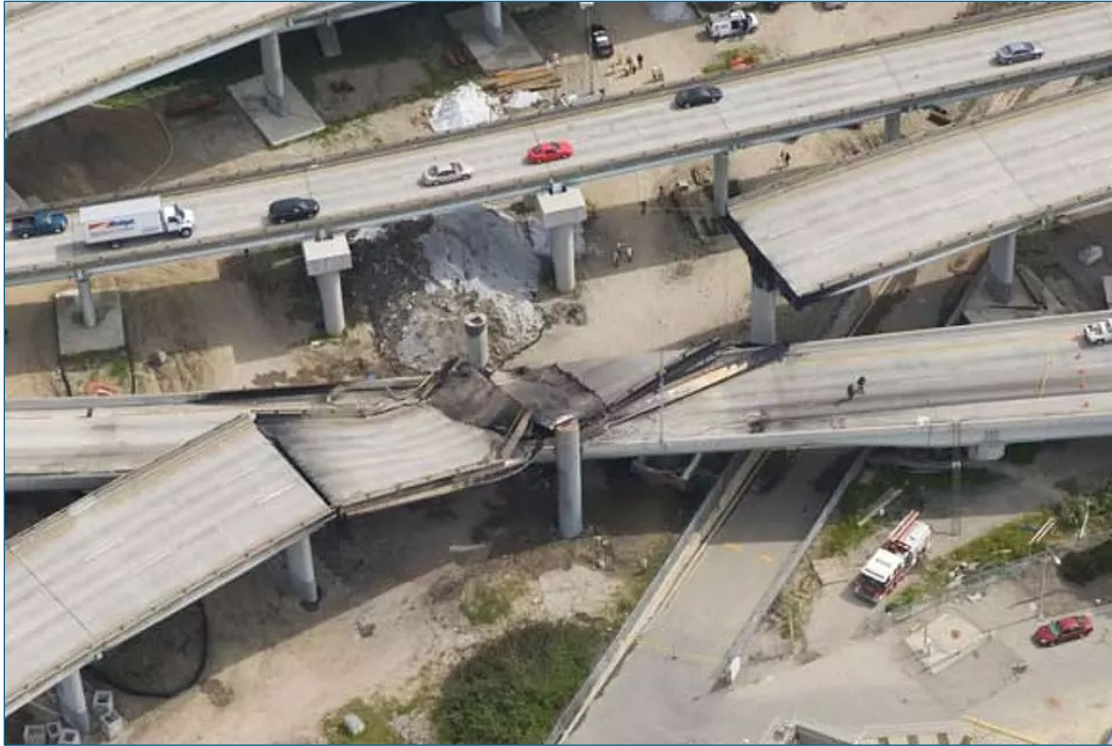
Figure 7. Photo. MacArthur Maze post-fire [108].

On April 29, 2007, a tanker truck carrying gasoline was traveling on I-880 in Oakland, California [102], [103]. The truck overturned at the MacArthur Maze interchange and started to burn. Approximately 8,600 gal of gasoline leaked from the wrecked truck and caught fire [4], [74], [102]. The fire spread along portions of I-880 and began to heat the steel girders of the overpass above [102], [104]. After approximately 20 min of intense heat, the steel girders gave way [4], [74], [105]. A 165-ft section of I-580 fell onto I-880 [103] (see figure 7).

The California Department of Transportation (CalTrans) worked quickly to close the damaged structures [103]. Inspectors found that there was minimal damage to the lower I-880 structure, and they were able to reopen it relatively quickly [106]. However, the collapsed spans of I-580 required full replacement [106]. Contractors worked around the clock, and the bridge was rebuilt in 25 days [106]. Repair costs were estimated at \$9 million; however, economic losses were estimated to be approximately \$156 million [107].

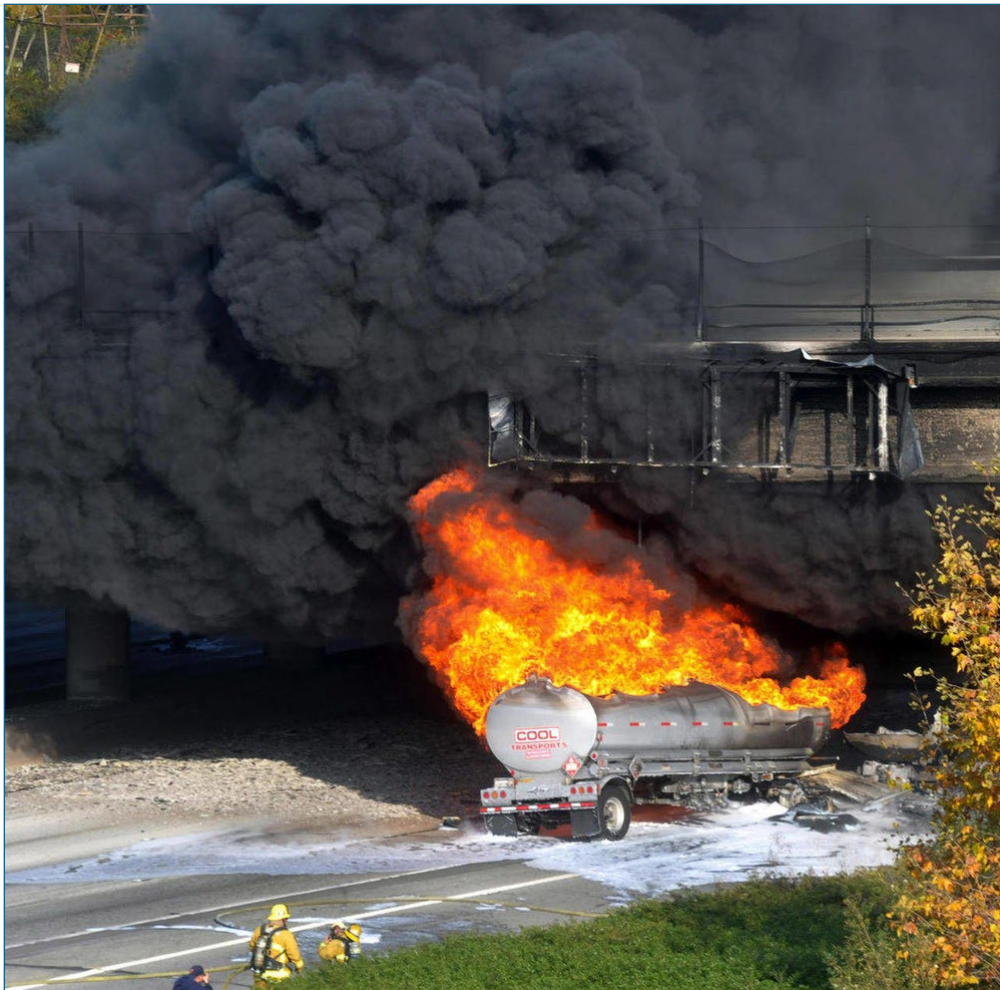
Figure 8. Photo. Paramount Boulevard bridge fire [113].

After the fire was extinguished, inspectors found damage to the concrete girders and deck, particularly significant spalling [110], [111]. One report indicated that the heat was sufficient to burst the concrete deck [110]. In the aftermath of the fire, CalTrans restored 1,000 ft² of roadway; in contrast, the affected bridge was removed by demolition because the damage was deemed irreparable [110], [111], [112].

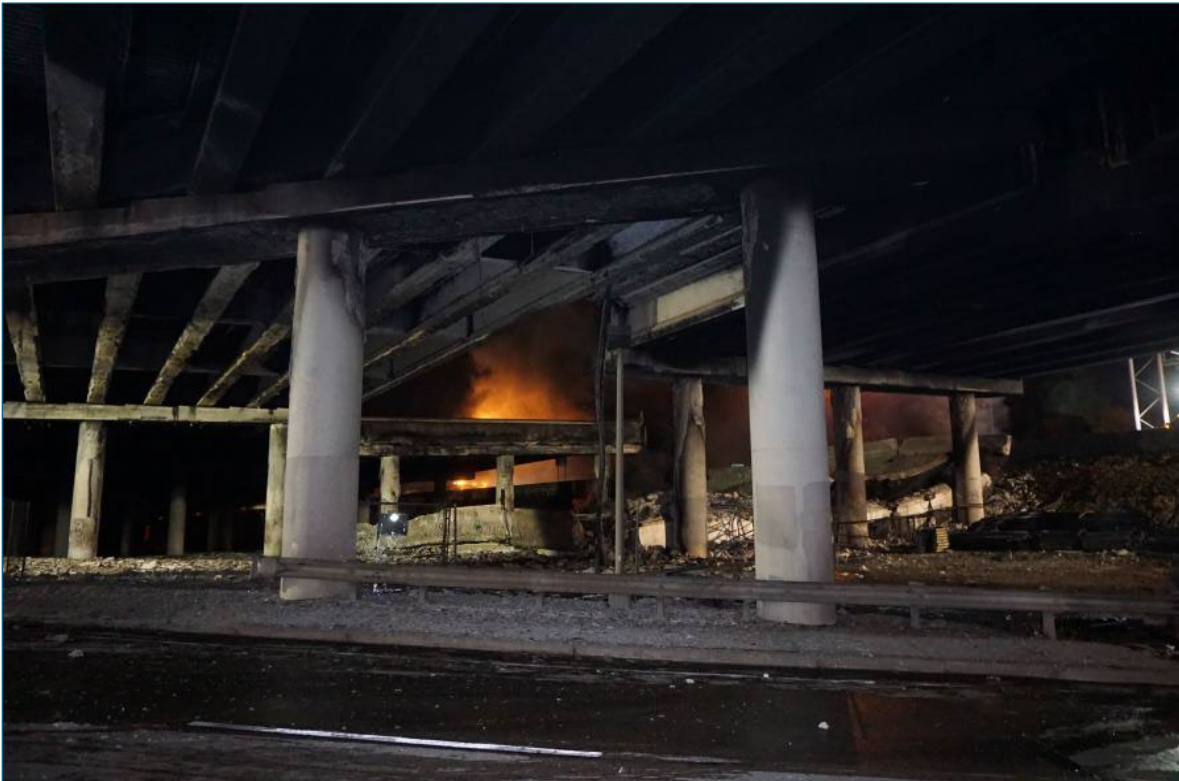
Figure 9. Photo. Atlanta Interstate bridge failure [119].

Several years before the fire, the Georgia Department of Transportation (GDOT) placed 76 reels of high-density polyethylene conduit and 9 racks of fiberglass conduit under the structure [114]. This material was highly flammable [4], [114], [117]. The police reported that the fire was started when a man ignited a shopping cart chair under the bridge [117]. This fire spread to the stored materials [117]. Once the conduit was ignited, the material melted, creating an even larger flame [114]. The extreme heat caused the span to deflect and fail (see figure 9) [4], [114], [115]. This was primarily caused by the loss of prestressing in the concrete girders [114].

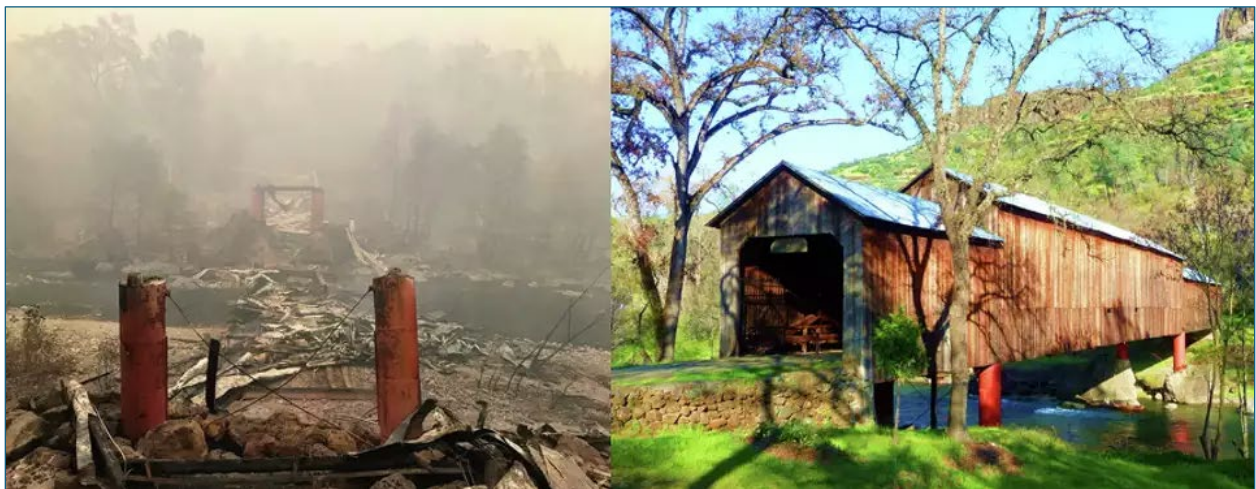
Figure 10. Photos. Honey Run Covered Bridge post-fire (left) and pre-fire (right) [122].

The Honey Run Covered Bridge was constructed in the late 1880s in Butte County, California [120], [121], [122]. The three-span Pratt truss spanned 238 ft across Butte Creek [120], [122]. In 1988, the bridge was added to the National Register of Historic Places [120], [122]. At the time of its destruction, the Honey Run Covered Bridge was considered the last of its kind (see figure 10, right photo) [122].

Early in the morning on November 8, 2018, a 911 call reported a fire beneath a Pacific Gas & Electric Company (PG&E) transmission tower [123], [124], [125]. This fire encountered a dry and windy California environment that allowed the fire to spread rapidly [125], [126]. In just over an hour from initial reports, the fire, known as the Camp Fire, spread to the town of Paradise and the Honey Run Covered Bridge [127]. The timber bridge was soon engulfed in flames and destroyed (see figure 10, left photo) [120], [122].

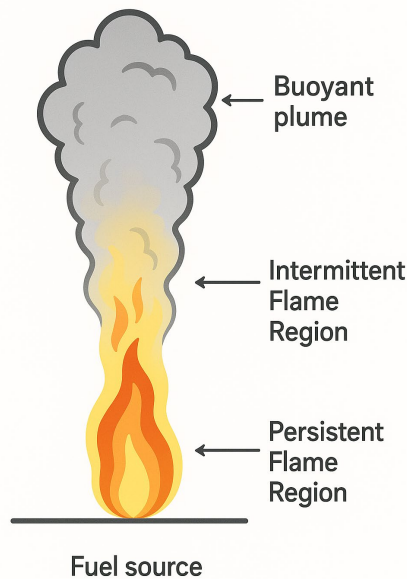
Figure 11. Diagram. Fire plume.

Buoyancy is the upward force that causes hot gases and flames to rise toward structural elements (see figure 11) [263], [264]. This occurs as the heated air becomes less dense and rises relative to the surrounding cooler air [264], [265], [266]. Buoyancy will concentrate smoke and heat to structural elements above the fire, increasing heat flux [264], [265], [266], [267].

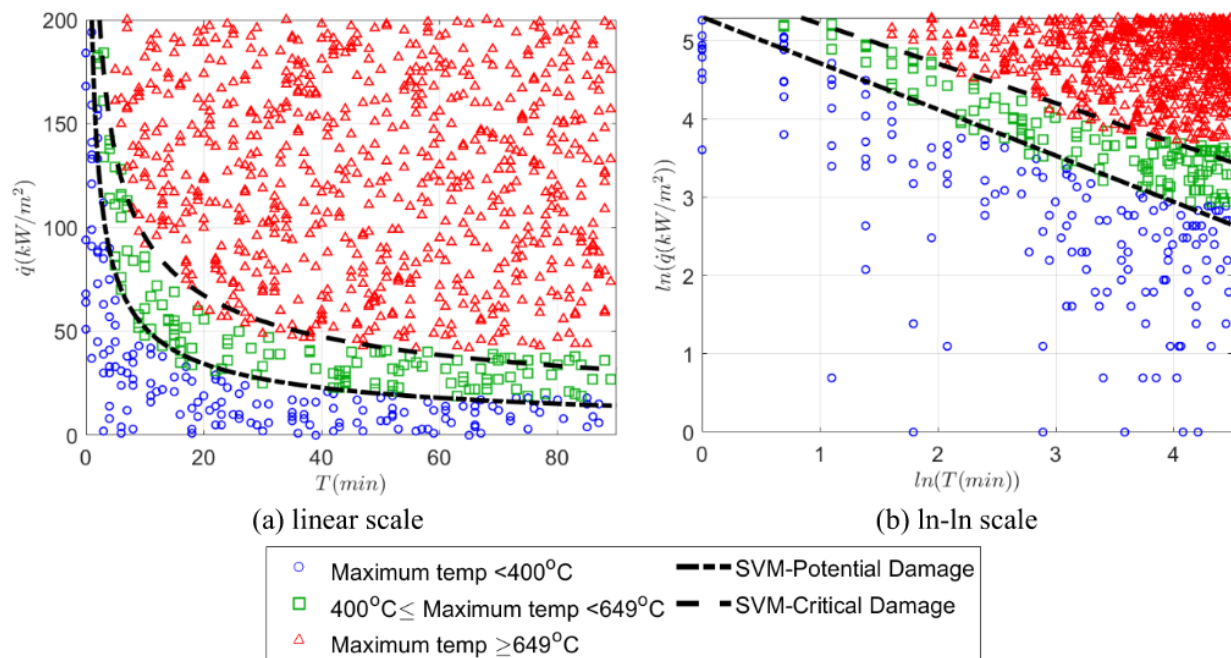
**Figure 12. Graphs. Damage classification graphs for steel girders [58]
SVM = support vector machine.**

Quiel et al. performed a two-dimensional (2D) thermal finite element analysis across numerous combinations of incident heat flux (\dot{q}'') and exposure duration (pp. 36–39). Each simulation outcome is plotted per established temperature thresholds and is shown on the graphs in figure 12 and figure 13. The graphs show a clear distinction between areas of potentially no damage, potential damage, and critical damage.

To place a fire on the graph, Quiel et al. obtained the peak incident heat flux at the girder using a modified point source model (pp. 36–39). This model is shown in equation 1 (pp. 22–24). In the equation, $\chi_{r,mps}$ is the radiative fraction, $\dot{Q}_{f,max}$ is the peak heat-release rate of the fire, θ is the angle between the line of sight and the closest bridge element, R is the distance from the modified point source to the target, and n is an exponent calibrated to 2.2. Once \dot{q}'' is obtained, this can be plotted against the exposure time.

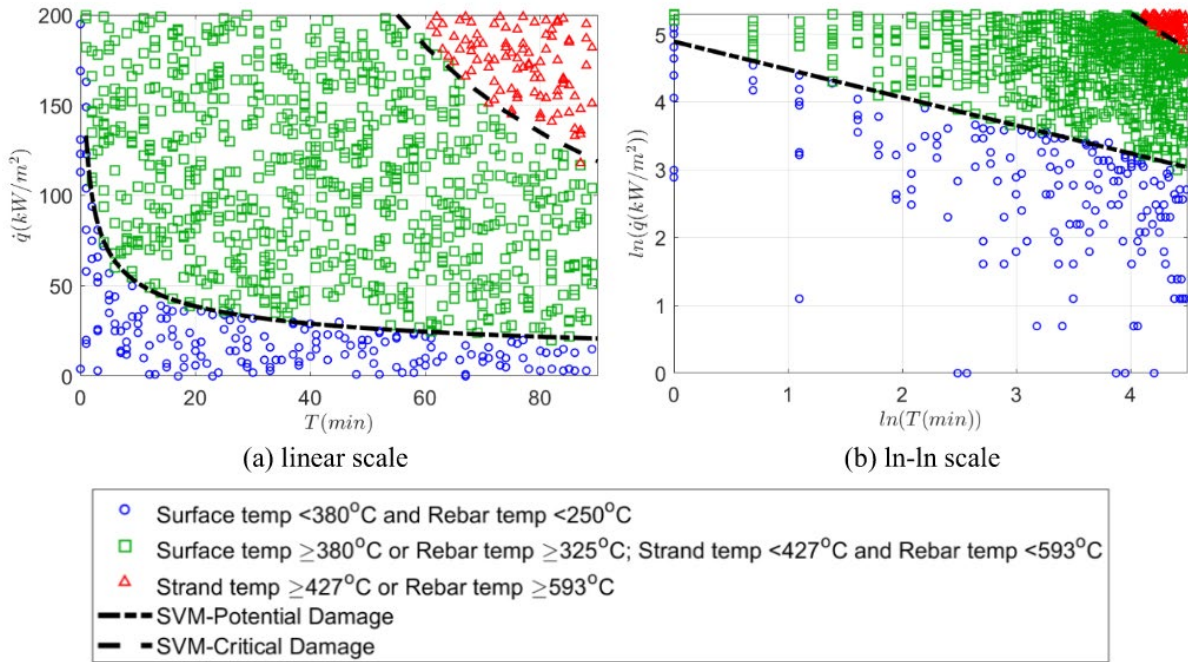
Figure 13. Graphs. Damage classification graph for concrete girders [58]. SVM = support vector machine.

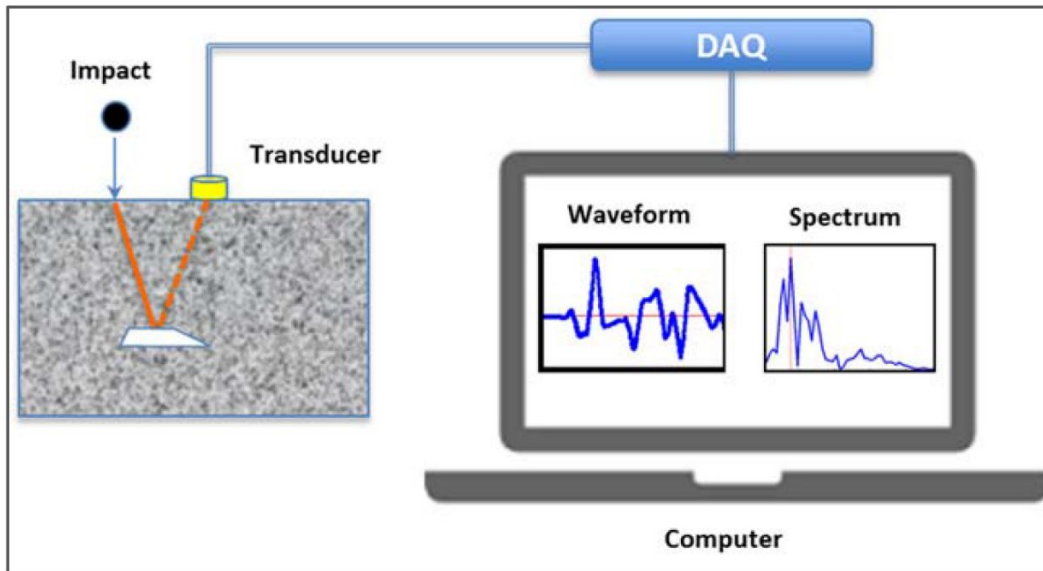
Figure 18. Schematic. Impact echo schematic [494].

numerous test points and often traffic control [1]. Interpretation relies on specialized software and highly trained personnel [1]. These factors limit the suitability of IE for rapid post-fire triage of a bridge structure.

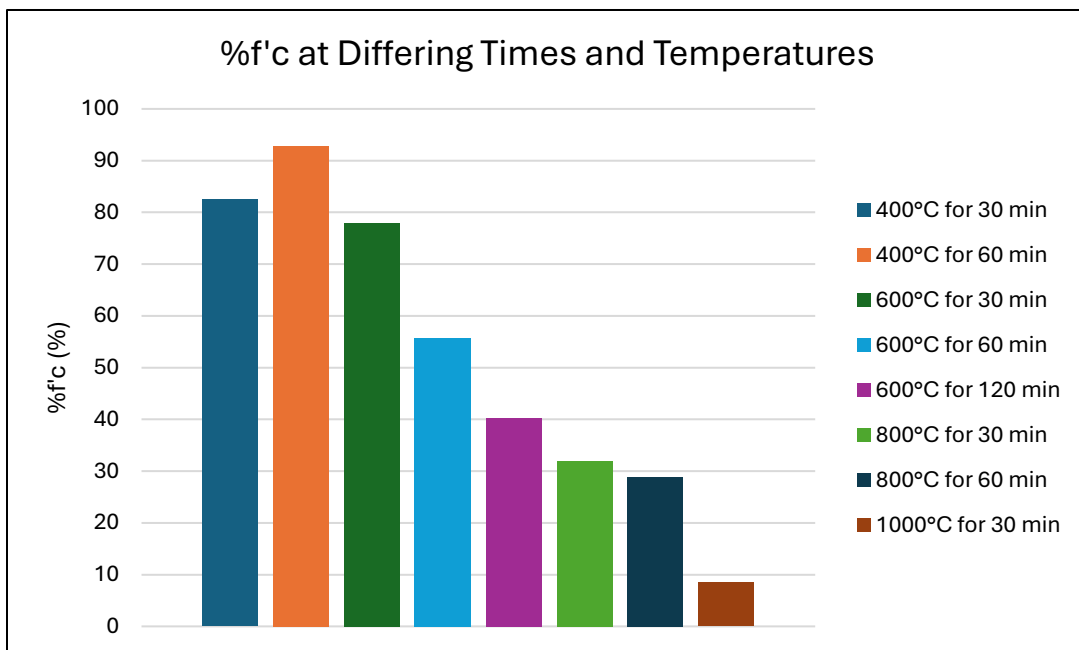
Figure 20. Chart. %f_c at differing temperatures and times.

There is an irregularity in the 400°C burns that lasted for 60 min, where the testing shows an increase in the residual capacity for the longer duration burn. This difference is viewed by the research team as variability within the experiment rather than an indication that increasing burn times at lower temperatures can improve the residual compressive strength. Rather, when viewing the overall picture, figure 20 indicates that temperature dominates over time in driving strength loss.

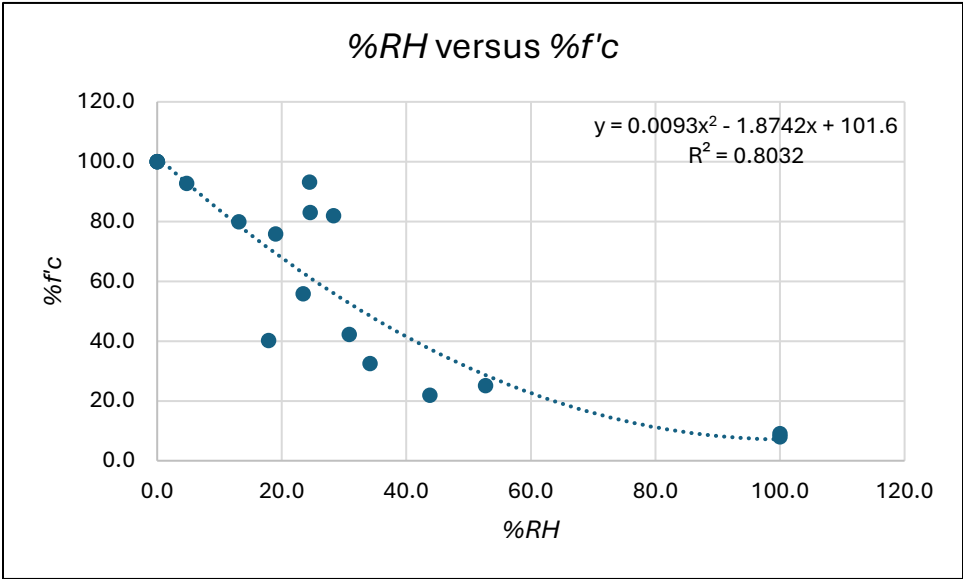
Figure 22. Graph. %RH versus %f'c.

Figure 22 shows the relationship between %RH and %f'c, and it is expressed numerically in equation 10. This relationship shows a decreasing, nonlinear trend. Small changes in RH generally correspond to high remaining capacity. However, larger changes are associated with notable losses in concrete compressive strength. The curve flattens at high %RH, indicating extremely diminished residual capacity as the damage becomes severe.

$$\%f'c = 0.0093\%RH^2 - 1.87\%RH + 101.6$$

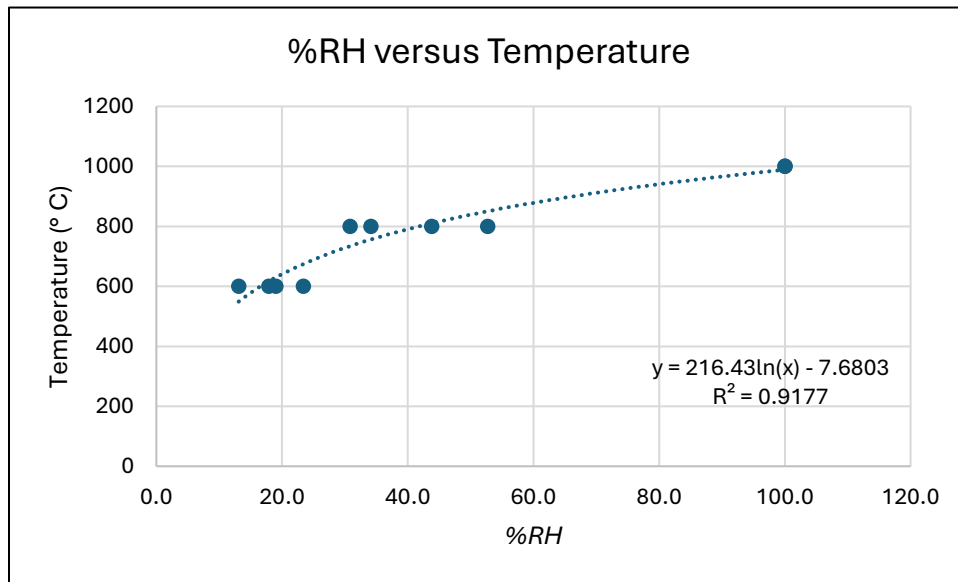
Figure 23. Graph. %RH versus temperature.

Figure 23 shows the relationship between the percent change in RH readings compared to concrete surface temperatures when cooled to ambient temperature. The logarithmic model, shown in equation 11, shows a monotonic increase. Larger changes in RH are associated with higher estimated temperatures. The curve's shape indicates diminishing sensitivity at higher %RH. The R^2 value suggests that the relationship captures most variability in the dataset. This lends support to %RH as a screening proxy for temperature levels.

$$T_{surface} = 216.43 \ln(\%RH) - 7.68$$

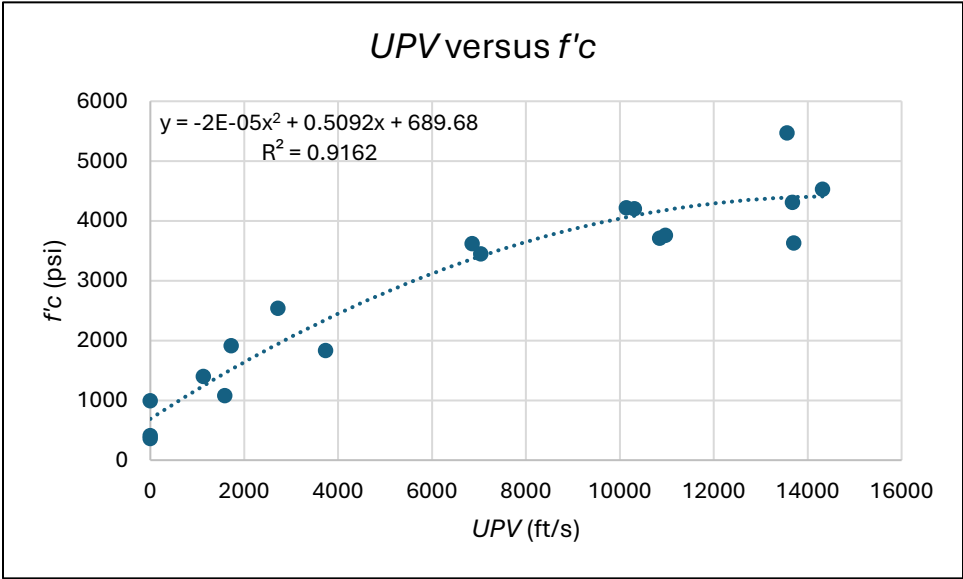
Figure 24. Graph. *UPV* versus *f'c*.

Figure 24 plots the *UPV* against measured compressive strength for all cylinders. Equation 12 is the mathematical model of the polynomial trend line shown in figure 24. The curve shows a nonlinear, increasing relationship. As *UPV* increases, the estimated *f'c* also increases. The negative quadratic term produces a gentle plateau at higher velocities. This indicates that the model is most sensitive to low to mid-*UPV* range. This range is associated with deteriorated concrete.

$$f'c = -2 \times 10^{-5}(UPV^2) + 0.51UPV + 689.68 \qquad \text{Equation 12}$$

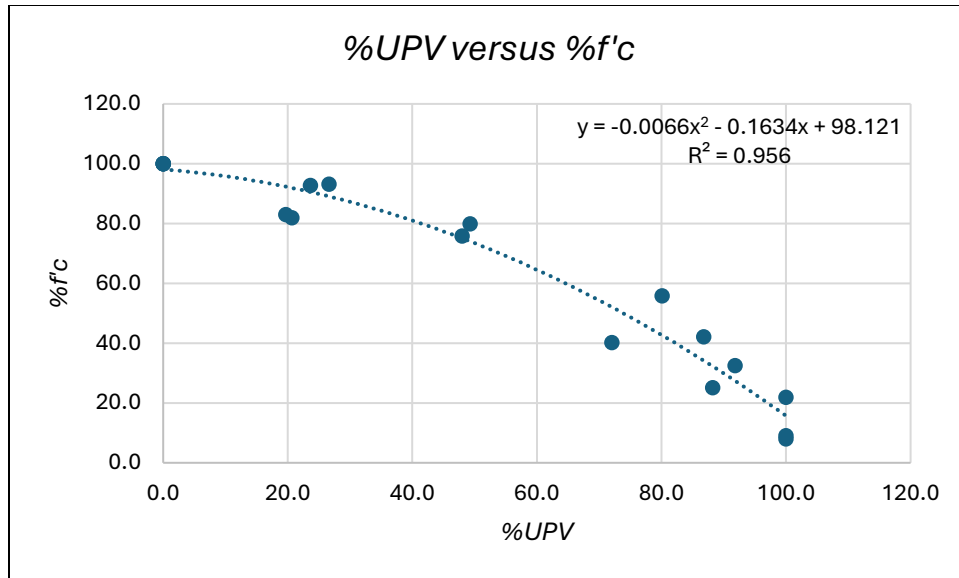
Figure 25. Graph. %UPV versus %f'c.

The coefficient of determination is shown to be approximately 0.96. This model explains most of the variability in the dataset, and the high correlation makes the model suitable for screening. Further testing is needed to determine whether this method can produce a universal model or it remains dependent on the mix design.

$$\%f'c = -0.0066(\%UPV^2) - 0.16\%UPV + 98.12$$

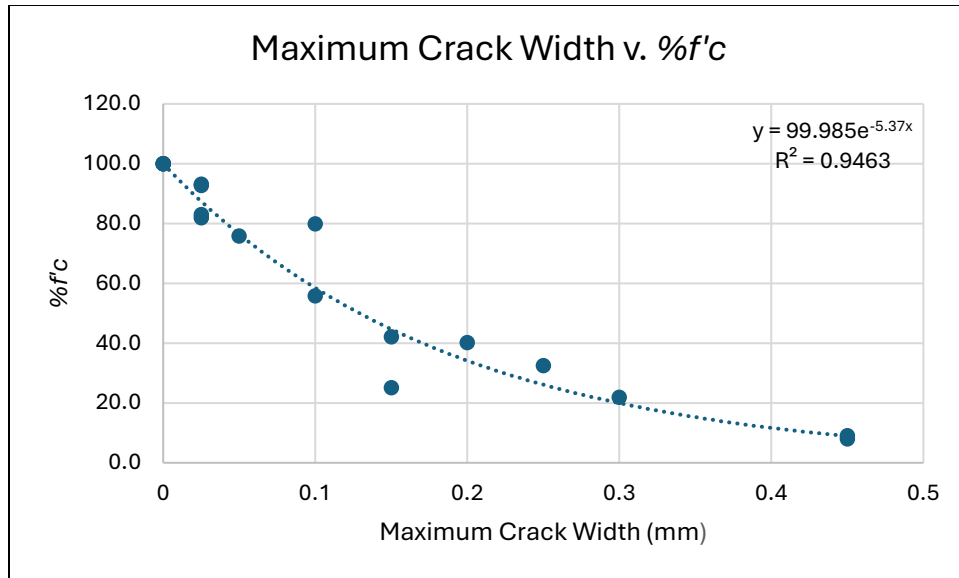
Figure 26. Graph. Maximum crack width versus %f'c.

During burn testing, the researchers documented fire-related distress for each heated specimen. Aside from the two explosive failures that fractured during ramp up, the predominant observations were cracking and minor discoloration. Notably, the maximum measured crack width showed an inverse relationship with residual compressive capacity. Wider cracks tended to coincide with lower remaining strength. This relationship (illustrated in figure 26) opens the possibility that crack width can be a practical screening indicator as engineers are making assessments of fire-damaged concrete.

$$\%f'c = 99.99e^{-5.37w_{c,max}}$$

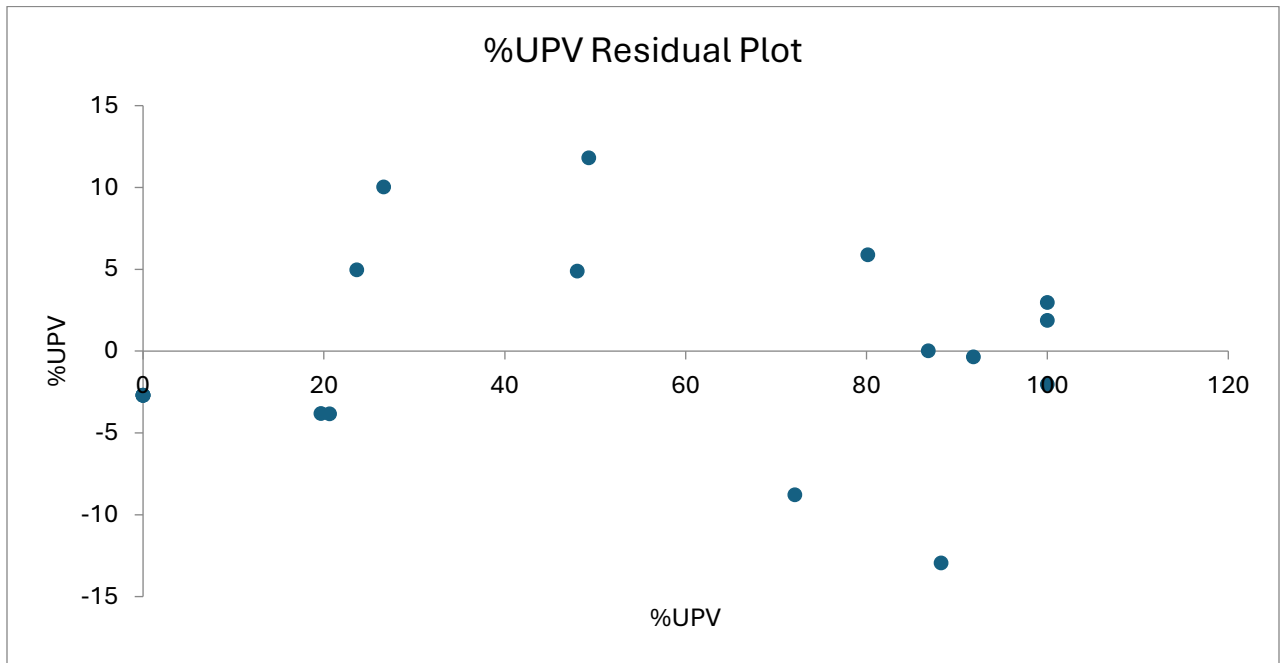
Figure 31. Plot. Three-factor %UPV residual plot.

Residual plots for the three independent variables (see figure 30–figure 32) show points scattered about zero, with no visible curvature. This indicates the absence of strong evidence of nonlinearity or heteroscedasticity over the dataset. Figure 33 presents the same conclusion for the standardized residual plot.
