**DOT/FAA/TC-26/15**

# **National Airport Pavement Test Facility Construction Cycle 9**

## **Volume 3—Geosynthetic Test**

Final Report

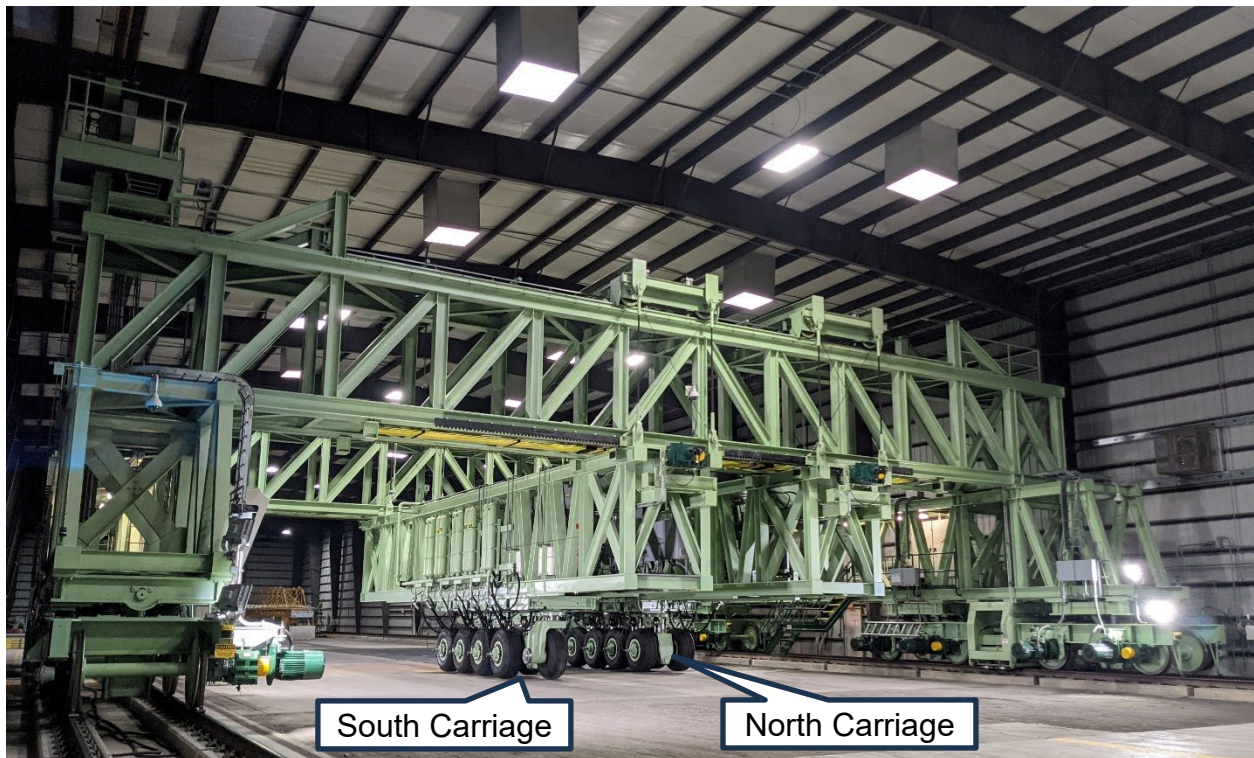
Figure 1. National Airport Pavement Test Vehicle

Wander Pattern. The National Airport Pavement Test Vehicle (NAPTIV), shown in Figure 1, executes a wander pattern consisting of a repeated sequence of 66 passes arranged in 9 longitudinal tracks. The lateral spacing between adjacent tracks is 10.25 in. The NAPTIV wander pattern is designed to approximate a normal lateral distribution of aircraft traffic with a standard deviation from centerline equal to 30.54 in.

The instrumentation layout was designed considering traffic wander. As discussed in Section 1.3.1, the traffic followed a defined wander pattern giving an approximately normal lateral distribution. The center positions of the north and south carriages (see Figure 1) were set at transverse offsets -15 and +15 ft, respectively. Those center offsets were assigned to wander track 0. At the outermost wander positions (tracks -4 and 4), the outer wheels of the load modules could traverse 5,662 ft north and south of center offsets. For example, the outer wheels of LFC-3N operated between -9.338 and -20.662 ft. Areas outside these limits were considered untrafficked. Further details on the wander pattern are presented in Section 4.

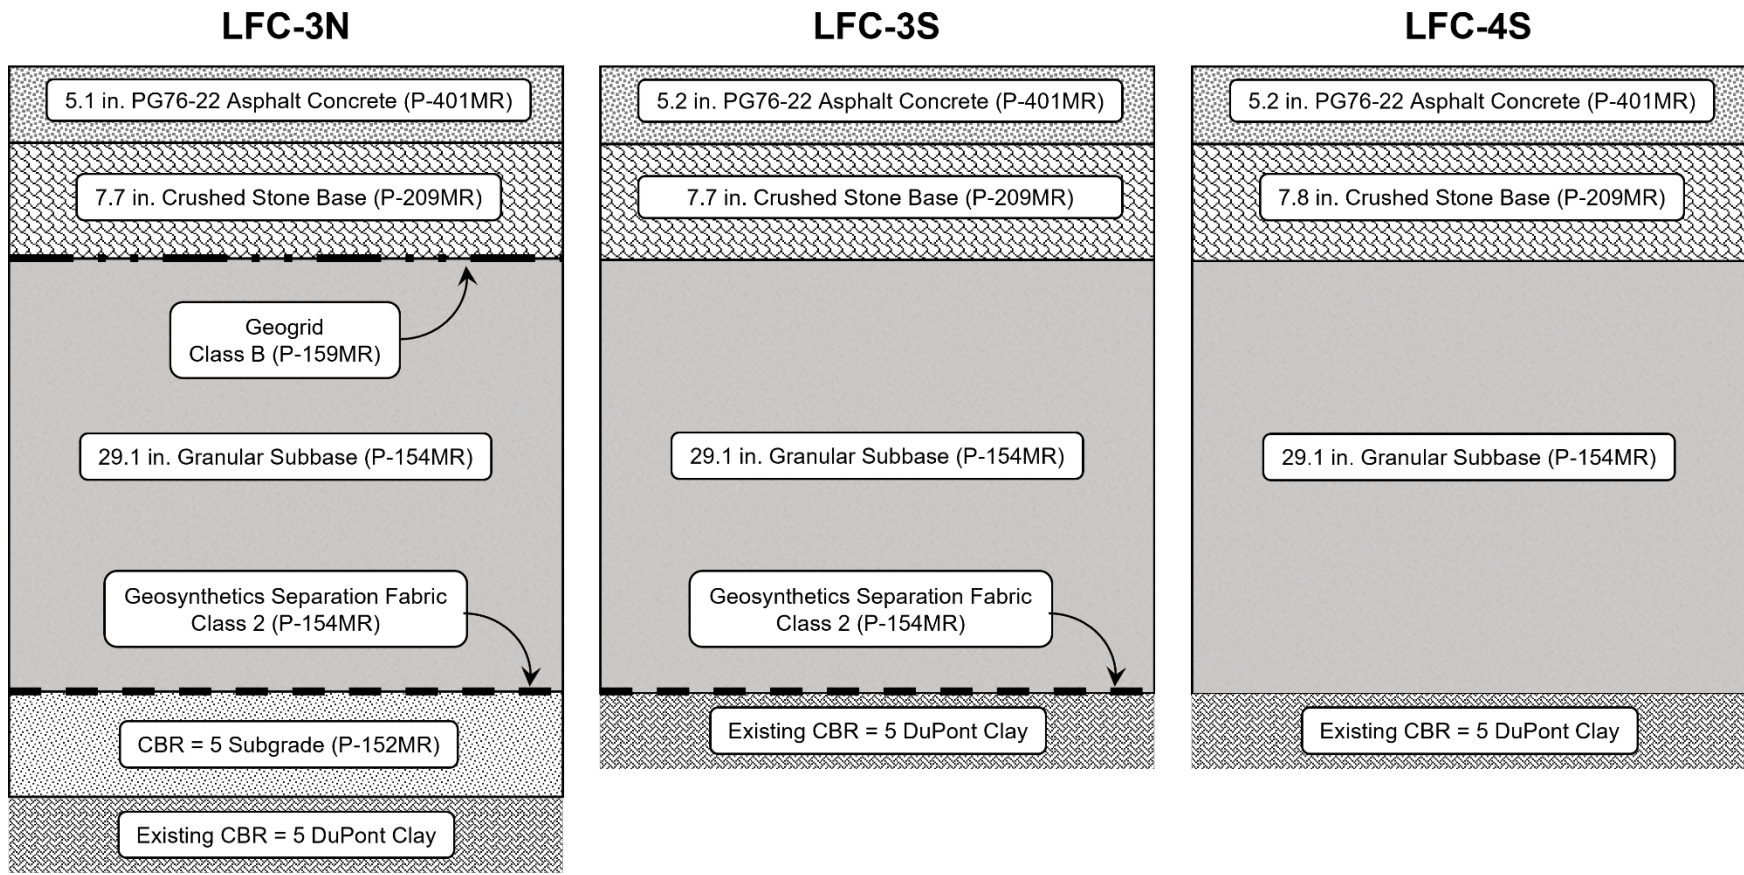
Figure 3. As-Built Cross-Sections of Geosynthetic Test Items

As shown in Figure 3, LFC-3N is the only section of the three that incorporated P-152 fill from the stockpile. This fill added complexity to achieving a uniform strength subgrade. The existing subgrade prior to construction already included two types of Dupont clay. With the addition of the fill there were three variations of subgrade with distinct strength-moisture relationships. As a result, achieving a consistent subgrade for LFC-3N, LFC-3S, and LFC-4S was problematic. Additional details pertaining to the prepared subgrade placement can be found in Tomlinson et al. (2022).

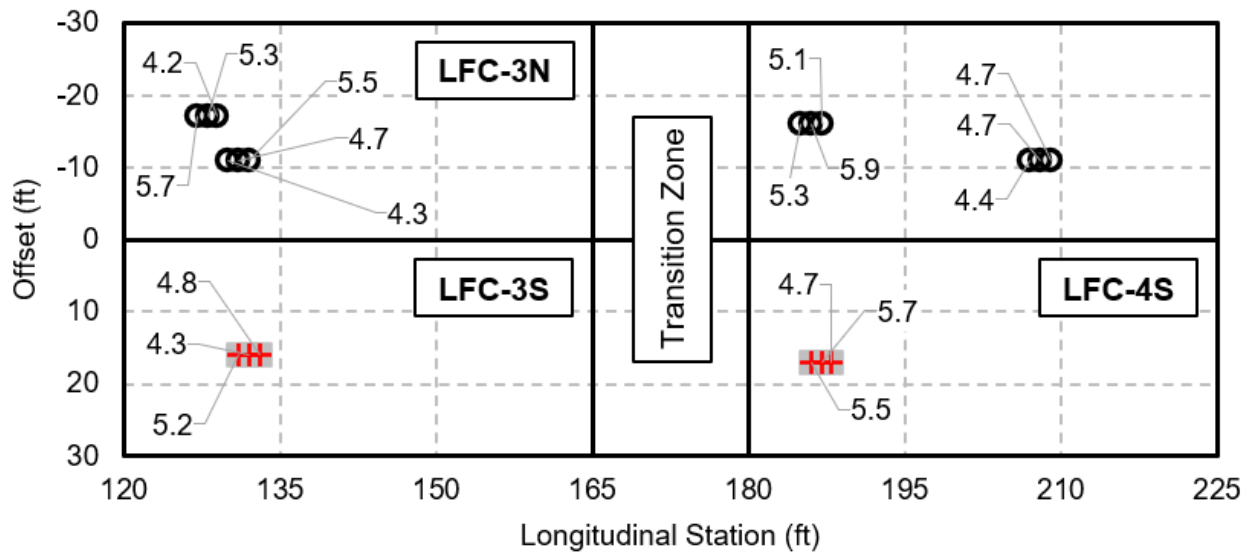
Figure 4. Subgrade CBR Values in Geosynthetics Test Items

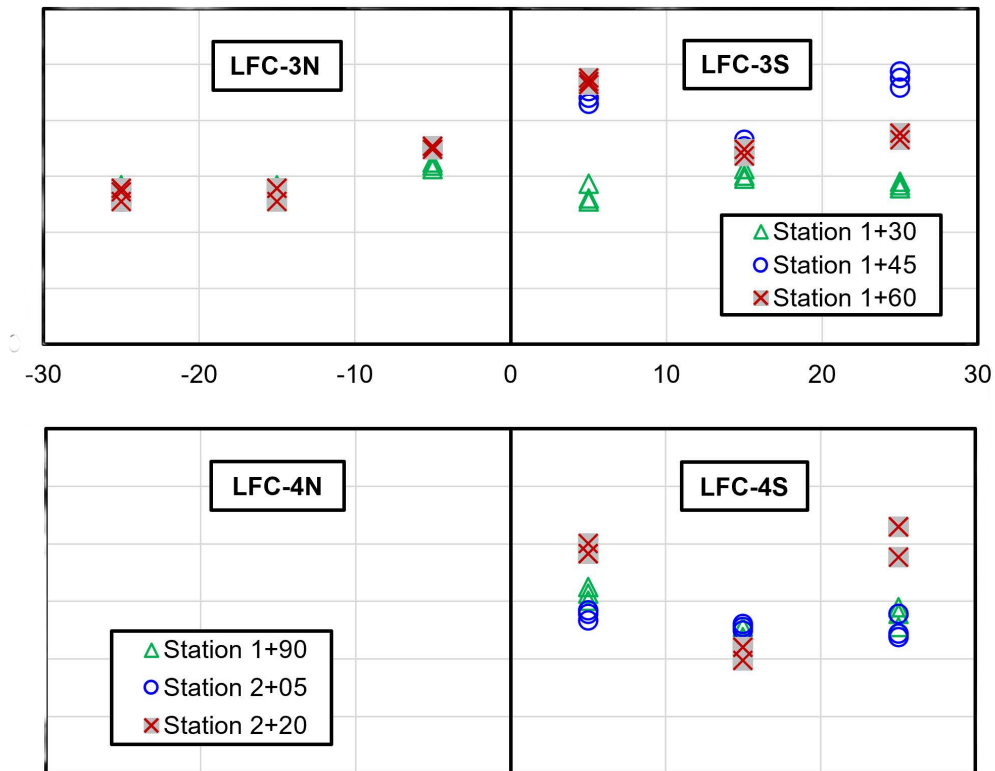
Figure 5 plots the results of vane shear tests against the transverse offset. Test item LFC-3N exhibited the least variability in strength. The lowest strength was observed around the center area of test item LFC-4S.

Figure 5. As-Built Subgrade Shear Strength in Geosynthetics Test Items Measured with Vane Shear Tests

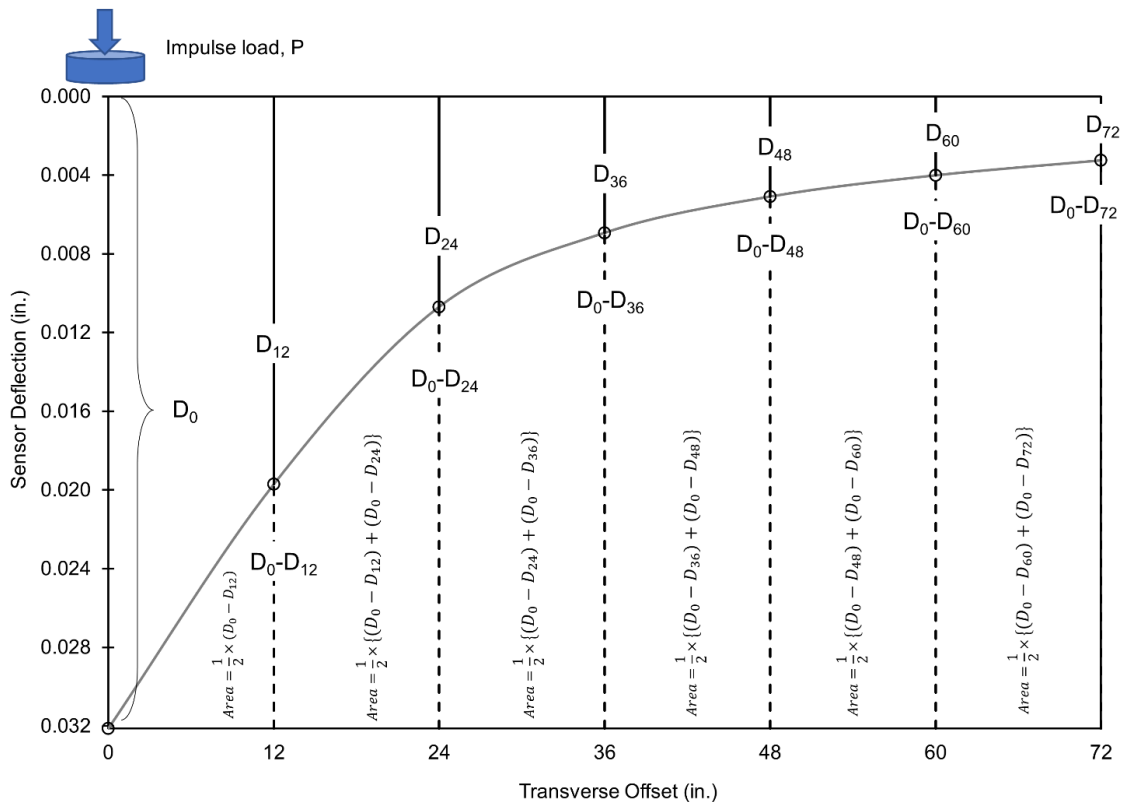
Figure 15. Sample HWD Deflection Basin

$$AUPP = \frac{1}{2} \times \{11D_0 - 2(D_{12} + D_{24} + D_{36} + D_{48} + D_{60}) - D_{72}\} \quad (3)$$

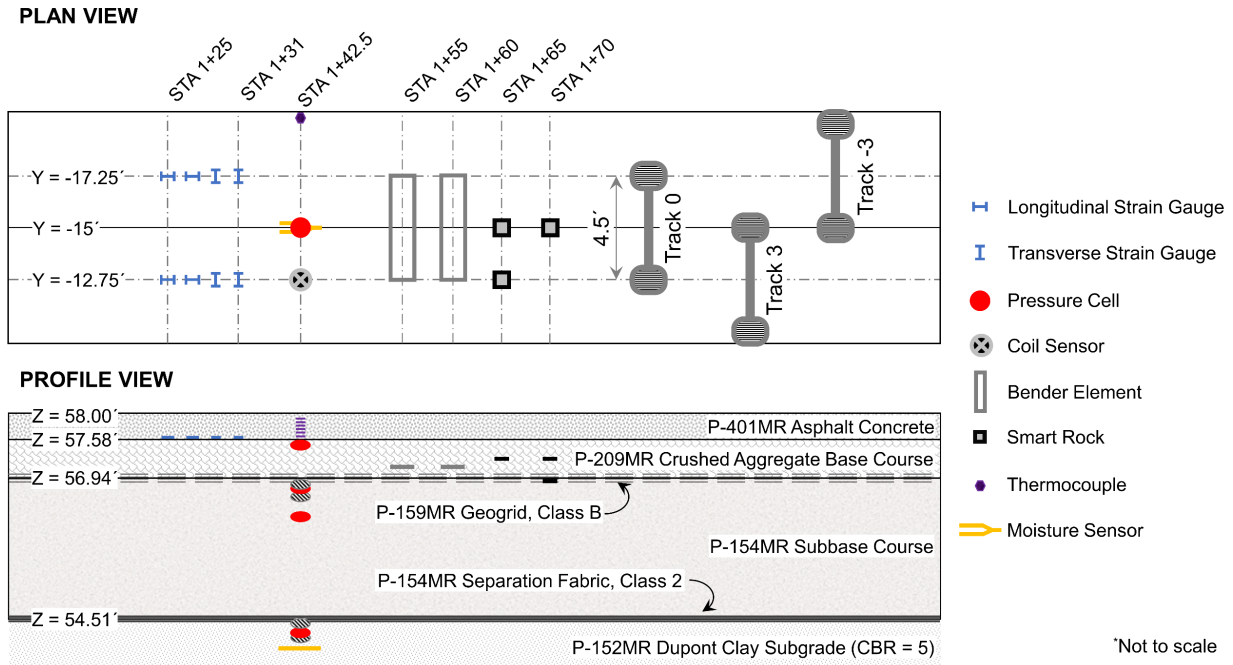
Embedded sensors included asphalt strain gauges (ASGs), coil sensors (CSs), pressure cells (PCs), moisture sensors and thermocouples, in addition to bender elements (BEs) and SmartRock sensors as discussed below. Details of the installation are found in Tomlinson et al. (2022). Figure 17, Figure 18, and Figure 19 show the sensor layouts for the three test items making up the CC9 Geosynthetics test area. Appendix A lists sensor locations for each test item.

Figure 17. Layout of Instrumentation in LFC-3N (Geogrid-reinforced)

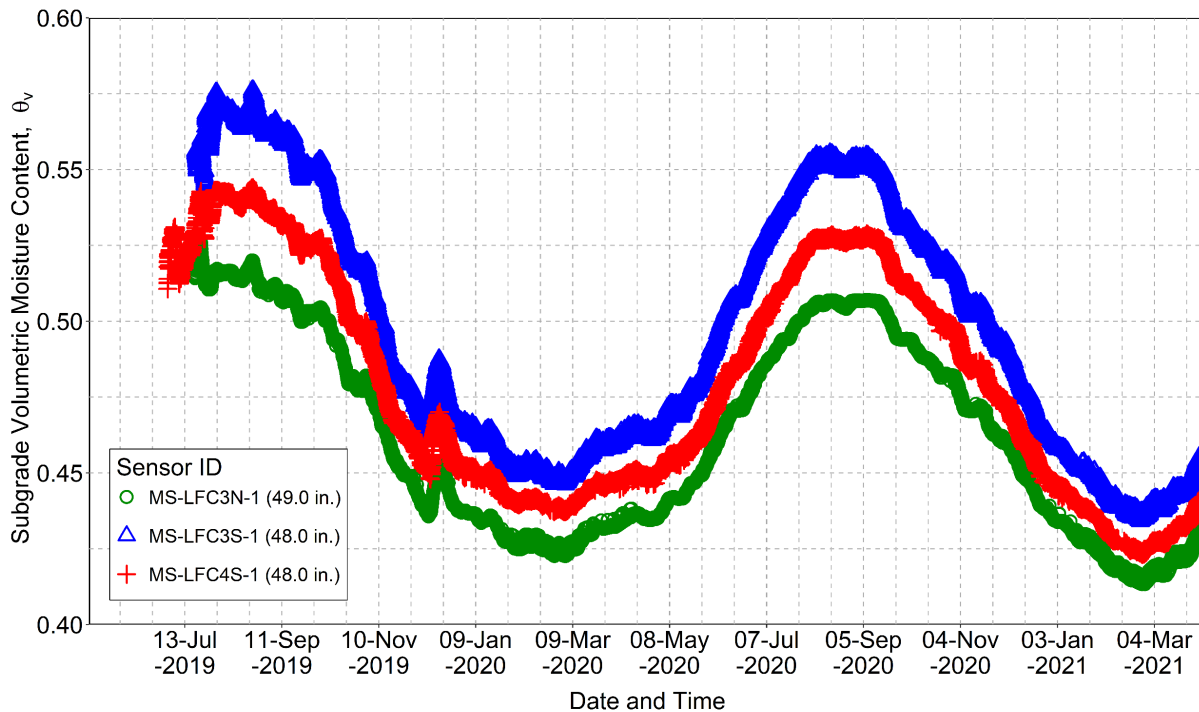
Construction of CC9 was completed in December 2019 but traffic testing did not start until April 2021. In the interim, the volumetric moisture content  $\theta_v$  was closely monitored from the embedded moisture sensors. Despite the test items being in an enclosed facility, moisture seepage and seasonal variation are known to affect  $\theta_v$ , hence in situ subgrade strength. Figure 20 shows the change in  $\theta_v$  in the clay subgrade over time. Seasonal variation in MC was evident from the observed cyclic trend. The MC in test item LFC-3S (with the geotextile separation fabric) was consistently higher than in the other test items.

Figure 20. Change in Volumetric MC from Construction to Start of Traffic

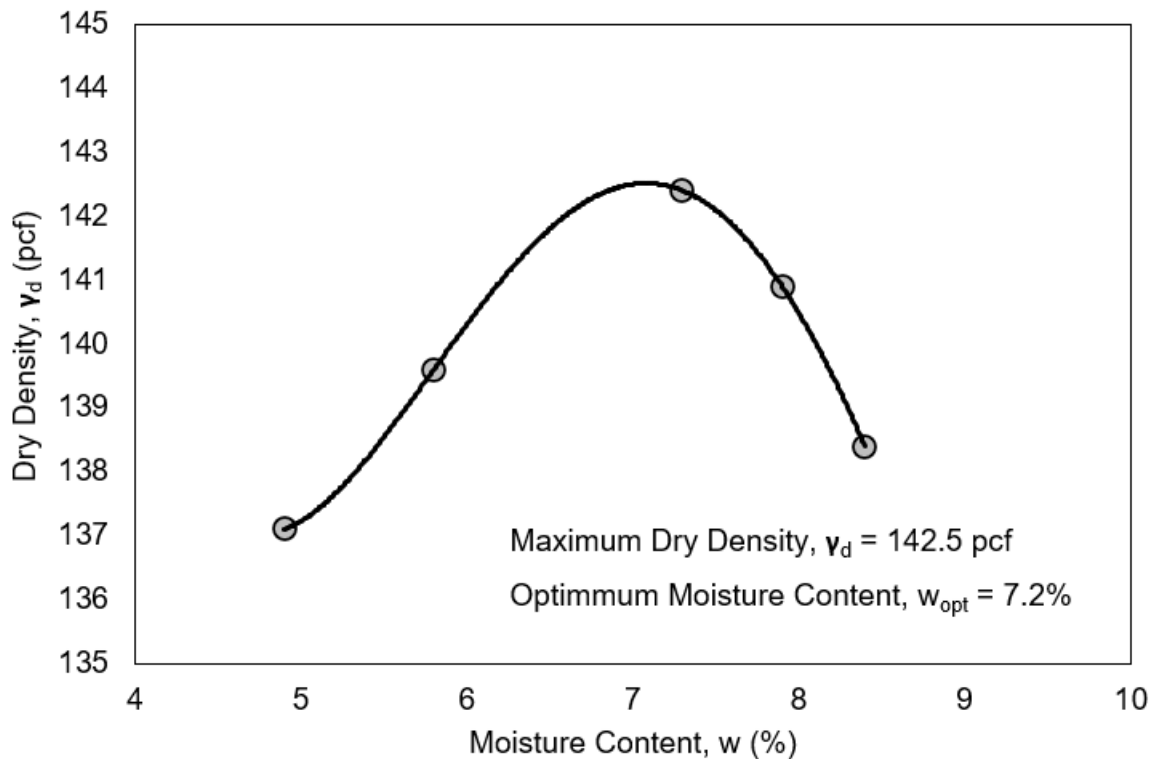
Compaction requirements for the granular subbase (P-154MR) and base (P-209MR) materials were determined using modified compactive effort following ASTM D1557 (Method A) (ASTM, 2021). Moisture-density relationships are presented in Figure 21 and Figure 22. As reported in Tomlinson et al. (2022), the optimum moisture content (OMC) for P-154 was higher than that of P-209 due to the relatively higher percentage of fine content (10.2% and 3.4%, respectively passing the No. 200 sieve).

Figure 21. Moisture-Density Relationship of Granular Subbase (P-154MR)

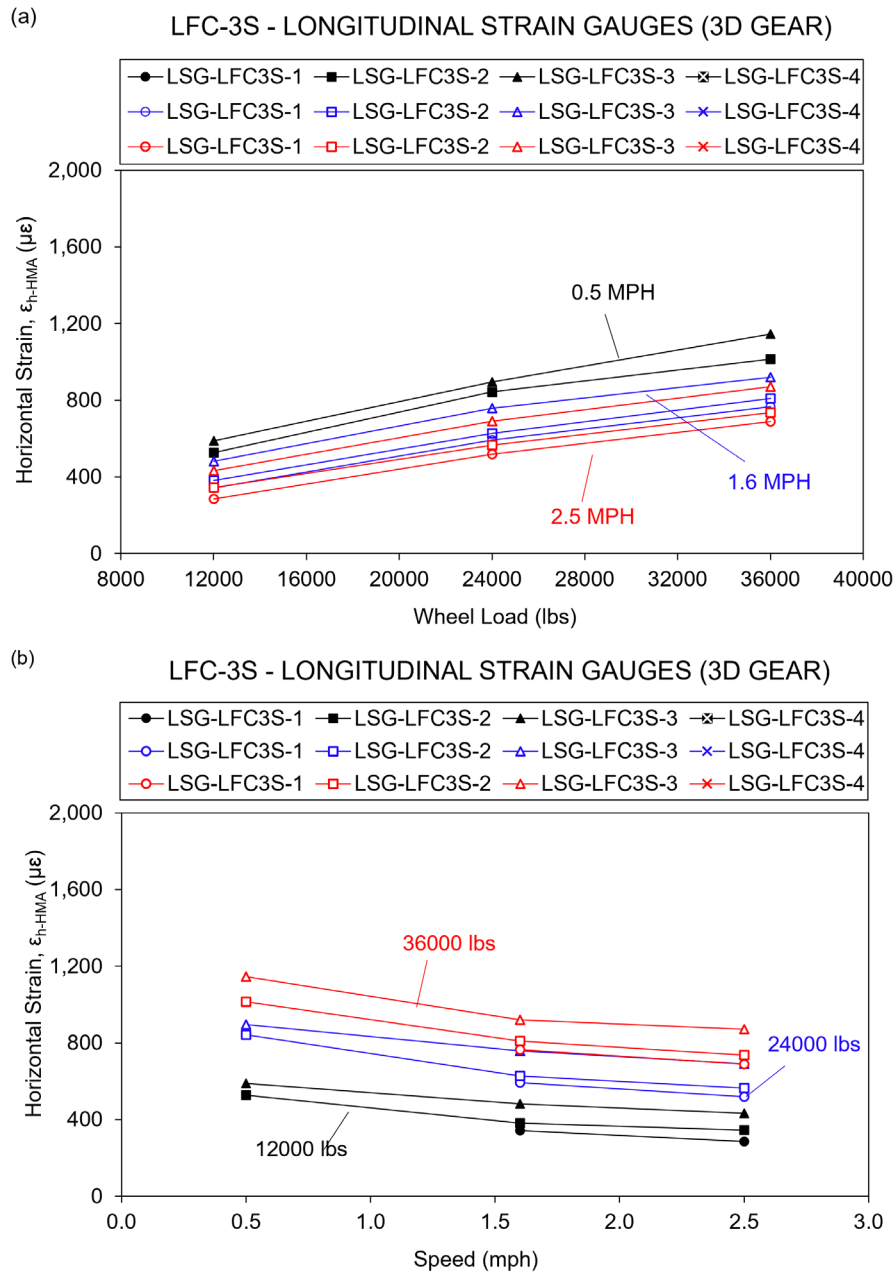
Figure 30 and Figure 31 show examples of ASG slow-roll test data. In Figure 30 (LFC-3S), the four longitudinal strain gauges (LSGs) all responded as expected to increasing wheel load and decreasing vehicle speed. In Figure 31 (LFC-4S), there were some anomalous transverse strain gauge (TSG) responses. TSG-LFC-4S-3 appears to be an unreliable gauge, responding inconsistently to increases in load in Figure 31(a), and responding disproportionately to changes in vehicle speed in Figure 31(b).

Figure 30. Slow-Roll Response of LSGs in LFC-3S: (a) Effect of Wheel Load and (b) Effect of Vehicle Speed

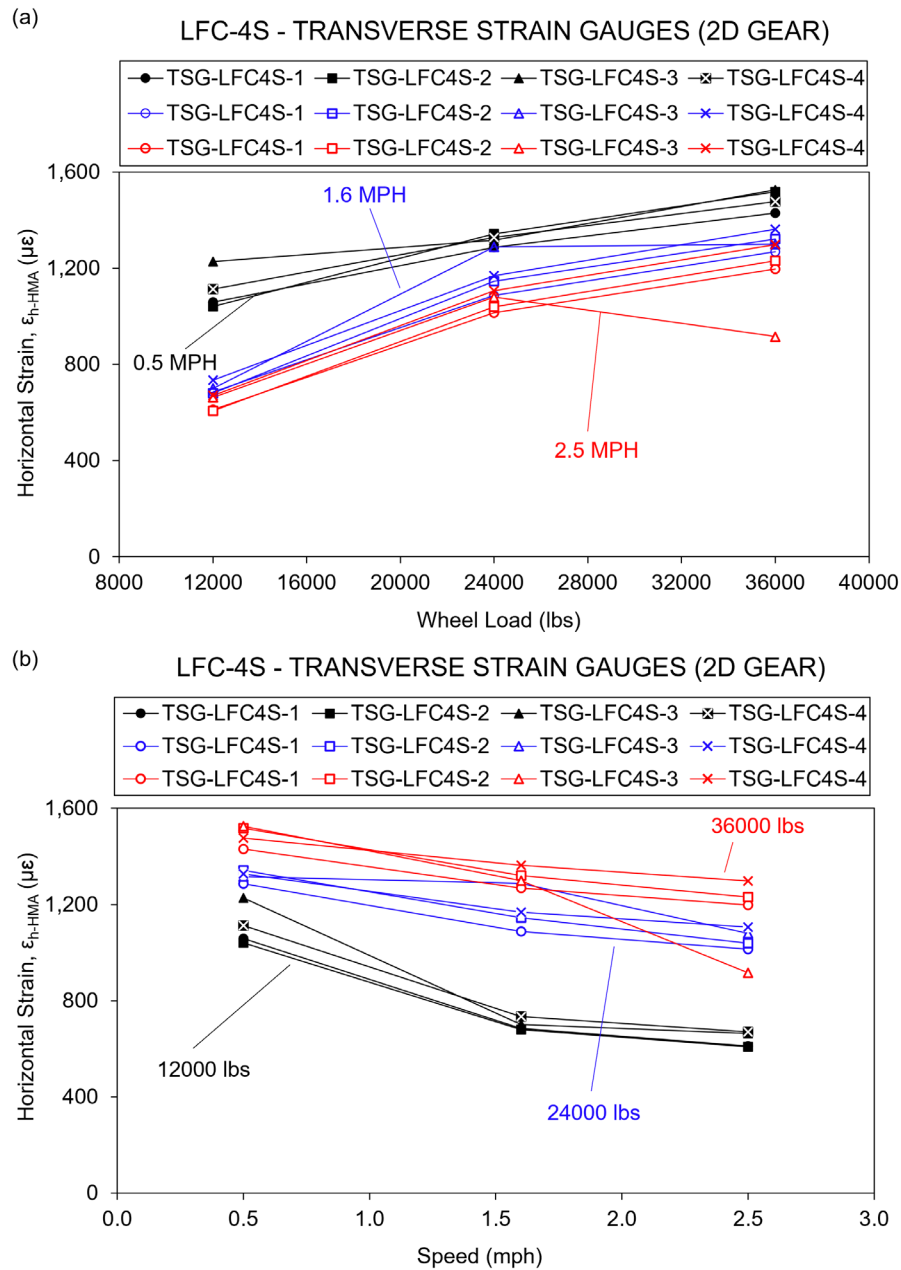
Figure 31. Slow-Roll Response of TSGs in LFC-4S: (a) Effect of Wheel Load and (b) Effect of Vehicle Speed

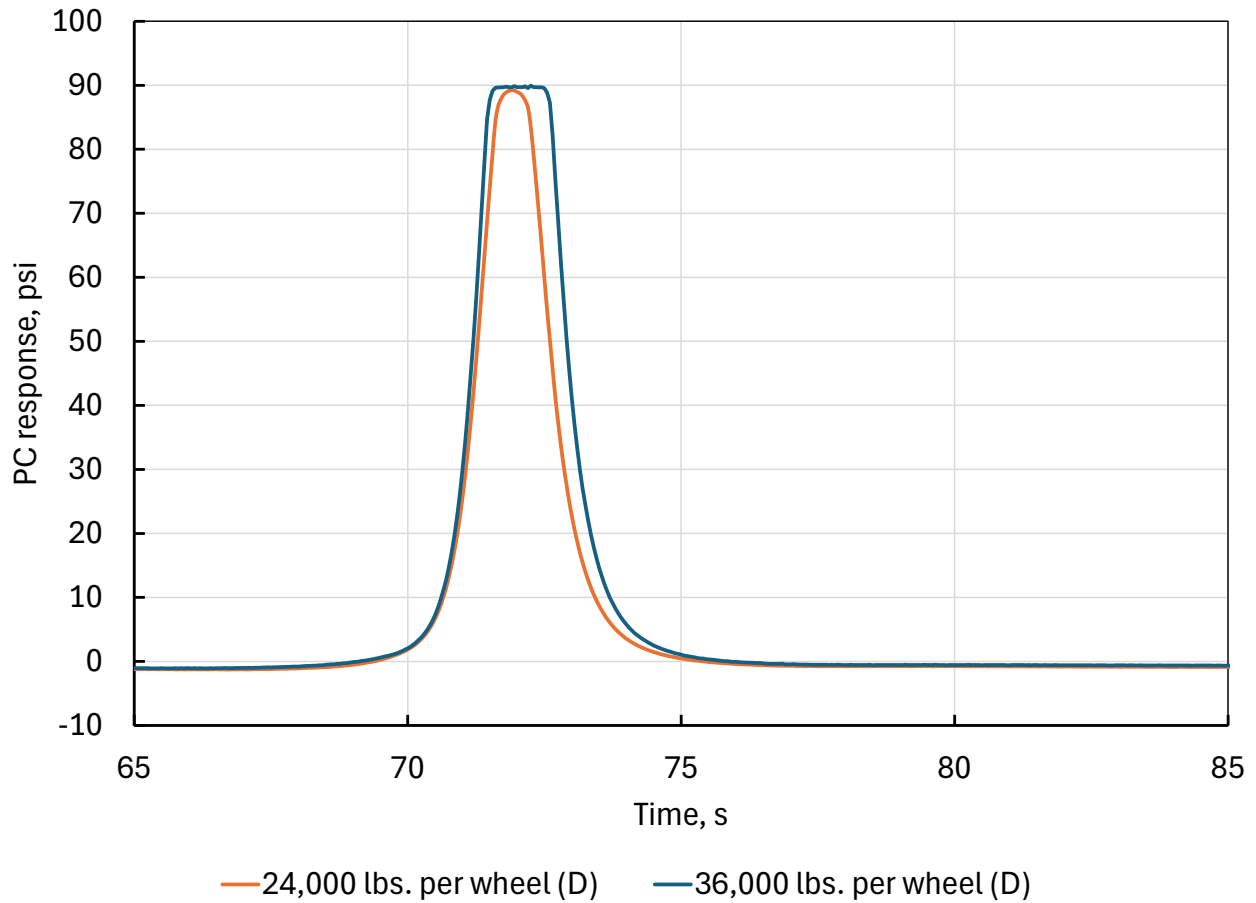
the response curve at 36,000 lb (Figure 33) reveals a saturation zone near the peak stress. The response to the 24,000-lb/wheel D gear is still within range, but the response to the 36,000 lb/wheel D gear is cut off, so the peak values appear to be equal. As discussed in Section 5, the fact that the PCs at the top of the base were undersized limited their value for analysis and probably led to their early failure.

Figure 33. Slow-Roll (0.5 mph) Response of PC-LFC3N-1 Showing Signal Saturation at High Loads (Test Date November 13, 2020)

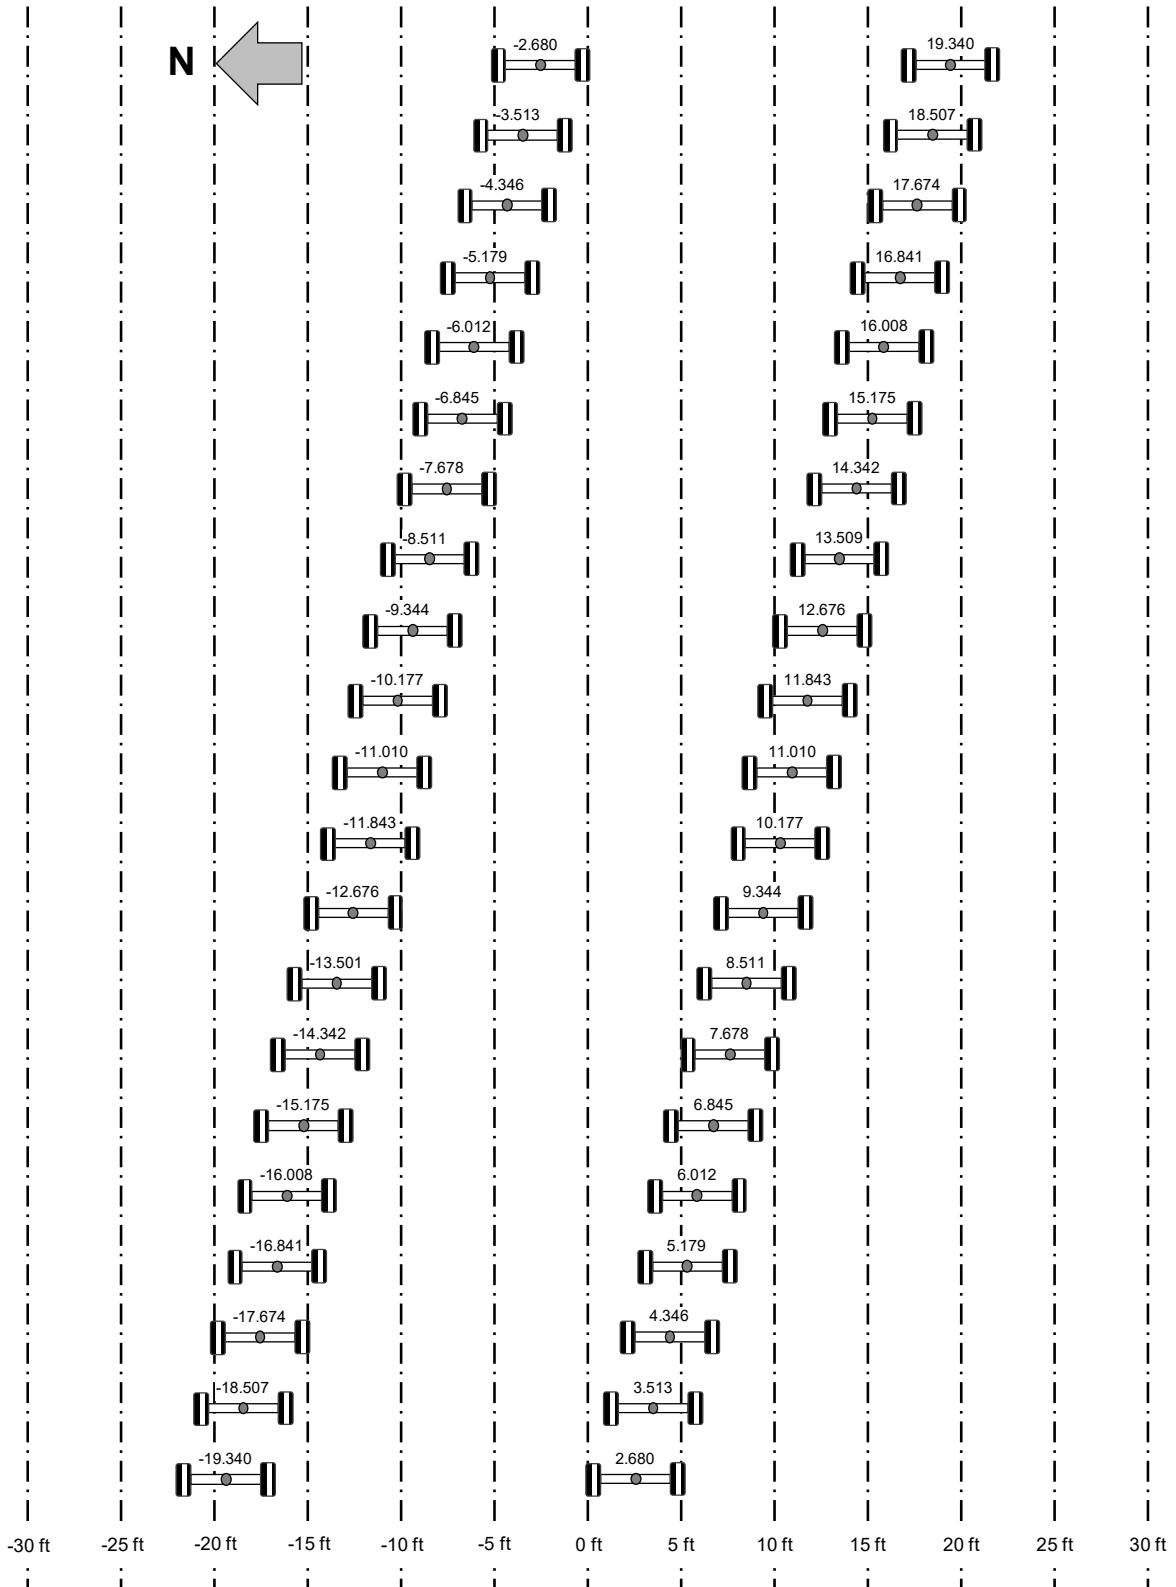
Figure 34. Carriage Positions for Each Pass of Proof-Roll Wander

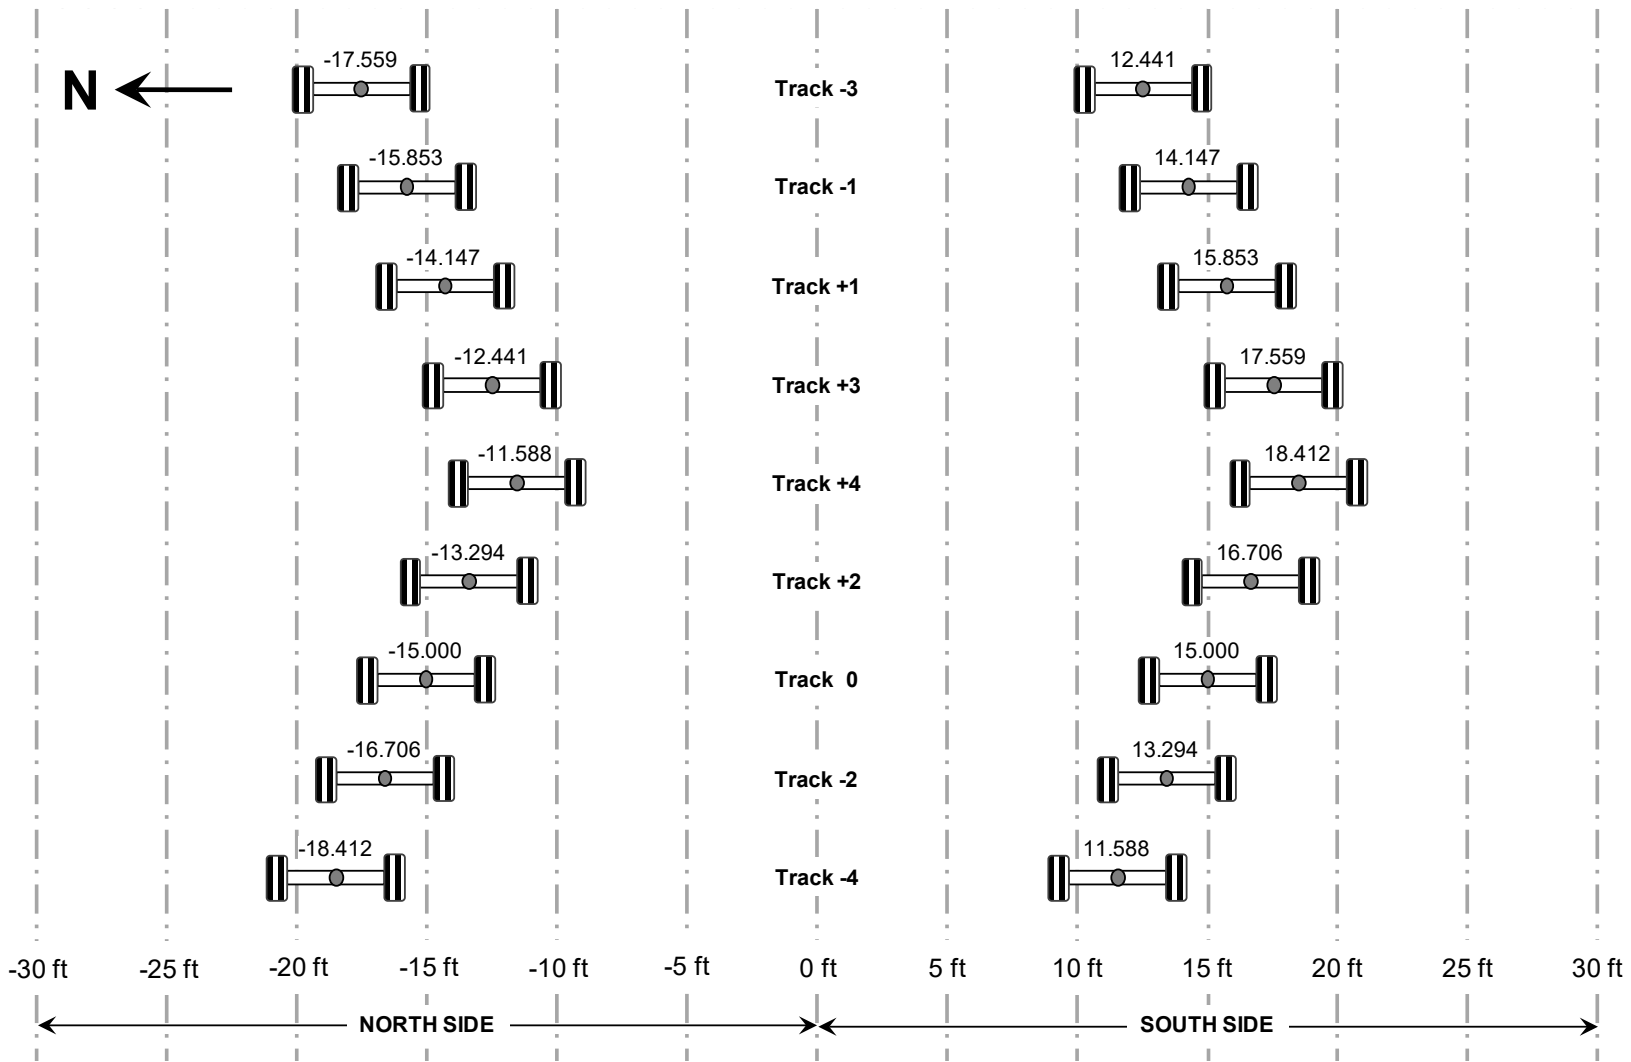
Figure 35. Construction Cycle 9 Traffic Wander Wheel Tracks

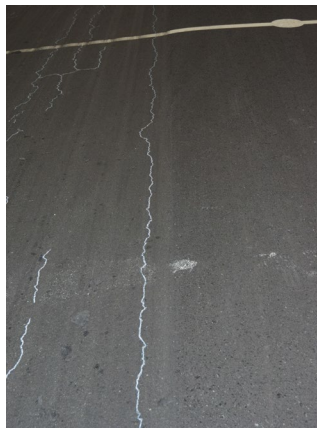
Crack maps developed during the manual distress survey were reviewed to track the first appearance and progress of cracks. Surface distresses included longitudinal cracks in the trafficked area that later developed into interconnected, or alligator, cracks. For each test item, lengths of individual cracks and areas of alligator cracks were carefully measured and recorded in a schematic as they appeared. Figure 36(a) shows a typical longitudinal crack at the wander limit, and Figure 36(b) shows the evolution from linear cracks to alligator cracks. (Cracks have been highlighted on the pavement surface using markers).

(a) Linear crack at edge of traffic area

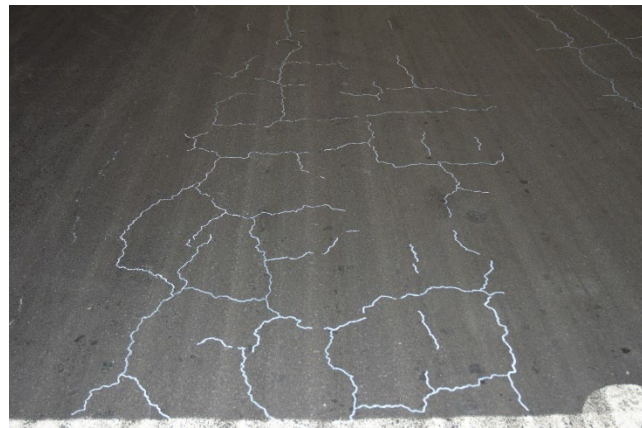
(b) Area of alligator cracking

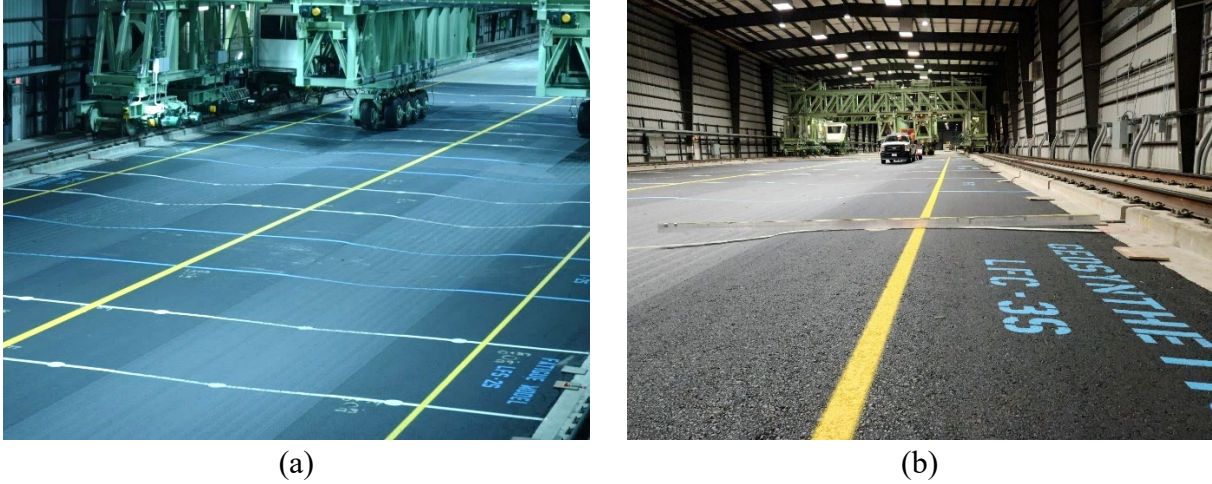
All three test items experienced deep ruts accompanied by large upheavals outside the traffic lane. As discussed in Section 4.2.2, upheavals exceeding 1 in. in flexible pavements are characteristic of a classic bearing capacity failure. By this standard, all three test pavements failed structurally before the end of traffic (Figure 37).

Figure 37. Final Surface Condition of Geosynthetic Test Items: (a) View Facing Northeast Toward the Geosynthetics Test Area Showing Heavily Deformed Surface (November 8, 2022) and (b) Upheaval, Test Item LFC-3S (November 3, 2022) (The trafficked area is on the left. The shoulder was initially level with the curb [right].)

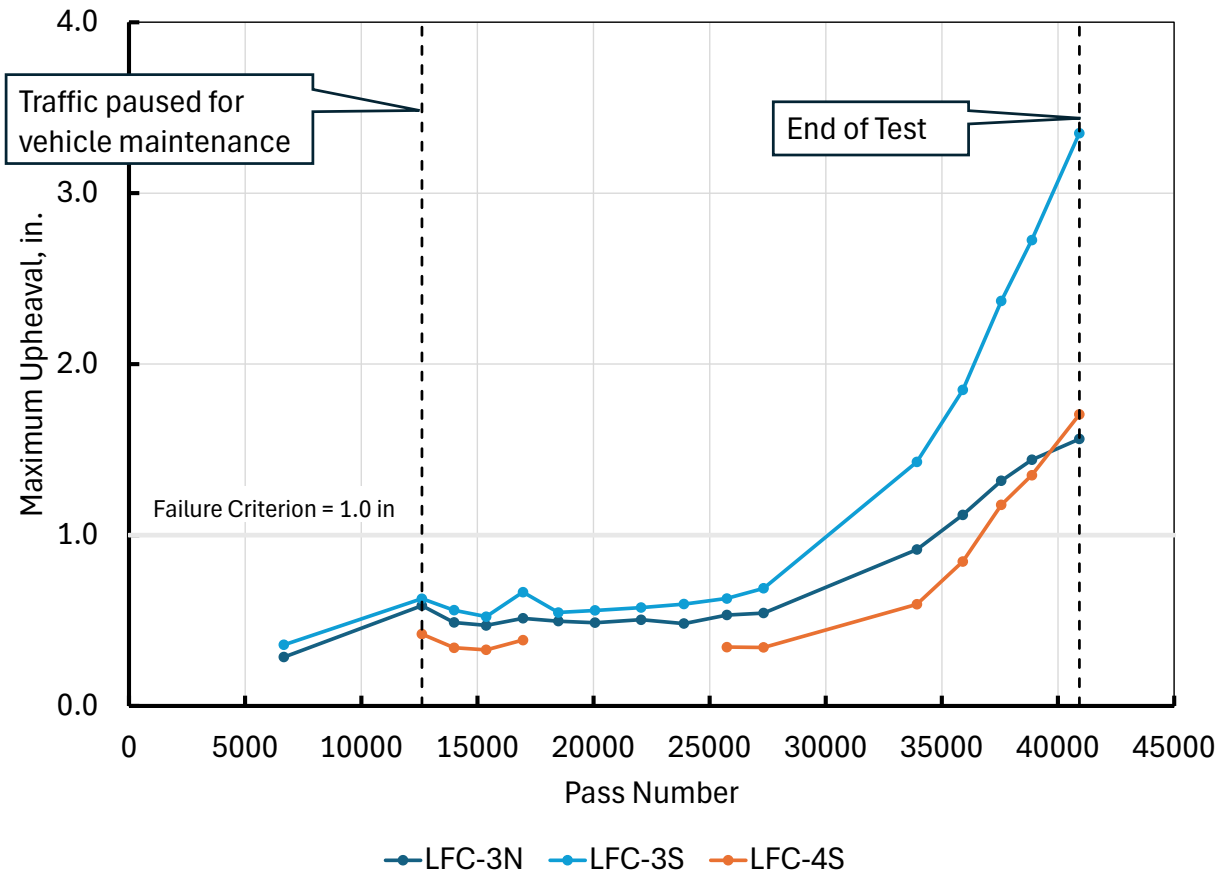
Figure 38 shows the evolution of surface upheaval with traffic in test items LFC-3N (geogrid plus geotextile), LFC-3S (geotextile only), and LFC-4S (control). Upheaval is measured relative to the original surface grade outside of the trafficked area. Figure 37 is annotated to show significant events that affected the observed upheaval trend. Appendix B gives the stations and offsets at which the maximum upheavals were recorded for each date. Positive upheaval values greater than approximately 1 in. are associated with subgrade shear failure. As shown in Figure 38, the upheaval increased sharply after the start of summer 2022 (approximately pass 27,000). Test item LFC-3S (geosynthetic separation layer only) consistently had the highest upheaval.

Figure 38. Evolution of Surface Upheaval in Geosynthetics Test Items

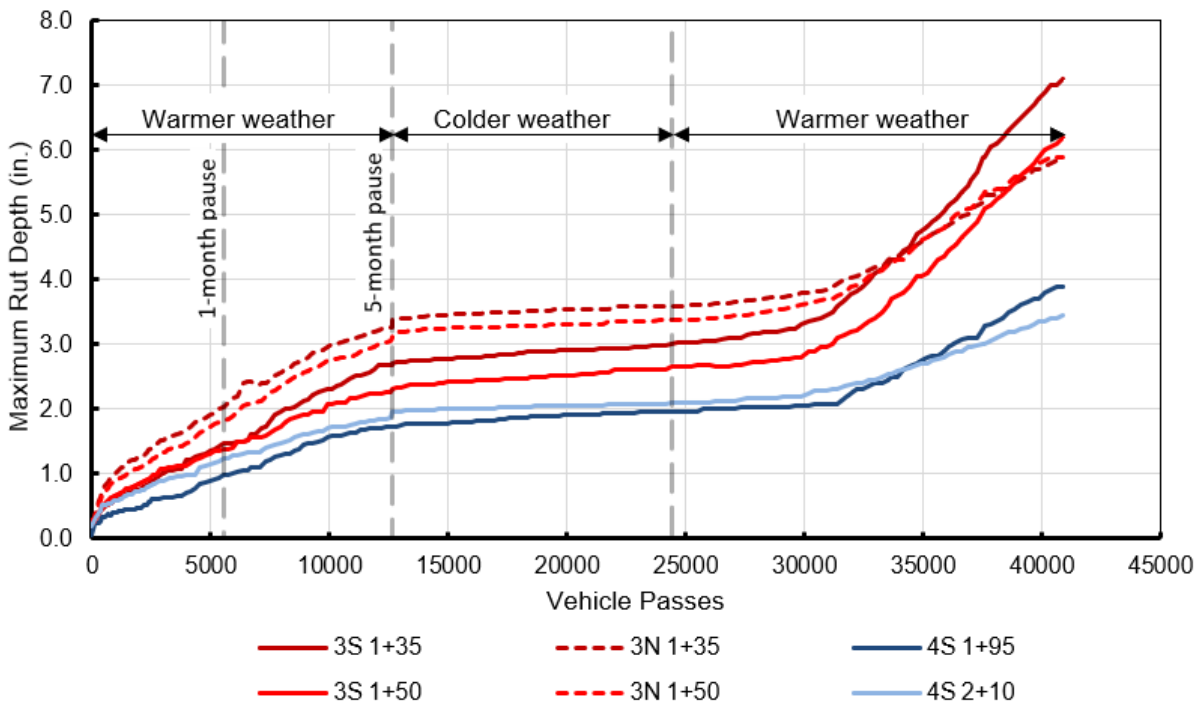
Figure 39 shows rut measurements taken using a 16-ft physical straightedge. The straightedge rut was measured from peak (or more precisely, from a point on a straight line connecting two peaks) to trough in the deformed section. As shown in Figure 39, straightedge ruts were measured at two stations within each test item. Rutting initially accumulated rapidly, with all test items reaching a rut depth of 1.5 in. by 10,000 passes. In this initial consolidation phase, the ruts in both geosynthetic-reinforced test items (LFC-3N and LFC-3S) were higher than the control (LFC-4S). After 12,600 passes, the test was paused for extended vehicle maintenance (Section 4.2.3). When traffic resumed following the winter cold weather, the asphalt had stiffened and the rate of rut accumulation decreased. The lateral confinement benefit of the geogrid in LFC-3N only became evident at about 38,000 passes when the total rut in the non-geogrid test item LFC-3S surpassed it and continued to increase. However, at this point all three test items were structurally failed. Regardless, the accumulated surface rut in control test item LFC-4S was consistently less than in either of the two reinforced test items.

Figure 39. Rut Accumulation from Physical Straightedge in Geosynthetics Test Items

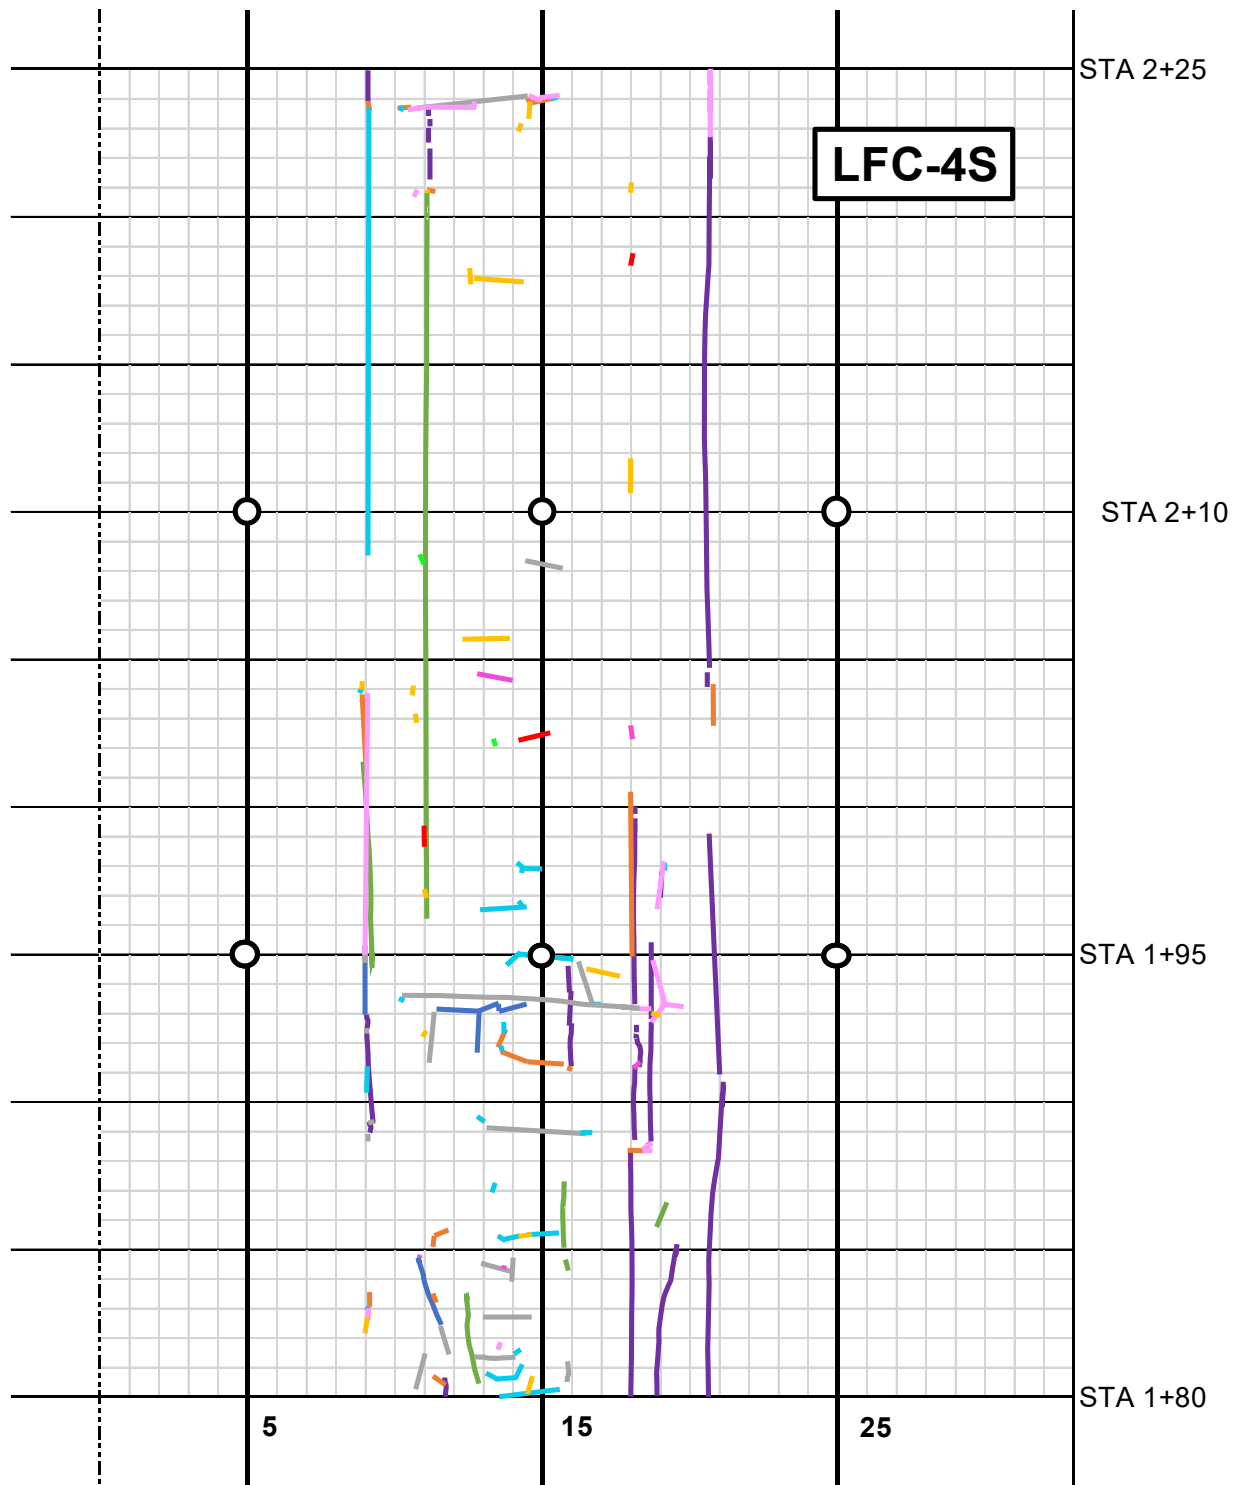
Figure 41. Crack Map for LFC-4S (final condition as of October 7, 2022)

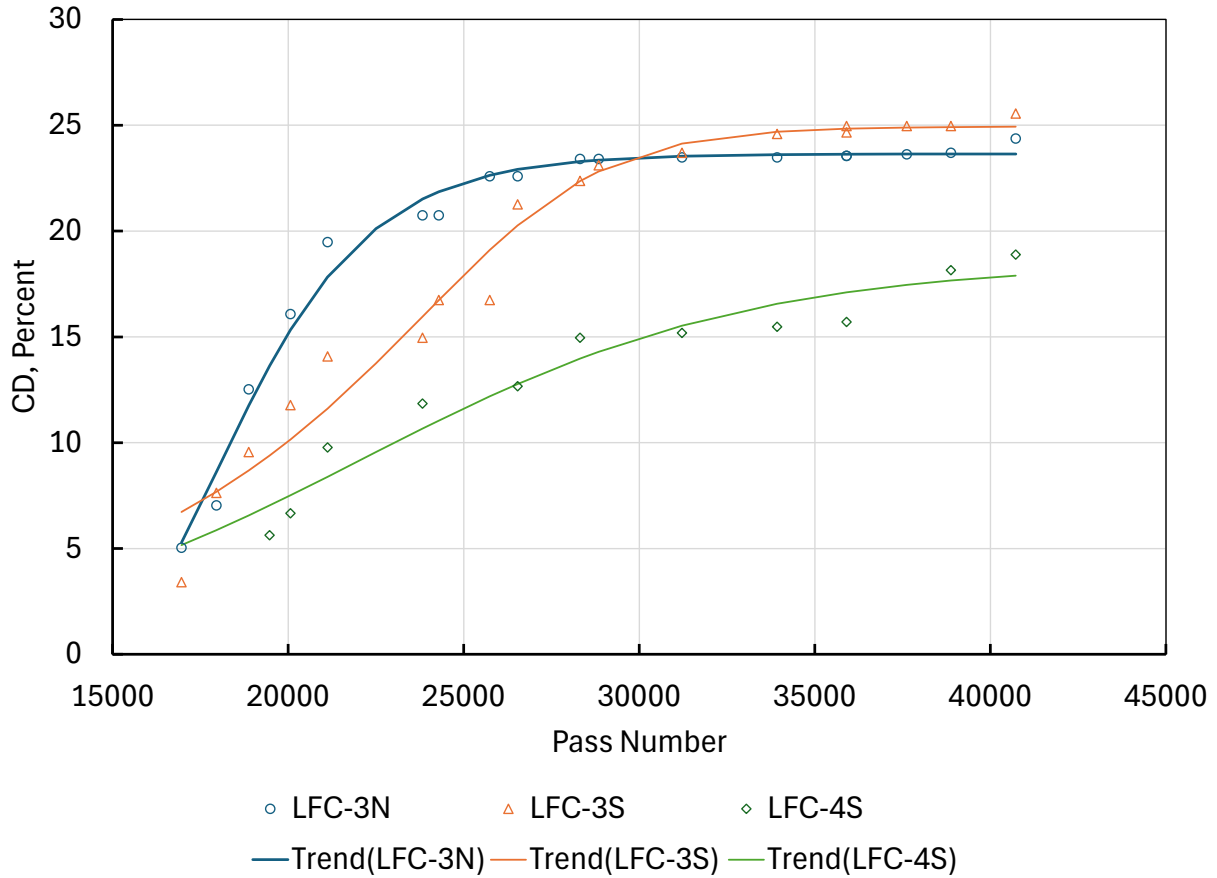
Figure 42. Growth of CD with Traffic

Support from the geogrid reinforcement may have improved load distribution in the underlying layers at a later stage of trafficking, thereby slowing the rate of crack accumulation in LFC-3N compared to LFC-3S. Table 17 gives the best-fit parameters for the CC9 data.
